**Site Specific Report  
CR-NAVFAC EXWC-CIOFP-1310**

**TANK INSPECTIONS AND ASSESSMENTS AT  
NAVAL AIR STATION  
SIGONELLA, ITALY**

November 2012

Contract No. N62583-10-D-0340  
Delivery Order No. 0018

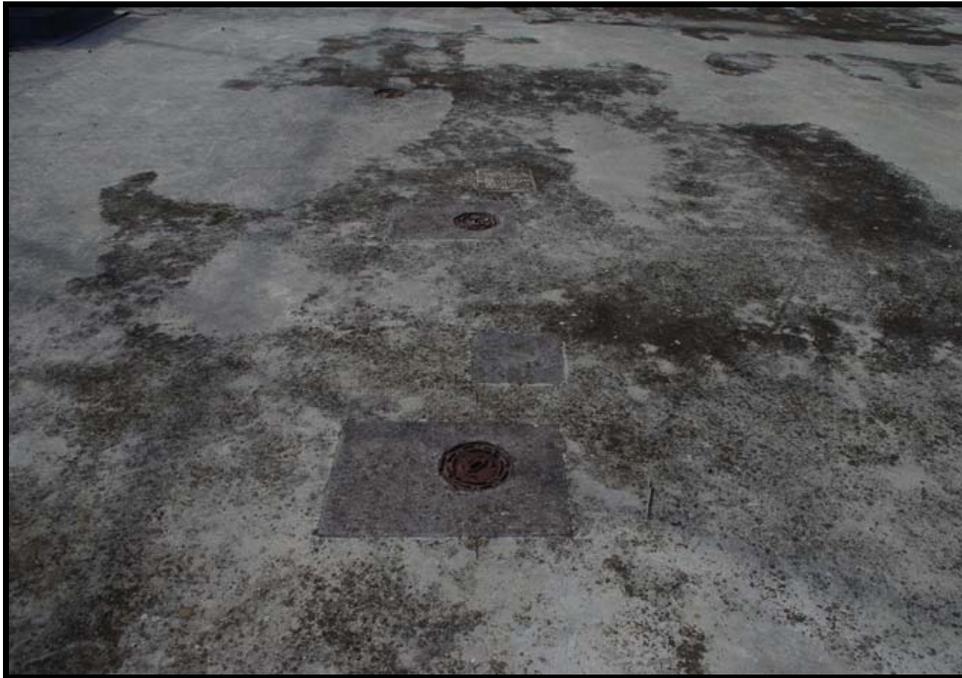
PHOTO 3.1-37 Corrosion on capped openings in roof.

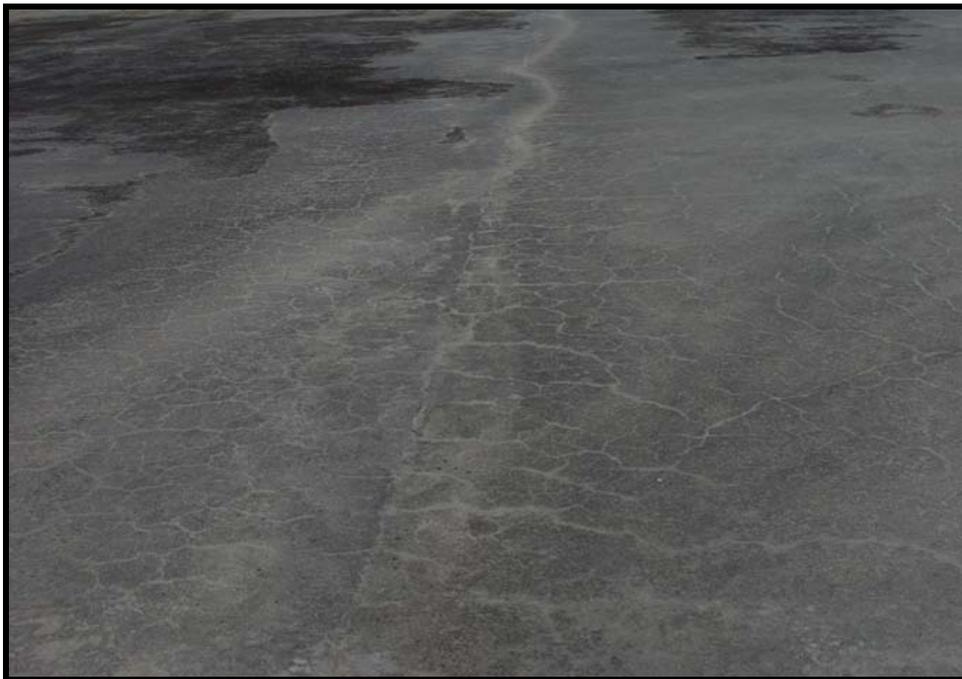
PHOTO 3.1-38 Cracks in roof.

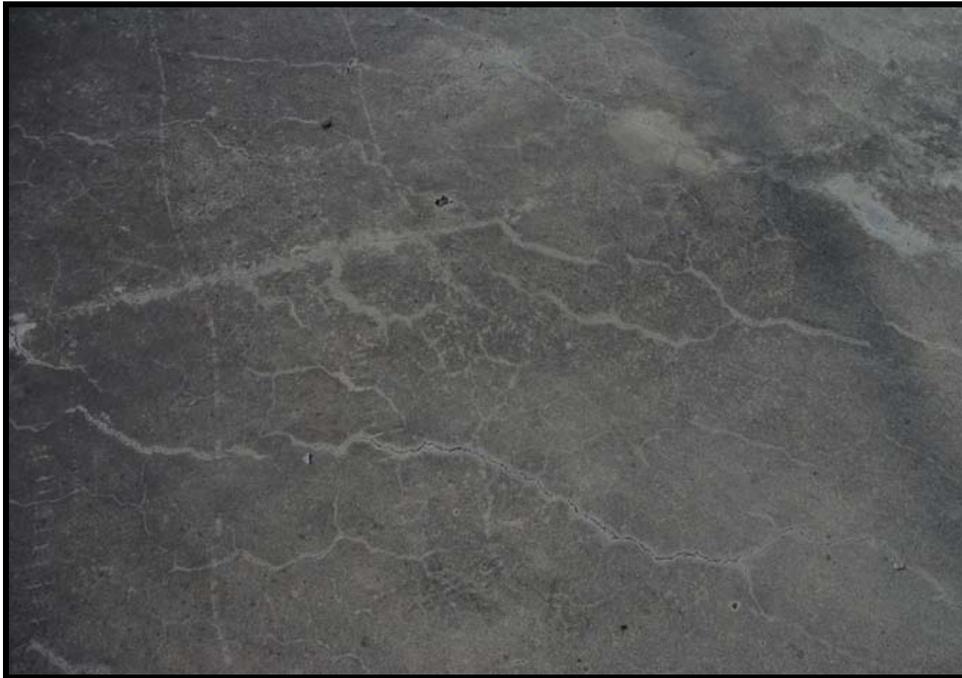
PHOTO 3.1-39 Cracks in roof.

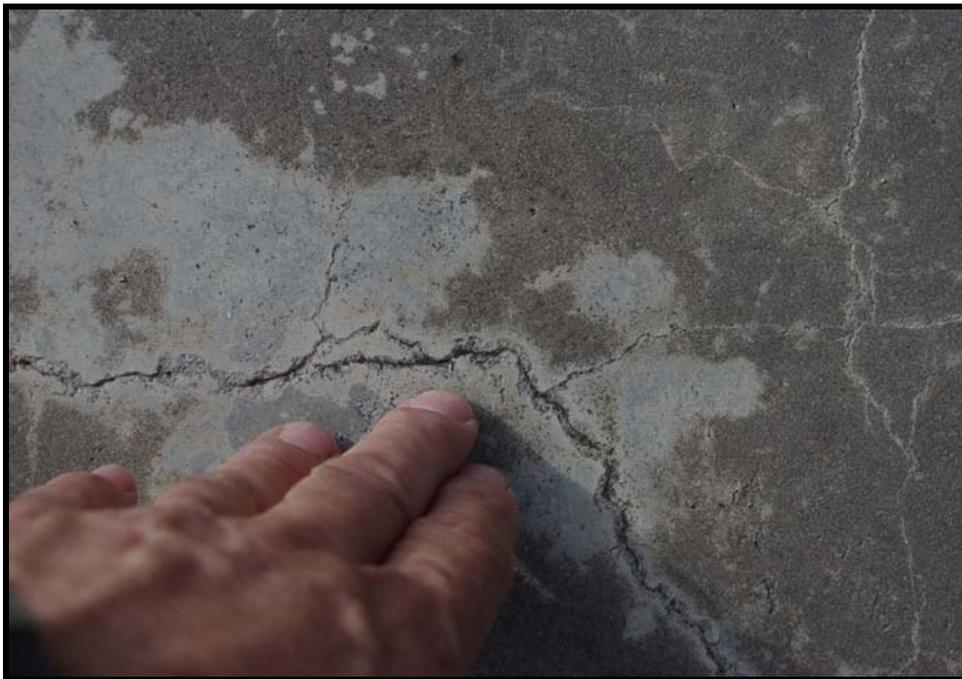
PHOTO 3.1-40 Cracks in roof.

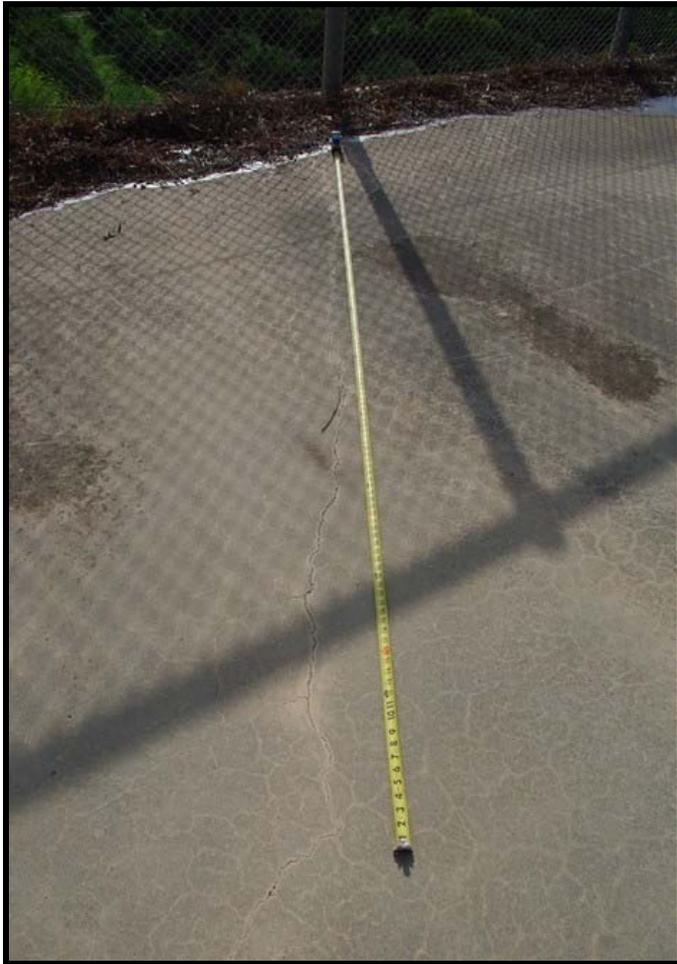
PHOTO 3.1-41 Cracks in roof.

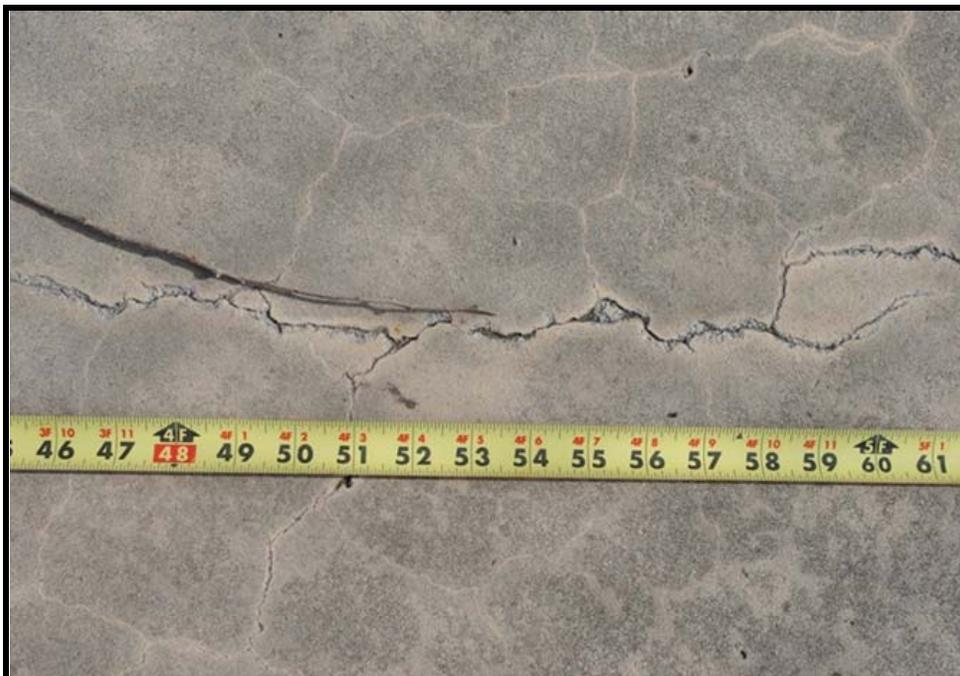
PHOTO 3.1-42 Cracks in roof.

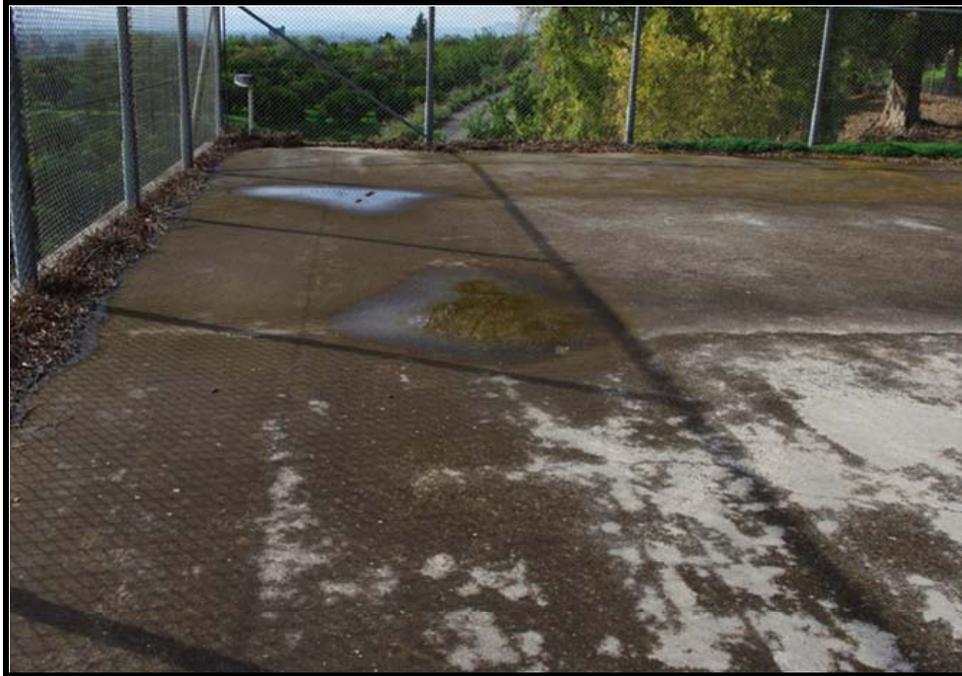
PHOTO 3.1-43 Standing water, moss, and debris on roof.

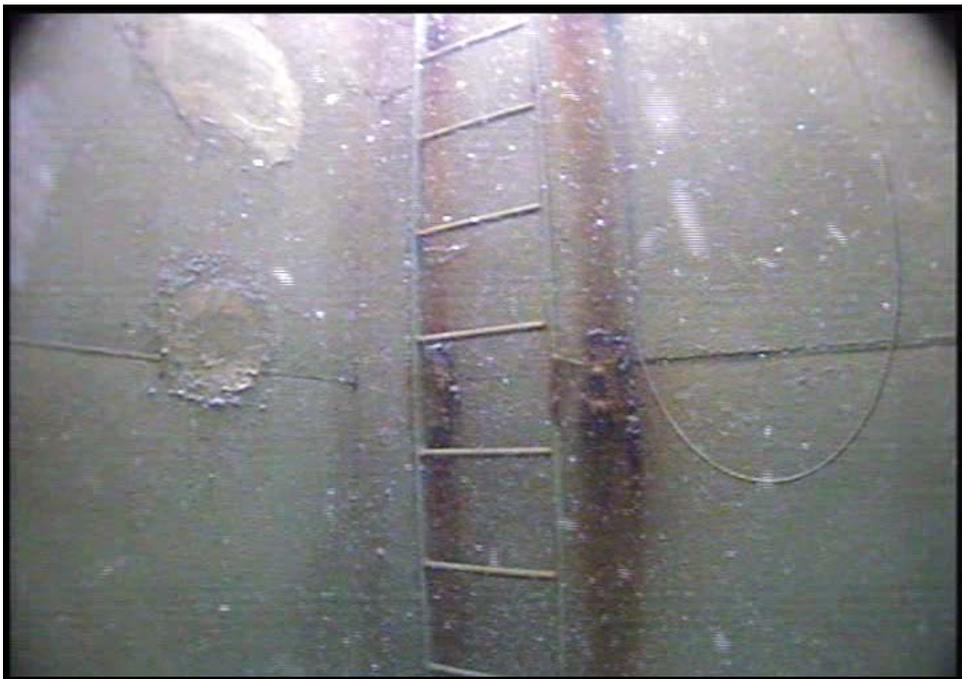
PHOTO 3.1-52 Shell interior and corrosion on abandoned interior ladder bracket remains.

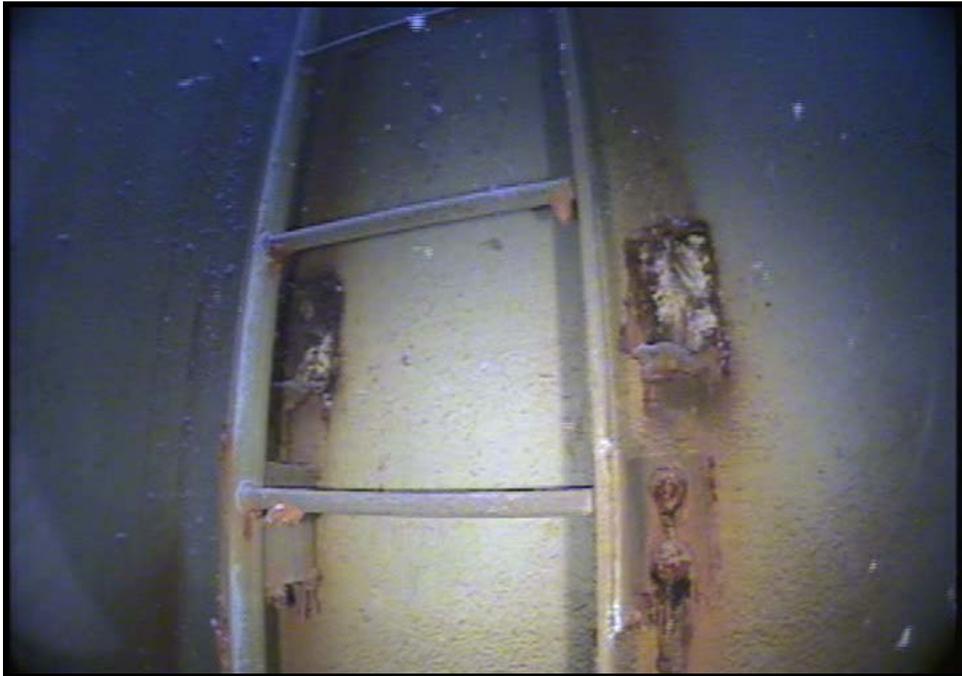
PHOTO 3.1-53 Corrosion and rust tubercles on interior ladder bracket bolts and abandoned bracket remains.

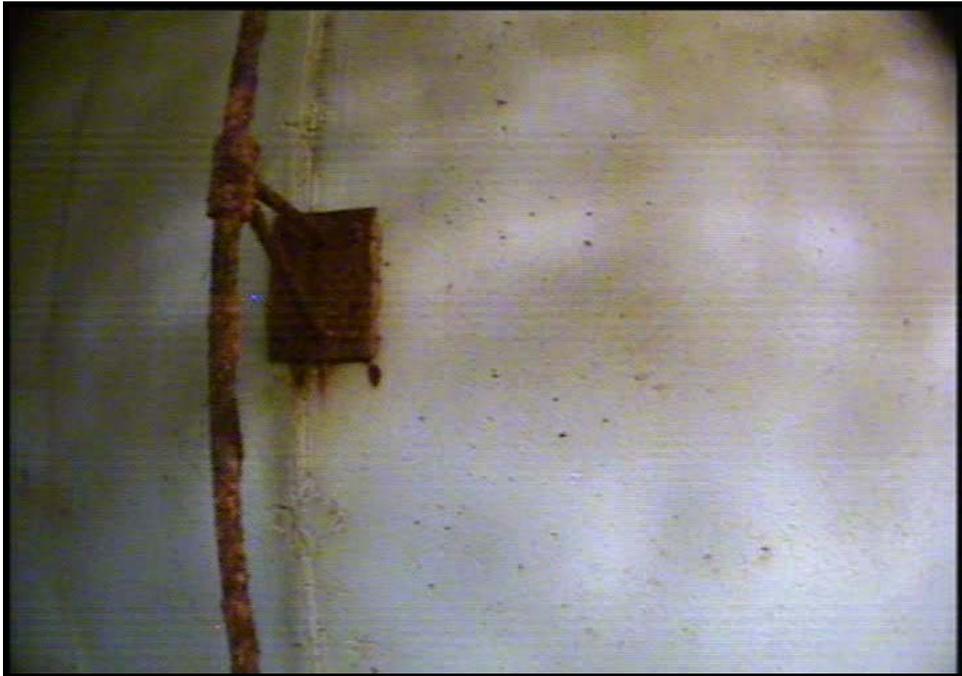
PHOTO 3.1-55 Corrosion on interior pipe and bracket.

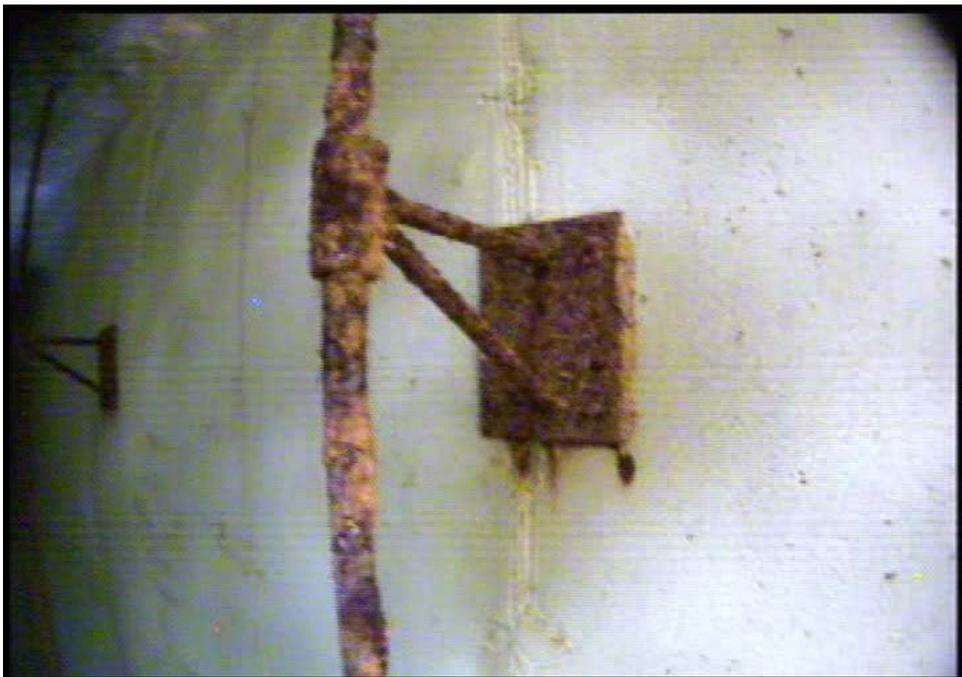
PHOTO 3.1-56 Corrosion on interior pipe and bracket.

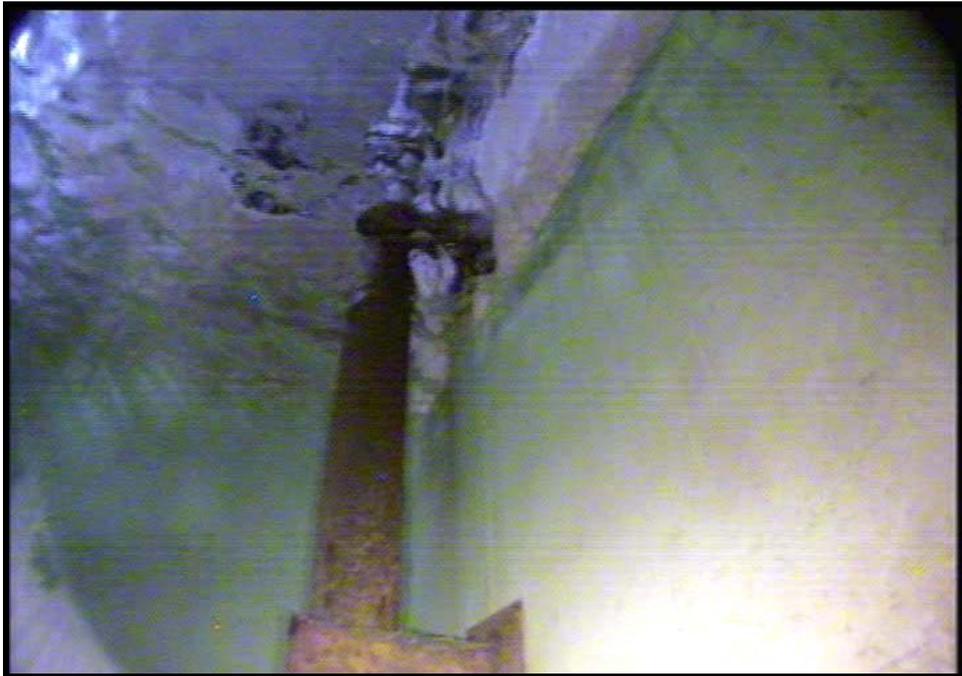
PHOTO 3.1-57 Corrosion on interior pipe and bracket.

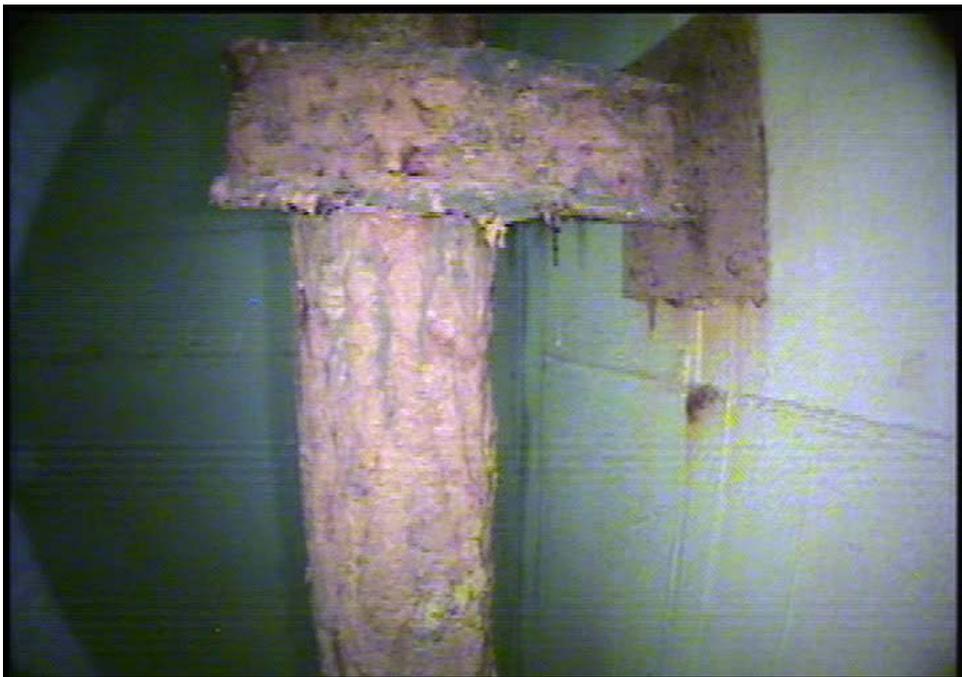
PHOTO 3.1-58 Corrosion on interior pipe and bracket.

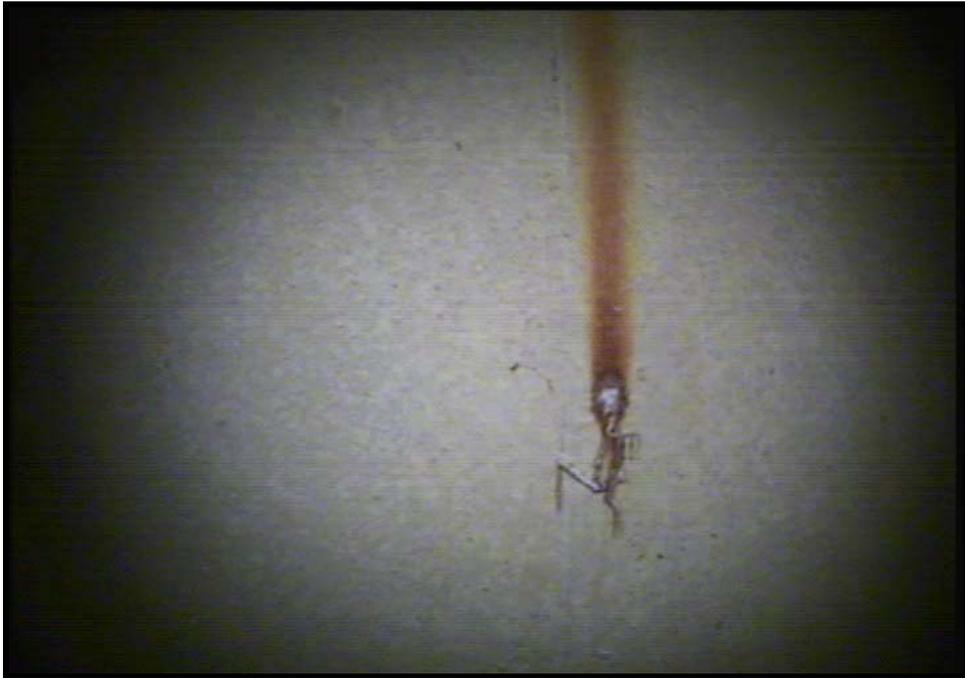
PHOTO 3.1-59 Corrosion and rust staining at exposed steel on shell.

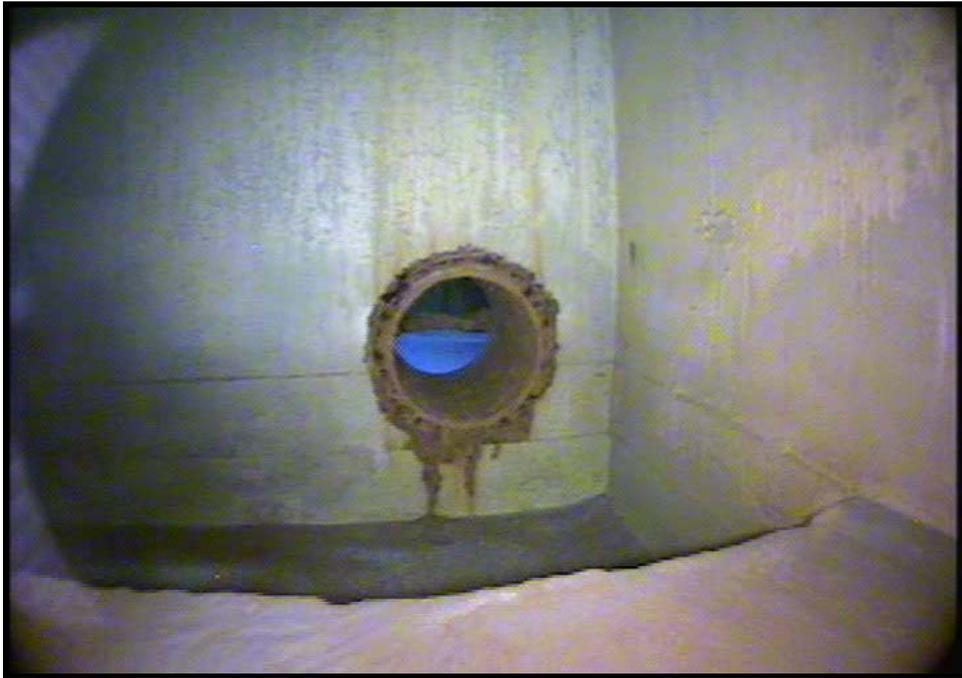
PHOTO 3.1-69 Corrosion around pipe opening above sump.

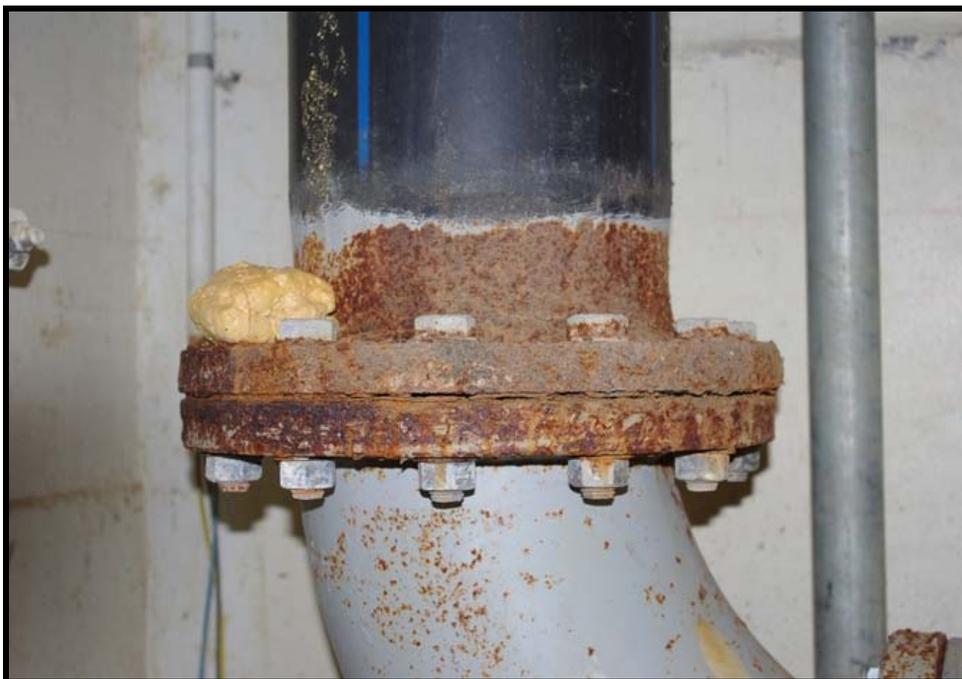
PHOTO 3.2-16 Corrosion on piping.

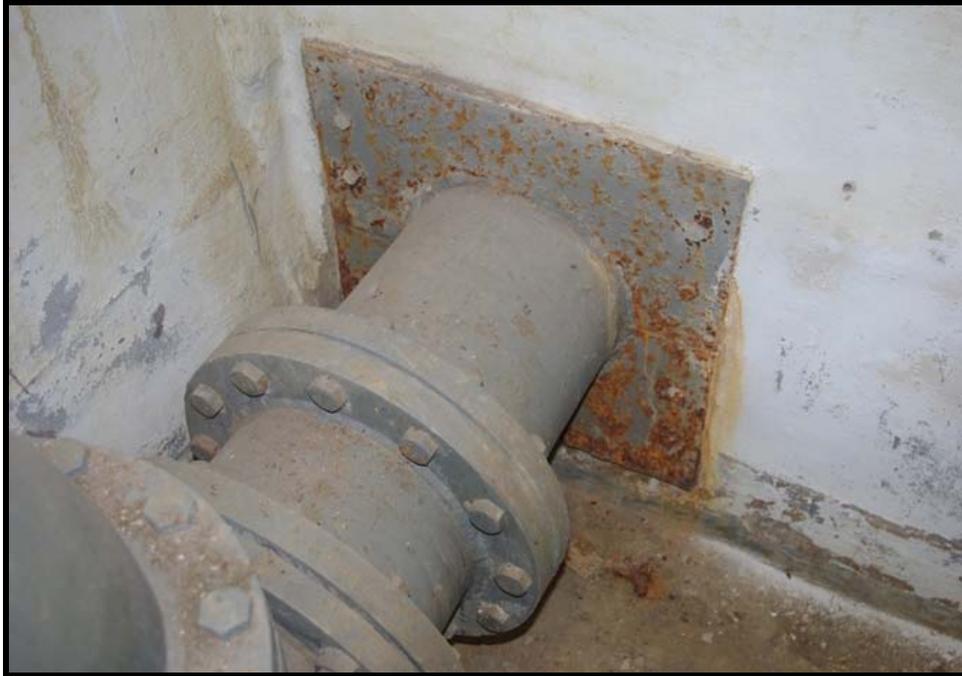
PHOTO 3.2-17 Corrosion around pipe penetration.

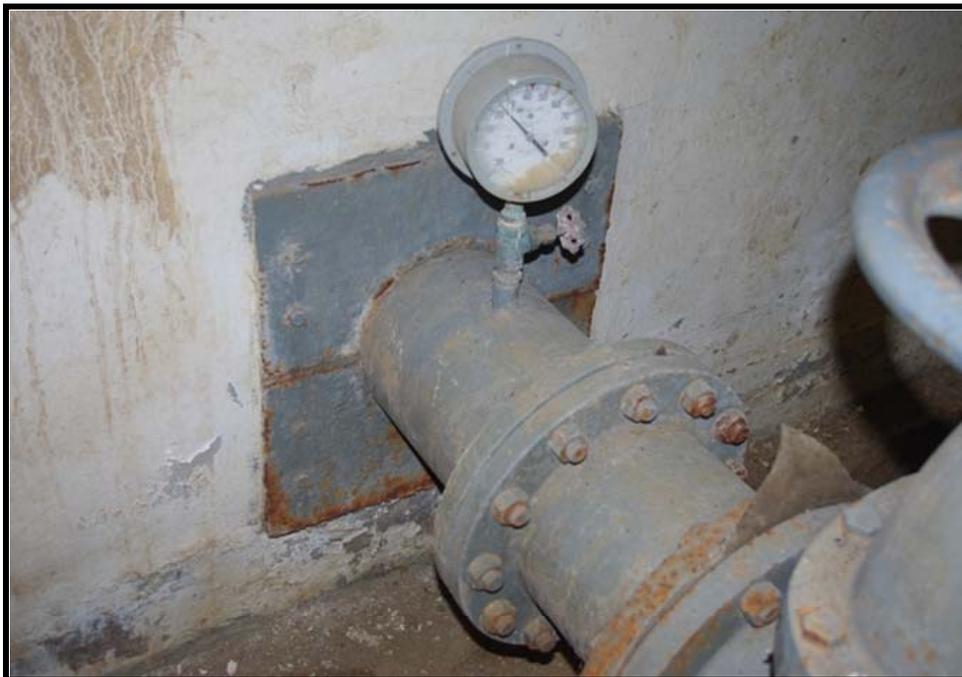
PHOTO 3.2-18 Corrosion around pipe penetration and gage on pipe.

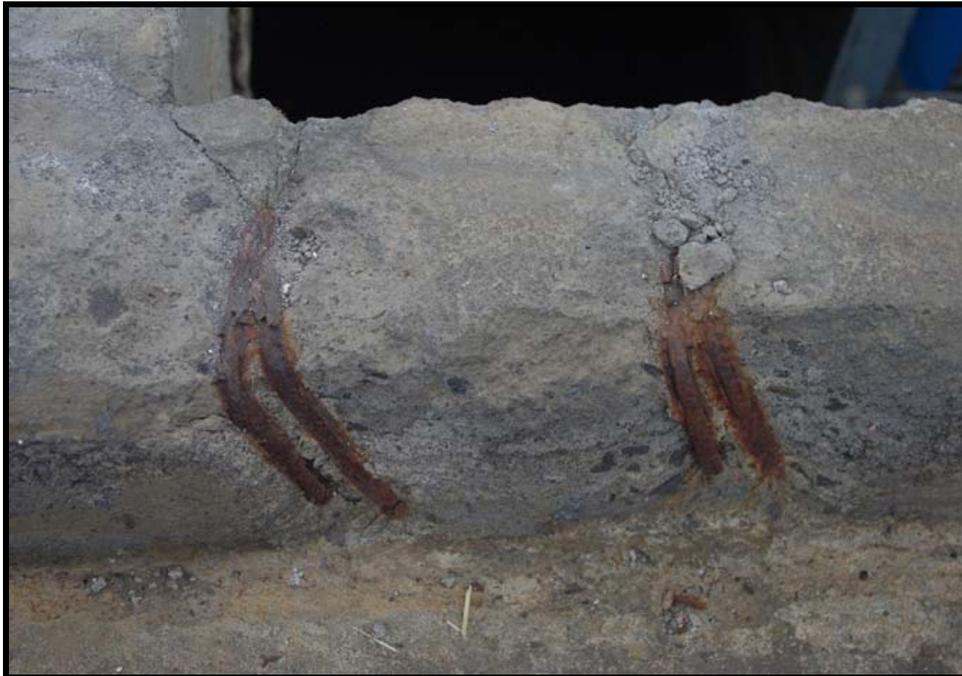
PHOTO 3.2-35 Corrosion on exposed steel in roof manhole neck.

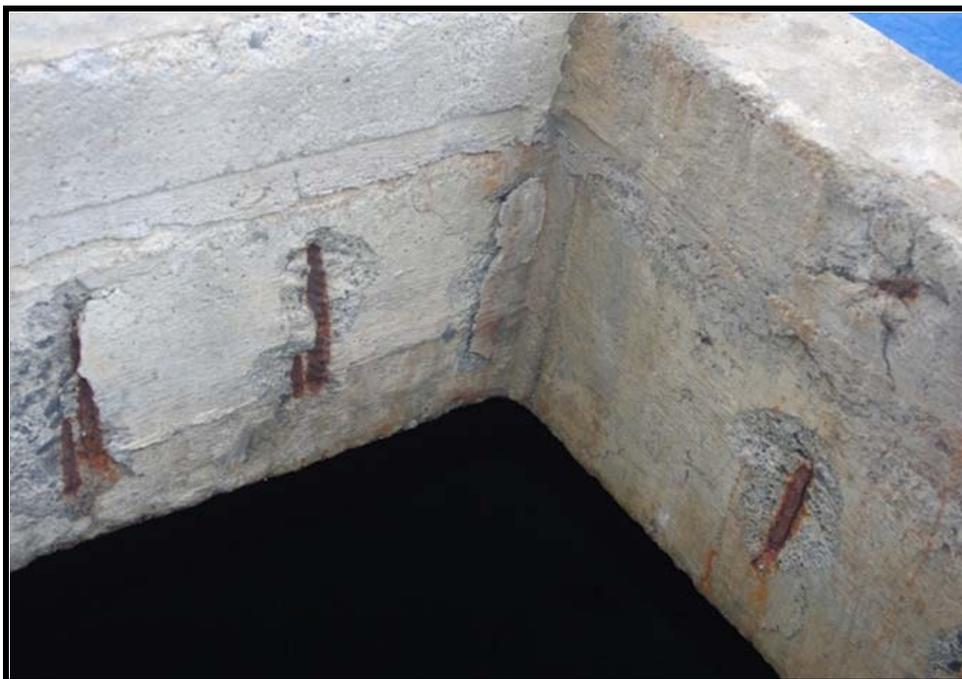
PHOTO 3.2-36 Corrosion on exposed steel in roof manhole neck.

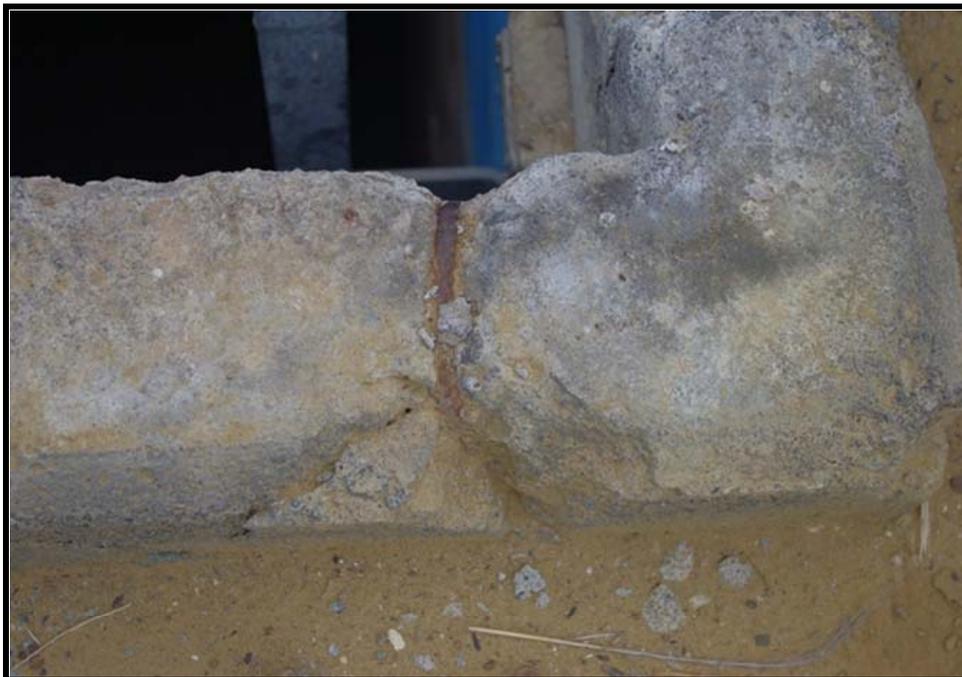
PHOTO 3.2-38 Corrosion on exposed steel at deteriorated concrete in roof manhole neck.

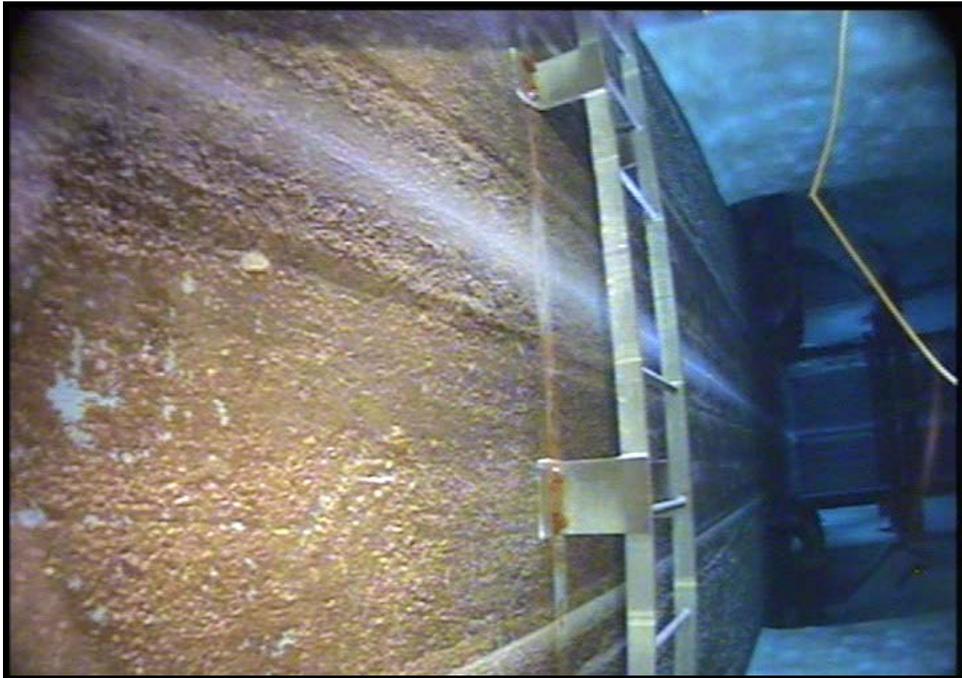
PHOTO 3.2-55 Interior ladder and brackets. Note corrosion on bolts.

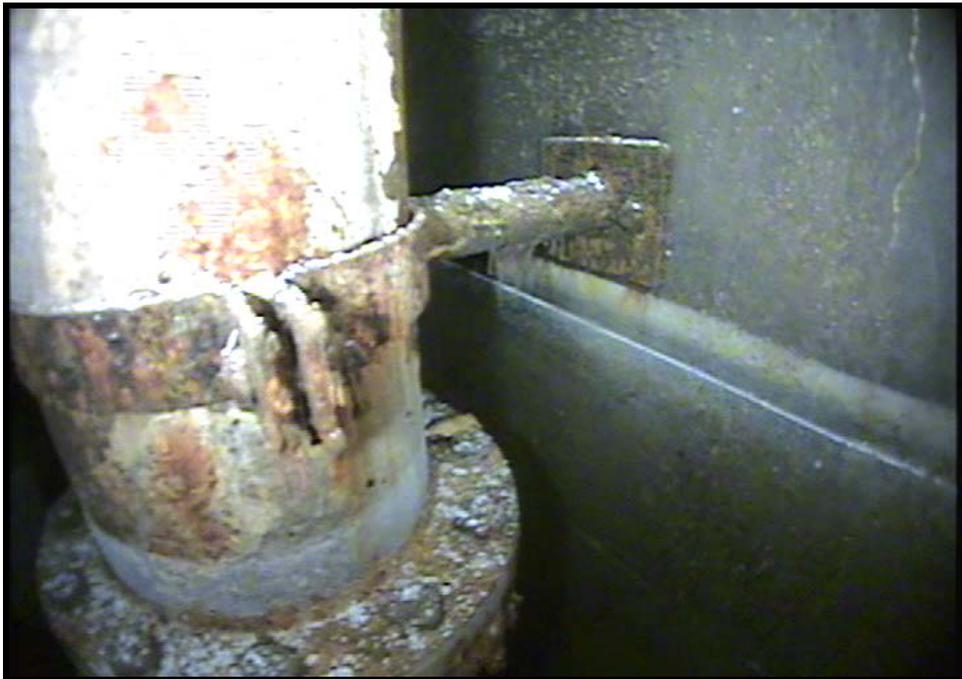
PHOTO 3.2-58 Corrosion on interior piping and bracket.

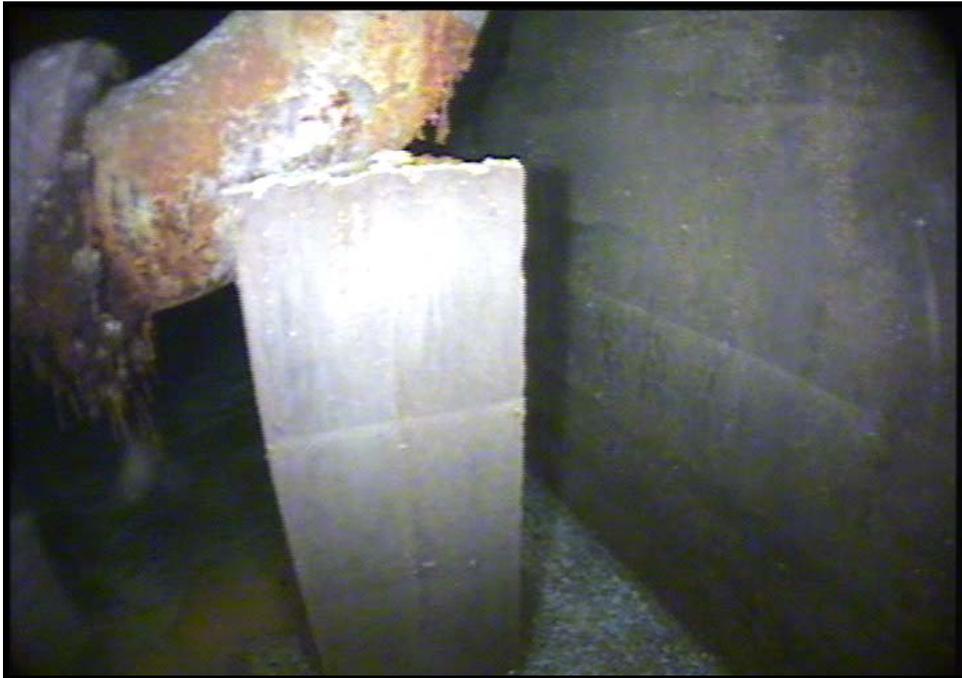
PHOTO 3.2-59 Corrosion interior piping and interior piping splash block.

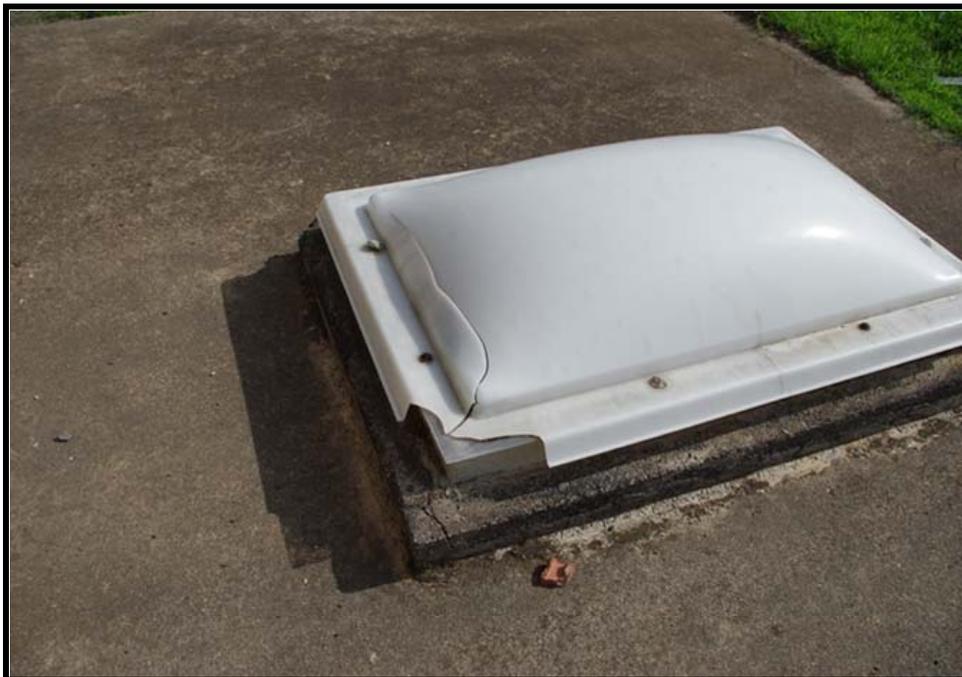
PHOTO 3.3-10 Cracks in valve vault access opening cover.

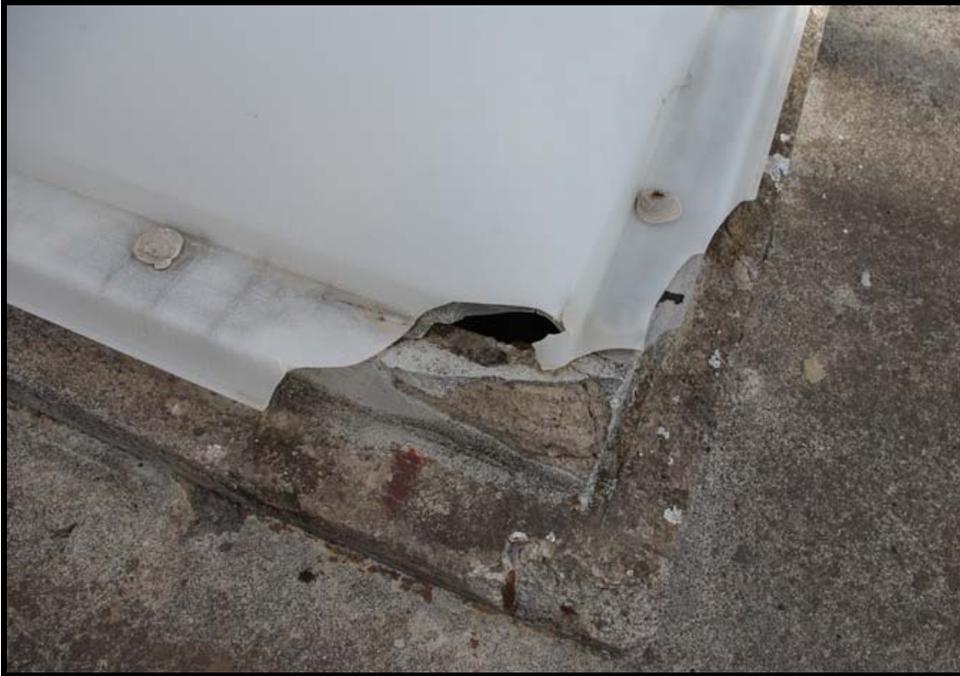
PHOTO 3.3-11 Cracks and hole in valve vault access opening cover.

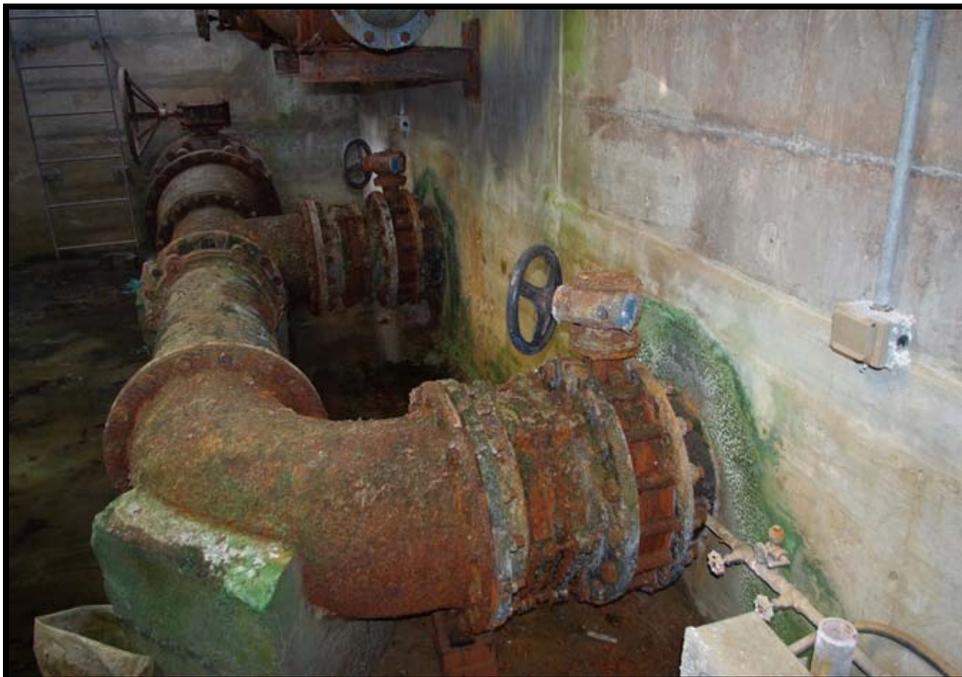
PHOTO 3.3-14 Corrosion and mildew on valve vault piping.

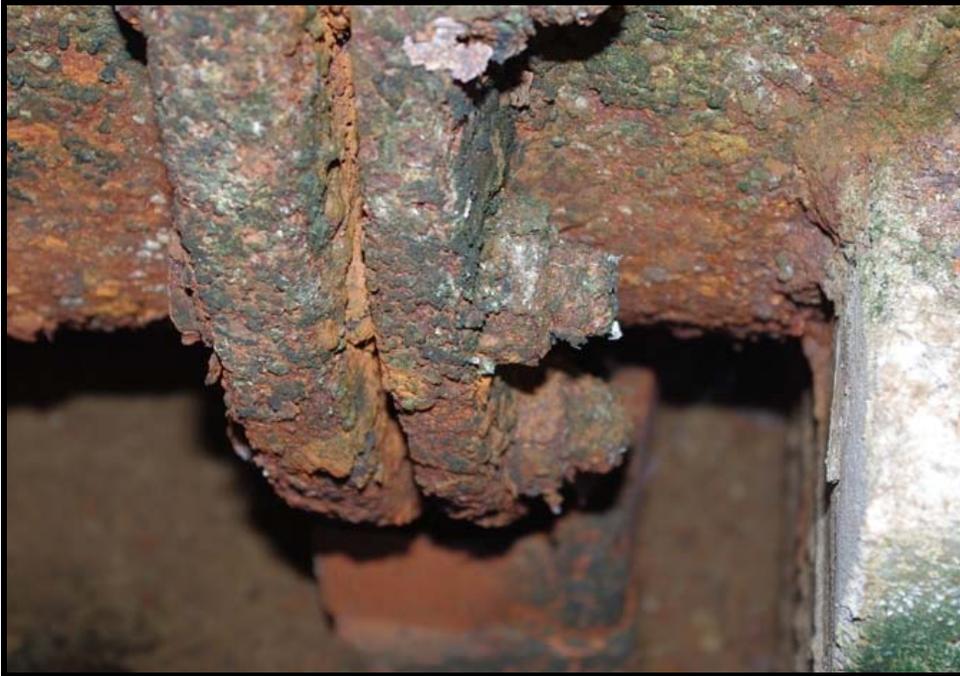
PHOTO 3.3-15 Corrosion and mildew on valve vault piping.

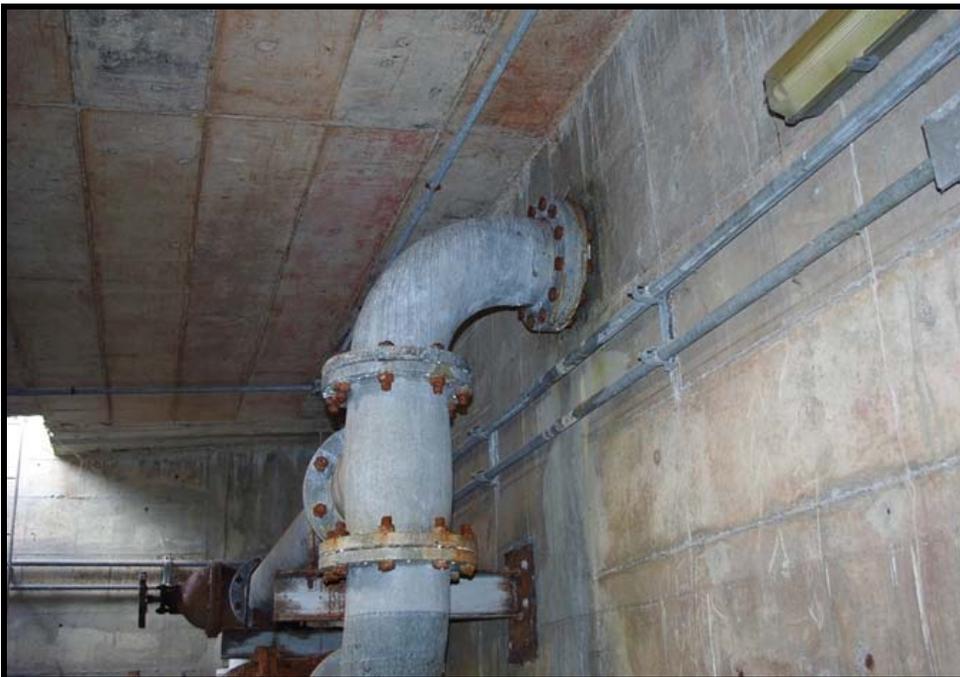
PHOTO 3.3-16 Corrosion on valve vault piping nuts and bolts.

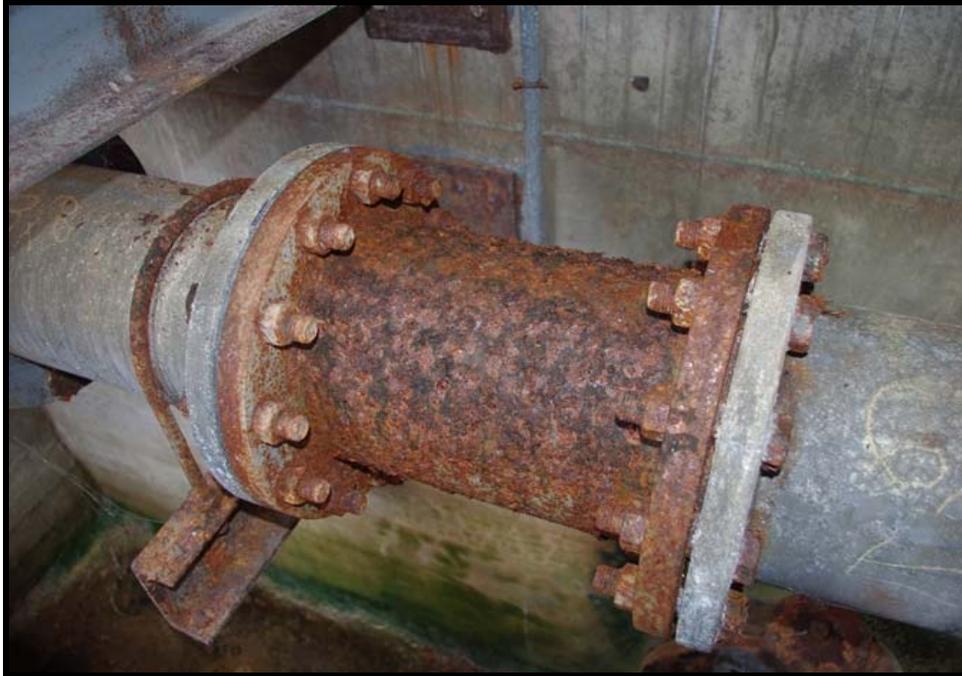
PHOTO 3.3-17 Corrosion on valve vault piping.

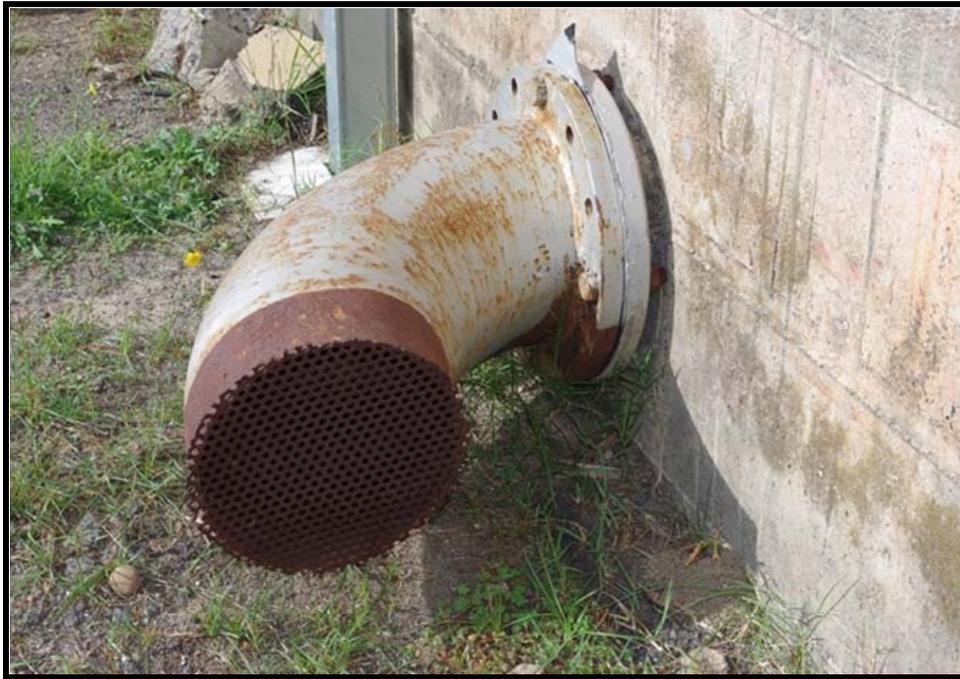
- ◆ a leak was located in the shell,
- ◆ the overflow pipe screening could allow the ingress of insects into the tank, and
- ◆ the roof vent screening could allow the ingress of insects into the tank.

PHOTO 3.3-21 Corrosion on overflow pipe screening. Note open bolt holes in flange.

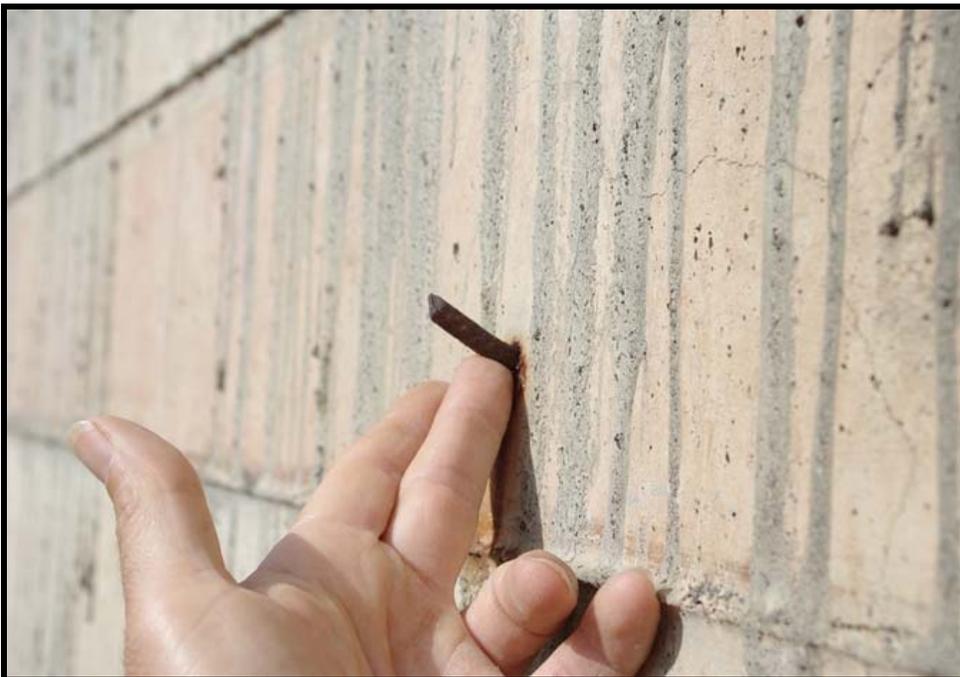
**Exterior Concrete:** The concrete exterior surfaces were in generally good condition except for the corrosion observed on some exposed rebar near the top of the shell. The exterior concrete should be re-evaluated in 3 to 4 years to determine if repairs are necessary at that time, especially at the area of exposed rebar previously mentioned.

PHOTO 3.3-26 Corrosion on exposed rebar in shell.

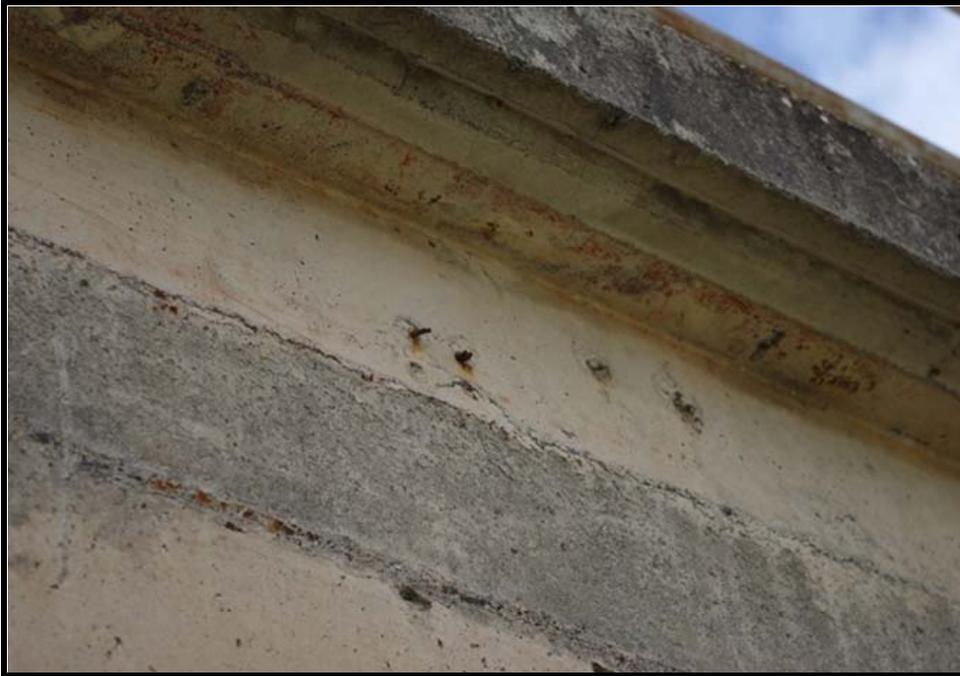
PHOTO 3.3-27 Corrosion on exposed rebar in shell.

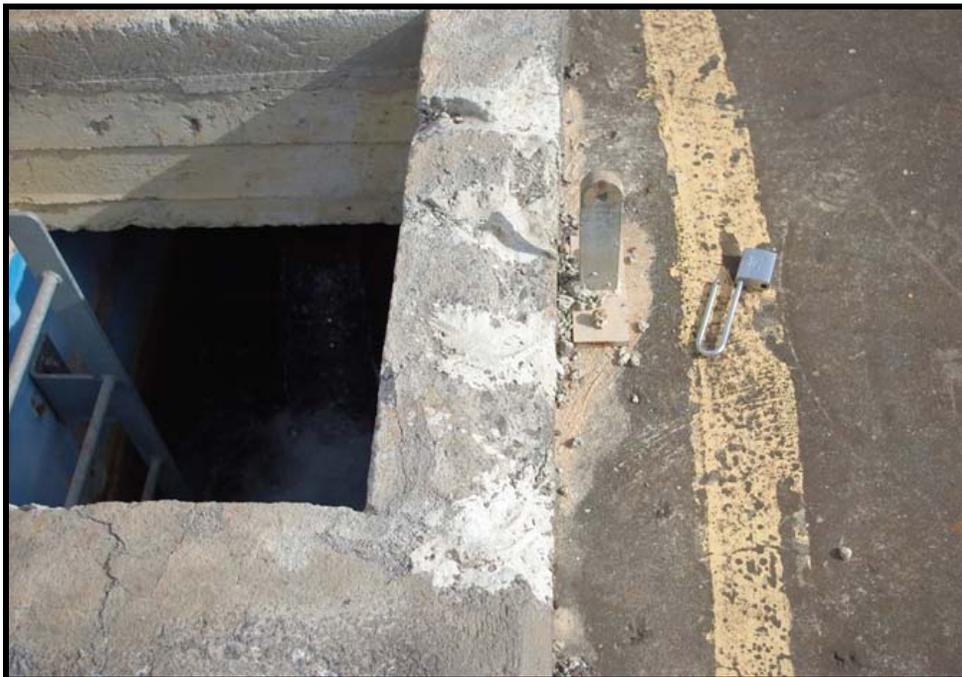
PHOTO 3.3-34 Deteriorated roof manhole neck.
