**Site Specific Report  
CR-NAVFAC EXWC-CIOFP-1310**

**TANK INSPECTIONS AND ASSESSMENTS AT  
NAVAL AIR STATION  
SIGONELLA, ITALY**

November 2012

Contract No. N62583-10-D-0340  
Delivery Order No. 0018

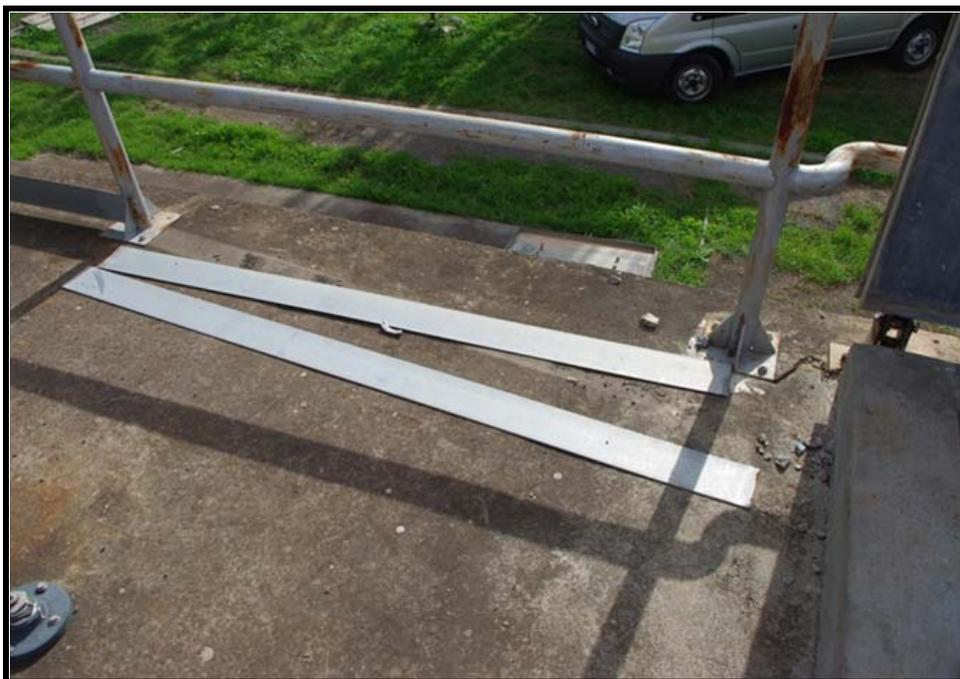
- ◆ some of the toe bar sections had broken (29 CFR 1910.23(e)(4)),
- ◆ the valve vault ladder width was less than required by OSHA (29 CFR 1910.27(b)(1)(iii)),

PHOTO 3.3-40 Broken toe bar section.

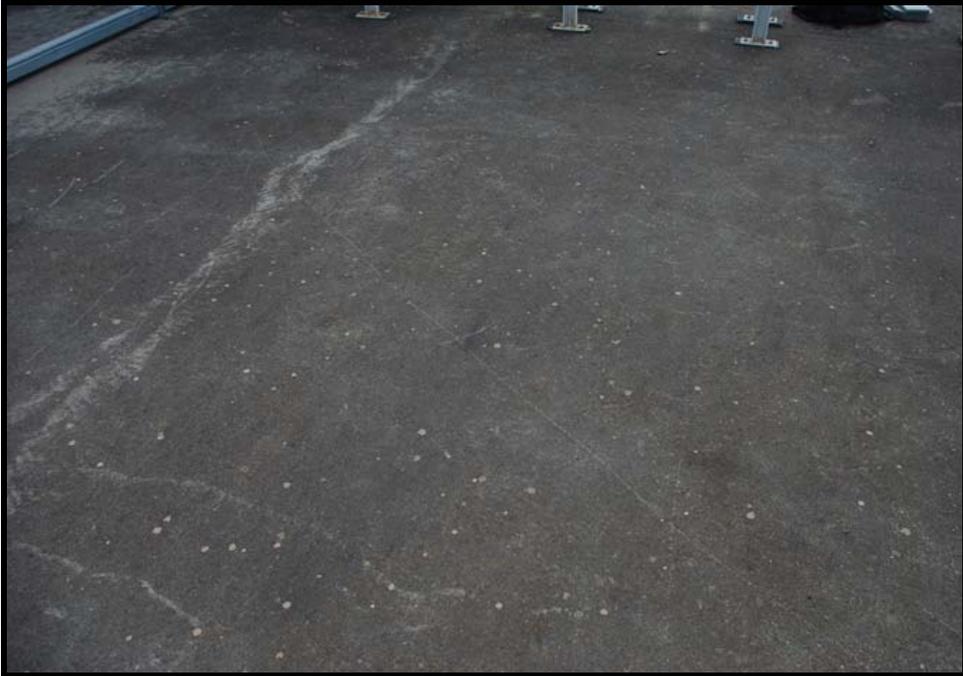
PHOTO 3.3-41 Cracks in roof.

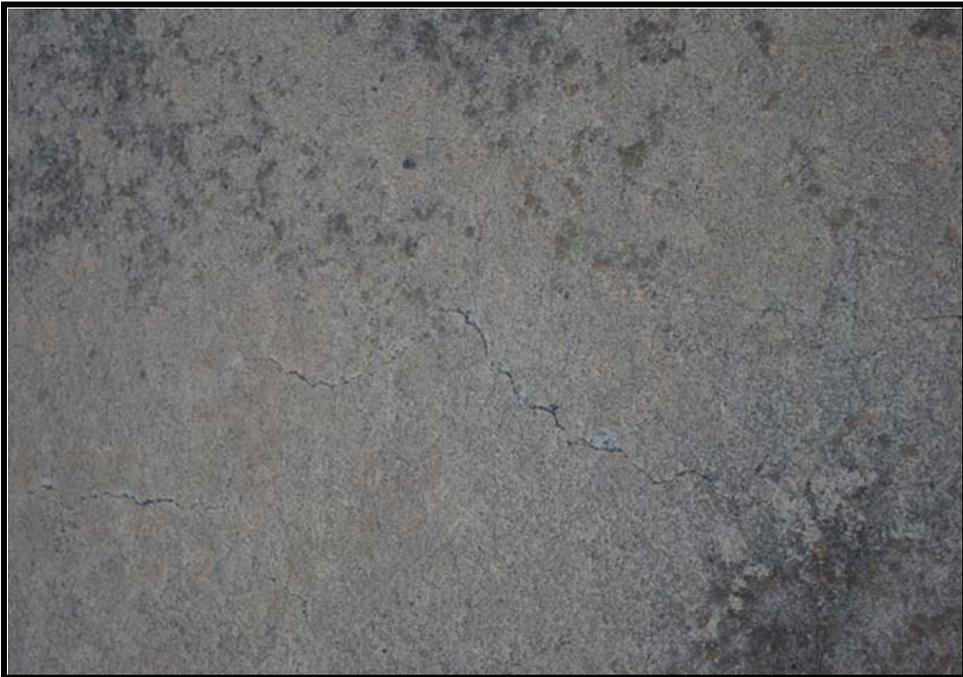
PHOTO 3.3-42 Hairline cracks in roof.

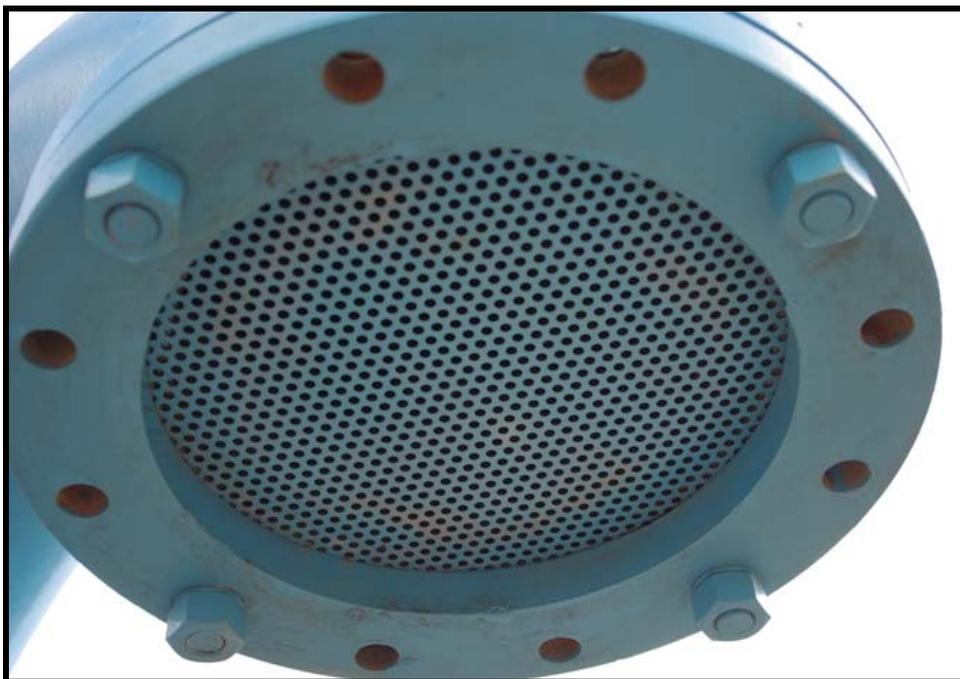
PHOTO 3.3-46 Open bolt holes at flange around roof vent screening.

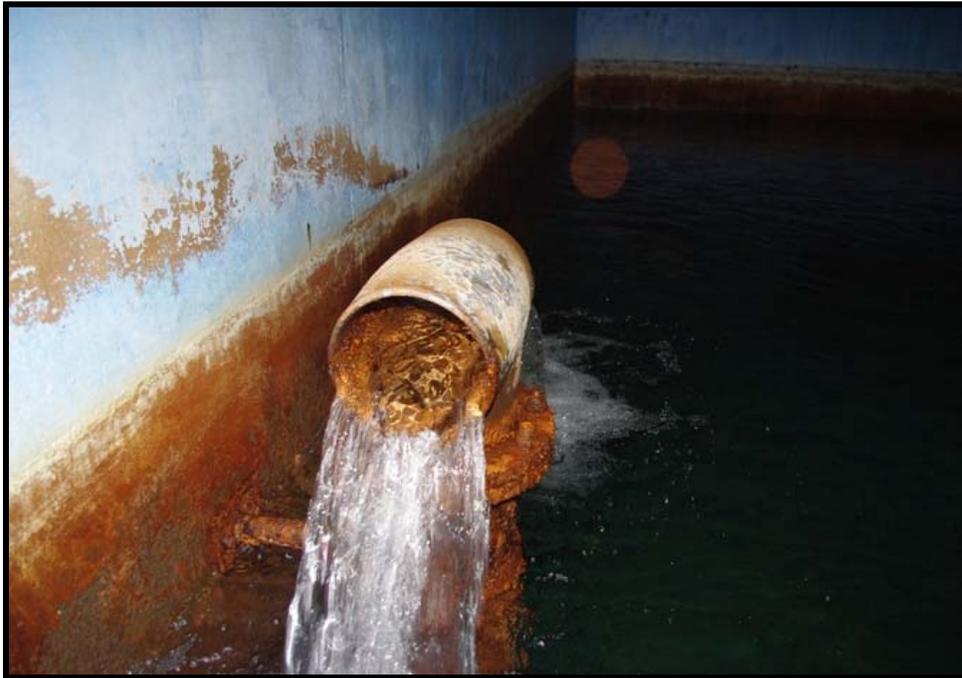
PHOTO 3.3-53 Corrosion on inlet pipe.

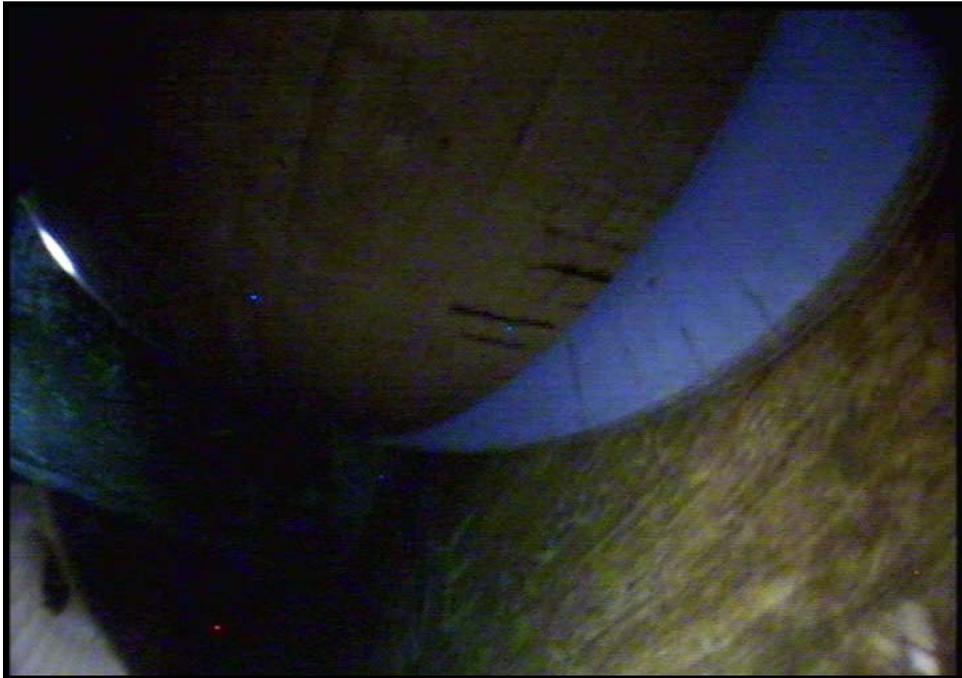
PHOTO 3.3-55 Corrosion on exposed steel in roof.

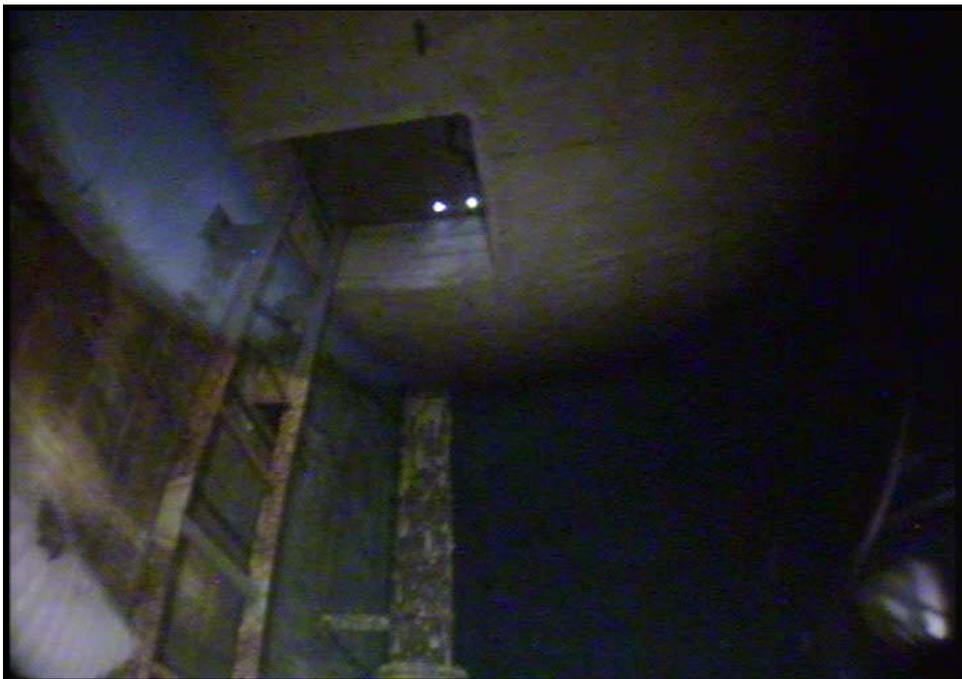
PHOTO 3.3-56 Interior ladder and corrosion on interior piping.

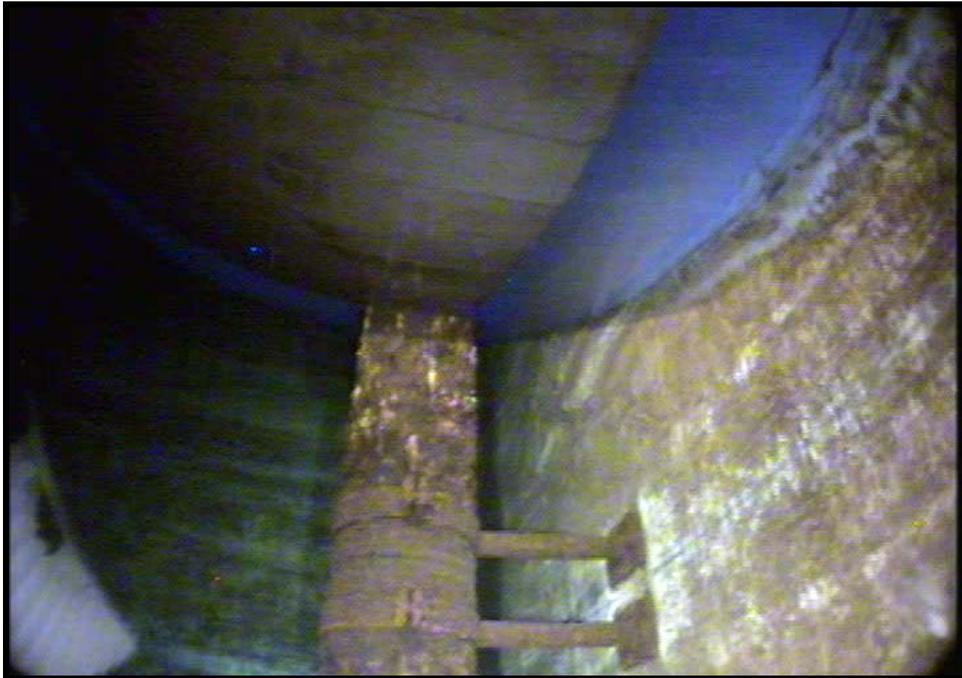
PHOTO 3.3-57 Corrosion on interior piping and brackets.

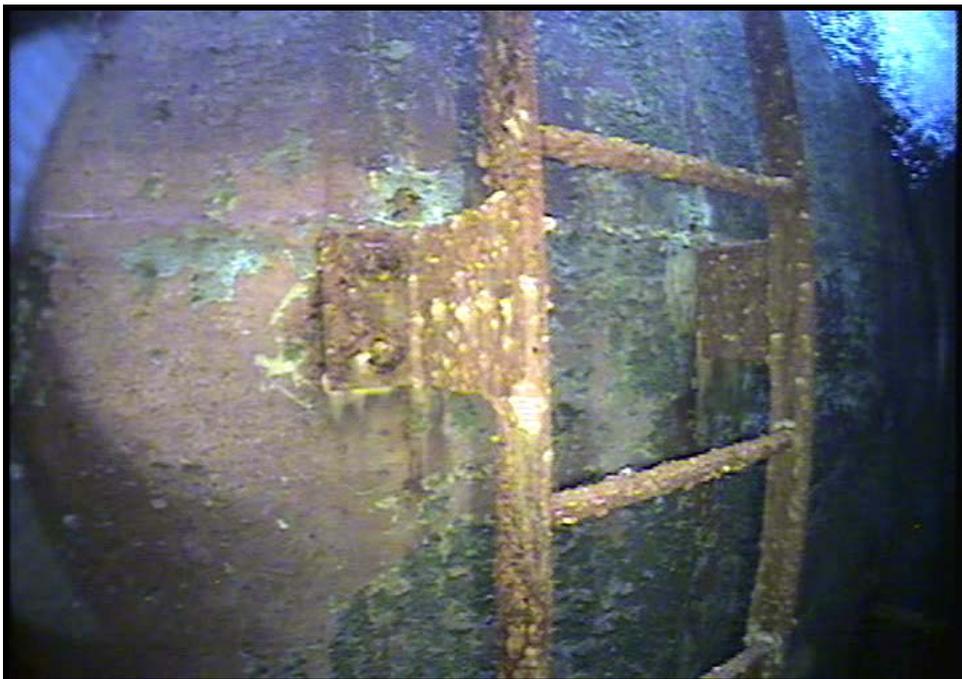
A ladder is located beneath each roof manhole, and the ladders have bolted brackets (See photo 3.3-56). The interior ladders have been replaced since the previous evaluation, but the ladders are covered with corrosion and rust tubercles (See photos 3.3-58 through 3.3-61). The ladders are not equipped with safe-climbing devices, and the safety cage has been removed from the north ladder. OSHA and safety-related deficiencies include: (1) the 24-1/4 in. (616 mm) head clearance does not meet the required 30 in. (762 mm) minimum, and (2) the rust tubercles on the ladders could injure the climber's hands.

PHOTO 3.3-58 Corrosion and rust tubercles on interior ladder and brackets.

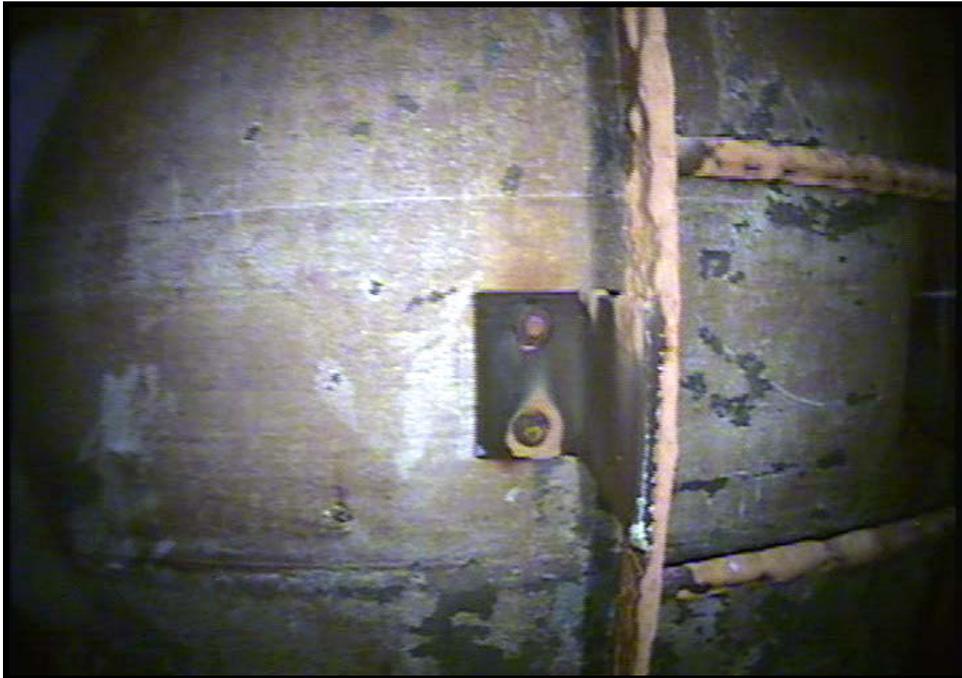
PHOTO 3.3-59 Corrosion and rust tubercles on interior ladder and bracket bolts.

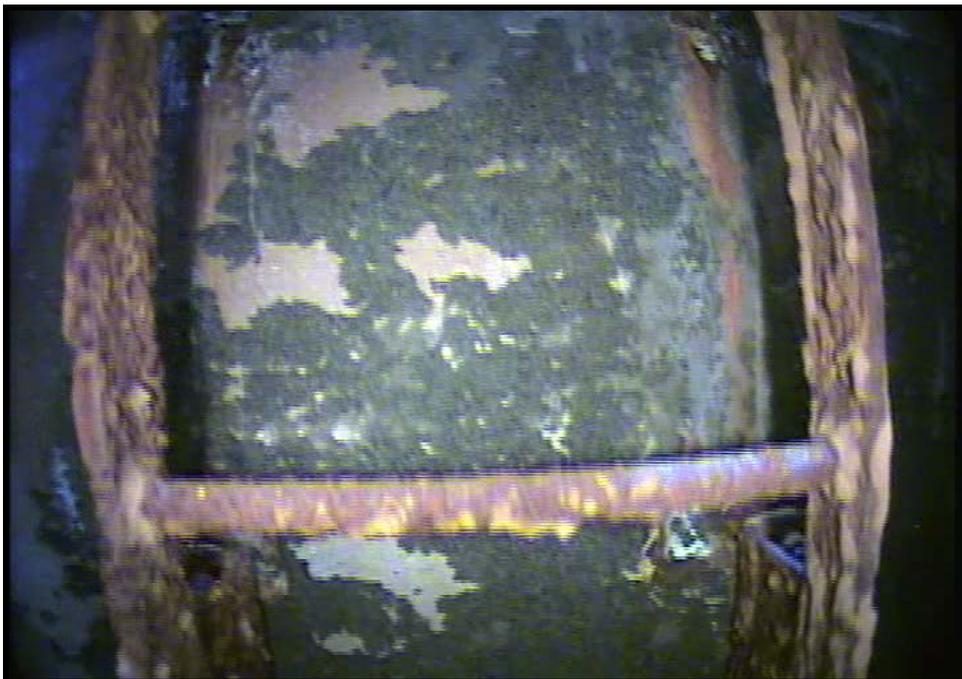
PHOTO 3.3-60 Corrosion and rust tubercles on interior ladder.

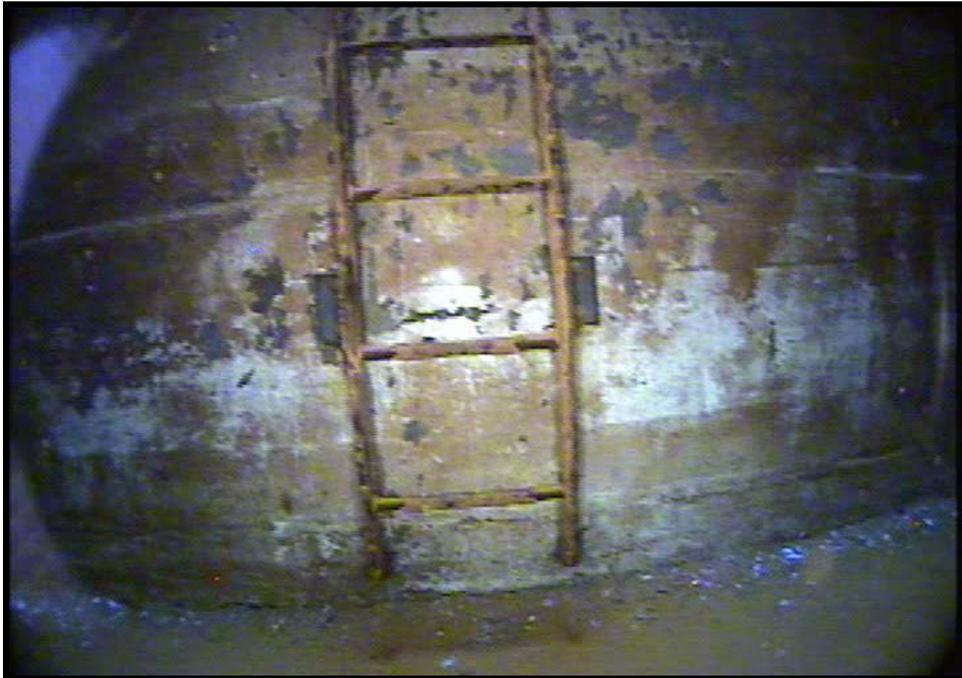
PHOTO 3.3-61 Corrosion and rust tubercles on interior ladder.

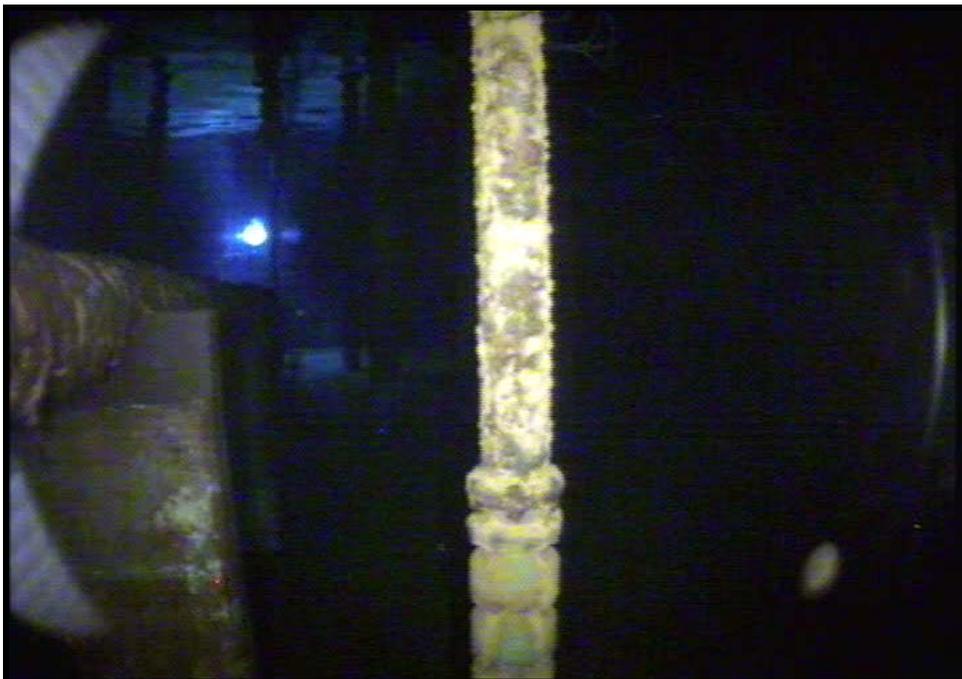
PHOTO 3.3-62 Corrosion and rust tubercles on interior piping.

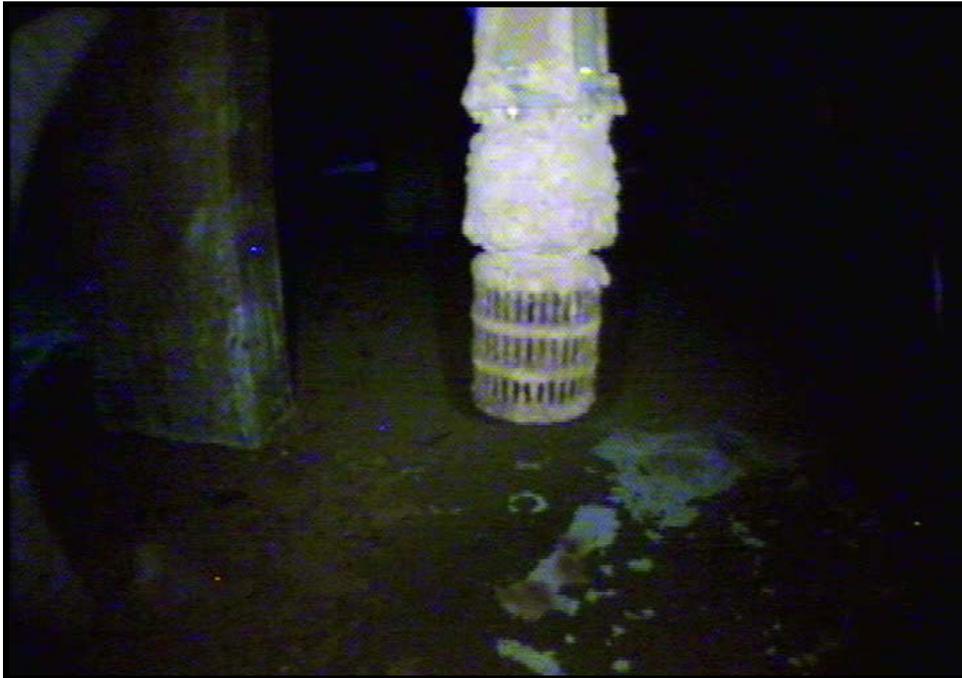
PHOTO 3.3-63 Corrosion and rust tubercles on interior piping.

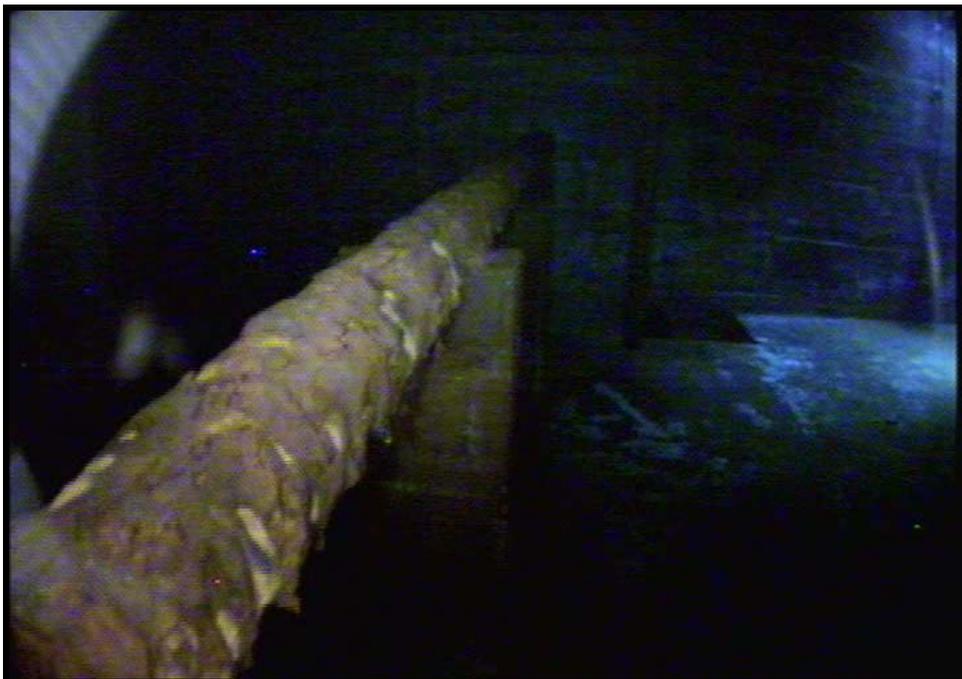
PHOTO 3.3-64 Corrosion and rust tubercles on interior piping.

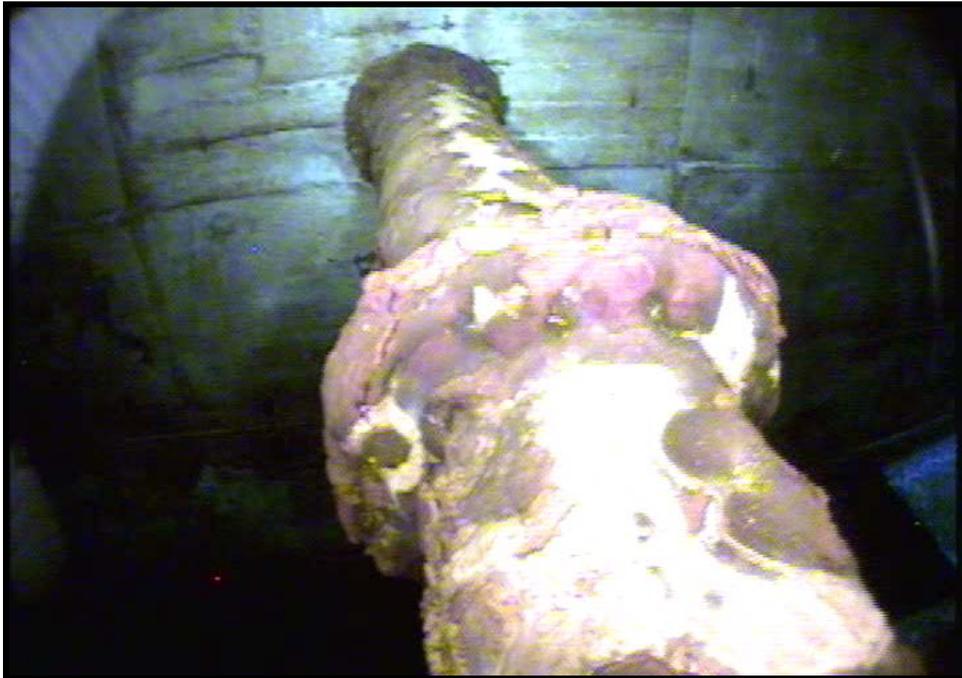
PHOTO 3.3-65 Corrosion and rust tubercles on interior piping.

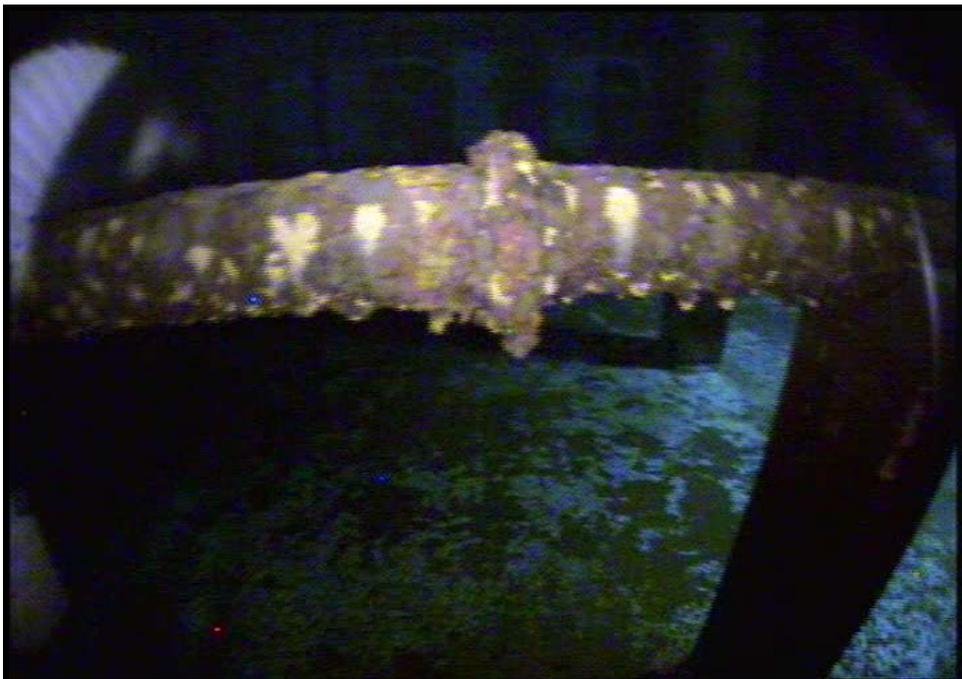
PHOTO 3.3-66 Corrosion and rust tubercles on interior piping.

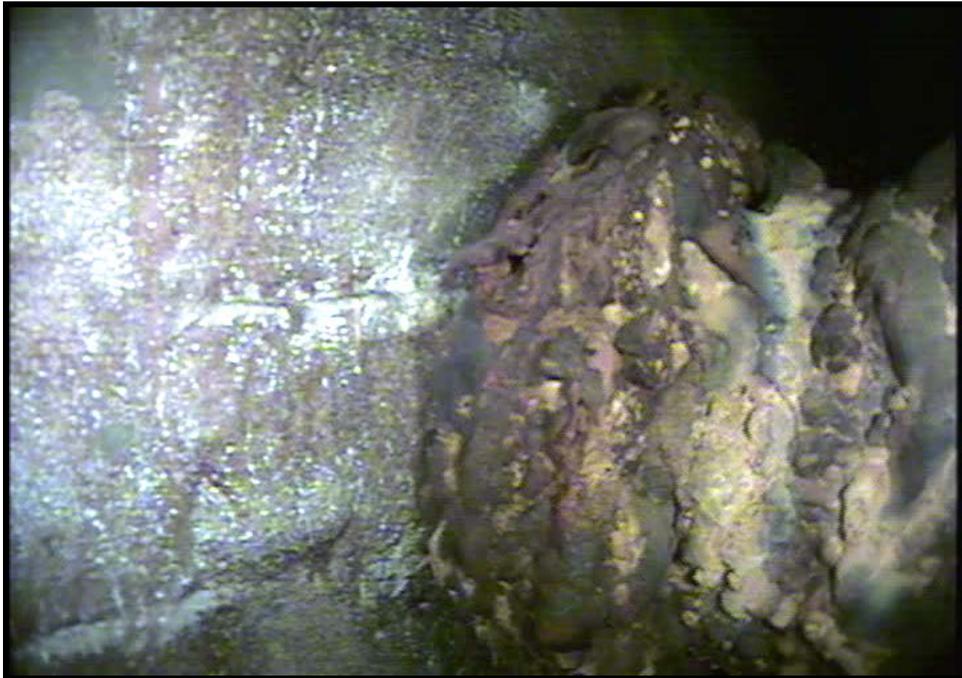
PHOTO 3.3-67 Corrosion and rust tubercles on interior piping.

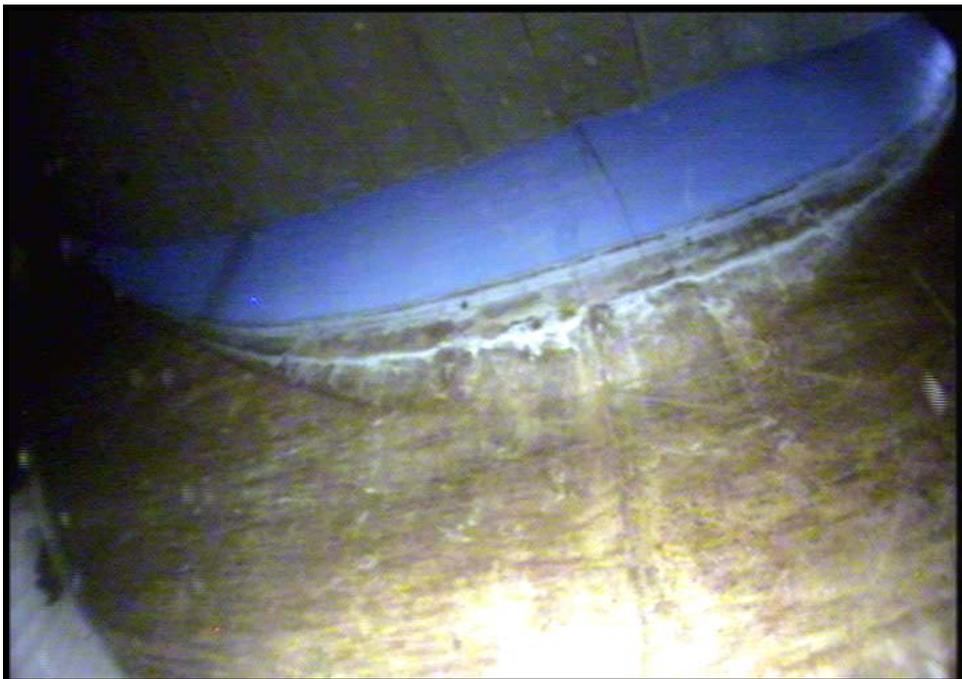
PHOTO 3.3-68 Efflorescence near top of shell.

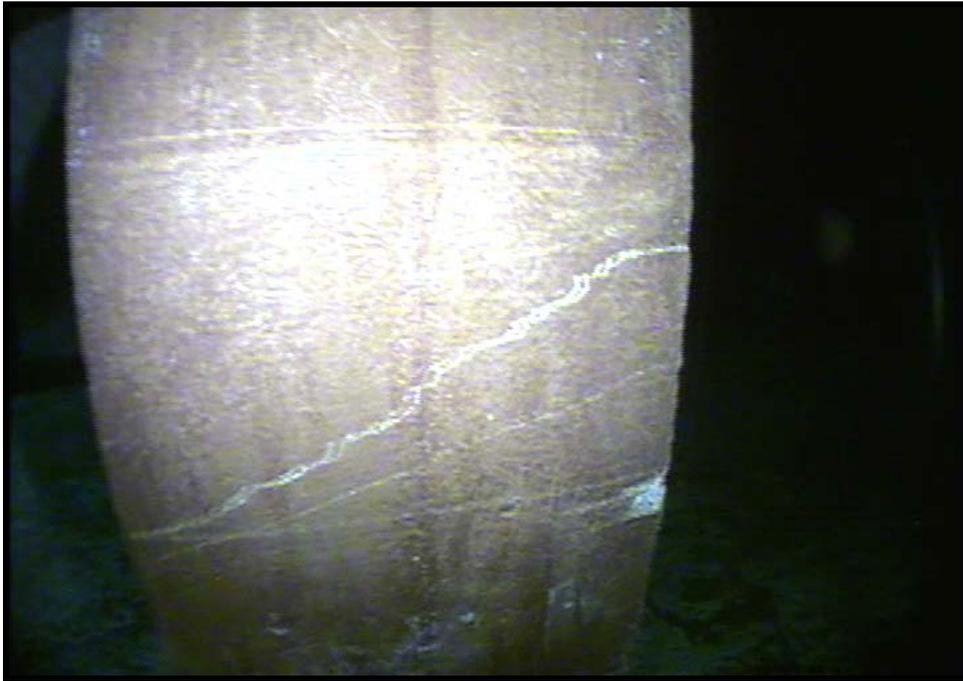
PHOTO 3.3-79 Cracking in concrete block under piping.
