3.10 TANK 425

Tank 425 stores nonpotable water for the Naval Air Station in Sigonella, Italy.

3.10.1 Description of the Facility

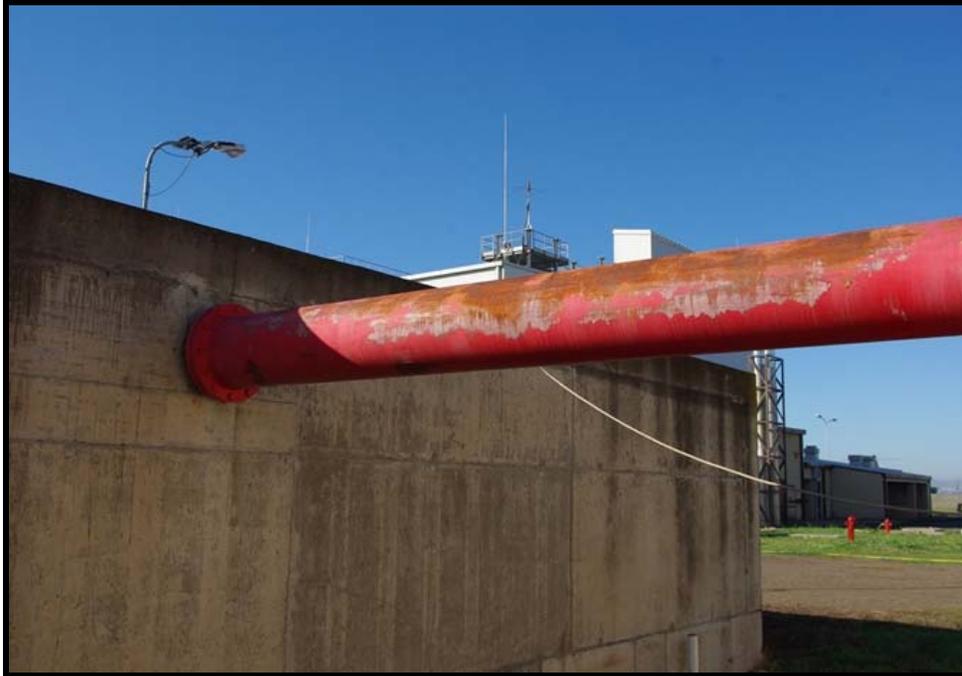
The inlet pipe extends from below grade up the south side of the shell and penetrates the roof (See photo 3.10-12). The inlet pipe has a flat bar bracket (See photo 3.10-13). At the roof, the inlet pipe splits into four pipes each of which has a valve wheel above its penetration through the roof (See photos 3.10-25 through 3.10-28). A pipe extends from each vault and penetrates the north side of the shell. Two pipes extend from the adjacent pump house and also penetrate the north side of the shell, and one of these pipes also has a conduit running with it (See photo 3.10-17). There is corrosion on the pump house pipes (See photos 3.10-15, 3.10-16, 3.10-18, and 3.10-19).

PHOTO 3.10-15 Corrosion on exterior piping.

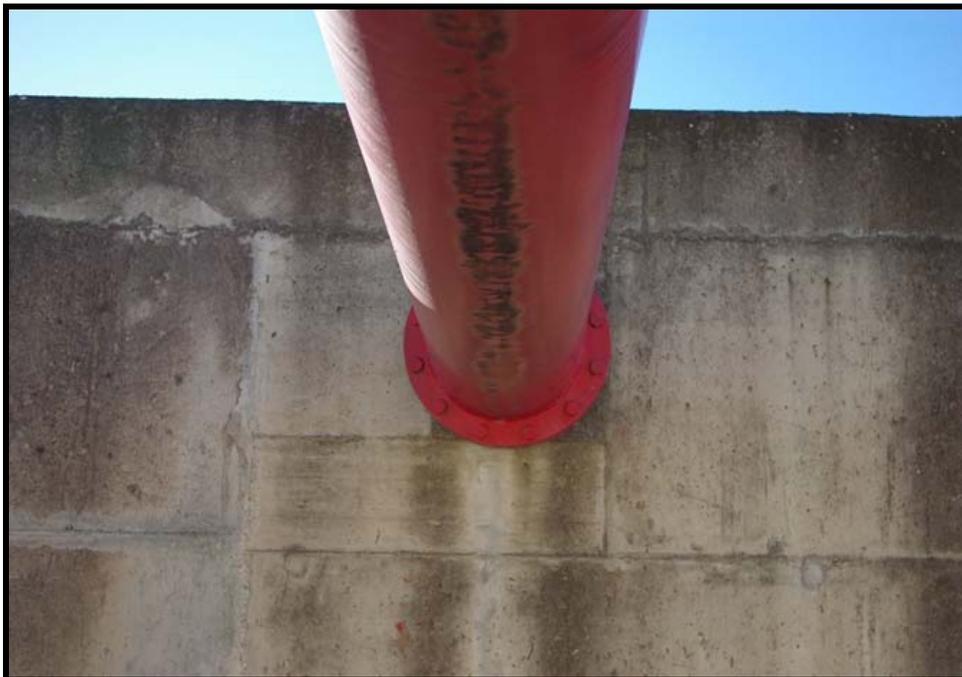
PHOTO 3.10-16 Corrosion on exterior piping.

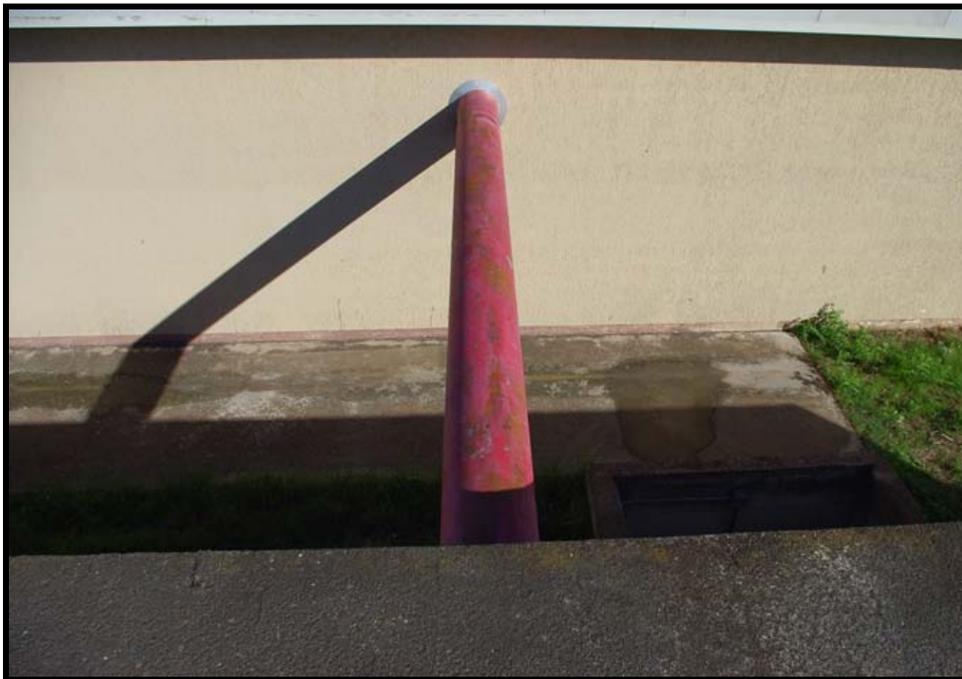
PHOTO 3.10-18 Corrosion on exterior piping.

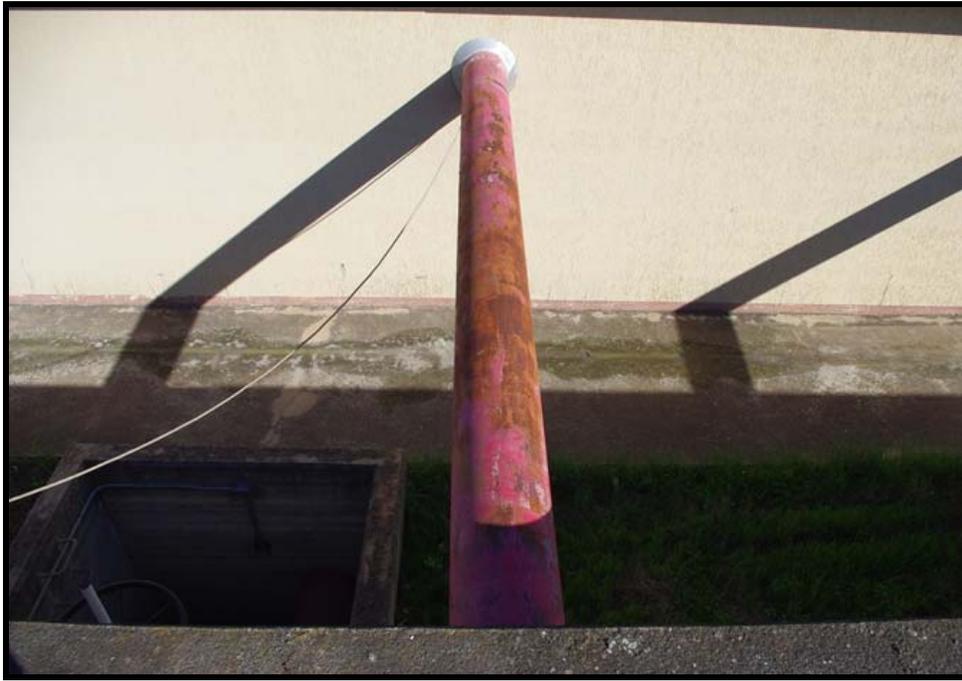
PHOTO 3.10-19 Corrosion on exterior piping.

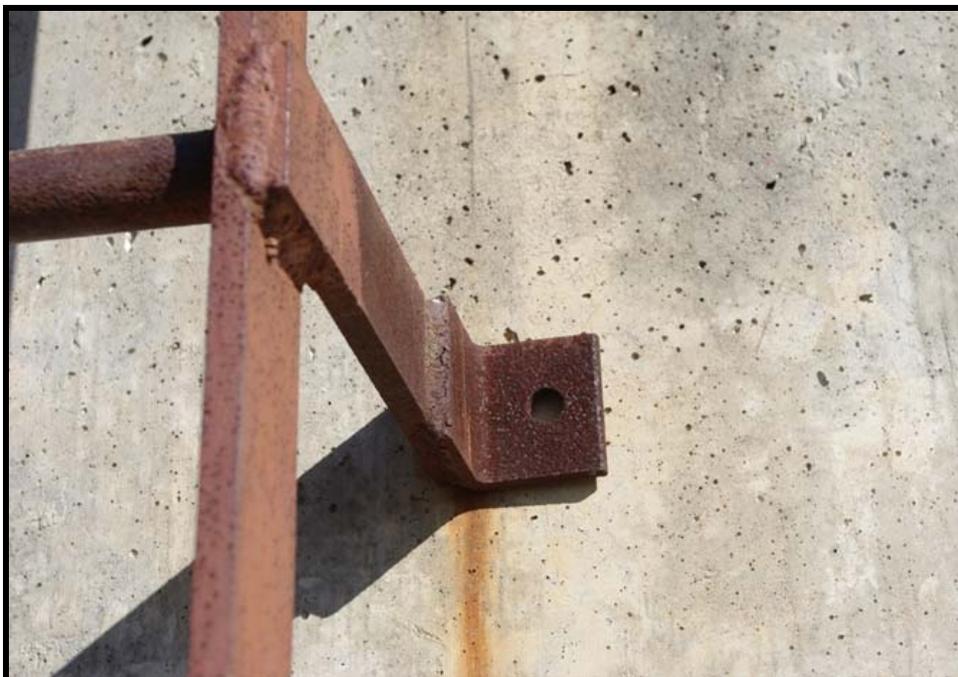
A ladder extends from the ground to the roof of the tank which has terminals at the roof (See photos 3.10-20, 3.10-21, and 3.10-24). The ladder is equipped with two sets of brackets although only the top brackets are bolted to the tank (See photos 3.10-22 and 3.10-23). The ladder does not have a safe-climbing device. A ladder-gate vandal deterrent is located at the base of the ladder although it does not have a lock (See photos 3.10-20 and 3.10-21). OSHA and safety-related deficiencies include: (1) the 11-1/8 in. (283 mm) ladder width does not meet the minimum required 16 in. (406 mm), (2) the 1-3/4 in. (45 mm) x 3/8 in. (9 mm) side rails do not meet the required 2-1/2 in. (61 mm) x 3/8 in. (9 mm) minimum, and (3) the vandal deterrent is not locked.

PHOTO 3.10-22 Corrosion on exterior ladder and bracket. Note open bolt hole.

Exterior Ladder: The exterior ladder should be replaced with a new ladder which meets current OSHA requirements and has its brackets sufficiently bolted into the concrete. The vandal deterrent should be locked.

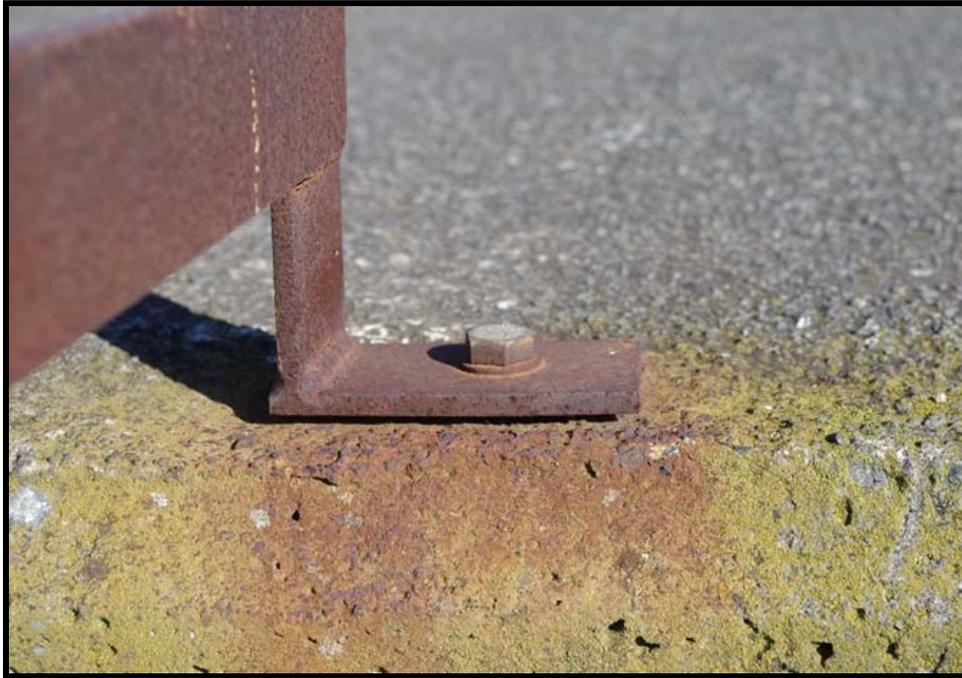
PHOTO 3.10-23 Corrosion on exterior ladder bracket at roof.

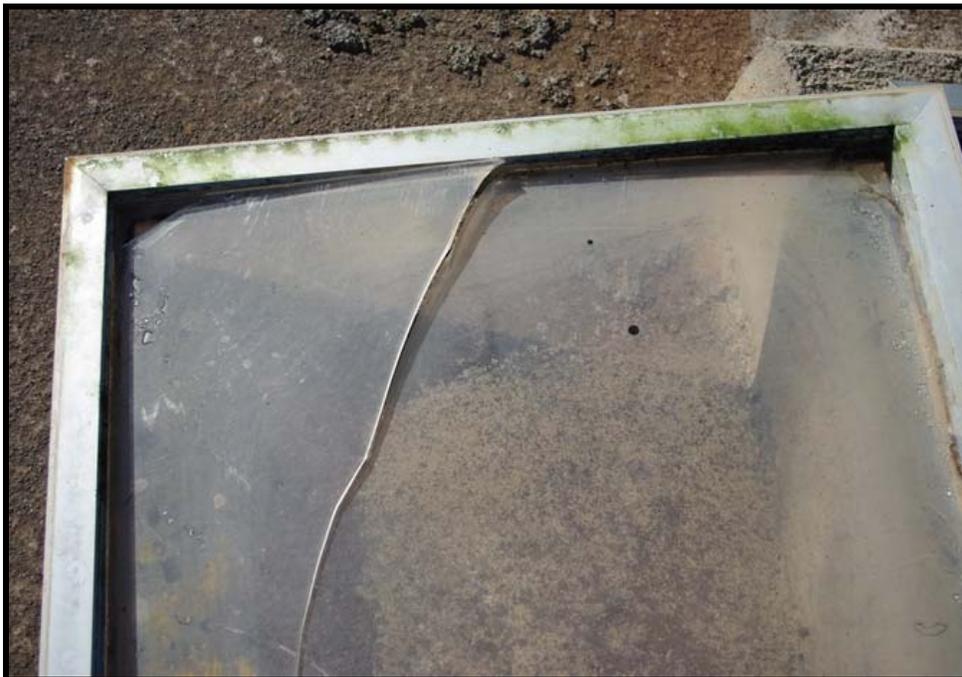
The roof has a hinged cover manhole above each of the two chambers, but the manholes are not locked (See photos 3.10-25, 3.10-26, 3.10-28, 3.10-29, and 3.10-31). The roof manholes have a gasket material which is cracked in one of the manholes (See photo 3.10-30). There is deterioration in the interior concrete surfaces of one of the manholes (See photo 3.10-32).

PHOTO 3.10-30 Cracked gasket in roof manhole.

Roof Manholes: The broken gasket on one of the manhole covers should be replaced.

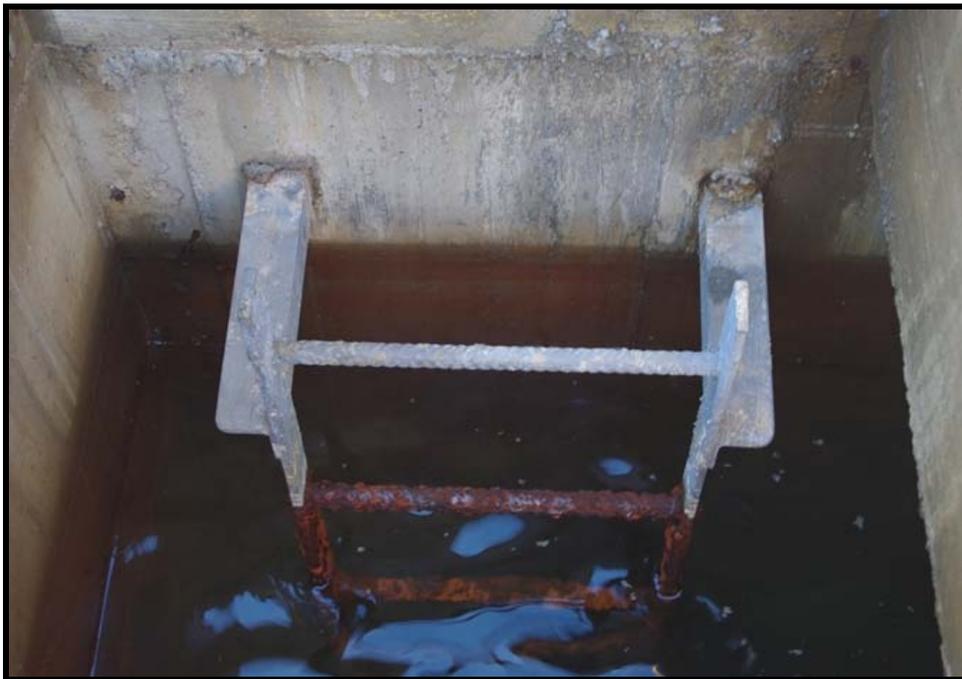
PHOTO 3.10-32 Deterioration in roof manhole neck.

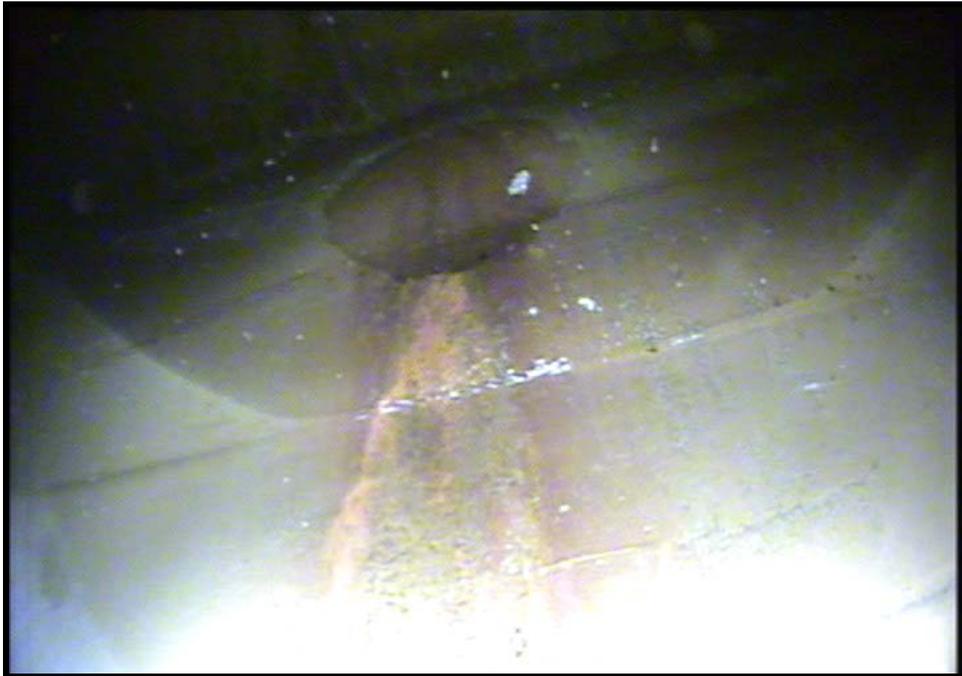
PHOTO 3.10-43 Rust staining beneath shell pipe opening.

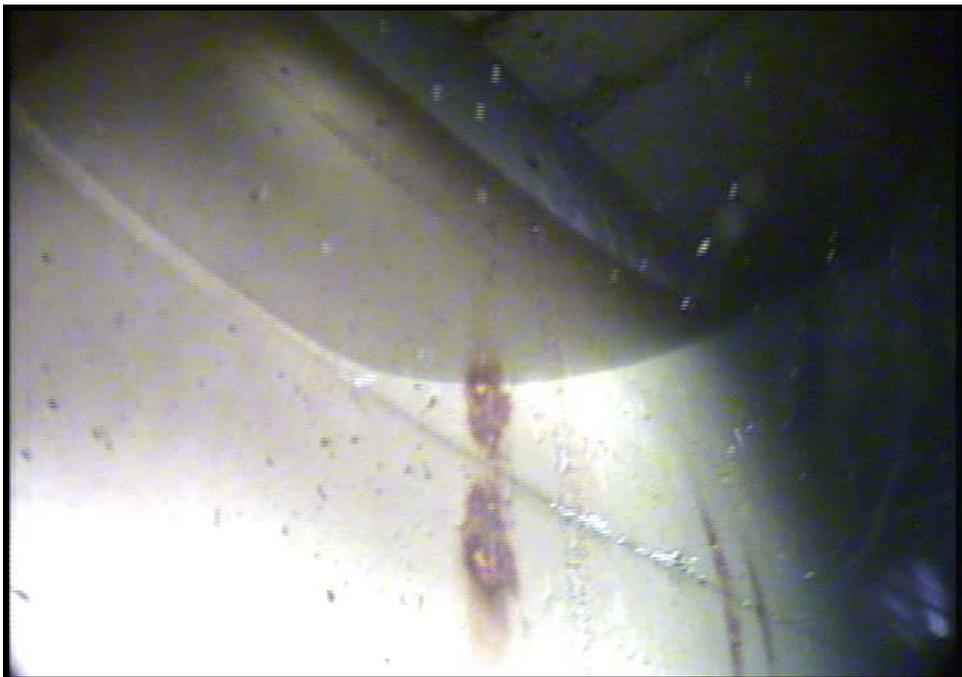
Most of the interior concrete surfaces are in good condition except for a few areas of corrosion at exposed steel and efflorescence located on the shell (See photos 3.10-40 and 3.10-44 through 3.10-49). A sealant material which is located in some of the corners appears intact (See photo 3.10-50). A layer of silt restricts the evaluation of the floors, and what appears to be a few small pieces of concrete are located in the silt (See photos 3.10-60 and 3.10-65). What appears to be a metal sheet is lying on the floor and covered with silt (See photos 3.10-62 through 3.10-64). The purpose of the metal sheet could not be determined at the time of the field evaluation.

PHOTO 3.10-44 Corrosion on at exposed steel on shell.

Interior Concrete: The interior concrete surfaces appeared to be in adequate condition as no significant cracking and chipping were observed. The interior surfaces should be re-evaluated in 3 to 4 years to determine if repairs are required at that time.

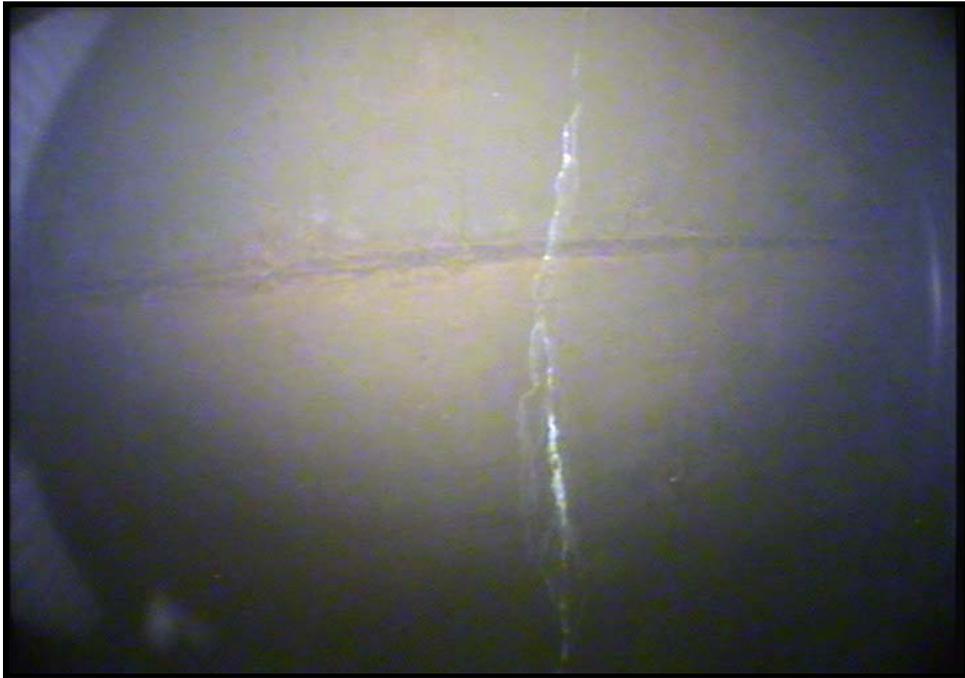
PHOTO 3.10-45 Efflorescence on shell.

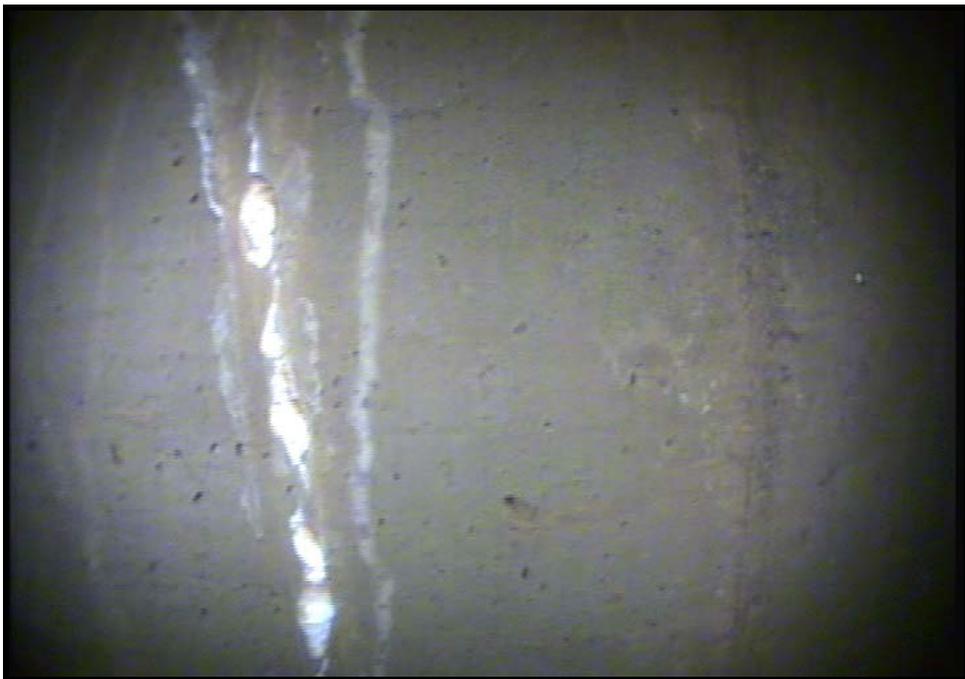
PHOTO 3.10-46 Efflorescence on shell.

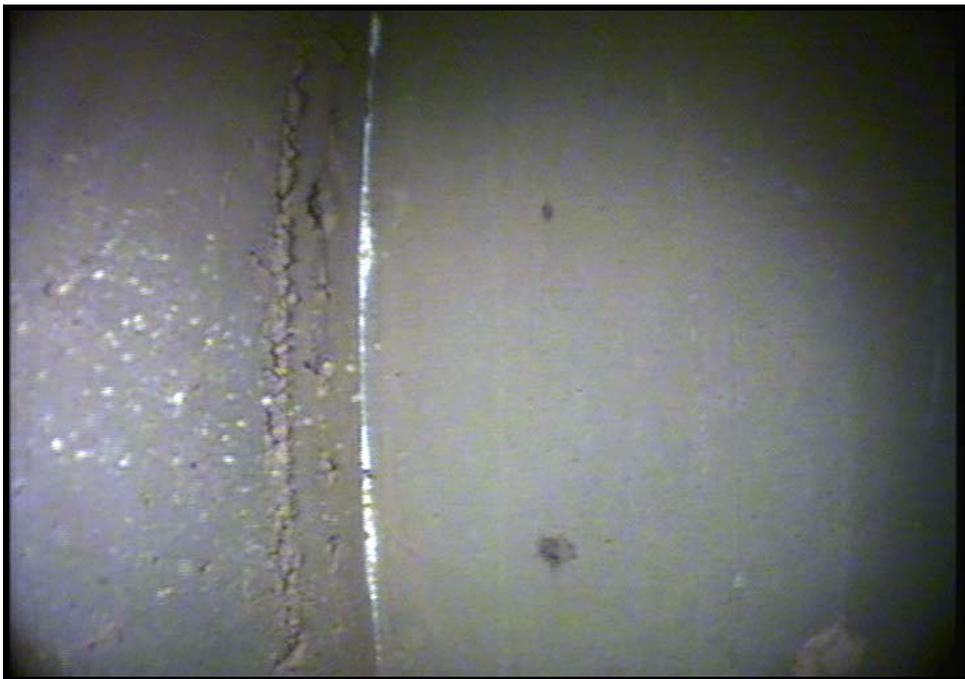
PHOTO 3.10-48 Efflorescence at corner.

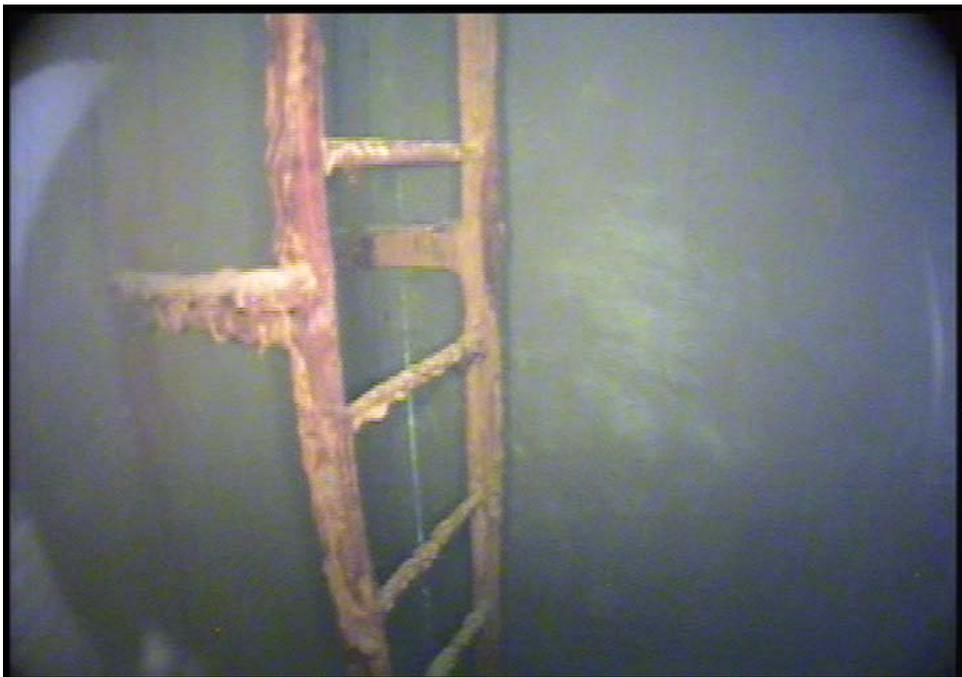
A ladder is located in each chamber beneath the roof manhole, and the ladders are welded to brackets which are cast into the concrete shell. There are corrosion and rust tubercles on ladder surfaces beneath the roof manholes (See photos 3.10-52 through 3.10-56). The ladders do not have safe-climbing devices. OSHA and safety-related deficiencies include: (1) the 2 in. (51 mm) x 3/8 in. (9 mm) ladder side rails do not meet the required 2-1/2 in. (64 mm) x 3/8 in. (9 mm) minimum, and (2) the rust tubercles could injure the climber (See photos 3.10-53 through 3.10-57).

PHOTO 3.10-52 Corrosion and rust tubercles on interior ladder.

Interior Ladders: Interior ladders are susceptible to accelerated rates of corrosion. If the Navy decides to keep an interior ladder, the existing ladders should be replaced with new ladders which meet current OSHA requirements.

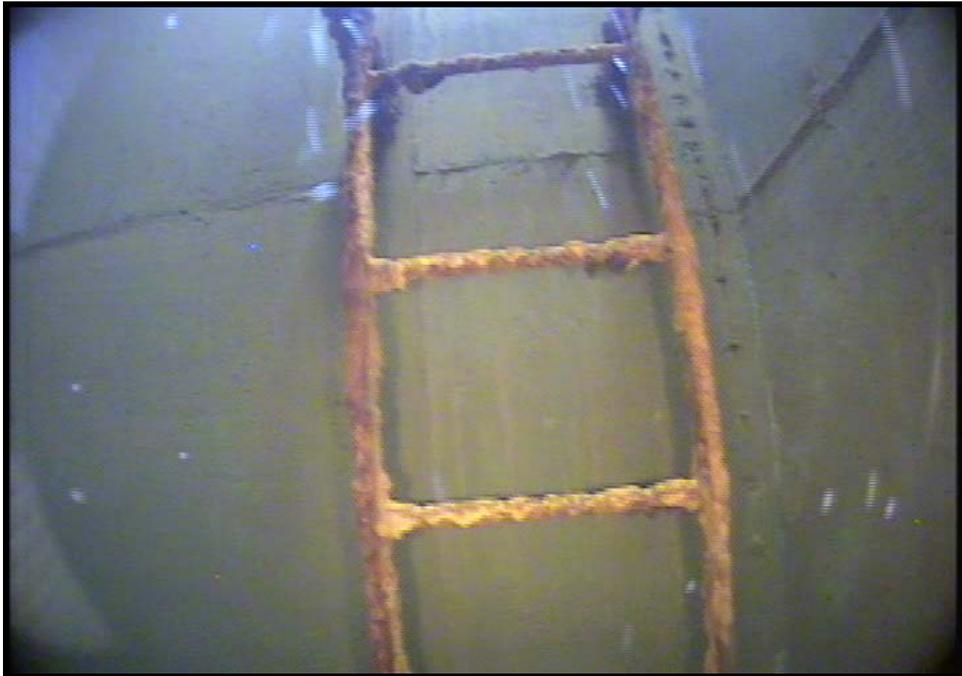
PHOTO 3.10-53 Corrosion and rust tubercles on interior ladder.

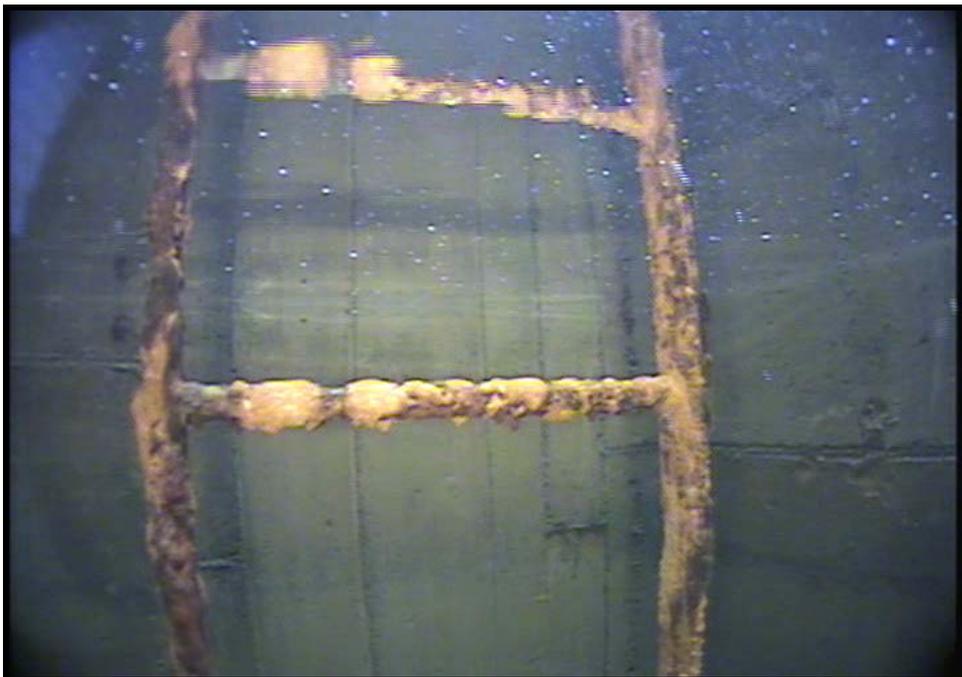
PHOTO 3.10-54 Corrosion and rust tubercles on interior ladder.

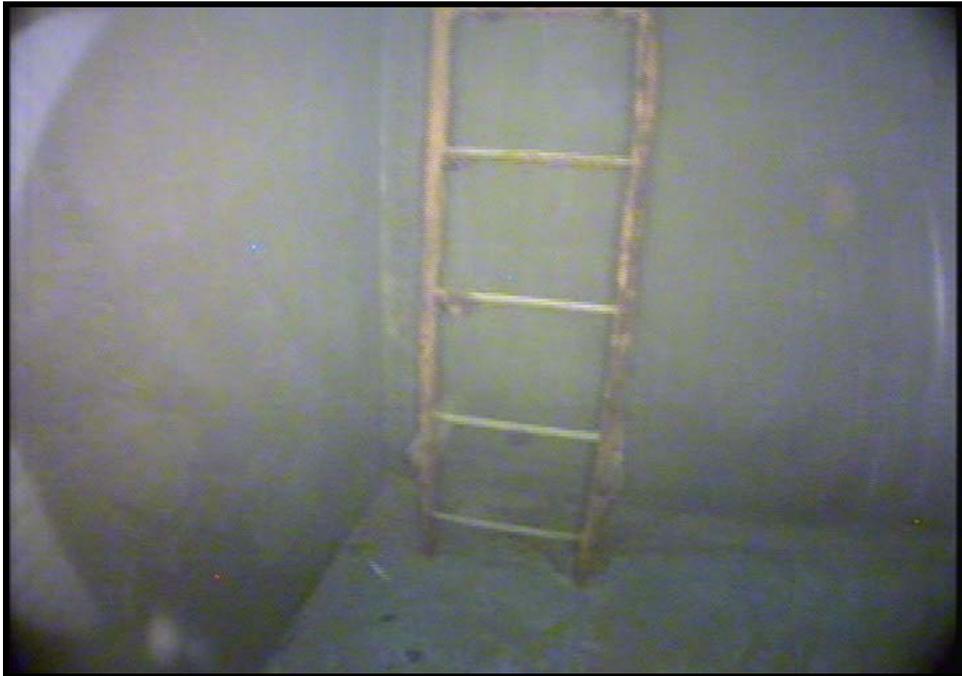
PHOTO 3.10-55 Corrosion and rust tubercles on interior ladder.

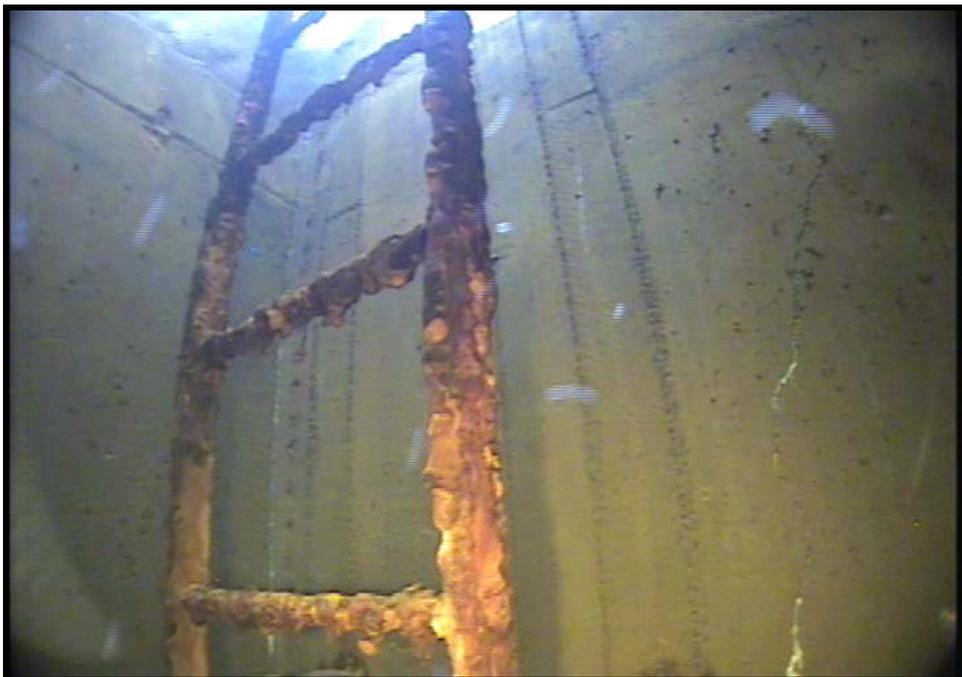
PHOTO 3.10-56 Corrosion and rust tubercles on interior ladder.

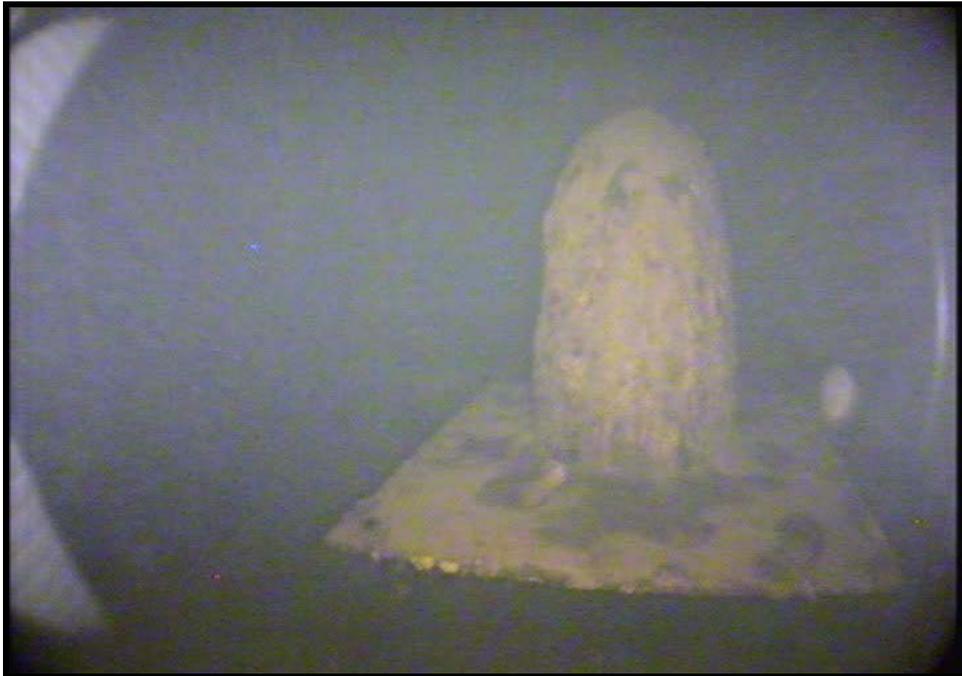
PHOTO 3.10-57 Corrosion and rust tubercles on interior piping.

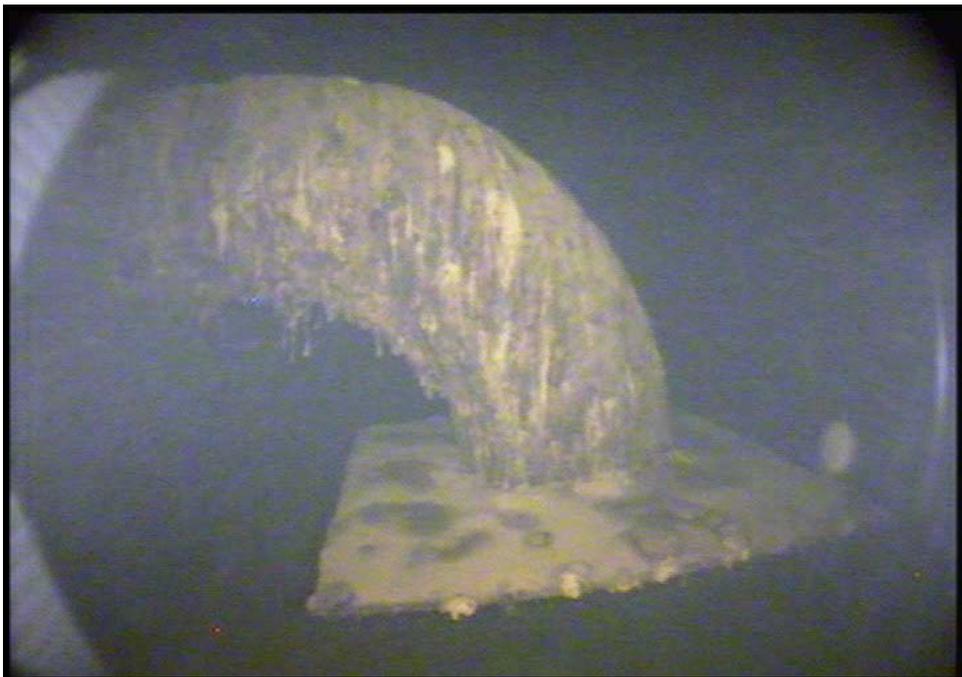
PHOTO 3.10-58 Corrosion and rust tubercles on interior piping.

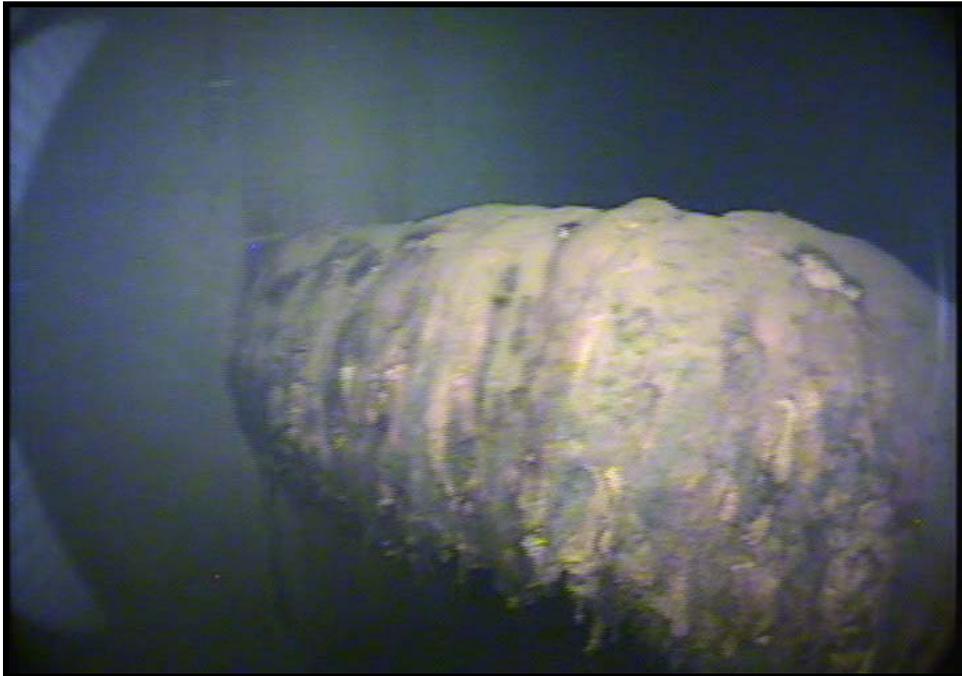
PHOTO 3.10-59 Corrosion and rust tubercles on interior piping.

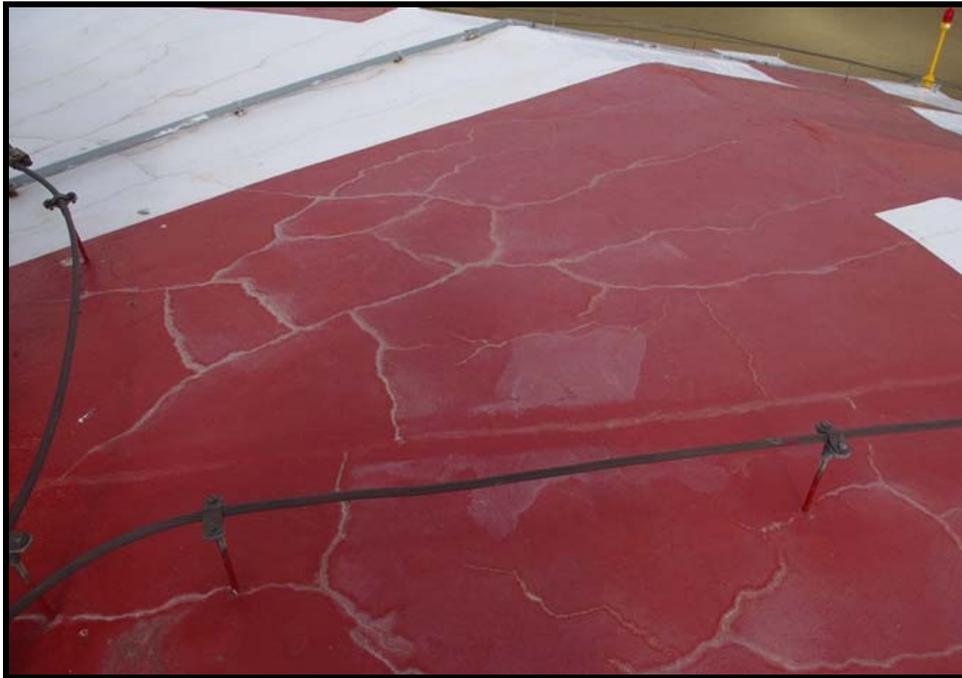
The concrete roof surfaces are covered with a fabric-type coating (See photo 3.11-16). The coating has peeled and chipped in areas, and there are several cracks in the coating (See photos 3.11-17 through 3.11-24). Due to the thickness of the coating, it is difficult to determine if the roof surface is cracking as well. Grounding cables and conduits extend across the roof, and there are three hooks on the roof (See photos 3.11-18 through 3.11-21 and 3.11-23). Note: the hooks should not be used for rigging purposes.

PHOTO 3.11-17 Cracks in roof, and grounding cables on roof.

Exterior Concrete: The exterior concrete surfaces were in generally good overall condition as no significant cracking and spalling were noted. However, due to the thickness of the roof coating, it could not be determined if the cracks observed at the roof extended to the concrete. The exterior surfaces should be re-evaluated in 4 to 5 years to determine if repairs are required at that time. When cracks develop, they should be prepared according to the specifications of the concrete crack repair material manufacturer. These areas to be repaired should be prepared by wet blast cleaning to remove dust, laitance, grease, or other bond inhibiting materials and blown off with high-pressure air. The cracks in the concrete should then be repaired by routing out the crack to a minimum depth of 1 in. (25 mm, with a minimum 90° angle from the surface) and repairing with a cement-based patching compound. The sequence and performance of these concrete repairs shall be such that the structural integrity of the tank area is not compromised. Prior to exterior repairs, the roof coating should be removed, and the concrete should be carefully evaluated.

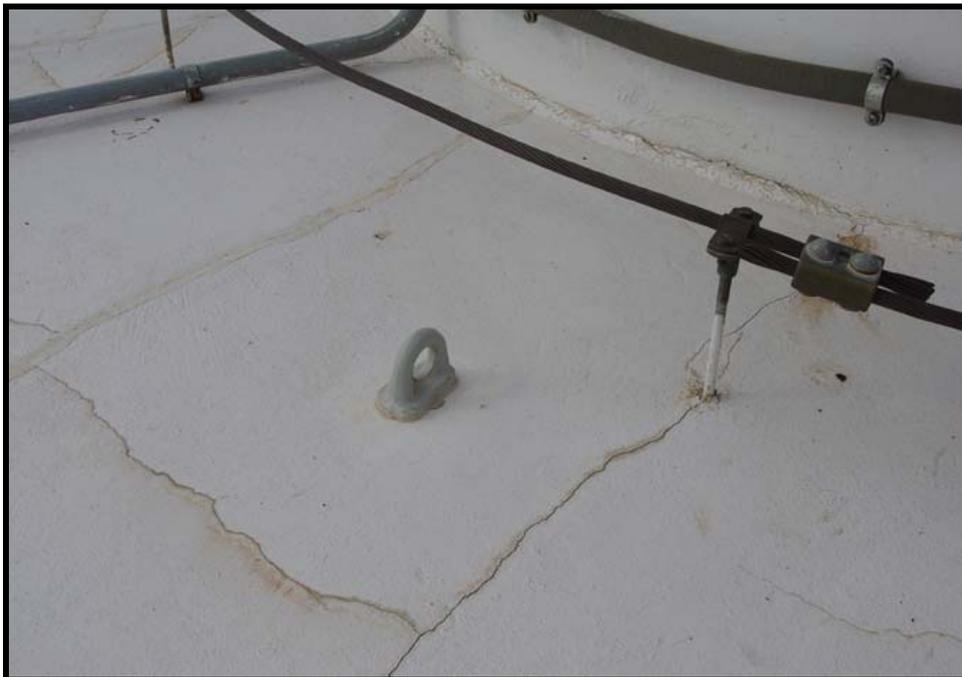
PHOTO 3.11-18 Unused lug, cracks in roof, and grounding cable on roof.

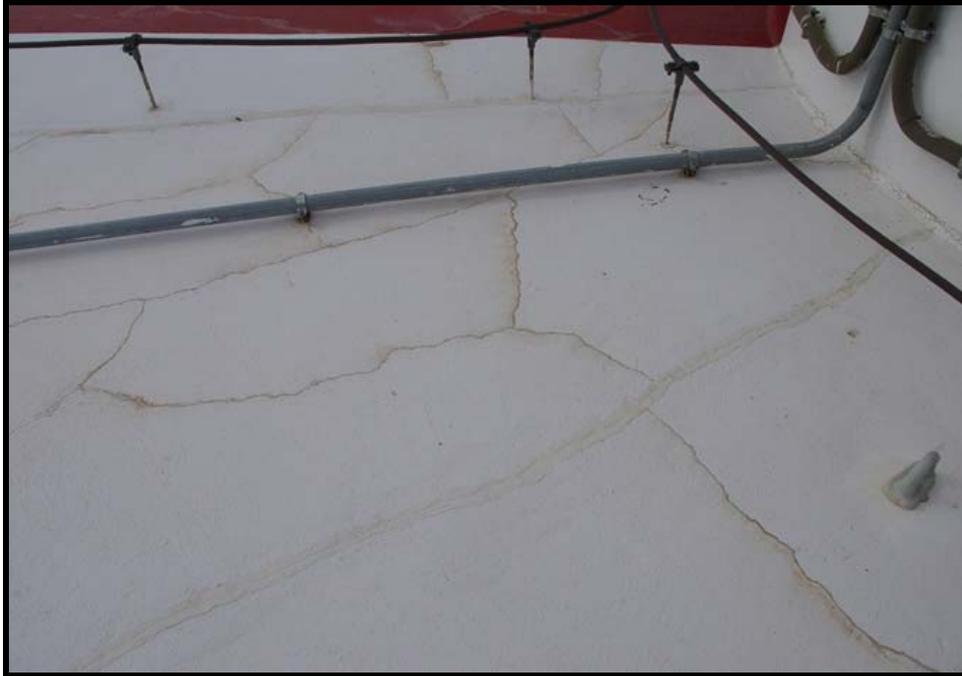
PHOTO 3.11-19 Cracks in coating and roof, and conduit on roof.

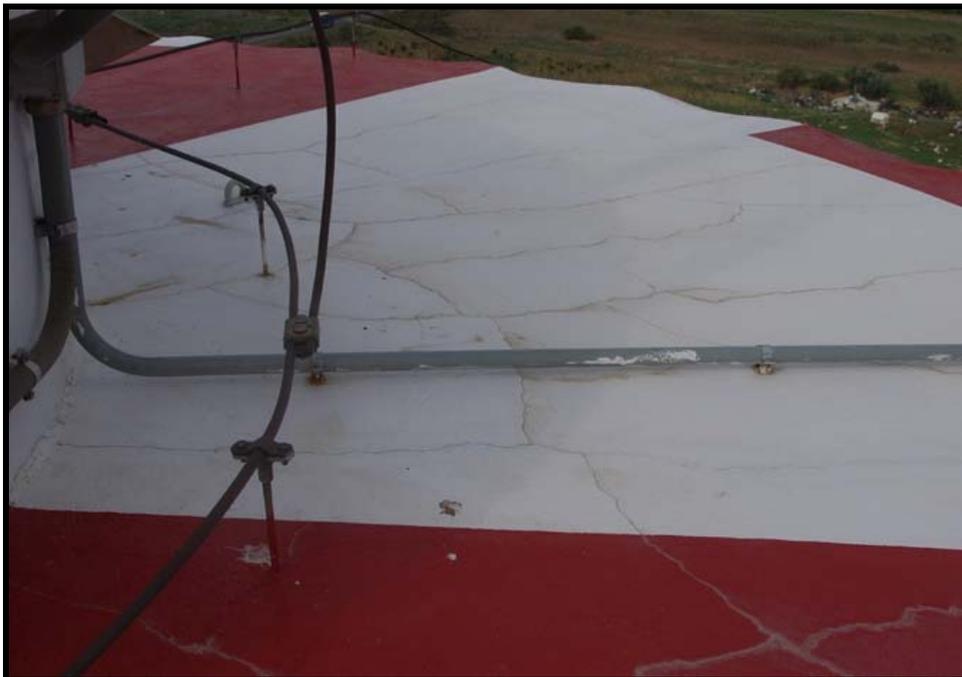
PHOTO 3.11-20 Grounding cable, conduit, and cracks in coating and roof.

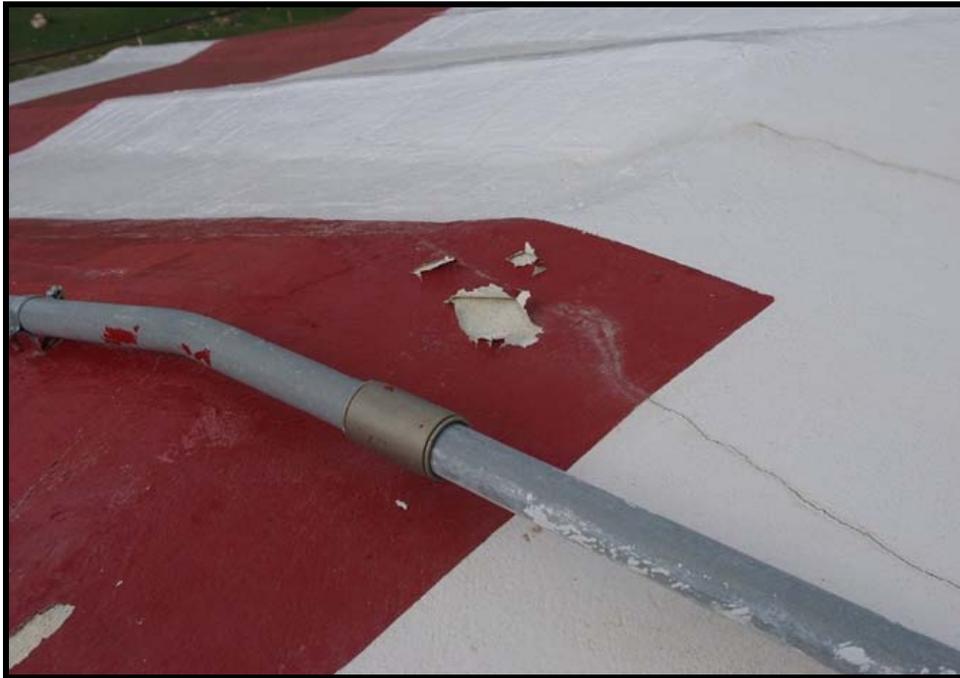
PHOTO 3.11-21 Peeled coating and conduit on roof.

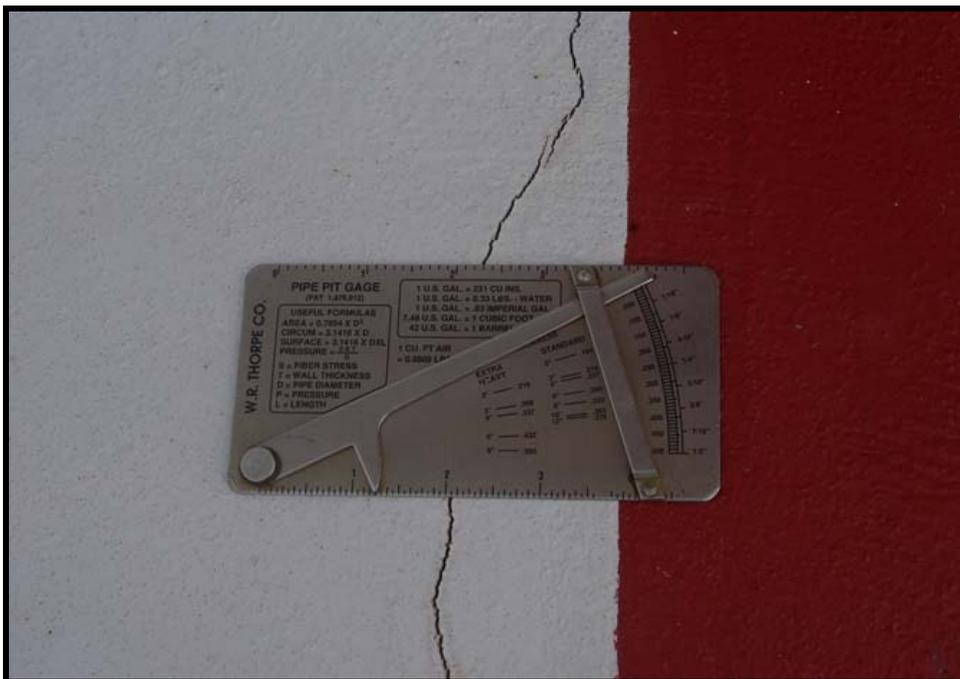
PHOTO 3.11-22 Crack in roof.

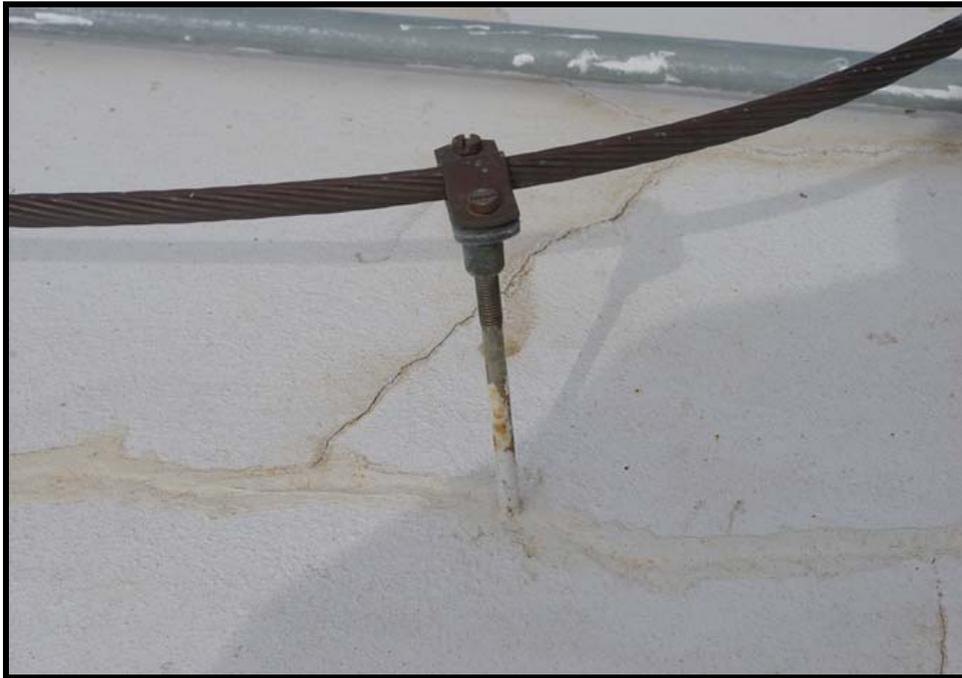
PHOTO 3.11-23 Grounding cable and cracks in roof.

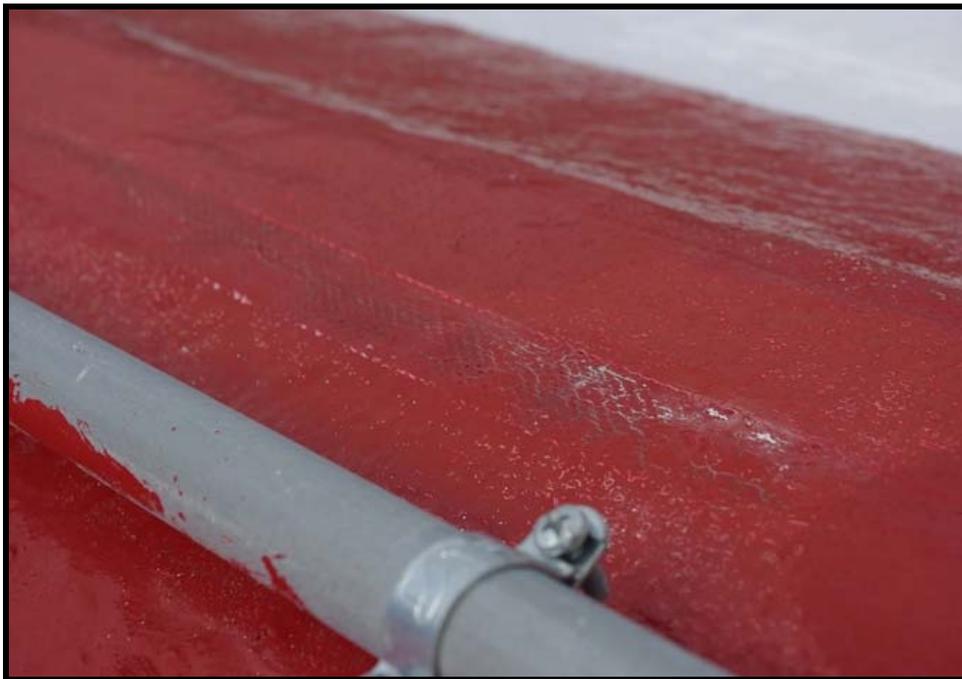
PHOTO 3.11-24 Faded coating on roof.

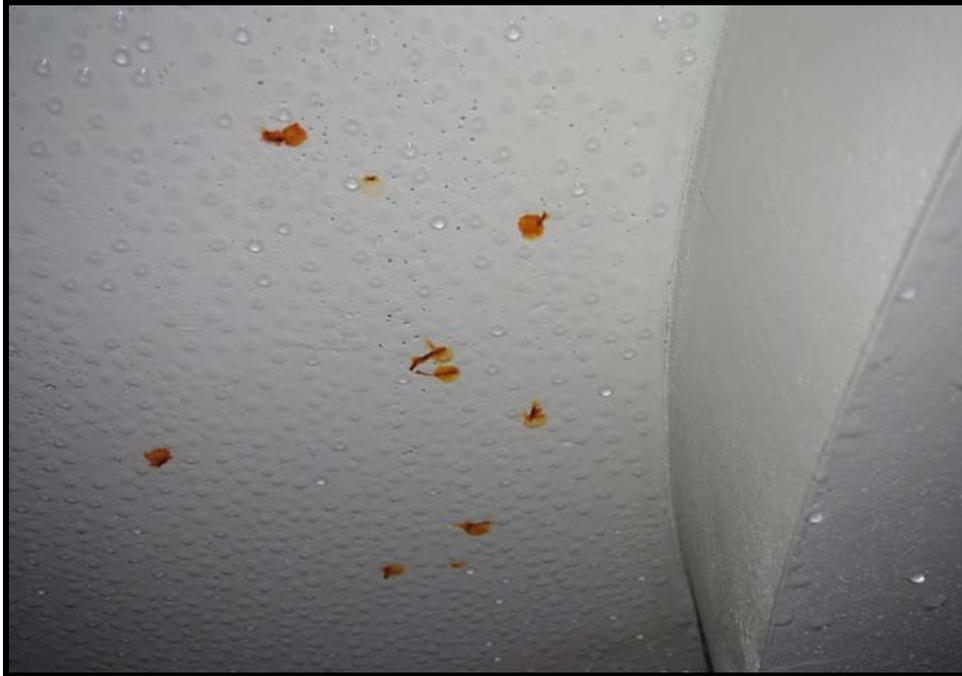
PHOTO 3.11-81 Rust staining on interior container roof.

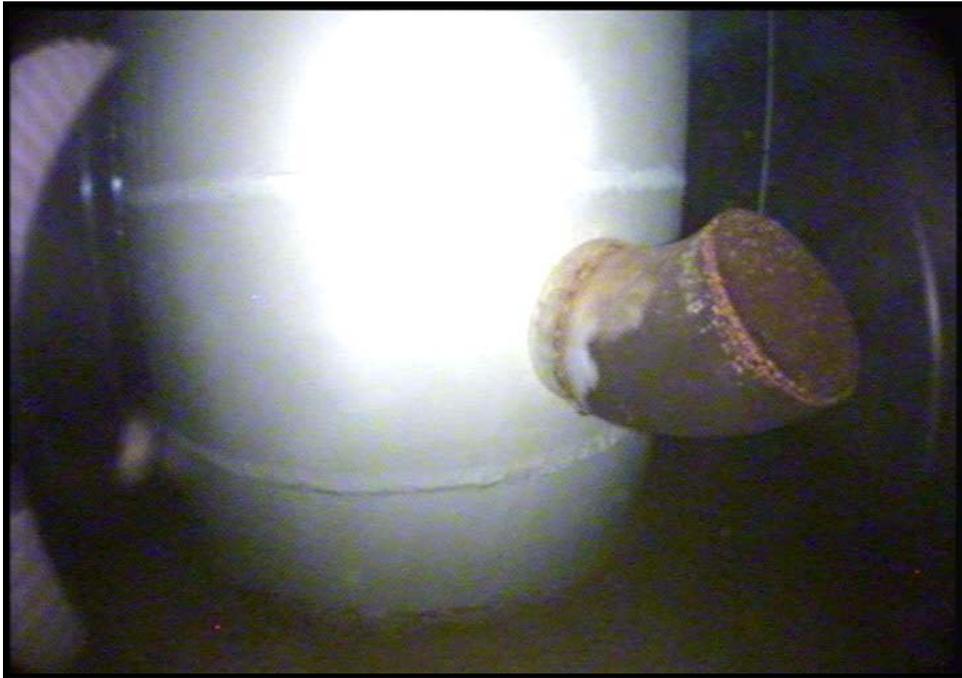
The inlet/outlet pipe projects from near the base of the access tube and is covered with corrosion (See photos 3.11-101 and 3.11-102). A drain pipe opening is located adjacent to the access tube penetration through the bowl dome (See photo 3.11-103).

PHOTO 3.11-101 Corrosion on pipe projection.

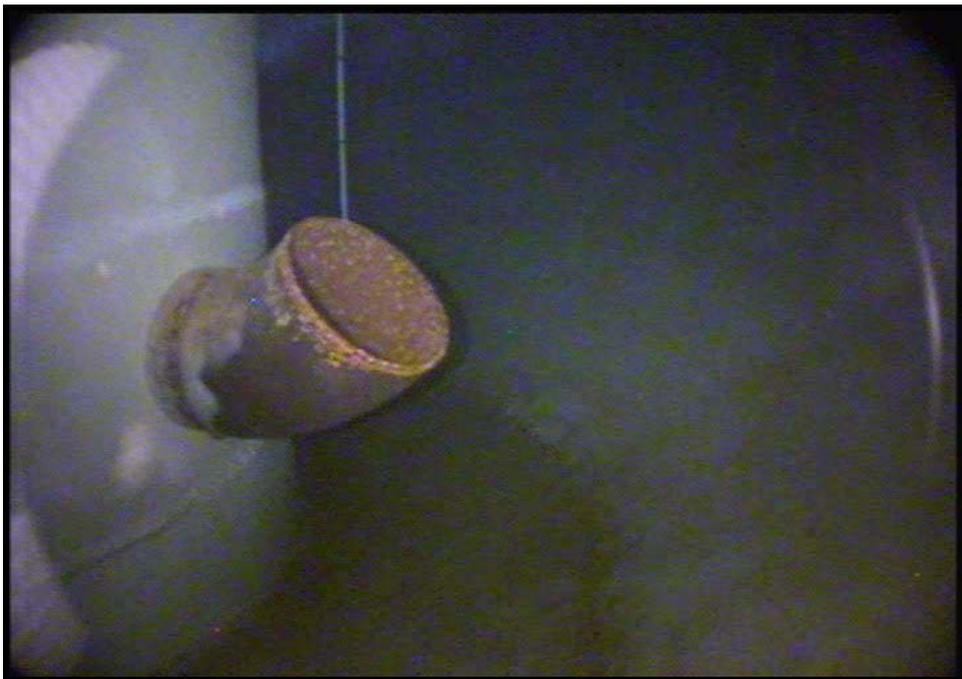
PHOTO 3.11-102 Corrosion on pipe projection.
