3.10 TANK 425

Tank 425 stores nonpotable water for the Naval Air Station in Sigonella, Italy.

3.10.1 Description of the Facility

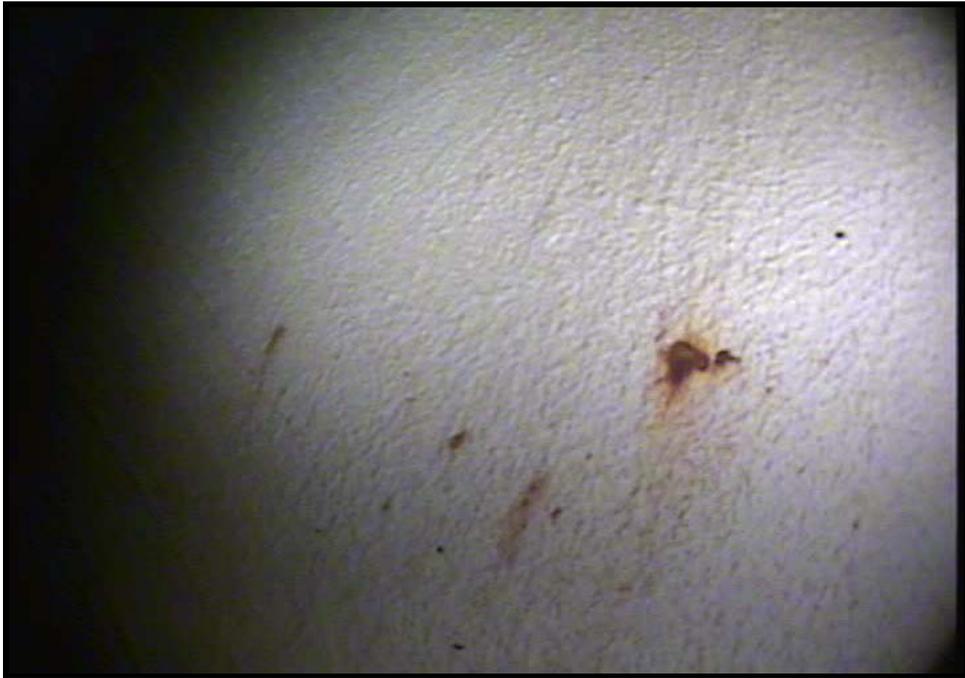
PHOTO 3.11-107 Rust staining on bowl cone.

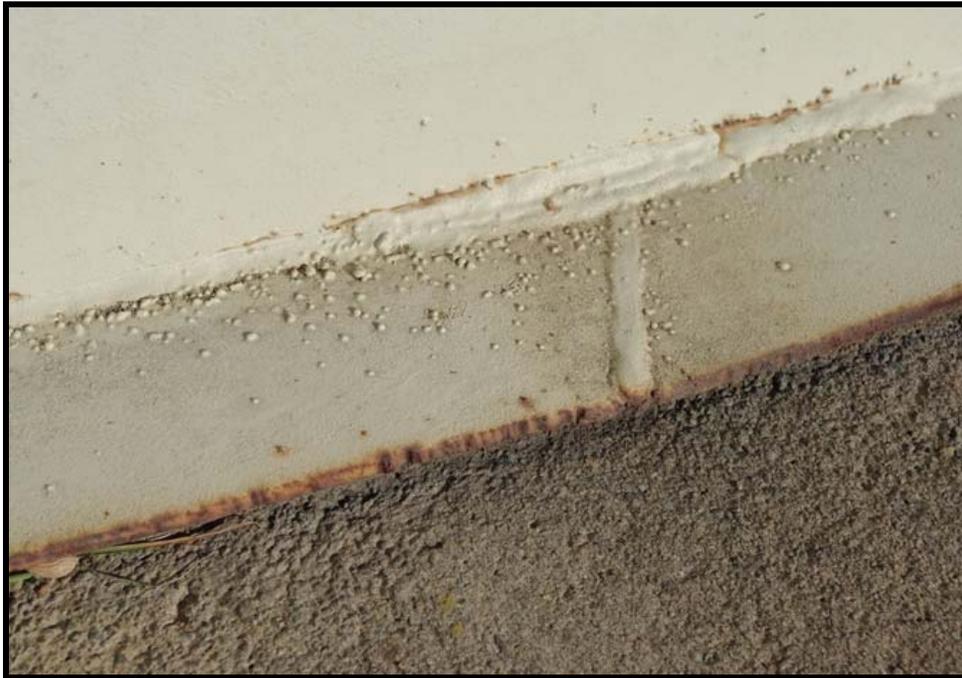
PHOTO 3.12-7 Corrosion along edge and weld spatter on top surface of bottom plate.

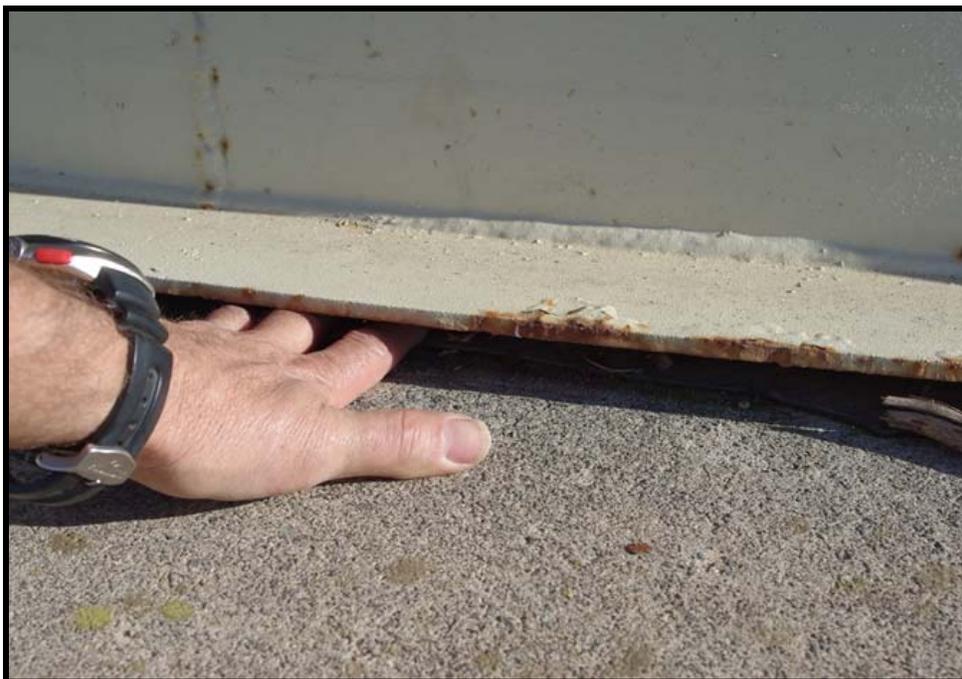
PHOTO 3.12-8 Gap between foundation and bottom plate.

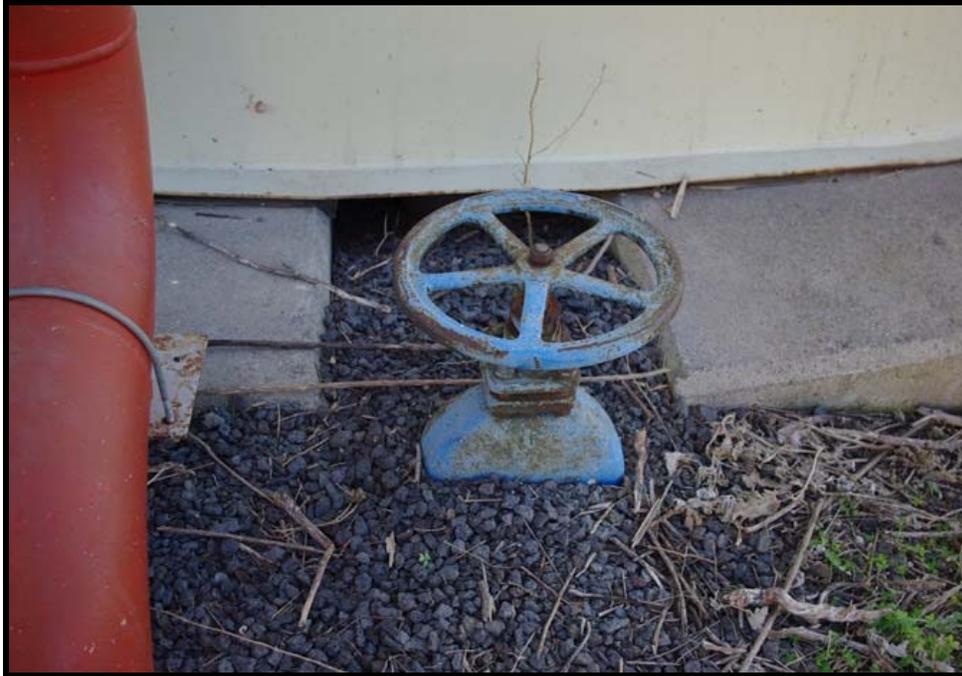
PHOTO 3.12-11 Corrosion on valve for exterior piping.

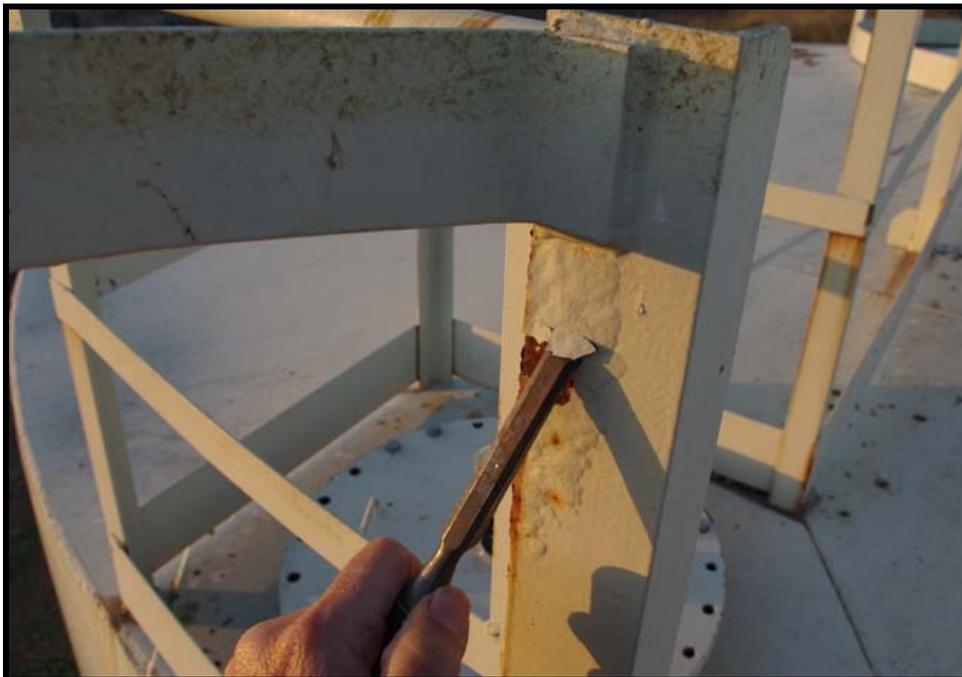
PHOTO 3.12-28 Corrosion on roof safety railing.

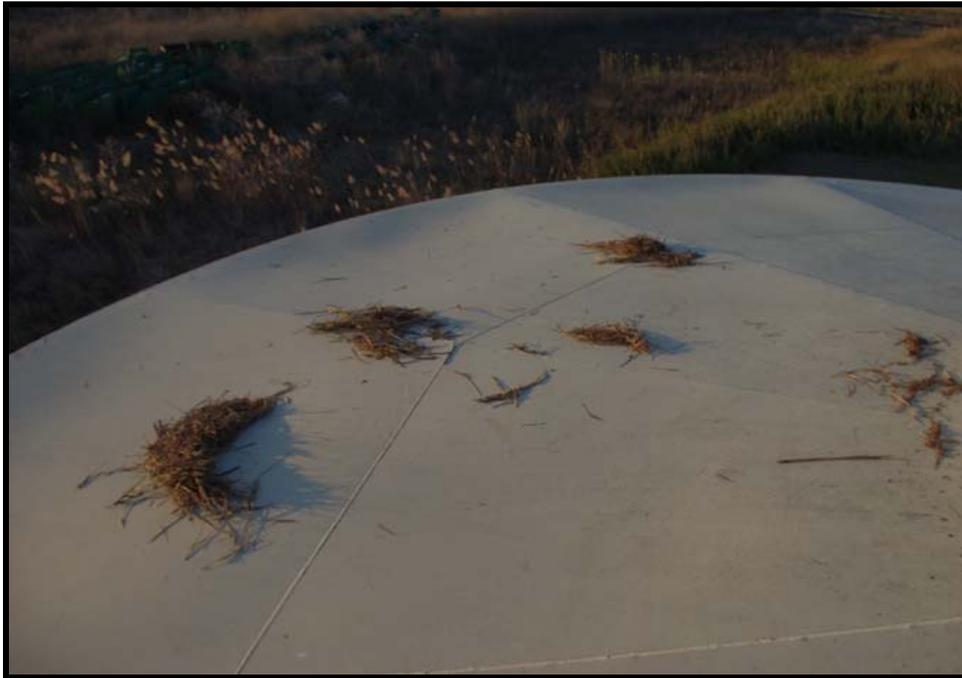
PHOTO 3.12-29 Debris on roof.

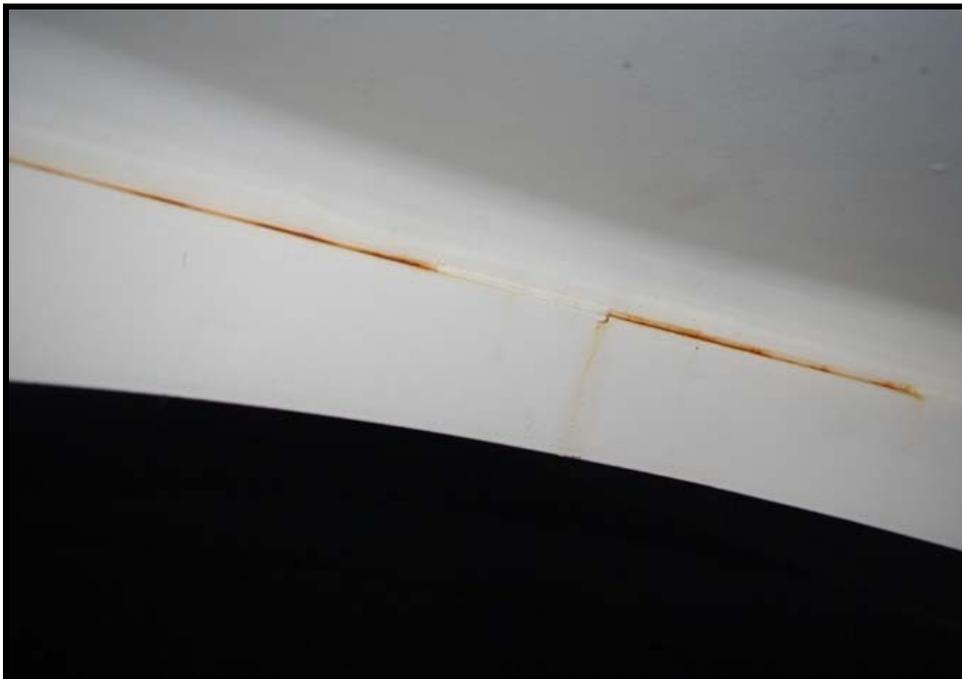
PHOTO 3.12-38 Rust staining along roof stiffener.

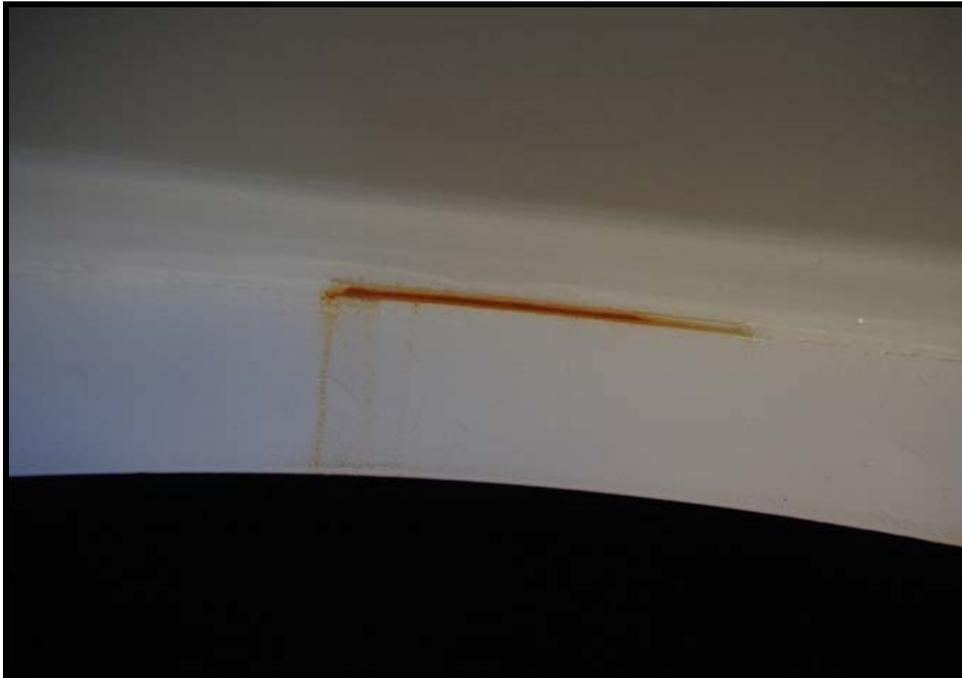
PHOTO 3.12-39 Rust staining along roof stiffener.

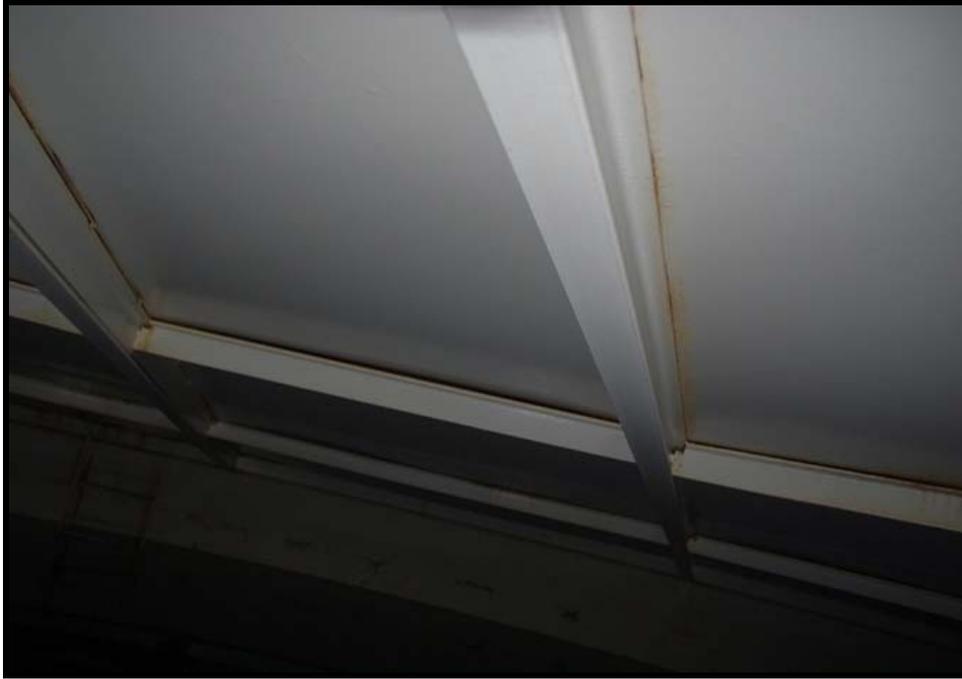
PHOTO 3.12-41 Rust staining along roof stiffeners.

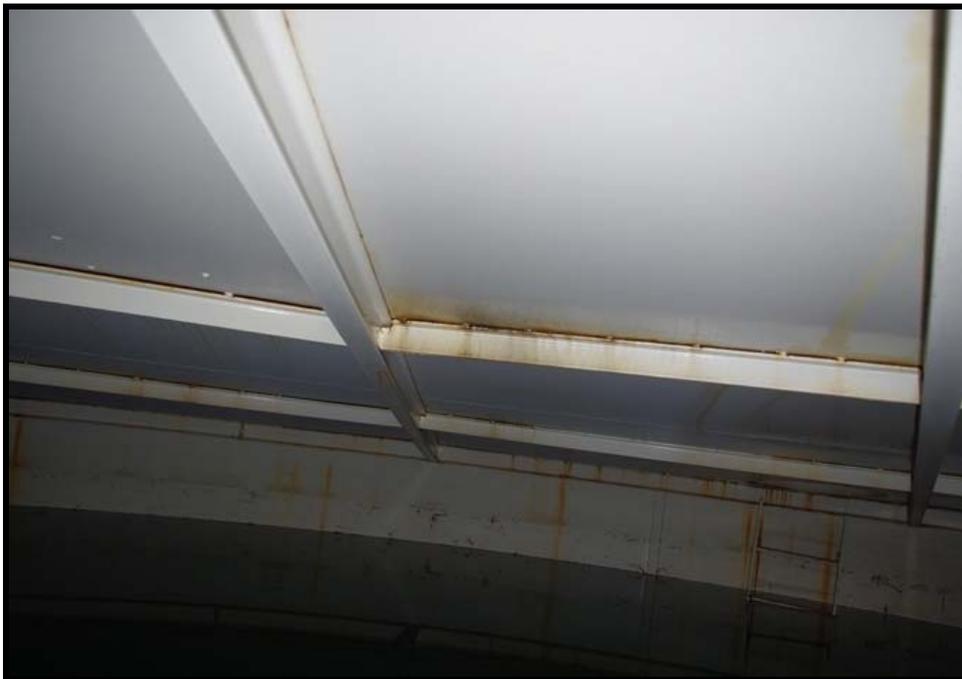
PHOTO 3.12-42 Rust staining along roof stiffeners.

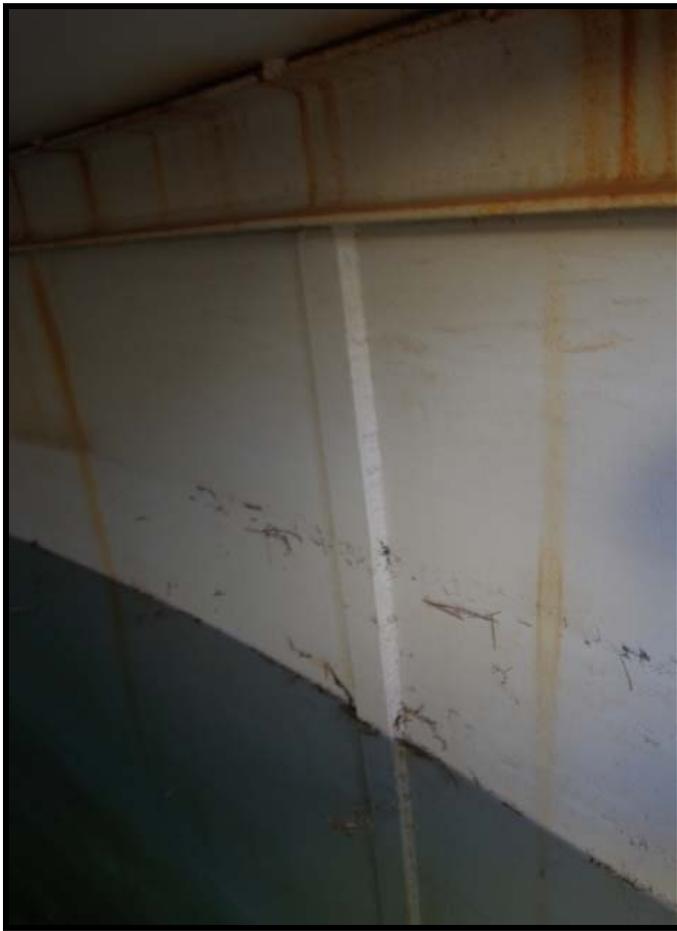
PHOTO 3.12-45 Rust staining on upper shell.
