Subject: **Roof Inspection and Draft Report**

Repair Building 1001 and interior improvements for DAPS  
Project No.: Qu1402M  
HJCG No: 2015-089  
Marine Corps Base, Quantico Virginia

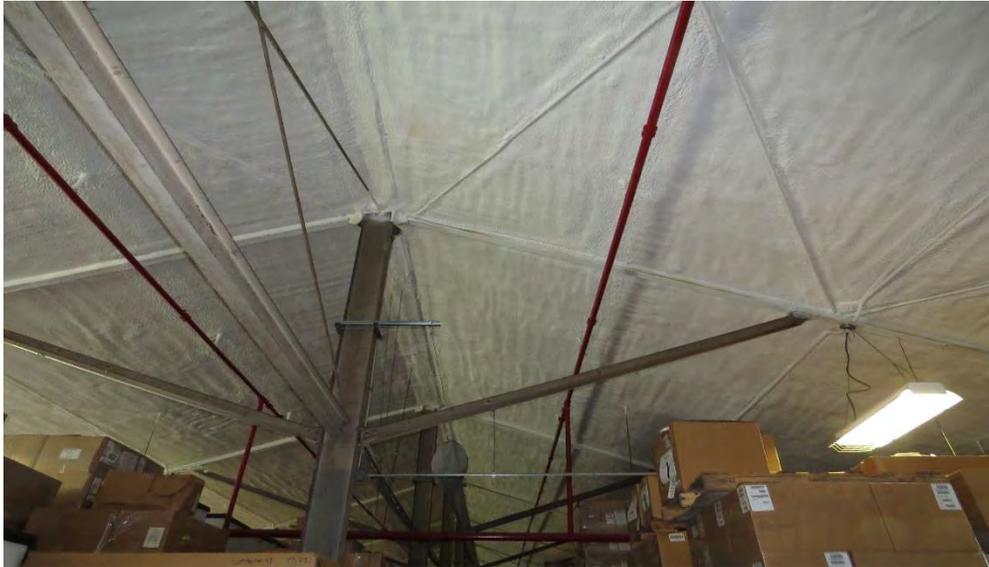
During the inspection, a spray foam adhesive appears to have been installed onto the underside of the existing decking. The thickness of the insulation is unknown, and the roof deck was not visible at the time of the inspection.

**Photo 01:** Overview of the underside of the roof deck. A sprayed in place polyurethane foam was sprayed to the underside of the roof deck and painted.

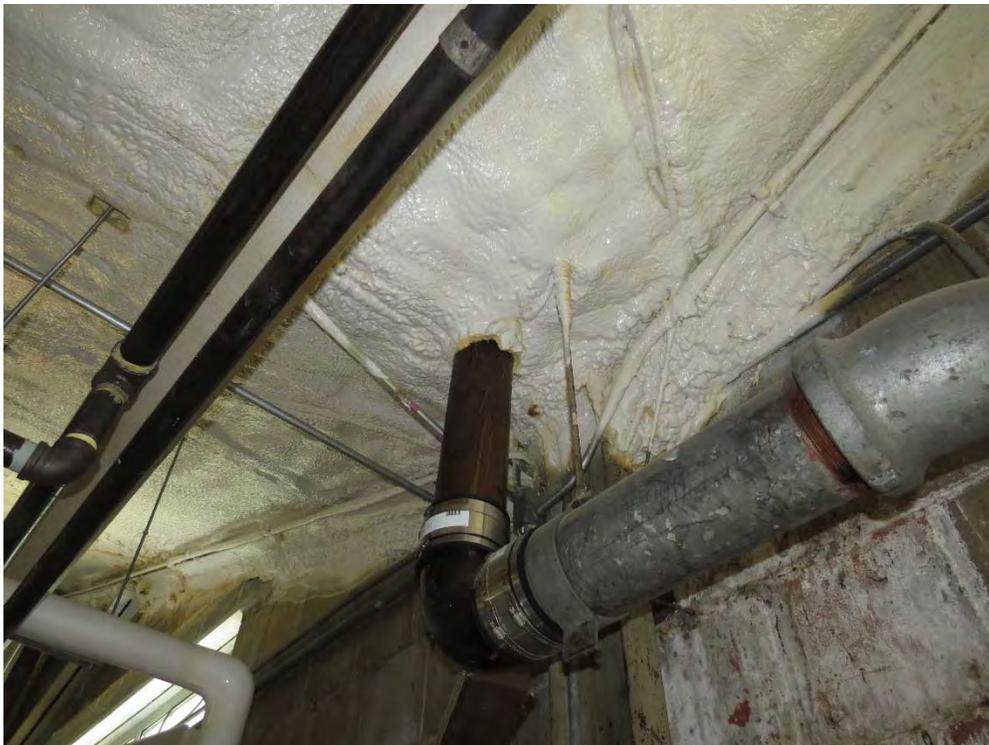
**Photo 02:** Detailed view of the spray foam applied to the deck and the drainpipe.

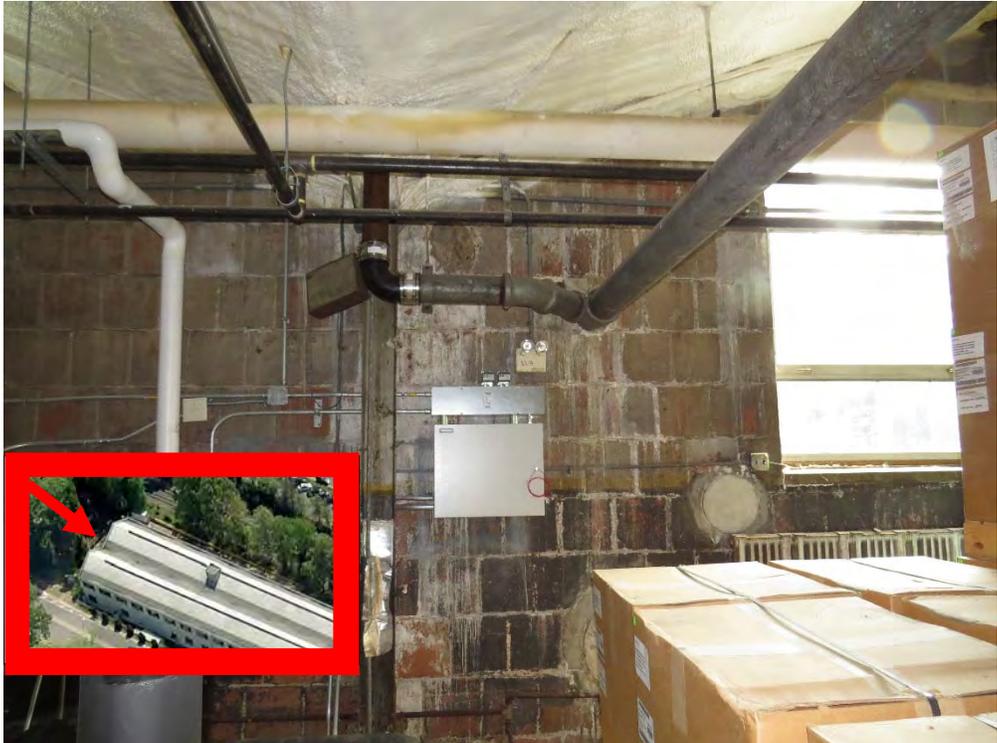
The roof leaks located at the northern most location was at the center of the building, adjacent to the centermost roof drain along the northern wall. The leaks occur following a heavy rain.

**Photo 03:** Overview of the leak location at the northern wall.

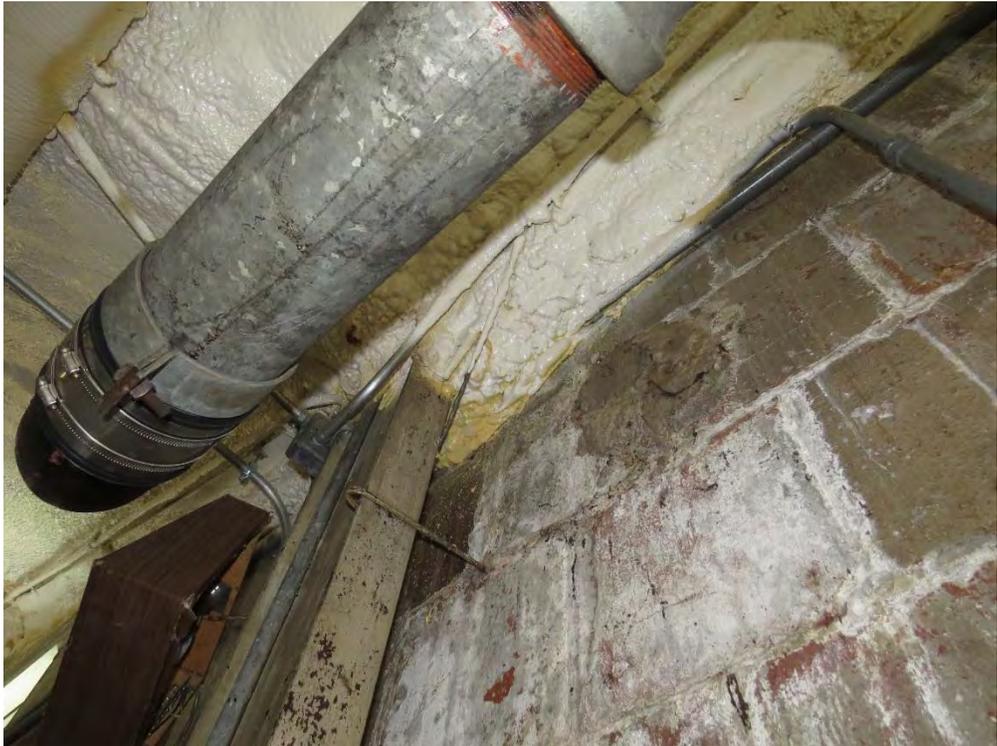
**Photo 04:** Detailed view of the spray foam applied at the drainpipe.

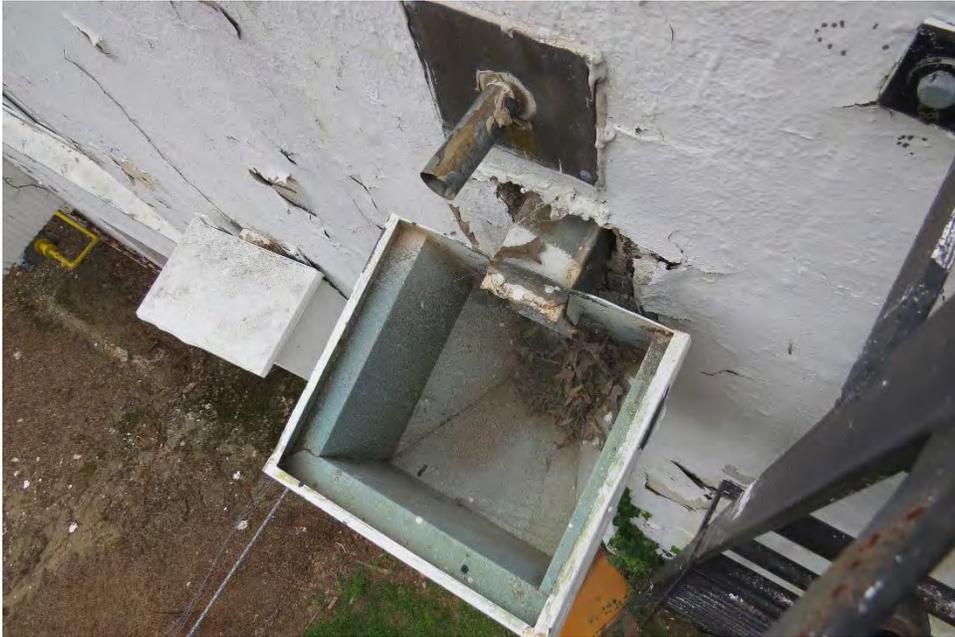
While the drain strainer was restricted, and it is likely that this area ponded water, it appears that the roof drain carries water from the roof, through interior piping. The stains on the wall indicate that the water infiltration may be coming from the abandoned exterior copper conductor. The exterior scupper box was found to be open and loose, allowing water to flow into the building.

**Photo 05:** Overview of the scupper from exterior ladder.

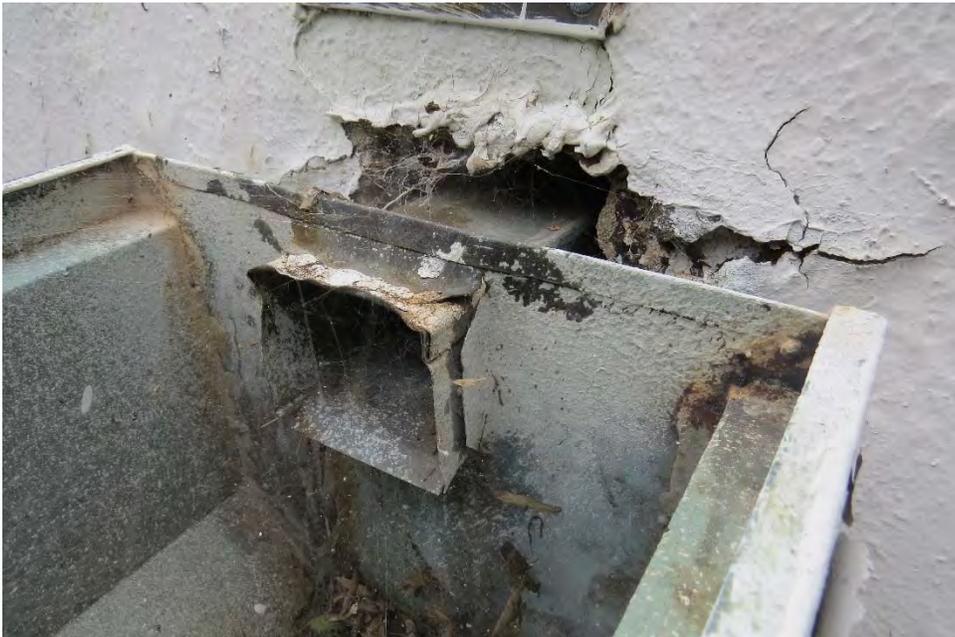
**Photo 06:** Detailed view of the loose conductor.

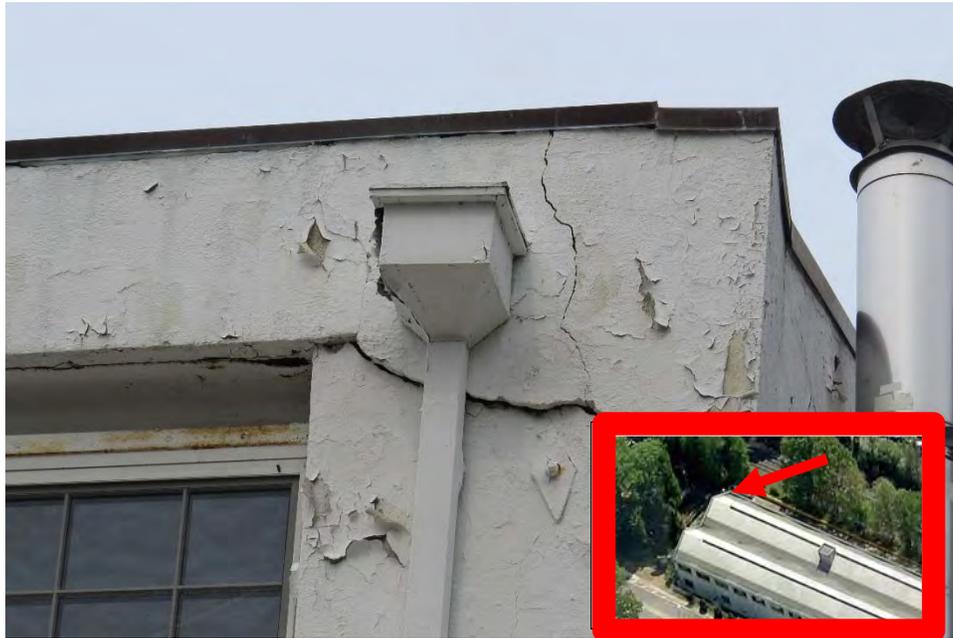
This condition was also noted at the northeast corner, with displaced masonry observed.

**Photo 07:** Overview of the northeast conductor box and exterior masonry conditions

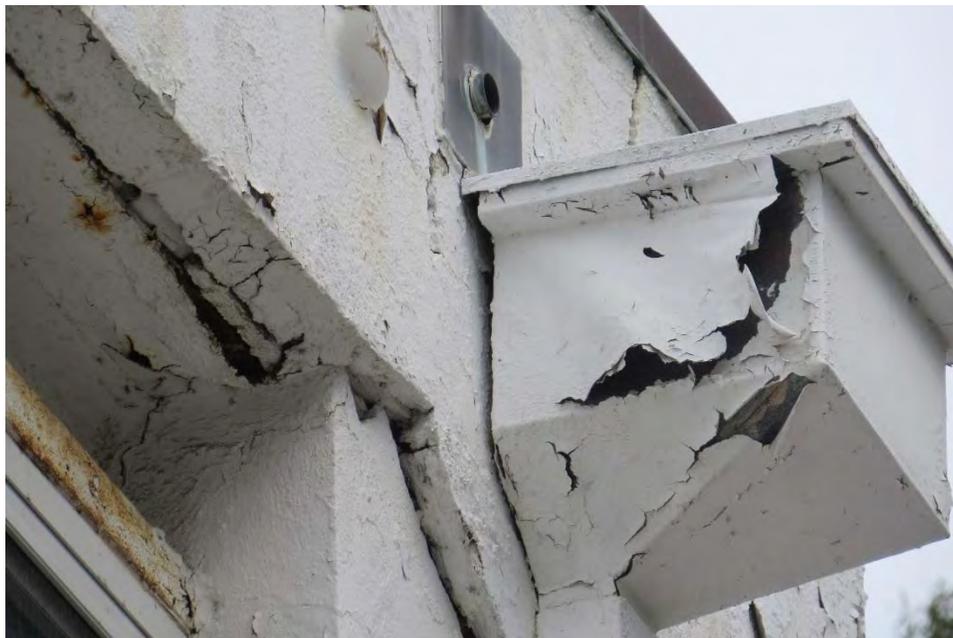
**Photo 08:** Detailed view of the drain conductor.

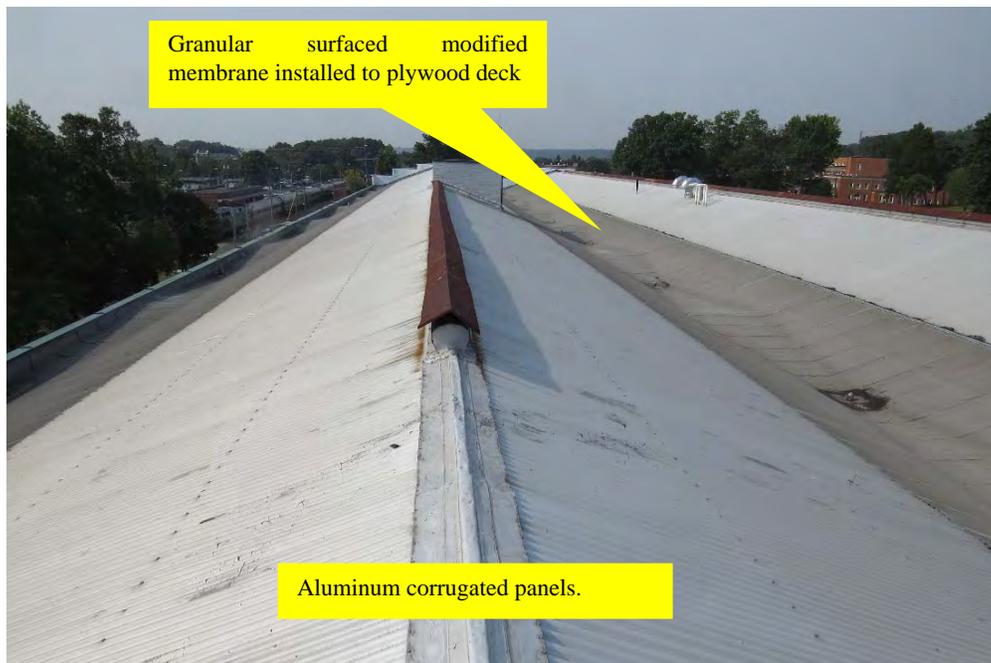
The corrugated steep sloped roof panels extend 16' from peak to eave overlapping and draining onto the granular surfaced modified membrane. Numerous fasteners were found to be loose and missing, resulting in several overlapping panels found to be loose and open.

**Photo 10:** Overview of the roof area looking south from the north wall.

It is our recommendation that the corrugated metal, and granular surfaced main roof areas be removed to the existing roof deck, and a new insulated roof system and all related metal flashing components be installed that includes a long-term (20-30 year) Manufacturer's labor and material warranty.

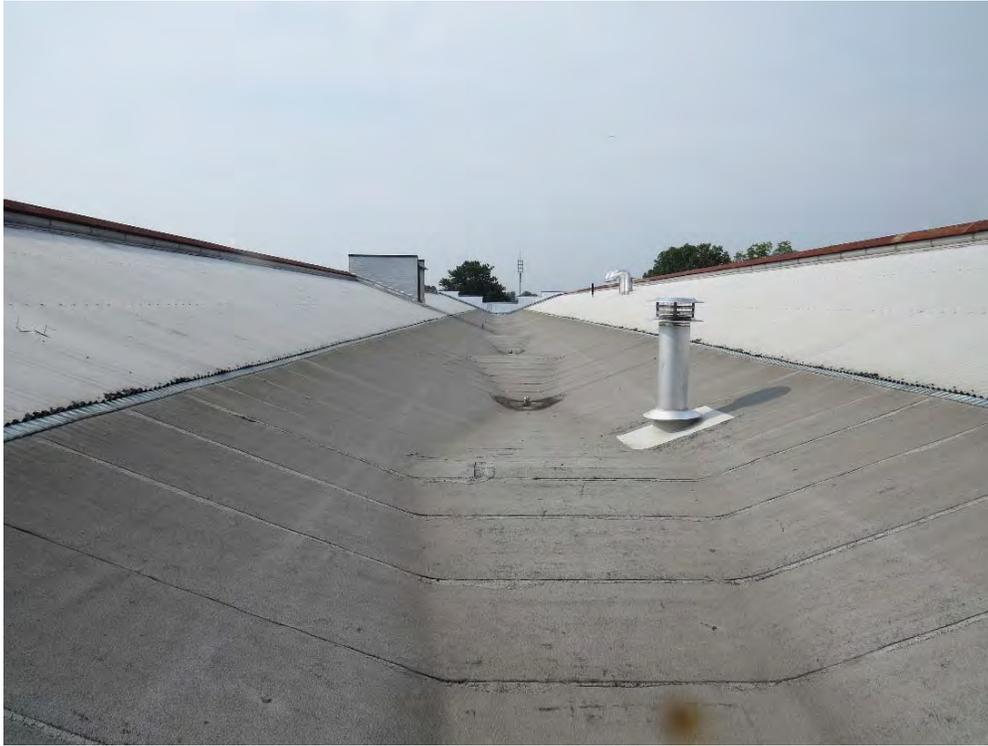
The roof areas covered by the granular surfaced membrane were found to be in generally poor condition, with numerous deficiencies observed that include clogged drain strainers open field seams and splits that coincided with loose plywood decking.

**Photo 11:** Overview of the granular surfaced membrane looking south from the north.

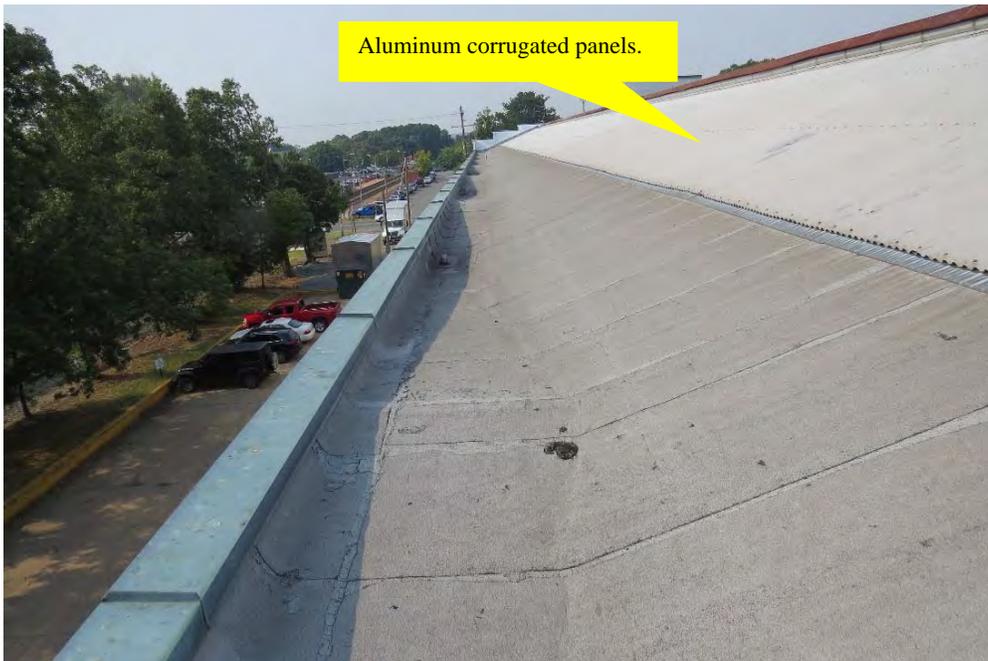
The 10' areas along the eastern and western ends of the building are also covered with the granular surfaced membrane with similar crickets and deficiencies observed.

**Photo 12:** Overview of the membrane looking south from the north.

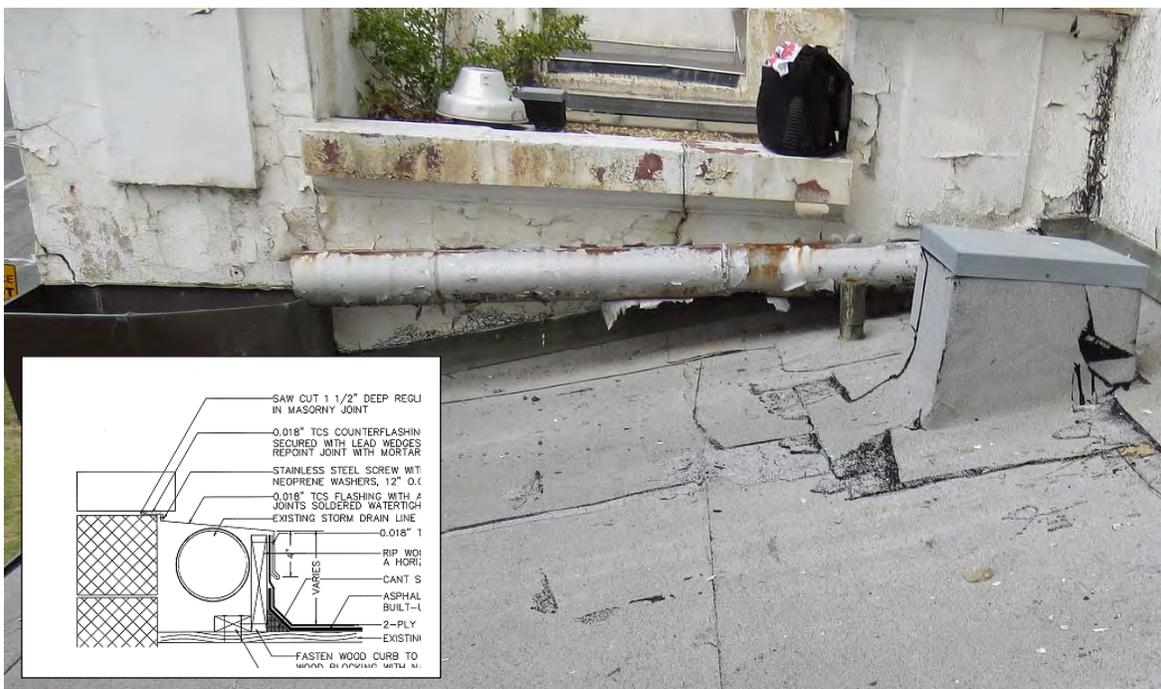
A gravel surfaced built-up roof covers the western roof area, while the rubberized waterproofing system is installed on the center roof area, and is installed as shown within the documents previously reviewed. The granular surfaced membrane is also installed to the wood deck of the one story addition to the east as shown on the drawings; however, the pipe enclosure was not installed as specified.

**Photo 14:** Overview of the pipe running across the roof surface of the eastern lower sloped roof.

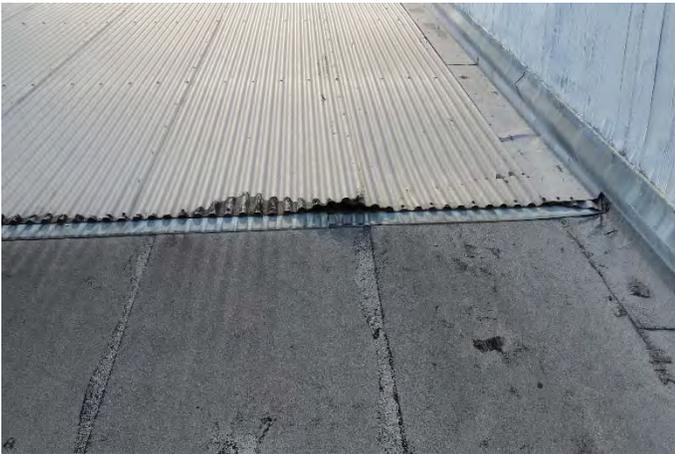
During the inspection loose and missing fasteners were observed at numerous locations. Several areas of the corrugated aluminum roof panels were found loose and unsecured, potentially allowing wind driven rain or snow to enter below the metal panels.

**Photo 21:** Overview of loose metal roof panels.

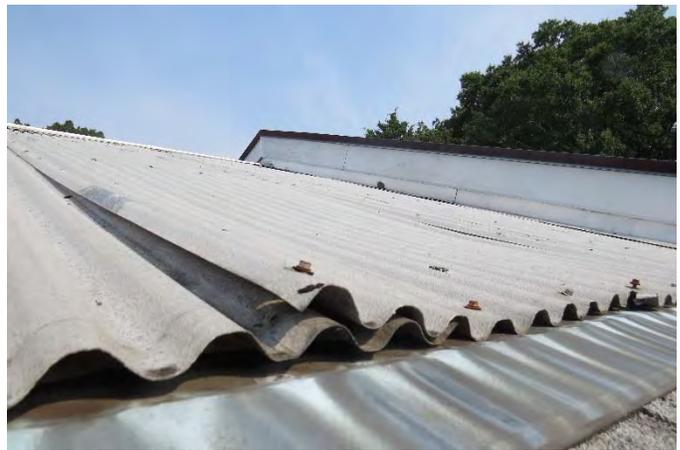
**Photo 22:** Detailed view of loose metal roof panels.

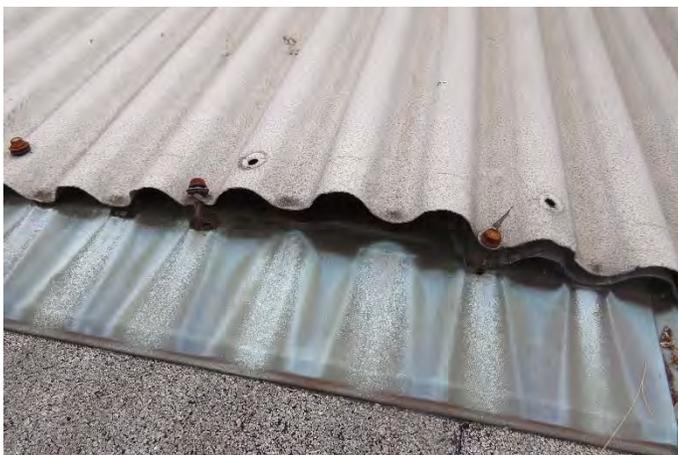
**Photo 23:** Overview of missing fasteners and loose panels.

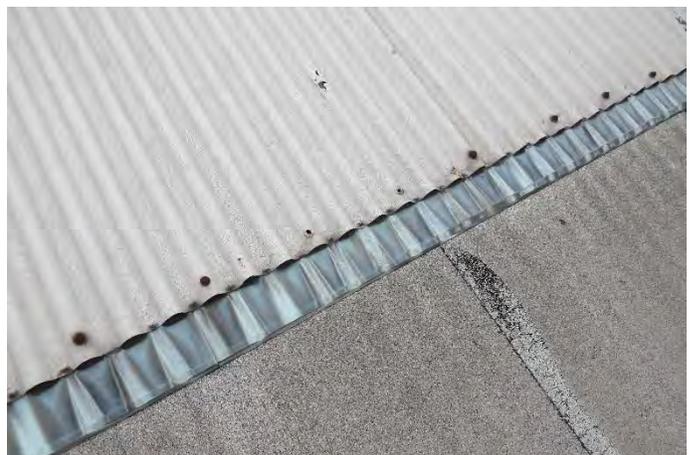
**Photo 24:** Overview of missing fasteners.

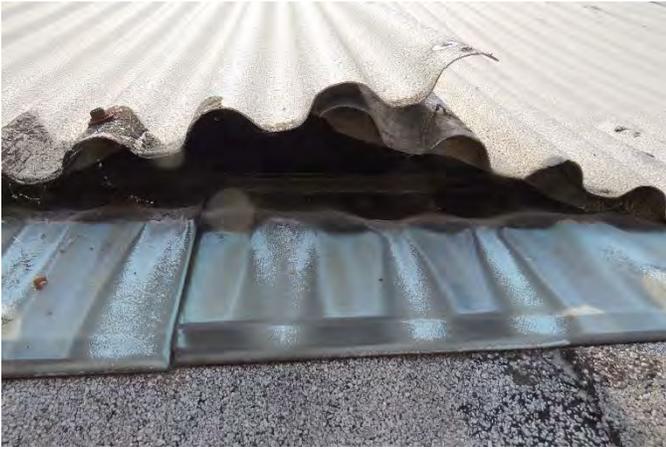
**Photo 25:** Detailed view of failed fasteners.

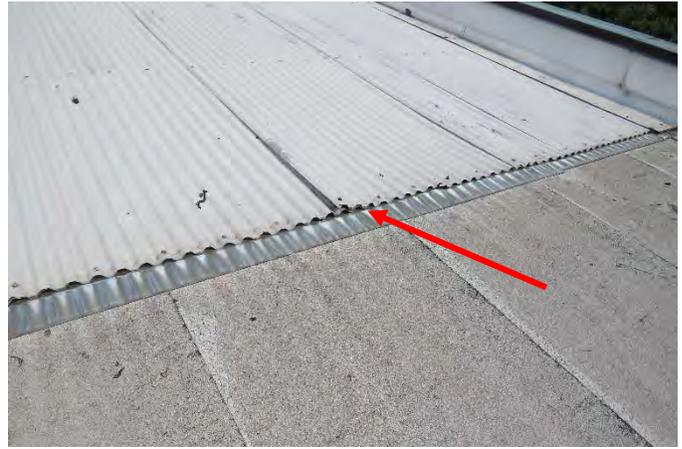
**Photo 26:** Overview of failed fasteners.

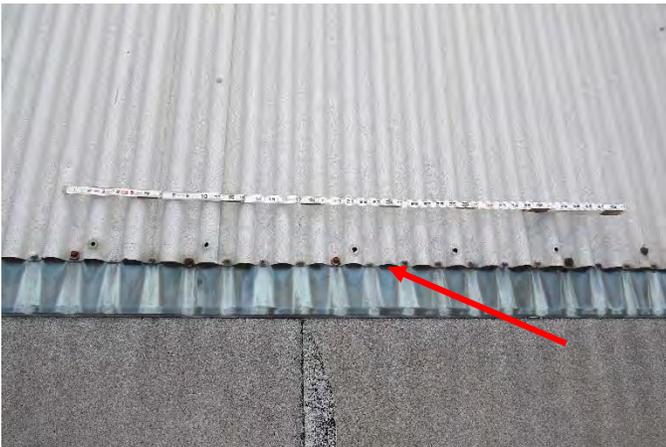
**Photo 27:** Overview of repaired metal panels and unsealed holes from previously installed failed fasteners.

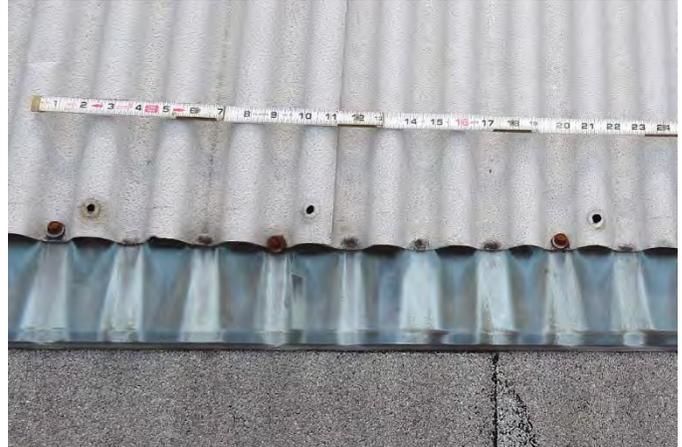
**Photo 28:** Detailed view of repaired metal panels and unsealed holes from previously installed failed fasteners.

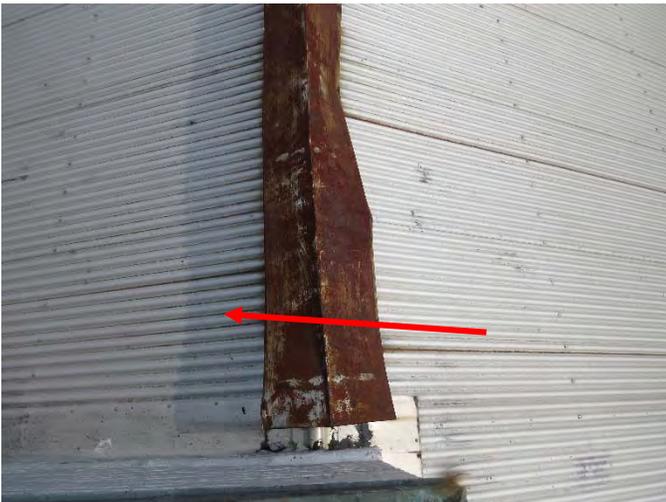
**Photo 29:** Overview of weathered ridge cap

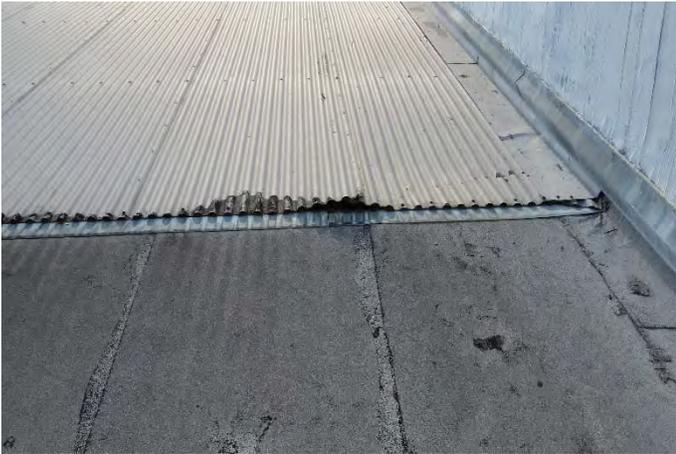
During the inspection loose and unsecured corrugated aluminum roof panels were found along the gutter edge where areas of missing or loose fasteners were noted. These areas can potentially allow wind driven rain or snow to enter below the metal panels and into the building if left unaddressed.

**Photo 31:** Overview of loose metal roof panels.

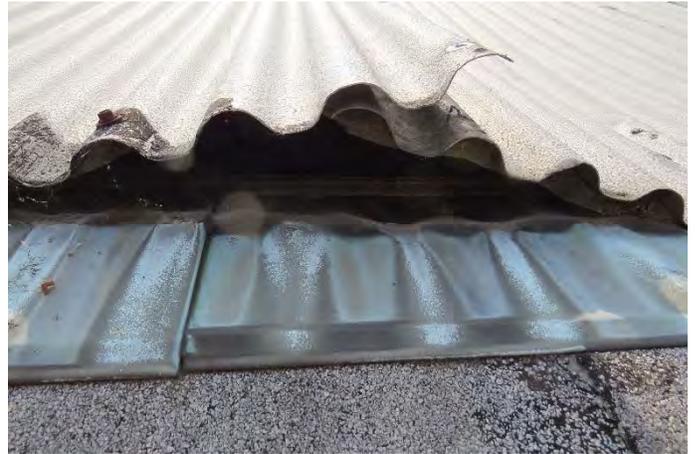
**Photo 32:** Detailed view of loose metal roof panels.

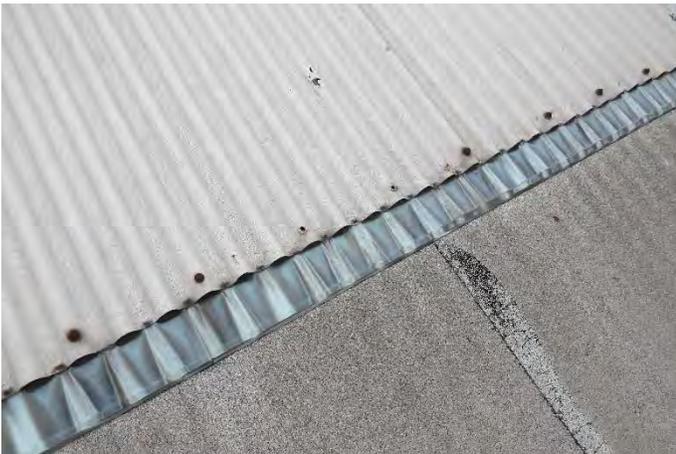
**Photo 33:** Overview of loose metal roof panels.

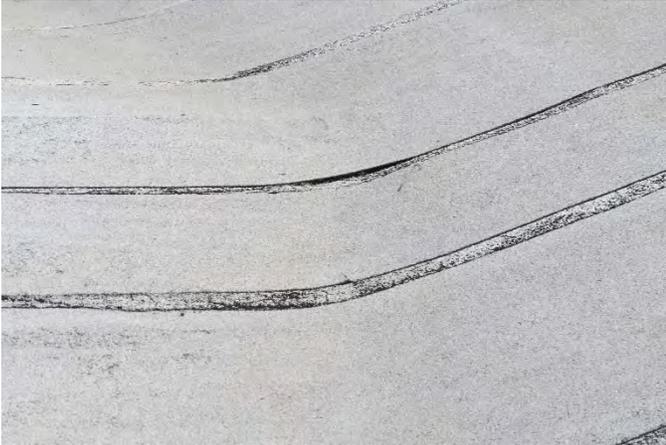
Numerous splits and cracks were noted throughout the roof. The splits and cracks are at various stages, with some cracks completely through the membrane, and other cracks through the top layer into the reinforcement. These cracks will continue to allow water to enter the building.

**Photo 37:** Overview of open field seams.

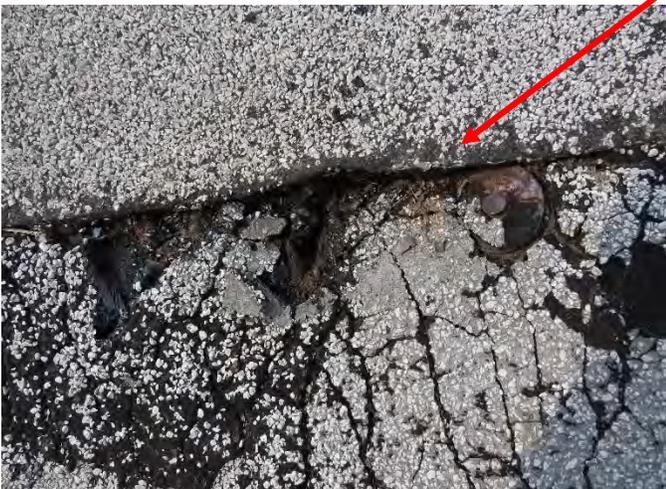
**Photo 39:** Detailed view of membrane splits. Note the fastener used in an attempt to secure the lap. The plywood was observed through the membrane splits at this

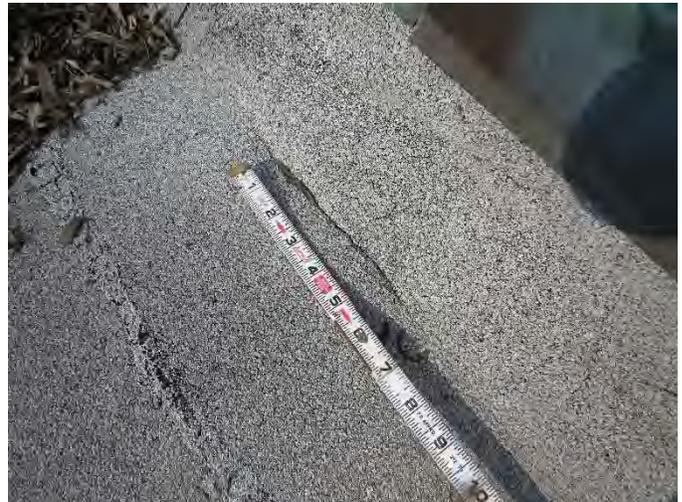
**Photo 40:** Detailed view of membrane split.

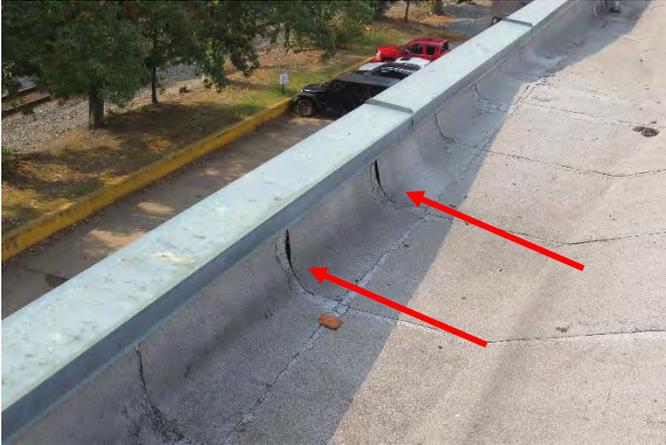
Numerous splits and cracks were noted throughout the roof. The splits and cracks are at various stages, with some cracks completely through the membrane, and other cracks through the top layer into the reinforcement. These cracks will allow water to enter the building.

**Photo 41:** Detailed view of membrane split.

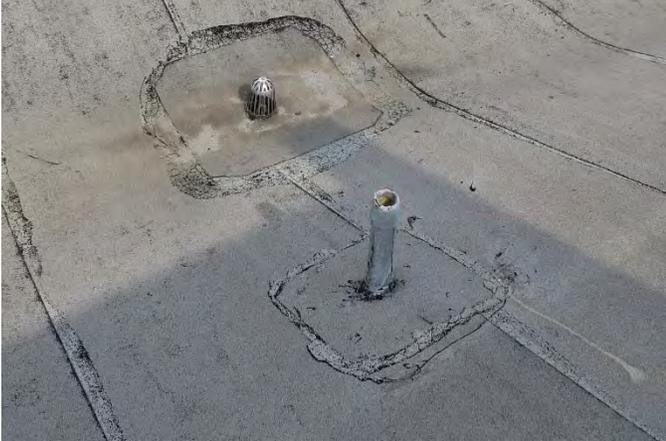
The lead flashings installed at the base of an existing plumbing vents were found to be weathered, split and open, providing a path for water to enter the building.

**Photo 45:** Overview of lead flashing.

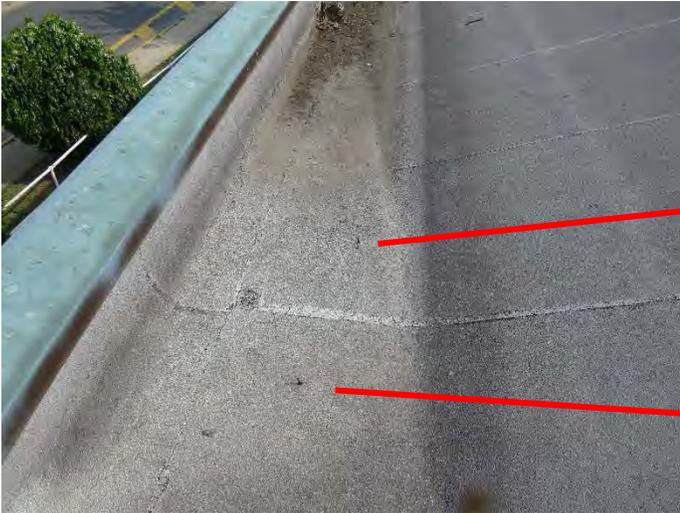
The nails used to secure the plywood decking at several locations had backed out through the roof membrane as shown below

**Photo 49:** Overview of plywood deck fasteners backing out through the membrane

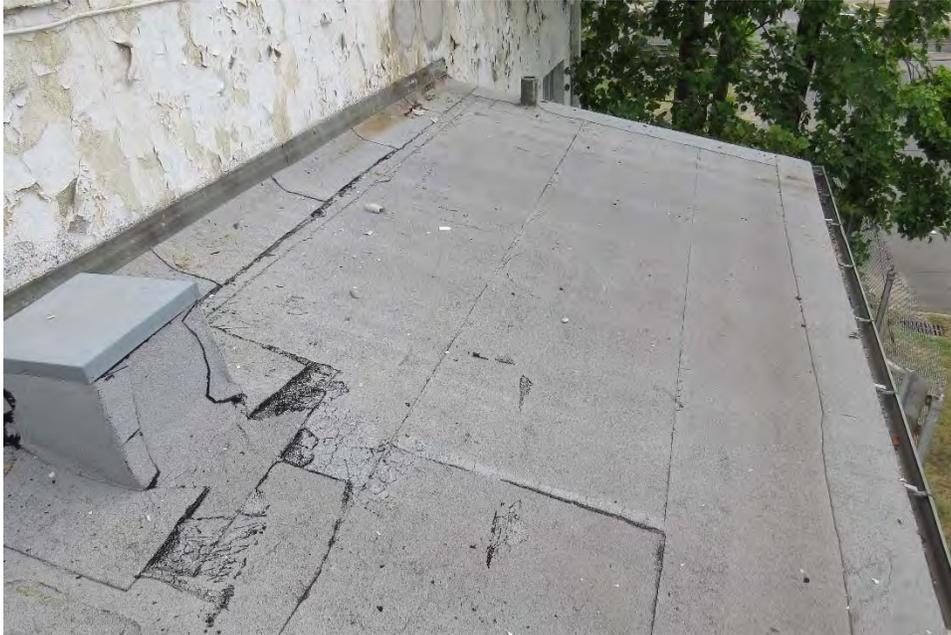
The granular surfaced modified membrane installed onto the southern sloped shed roof is in generally fair condition with a weathered surface observed. Generally the roof membrane is functioning as intended; however, the rising wall conditions are suspect and are potential points of water entry into the building if unaddressed.

**Photo 63:** Overview of the lower southern granular surfaced membrane covering the sloped shed roof looking east from the west.

The roof areas on the lower areas should also be considered for replacement once the exterior masonry work has been completed.

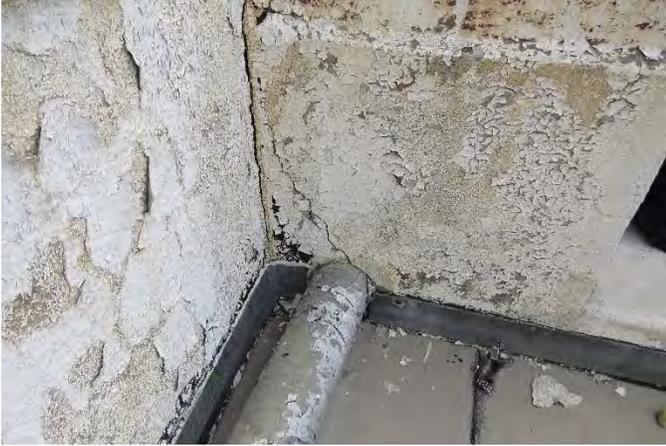
Numerous masonry cracks were observed at the rising wall at various flashing transitions. These cracks, if unaddressed can allow water to enter the building.

**Photo 65:** Overview of rising wall conditions adjacent to the rising wall flashing.

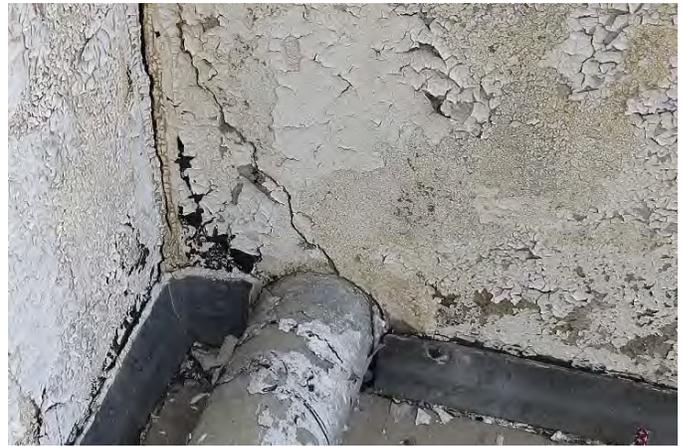
**Photo 66:** Detailed view of rising wall conditions.

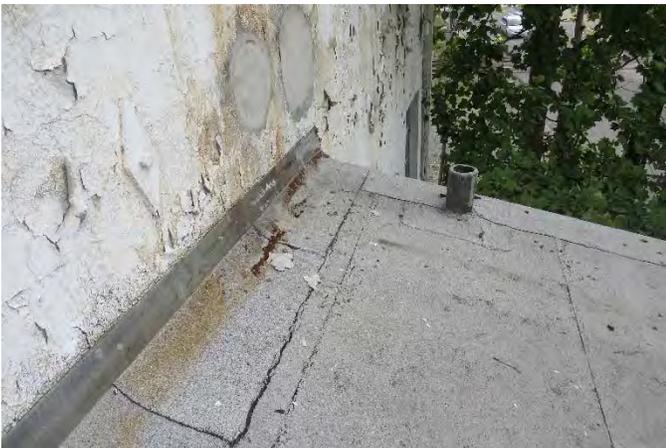
**Photo 67:** Overview of rising wall conditions.

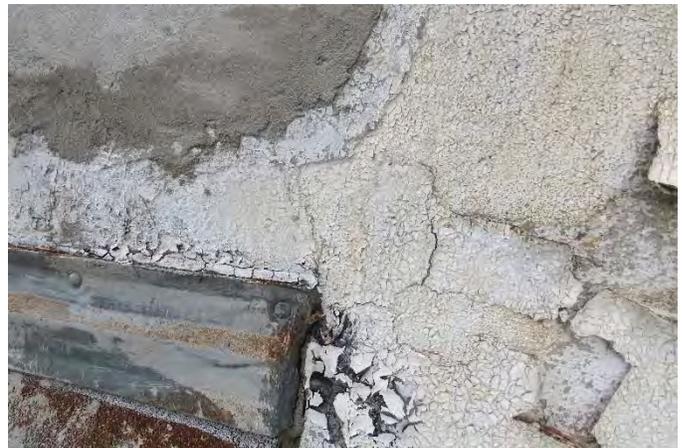
**Photo 68:** Detailed view of rising wall conditions adjacent to the rising wall counterflashing.

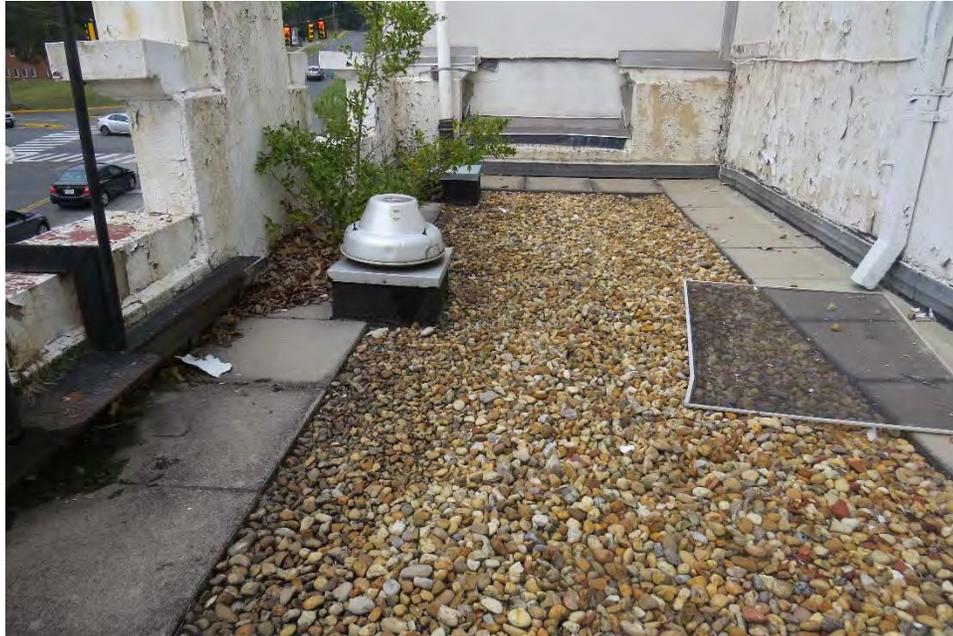
The existing rubberized asphalt protected waterproofing system appears to be functioning as intended. The rubberized membrane is protected with a layer of extruded polystyrene insulation and covered with filter fabric and pea gravel. Rising wall conditions and plant growth on the existing roof are areas of concern.

**Photo 69:** Overview of the roof system. Note plant growth behind roof curb.

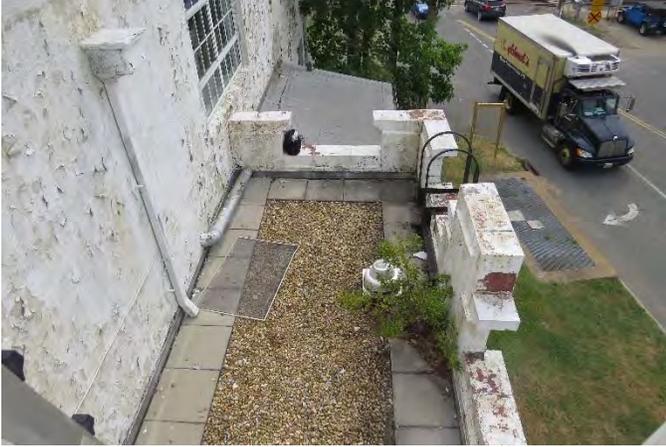
Several masonry transitional points were found to be open and unprotected. The inside corner of the roof area and rising wall conditions are open allowing wind driven rain to enter the building.

**Photo 71:** Overview of roof area from above.

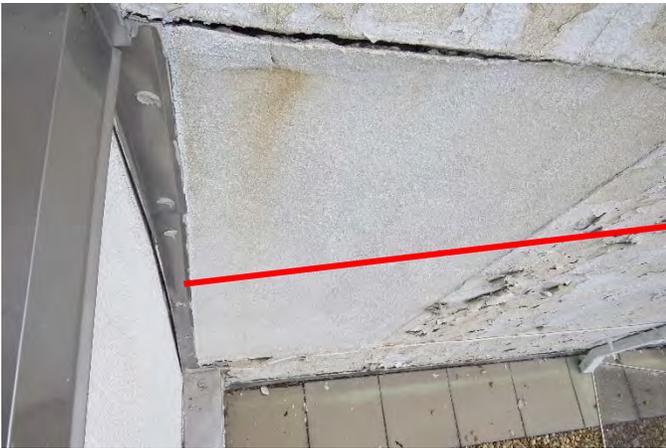
**Photo 73:** Overview of trim rising wall conditions.

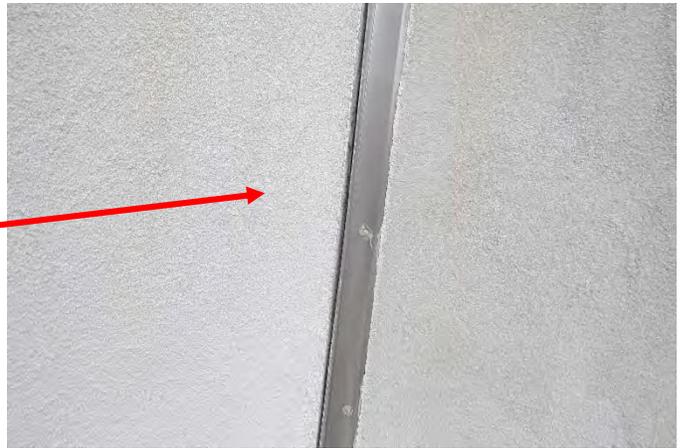
**Photo 74:** View of open metal trim used to cover masonry transition.

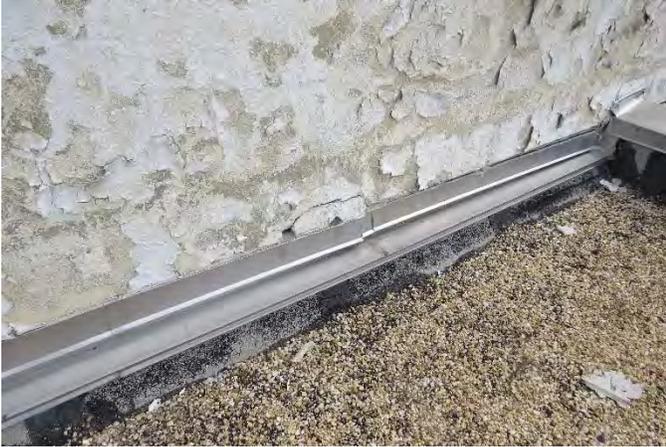
The rising walls continue to be areas of concern, with cracks, broken mortar, loose and open counterflashing observed that will allow wind driven rain to enter the building if unaddressed.

**Photo 71:** Overview wall condition above counterflashing.

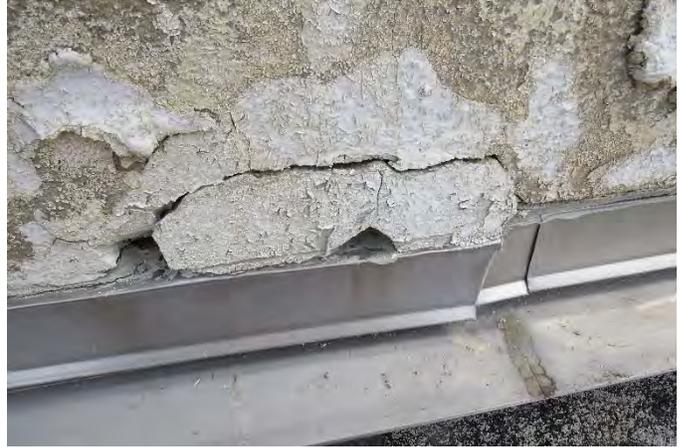
**Photo 72:** Detailed view wall condition above counterflashing.

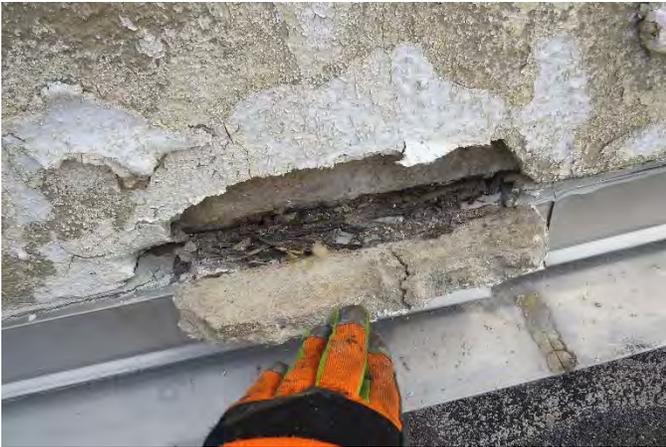
**Photo 73:** Detailed view wall condition above counterflashing.

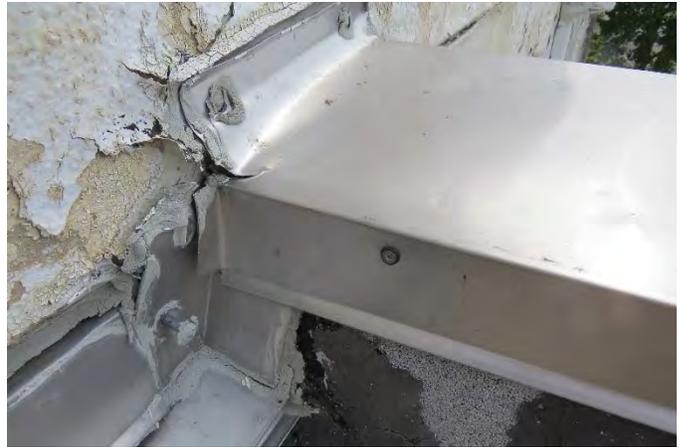
**Photo 74:** View of open counterflashing

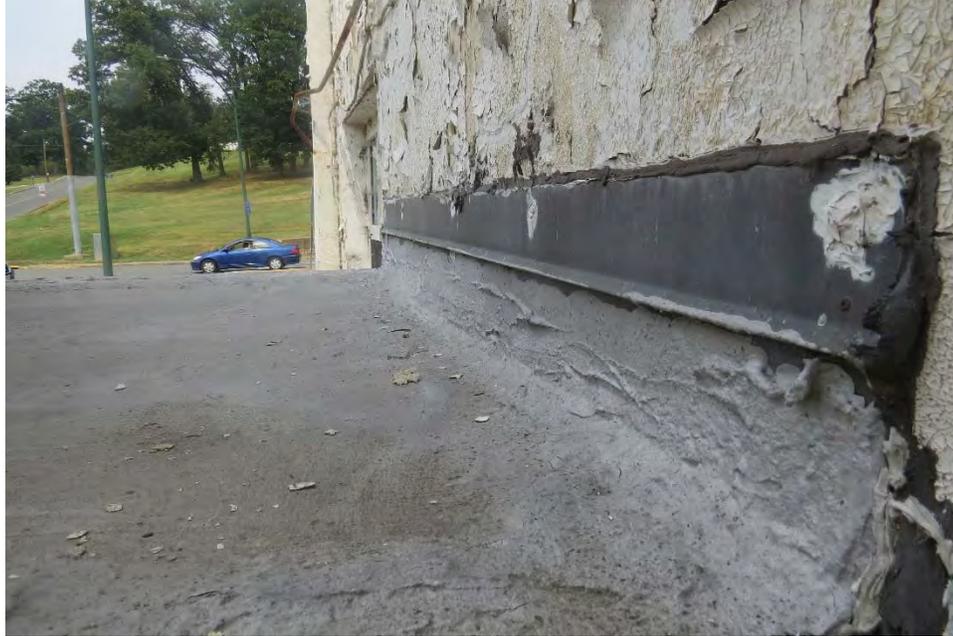
The rising wall above the roof area continues to be an area of concern, with failed coatings and sealant repairs observed that will allow wind driven rain to enter the building if unaddressed.

**Photo 77:** View of the membrane covering the front vestibule.

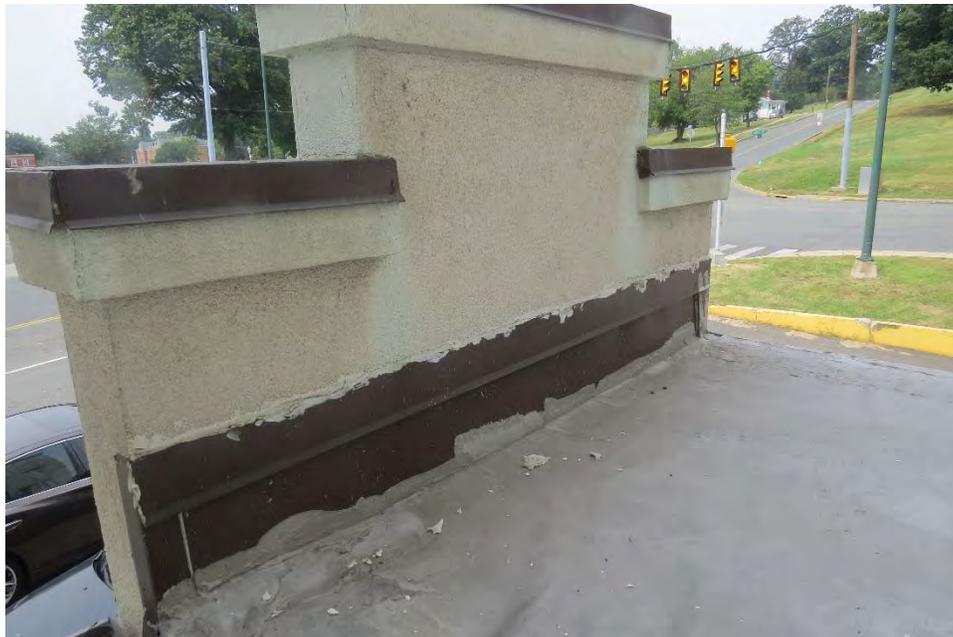
**Photo 78:** View of the membrane counterflashing and copings covering the front vestibule.

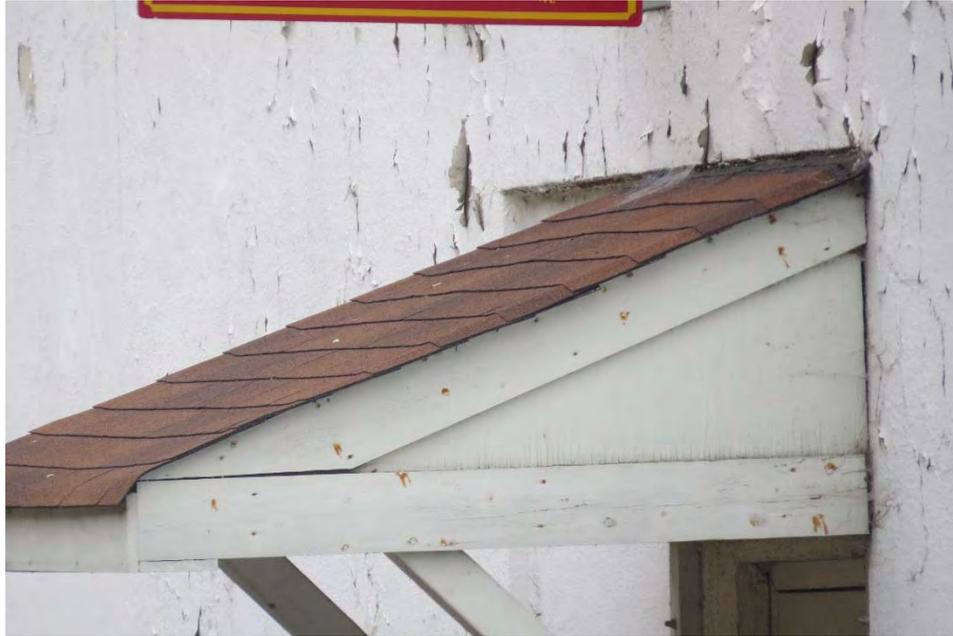
The existing shingles covering the western access door are functioning as intended. It appears that the wood framing supporting the shed type roof was secured to the existing wall without the appropriate counterflashing at the roof to wall transition.

**Photo 79:** Overview of the shingles covering the western access door.

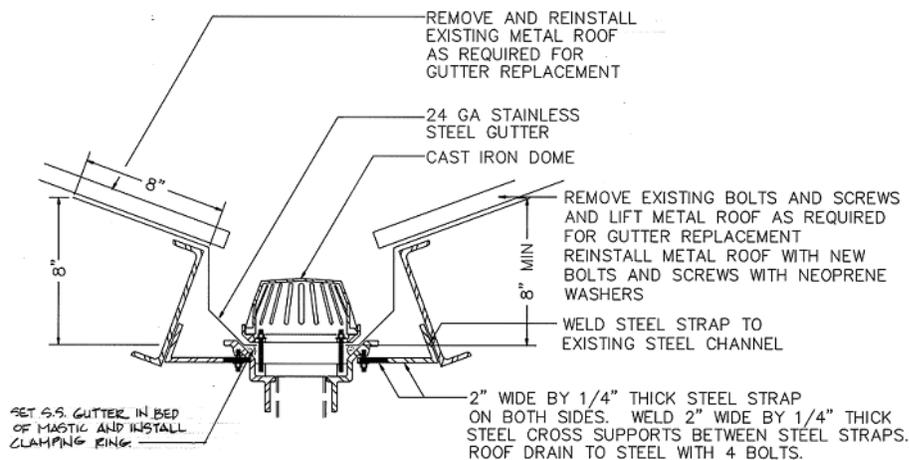
**Plate 1:** Details extracted from the Roof Replacement drawings dated November 1993, prepared by Seal Engineering Inc, of Alexandria, Virginia

As previously noted, the drawings reviewed, did not depict the actual conditions found on the main roof area, as noted earlier in Photograph 11 and 12. The stainless steel gutter linings were not installed as shown on the details below that were part of the Roof Replacement drawings dated November 1993, prepared by Seal Engineering Inc, of Alexandria, Virginia.
