Job Name: NAB COMMISSARY SITE

ATEC Environmental Consultants appreciates this opportunity to conduct a soil and water sampling program of the NAB Commissary Site, on the Little Creek Amphibious Base located in Virginia Beach, Virginia. The purpose of this assessment is to verify initial findings noted in ATEC's Phase II Site Assessment dated August 1, 1990 and to address the concerns that contamination exists in the area of the new building location.

FUEL FACILITY LEAKAGE STUDY
AT THE NAVAL AMPHIBIOUS BASE,
LITTLE CREEK, VIRGINIA

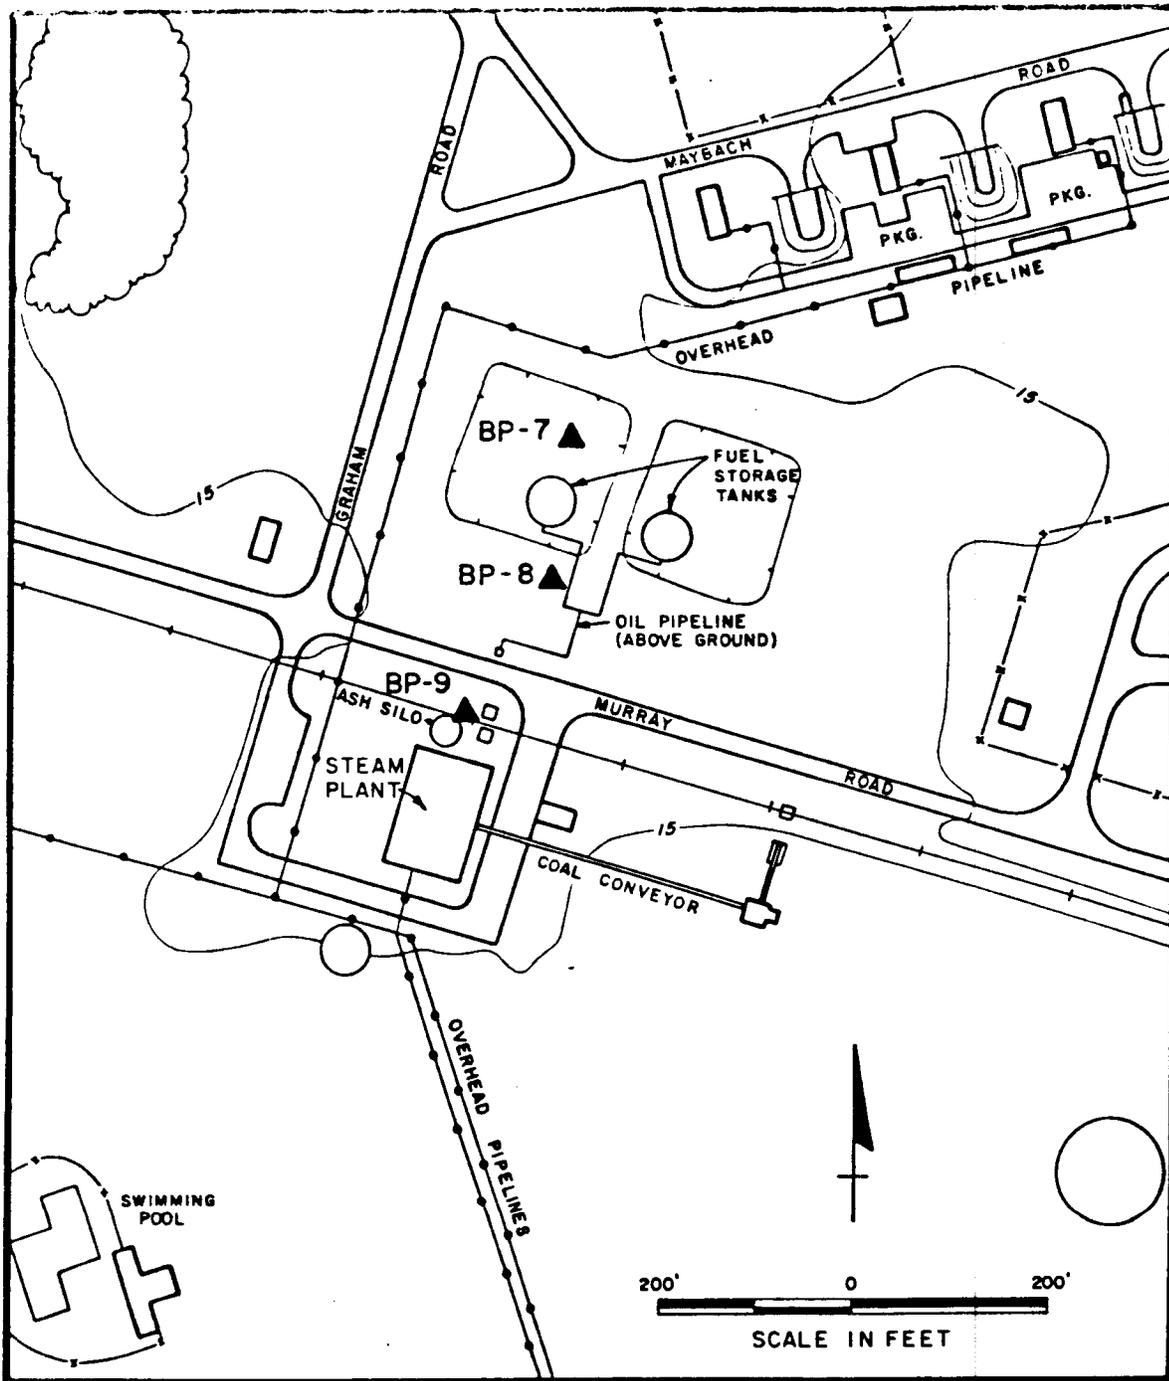
Figure 3: Steam Plant area, showing locations of backhoe pits.

Backhoe Pit BP-7 was located north of the western fuel-storage tank, across Murray Road from the plant. The excavation indicated a clayey-silt layer near the surface, which was underlain by about 5 feet of well sorted sand fill. The sand fill was underlain by poorly sorted naturally occurring sand. No standpipe was installed in the excavation due to severe wall collapsing and the location of the pit in the fuel-storage tank berm. No fuel was observed in the sediments from BP-7, nor in groundwater that accumulated in the excavation.

Backhoe Pit BP-8 was located in the unpaved parking lot across Murray Road from the Steam Plant (Figure 3). It exhibited 4 feet of sand near the surface, which was underlain by a stratigraphic sequence similar to that observed from the surface down in BP-7. No standpipe was installed in BP-8 due to wall collapsing. No fuel was observed in BP-8.

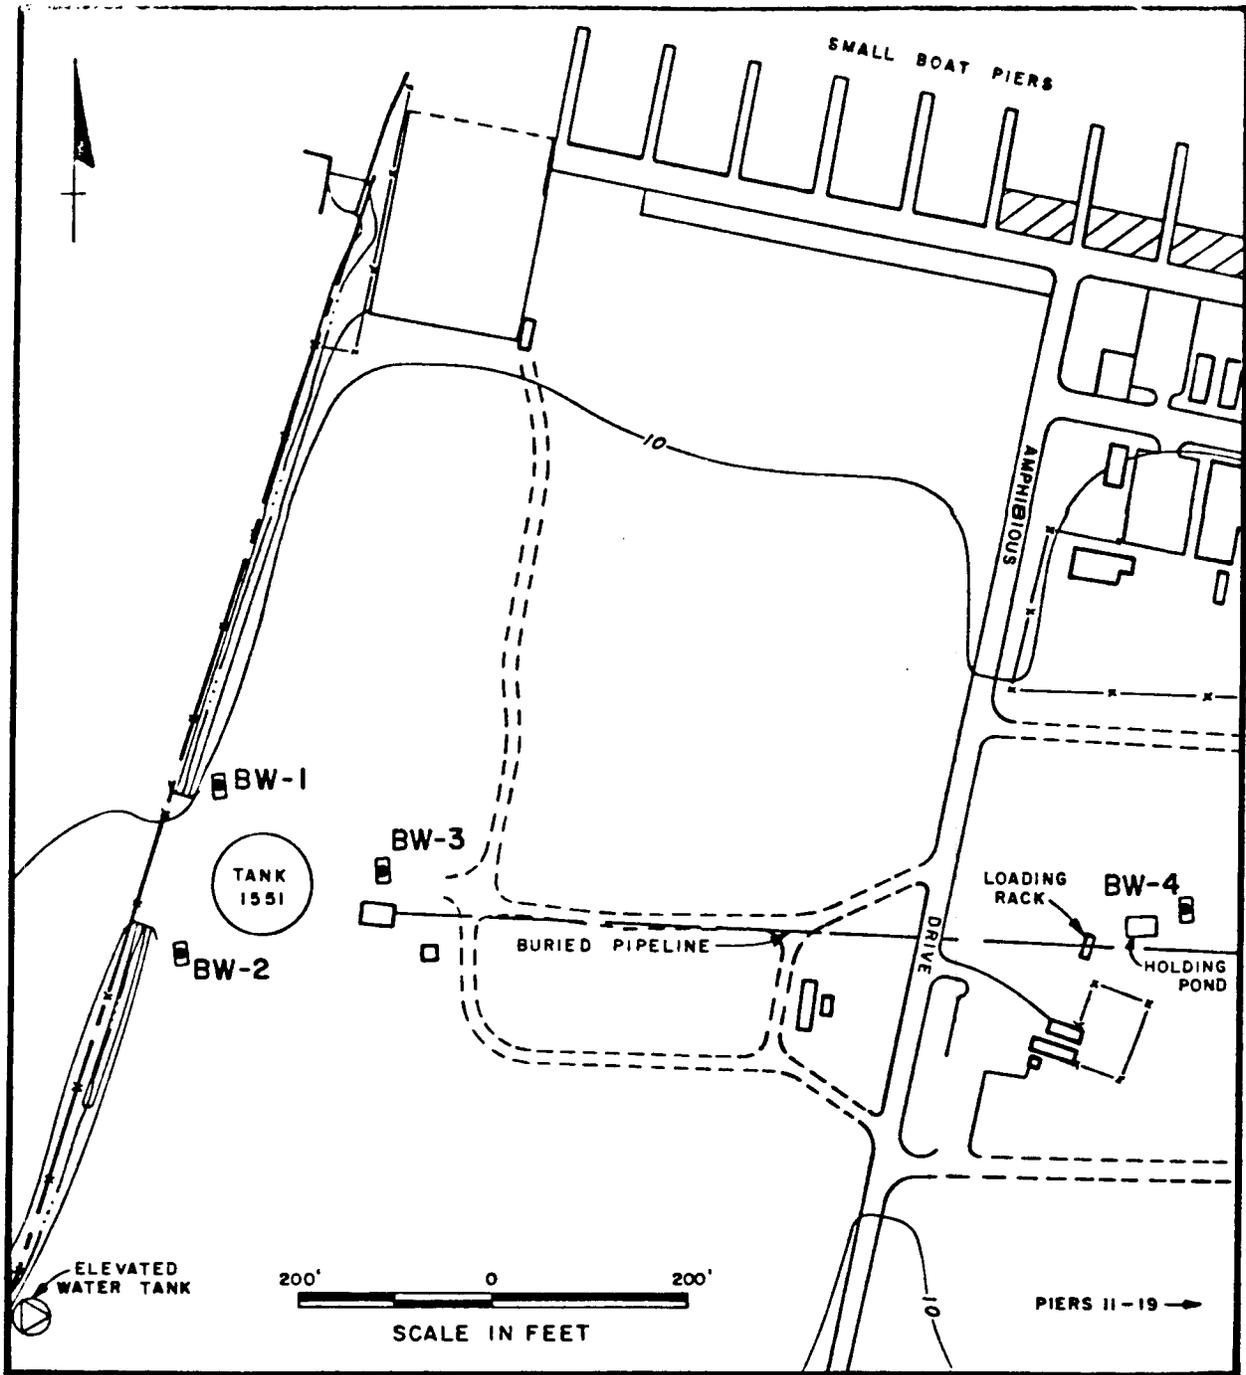
Figure 5: Tank 1551 area, showing locations of backhoe pits and standpipes.

Backhoe Pit BW-1 was located approximately 30 feet north of the buried tank. In it well-sorted sand fill occurred to the pit's total depth of about 8 feet. Groundwater entered the pit at a depth of about 7 feet. However, no fuel was observed in the groundwater or in sediment from the pit.

A standpipe was installed in BW-1 to permit subsequent groundwater monitoring. Standpipe construction materials and methods of installation are described in the Methods section of this report. Samples from the standpipe confirmed that no fuel has accumulated on the water table in the vicinity of BW-1.

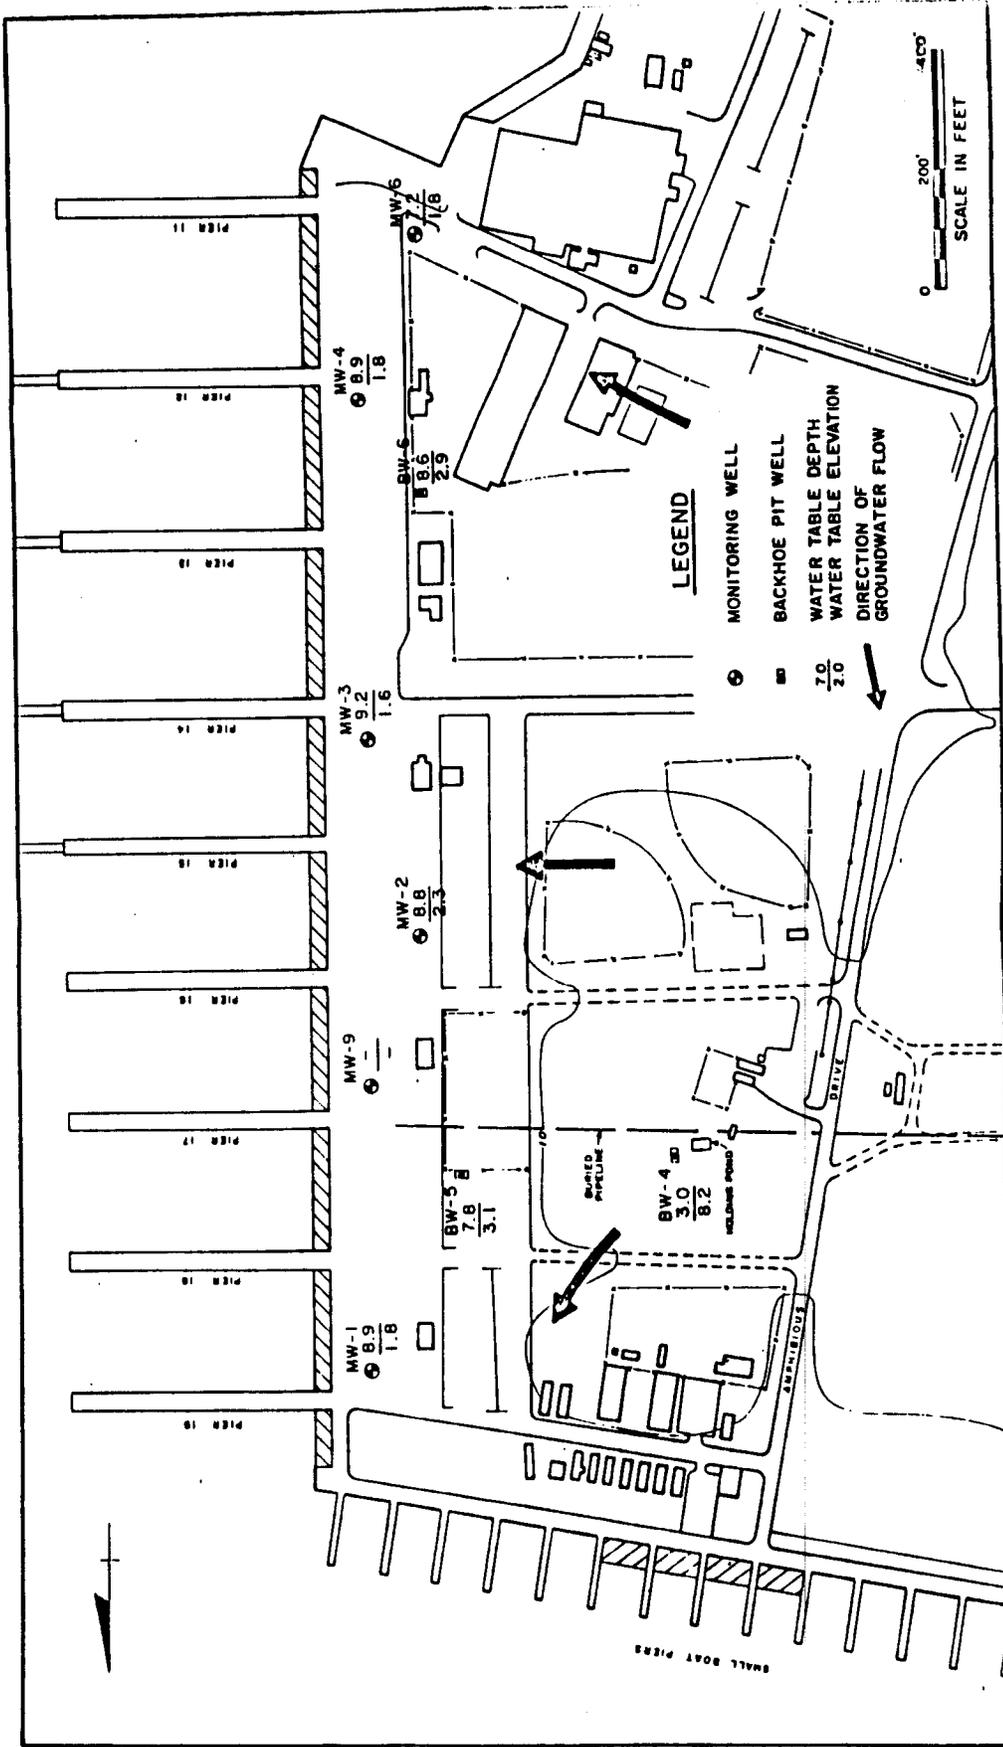
Figure 6: Pier 11-19 area, showing locations of monitoring points and water-table levels. Arrows show directions of groundwater flow.

Backhoe Pit BW-4 was excavated near a catch basin which holds runoff from the loading area between the piers and Tank 1551 (Figure 6). It is also located near the underground pipeline which connects Tank 1551 to the pier area. Although this

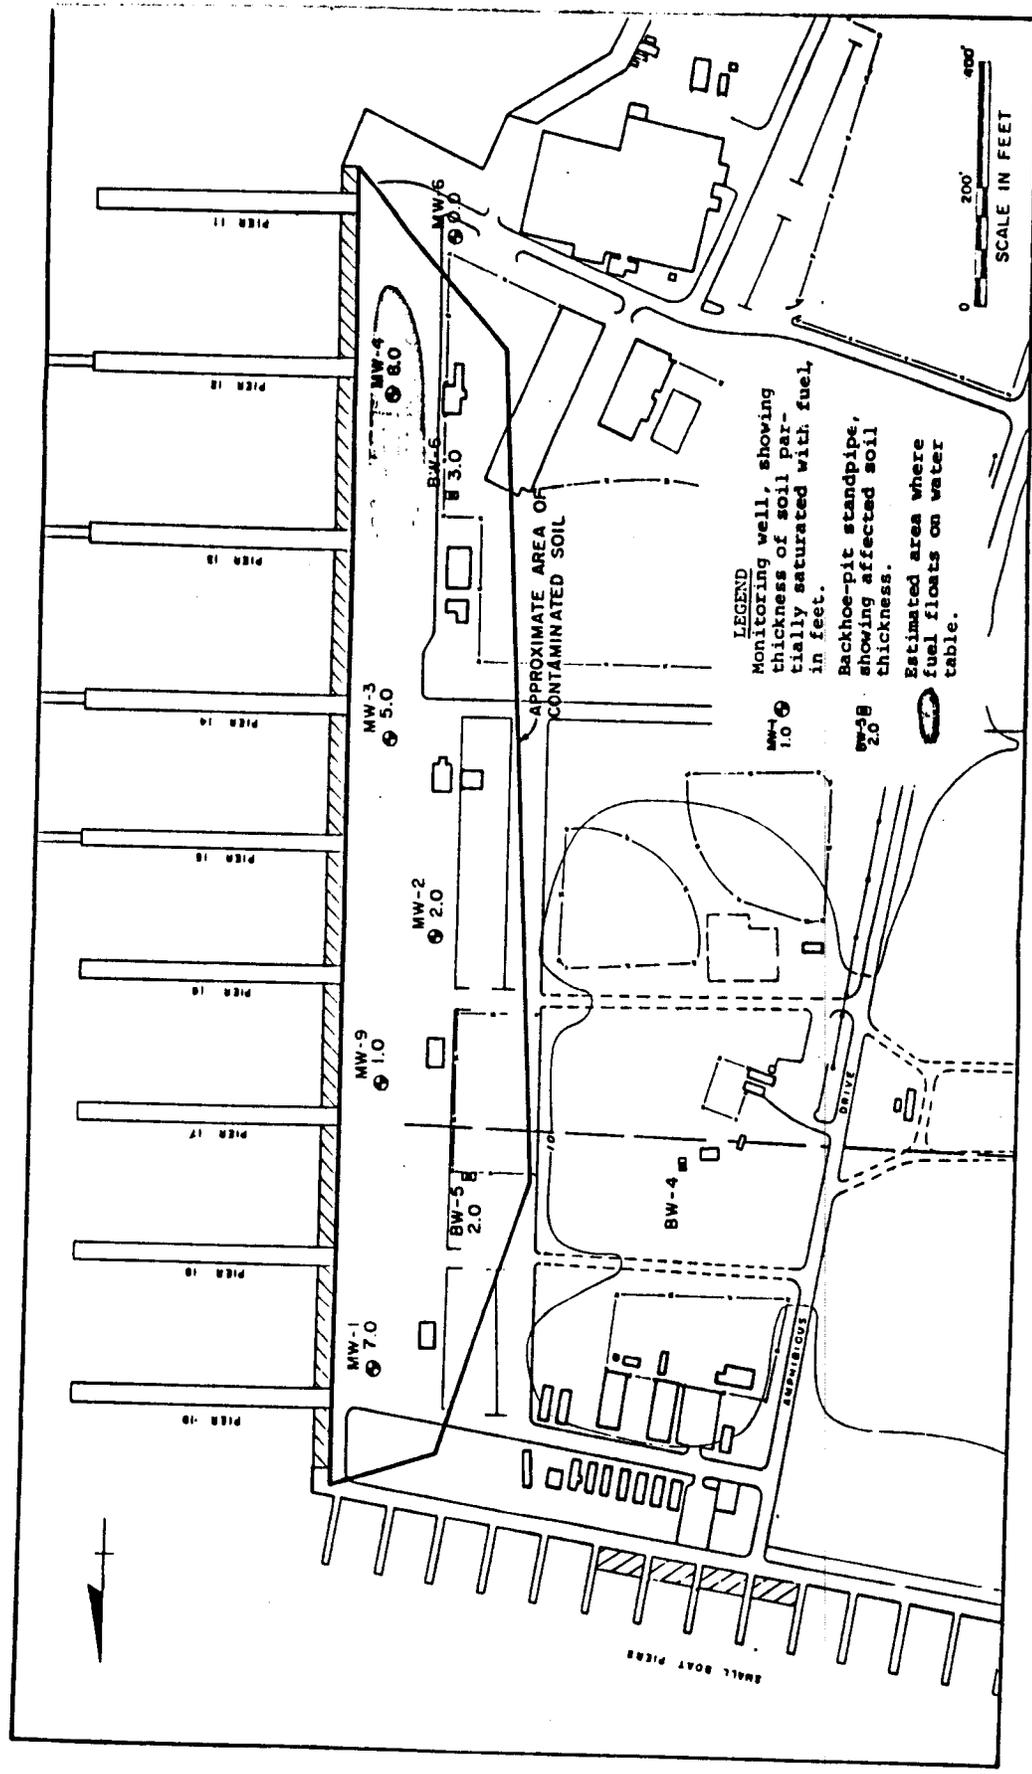
Figure 7: Pier 11-19 area, showing subsurface monitoring points and thickness of soil which is partially saturated with fuel, at each point.

Assuming an average soil concentration of 0.105 percent, and the average affected thickness in the area outlined on Figure 7, it is estimated that the volume of fuel in the unsaturated zone is about 17,000 gallons.

In view of sampling limitations, the actual amount of fuel in the unsaturated zone near Piers 11 to 19 may differ considerably from this. Since the soil samples used for these analyses came from the borings which had the greatest thickness of contaminated sediments (Figure 1), they may be more representative of more highly contaminated areas. However, even if the lowest measured

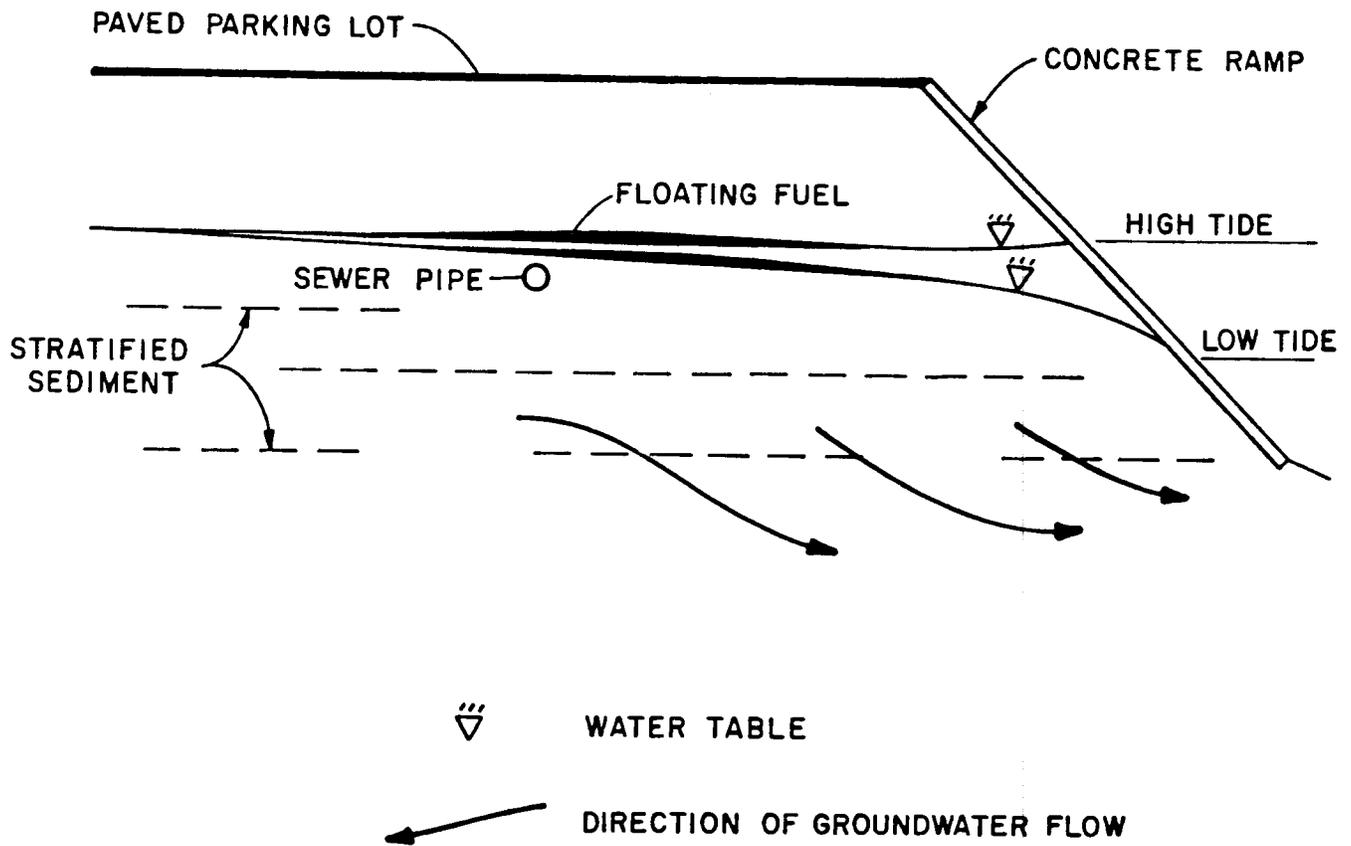
Figure 8: Schematic cross section showing groundwater system and floating fuel beneath parking area near Piers 11-19.

The damming effect has probably prevented the observed fuel in the saturated zone from discharging into the Cove. The fuel slug remains floating on the water table, while groundwater continues to flow beneath it and discharge into the Cove. The slug cannot flow westward because of the upward slope of the water table in that direction. This results in the slug having an elongate shape parallel to the shore, as shown in Figure 7.

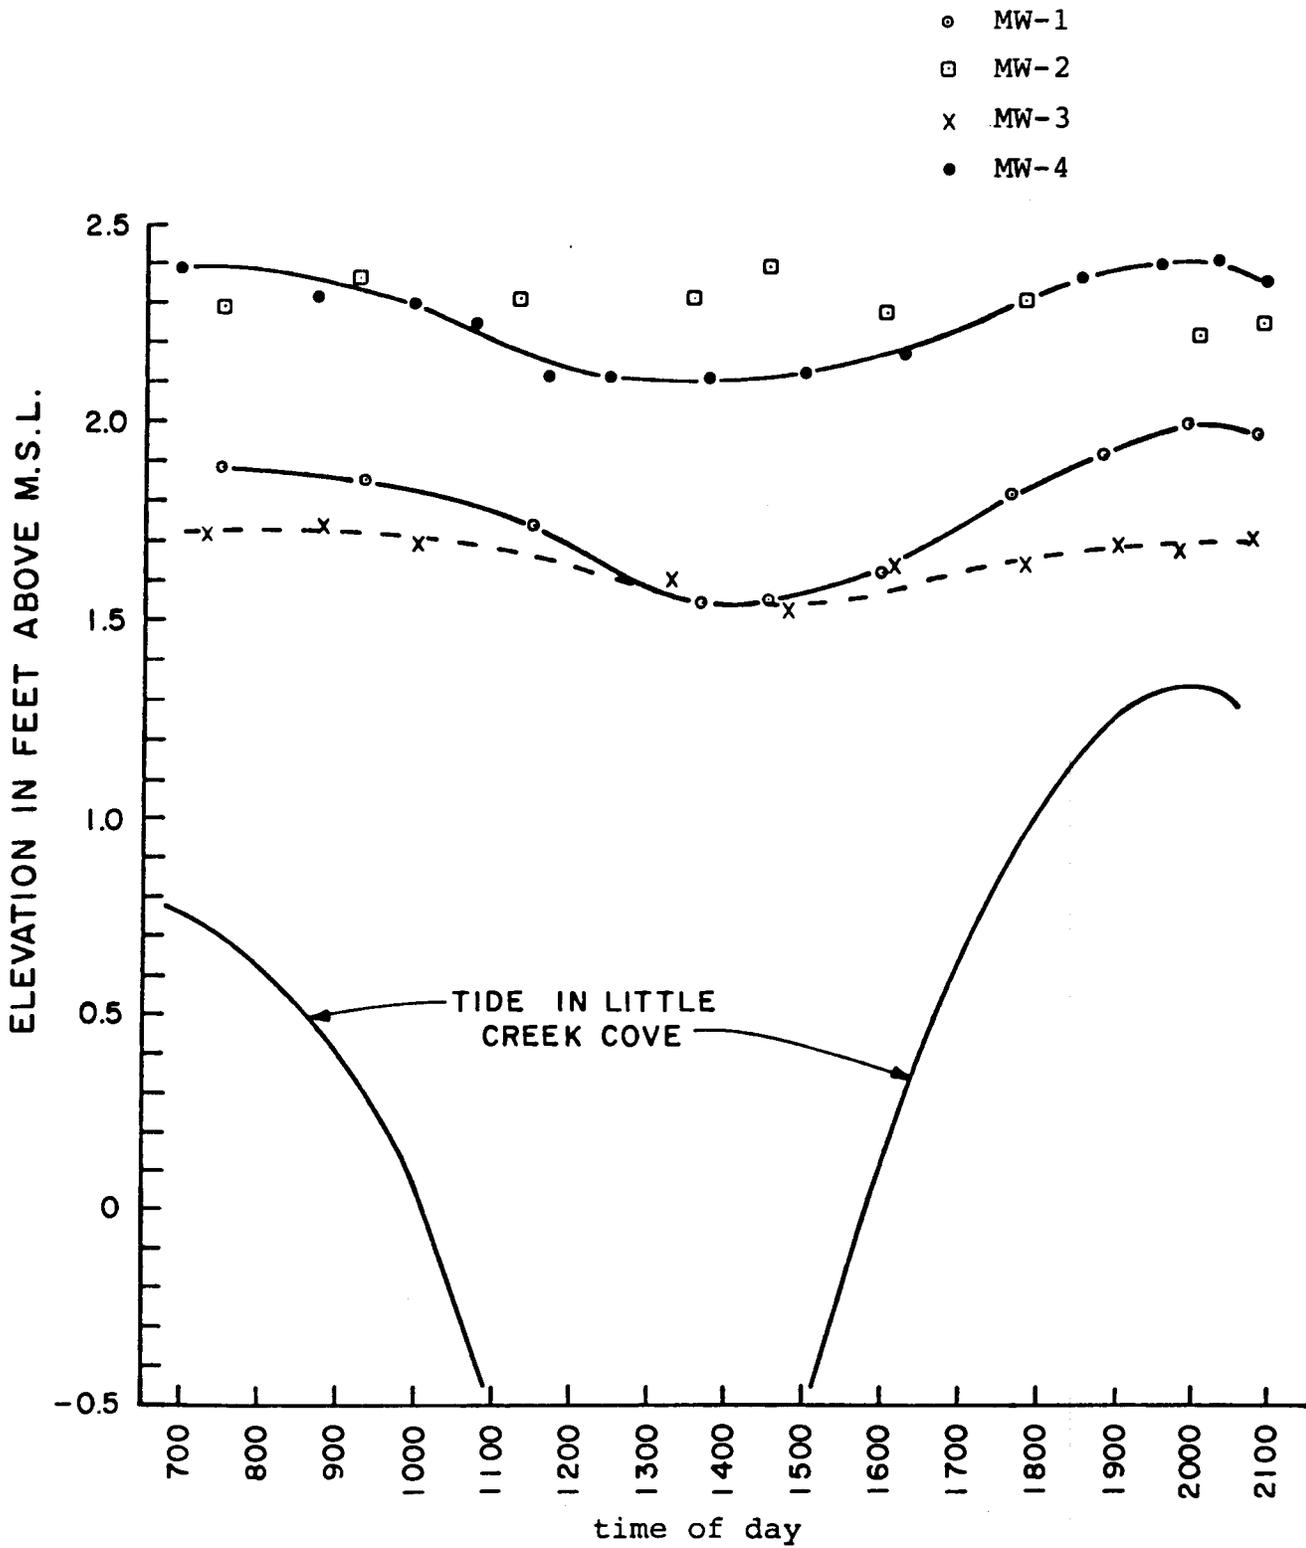
Figure 9: Water table stage in four monitoring wells on August 31, 1982. Tidal level in Little Creek Cove is also shown.

While this situation apparently reflects general conditions beneath the parking lot, there are short-term changes which result from tidal activity. Typical water table fluctuations over the course of one day are shown in Figure 9, based on

measurements of four monitoring wells near the piers. Two of the wells closest to the Cove, MW-1 and MW-3, show a tidal fluctuation which is delayed about one hour from that in the Cove. The amplitude in them is about 1/10 of that in the Cove, or about 0.25 feet.

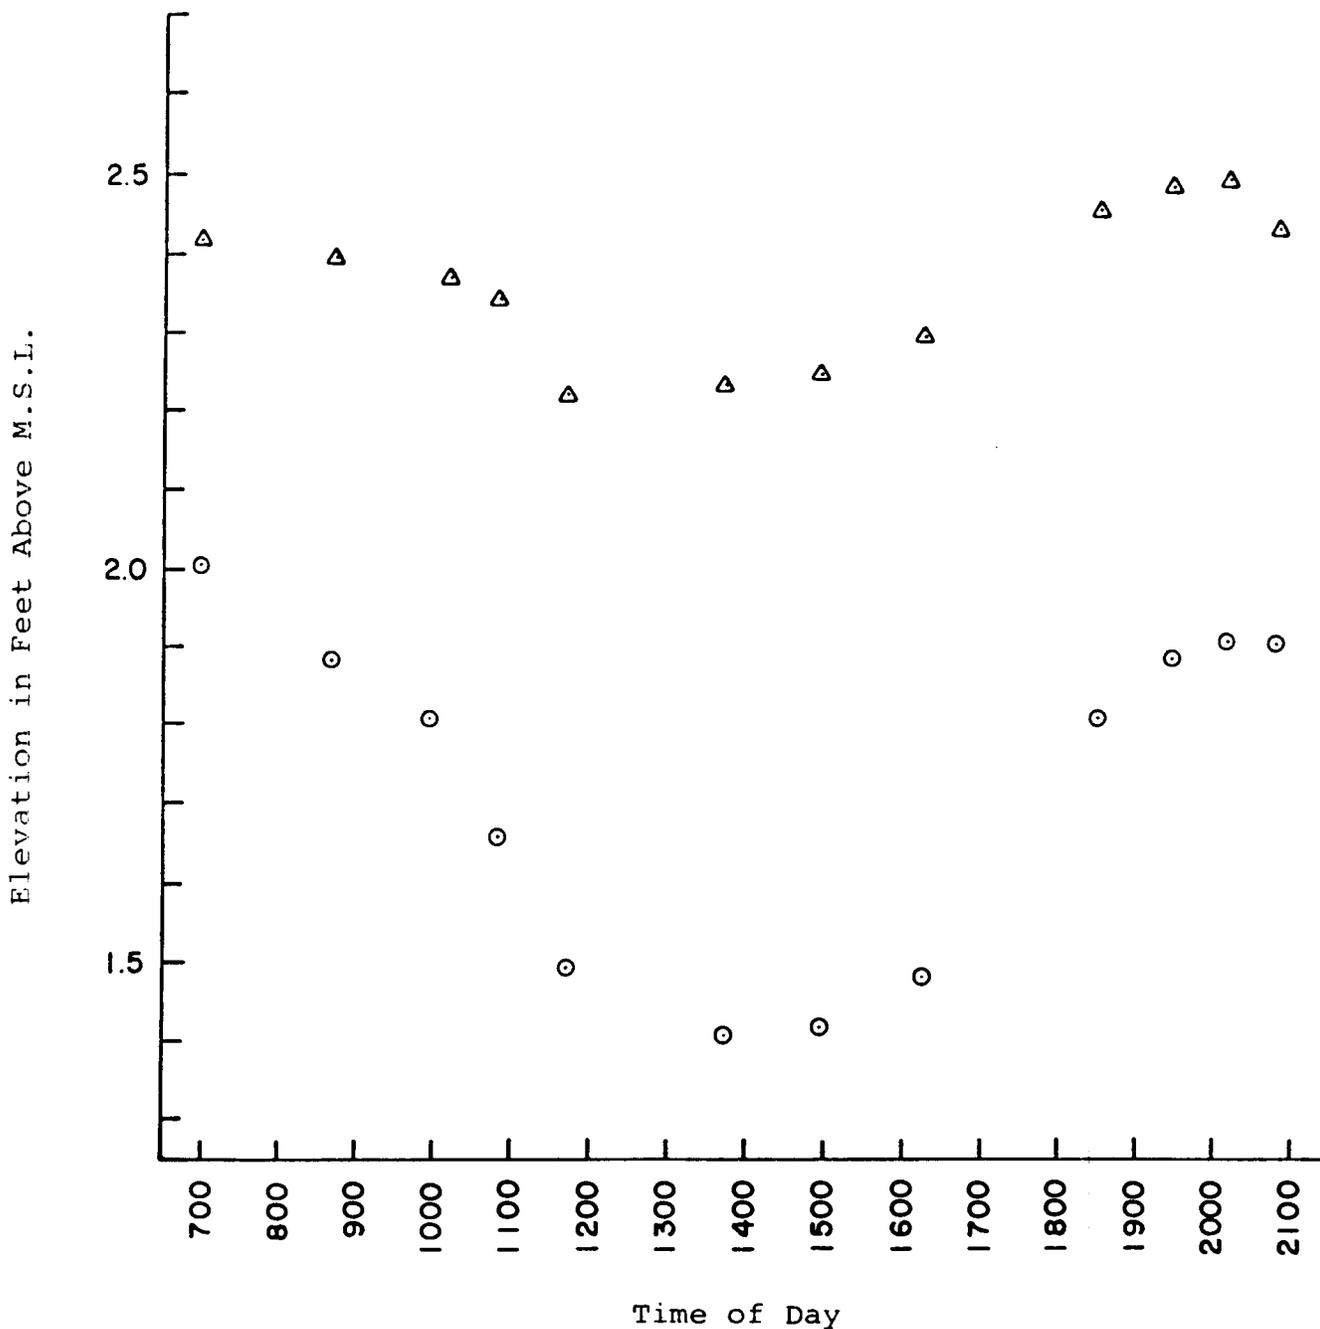
Figure 10: Elevation of floating-fuel surface, and fuel/water interface, versus time of day in MW-4. Measured August 31, 1982.

Head conditions in MW-4 are shown in more detail in Figure 10. The groundwater surface (water table) generally fluctuated between elevations of 1.5 and 2.0 feet, as it did in MW-1 and MW-3. The fuel surface fluctuated between 2.25 and 2.50 feet. As Figure 11 illustrates, the fuel slug thickness was proportional to tidal stage, being about 0.5 feet at high tide and 0.8 feet at low tide.

To some extent this thickness change may reflect hydraulic conditions immediately around and in the monitoring well. However, it probably also indicates that the fuel slug as a whole alternately disperses and contracts with each tidal wave.

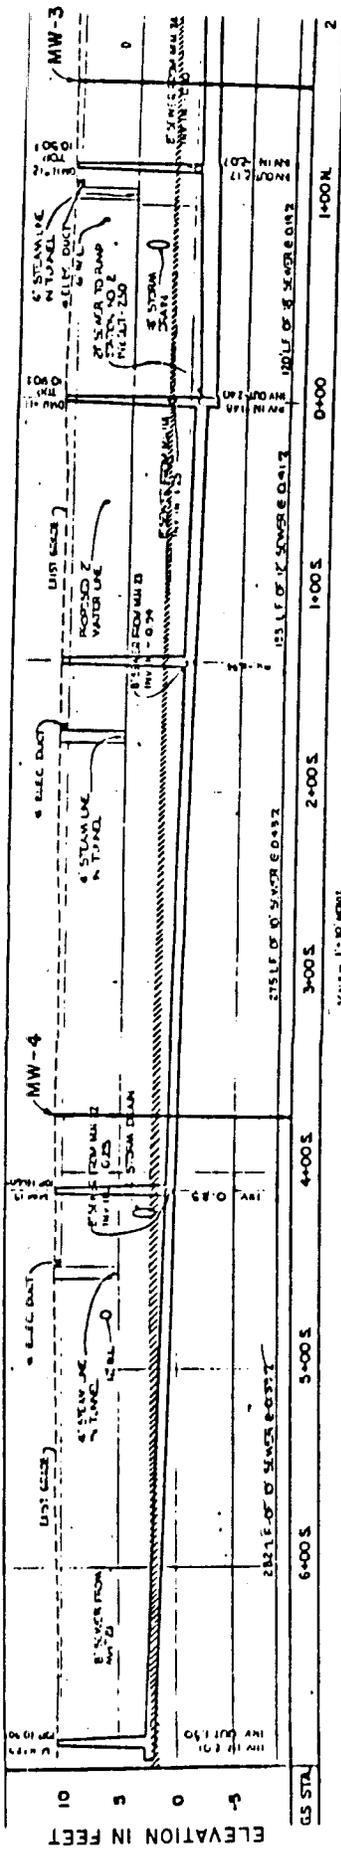
Figure 12: Sewer profiles from the Pier 11-14 area, showing zone of measured tidal fluctuation. Floating fuel could enter the sewer where the zone of tidal fluctuation intersects the sewer.

In the Pier 11-19 area as a whole, the zone of water table fluctuation coincides with the sewer line at both ends of the area and at manholes and laterals. These areas are also shown in Figure 13, and would be potential entry points if floating fuel is present there.

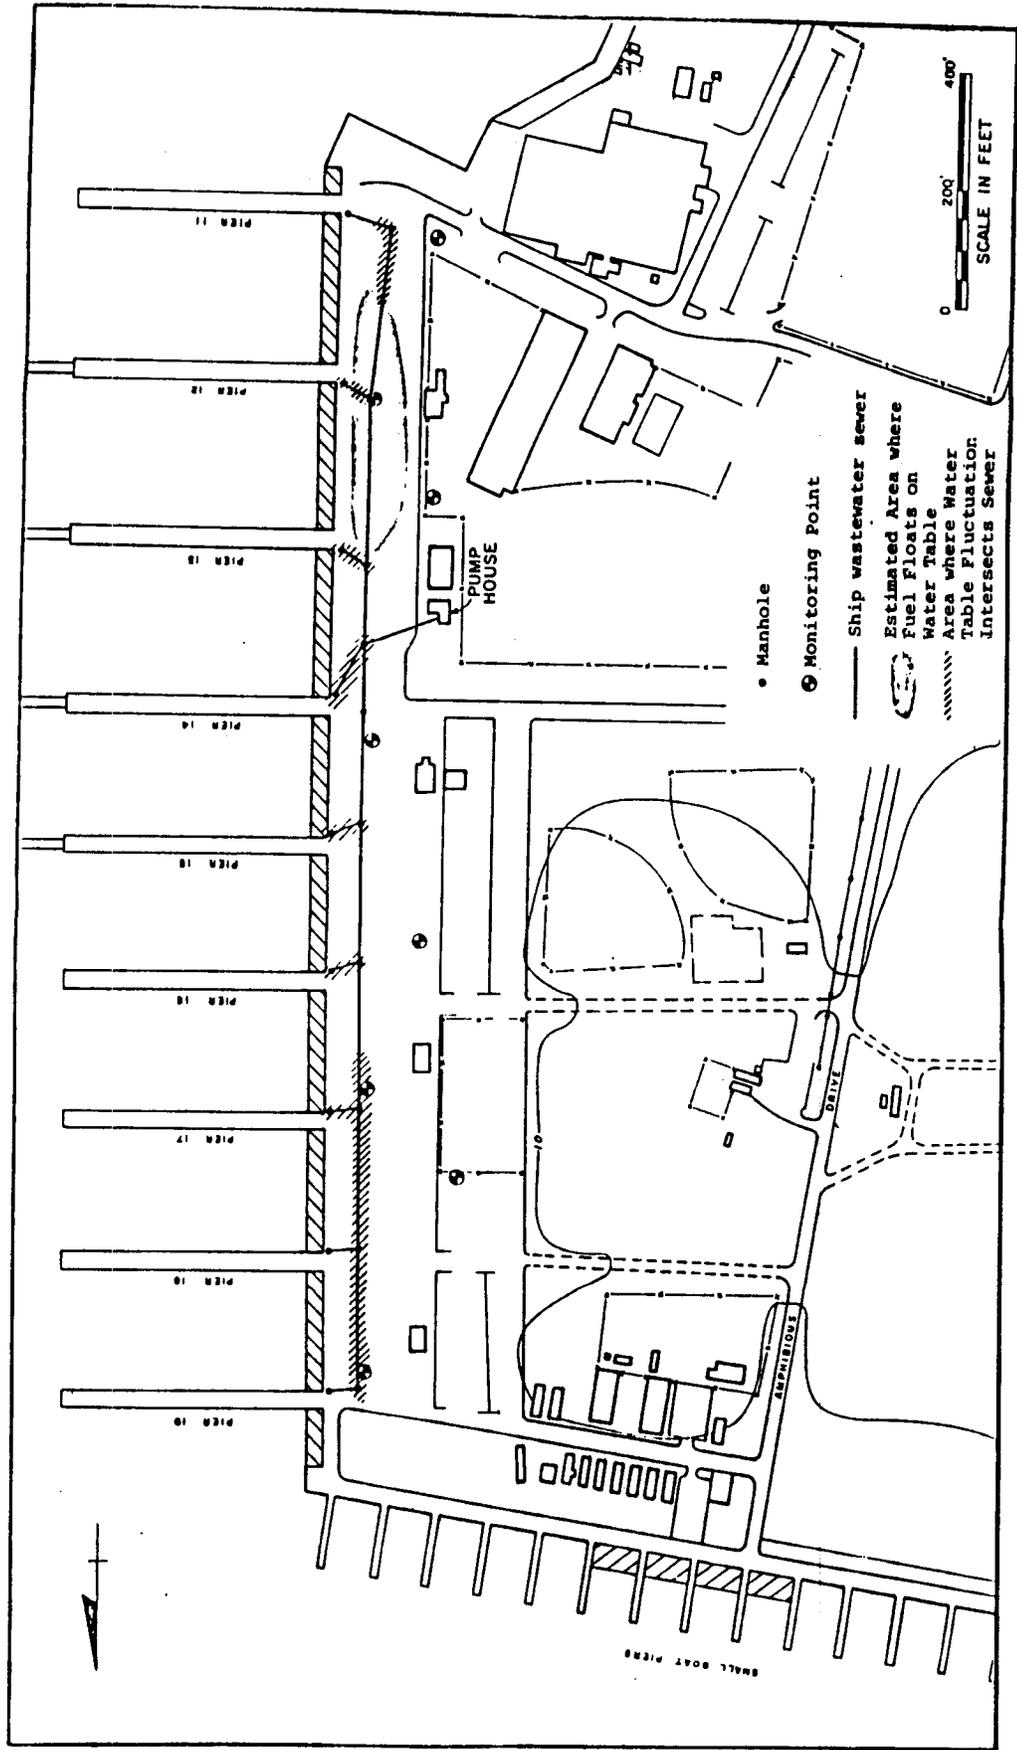
Figure 13: Pier 11-19 area, showing location of ship wastewater sewer, estimated area of floating fuel slug, and areas where water table intersects sewer.

The greatest potential for fuel influx into the ship wastewater sewer is in those places near Pier 12 where the floating fuel occurs at the same elevation as the sewer. These areas are shown in Figure 13.

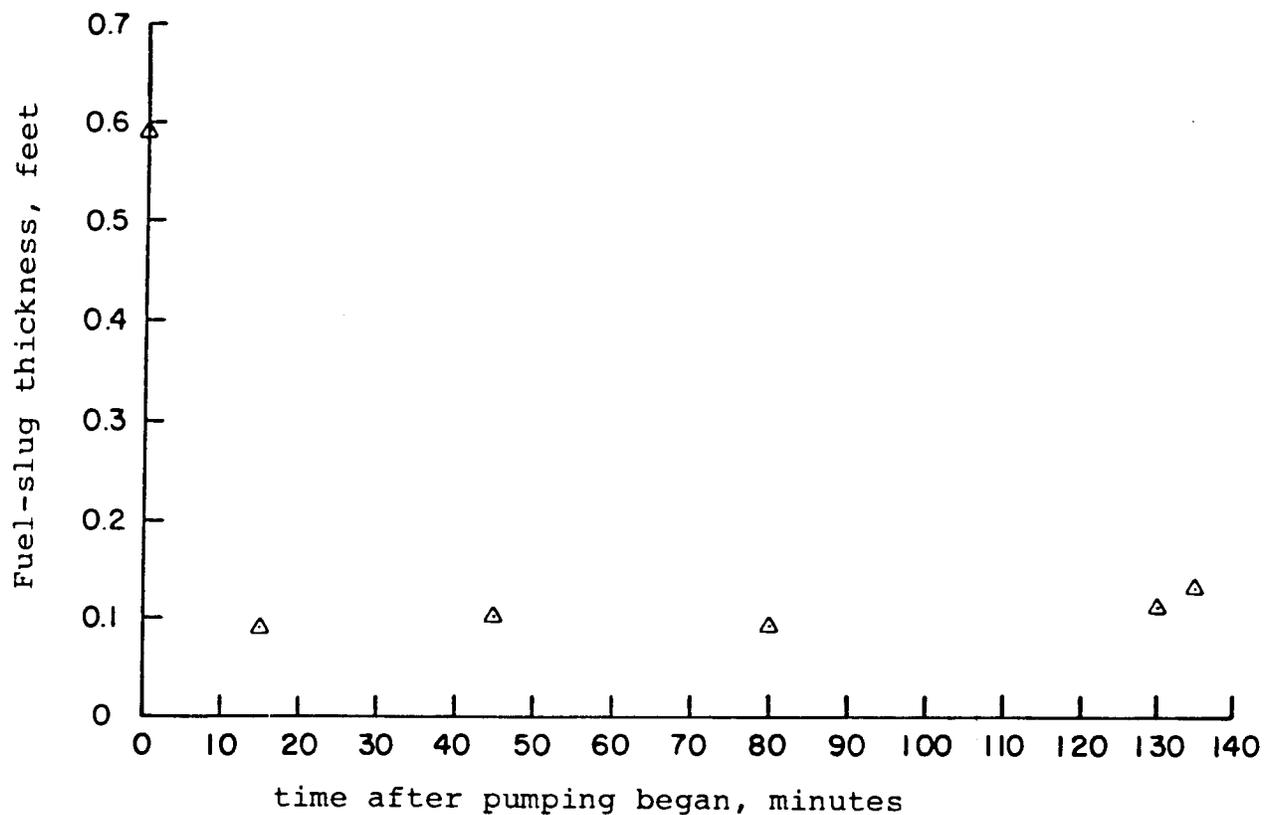
Figure 15: Change of fuel-slug thickness in MW-4 when water level in well was drawn down four feet. Initial slug thickness 0.59 feet.

Pumping commenced with 0.6 feet of fuel floating in the well. Much of this fuel disappeared as the well was drawn down. Figure 15 shows that about 0.1 feet of fuel was measured in the

well soon after pumping began. After 140 minutes of pumping, the fuel thickness remained at 0.1 feet; therefore, however, virtually no fuel entered the well during pumping.
