Environmental Survey – Building 3000  
Naval Station Great Lakes  
Great Lakes, Illinois

EDI Project No. 1602.010.01

SUBJECT: Environmental Survey - Buildings 3000  
Great Lakes, Illinois  
EDI Project No. 1602.010.01

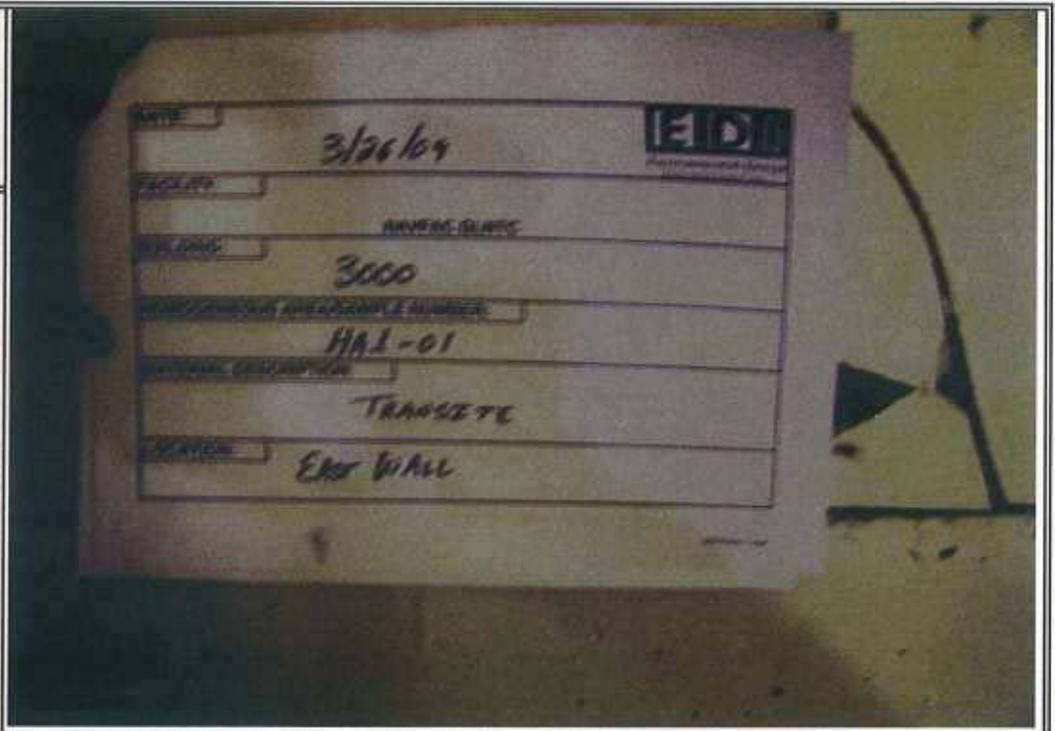
PHOTO #1

Location	Material Description	Quantity	Results	Condition
Bldg #3000 E. Wall, Ceiling Room #2	Transite	Approximately 1,500 square/feet	25-30% Chrysotile	Good
Bldg #3000 West, South & North Walls	Interior Window Caulk	Approximately 100 linear/feet	1-5% Chrysotile	Good
Bldg #3000 West, South & North Walls	Exterior Window Glaze	Approximately 100 square/feet	1-5% Chrysotile	Good
Bldg #3000 Roof	Roof Caulk	Approximately 1,900 linear/feet	1-5% Chrysotile	Good

**Description:** Transite  
**Sample #** HA1-01

Prior to renovation of the building, ACM must be abated by an IDPH-licensed contractor using IDPH-licensed supervisors and workers.

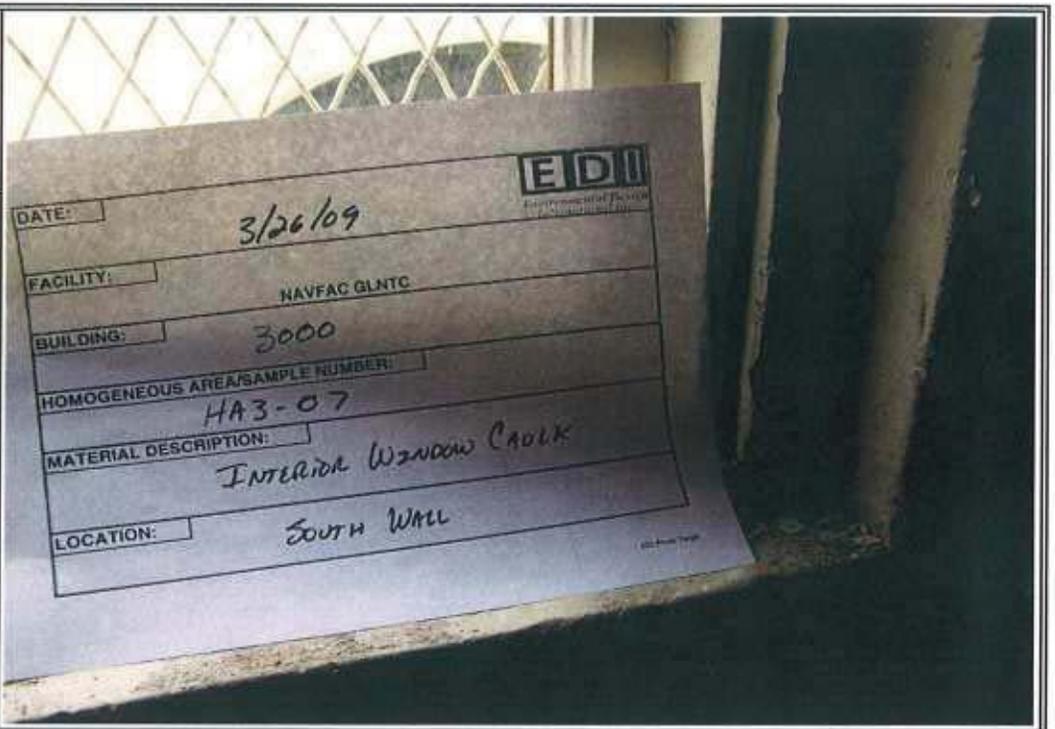
PHOTO #2

**Description:** Interior Window Caulk  
**Sample #** HA3-07

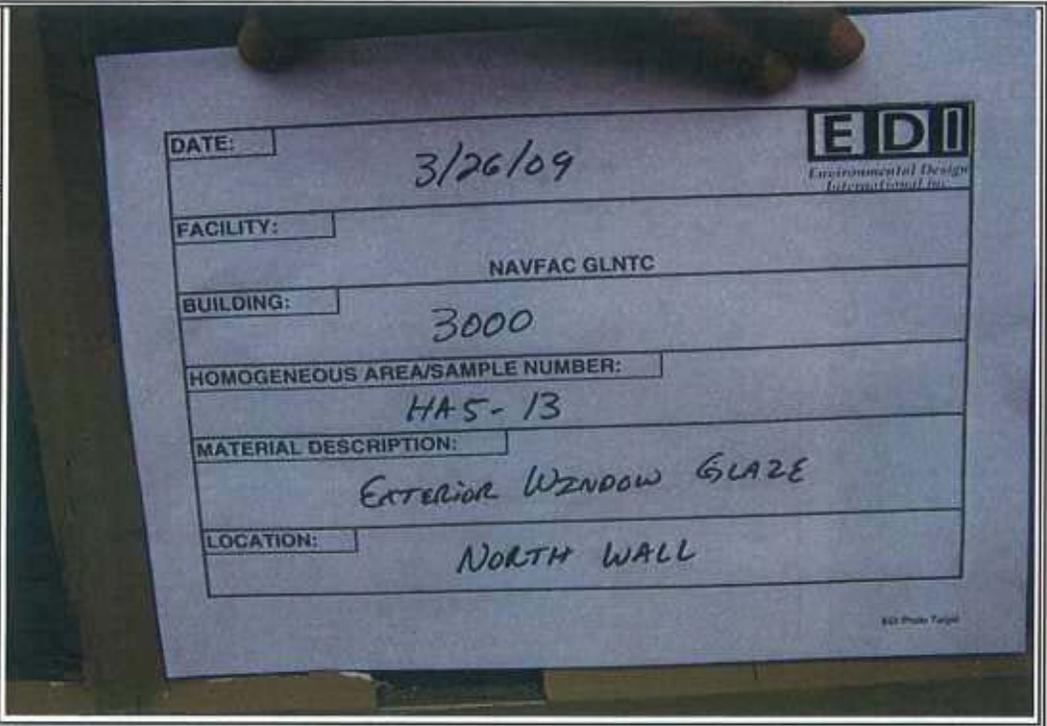
PHOTO #3

Description: Exterior  
Window Glaze  
Sample # HA5-13

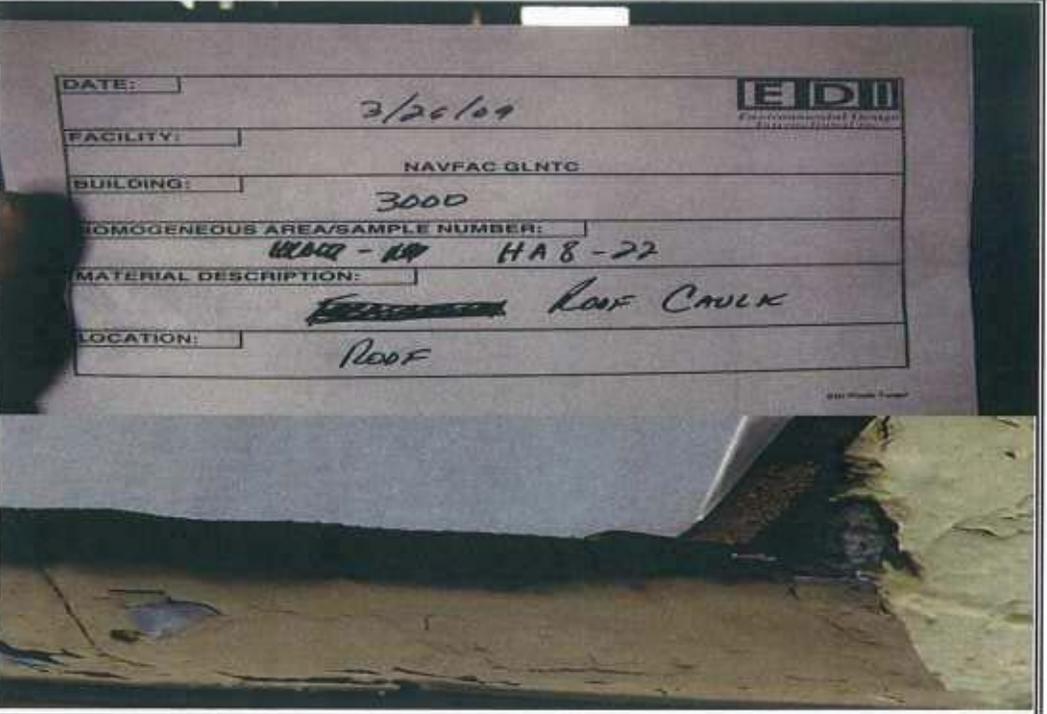
PHOTO #4

Description: Roof  
Caulk  
Sample # HA8-22

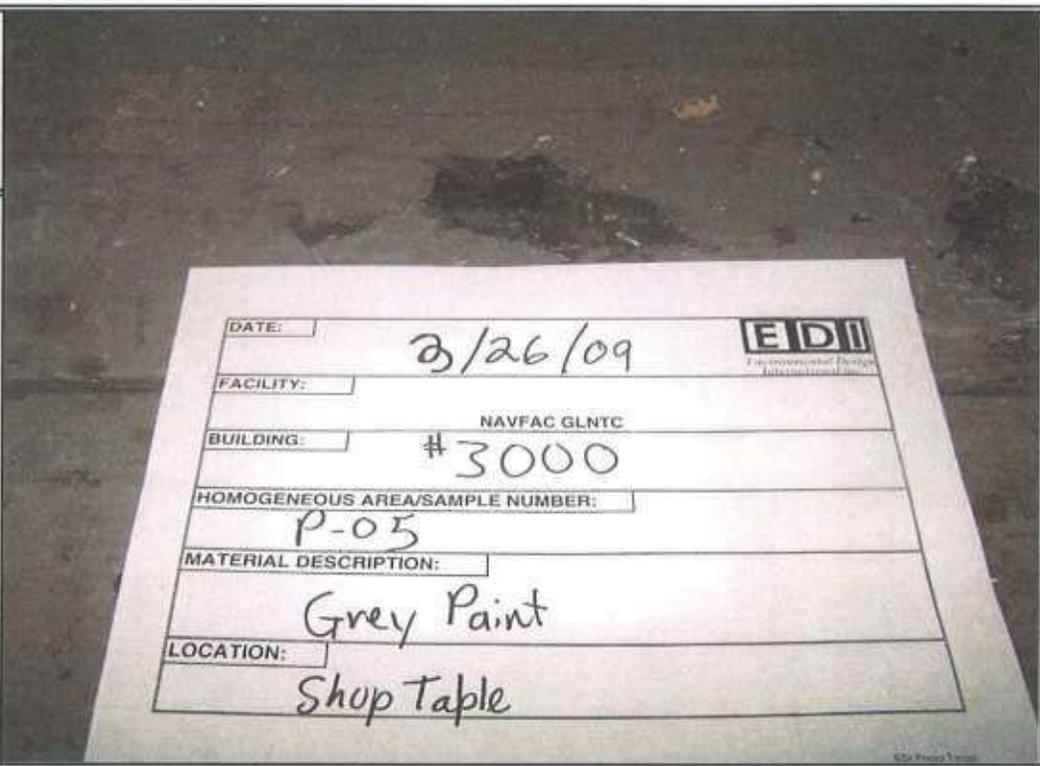
**PHOTO #5**

Location	Material Description	Quantity	Results	Condition
Bldg #3000 Stairs & Rear Shop Table	Grey Paint	Approx. 90 square/feet	5.0% Lead	Poor

**Description:** Grey Paint  
**Sample #** P-05

Contractors working on components with paint that contains lead should comply with applicable OSHA standards, and other appropriate federal, state and local regulations, if their activities will disturb paint that may cause a release of lead from the painted component. All LBP should be

removed and disposed of in accordance with all applicable federal, state and local regulations prior to renovation or demolition of Building 3000 that may disturb the LBP.

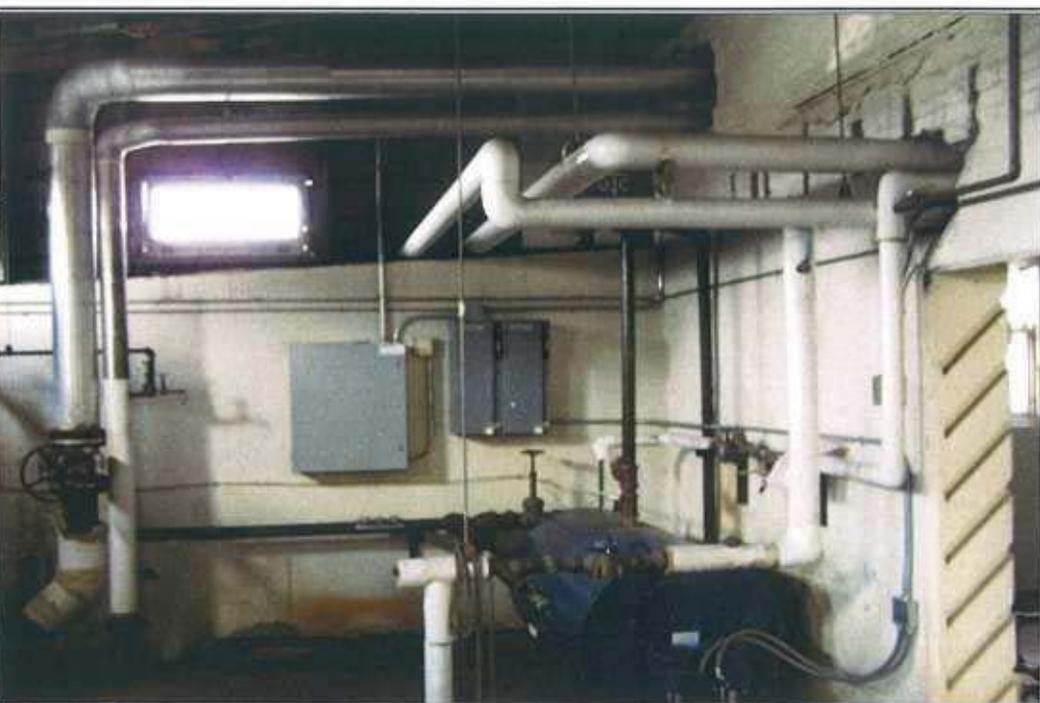
**PHOTO #6**

**Description:** TSI  
**Sample #** No samples  
taken insulation  
identified as Fiber  
Glass

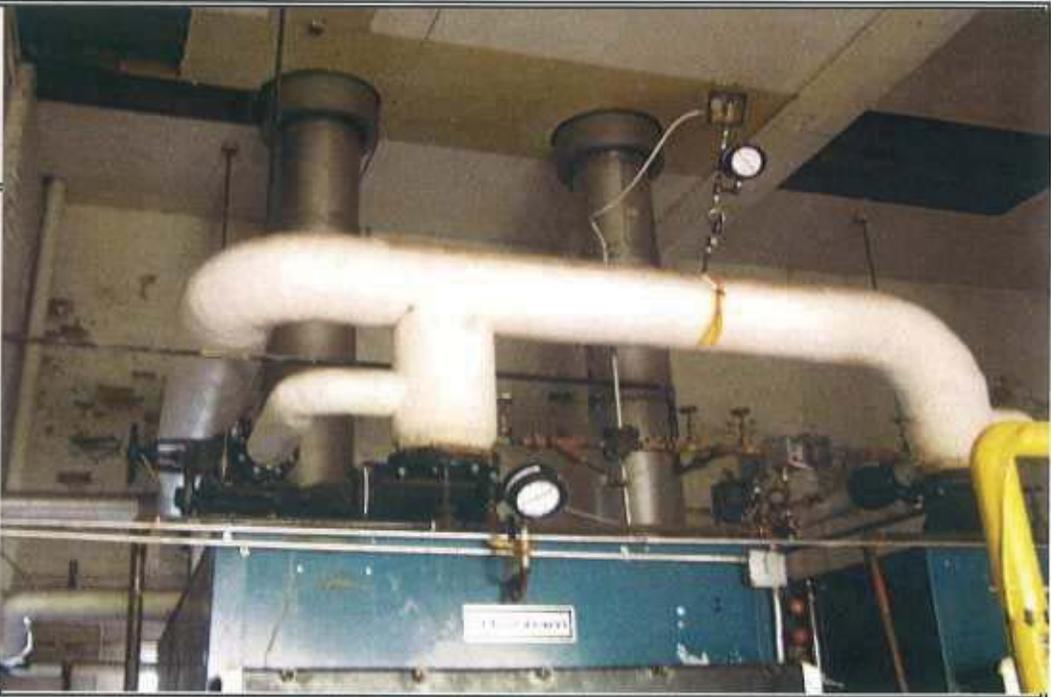
**PHOTO # 7**

**Description:** TSI  
**Sample #** No samples  
taken insulation  
identified as Fiber  
Glass
