Limited Environmental Survey
Above Ground Steam Lines
Naval Station Great Lakes
Great Lakes, Illinois

EDI Project No. 1602.029.01

February 9, 2012 Approved for Release By

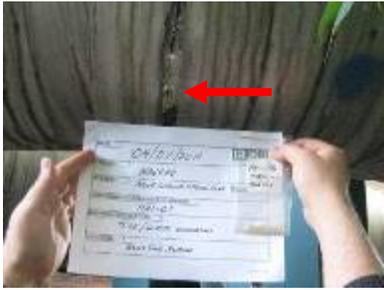
HA1: Blue line, elbow, TSI, white

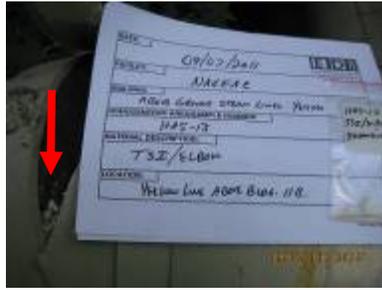
HA5: Yellow line, elbow, TSI

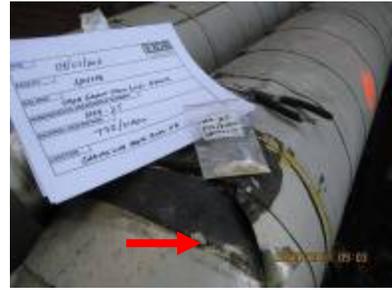
HA9: Orange line, elbow, TSI

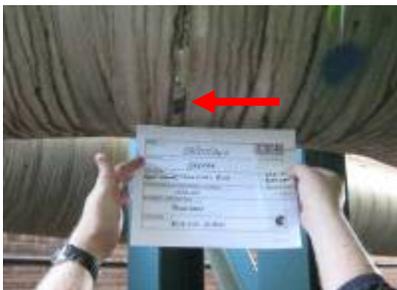
HA2: Blue line, elbow, black wrap

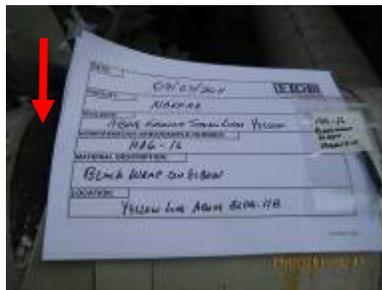
HA6: Yellow line, elbow, black wrap

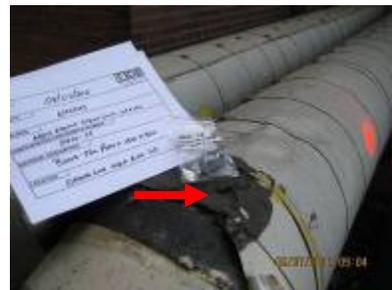
HA10: Black Tar Patch

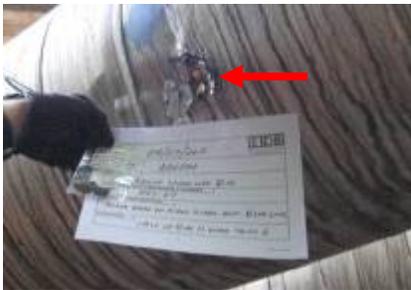
HA3: Blue line, black wrap on fiberglass run

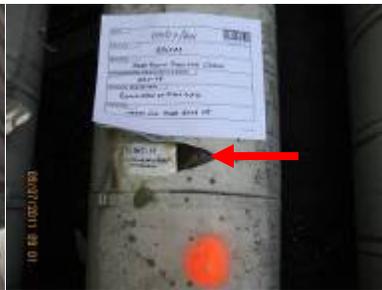
HA7: Orange line, black wrap on fiberglass run

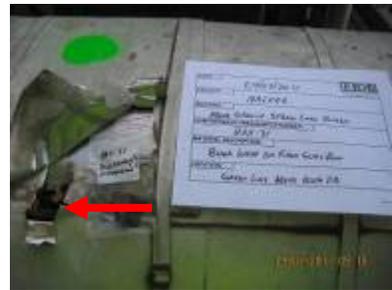
HA11: Green line, black wrap on fiberglass run

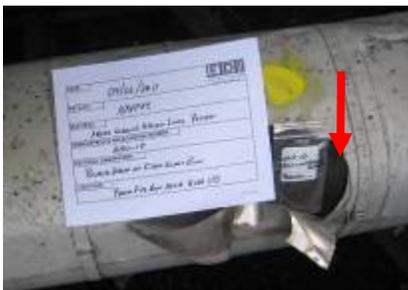
HA4: Yellow line, black wrap on fiberglass run

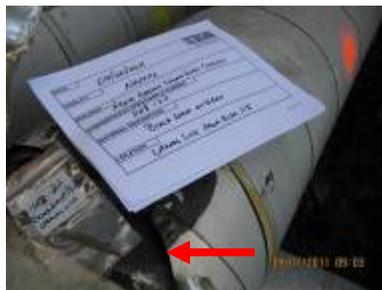
HA8: Orange line, elbow, black wrap

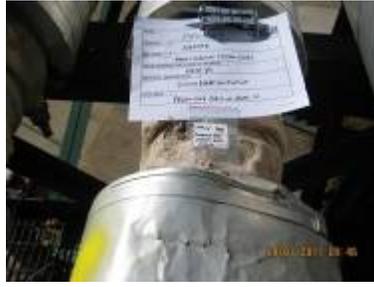
Cloth Wrap on fittings Blue, Green, Yellow & Orange Lines (HA12, HA13, HA14, & HA15): The insulation cloth wrap identified as the above referenced HAs was identified on all the lines (blue, green, yellow, and orange). The material tested positive for asbestos, reported as 95% Chrysotile. The cloth wrap was observed in sporadic locations along the above ground steam lines.

HA14: Yellow line, fitting, cloth wrap

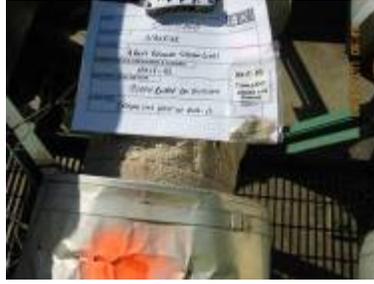
HA15: Orange line, fitting, cloth wrap

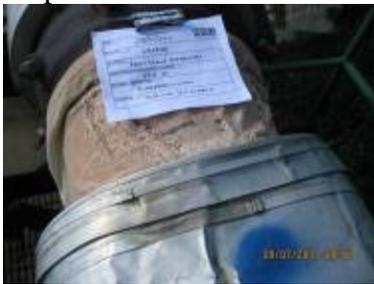
HA12: Blue line, fitting, cloth wrap

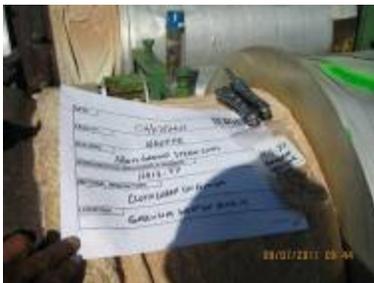
HA13: Green line, fitting, cloth wrap

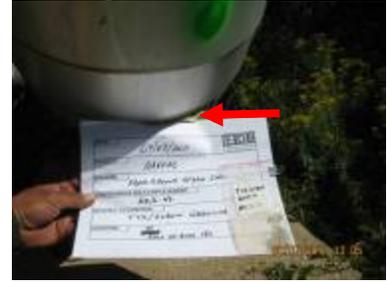
HA16: Green line, elbow, TSI

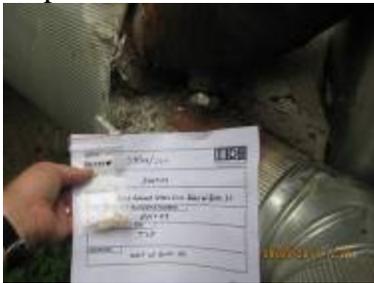
TSI over Fiberglass White Line & a Patching material (HA17 & HA18): The insulation over the fiberglass on the white line tested positive for asbestos, reported as 20% Chrysotile. A patch material observed at one location on the white line tested positive for asbestos, reported as PC 1.5% Chrysotile.

HA17: White line, TSI over fiberglass, at emergence from larger pipe

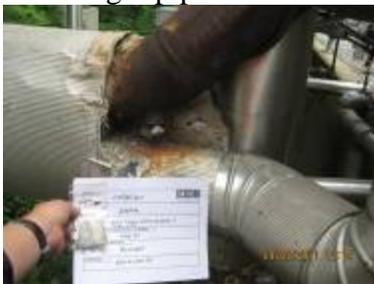
HA18: White line, patching, at emergence from larger pipe.

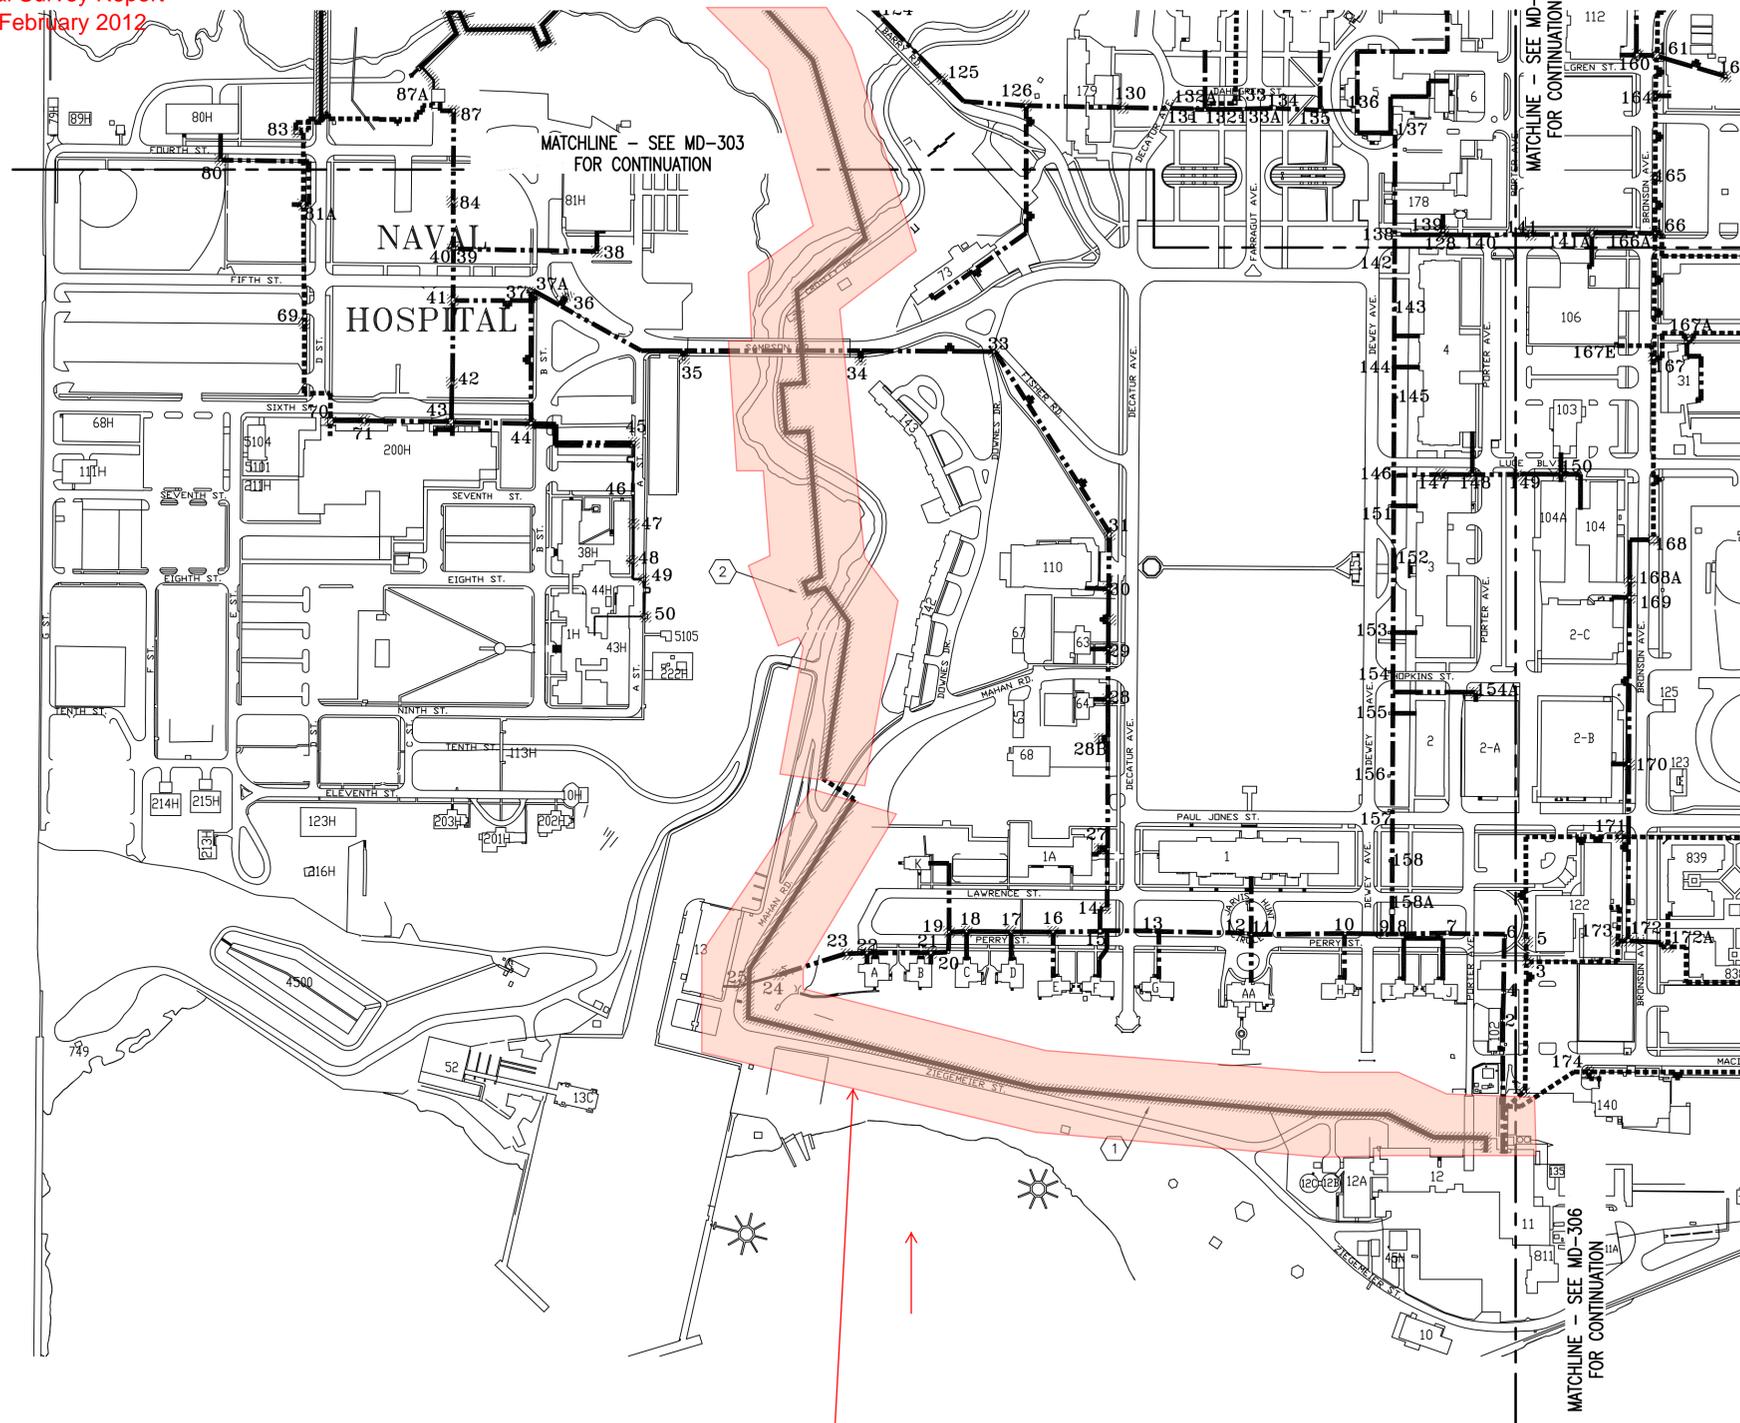
Drawing 6: Location Map of Identified ACM Materials
from Above Ground Steam Lines (Drawing MD-304)

Above Ground Steam Lines: ACM included elbows, black wrap, and cloth wrap
Piping wrap was foam or fiberglass - 4 lines HAS similar across all Aboveground Steam Lines.

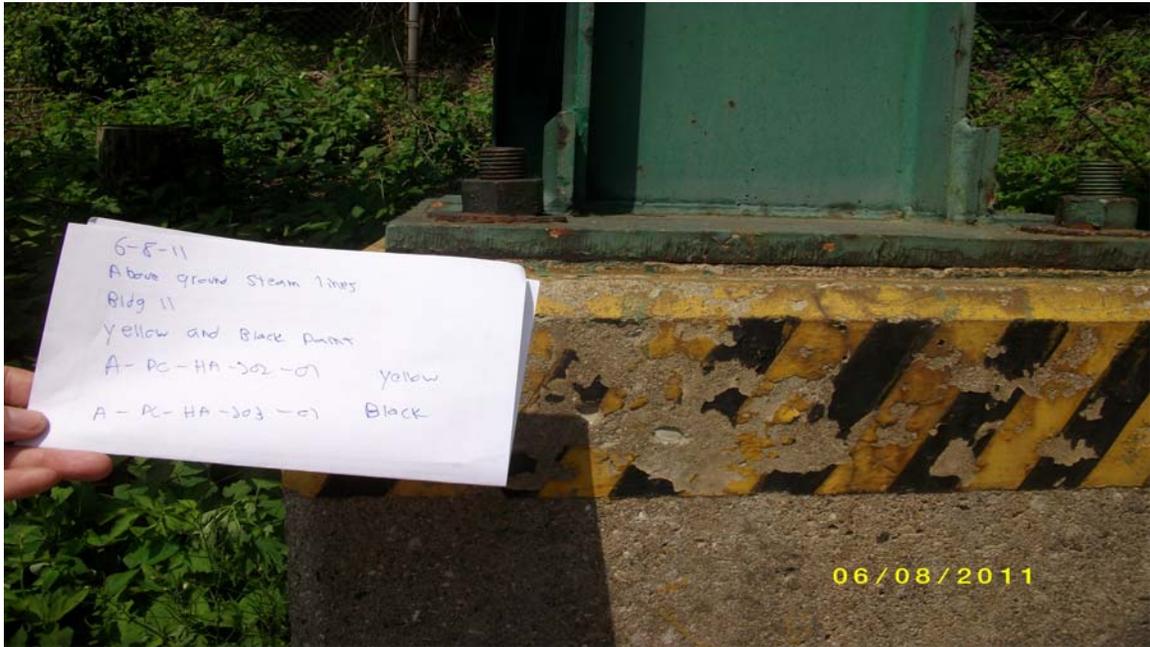
Black and Yellow paint on concrete support. Green paint on metal support.

LBP abatement is recommended prior to demolition of metal and concrete supports for the aboveground steam lines. Quantities for LBP are documented on Appendix D.

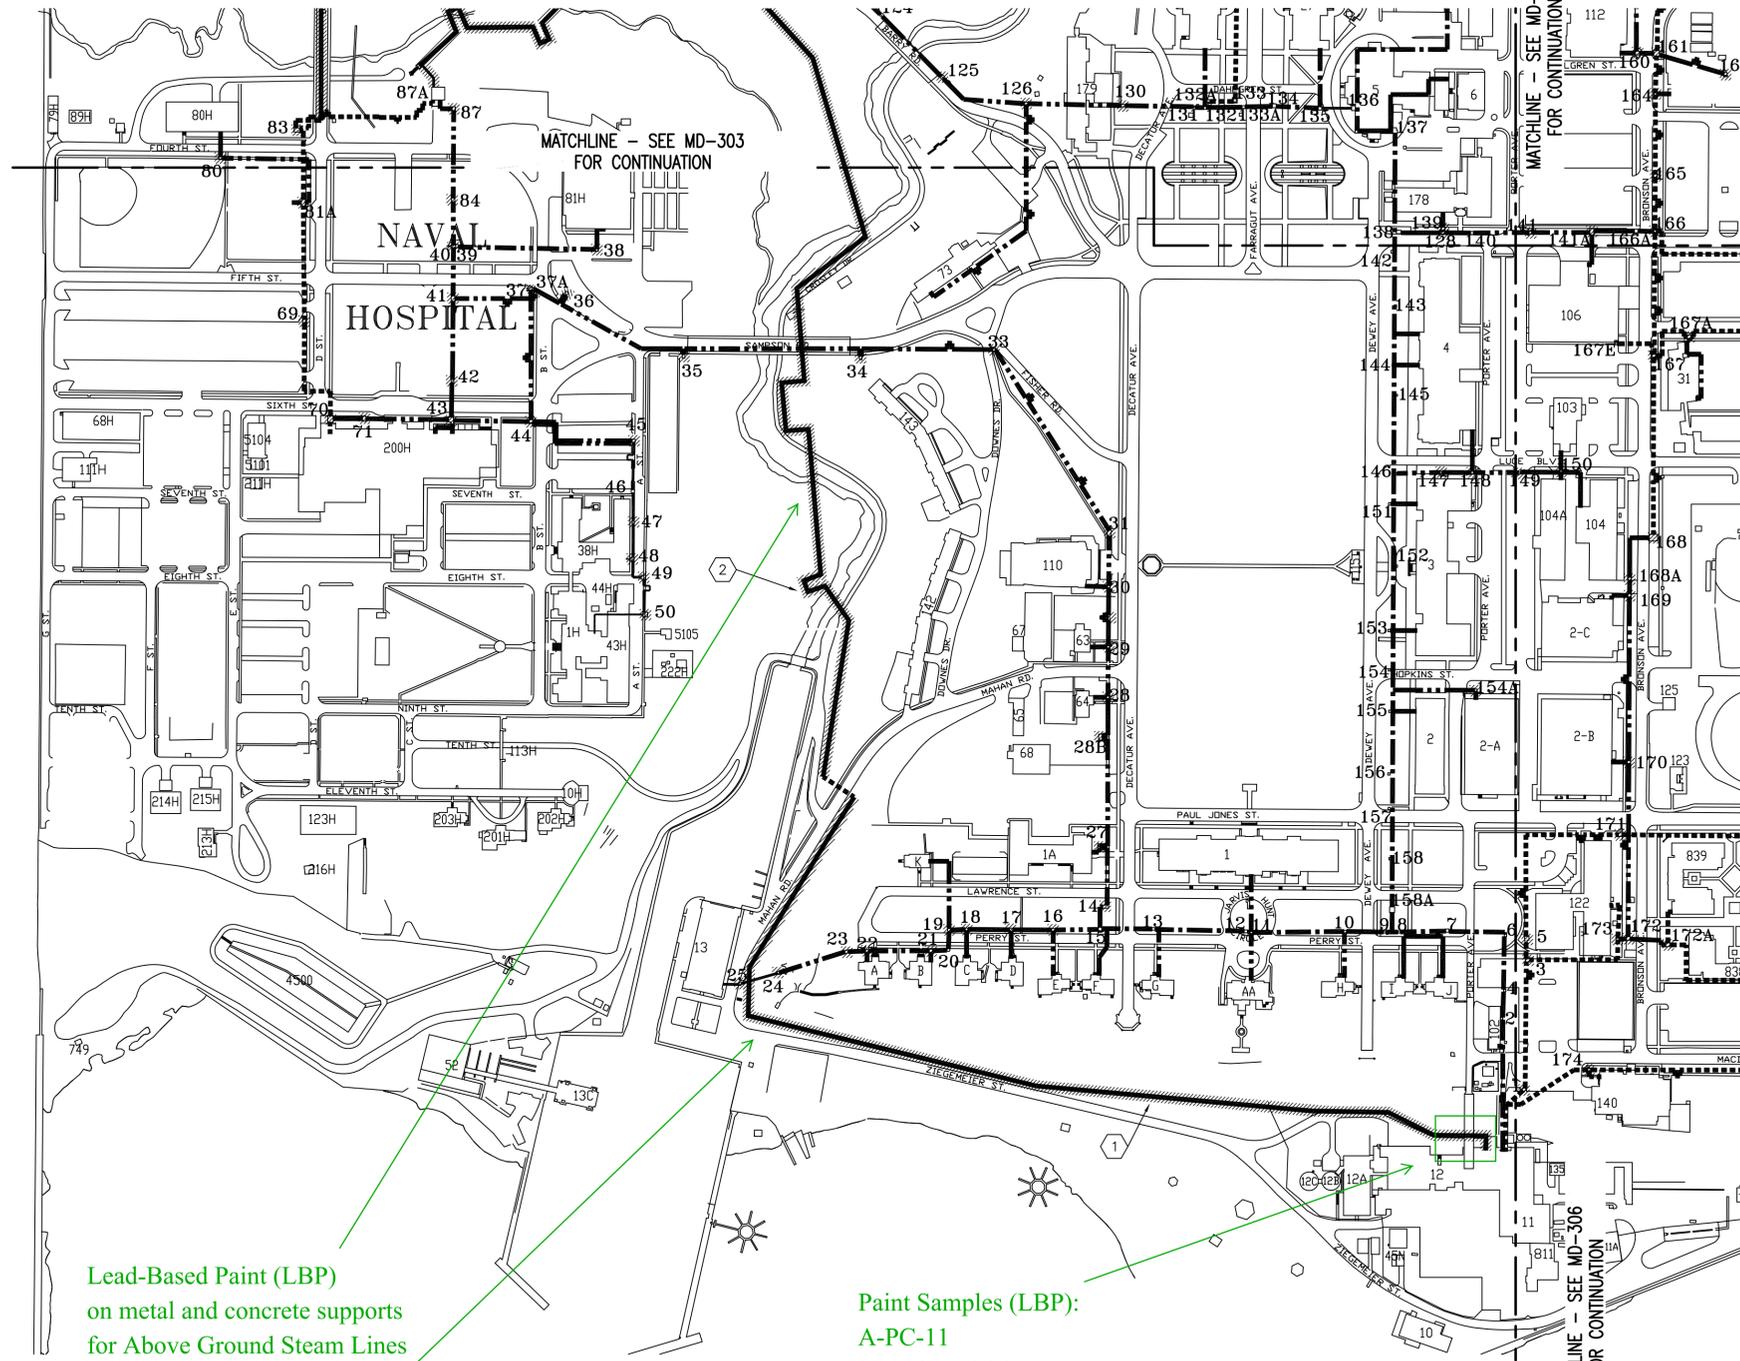
Lead-Based Paint (LBP)
on metal and concrete supports
for Above Ground Steam Lines

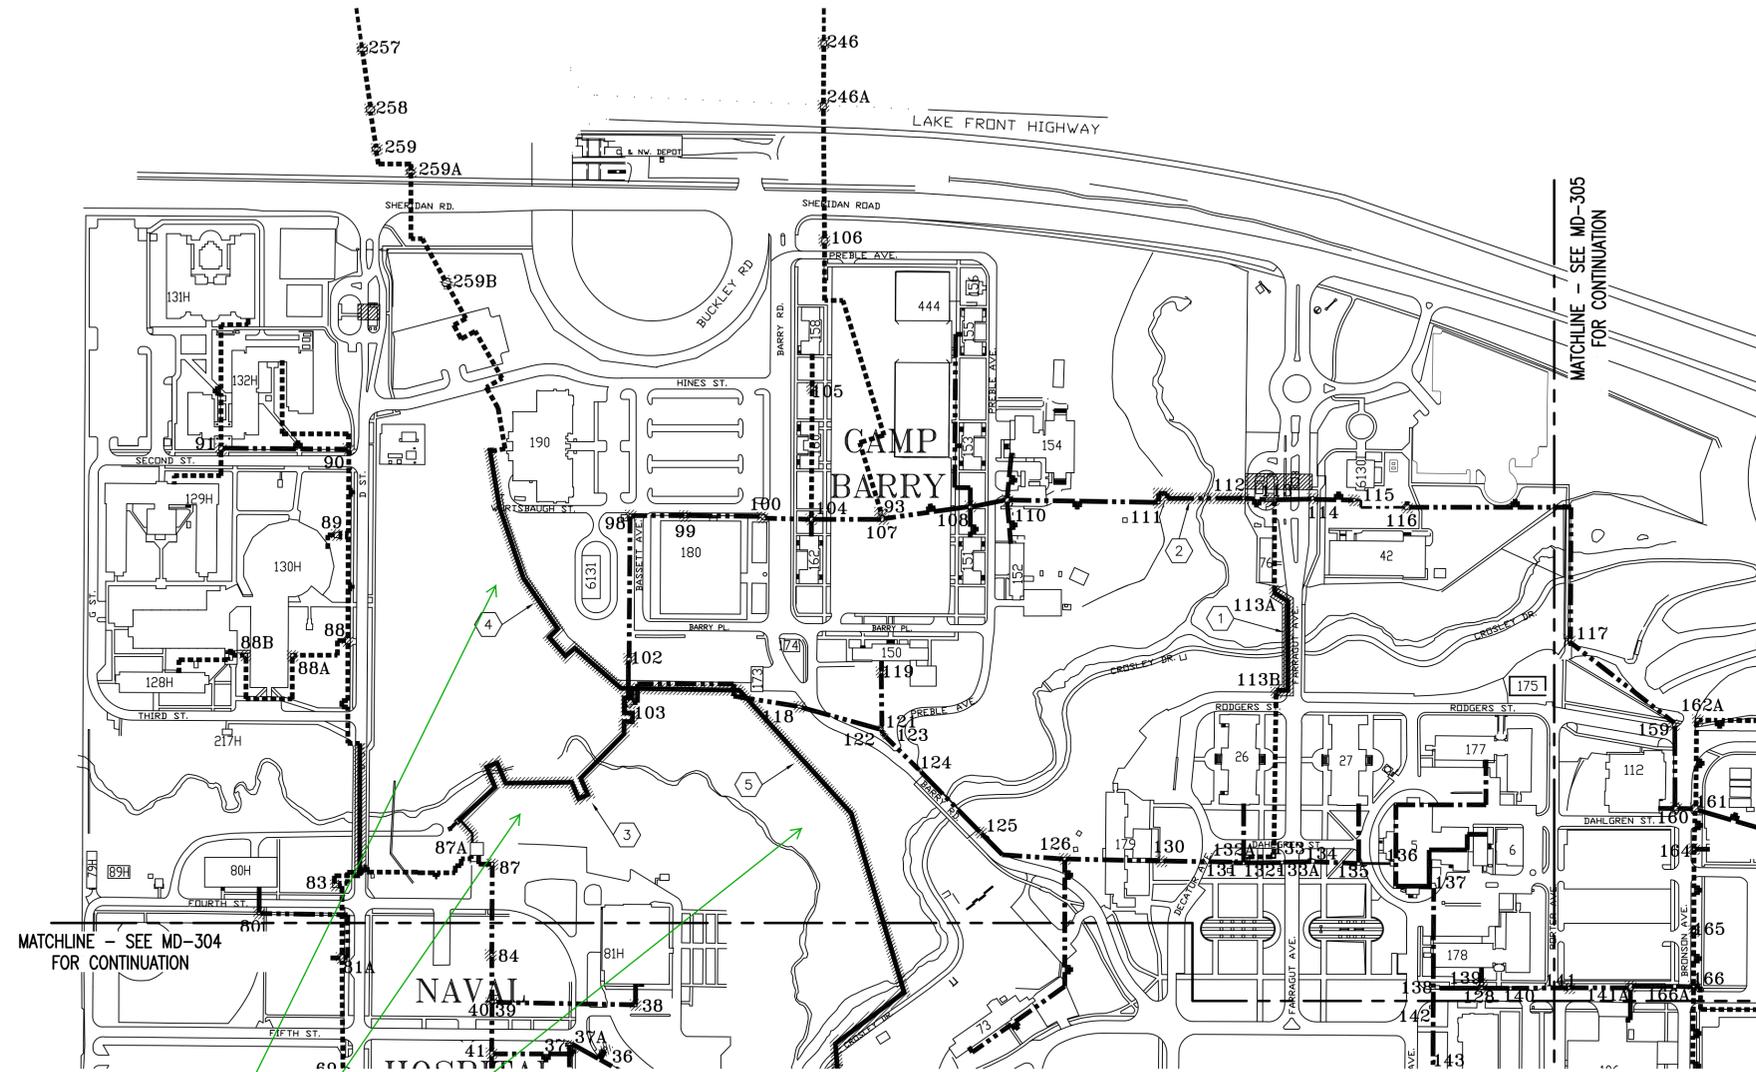
Lead-Based Paint (LBP)
on metal and concrete supports
for Above Ground Steam Lines
