U.S. NAVAL TRAINING STATION
GREAT LAKES, ILL.
RAILROAD TRESTLE
TO POWER HOUSE
REPLACEMENTS AND REPAIRS.

Utility Bridge S-4

February 1997

REPORT ON
INSPECTION, STRUCTURAL ANALYSIS
AND CLASSIFICATION OF
UTILITY BRIDGE S-4

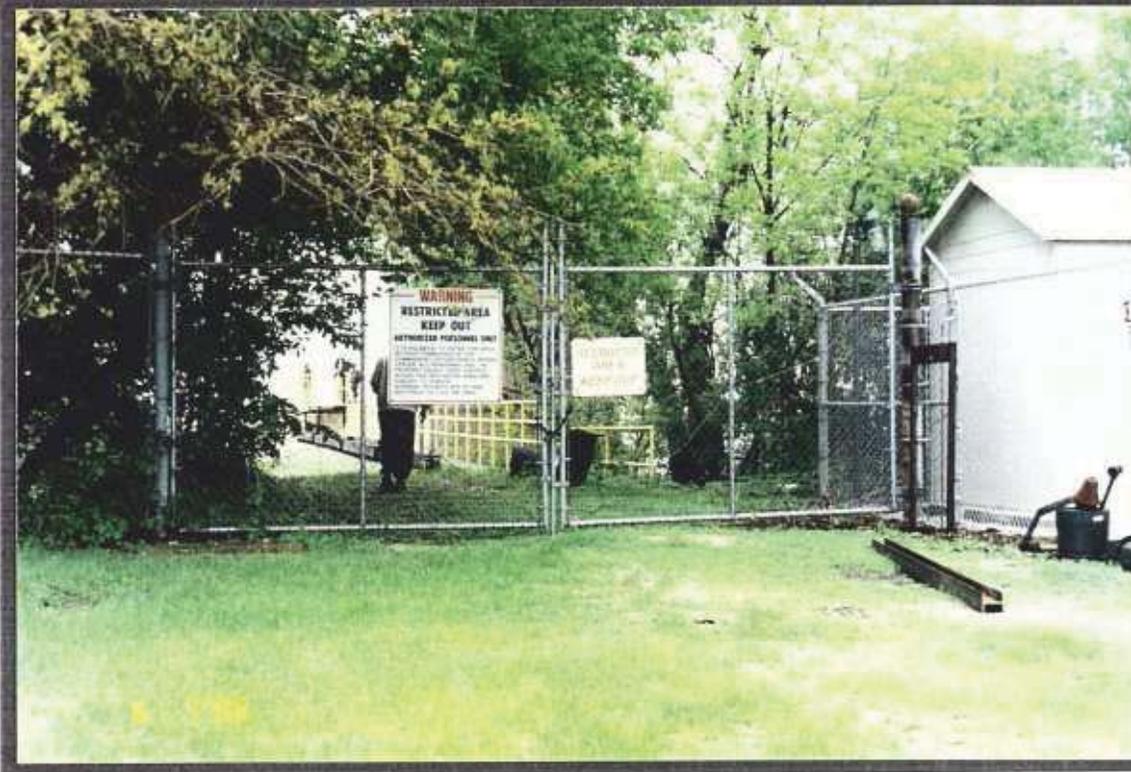
Photograph No. 1

The west bridge approach has a large chain link fence entrance gate with two signs attached to it. The signs indicate a "Restricted Area - Keep Out". There is no other barrier to restrict vehicles from using the bridge (See Photograph 1). There is no pavement at west bridge approach. There is a

Looking East at the West bridge approach and entrance gate.

1. Post a sign at the gate to limit the maximum axle weight to 0.8 ton.
2. Remove south timber curb, and reinstall it above the south bridge girder (7'-2" from north deck edge).

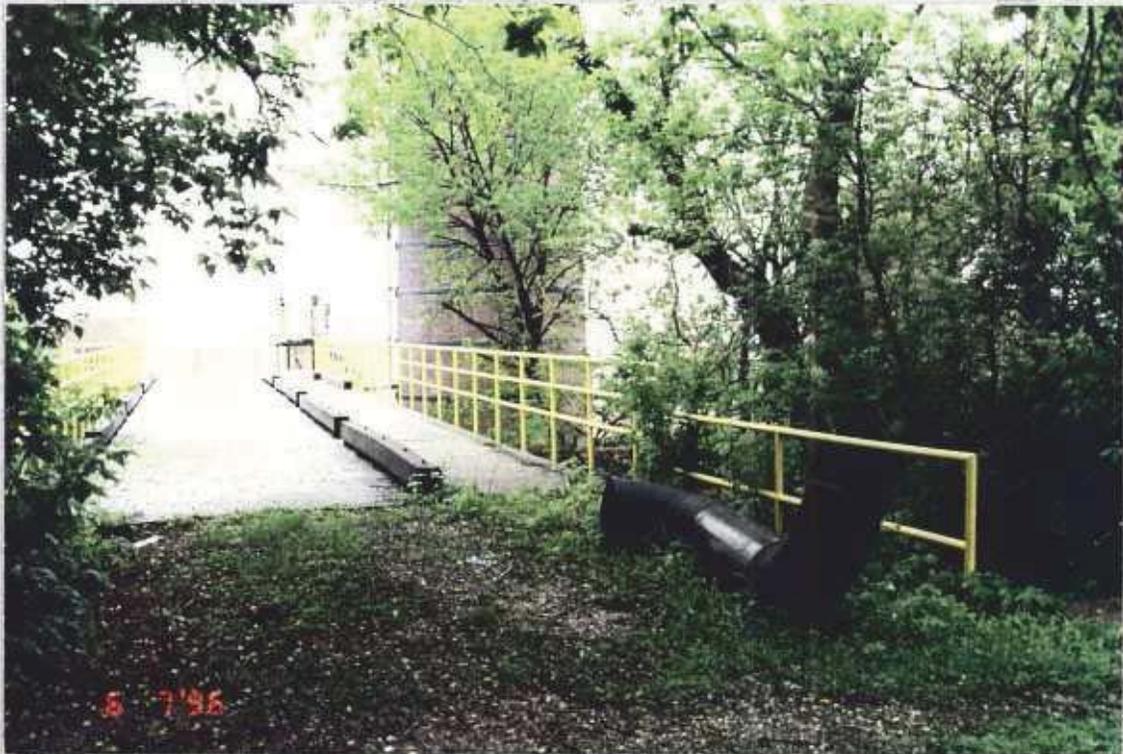
Photograph No. 2

heavy 14 inch pipe blocking the pedestrian way. The east end of bridge is a dead end, with stairs that go down to the roof of building 11. (See Photograph No. 2)

The timber curbs, 7 ½" x 7 ½" x 16'-0", are located at 1'-2" and 11'-0" from north edge of deck and are anchored to the bridge deck (See Photograph 2). The function of the south timber curb is to prevent vehicle access over the cantilevered part of the deck at the south. Presently, a truck can access that part of the deck. Therefore, a sign must be installed to alert the user to this fact. The handrails are in good condition.

Looking East at the Bridge deck.

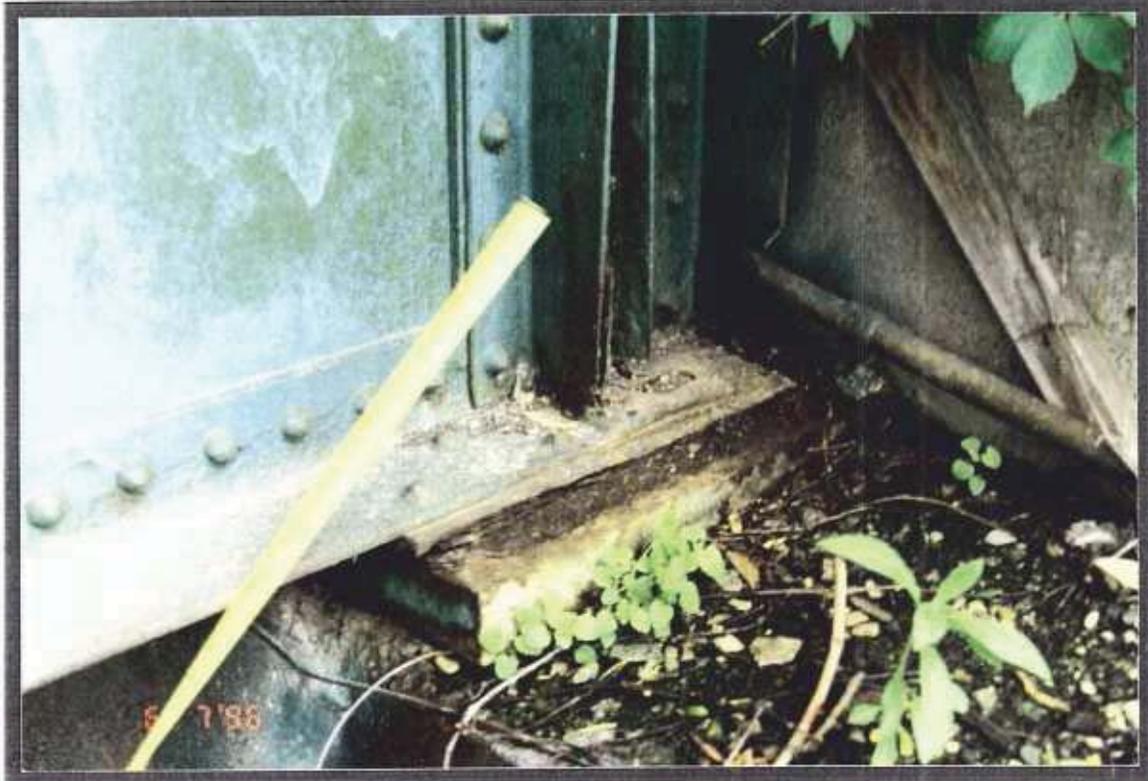
Photograph No. 3

Both girders are supported by steel plate bearings at the west end of the bridge. Both bearings, at that location, are in poor condition. The masonry plates are corroded and the sole plates are severely corroded. The exposed portion and the nut of both anchor bolts at the north girder and one at the south girder are rusted away (See Photograph No. 3). Because of poor condition of bearings, longitudinal movement of bridge is restricted.

The two riveted plate girders are fair to poor condition. The girder bearing stiffener angles above the west abutment are severely corroded at both girders, and there is significant rust packing between outstanding legs (See Photograph No. 3). There are severe rust packs between angles and cover plate at the bottom flange of girders (See Photograph No. 4). The rust packs have caused the cover plates to bulge out. The bottom flange angle and rivets on south side of the south girder are severely corroded. Most of the stiffener angles at that location are rusted away (See Photograph 21). The top flange cover plate of both girders have 50% to 80% section loss in all spans due to corrosion (See Photograph 5). The bottom flange angles of both girders have about 25% of section loss due to corrosion. Additionally, during installation of new floor beams, the top flange cover plates of both girders were cut (See Photograph 6). This condition has created a discontinuous cover plate, which drastically affects the load carrying capacity of the bridge.

West bearing plate of North girder. Missing anchor bolt, corroded masonry plate and bearing stiffeners are noted.

8. For the girder bearings at the west abutment, replace the anchor bolts, clean and paint bearing plates, and grease sliding surfaces.
9. Repair the longitudinal floor channels of the south walkway.

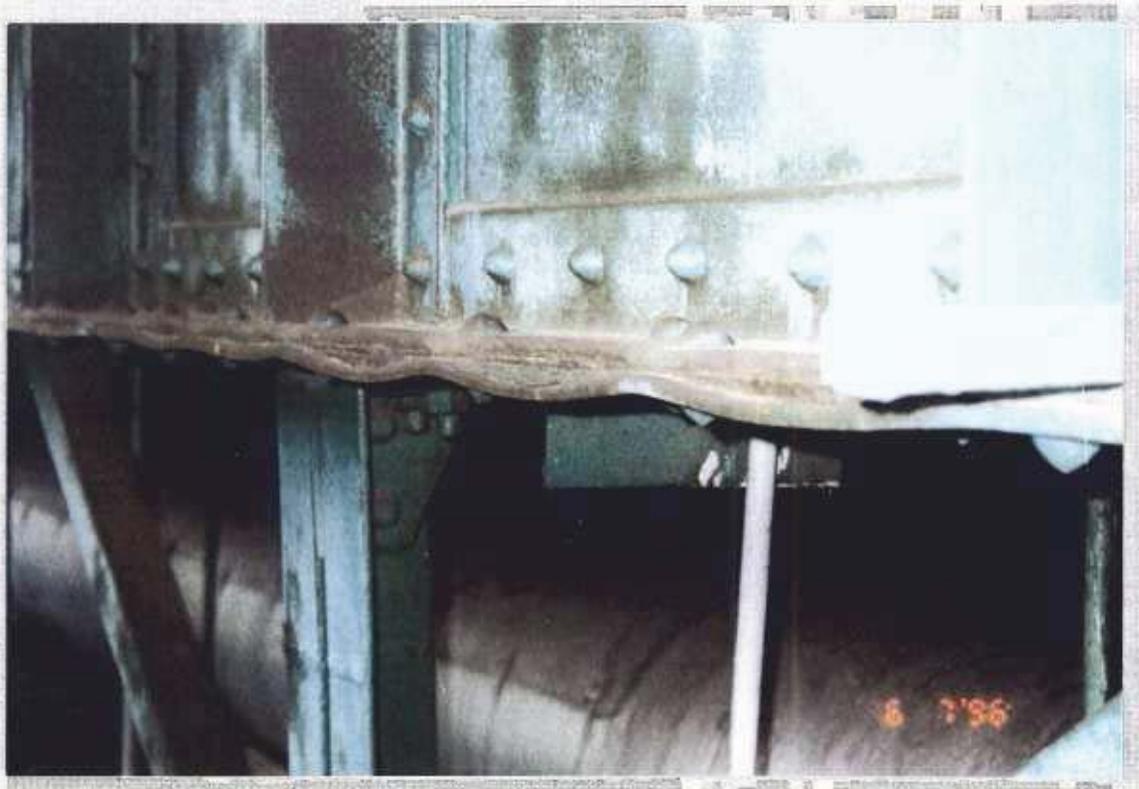
Photograph No. 4

Bottom flange of North girder is shown. This is a typical condition for bottom flange of both girders.

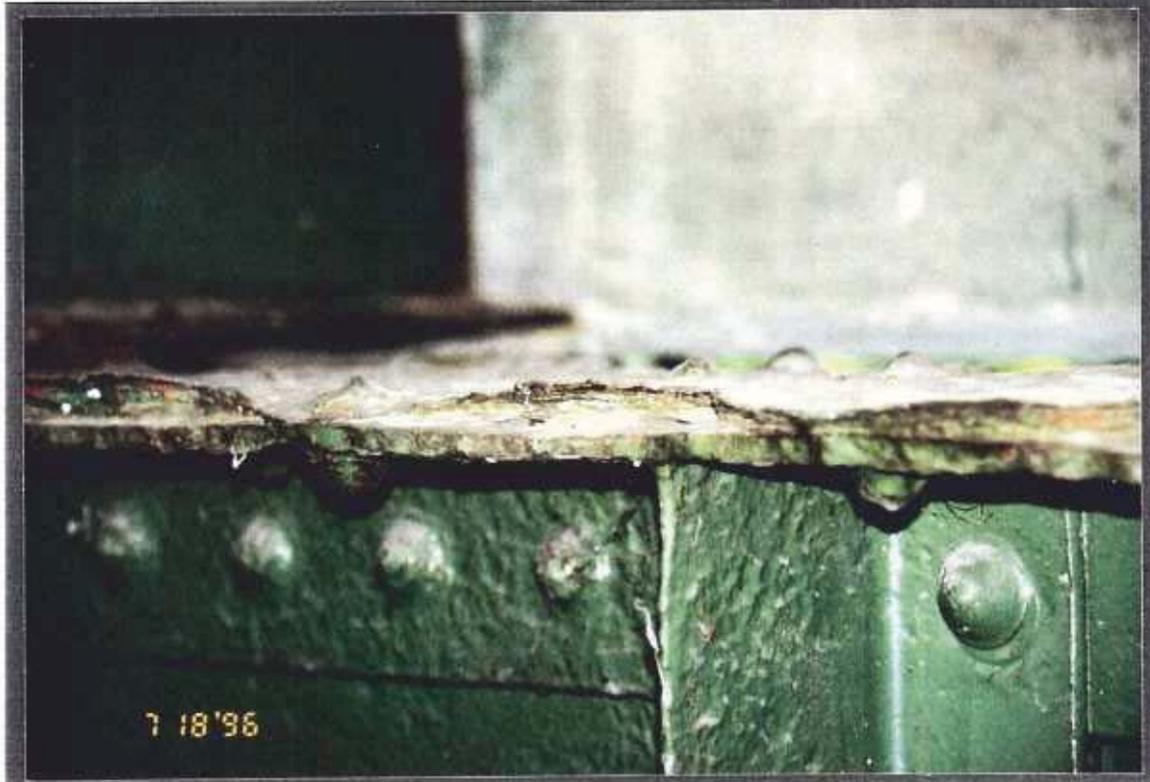
Photograph No. 5

Top cover plate and rivets of South girders is severely corroded.
A typical condition for both girders.

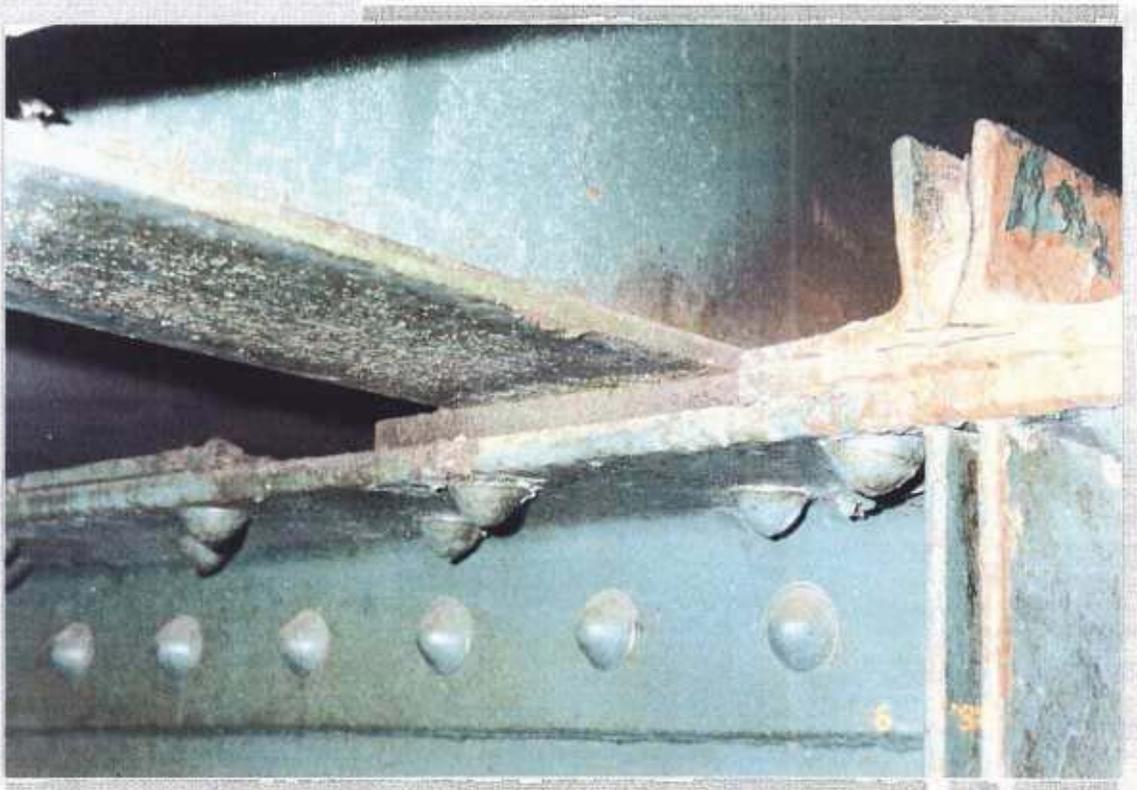
Photograph No. 6

Top cover plate of both girders has been cut.

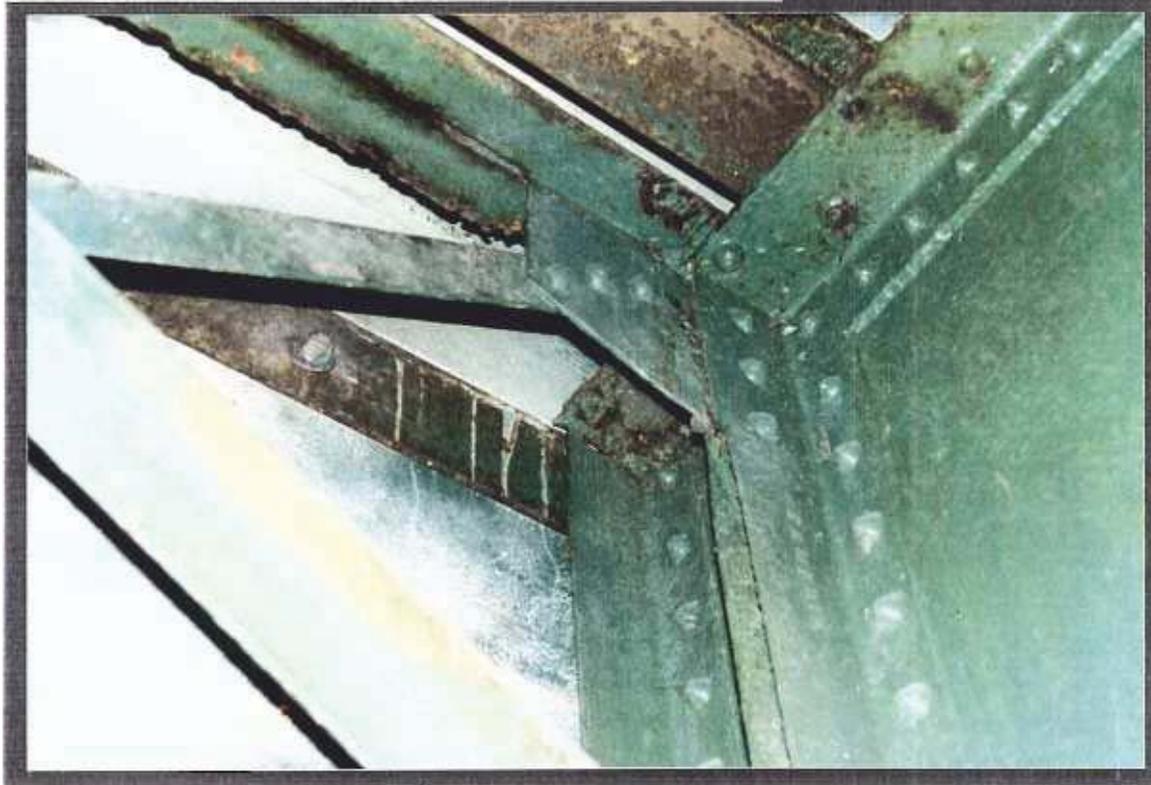
Photograph No. 7

The girders transverse bracings are in fair to poor condition. The horizontal leg of the top horizontal angles above west abutment have corroded to knife condition (See Photograph 7). All gusset plates, for the transverse bracing at west abutment, are severely corroded. (See Photograph 19).

Transverse bracing at West abutment.
Top horizontal member is severely corroded.

6. Replace the transverse bracing and bearing stiffener angles over the west abutment.
7. Straighten the lower longitudinal trestle bracing members, and reinforce by adding lateral bracing between them.

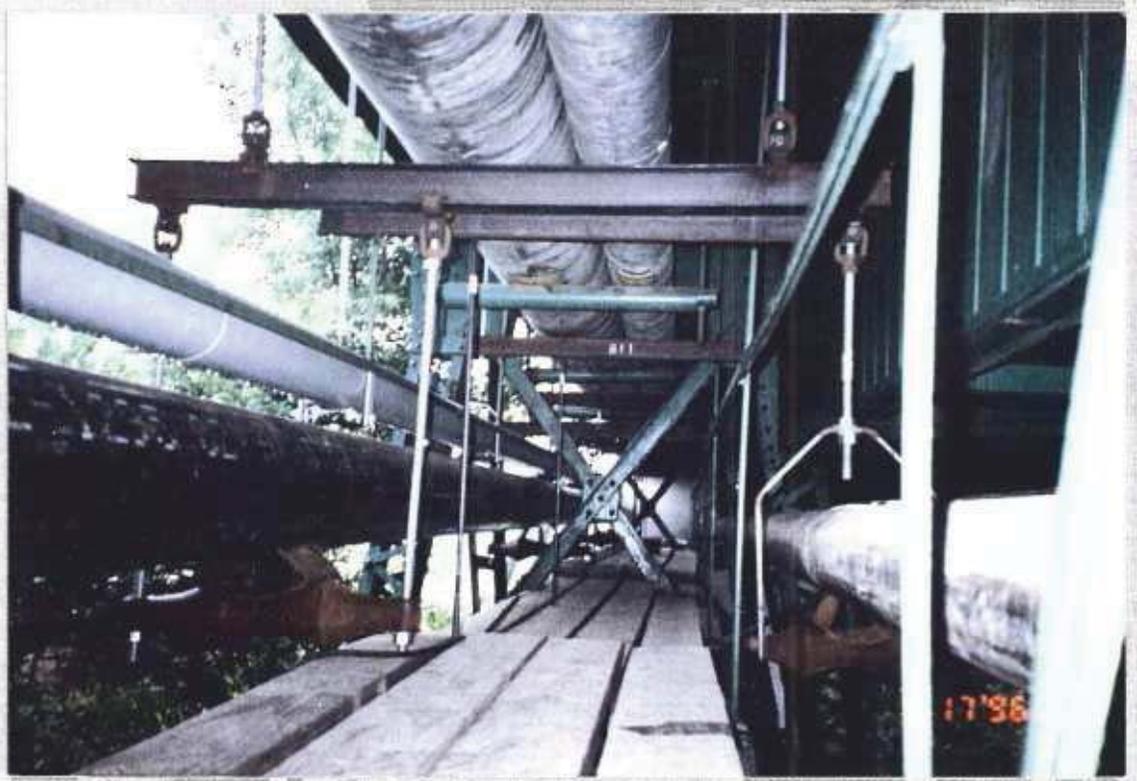
Photograph No. 8

The north walkway under the deck is in good condition. Cross channels, angles and hang rods are not painted. Walkway planks are new, and are in very good condition (See Photograph No. 8).

Looking East at the North walkway under the deck.
Generally in good condition.

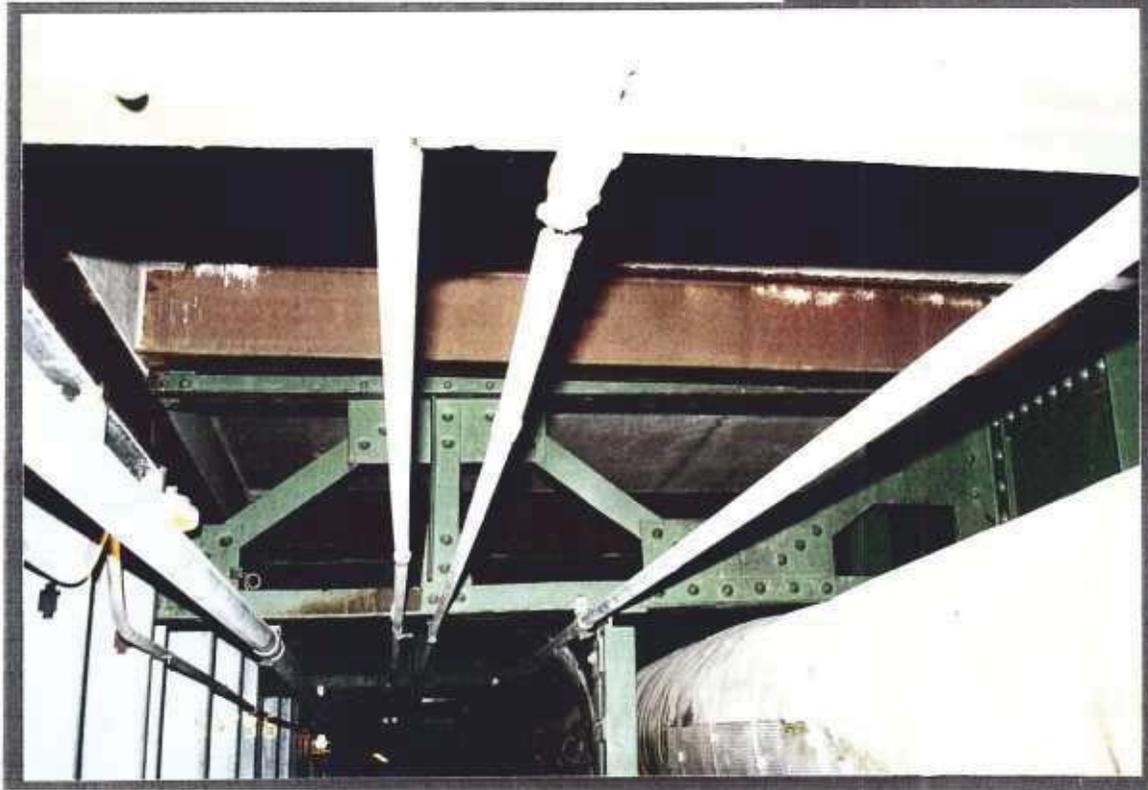
Photograph No. 9

The floor beams, supporting concrete deck, are in good condition. They are unpainted and have moderate rusting condition. (See Photograph 9).

The south walkway is supported by truss cantilevers out from the south girder (See Photograph 9). The top angles of the cantilever trusses are severely corroded. The horizontal leg of these angles are corroded to knife condition, or corroded away in the vicinity of the south bridge girder (See Photograph No. 10). The cantilevers are deflected 1" to 3" at the south end (See Photograph 9).

Looking West inside the South tunnel. Note the deflection of the cantilever supporting the tunnel and unpainted floor beams.

10. Sand-blast and paint all floor beams.

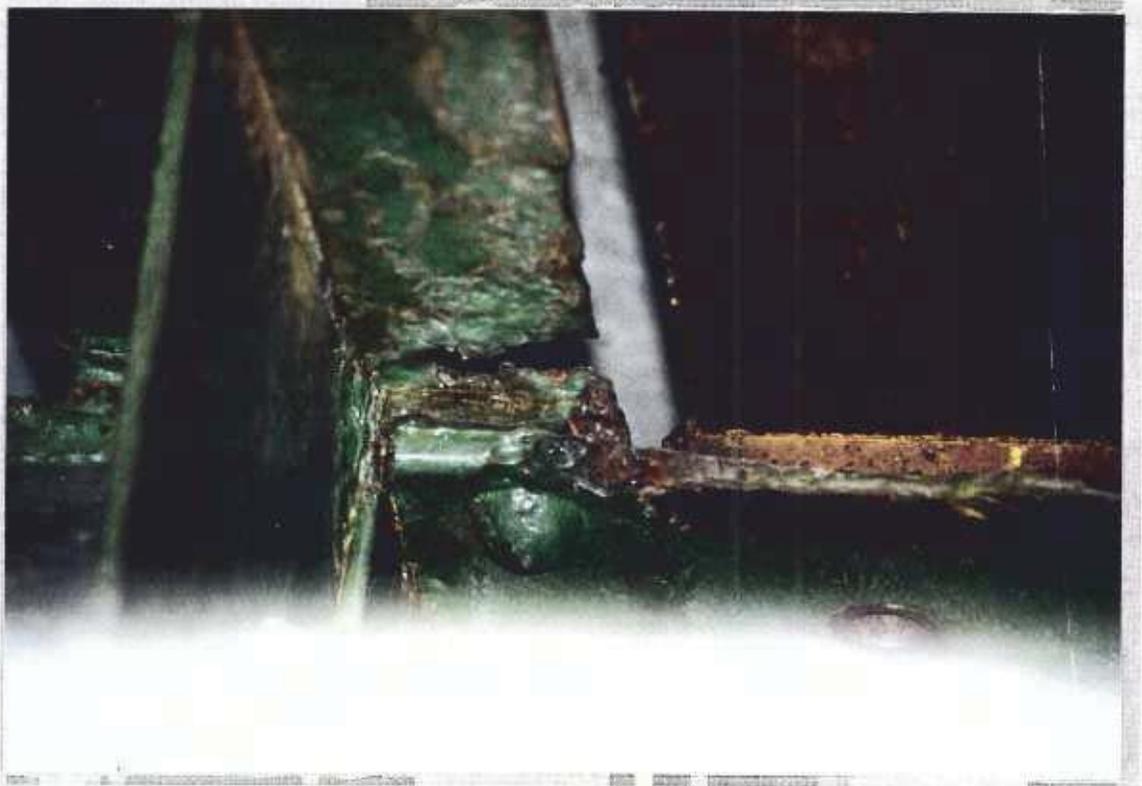
Photograph No. 10

The top chords of the cantilever trusses at the south are heavily corroded. As evident by the structure, the applied loads from utility pipes and the south walkway have caused permanent deflection of those trusses. This deflection would increase with time, and eventually cause failure of the south walkway. In order to avoid expensive repairs to the structure and pipes, we recommend repairing the corroded truss members as soon as possible.

Top member of the South tunnel cantilever is severely corroded at the girder flange. A typical condition.

4. On the bridge deck, extend the south timber curb to Building 11 as shown on the plan.
5. As indicated in Section 6.0, repair of the top chords of the cantilever trusses under the bridge deck at the south girder is a high priority.

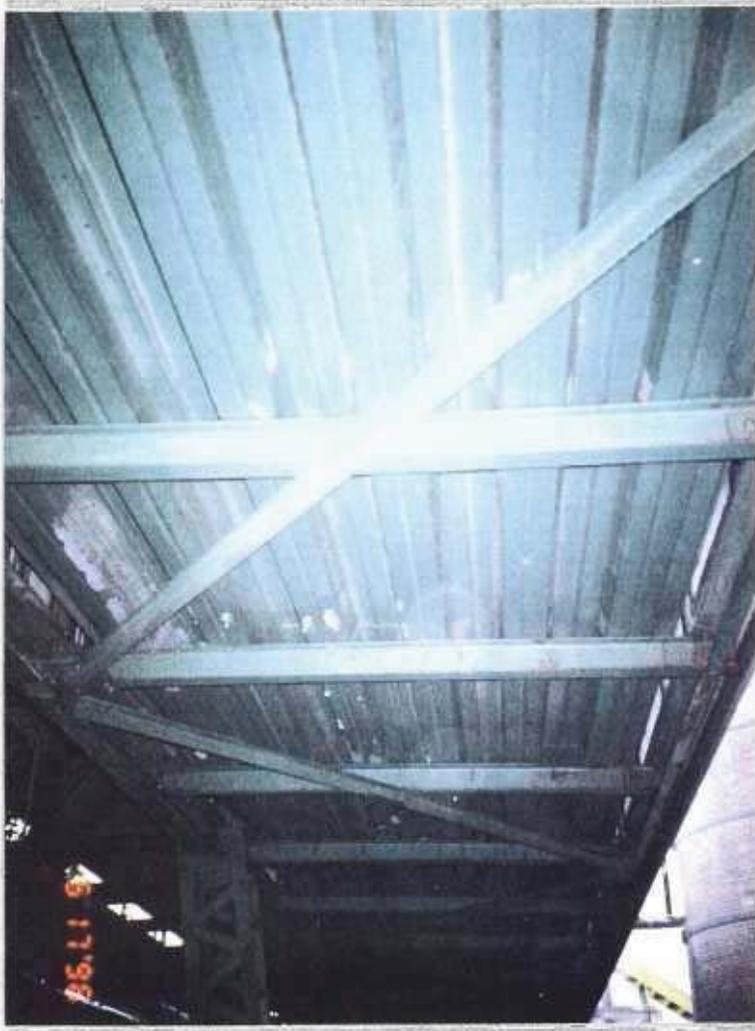
Photograph No. 11

The 4" beams supporting the light gauge metal flooring, and the lateral bracing, are in fair condition (See Photograph No. 11). The south metal panel wall is in good condition (See Photograph 12).

Left:
Looking East at the underside of
South tunnel walkway.
Components generally in fair
condition.

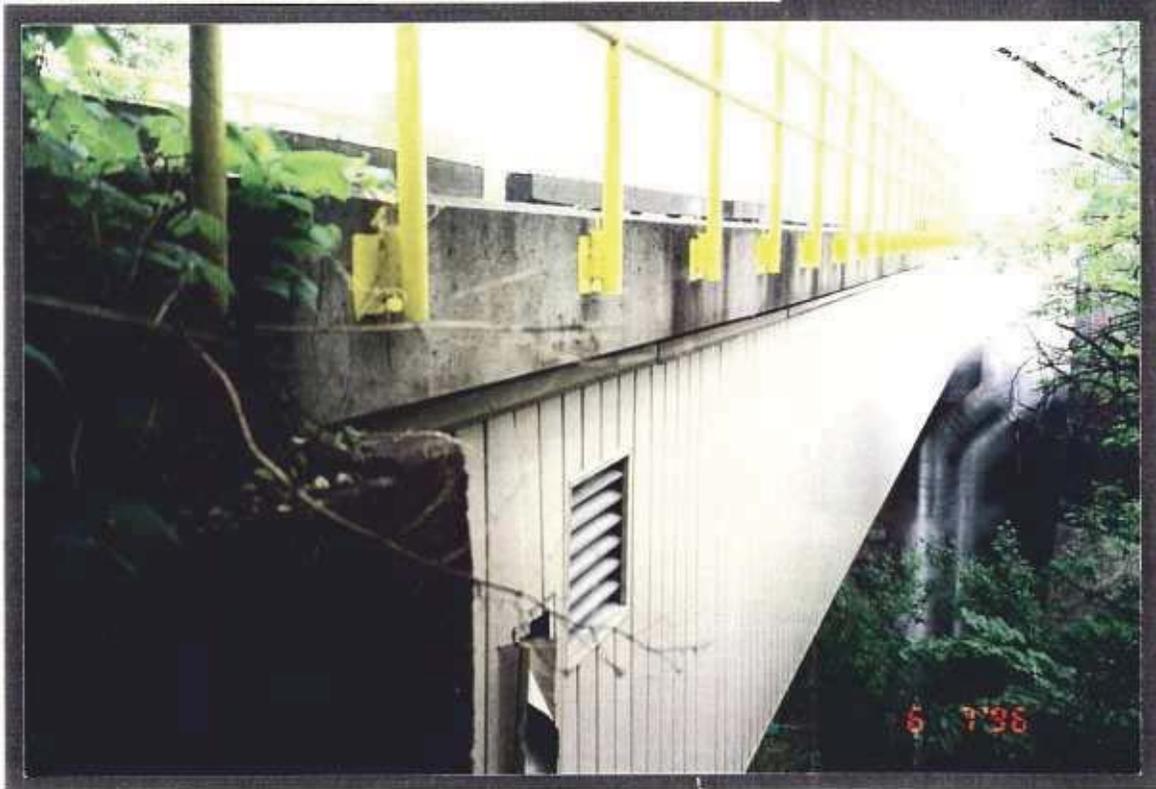
Photograph No. 12

Bottom:
Looking East at South wall
of the South tunnel.
Components generally in
fair condition.

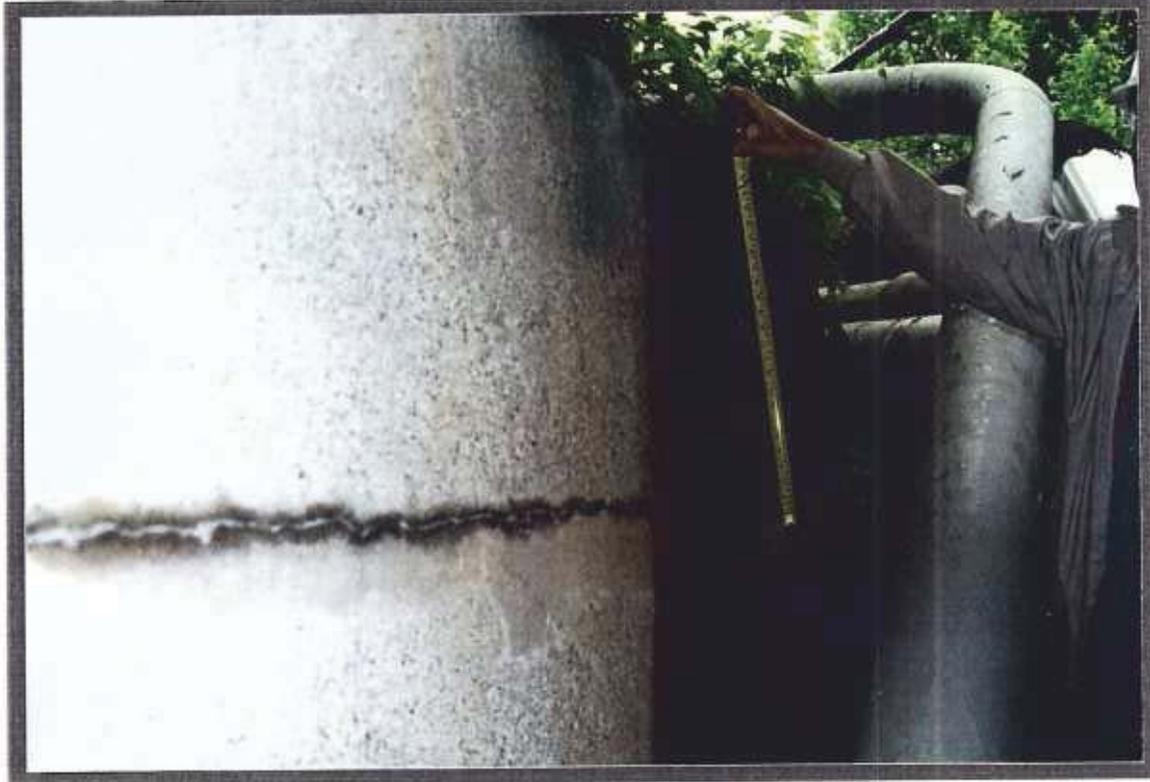
Photograph No. 13

The concrete of west abutment is in fair condition. There are hairline cracks and spalls on the backwall. There is a horizontal open crack with efflorescence 2'-0" below the top of the breast wall (See Photograph 13). It appears that this crack has formed at location of a construction joint. There is also a vertical crack below the south utility tunnel support, and a spall beneath the masonry plate of north bearing. Dirt and debris has accumulated on the top of the breast wall (See Photograph 3).

View of breast wall at West abutment which has an open horizontal crack.

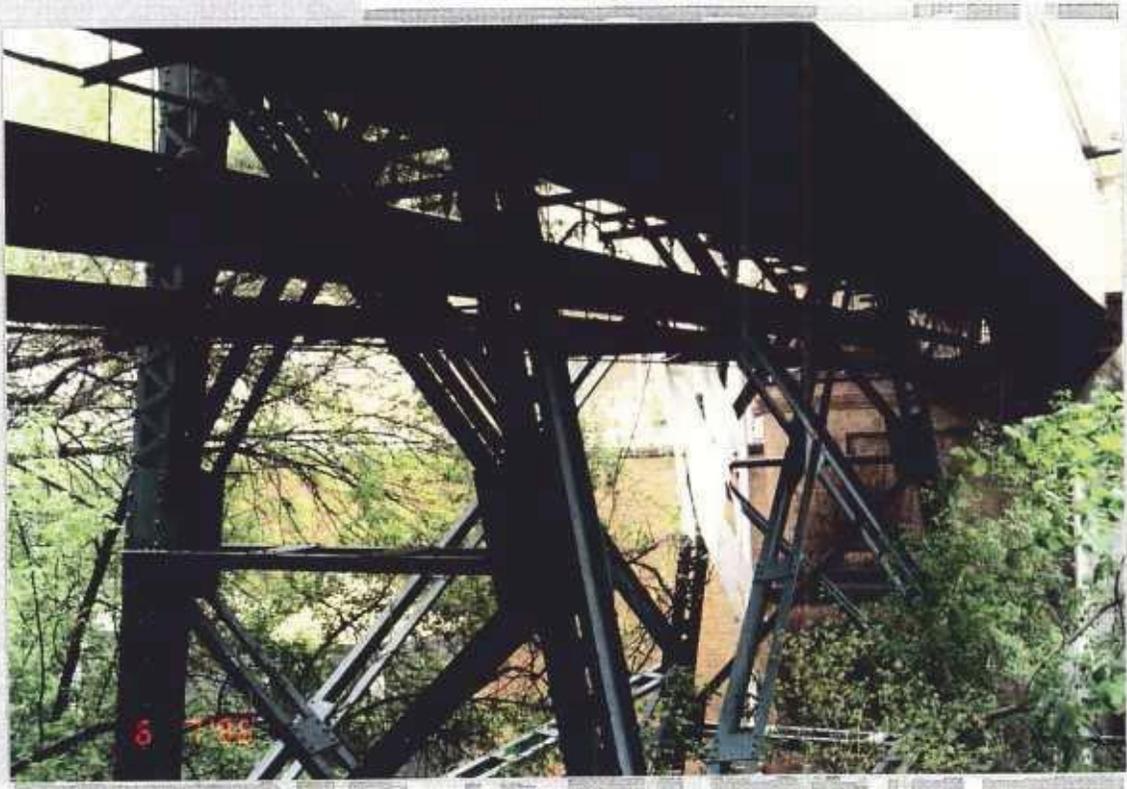
Photograph No. 14

View looking East at the superstructure. Trees growing around the base of the structure should be removed.

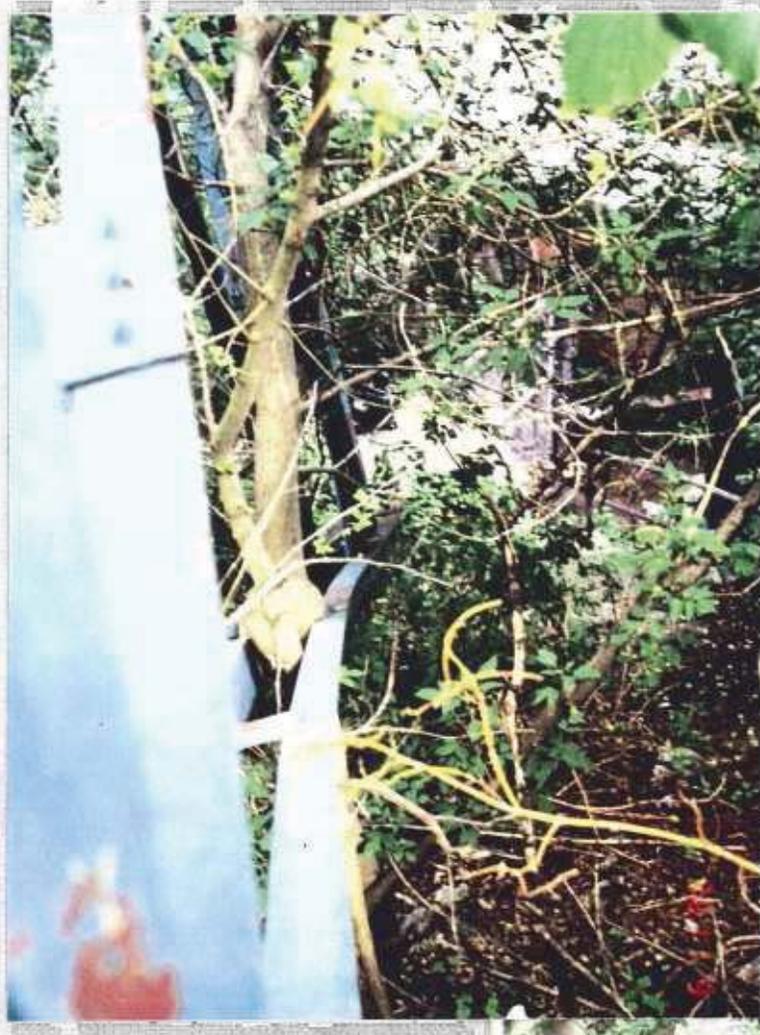
Photograph No. 15

The columns and transverse vertical bracings at bent 1 and 2 are in good condition. The south and north lower longitudinal bracing member is bent inward 3" to 5" (See Photograph No.15 and 16). There is a tree which has grown between the two angles of the bottom steel member. There is rust

Left:
Looking East. Sloped bottom member of South longitudinal bracing is bent inwards by 3" to 5".

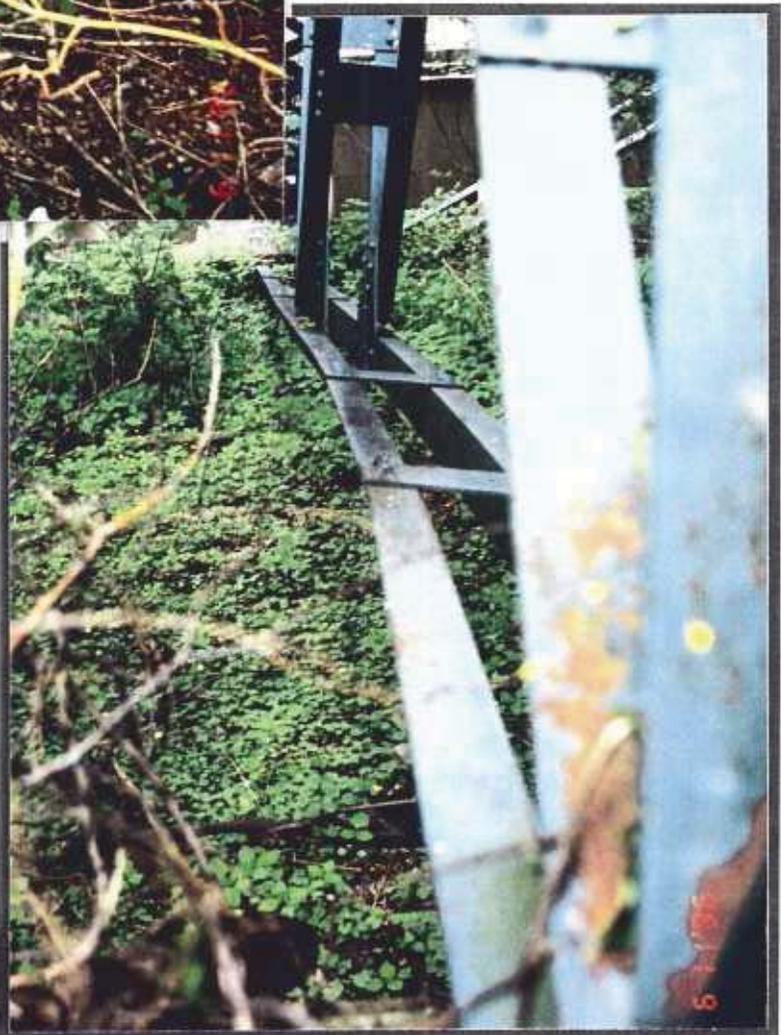
Photograph No. 16

Right:
Looking East.
Sloped bottom member of North longitudinal bracing is bent inwards by 3" to 5".

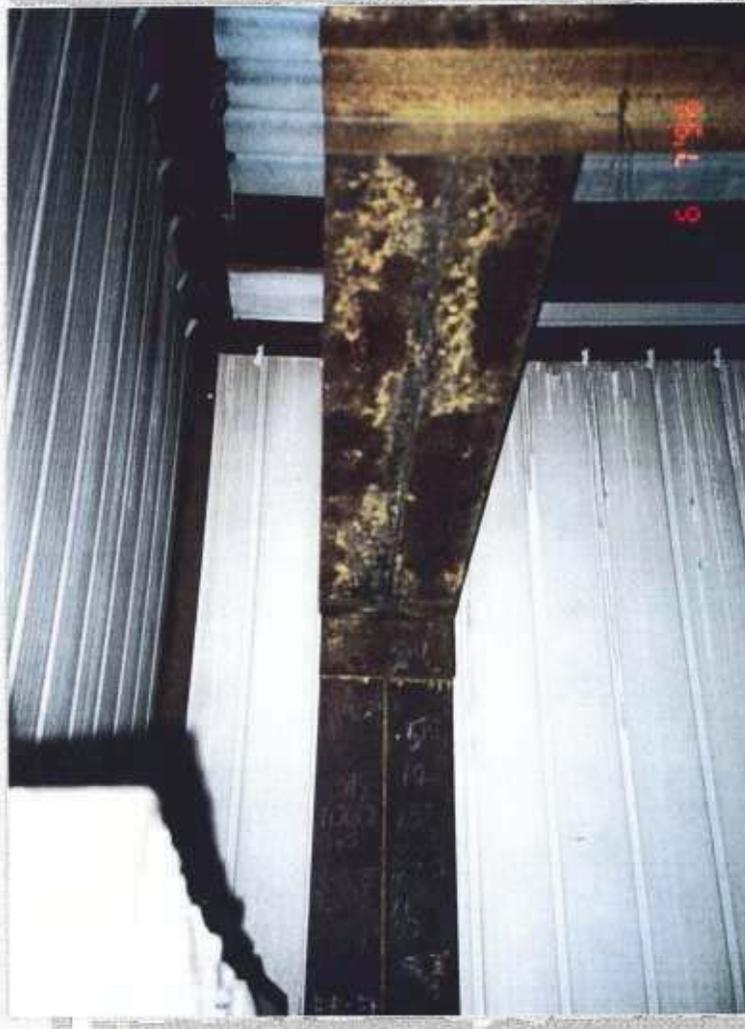
Photograph No. 17

The east ends of bridge girders are supported by a riveted steel plate bent which is located inside the building 11. The accessible part of the steel bent is in fair condition. It was noted that the bent members are rusted since they have not been painted (See Photograph 17). All parts of the steel bent are not accessible for verification.

Left:
Looking North at the steel frame supporting East end of bridge girders.
Accessible part of frame was verified to be in fair condition.

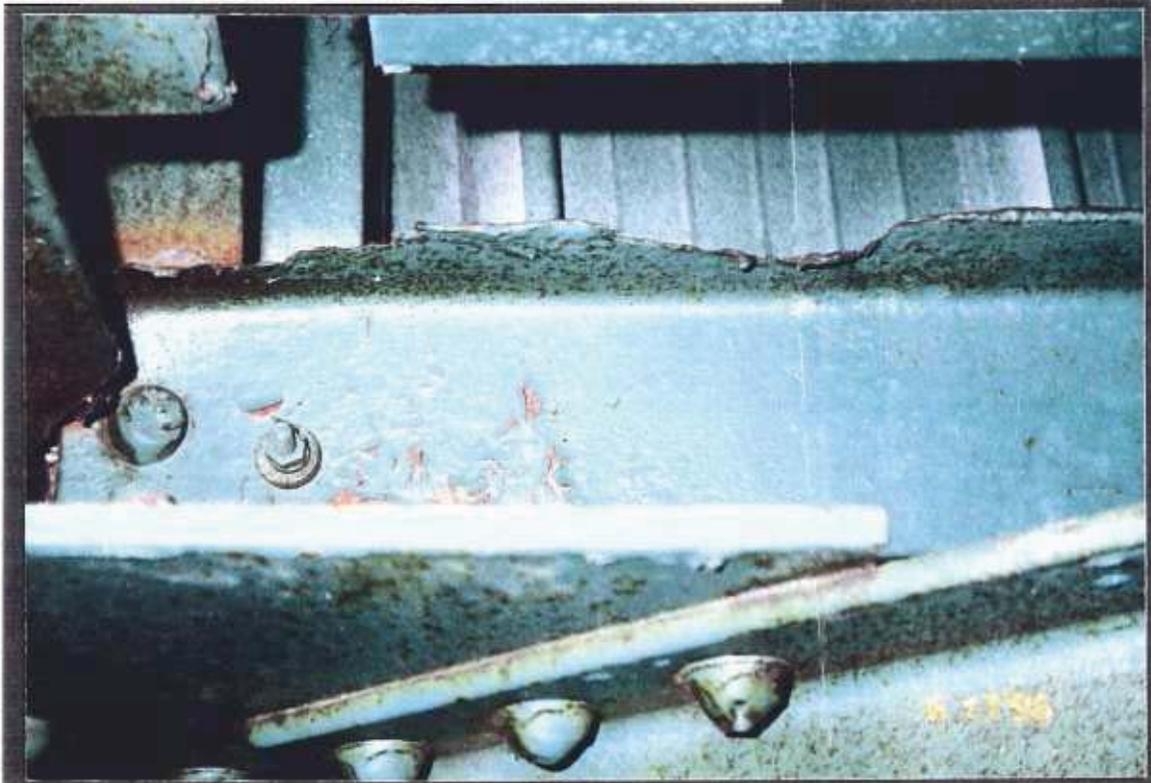
Photograph No. 18

The bottom longitudinal channels, supporting tunnel floor cross beams, are in poor condition. There are heavy corrosion losses in the channel flanges (See Photograph No. 18).

Bottom:
Severely corroded flange of longitudinal channel supporting South tunnel floor cross members.

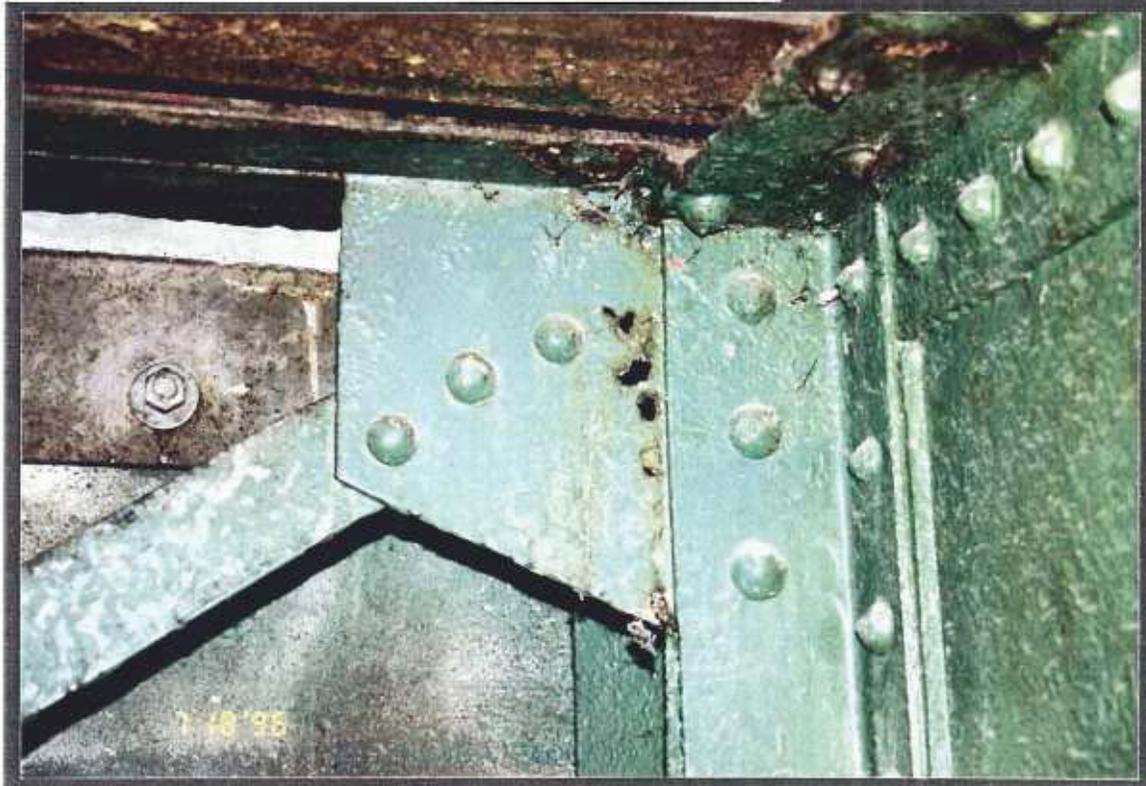
Photograph No. 19

North top gusset plate of transverse bracing at abutment is severely corroded and has rust holes.

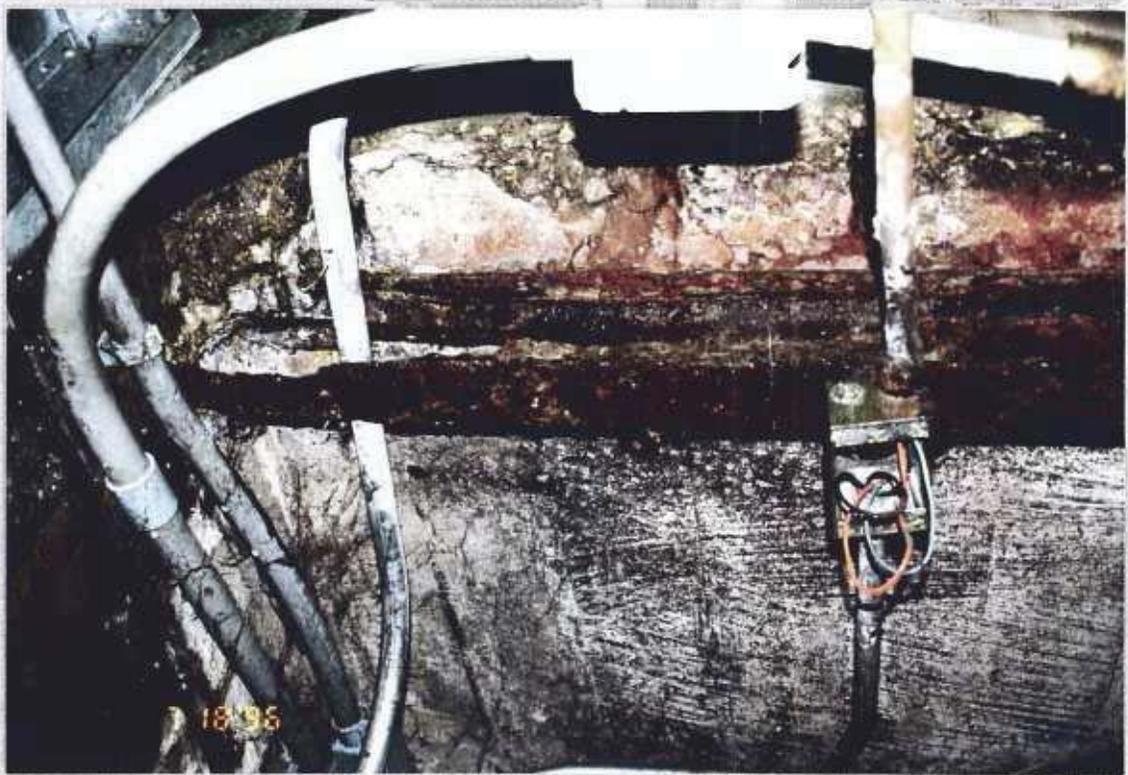
Photograph No. 20

The wingwalls are in fair condition. The concrete walls, ceiling and slab at the entrance to the underground utility tunnel are in poor condition. The concrete edge of tunnel ceiling has a severe spall, and the I-4 beam is severely corroded (See Photograph 20). There are large open horizontal and vertical cracks between abutment and the north tunnel wall.

Concrete ceiling of the underground tunnel entrance, looking North up. Severe spalling and corroded steel beam.

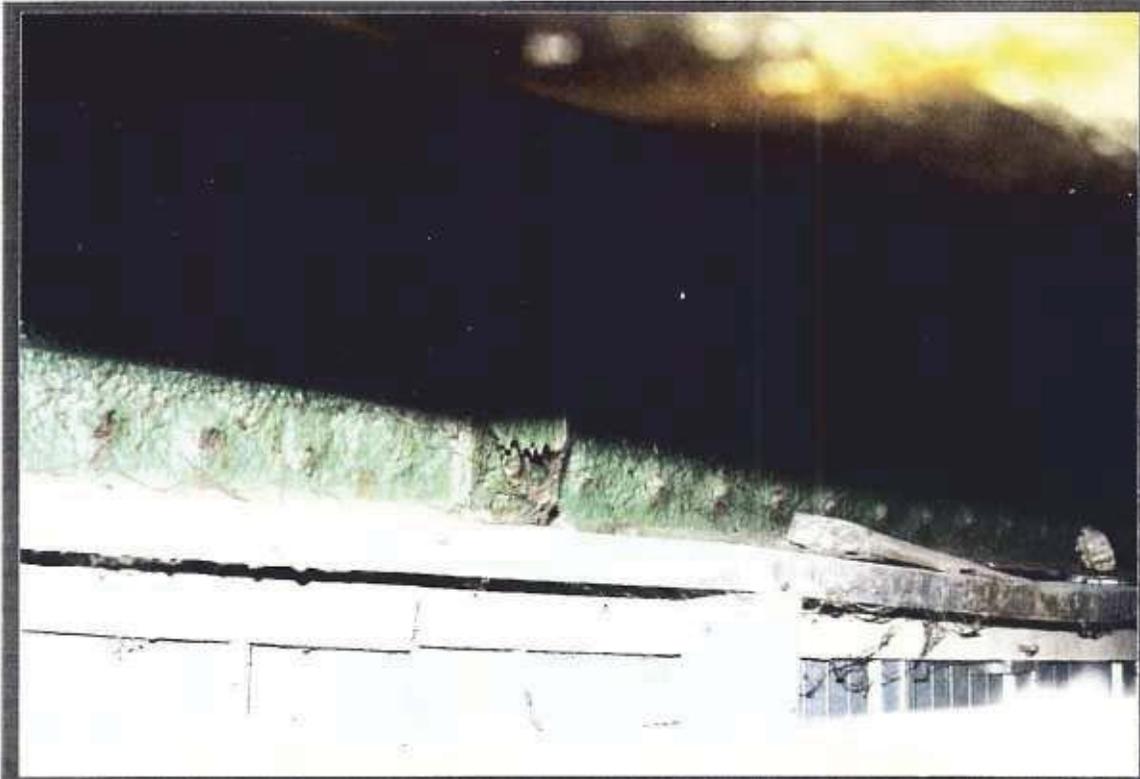
Photograph No. 21

Top:
South face of South girder.
Note the rusted away
girder stiffener and rivets.
View is blocked by a pipe.

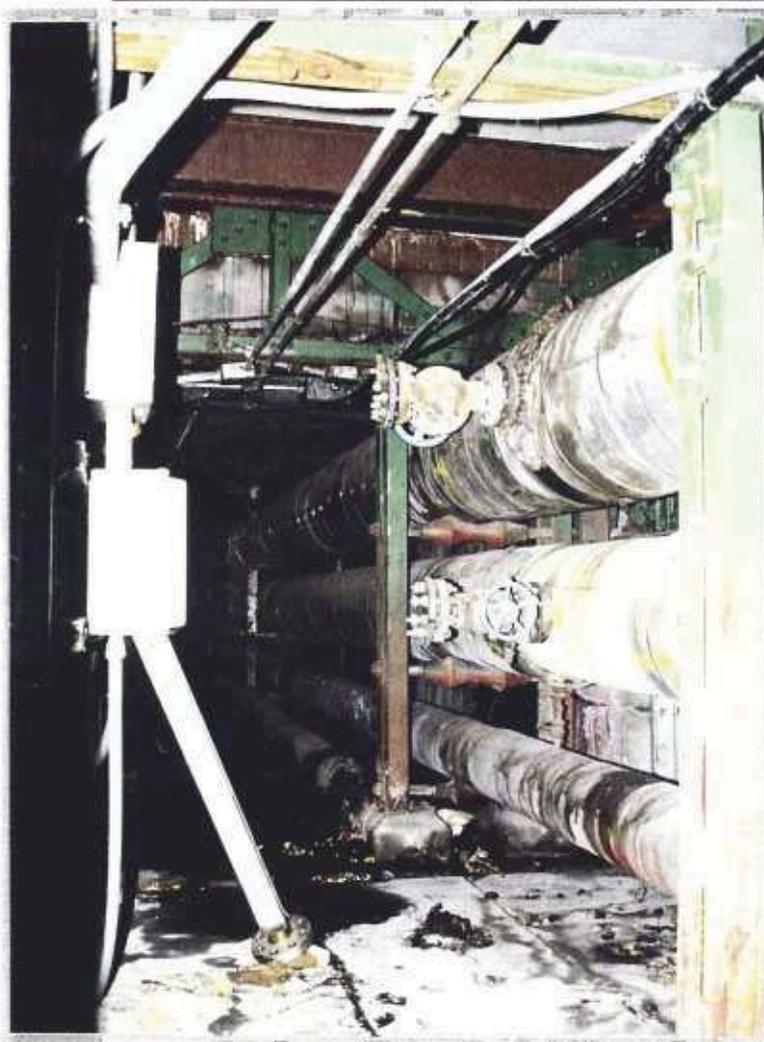
Photograph No. 22

Left:
Looking West at the entrance the
underground utility tunnel.
Note general concrete deterioration
and water accumulation
in the tunnel.
