REPORT
on
**INSPECTION, STRUCTURAL ANALYSIS
AND CLASSIFICATION FOR:**

Utility Bridge No. 737

February 1997

REPORT ON
INSPECTION, STRUCTURAL ANALYSIS
AND CLASSIFICATION OF
UTILITY TRESTLE NO. 737

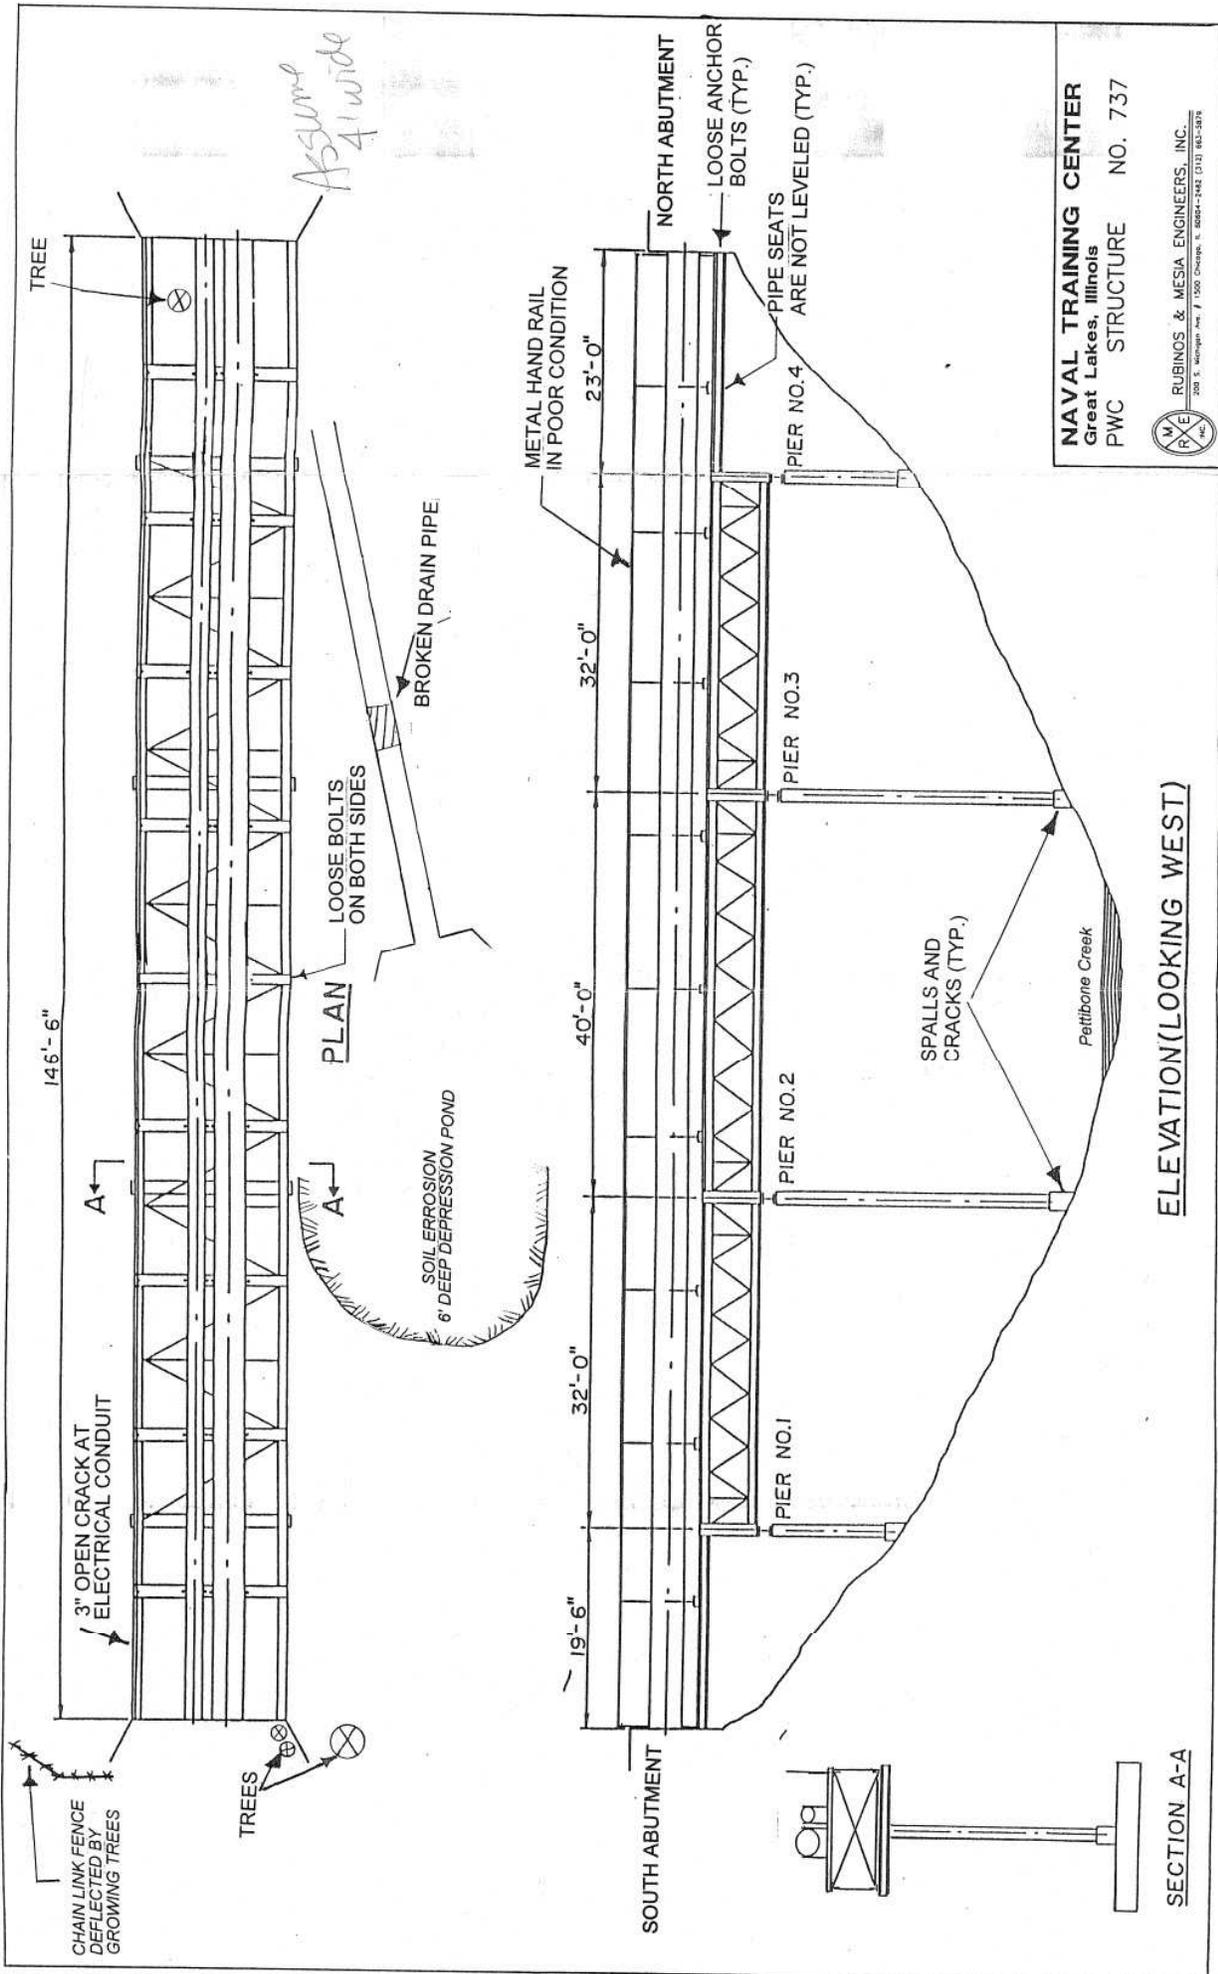
ELEVATION (LOOKING WEST)

3" OPEN CRACK AT ELECTRICAL CONDUIT

PLAN
LOOSE BOLTS ON BOTH SIDES

SOIL EROSION 6' DEEP DEPRESSION POND

BROKEN DRAIN PIPE

METAL HAND RAIL IN POOR CONDITION

LOOSE ANCHOR BOLTS (TYP.)

PIPE SEATS ARE NOT LEVELED (TYP.)

SPALLS AND CRACKS (TYP.)

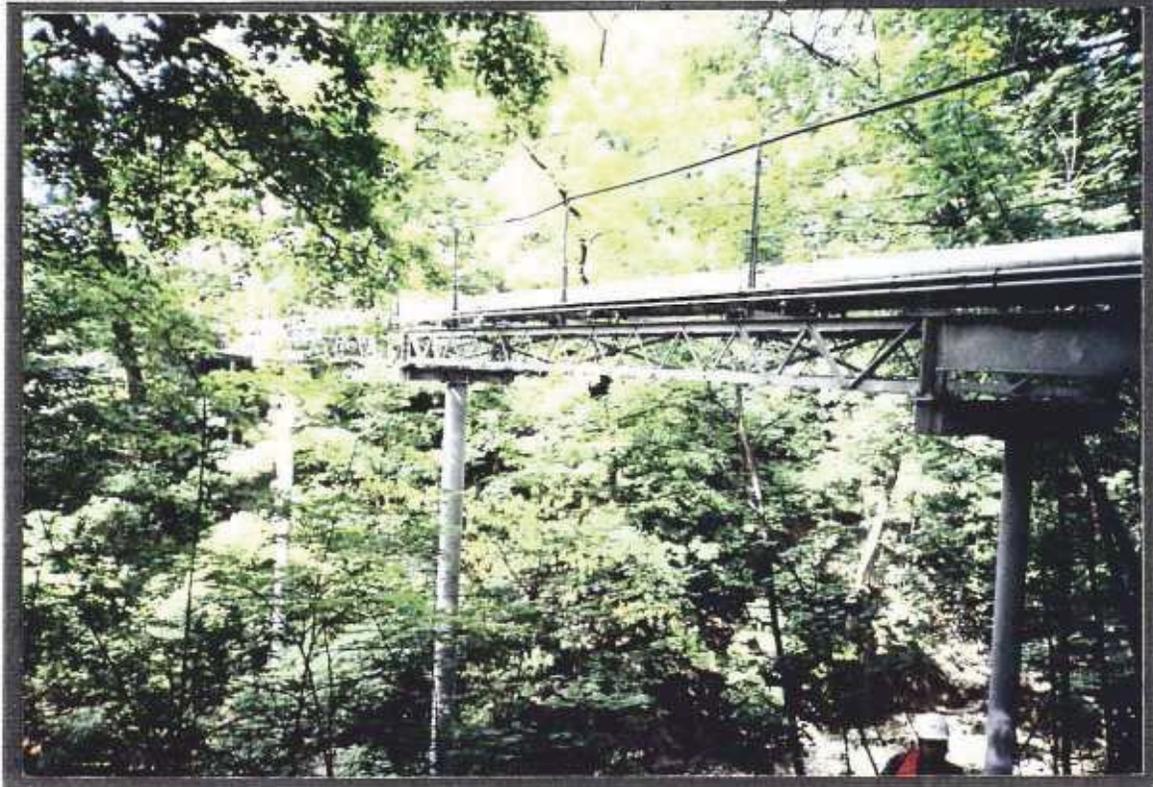
Photograph No. 2

There is a metal handrail along the west fascia of the trestle. The rail is generally loose and in poor condition. To prohibit access to trestle, there are also two metal posts with barbed wires connected in between, which are generally in good condition (See Photograph No. 2).

Top view of utility pipes looking South.
Note deflected handrail and barbed wire gate.

7. Post caution signs at both north and south entrances and/or place a fixed barbed wire gate similar to the one at the north end.
 8. Repair loose hand rail by welding posts to top chords and the top flange of the west fascia beams.

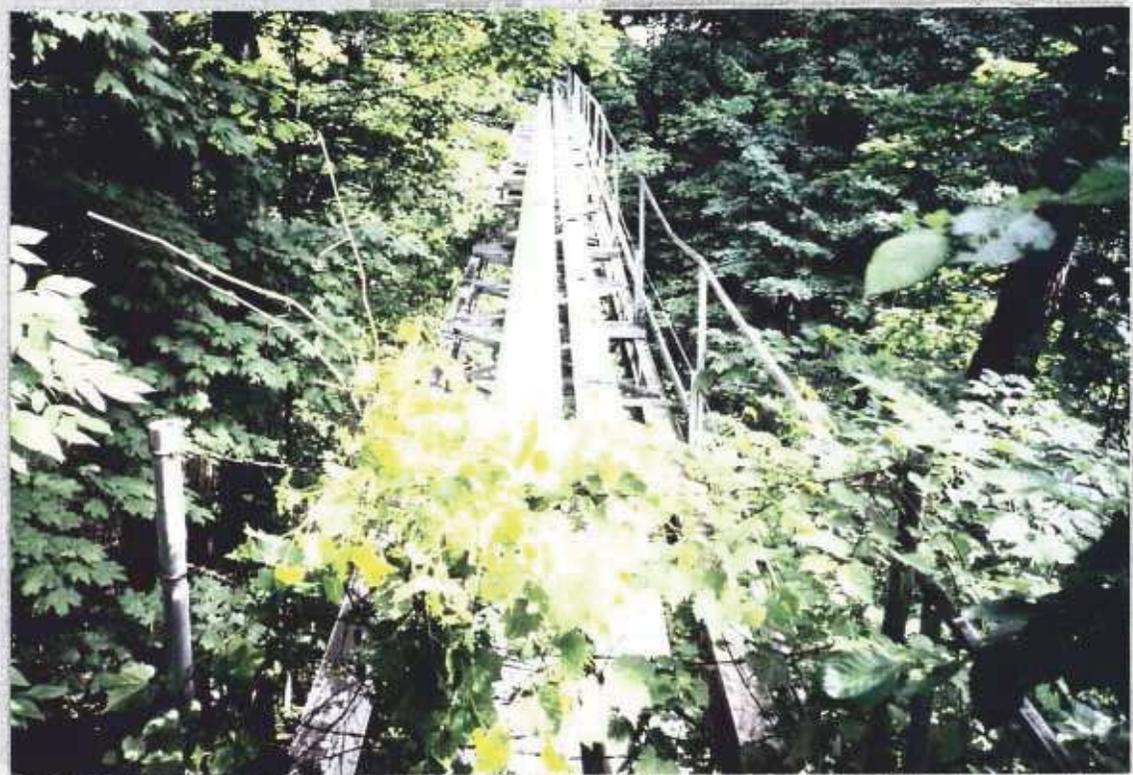
Photograph No. 3

At the south abutments, there were (6) unused bolt holes, and four of the nine existing bolts are anchored into a relatively weak brick wall under the utility pipes (See photograph No. 3) . There are two loose bolts at the east bracket.

Several unused bolt holes at South abutment steel channel.
Note exposed bottom of wall due to soil erosion.

3. Repair and replace, as needed, loose anchor bolts at both abutments. New anchors should be installed with extension to allow for 1" longitudinal movement of the end spans. Also, fill unused bolt holes with non-shrink grout.

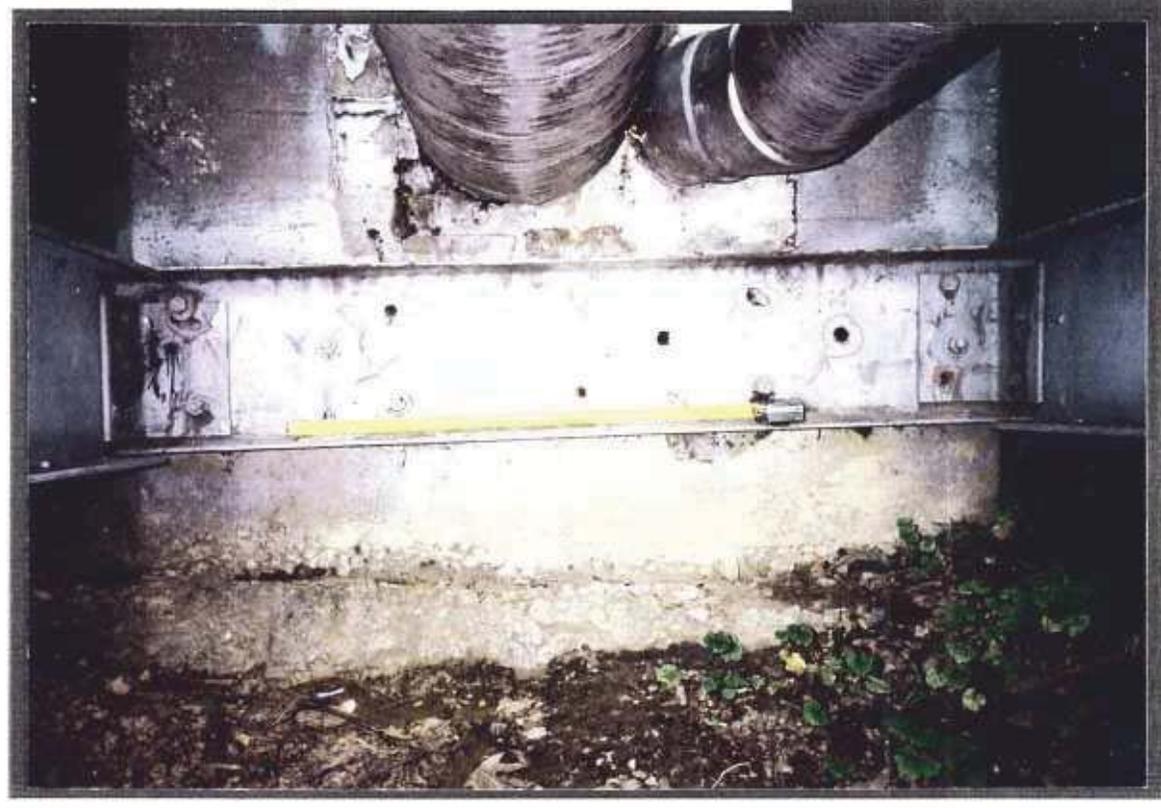
Photograph No. 4

At the north abutment, there are four loose anchor bolts, three of which are anchored into the relatively weak brick wall under the utility pipes.

Four loose anchored bolts at North abutment steel channel.
Note 3 bolts are anchored to brick wall.

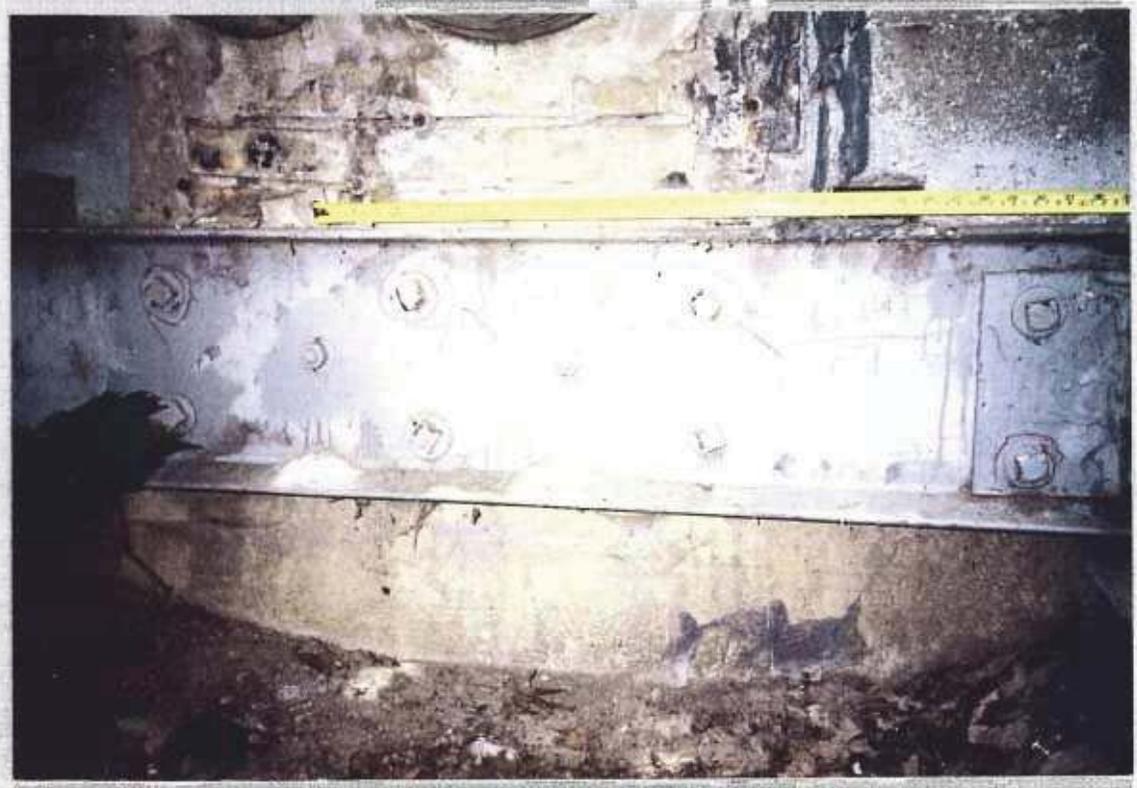
Photograph No. 5

- I. Uneven lengths of bolts over transverse channels (See photograph No. 5).
- II. Bolt holes, which are field flame cut, are not evenly round and relatively larger than the bolt size (See photograph No. 6). There were several of these holes unused.

Typical sloped pipe seat at span No.5.
Note nuts without base washers.

2. Repair bolted connections at utility pipe seats. The work requires leveling all sloped and settled seats by means of raising associated bolts and then placing washers under the nuts at the top of transverse steel channels.

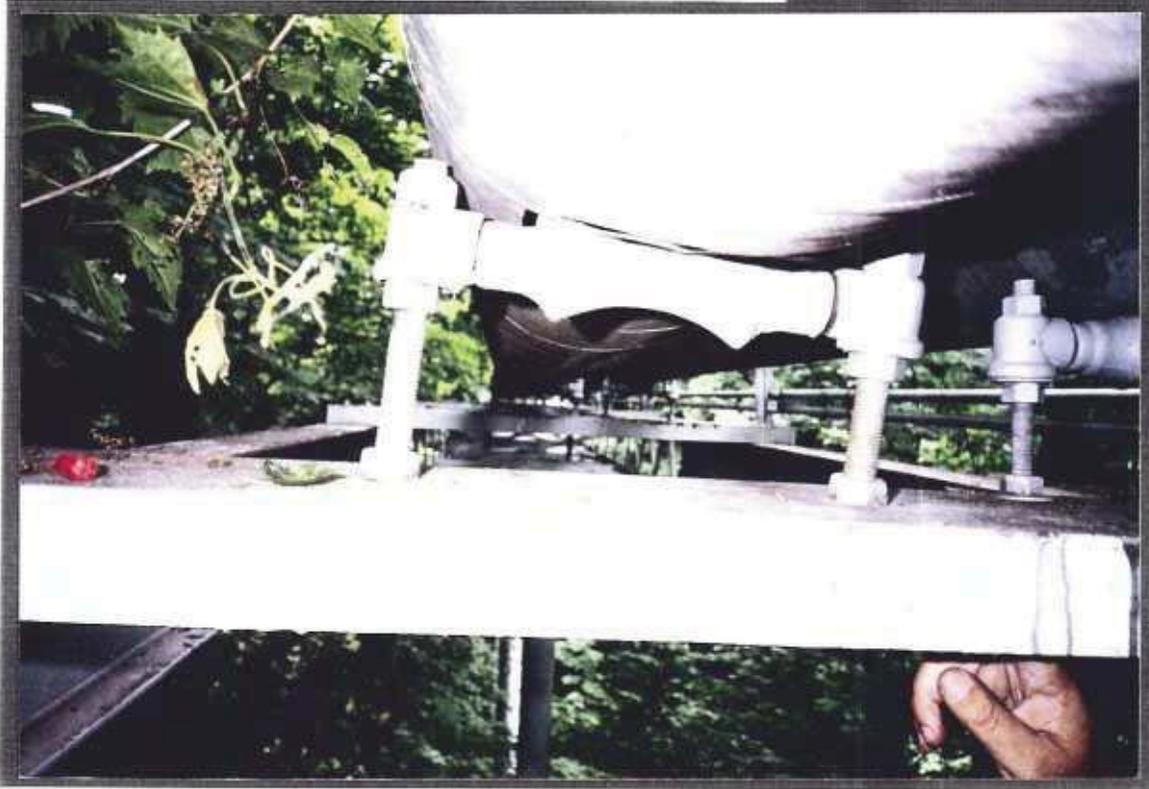
Photograph No. 6

Several different size holes unused, typical at transverse steel channels.

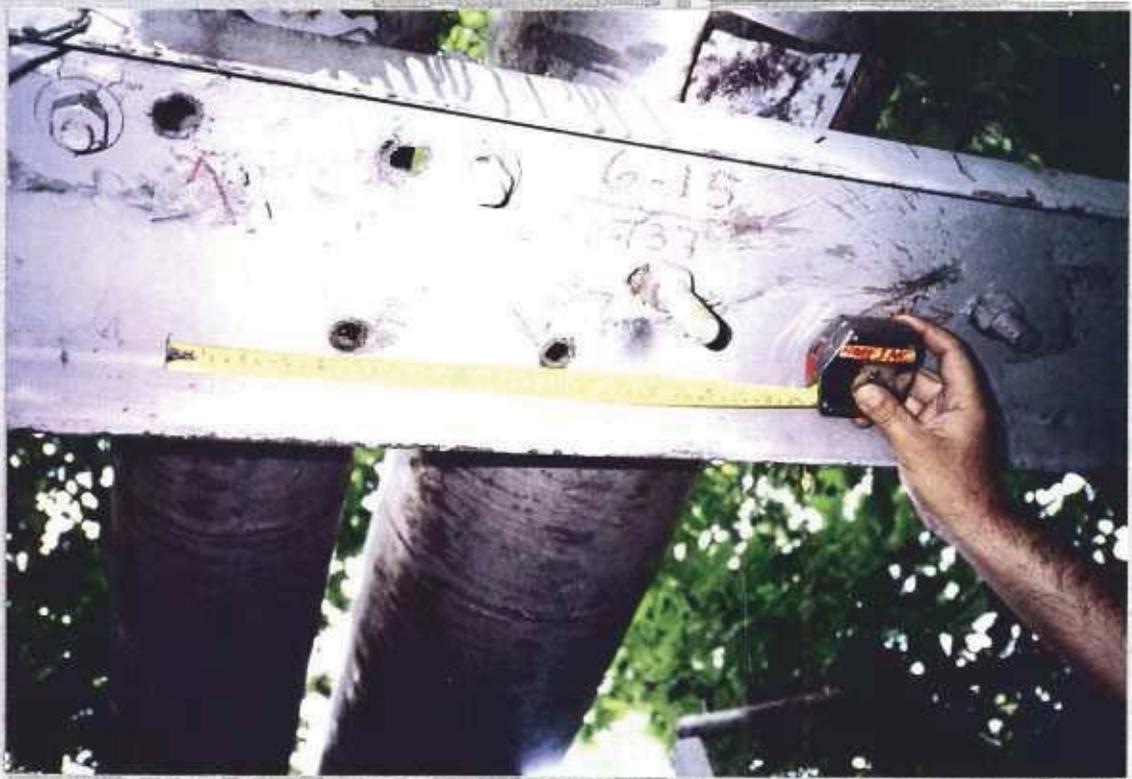
Photograph No. 7

Piers No. 1 to 4 are galvanized steel bents, each consisting of wide flange beam welded to steel pipe at the top and is anchored to concrete pedestals at the bottom. The steel bents and welds typically exhibit minor corrosion with peeling paint (See photograph No. 7).

Typical corrosion and peeling of paint.
Looking South at inside of box truss.

2. Spot clean and galvanize paint localized corroded areas in the steel structure.

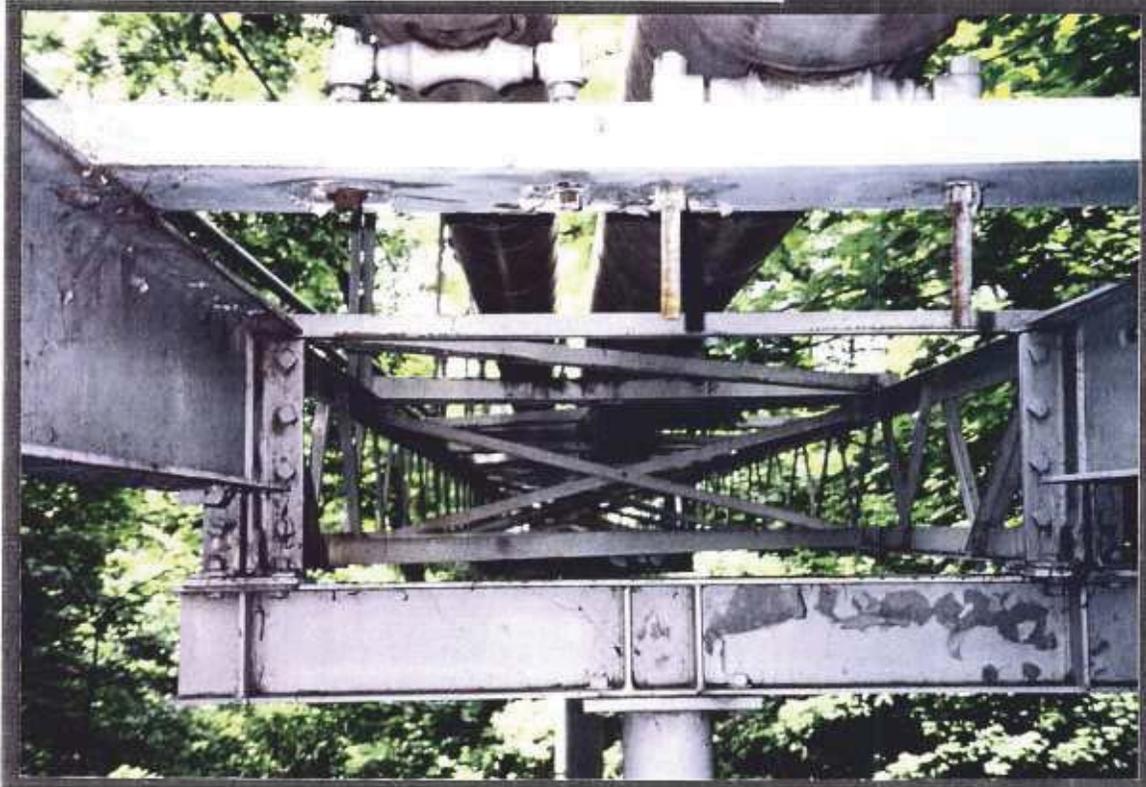
Photograph No. 8

Type 2 consists of metal collars, bolted at the flared ends, resting on double steel angles which are welded to transverse steel channels. The steel channels typically have several flame cut holes (See photograph No.'s 8 and 9). Those seats are generally in good condition.

Underside of box truss.

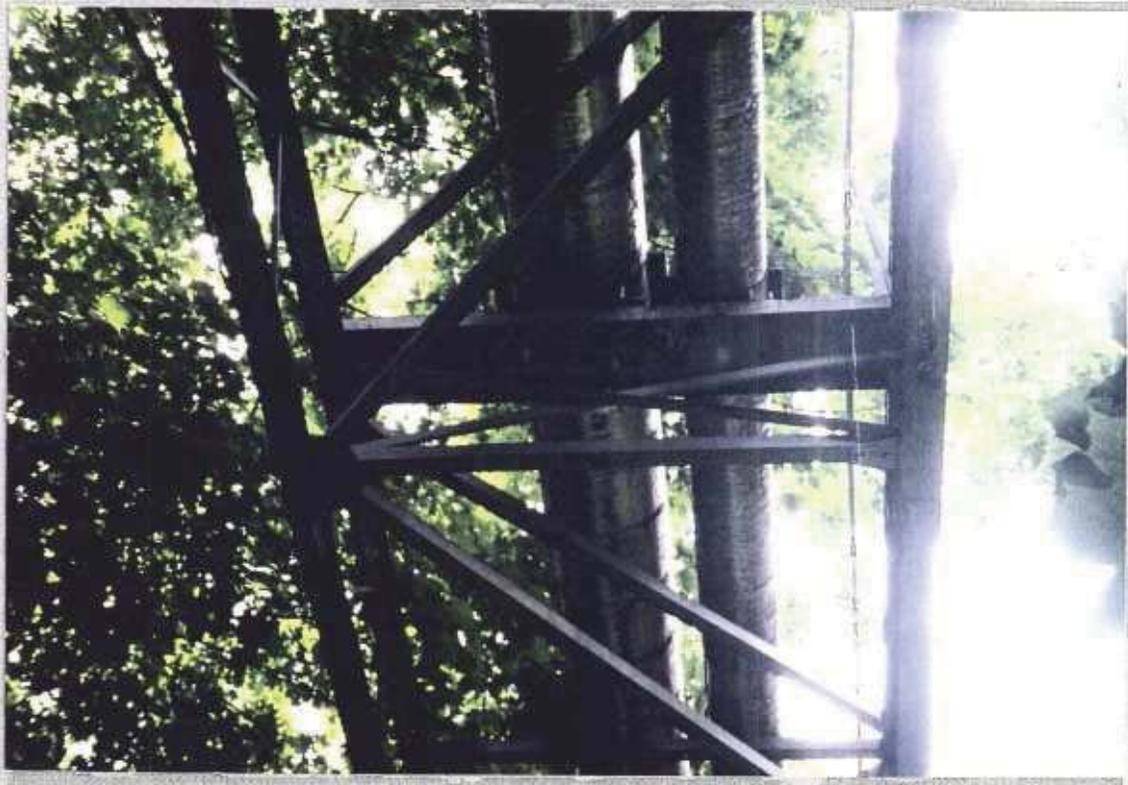
Photograph No. 9

Close-up view showing unused holes.
Note steel collars seated at welded angles.

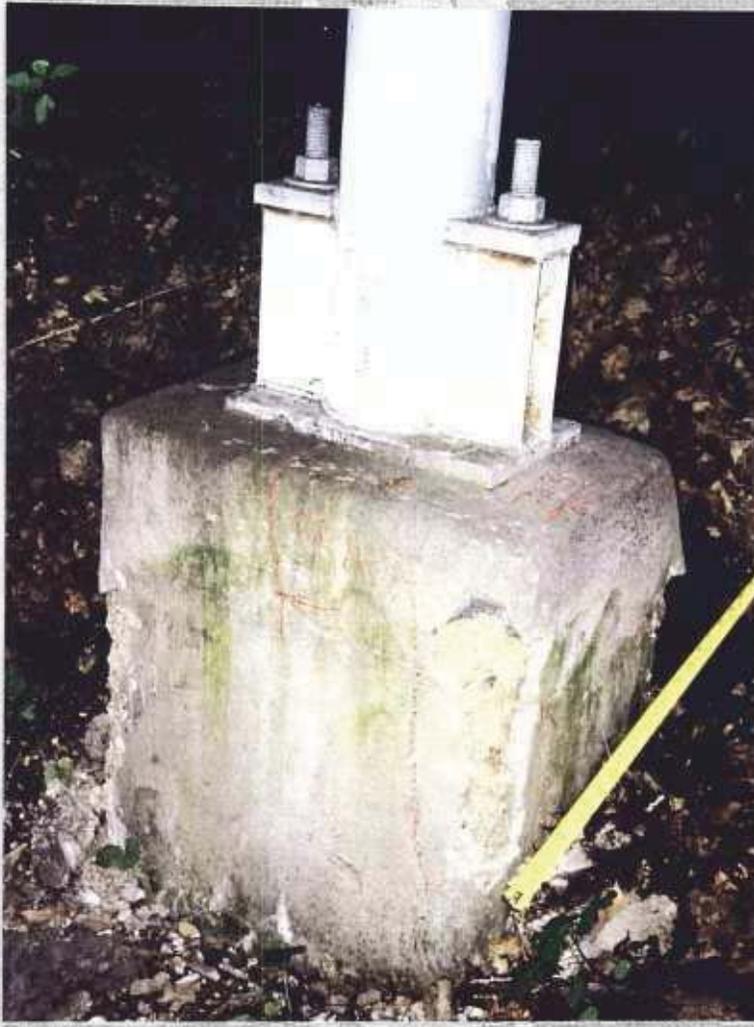
Photograph No. 12

The soil around Pier No. 2 has settled, with noticeable separation of the soil transversely along the north face of the pedestal (See photograph No. 12).

Left:
Spalls at all four corners of pier No.1 pedestal. Note crack radiating from base plate.

Bottom:
Hollow concrete at top of pier No. 2 pedestal. Note transverse crack due to settlement of soil .

backfilling. Follow this with a layer of crushed volcano stone at both slopes (Similar to "D" street bridge slopes). We recommend removing wet soil around Pier No. 2, and replacing with compacted CA-6.

- II. Repairs to be completed within the next 2-4 years.
1. Repair spalled and cracked areas of concrete pedestals. Remove loose and hollow areas of concrete, clean associated areas, and then patch with non-shrink grout. Cracks need to be sealed by low pressure injected epoxy sealer.

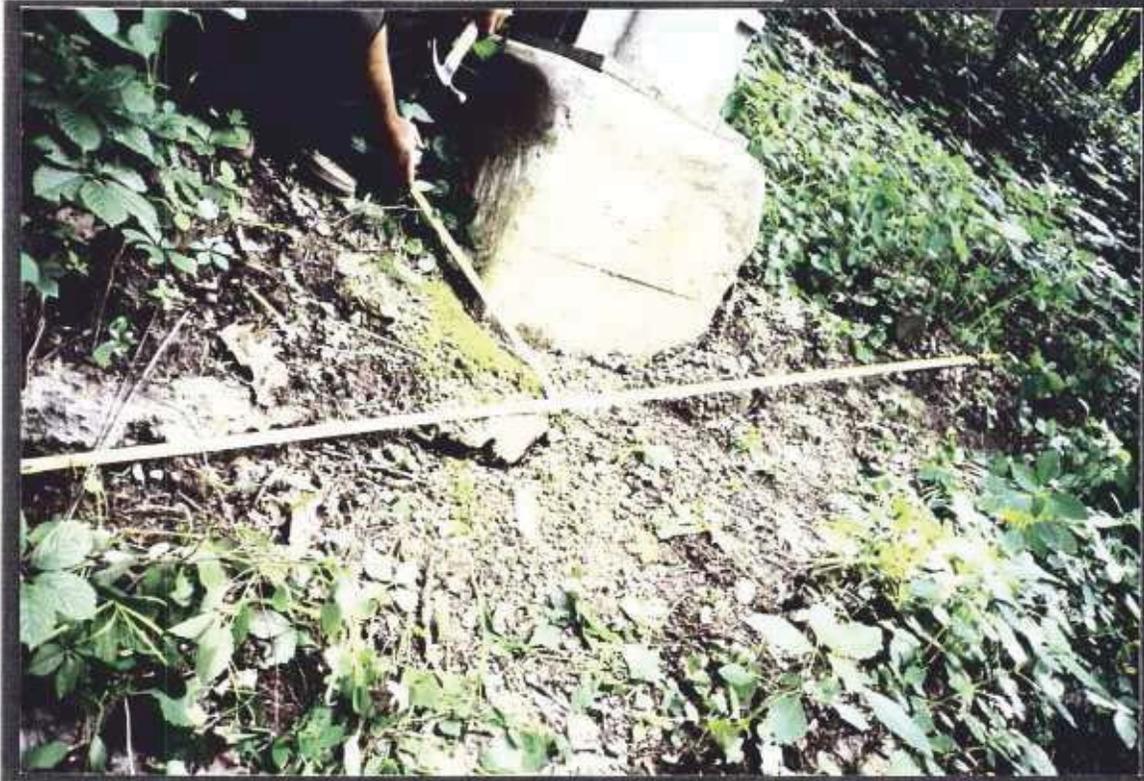
Photograph No. 13

Spall along North upper edge of pier No. 3 pedestal.
Note steep slope on the South of pedestal.

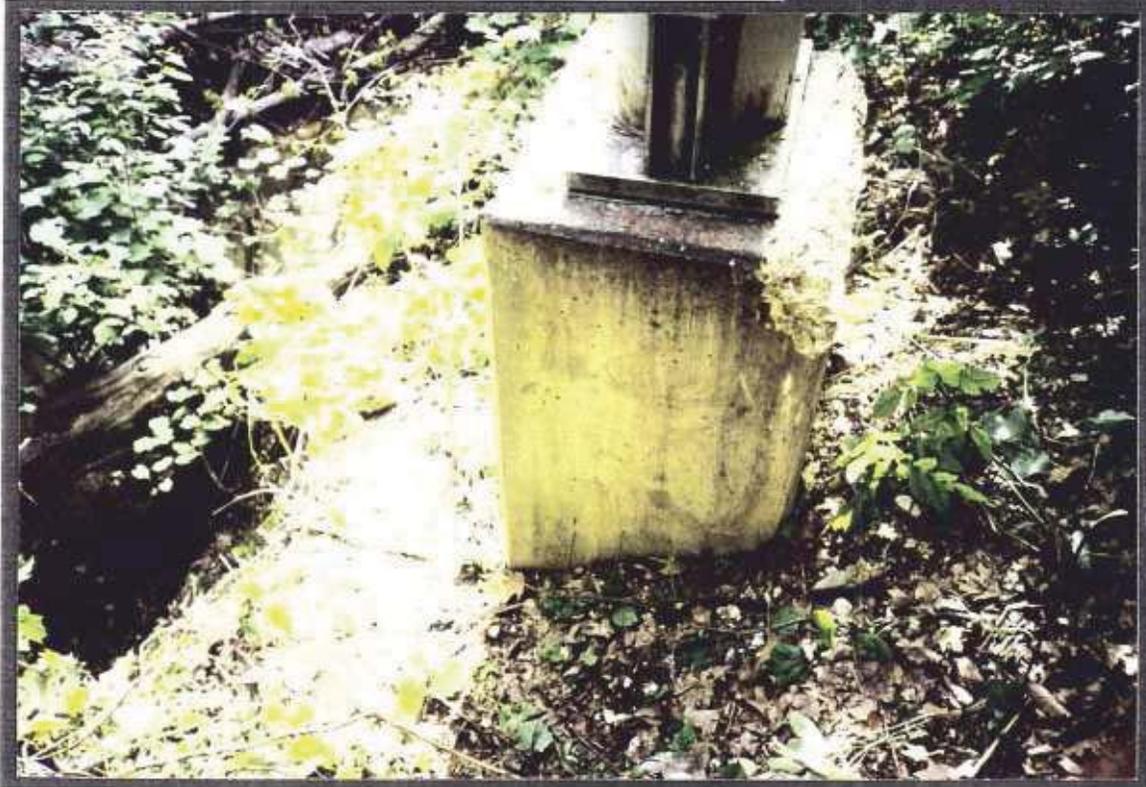
Photograph No. 14

Minor Deterioration at pier No. 4 pedestal.
Note broken metal drain pipe to the East of structure

4. Tighten loose bolts at the 5th transverse steel channel from north.
 5. Repair broken drain pipe east of Pier No. 4.
 6. Repair small wood dam, or replace with one similar to the timber dam at Utility Structure No. 74.

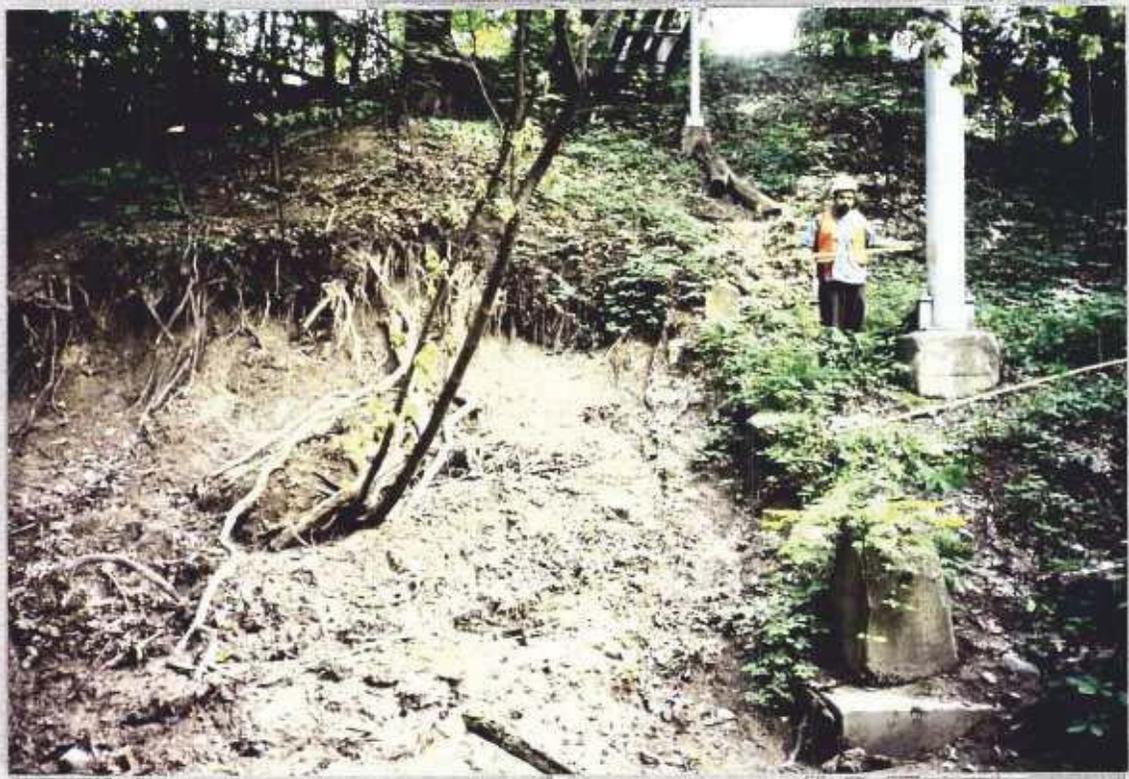
Photograph No. 17

The north slope has a similar condition, where the depression is relatively smaller, and just west of Pier No. 3 (See photograph No. 17).

General view at North slope. Note soil erosion, drain pipe, and remains of original construction.

1. Repairs required for the present time:
 1. Stabilize both south and north slopes. The work is mainly mixing dry soil with wet soil in the eroded areas, and then

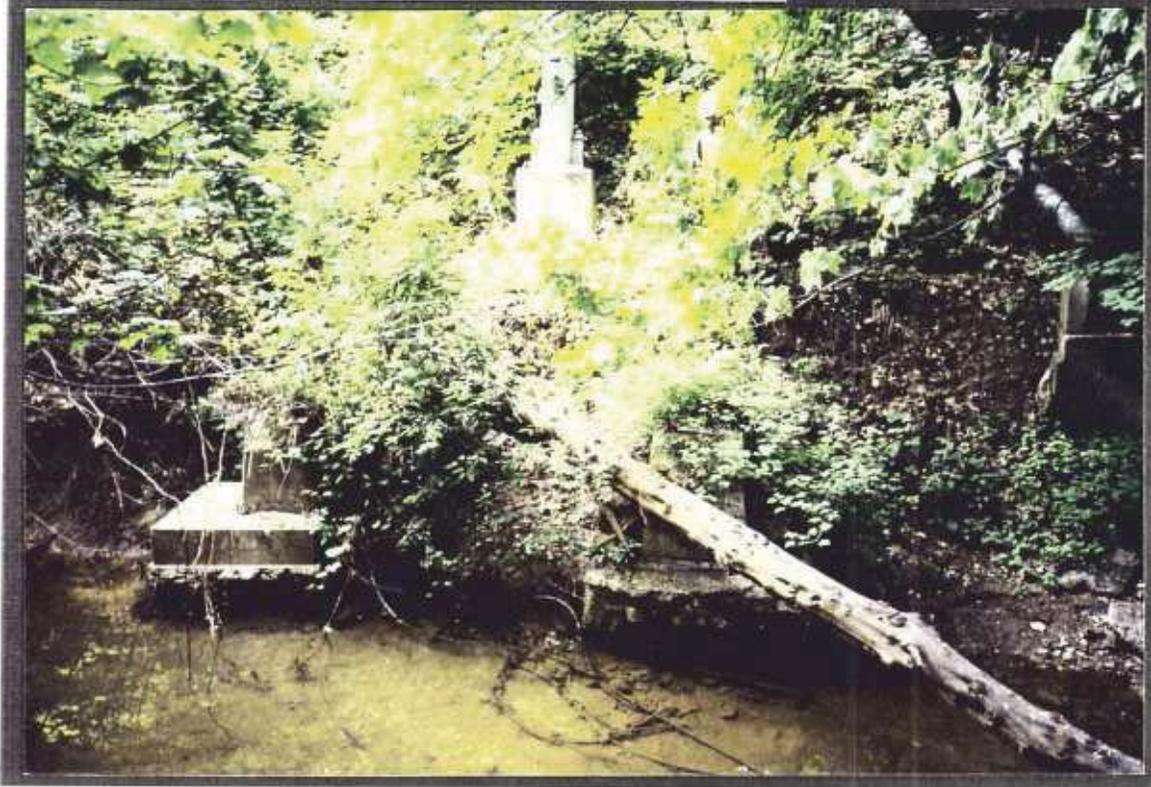
Photograph No. 18

There is a broken corrugated drain metal pipe to the east of Pier No. 3. There is a small wood dam between Pier No. 3 and 4, in poor condition (See photograph No. 18). At both east and west slopes, the soil is relatively spongy and erodes easily under foot traffic.

Deflected wood dam between piers No.3 and 4, at North slope.
