Photolog of Steam Pits

Naval Station Great Lakes
Basewide Steam Lines Targeted for Demolition
Photolog of Steam Pits
Week 1: June 6-10 2011
Photographed by Alpna Chaudhary

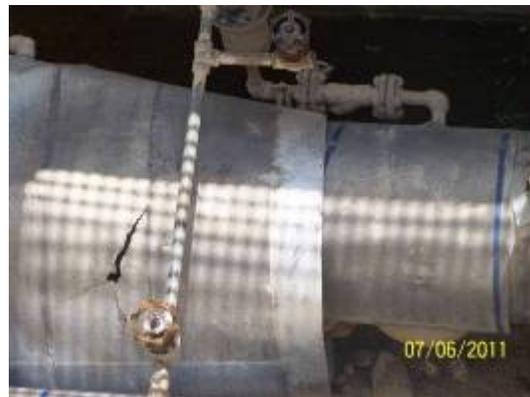
Photo 22: Steam pit 401: view of damaged 18" pipe jacket.

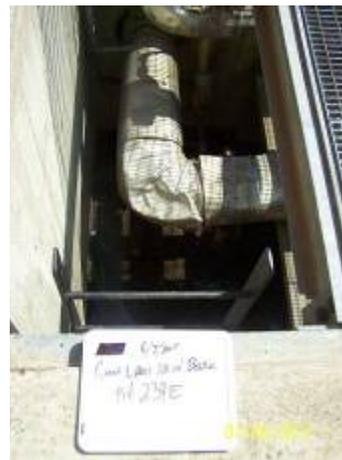
Photo 27: Steam pit 239E: view of damaged jacket, fiberglass insulation found.

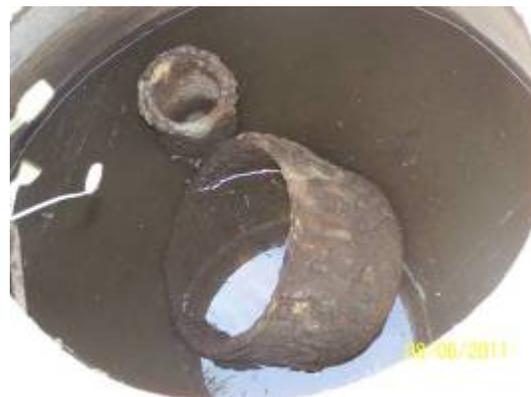
Photo 36: Steam pit 4: view of damaged pipe jacket.

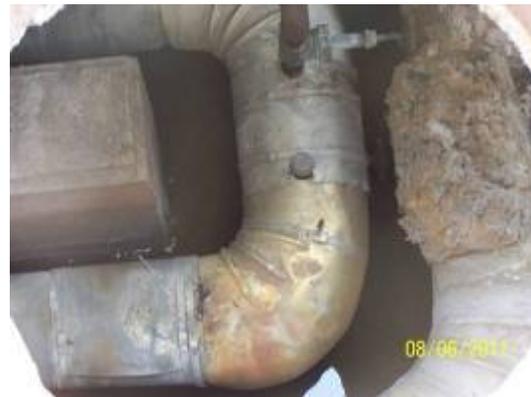
Photo 62: Steam pit 36: view of exposed fiberglass on 18" pipe.

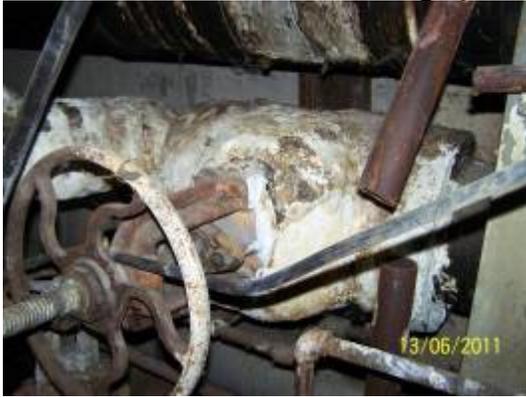
Photo 7: Steam pit 155: Damaged insulation - Sample P-155-HA-36-107

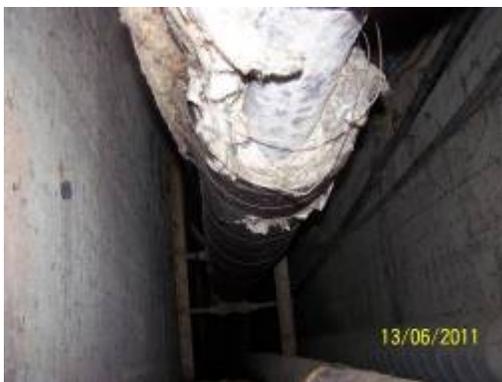
Photo 15: Steam pit 146: view of 18” pipe with damaged insulation.

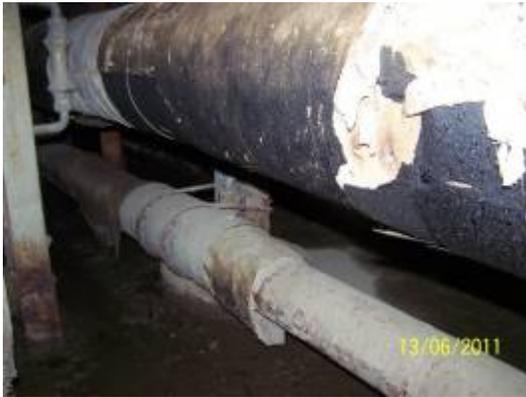
Photo 19: Steam pit 145: view of damaged insulation.

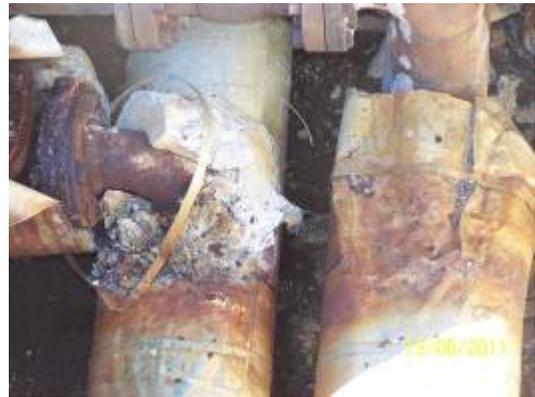
Photo 23: Steam pit 128: view of damaged elbow insulation.
