Portsmouth Naval Shipyard  
Seavey Island  
Kittery, ME

## **Hazardous Building Material Assessment**

July 2015

Re: **Hazardous Building Materials Assessment  
Portsmouth Naval Shipyard  
Kittery, ME 03904**

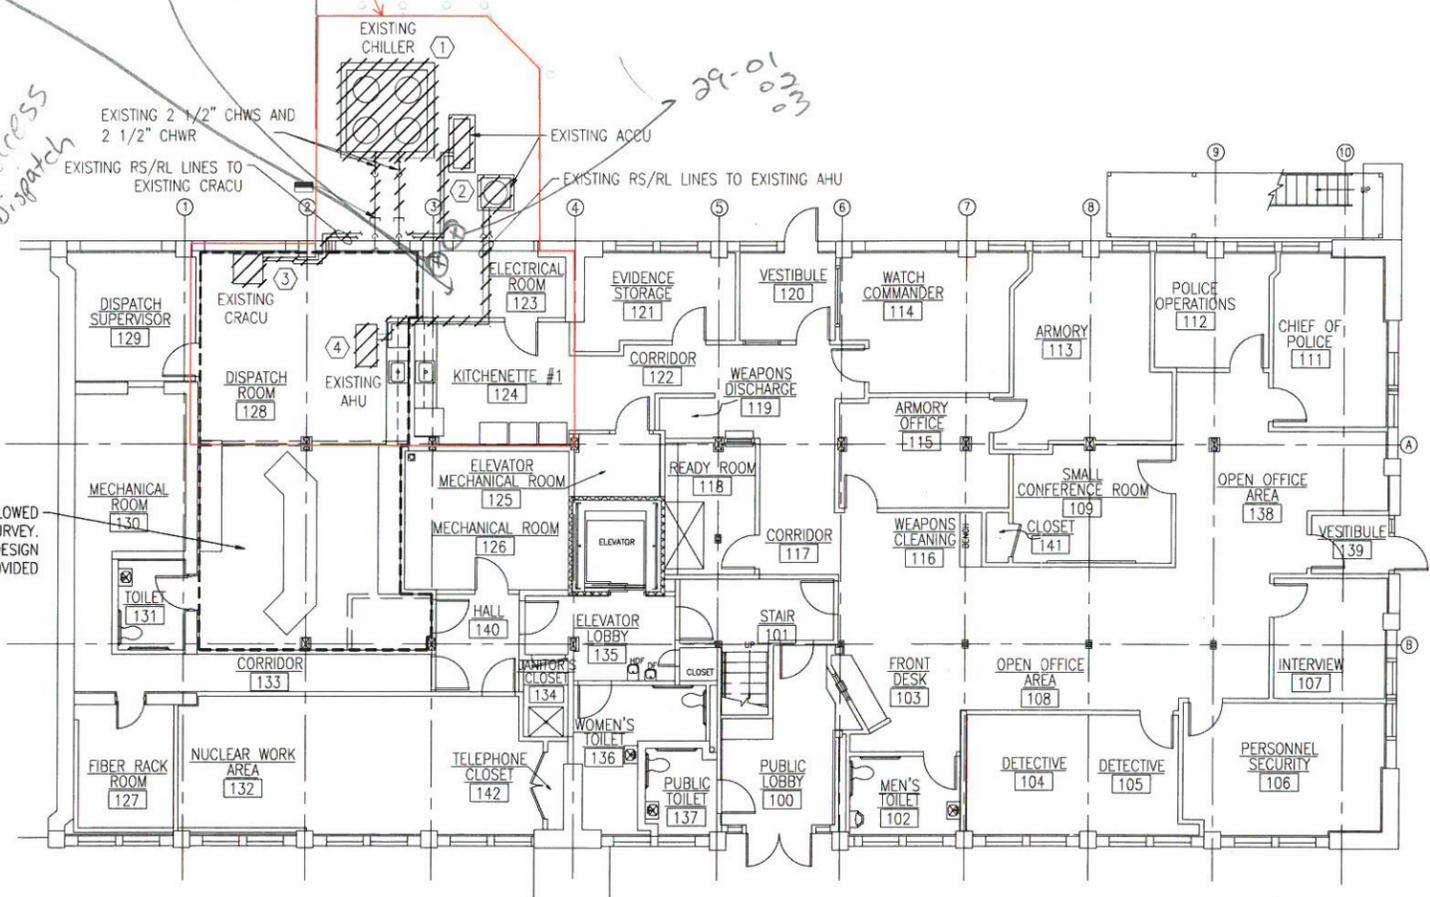
NOTE THAT ACCESS WAS NOT ALLOWED. THERE MAY BE OTHER AREAS THAT WORK WILL OCCUR.

CSI ENGINEERING NOT ALLOWED ACCESS DURING SURVEY. ASSUMPTIONS BASED ON DESIGN DOCUMENTS PROVIDED

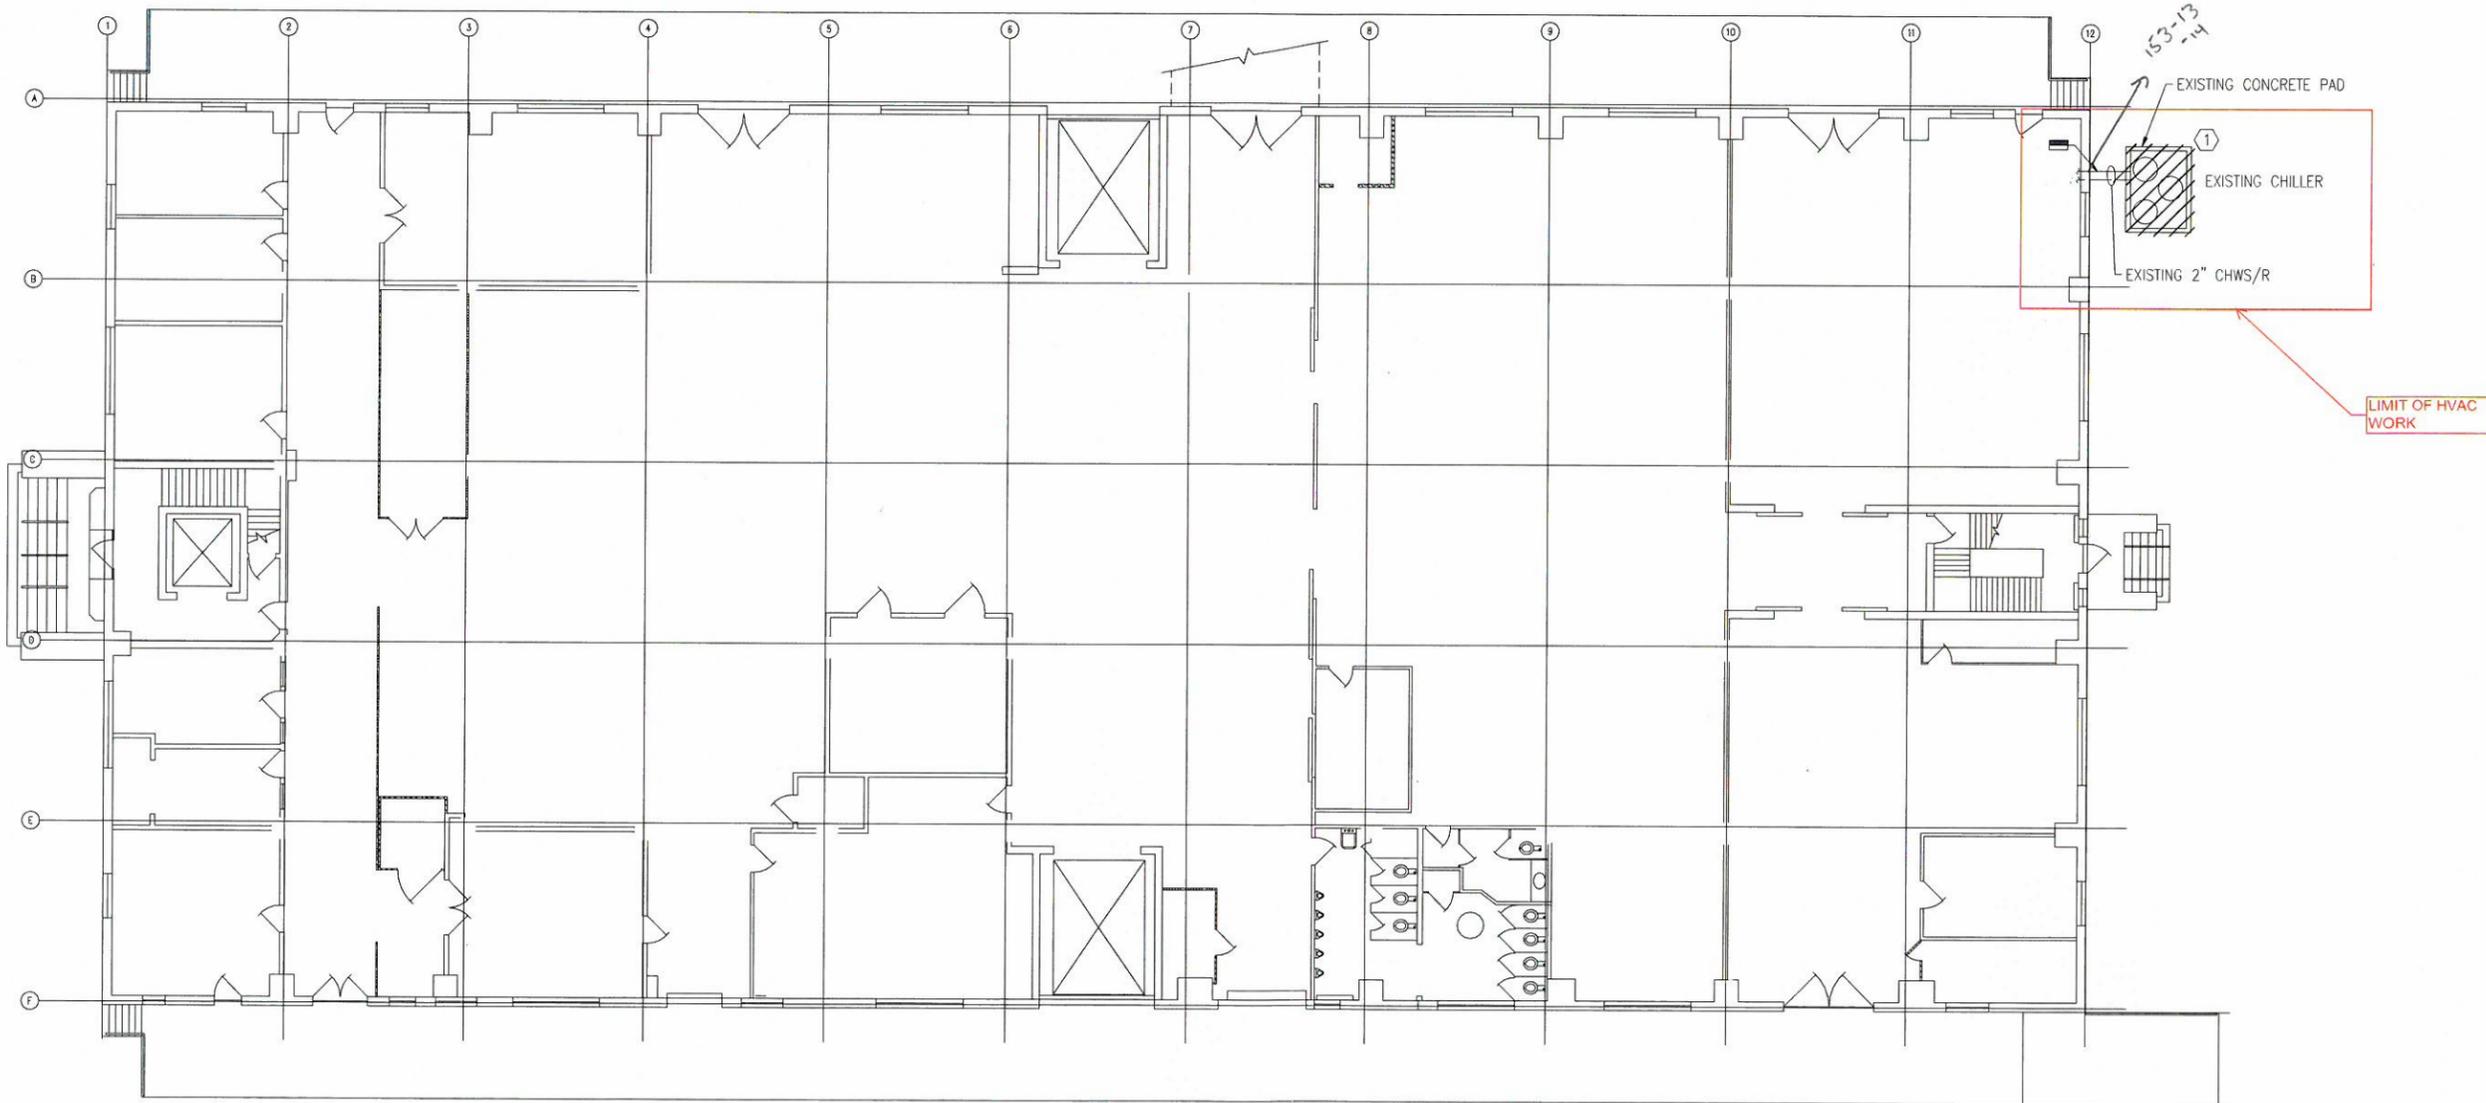
**BUILDING 153 HVAC FIRST FLOOR DEMO PLAN**  
1/8" = 1'-0"

unit mounted on brackets attached to the wall unit not sitting on roof  
No Access to roof

Samples 1-12  
# LBP sample

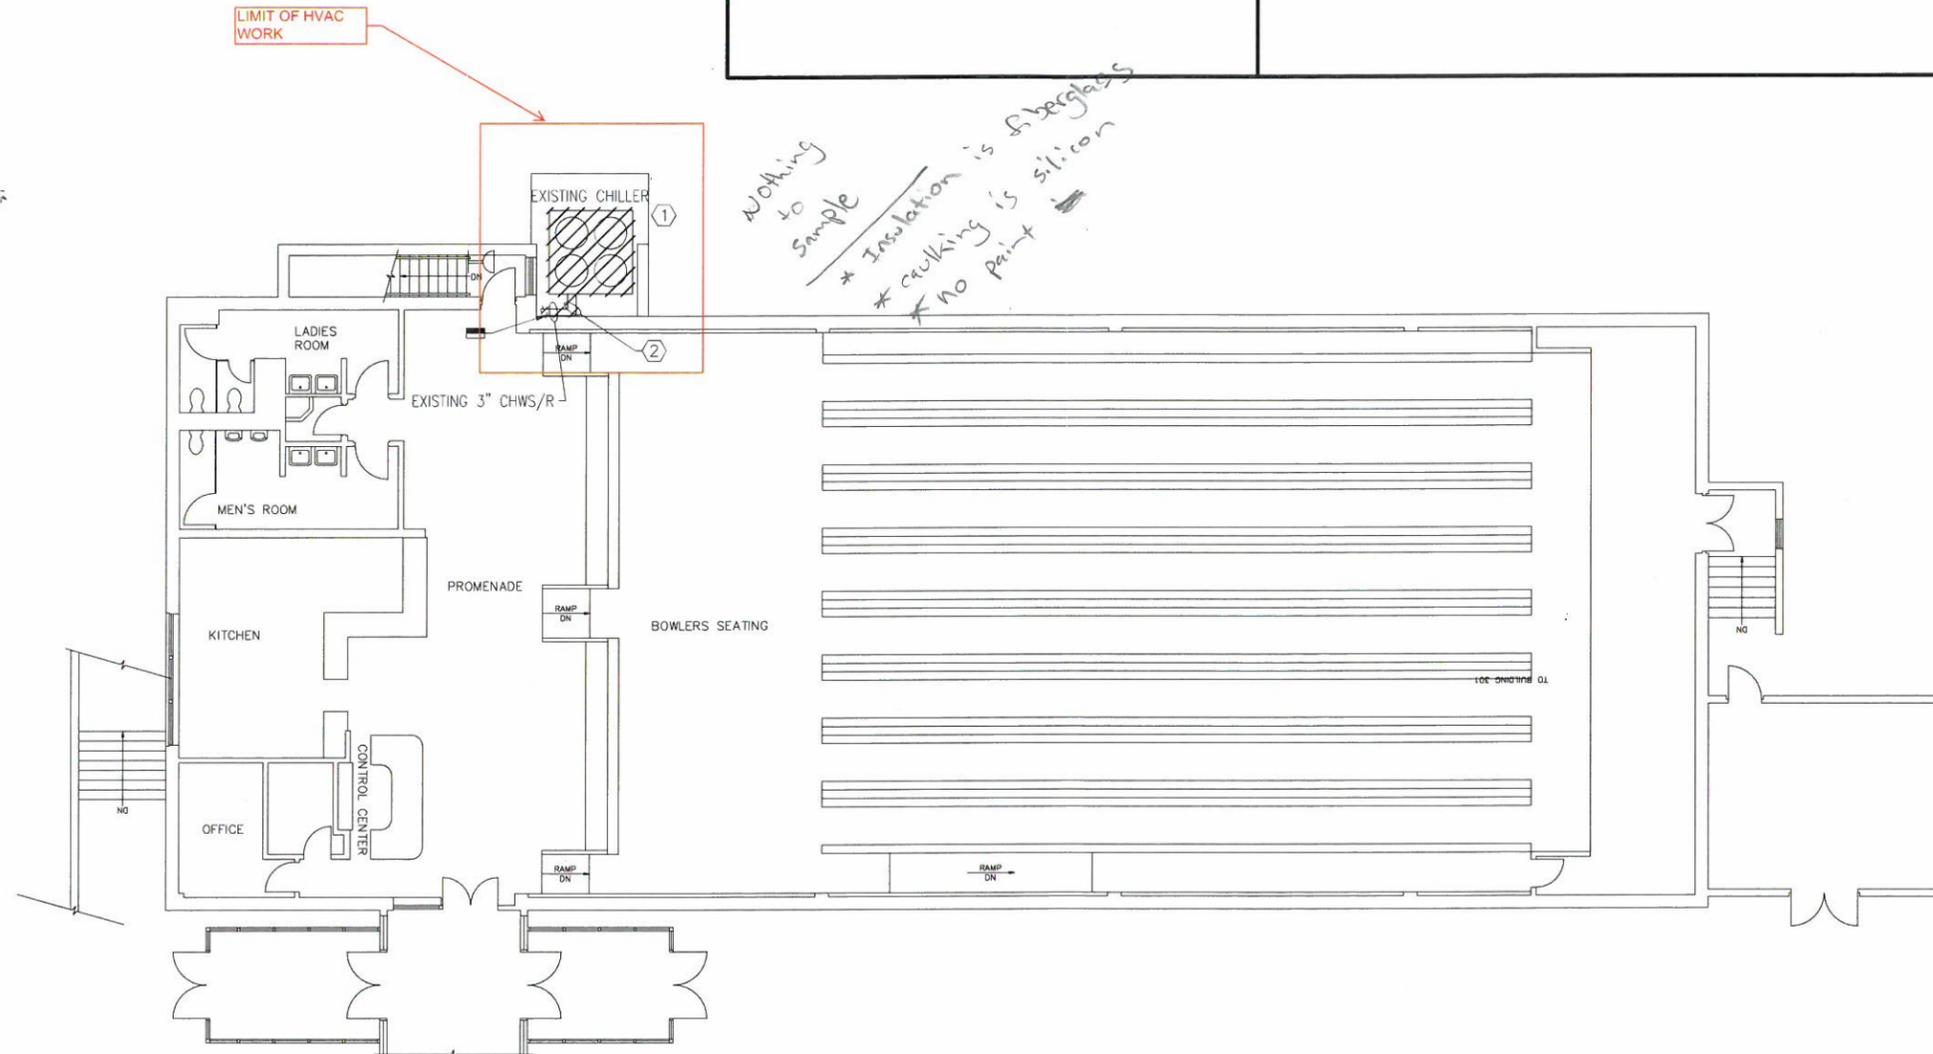
**BUILDING 308 HVAC FIRST FLOOR DEMO PLAN**  
 1/8"=1'-0"

*Nothing to sample  
 \* Insulation is fiberglass  
 \* caulking is silicon  
 \* no paint*
