### Design-Build RFP for the SIMULATOR CENTER and RANGE CONTROL BUILDING

FY'16 MCON PROJECT P-1346

# REPORT OF HAZARDOUS MATERIALS CONSULTING SERVICES

P1346 SIMULATOR CENTER AND RANGE  
DEVELOPMENT CONTROL BUILDING  
DEMOLISH BUILDINGS 134, 430 AND 529  
MARINE CORPS BASE, CAMP LEJEUNE  
JACKSONVILLE, NORTH CAROLINA  
JV PROJECT #09049.22B  
**GER** 130-6168

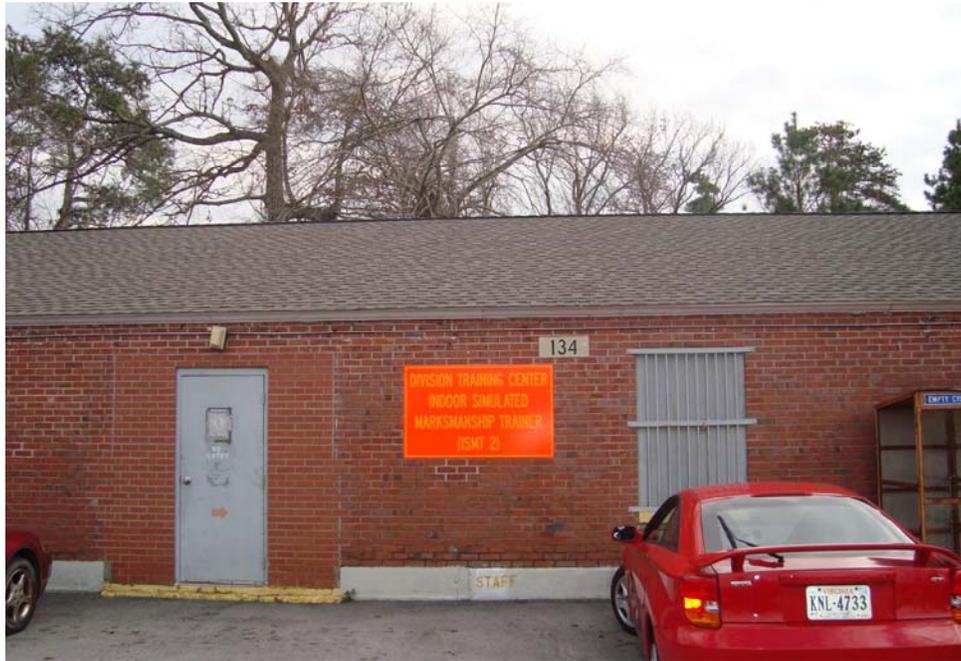
- ***Textured material, gray*** (2% Chrysotile): located on exterior foundation of **Building 134**. This material is classified as Category II ACM and was in good condition at the time of the survey. (Estimated quantity- 560 SF)
- ***9" black floor tile & adhesive*** - (5-7% Chrysotile): 9" floor tile and mastic is found in the office of **Building 430**. This material is classified as Category I ACM and was in good condition at the time of the survey. (Estimated quantity- 150 SF)
- ***Black roof sealant at vents*** (asbestos content not shown): located around perimeter of roof vents on **Building 430**. This material is classified as Category I ACM and was in good condition at the time of the survey. (Estimated quantity- 70 LF)

Photo 1: Typical exterior materials at Building 134 included asphalt roof shingles and sealants. Exterior gray textured material on foundation is asbestos-containing.

**gray textured material on foundation, 9" black floor tile/mastic, and black asphalt sealant at vents** are classified as Category I and II non-friable ACM in buildings scheduled for demolition. Removal is not required, prior to demolition, if the material is in good condition and is not friable. However, wet methods must be used during the demolition process and personal and area monitoring should be performed. Additionally, recycling of demolition debris is prohibited. All demolition debris must be considered asbestos containing and be taken to a landfill that accepts Category I and II non-friable ACBM. However, the contractor may have the option of removing all asbestos containing materials prior to demolition which would allow the demolition debris to be classified as regular construction waste therefore allowing recycling.

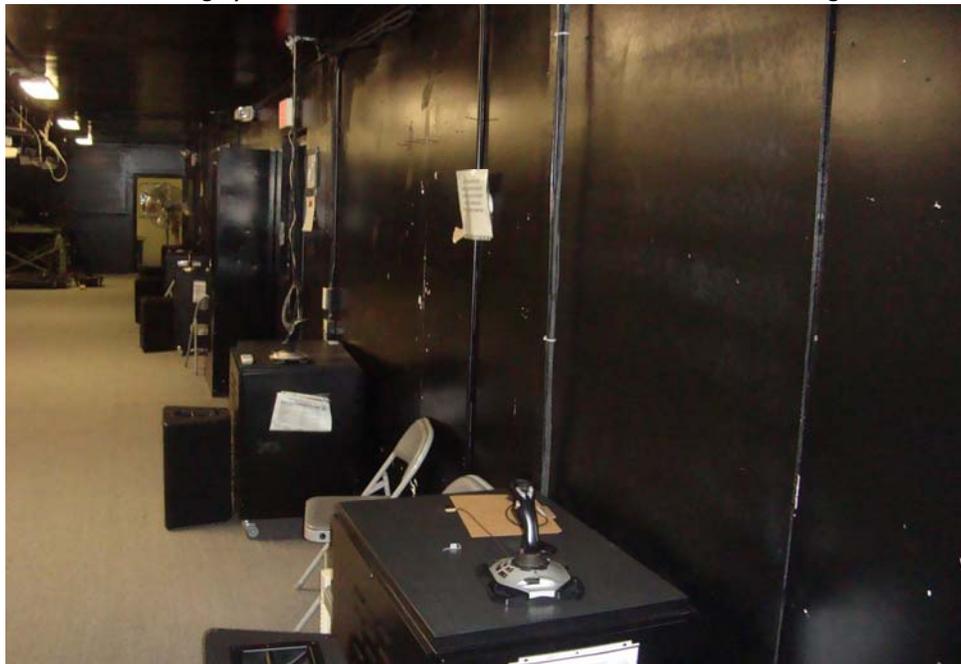
Photo 2: Typical materials associated with the interior of Building 134 included carpet and drywall/joint compound. No interior materials were found to contain asbestos.

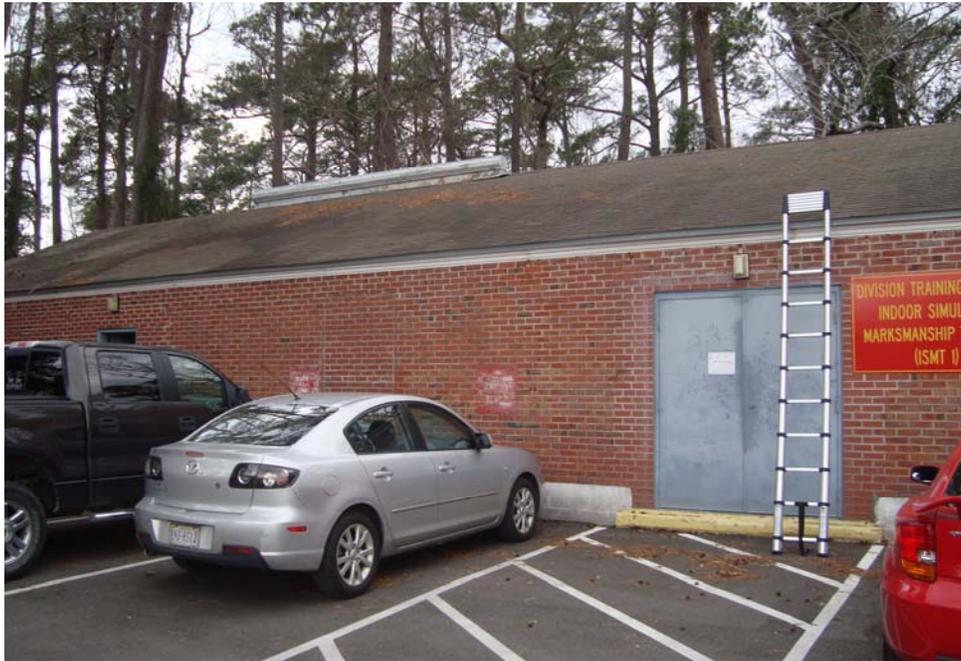
***Building 430*** - Asbestos-containing 9" floor tile & mastic still exists in the office. Asbestos-containing black roof sealant at vents on roof still exists. Asbestos-containing heat shielding/debris and transite panels have been removed and or cleaned up in attics

Photo 3: Typical exterior materials at Building 430 included asphalt roof shingles, cements and sealants. Black roof sealant at vents is asbestos-containing.

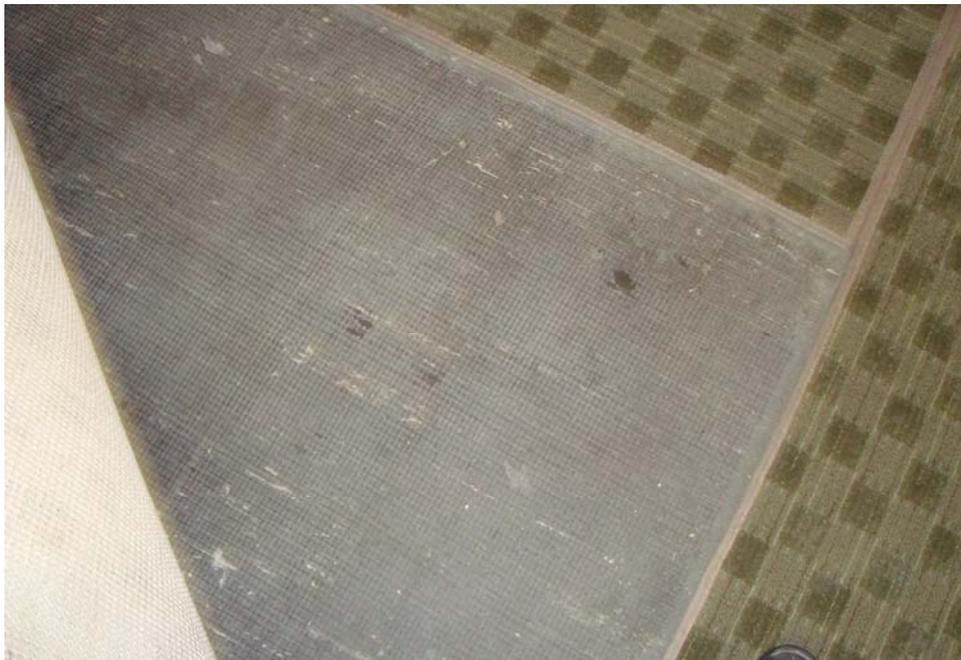
Photo 4: Typical materials associated with the interior of Building 430 included carpet, floor tile and drywall/joint compound. 9" black floor tile in the office is asbestos-containing.

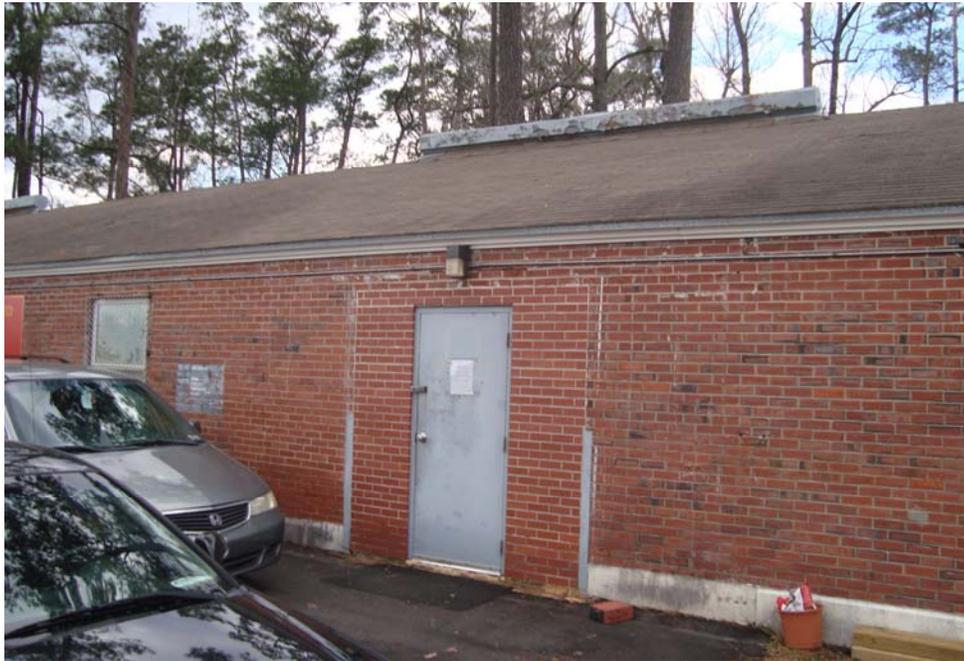
Photo 5: Typical exterior materials at Building 529 included asphalt roof shingles, cements and sealants. No exterior materials were found to contain asbestos.

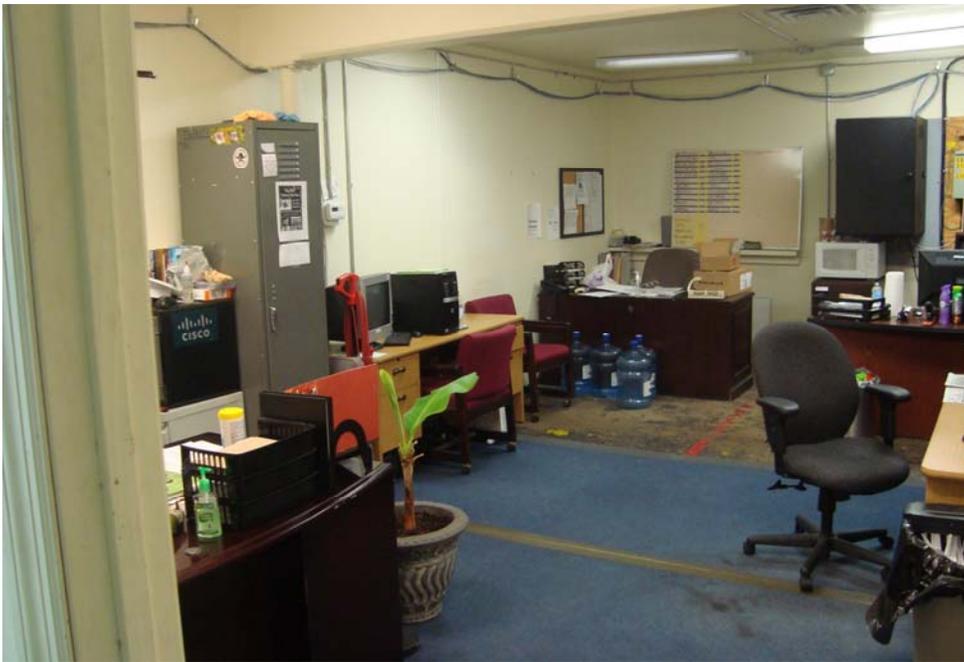
Photo 6: Typical materials associated with the interior of Building 529 included carpet and drywall/joint compound. No interior materials were found to contain asbestos.
