**Hazardous Materials  
Survey Report  
Of  
MCAS Building 1039  
(Applied Instrument Building)

Marine Corps Air Station  
Beaufort, South Carolina**

Inspection Date: 10/14/2015  
Report Issue Date: 12/07/2015

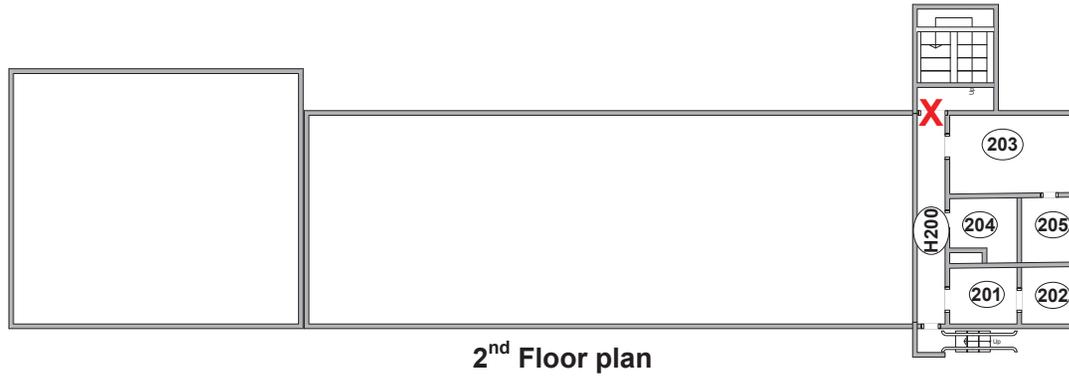
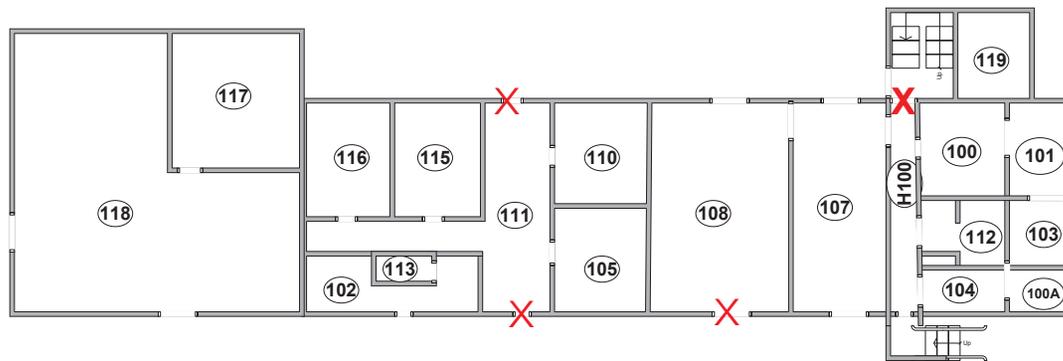
X H-14 – Fire doors (5 each) located in 1<sup>st</sup> & 2<sup>nd</sup> floor stairwells

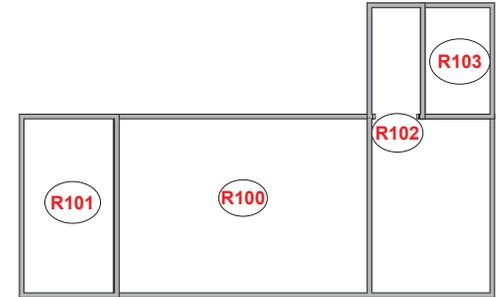
ROOF PLAN

H-10 – Roof flashing mastic around roof perimeter & penetrations  
Exact locations not shown on drawing (Approx 450 LF)

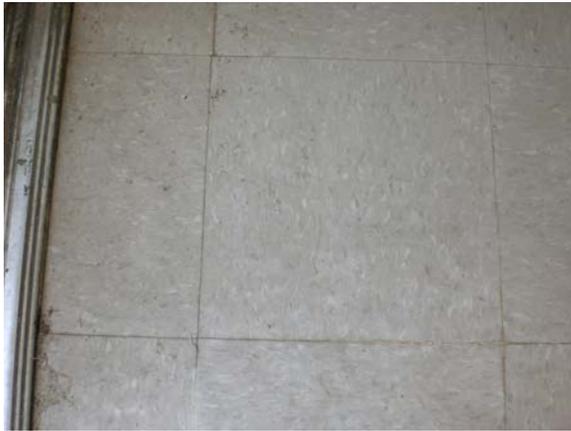
**H-1** 12" gray floor tile/mastic (non-ACM)

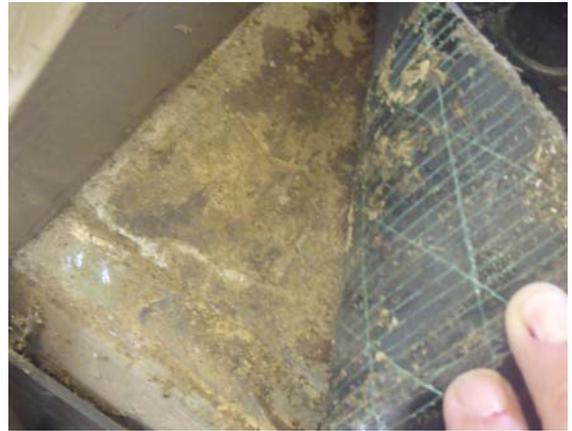
**H-2** Black cove mastic (non-ACM)

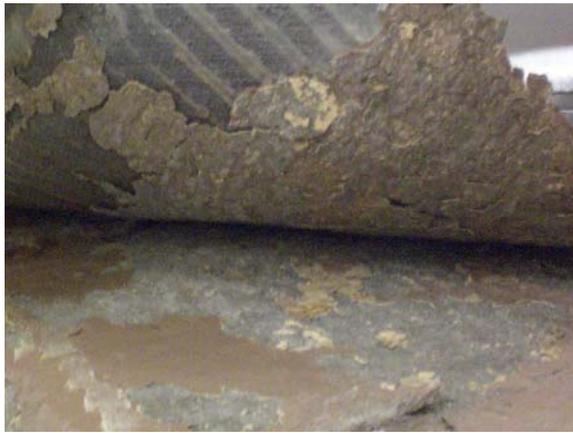
**H-3** Brown stair tread mastic (non-ACM)

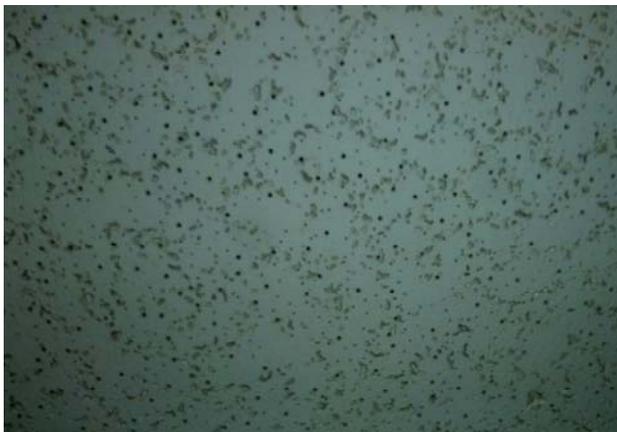
**H-5** Grooved ceiling tile (Non-ACM)

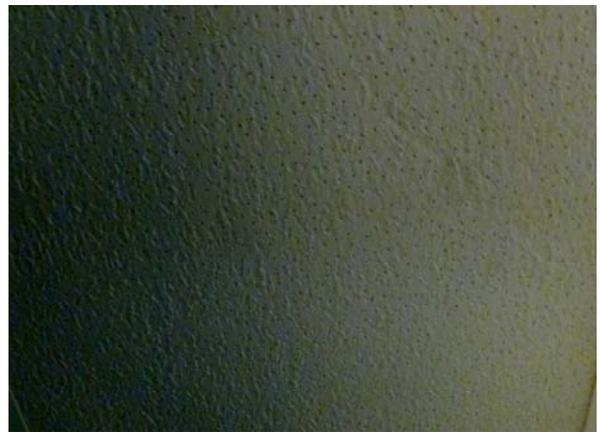
**H-6** Pitted ceiling tile (Non-ACM)

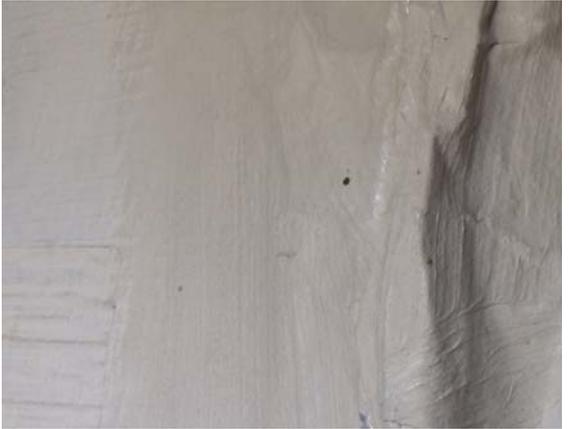
<p><b>H-7</b> Gypsum board/joint compound (Non-ACM)</p>	<p><b>H-8</b> White vent duct mastic (Non-ACM)</p>

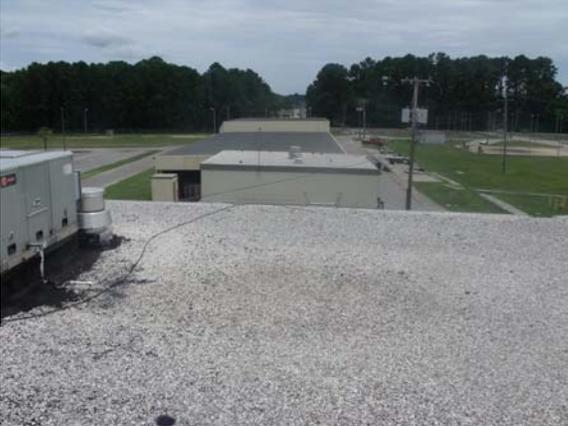
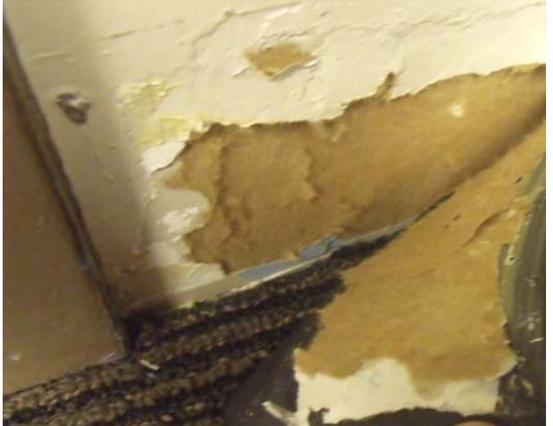
- **H-10:** Misc., Black flashing mastic is accessible, non-friable ACM, in good condition with a low potential for disturbance. (Approx 418 linear feet)
- **H-14:** Misc., Fire doors, is assumed non-friable ACM in good condition with a low potential for disturbance. (2 each)

<p><b>H-9</b> Roofing tar (Non-ACM) <b>H-10</b> roofing flashing/sealer (ACM)</p>	<p><b>H-11</b> White cove mastic (Non-ACM)</p>

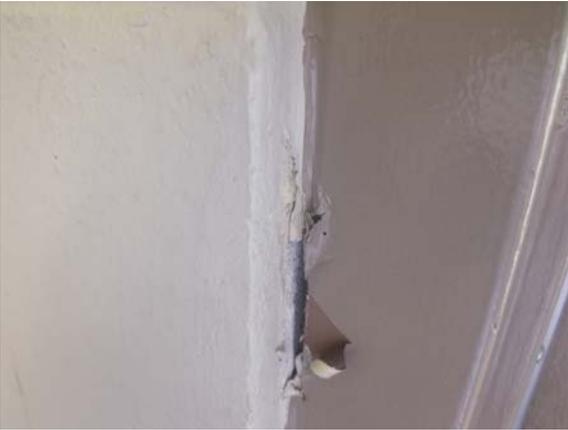
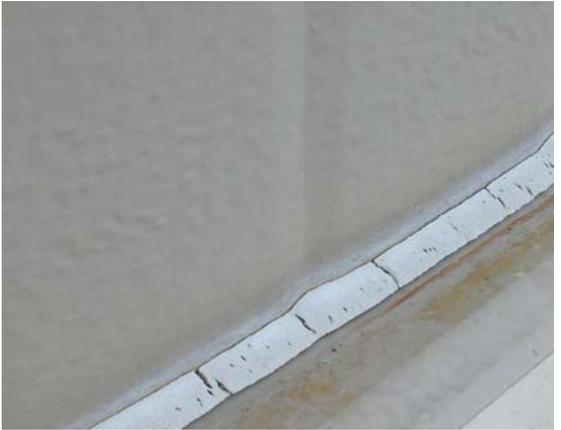
<p><b>H-12</b> White door/ window caulking (Non-ACM)</p>	<p><b>H-13</b> White roof caulking (Non-ACM)</p>

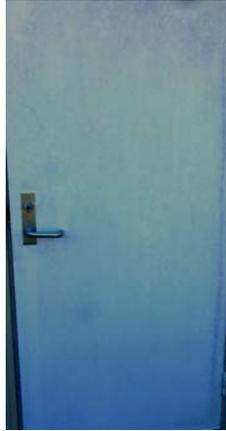
**H-14** Fire door-Typical (**Assumed ACM**)

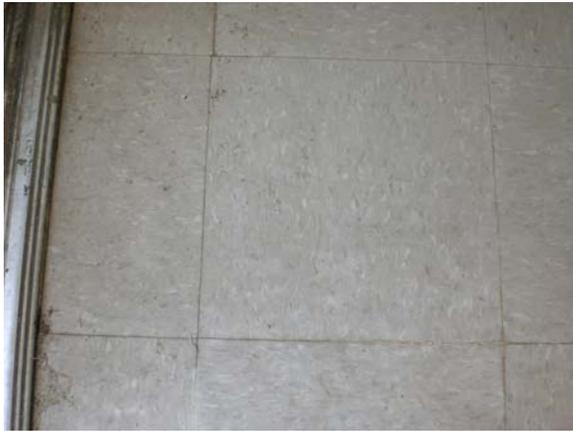
**H-1** 12" gray floor tile/mastic (non-ACM)

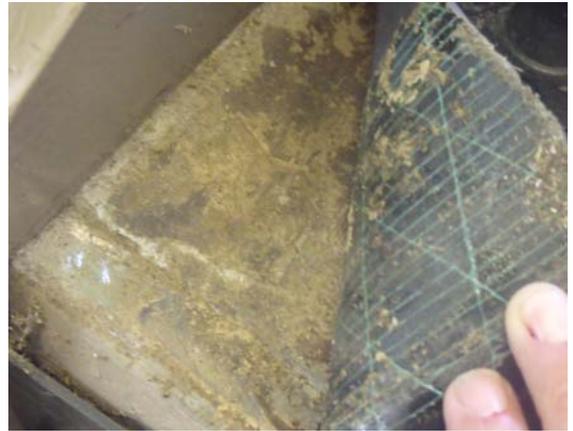
**H-2** Black cove mastic (non-ACM)

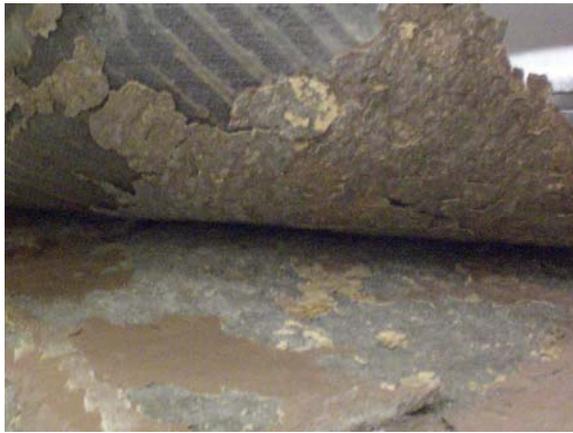
**H-3** Brown stair tread mastic (non-ACM)

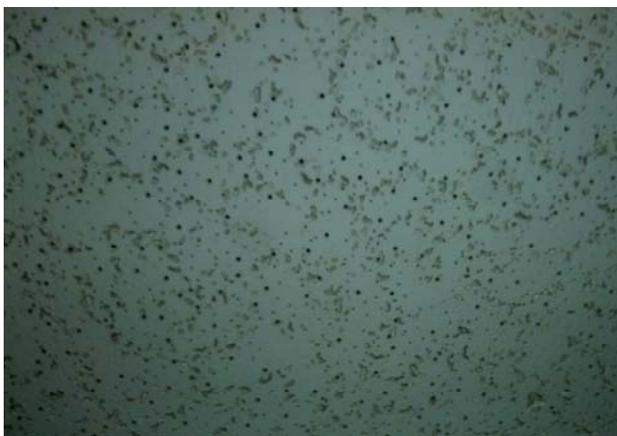
**H-5** Grooved ceiling tile (Non-ACM)

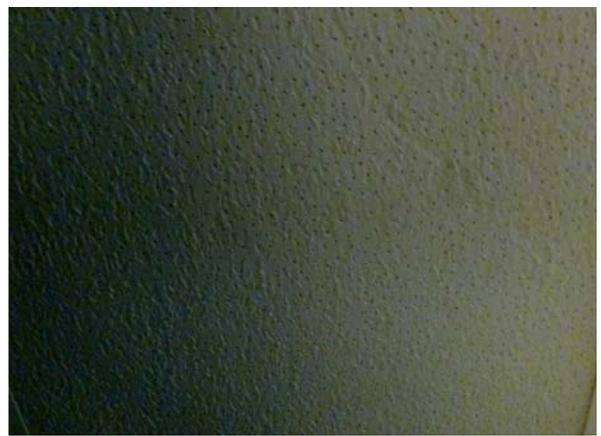
**H-6** Pitted ceiling tile (Non-ACM)

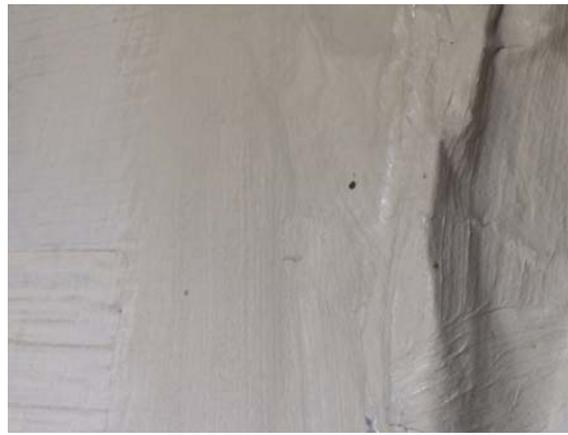
**H-8** White vent duct mastic (Non-ACM)

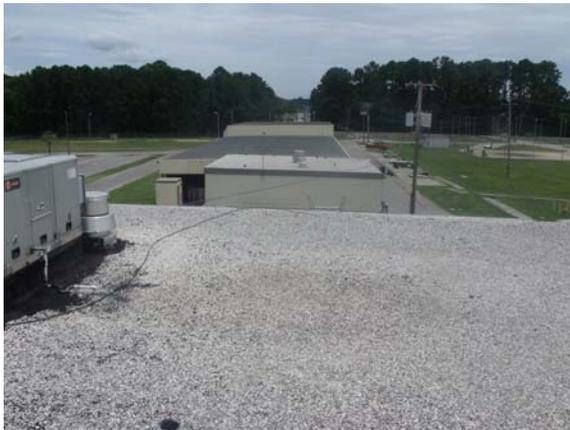
- ❖ H-9: Roofing tar
  - ❖ H-10: Misc., Black flashing mastic is accessible, non-friable ACM, in good condition with a low potential for disturbance. (Approx. 450 linear feet)

**H-9** Roofing tar (Non-ACM)  
**H-10** roofing flashing/sealer (ACM)

KCI recommends removing and disposing of all friable and non-friable ACMs that are anticipated to be affected by the proposed renovation/demolition activities in accordance with applicable Federal, State, and local regulations.

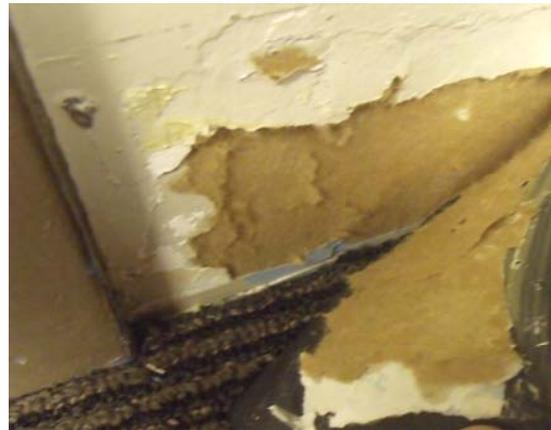
**H-11** White cove mastic (Non-ACM)

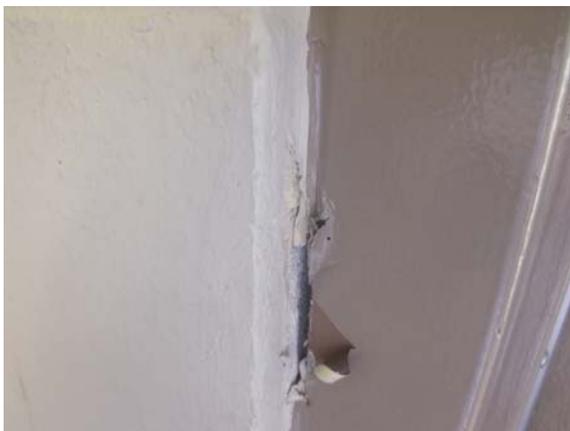
**H-12** White door/ window caulking (Non-ACM)

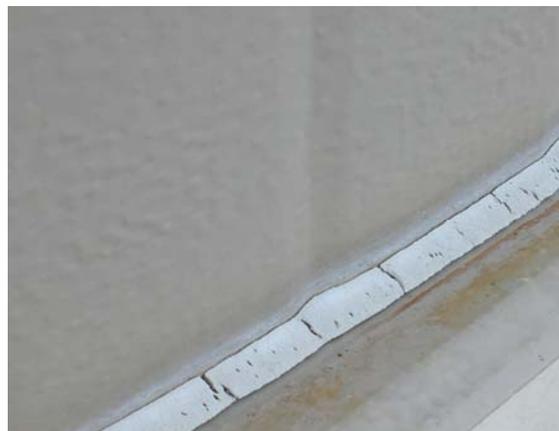
**H-13** White roof caulking (Non-ACM)

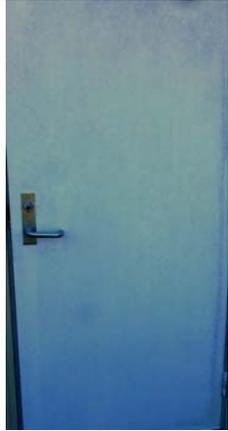
- H-10: Misc., Black flashing mastic is accessible, non-friable ACM, in good condition with a low potential for disturbance. (Approx. 450 linear feet)
- H-14: Misc., Fire doors, is assumed non-friable ACM in good condition with a low potential for disturbance. (5 each). KCI identified 3 additional doors with a fire – rating label located in Rooms 111 and 108 and have assumed to be ACM.

**H-14** Fire door-Typical (**Assumed  
ACM**)

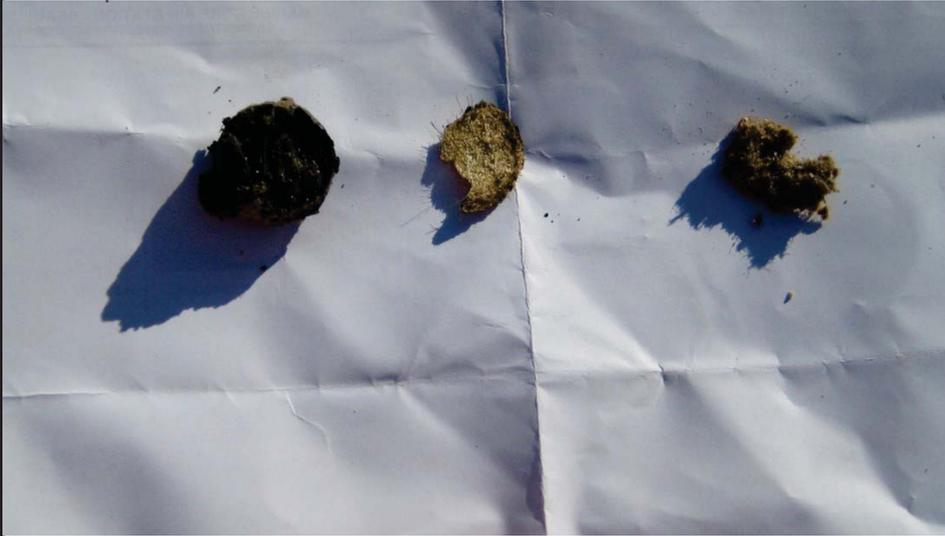
H-15: Brown Insulation beneath roofing tar (Non ACM)
