WINDOW REPLACEMENT & REPAIR
NAVAL AIR STATION PENSACOLA
PENSACOLA, FL

SUBMITTAL NAME: **ASBESTOS & LEAD PAINT SURVEYS**
SUBMITTAL PERCENTAGE: FINAL
SUBMITTAL DATE: JULY 3, 2014

**LIMITED ASBESTOS CONTAINING MATERIALS SURVEY,
LEAD-BASED PAINT SURVEY, AND
WASTE CHARACTERIZATION FOR LEAD
BUILDINGS 38, 40, 73, 223, 606, AND 627
NAVAL AIR STATION PENSACOLA
PENSACOLA, ESCAMBIA COUNTY, FLORIDA**

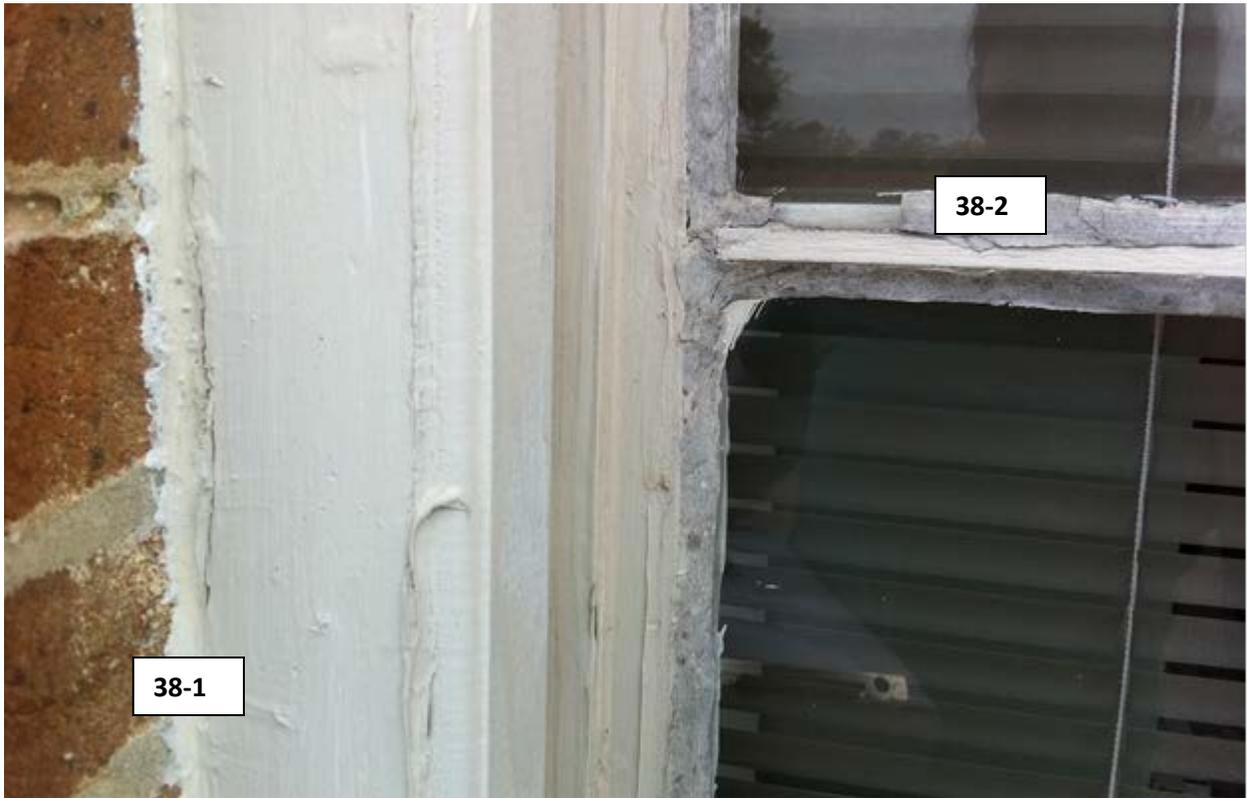
1. View of exterior window caulk (38-1) and exterior window glazing (38-2) at Building 38.

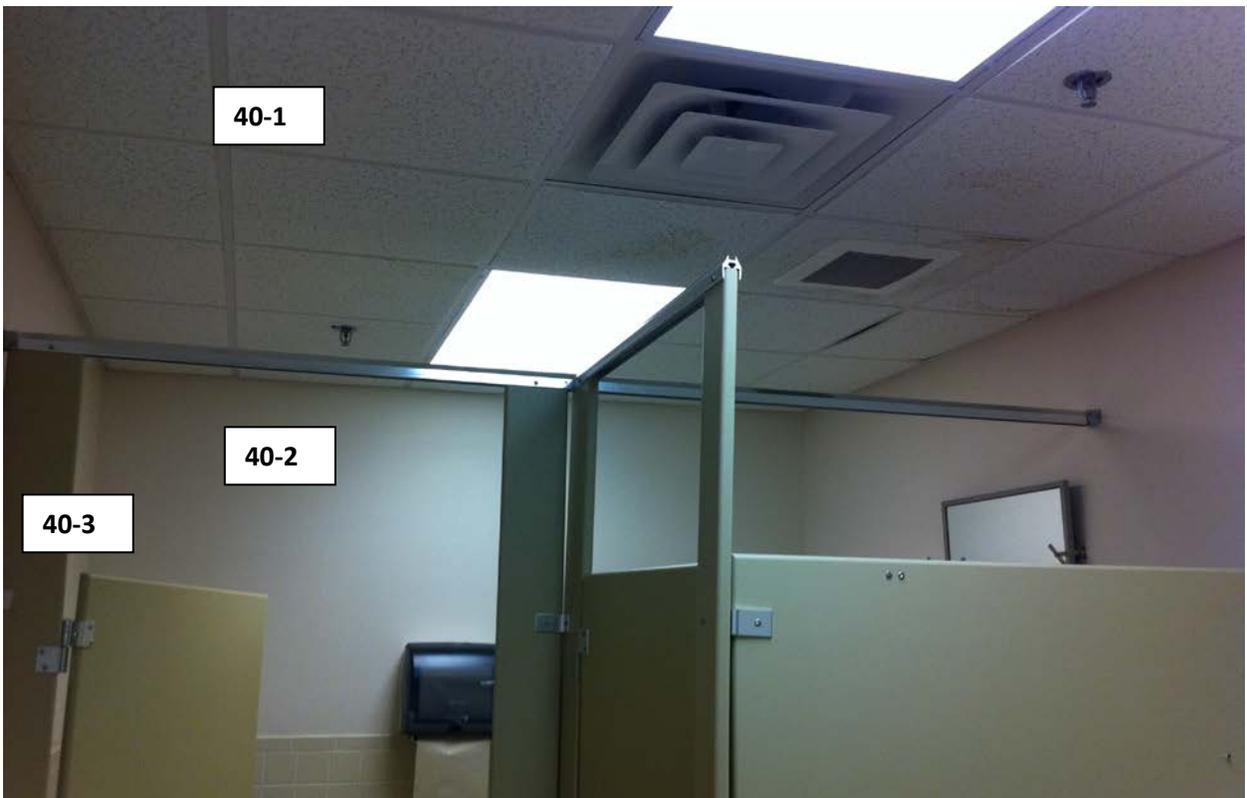
2. View of ceiling tile (40-1), drywall (40-2), and joint compound (40-3) in the female head at Building 40.

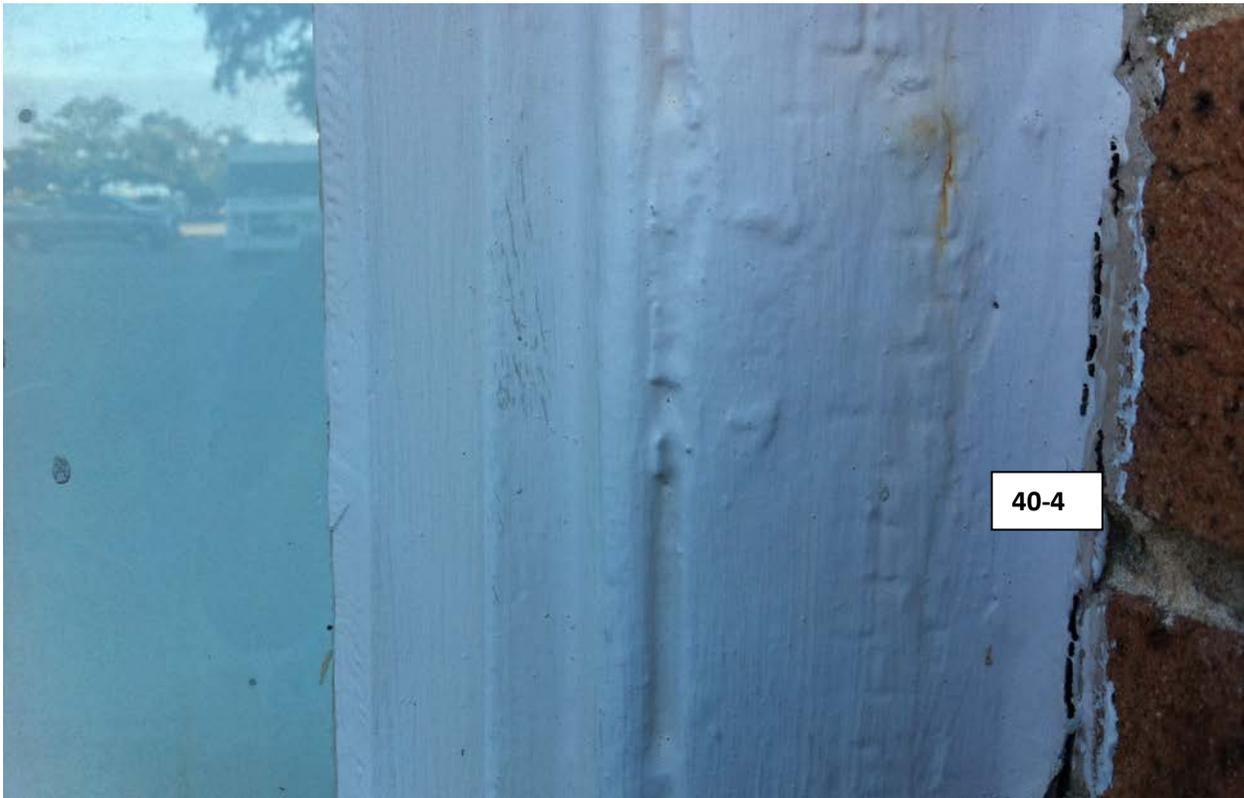
3. View of exterior window caulk (40-4) at Building 40.

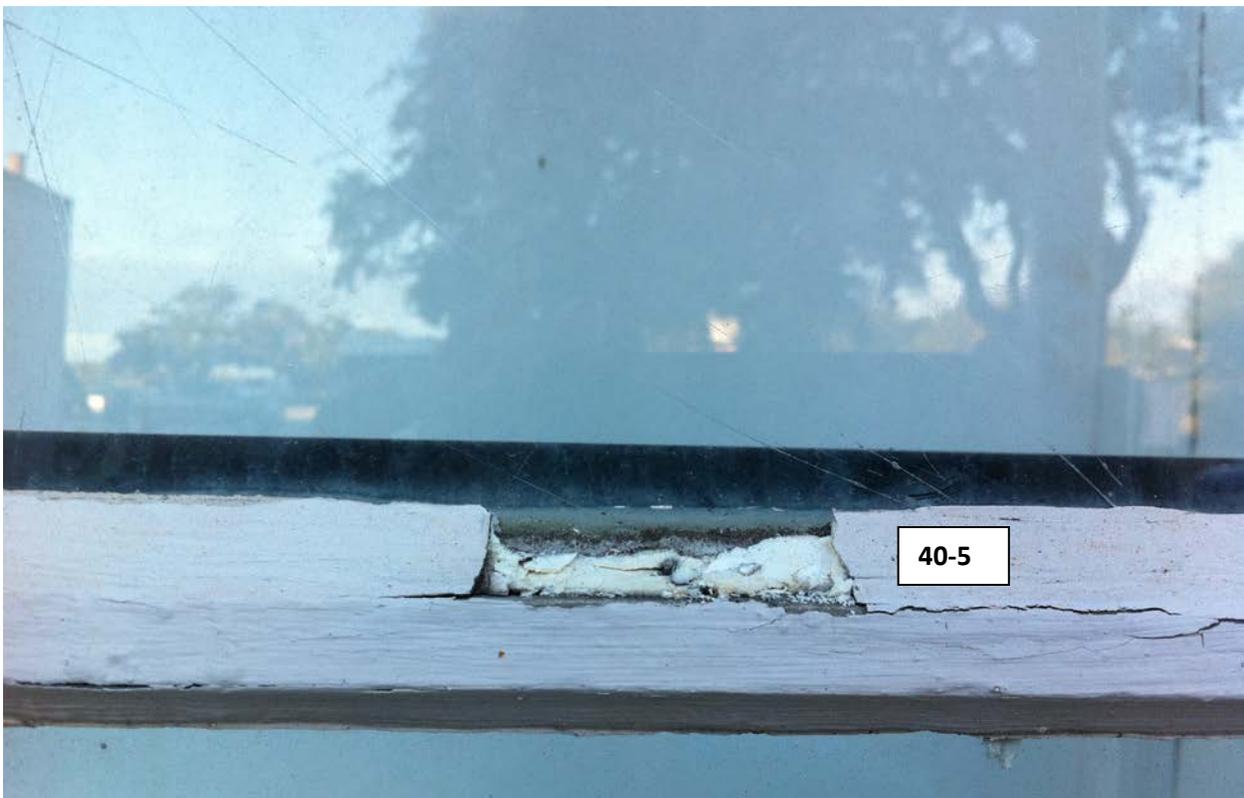
4. View of exterior window glaze (40-5) at Building 40.

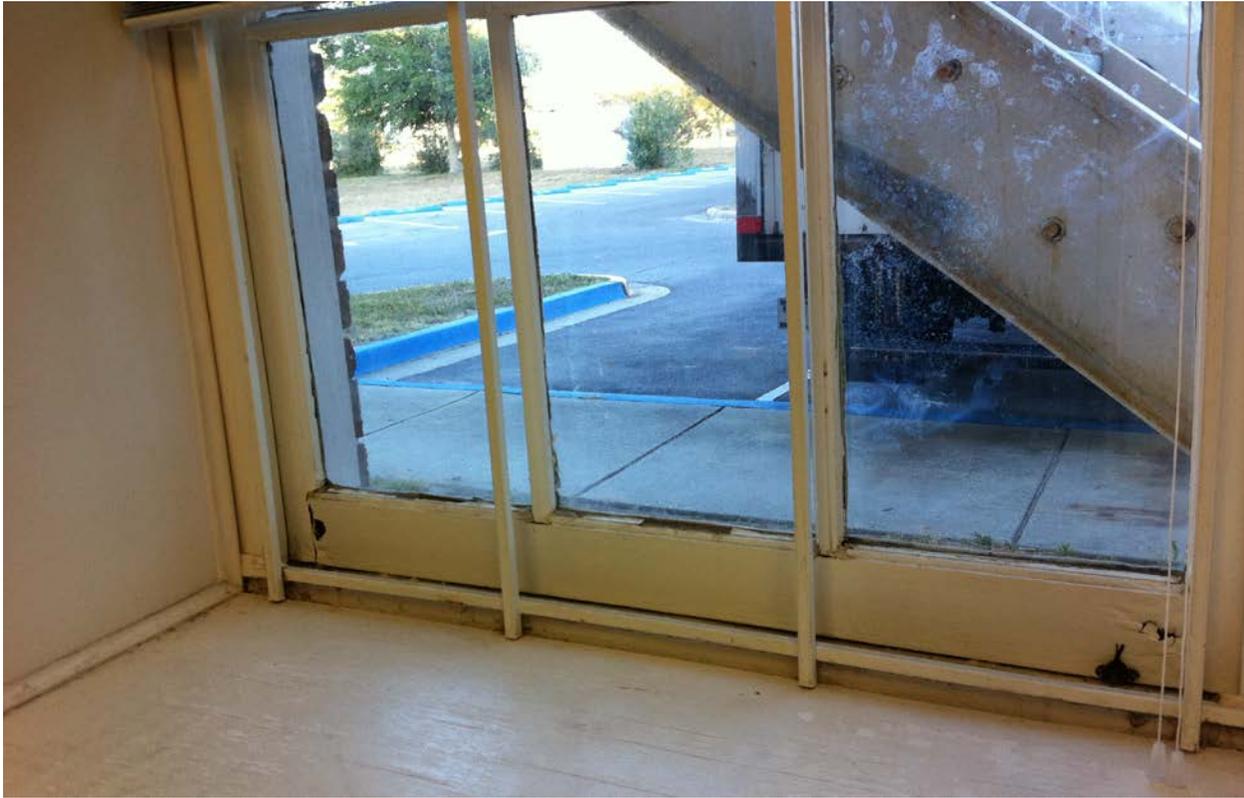
5. View of the interior of the window at Building 40. No homogeneous areas identified.

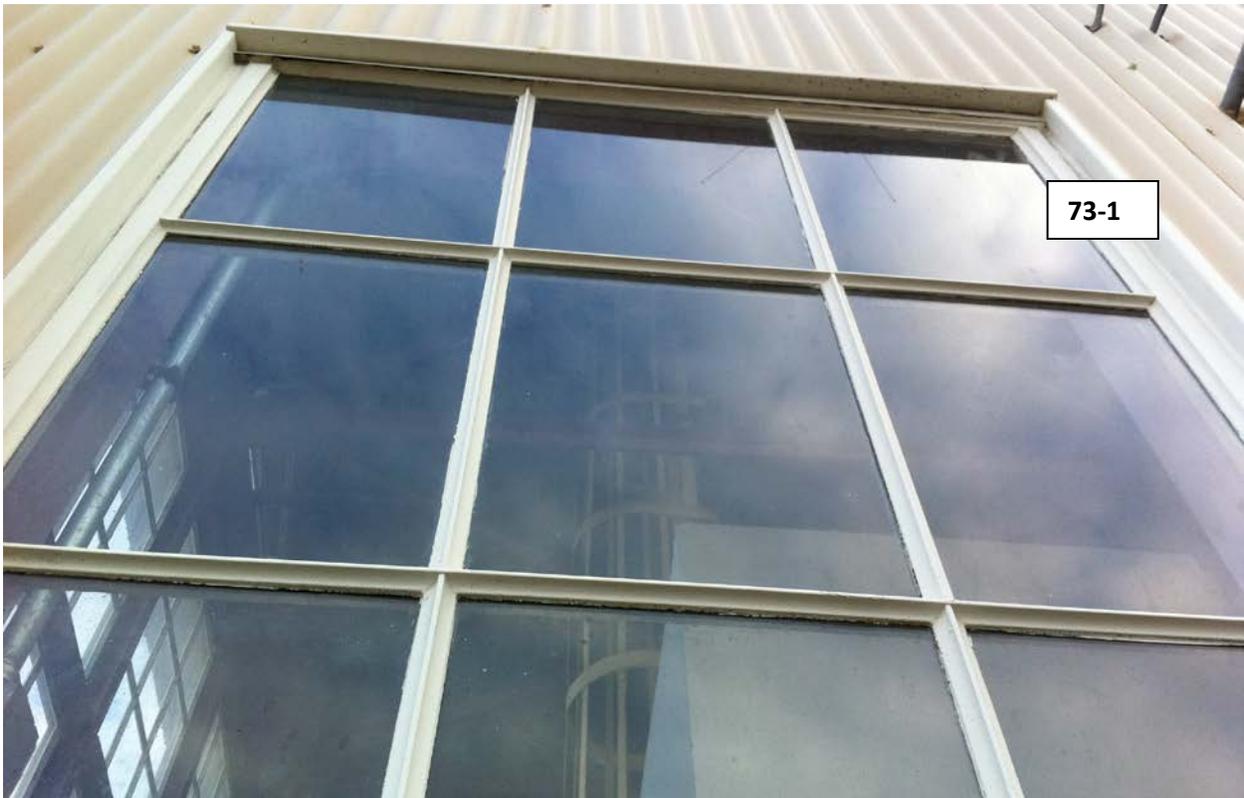
6. View of the exterior window caulk (73-1) at Building 73.

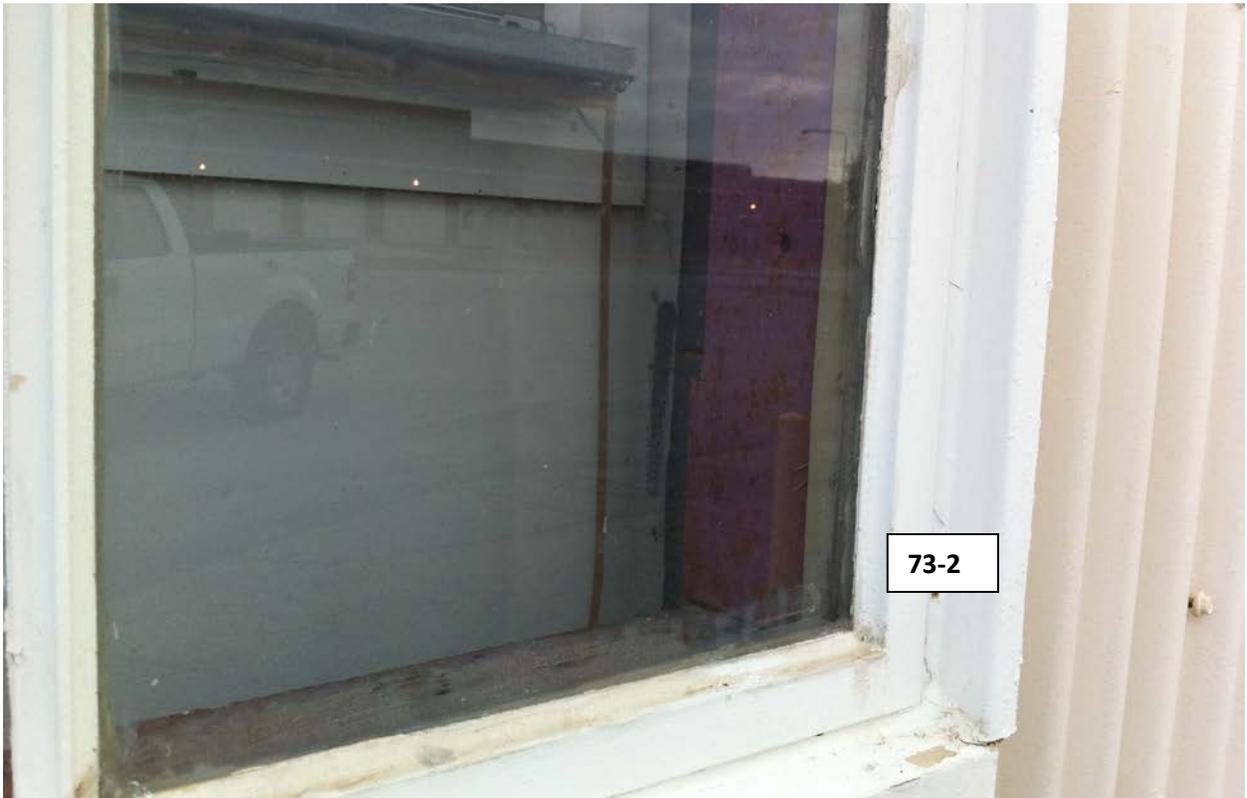
7. View of the exterior window caulk (73-2) on the attached office at Building 73.

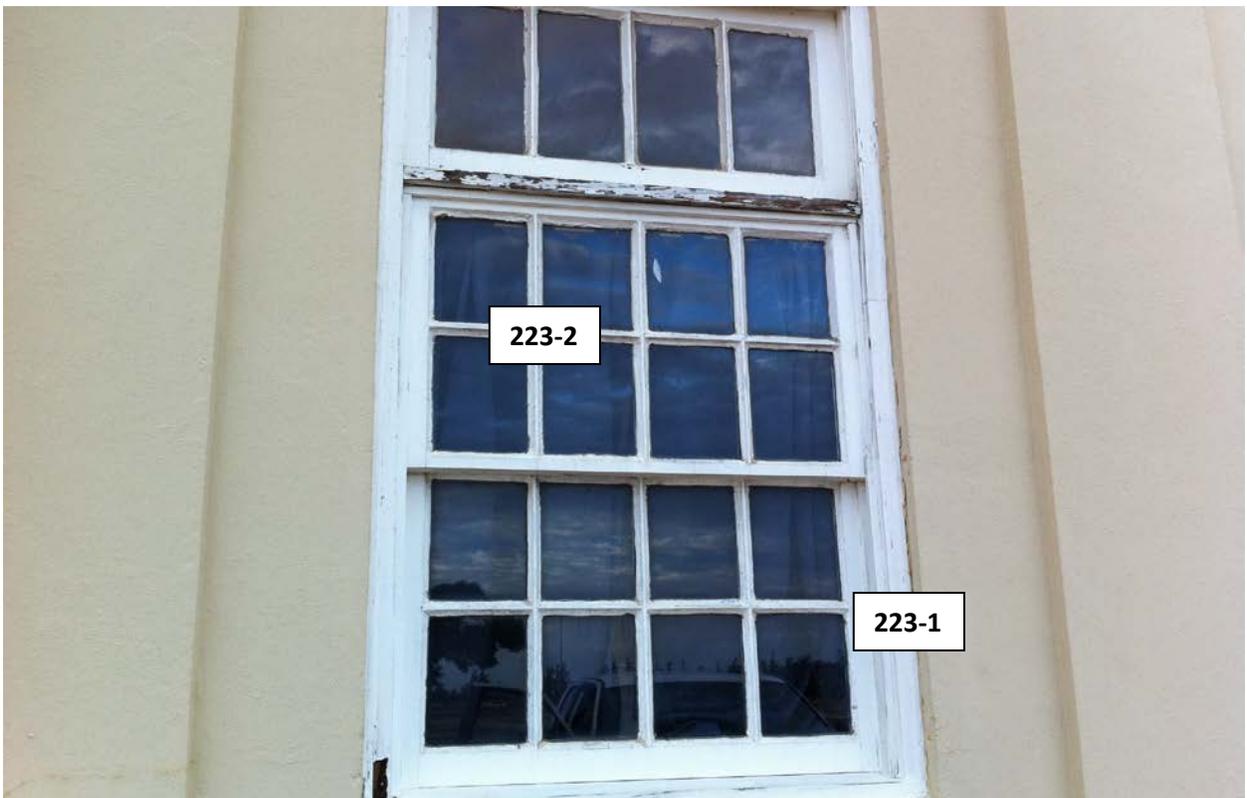
8. View of the exterior window caulk (223-1) and glaze (223-2) at Building 223.

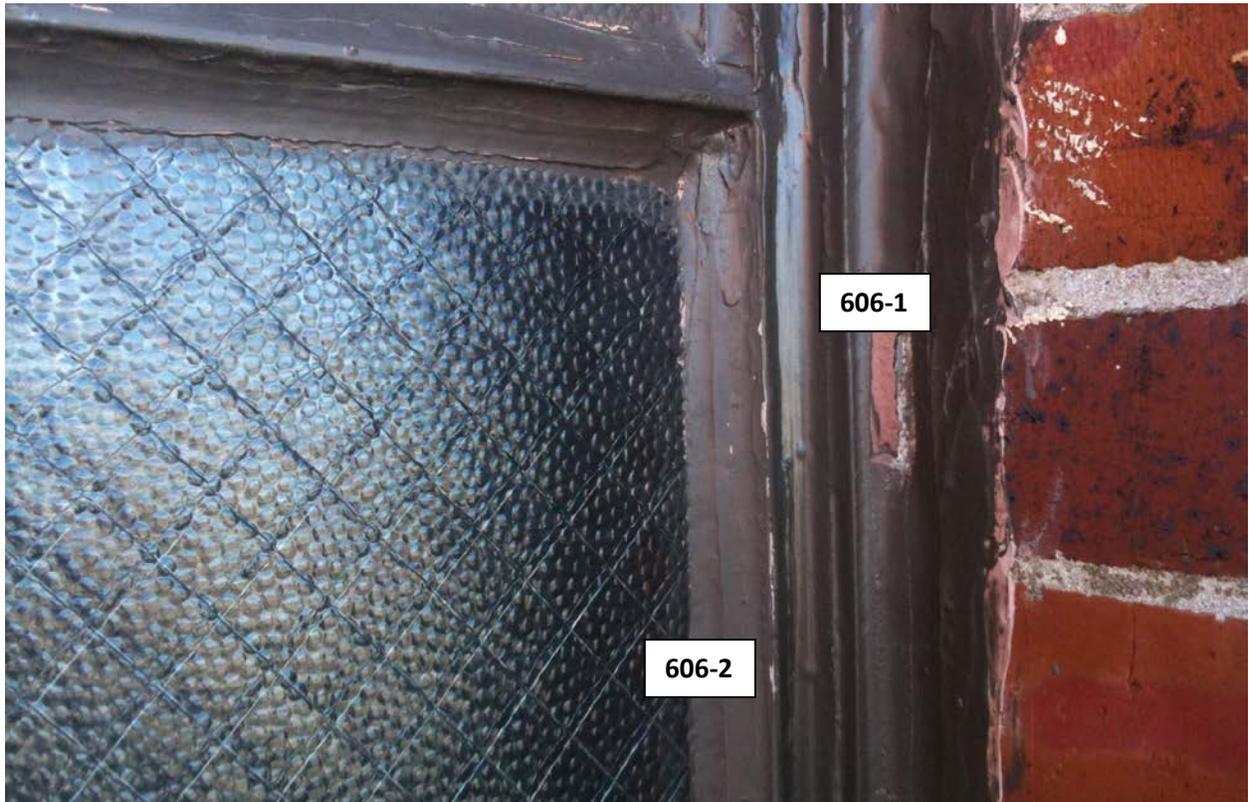
9. View of the exterior window caulk (606-1) and glaze (606-2) at Building 606.

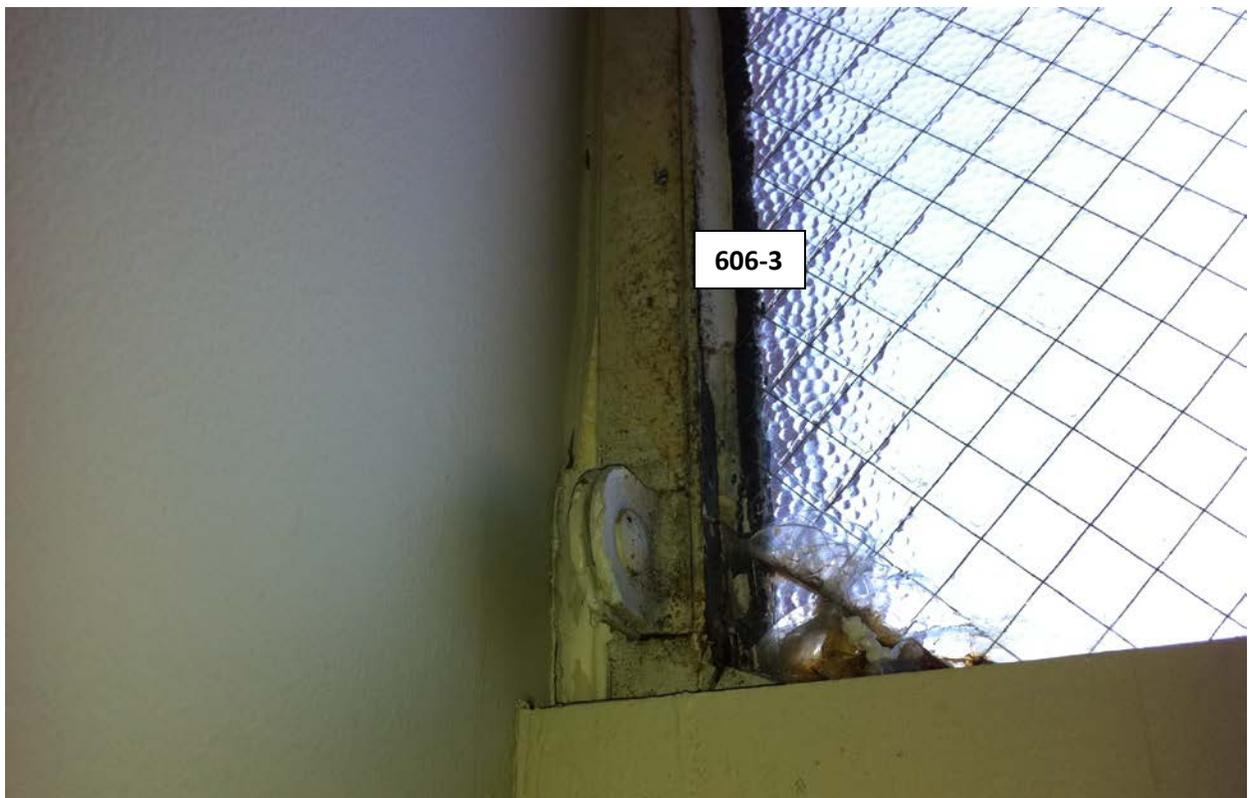
10. View of the interior window glaze (606-3) at Building 606.

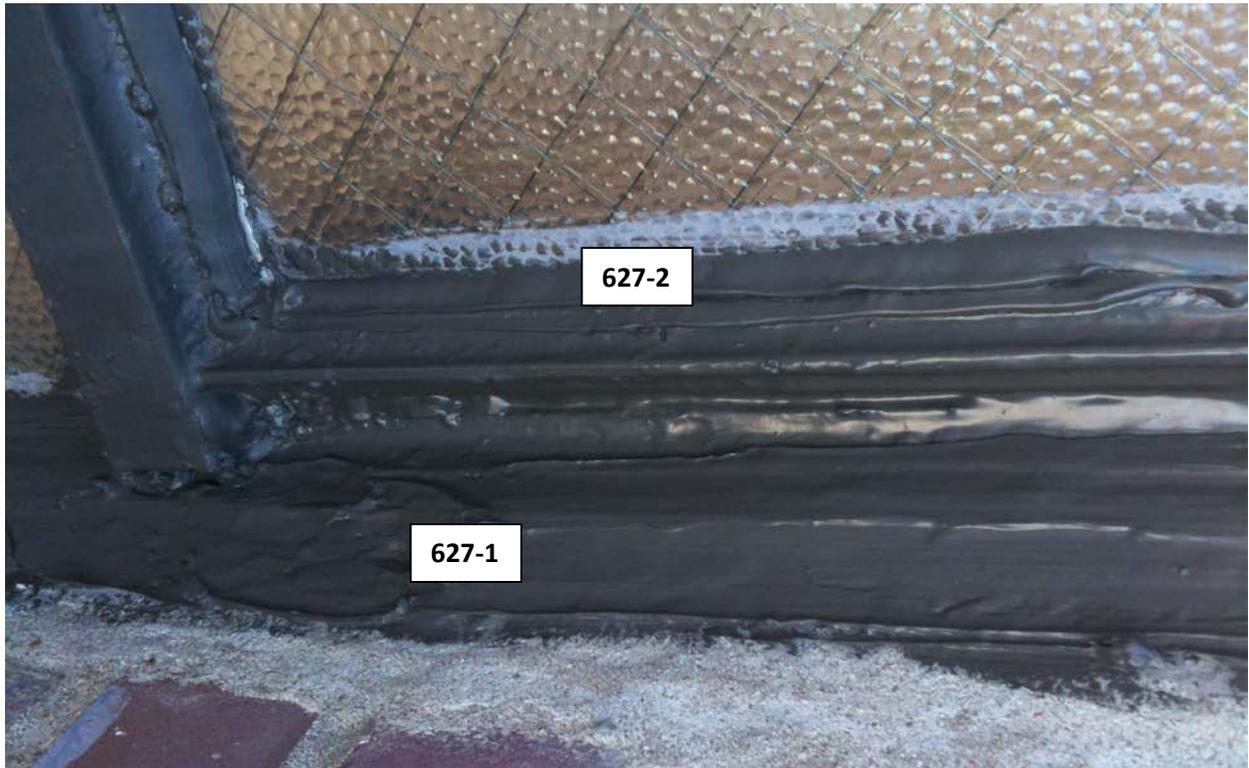
11. View of the exterior window caulk (627-1) and glaze (627-2) at Building 627.

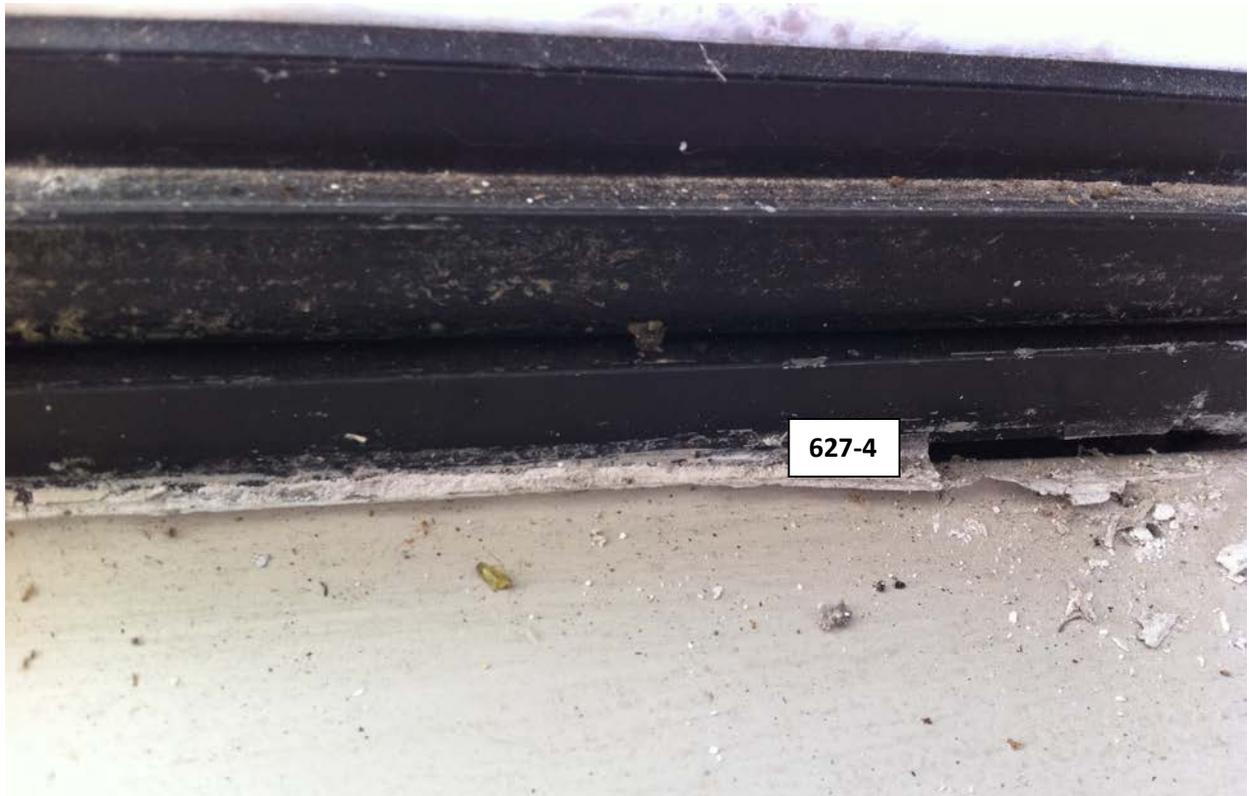
12. View of the interior window caulk (627-4) at Building 627.

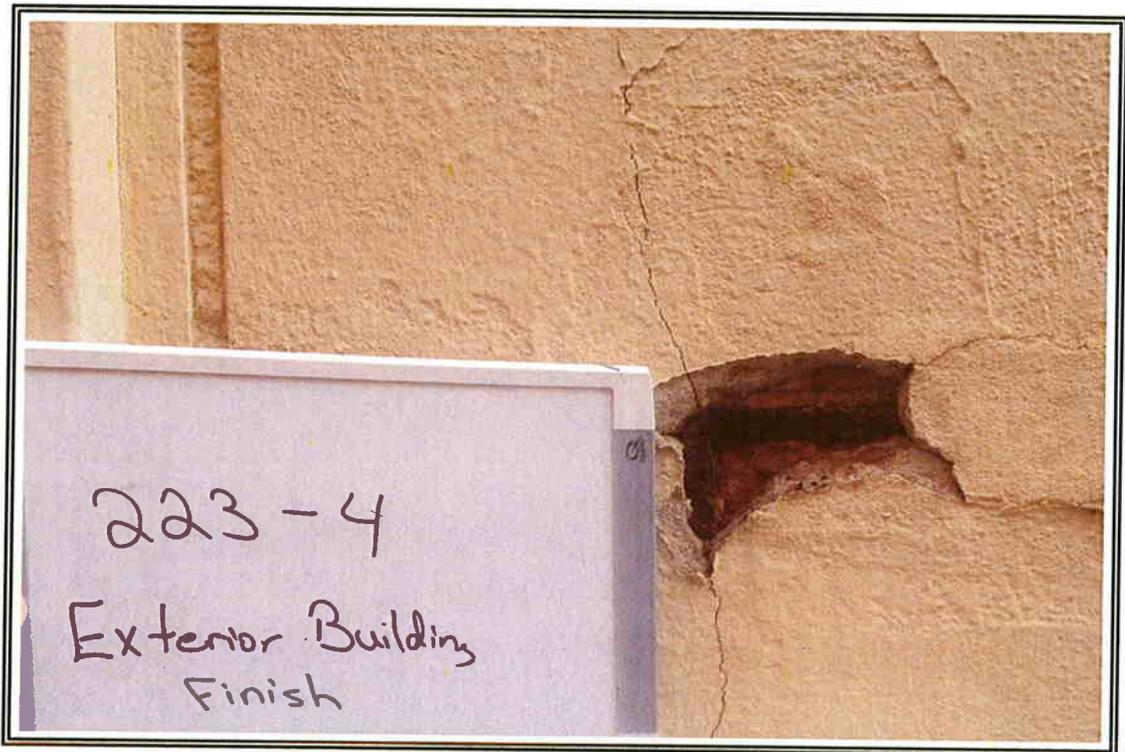
2. Close-up view of the exterior stucco finish.
