June 4, 2015  
**Revised June 5, 2015**

**Reference:** **Geotechnical Investigation – Pavement Cores**  
*REPAIR AIRFIELD/RUNWAY FORREST SHERMAN FIELD*  
 NAS Fort Pensacola, Florida  
 NAVFAC Project No.: ST 1112225  
 UES Project No.: 1730.1500048.0000  
 UES DOCS Report No.: 1235270

**REPAIR AIRFIELD/RUNWAY FORREST SHERMAN FIELD**

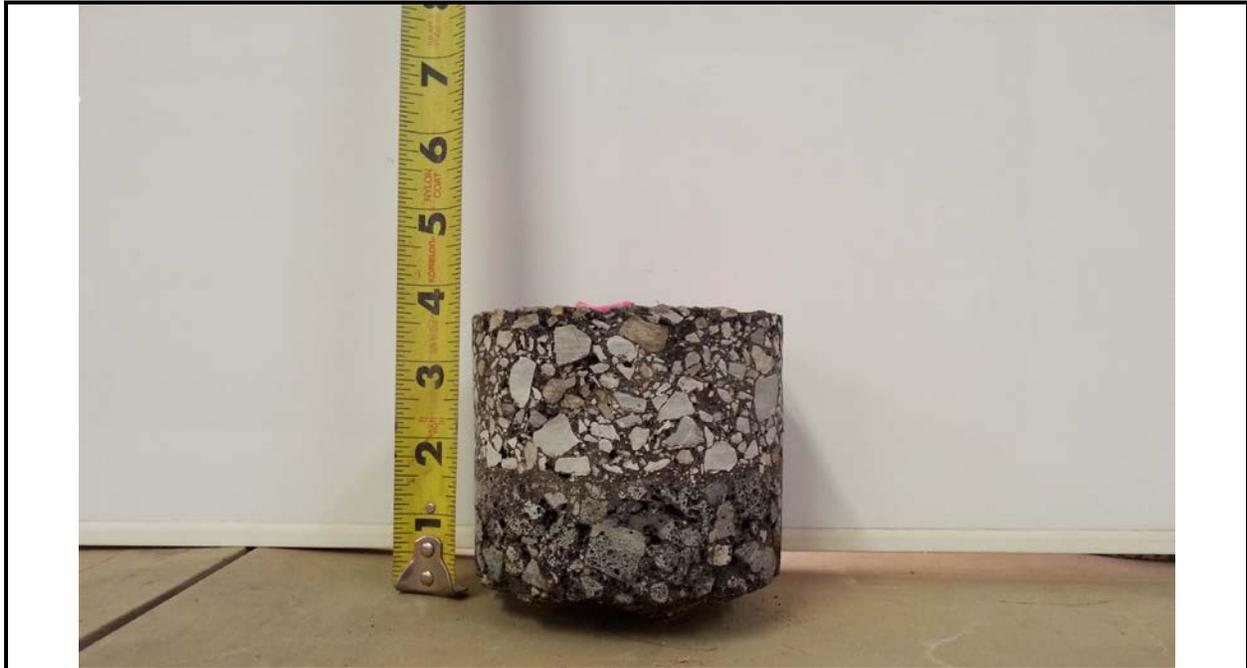
Pavement Core B-1.  
Approximately 2 layers of flexible pavement. No noticeable separation geotextile. No observed cracking or delamination.

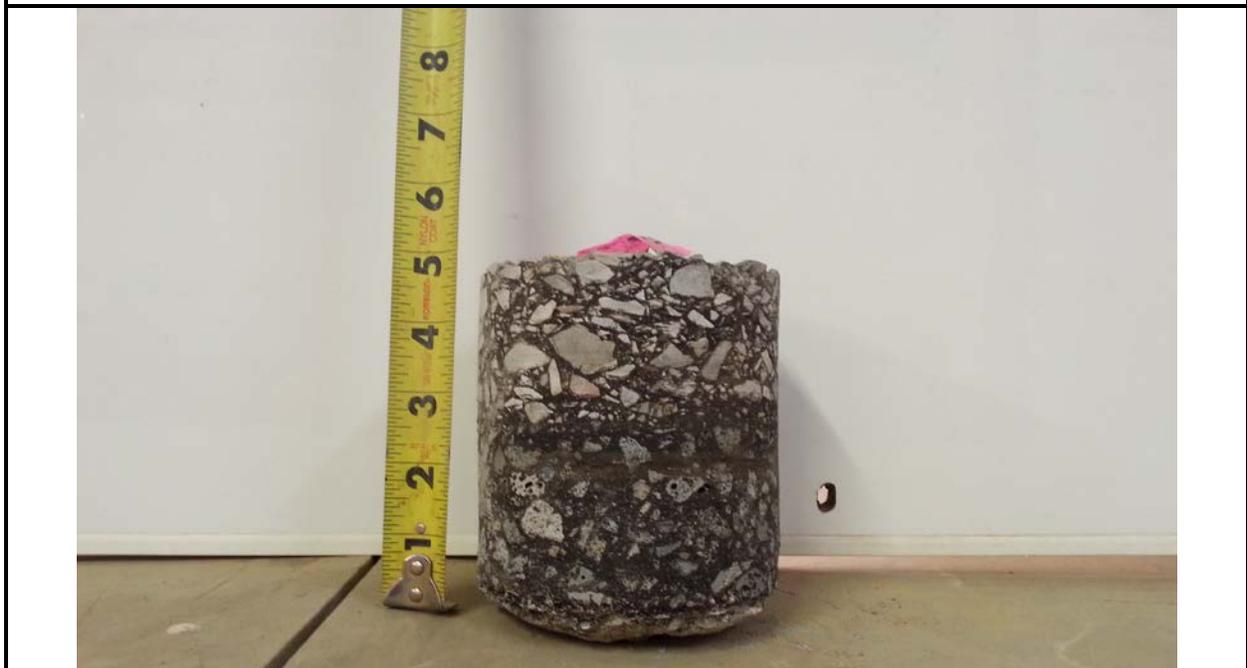
Pavement Core B-2.  
Approximately 3 layers of flexible pavement. No noticeable separation geotextile. No observed cracking or delamination.

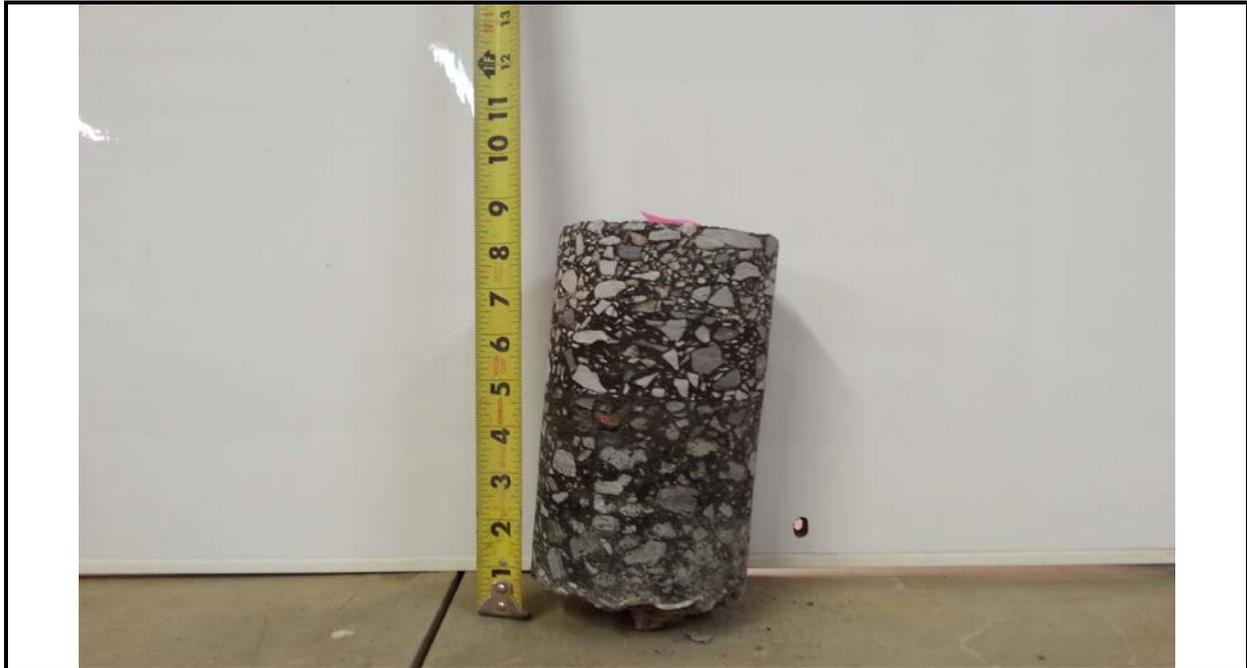
Pavement Core B-5.  
Approximately 4 layers of flexible pavement. No noticeable separation geotextile. No observed cracking or delamination.

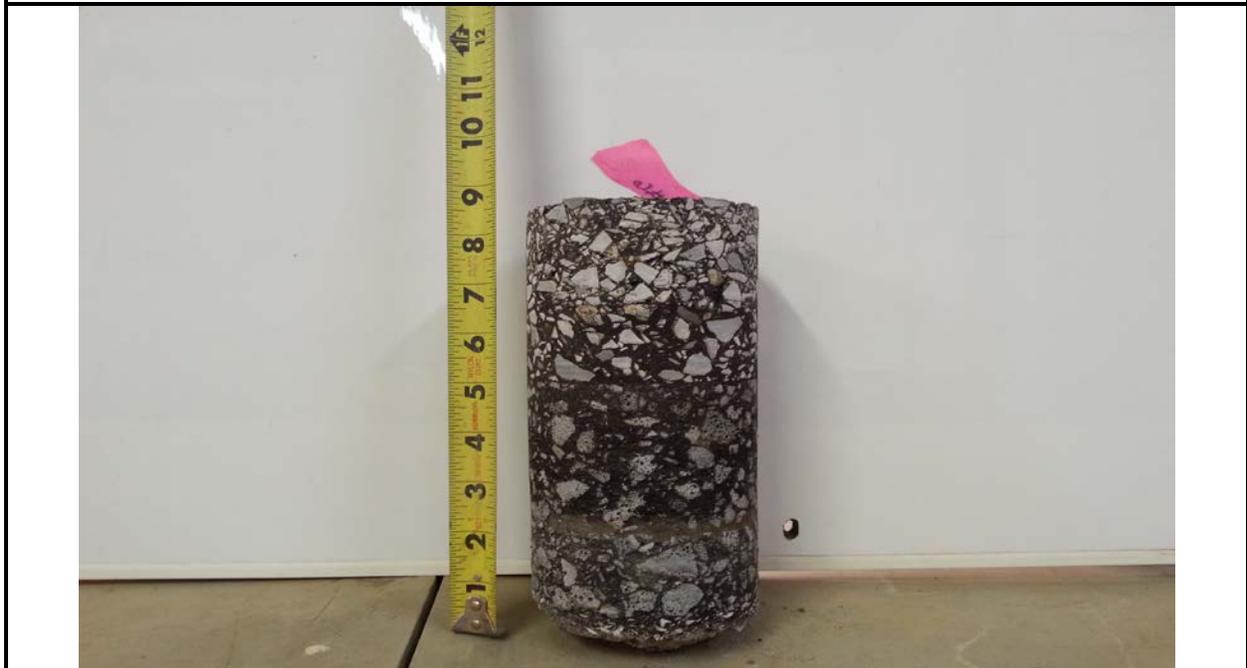
Pavement Core B-6.  
Approximately 4 layers of flexible pavement. No noticeable separation geotextile. No observed cracking or delamination.

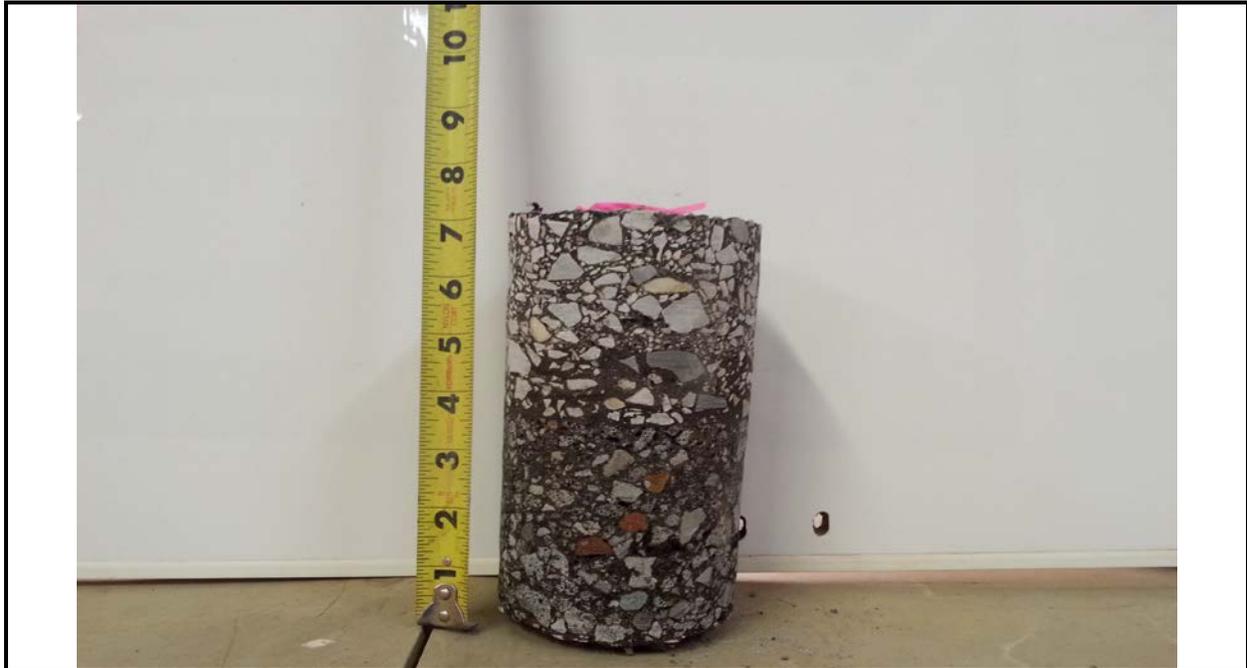
Pavement Core B-7.  
Approximately 4 layers of flexible pavement. No noticeable separation geotextile. No observed cracking or delamination.

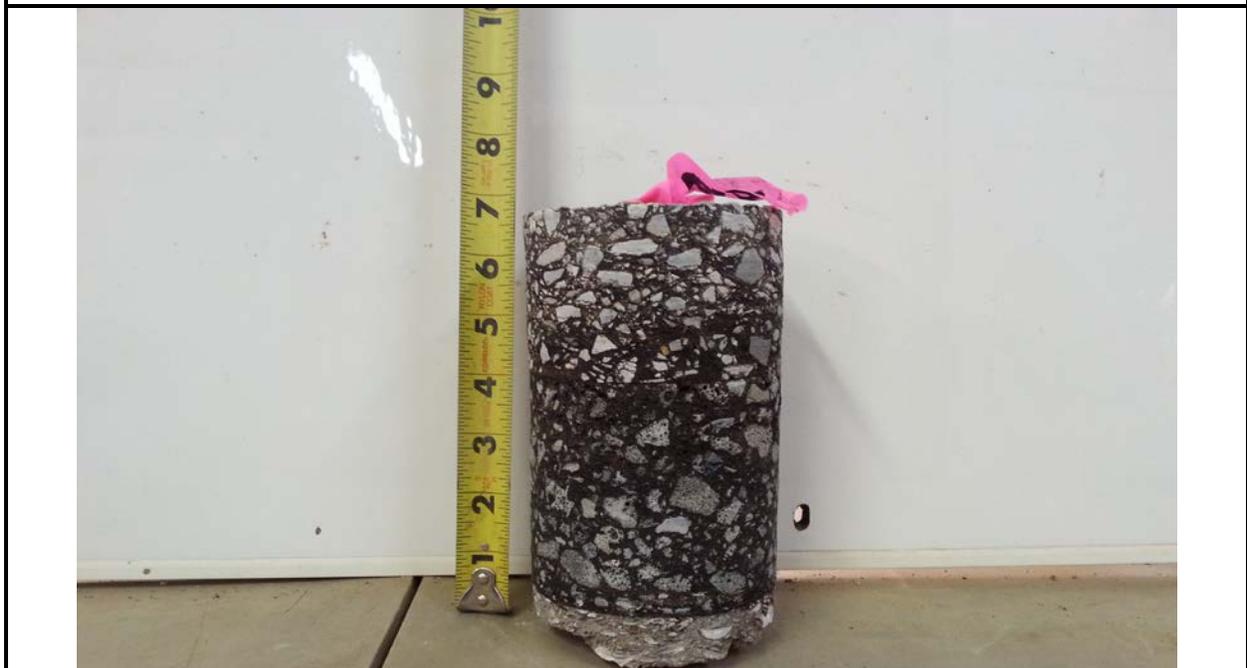
Pavement Core B-8.  
Approximately 4 layers of flexible pavement. No noticeable separation geotextile. No observed cracking or delamination.

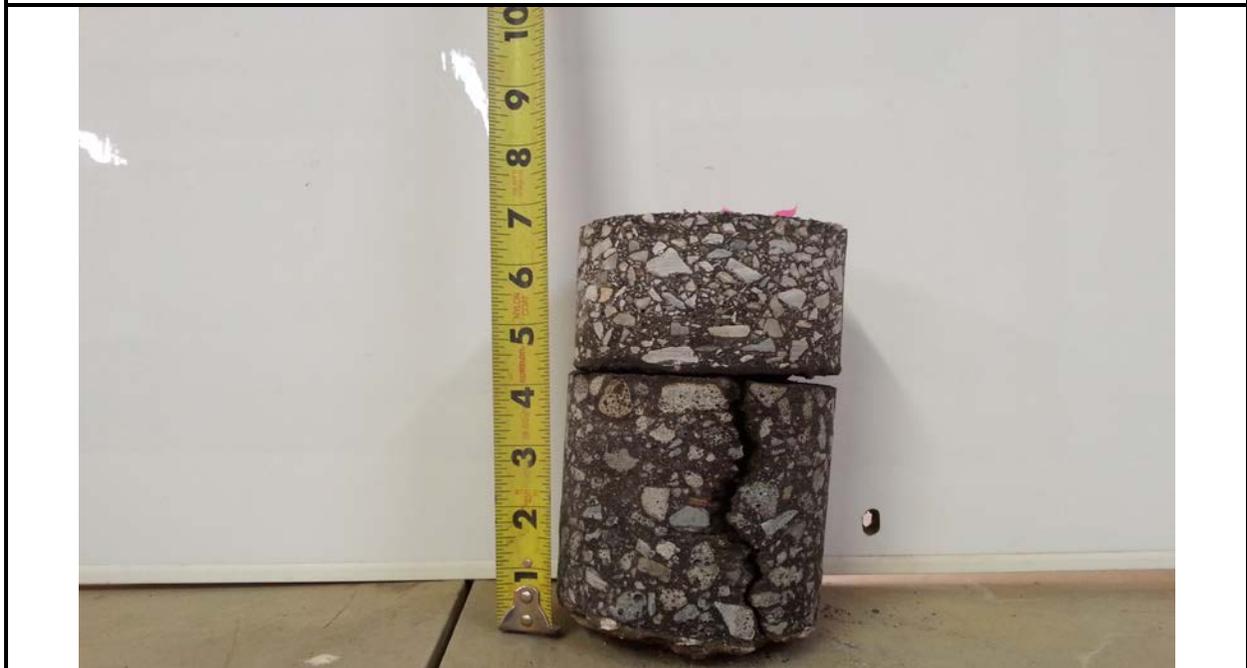
B-12	504794.27	1079783.42	6.25	Approximately 4 layers of flexible pavement. Separation geotextile located 2.25" below the pavement surface. Core delaminated directly below the geotextile. Cracking was observed beginning at the base of the geotextile and extending down to the base of the pavement core (Bottom-up cracking).
B-13	504724.29	1079492.76	6.25	Approximately 4 layers of flexible pavement. Separation geotextile located 2.75" below the pavement surface. No observed cracking or delamination.
B-14	504674.28	107967943	6.25	Approximately 4 layers of flexible pavement. Separation geotextile located 2.125" below the pavement surface. No observed cracking or delamination.
B-15	504295.19	1079742.28	3.375	Approximately 2 layers of flexible pavement. Separation geotextile located 2.25" below the pavement surface. No observed cracking. No recovery of the bottom portion of the core (below separation geotextile).

Pavement Core B-12.  
Approximately 4 layers of flexible pavement. Separation geotextile located 2.25" below the pavement surface. Core delaminated directly below the geotextile. Cracking was observed beginning at the base of the geotextile and extending down to the base of the pavement core (Bottom-up cracking).

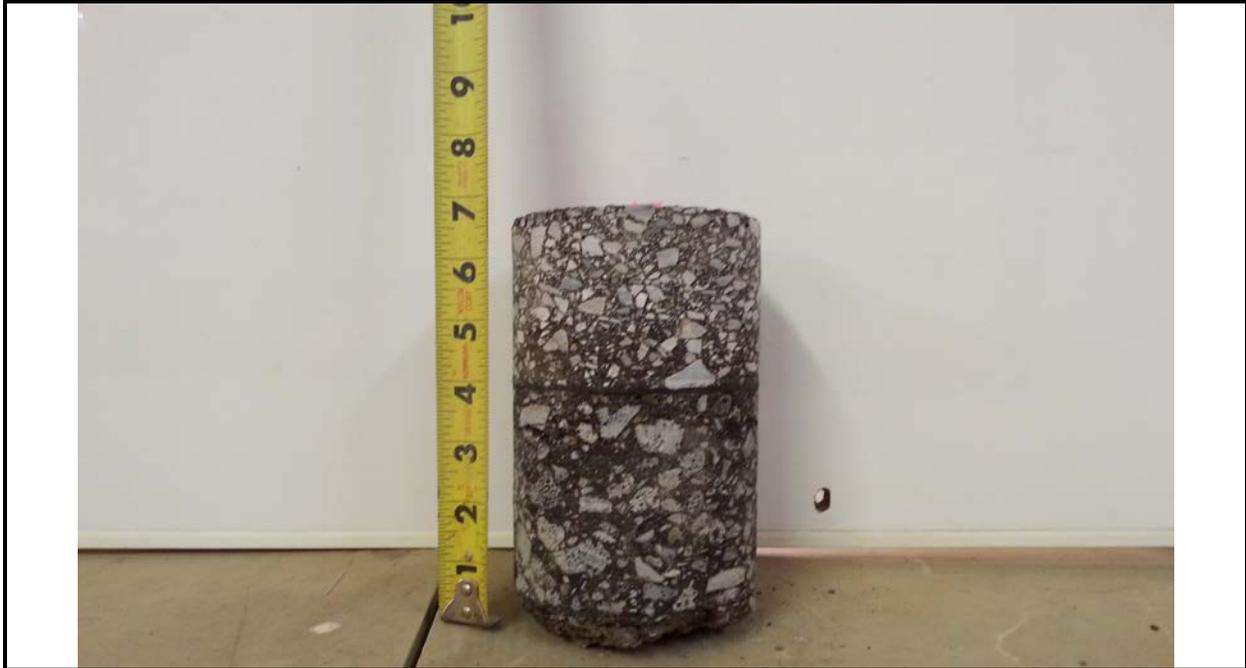
Pavement Core B-13.  
Approximately 4 layers of flexible pavement. Separation geotextile located 2.75" below the pavement surface. No observed cracking or delamination.

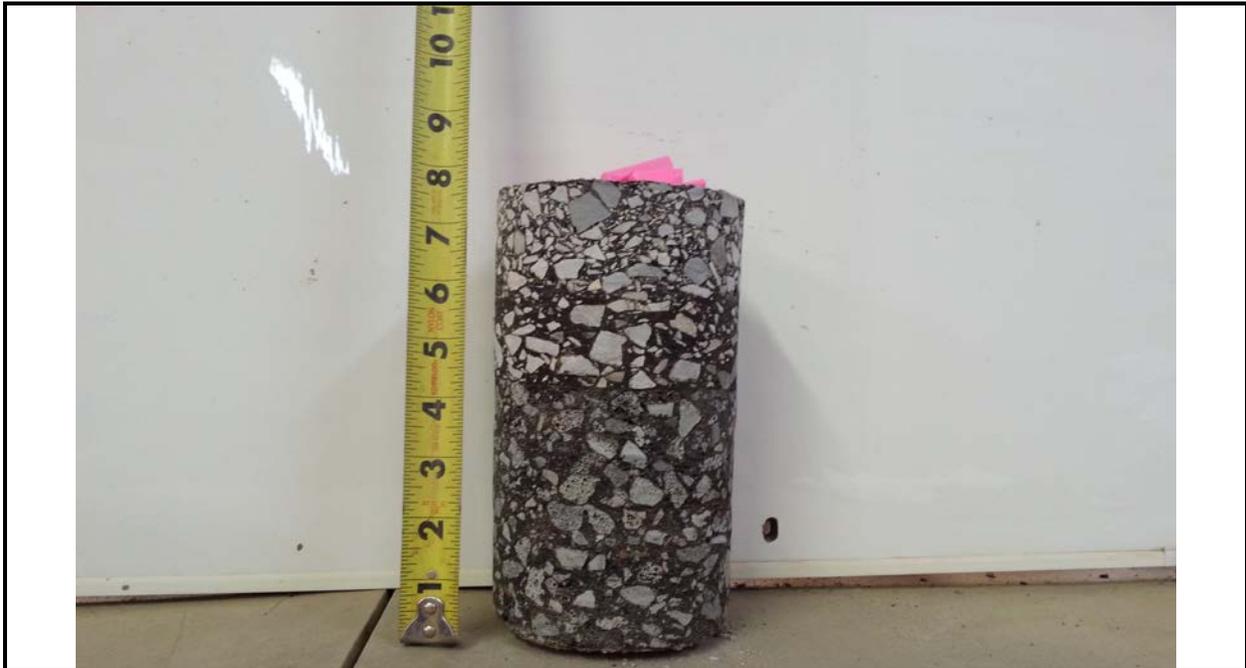
Pavement Core B-17  
Approximately 4 layers of flexible pavement. No noticeable separation geotextile. No observed cracking or delamination.

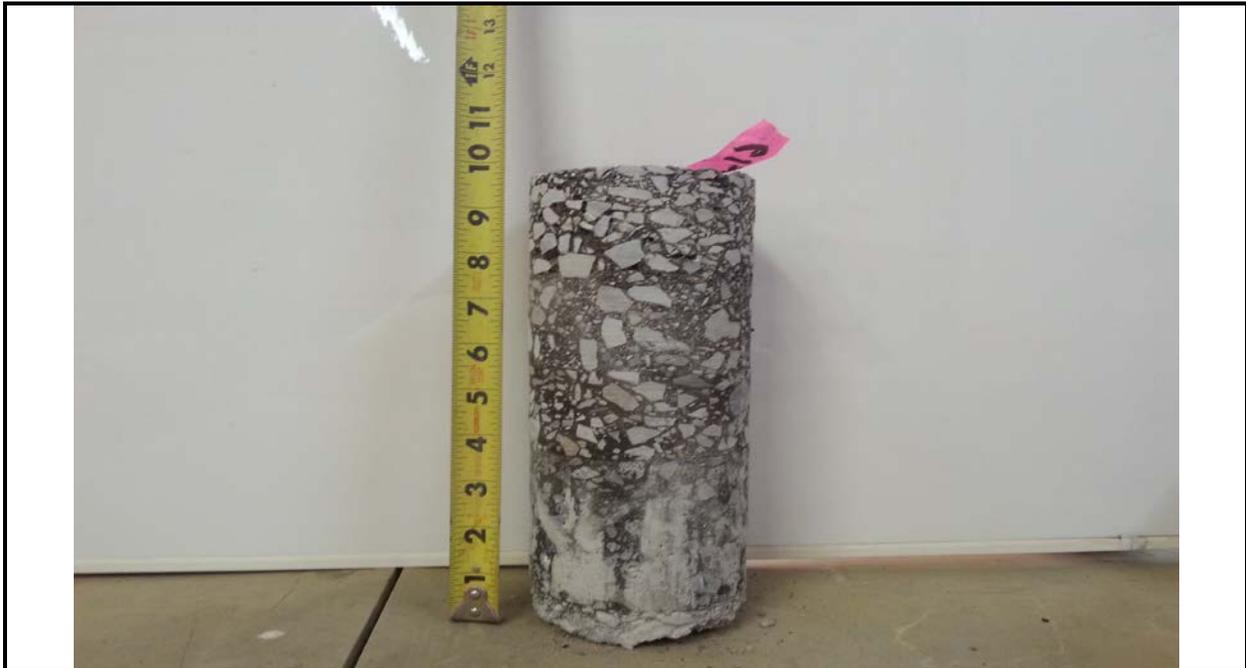
Pavement Core B-19.  
Approximately 4 layers of flexible pavement. No noticeable separation geotextile. No observed cracking or delamination.

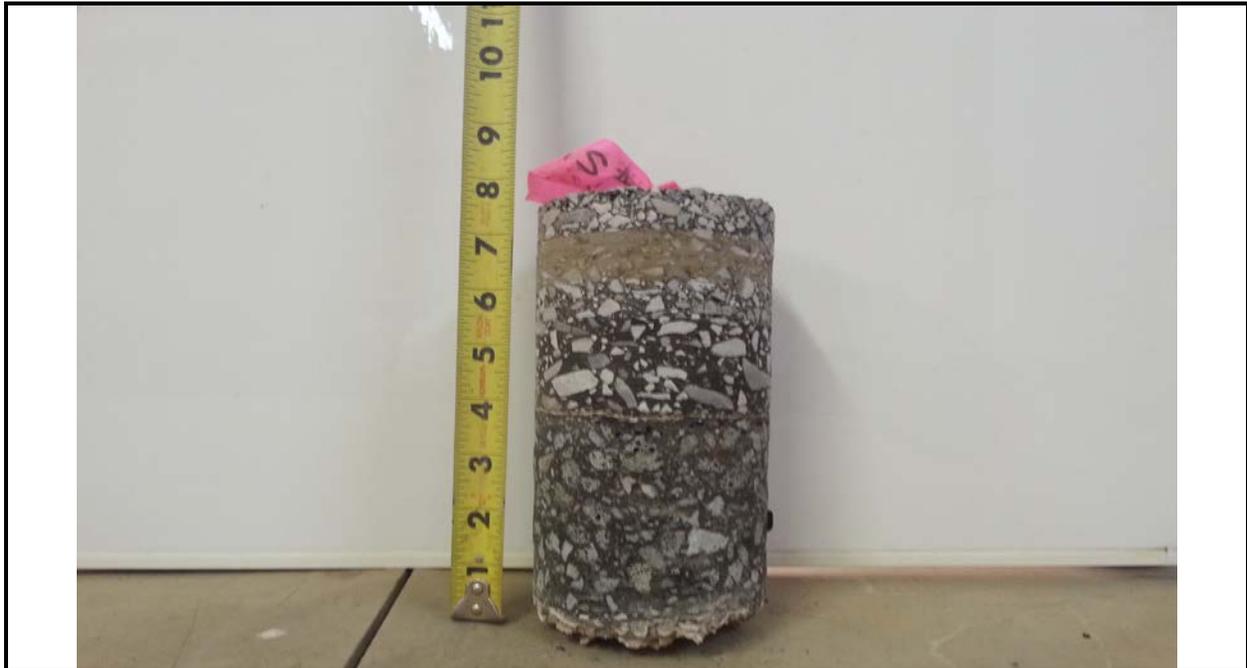
Pavement Core B-21.  
Approximately 4 layers of flexible pavement. No noticeable separation geotextile. No observed cracking or delamination.

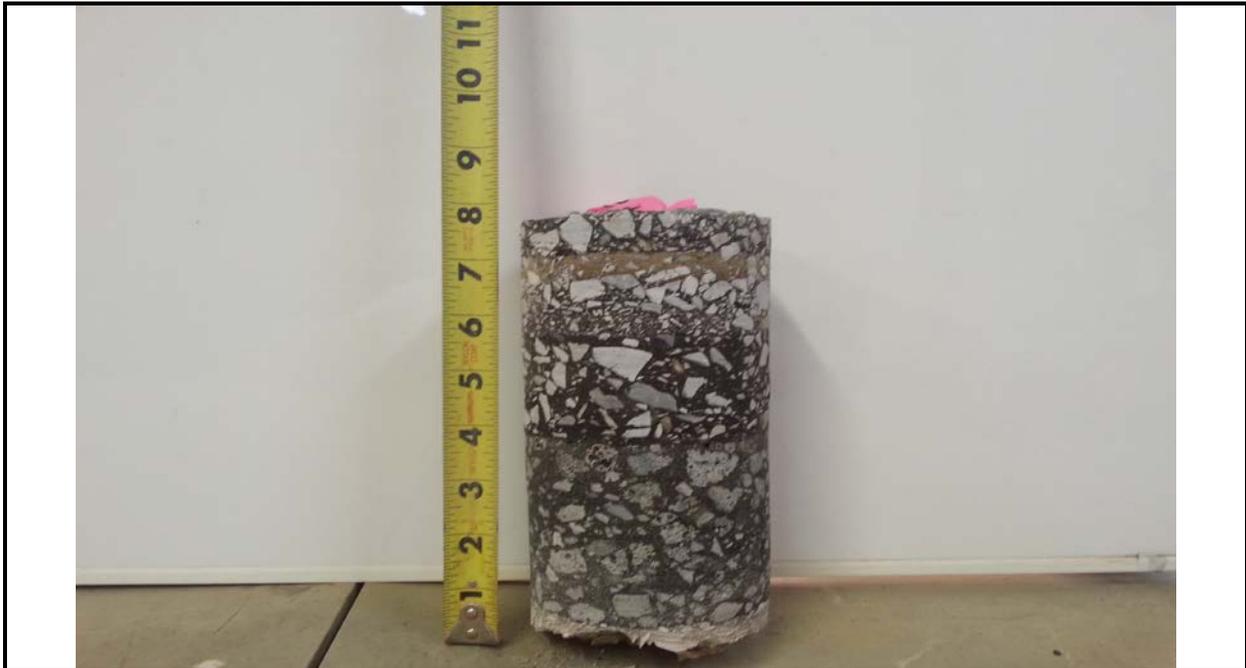
Pavement Core B-23.  
Approximately 4 layers of flexible pavement. No noticeable separation geotextile. No observed cracking or delamination.

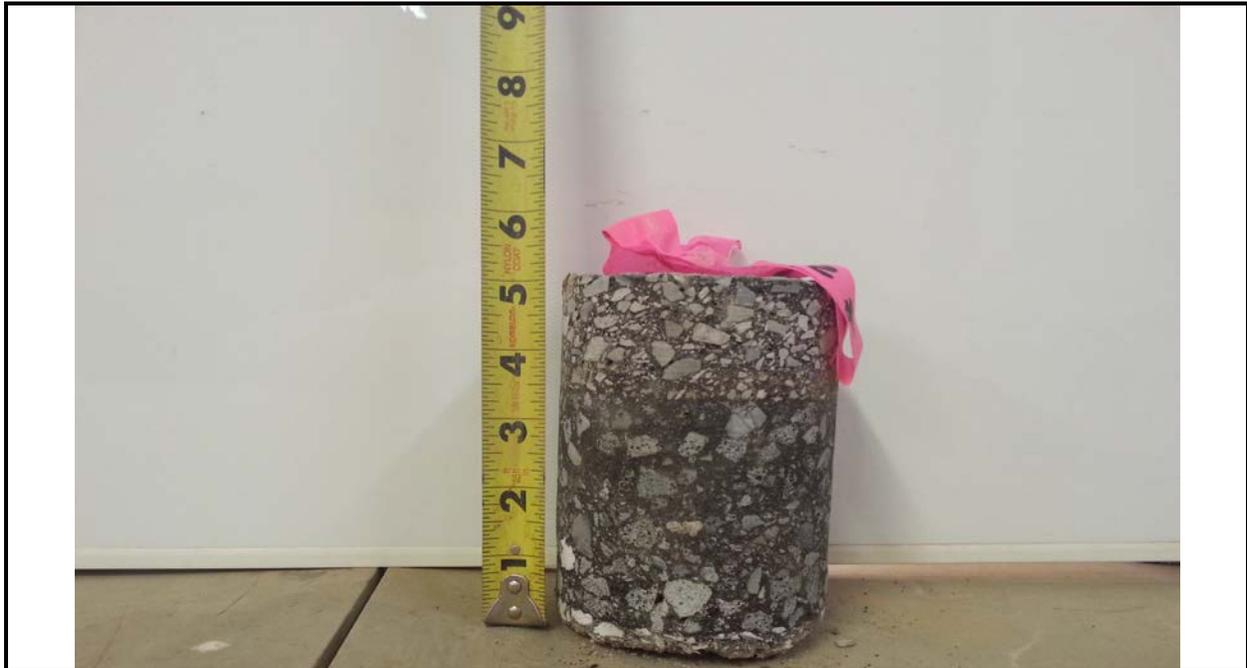
Pavement Core B-29.  
Approximately 3 layers of flexible pavement. No noticeable separation geotextile. No observed cracking or delamination.

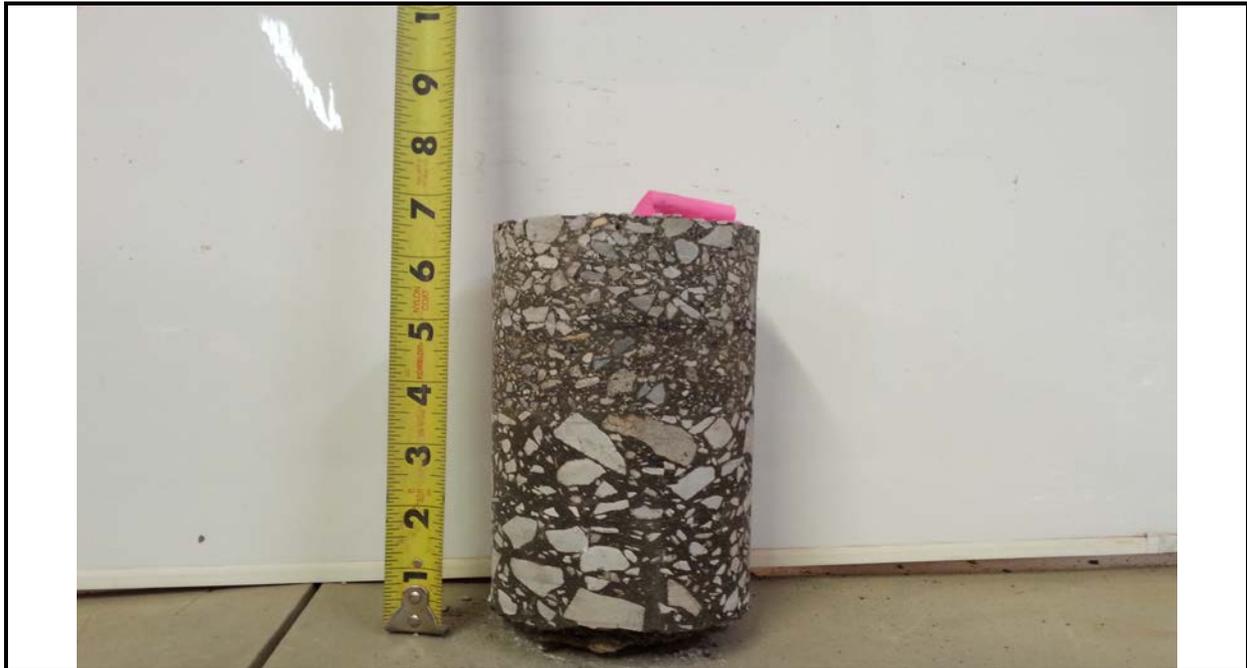
Pavement Core B-31.  
Approximately 4 layers of flexible pavement. Separation geotextile located 1.5" below pavement surface. No observed cracking or delamination.

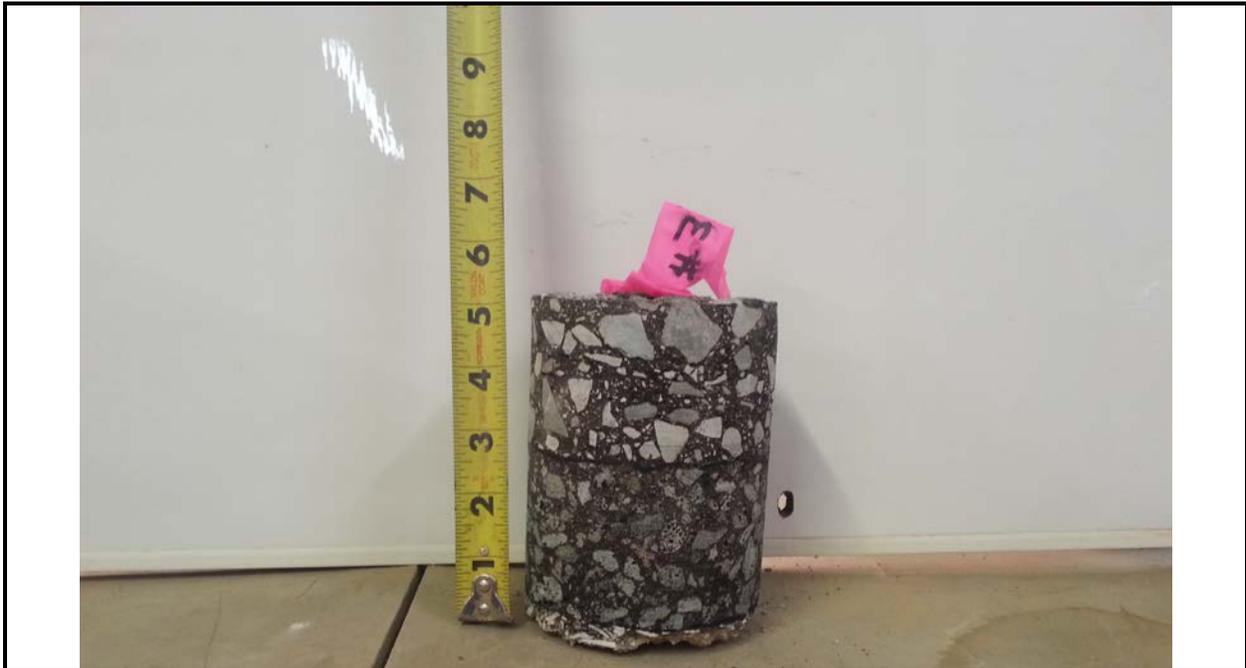
Pavement Core B-39.  
Approximately 3 layers of flexible pavement. Separation geotextile located 2.25" below pavement surface. No observed cracking or delamination.

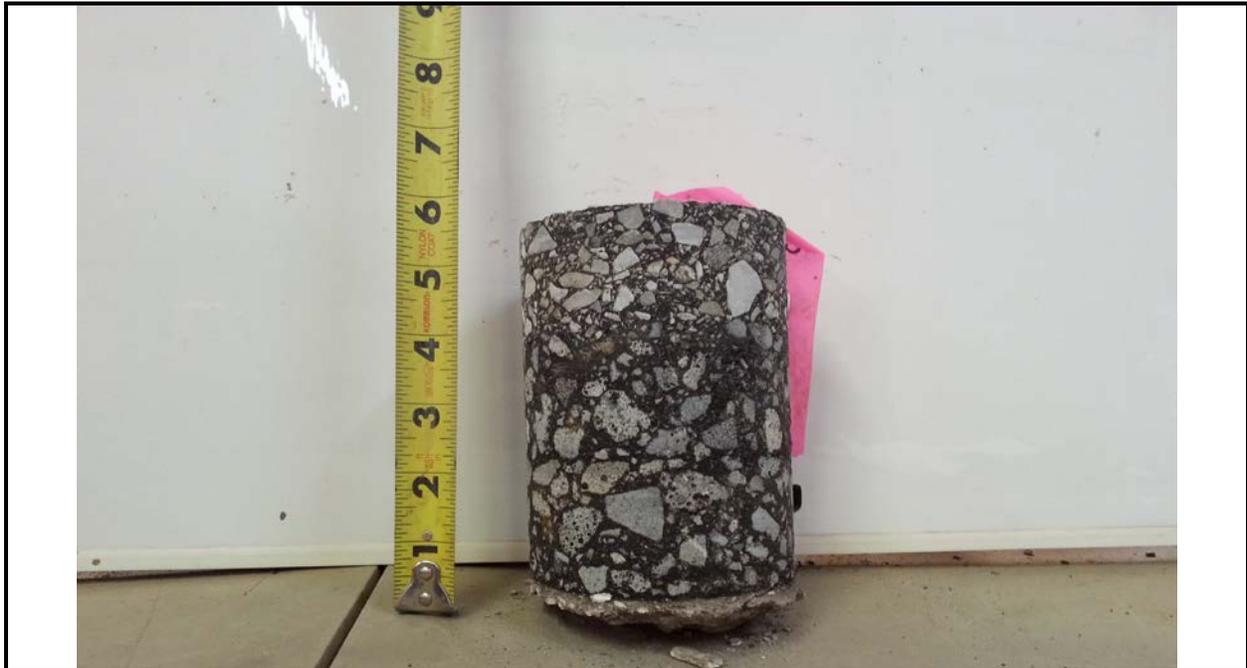
Pavement Core B-43.  
Approximately 3 layers of flexible pavement. Separation geotextile located 3.25" below pavement surface. No observed cracking or delamination.

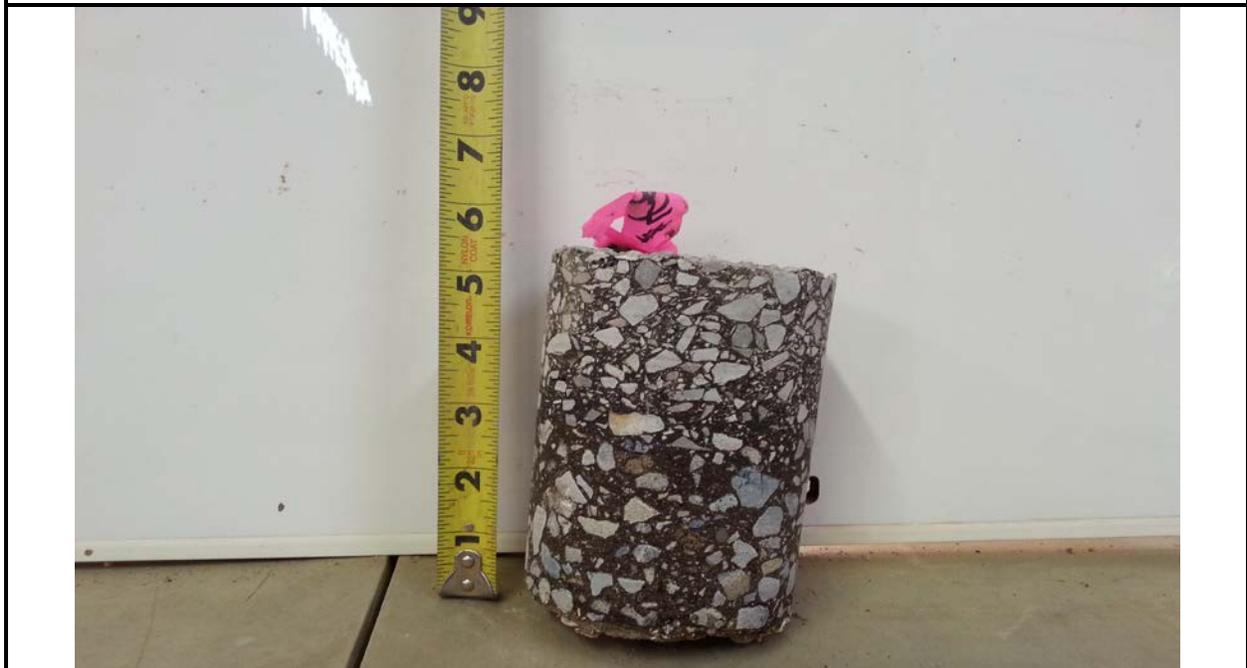
Pavement Core B-44.  
Approximately 3 layers of flexible pavement. No noticeable separation geotextile. No observed cracking or delamination.

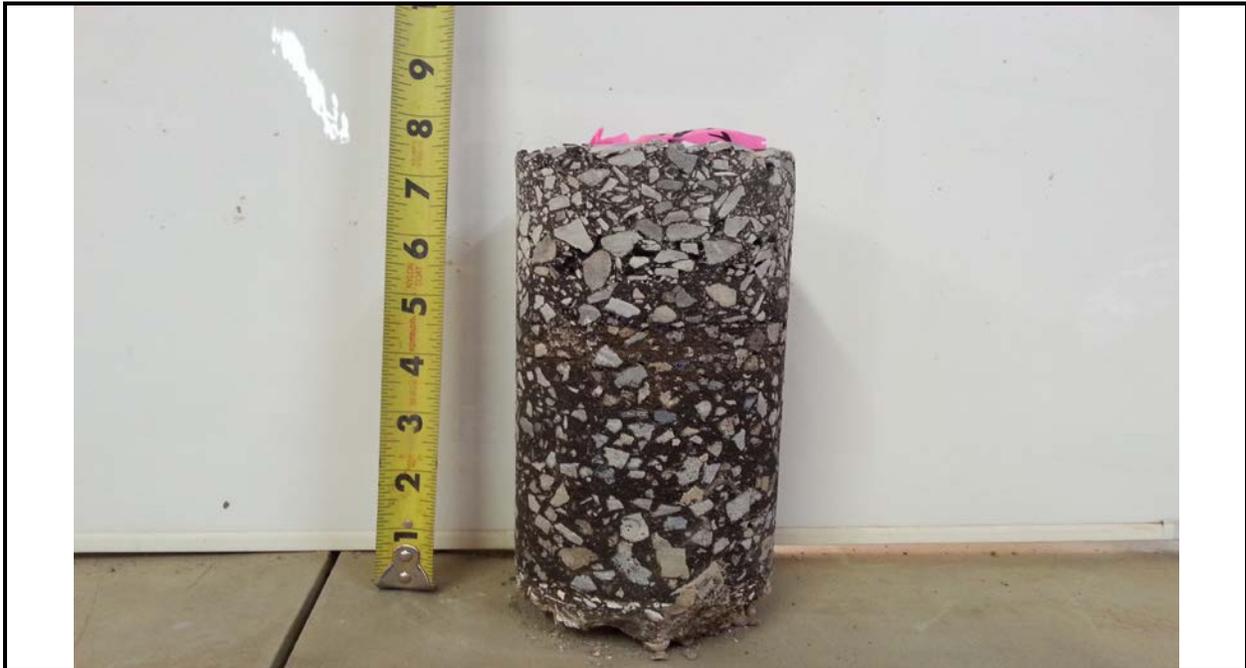
Pavement Core B-47  
Approximately 4 layers of flexible pavement. No noticeable separation geotextile. No observed cracking or delamination.

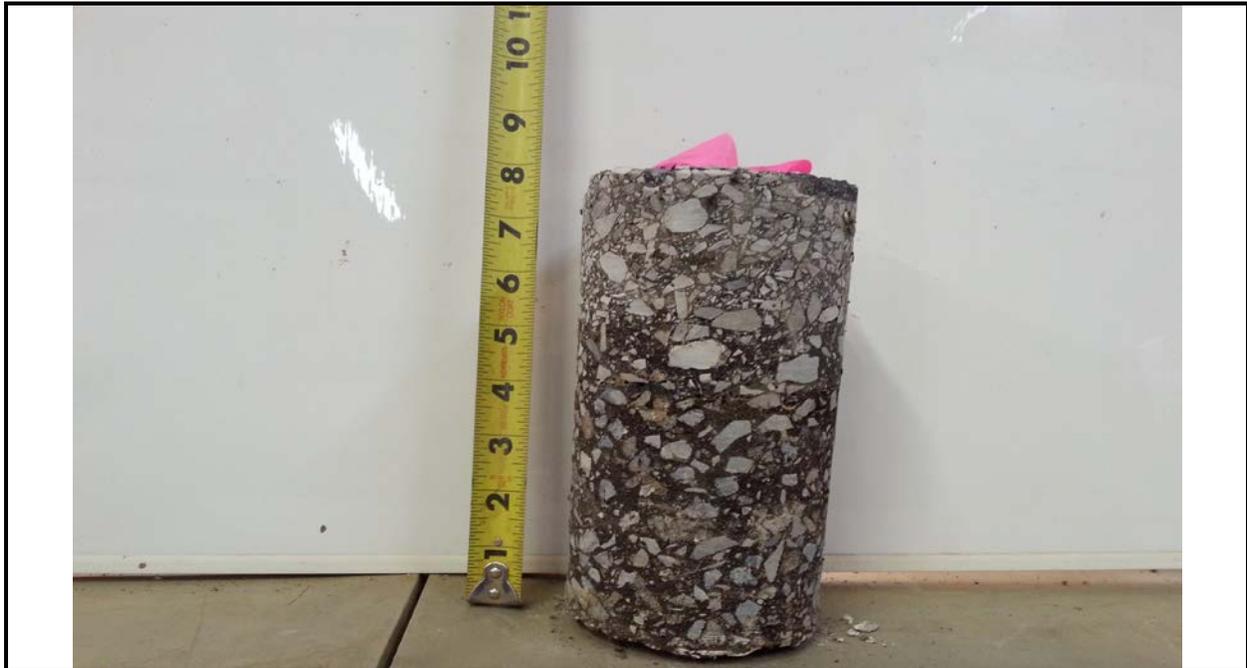
Pavement Core B-51.  
Approximately 4 layers of flexible pavement. No noticeable separation geotextile. Cracking observed beginning at pavement surface, extending down to 1/2" below pavement surface (Top-down Cracking). Cracking was observed in one location.

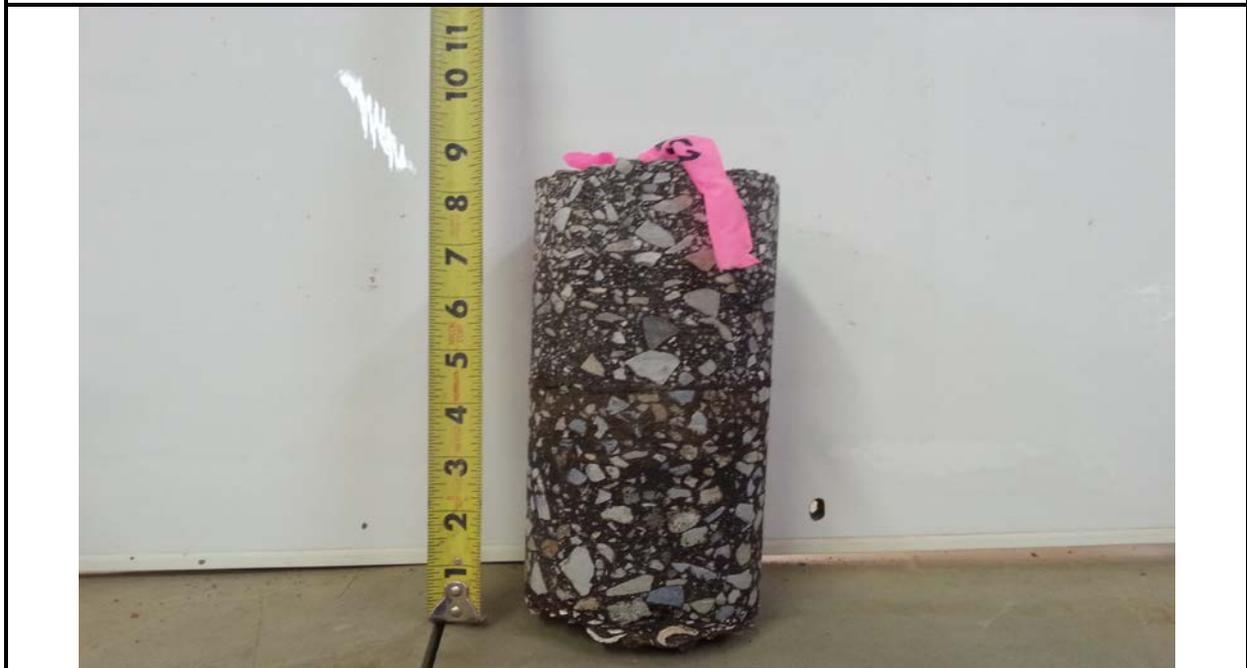
Pavement Core B-52.  
Approximately 4 layers of flexible pavement. Separation geotextile located at 3.75" below pavement surface. No observed cracking or delamination.

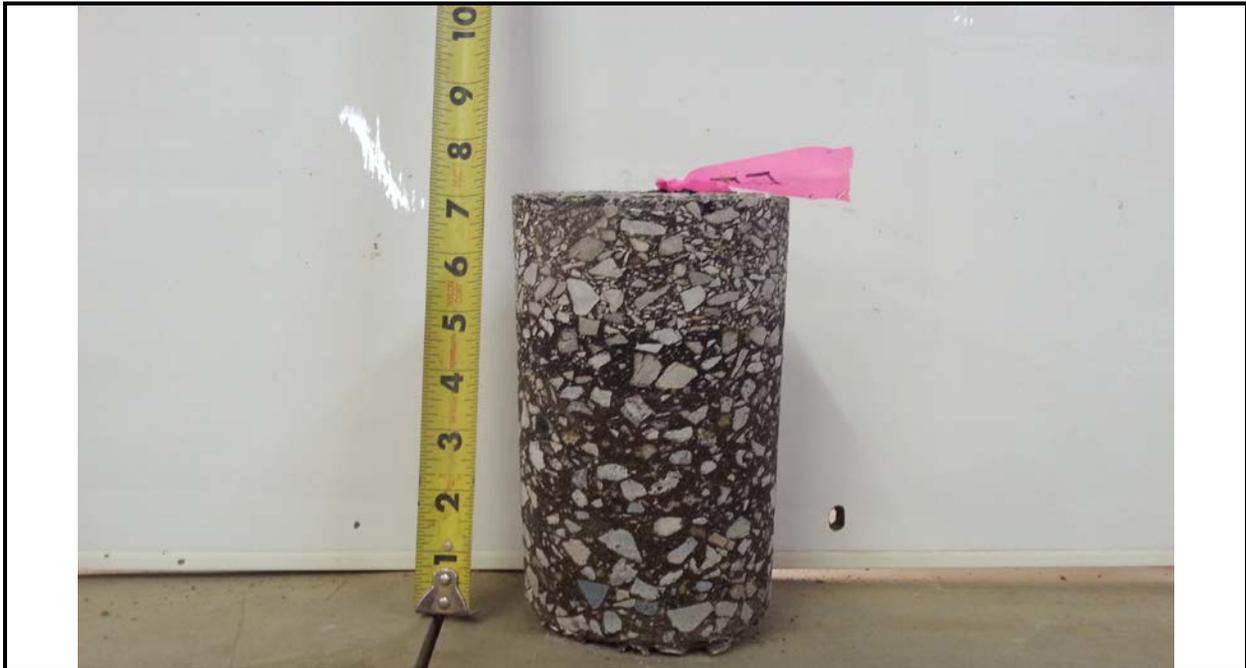
Pavement Core B-55.  
Approximately 4 layers of flexible pavement. No noticeable separation geotextile. No observed cracking or delamination.

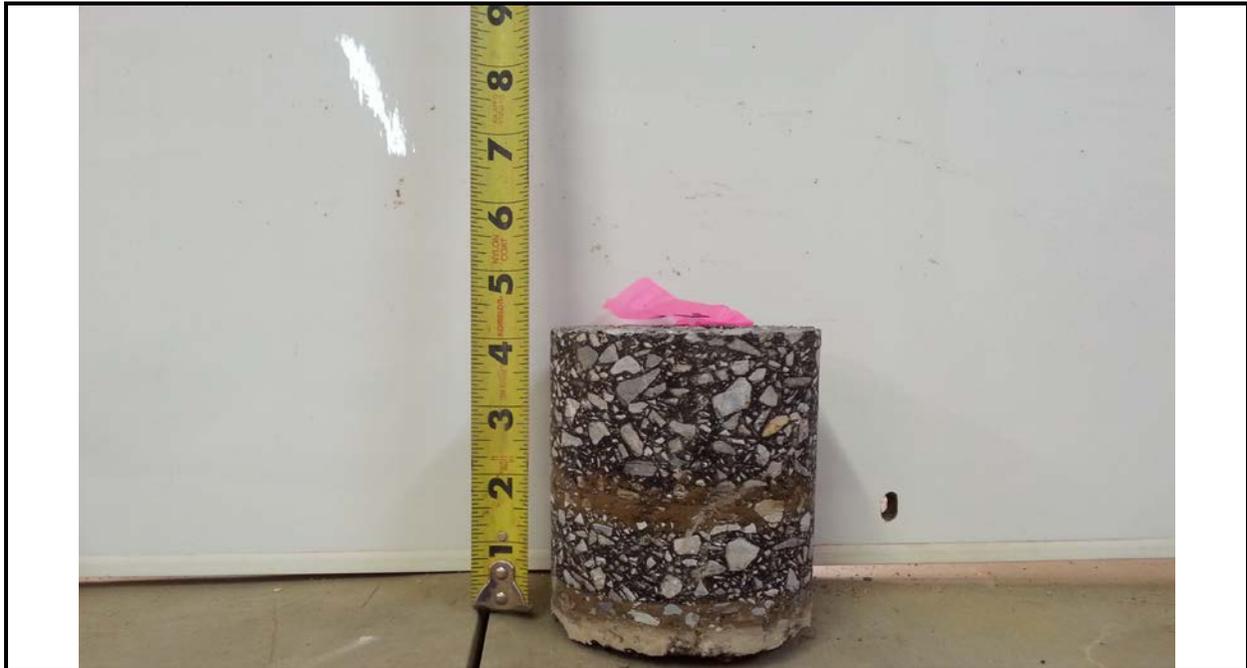
Pavement Core B-61.  
Approximately 2 layers of flexible pavement. No noticeable separation geotextile. No observed cracking or delamination.

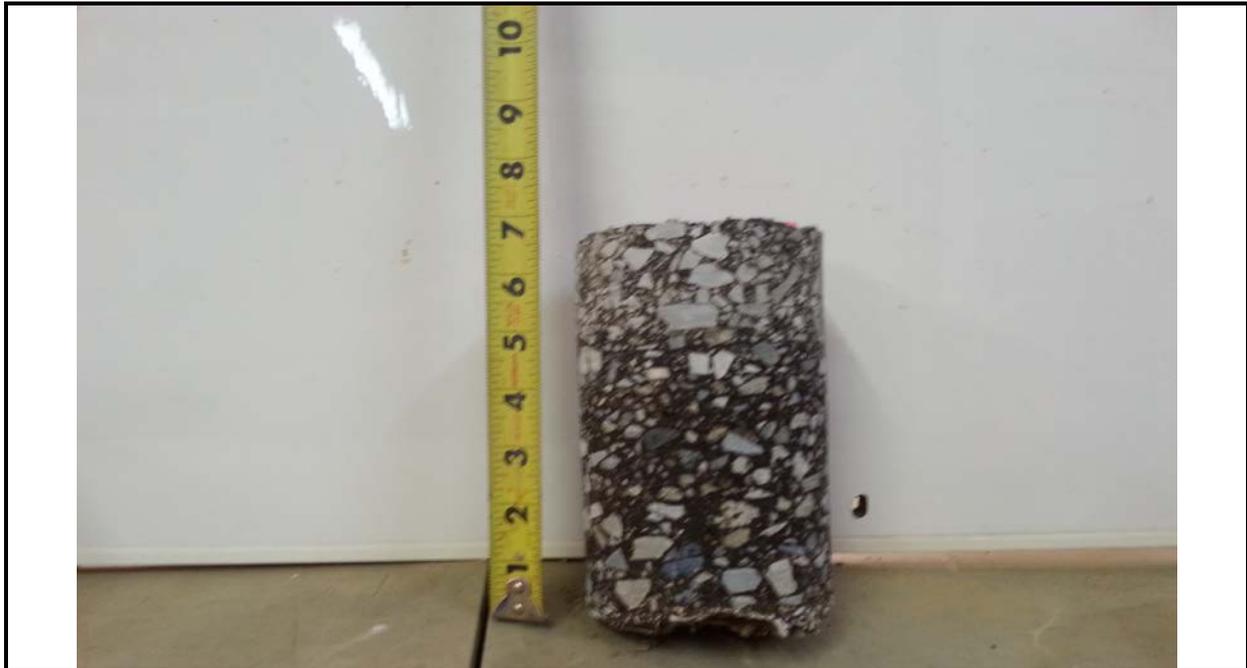
Pavement Core B-63.  
Approximately 4 layers of flexible pavement. No noticeable separation geotextile. No observed cracking or delamination.

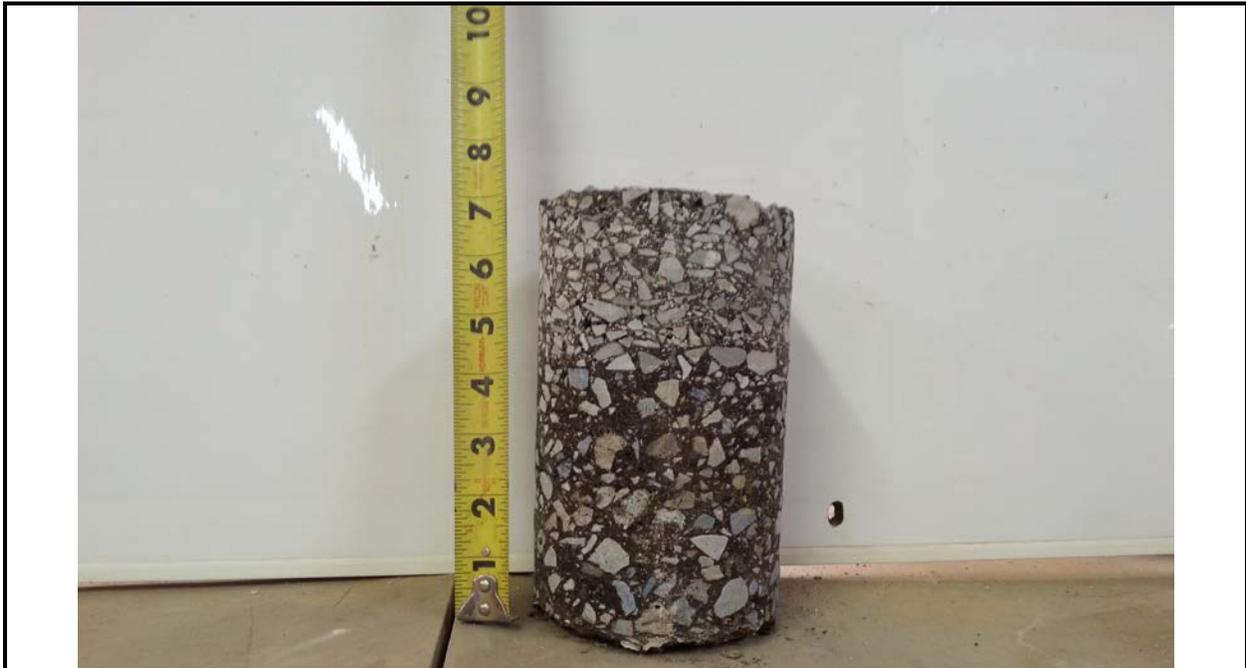
Pavement Core B-65.  
Approximately 4 layers of flexible pavement. No noticeable separation geotextile. Observed possible signs of future delamination 4.5" below pavement surface.

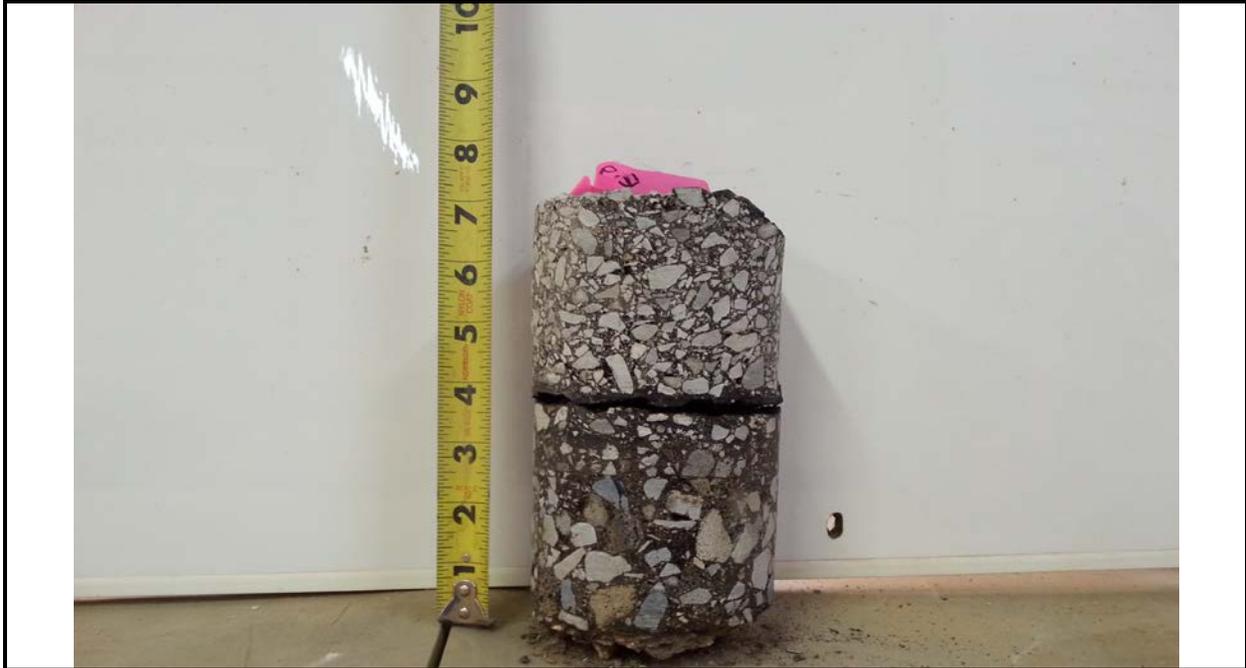
Pavement Core B-69.  
Approximately 4 layers of flexible pavement. Separation geotextile located 3" below pavement surface. Core delaminated directly below separation geotextile.

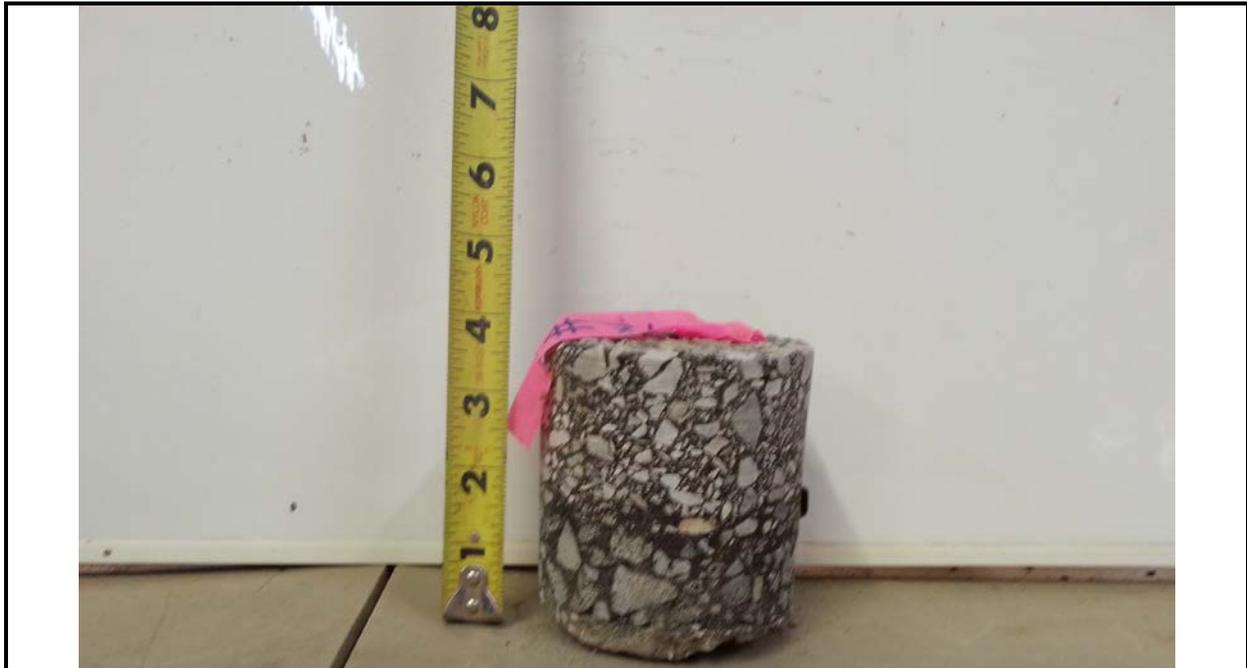
Pavement Core B-71.  
Approximately 2 layers of flexible pavement. No noticeable separation geotextile. No observed cracking or delamination.
