June 4, 2015  
**Revised June 5, 2015**

**Reference:** **Geotechnical Investigation – Pavement Cores**  
*REPAIR AIRFIELD/RUNWAY FORREST SHERMAN FIELD*  
 NAS Fort Pensacola, Florida  
 NAVFAC Project No.: ST 1112225  
 UES Project No.: 1730.1500048.0000  
 UES DOCS Report No.: 1235270

**REPAIR AIRFIELD/RUNWAY FORREST SHERMAN FIELD**

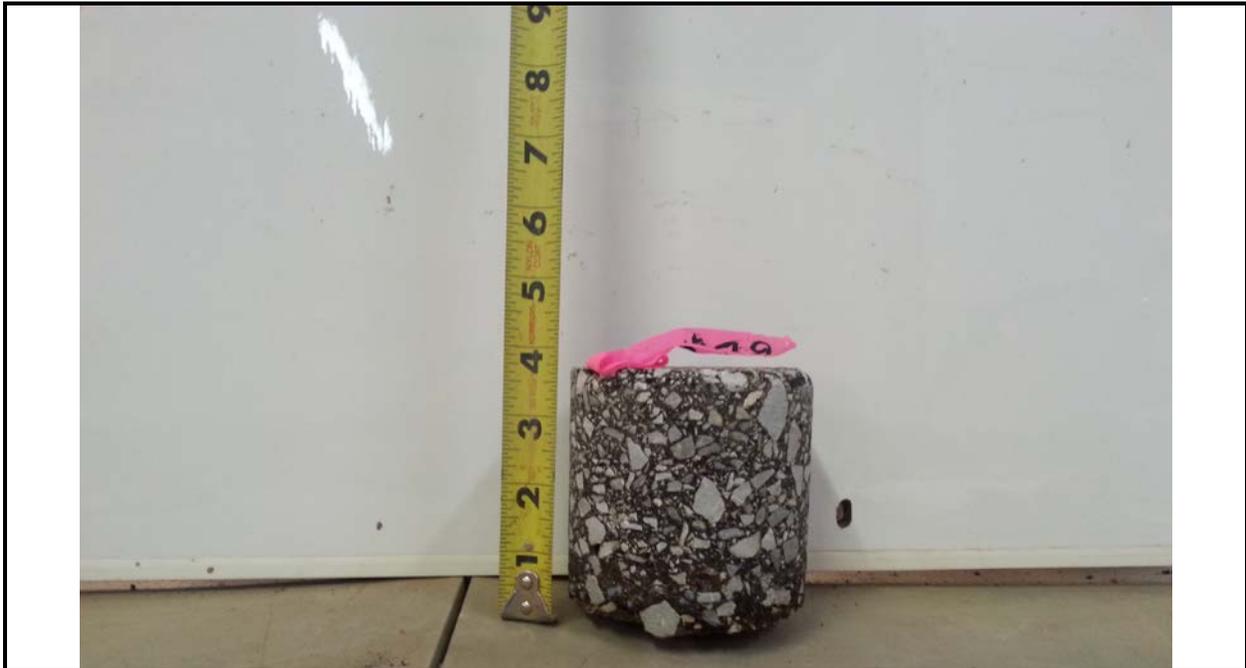
Pavement Core B-79.  
Approximately 2 layers of flexible pavement. No noticeable separation geotextile. No observed cracking or delamination.

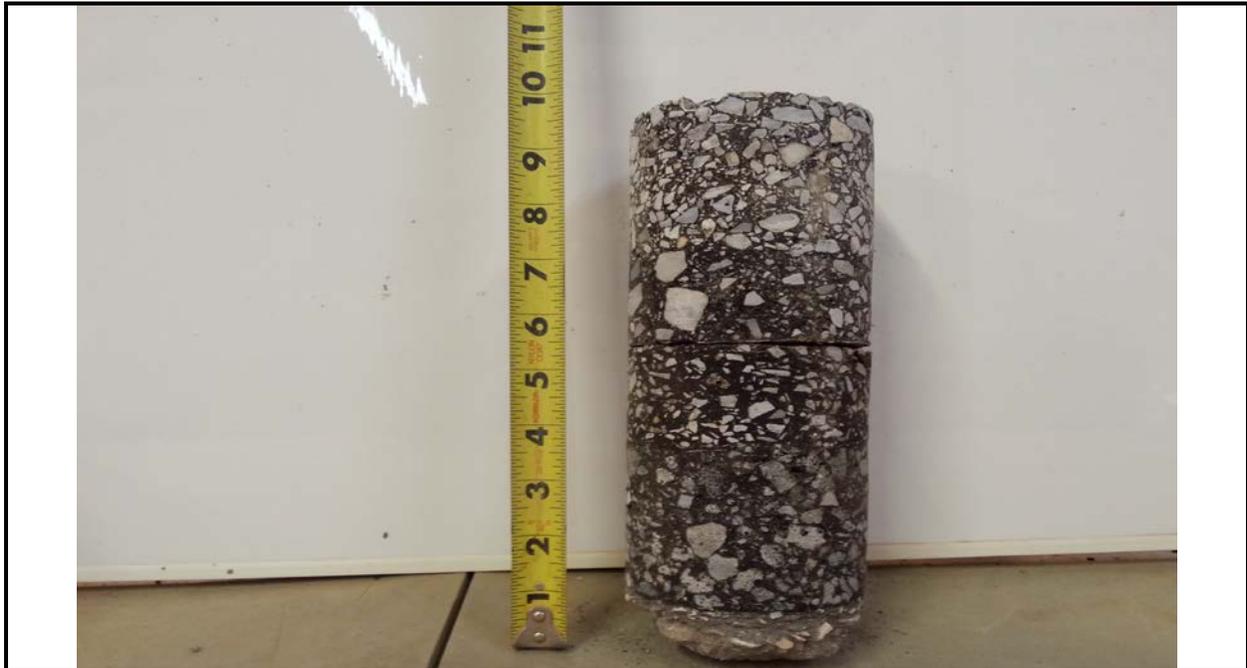
Pavement Core B-81.  
Approximately 5 layers of flexible pavement. No noticeable separation geotextile. Core delaminated 4.125" below the pavement surface.

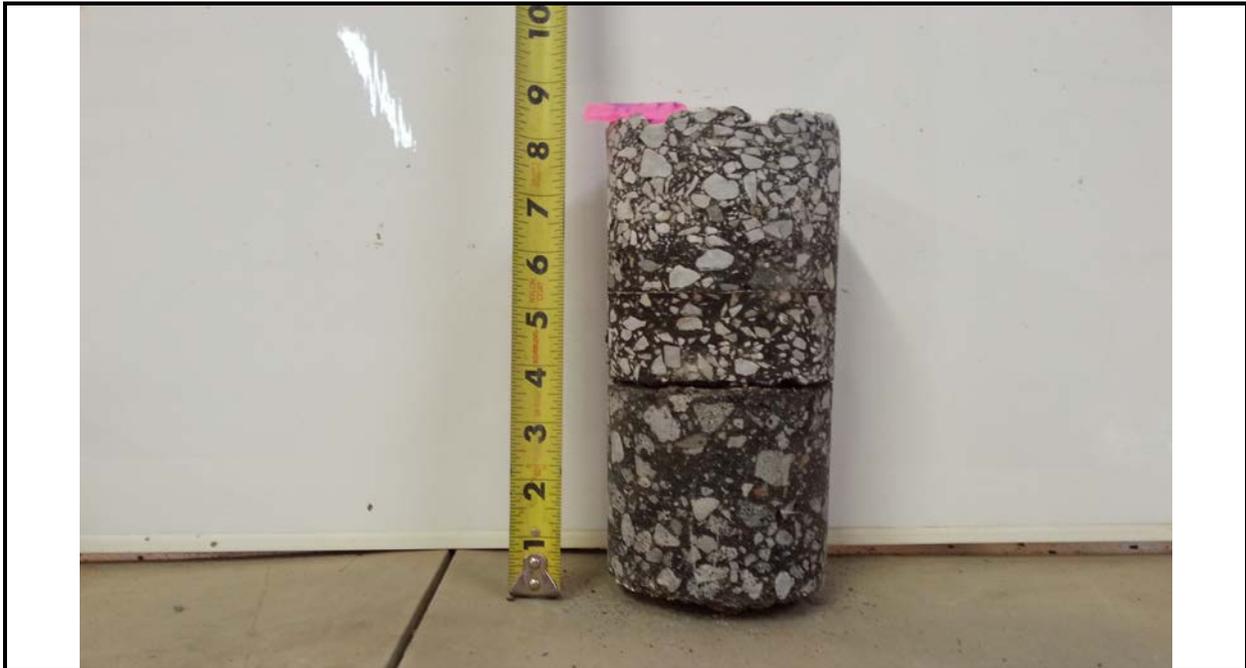
Pavement Core B-83.  
Approximately 5 layers of flexible pavement. No noticeable separation geotextile. Core delaminated 4.25" below the pavement surface.

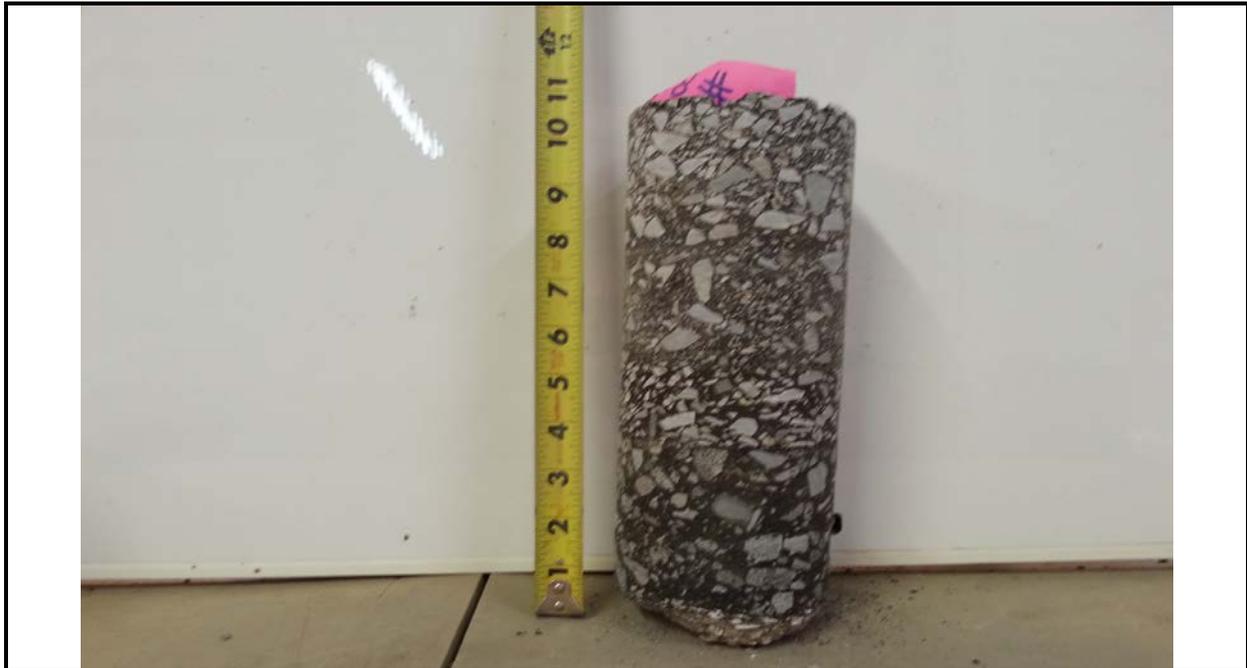
Pavement Core B-87.  
Approximately 6 layers of flexible pavement. No noticeable separation geotextile. No observed cracking or delamination.

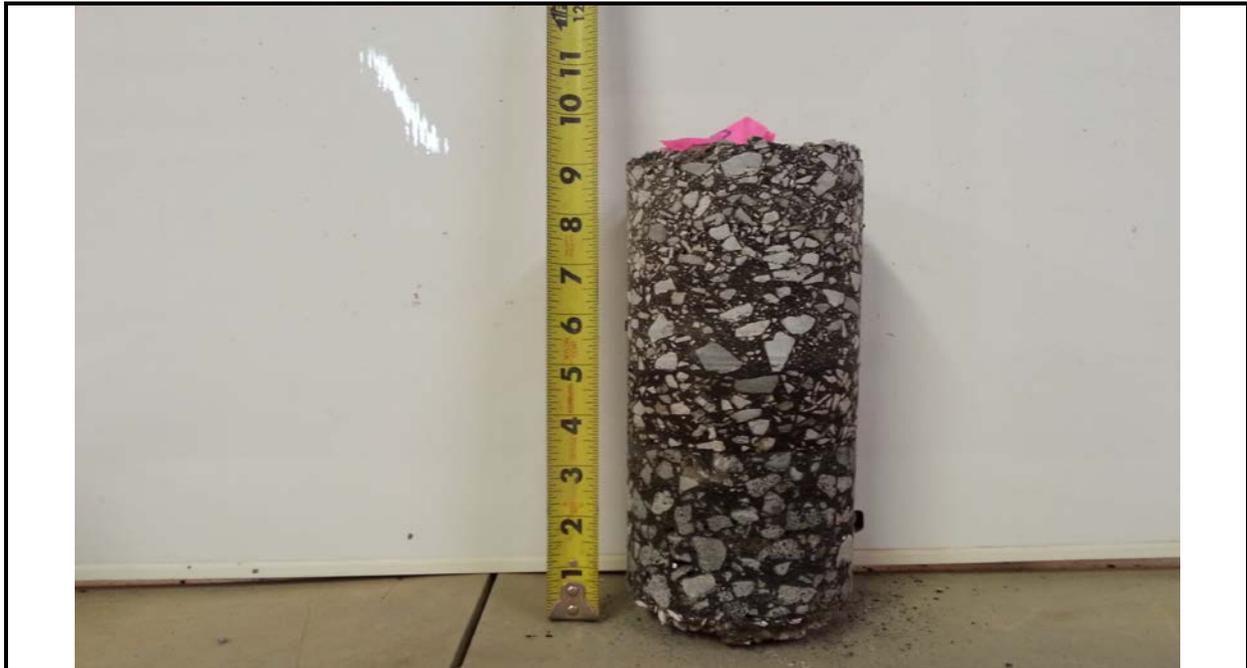
Pavement Core B-89.  
Approximately 5 layers of flexible pavement. Separation geotextile located 4.625" below pavement surface. No observed cracking or delamination.

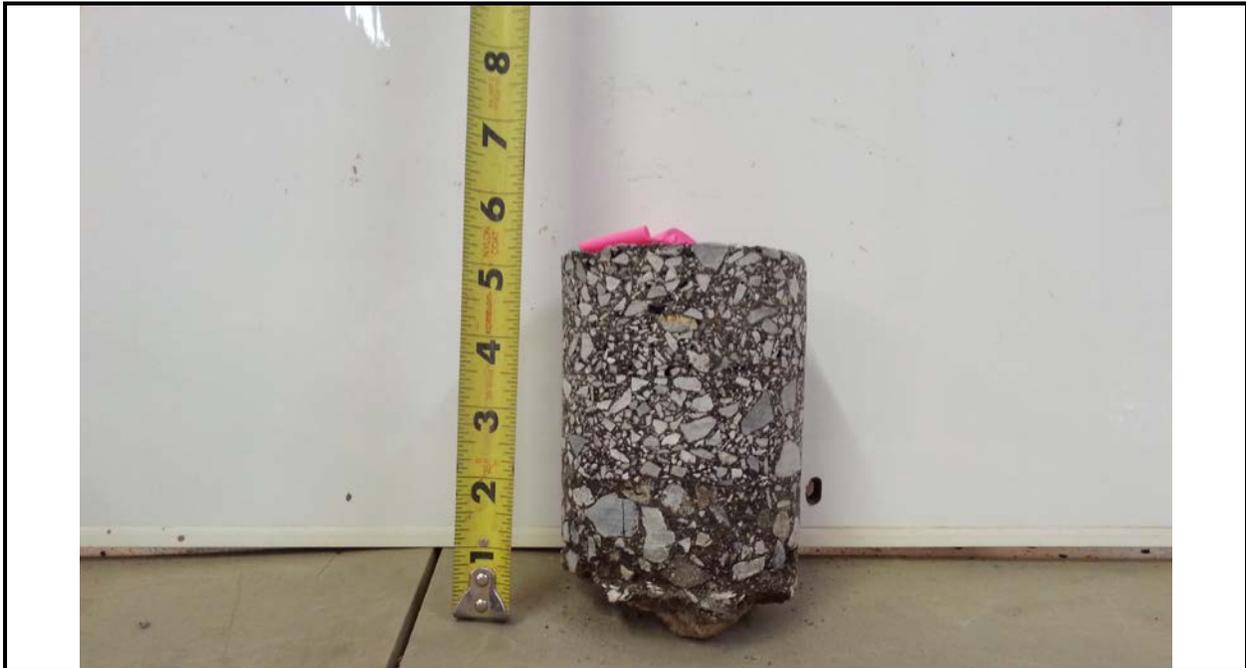
Pavement Core B-93.  
Approximately 3 layers of flexible pavement. No noticeable separation geotextile. No observed cracking or delamination.

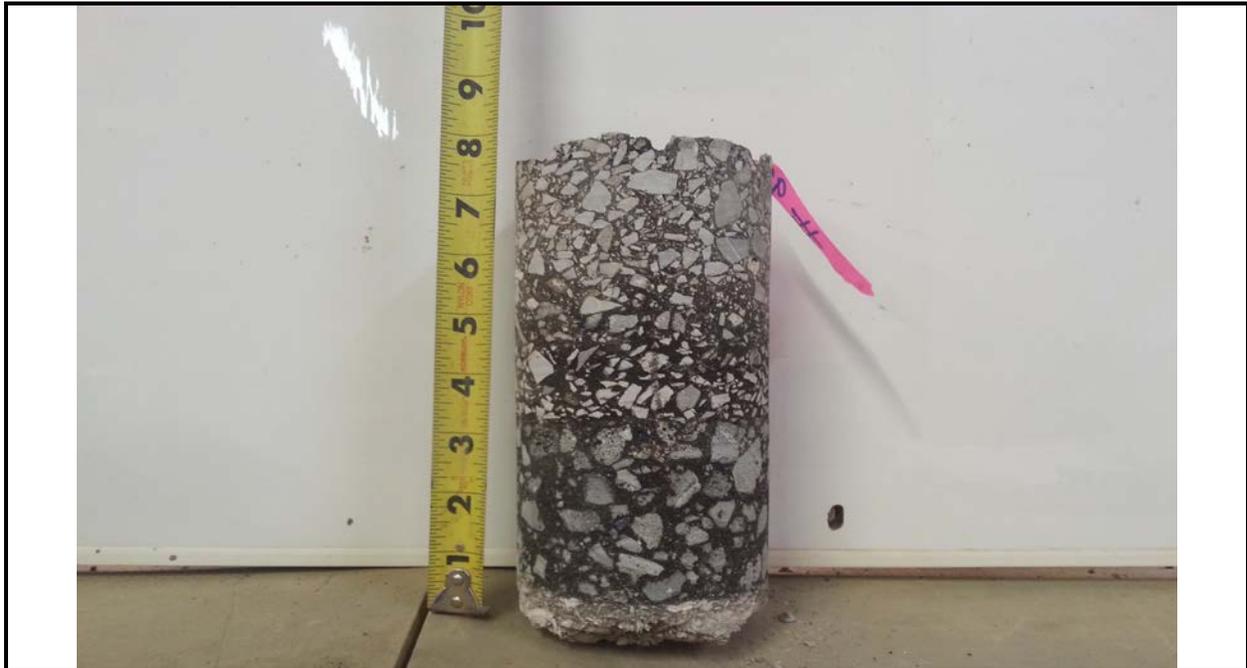
Pavement Core B-95.  
Approximately 5 layers of flexible pavement. No noticeable separation geotextile. No observed cracking or delamination.

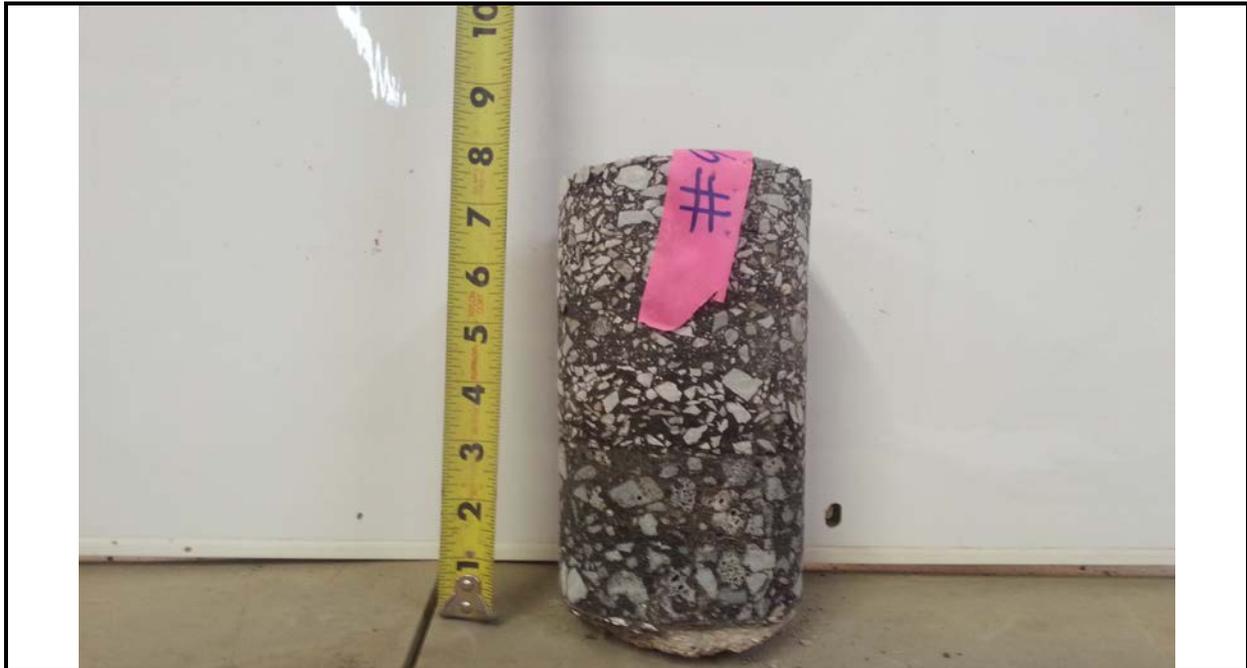
Pavement Core B-97.  
Approximately 5 layers of flexible pavement. No noticeable separation geotextile. Cracking observed beginning at pavement surface, extending down 0.25" below pavement surface (Top-down Cracking).

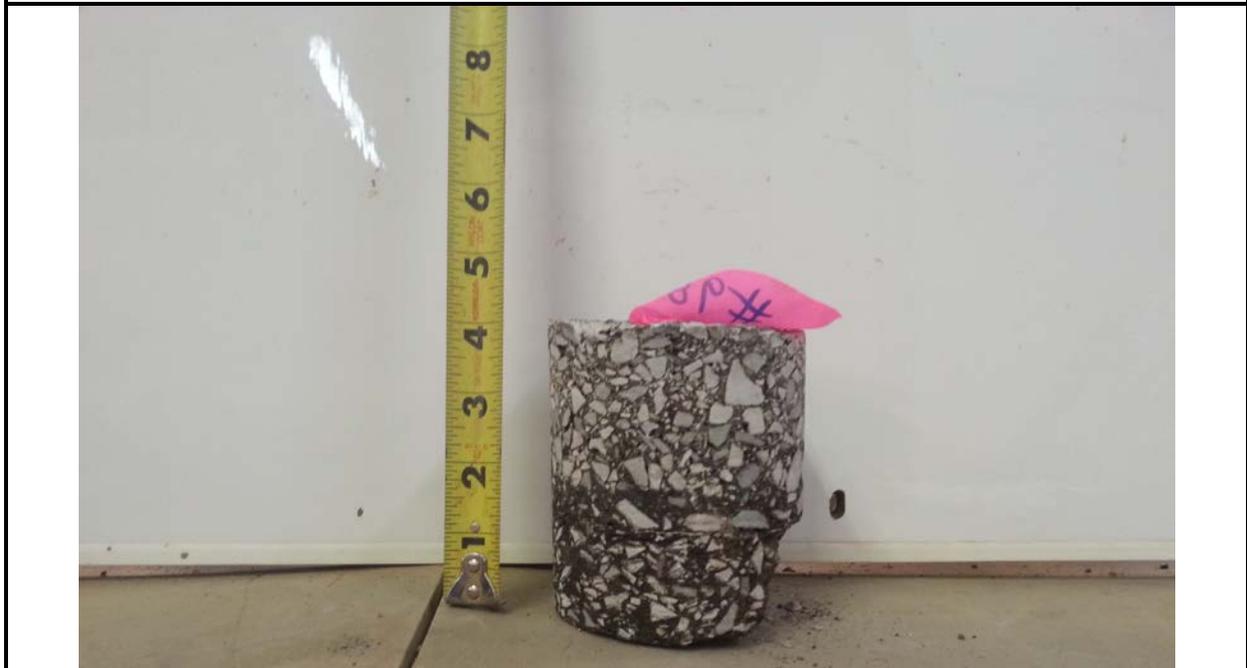
Pavement Core B-98.  
Approximately 3 layers of flexible pavement. No noticeable separation geotextile. Mechanical break during coring extraction. Full depth of asphalt was measured to be 7.5" at this location.

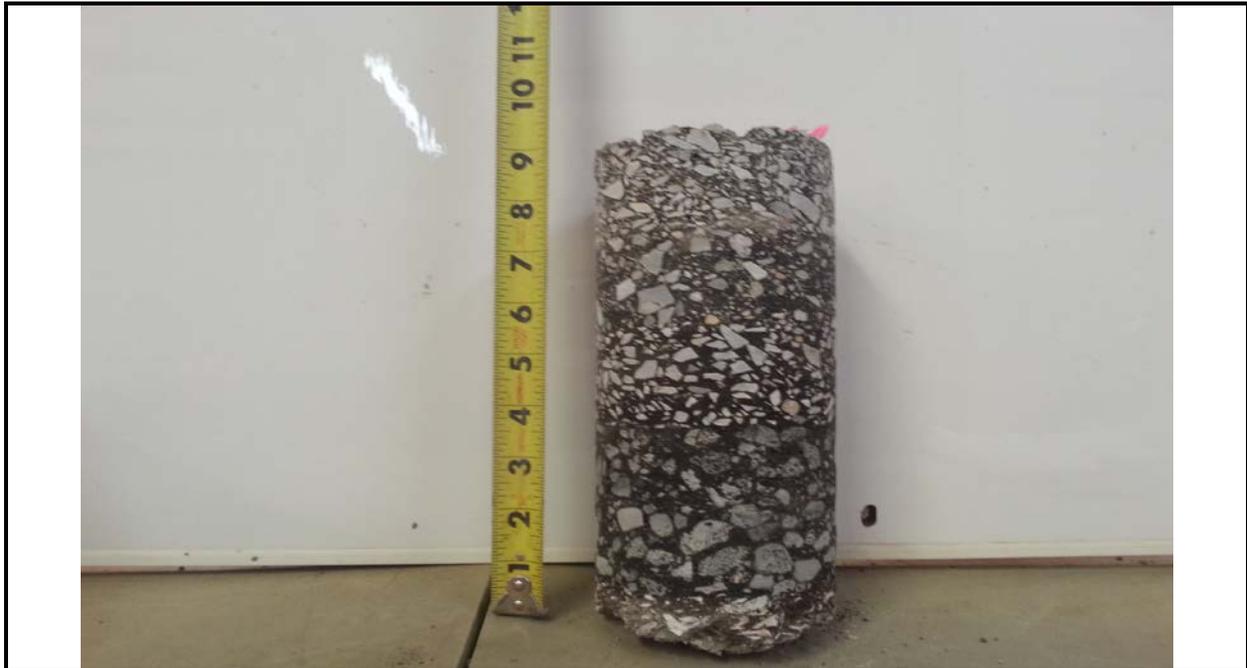
Pavement Core B-99.  
Approximately 5 layers of flexible pavement. No noticeable separation geotextile. No observed cracking or delamination.

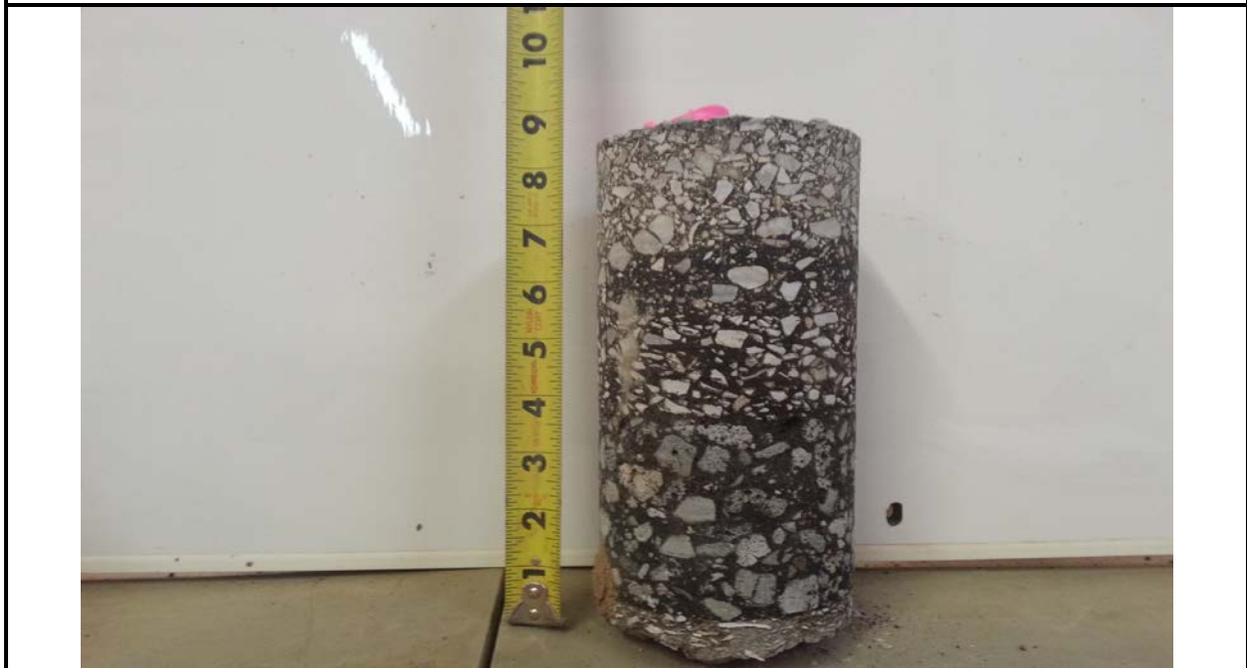
Pavement Core B-100.  
Approximately 5 layers of flexible pavement. No noticeable separation geotextile. No observed cracking or delamination.

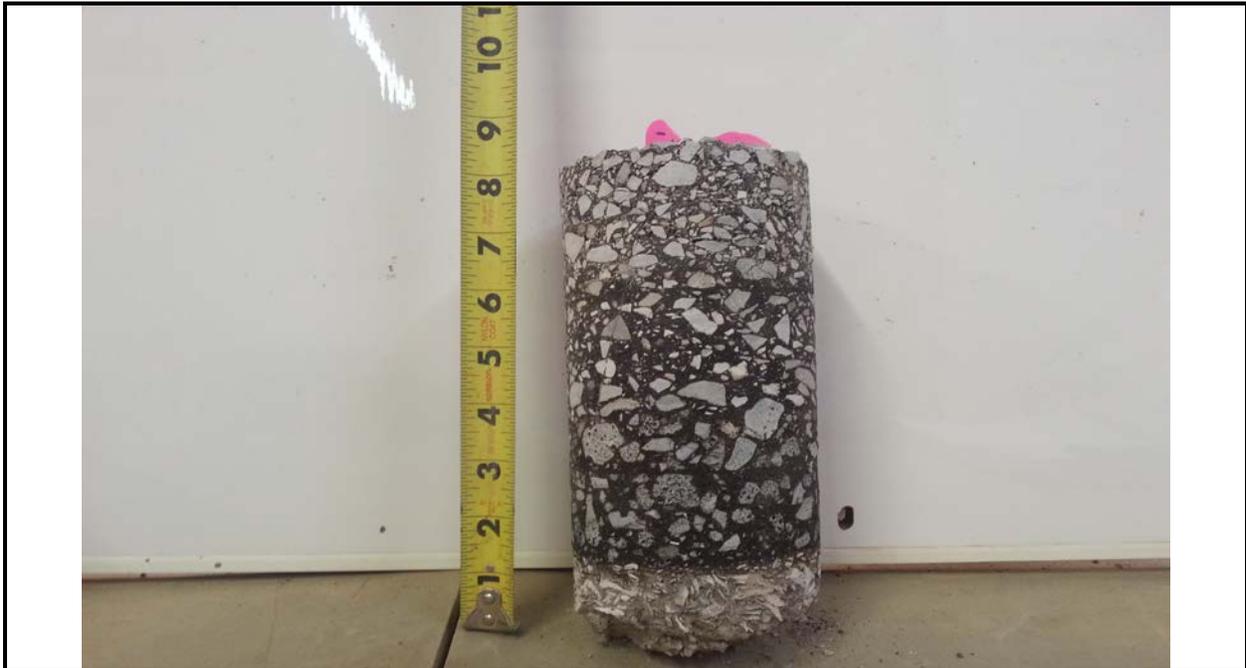
Pavement Core B-101.  
Approximately 5 layers of flexible pavement. No noticeable separation geotextile. No observed cracking or delamination.

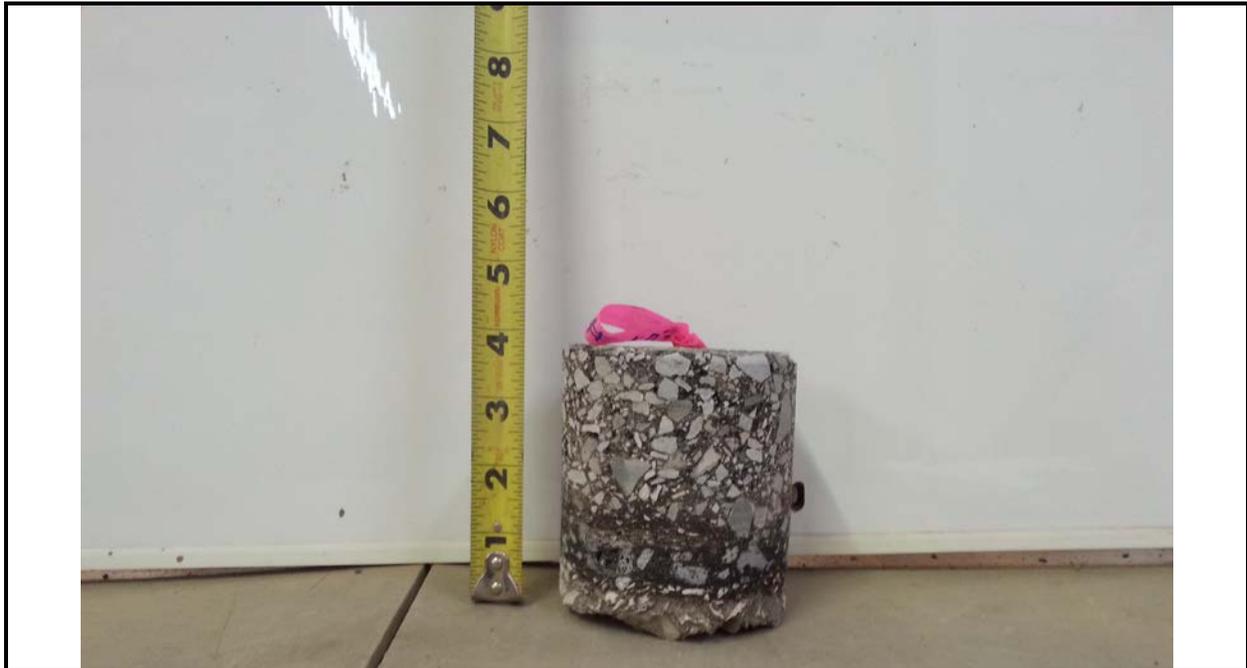
Pavement Core B-103.  
Approximately 3 layers of flexible pavement. No noticeable separation geotextile. No observed cracking or delamination.

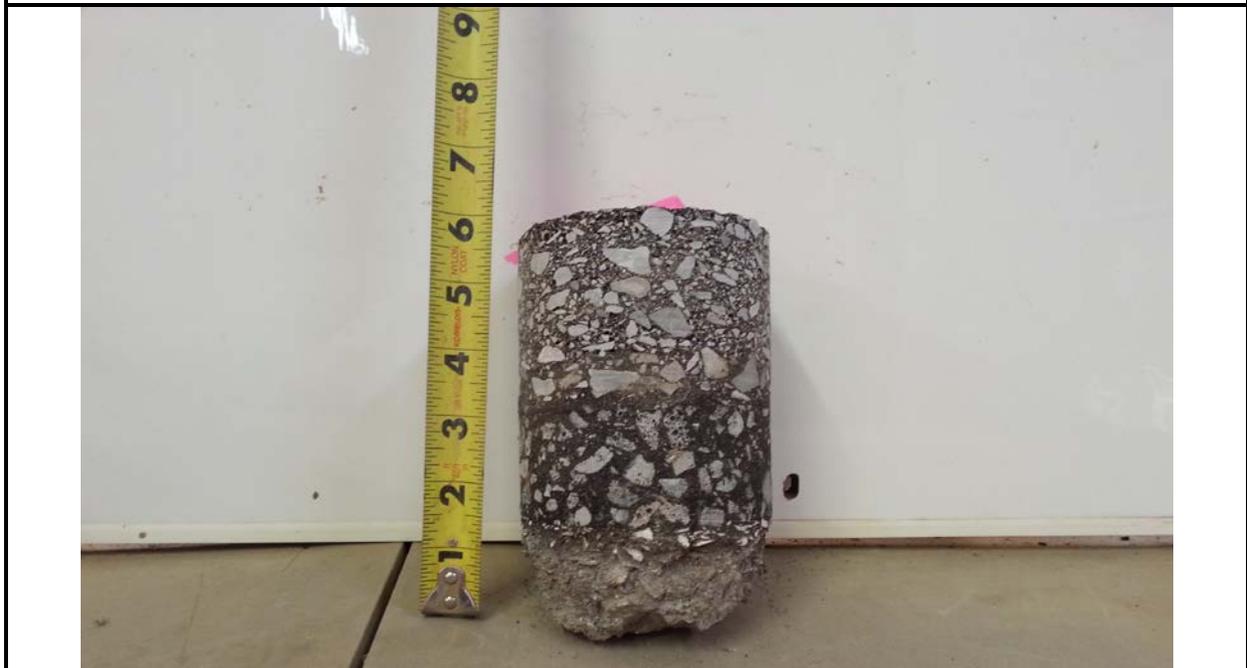
Pavement Core B-104.  
Approximately 3 layers of flexible pavement. No noticeable separation geotextile. No observed cracking or delamination.

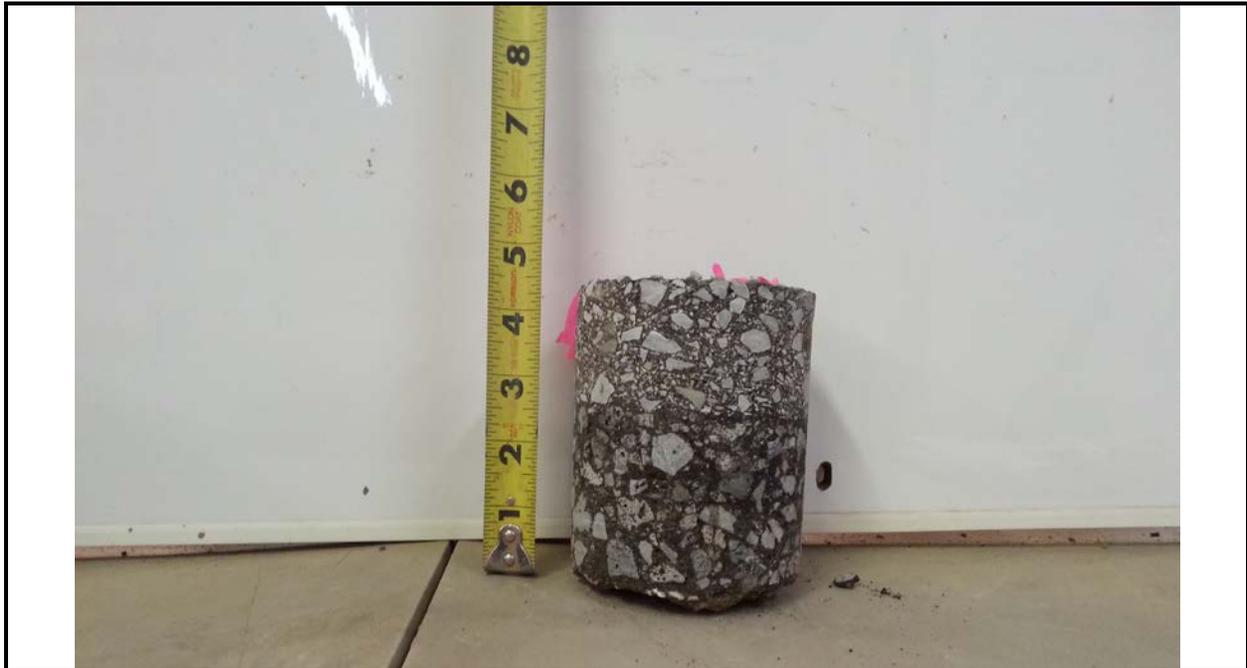
Pavement Core B-109.  
Approximately 3 layers of flexible pavement. No noticeable separation geotextile. Cracking observed beginning 2" below pavement surface, extending down to base of pavement core (Bottom-up Cracking). Cracking observed in two locations.

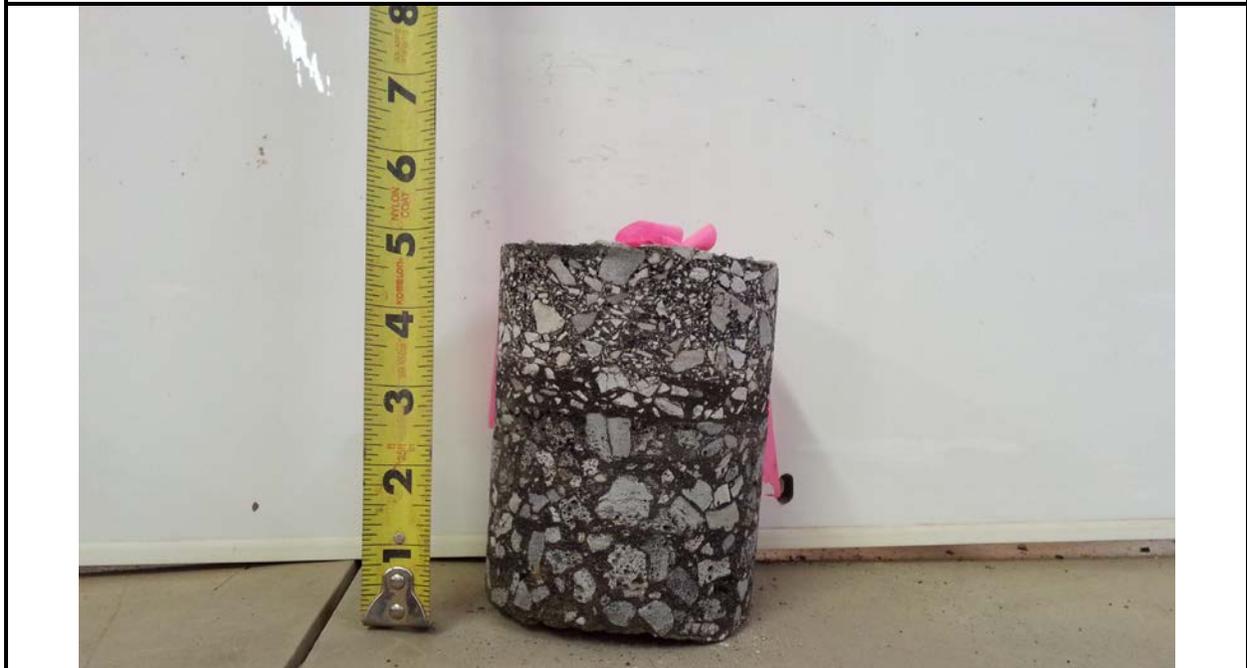
Pavement Core B-110.  
Approximately 4 layers of flexible pavement. No noticeable separation geotextile. No observed cracking or delamination.

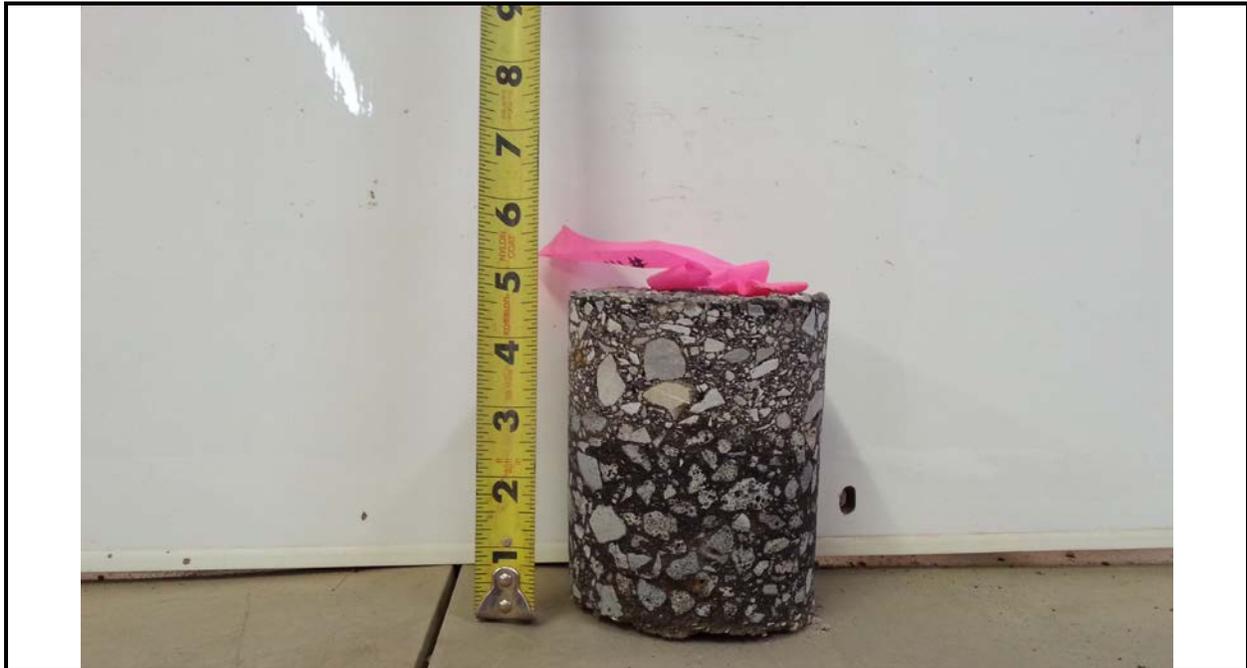
Pavement Core B-111.  
Approximately 3 layers of flexible pavement. No noticeable separation geotextile. No observed cracking or delamination.

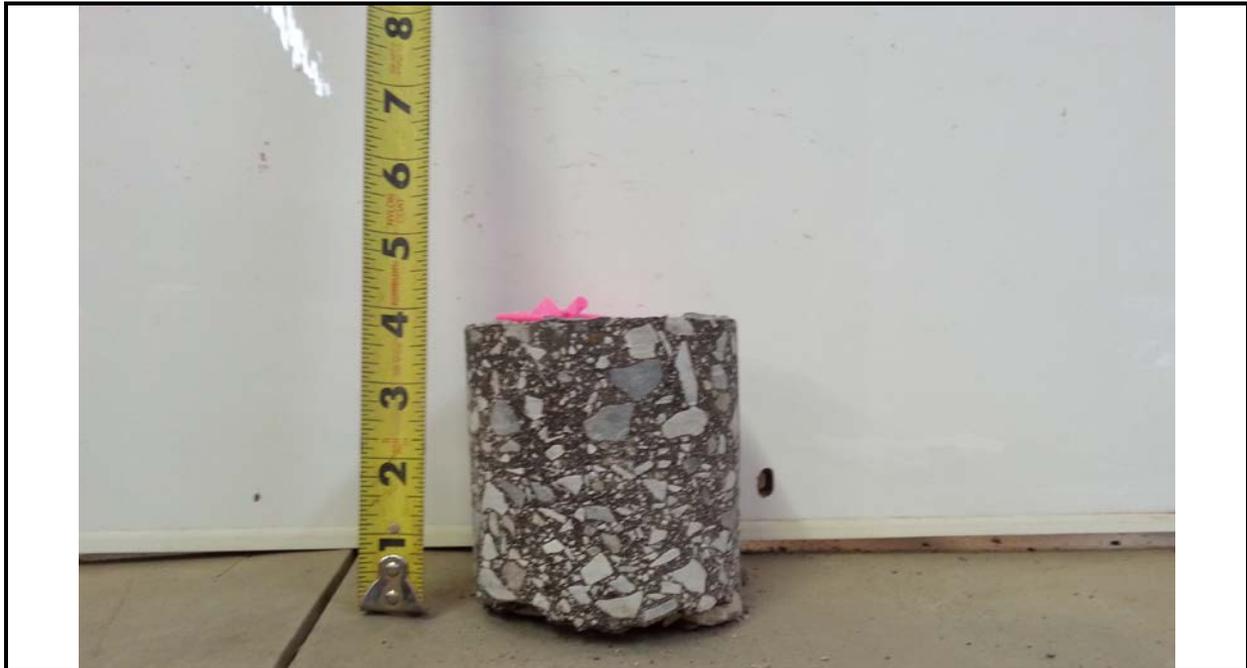
Pavement Core B-113.  
Approximately 2 layers of flexible pavement. No noticeable separation geotextile. No observed cracking or delamination.

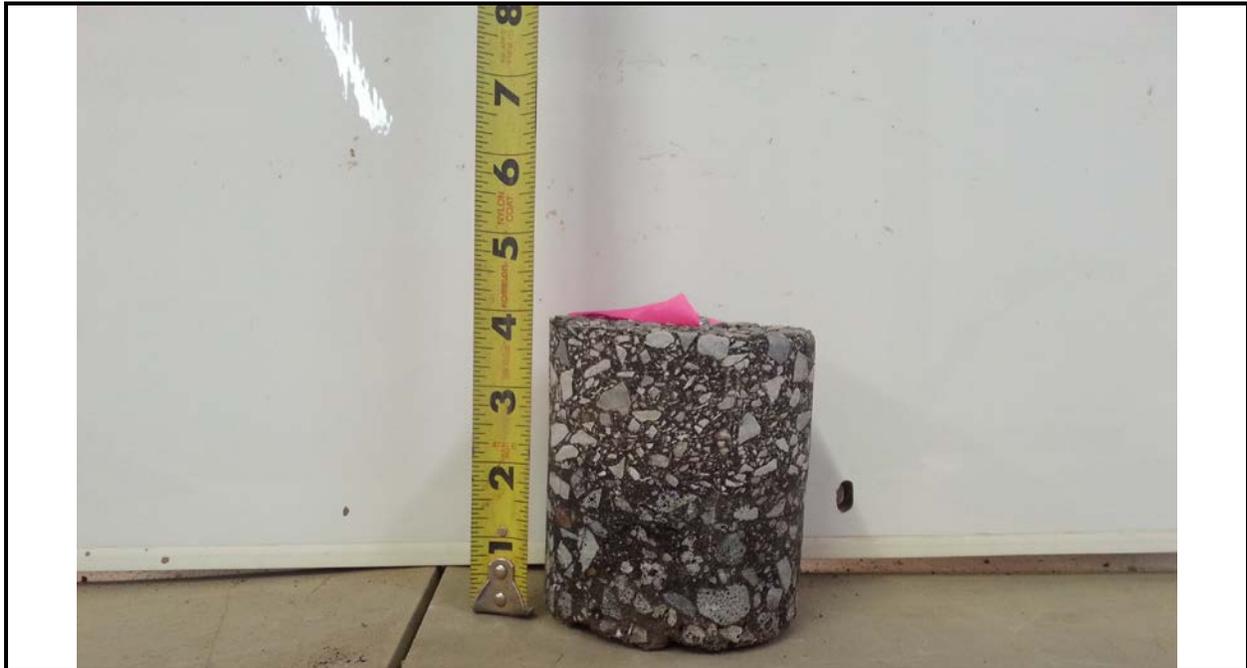
Pavement Core B-117.  
Approximately 3 layers of flexible pavement. No noticeable separation geotextile. No observed cracking or delamination.

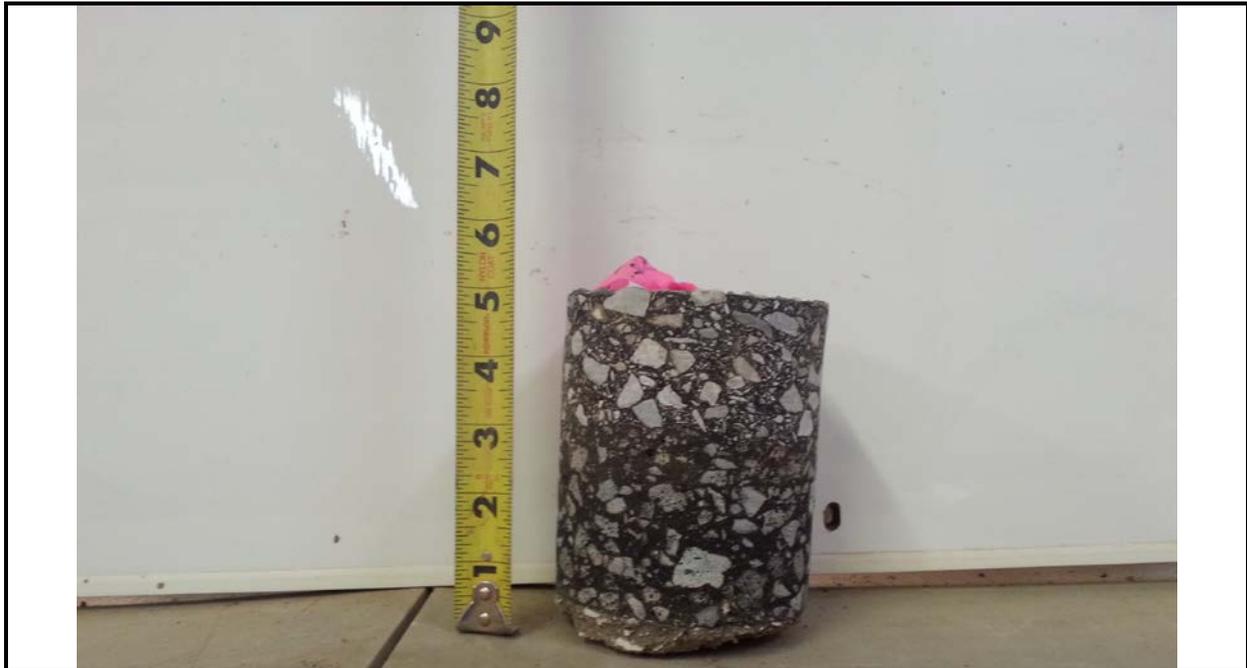
Pavement Core B-119.  
Approximately 3 layers of flexible pavement. No noticeable separation geotextile. No observed cracking or delamination.

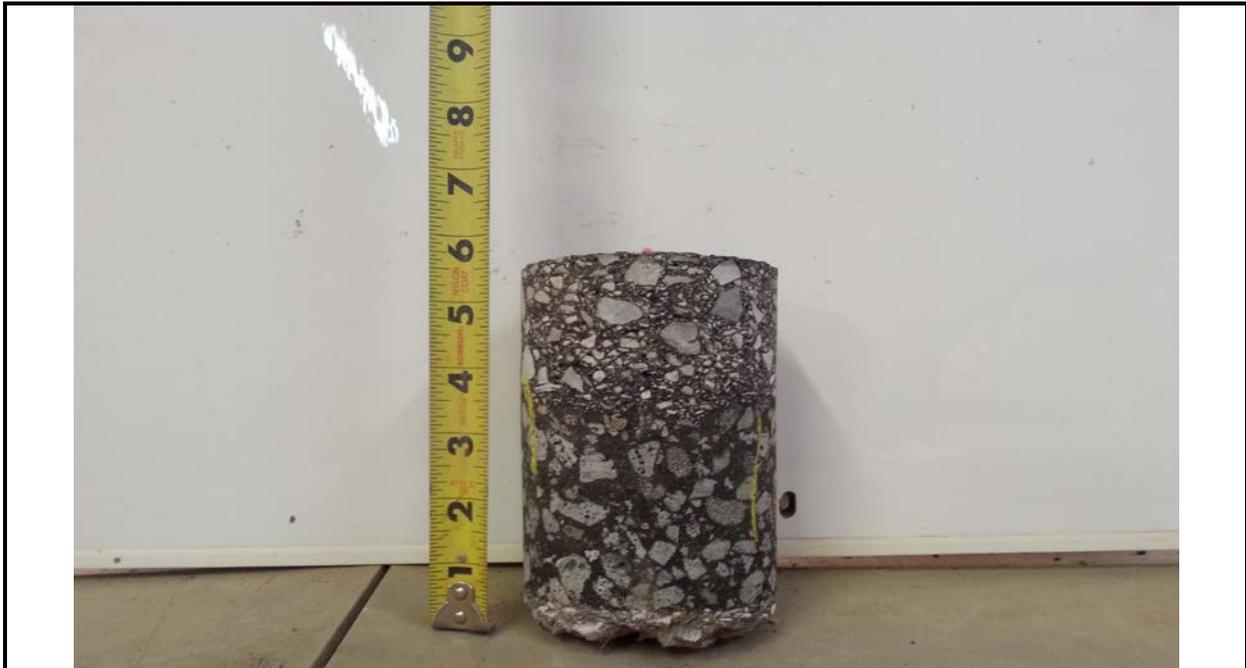
Pavement Core B-121.  
Approximately 3 layers of flexible pavement. No noticeable separation geotextile. No observed cracking or delamination.

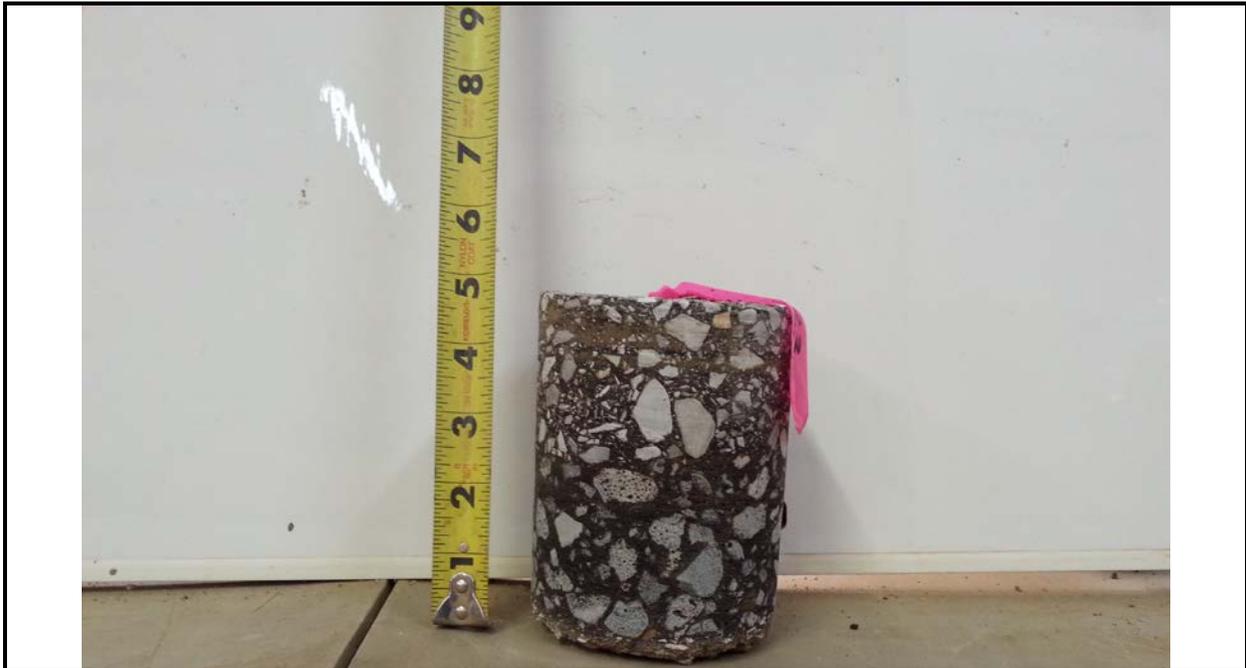
Pavement Core B-123.  
Approximately 4 layers of flexible pavement. No noticeable separation geotextile. No observed cracking or delamination.

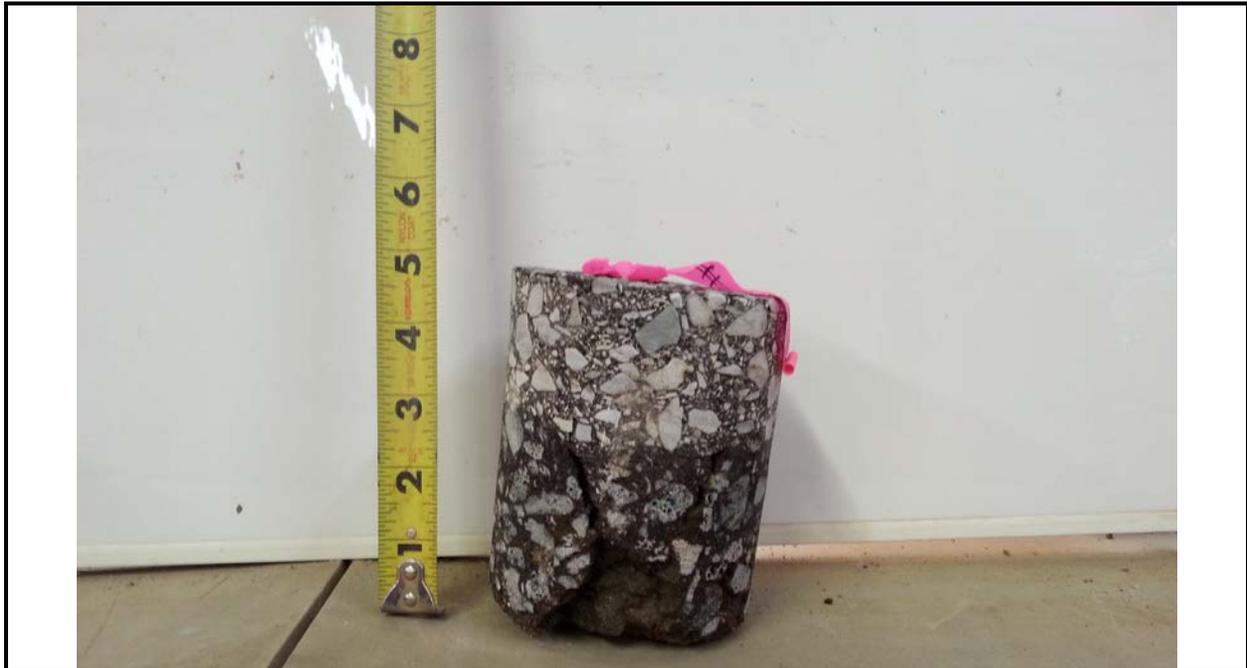
Pavement Core B-127.  
Approximately 4 layers of flexible pavement. No noticeable separation geotextile. No observed cracking or delamination.

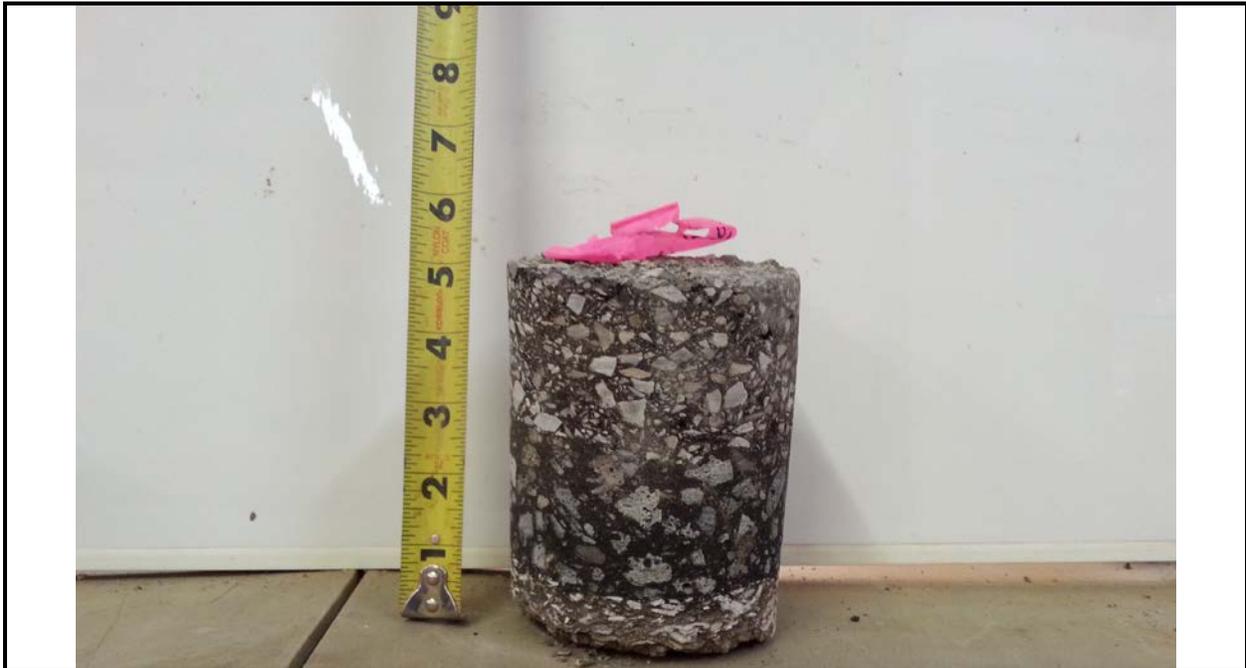
Pavement Core B-129.  
Approximately 4 layers of flexible pavement. No noticeable separation geotextile. No observed cracking or delamination.

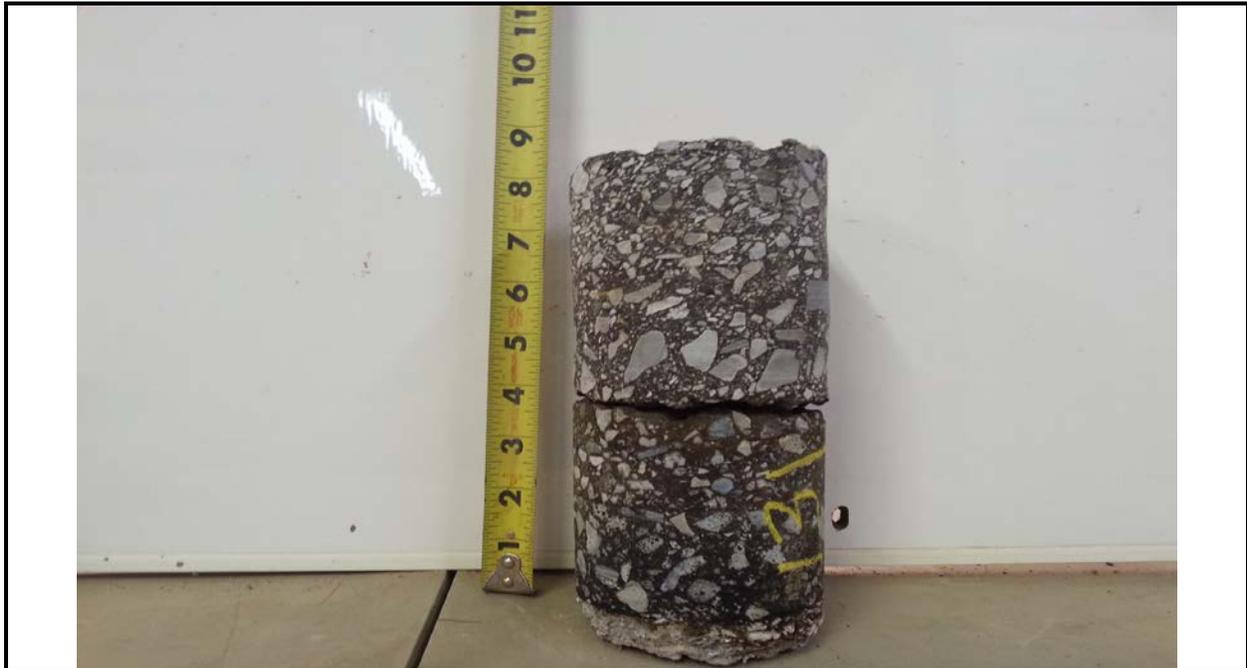
Pavement Core B-131.  
Approximately 4 layers of flexible pavement. No noticeable separation geotextile.  
Delamination observed 4" below pavement surface.

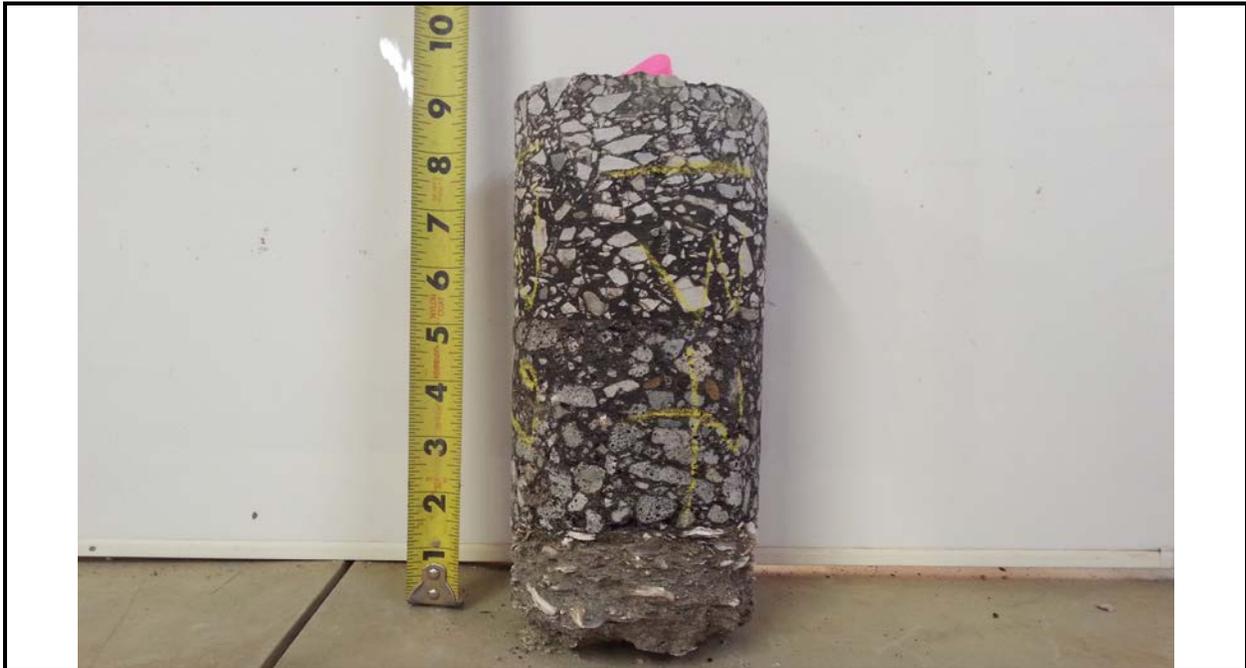
Pavement Core B-137.  
Approximately 4 layers of flexible pavement. Separation geotextile located 1 3/4" below pavement surface. No observed cracking or delamination.
