June 4, 2015  
**Revised June 5, 2015**

**Reference:** **Geotechnical Investigation – Pavement Cores**  
*REPAIR AIRFIELD/RUNWAY FORREST SHERMAN FIELD*  
 NAS Fort Pensacola, Florida  
 NAVFAC Project No.: ST 1112225  
 UES Project No.: 1730.1500048.0000  
 UES DOCS Report No.: 1235270

**REPAIR AIRFIELD/RUNWAY FORREST SHERMAN FIELD**

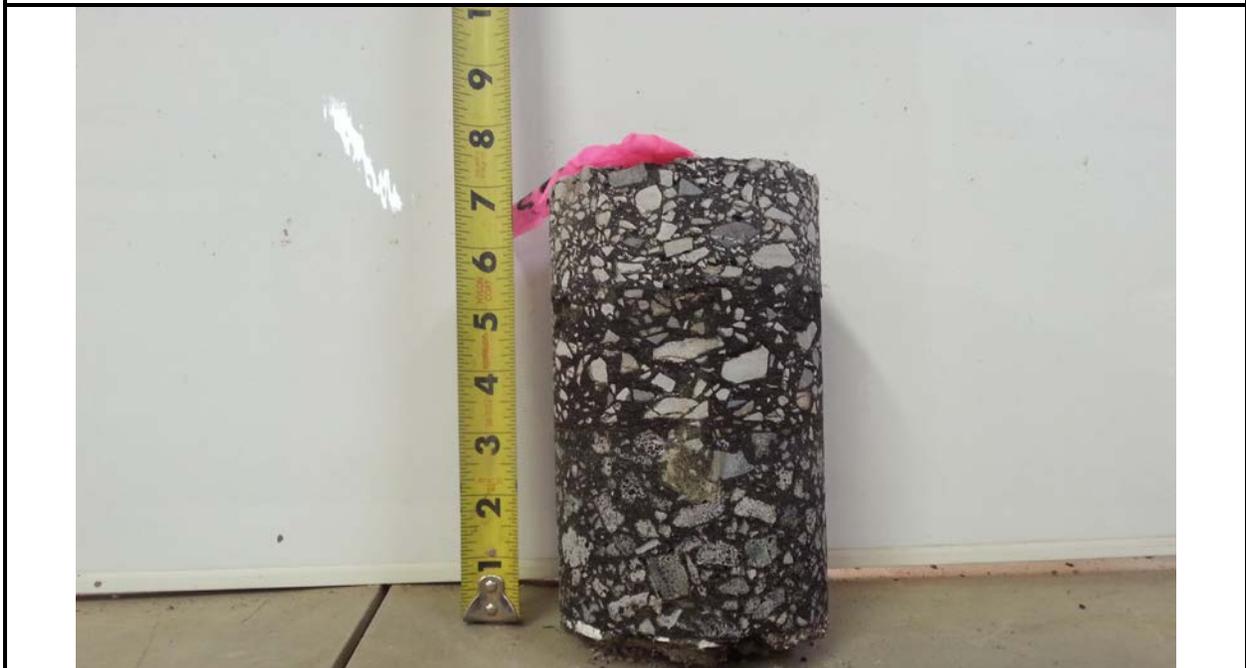
Pavement Core B-138.  
Approximately 4 layers of flexible pavement. Separation geotextile located 1 5/8" below pavement surface. No observed cracking or delamination.

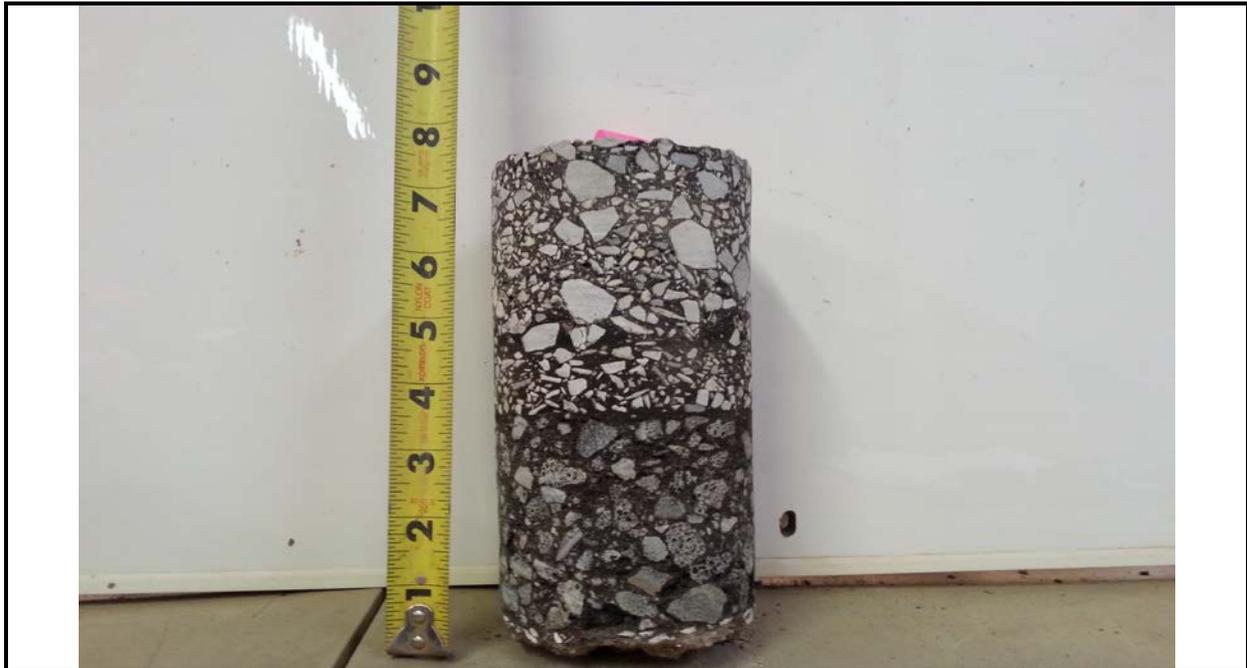
Pavement Core B-139.  
Approximately 4 layers of flexible pavement. No noticeable separation geotextile. Side of core sheared off during core extraction.

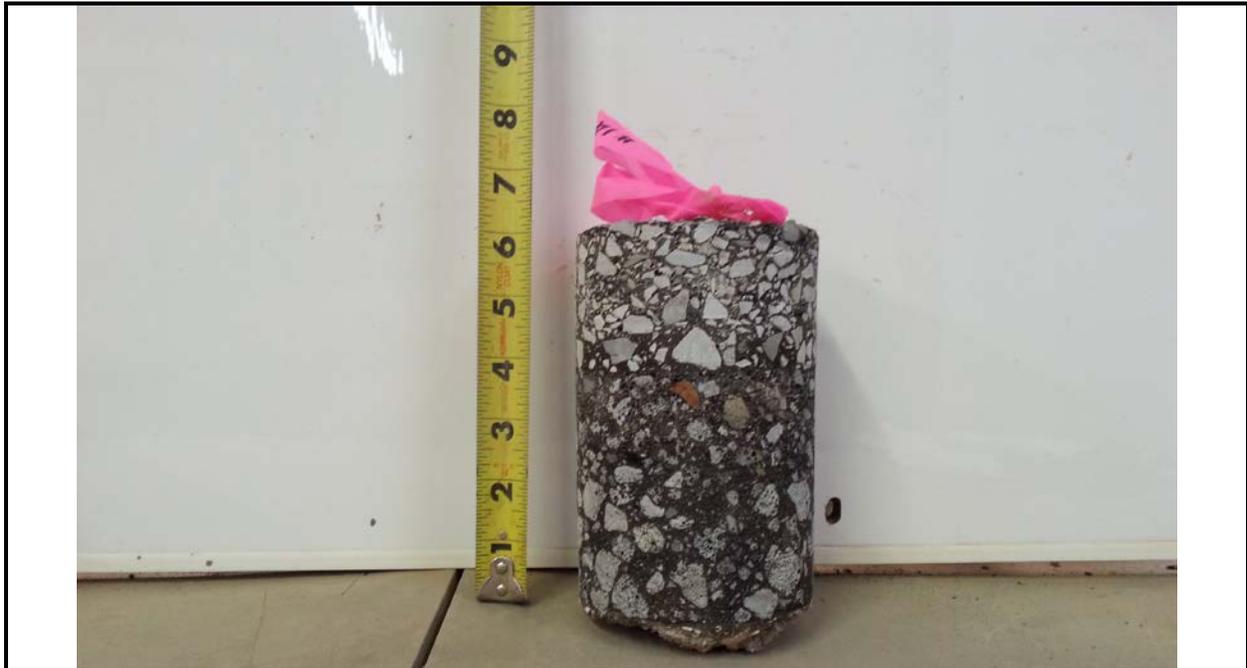
Pavement Core B-147.  
Approximately 4 layers of flexible pavement. No noticeable separation geotextile. No observed cracking or delamination.

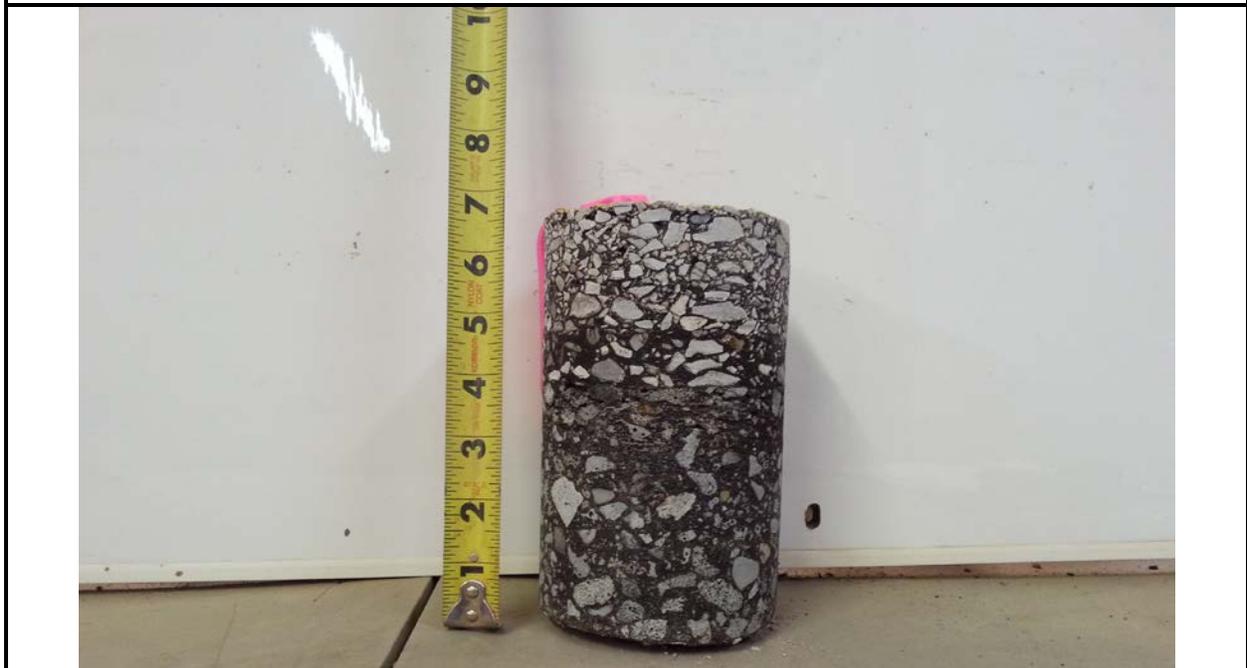
Pavement Core B-148.  
Approximately 4 layers of flexible pavement. No noticeable separation geotextile. No observed cracking or delamination.

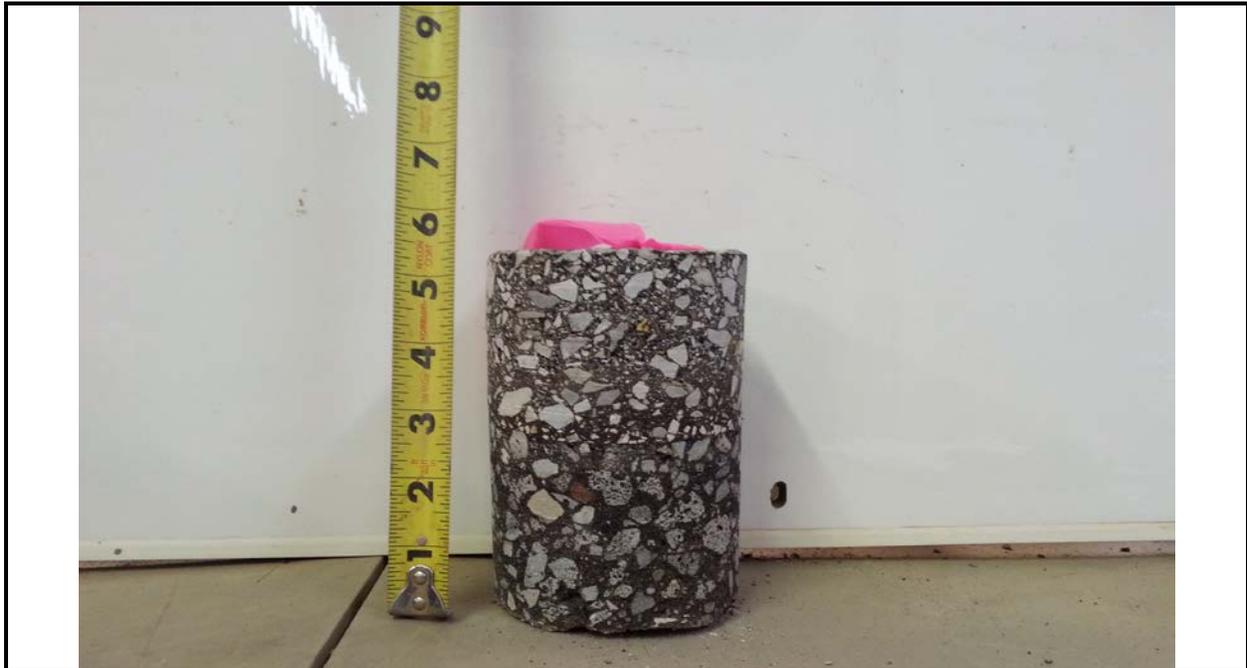
Pavement Core B-149.  
Approximately 4 layers of flexible pavement. No noticeable separation geotextile. No observed cracking or delamination.

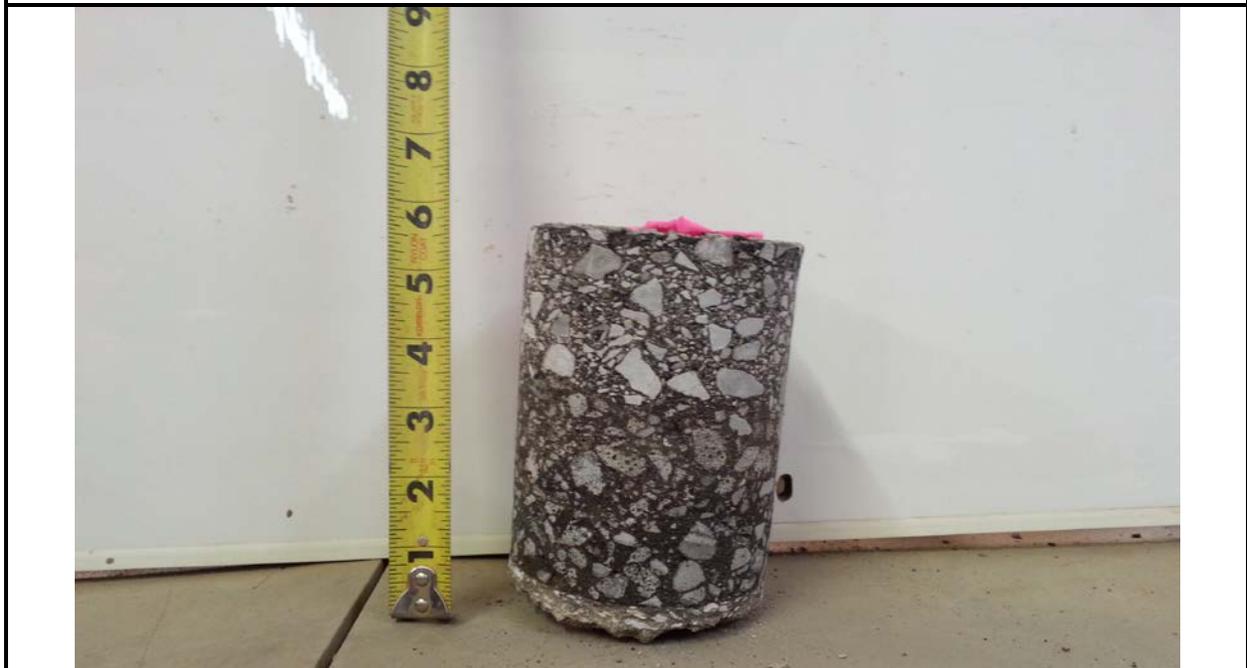
Pavement Core B-150.  
Approximately 3 layers of flexible pavement. No noticeable separation geotextile. No observed cracking or delamination.
