NAVIMFAC PACNORWEST **ORIGINAL IF RED**  
**ENGINEERING MEMORANDUM**

SER. NO.: 841/198M-11

**SUBJECT:** TRIPER/AERP, Low Pressure Air Compressor, Incorrect Rotor

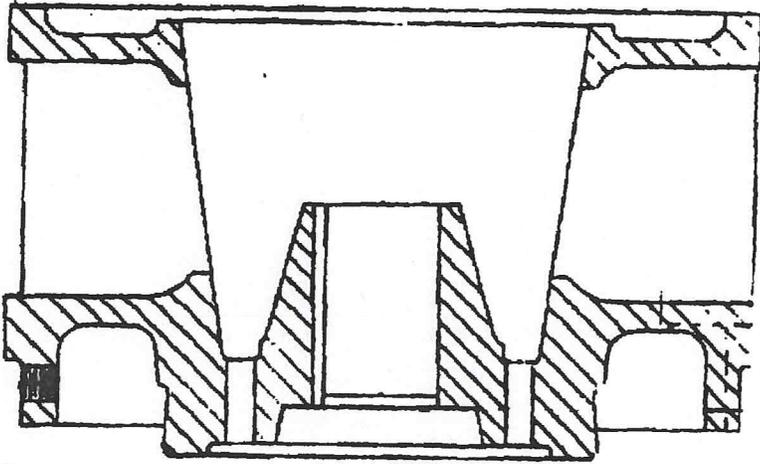
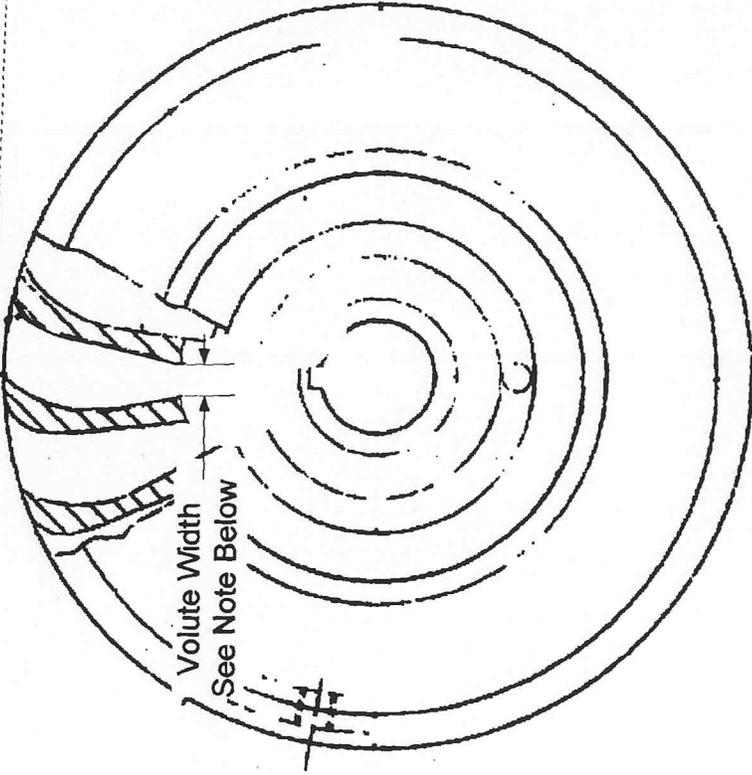
## LPAC Rotor Sketch

- b. The nominal width of the volute opening in the new rotors (see reference (a) and enclosure (1)) is approximately 3/8" across. This dimension on an in-service rotor marked with the Nash part number is about 1/4". Follow up discussions with Nash POC Mr. John Edman has confirmed the 1/4" wide volute opening best reflects the configuration depicted by the OEM's proprietary drawings.

Note: The width of the volute opening for in-service rotors marked with the Nash part number is 1/4", while the rotors received from supply have a volute nominal width of 3/8".

2. Defective rotors shall be returned to the stock system using a QDR based on the following:
  - a. Unlike older rotors removed from in-service compressors, the new rotors received from the stock system are not marked with the Nash part number.

3. Until stock system records indicate they are again providing rotors manufactured by Nash (Cage code 42280), replacement rotors shall be purchased directly from the OEM.
