## Summary

Building 1001 is an existing circa 1919 structure that houses the Document Services Group and other warehousing/storage functions at the Marine Corps Base, Quantico (MCAF). The building is in need of exterior envelope repairs to address deteriorating painted stucco finish and a leaking roof as well as hazardous material abatement and HVAC upgrades.

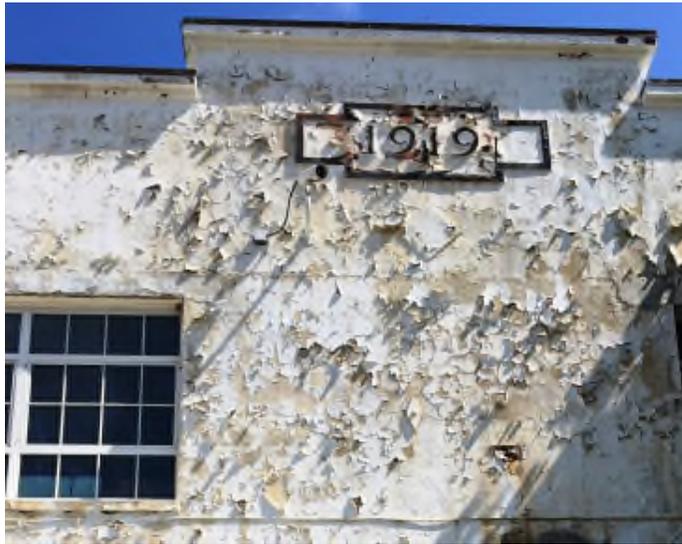
- Exterior walls have been evaluated and the badly deteriorated stucco finish over masonry is in urgent need of repair. In addition components of the existing wall system contain hazardous materials (refer to the Hazardous Materials Report in Appendix # for additional information).
  - The painted finish on the stucco, which contains lead paint, is badly flaking and needs to be removed (abated).

- The approach to the repair of the exterior wall conditions is as follows:
  - Fully remove (abate) lead paint
  - Fully remove (abate) existing stucco to expose existing masonry wall behind stucco
  - Repair and repoint cracked and displaced masonry
  - Install new exterior stucco finish system to include air and moisture barrier

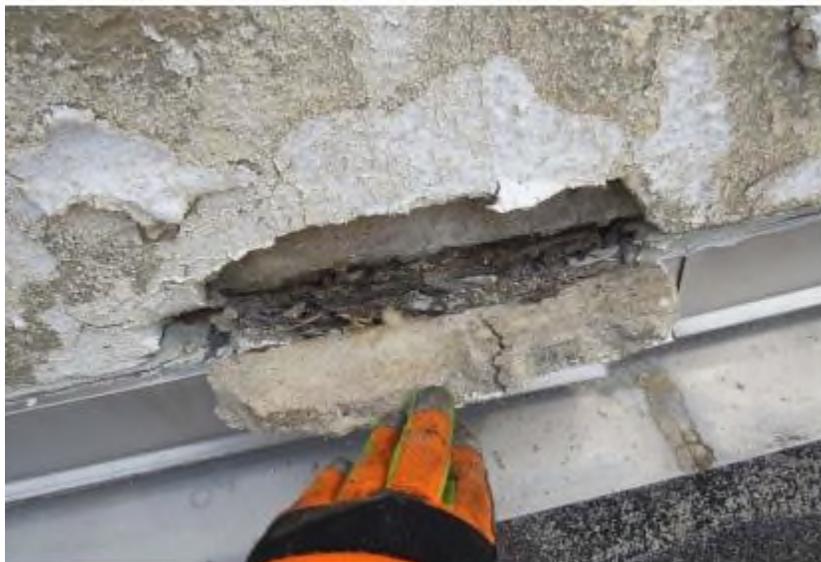
- The stucco system contains asbestos and has many areas that are cracking and/or spalling creating paths for water intrusion into the exterior masonry wall.

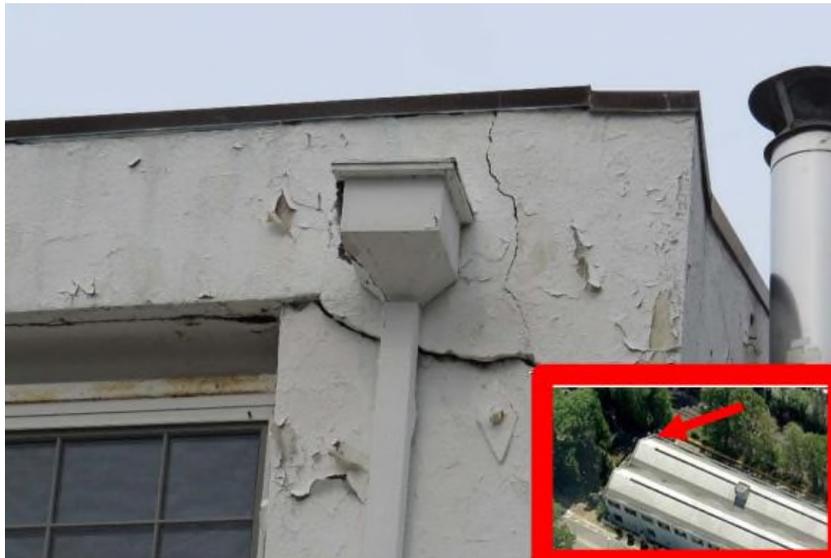
- In addition, the masonry wall to which the stucco is covering exhibits several areas of concern where cracks indicate measurable displacement of the masonry, creating a greater concern for the structural conditions obscured behind the stucco finish.

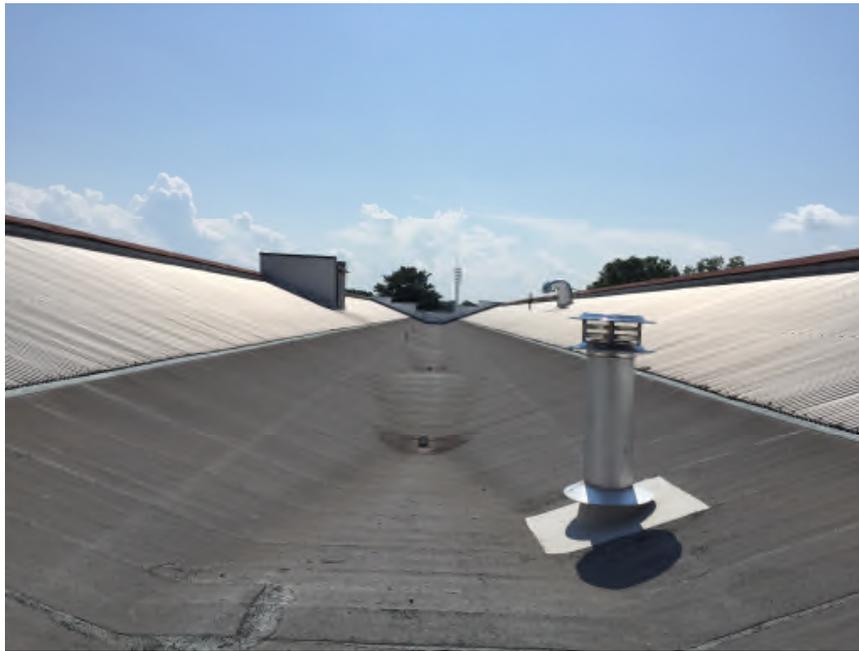
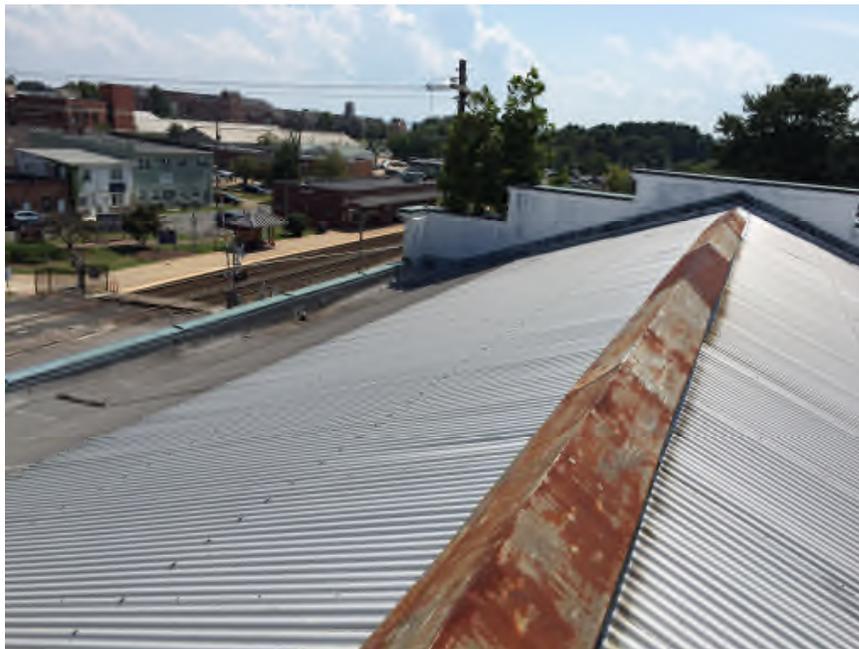
- The roof of Building 1001 is leaking and is beyond it's useful life (refer to the Roof Investigation Report in Appendix # for detailed information on the existing roof condition.)

- The recommended approach to repairing the failing roof systems is full replacement at all roof areas by removing the existing roof membrane and associated insulation, flashings, and other roof system components down to the structural deck and installing a new modified bitumen (2 ply) roof system with granulated cap sheet at all roof areas except the loading dock. The corrugated metal roof over the loading dock will be removed to facilitate the stucco wall finish work and replaced with a new metal standing seam roof.
