HAZARDOUS MATERIALS SURVEY

**REPLACEMENT OF CONDENSATE PUMP STATIONS
(BUILDINGS 22 & 347)
PORTSMOUTH NAVAL SHIPYARD
KITTERY, MAINE**

June 23, 2014

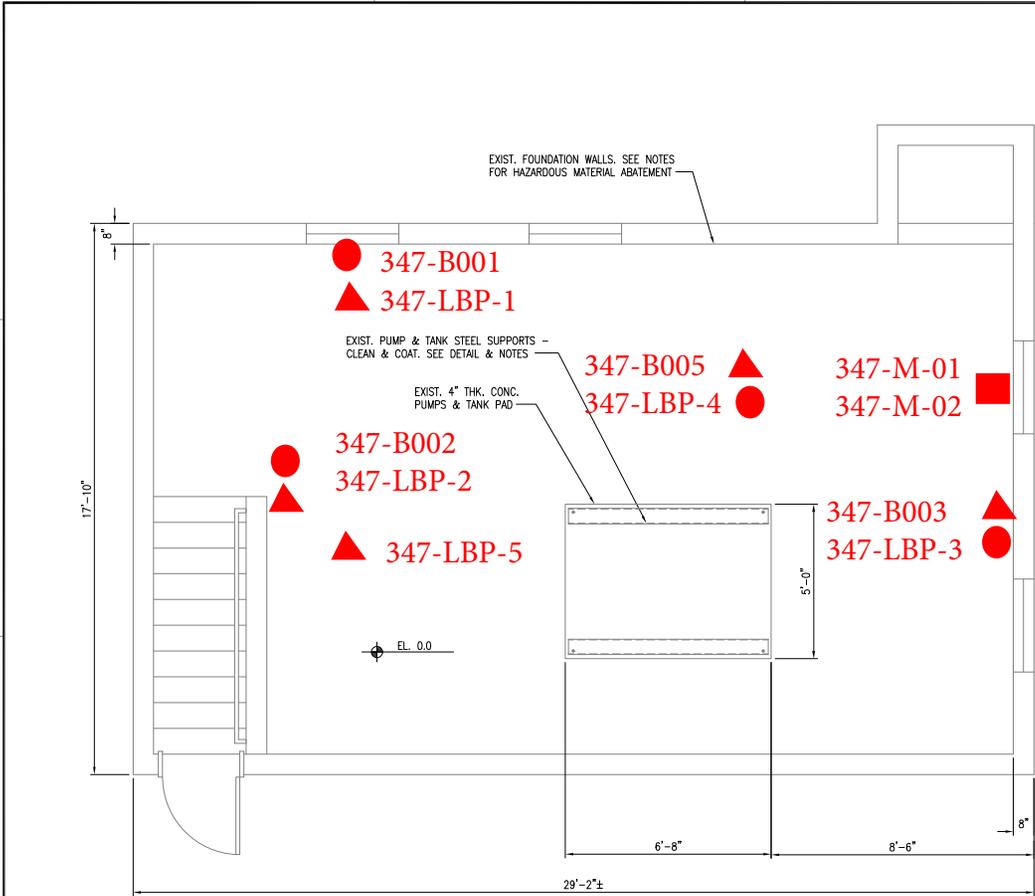
Figure 1B Hazardous Materials Survey - Sample Locations - Bldg 347

In addition to the six homogenous materials sampled, two additional homogenous materials (347-B006, Gaskets on Steam Piping and 347-B004, Transite Panels at Entrance) were not sampled and are assumed to contain asbestos. The Transite Panels at the entrance to the Building 347 pump station were labeled “Danger Contains Asbestos.”

Asbestos Containing Material	Homogenous Material #	Location	Quantity	
			(English)	(Metric)
Transite Panels	347-B004	Entrance to Bldg 347	75 sf	7 m ²
Gaskets	347-B006	Steam Piping in Bldg 347	6 Each

- Light grey over green on lower walls (Bldg 347)
- Light grey over white on ceiling (Bldg 347)
- Light grey over white on upper walls (Bldg 347)
- Light grey over orange on steel beams in ceiling (Bldg 347)
- Grey on piping in ceiling (Bldg 347)
- Yellow on ladder (Bldg 22)

On June 13, 2014, Wilcox & Barton, Inc. inspected Building 347 pump station for the presence of mold. Mold was observed on plywood on the northern wall of the pump station. In addition, excess moisture was present in the space, as evidenced by roof leaks, moisture infiltration through exterior walls, and condensation. The mold growth appeared black to dark brown in color. Mold samples were collected at the locations depicted on Figure 1B.

Mold Sample #	Sample Location	Fungal Growth	Growth Rating ¹	Miscellaneous Spores/Pollen ²	Debris Loading ³
347-M-01	Plywood on North Wall, Bldg 347	Aspergillus	4+	None	Low Debris
347-M-02	Plywood on North Wall, Bldg 347	Aspergillus	3+	None	Low Debris

Any demolition or renovation that could disturb ACM must comply with state and federal environmental and safety standards. In accordance with 40 CFR Part 61, *National Emissions Standards for Hazardous Air Pollutants* (NESHAPs), a contractor conducting any demolition that will disturb regulated ACM must: (1) notify the EPA Administrator of such activities; (2) use proper removal procedures; (3) use proper engineering controls to limit emissions of asbestos fibers; and (4) utilize proper waste disposal. Also in accordance with NESHAPs, ACM that will be disturbed must be removed by a licensed asbestos abatement contractor prior to initiation of any building demolition or renovation activities. If any hidden and previously undetected suspect ACM is uncovered during demolition activities, work must be stopped and the material tested for asbestos content. All ACM must be disposed of in accordance with all applicable state and federal requirements.

Mold identified within Building 347 should be remediated in accordance with the EPA *Mold Remediation in Schools and Commercial Buildings* (EPA 402-K-01-001). Remediation may involve a variety of abatement methods based on the impacted material, including cleaning with a biocide, high-efficiency particulate air vacuuming, removal of impacted materials, and worker protection practices. Mold remediation should be performed in conjunction with elimination of moisture problems within the building in order to be effective.

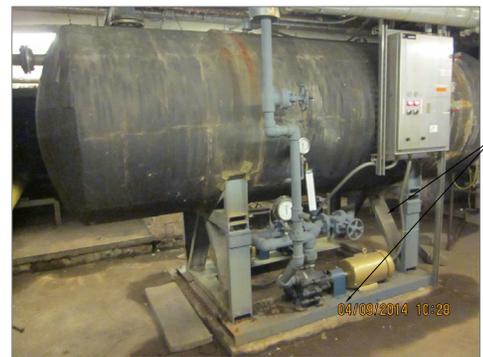
TANK SUPPORTS
SCALE: NOT TO SCALE

EXIST. TANK STEEL SUPPORTS. CLEAN & COAT. SEE NOTES
