## **LIMITED HAZARDOUS MATERIALS REPORT**

**Naval Facilities Engineering Command (NAVFAC)  
Building 446 HVAC Replacement  
Building 446 CHI, Surface Warfare Officers School  
(SWOS)  
Naval Station Newport  
Newport, RI**

**STV Project Number 3016436  
Contract N40085-11-D7211  
eProjects Work Order No.: 1312379**

**03 October 2014**

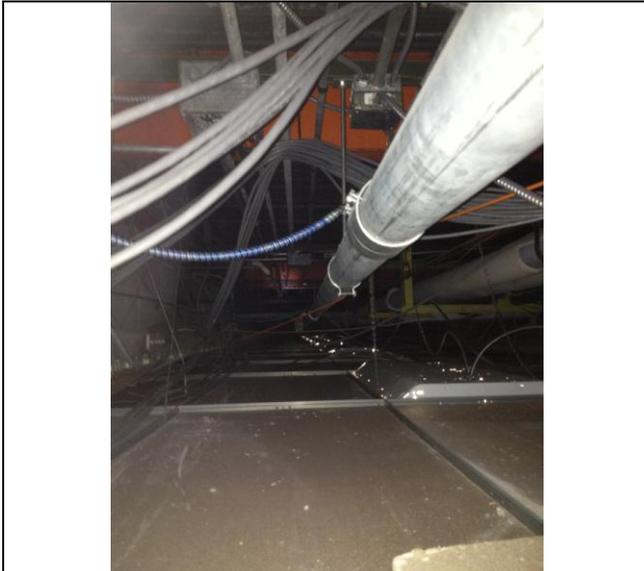
**A1** Debris on Top of Ceiling Tiles –  
(Positive ACM) Second Floor Only

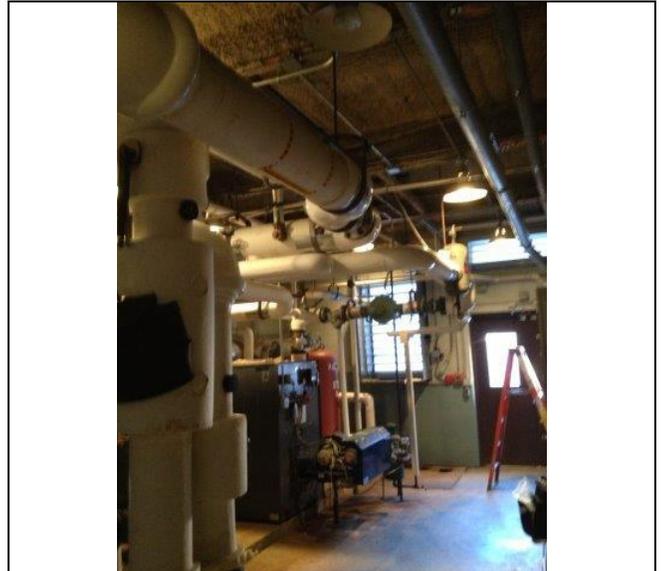
**A2** HA # 1 - Room 155 Fireproofing (Non  
ACM)

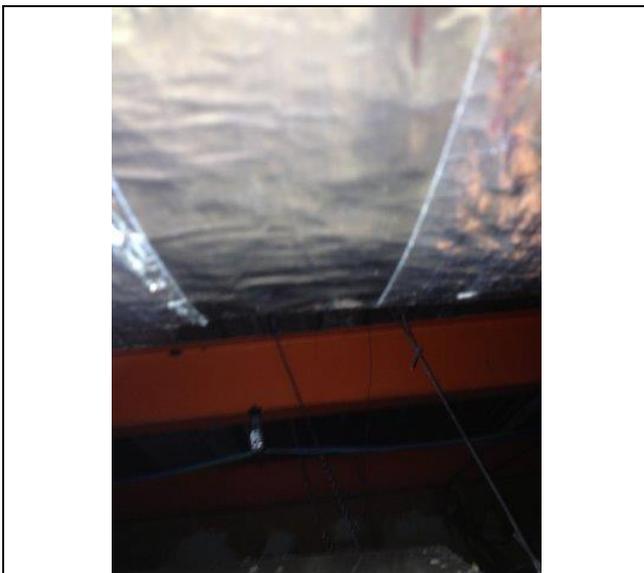
**A3** HA # 2 - Silver Tape on Fiberglass Duct  
Insulation

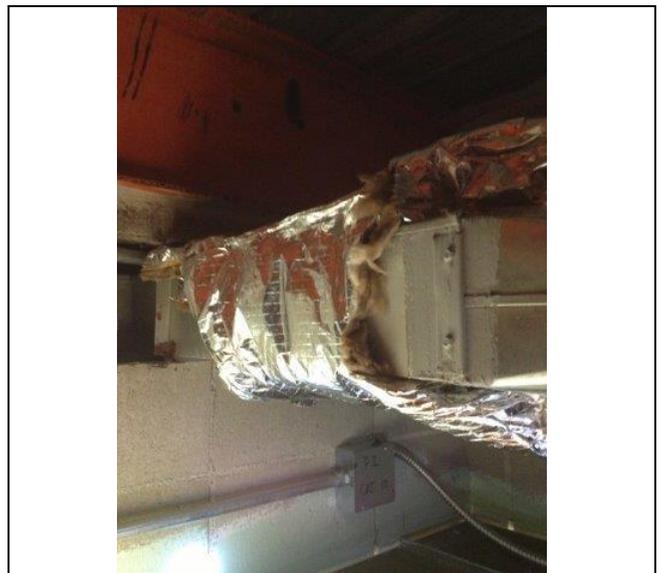
**A4** HA # 3 Silver Tape on Fiberglass Duct  
Insulation (Non ACM)

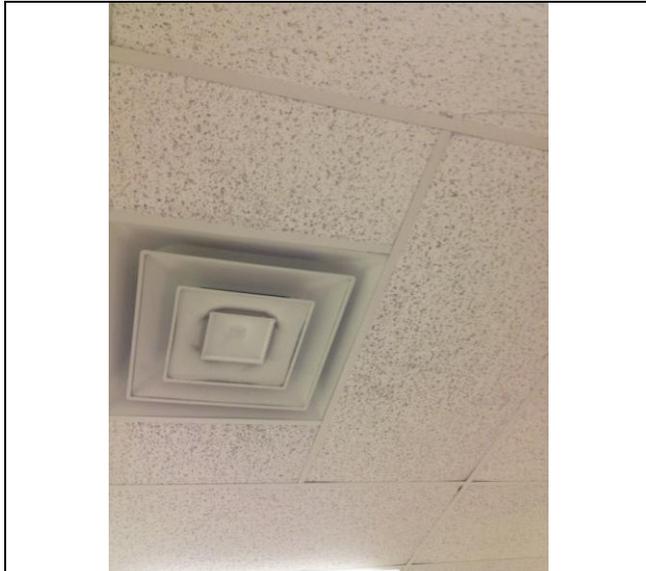
**A5**

**HA#5 – Room 107 – 2' x 4' Ceiling Tile with Pinholes & Fissures – (Non ACM)**

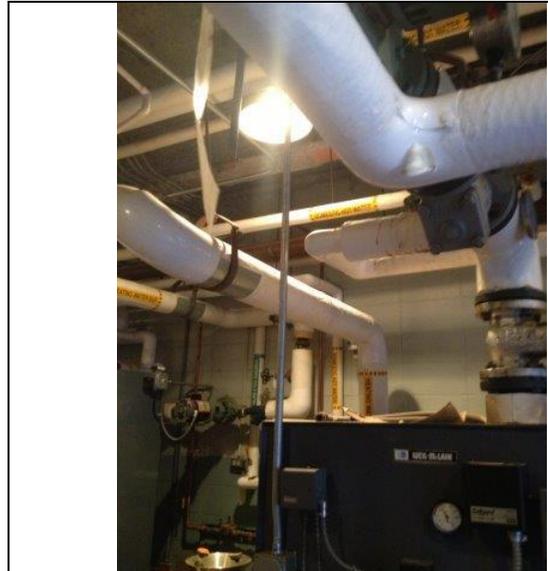
**A6**

**HA # 6 - White Paper on Fiberglass Pipe TSI**

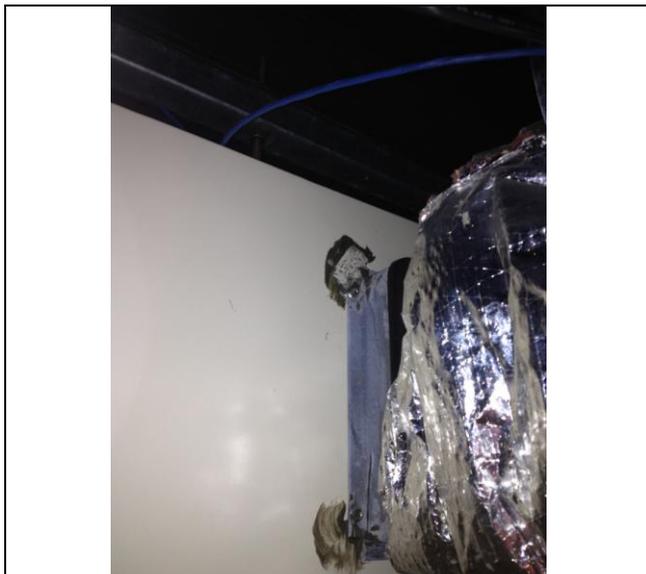
**A7**

**HA # 7 – Gray Mastic on Ceiling Heating Unit to Duct (Non ACM)**

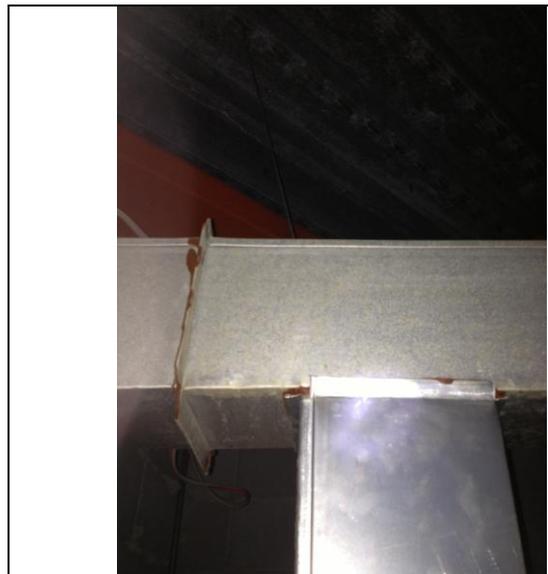
**A8**

**HA # 9 – Room 127 – Gray Duct Seam Sealant – (Non ACM)**

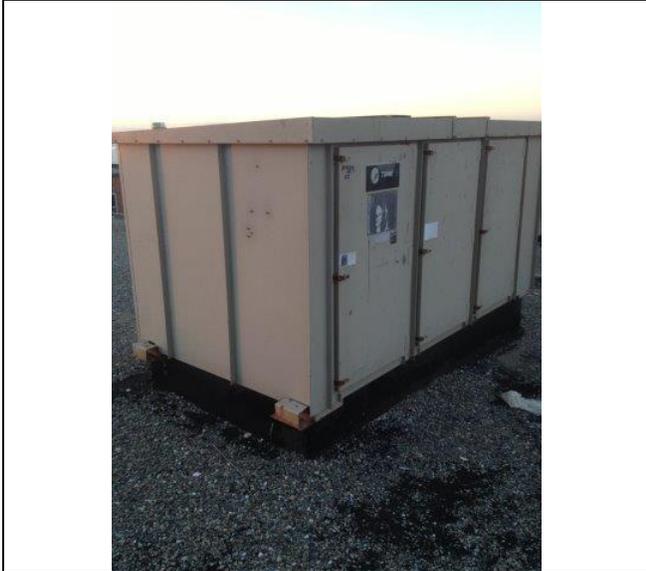
**A9 HA # 11 - Black Flashing**

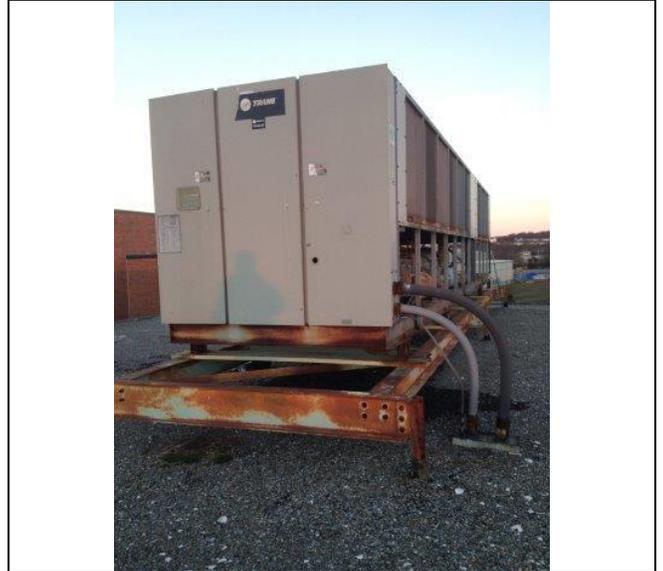
**A10 HA # 16 - Black Pitch Pocket at Chiller**

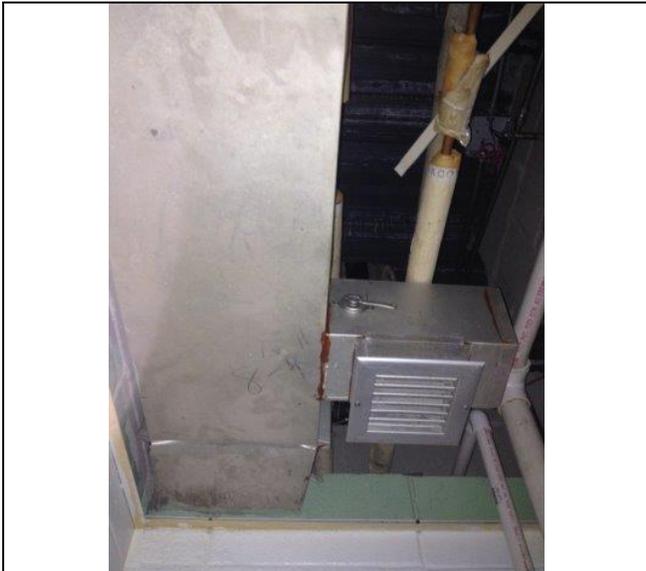
**A11 Red Duct Seam Sealant (Positive ACM)**
