**CONTRACTOR REPORT
CR-NAVFAC EXWC-CIOFP-DRAFT
Volume II of III - Bulkheads**

**WATERFRONT FACILITIES
INSPECTIONS AND ASSESSMENTS AT
NORFOLK NAVAL STATION
NORFOLK, VIRGINIA**

On Site: Jan-29-2013

Norfolk Naval Station Norfolk, Virginia

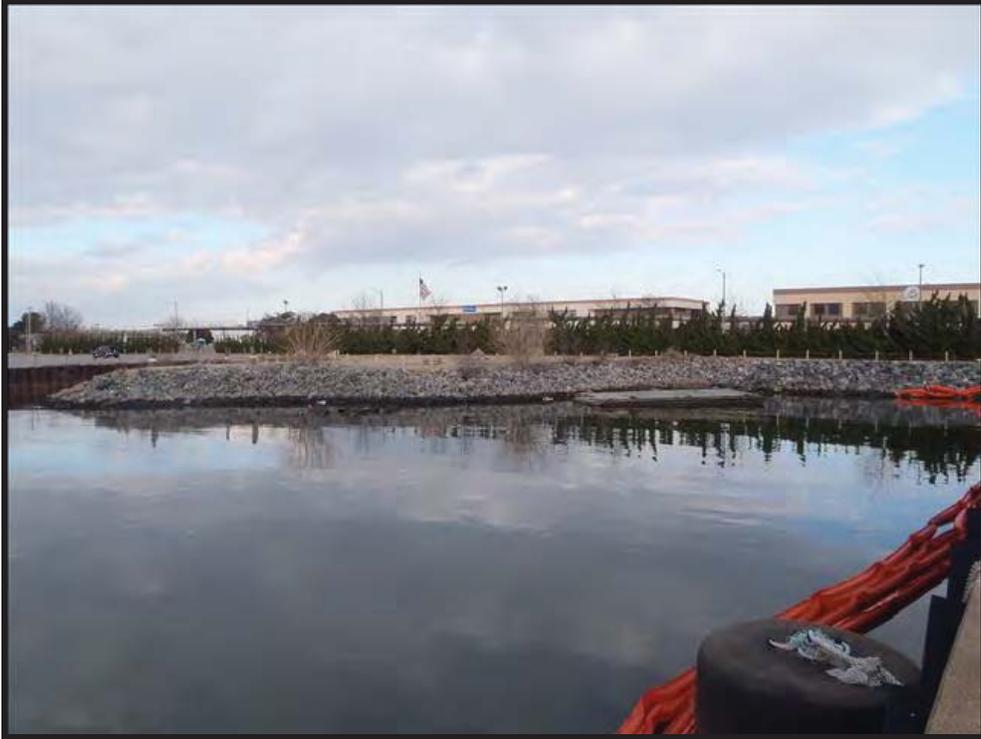
Photo 3.5-1: Overview of Patriot Point from shore, looking northeast.

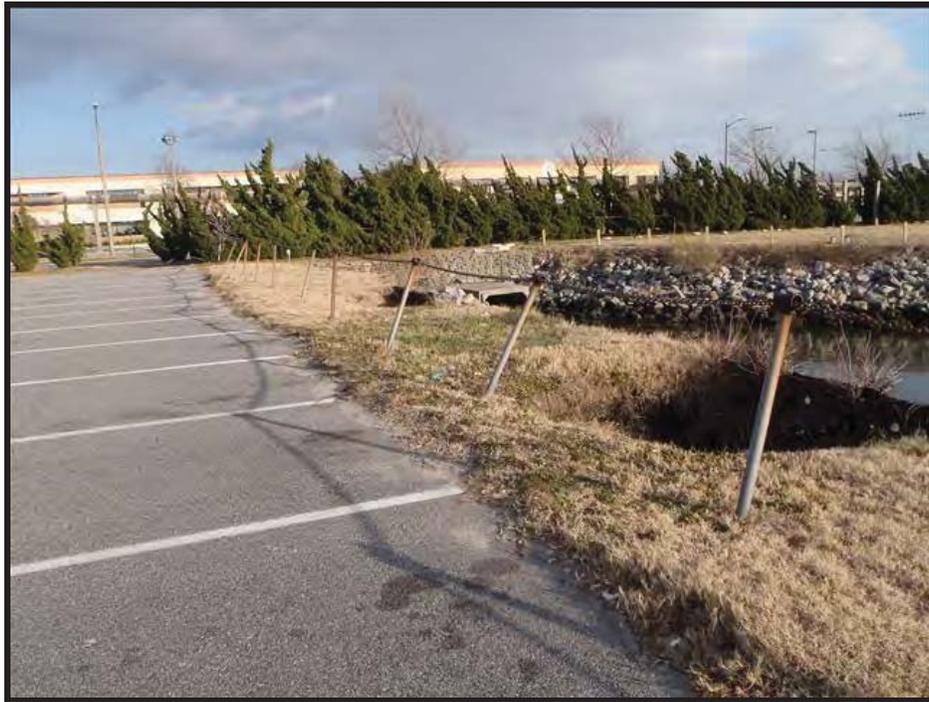
Photo 3.5-13: Edge of wash-out at Sta. 0+80 located 3 ft from the asphalt parking area.

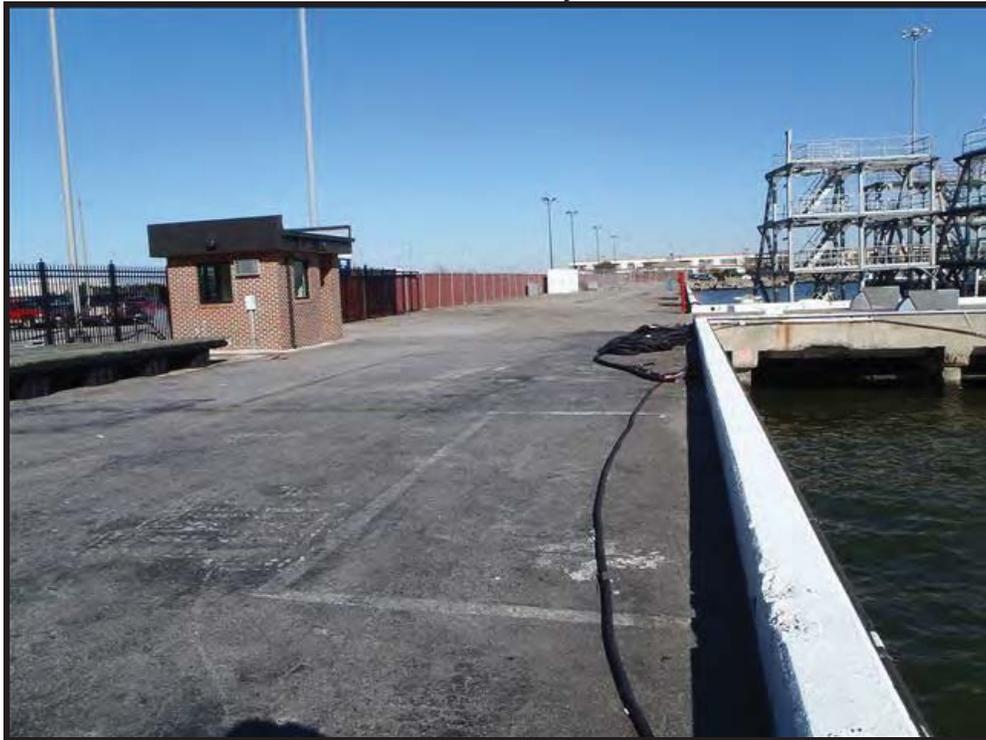
Photo 3.6-1: Overview of CEP175 Platform from shore, Sta. 6+50, looking east.

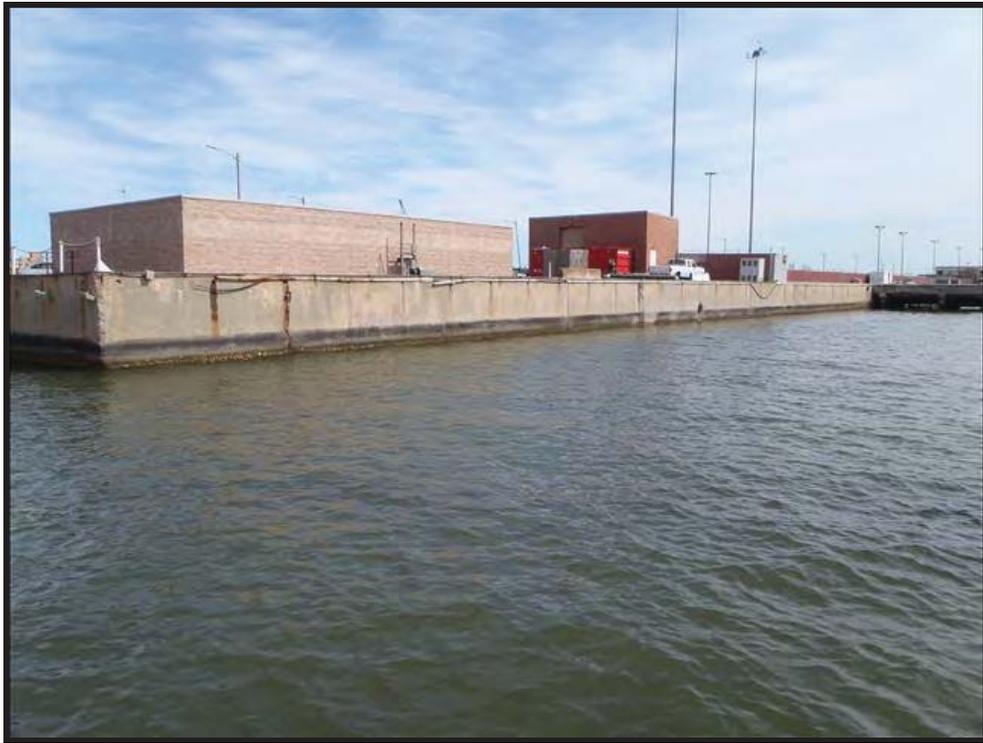
Photo 3.6-7: Overview of CEP175 Platform from the water, Sta. 19+10, looking east.

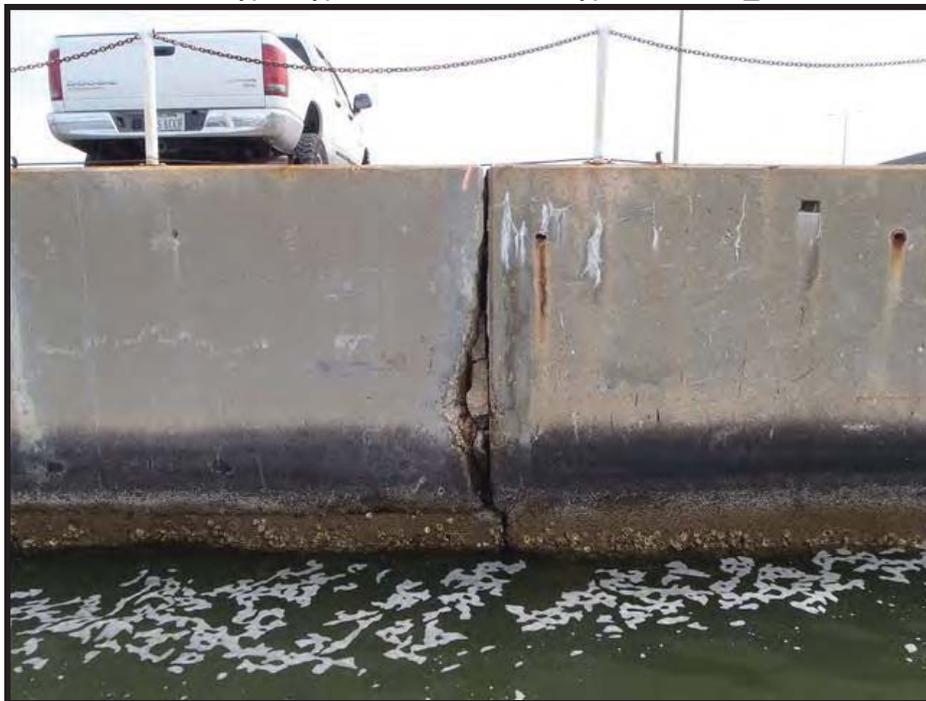
Photo 3.6-8: Typical view of the reinforced concrete sheet pile cap.

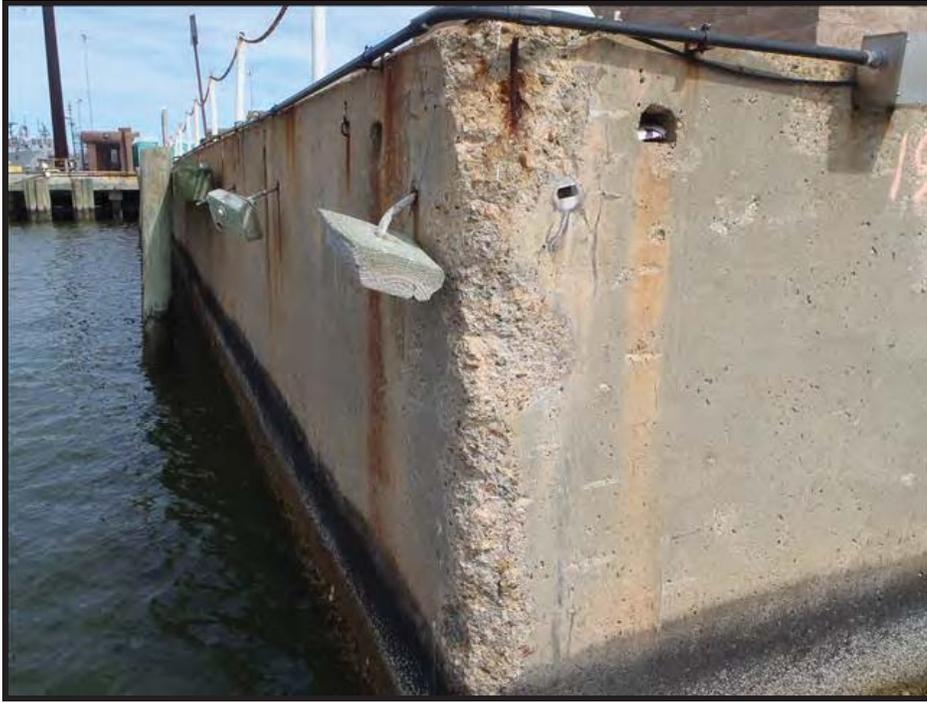
Photo 3.6-9: View of the open mechanical spall on the sheet pile cap, Sta. 9+09.

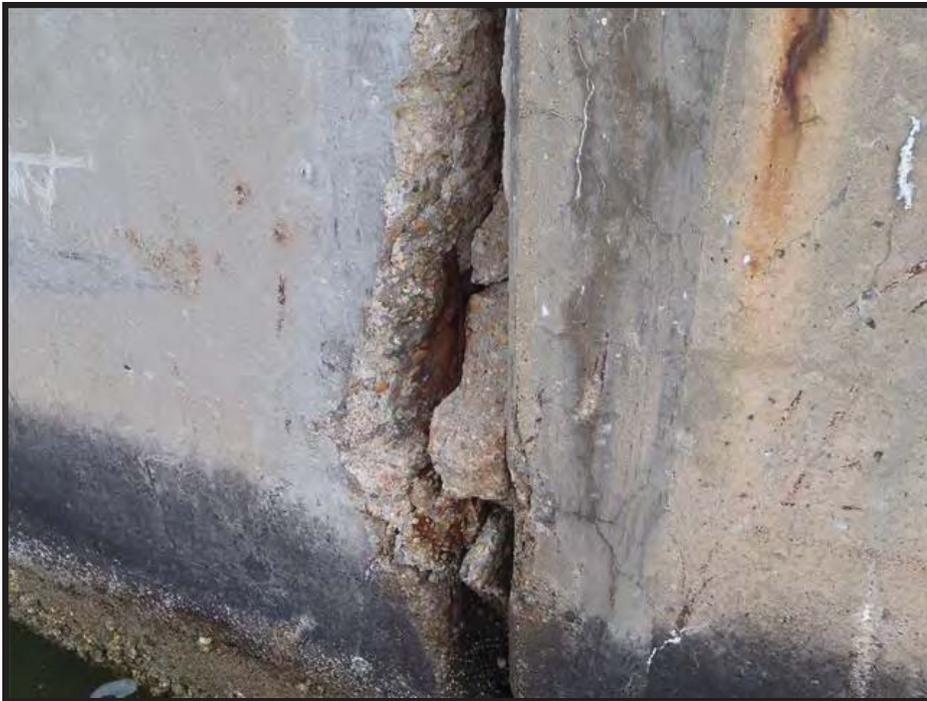
Photo 3.6-10: View of the open mechanical spall on the sheet pile cap at joint, Sta. 13+50.

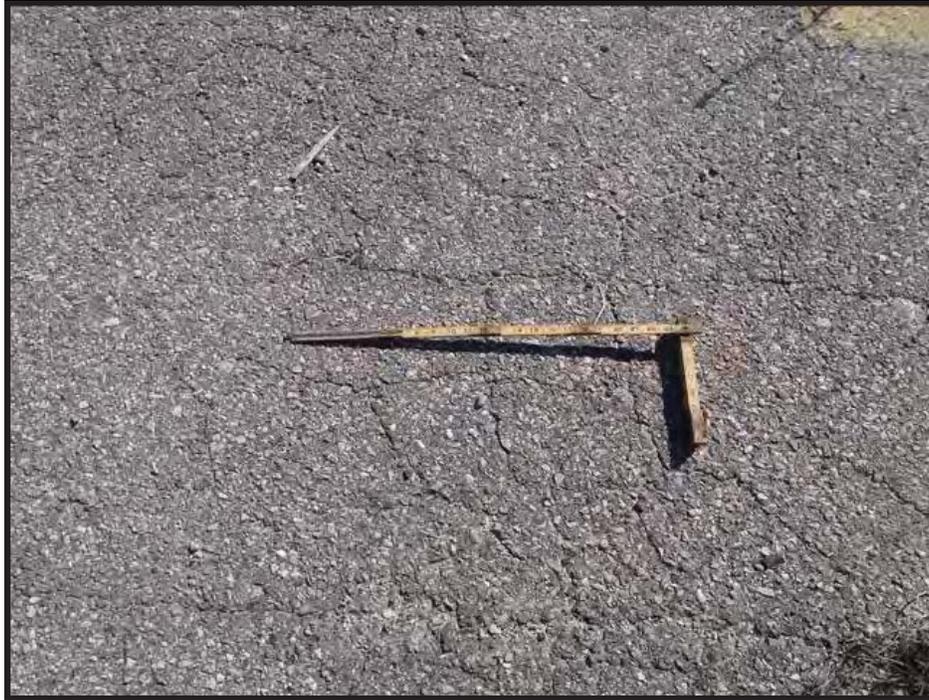
Photo 3.6-20: Typical view of map pattern cracking in asphalt on-grade deck.

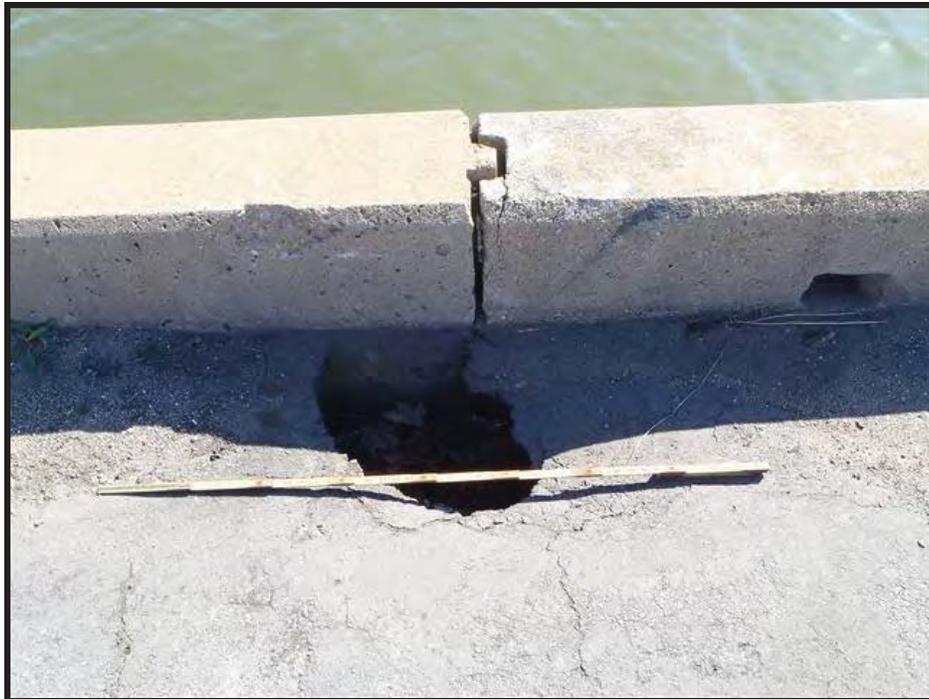
Photo 3.6-21: Typical view of 16 sq ft by 24 in. deep sinkhole, Sta. 1+85.

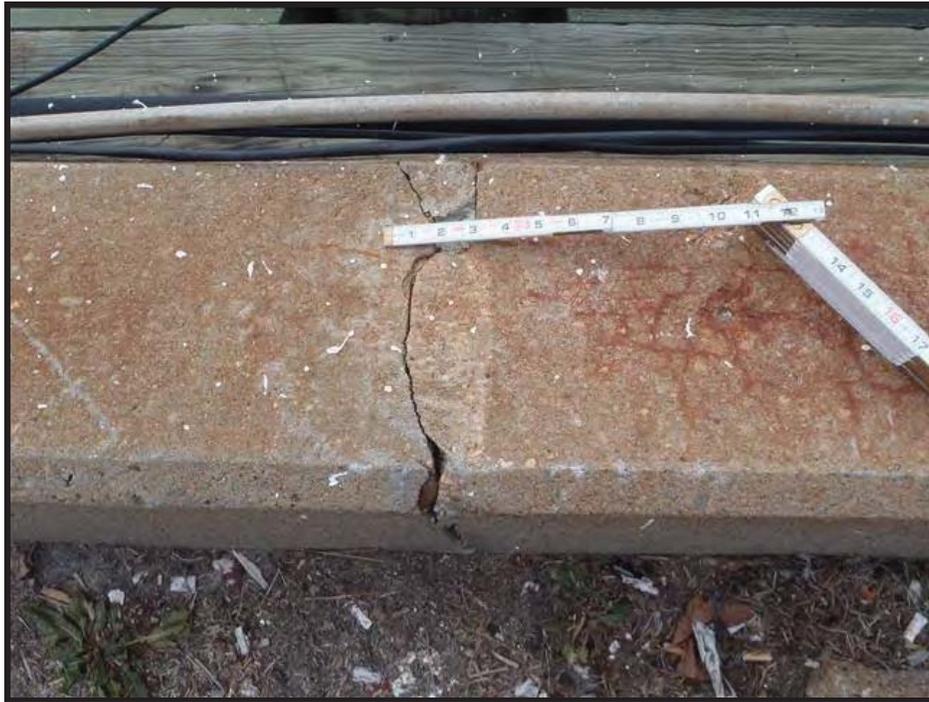
Photo 3.6-29: View of transverse crack at a joint in the curb at Sta.9+87.

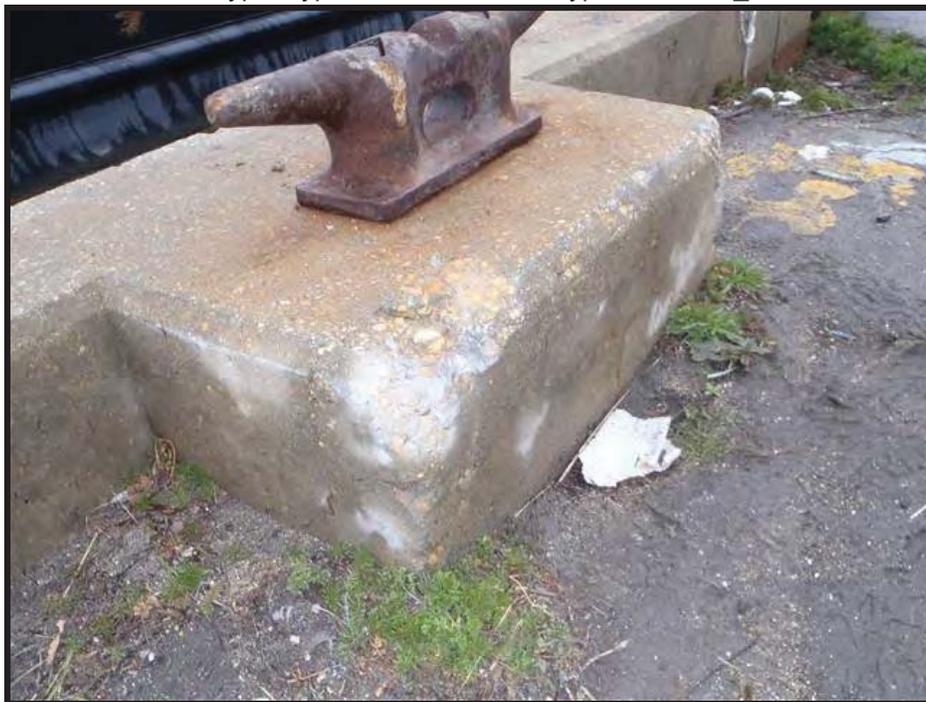
Photo 3.6-30: General view of typical cleat mooring foundation.

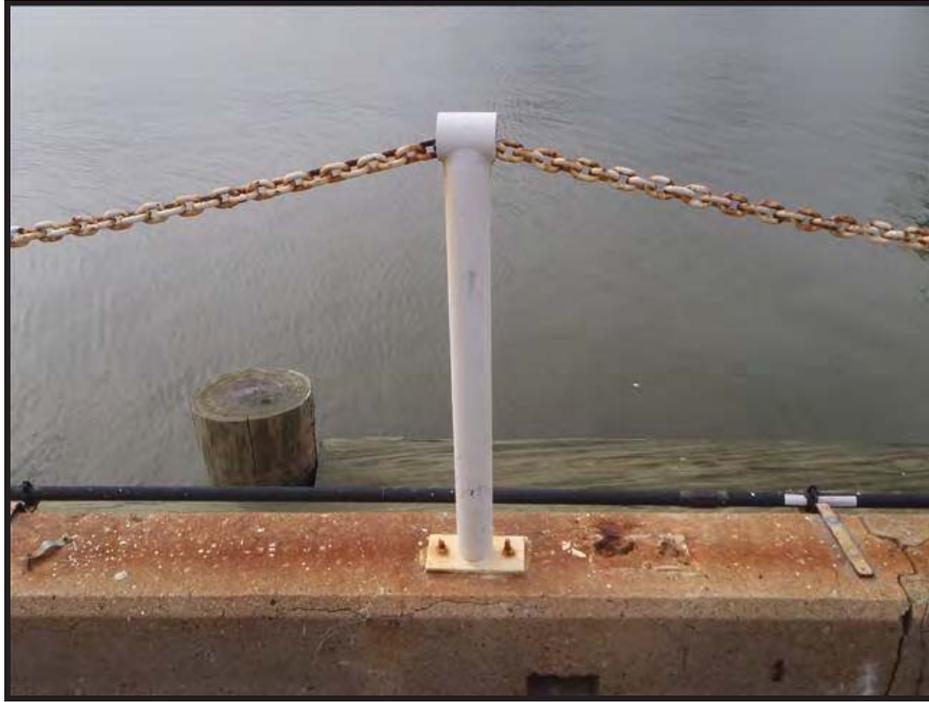
Photo 3.6-31: Typical view of guard post and chain rail.

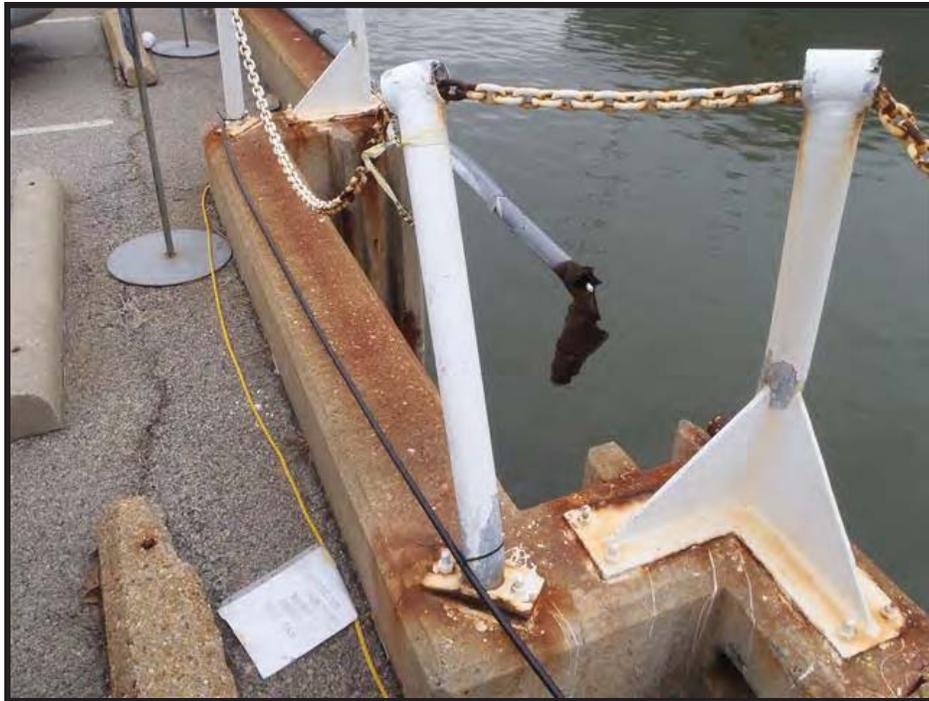
Photo 3.6-32: View of the bent guard post, Sta. 12+40.

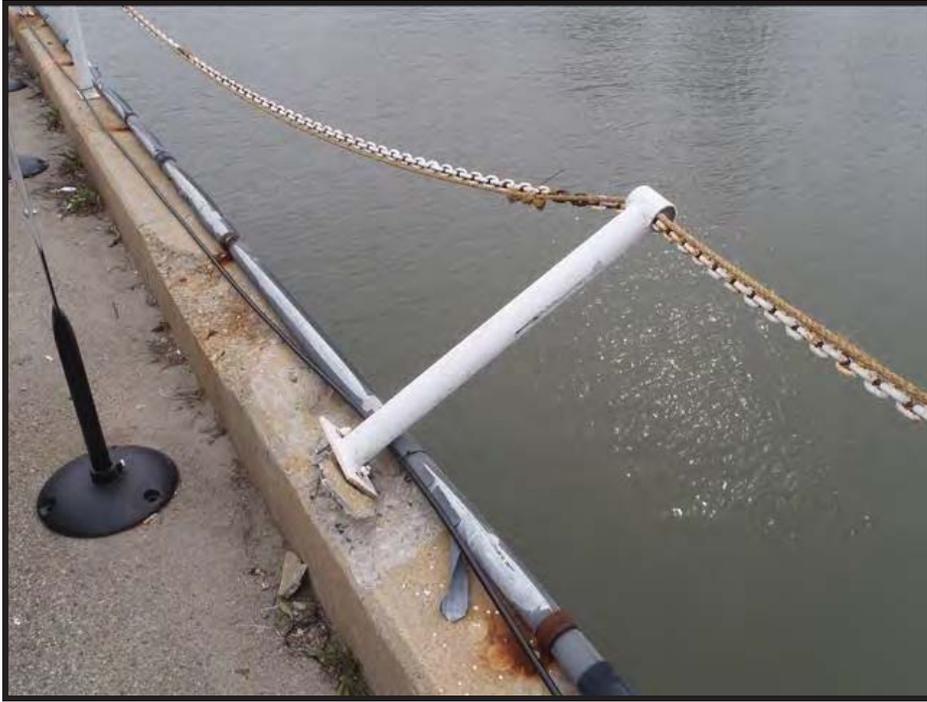
Photo 3.6-33: View of a detached guard post, Sta. 14+65.

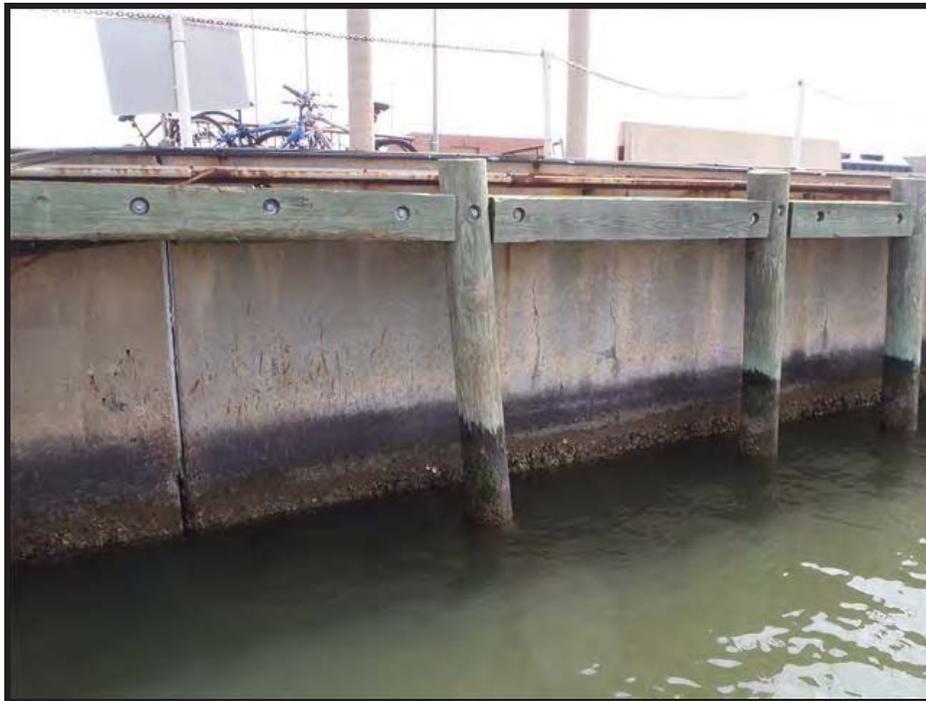
Photo 3.6-34: Typical view of 12 in. diameter, CCA treated timber fender piles.

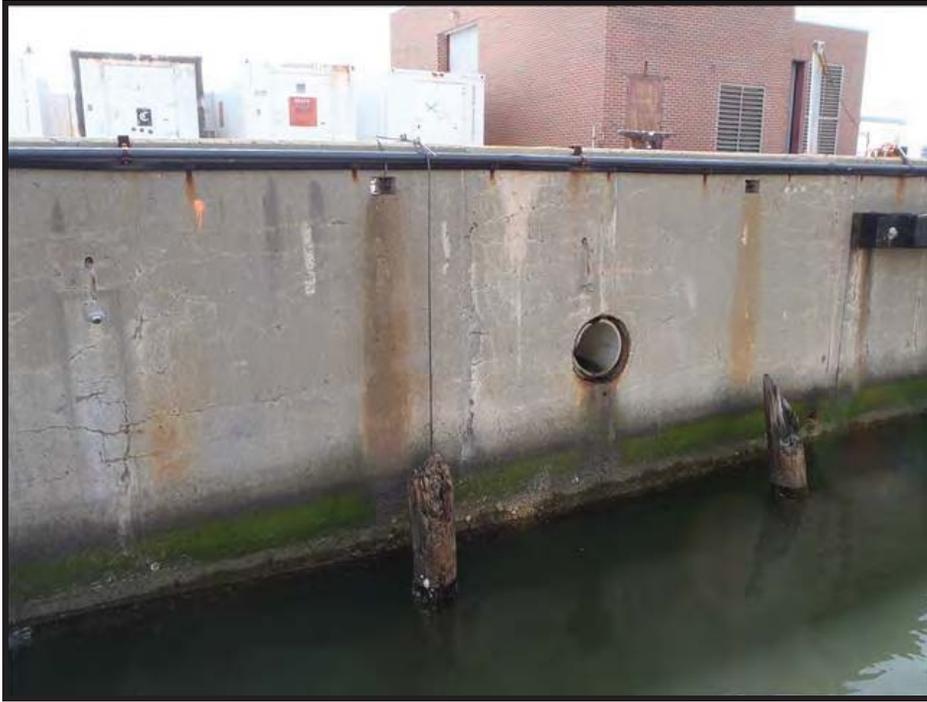
Photo 3.6-35: View of broken timber fender piles, Sta. 20+60.

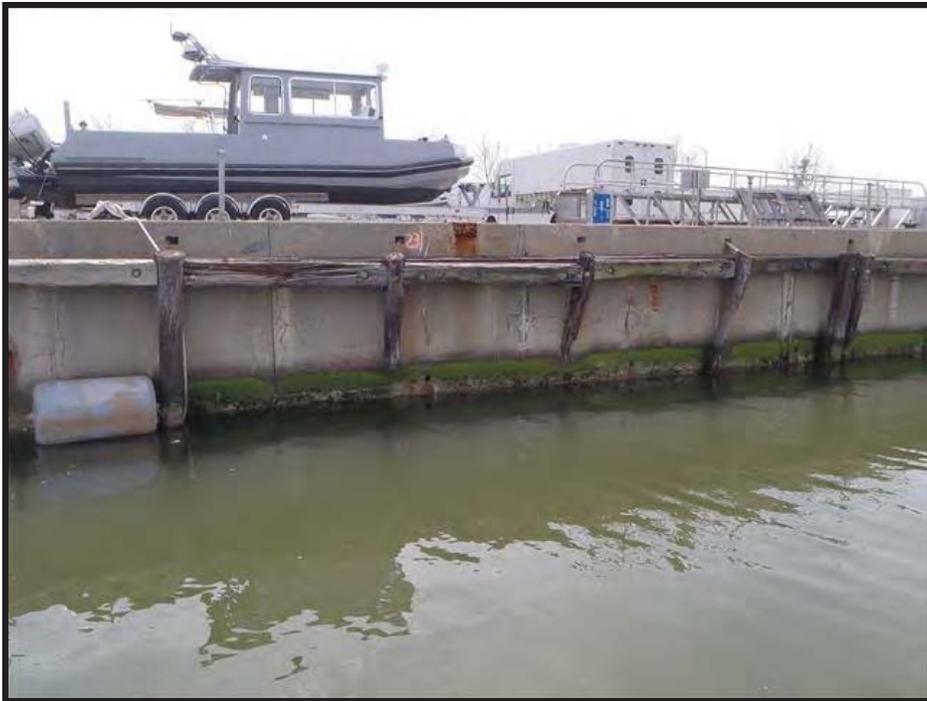
Photo 3.6-36: View of broken timber fender piles, Sta. 23+00.

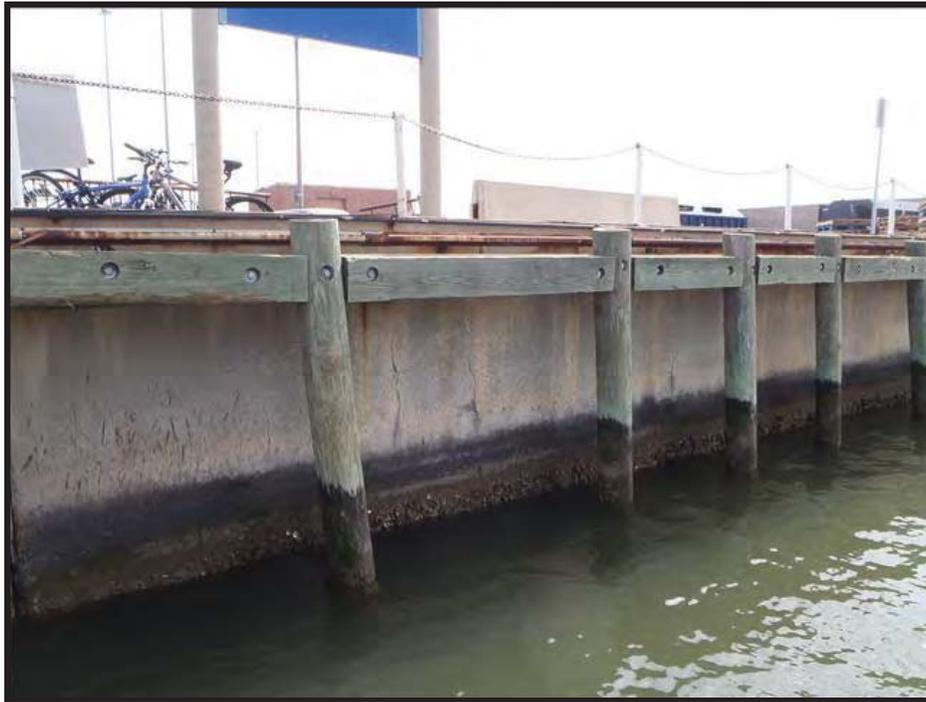
Photo 3.6-37: Typical view of a 12 in. by 12 in. treated timber fender chocks.

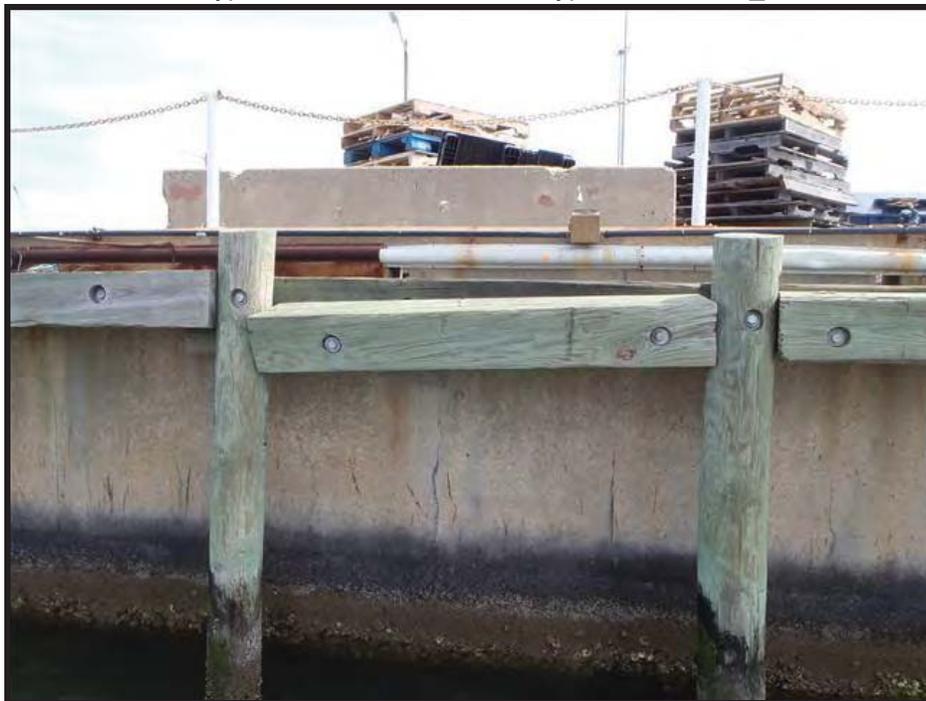
Photo 3.6-38: View of a detached timber fender chock, Sta. 9+75.

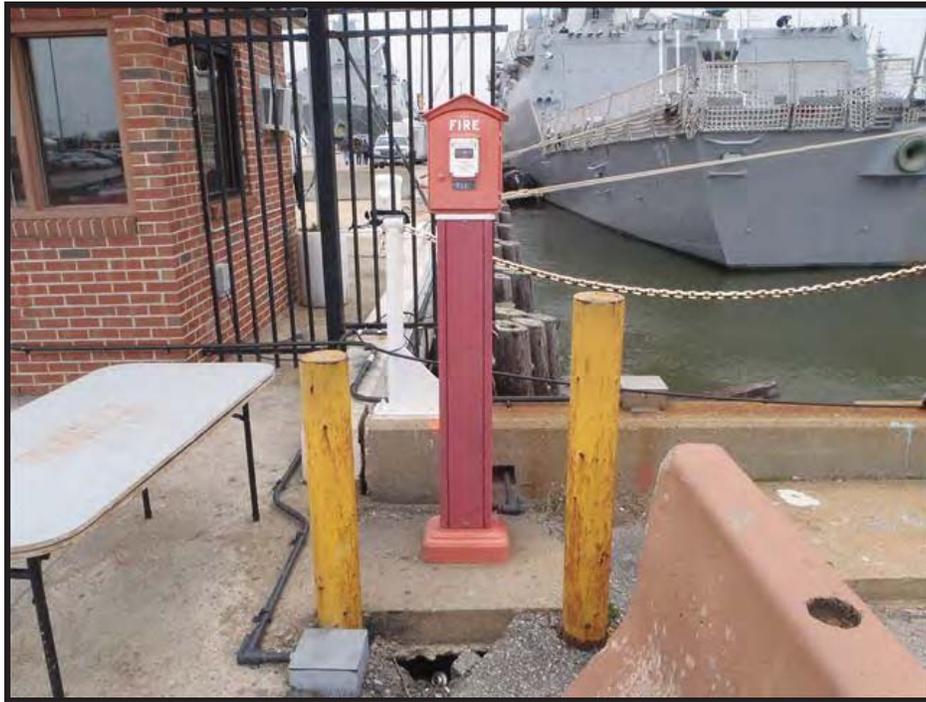
Photo 3.6-49: Typical view of the fire alarm and two guard posts, Sta. 11+25.

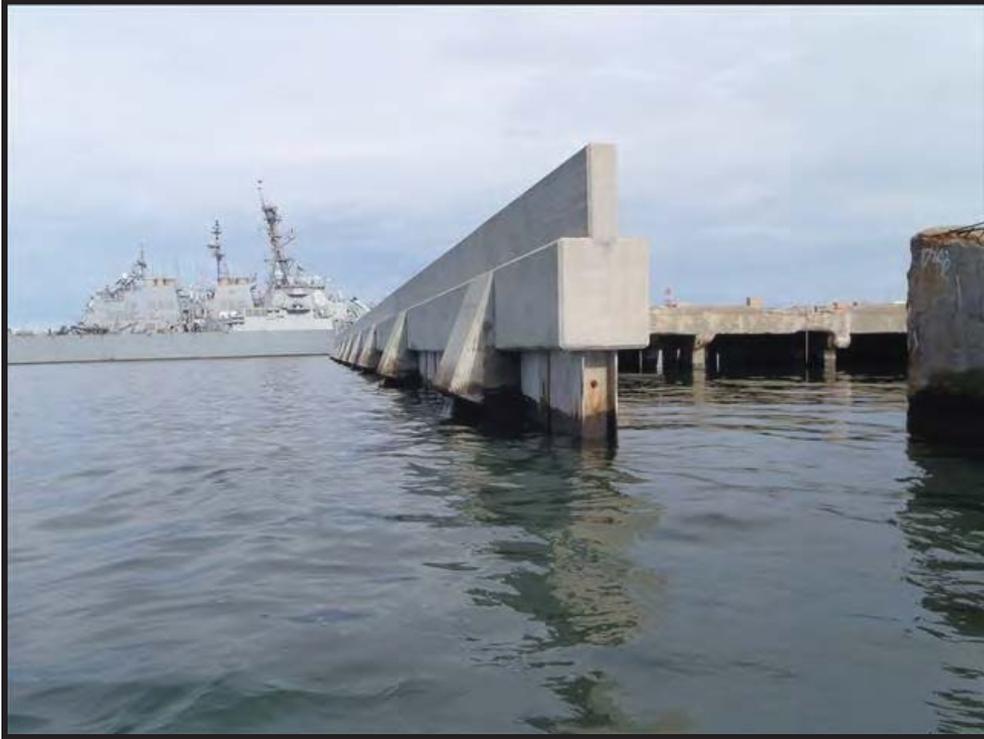
Photo 3.7-1: Overview of CEP169A 5T Breakwater, looking northeast.

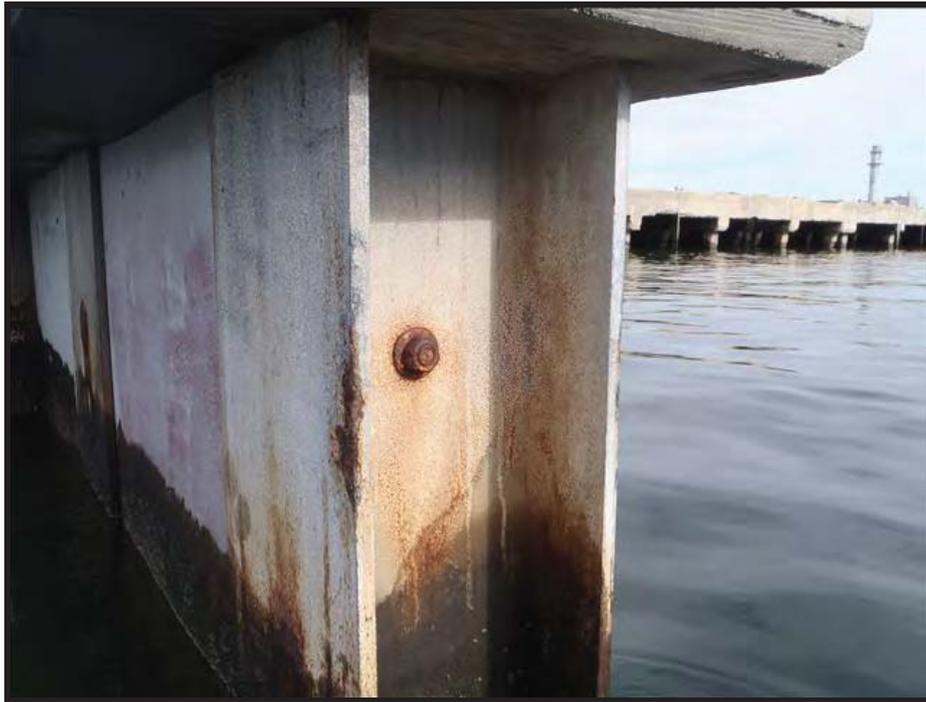
Photo 3.7-3: View of a steel H-pile.

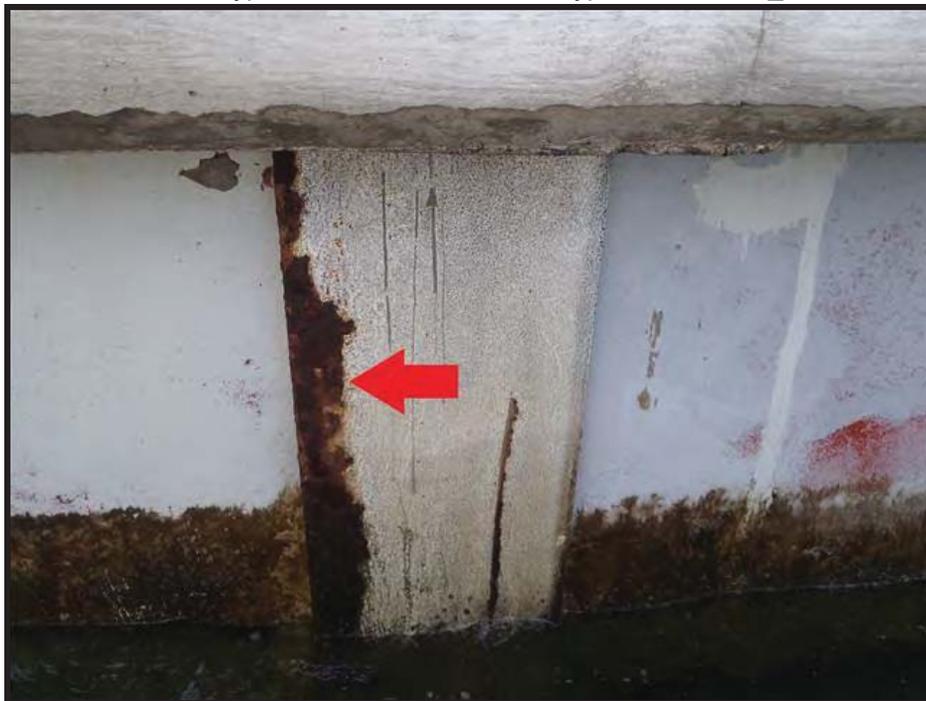
Photo 3.7-4: View of a steel H-pile on the west side of the breakwater with coating loss and rust scale.

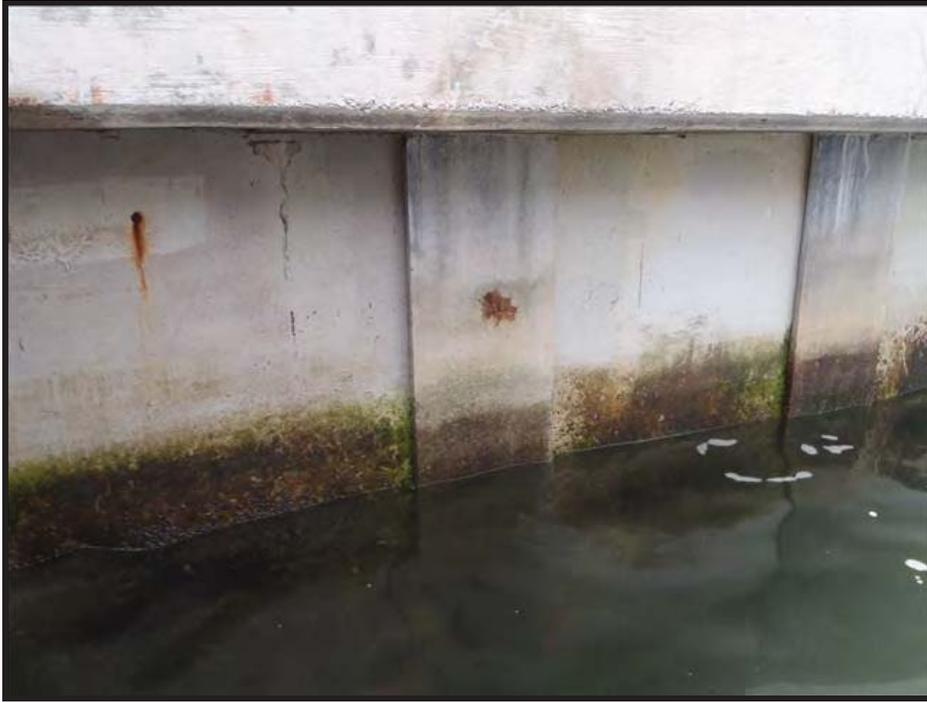
Photo 3.7-10: Typical condition of reinforced concrete sheet piles.

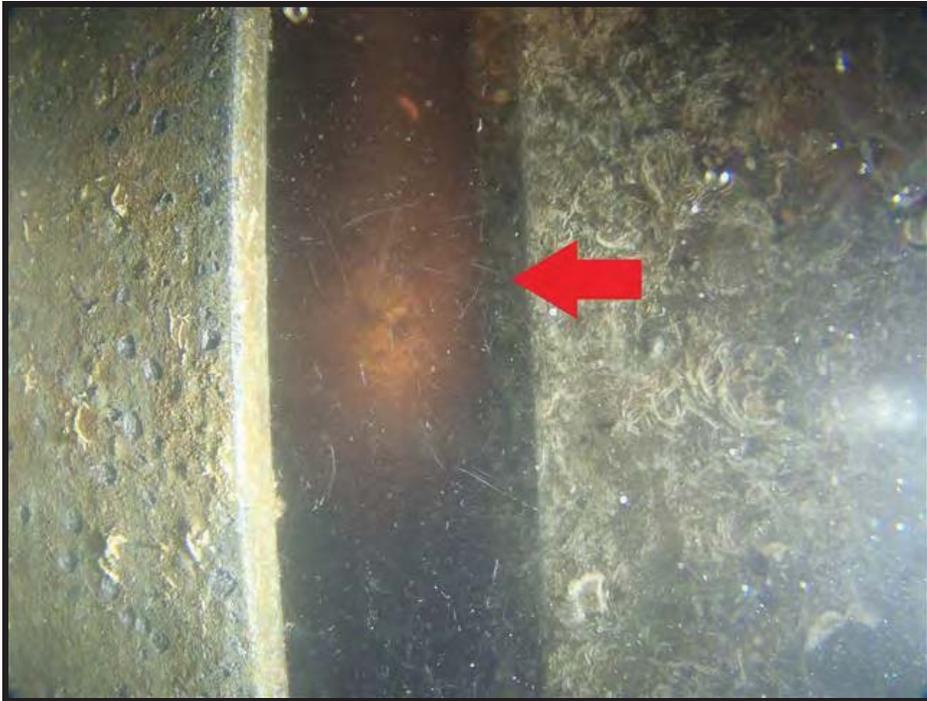
Photo 3.7-11: View of a 3 in. gap between a concrete sheet pile and steel H-pile.

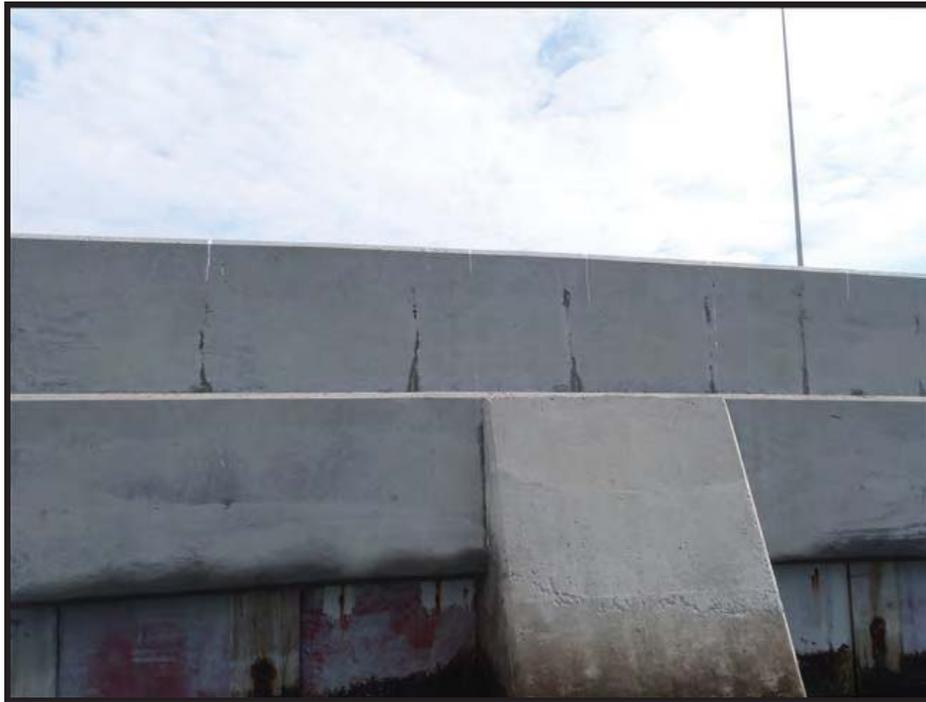
Photo 3.7-18: View of typical hairline cracking on the wave screen wall.

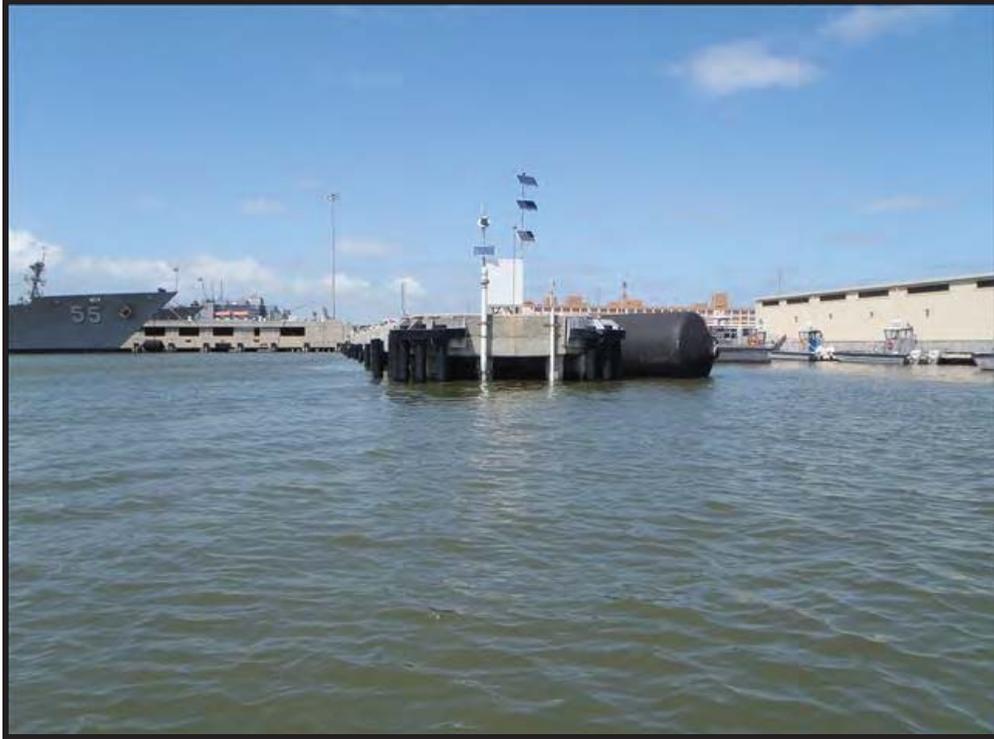
Photo 3.11-1: Overview of CEP169 Breakwater from basin, looking north.

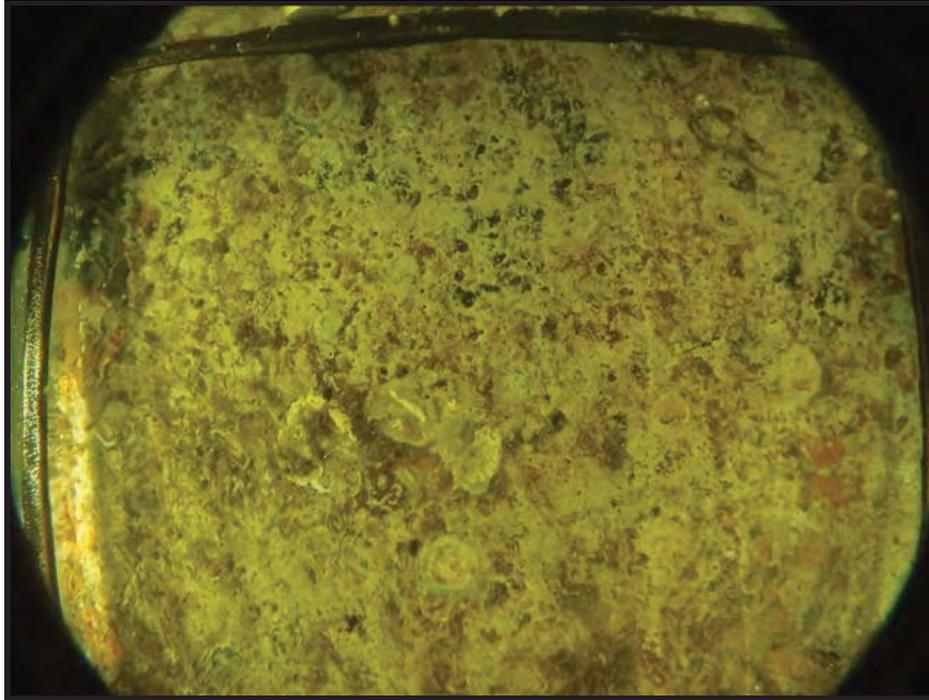
Photo 3.11-6: Typical condition of a vertical concrete pile below water.

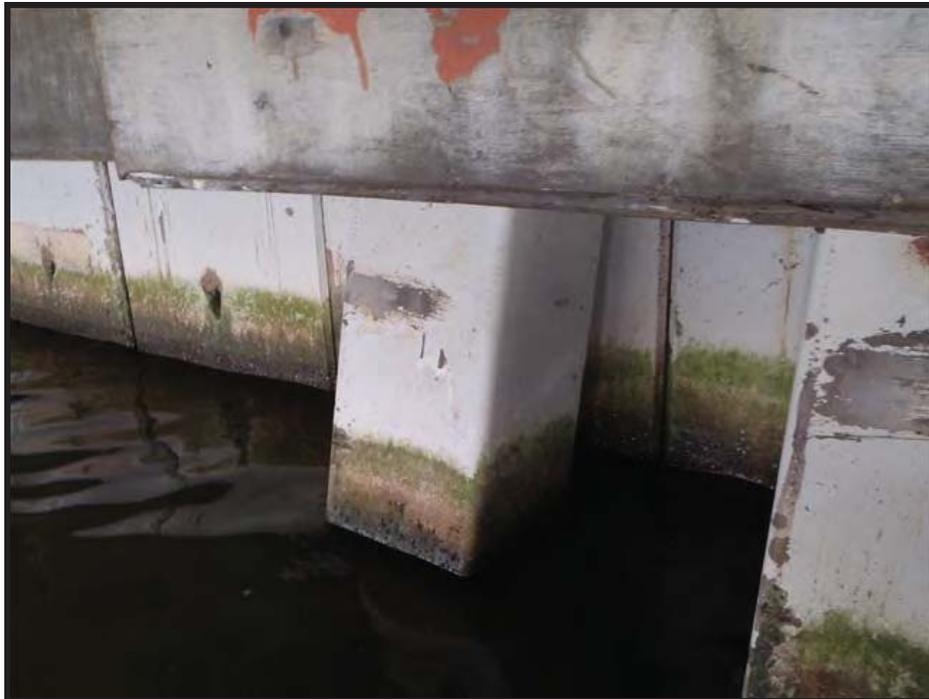
Photo 3.11-7: View of a battered 18 in. square concrete pile supporting the breakwater.

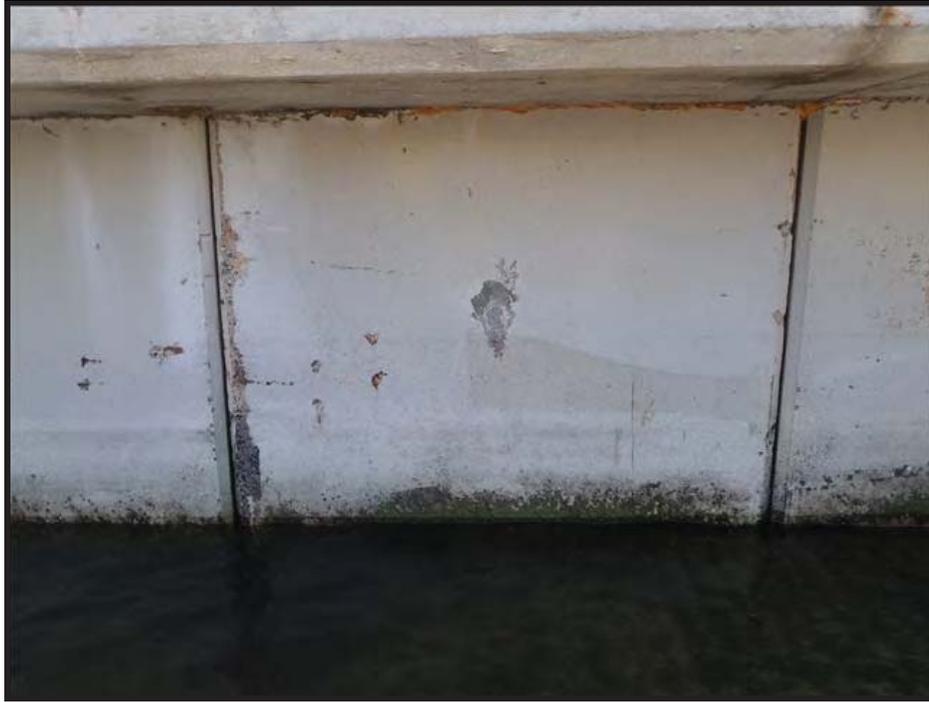
Photo 3.11-9: View of reinforced concrete sheet piles.

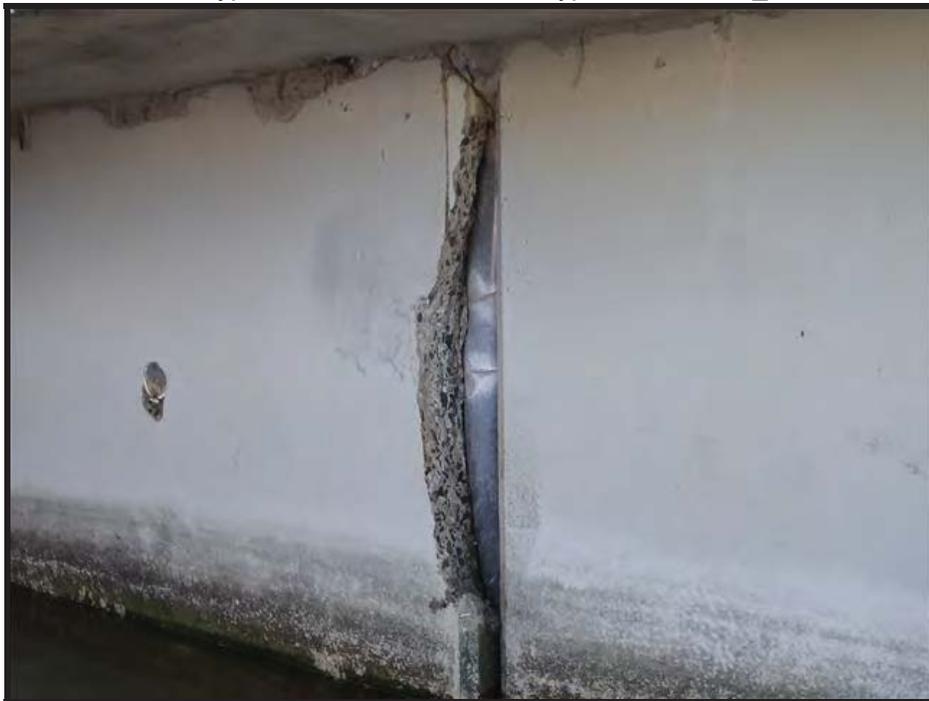
Photo 3.11-10: Open mechanical spall located at a concrete sheet pile joint.

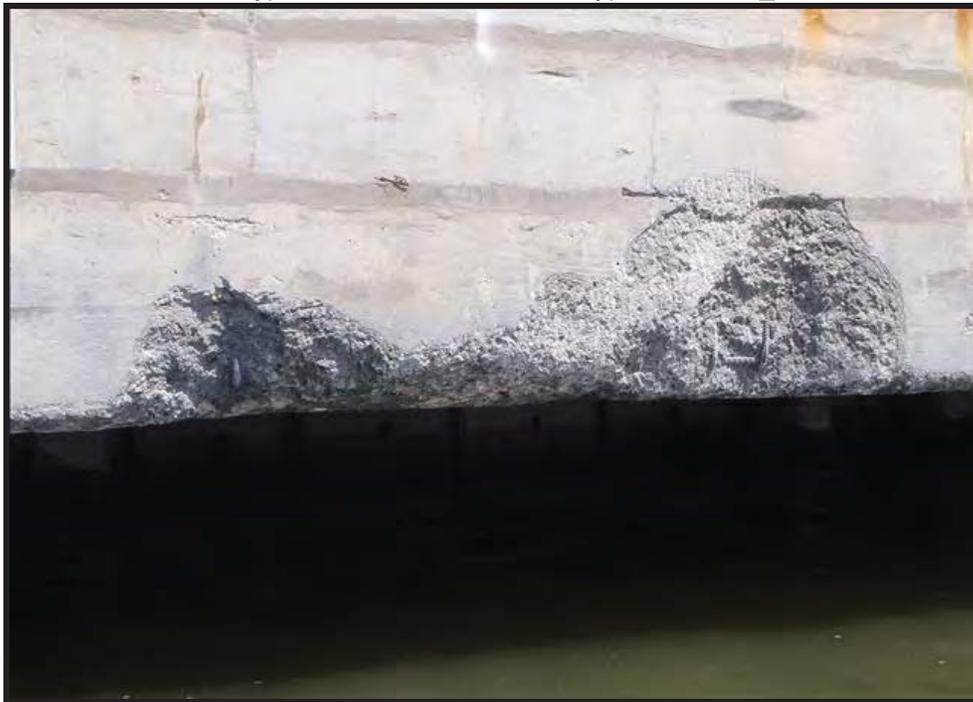
Photo 3.11-16: View of an open corrosion spall located on the outboard face of the pile cap with four exposed reinforcing bars.

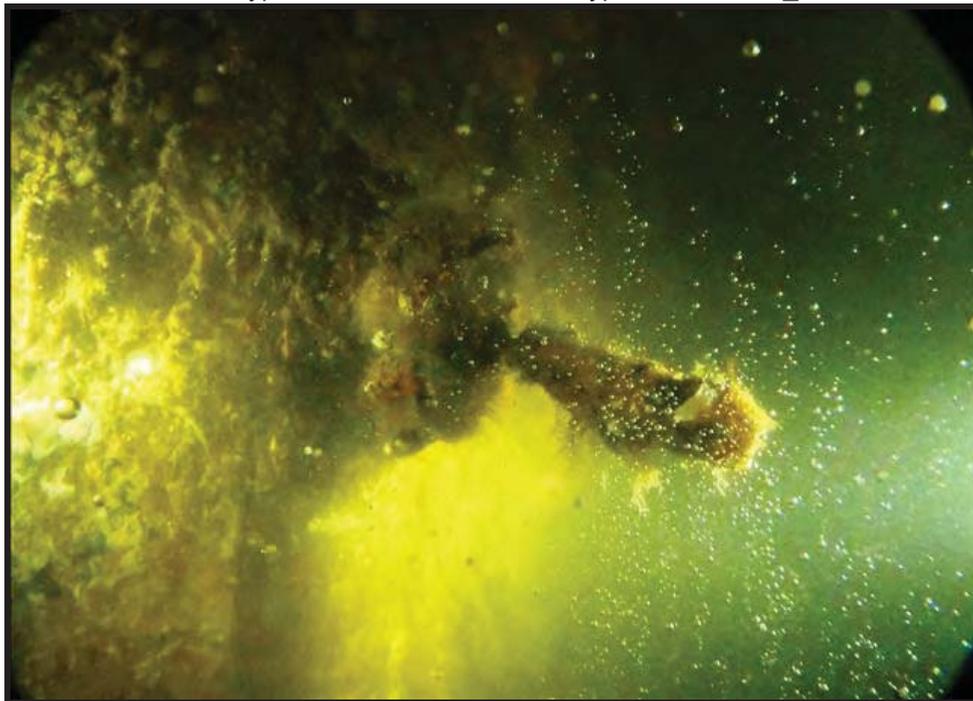
Photo 3.11-17: Underwater view of the unsecured tie rod.

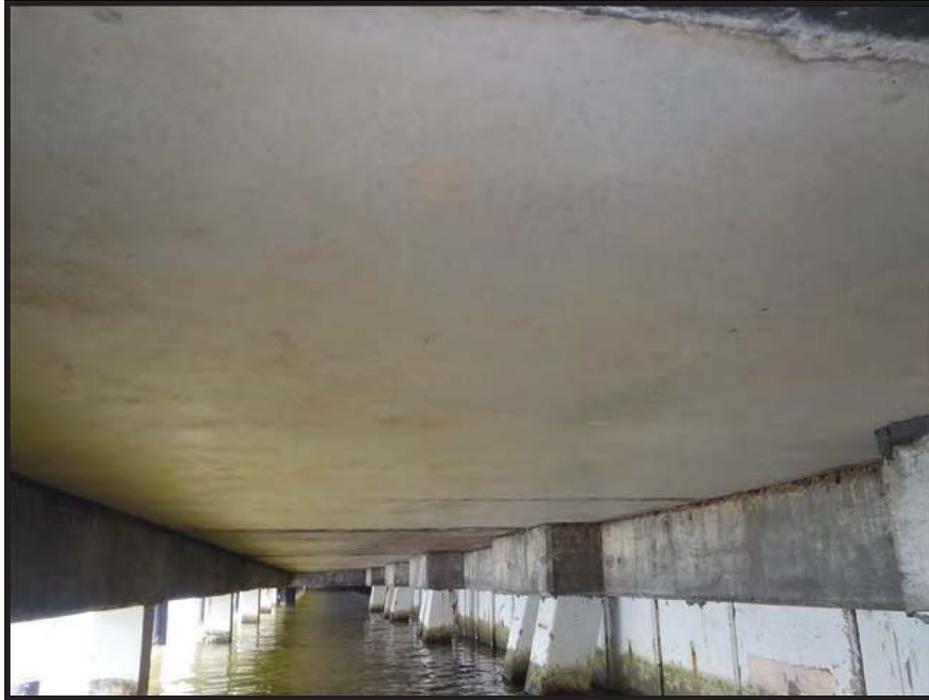
Photo 3.11-21: View of the underside of the deck.
