**CONTRACTOR REPORT
CR-NAVFAC EXWC-CIOFP-DRAFT
Volume II of III - Bulkheads**

**WATERFRONT FACILITIES
INSPECTIONS AND ASSESSMENTS AT
NORFOLK NAVAL STATION
NORFOLK, VIRGINIA**

On Site: Jan-29-2013

Norfolk Naval Station Norfolk, Virginia

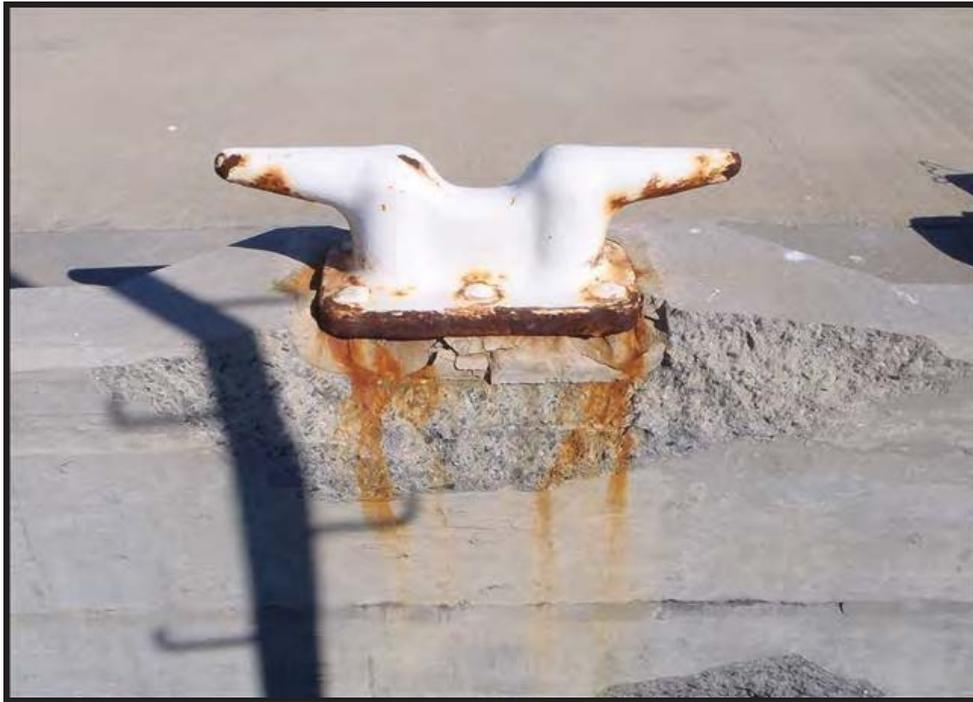
Photo 3.11-24: Open mechanical spall on the outboard side of a mooring foundation.

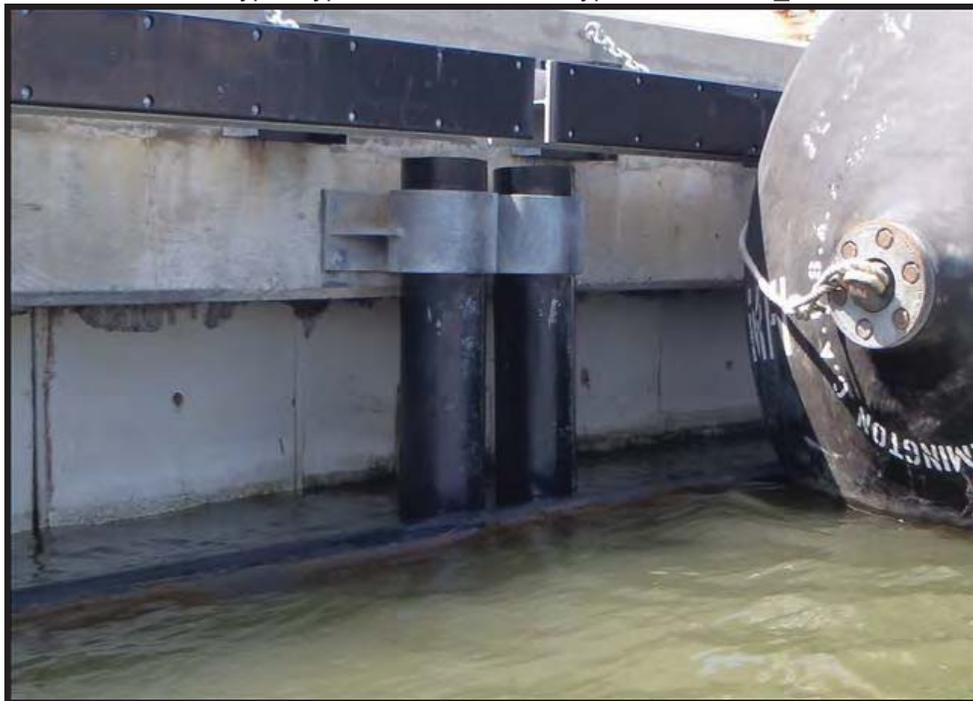
Photo 3.11-26: View of a fiberglass reinforced HDPE fender pile cluster.

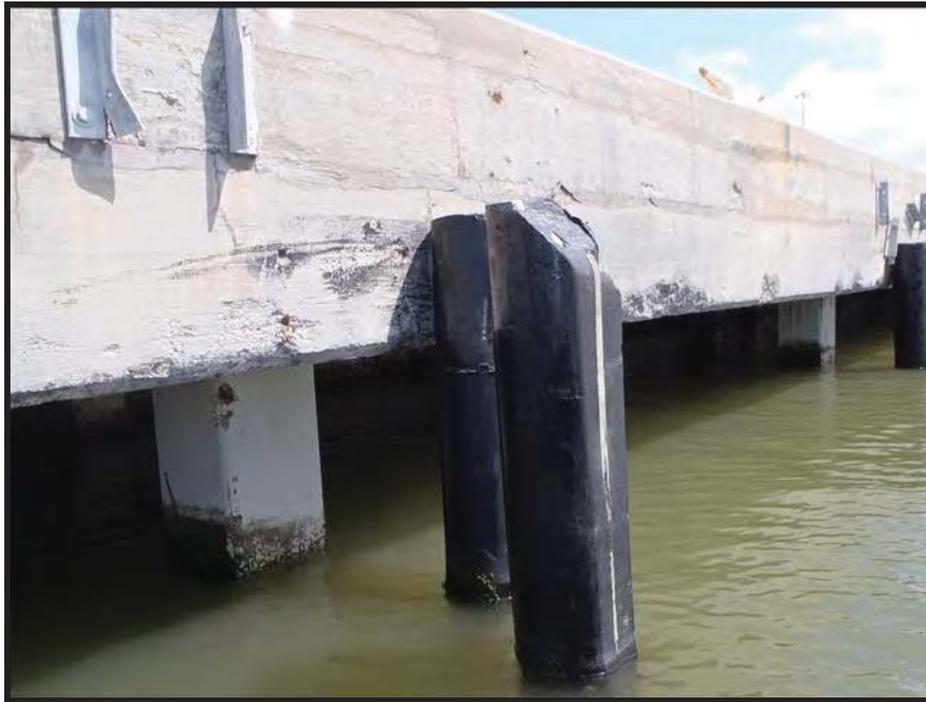
Photo 3.11-27: View of a detached and broken fender pile cluster.

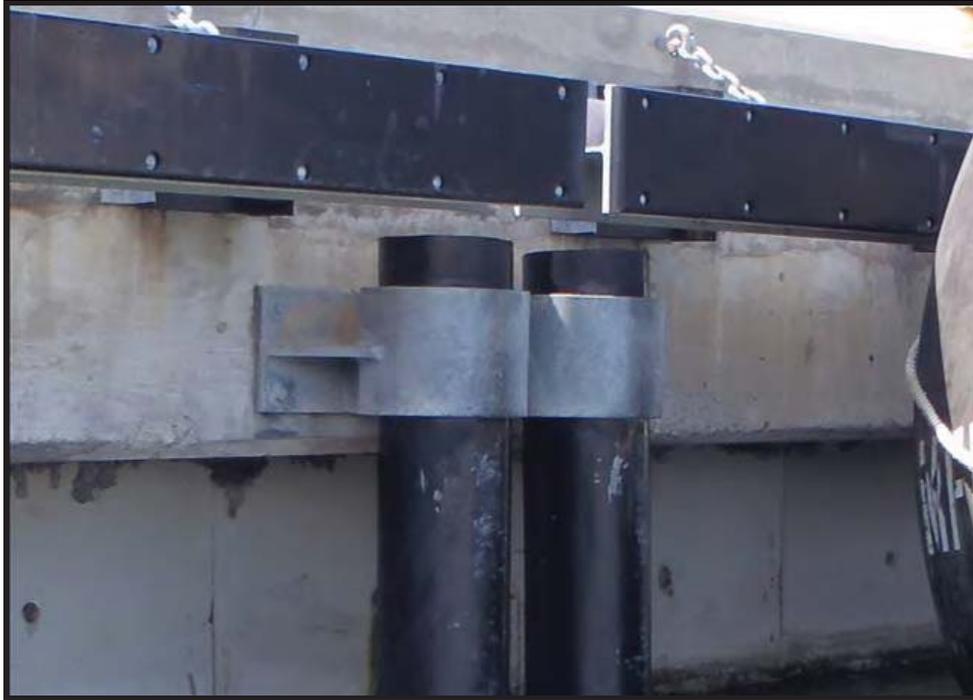
Photo 3.11-30: View of a galvanized steel fender pile guide assembly.

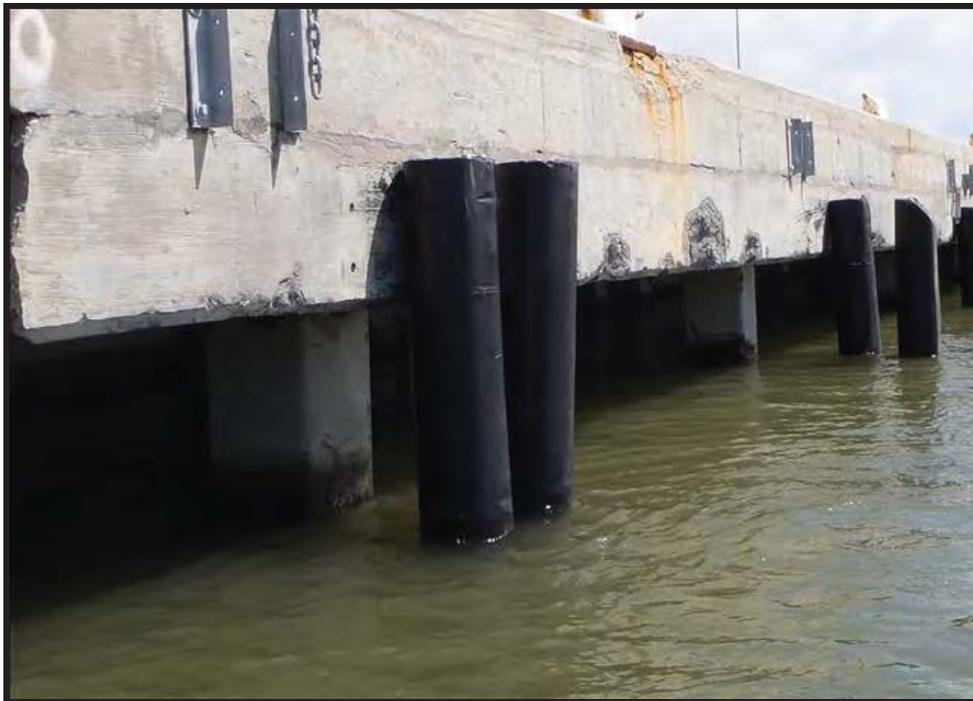
Photo 3.11-31: View of detached piles as the result of a missing pile guide assembly.

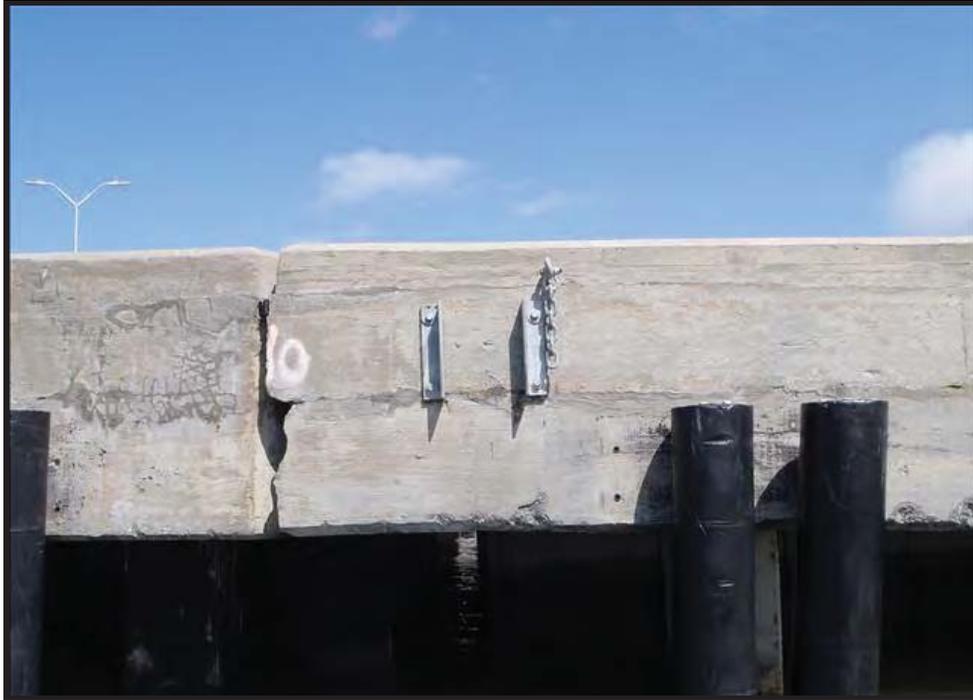
Photo 3.11-33: View of a typical missing molded fender.

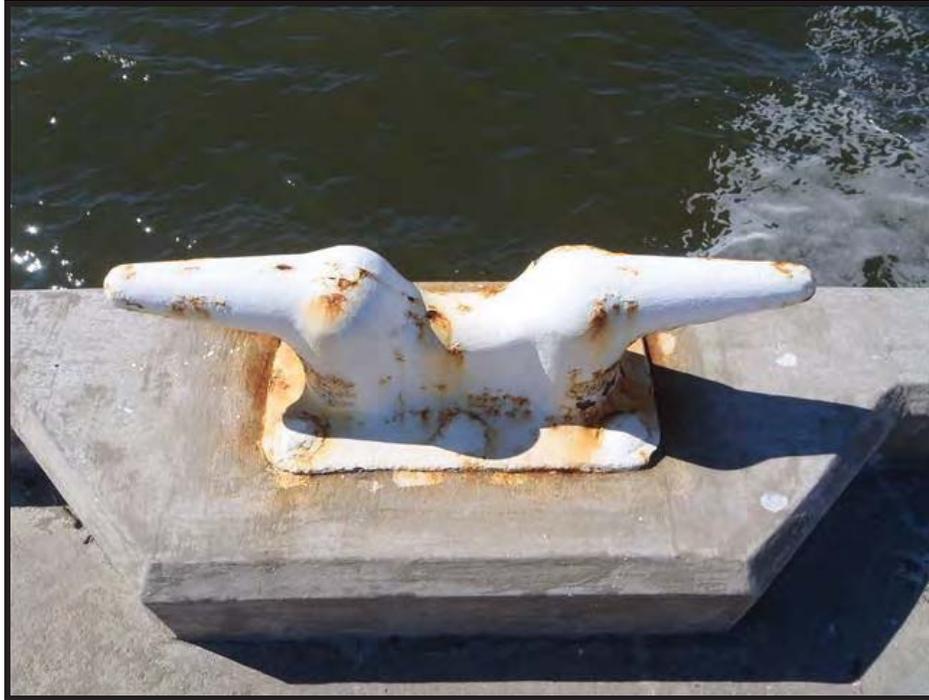
Photo 3.11-38: View of a typical 42 in. cleat.

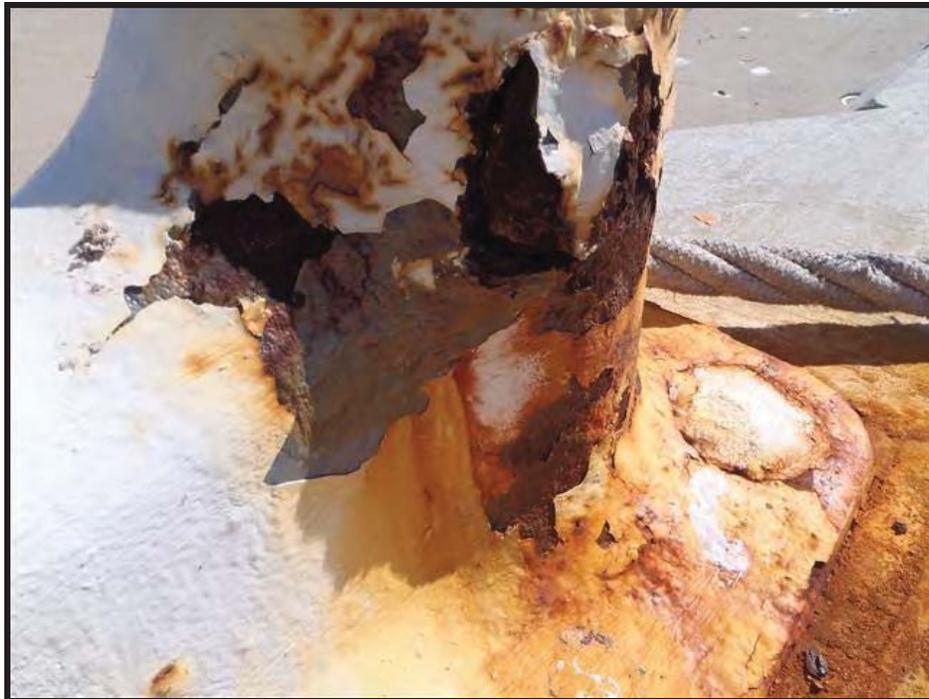
Photo 3.11-39: View of heavy corrosion and visible section loss on a 42 in. cleat.

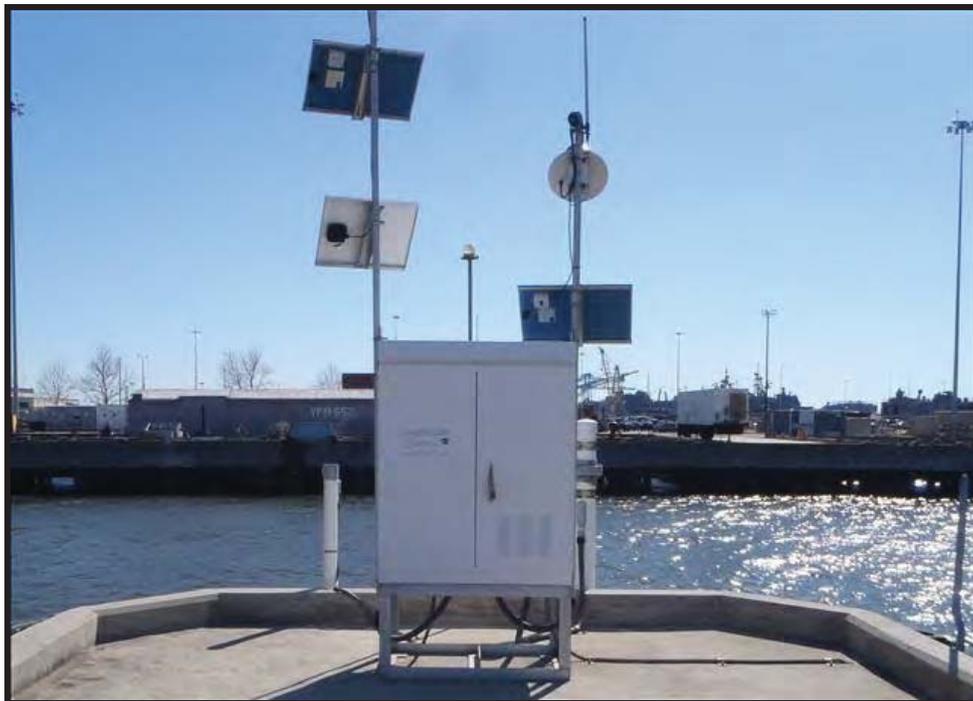
Photo 3.11-42: View of the water level gauge station.

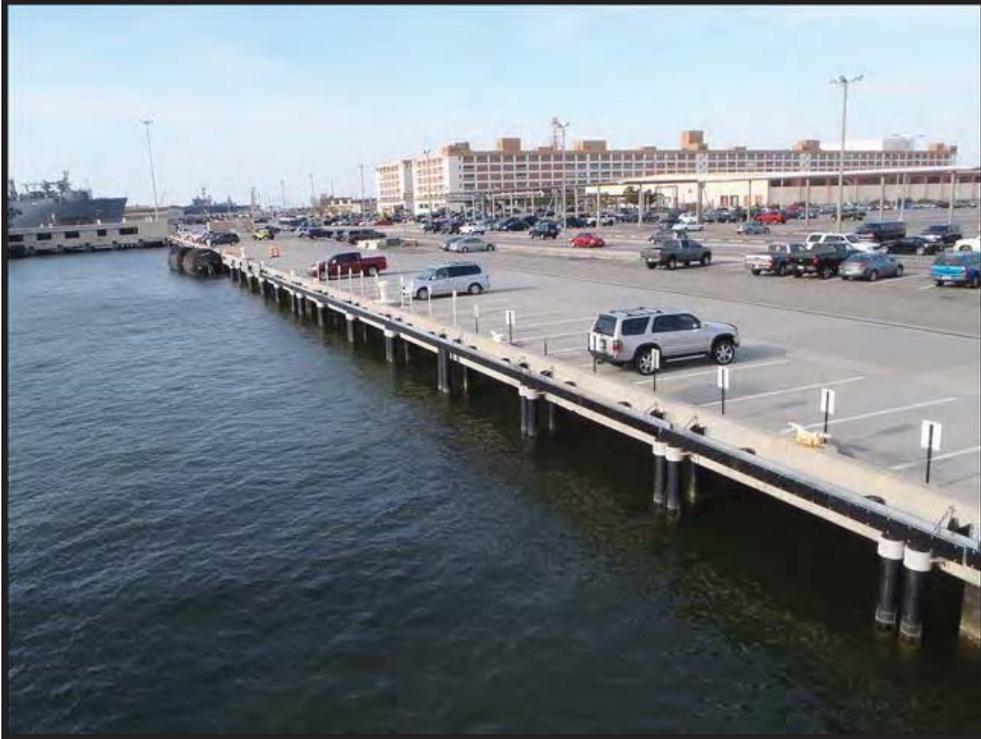
Photo 3.12-1: Overview of Z308 Bulkhead and Platform near Sta. 3+00, looking north.

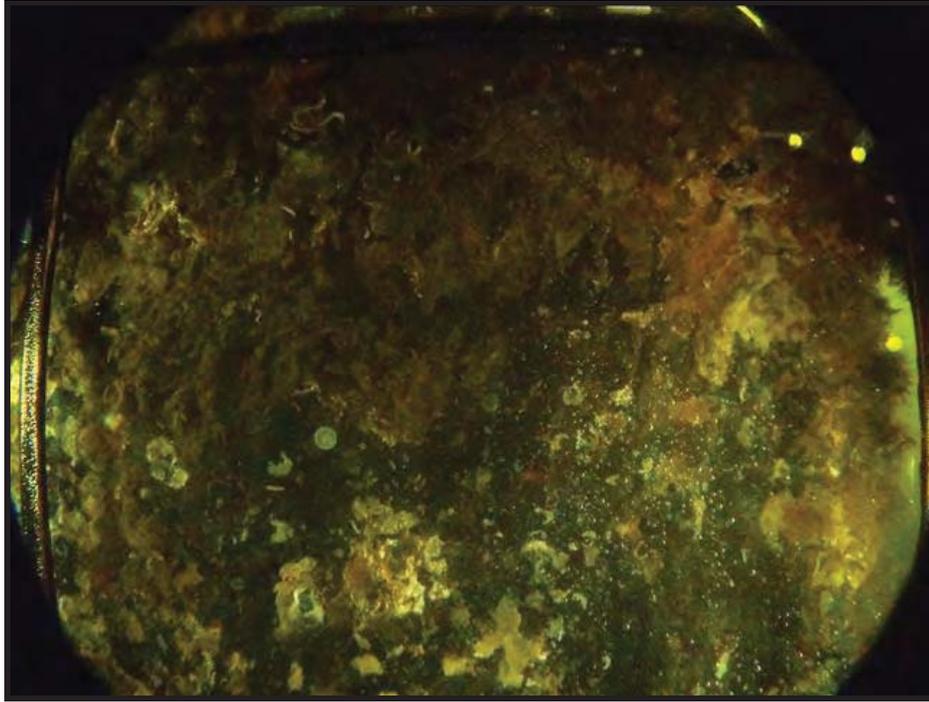
Photo 3.12-8: Typical condition of a concrete pile below water.

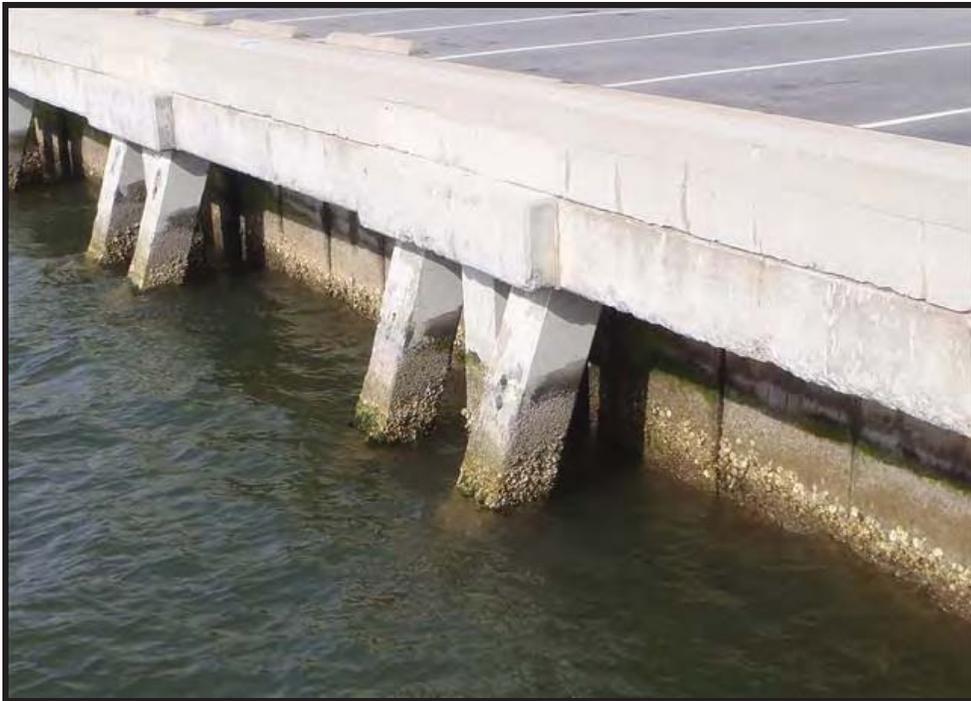
Photo 3.12-9: View of the concrete piles supporting the bulkhead.

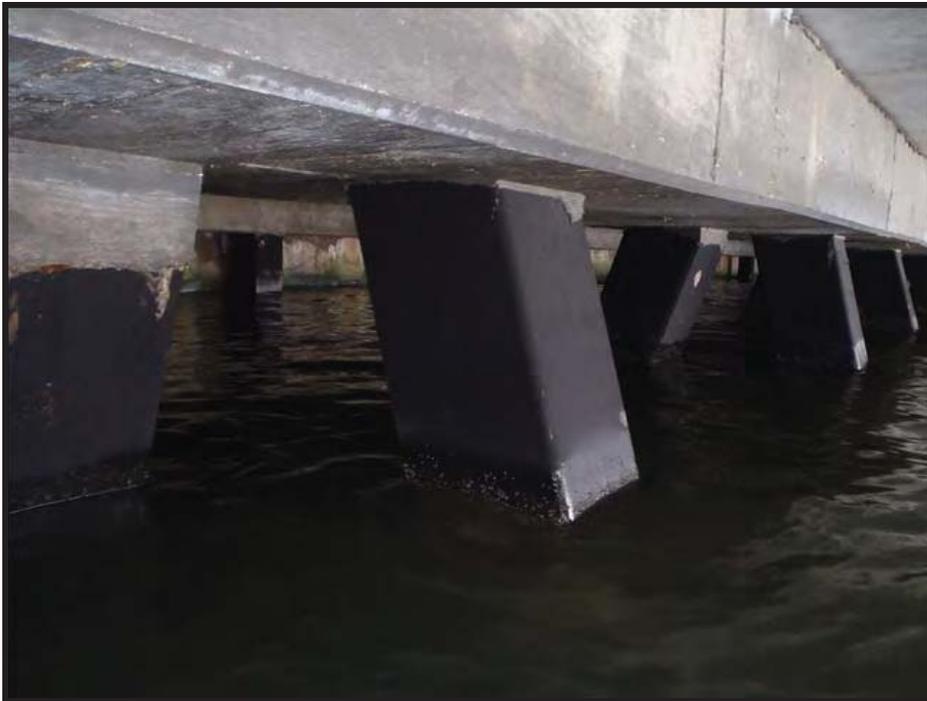
Photo 3.12-11: View of a battered 18 in. square concrete pile supporting the platform.

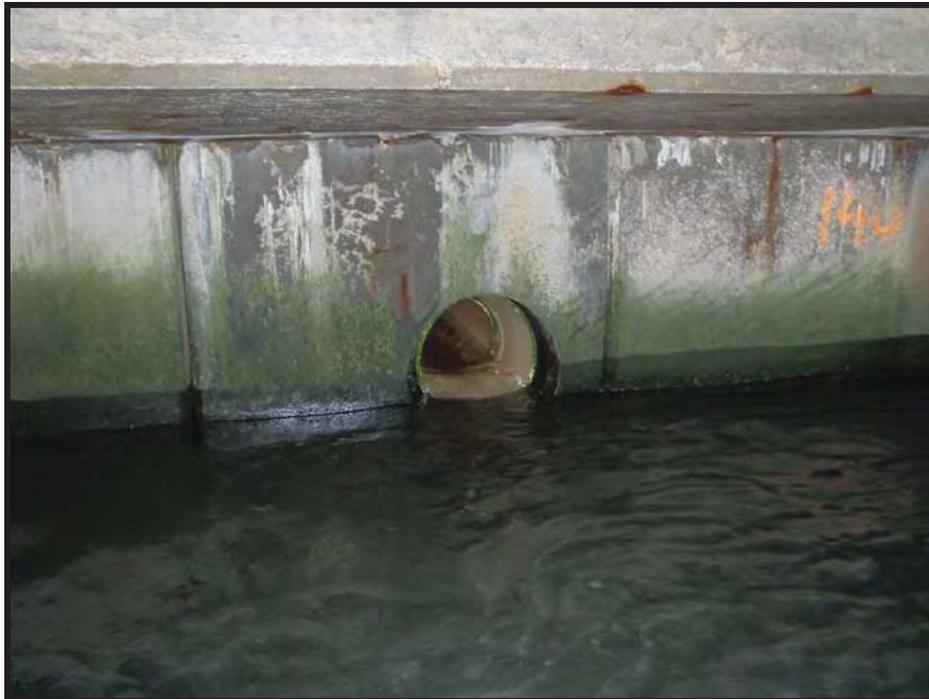
Photo 3.12-13: View of an outfall pipe in the reinforced concrete sheet piles.

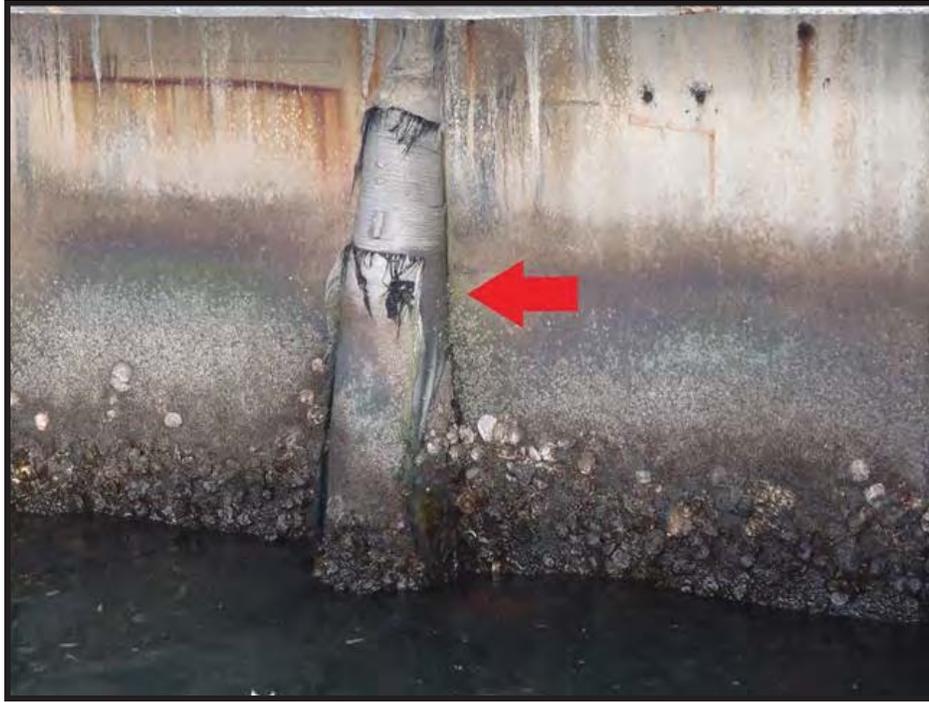
Photo 3.12-14: View of joint backing material penetrating through a gap in the concrete sheet piles.

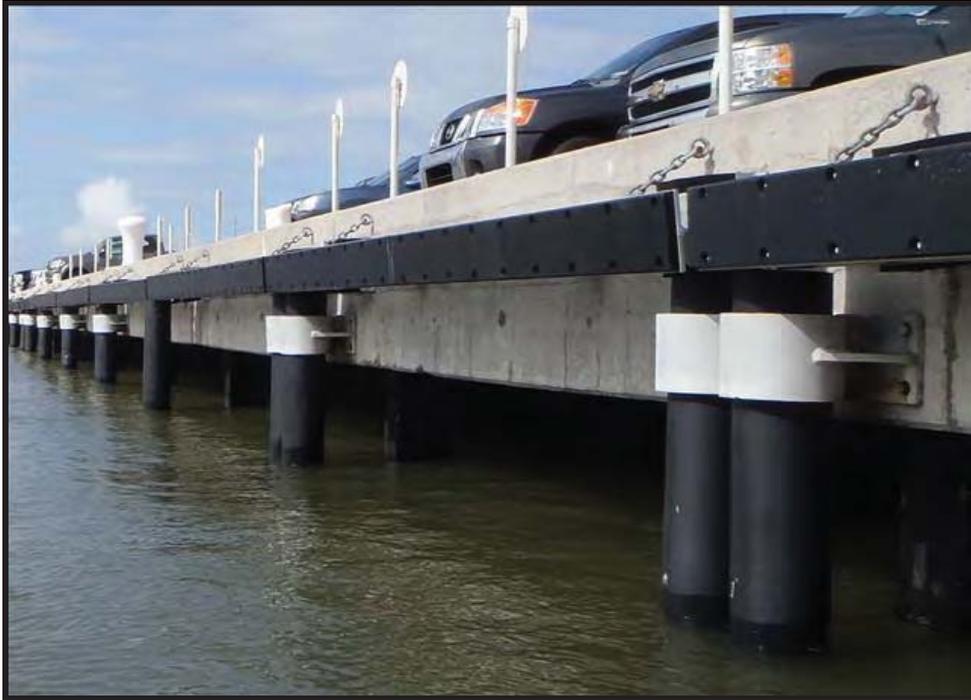
Photo 3.12-15: Overview of the pile cap supported by the outboard platform piles.

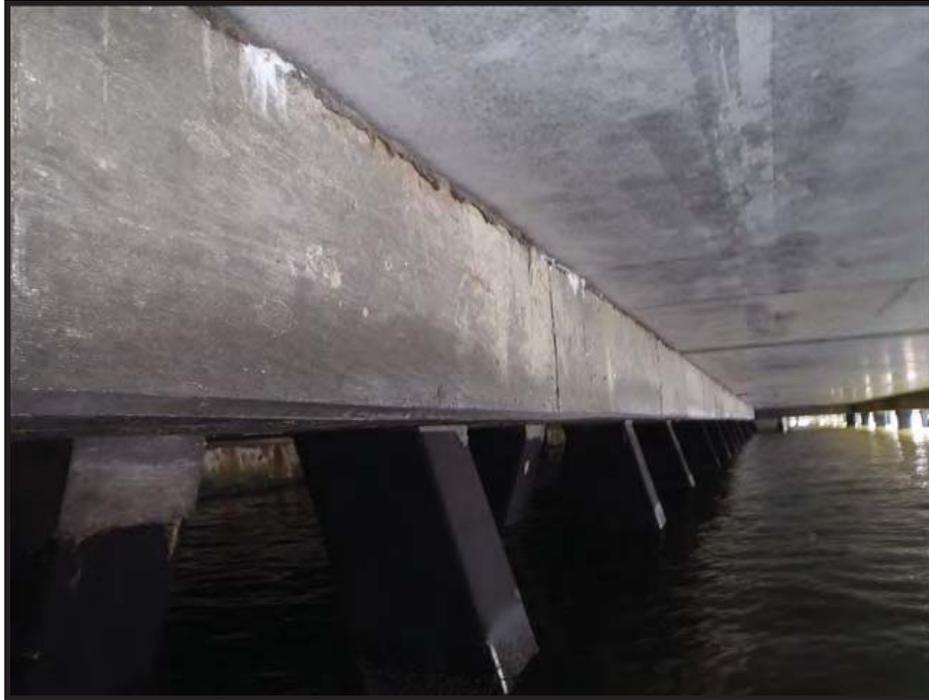
Photo 3.12-17: View of the pile cap supported by the middle row of platform piles, typical from Sta. 0+00 to Sta. 8+42.

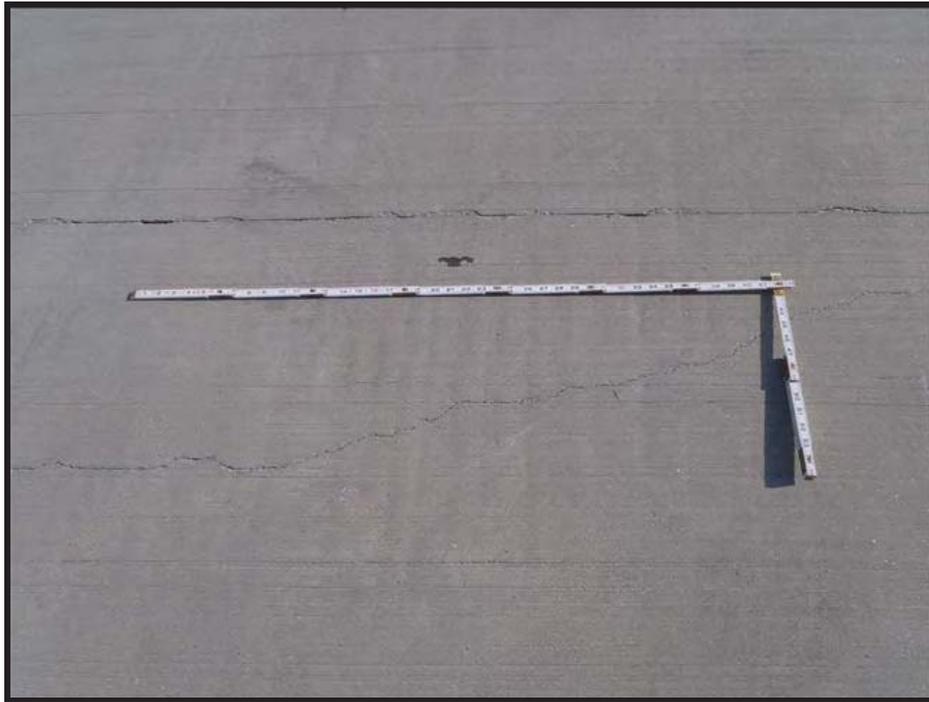
Photo 3.12-22: Typical hairline crack located on the topside of the deck.

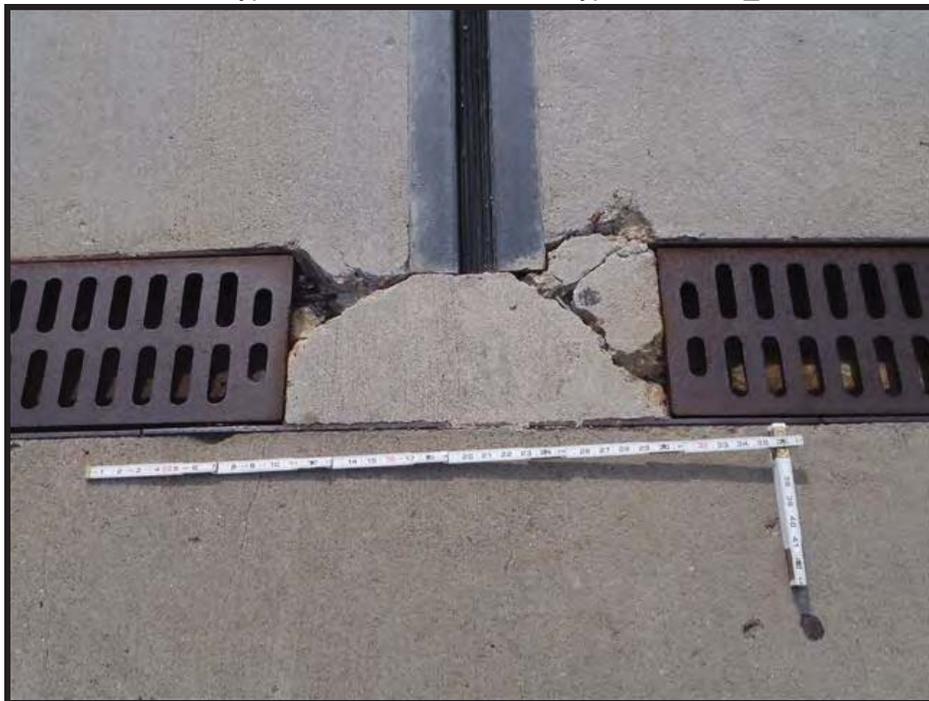
Photo 3.12-23: Open mechanical spall located on the topside of the deck at an expansion joint.

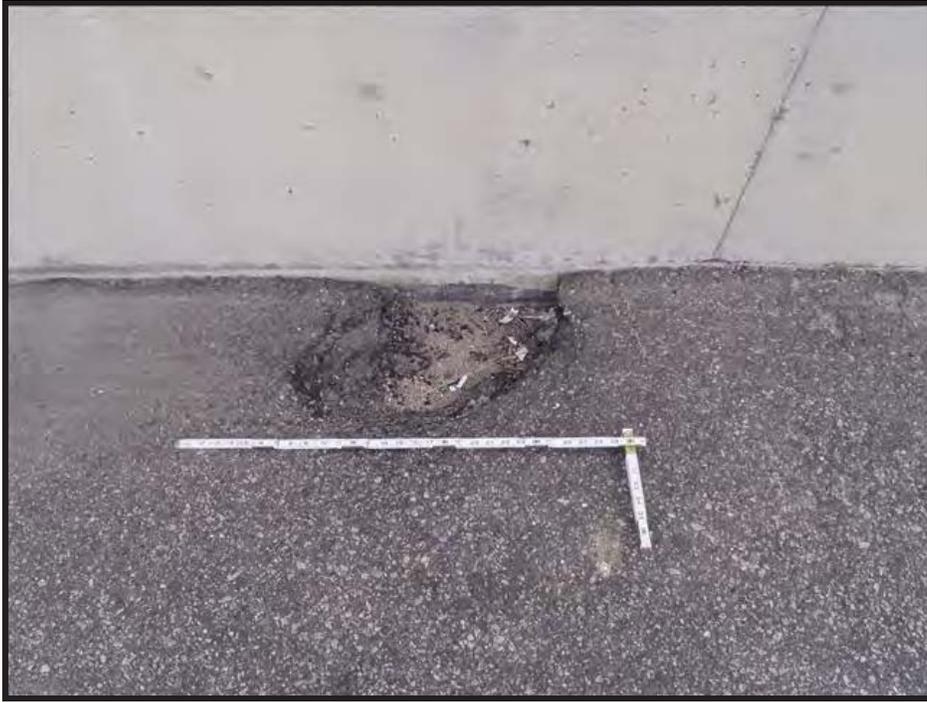
Photo 3.12-24: Pothole located in the asphalt near Pier 7.

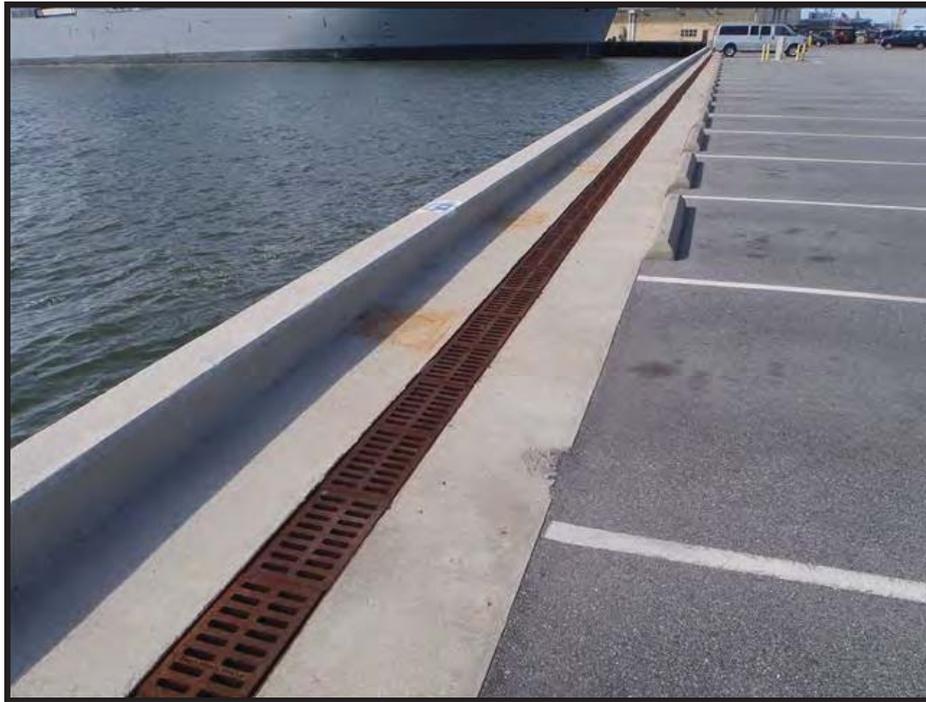
Photo 3.12-26: View of the reinforced concrete curb.

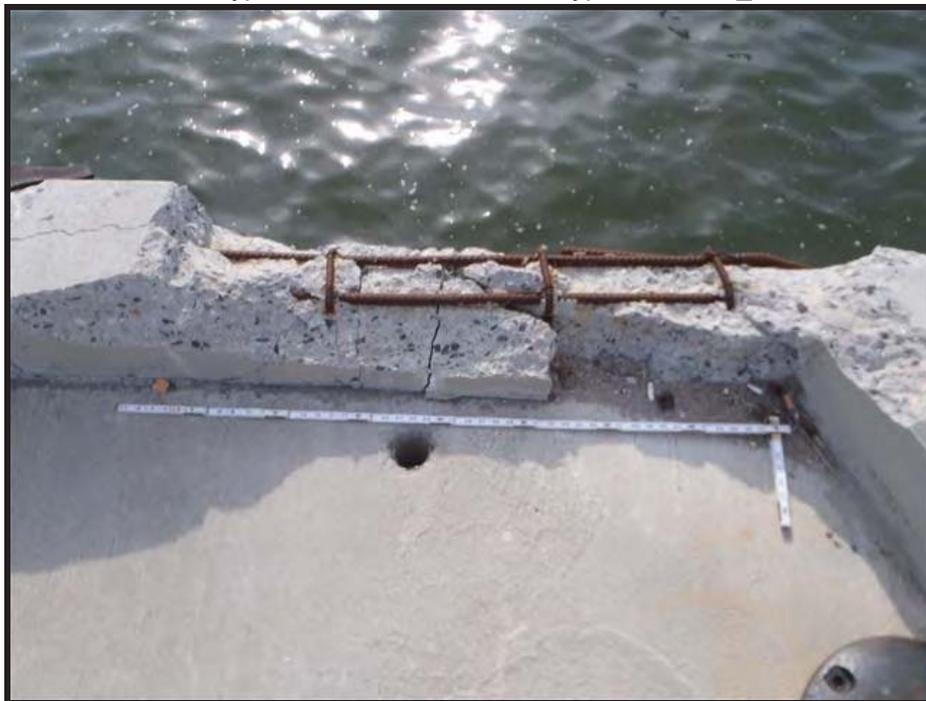
Photo 3.12-27: Spall located on the curb as a result of impact damage with six exposed reinforcing bars.

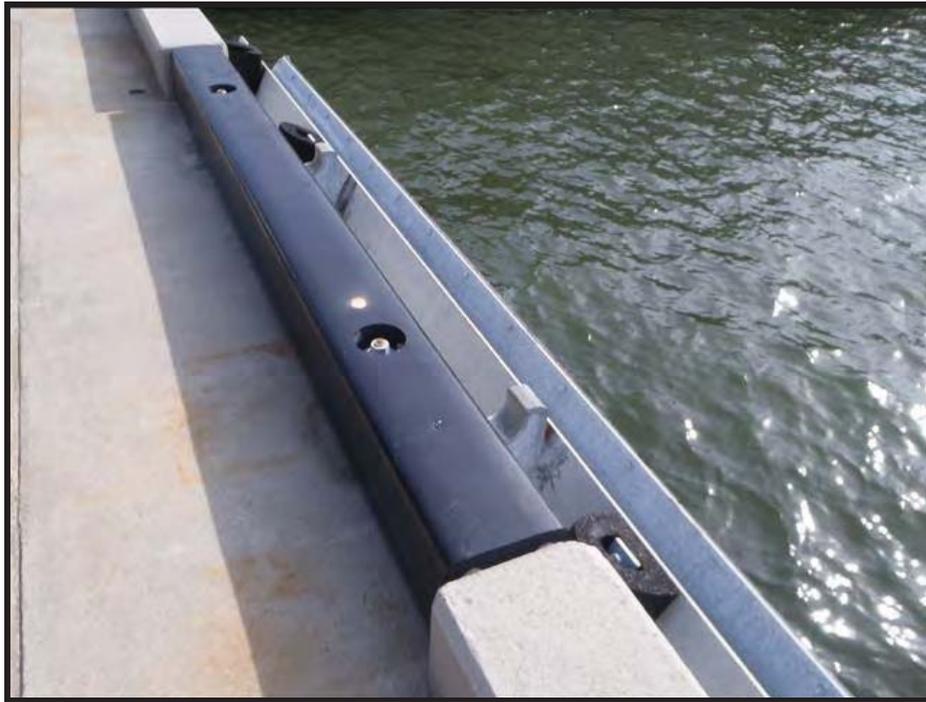
Photo 3.12-28: View of a HDPE curb section.

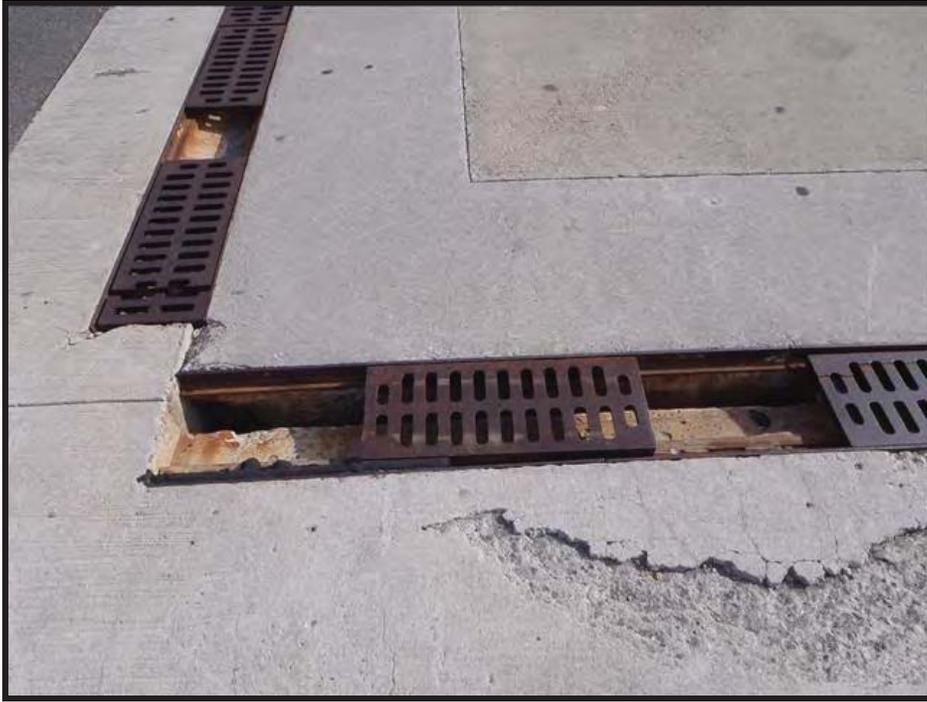
Photo 3.12-39: View of loose and missing deck drain covers at Sta. 8+40.

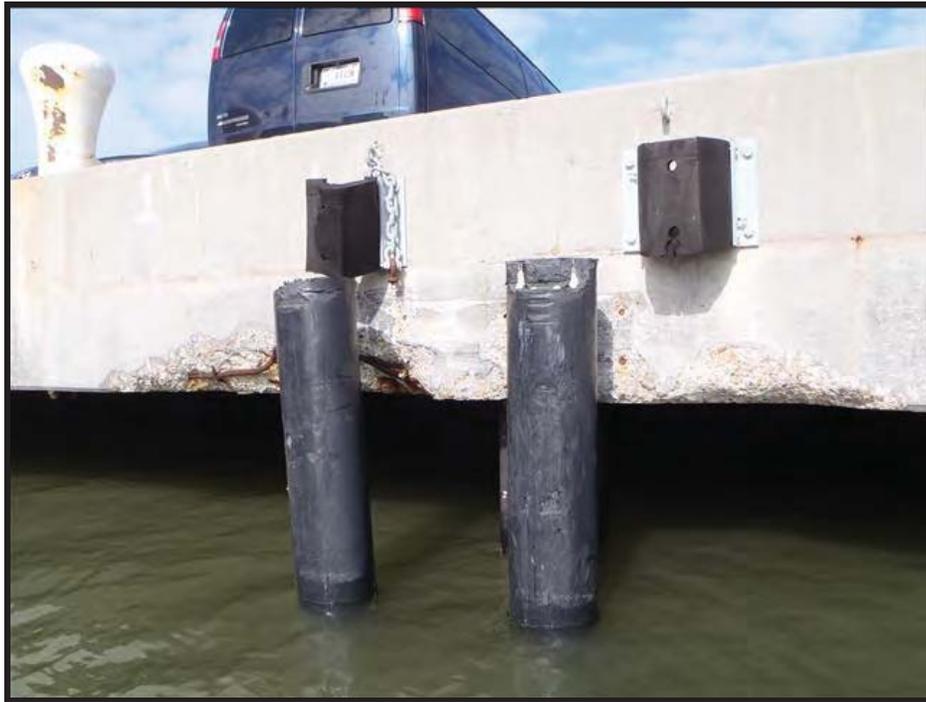
Photo 3.12-41: View of a typical detached fender pile cluster along the platform as a result of missing pile guide supports.

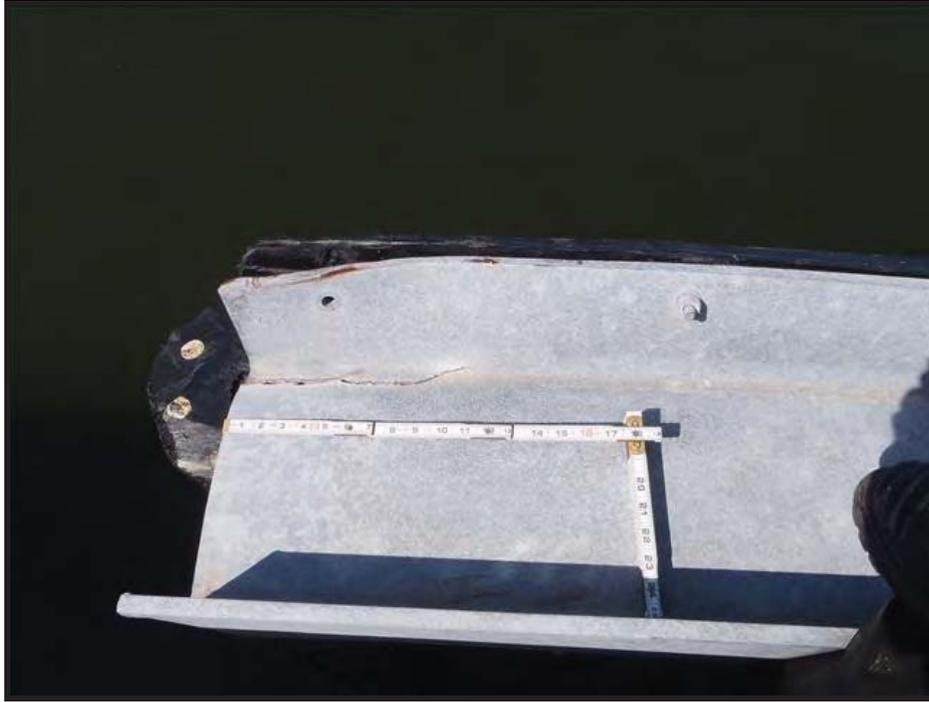
Photo 3.12-46: View of impact damage located on a fender wale at Sta. 12+75.

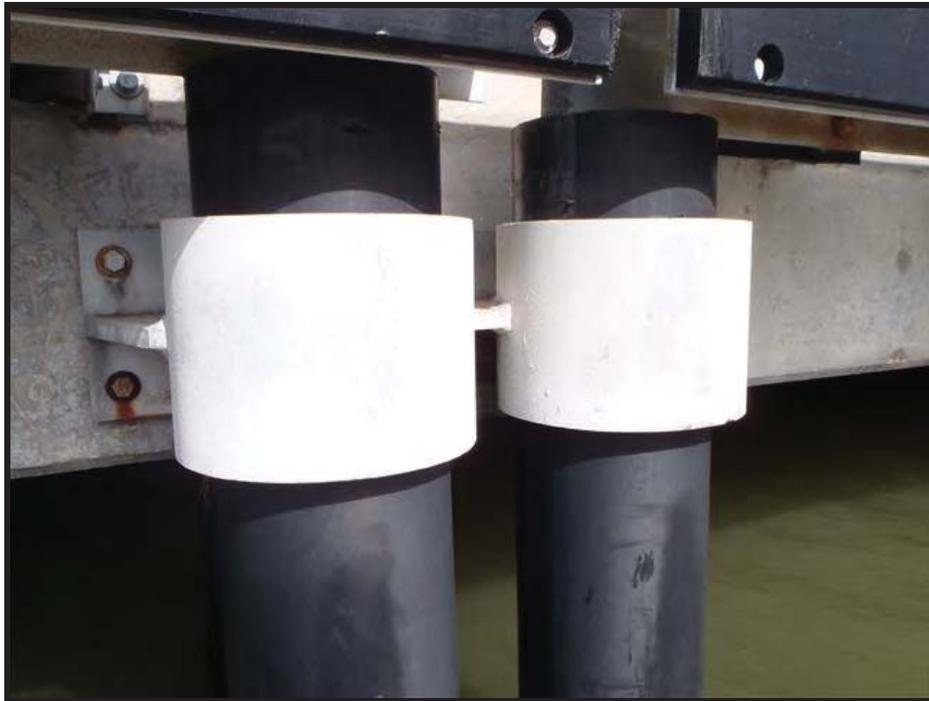
Photo 3.12-47: View of a galvanized steel fender pile guide assembly.

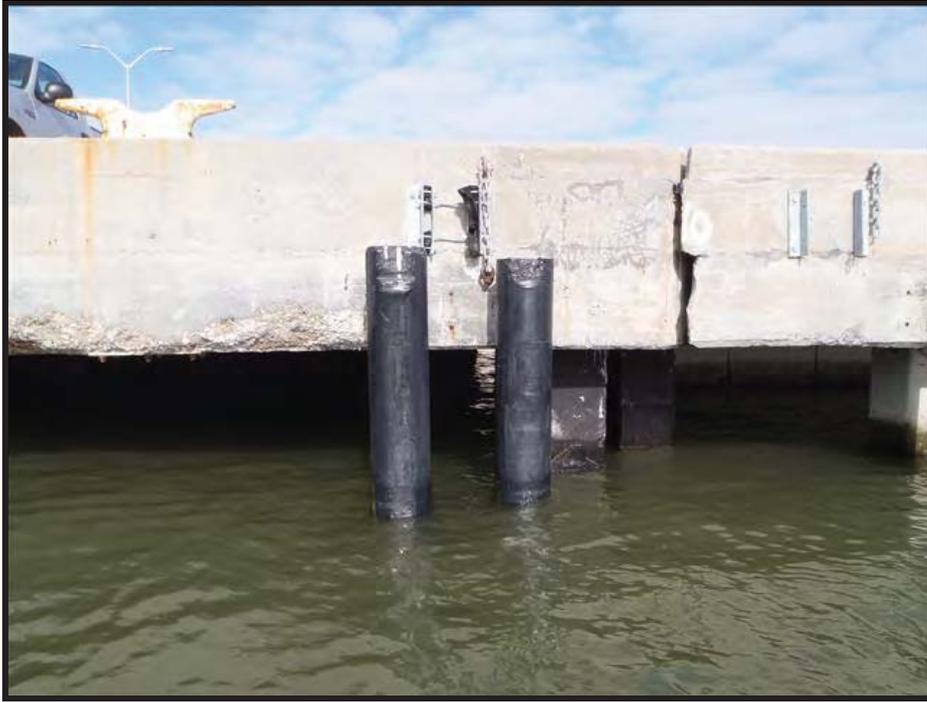
Photo 3.12-48: View of detached piles as the result of a missing pile guide assembly.

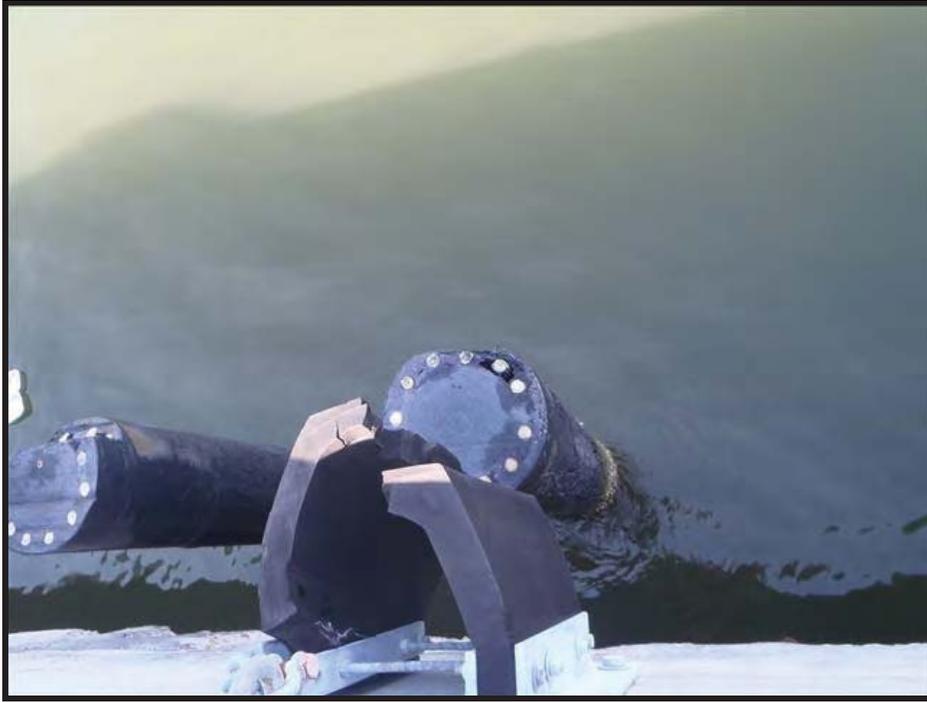
Photo 3.12-50: View of a typical broken and non-functioning rubber fender.

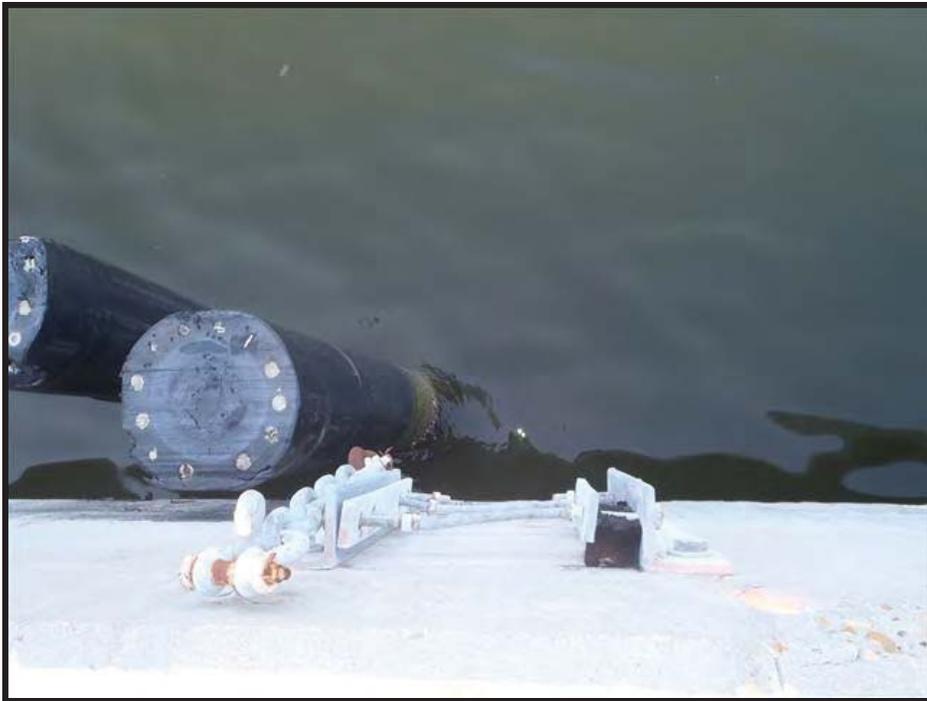
Photo 3.12-51: View of a typical missing rubber fender.
