PART SIX – ATTACHMENTS

**P707 Embassy Security Guard, BEQ and
Ops Facility**

Marine Corps Base, Quantico, Virginia

RFP, 5 May 2016

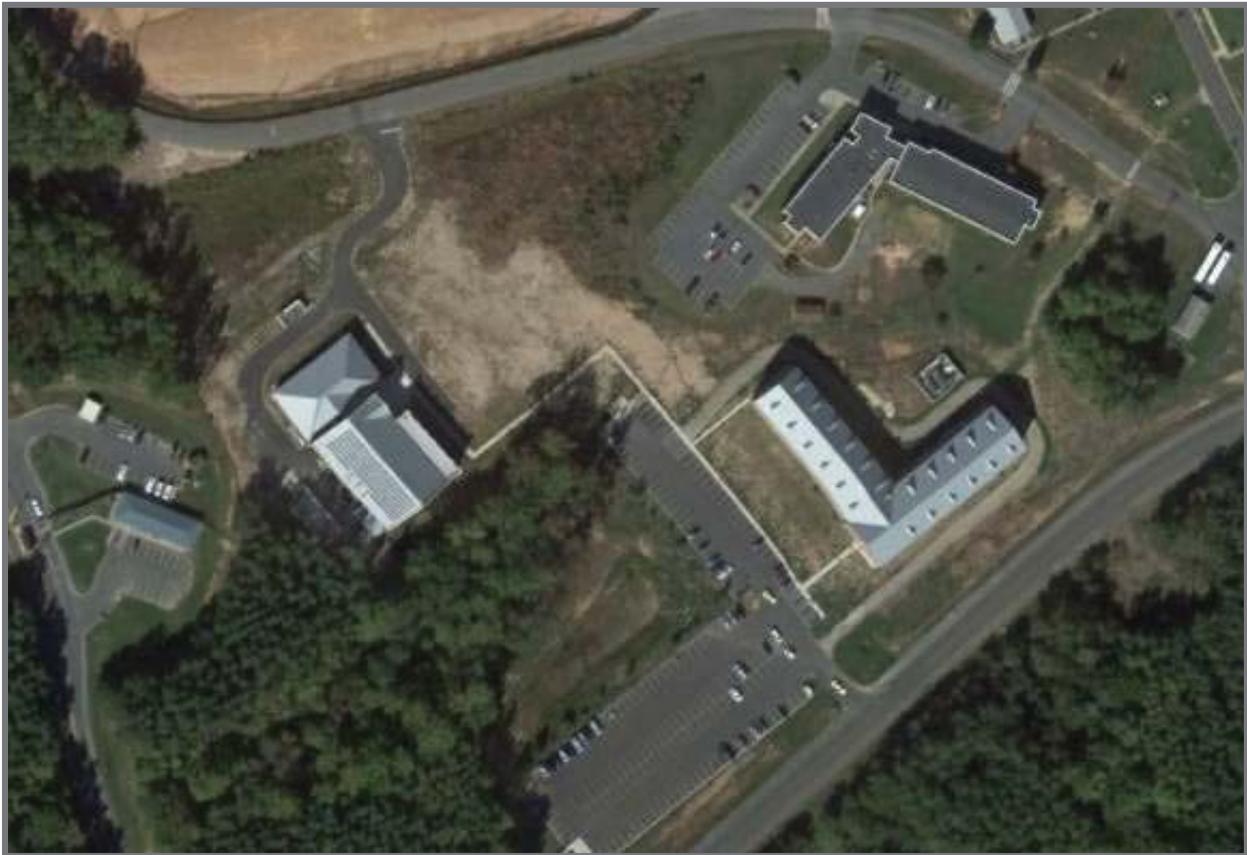
Figure 1: Site Vicinity Map

The site is located at the intersection of Browning Road and Garand Road at the Marine Corps Base in Quantico, Virginia. A site vicinity map is included as Figure 1 at the end of this report. The existing building is approximately 30,460 SF, with surrounding parking lots. The elevation (EL) at the site ranges from approximately EL 330 to EL 341.

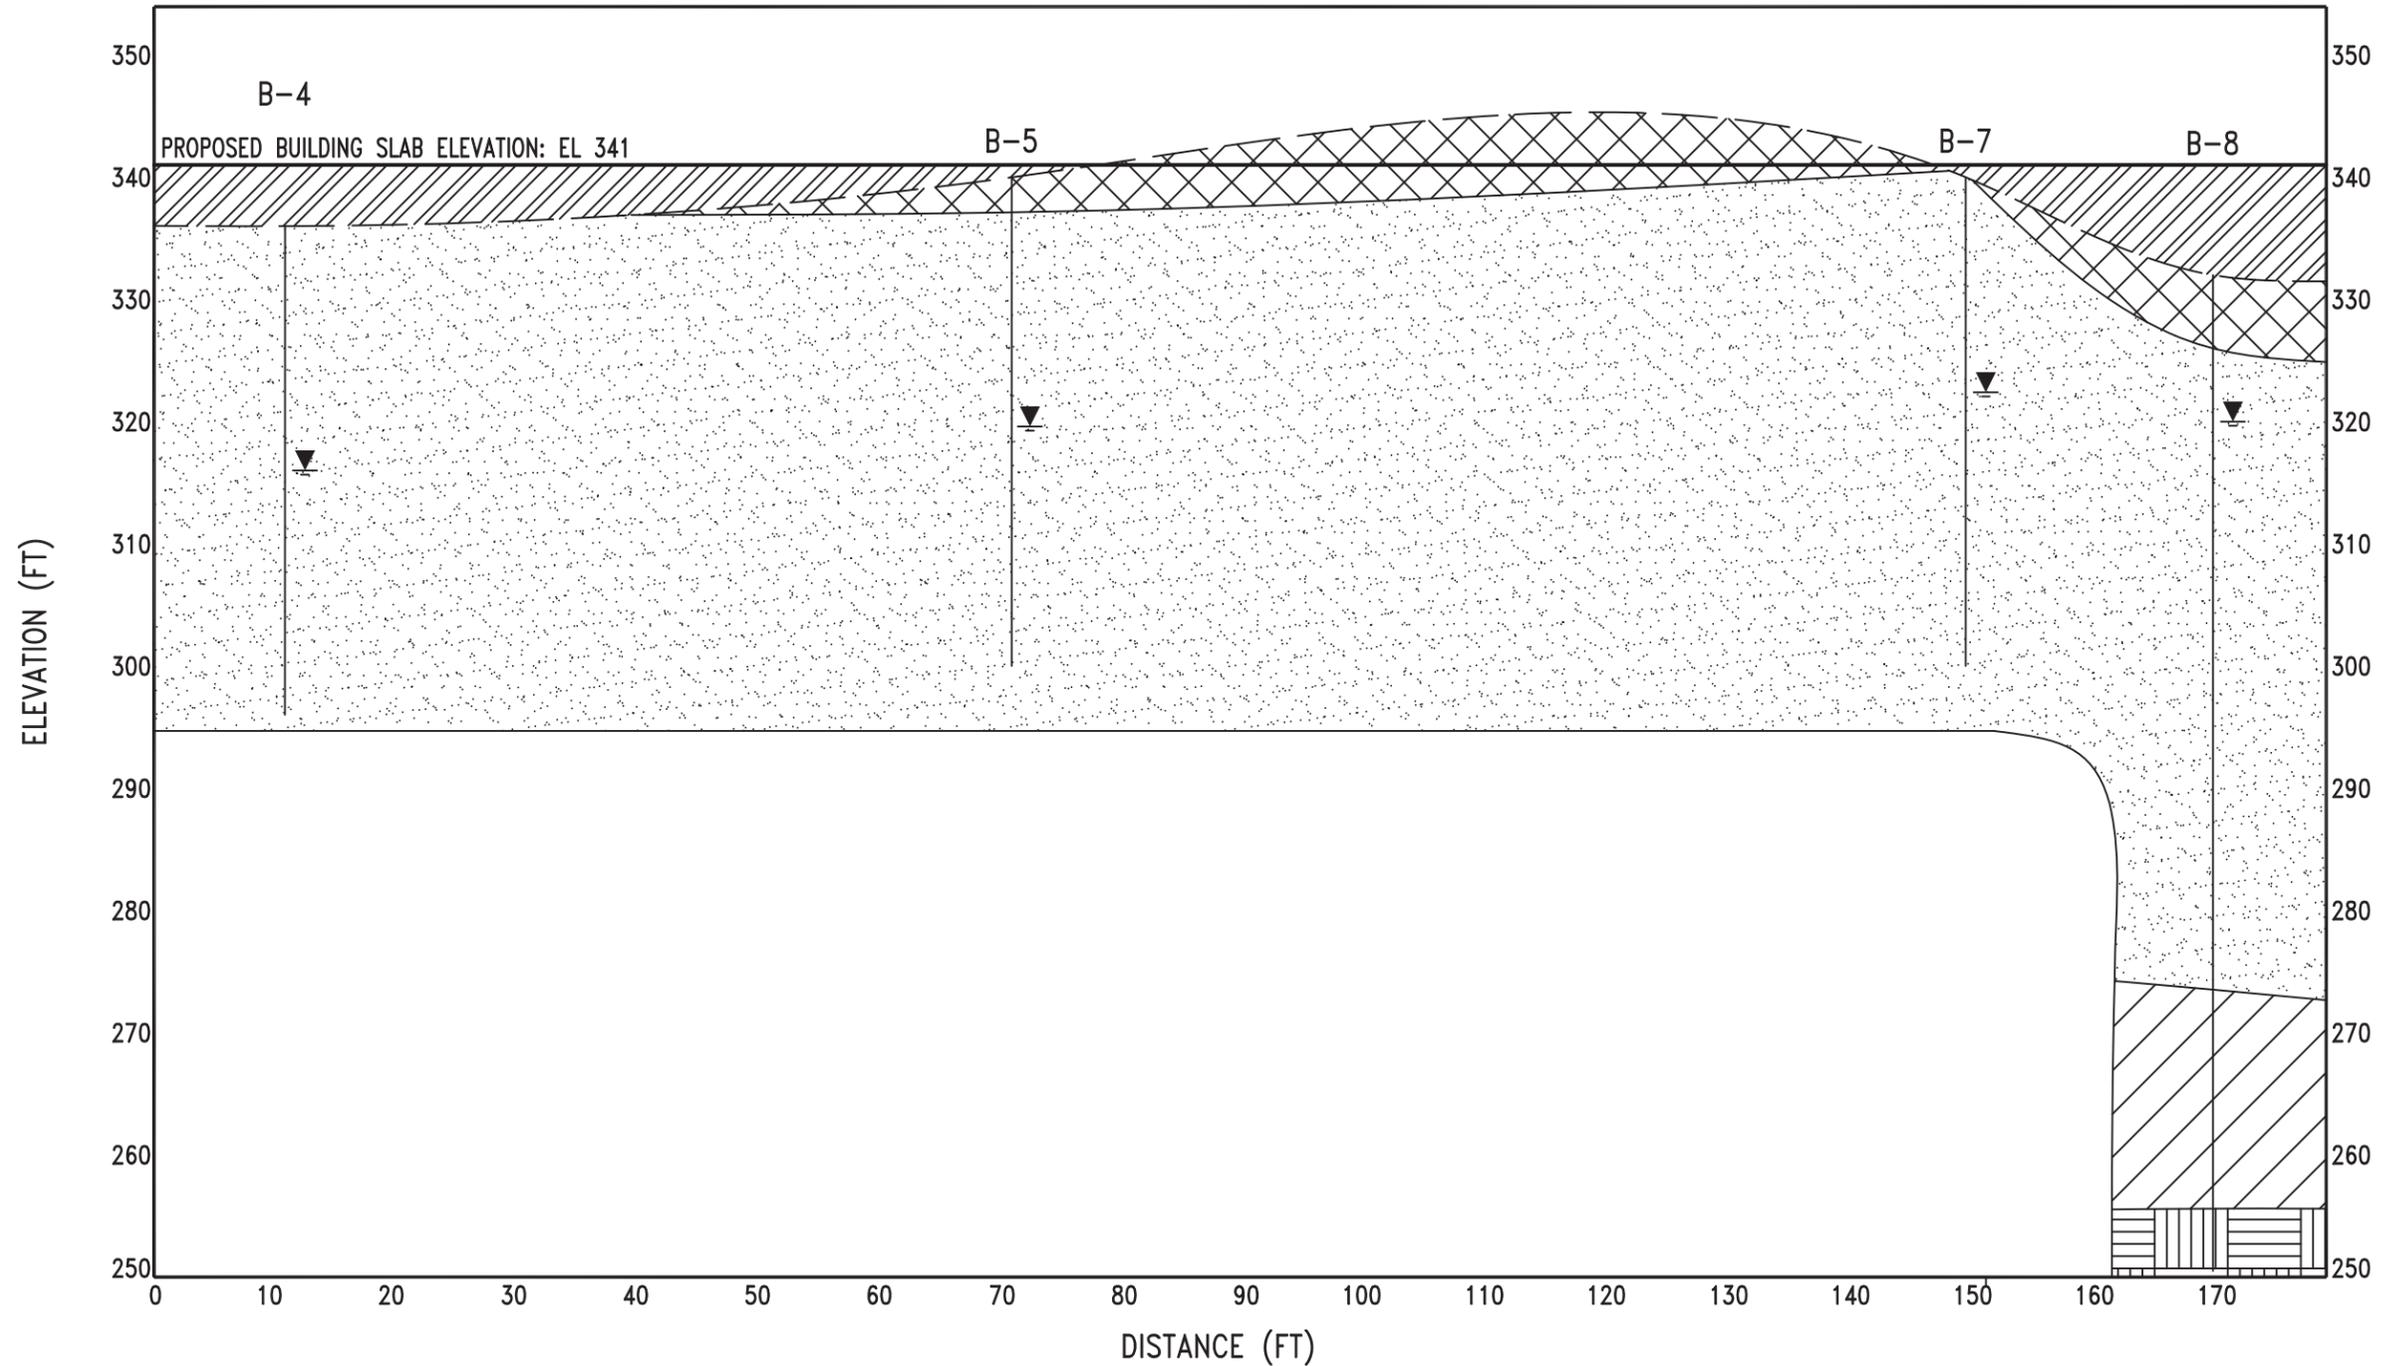
Two estimated subsurface diagrams A-A' and B-B' have been prepared to illustrate the subsurface conditions indicated by the test borings and their relations to the proposed building grades. The subsurface diagrams are presented as Figures 2 and 3 in Appendix A, with the diagram locations presented on Figure 4 in Appendix A.

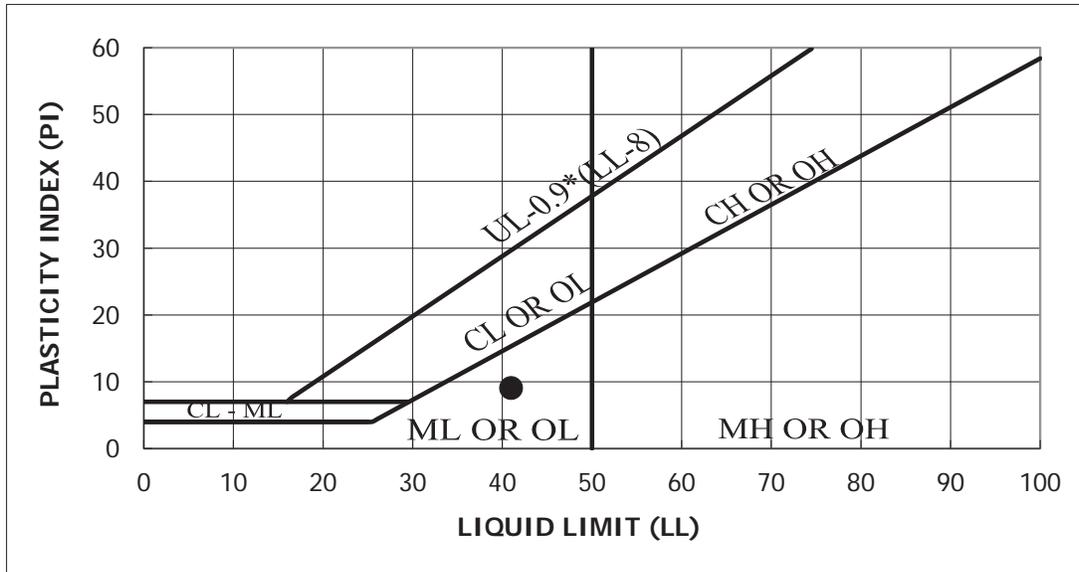
LIQUID AND PLASTIC LIMIT - ASTM D4318			
Project No.	13216.03	Project Name	Embassy Security BEQ and Ops Facility
Test Boring No.	B-3	Depth (Feet)	1.0'-3.0'
Lab Order No.	3712-1	Date	1/19/2016

Material Description	LL	PL	PI	% Passing		USCS	w (%)
				#4	#200		
SILTY SAND	41	32	9	100.0	46.1	SM	15.5
Color	Brown		AASHTO Classification		A-5

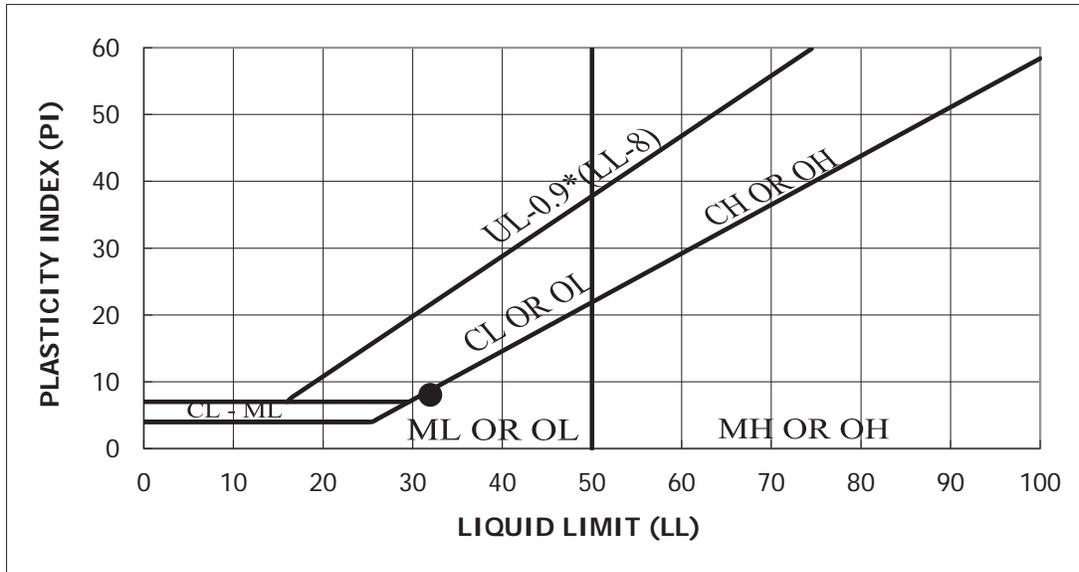
LIQUID AND PLASTIC LIMIT - ASTM D4318			
Project No.	13216.03	Project Name	Embassy Security BEQ and Ops Facility
Test Boring No.	B-5	Depth (Feet)	2.0'-4.0'
Lab Order No.	3712-2	Date	1/19/2016

Material Description	LL	PL	PI	% Passing		USCS	w (%)
				#4	#200		
SILTY SAND	32	24	8	96.6	36.9	SM	20.7
Color	Brown		AASHTO Classification			A-4

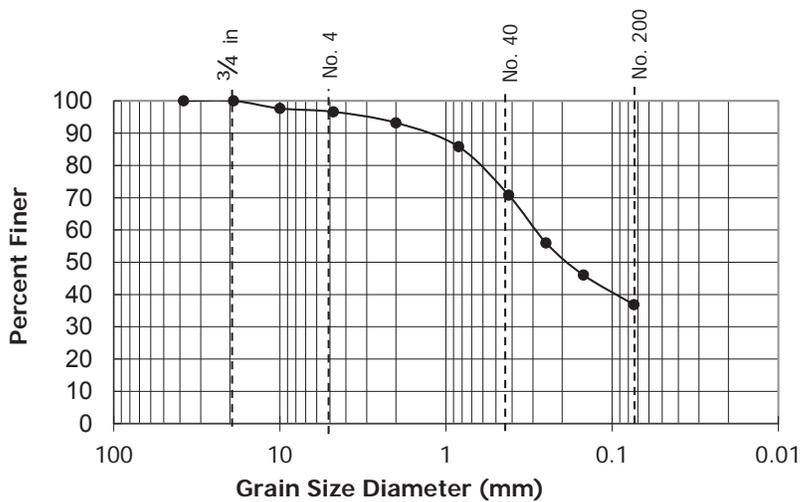
GRAIN SIZE ANALYSIS - ASTM D422			
Project No.	13216.03	Project Name	Embassy Security BEQ and Ops Facility
Test Boring No.	B-5	Depth (Feet)	2.0'-4.0'
Lab Order No.	3712-2	Date	1/19/2016

SIEVE	% Passing
1 1/2 "	100
3/4"	100
3/8"	98
#4	97
#10	93
#20	86
#40	71
#60	56
#100	46
#200	37
Pan	--

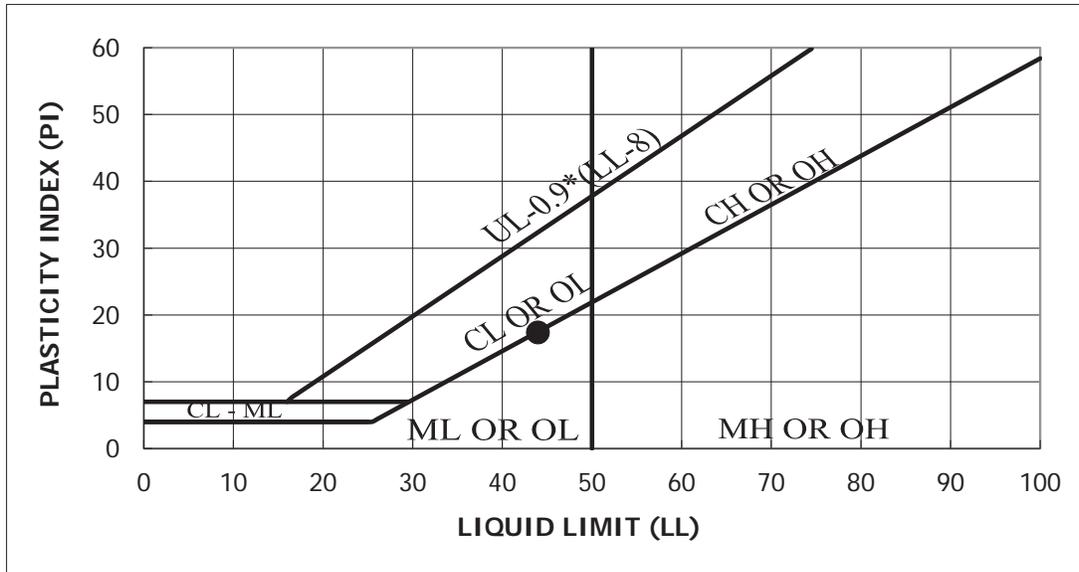
LIQUID AND PLASTIC LIMIT - ASTM D4318			
Project No.	13216.03	Project Name	Embassy Security BEQ and Ops Facility
Test Boring No.	B-8	Depth (Feet)	2.0'-4.0'
Lab Order No.	3712-3	Date	1/19/2016

Material Description	LL	PL	PI	% Passing		USCS	w (%)
				#4	#200		
sandy Silt	44	27	17	100.0	63.3	ML	19.8
Color	Brown		AASHTO Classification		A-7-6

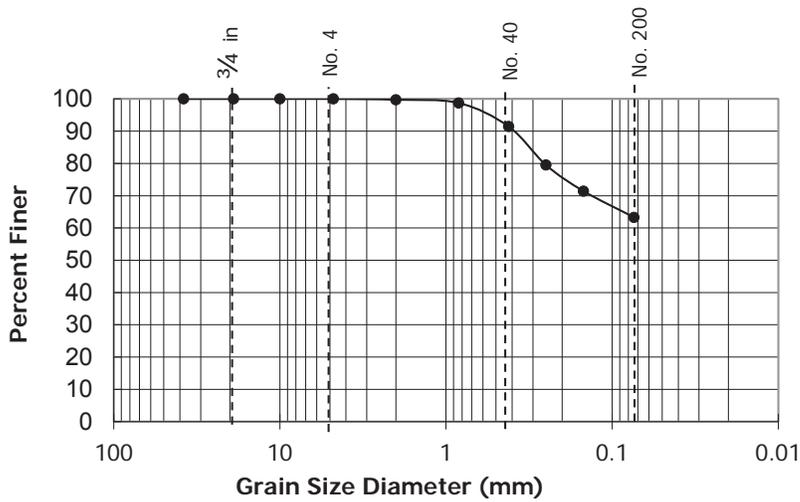
GRAIN SIZE ANALYSIS - ASTM D422			
Project No.	13216.03	Project Name	Embassy Security BEQ and Ops Facility
Test Boring No.	B-8	Depth (Feet)	2.0'-4.0'
Lab Order No.	3712-3	Date	1/19/2016

SIEVE	% Passing
1 1/2 "	100
3/4"	100
3/8"	100
#4	100
#10	100
#20	99
#40	91
#60	79
#100	71
#200	63
Pan	--

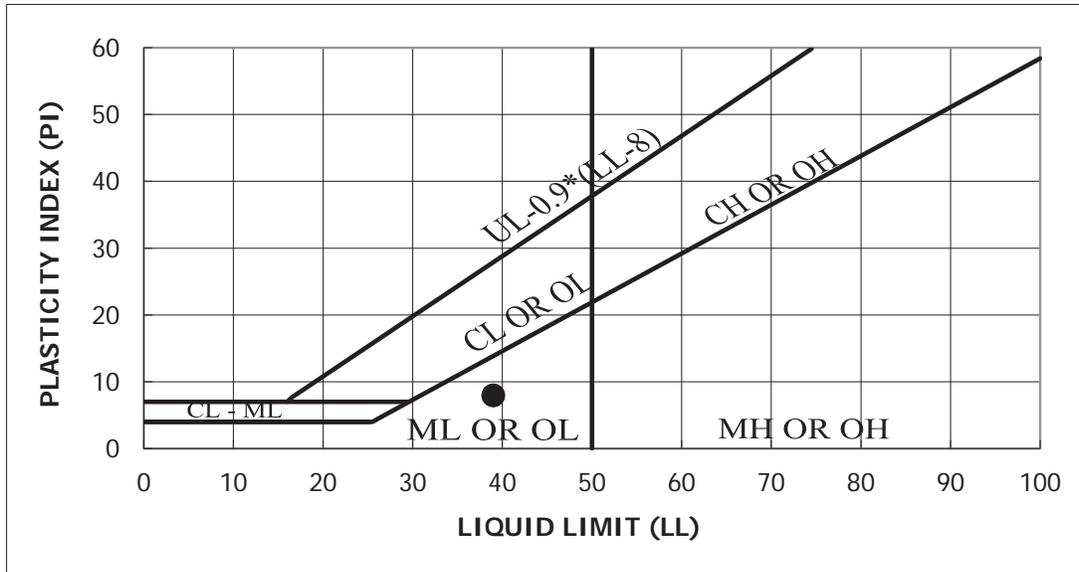
LIQUID AND PLASTIC LIMIT - ASTM D4318			
Project No.	13216.03	Project Name	Embassy Security BEQ and Ops Facility
Test Boring No.	B-8	Depth (Feet)	6.0'-8.0'
Lab Order No.	3712-4	Date	1/19/2016

Material Description	LL	PL	PI	% Passing		USCS	w (%)
				#4	#200		
SILTY SAND	39	31	8	100.0	43.6	SM	22.3
Color	Pink		AASHTO Classification		A-4

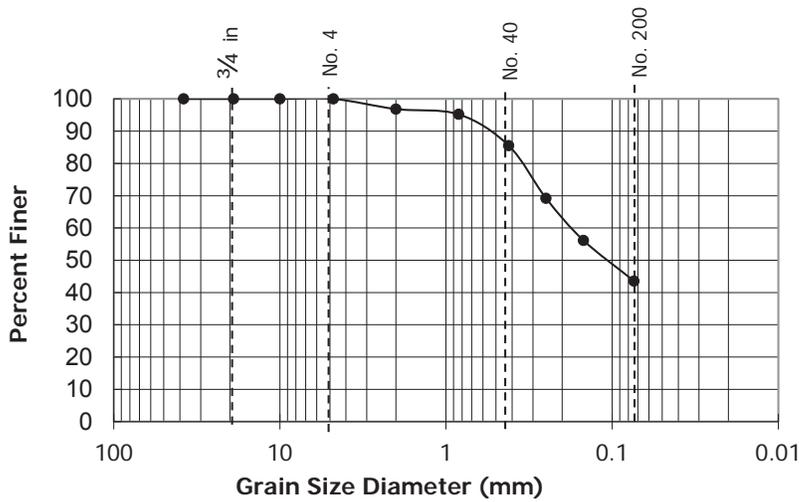
GRAIN SIZE ANALYSIS - ASTM D422			
Project No.	13216.03	Project Name	Embassy Security BEQ and Ops Facility
Test Boring No.	B-8	Depth (Feet)	6.0'-8.0'
Lab Order No.	3712-4	Date	1/19/2016

SIEVE	% Passing
1 1/2 "	100
3/4"	100
3/8"	100
#4	100
#10	97
#20	95
#40	86
#60	69
#100	56
#200	44
Pan	--

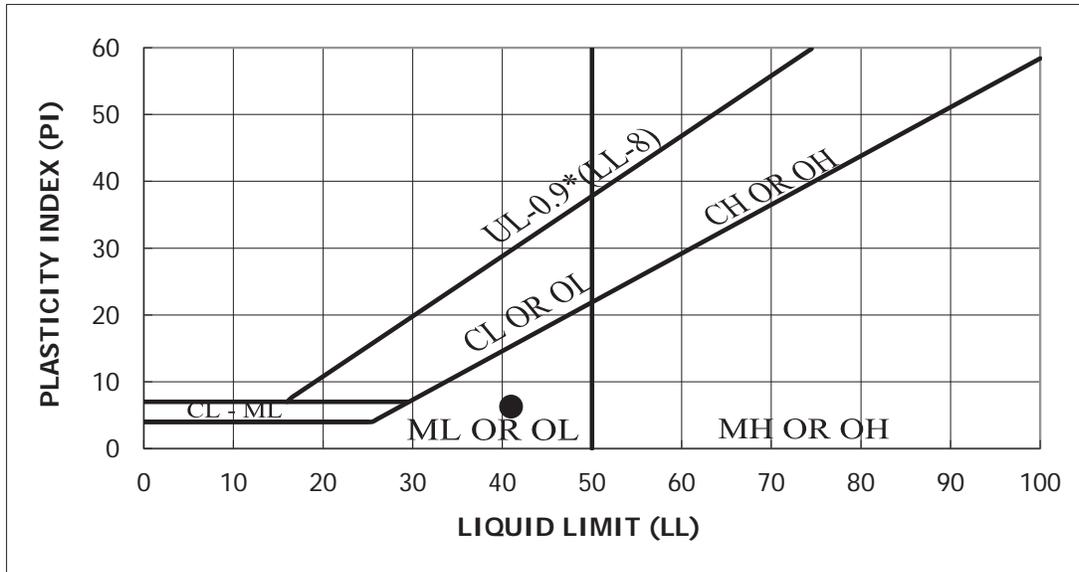
LIQUID AND PLASTIC LIMIT - ASTM D4318			
Project No.	13216.03	Project Name	Embassy Security BEQ and Ops Facility
Test Boring No.	B-8	Depth (Feet)	10.0'-12.0'
Lab Order No.	3712-5	Date	1/19/2016

Material Description	LL	PL	PI	% Passing		USCS	w (%)
				#4	#200		
SILTY SAND	41	35	6	99.4	45.4	SM	23.0
Color	Pink		AASHTO Classification		A-5

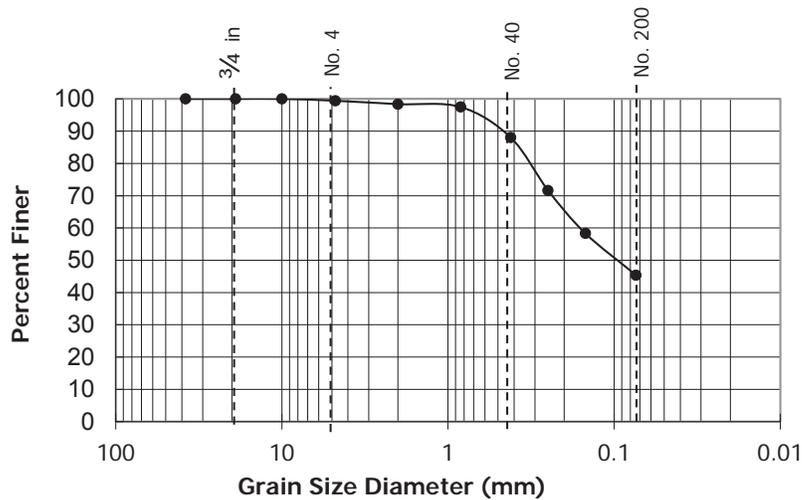
GRAIN SIZE ANALYSIS - ASTM D422			
Project No.	13216.03	Project Name	Embassy Security BEQ and Ops Facility
Test Boring No.	B-8	Depth (Feet)	10.0'-12.0'
Lab Order No.	3712-5	Date	1/19/2016

SIEVE	% Passing
1 1/2 "	100
3/4"	100
3/8"	100
#4	99
#10	98
#20	97
#40	88
#60	72
#100	58
#200	45
Pan	--

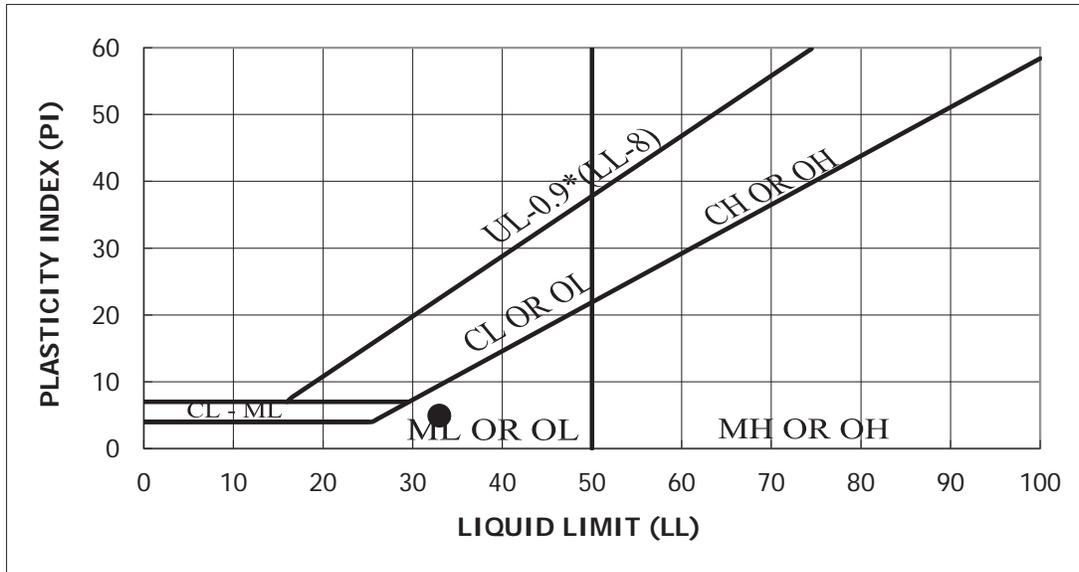
LIQUID AND PLASTIC LIMIT - ASTM D4318			
Project No.	13216.03	Project Name	Embassy Security BEQ and Ops Facility
Test Boring No.	B-8	Depth (Feet)	33.5'-35.0'
Lab Order No.	3712-6	Date	1/19/2016

Material Description	LL	PL	PI	% Passing		USCS	w (%)
				#4	#200		
SILTY SAND	33	28	5	100.0	31.9	SM	15.0
Color	Gray		AASHTO Classification		A-2-4

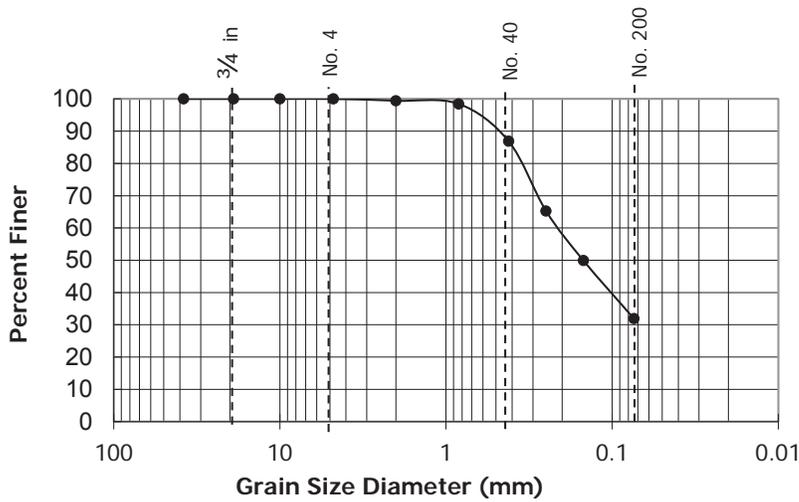
GRAIN SIZE ANALYSIS - ASTM D422			
Project No.	13216.03	Project Name	Embassy Security BEQ and Ops Facility
Test Boring No.	B-8	Depth (Feet)	33.5'-35.0'
Lab Order No.	3712-6	Date	1/19/2016

SIEVE	% Passing
1 1/2 "	100
3/4"	100
3/8"	100
#4	100
#10	99
#20	98
#40	87
#60	65
#100	50
#200	32
Pan	--

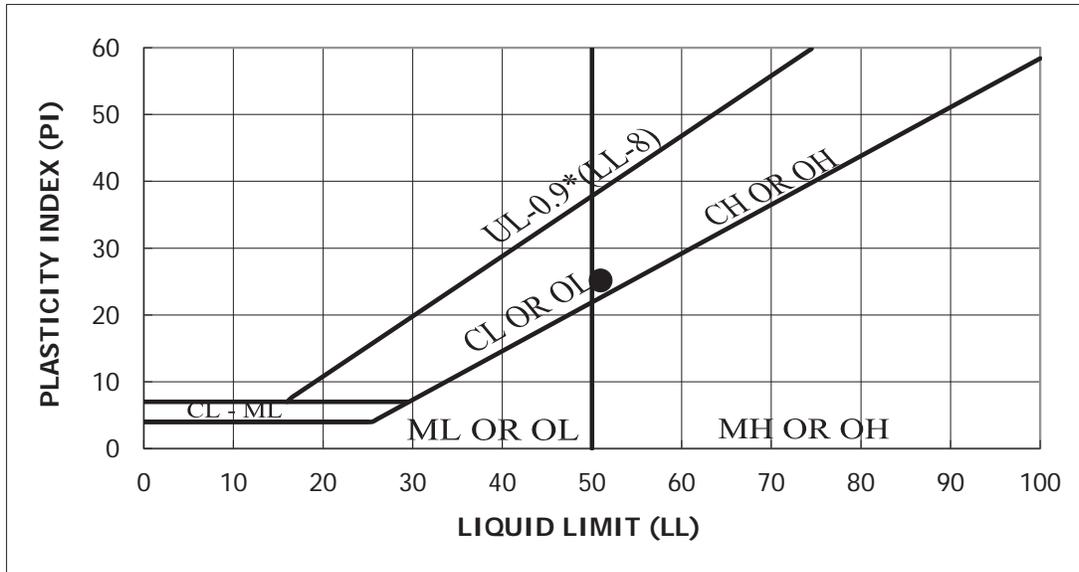
LIQUID AND PLASTIC LIMIT - ASTM D4318			
Project No.	13216.03	Project Name	Embassy Security BEQ and Ops Facility
Test Boring No.	P-1	Depth (Feet)	0.0'-5.0'
Lab Order No.	3712-7	Date	1/19/2016

Material Description	LL	PL	PI	% Passing		USCS	w (%)
				#4	#200		
sandy Fat Clay	51	26	25	99.6	52.6	CH	19.5
Color	Orange Brown		AASHTO Classification		A-7-6

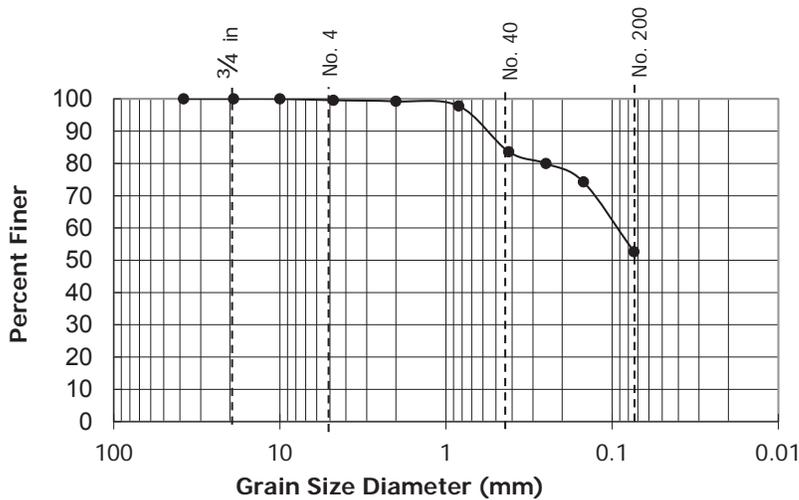
GRAIN SIZE ANALYSIS - ASTM D422			
Project No.	13216.03	Project Name	Embassy Security BEQ and Ops Facility
Test Boring No.	P-1	Depth (Feet)	0.0'-5.0'
Lab Order No.	3712-7	Date	1/19/2016

SIEVE	% Passing
1 1/2 "	100
3/4"	100
3/8"	100
#4	100
#10	99
#20	98
#40	84
#60	80
#100	74
#200	53
Pan	--

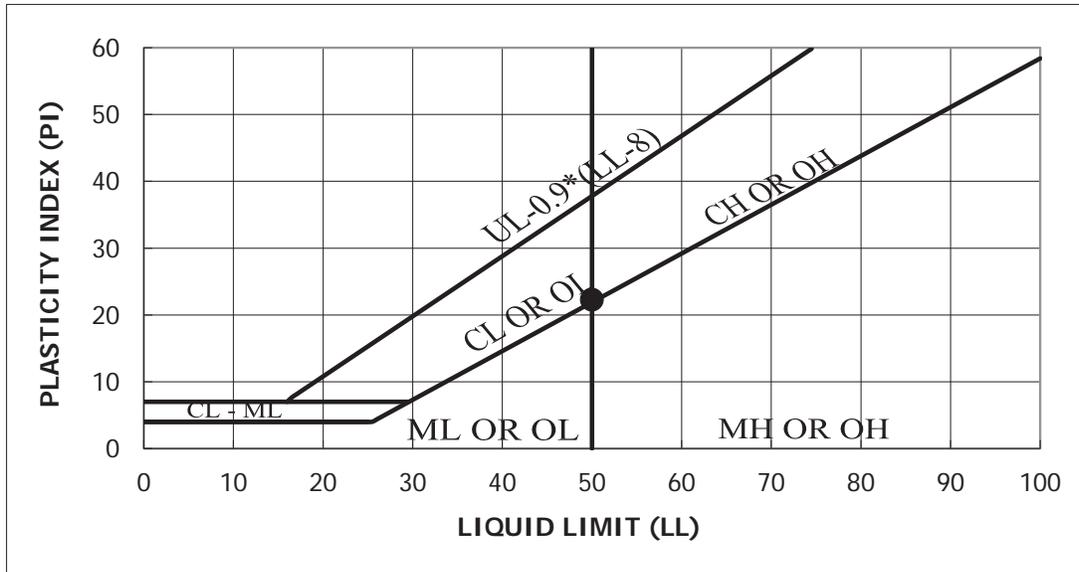
LIQUID AND PLASTIC LIMIT - ASTM D4318			
Project No.	13216.03	Project Name	Embassy Security BEQ and Ops Facility
Test Boring No.	P-2	Depth (Feet)	0.0'-5.0'
Lab Order No.	3712-8	Date	1/19/2016

Material Description	LL	PL	PI	% Passing		USCS	w (%)
				#4	#200		
sandy Fat Clay	50	28	22	98.4	56.4	CH	18.5
Color	Orange Brown		AASHTO Classification		A-7-6

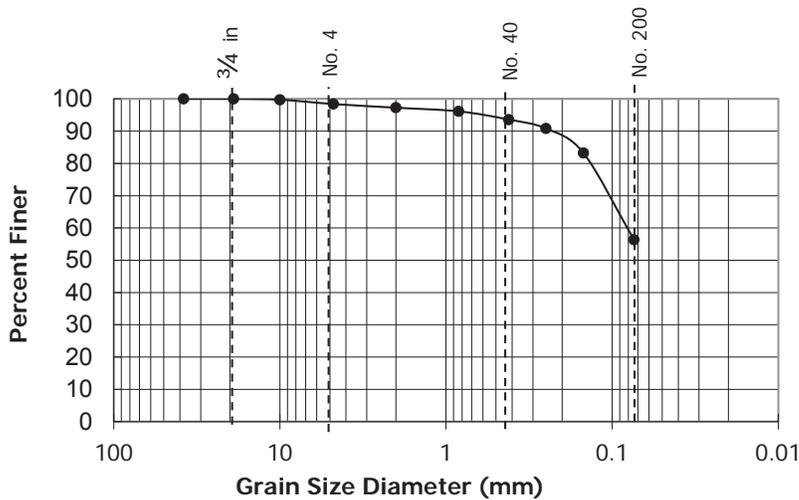
GRAIN SIZE ANALYSIS - ASTM D422			
Project No.	13216.03	Project Name	Embassy Security BEQ and Ops Facility
Test Boring No.	P-2	Depth (Feet)	0.0'-5.0'
Lab Order No.	3712-8	Date	1/19/2016

SIEVE	% Passing
1 1/2 "	100
3/4"	100
3/8"	100
#4	98
#10	97
#20	96
#40	94
#60	91
#100	83
#200	56
Pan	--

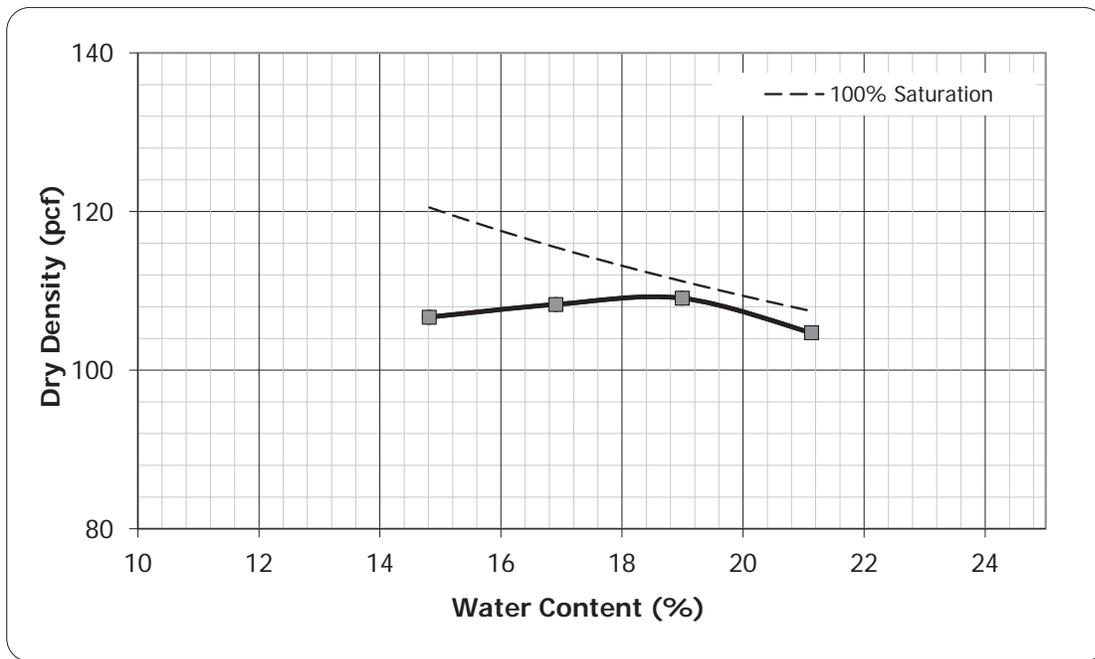
MOISTURE DENSITY RELATIONSHIP - ASTM D 1557			
Project No.	13216.03	Project Name	Embassy Security BEQ and Ops Facility
Test Boring No.	P-1	Depth (Feet)	0.0'-5.0'
Lab Order No.	3712-7	Date	1/19/2016

TEST RESULTS	Before Correc.	After Correc.	Color					
Maximum Dry Density (pcf)	109.5	--	Orange Brown					
Optimum Moisture Content (%)	18.8	--	Orange Brown					
Material	Classification		Nat. Moist. (%)	Sp. G. (Assumed)	LL	PI	% > # 4	% < # 200
sandy Fat Clay	USCS	AASHTO	19.5	2.7	51	25	0.4	52.6
	CH	A-7-6

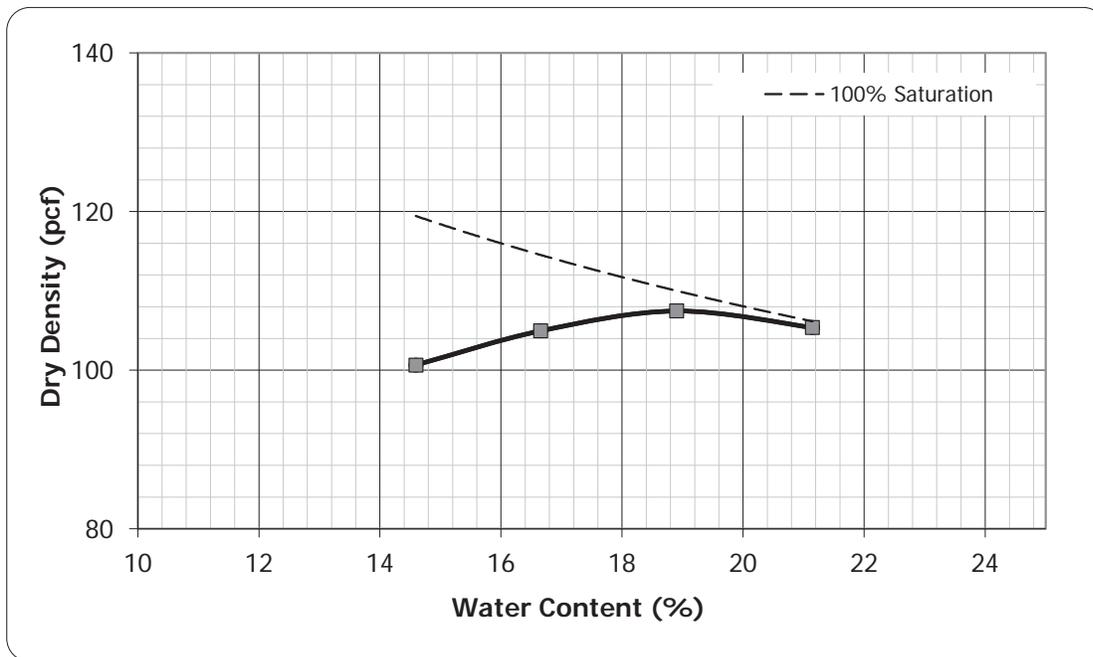
MOISTURE DENSITY RELATIONSHIP - ASTM D 1557			
Project No.	13216.03	Project Name	Embassy Security BEQ and Ops Facility
Test Boring No.	P-2	Depth (Feet)	0.0'-5.0'
Lab Order No.	3712-8	Date	1/19/2016

TEST RESULTS	Before Correc.	After Correc.	Color					
Maximum Dry Density (pcf)	107.5	--	Orange Brown					
Optimum Moisture Content (%)	18.8	--	Orange Brown					
Material	Classification		Nat. Moist. (%)	Sp. G. (Assumed)	LL	PI	% > # 4	% < # 200
sandy Fat Clay	USCS	AASHTO	18.5	2.65	50	22	1.6	56.4
	CH	A-7-6

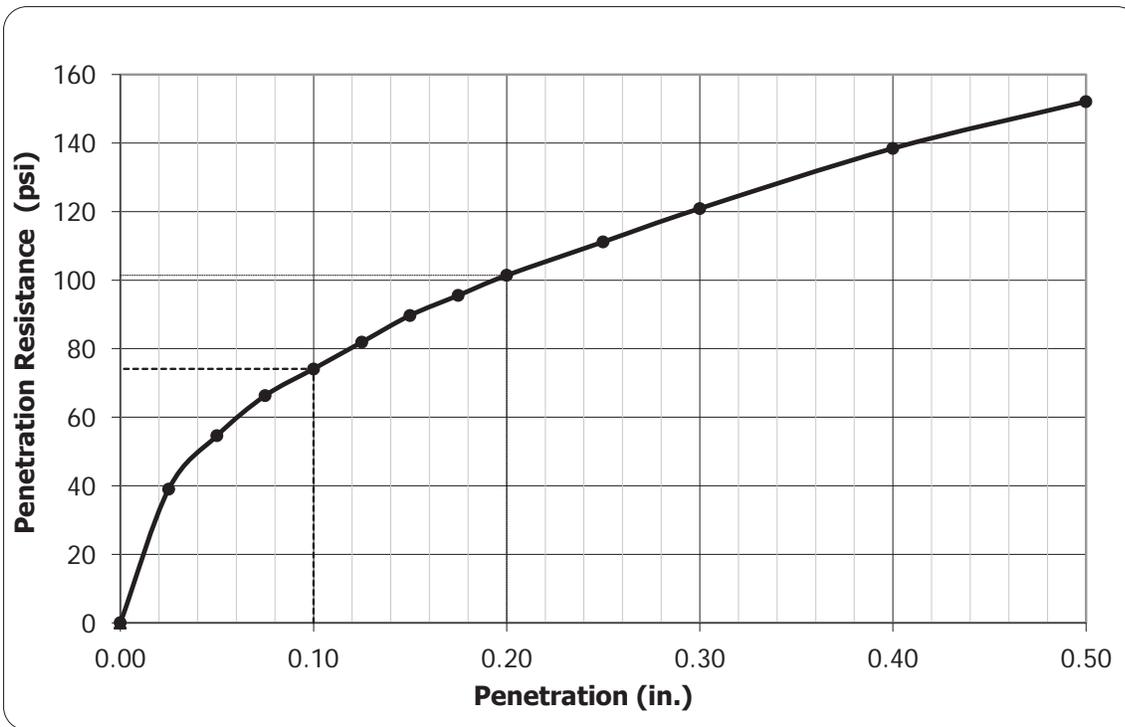
CALIFORNIA BEARING RATIO (CBR) TEST - ASTM- D1833			
Project No.	13216.03	Project Name	Embassy Security BEQ and Ops Facility
Test Boring No.	P-1	Depth (Feet)	0.0'-5.0'
Lab Order No.	3712-7	Date	1/19/2016

Molded	
Dry Density (pcf)	110.0
Moisture (%)	19.3
Percent of Max. Density (%)	100.4

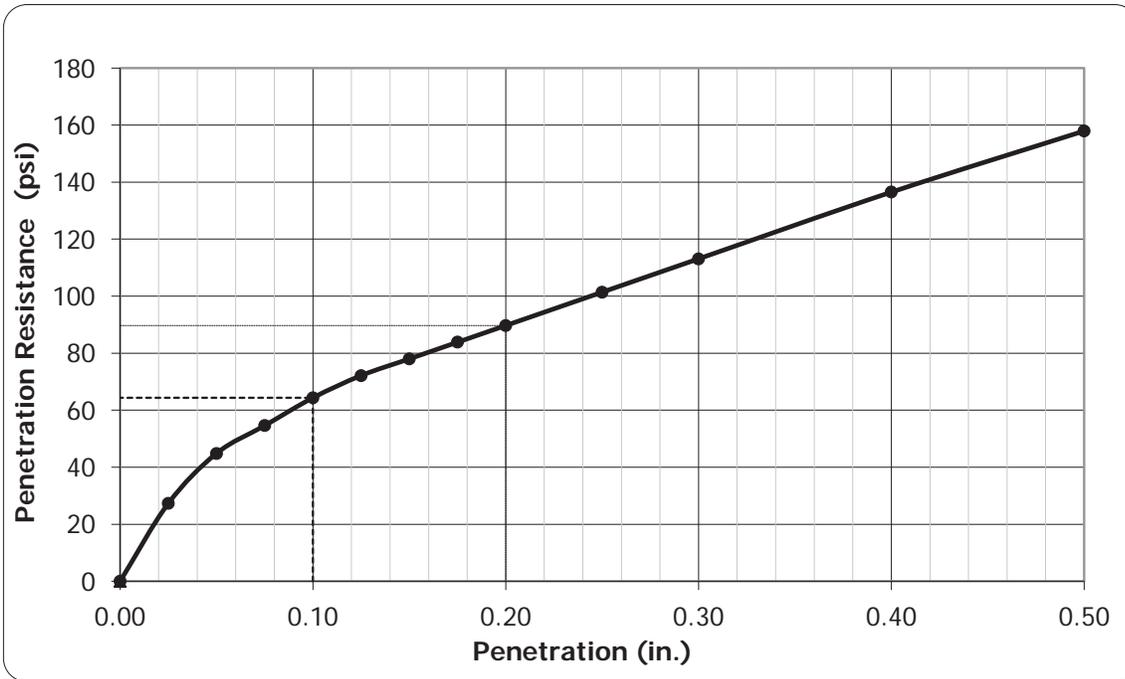
CALIFORNIA BEARING RATIO (CBR) TEST - ASTM- D1833			
Project No.	13216.03	Project Name	Embassy Security BEQ and Ops Facility
Test Boring No.	P-2	Depth (Feet)	0.0'-5.0'
Lab Order No.	3712-8	Date	1/19/2016

Molded	
Dry Density (pcf)	108.1
Moisture (%)	19.2
Percent of Max. Density (%)	100.5

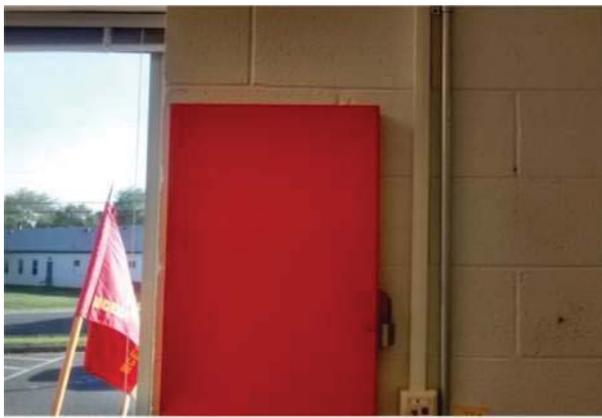
LBP: Lead paint detected, orange metal cabinet, XRF023.

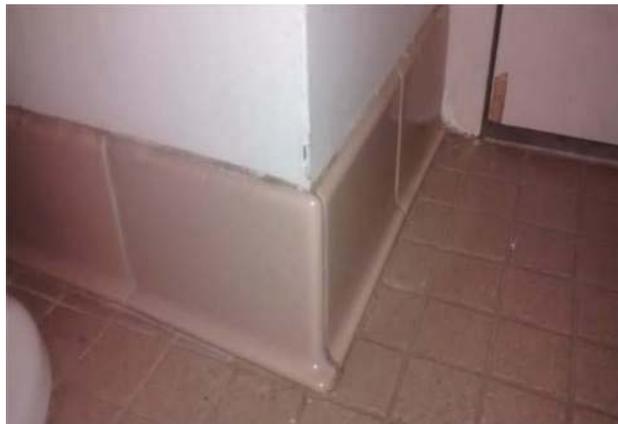
Lead: Lead detected $>1.0 \mu\text{g}/\text{ft}^2$ in tan hard tiles, XRF048 (typical)

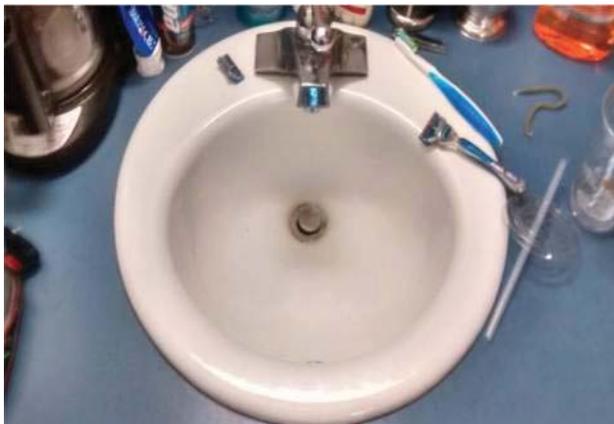
Lead: Lead detected $>1.0 \mu\text{g}/\text{ft}^2$ in white ceramic sinks, XRF049 (typical).

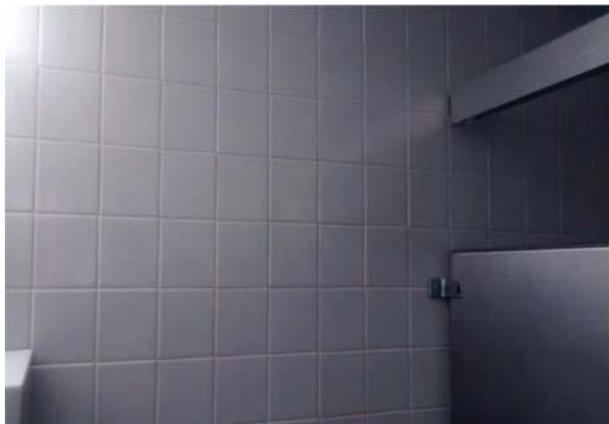
Lead: Lead detected $>1.0 \mu\text{g}/\text{ft}^2$ in light blue hard tiles, XRF065 (typical).

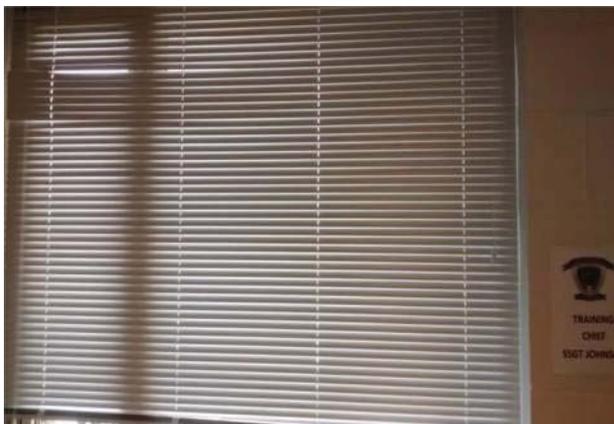
Lead: Lead detected $>1.0 \mu\text{g}/\text{ft}^2$ in white metal mini-blinds, XRF083 (typical).

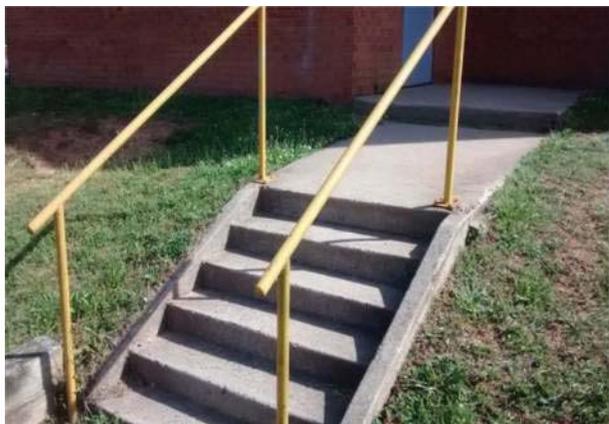
LBP: Lead paint detected, yellow metal railings, XRF 107.

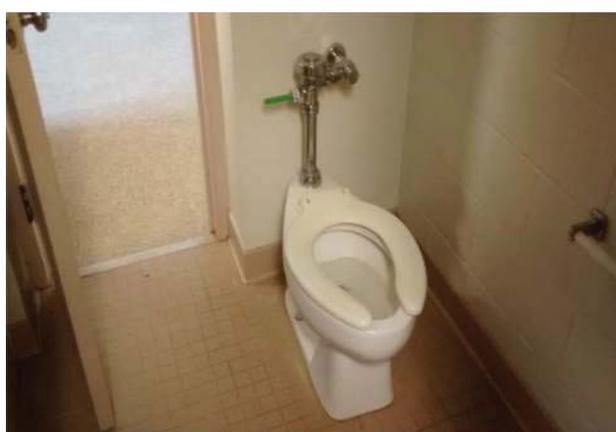
Lead: Lead detected $>1.0 \mu\text{g}/\text{ft}^2$ in white ceramic toilets, XRF0120 (typical).

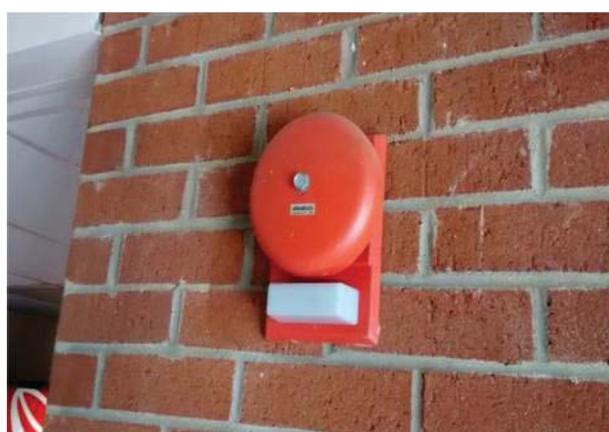
LBP: Lead paint identified on red fire bells, XRF131 (typical)

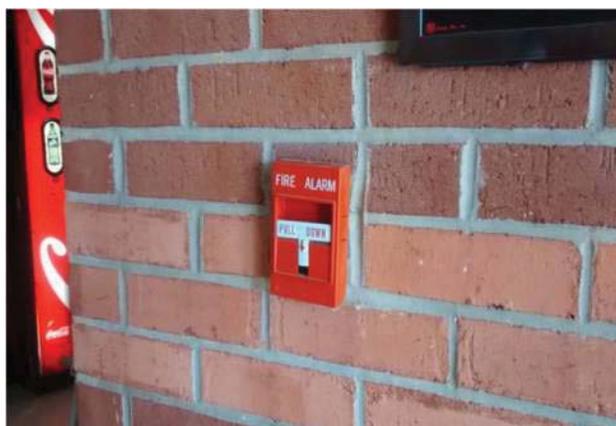
LBP: Elevated lead in paint identified on fire pulls, XRF132 (typical).

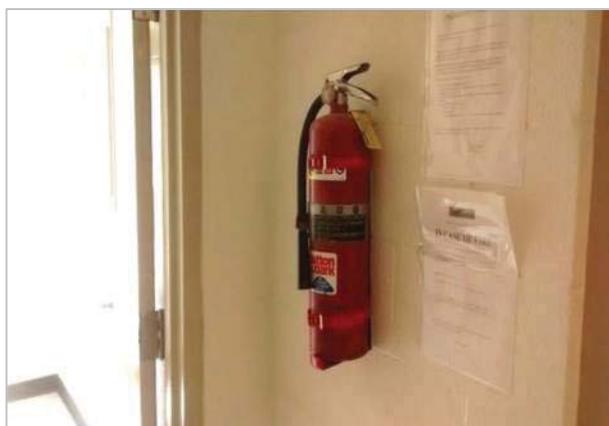
LBP: Lead paint detected on fire extinguishers, XRF215 (typical).

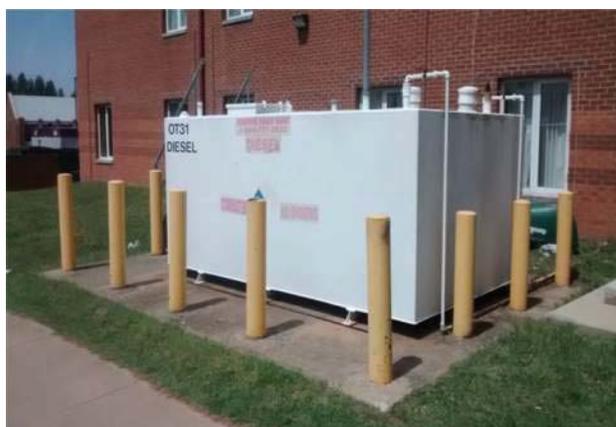
Lead: Lead detected $>1.0 \mu\text{g}/\text{ft}^2$ in yellow metal bollards, XRF230 (typical).

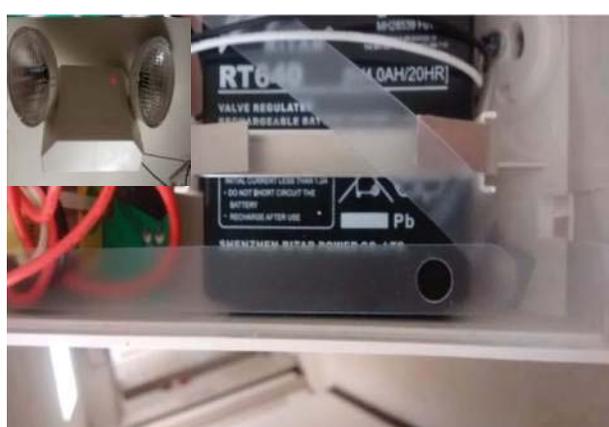
Lead: Emergency lighting with lead battery pack (typical).

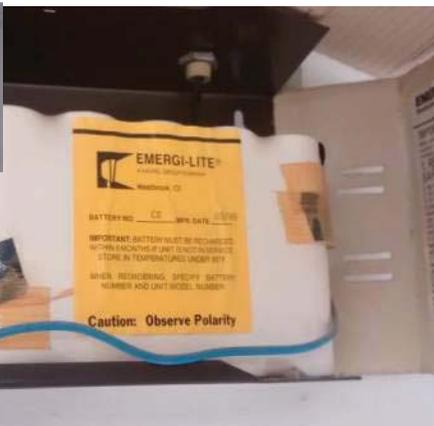
Lead: Emergency lighting with lead battery (typical).

Mercury: Fluorescent bulbs contain mercury, recycle as universal waste (typical).

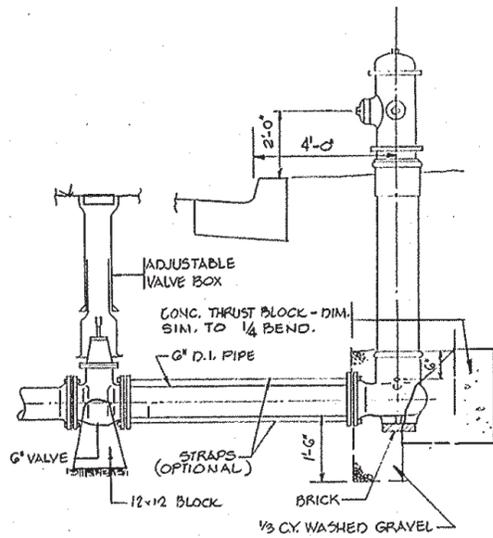
BEND TYPE	THRUST BLOCK DIMENSIONS - G PIPE			
	B	C	D	E
1/4 (90°)	5'-0"	2'-0"	1'-0"	2'-6"
1/8 (45°)	2'-8"	2'-0"	0'-8"	1'-0"
1/16 (22 1/2°)	1'-0"	1'-6"	0'-8"	1'-0"
1/32 (11 1/4°)	1'-6"	1'-0"	0'-8"	1'-0"
