PART SIX – ATTACHMENTS

**P707 Embassy Security Guard, BEQ and
Ops Facility**

Marine Corps Base, Quantico, Virginia

RFP, 5 May 2016

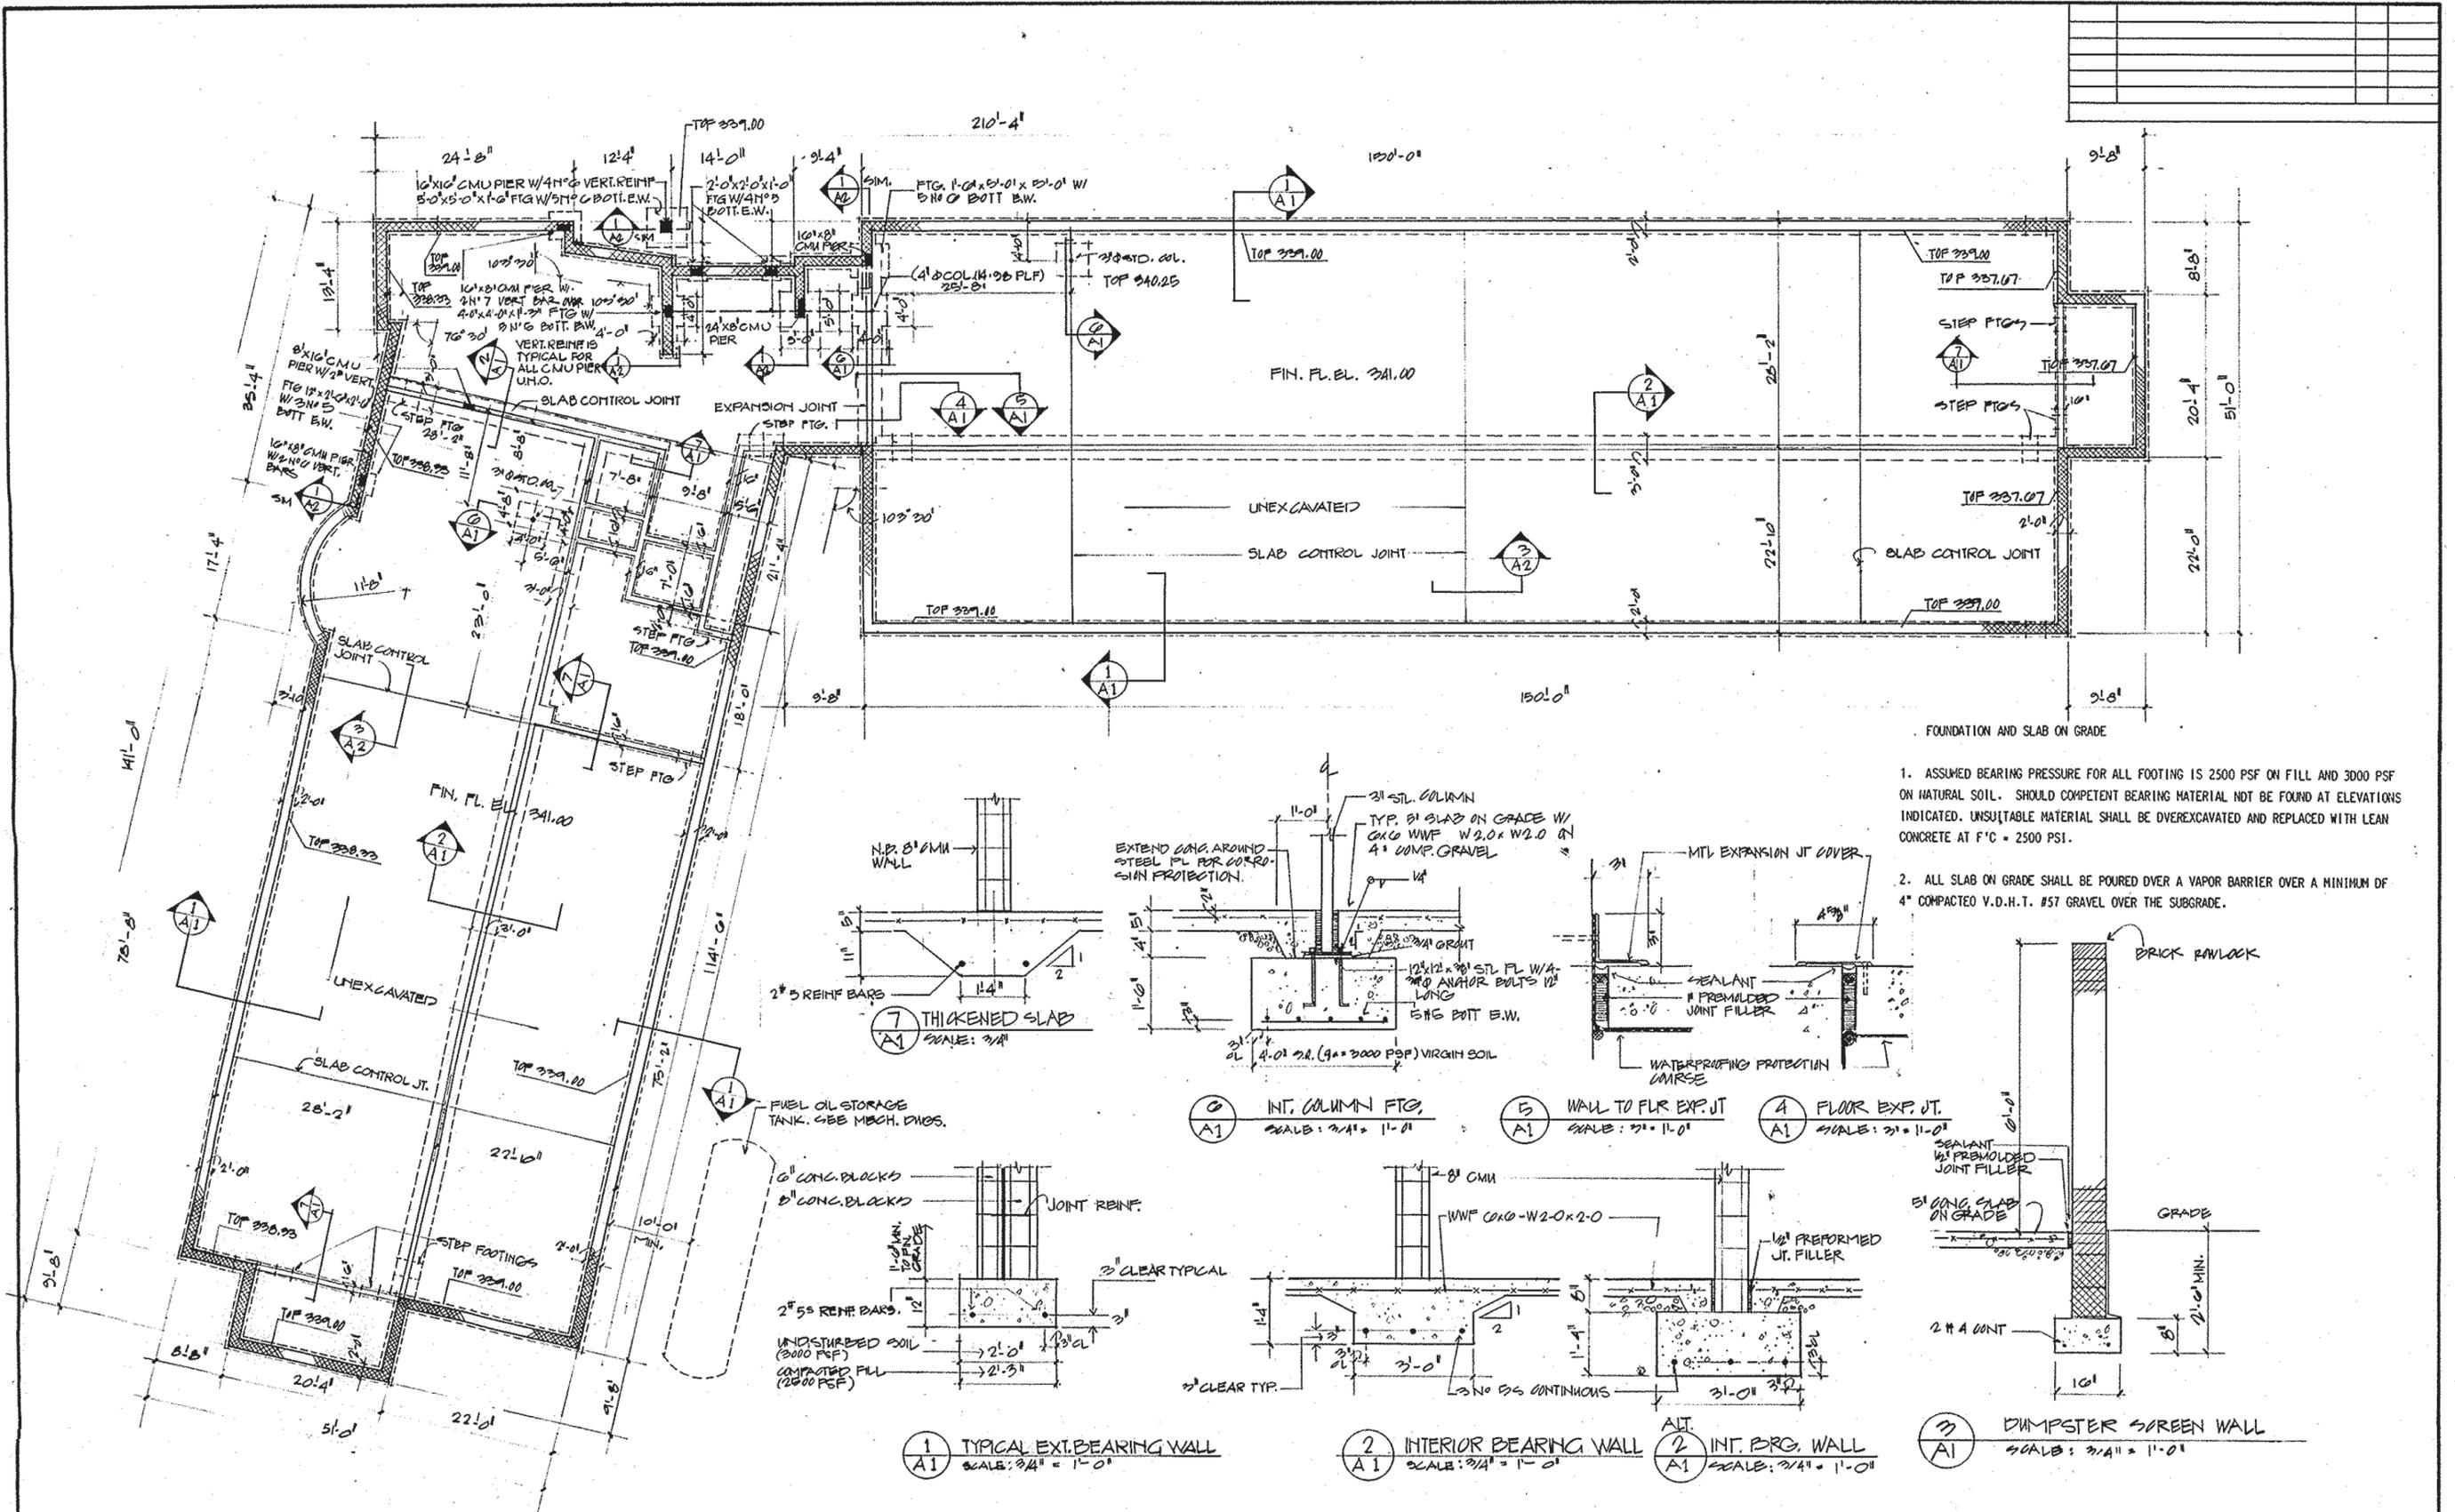
- FOUNDATION AND SLAB ON GRADE
1. ASSUMED BEARING PRESSURE FOR ALL FOOTING IS 2500 PSF ON FILL AND 3000 PSF ON NATURAL SOIL. SHOULD COMPETENT BEARING MATERIAL NOT BE FOUND AT ELEVATIONS INDICATED. UNSUITABLE MATERIAL SHALL BE OVEREXCAVATED AND REPLACED WITH LEAN CONCRETE AT F'C = 2500 PSI.
 2. ALL SLAB ON GRADE SHALL BE POURED OVER A VAPOR BARRIER OVER A MINIMUM OF 4" COMPACTED V.D.H.T. #57 GRAVEL OVER THE SUBGRADE.
