Asbestos and Hazardous Materials Assessment

**Project #1 – Center Loop Steam and Condensate Repairs
Portsmouth Naval Shipyard
FY16 eMMRP Energy Projects
Kittery, York County, Maine**

August 20, 2015

Terracon Project No. J3147111

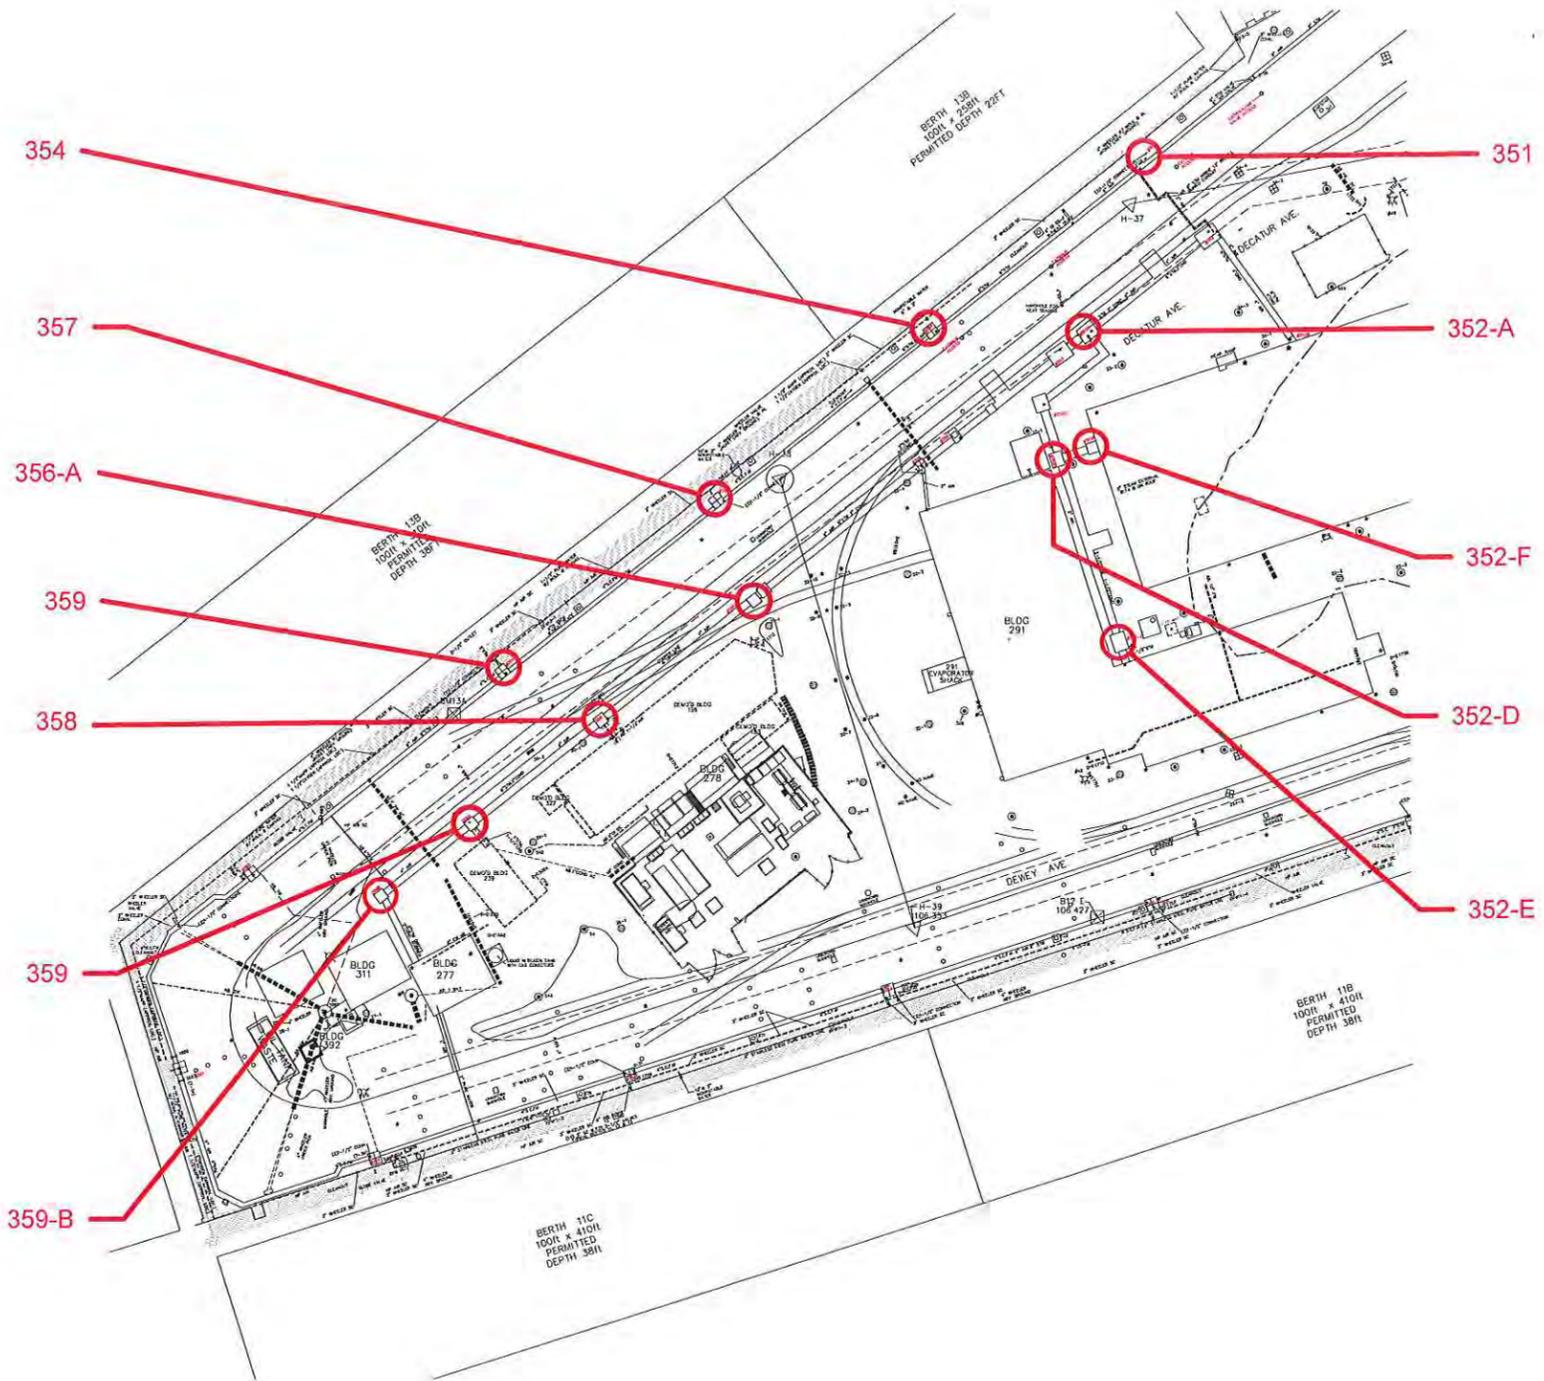
SITE PLAN – PROJECT #1

Location	Notes
Vault 351	Tested concrete and suspect ACM Blue paint associated with valve and handle - beyond "arms-length", thus not sampled 2 steam lines and 1 condensate (no insulation), debris in bottom of encasement
Vault 352-B	White hard-packed insulation on 6-inch steam line and debris in soil White cloth wrap associated with steam pavement penetration Red paint associated with 4-inch condensate line - beyond "arms-length", thus not sampled
Vault 352	Rotted crossmembers 6-inch steam line - no insulation 4-inch condensate - black wrapped line - beyond "arms-length", thus not sampled 4-feet of water inside manhole Concrete encasement - elect. Inside with sump
Vault 352-A	Column support paint (blue) LCP&PCB
Vault 352-C	Blue pipe thread caulk - sampled Steam line and condensate lines continue
Vault 352-D	Soil tested - ACM (wet) Adhesive on foam insul. Debris tested - suspect ACM Steam and condensate lines continue

Vault 352-E&F	Not accessible "No unauthorized persons"
Vault 356	Not accessible "Construction area"
Vault 356-A	Cream paint on concrete supports - sampled Soil sampled at base of vault - suspect ACM Concrete sampled - suspect ACM Steam and condensate lines continue
Vault 358	Not accessible "Construction area", thus Terracon did not view or sample from this location.
Vault 359-A to End	Not accessible "Construction area", thus Terracon did not view or sample from this location.

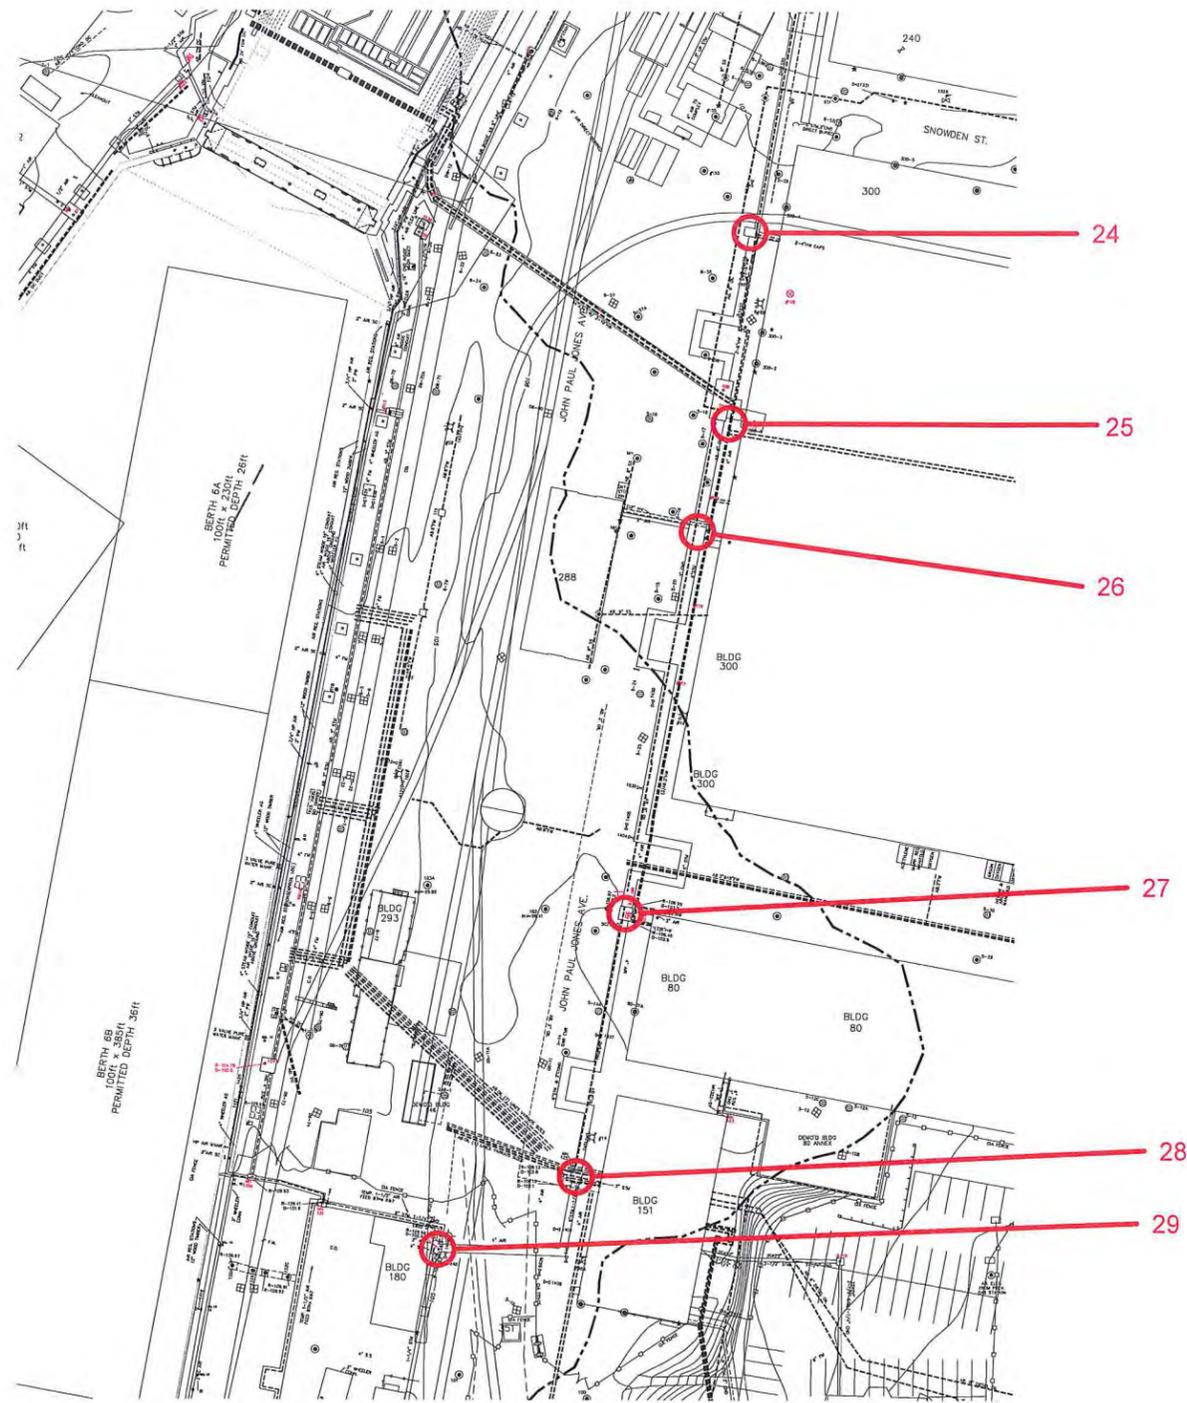
SITE PLAN - PROJECT #2

Location	Notes
Manhole 24	Metal jacket over foam insulation (flange) - sampled adhesive for ACM/PCB 6 flanges - silver coating on flange insulation - sampled Water in bottom with sediment - sampled
Manhole 25/26	White paper/adhesive associated with foam and metal wrap (west end pipe) sampled for ACM/PCB Sediment from bottom of manhole tested for ACM
Pavement	White masonry concrete expansion joint caulk Dark gray masonry concrete expansion joint caulk
Manhole 27	Steel elbows with gray paint (beyond "arms-length", thus not sampled) Metal jacket over foam insulation - paper on interior of metal pipe - sampled Water drain inside manhole, & sediment on floor is wet
Manhole 28	Open at time of visit; Navy appears to be pumping water out of manhole Metal jackets over foam insulation (4-inch & 6-inch pipes) - sampled paper under metal sheeting with alternative tools as directed by JV Casco Bay. Sump pump present and operating in manhole

Manhole #29	Sheath on 6-inch MAG insulation is labelled "Asbestos - Free" Three (3) 4-inch lines and one (1) 2-inch line Sump pump present but not operating in manhole
