Limited Environmental Survey
Steam Chases
Naval Station Great Lakes
Great Lakes, Illinois

SUBJECT: Limited Environmental Survey– Steam Chases
Naval Station Great Lakes
Great Lakes, Illinois
EDI Project No. 1602.029.01

Naval Station Great Lakes
 Photo Log of Chase Steam Lines
 September 9, 2011
 Photographed by Jose Aguilera & Jason Janssen

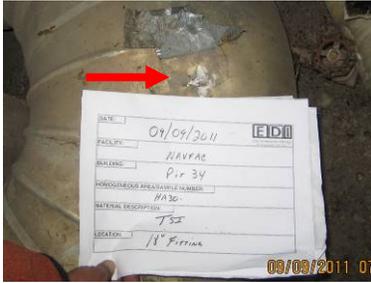
HA30: 18" fitting TSI, at pit 34

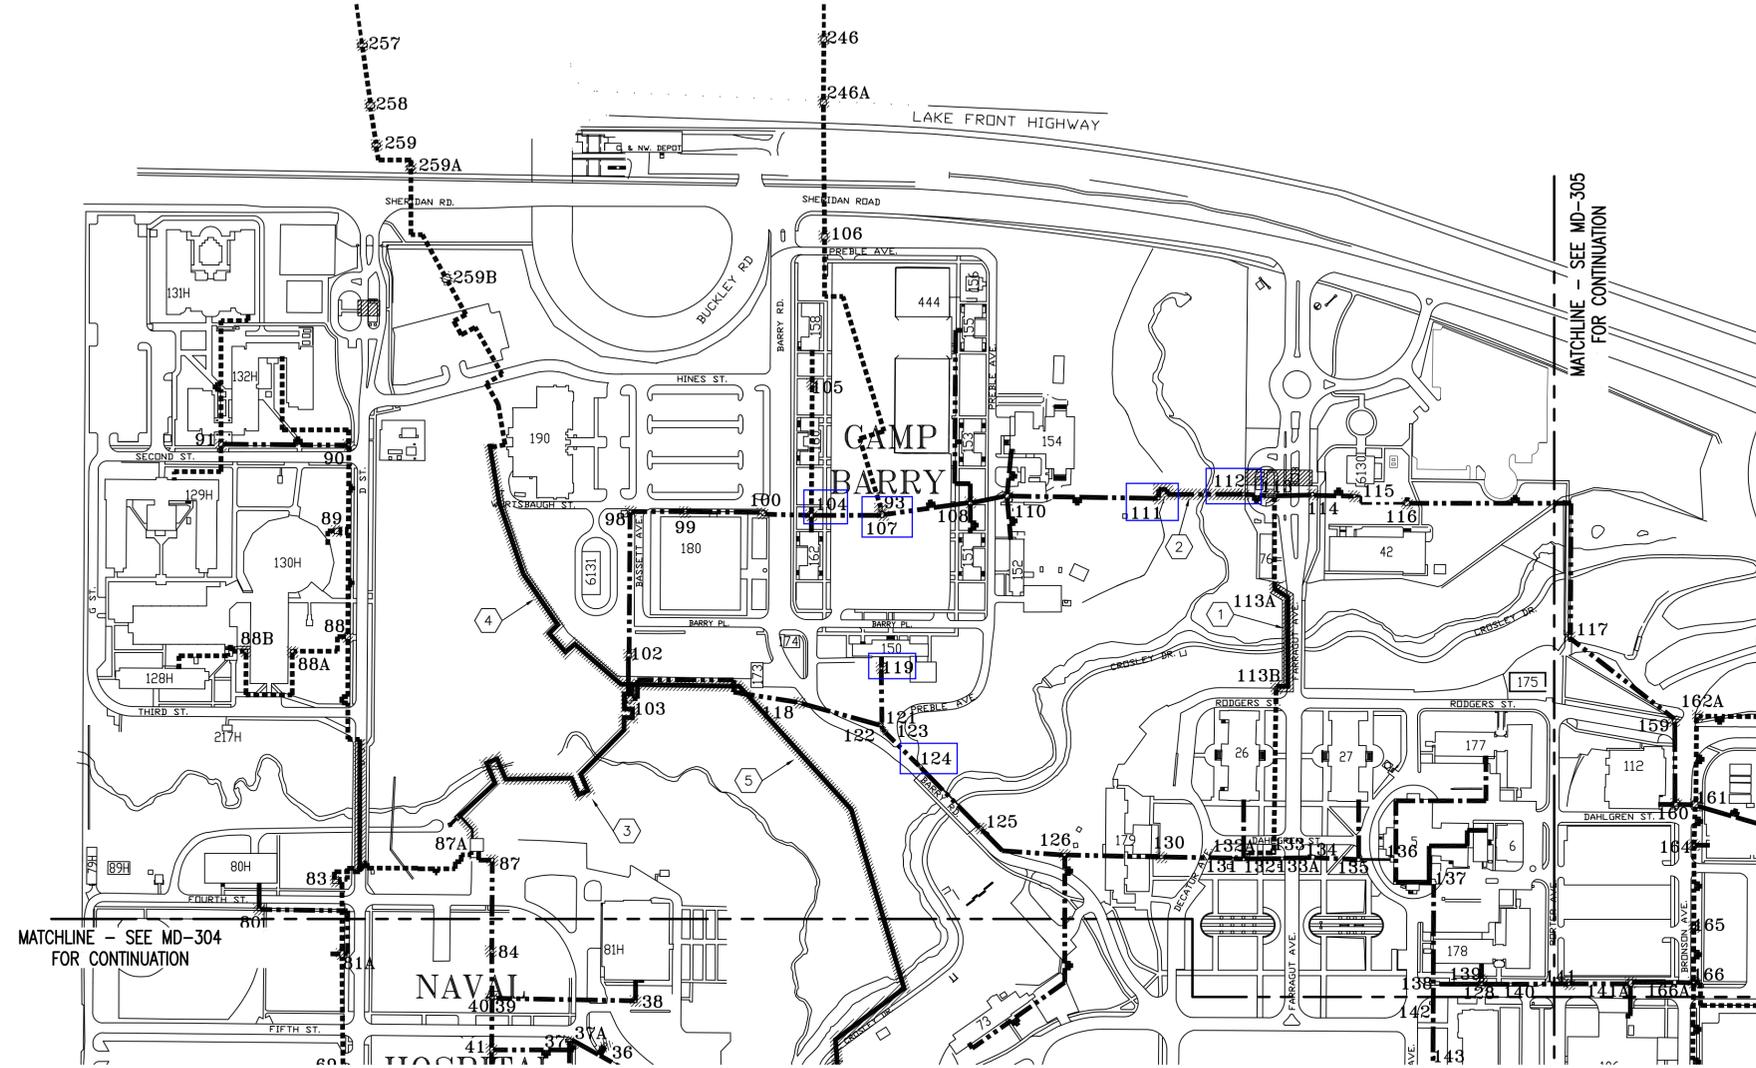
No ACM found in samples collected along Chases

□ Samples collected at these pits for ACM.
 Results indicate no asbestos in Chases.

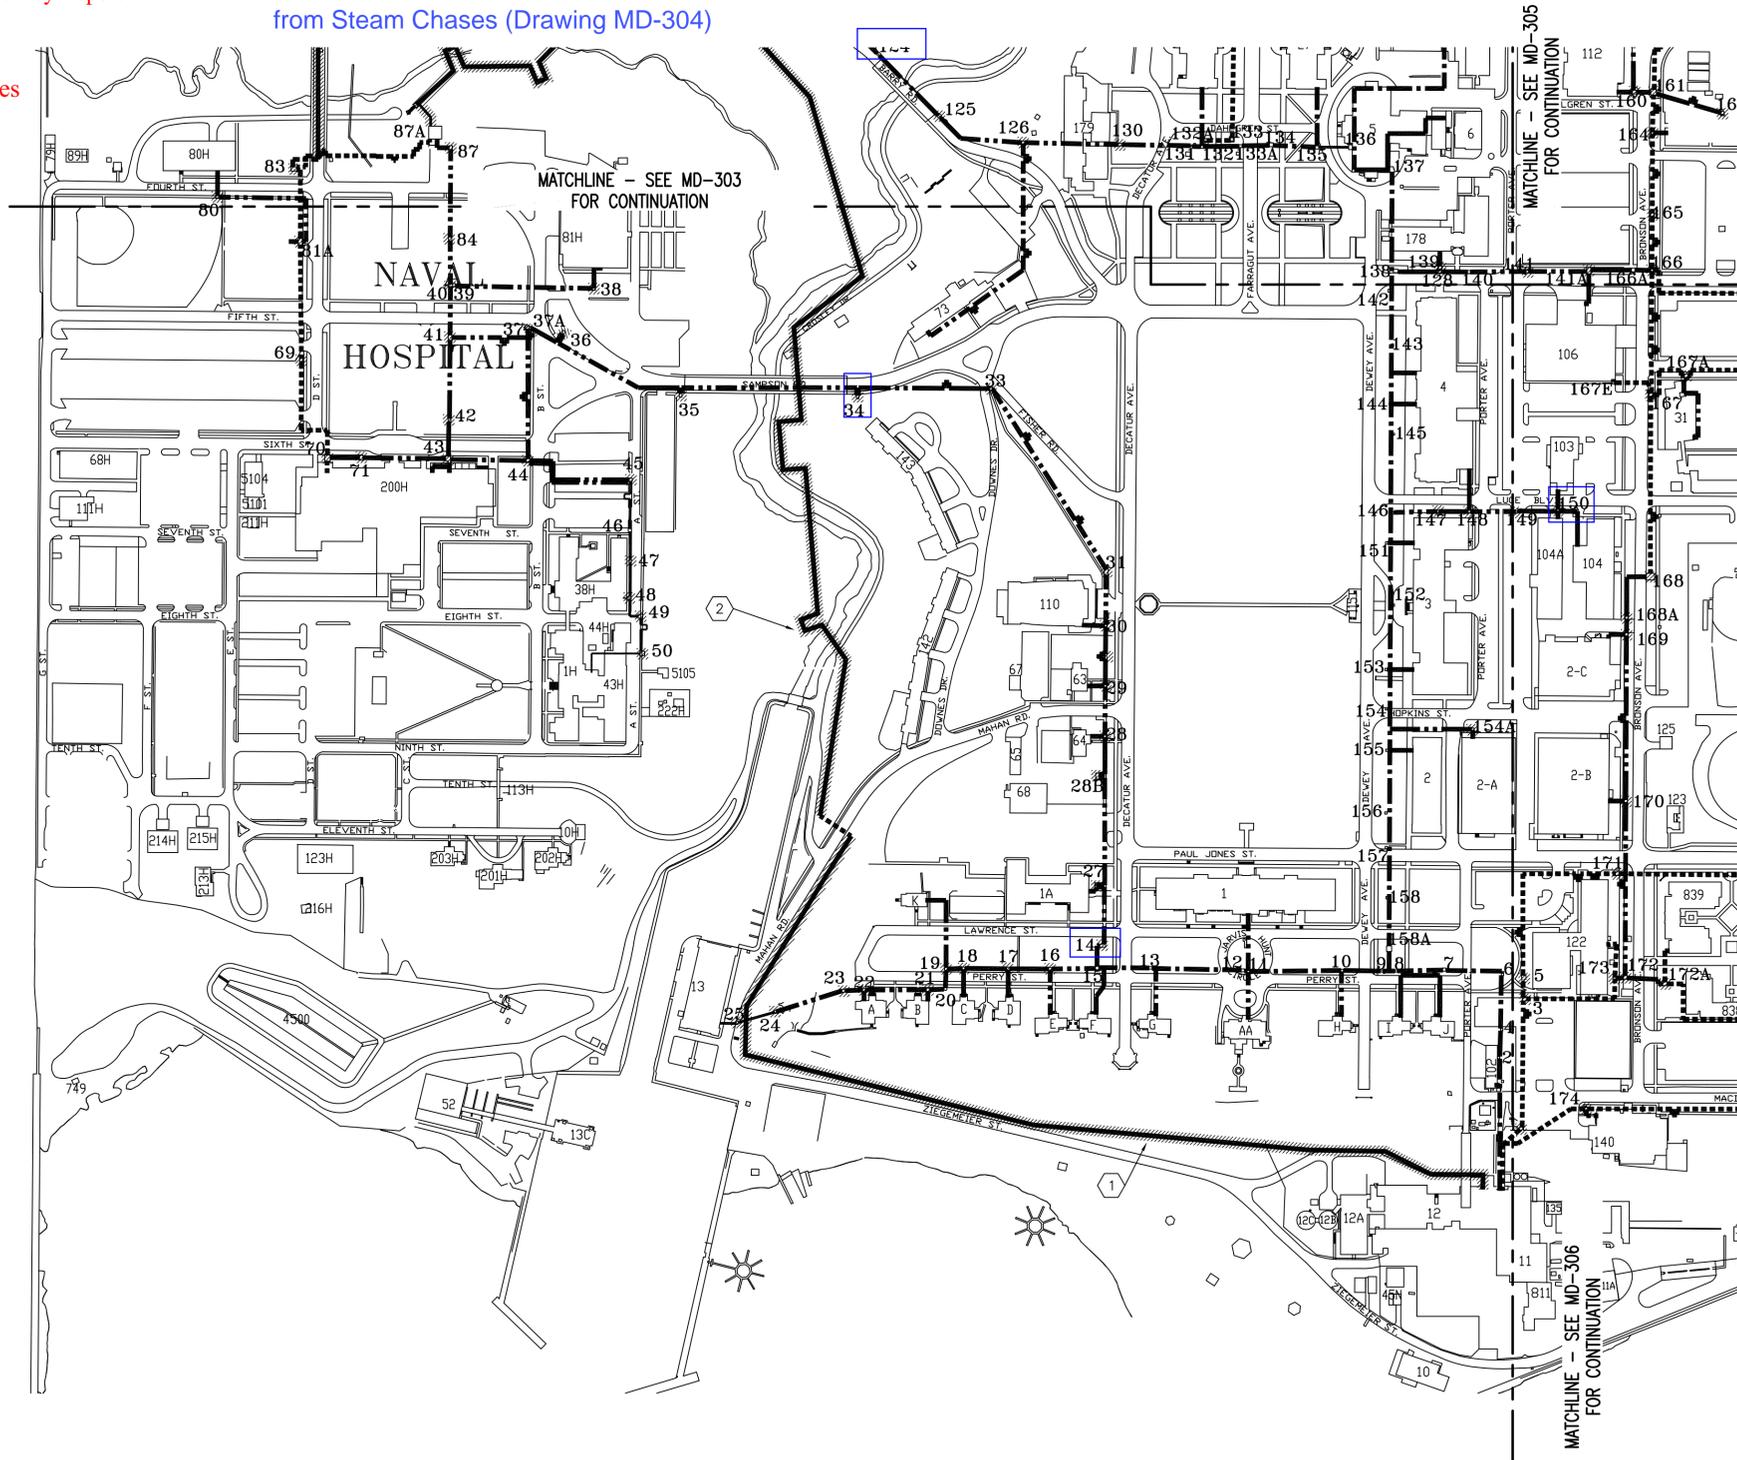
No ACM found in samples
 collected along Chases

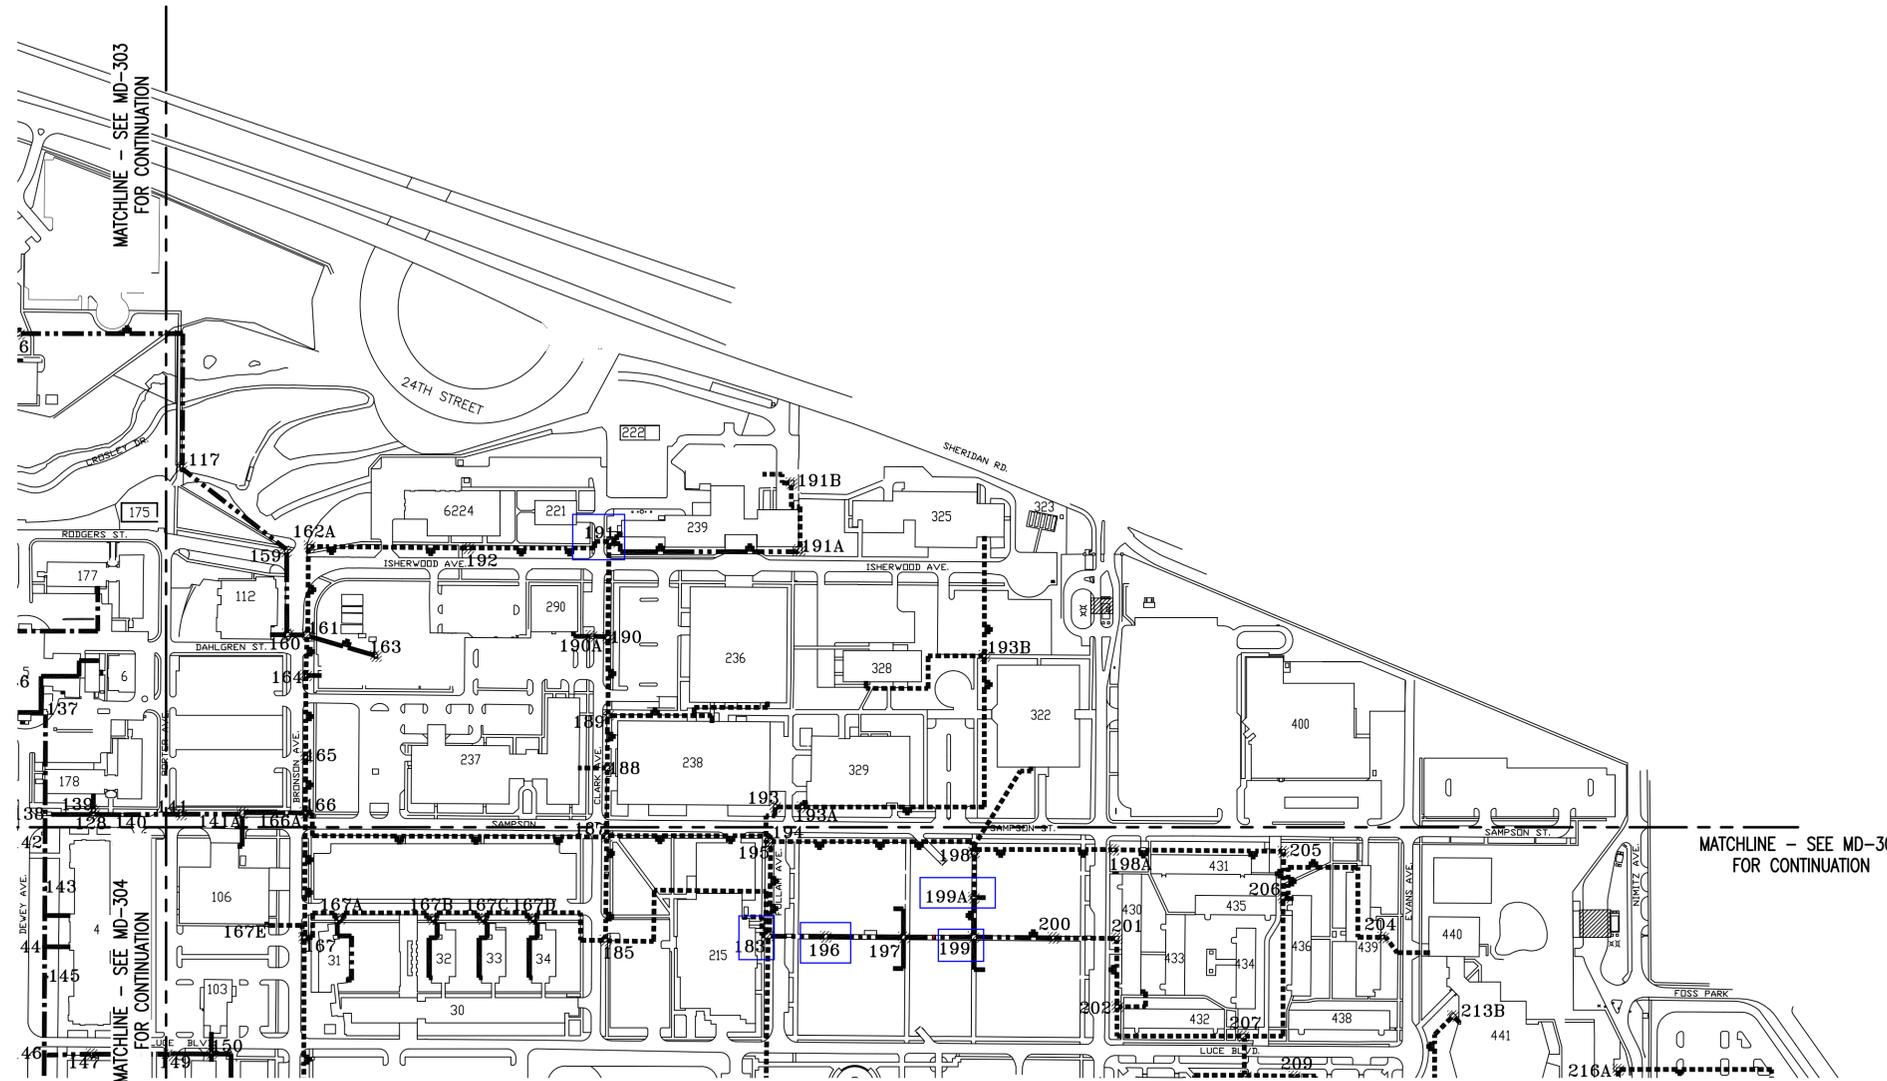
No ACM found in samples collected along Chases

☐ Samples collected at these pits for ACM.
 Results indicate no asbestos in Chases.

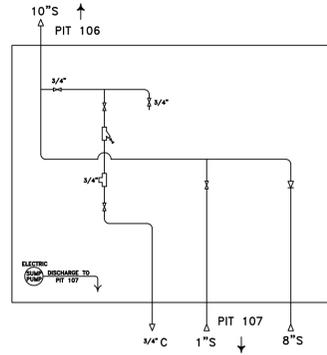
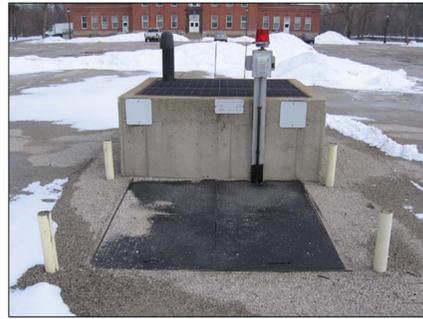
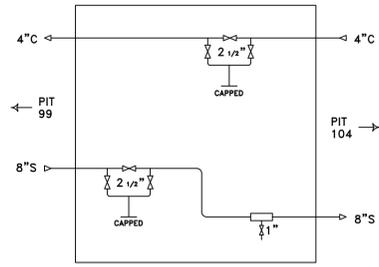
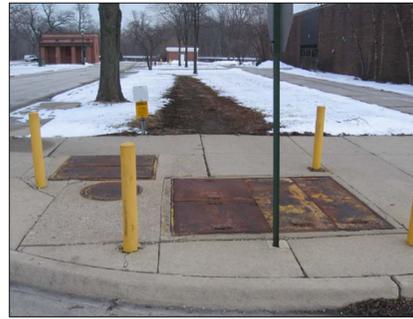
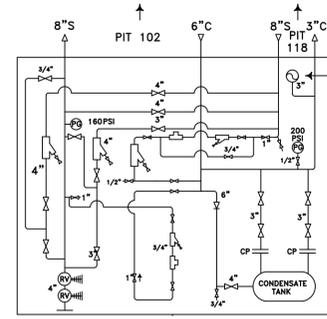
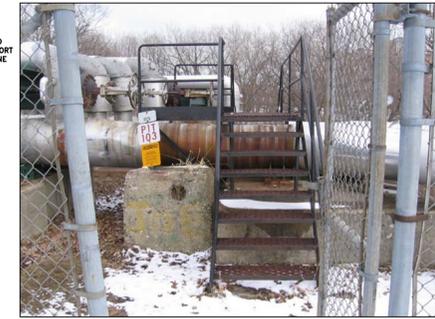
Drawing 5: EDI Suspect ACM Sampling Locations
Steam Chases
Pit 104

Fiberglass TSI observed

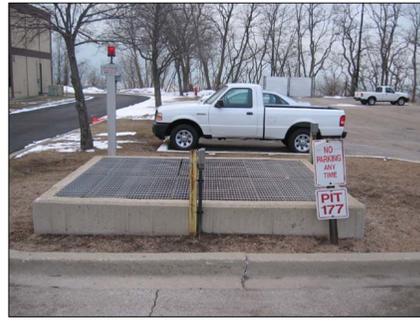
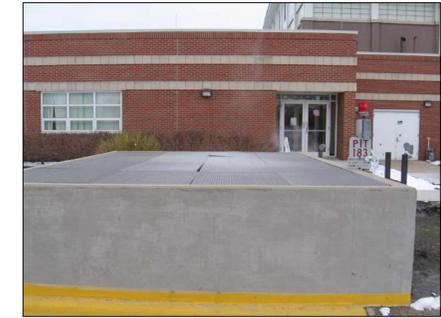
EDI Suspect ACM Sampling Locations
Steam Chases
Pit 183

■ Samples collected for ACM
— Steam Line observed in Chase not shown on drawing.
