**Hazardous Building Materials
Survey Report
For Building #678**

**Naval Station Newport
Newport, Rhode Island**

**H&S Environmental, Inc.
160 East Main Street, Suite 2F
Westborough, Massachusetts 01581**

September 2011

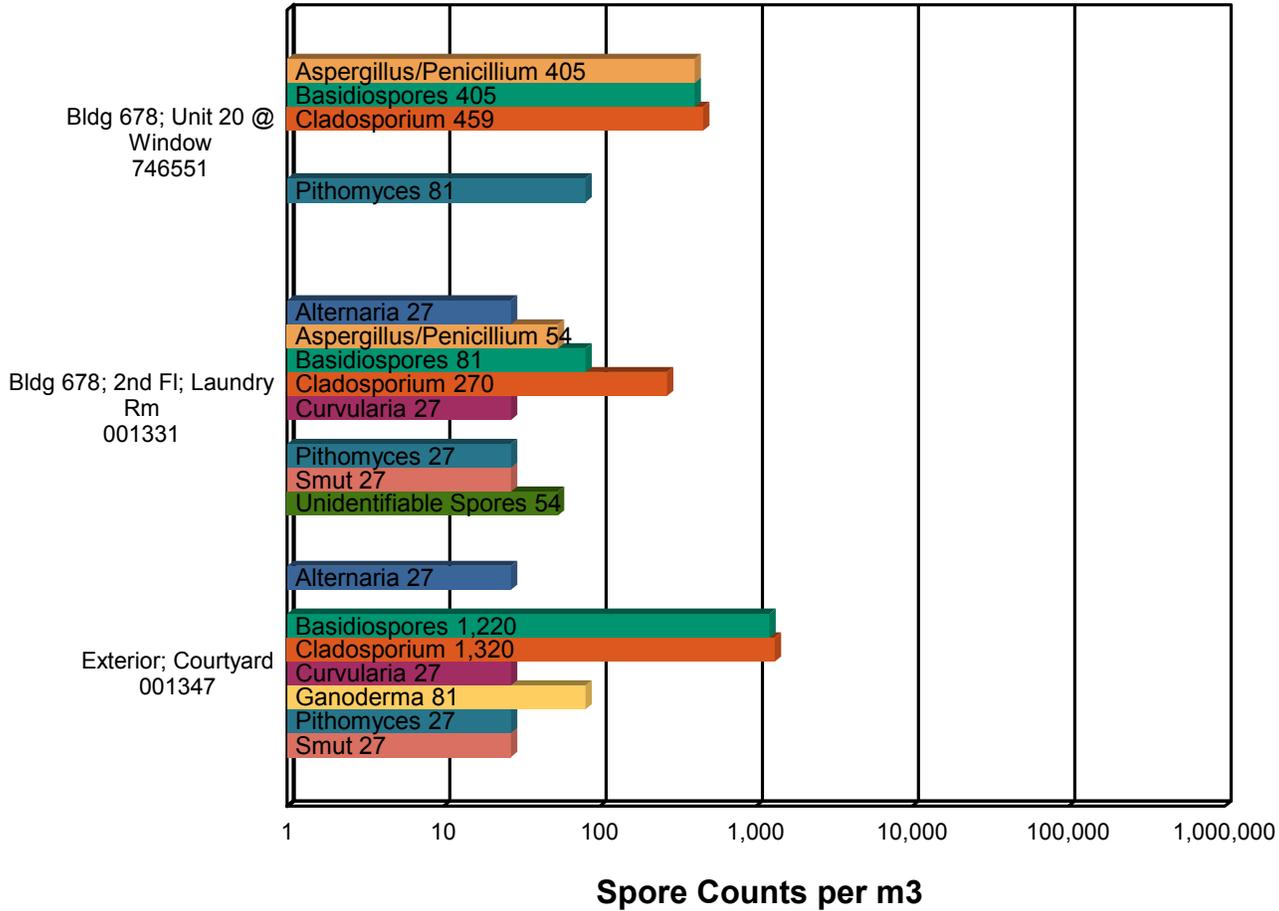
Spore Trap Report: Total Counts

* The chart is displayed using a logarithmic scale. Bar size is not directly proportional to the number of spores.

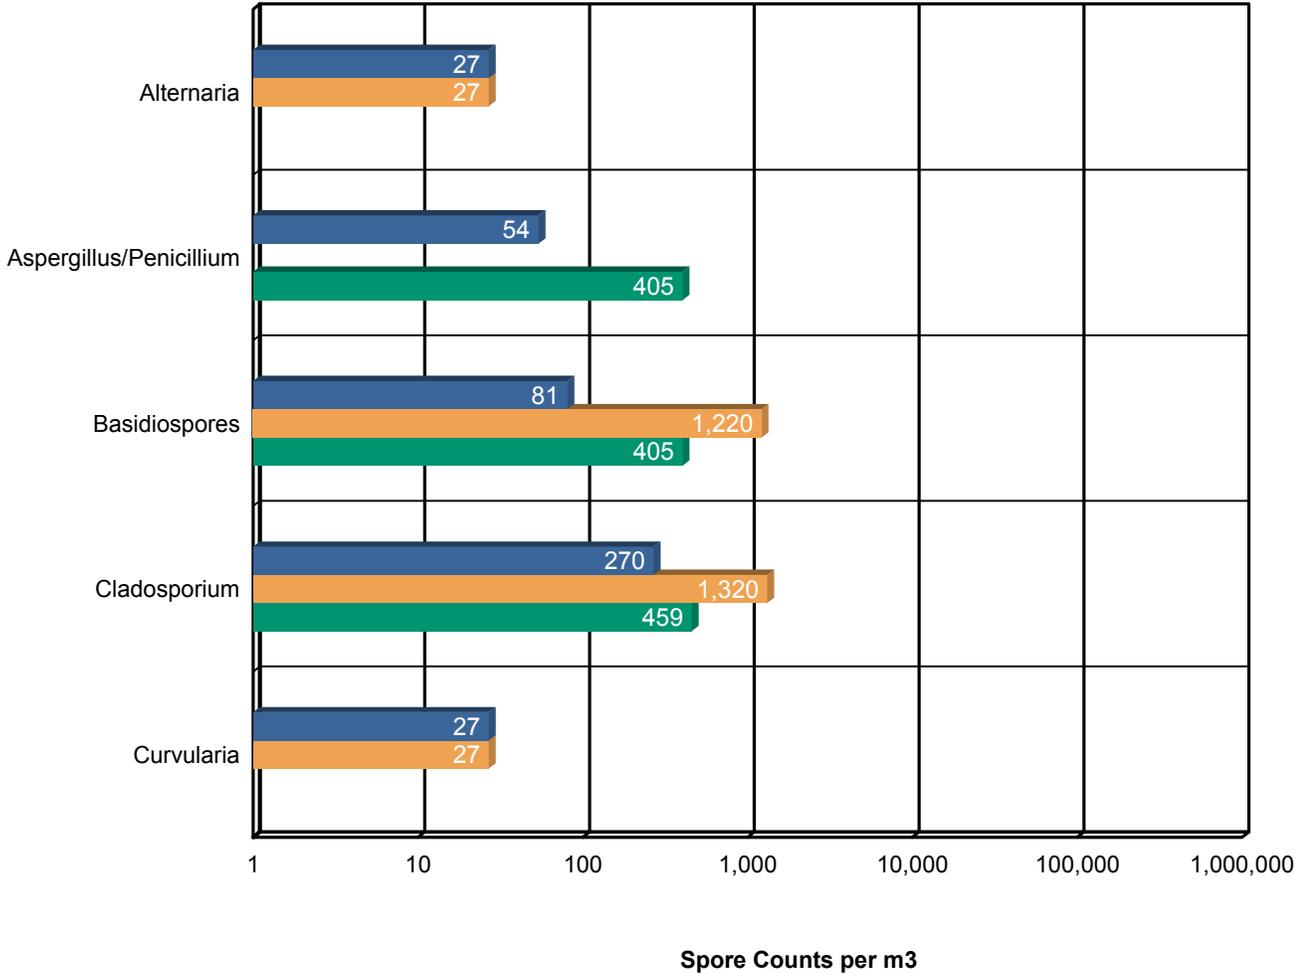
Background Comparison Chart

* The chart is displayed using a logarithmic scale. The bar size is not directly proportional to the number of spores.

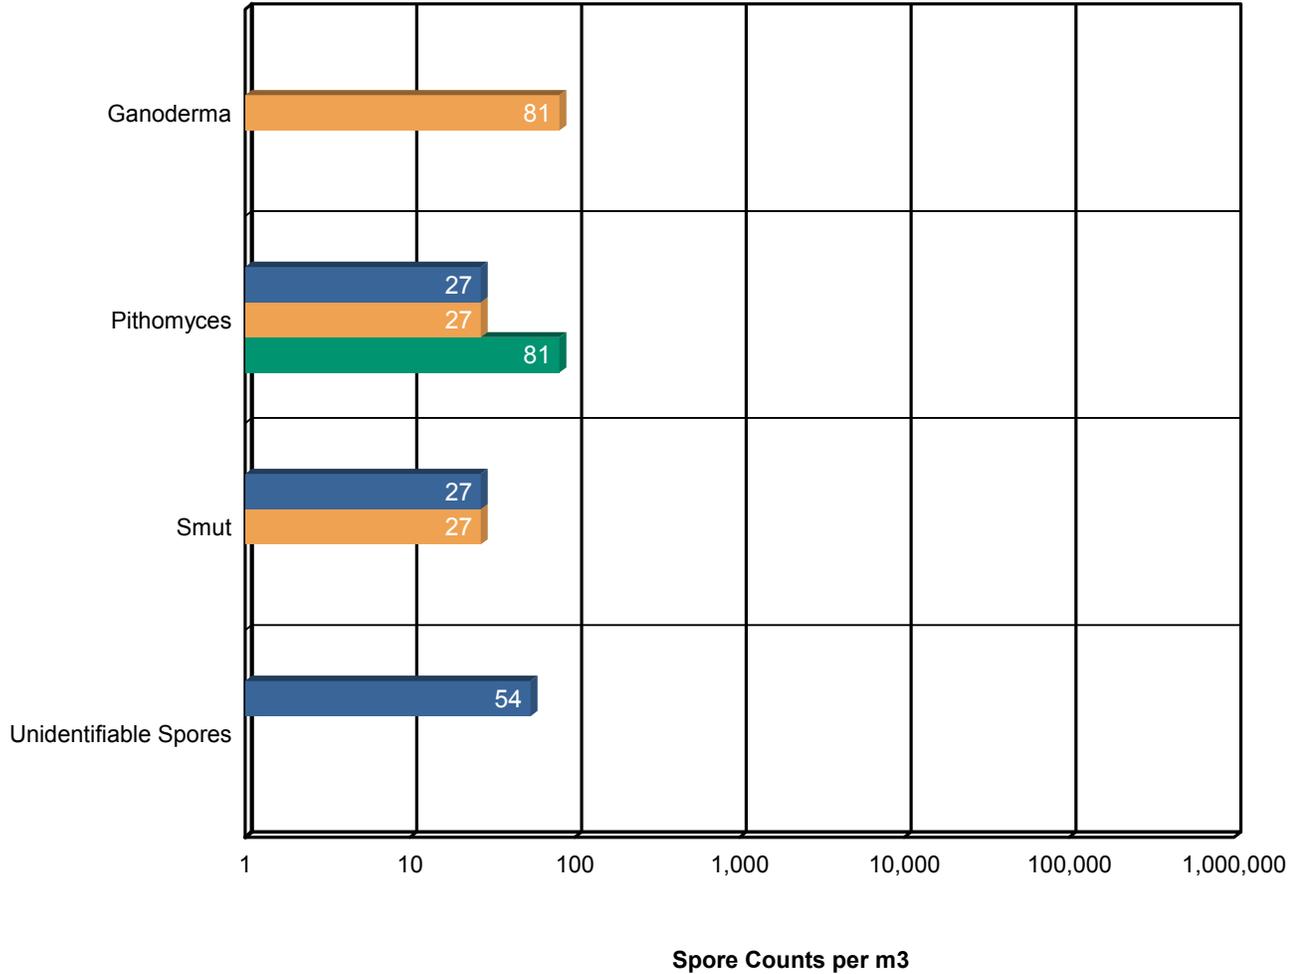
Background Comparison Chart

■ 001331 Bldg 678; 2nd Fl; Laundry Rm	■ 001347 Exterior; Courtyard	■ 746551 Bldg 678; Unit 20 @ Window
---	--	--

* The chart is displayed using a logarithmic scale. The bar size is not directly proportional to the number of spores.
