Figure 2-1
Proposed Solar Project Locations
NAVSTA Newport
Newport County, Rhode Island

**Proposed Solar Project Location:
McAllister Point Landfill
Naval Station Newport**
Newport County, Rhode Island

Environmental Condition of Property (ECP) Checklist

Title:	Lease McAllister Point landfill for Solar Photovoltaic Array
Installation:	Naval Station Newport Rhode Island
Parcel/Site Location and Description:	<p>NAVSTA Newport is located approximately 60 miles southwest of Boston, Massachusetts, and 25 miles south of Providence, Rhode Island. This naval facility consists of approximately 1,000 acres located on the western shore of Aquidneck Island, adjacent to Narragansett Bay, in the towns of Portsmouth and Middletown, and in the city of Newport, Rhode Island. Training and research and development have been the primary activities at NAVSTA Newport from 1974 to present. Land use surrounding the base is residential, commercial, and industrial. McAllister Point Landfill (Site 1) occupies approximately 11.5 acres and is located in the central portion of the facility.</p> <p>NAVSTA Newport was placed on the National Priorities List (NPL) in 1989. Site 1 was one of the operable units ide

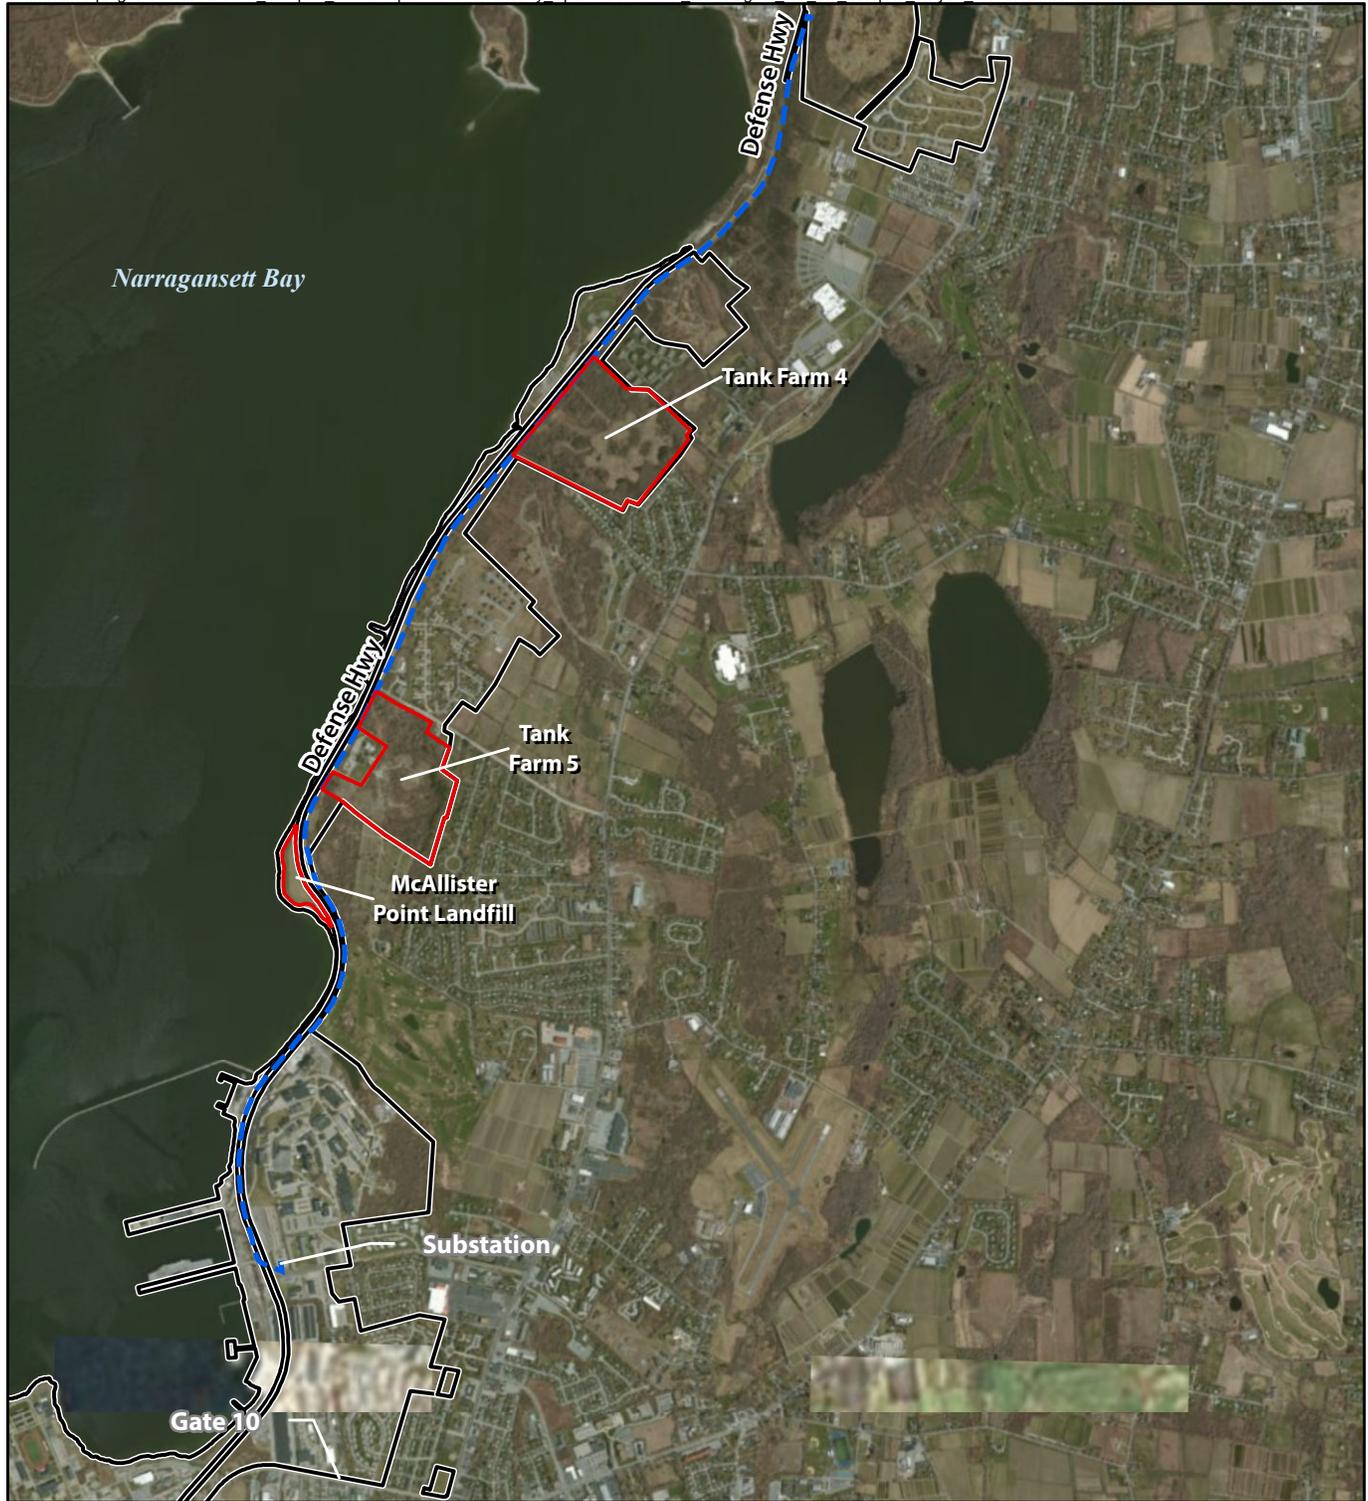
Navy Electrical Distribution Line

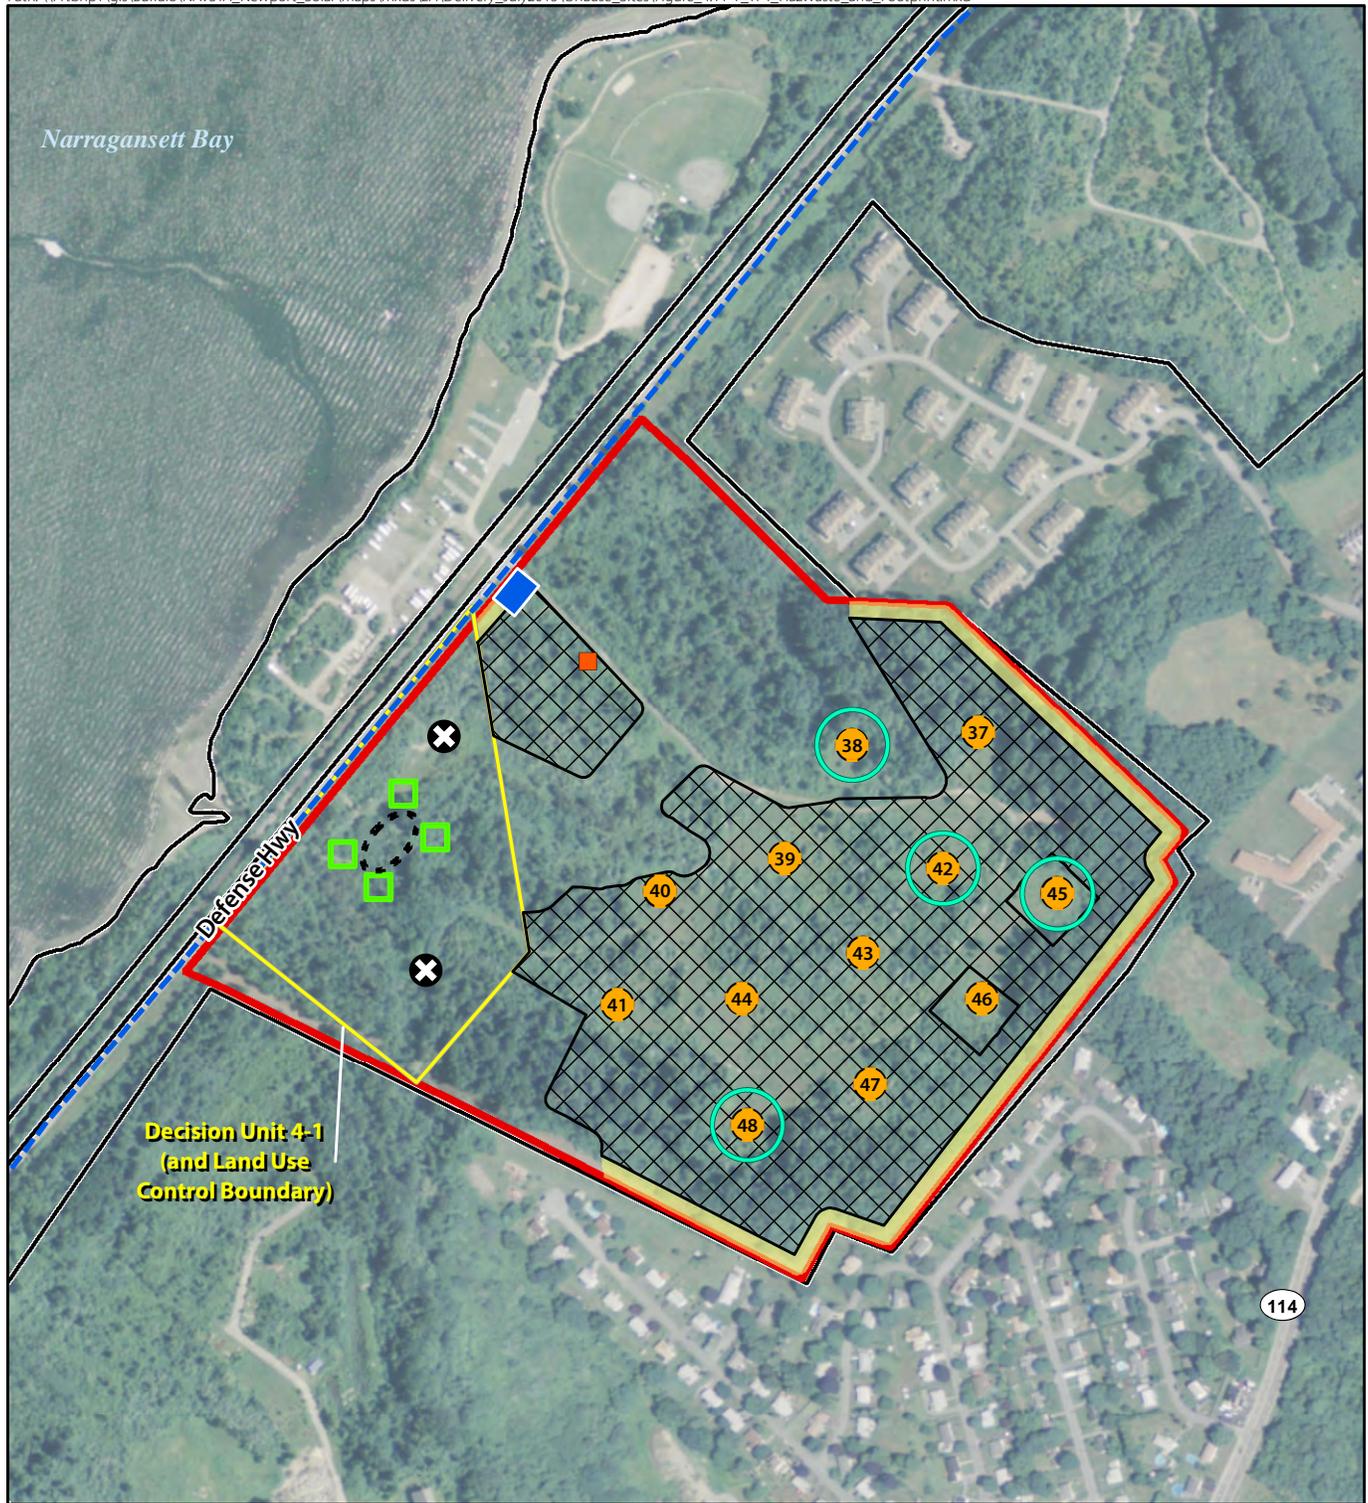
Figure 4.11-1
Alternative Site Location
Tank Farm 4, IRP Site 12
Naval Station Newport
Newport County, Rhode Island

Decision Unit 4-1
(and Land Use
Control Boundary)

*Additional vaults and structures could be present at the site

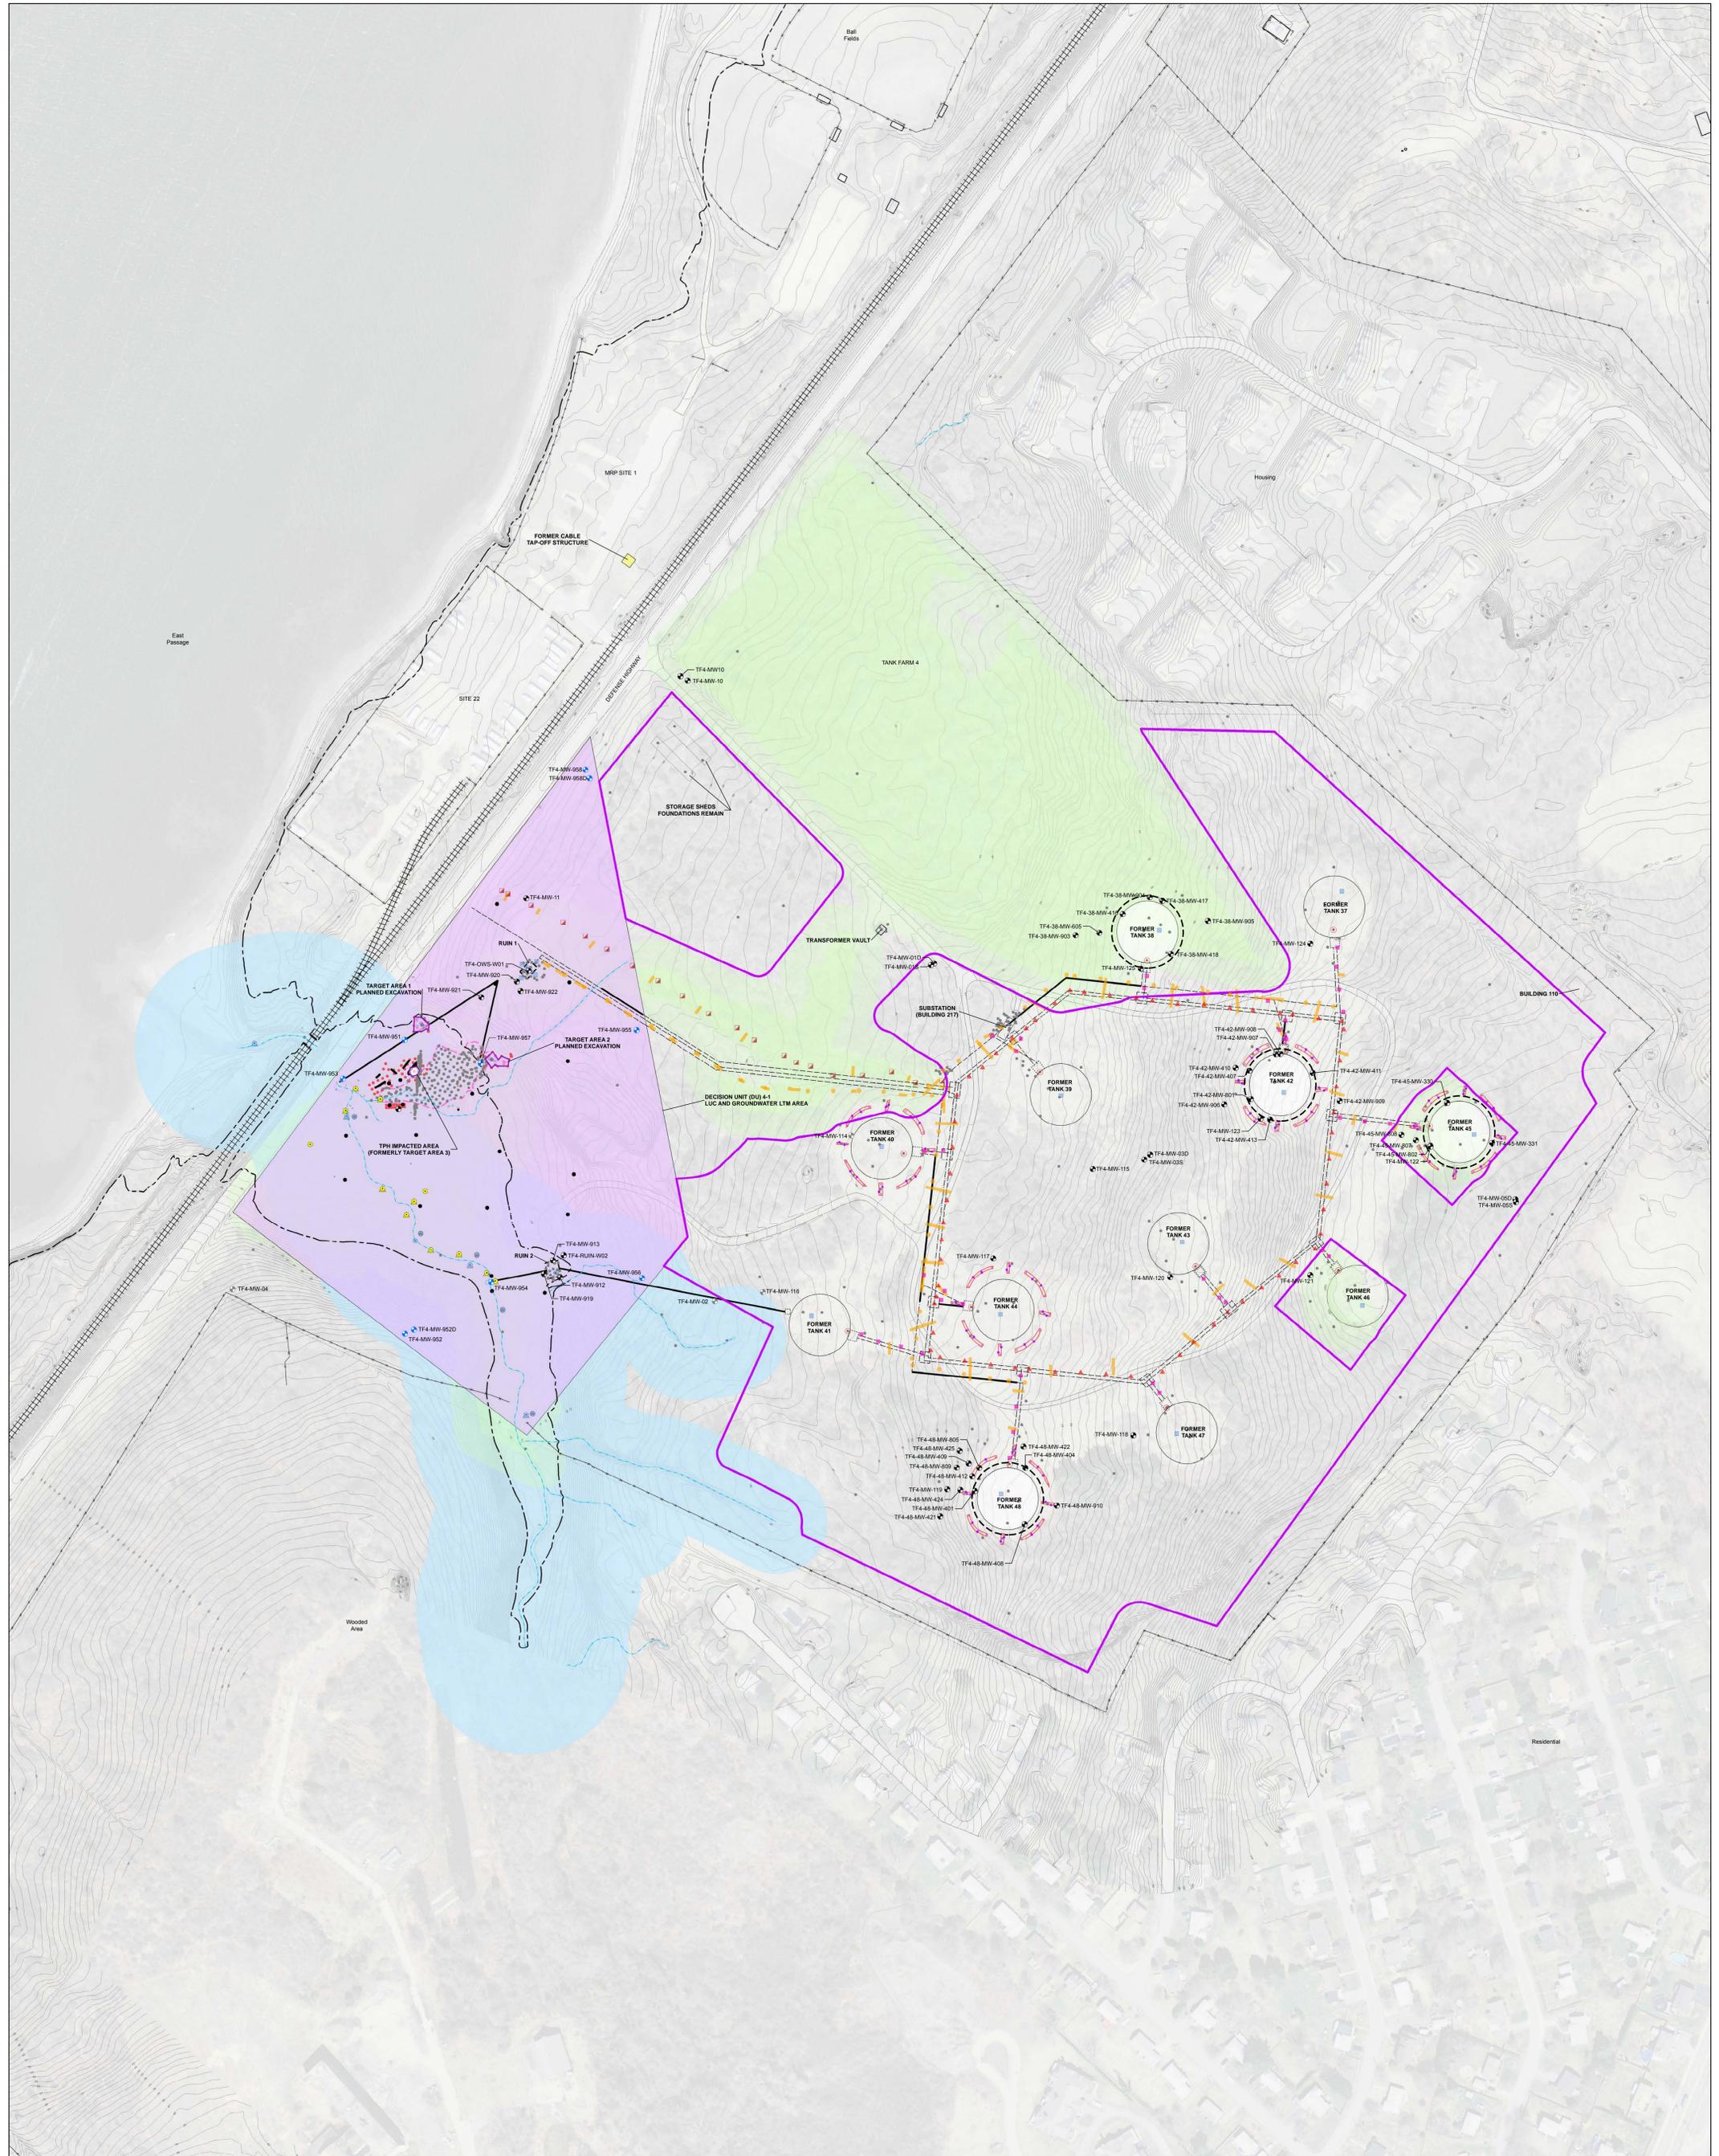
**FIGURE 1
SITE MAP**

SITE 12 - TANK FARM 4
NAVSTA NEWPORT, RHODE ISLAND

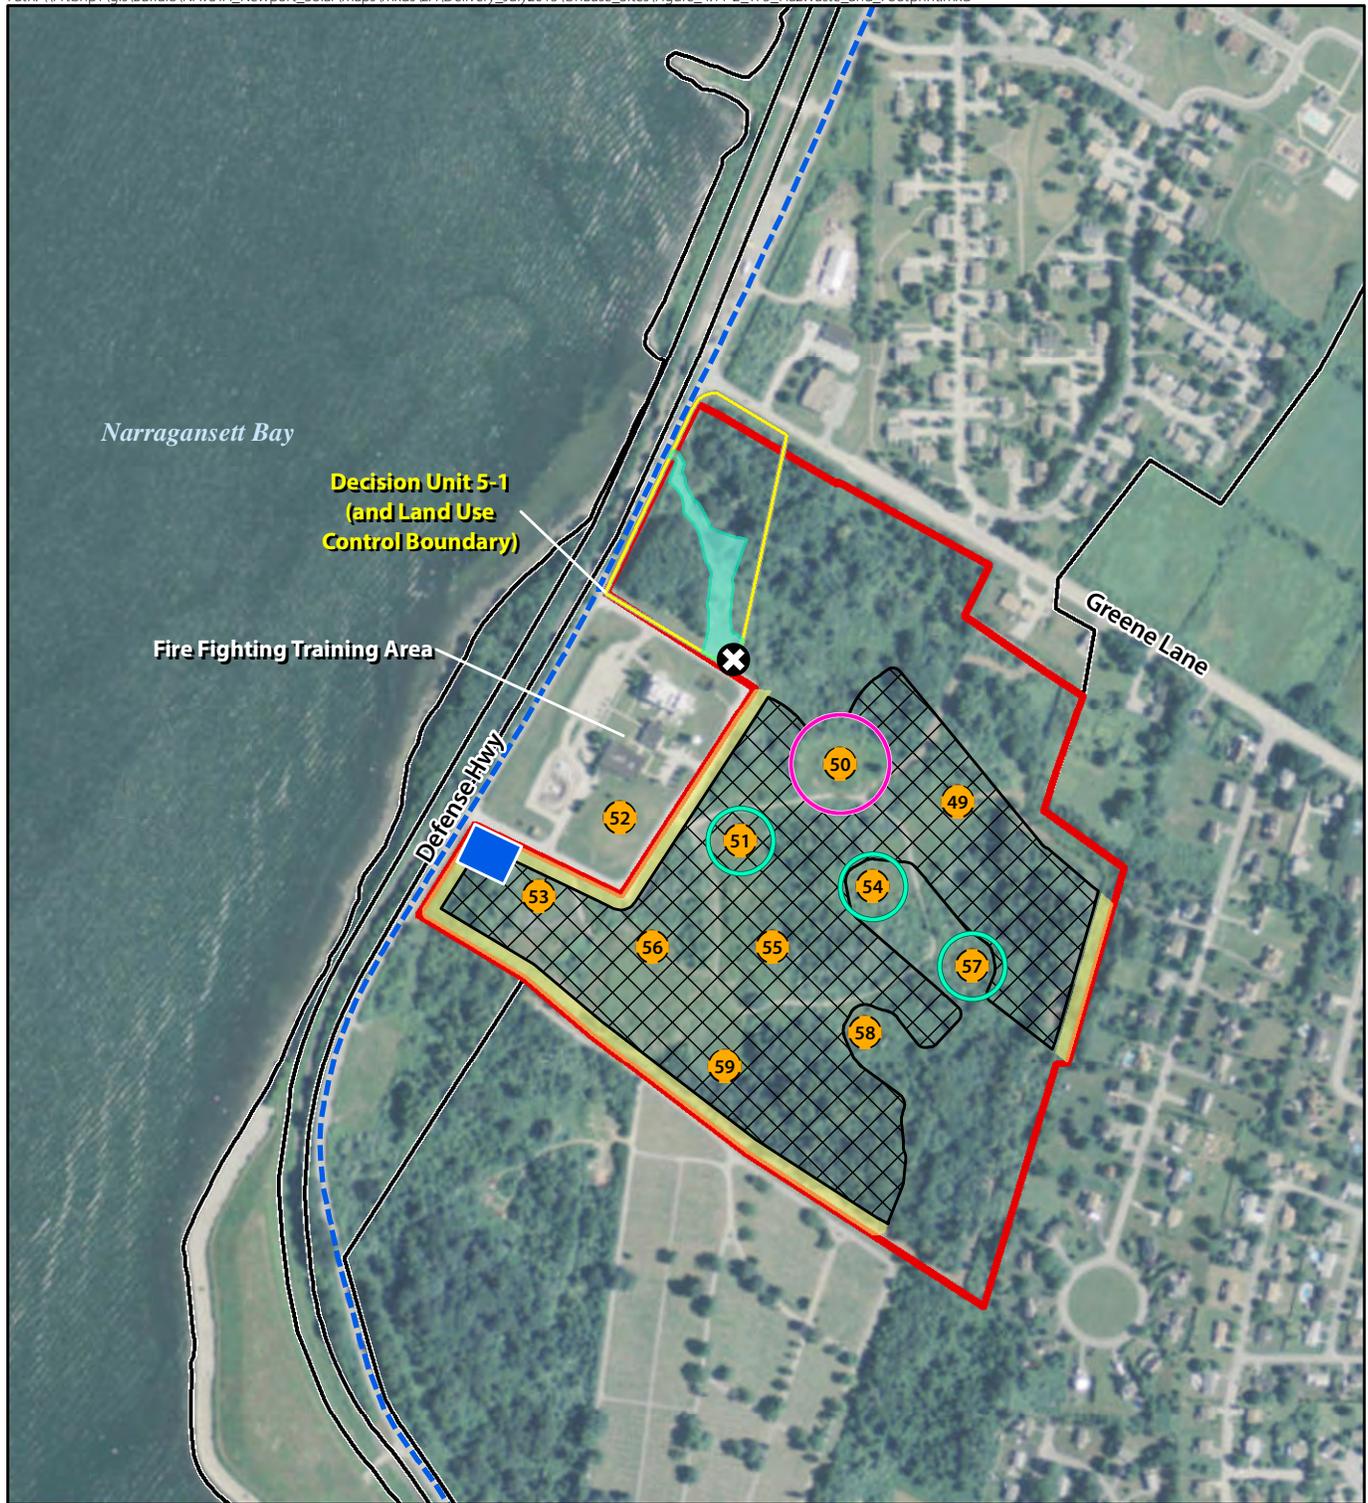
Figure 4.11-2
Alternative Site Location
Tank Farm 5, IRP Site 13
Naval Station Newport
Newport County, Rhode Island

Decision Unit 5-1
(and Land Use
Control Boundary)

- Future Soil Cover Area
- CERCLA Decision Unit
- Former Oil-Water Separator
- Demolished/Imploded Tank
- Tank 50 150-foot-radius corrective action buffer
- RIDEM UST land use restriction will apply (dimension of area not to scale)

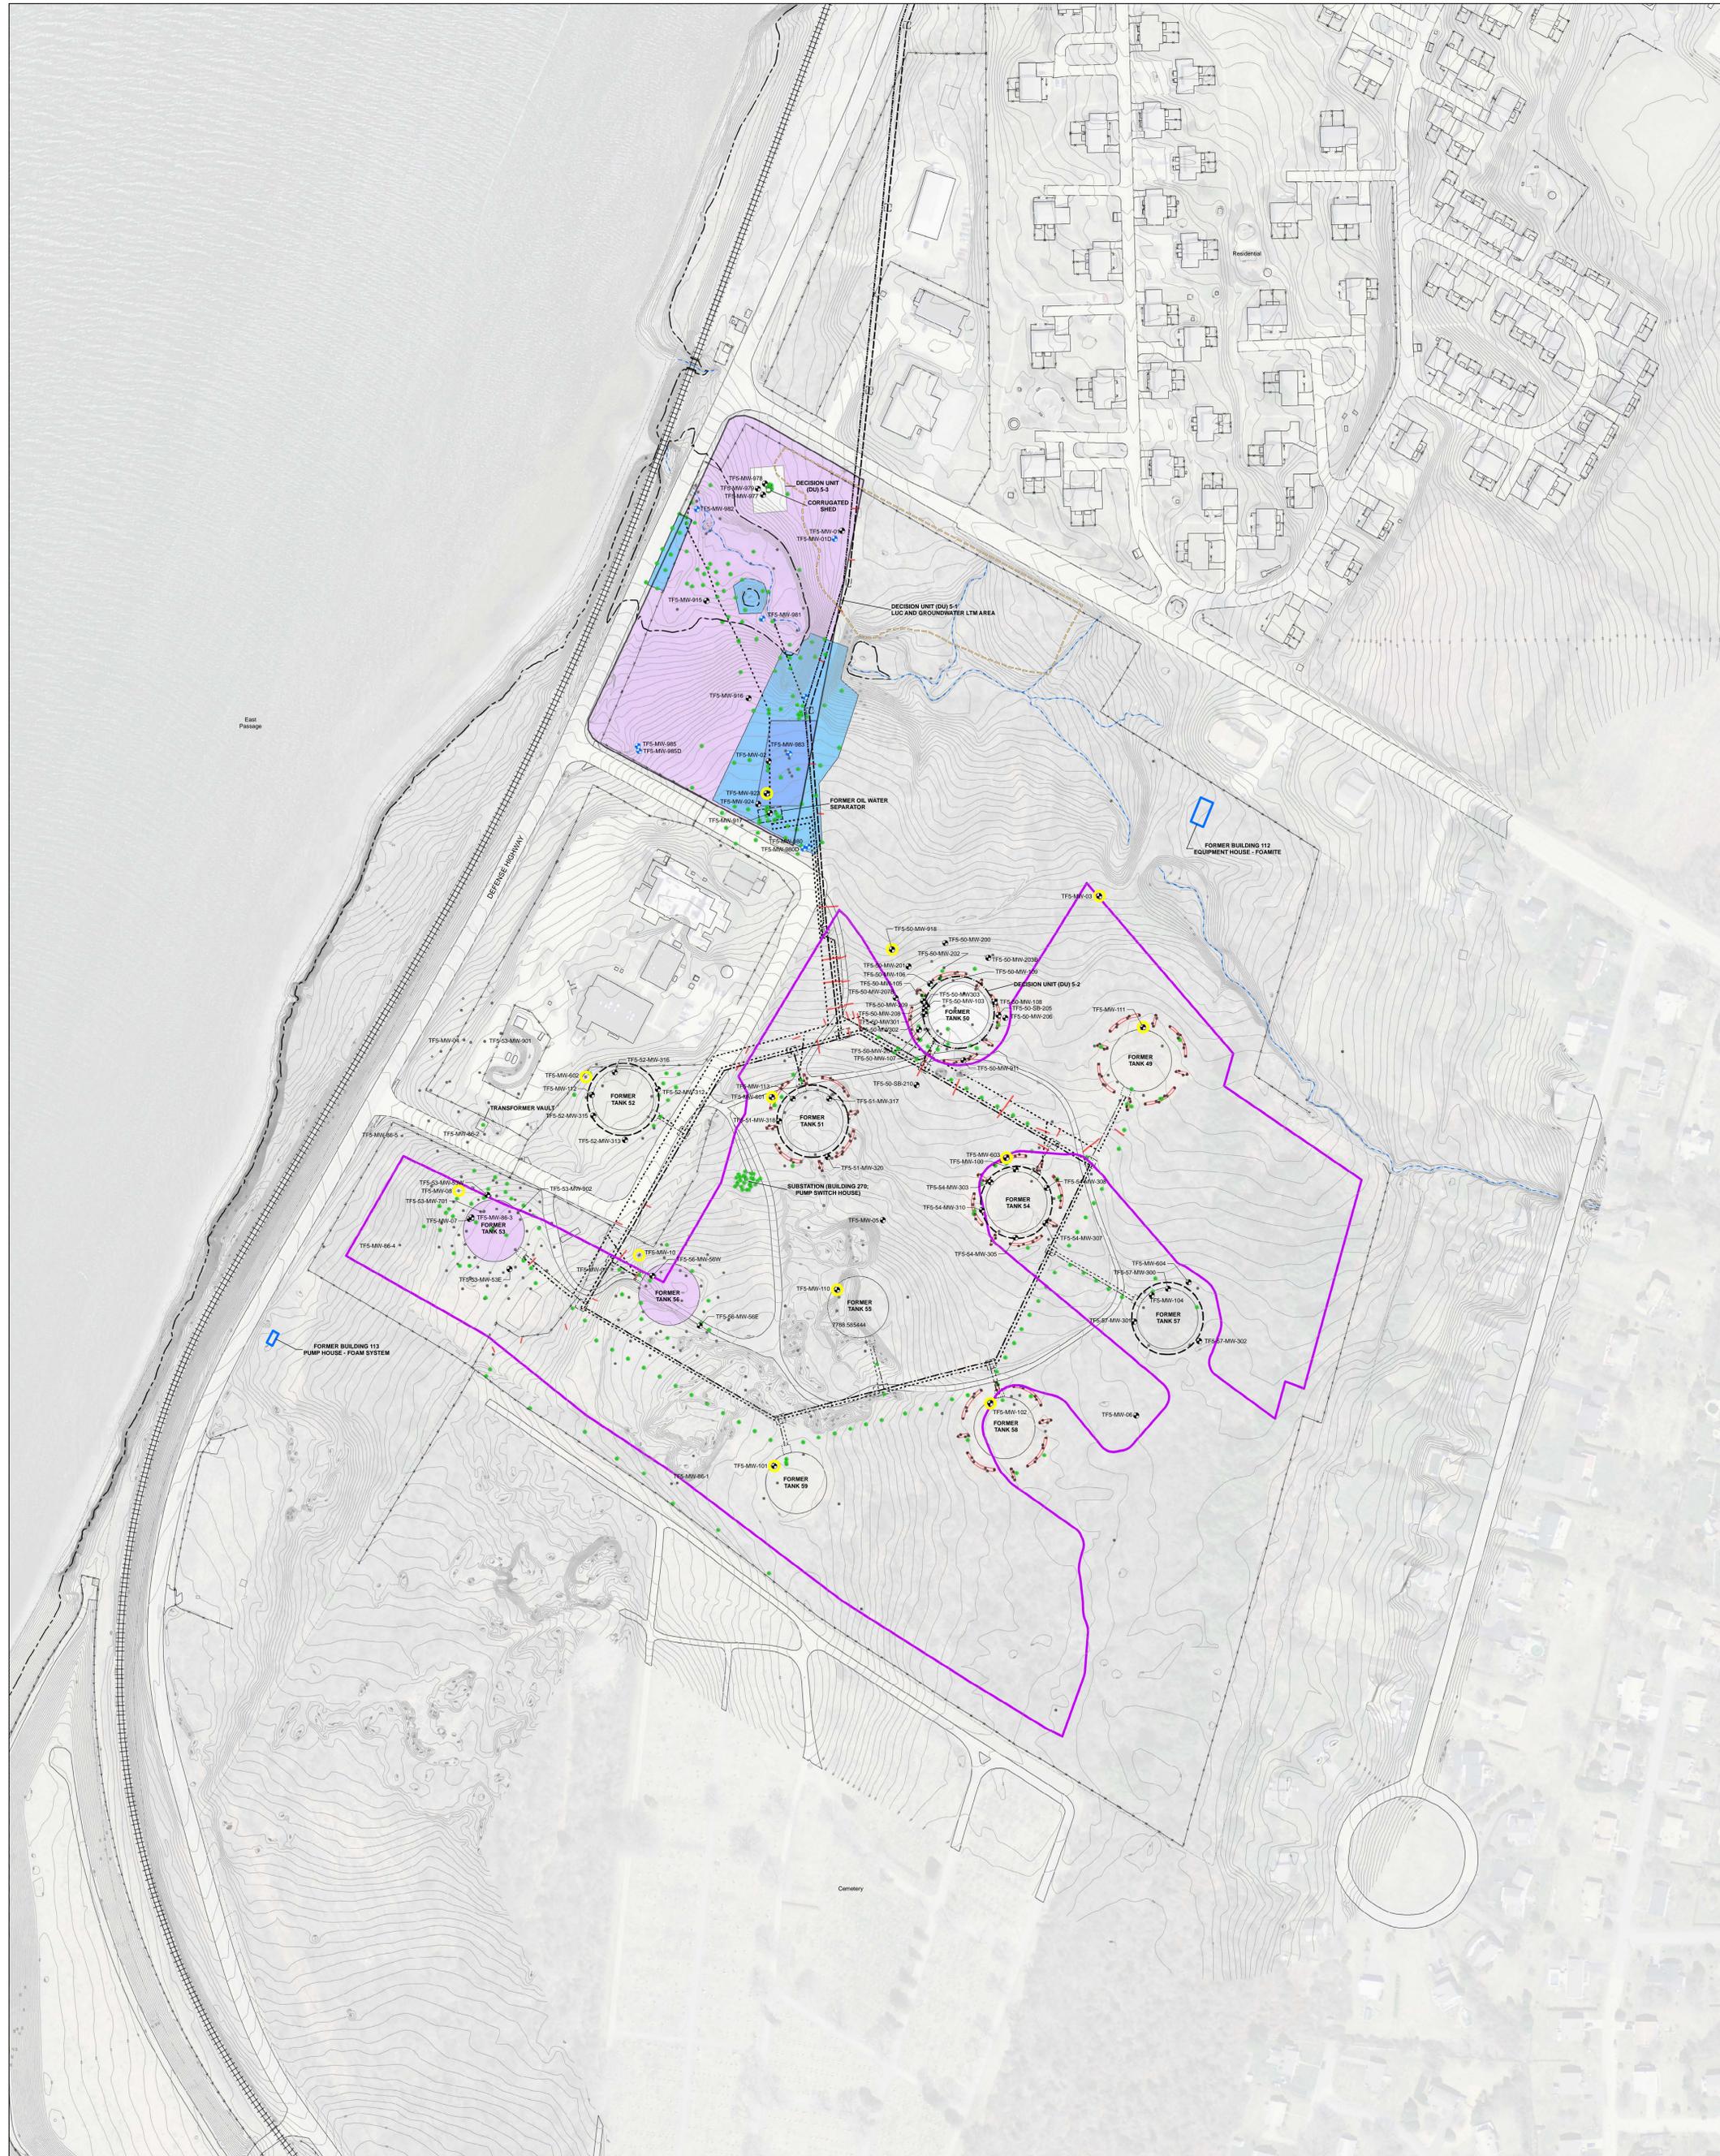
FIGURE 1
PROPOSED PFC SAMPLING LOCATIONS

SITE 13 - TANK FARM 5
 NAVSTA NEWPORT, RHODE ISLAND

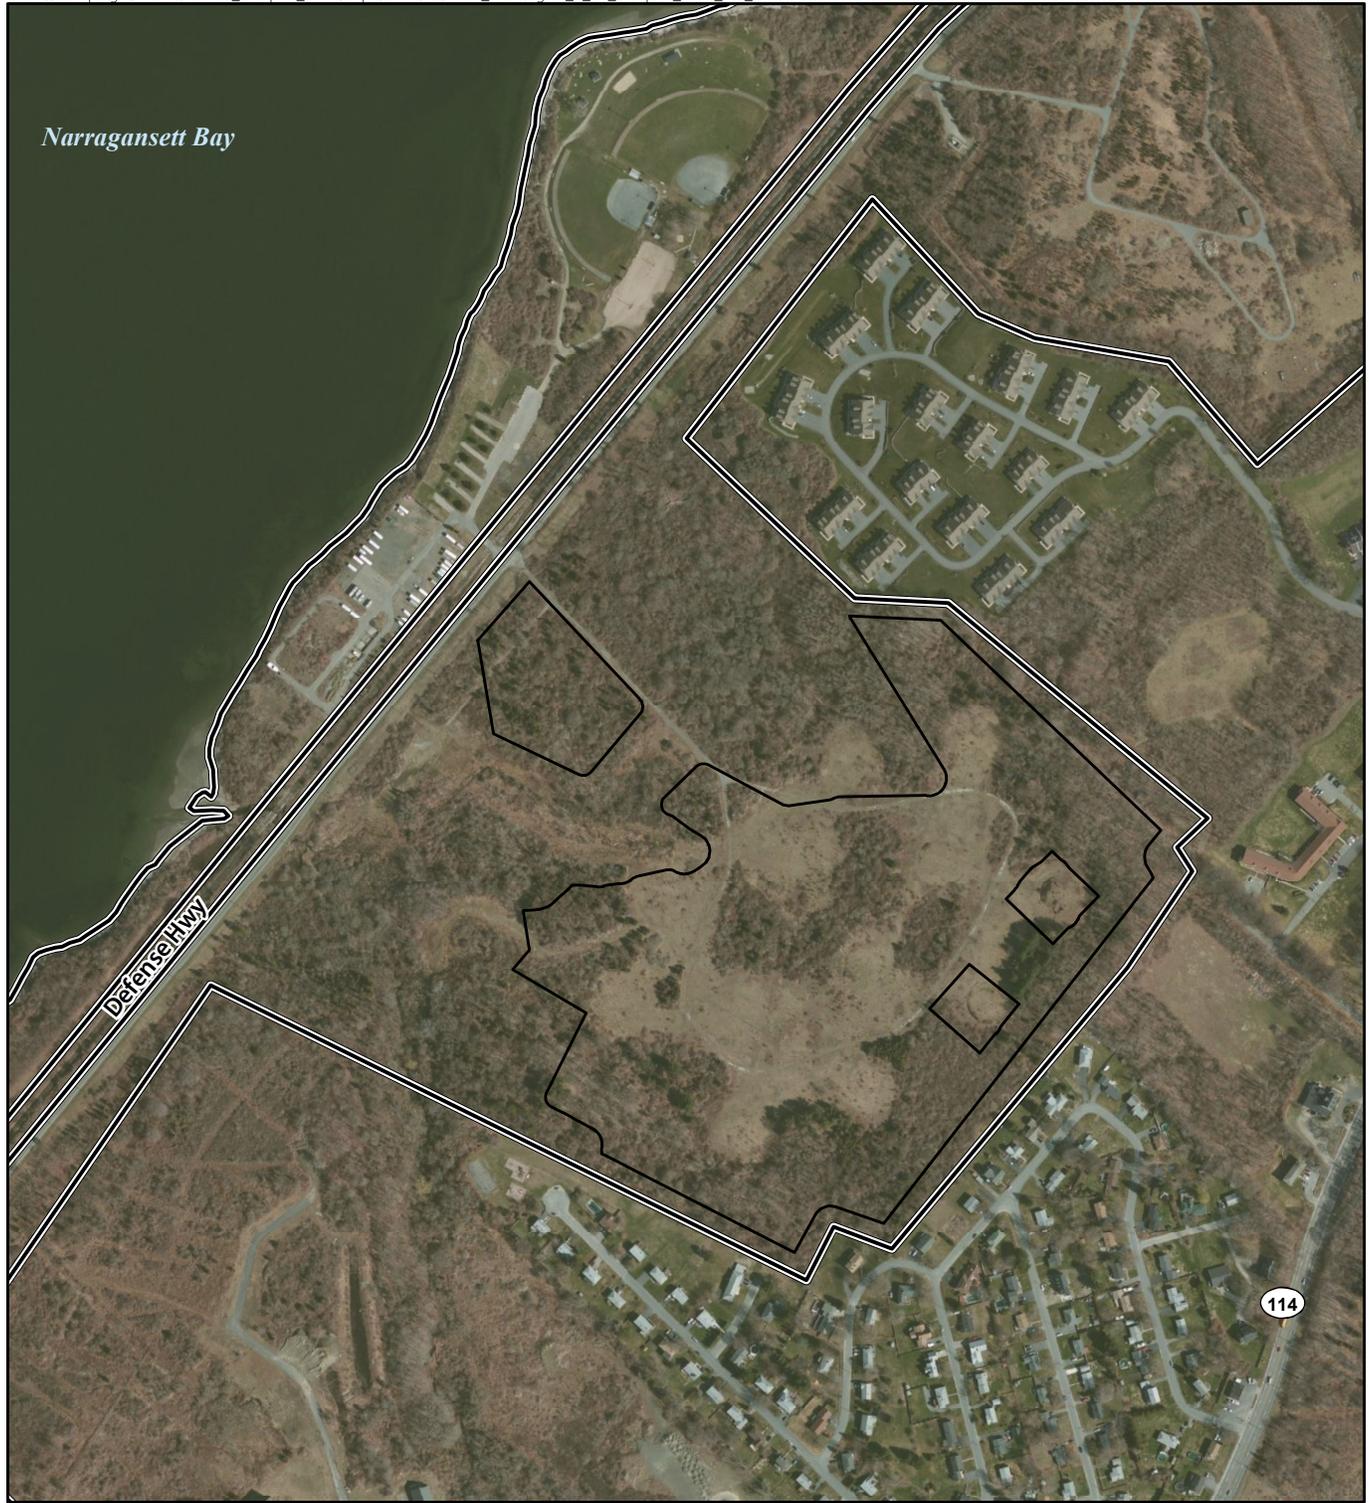
Figure A
Proposed Solar Project Footprint:
Tank Farm 4
Naval Station Newport
Newport County, Rhode Island

8. Tank Farm 4_Aproved USFWS Timber Footprint

are shown in "Figure A NS Newport Aerial TF4 V2. pdf"; (13) a hazardous material survey, which includes lead base paint and asbestos, must be performed before any building, structure, trench or ruin is disturbed;
