ENVIRONMENTAL SURVEY
P816 PHASE V AMENDED
BUILDING 11
NAVAL STATION GREAT LAKES, ILLINOIS

NAVFAC MIDWEST REQUEST NO. EPROJECT WO #: 1898016

ENVIRONMENTAL SURVEY P816 PHASE V – AMENDENDED REPORT BUILDING 11

ECG Project Number: A111305-104
Date: November 11, 2011

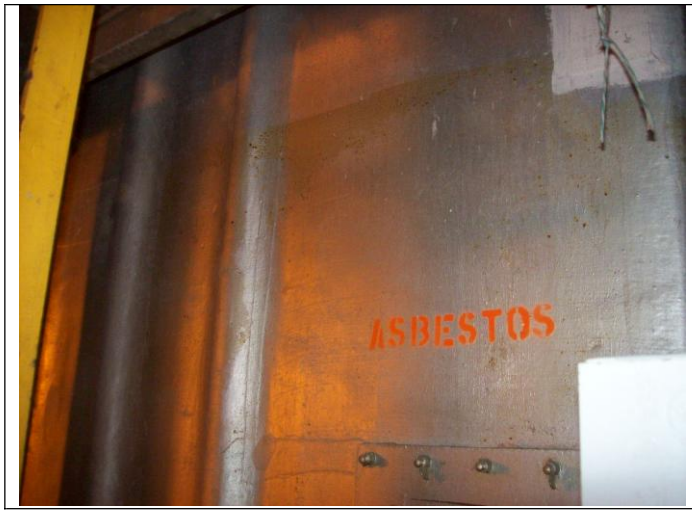
8. View of boiler insulation—Asbestos. (NE1)

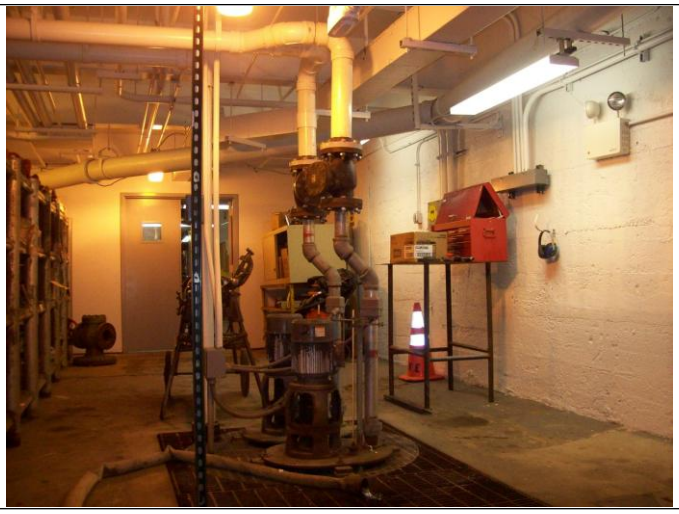
13. View of epoxy flooring. (NWB)

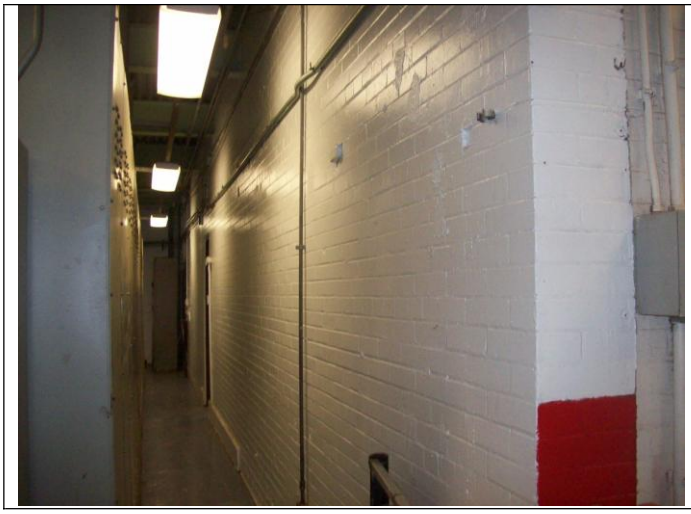
1. View of tan paint—Wall—Lead-based paint. (SW1)

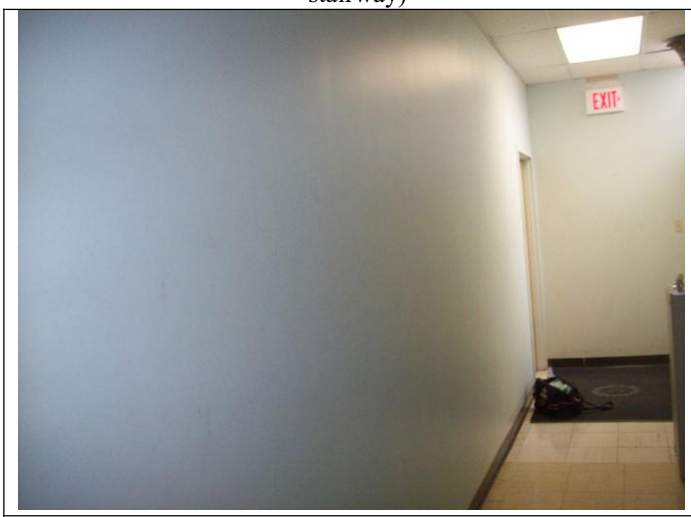
16. View of light blue green paint—Wall. (OFF3)

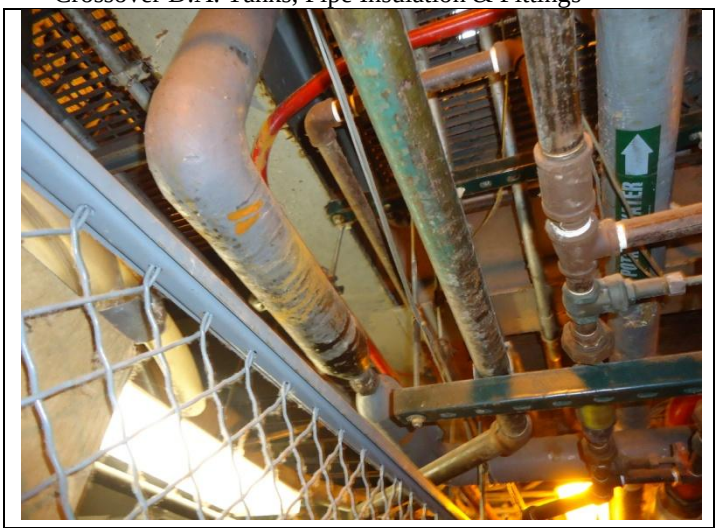
15. Assumed ACM, New Main FL. Side Small Pipe Over Storage Cage Near Boiler #6, Pipe Insulation & Fittings

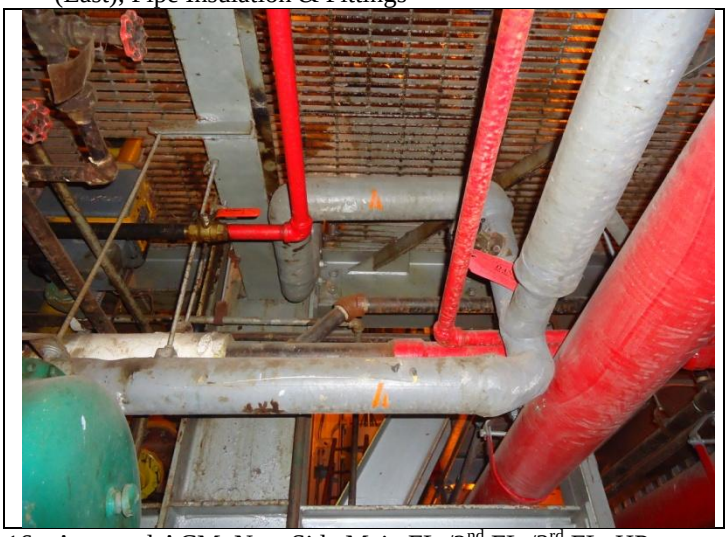
16. Assumed ACM, New Side Main FL./2nd FL./3rd FL. HP Return (Starts between Boiler #6&5), Pipe Insulation & Fittings

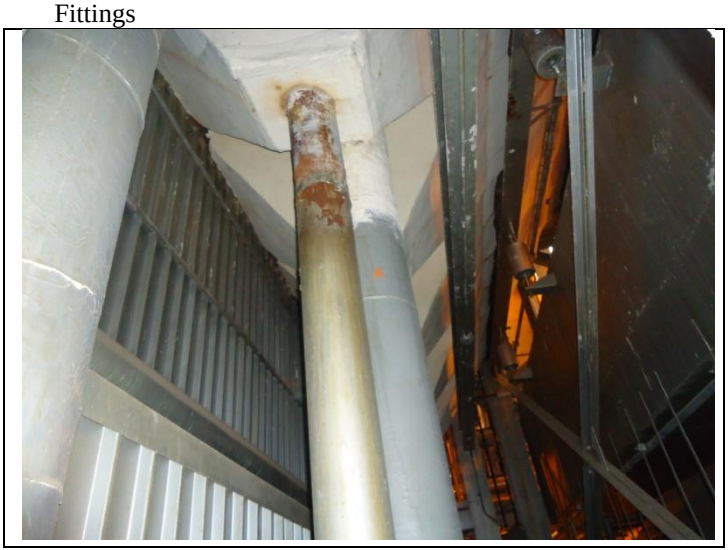
18. Assumed ACM, New Side Main FL. Large Steam Pipes North End Boiler #5, Pipe Insulation & Fittings

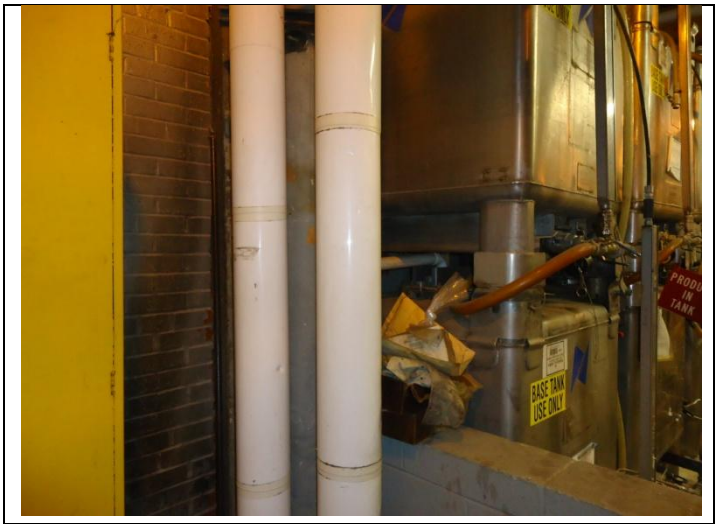
27. Assumed ACM, New Side Main FL./2nd FL./3rd FL. (North), Pipe Insulation & Fittings

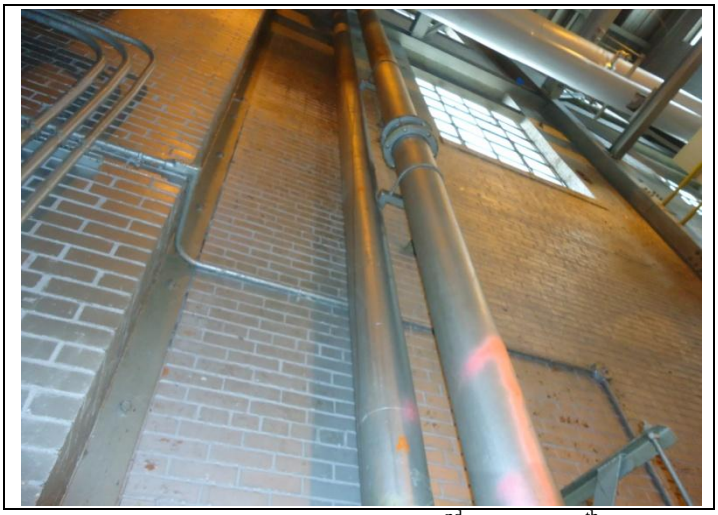
31. Assumed ACM, New Side (North) 2nd FL. Thru 4th FL., Pipe Insulation & Fittings

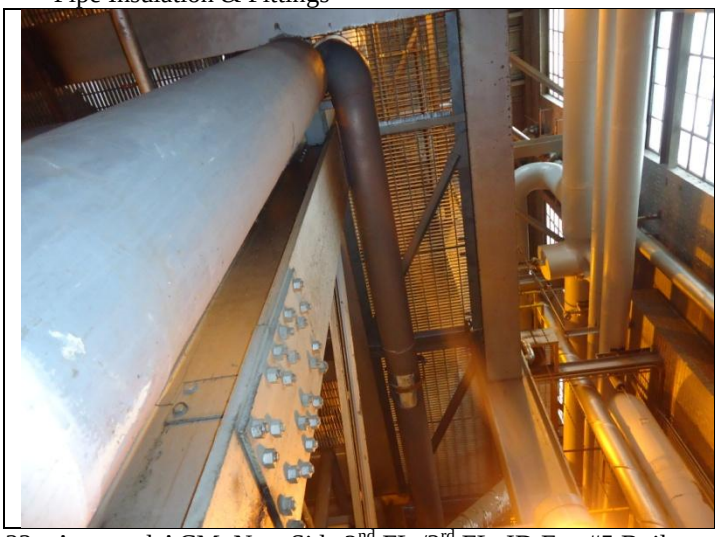
33. Assumed ACM, New Side 2nd FL./3rd FL. ID Fan #5 Boiler, Pipe Insulation & Fittings

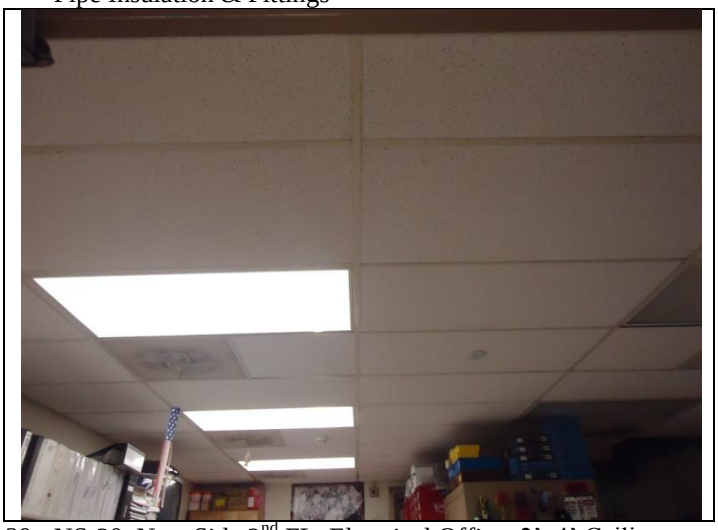
39. NS-20, New Side 2nd FL. Electrical Office, 2’x4’ Ceiling Tile

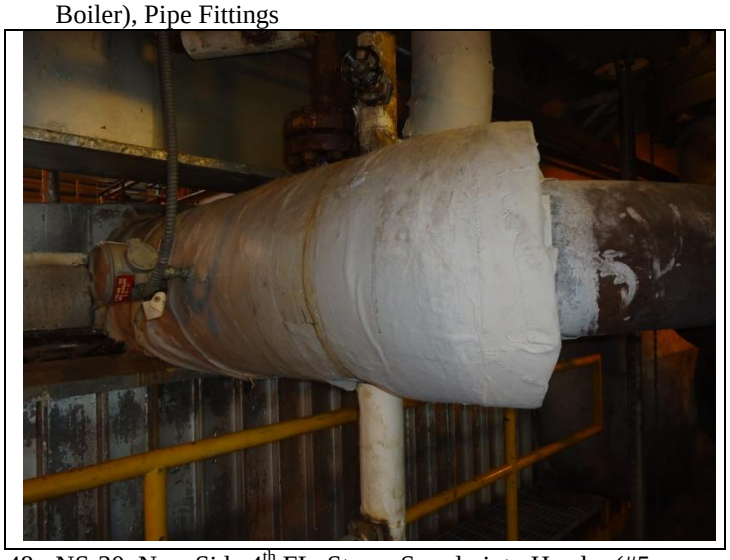
48. NS-30, New Side 4th FL. Steam Supply into Header (#5 Boiler), Pipe Fittings

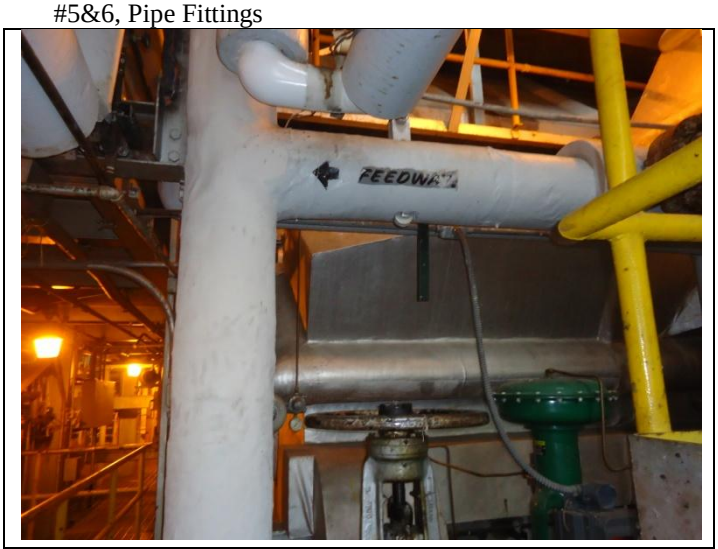
53. NS-33, New Side 4th FL. Feed Water North Pipe of Boiler #5, Pipe Insulation

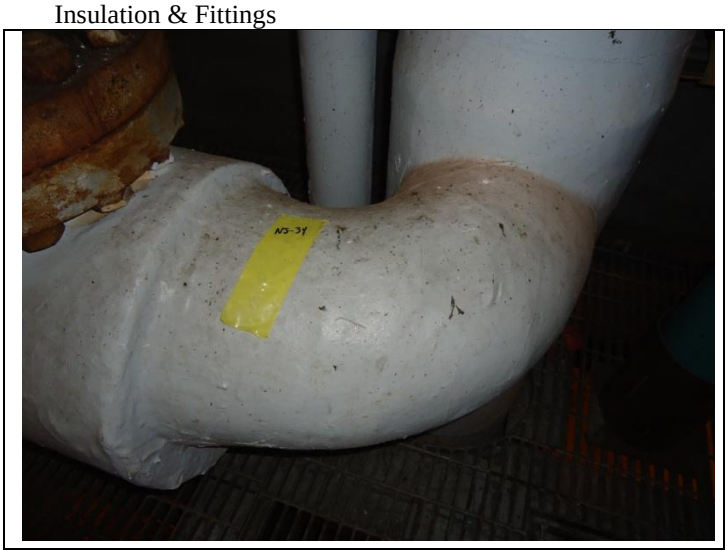
54. NS-34, New Side 4th FL. Feed Water North Pipe of Boiler #5, Pipe Fitting

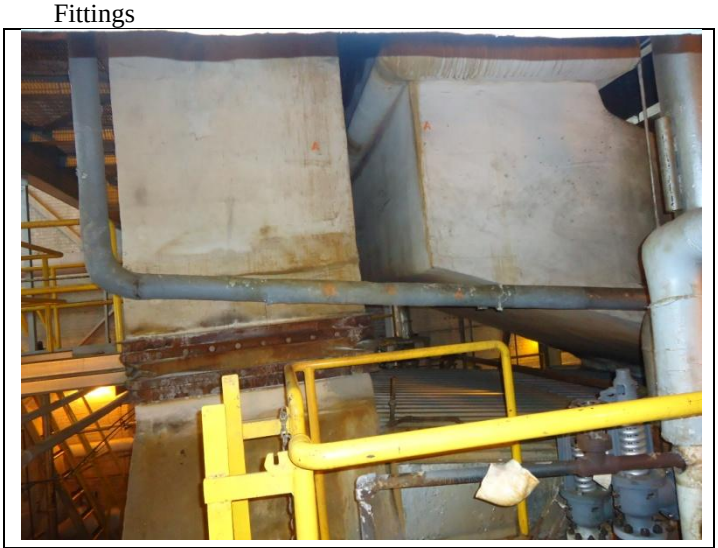
57. Assumed ACM, New Side 4th FL. Top of Boiler #6, Pipe Insulation & Fittings

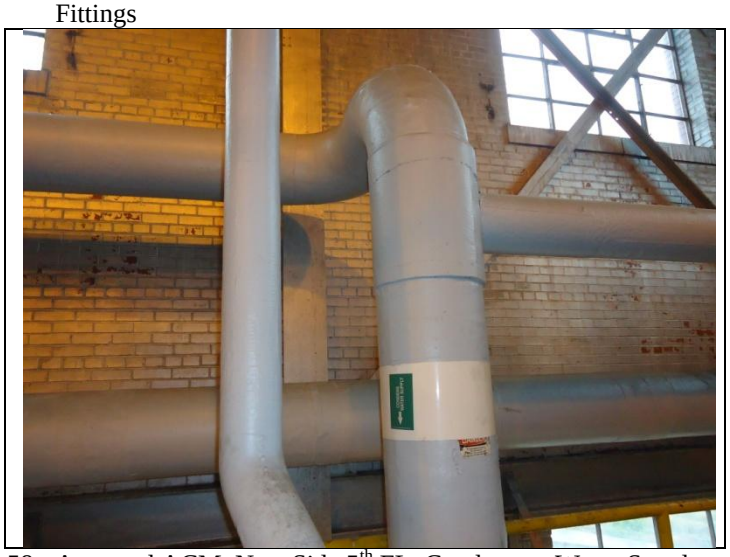
58. Assumed ACM, New Side 5th FL. Condensate Water Supply (Out of East DA Tank), Pipe Insulation & Fittings

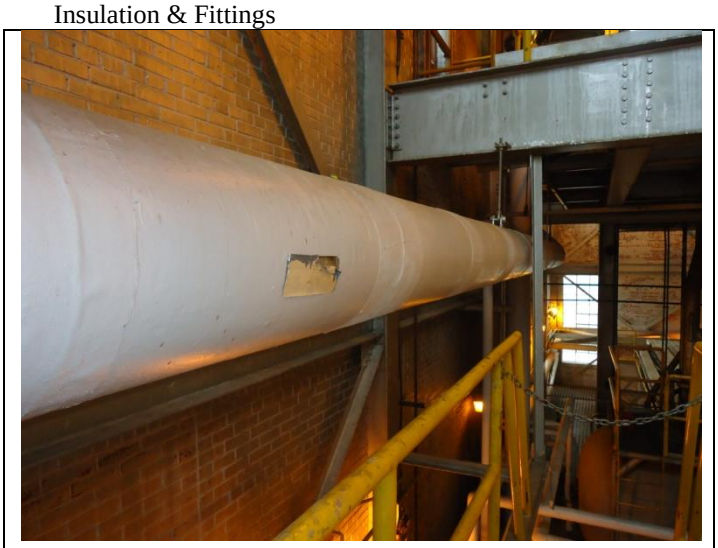
59. NS-43, New Side 5th FL. Northeast 25k Pipe, Pipe Insulation

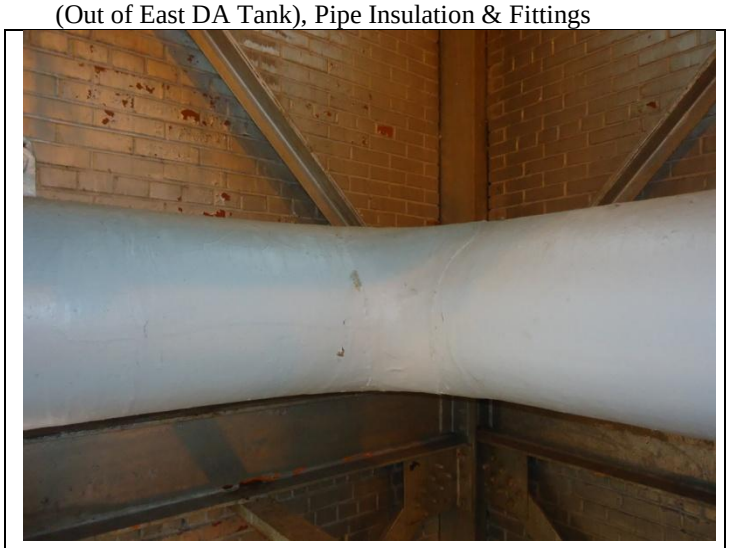
60. NS-44, New Side 5th FL. Northeast 25k Pipe, Pipe Fittings

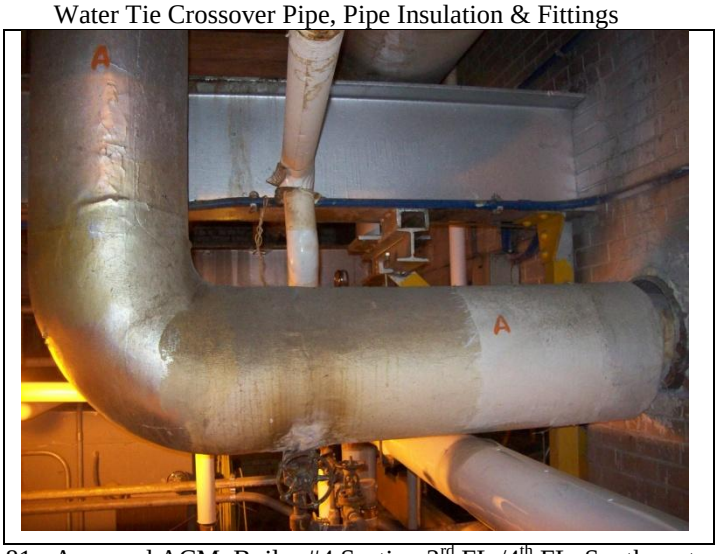
81. Assumed ACM, Boiler #4 Section 3rd FL./4th FL. Southwest Thru Wall, Pipe Insulation & Fittings

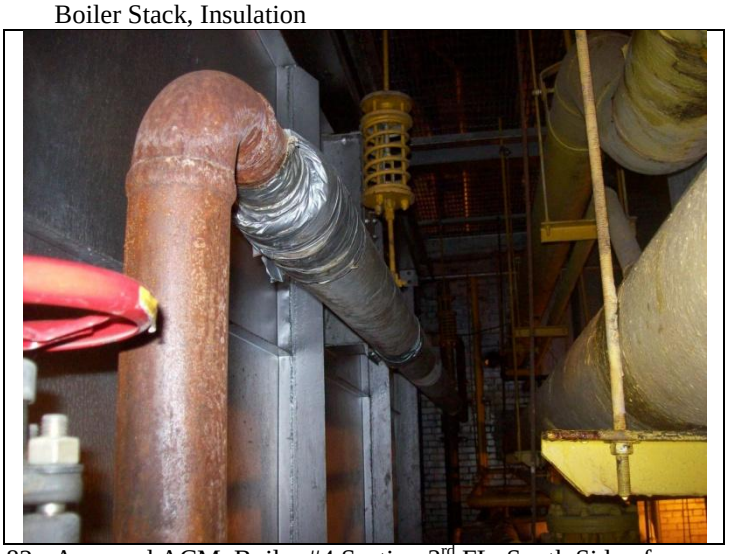
82. Assumed ACM, Boiler #4 Section 3rd FL. South Side of Boiler 4, Pipe Insulation

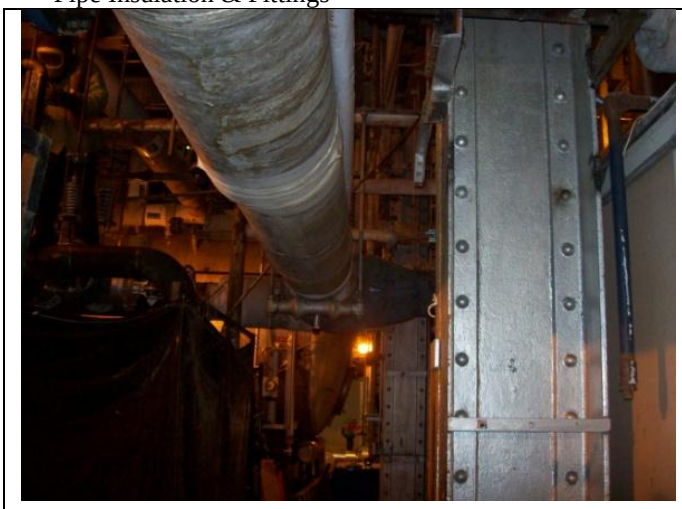
111. Assumed ACM, Old Side Main FL. Low Pressure Condenser DA (Walkway South of Office), Pipe Fittings

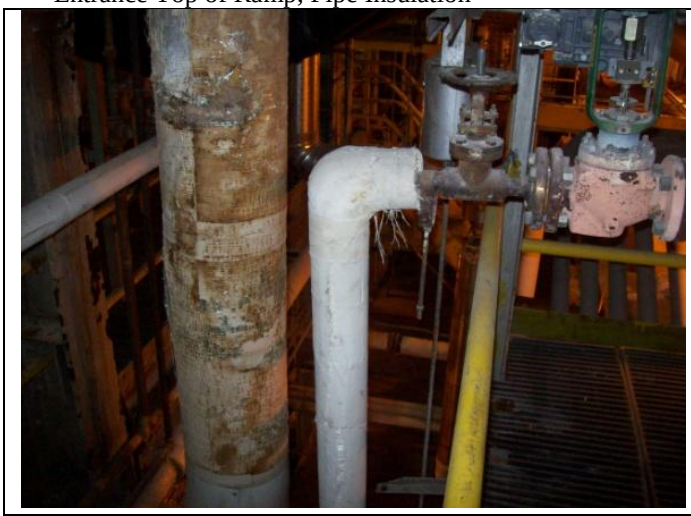
117. OS-3, Old Side 2nd FL. East Catwalk Trasar #4, Pipe Fittings

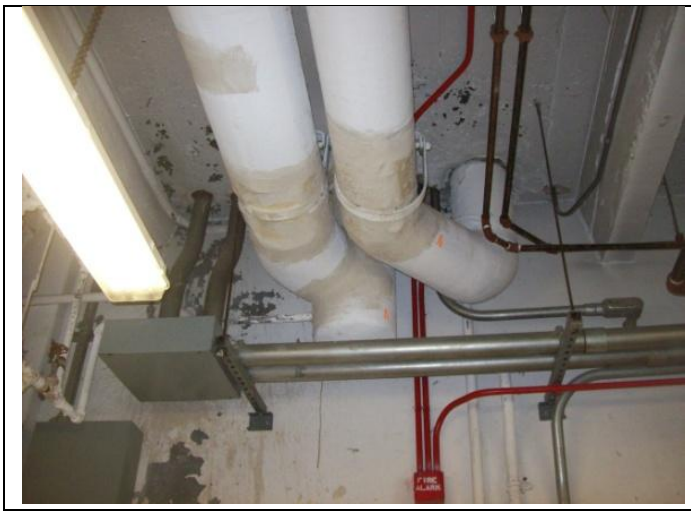
122. Assumed ACM, Engine Room Basement South Ceiling, Pipe Insulation & Fittings

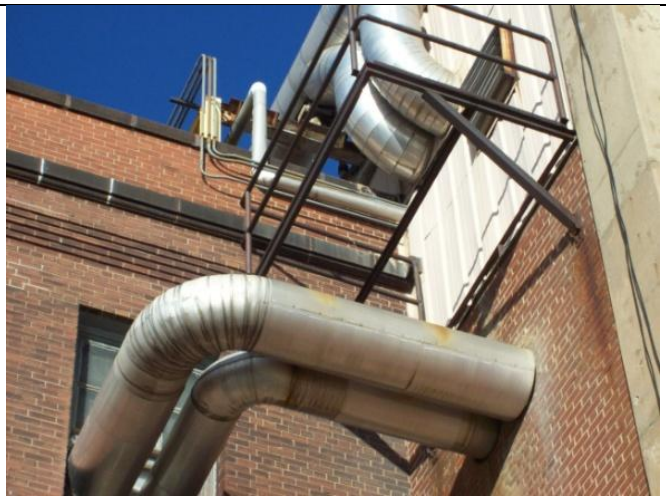
130. Assumed ACM, Boiler #4 4th FL./Penthouse Going Outside, Pipe Fittings

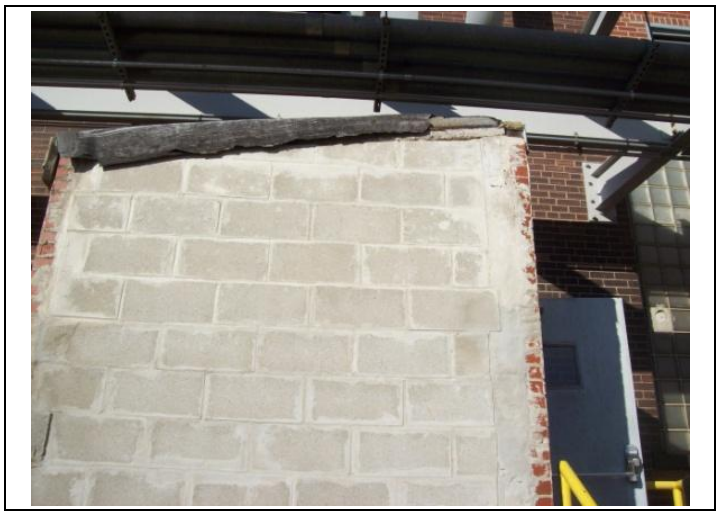
133. EX-07-09, Exterior. Over East Main Entrance to Old Side, Roofing Material

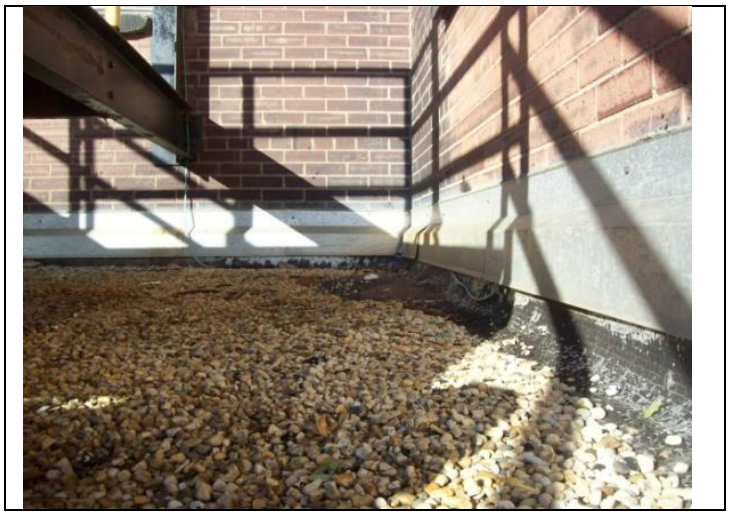
134. EX-10-12, Exterior SE Corner of Building 11 Ground FL., Roofing Flashing
