Hazardous Material Inspection Report

Buildings 8008, 8108, 8136, and 8143

Naval Air Station Patuxent River,
Webster Field OLF Maryland

December 2015 [Amended]

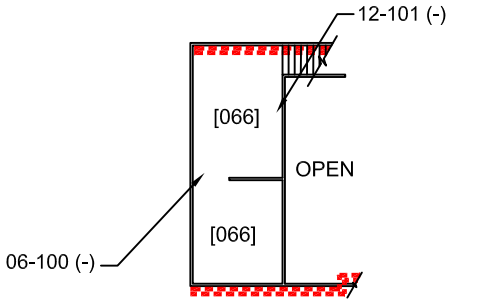
BUILDING 8008
SECOND FLOOR

HMs 01, 02, 03- Pipe Insulation and Fittings: Various Thermal System Insulation (TSI) materials were identified in multiple locations on the southside of the building, including the second floor loft area. The insulation materials are considered friable, and therefore regulated, ACM. There is an estimated 360 linear feet of ACM insulation present, including *Aircell*, *Magnesia*, and mudded insulations. Note: limited damage and debris is present above drop ceiling area of the southwest corner of the southwest break room.

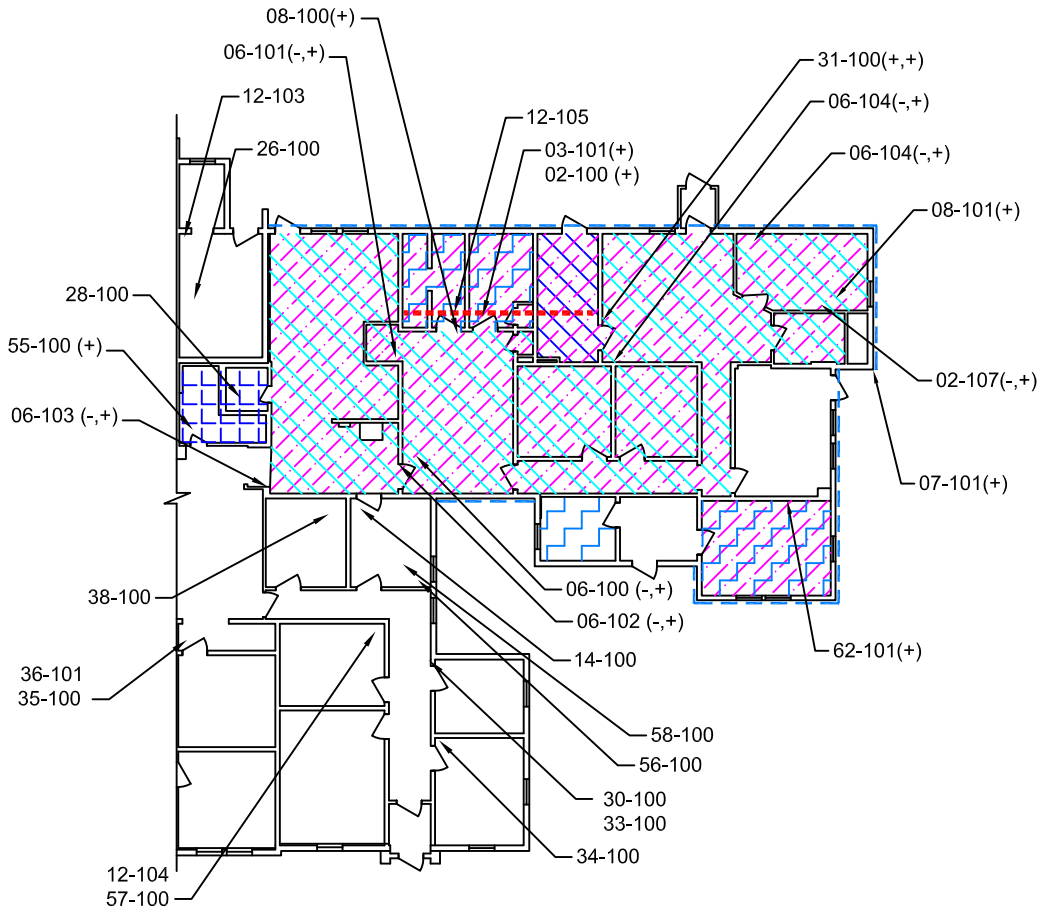
BUILDING 8008
FIRST FLOOR B

HMs 31, 36, 59- Floor tile: These vinyl composite floor tiles were identified in the first floor south center kitchen under wood [HM31, 12" Gray], south central foyer [HM36, 12" Gray thin], and north center shop [HM59, 12" Gray chunk]. The ACM tile appears to be present under the existing flooring and wood in the kitchen area, and is assumed throughout since flooring could not be removed to verify. For reference, the material is Non-friable Category I ACM and improper disturbance may render asbestos fibers airborne. There is an estimated 1,788 square feet of ACM floor tile present. Note: previous ACM HM05, 9" Pink tile appeared to be removed from the building and was not identified during the current inspection. *See also ACM floor tile mastics under these and other HM numbers.*

HM06, 29, 31, 62- Floor tile mastic/adhesive, black: This material was identified in most southwestern areas of the building (old/ original sections), including as residual where new flooring now exists. Although the material is not considered hazardous or friable, removal is required to ensure "non-disturbance" during renovations and to ensure proper underlayment for new flooring. There is an estimated 2,400 square feet of this ACM present under 12" Tan w/brown tile [HM06], 12" Off-white w/brown tile [HM29], 12" Gray tile [HM31], and as residual mastic [HM62].

HMs 07, 08- Asbestos Cement panels and siding: These ACM have been identified as exterior siding under existing metal, ceiling and wall panel sheets, and as residual pieces where ceilings or walls have been incompletely removed. For reference, the material is Non-friable Category II ACM and improper disturbance may render asbestos fibers airborne. There is an estimated 6,604 square feet of this ACM present.

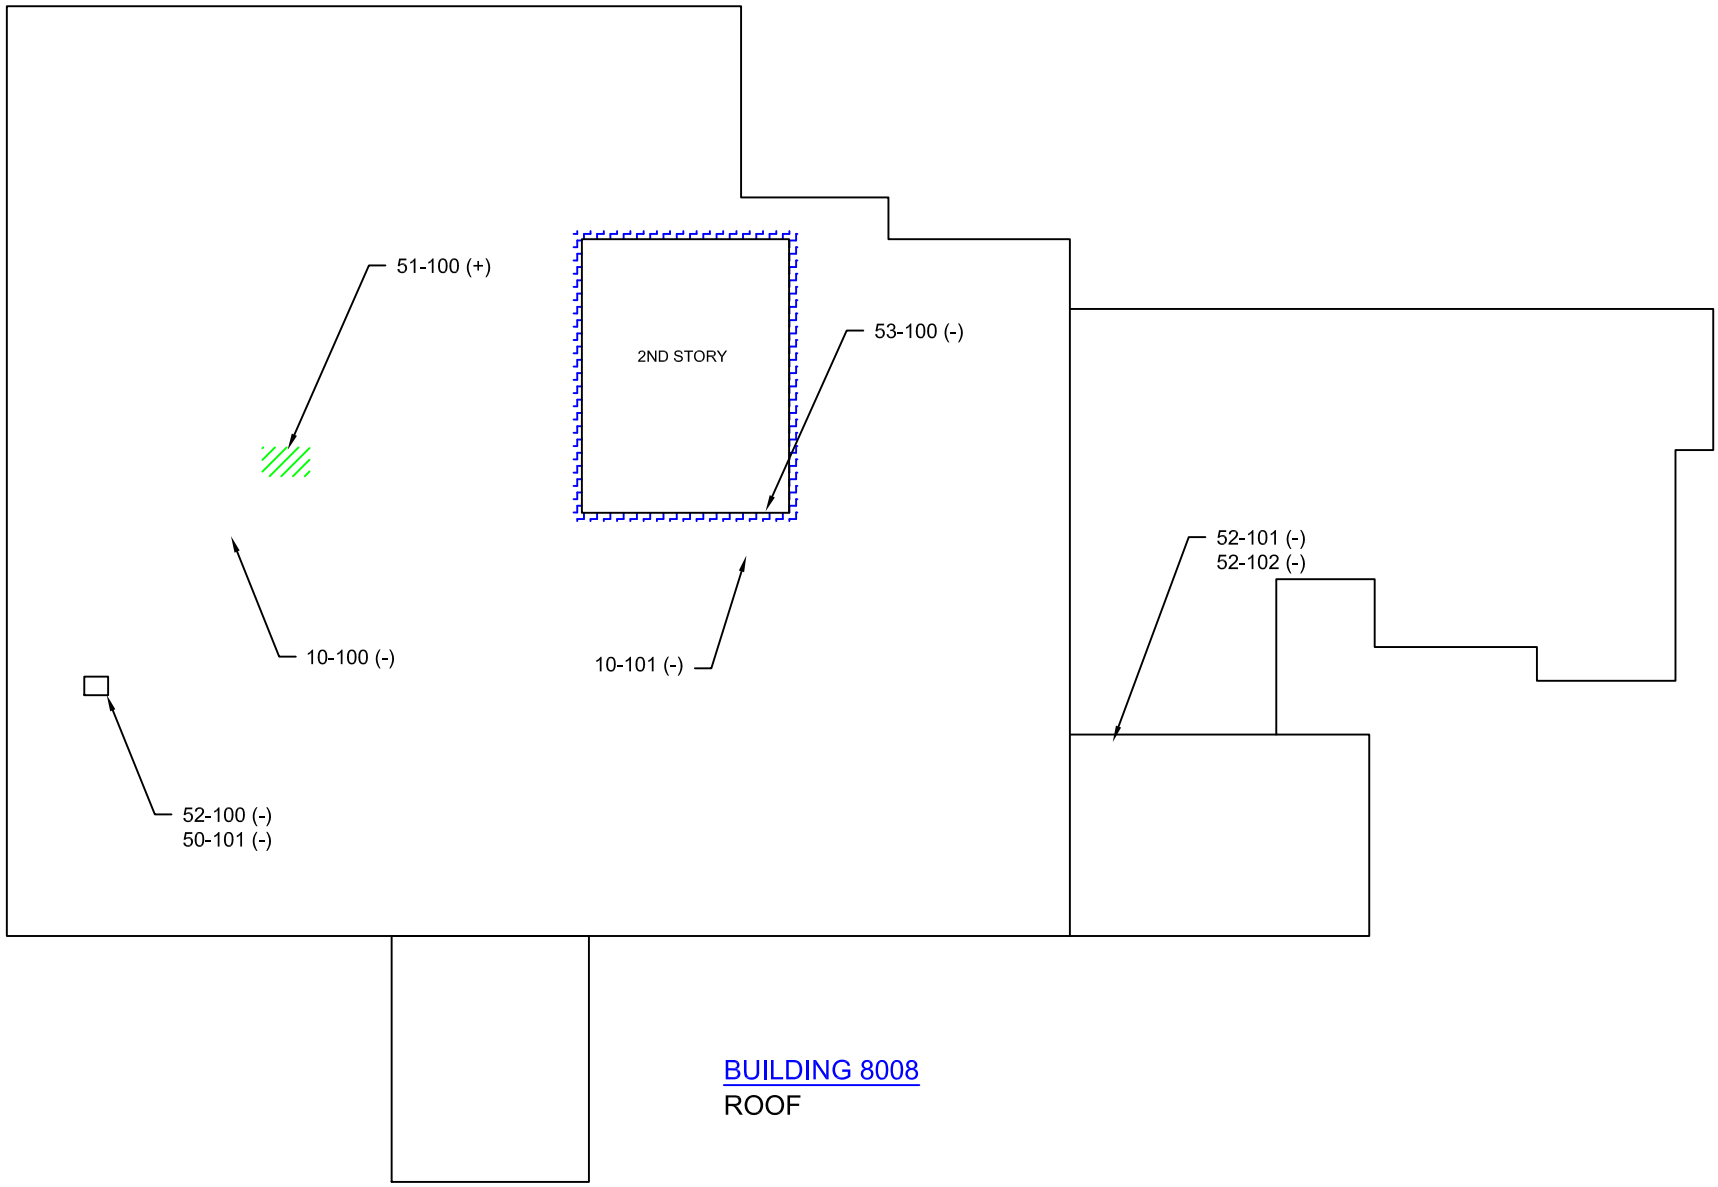
BUILDING 8008
ROOF

HM51- Roof sealant, gray: This material was identified as patching at flashings on the rolled asphalt roofing system. The material is not considered hazardous or friable and removal is not required. Multiple patches and sealants were tested and most were determined non-ACM. However, ACM roofing sealants may be covered with newer sealants and disturbance of roofing system components should be done with caution.

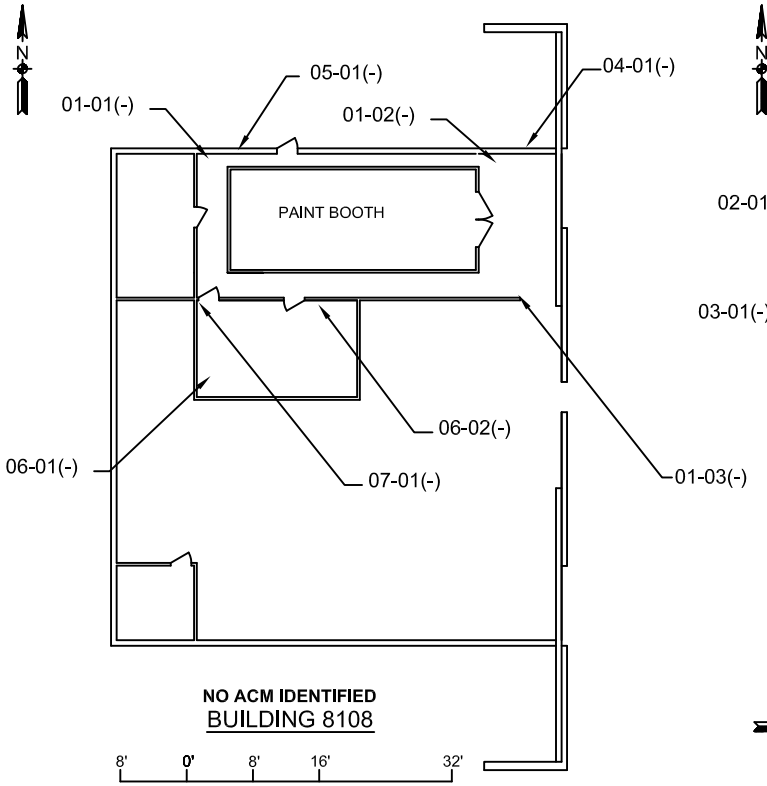
BUILDING 8108

NO ACM IDENTIFIED

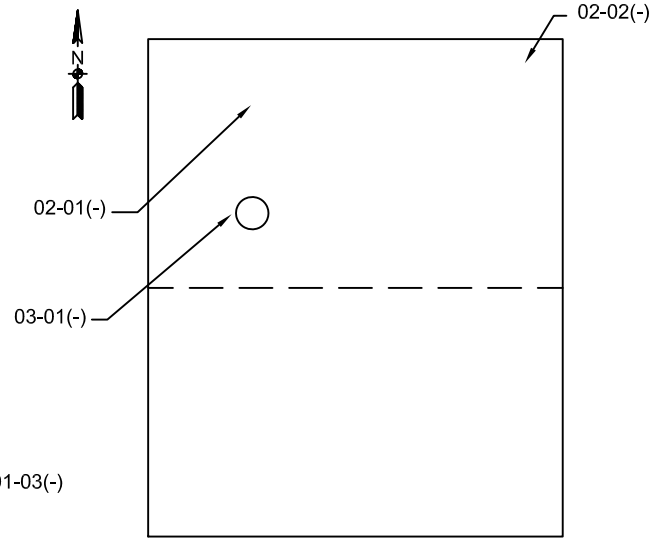
BUILDING 8108-ROOF

NO ACM IDENTIFIED

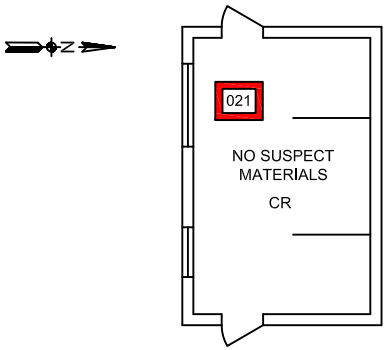
BUILDING 8136

NO ACM IDENTIFIED

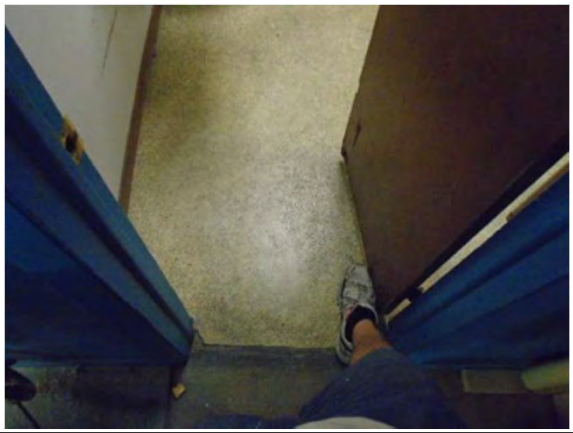
HM55- Vinyl sheet flooring: A tan mosaic pattern vinyl sheet flooring identified in the central restroom areas was determined to be ACM. The asbestos is present in the bottom felt layer. Although the material is presently considered Category I non-friable ACM, removal of this material is likely to disturb and damage the felts enabling fibers to become airborne and thus should be treated as a friable material. There is an estimated 144 square feet of ACM linoleum present.

8008 ACM: HM55 vinyl sheet flooring (typical).

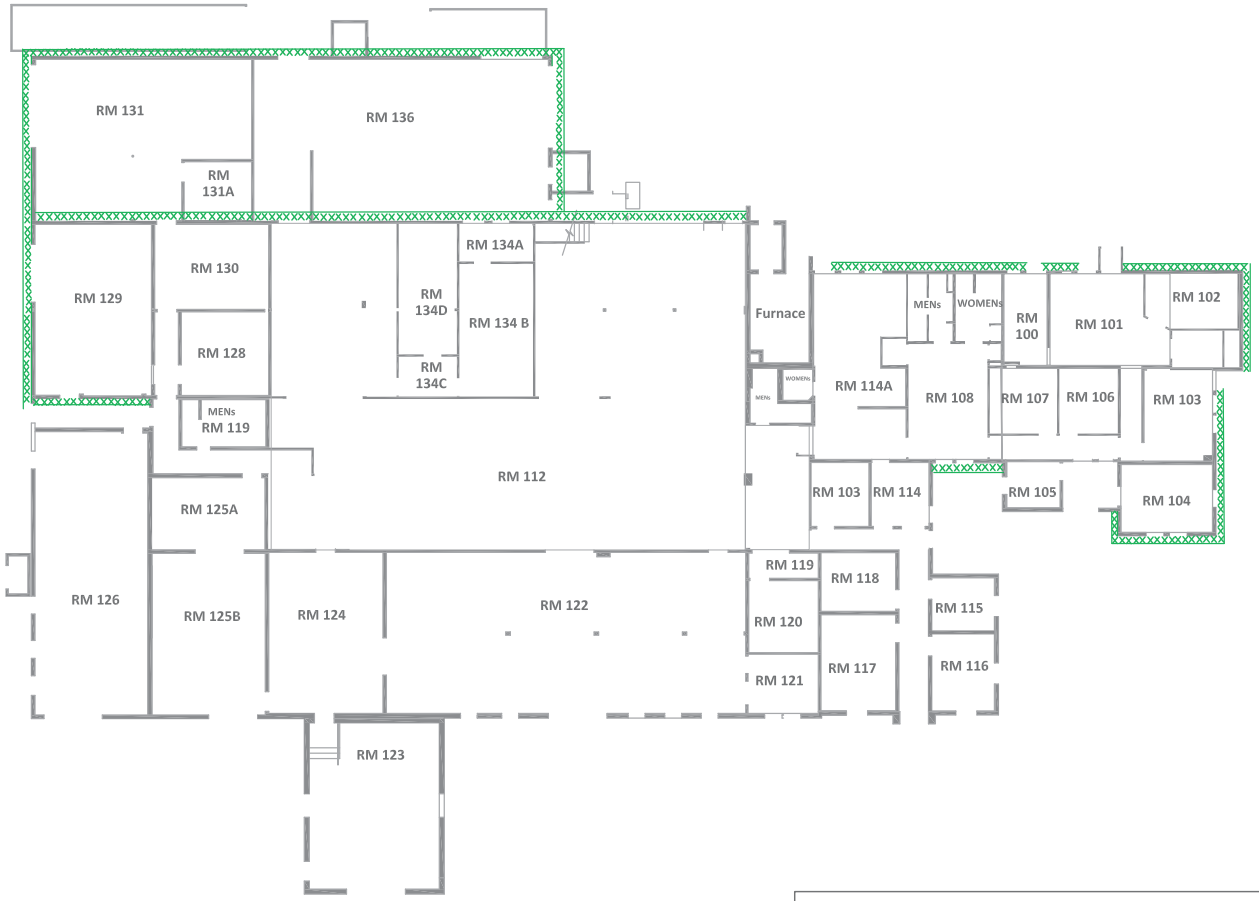
DRAWING HAZ-102
PHASE N/A

LEGEND
Transite Siding on walls

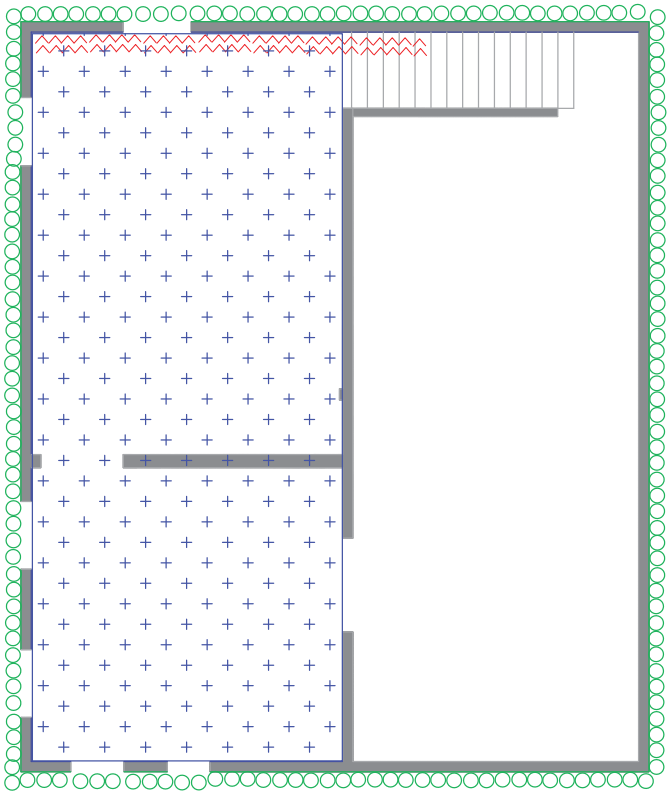
DRAWING HAZ-103
PHASE N/A

LEGEND
Pipe Insulation
Joint Compound on Drywall on Walls and Ceiling
Transite Siding/Board on Exterior Soffit and Walls

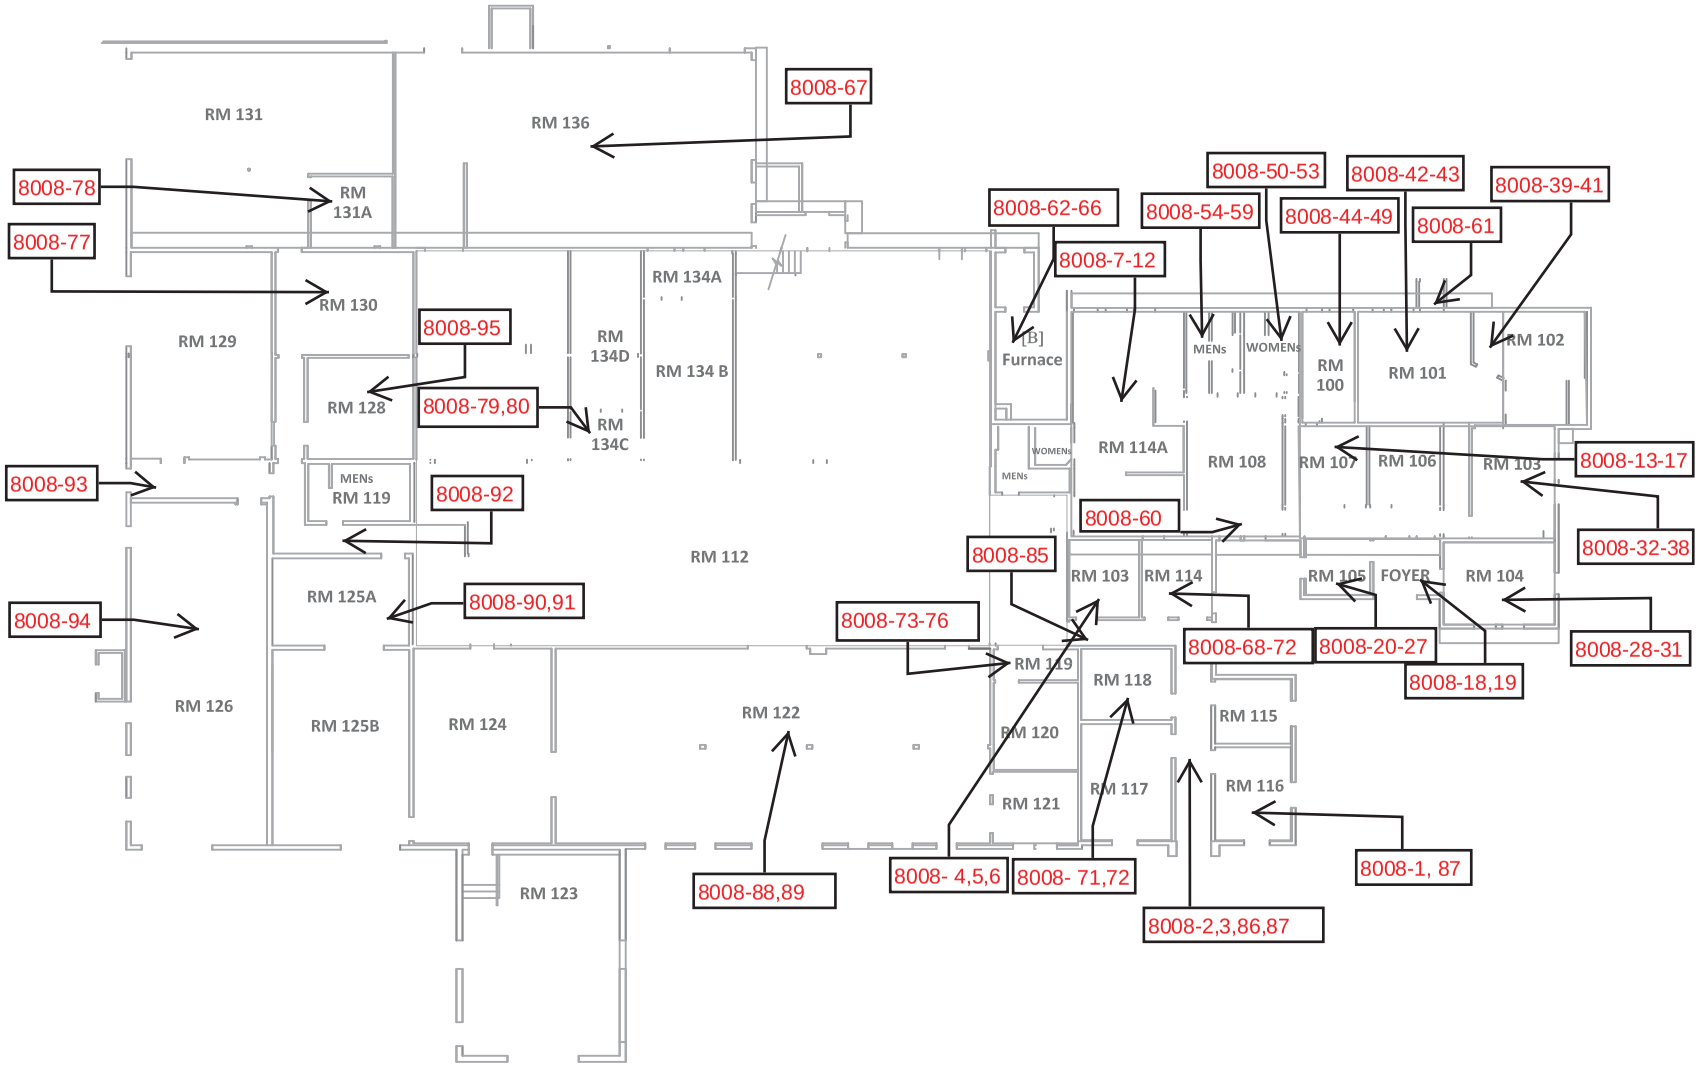
SUSPECT ACM SAMPLE LOCATIONS ON FIRST FLOOR

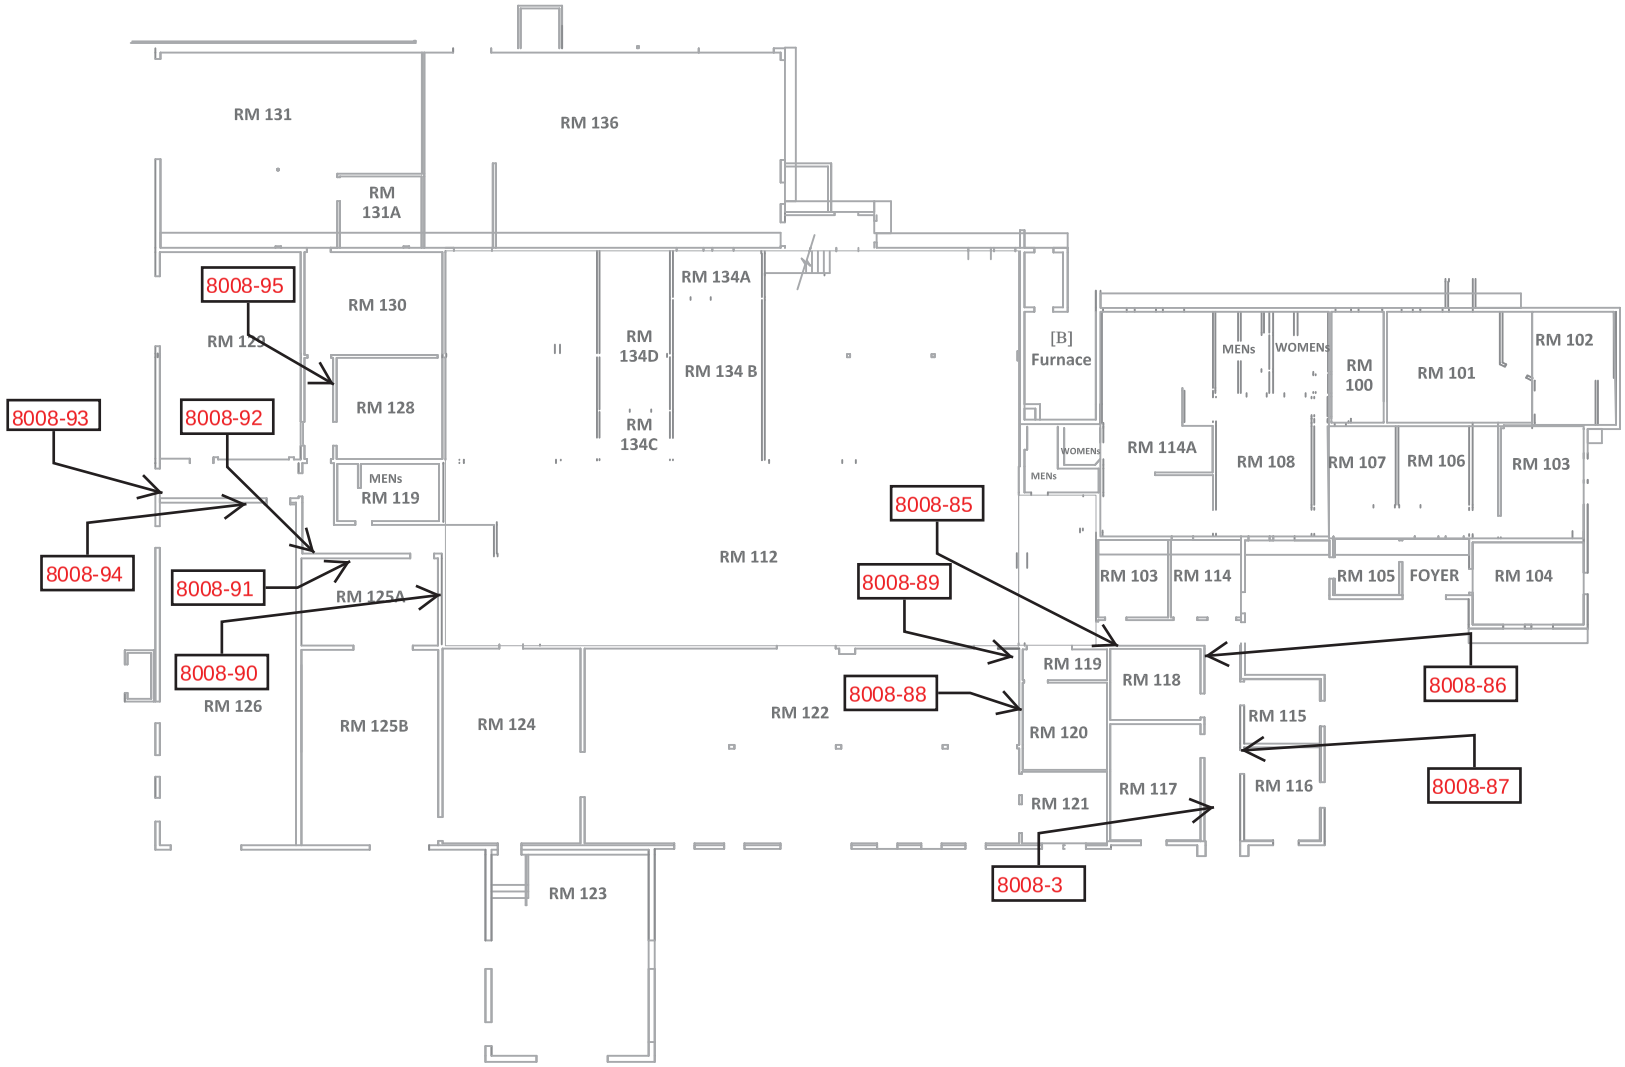
SAMPLE LOCATIONS FOR NON-ASBESTOS CONTAINING JOINT COMPOUND
