Job Name: NAB COMMISSARY SITE

ATEC Environmental Consultants appreciates this opportunity to conduct a soil and water sampling program of the NAB Commissary Site, on the Little Creek Amphibious Base located in Virginia Beach, Virginia. The purpose of this assessment is to verify initial findings noted in ATEC's Phase II Site Assessment dated August 1, 1990 and to address the concerns that contamination exists in the area of the new building location.

FUEL FACILITY LEAKAGE STUDY
AT THE NAVAL AMPHIBIOUS BASE,
LITTLE CREEK, VIRGINIA

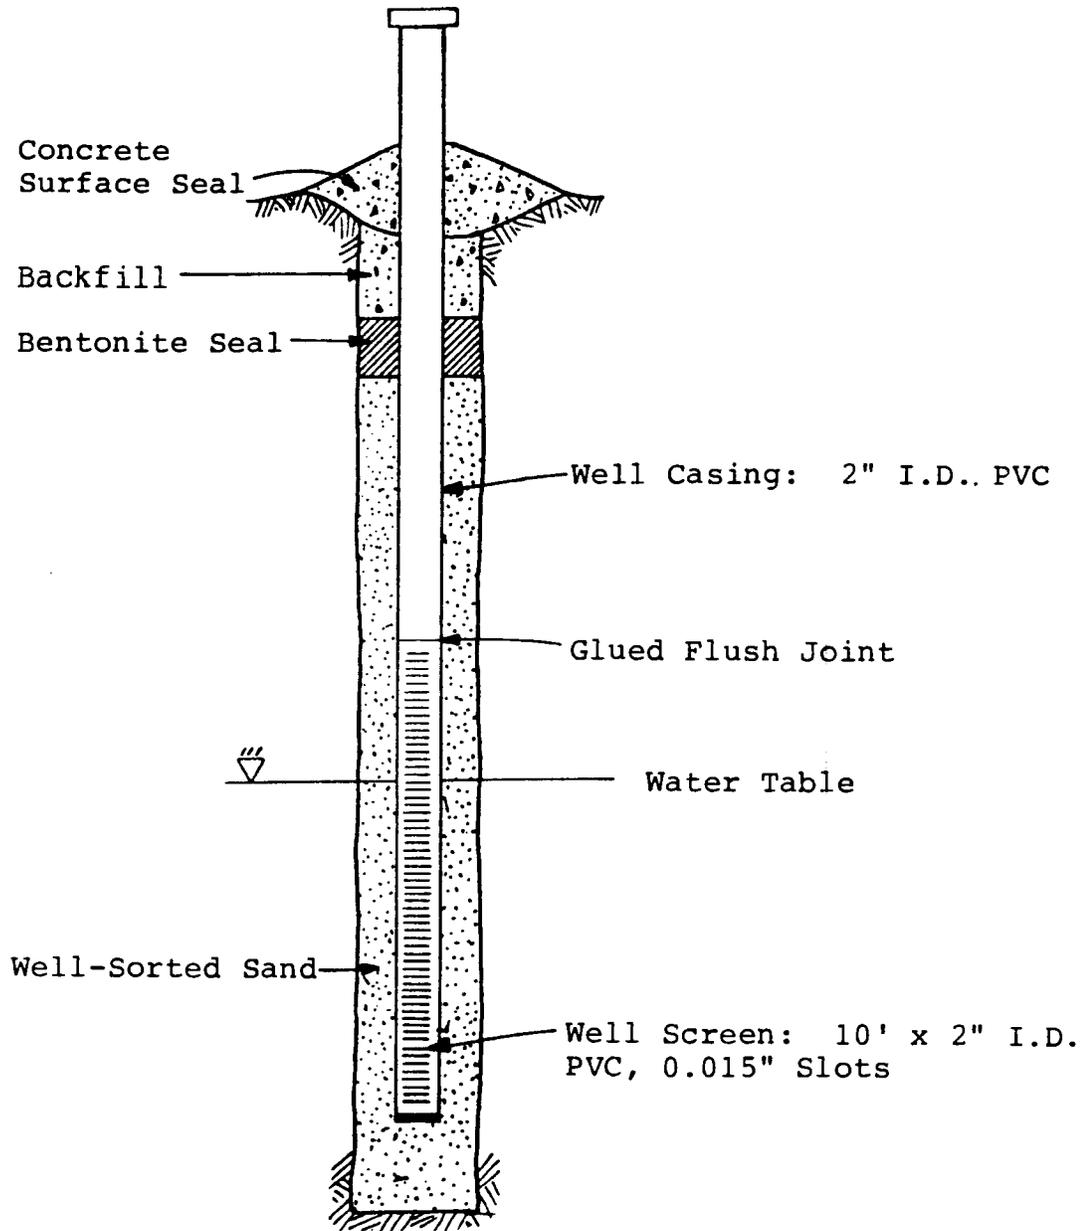
Figure 2: Schematic Monitoring Well Design

A schematic monitoring well design is illustrated in Figure 2. In the initial part of the well construction, after the hollow-stem augers were removed from the borehole, a 4-inch diameter pipe was inserted to keep the hole open. Each boring was then backfilled with well-sorted coarse sand to a depth that permitted the well to be screened above and below mean tidal level. A 10-foot long by 2-inch diameter section of well screen was then installed in the borehole and backfilled with well-sorted sand.

During the backfilling process the 4-inch casing was removed gradually to prevent the collapse of natural sediments onto the well screen. Approximately one foot of well-sorted sand was placed above the top of the screen. A bentonite seal was then installed and the remainder of the hole was backfilled. Those monitoring wells installed beneath pavement at Piers 11-19 were covered with 6-inch manholes which are flush to the pavement and concreted in. At other monitoring wells the casing sticks up 1-2 feet above the ground surface.

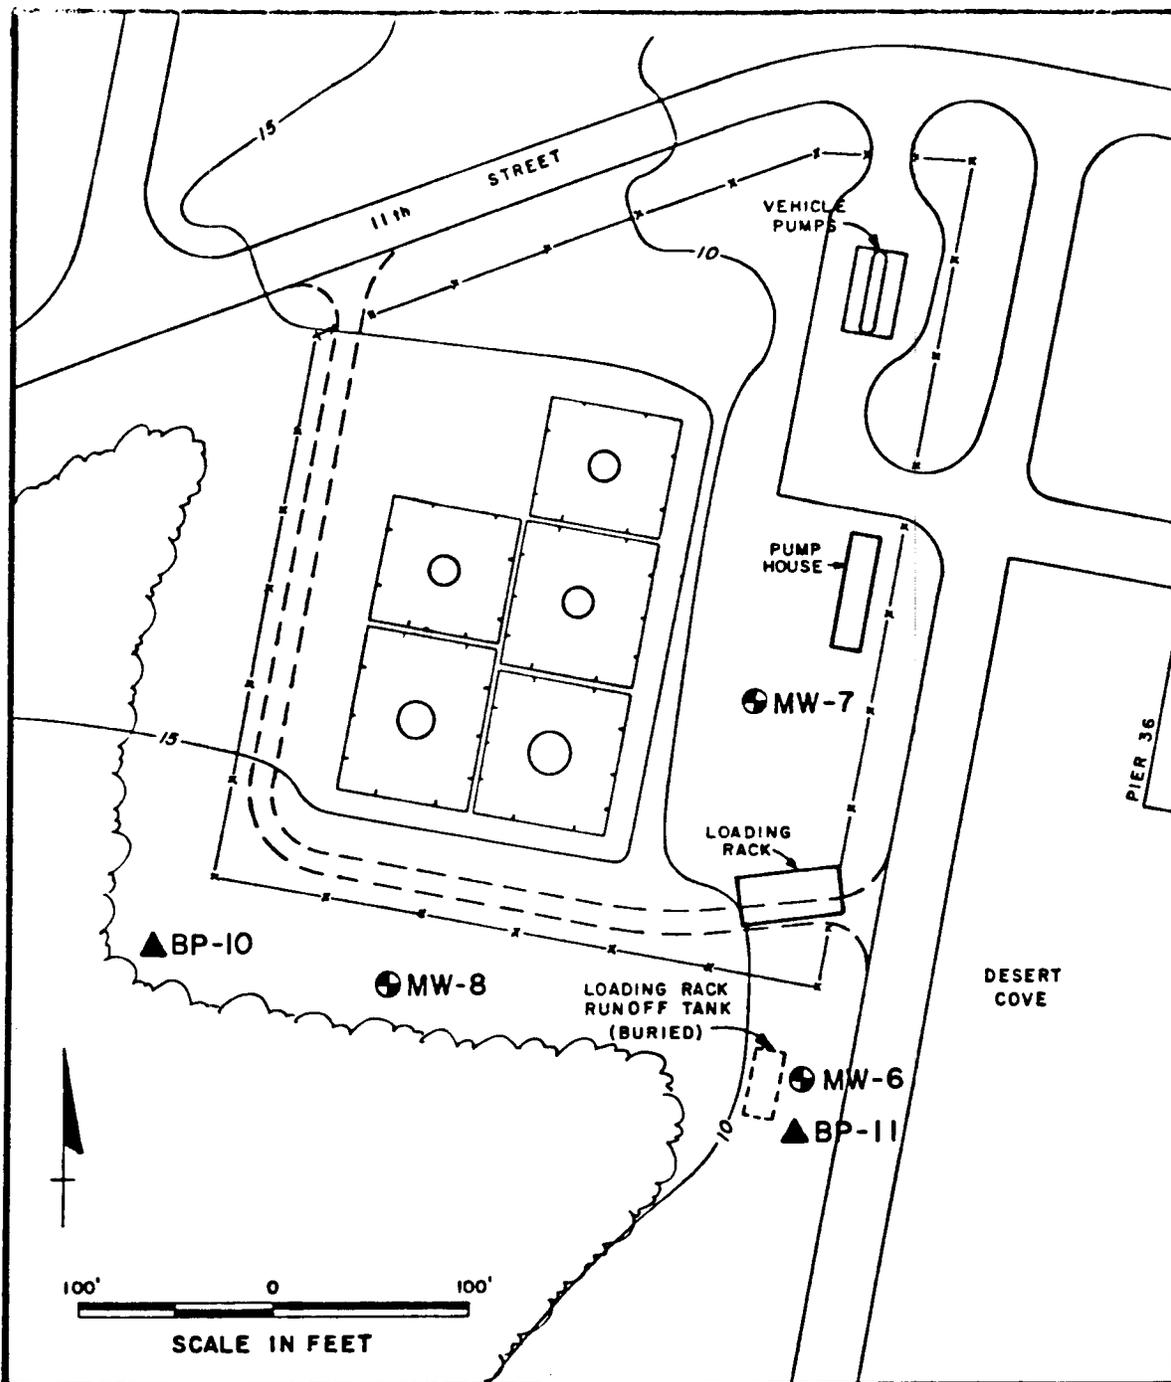
Figure 4: Fuel Farm area, showing locations of backhoe pits and monitoring wells.

Backhoe Pit BP-10 was located outside of the fence at the southwestern corner of the site. Sediment in it consisted primarily of dune sand; the upper three feet was fill comprised of well-sorted sand and miscellaneous organic debris. Although a small influx of perched groundwater occurred at a depth of about 5 feet, the water table was not encountered at the pit's total depth of 7.5 feet. Because of this and collapsing walls, no

Backhoe Pit BP-11 was located approximately 15 feet southwest of the buried tank that collects runoff from the loading rack (Figure 4). Sand fill occurred to the pit's total depth of 8 feet. Collapsing walls prevented digging to the water table; as a result, no standpipe was installed. No fuel was observed in the sediments from BP-11.

Monitoring Well MW-6 is located about 10 feet east of the buried tank near the loading rack (Figure 4). Stratigraphy in the upper 10 feet was essentially the same as that observed in BP-11. Naturally occurring sand and silt was found below 10 feet. No fuel was observed in split-spoon samples or on the water surface in the completed well.

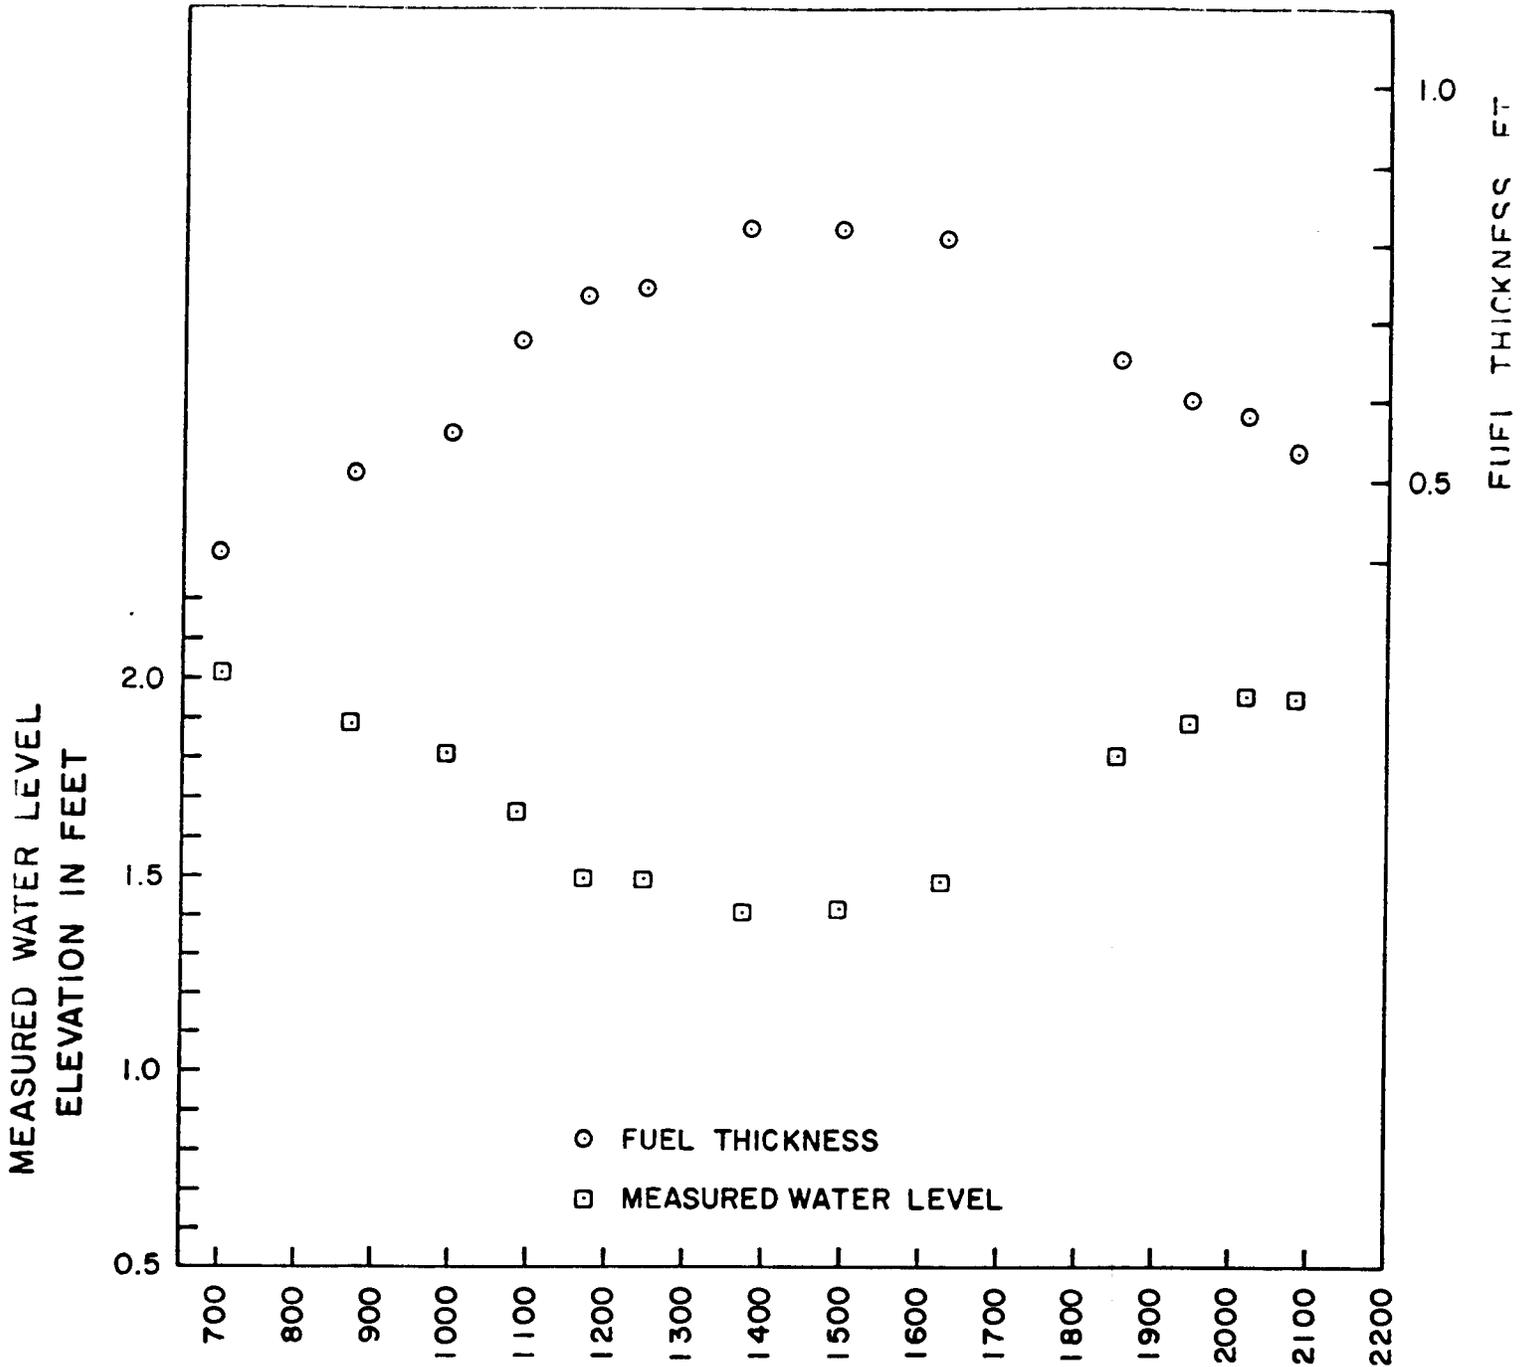
Figure 11: Elevation of fuel/water interface and fuel-slug thickness, versus time of day in MW-4 - Measured August 31, 1982.

Head conditions in MW-4 are shown in more detail in Figure 10. The groundwater surface (water table) generally fluctuated between elevations of 1.5 and 2.0 feet, as it did in MW-1 and MW-3. The fuel surface fluctuated between 2.25 and 2.50 feet. As Figure 11 illustrates, the fuel slug thickness was proportional to tidal stage, being about 0.5 feet at high tide and 0.8 feet at low tide.

Water table levels within a hundred feet of the cove show a distinct tidal response (Figure 9). The thickness of the fuel slug in MW-4 also varied with tidal stage, being thicker at low tide (Figures 10 and 11). This may reflect a periodic expansion
