REPORT
on
**INSPECTION, STRUCTURAL ANALYSIS
AND CLASSIFICATION FOR:**

Utility Bridge No. 737

February 1997

REPORT ON
INSPECTION, STRUCTURAL ANALYSIS
AND CLASSIFICATION OF
UTILITY TRESTLE NO. 737

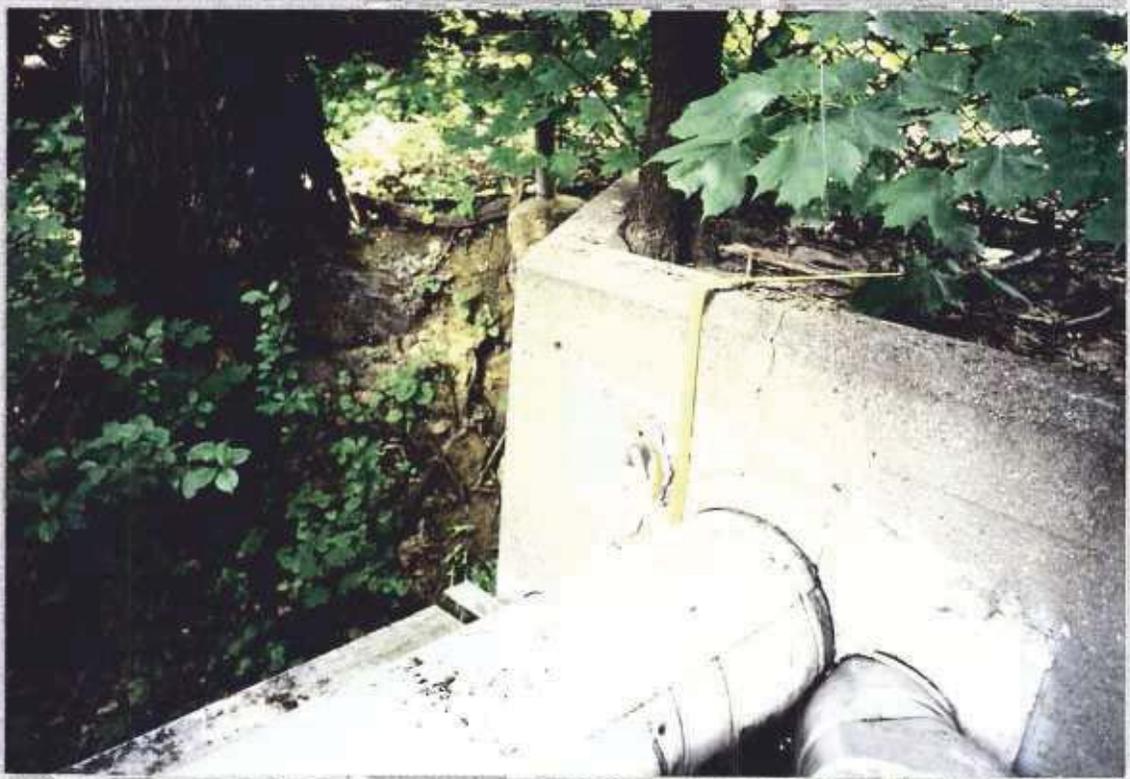
Photograph No. 10

The concrete stub-type abutment encasing both utility pipes is generally in good condition. There are a few vertical cracks and a small spall (See Photograph No. 10).

Vertical crack at south abutment.
Note growing trees and soil erosion.

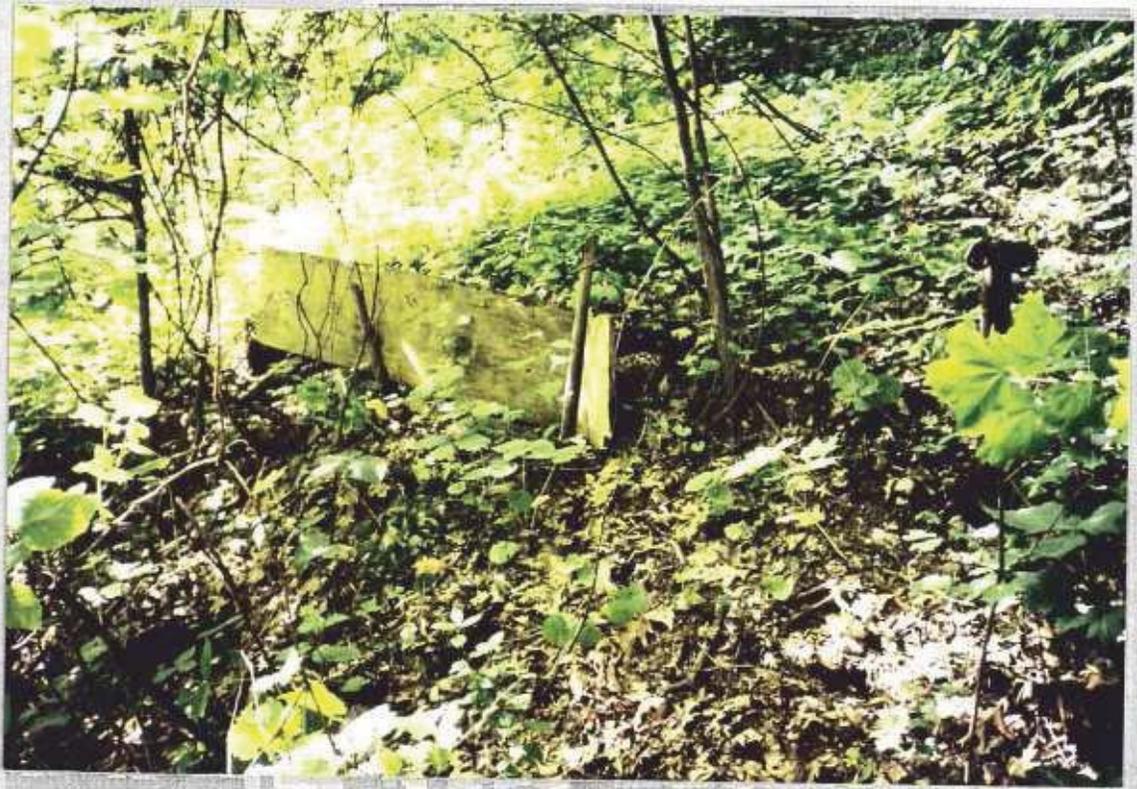
Photograph No. 18

There is a broken corrugated drain metal pipe to the east of Pier No. 3. There is a small wood dam between Pier No. 3 and 4, in poor condition (See photograph No. 18). At both east and west slopes, the soil is relatively spongy and erodes easily under foot traffic.

Deflected wood dam between piers No.3 and 4, at North slope.
