### Design-Build RFP for the SIMULATOR CENTER and RANGE CONTROL BUILDING

FY'16 MCON PROJECT P-1346

# REPORT OF HAZARDOUS MATERIALS CONSULTING SERVICES

P1346 SIMULATOR CENTER AND RANGE  
DEVELOPMENT CONTROL BUILDING  
DEMOLISH BUILDINGS 134, 430 AND 529  
MARINE CORPS BASE, CAMP LEJEUNE  
JACKSONVILLE, NORTH CAROLINA  
JV PROJECT #09049.22B  
**GER** 130-6168

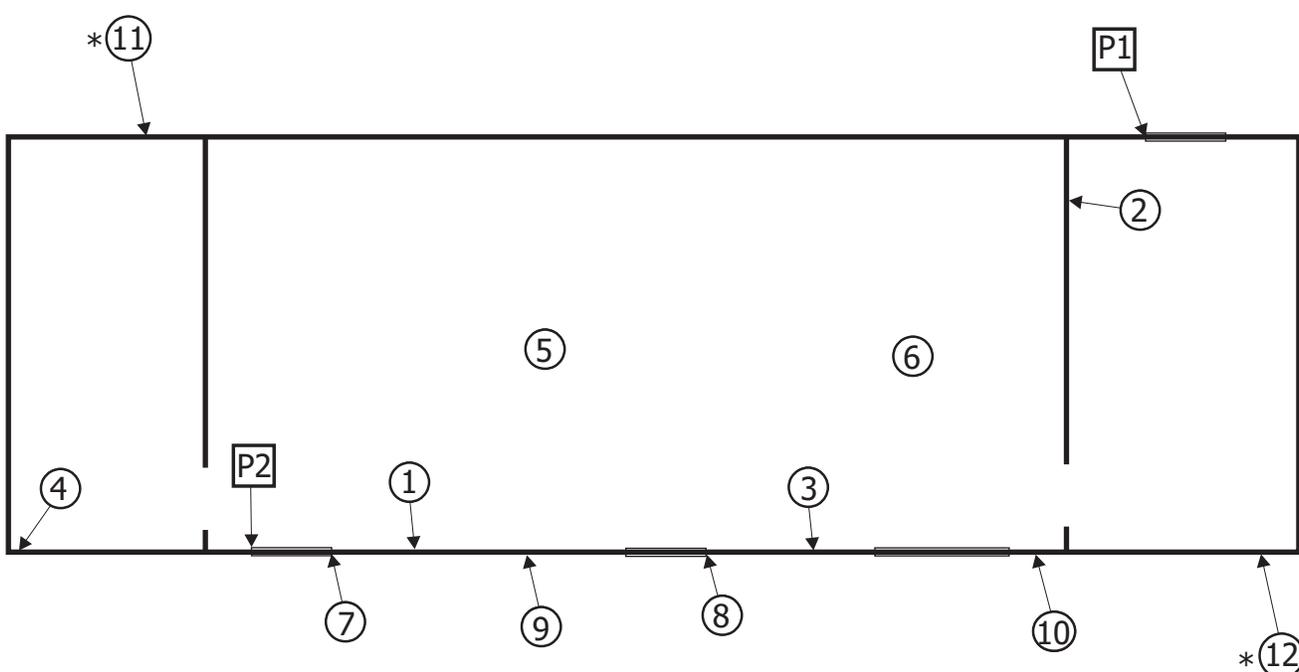
Building 134 Floor Plan

- ***Textured material, gray*** (2% Chrysotile): located on exterior foundation of **Building 134**. This material is classified as Category II ACM and was in good condition at the time of the survey. (Estimated quantity- 560 SF)
- ***9" black floor tile & adhesive*** - (5-7% Chrysotile): 9" floor tile and mastic is found in the office of **Building 430**. This material is classified as Category I ACM and was in good condition at the time of the survey. (Estimated quantity- 150 SF)
- ***Black roof sealant at vents*** (asbestos content not shown): located around perimeter of roof vents on **Building 430**. This material is classified as Category I ACM and was in good condition at the time of the survey. (Estimated quantity- 70 LF)

**gray textured material on foundation, 9" black floor tile/mastic, and black asphalt sealant at vents** are classified as Category I and II non-friable ACM in buildings scheduled for demolition. Removal is not required, prior to demolition, if the material is in good condition and is not friable. However, wet methods must be used during the demolition process and personal and area monitoring should be performed. Additionally, recycling of demolition debris is prohibited. All demolition debris must be considered asbestos containing and be taken to a landfill that accepts Category I and II non-friable ACBM. However, the contractor may have the option of removing all asbestos containing materials prior to demolition which would allow the demolition debris to be classified as regular construction waste therefore allowing recycling.

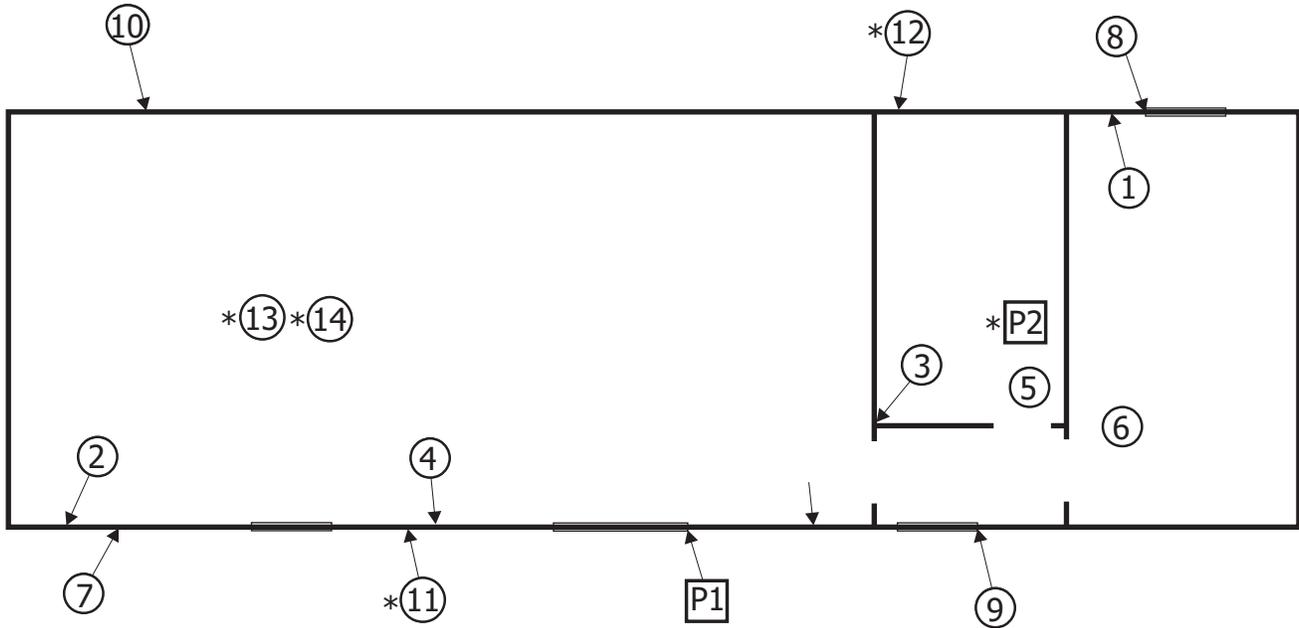
Building 529 Floor Plan

***Building 529*** - No previously identified asbestos-containing materials were observed. Asbestos-containing heat shielding/debris and transite panels have been removed and or cleaned up in attics.
