**Hazardous Materials  
Survey Report  
Of  
MCAS Building 1039  
(Applied Instrument Building)

Marine Corps Air Station  
Beaufort, South Carolina**

Inspection Date: 10/14/2015  
Report Issue Date: 12/07/2015

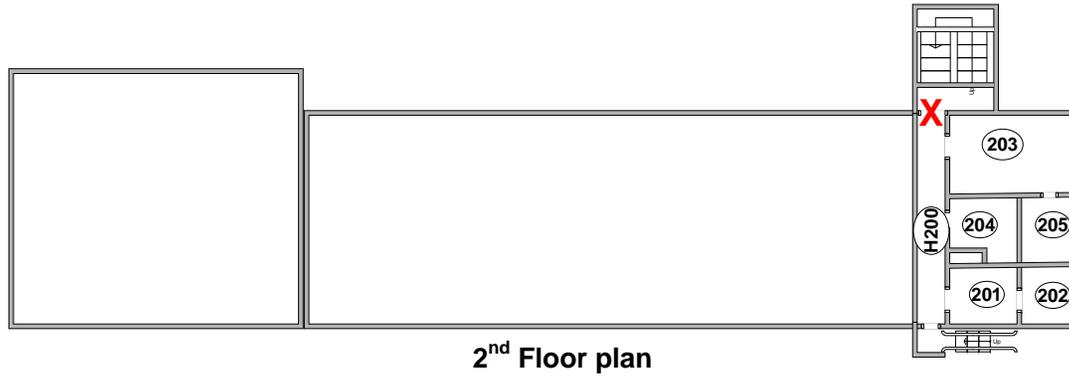
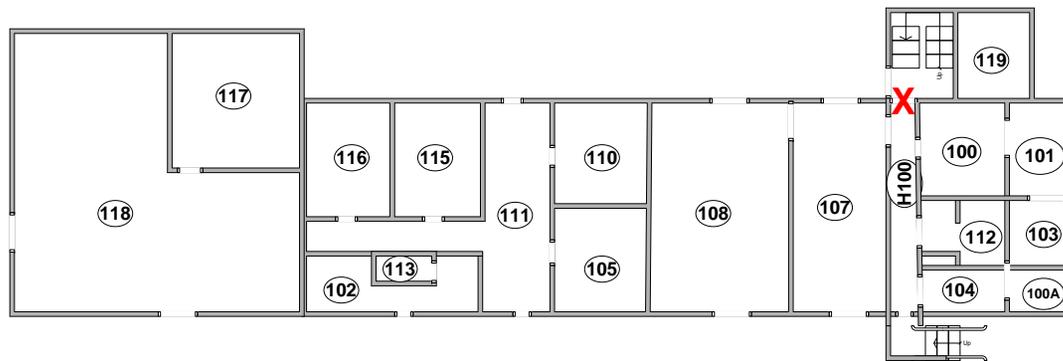
<b>SMALL BUSINESS GROUP, INC.</b>		
	<b>Asbestos Sample Locations – Building 1039</b>		
	<b>Marine Corps Air Station – Beaufort, SC</b>		
Date: 9/10/13	Scale: None	Sheet: 1 of 2

**X** H-14 – Fire doors (2 each) located in 1<sup>st</sup> & 2<sup>nd</sup> floor stairwells

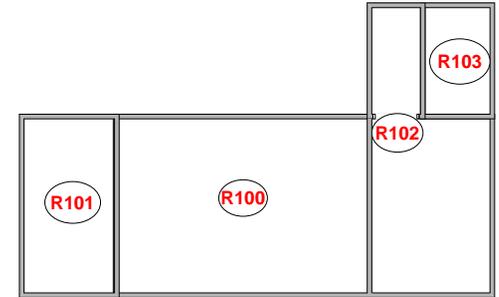
ROOF PLAN

**ASBESTOS CONTAINING MATERIAL**

H-10 – Roof flashing mastic around roof perimeter & penetrations  
Exact locations not shown on drawing (Approx 415 LF)
