WINDOW REPLACEMENT & REPAIR
NAVAL AIR STATION PENSACOLA
PENSACOLA, FL

SUBMITTAL NAME: **ASBESTOS & LEAD PAINT SURVEYS**
SUBMITTAL PERCENTAGE: FINAL
SUBMITTAL DATE: JULY 3, 2014

**LIMITED ASBESTOS CONTAINING MATERIALS SURVEY,
LEAD-BASED PAINT SURVEY, AND
WASTE CHARACTERIZATION FOR LEAD
BUILDINGS 38, 40, 73, 223, 606, AND 627
NAVAL AIR STATION PENSACOLA
PENSACOLA, ESCAMBIA COUNTY, FLORIDA**

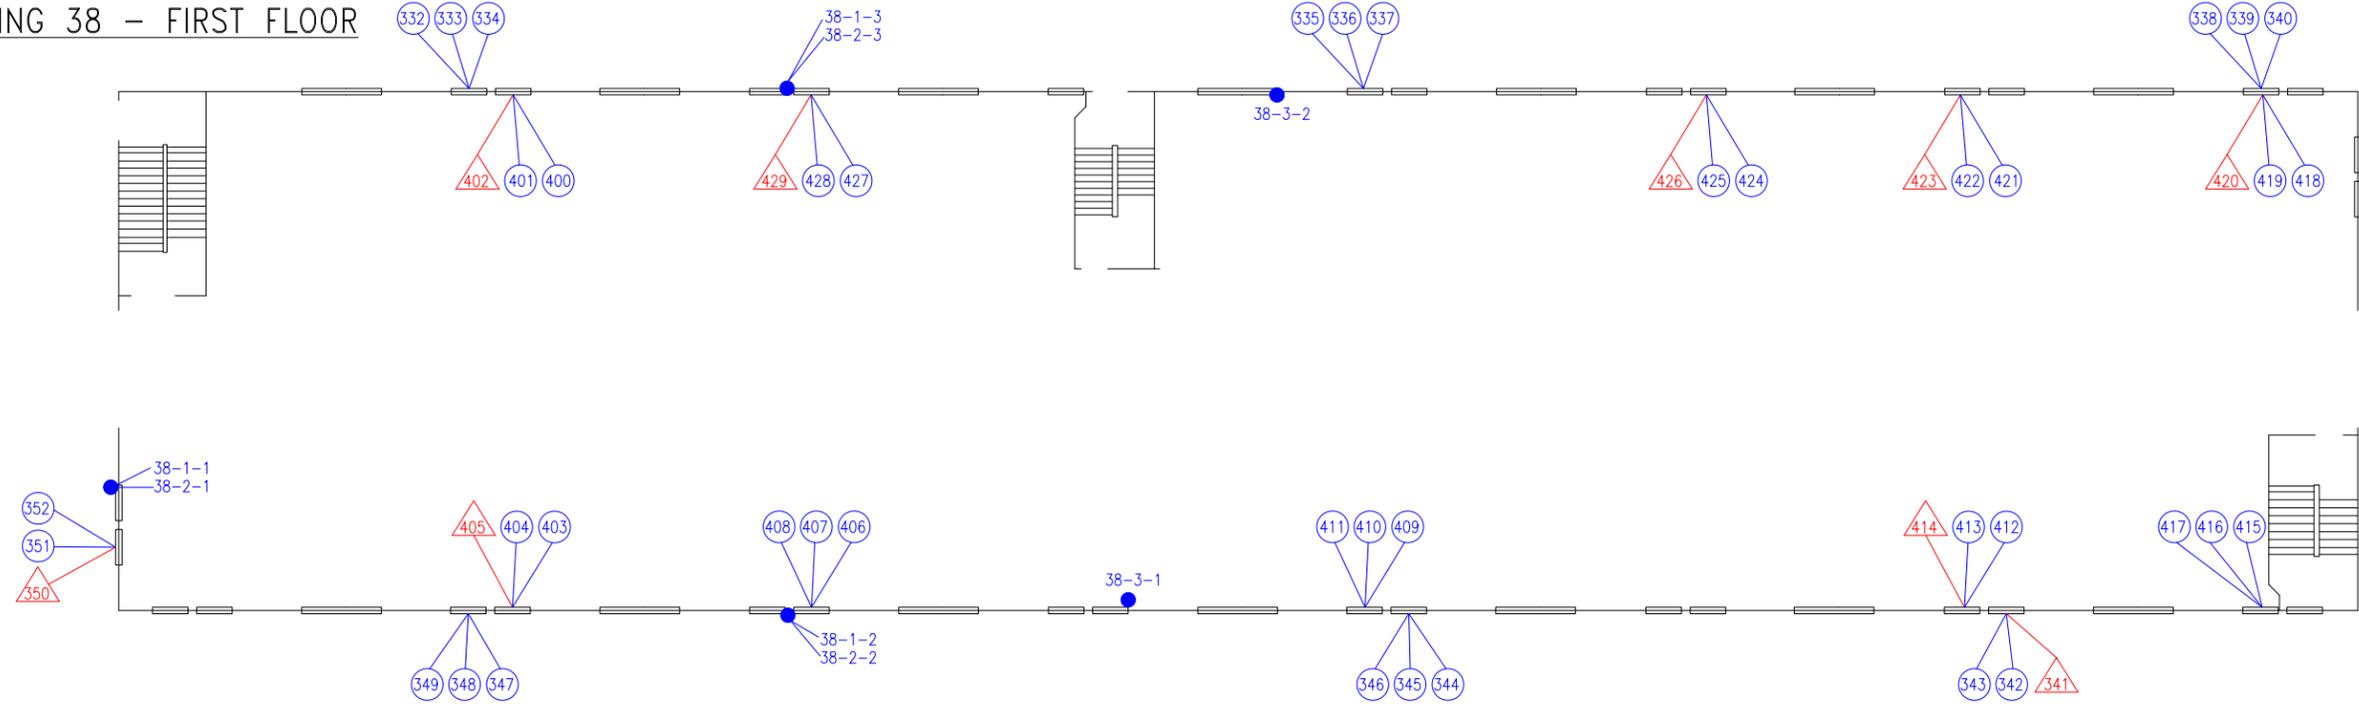
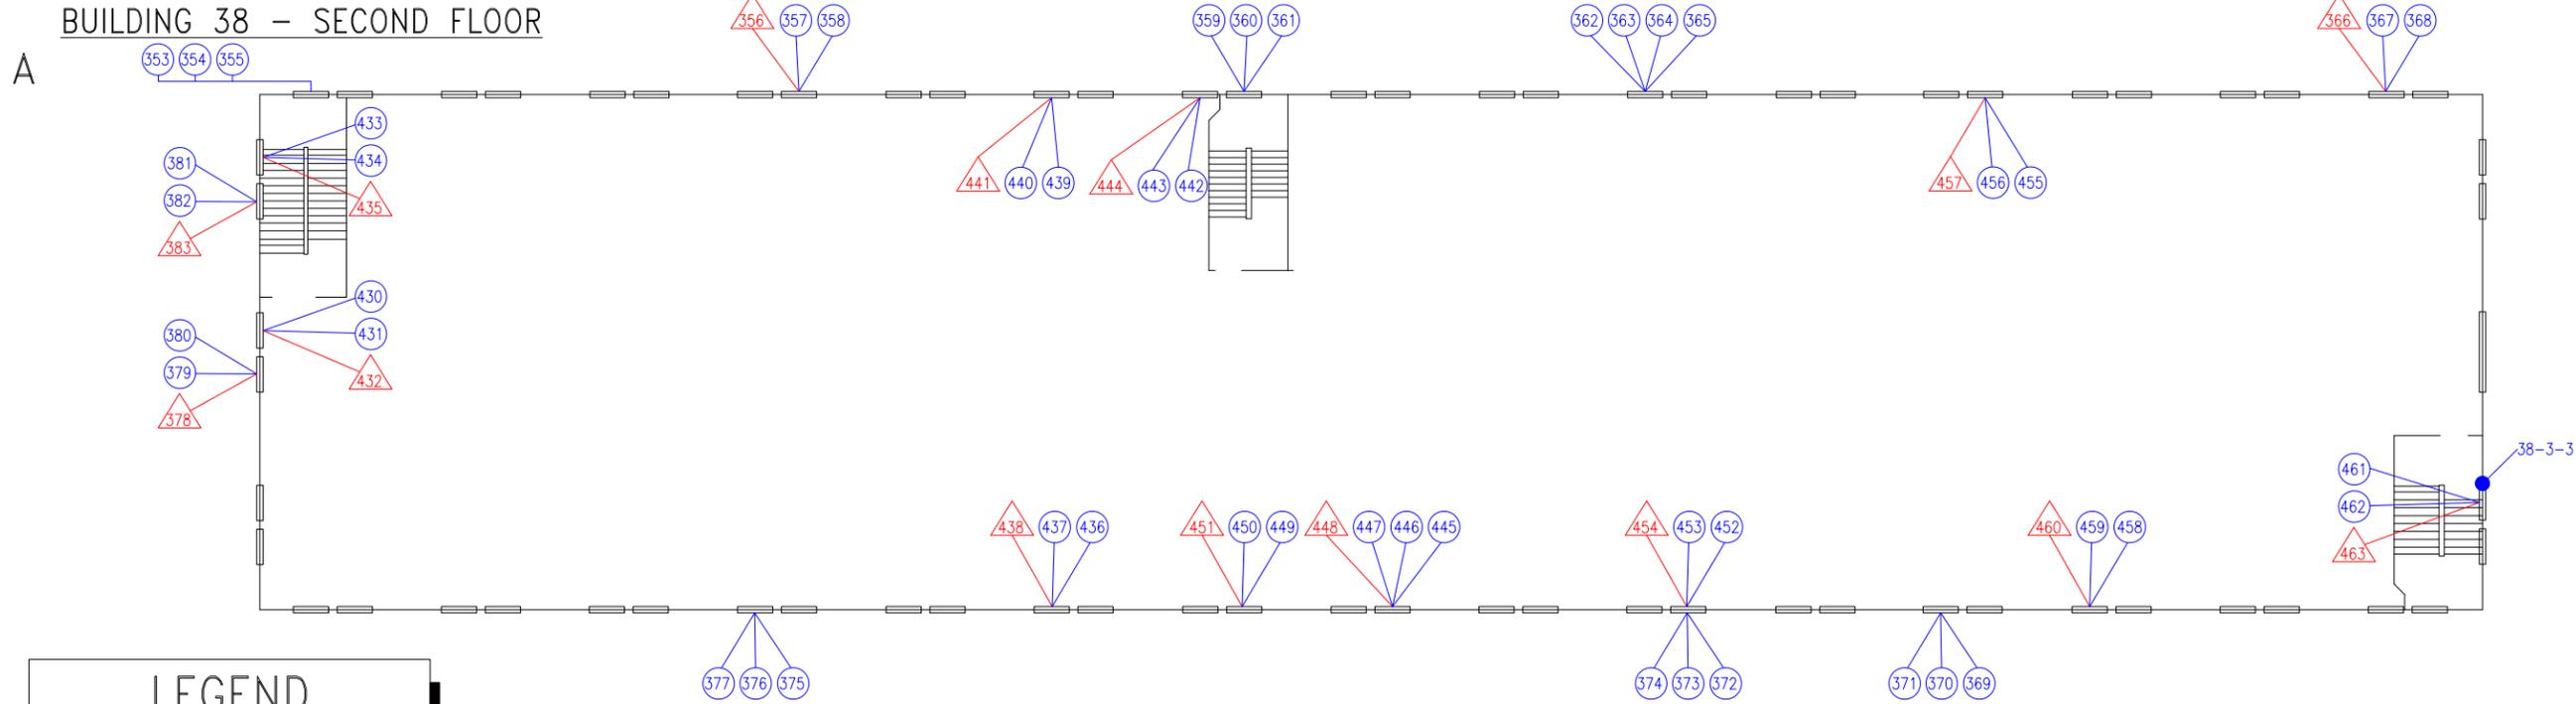
FIGURE 1

Asbestos sample results are summarized in Table 1. Sample locations and locations of ACMs are depicted on Figures 1 through 6. Consultant, inspector, and laboratory credentials are provided in Appendix A. A copy of the laboratory analytical results and appropriate Chain of Custody Records are included in Appendix B. Photographic Documentation is included as Appendix C.

A summary of XRF sample results are provided in Table 2. XRF sample locations are depicted on Figures 1 through 6.

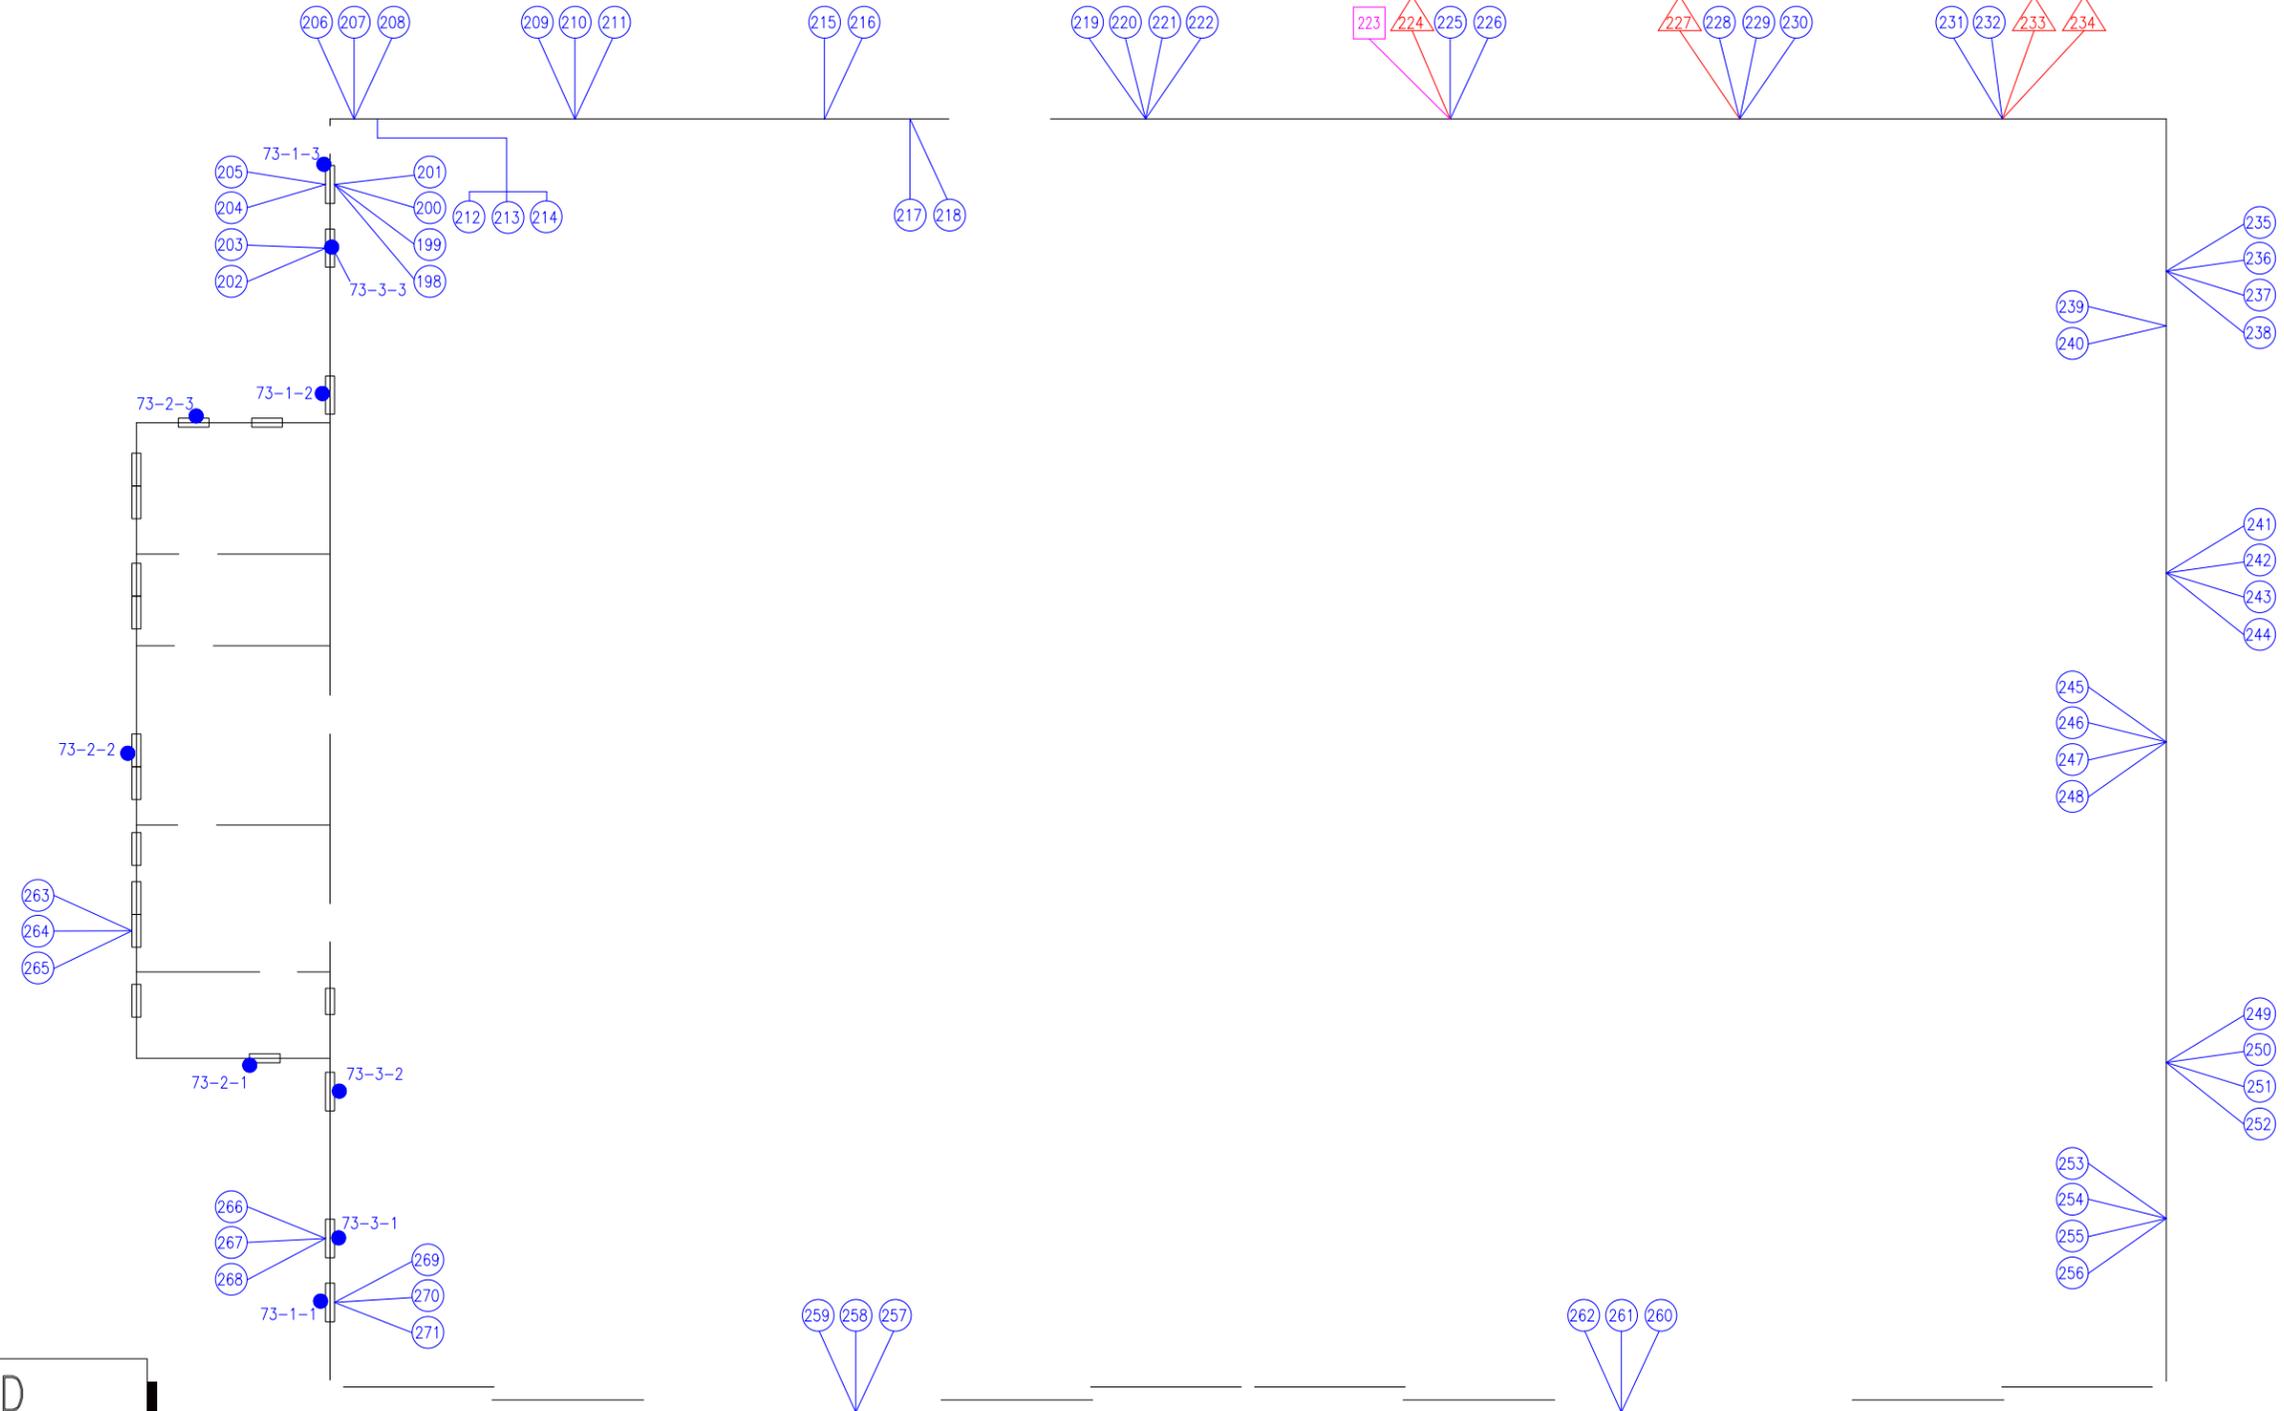
FIGURE 3

NOTE: XRF SAMPLE LOCATIONS SHOWN WITHIN THE BUILDING OUTLINE ARE UPPER LEVEL WINDOWS UNLESS OTHERWISE NOTED. XRF SAMPLE LOCATIONS SHOWN OUTSIDE THE BUILDING OUTLINE ARE LOWER LEVEL WINDOWS.

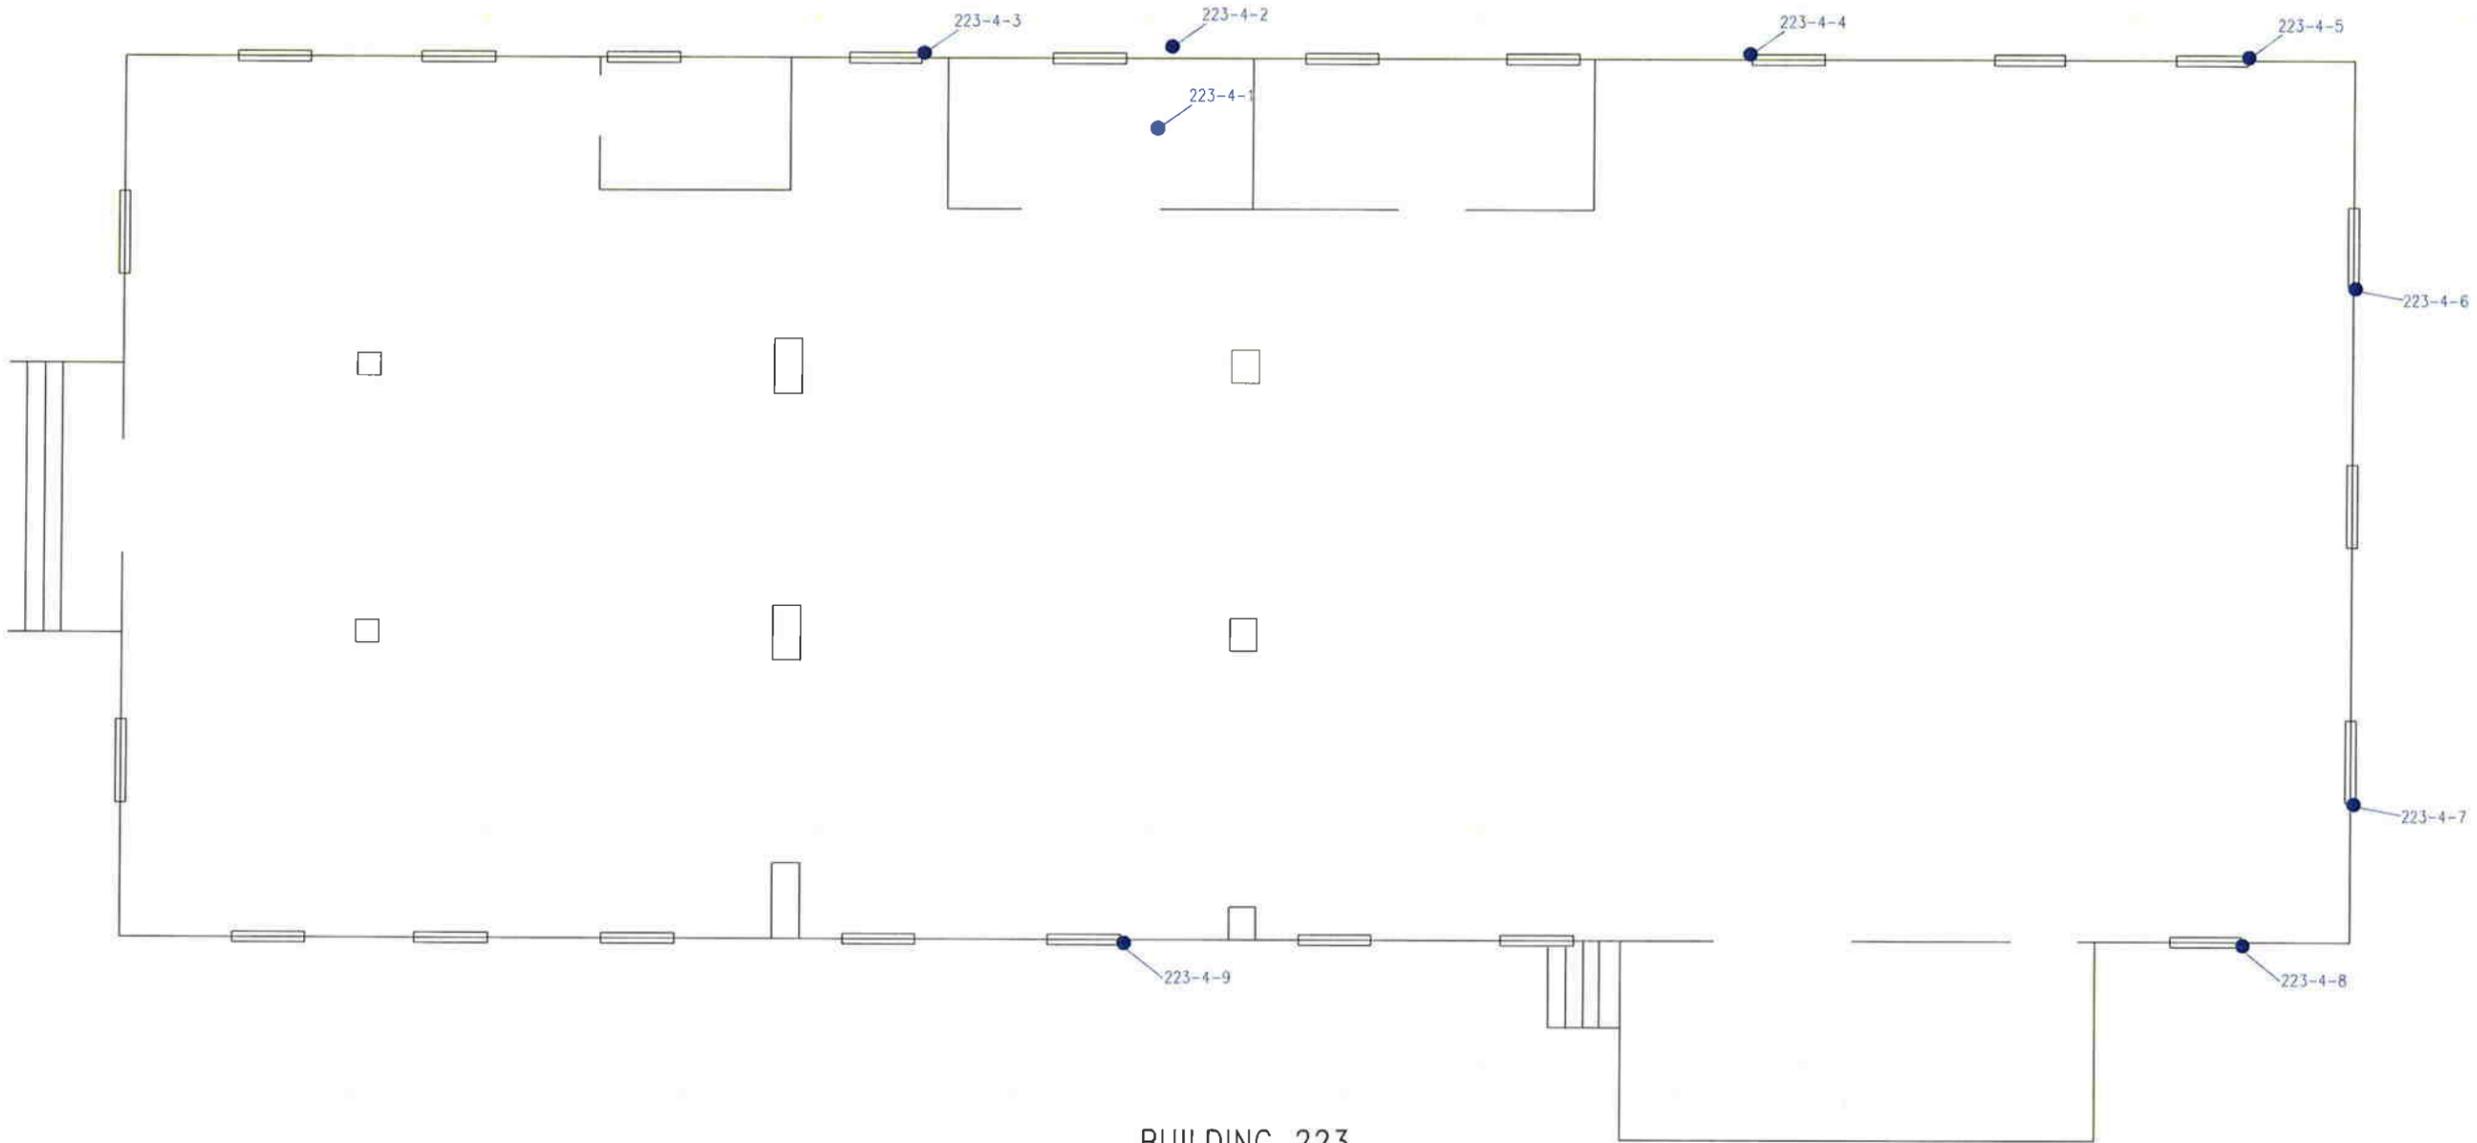
The limited additional asbestos sampling activities at the referenced site were conducted on November 30, 2012, by Mr. Curtis Mills, an Asbestos Hazard Emergency Response Act (AHERA)-certified Asbestos Building Inspector, under the direction of a DBPR-Licensed Asbestos Consultant (LAC). As requested, only exterior stucco finish samples were collected from surfaces which will be disturbed during scheduled renovation activities. The survey resulted in the collection of a total of nine bulk samples of suspect Asbestos Containing Materials (ACM). Samples were submitted to EMSL Laboratories, Inc. (EMSL) located in Orlando, Florida for analysis using the EPA recommended method of Polarized Light Microscopy (PLM) coupled with dispersion staining (Method No. EPA 600/R-93/116, 1993). EMSL is accredited by the National Voluntary Laboratory Accreditation Program (NVLAP) administered by the National Institute of Standards and Technology (NIST). A copy of inspector, LAC, and laboratory accreditations are included in Appendix A. Sample locations are shown on Figure 1 – Sample Locations. A photograph of the material is included in Appendix B.

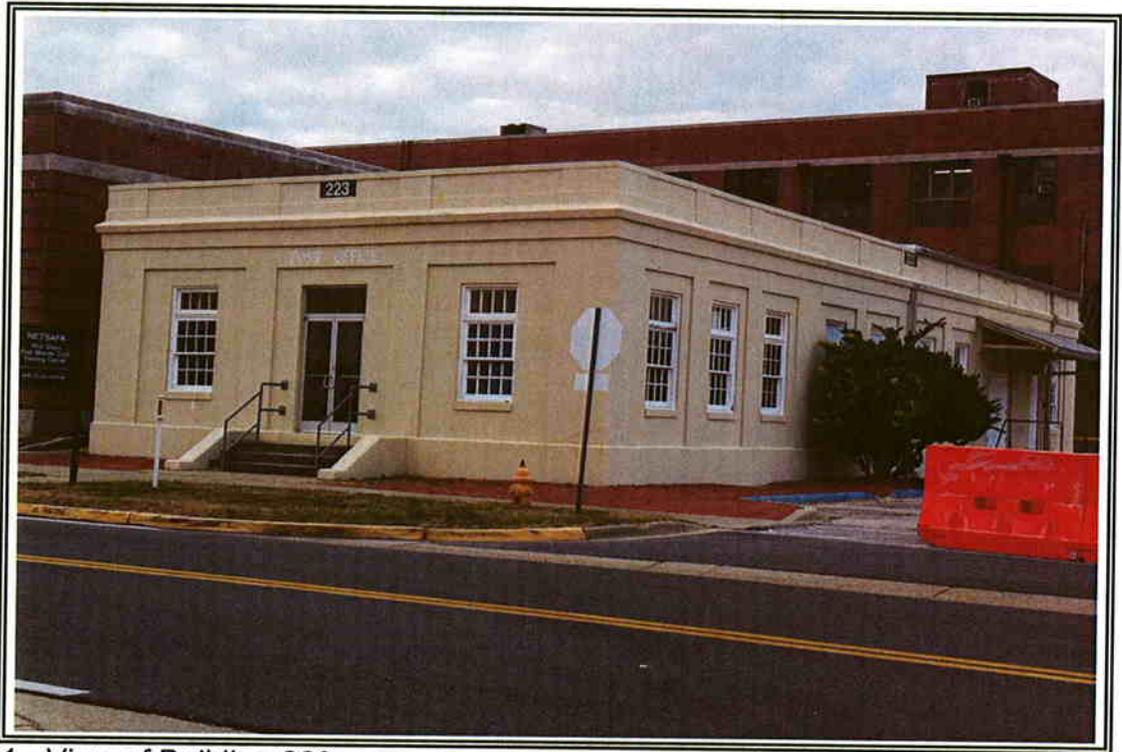
1. View of Building 223.
