June 4, 2015  
**Revised June 5, 2015**

**Reference:** **Geotechnical Investigation – Pavement Cores**  
*REPAIR AIRFIELD/RUNWAY FORREST SHERMAN FIELD*  
 NAS Fort Pensacola, Florida  
 NAVFAC Project No.: ST 1112225  
 UES Project No.: 1730.1500048.0000  
 UES DOCS Report No.: 1235270

**REPAIR AIRFIELD/RUNWAY FORREST SHERMAN FIELD**

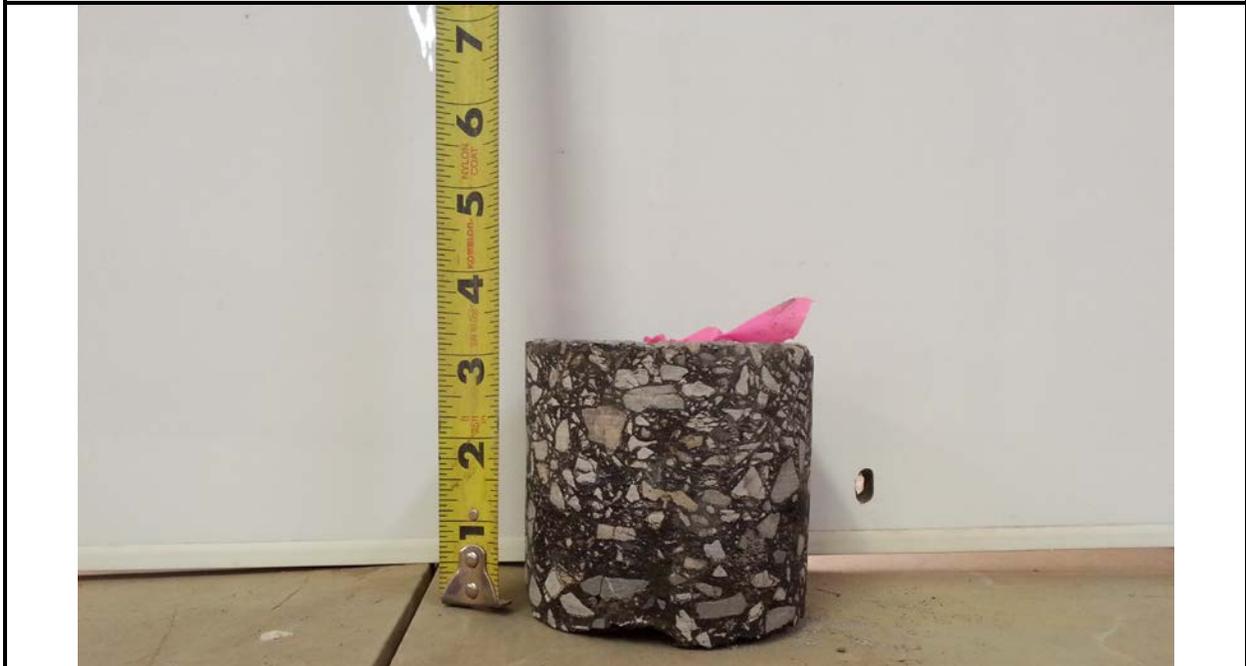
Pavement Core B-4.

Approximately 2 layers of flexible pavement. No noticeable separation geotextile. Core fractured 2.75" below the pavement surface (possible mechanical failure during core extraction). Bottom portion of core was not recovered.

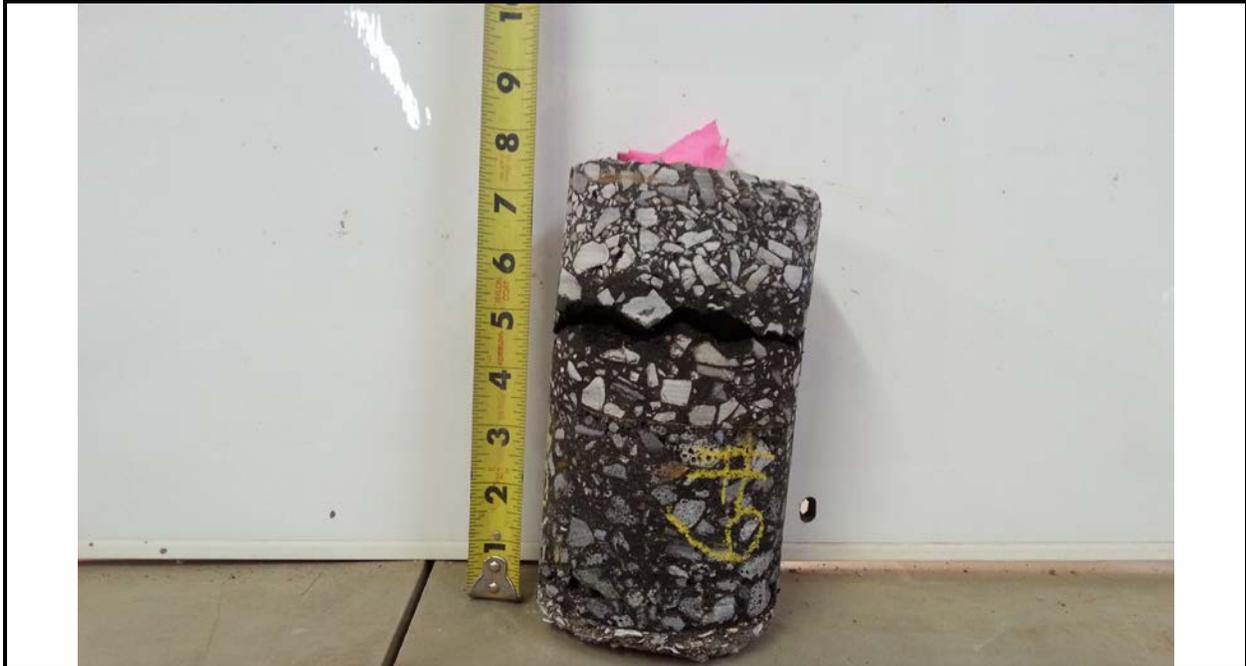
Pavement Core B-9.

Approximately 4 layers of flexible pavement. No noticeable separation geotextile. Separation occurred 2" below pavement surface (possible mechanical failure during core extraction).

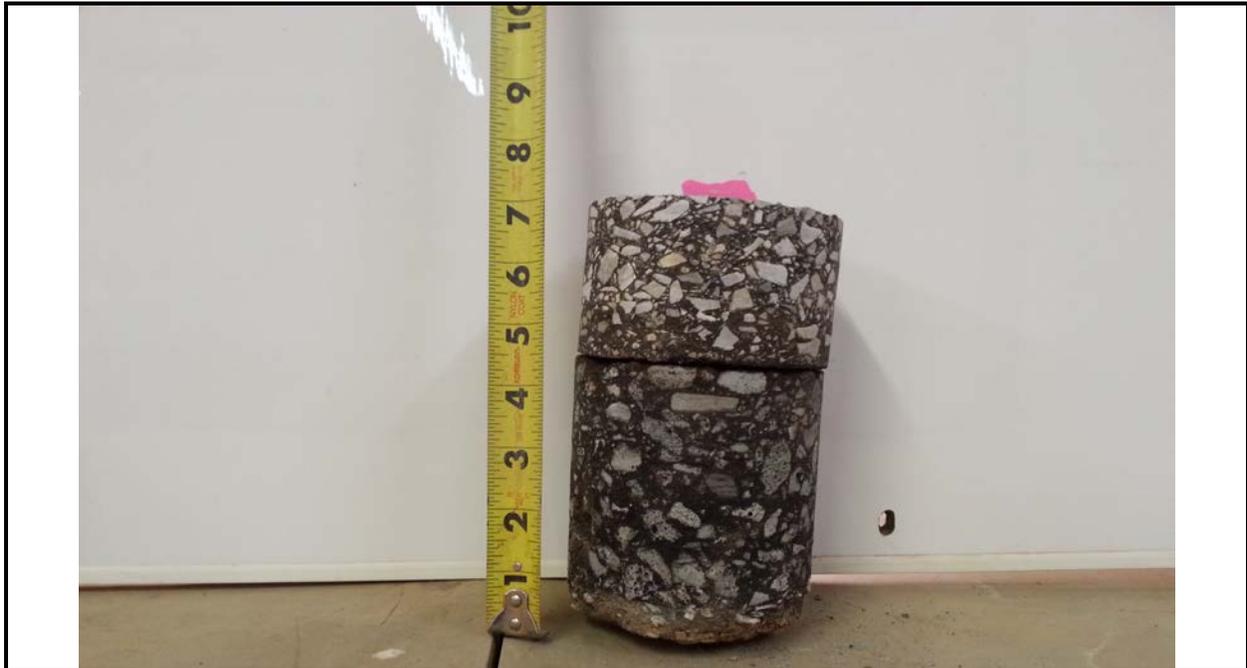
Pavement Core B-11.  
Approximately 4 layers of flexible pavement. Separation geotextile located 2.375" below the pavement surface. Core delaminated at the base of the geotextile.

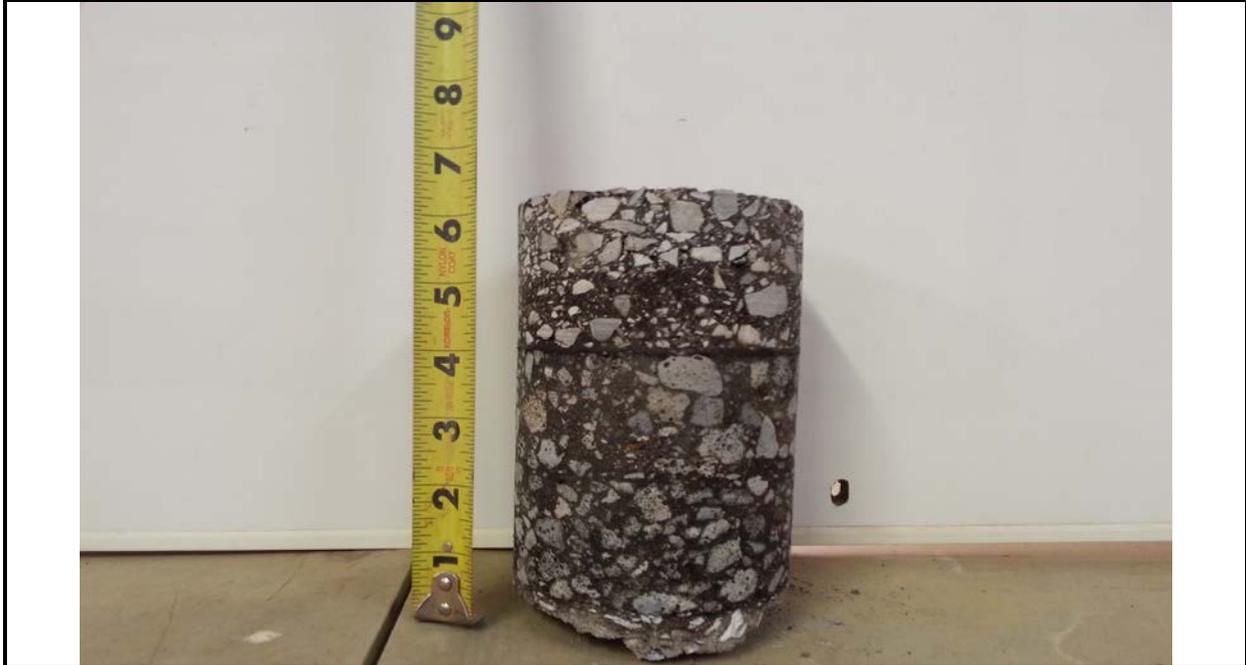
Pavement Core B-14.  
Approximately 4 layers of flexible pavement. Separation geotextile located 2.125" below the pavement surface. No observed cracking or delamination.

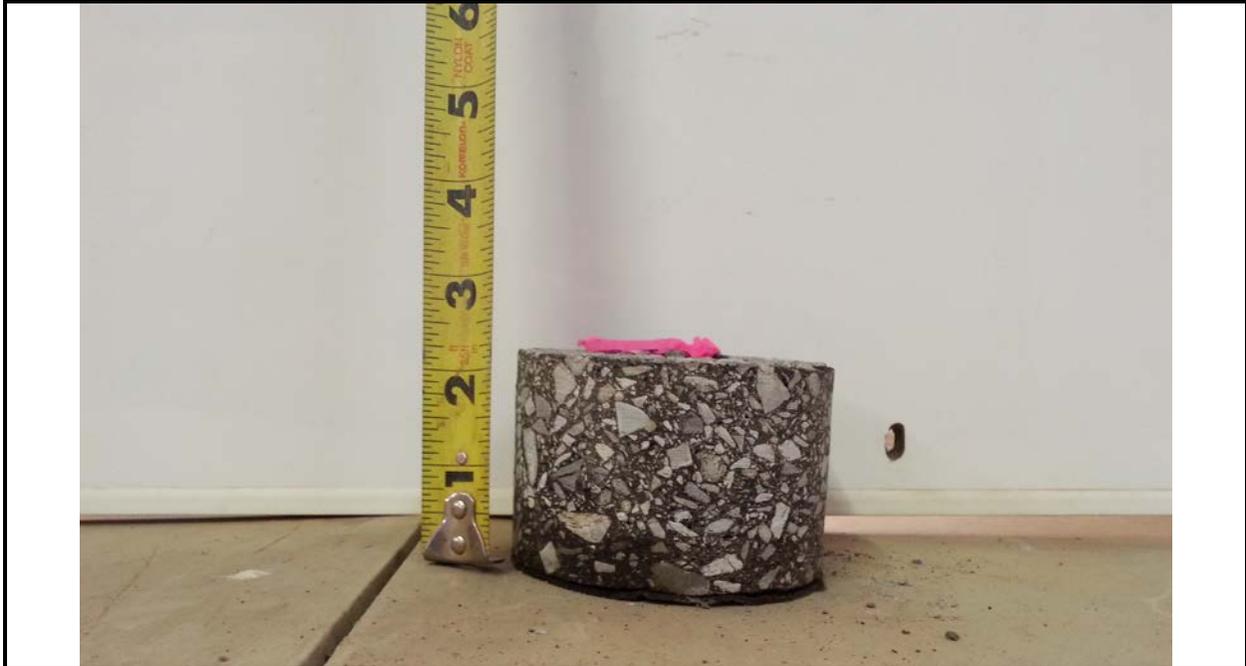
Pavement Core B-15.  
Approximately 2 layers of flexible pavement. Separation geotextile located 2.25" below the pavement surface. No observed cracking. No recovery of the bottom portion of the core (below separation geotextile).

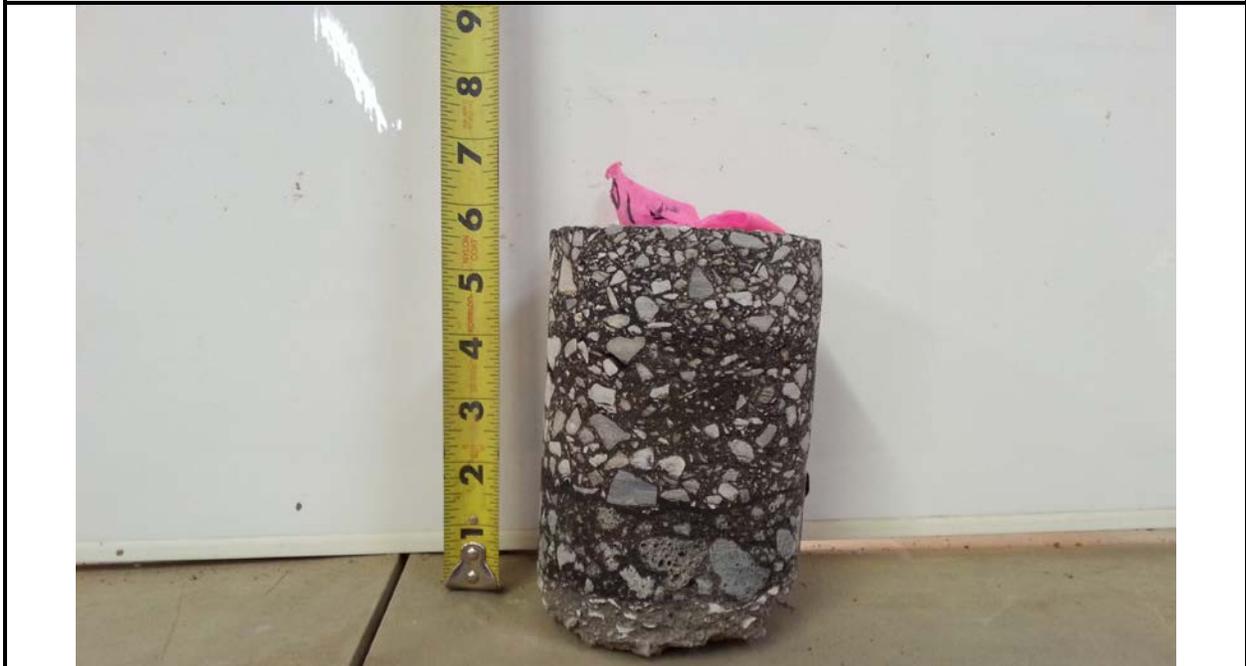
Pavement Core B-16.  
Approximately 4 layers of flexible pavement. Separation geotextile located 3.5" below pavement surface. No observed cracking or delamination.

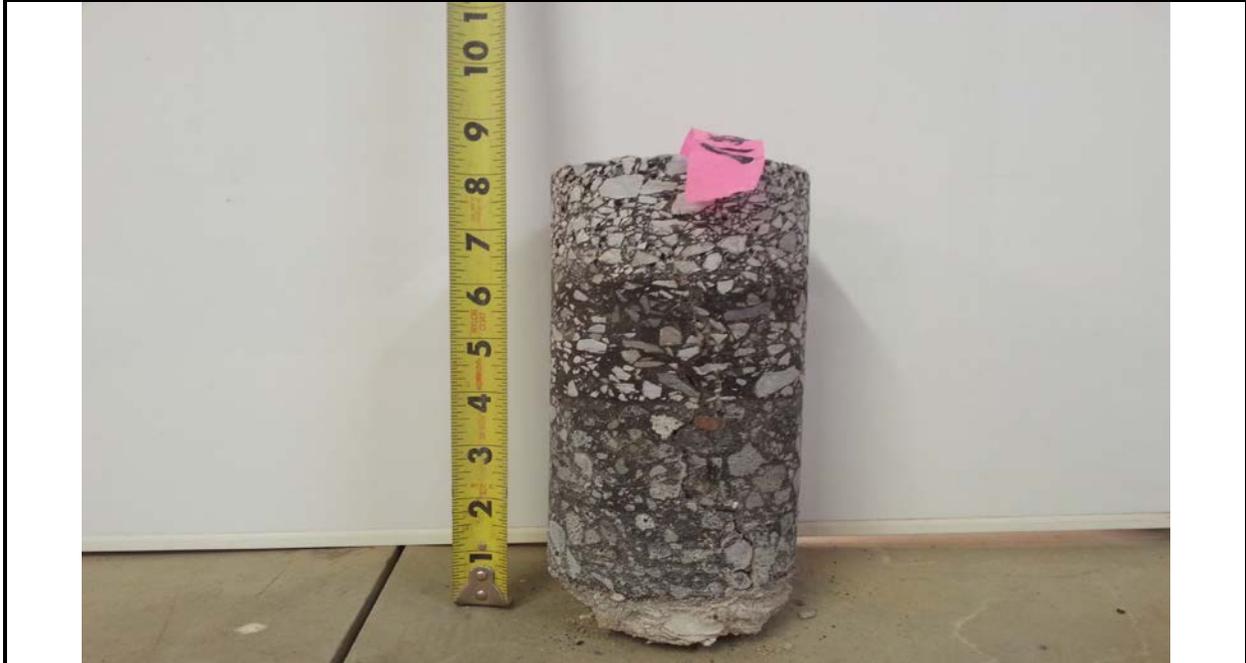
Pavement Core B-18.  
Approximately 4 layers of flexible pavement. No noticeable separation geotextile. Cracking was observed beginning 2.5" below the pavement surface and extending down to the base of the core (Bottom-up Cracking). Cracking was observed in two locations.

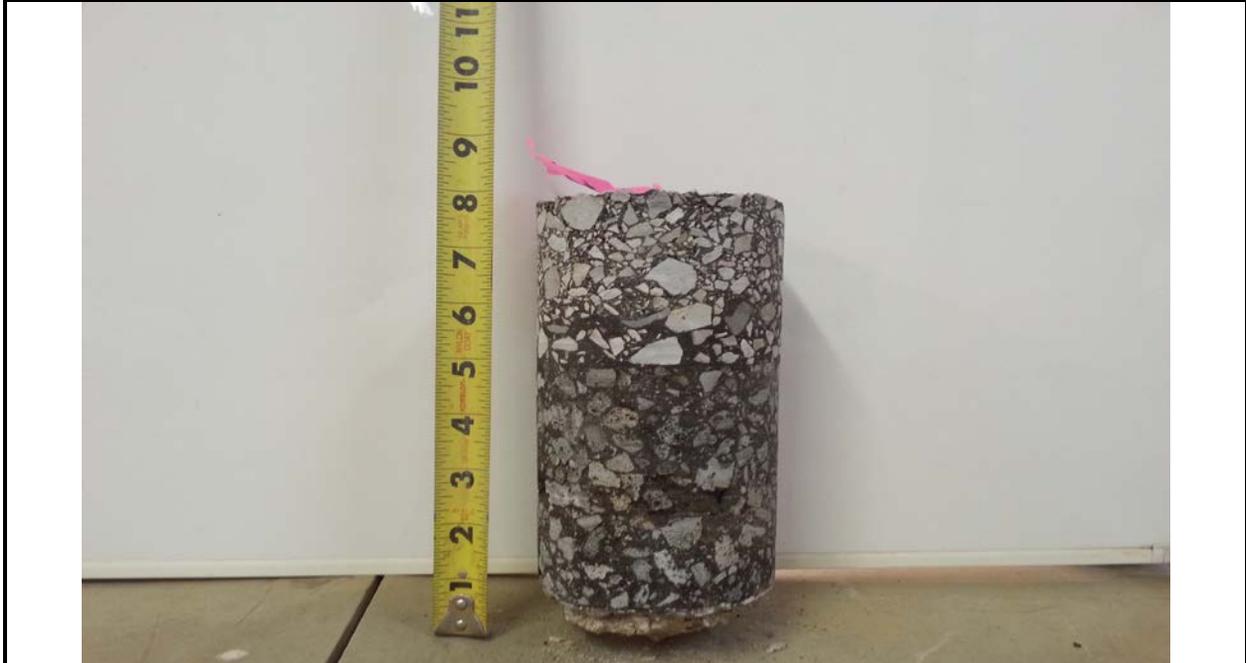
Pavement Core B-20.  
Approximately 4 layers of flexible pavement. No noticeable separation geotextile. Cracking was observed beginning 2.5" below the pavement surface and extending down to the base of the core (Bottom-up Cracking). Cracking was observed in two locations.

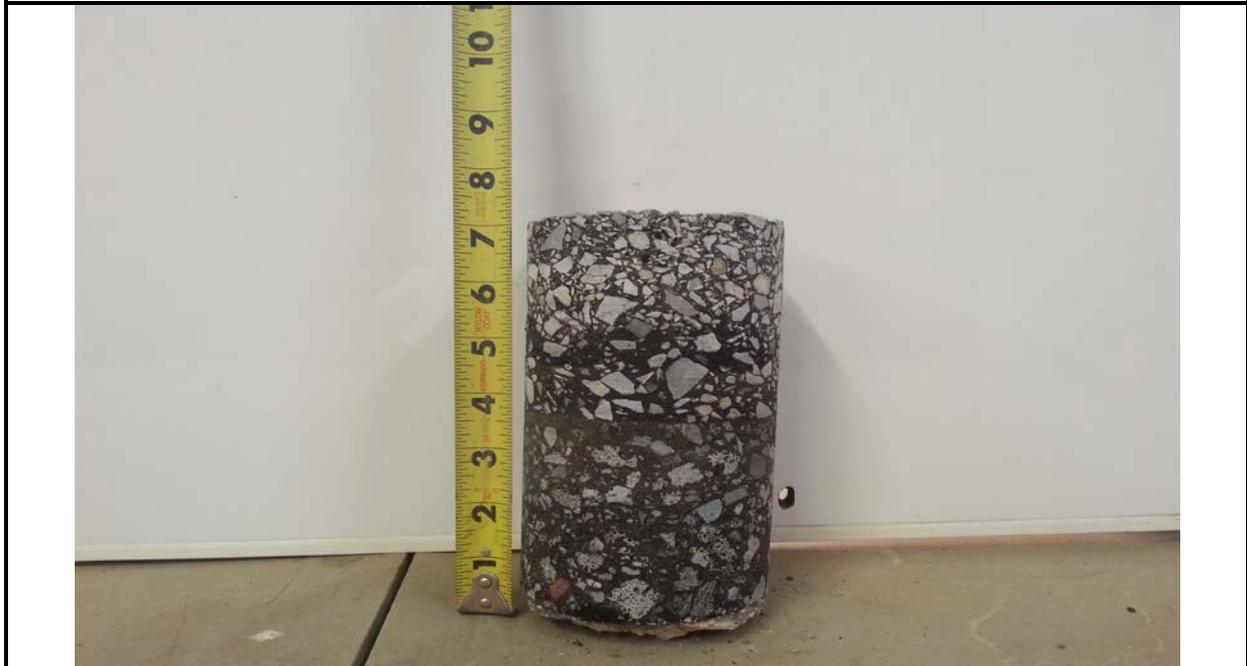
Pavement Core B-22.  
Approximately 4 layers of flexible pavement. Separation geotextile located 2.5" below top of pavement surface. No observed cracking or delamination.

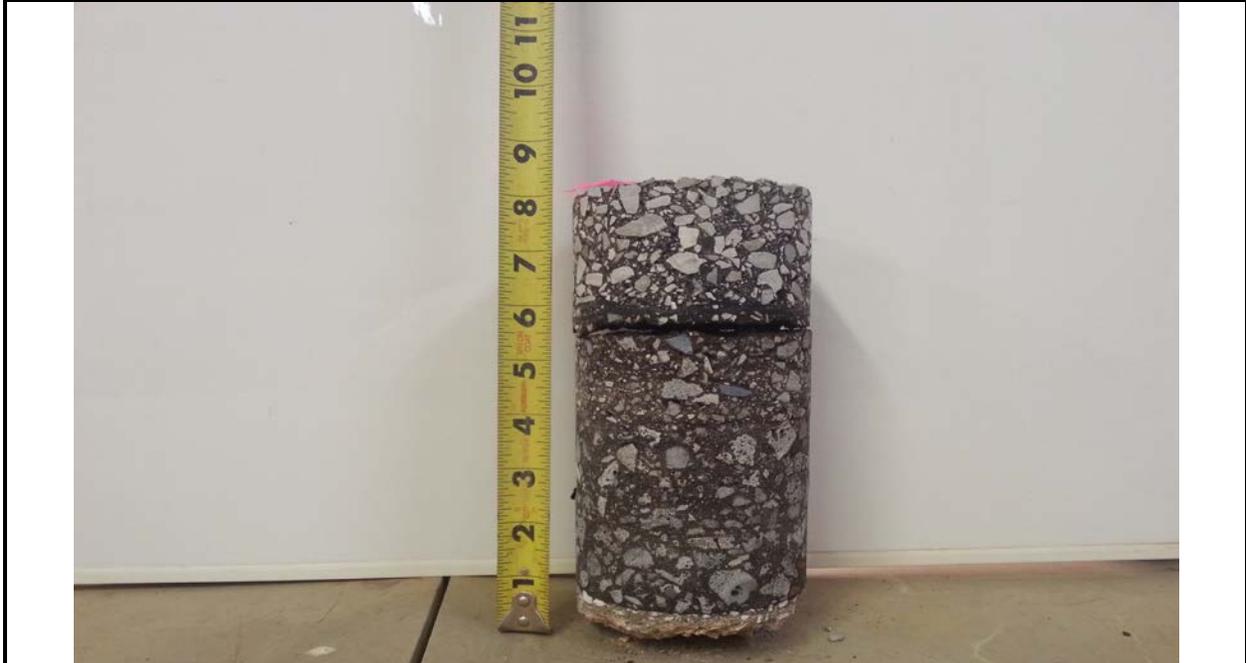
Pavement Core B-24.  
Approximately 4 layers of flexible pavement. Separation geotextile located 2.5" below the pavement surface. Core delaminated directly below the separation geotextile (possible mechanical failure during core extraction).

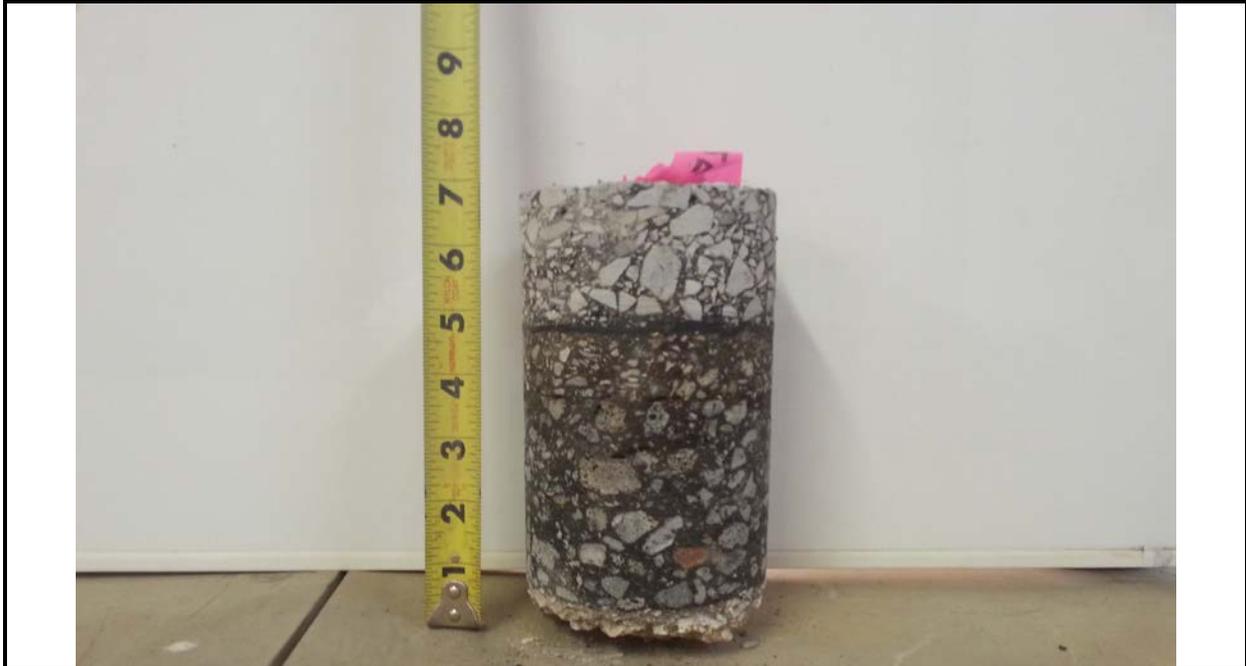
Pavement Core B-25.  
Approximately 4 layers of flexible pavement. Separation geotextile located 2" below the pavement surface. No observed cracking or delamination.

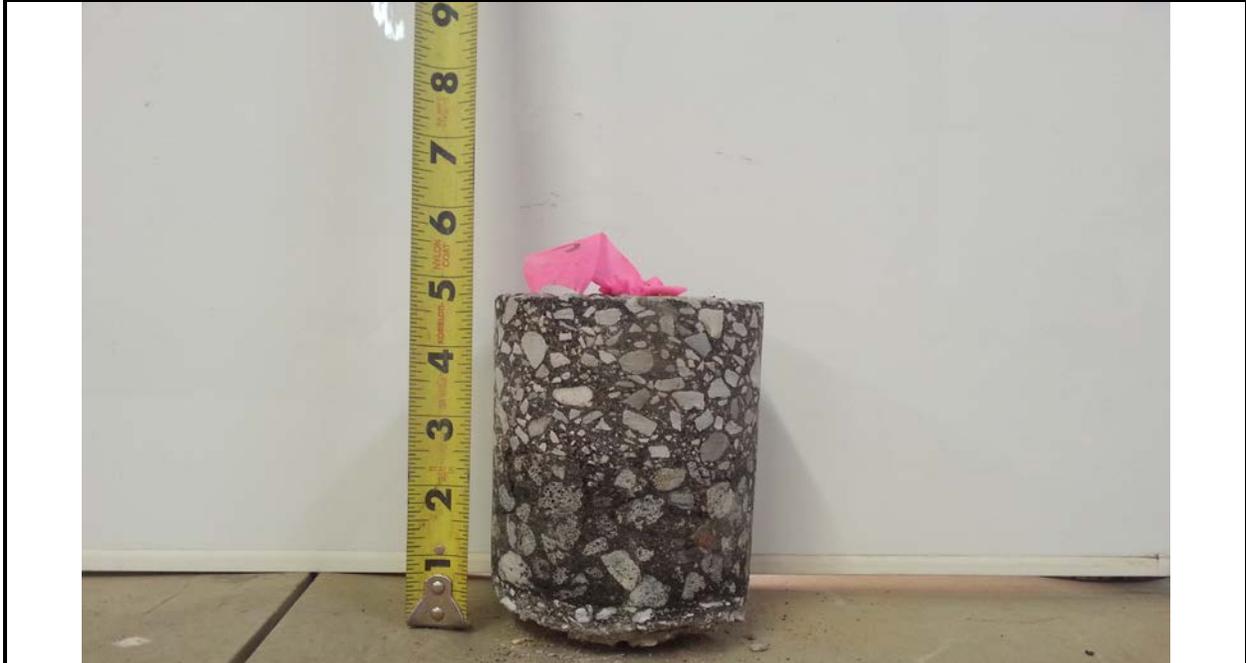
Pavement Core B-26.  
Approximately 2 layers of flexible pavement. No noticeable separation geotextile. No observed cracking or delamination.

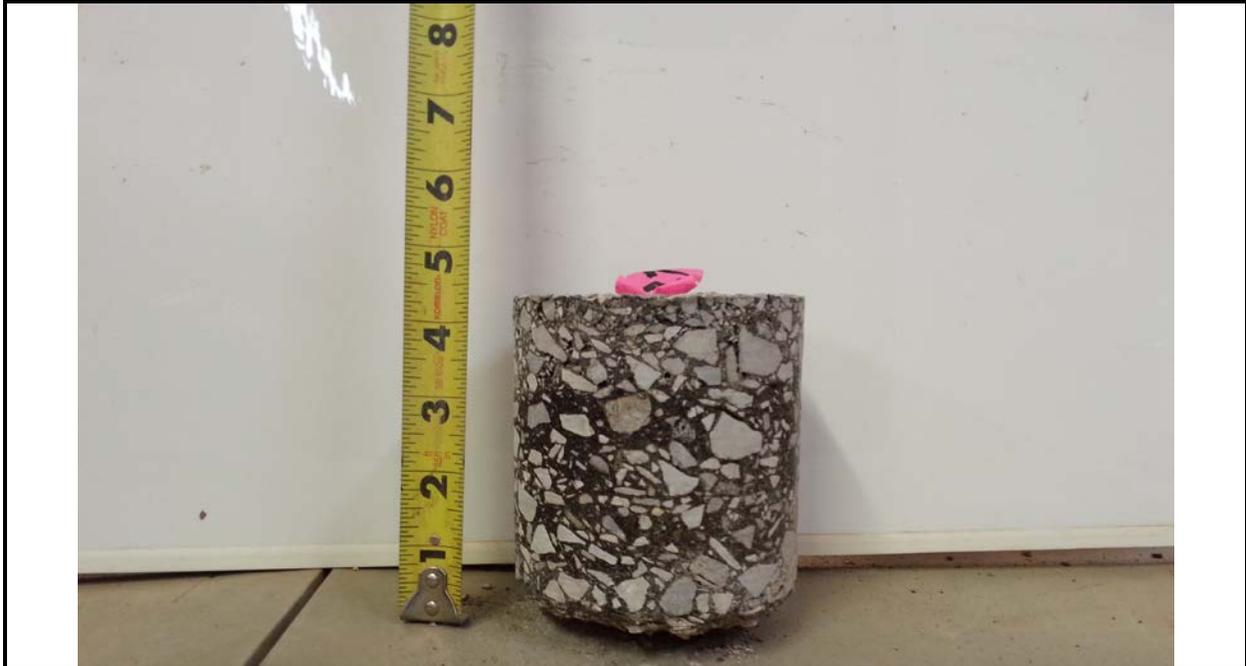
Pavement Core B-27.  
Approximately 3 layers of flexible pavement. No noticeable separation geotextile. No observed cracking or delamination.

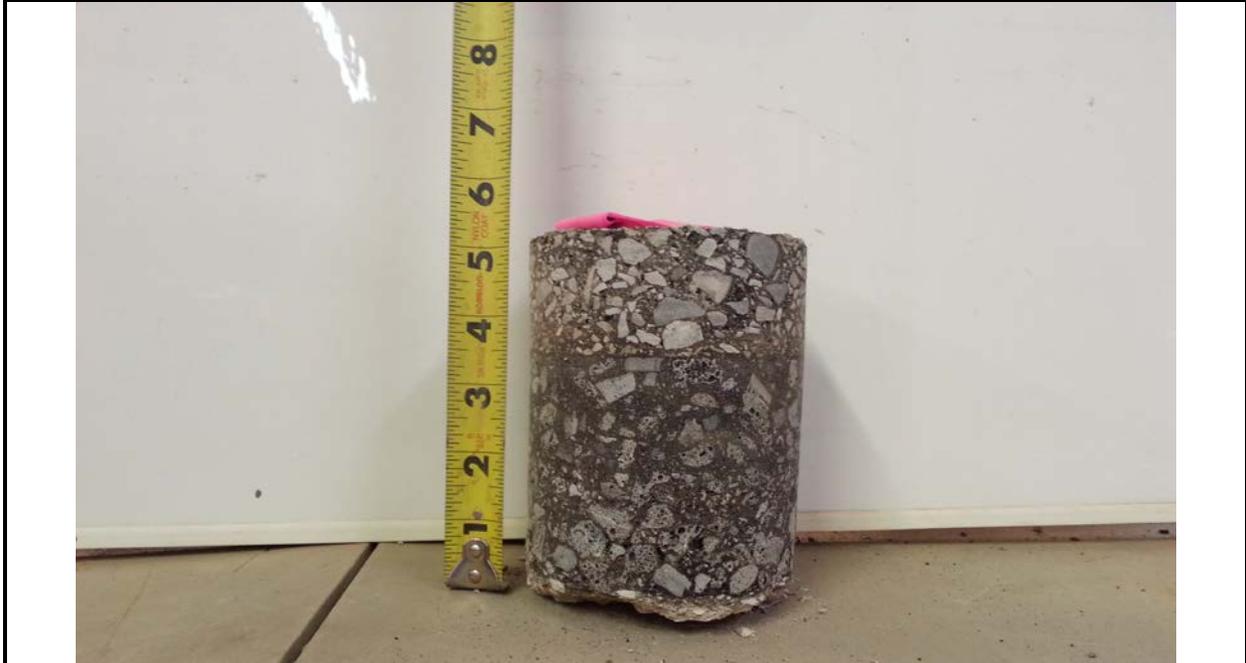
Pavement Core B-28.  
Approximately 3 layers of flexible pavement. No noticeable separation geotextile. No observed cracking or delamination.

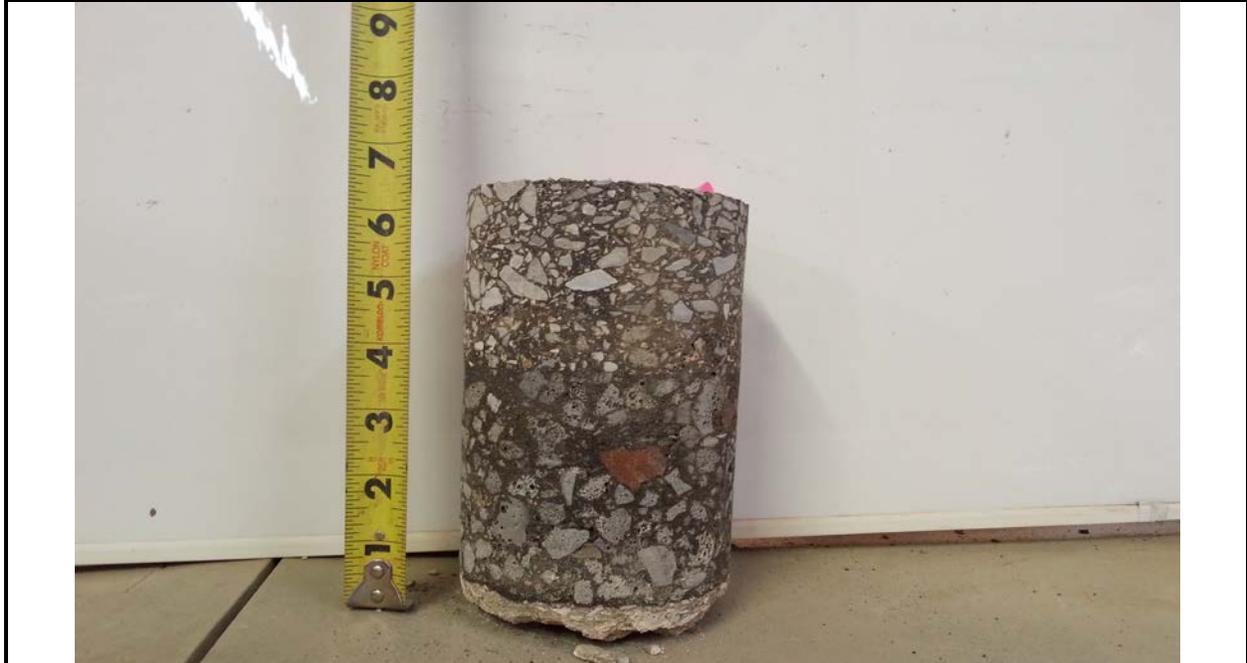
Pavement Core B-30.  
Approximately 4 layers of flexible pavement. No noticeable separation geotextile. No observed cracking or delamination.

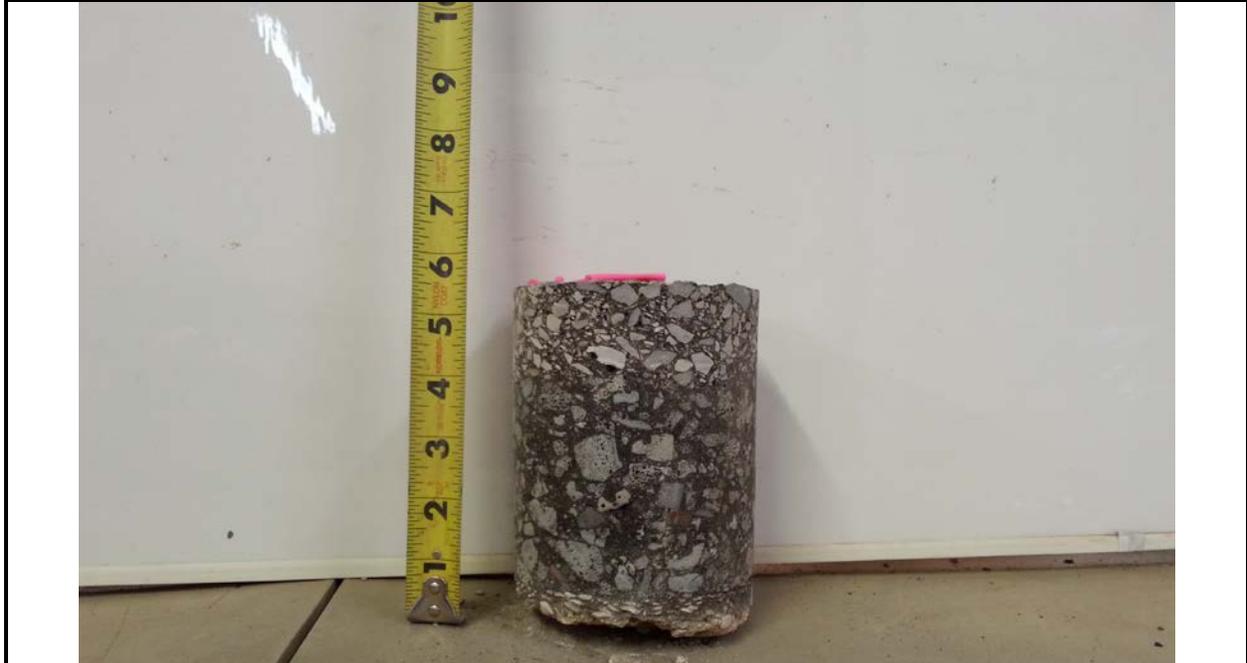
Pavement Core B-32.  
Approximately 3 layers of flexible pavement. No noticeable separation geotextile. No observed cracking or delamination.

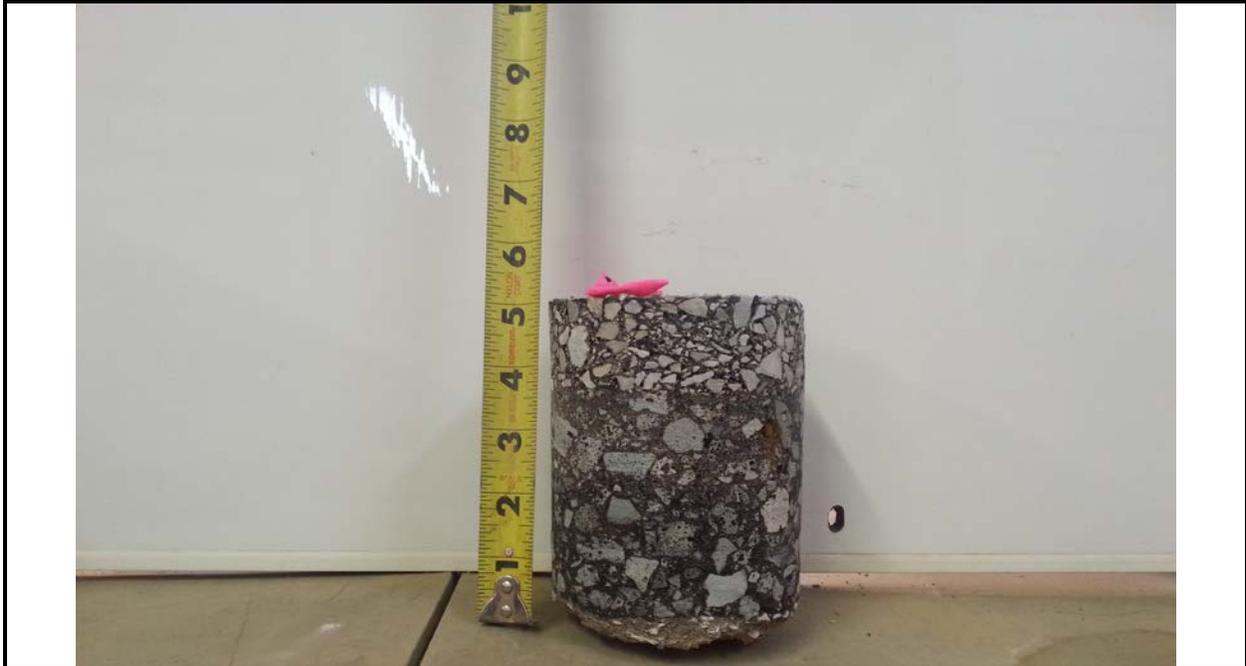
Pavement Core B-33.  
Approximately 3 layers of flexible pavement. No noticeable separation geotextile. No observed cracking or delamination.

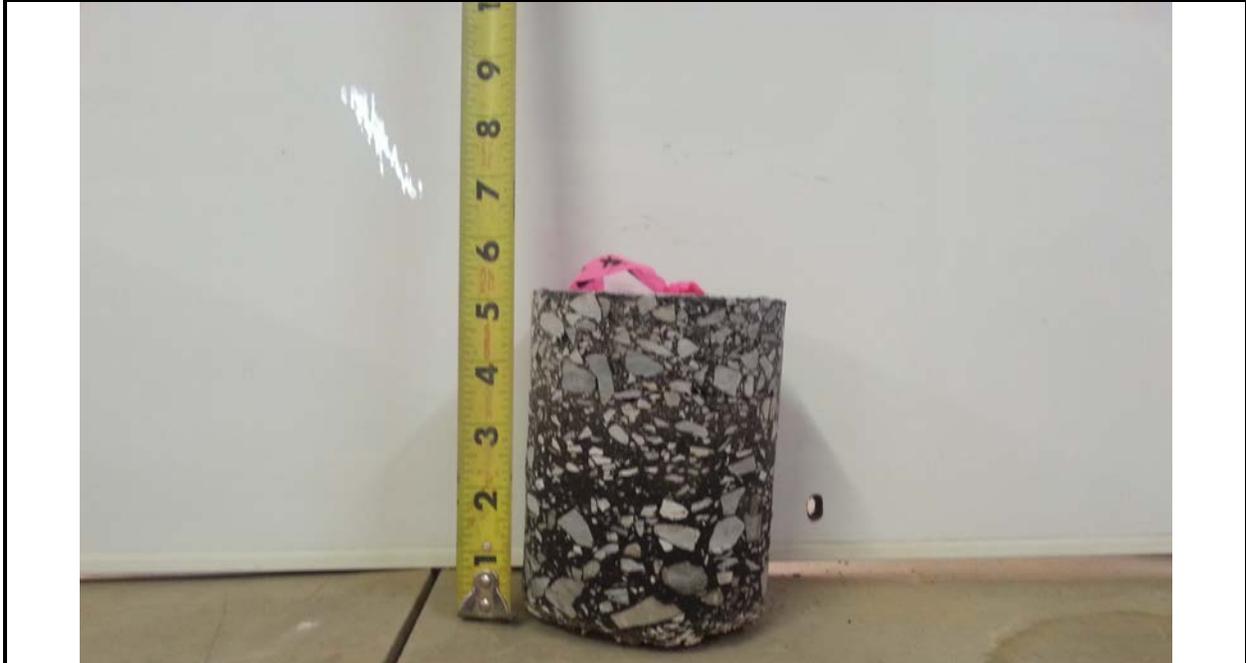
Pavement Core B-34.  
Approximately 3 layers of flexible pavement. No noticeable separation geotextile. No observed cracking or delamination.

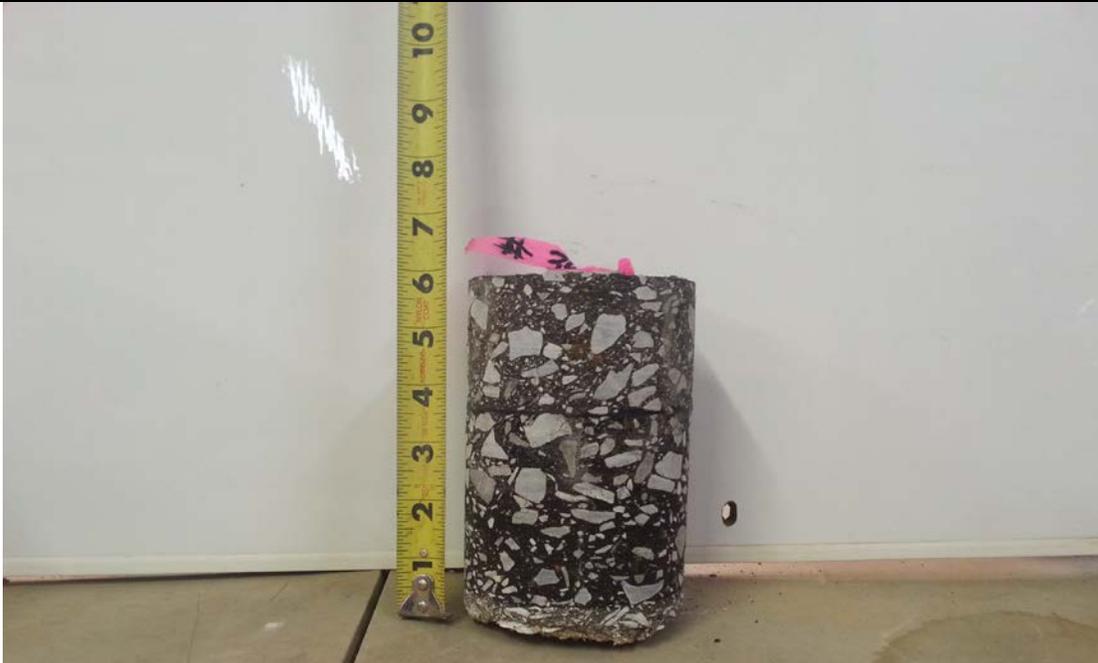
Pavement Core B-36.

Approximately 3 layers of flexible pavement. Separation geotextile located 2.25" below pavement surface. Cracking was observed beginning at the pavement surface and extending down approximately 0.5" (Top-down cracking). Cracking was observed in one location.

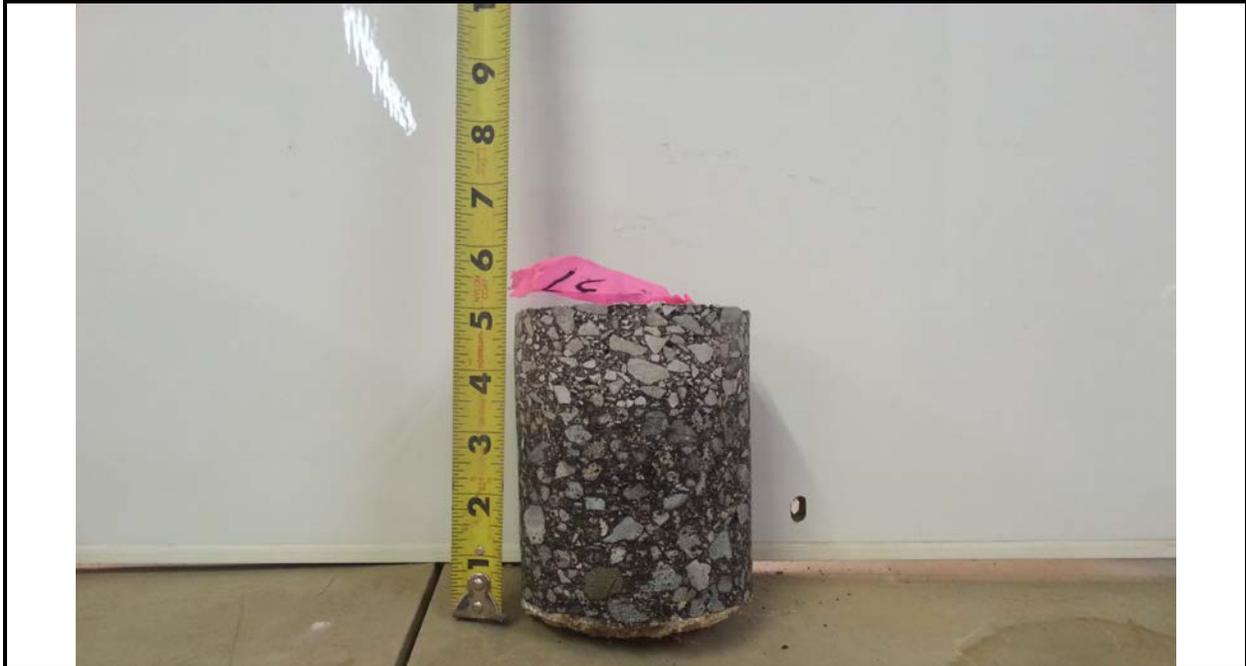
Pavement Core B-37.  
Approximately 3 layers of flexible pavement. No noticeable separation geotextile. No observed cracking or delamination.

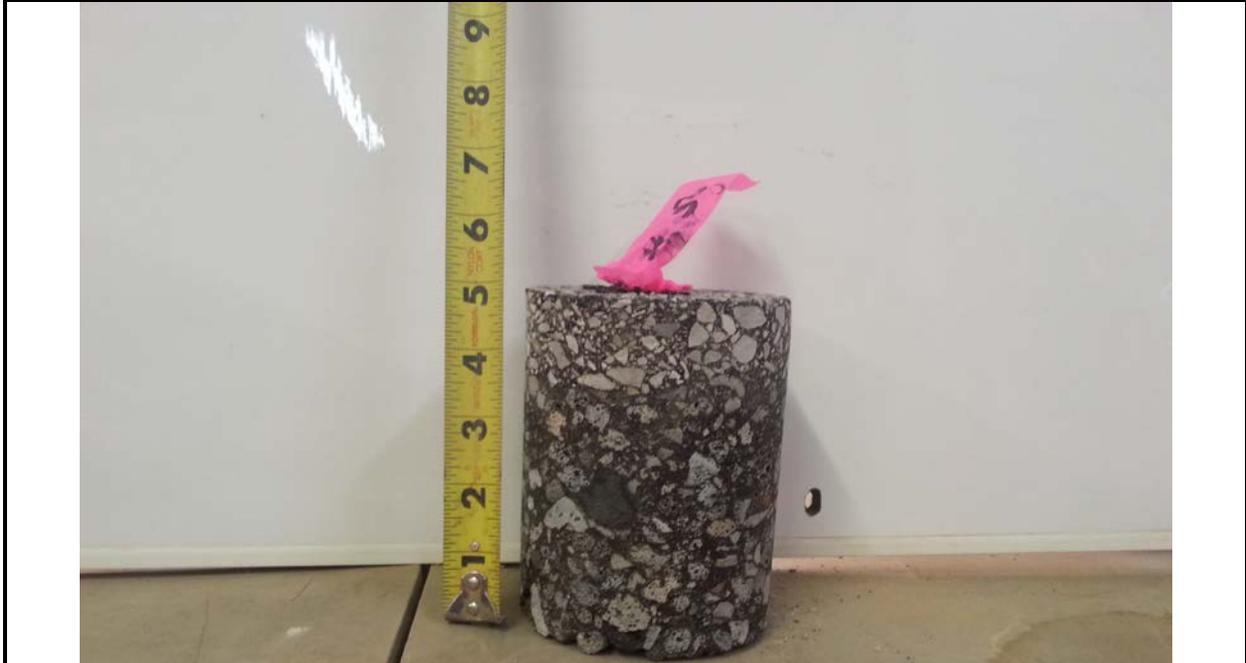
Pavement Core B-38.  
Approximately 3 layers of flexible pavement. No noticeable separation geotextile. No observed cracking or delamination.

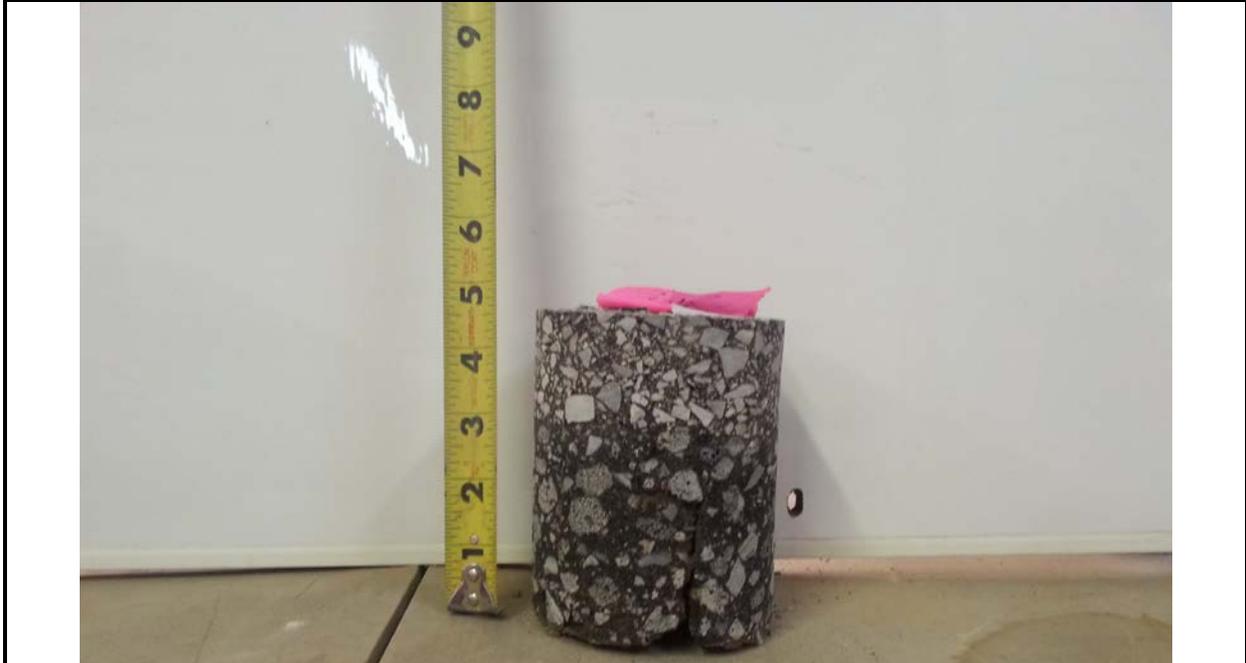
Pavement Core B-40.  
Approximately 3 layers of flexible pavement. No noticeable separation geotextile. Cracking observed beginning 1.625" below pavement surface and extending down to the base of the core (Bottom-up cracking). Cracking was observed in three locations.

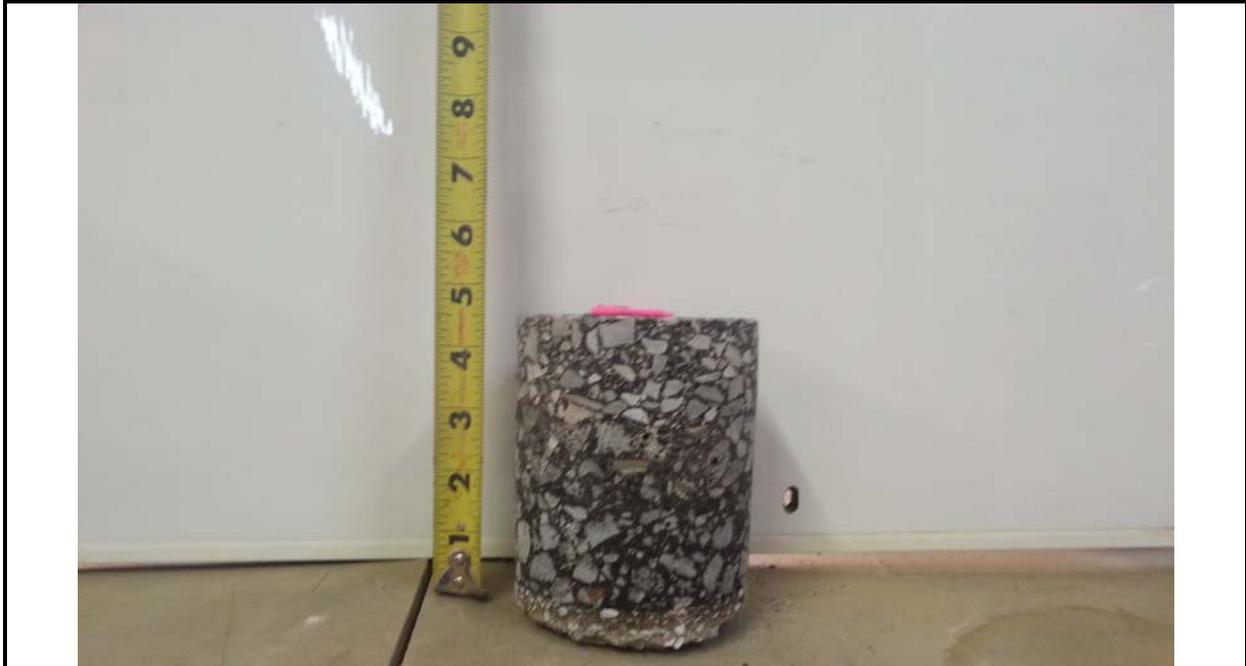
Pavement Core B-41.

Approximately 3 layers of flexible pavement. No noticeable separation geotextile. Cracking observed beginning 1.5" below the pavement surface and extending down to the base of the core (Bottom-up cracking). Cracking was observed in two locations.

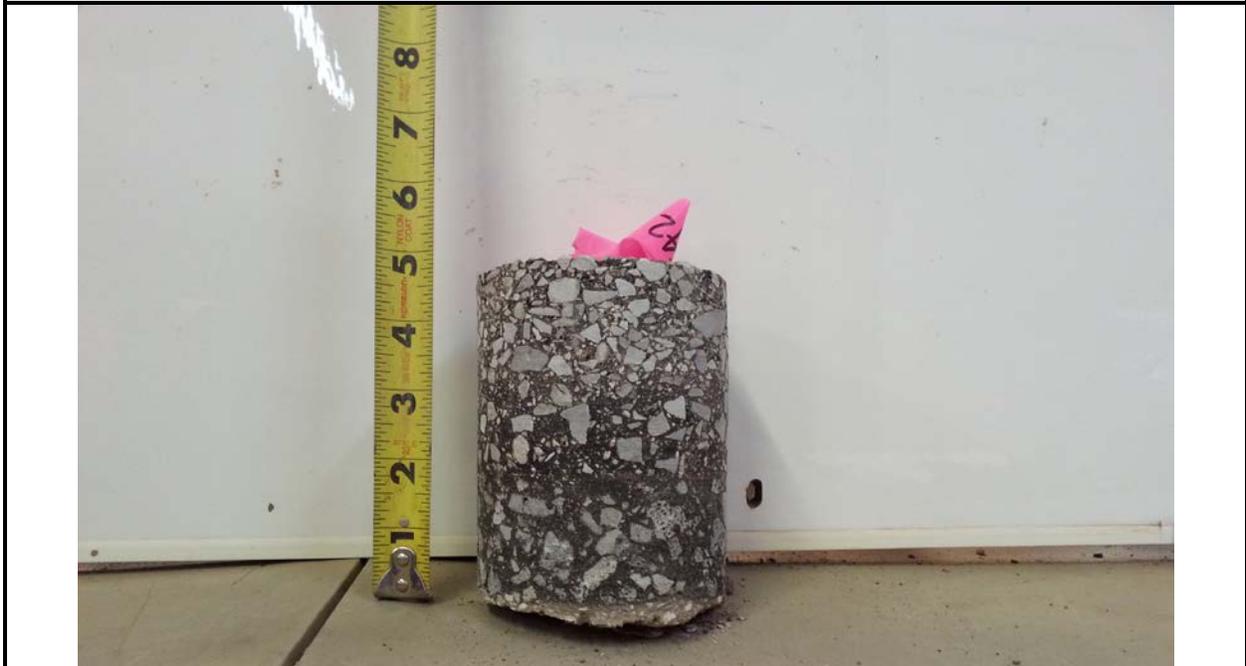
Pavement Core B-42.

Approximately 3 layers of flexible pavement. No noticeable separation geotextile. No observed cracking or delamination.

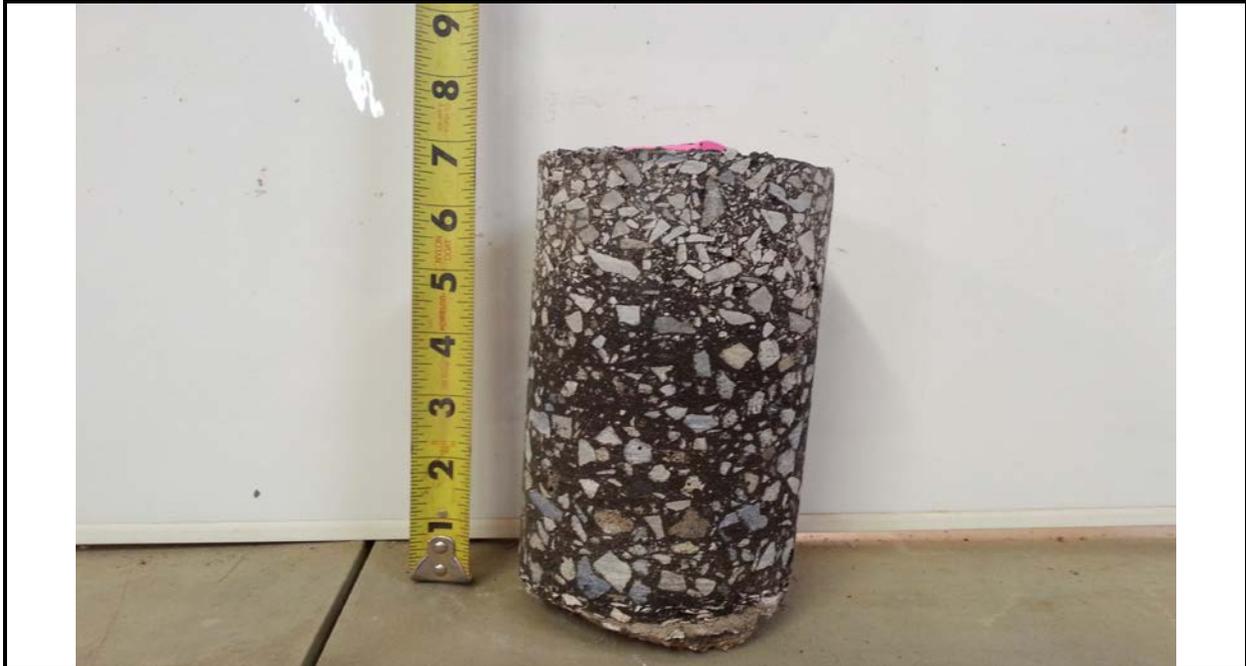
Pavement Core B-45.  
Approximately 4 layers of flexible pavement. No noticeable separation geotextile. No observed cracking or delamination.

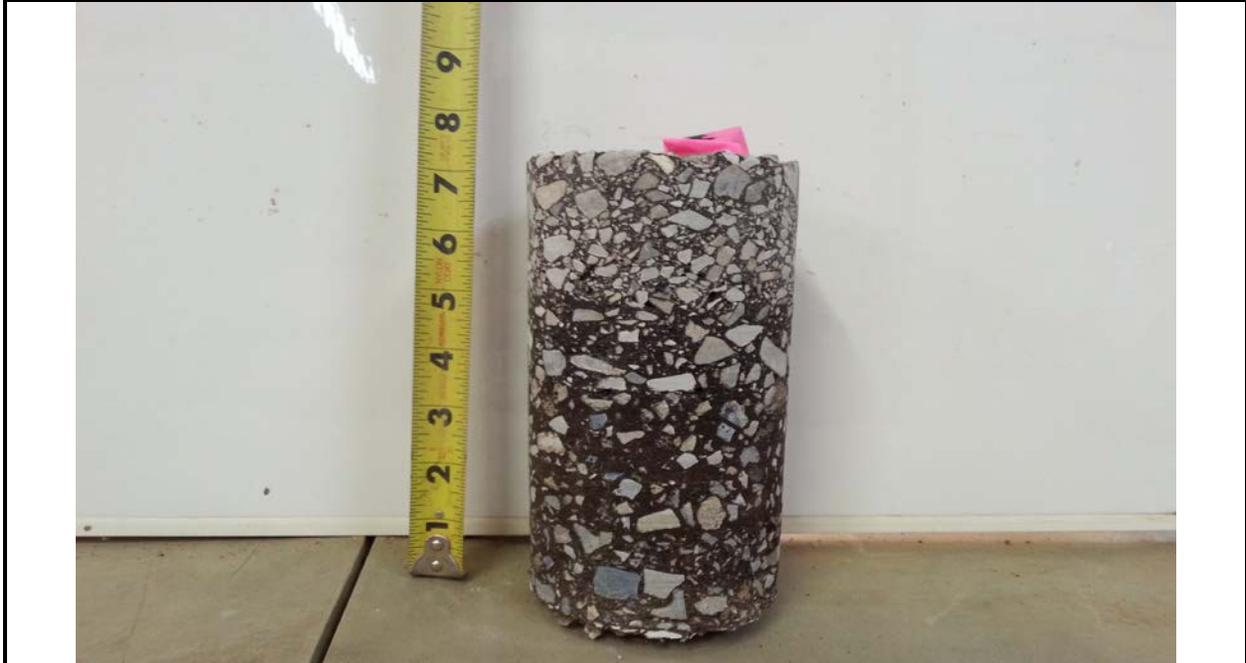
Pavement Core B-46  
Approximately 4 layers of flexible pavement. No noticeable separation geotextile. No observed cracking or delamination.
