June 4, 2015  
**Revised June 5, 2015**

**Reference:** **Geotechnical Investigation – Pavement Cores**  
*REPAIR AIRFIELD/RUNWAY FORREST SHERMAN FIELD*  
 NAS Fort Pensacola, Florida  
 NAVFAC Project No.: ST 1112225  
 UES Project No.: 1730.1500048.0000  
 UES DOCS Report No.: 1235270

**REPAIR AIRFIELD/RUNWAY FORREST SHERMAN FIELD**

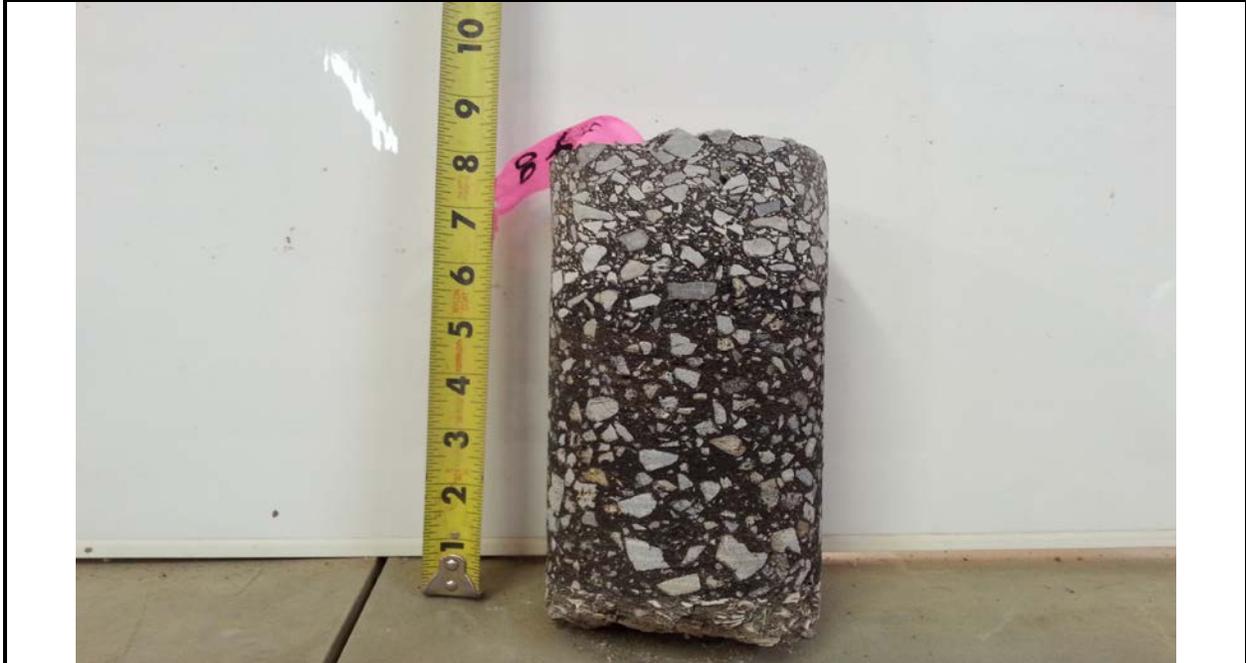
Pavement Core B-48  
Approximately 4 layers of flexible pavement. No noticeable separation geotextile. No observed cracking or delamination.

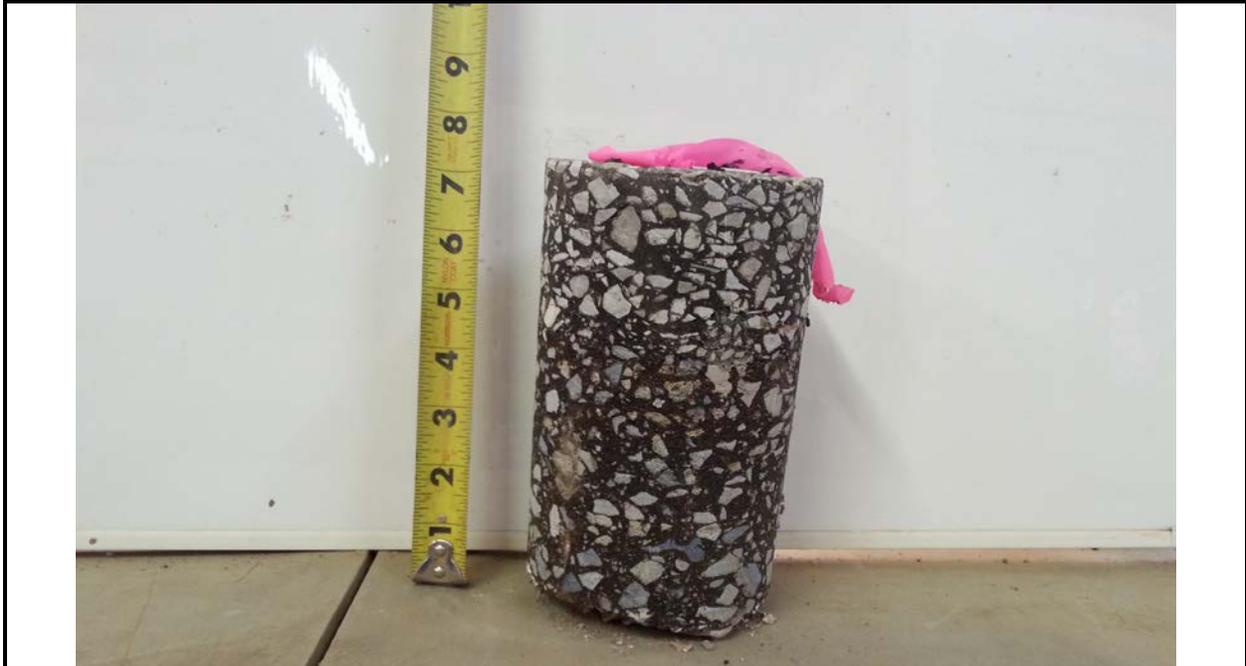
Pavement Core B-49  
Approximately 4 layers of flexible pavement. No noticeable separation geotextile. No observed cracking or delamination.

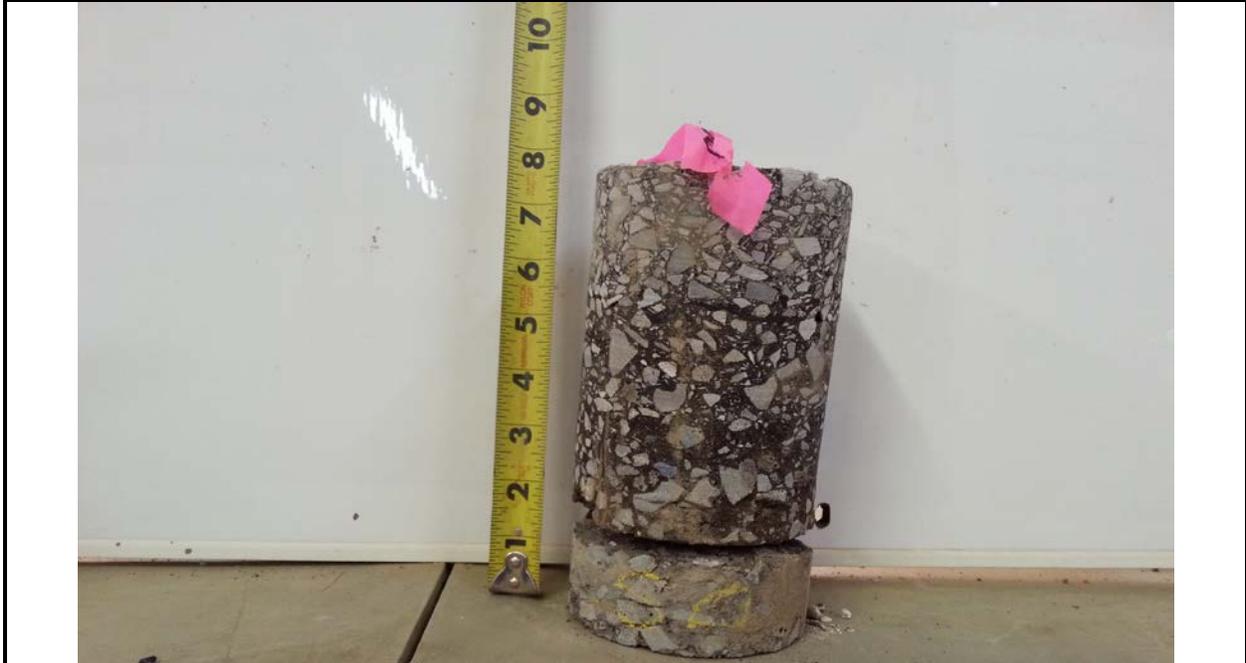
Pavement Core B-50  
Approximately 4 layers of flexible pavement. No noticeable separation geotextile. Core delaminated 5 5/8" below pavement surface.

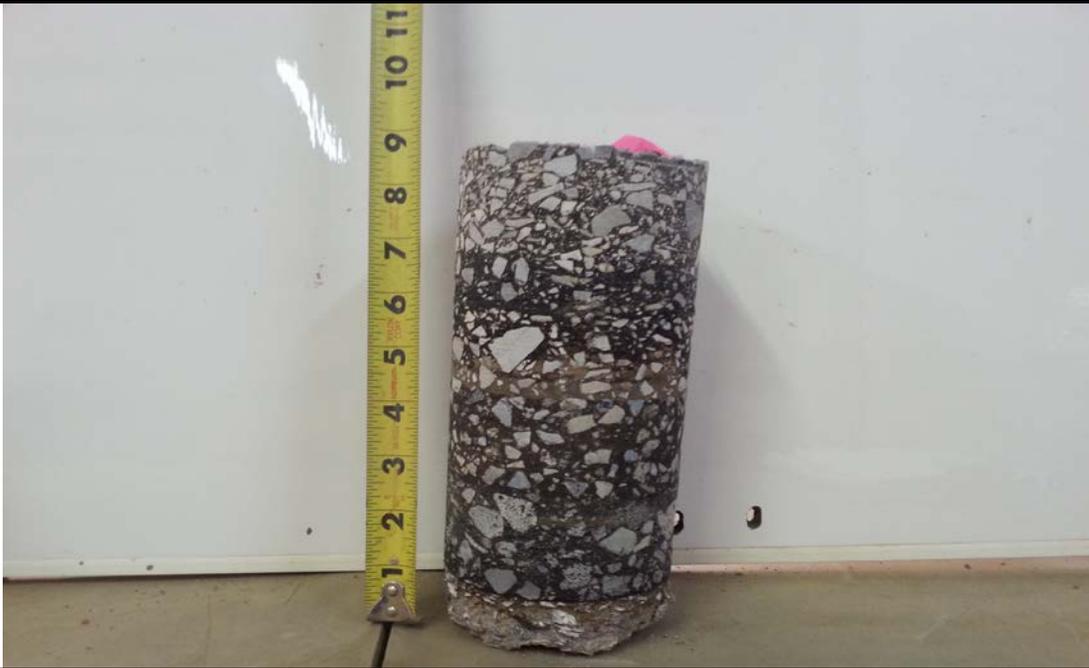
Pavement Core B-53.  
Approximately 4 layers of flexible pavement. Separation geotextile located at 2.625" below pavement surface. No observed cracking or delamination.

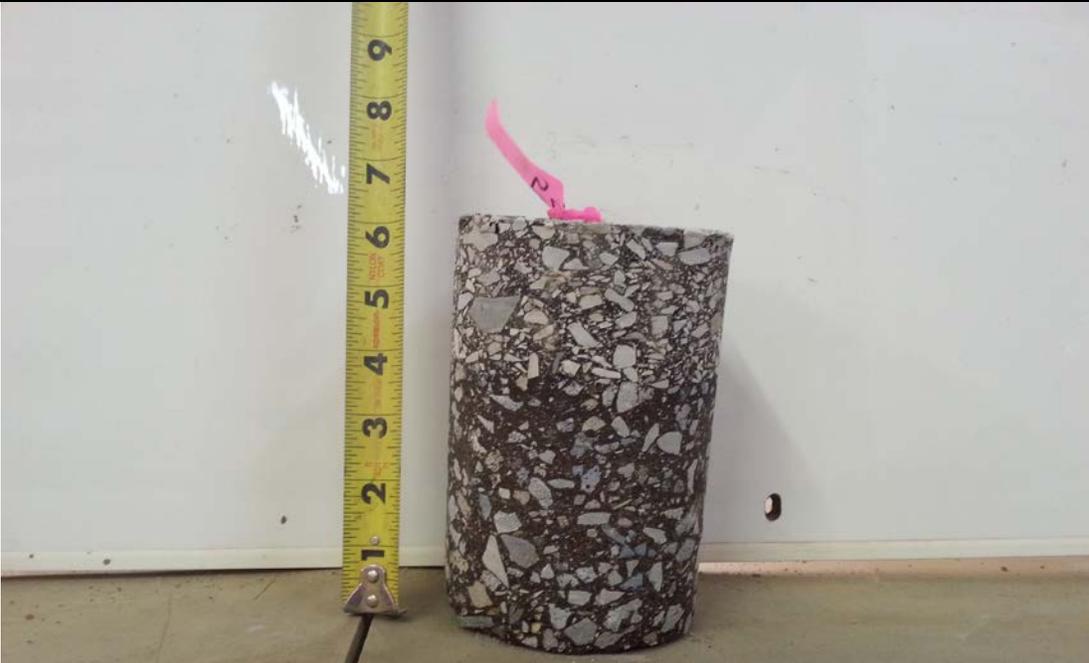
Pavement Core B-54.  
Approximately 3 layers of flexible pavement. No noticeable separation geotextile. No observed cracking or delamination.

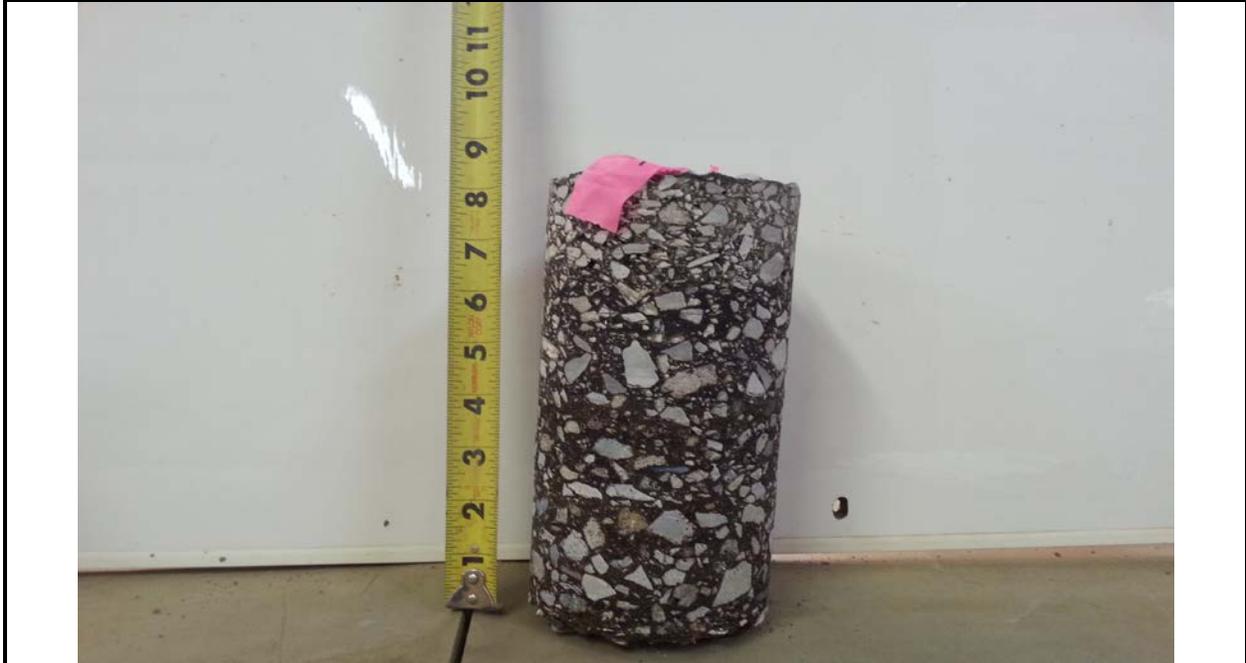
Pavement Core B-56.  
Approximately 4 layers of flexible pavement. No noticeable separation geotextile. No observed cracking or delamination.

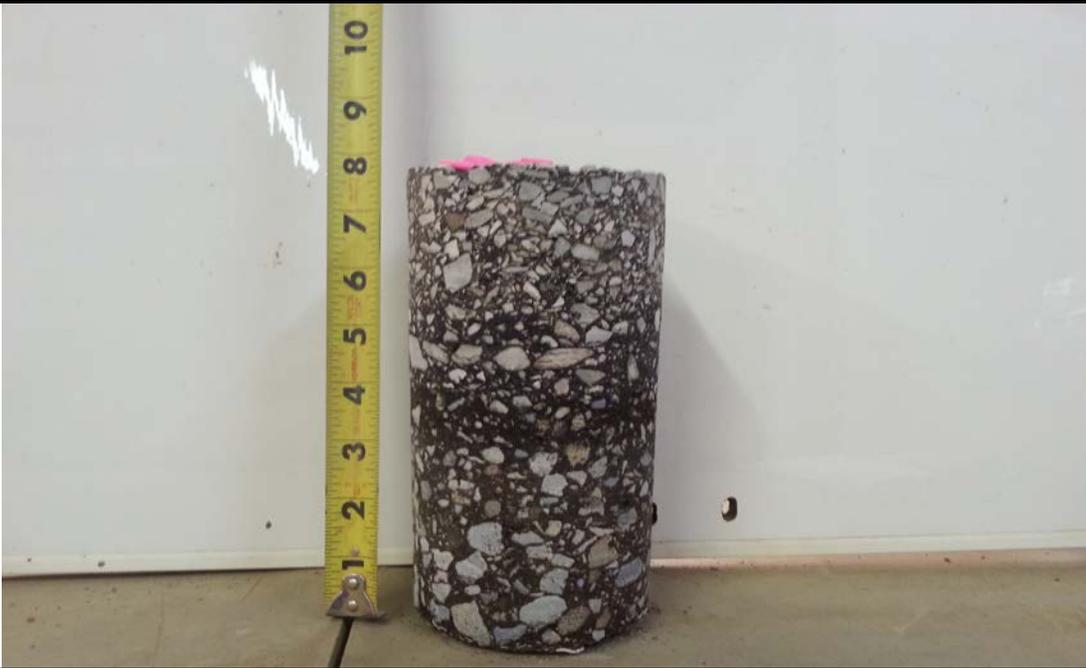
Pavement Core B-57.  
Approximately 4 layers of flexible pavement. No noticeable separation geotextile. No observed cracking or delamination.

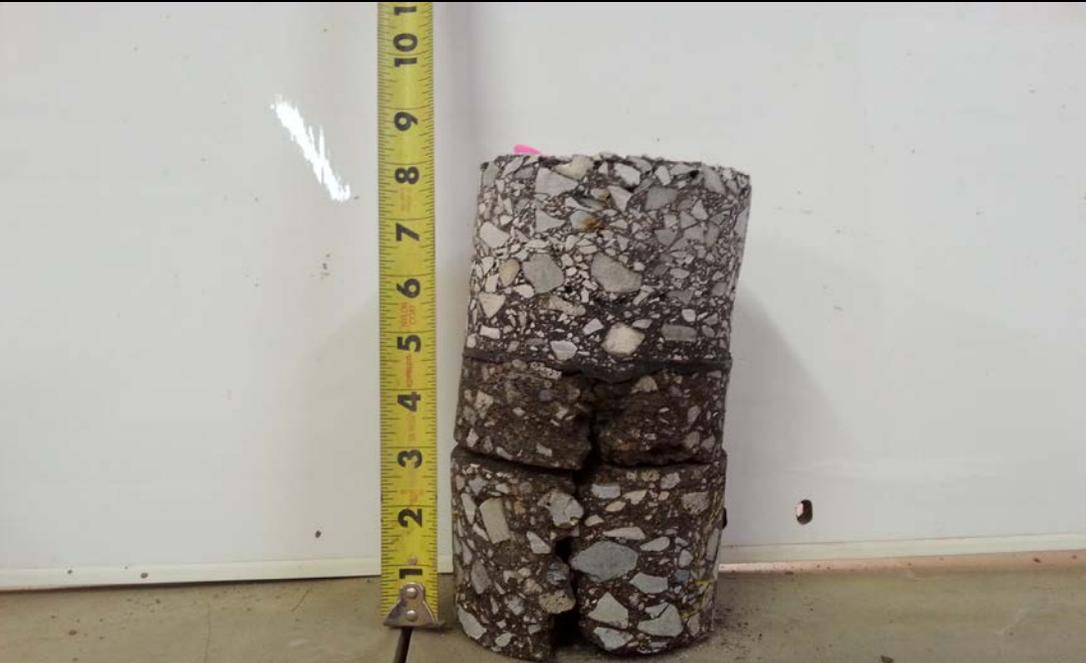
Pavement Core B-58.  
Approximately 4 layers of flexible pavement. No noticeable separation geotextile. No observed cracking or delamination.

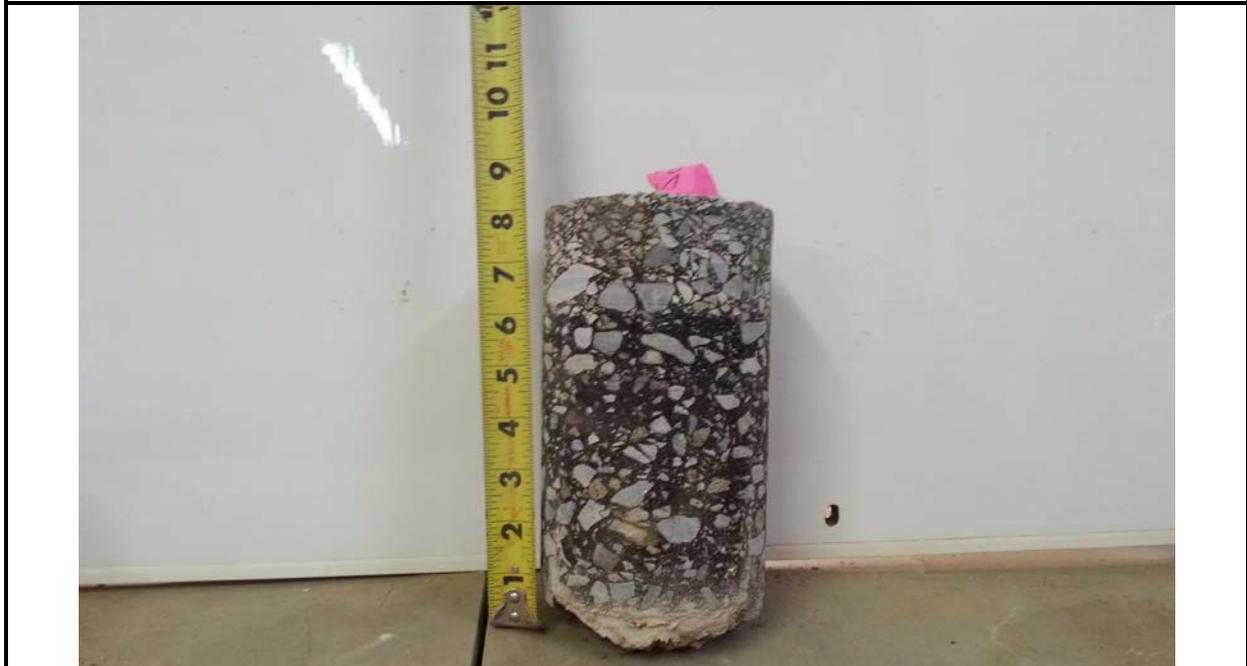
Pavement Core B-62.  
Approximately 4 layers of flexible pavement. No noticeable separation geotextile. No observed cracking or delamination.

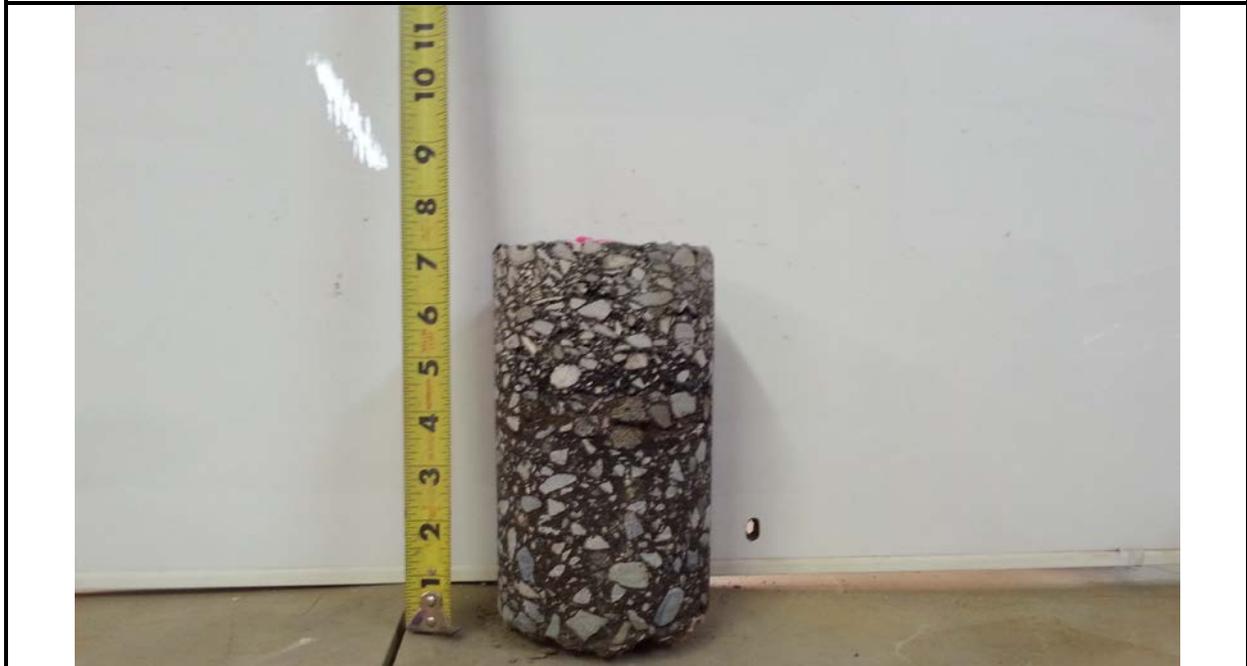
Pavement Core B-64.  
Approximately 4 layers of flexible pavement. No noticeable separation geotextile. Minor cracking located between 0.5" to 3.5" below pavement surface. Cracking was observed in multiple areas within this zone.

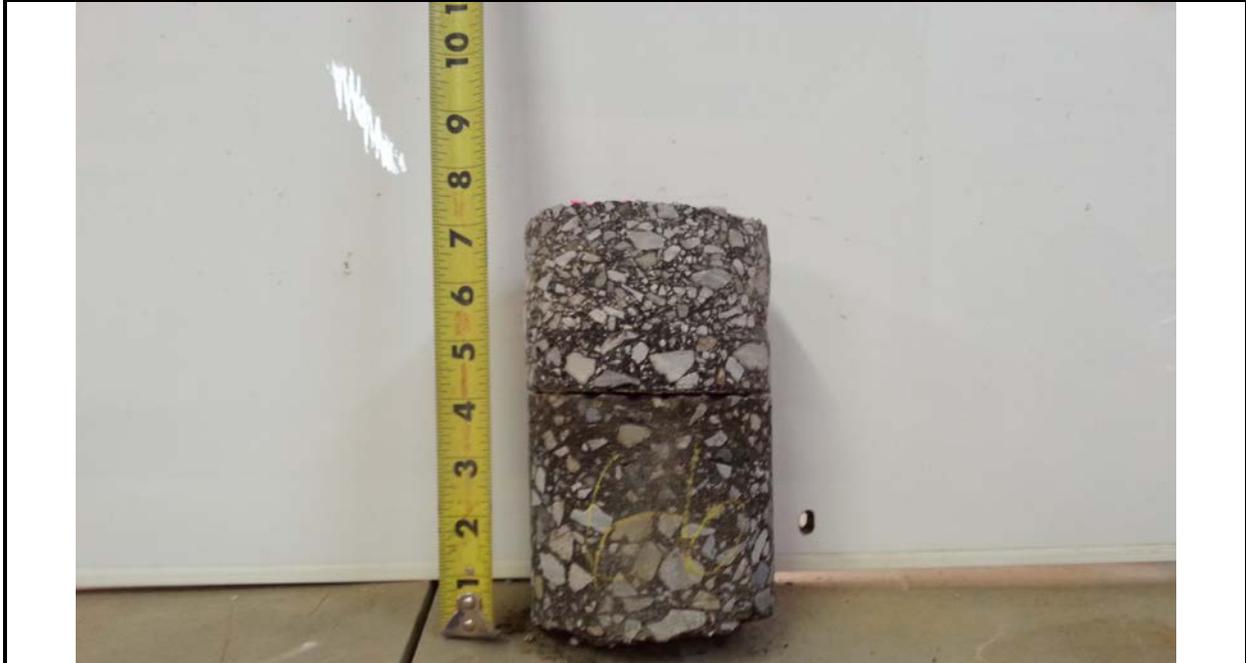
Pavement Core B-66.  
Approximately 4 layers of flexible pavement. No noticeable separation geotextile. Core delaminated 2.875" below pavement surface.

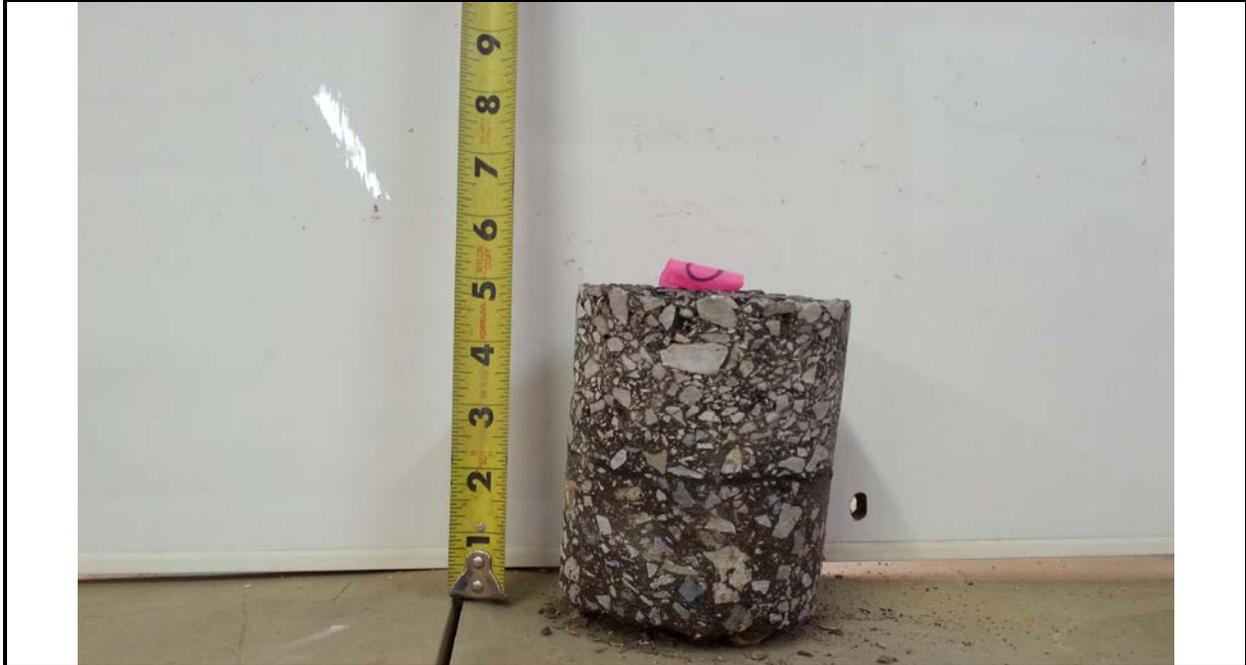
Pavement Core B-70.  
Approximately 4 layers of flexible pavement. Separation geotextile located 2.375" below pavement surface. No observed cracking or delamination.

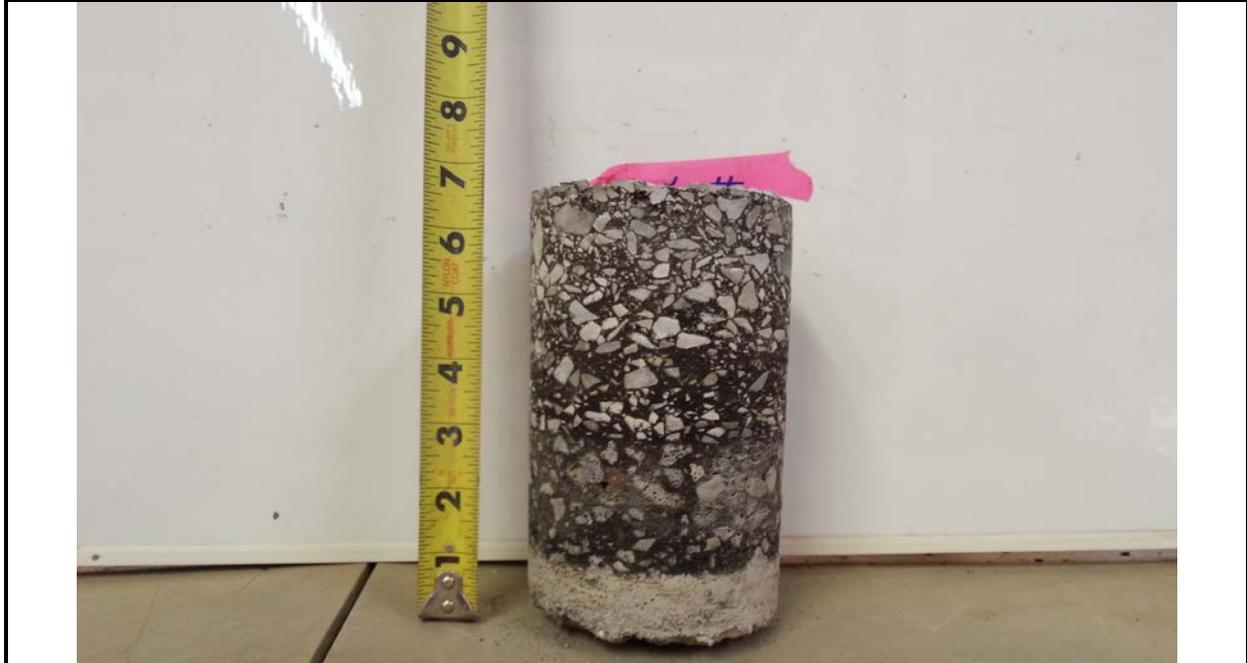
Pavement Core B-72.  
Approximately 4 layers of flexible pavement. No noticeable separation geotextile. No observed cracking or delamination.

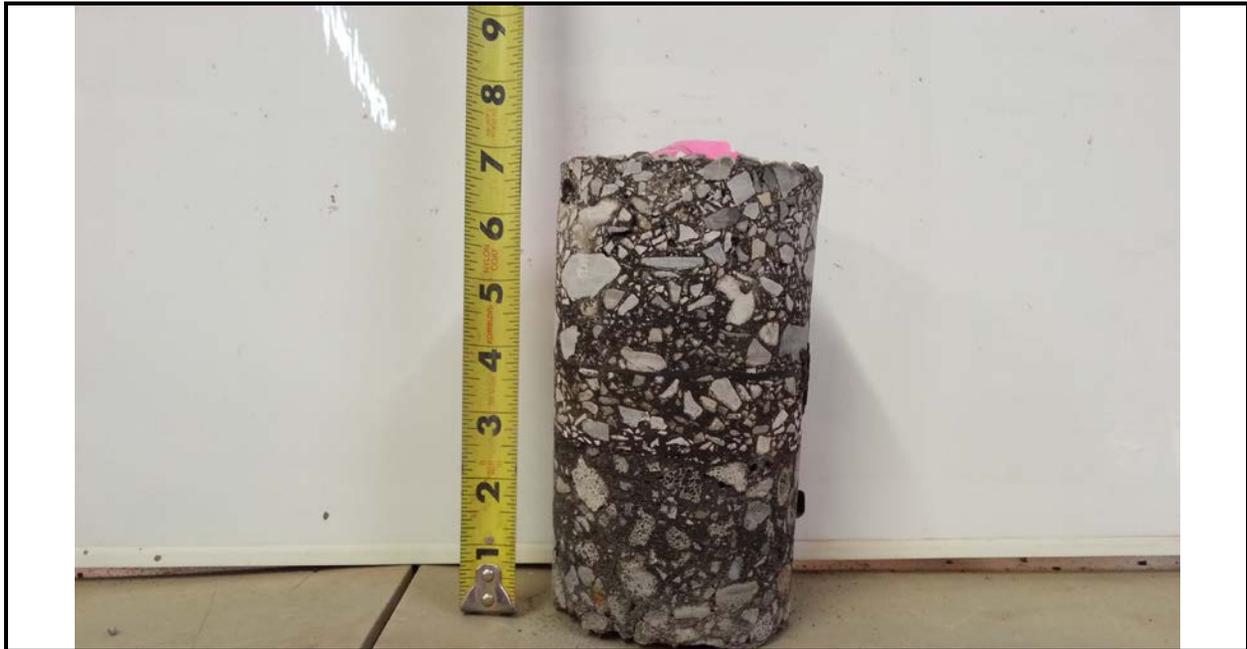
Pavement Core B-73.

Approximately 5 layers of flexible pavement. Separation geotextile located 2.75" below pavement surface. Cracking observed beginning 3.5" below pavement surface and extending down to the base of the pavement core (Bottom-up Cracking). Cracking observed in one location.

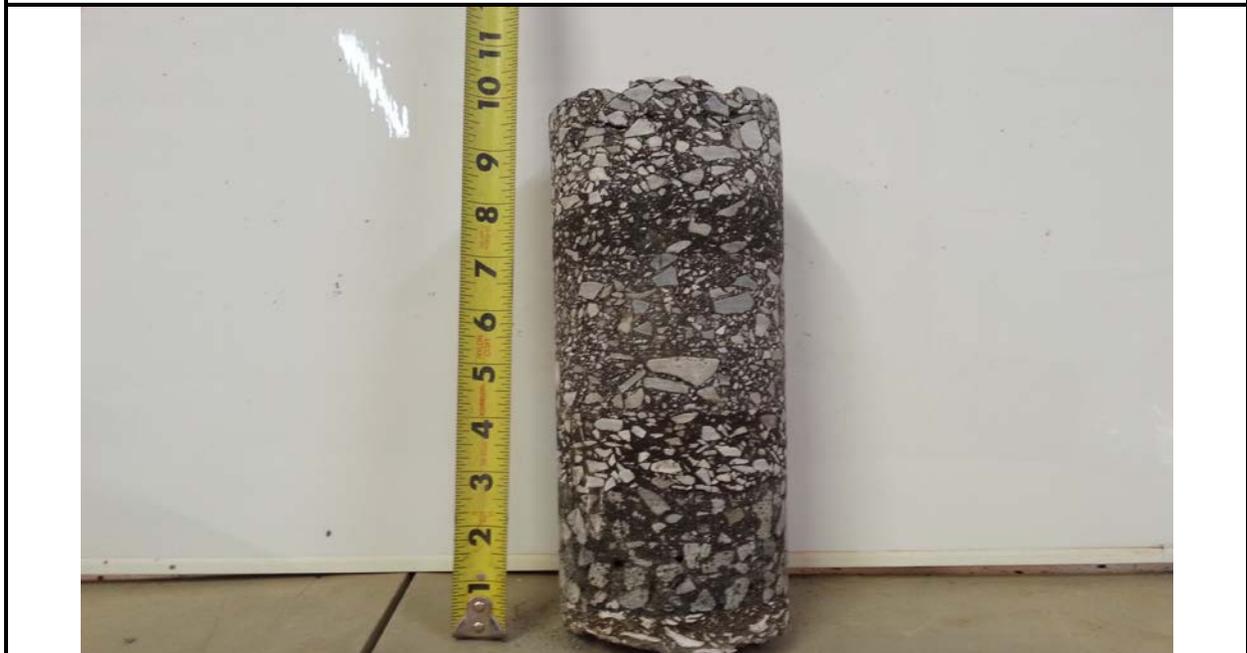
Pavement Core B-74.

Approximately 6 layers of flexible pavement. No noticeable separation geotextile. Cracking observed beginning 7" below pavement surface and extending down to the base of the pavement core (Bottom-up Cracking). Cracking observed in three locations.

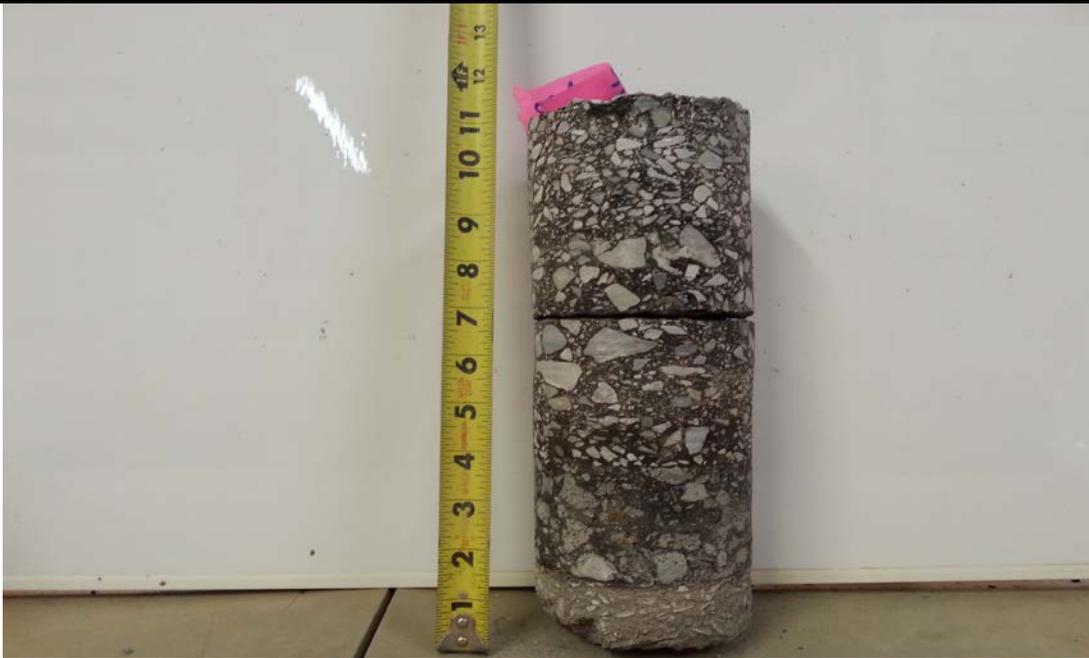
Pavement Core B-75.

Approximately 6 layers of flexible pavement. No noticeable separation geotextile. Cracking observed beginning 8" below pavement surface and extending down to base of the pavement core (Bottom-up Cracking). Cracking observed in two locations. Core delaminated 4.125" below pavement surface.

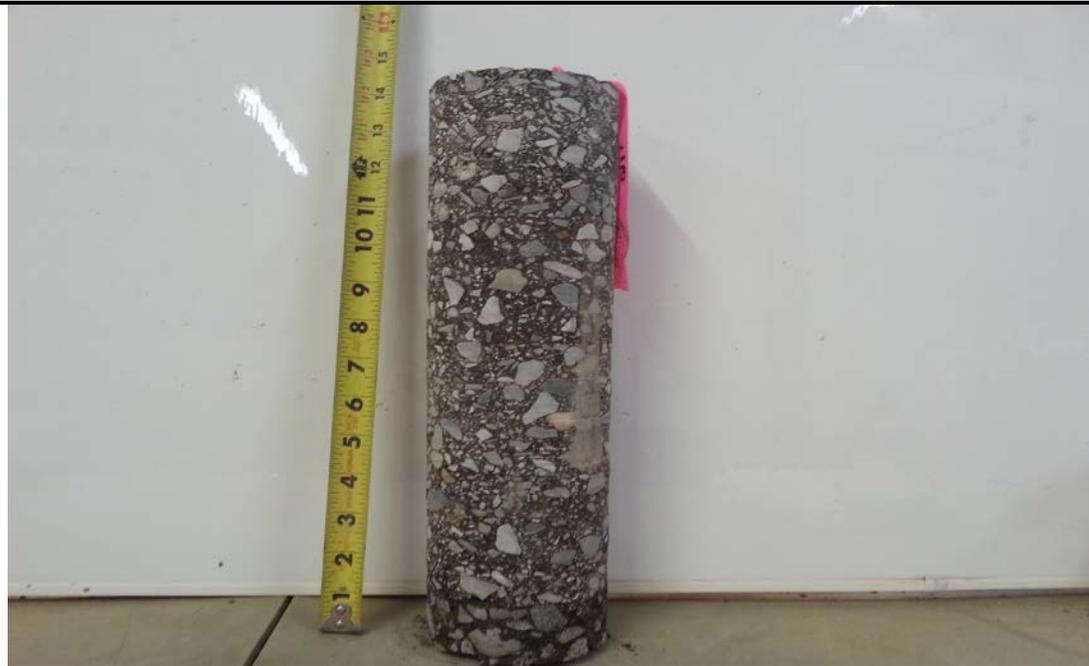
Pavement Core B-76.

Approximate number of pavement layers unavailable. No noticeable separation geotextile. No observed cracking or delamination. Bottom portion of core was not recovered.

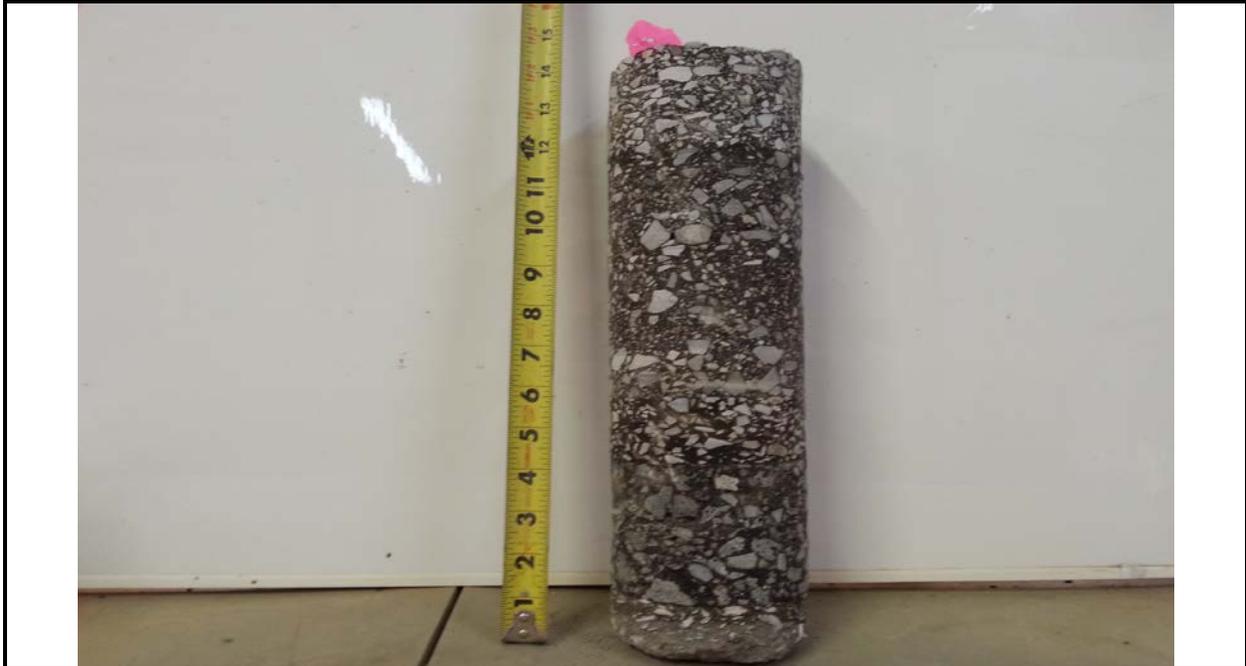
Pavement Core B-77.  
Approximately 8 layers of flexible pavement. No noticeable separation geotextile. No observed cracking or delamination.

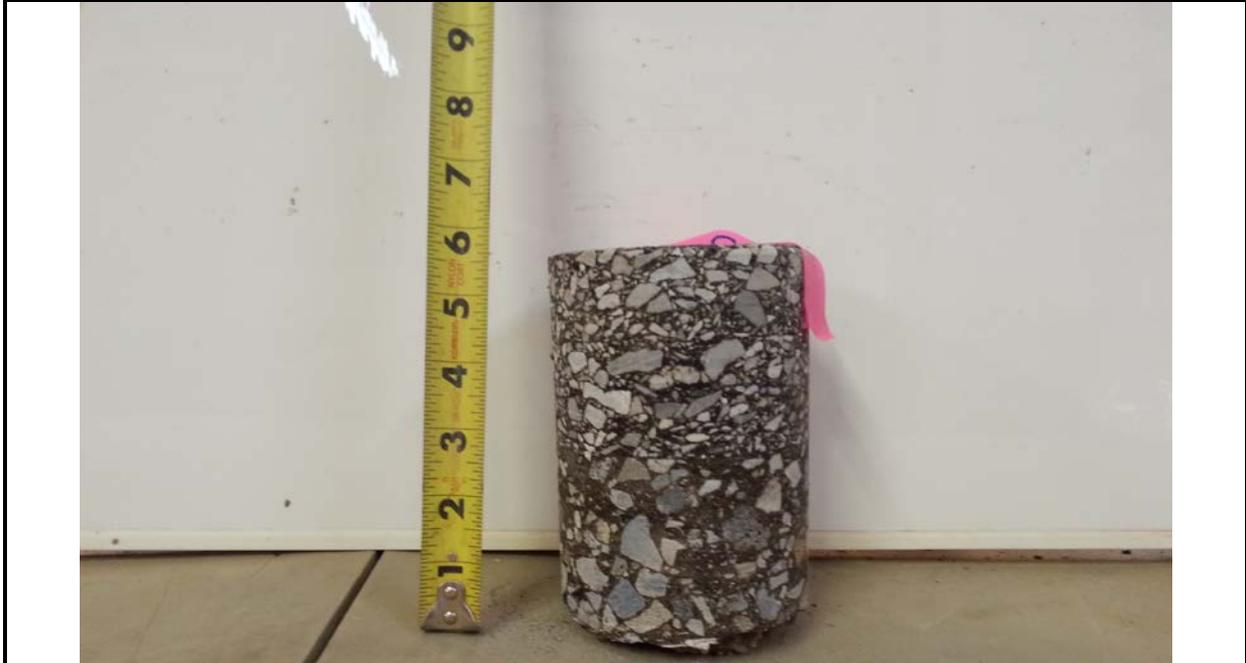
Pavement Core B-78.  
Approximately 3 layers of flexible pavement. No noticeable separation geotextile. No observed cracking or delamination.

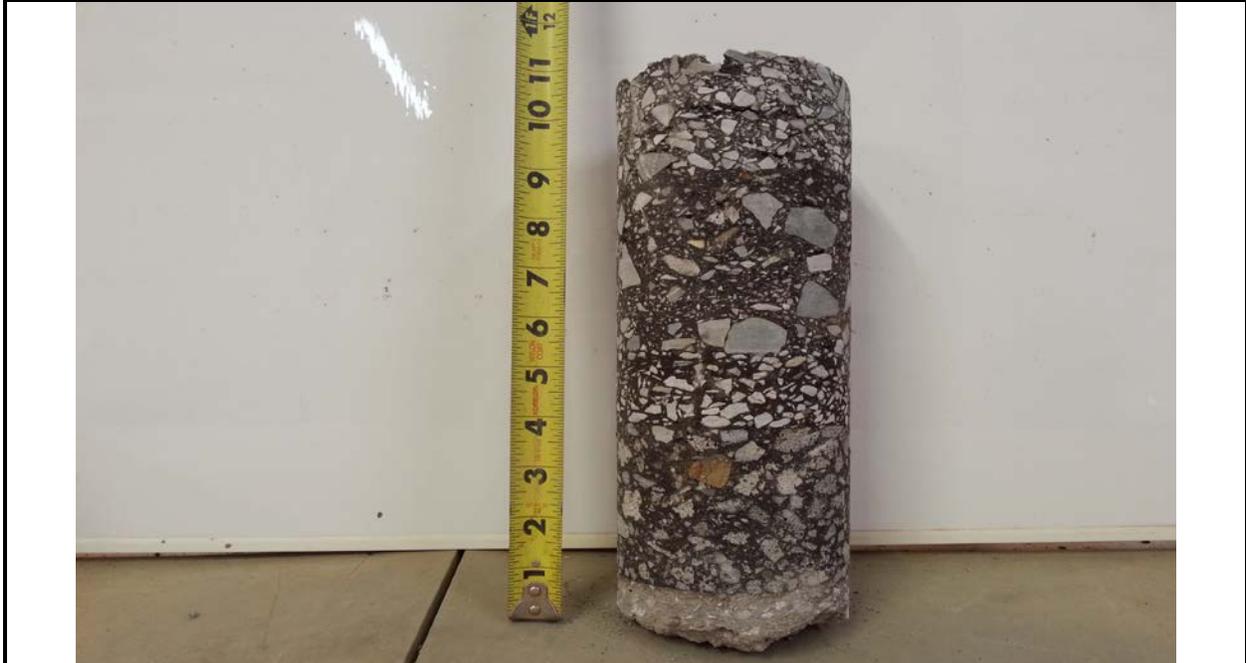
Pavement Core B-80.  
Approximately 6 layers of flexible pavement. No noticeable separation geotextile. Cracking observed beginning at the pavement surface and extending down to 1" below the pavement surface (Top-down Cracking). Cracking observed in one location.

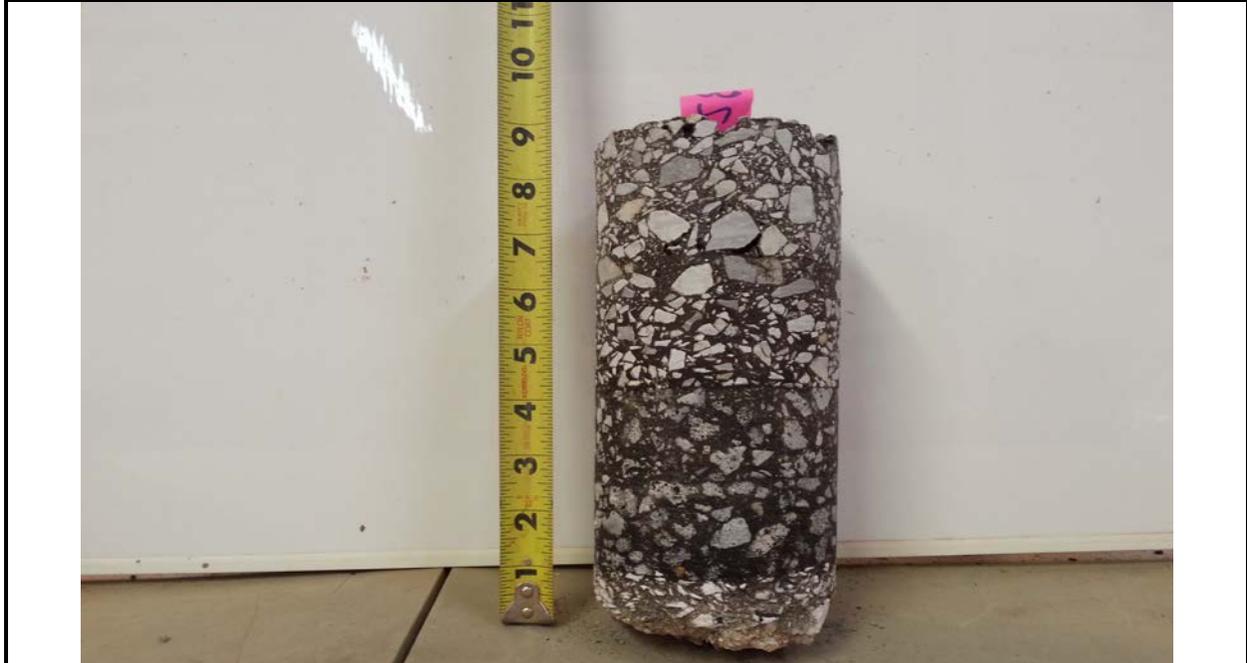
Pavement Core B-82.  
Approximately 5 layers of flexible pavement. No noticeable separation geotextile. No observed cracking or delamination.

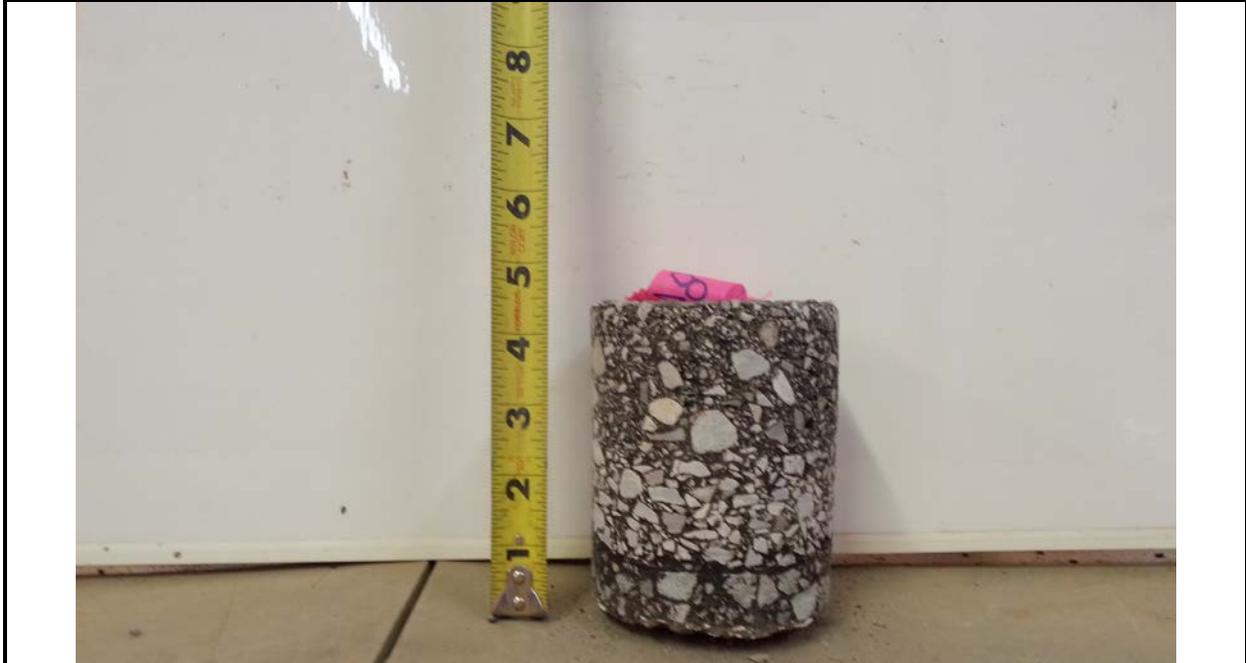
Pavement Core B-84.  
Approximately 3 layers of flexible pavement. Separation geotextile located 3.5" below the pavement surface. No observed cracking or delamination.

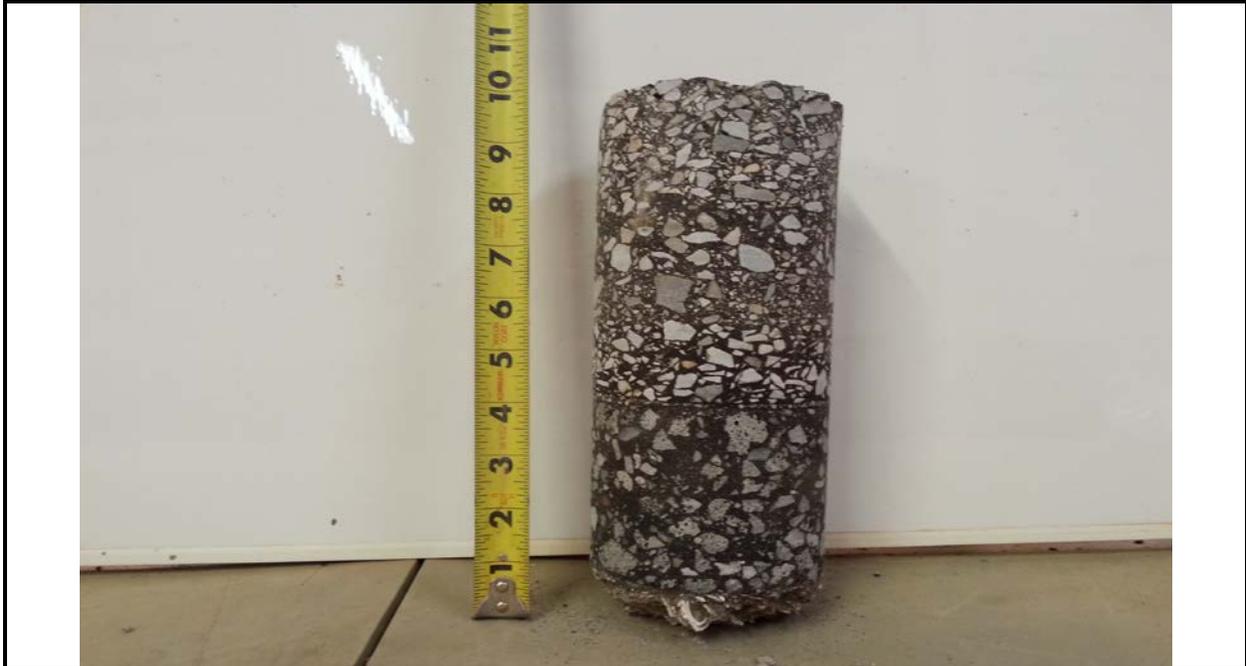
Pavement Core B-85.  
Approximately 6 layers of flexible pavement. No noticeable separation geotextile. No observed cracking or delamination.

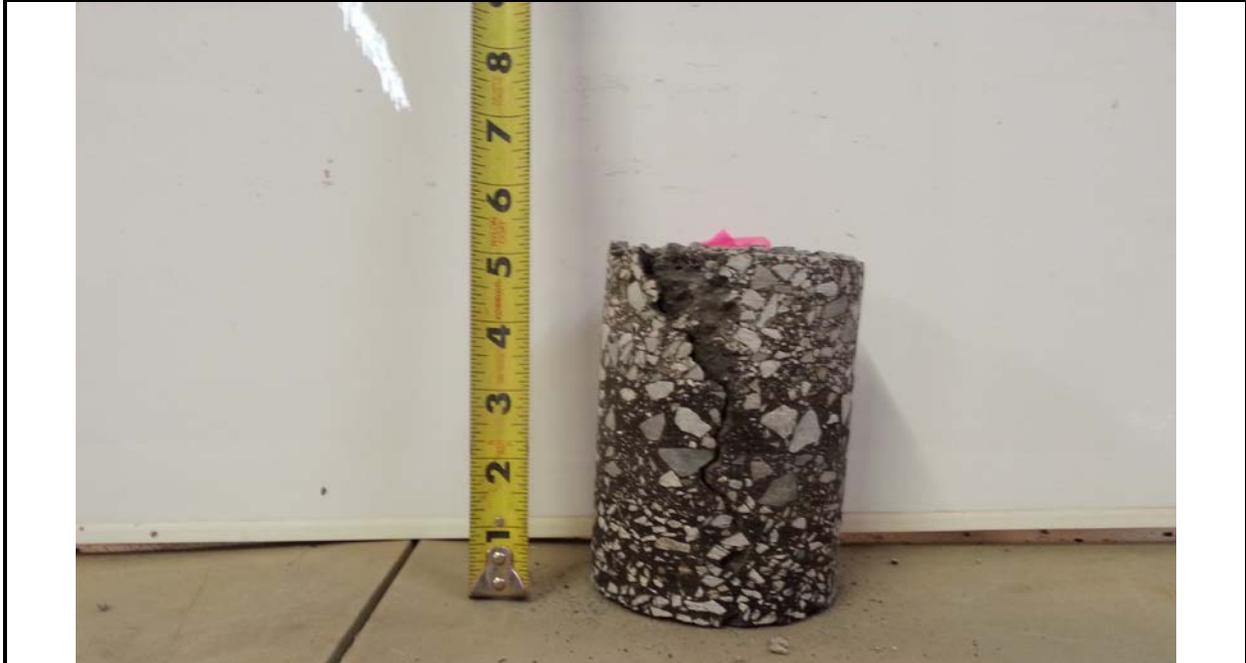
Pavement Core B-86.  
Approximately number of pavement layers unavailable. No noticeable separation geotextile.  
Full depth cracking. No recovery of core below 5.125" below pavement surface.

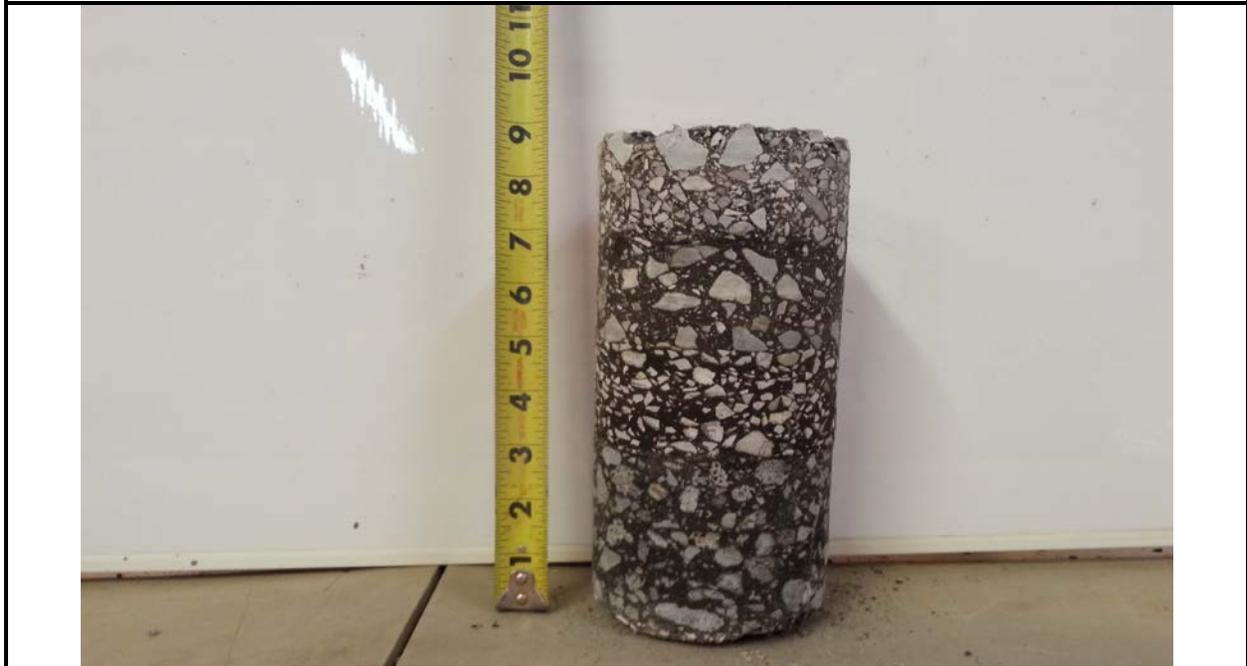
Pavement Core B-88.  
Approximately 5 layers of flexible pavement. No noticeable separation geotextile. No observed cracking or delamination.

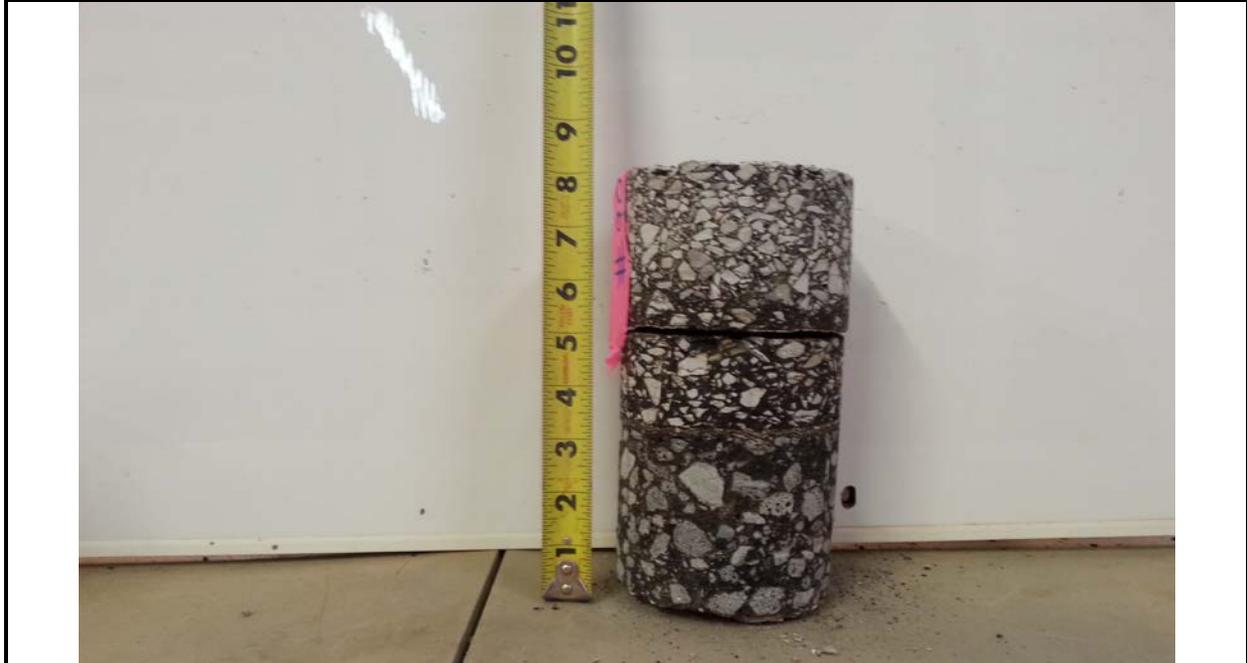
Pavement Core B-90.  
Approximately 5 layers of flexible pavement. No noticeable separation geotextile. Core delaminated 2.75" below pavement surface.

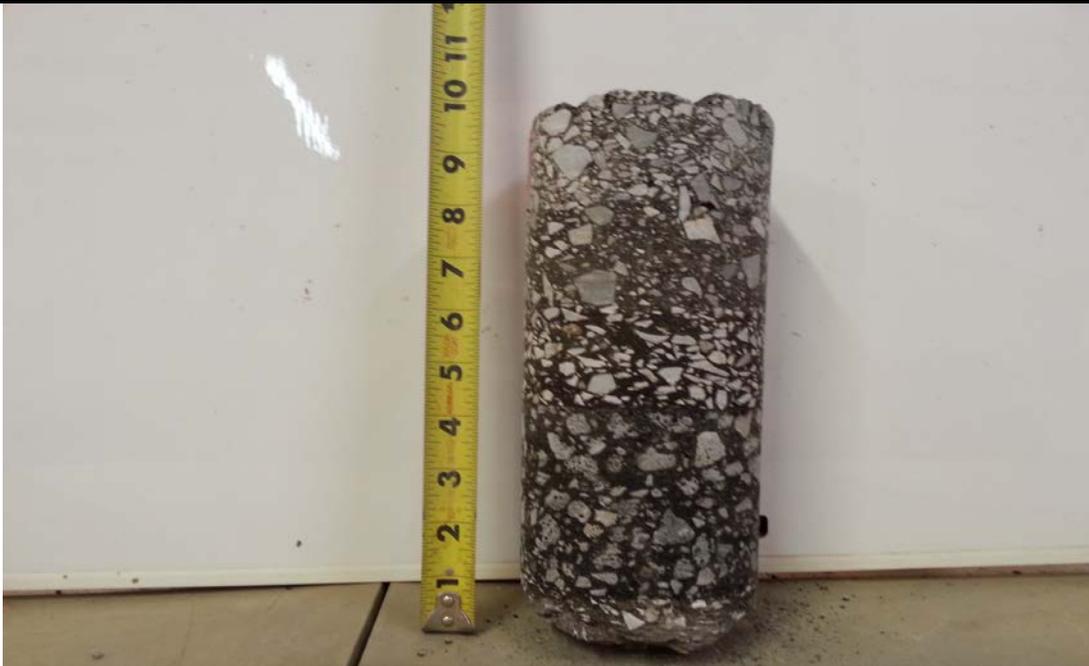
Pavement Core B-91.  
Approximately 5 layers of flexible pavement. No noticeable separation geotextile. No observed cracking or delamination.
