June 4, 2015  
**Revised June 5, 2015**

**Reference:** **Geotechnical Investigation – Pavement Cores**  
*REPAIR AIRFIELD/RUNWAY FORREST SHERMAN FIELD*  
 NAS Fort Pensacola, Florida  
 NAVFAC Project No.: ST 1112225  
 UES Project No.: 1730.1500048.0000  
 UES DOCS Report No.: 1235270

**REPAIR AIRFIELD/RUNWAY FORREST SHERMAN FIELD**

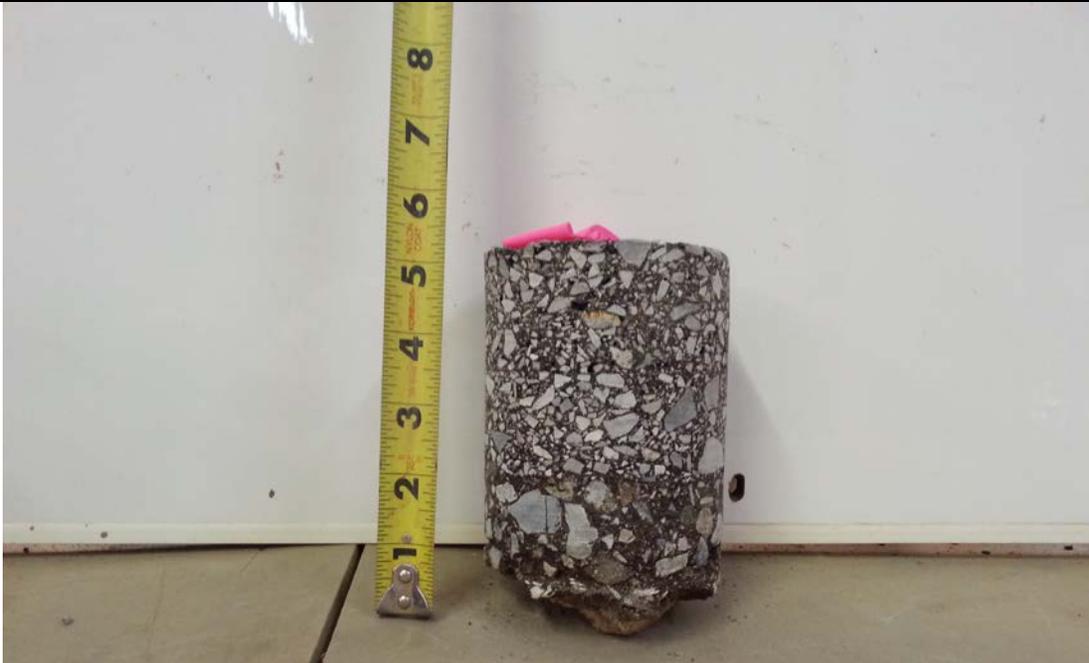
Pavement Core B-92.  
Approximately 5 layers of flexible pavement. No noticeable separation geotextile. Cracking observed beginning at 4.125" below pavement surface and extending down to the base of the pavement core (Bottom-up Cracking). Cracking observed in 2 locations.

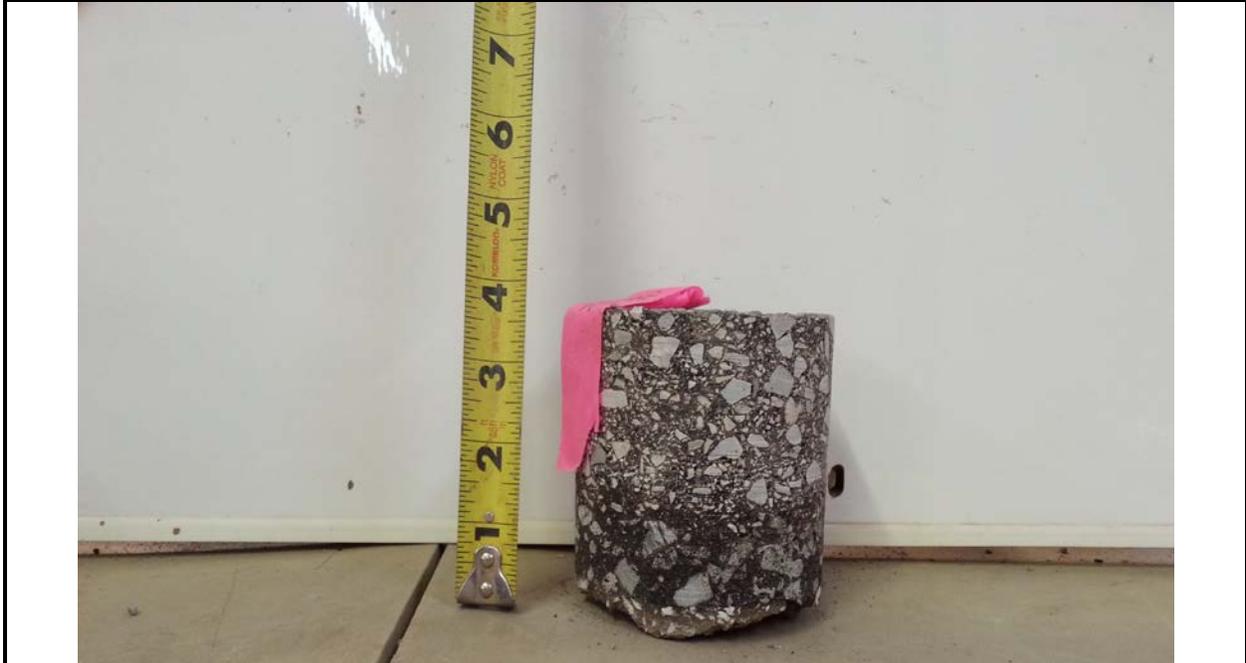
Pavement Core B-94.  
Approximately 3 layers of flexible pavement. No noticeable separation geotextile. No observed cracking or delamination.

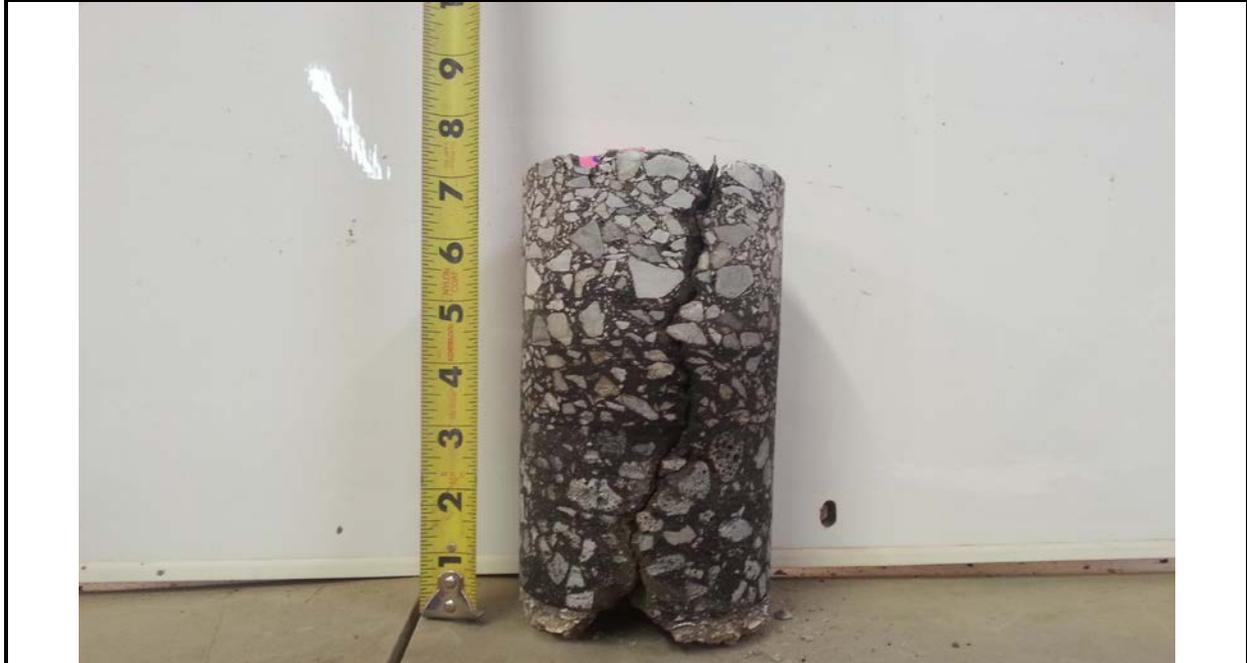
Pavement Core B-96.  
Approximately 5 layers of flexible pavement. No noticeable separation geotextile. Full depth cracking.

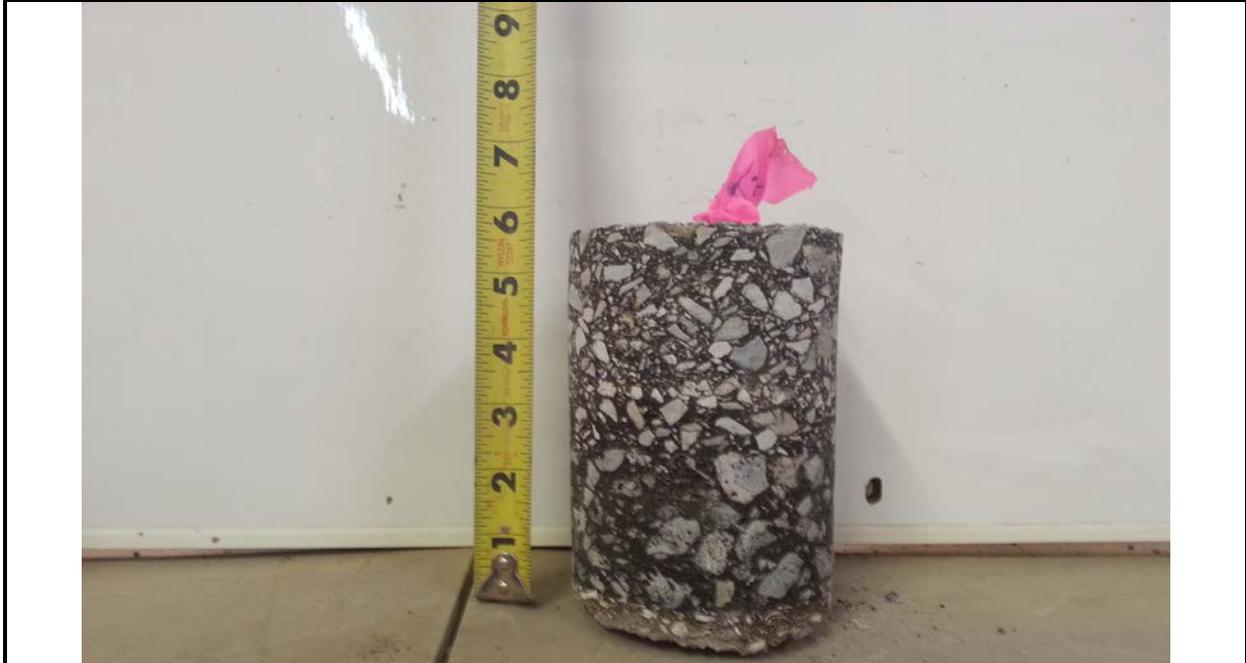
Pavement Core B-102.  
Approximately 3 layers of flexible pavement. No noticeable separation geotextile. No observed cracking or delamination.

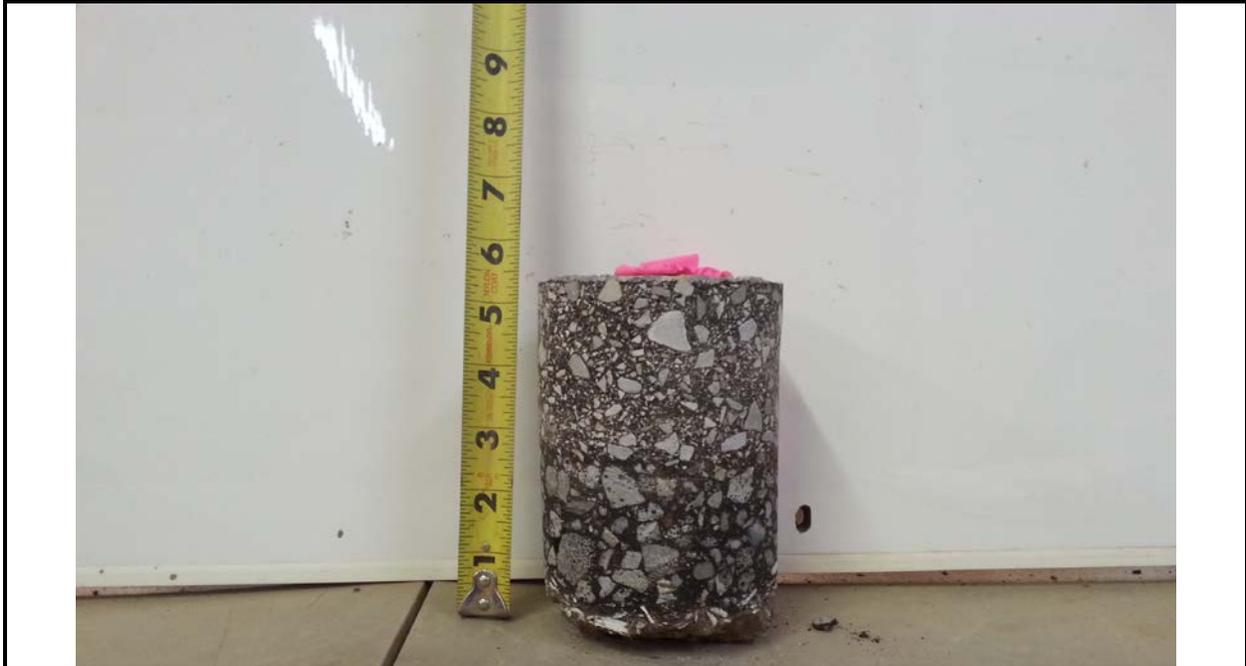
Pavement Core B-105.  
Approximately 3 layers of flexible pavement. No noticeable separation geotextile. No observed cracking or delamination.

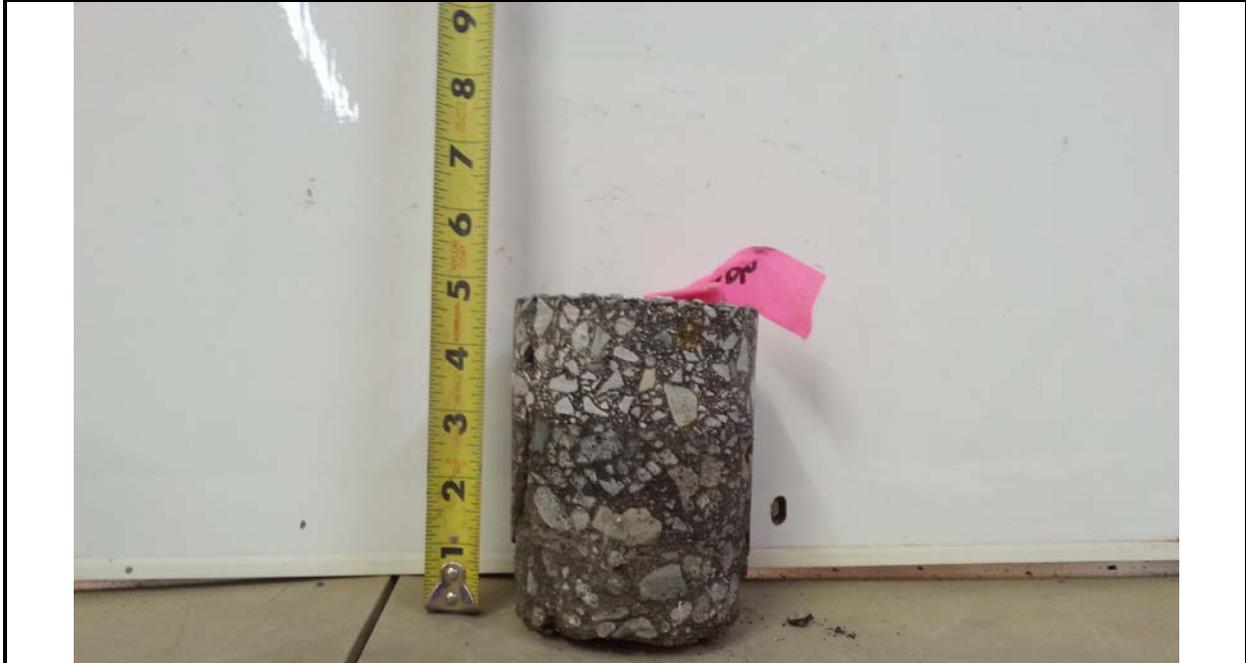
Pavement Core B-106.  
Approximately 3 layers of flexible pavement. No noticeable separation geotextile. No observed cracking or delamination.

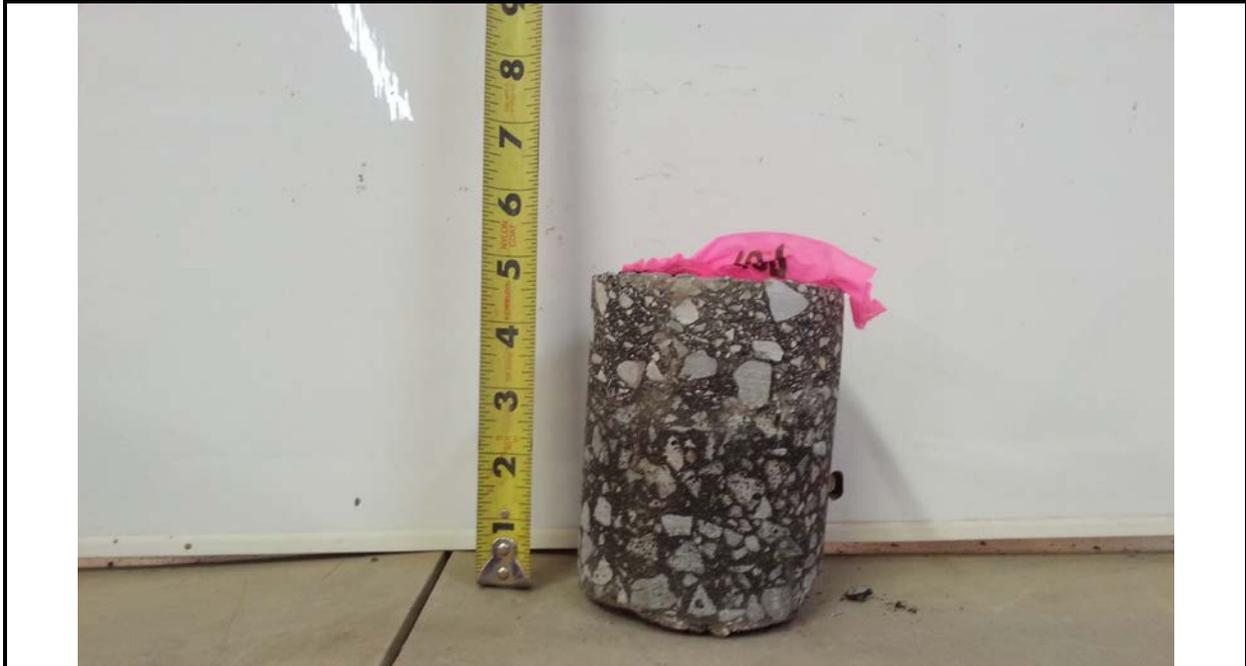
Pavement Core B-107.  
Approximately 3 layers of flexible pavement. No noticeable separation geotextile. No observed cracking or delamination.

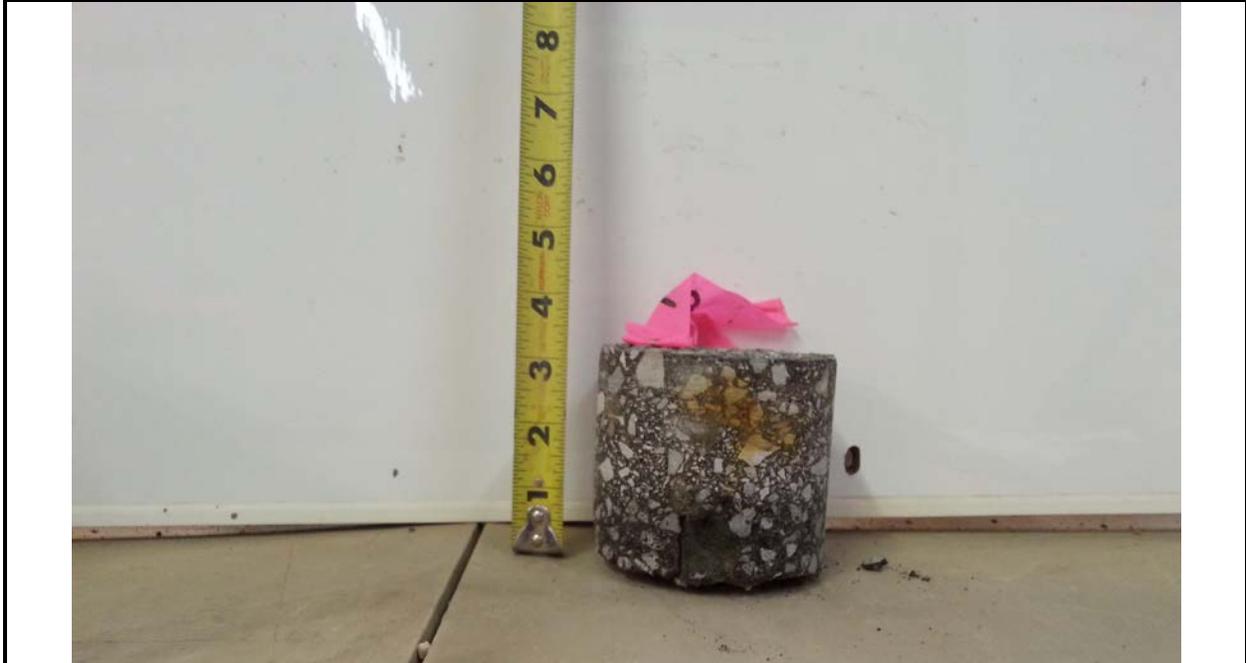
Pavement Core B-108.  
Approximately 2 layers of flexible pavement. No noticeable separation geotextile. Cracking observed beginning 2" below pavement surface, extending down to base of pavement core (Bottom-up Cracking). Cracking observed in three locations.

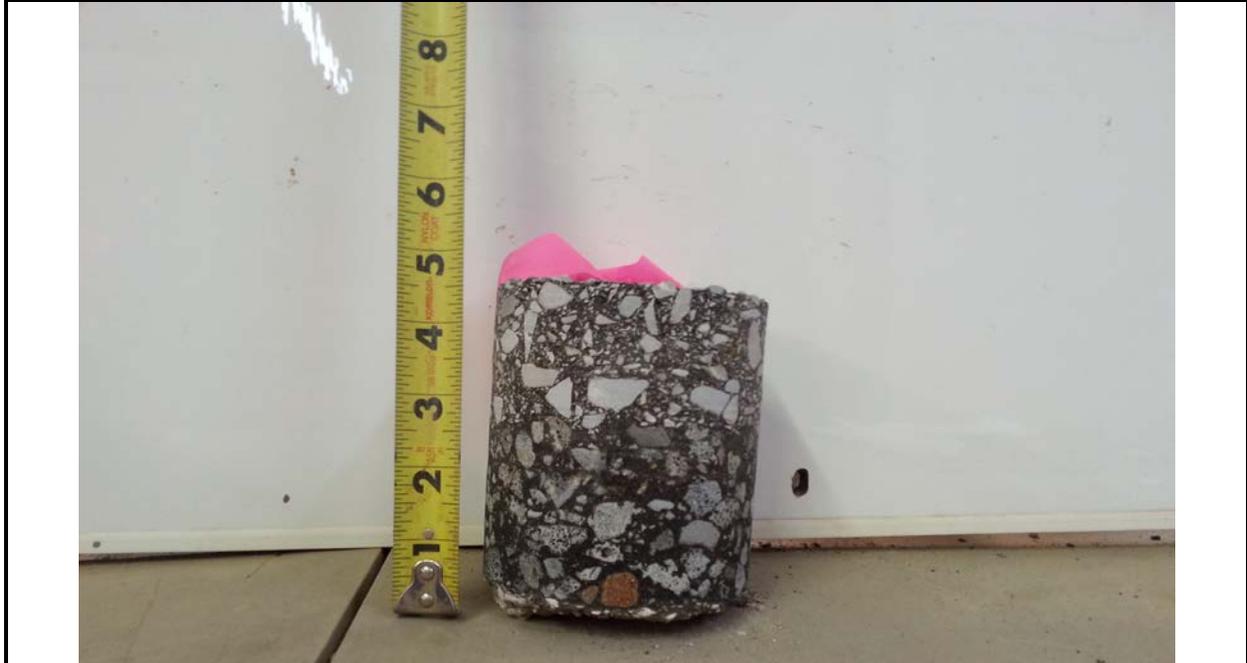
Pavement Core B-112.  
Approximately 3 layers of flexible pavement. No noticeable separation geotextile. No observed cracking or delamination.

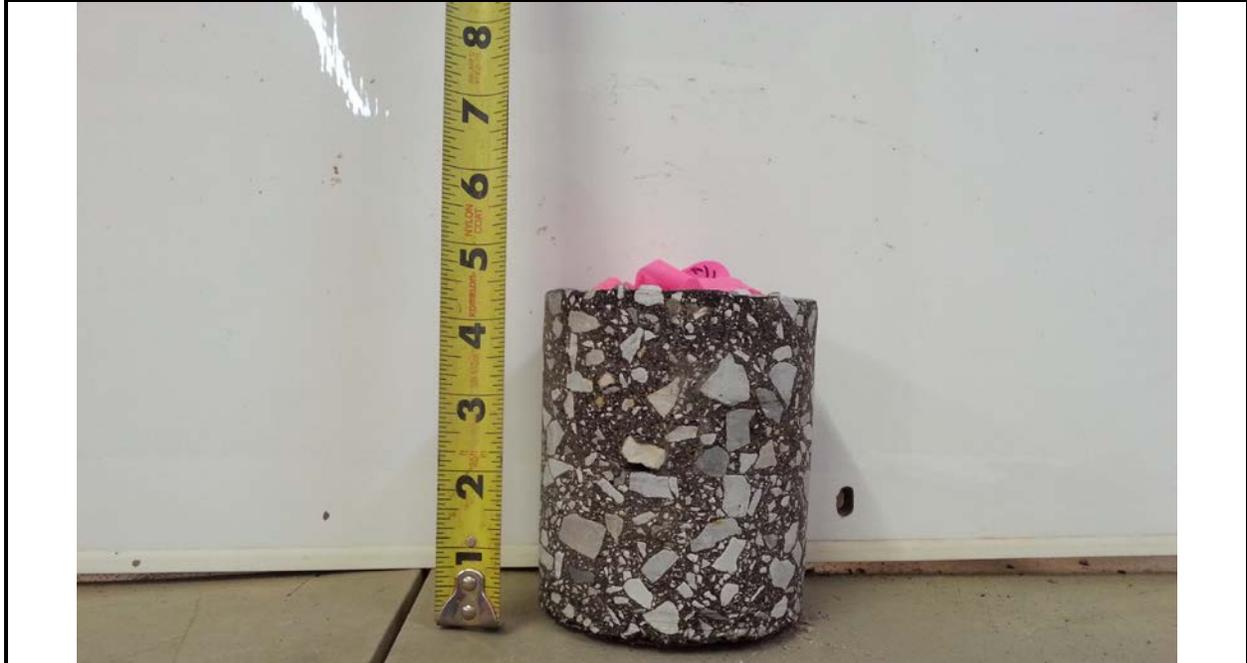
Pavement Core B-114.  
Approximately 2 layers of flexible pavement. No noticeable separation geotextile. No observed cracking or delamination.

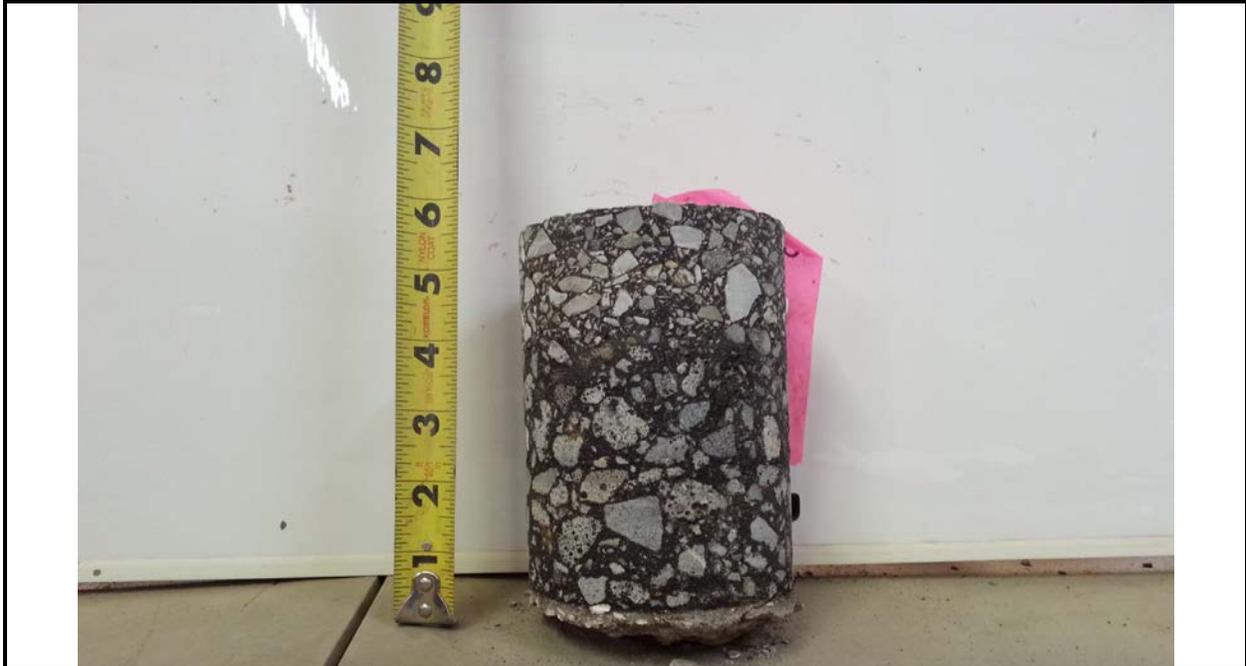
Pavement Core B-115.  
Approximately 2 layers of flexible pavement. No noticeable separation geotextile. No observed cracking or delamination.

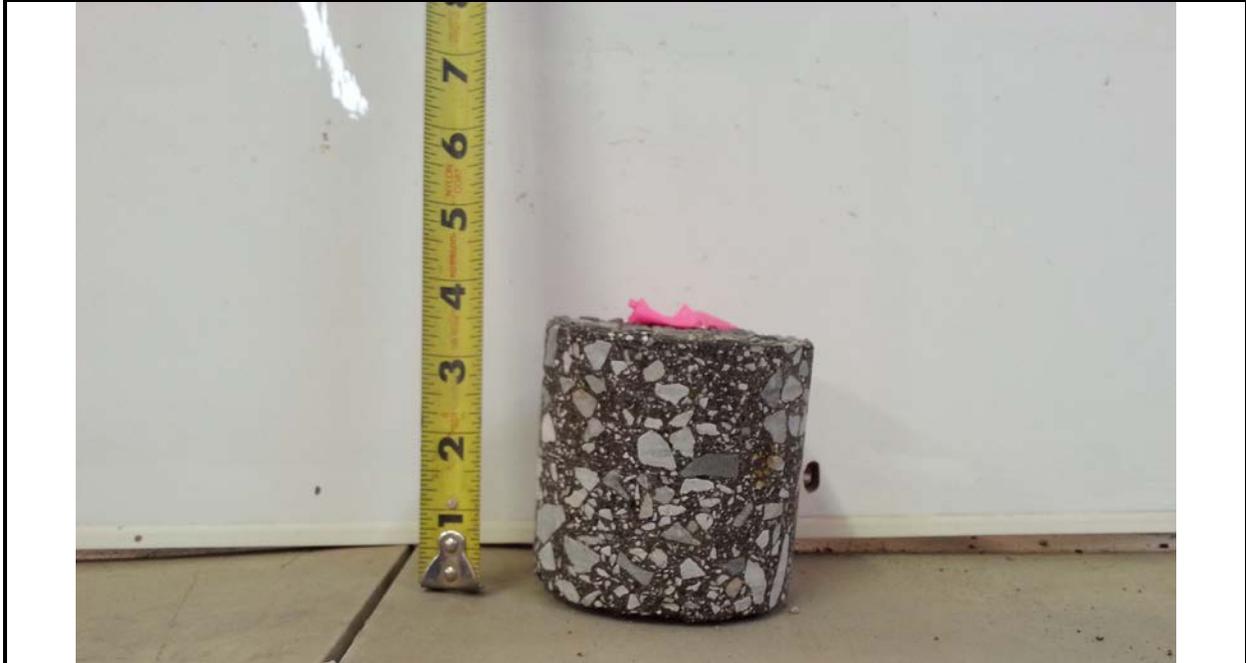
Pavement Core B-116.  
Approximately 2 layers of flexible pavement. No noticeable separation geotextile. No observed cracking or delamination.

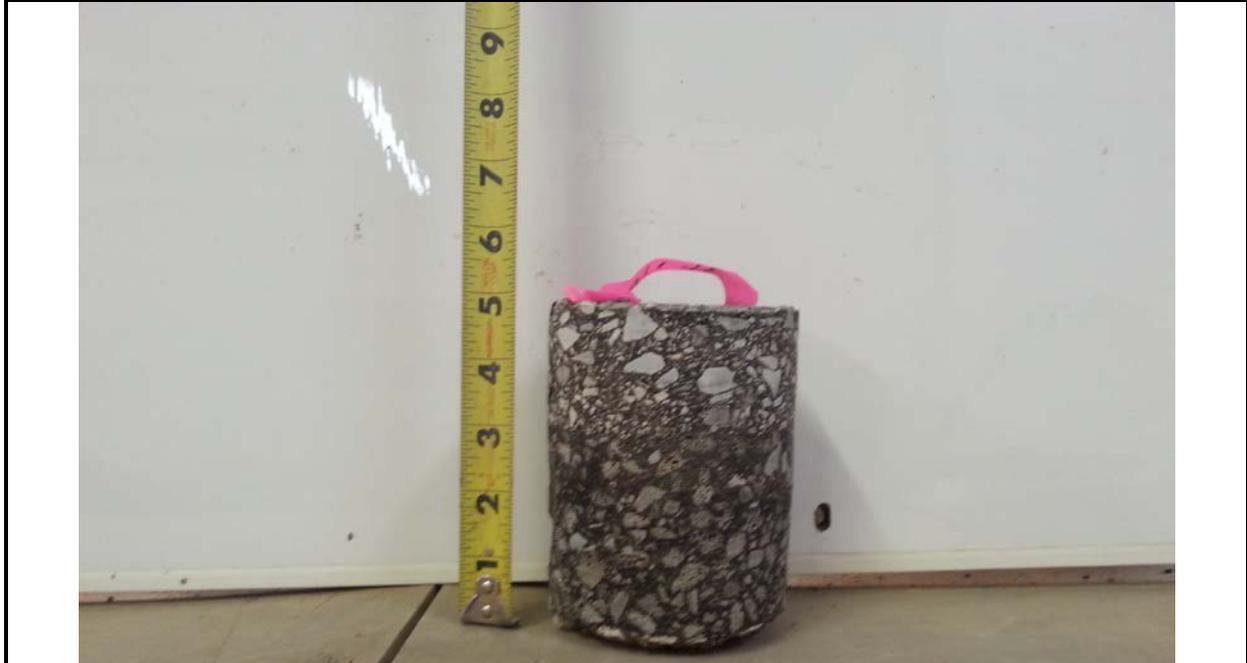
Pavement Core B-118.  
Approximately 3 layers of flexible pavement. No noticeable separation geotextile. No observed cracking or delamination.

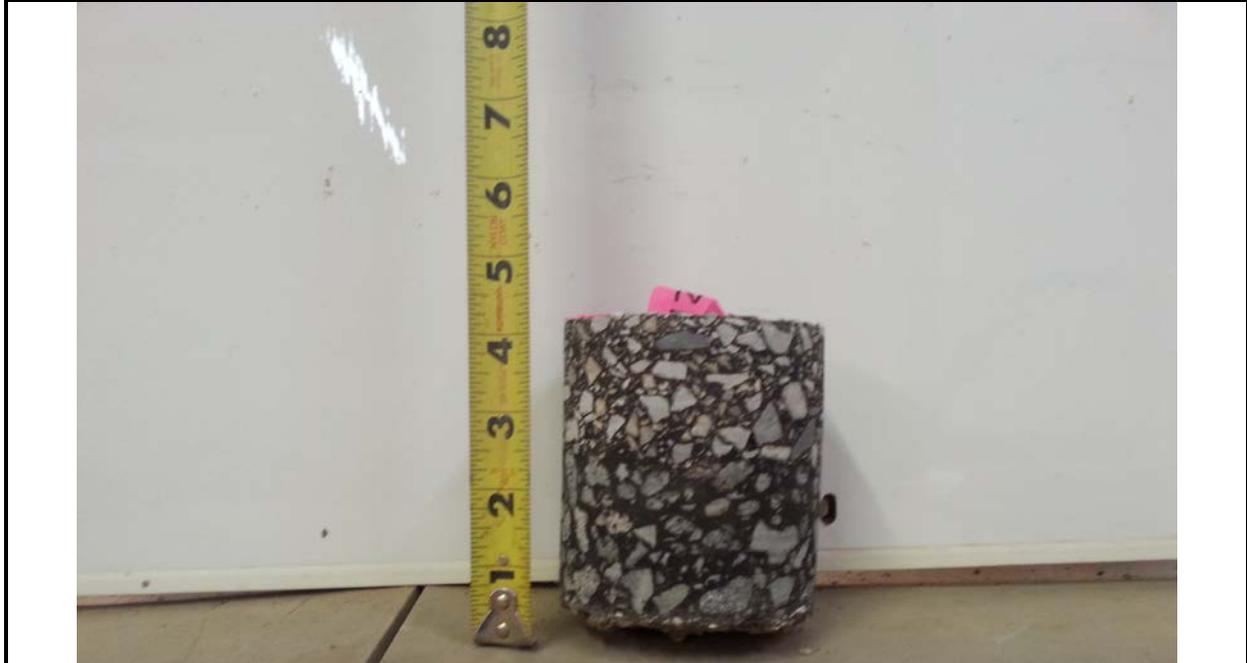
Pavement Core B-120.  
Approximately 3 layers of flexible pavement. No noticeable separation geotextile. No observed cracking or delamination.

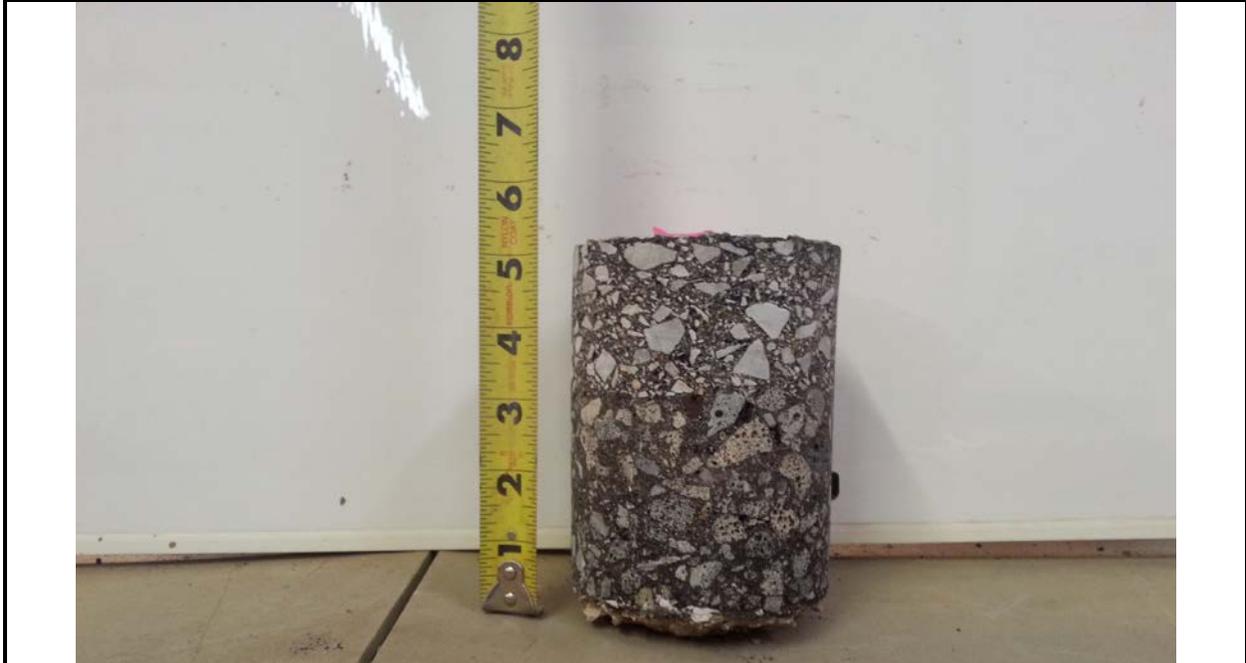
Pavement Core B-122.  
Approximately 3 layers of flexible pavement. No noticeable separation geotextile. No observed cracking or delamination.

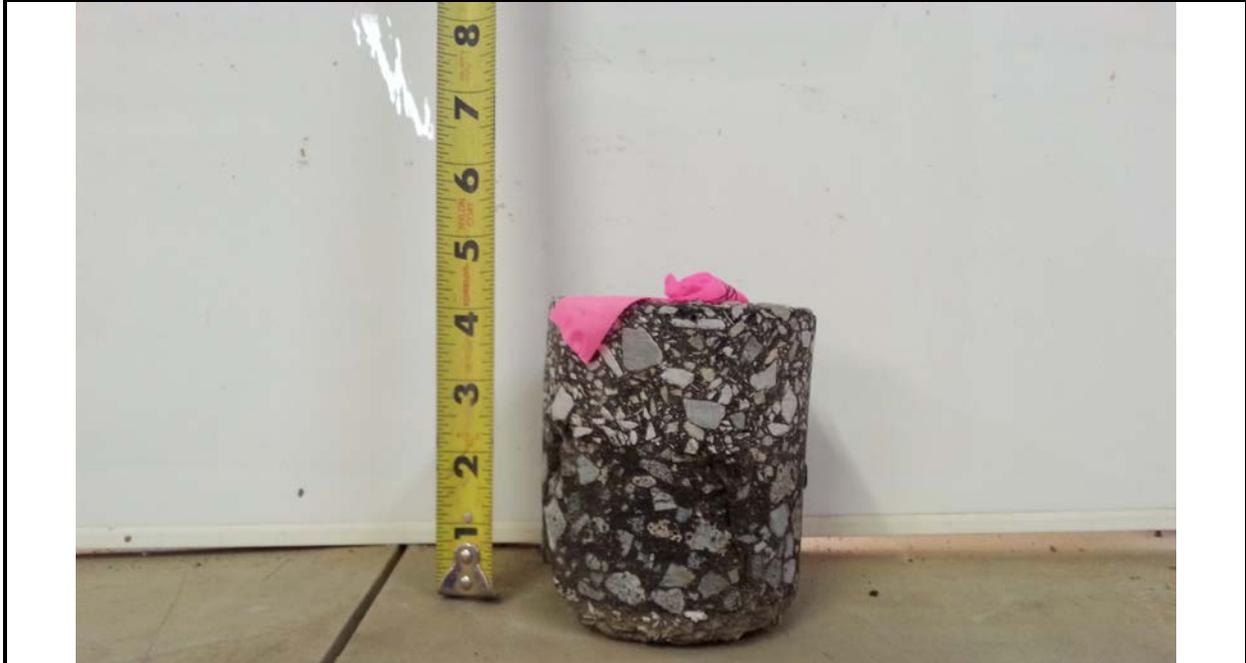
Pavement Core B-124.  
Approximately 4 layers of flexible pavement. No noticeable separation geotextile. No observed cracking or delamination.

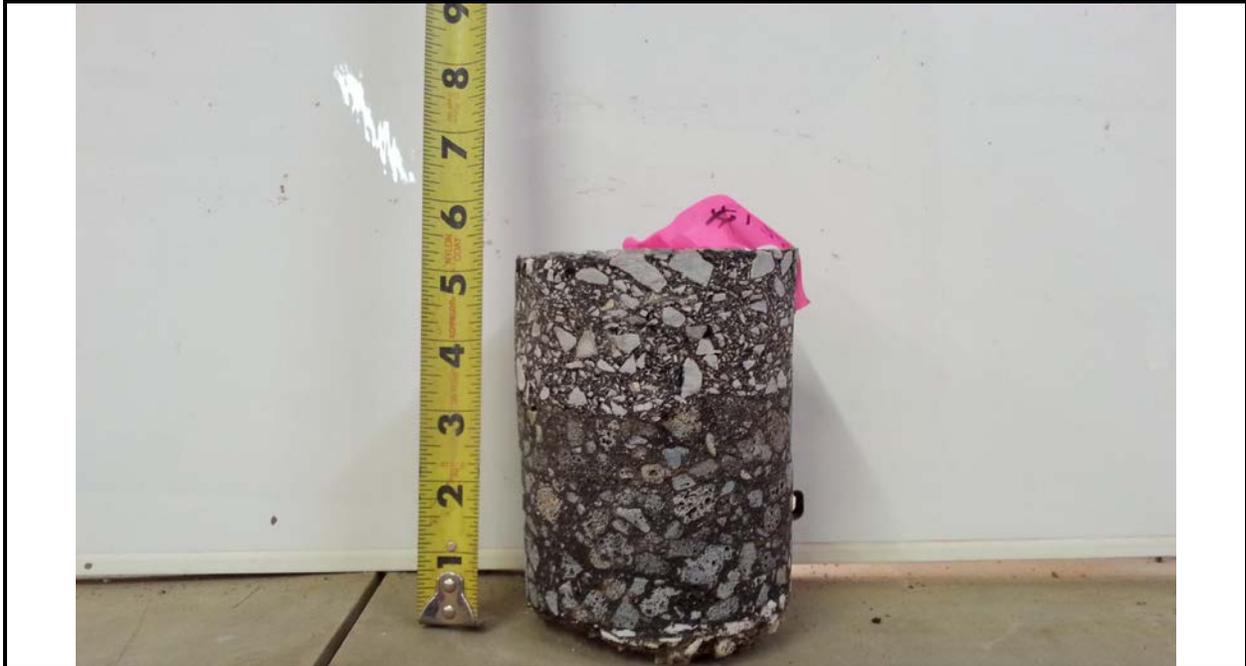
Pavement Core B-125.  
Approximately 4 layers of flexible pavement. No noticeable separation geotextile. No observed cracking or delamination.

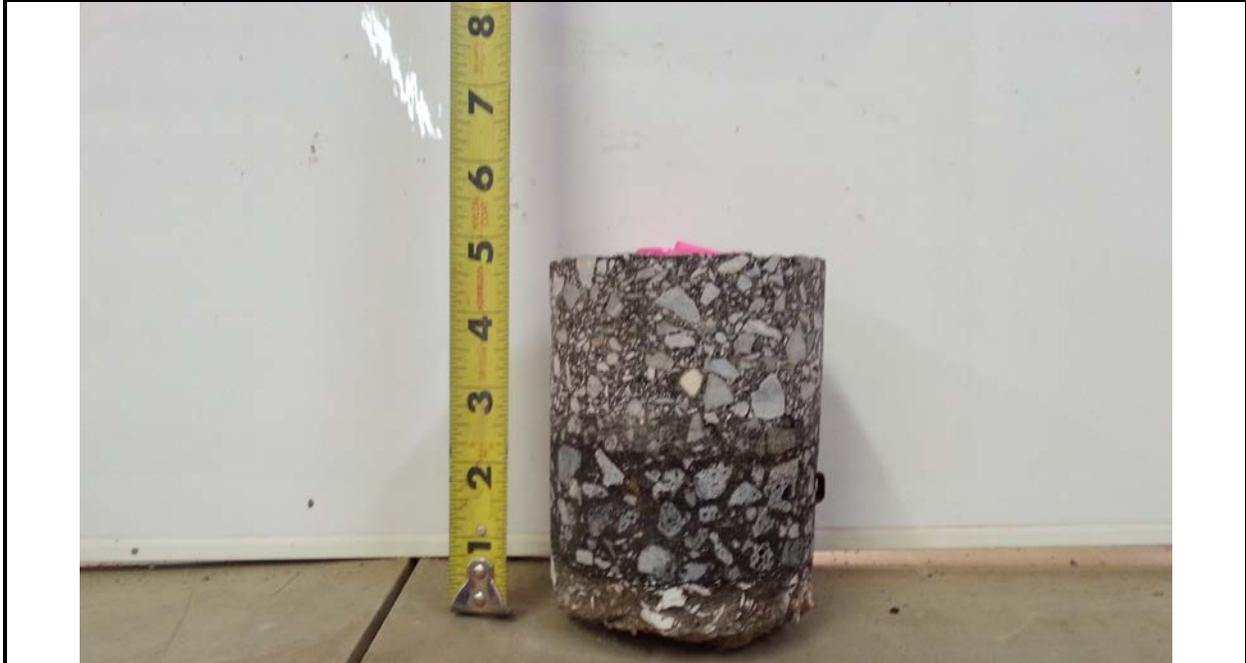
Pavement Core B-126.  
Approximately 4 layers of flexible pavement. No noticeable separation geotextile. No observed cracking or delamination.

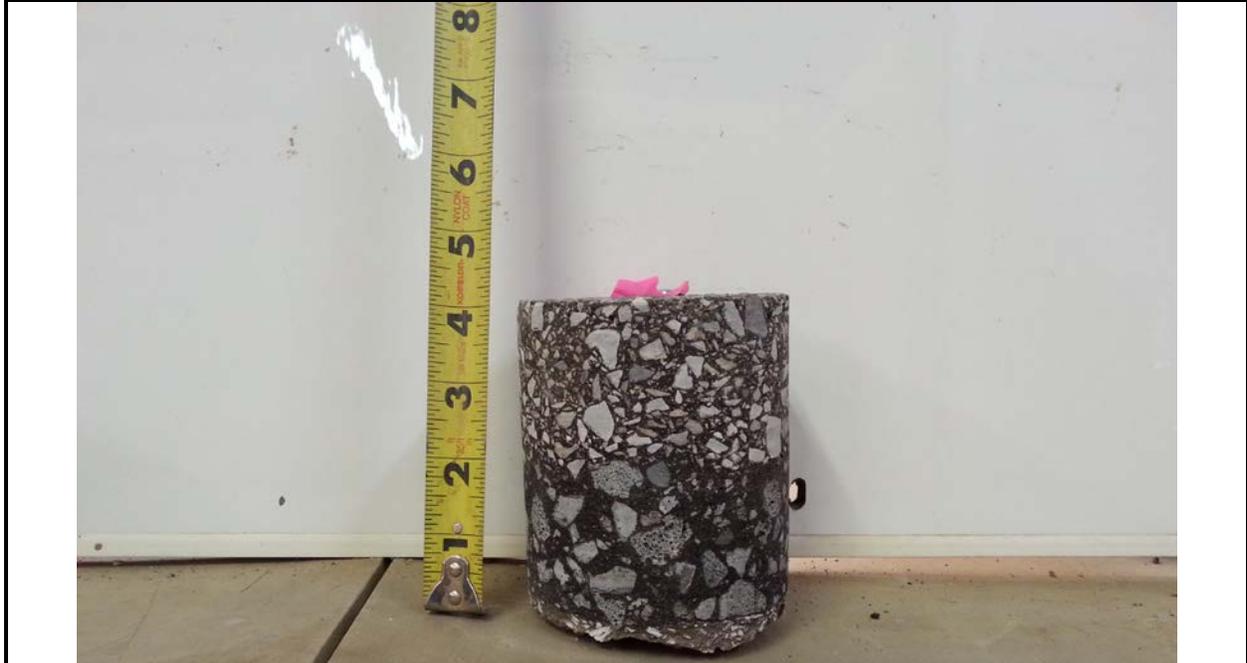
Pavement Core B-128.  
Approximately 4 layers of flexible pavement. No noticeable separation geotextile. No observed cracking or delamination.

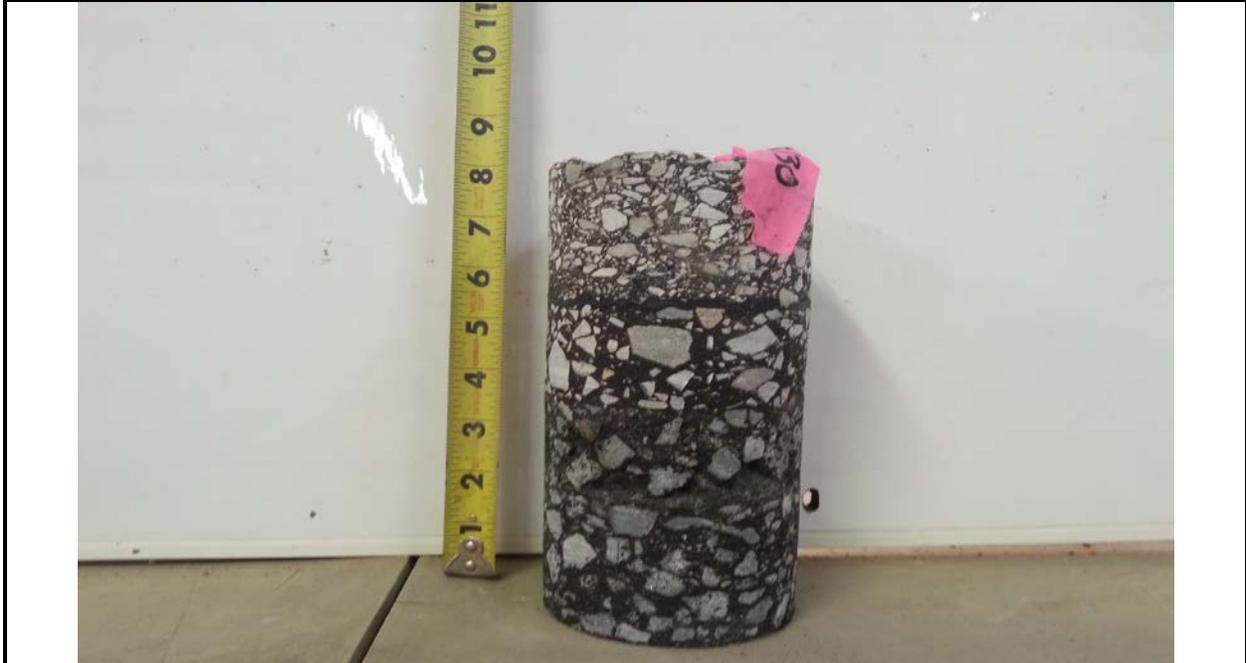
Pavement Core B-130.  
Approximately 4 layers of flexible pavement. Separation geotextile located 2 1/4" below pavement surface. No observed cracking or delamination.

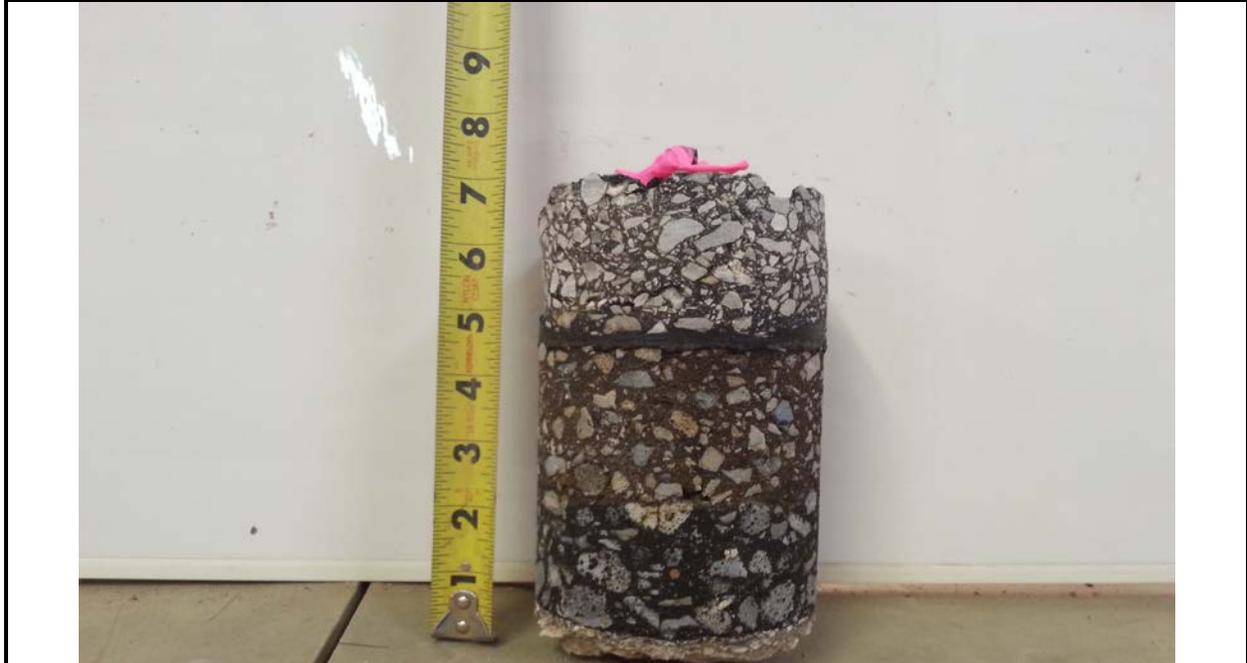
Pavement Core B-132.  
Approximately 3 layers of flexible pavement. Separation geotextile located 2" below  
pavement surface. No observed cracking or delamination.

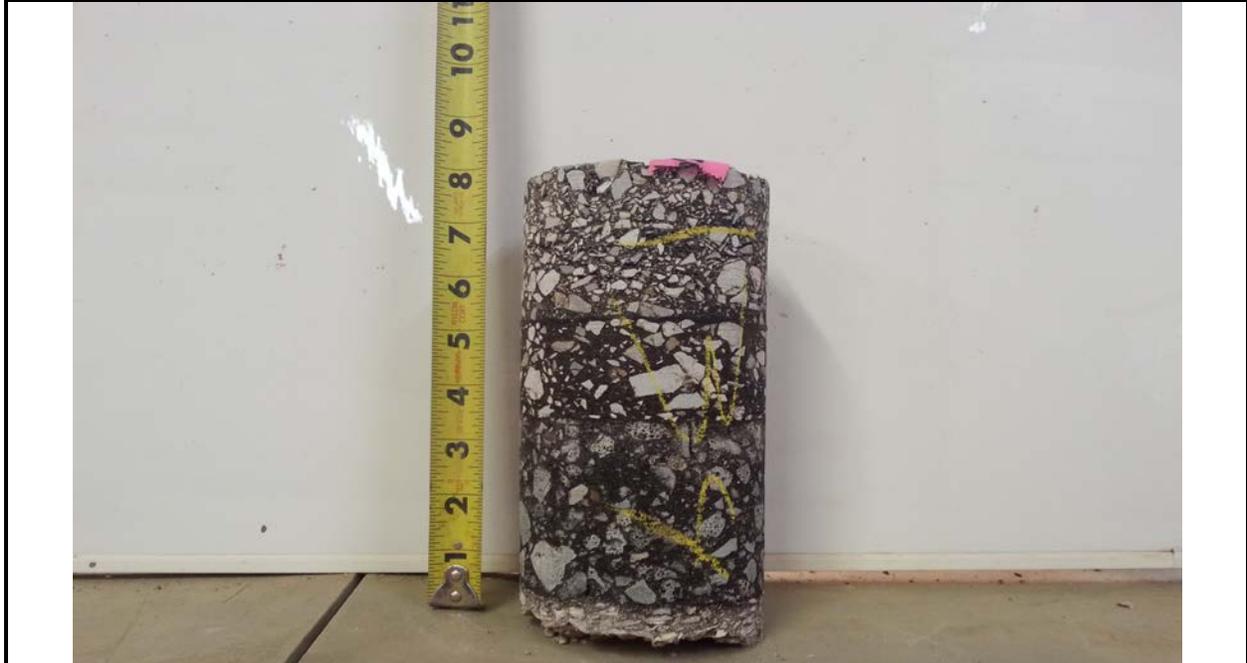
Pavement Core B-134.  
Approximately 4 layers of flexible pavement. Separation geotextile located 2 1/2" below pavement surface. No observed cracking or delamination.

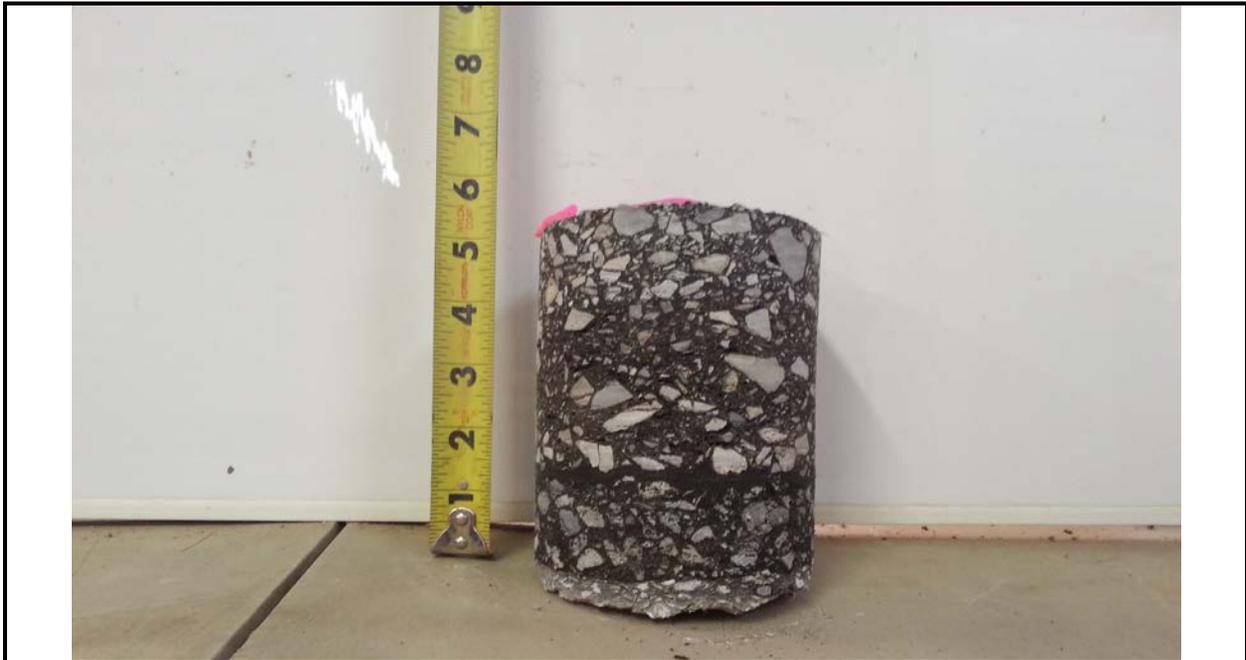
Pavement Core B-135.

Approximately 4 layers of flexible pavement. Separation geotextile at 3 5/8" below pavement surface. Cracking observed beginning 1 1/2" below pavement surface, extending down to base of core (Bottom-up Cracking). Cracking observed in two locations.

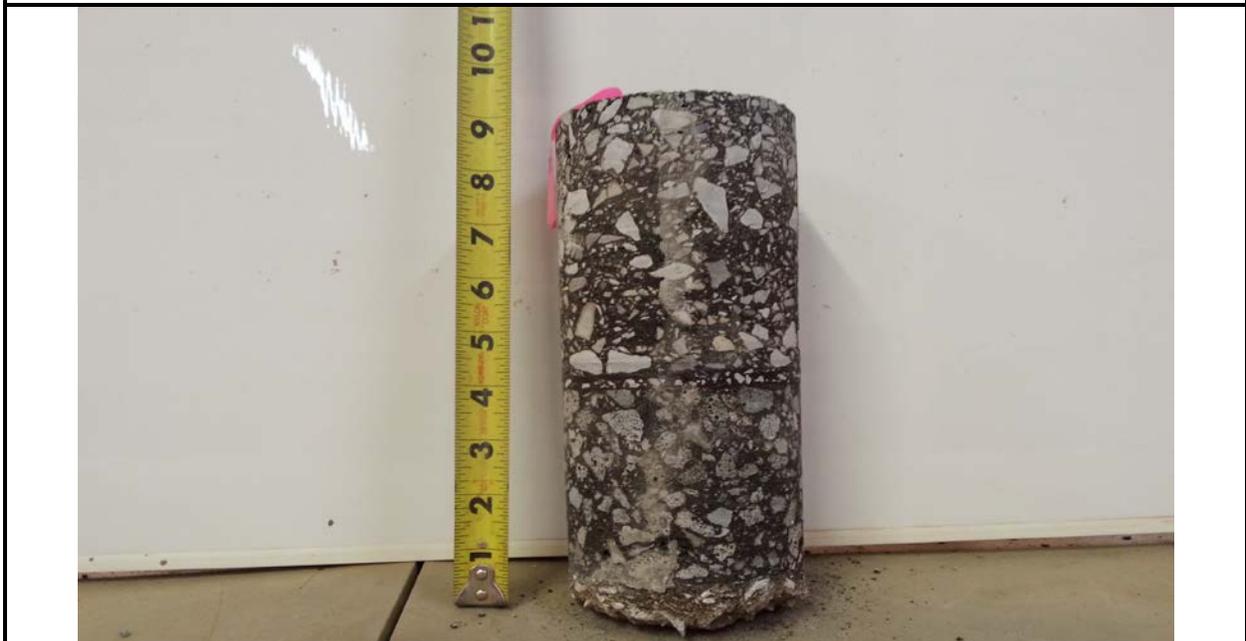
Pavement Core B-136.

Approximately 5 layers of flexible pavement. Separation geotextile located 4.625" below pavement surface. Cracking observed beginning 4.75" below pavement surface and extending down to the base of the pavement core (Bottom-up Cracking). Cracking observed in two locations.

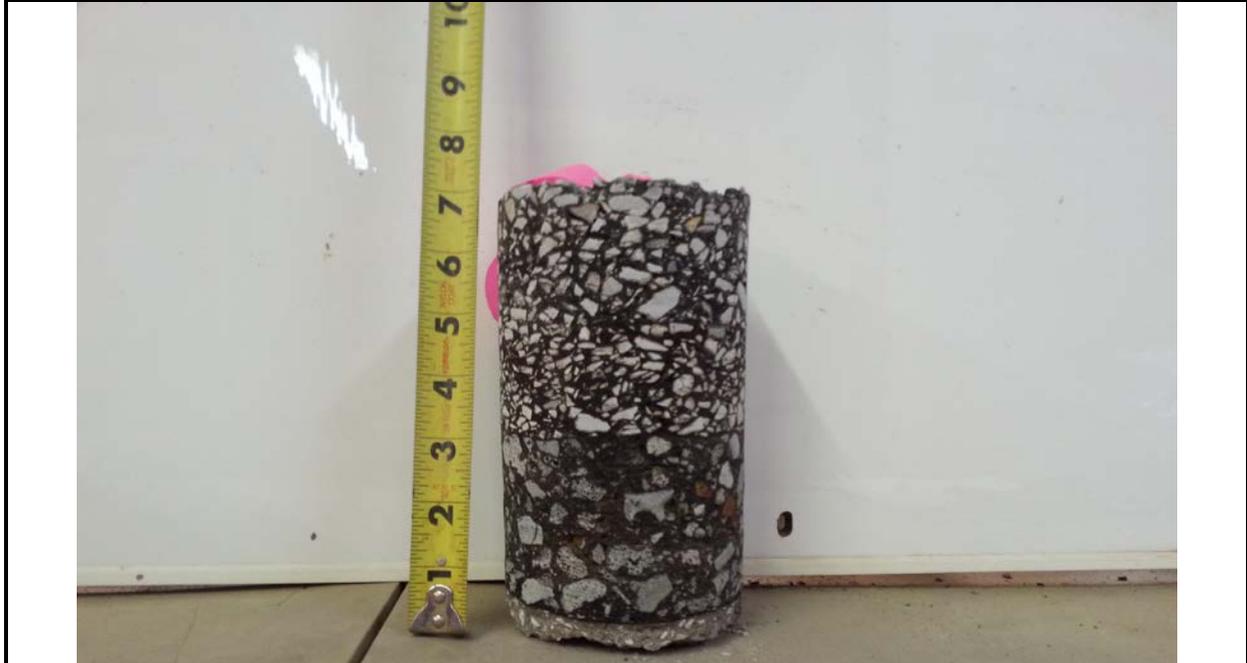
Pavement Core B-140.  
Approximately 4 layers of flexible pavement. No noticeable separation geotextile. Side of core sheared off during core extraction.

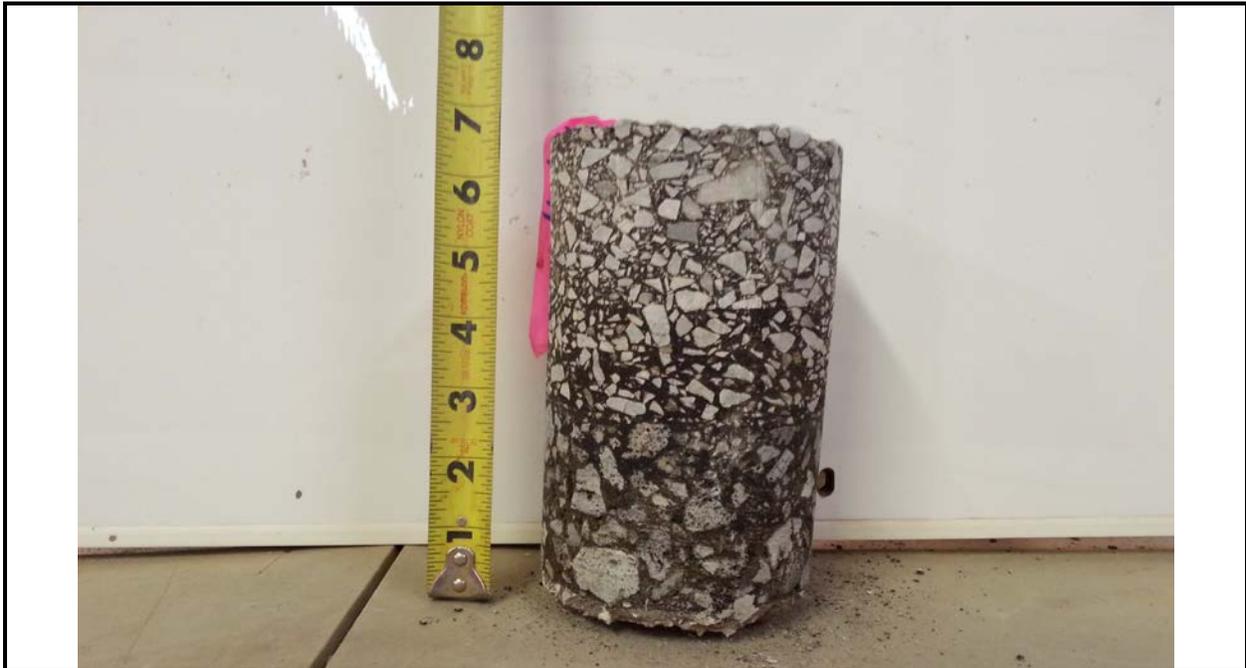
Pavement Core B-141.  
Approximately 4 layers of flexible pavement. No noticeable separation geotextile. Side of core sheared off during core extraction.
