June 4, 2015  
**Revised June 5, 2015**

**Reference:** **Geotechnical Investigation – Pavement Cores**  
*REPAIR AIRFIELD/RUNWAY FORREST SHERMAN FIELD*  
 NAS Fort Pensacola, Florida  
 NAVFAC Project No.: ST 1112225  
 UES Project No.: 1730.1500048.0000  
 UES DOCS Report No.: 1235270

**REPAIR AIRFIELD/RUNWAY FORREST SHERMAN FIELD**

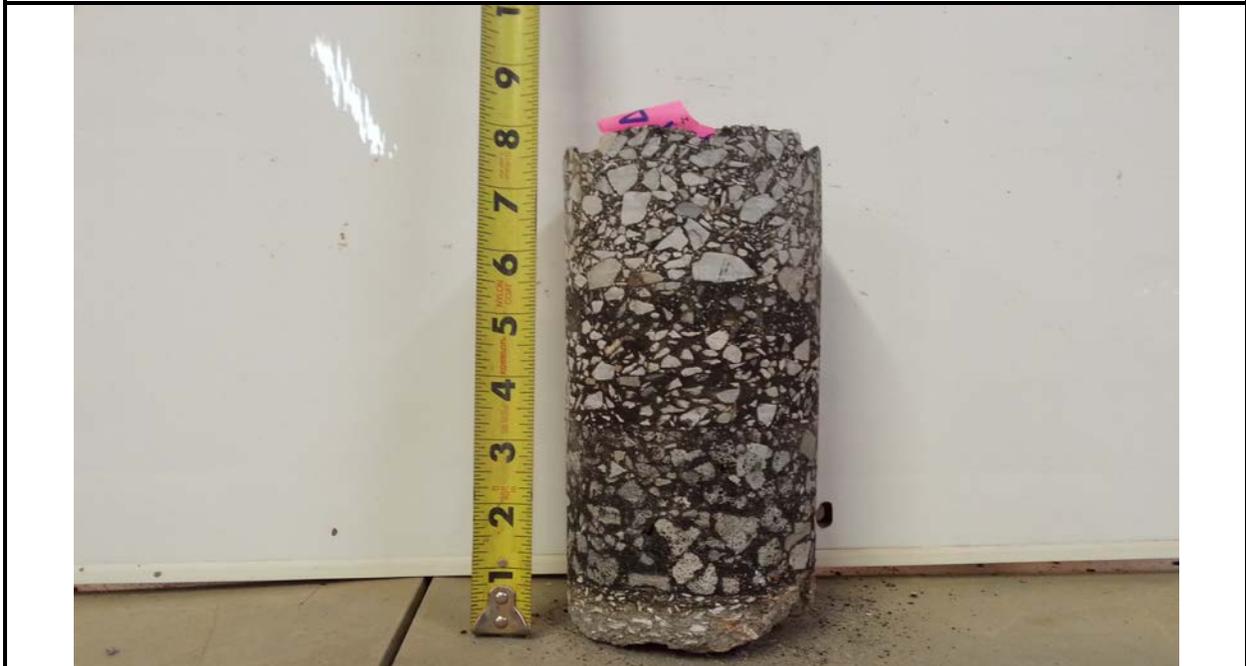
Pavement Core B-142.  
Approximately 5 layers of flexible pavement. No noticeable separation geotextile. Cracking observed beginning 5.75" below pavement surface and extending down to the base of the pavement core (Bottom-up Cracking). Cracking observed in one location.

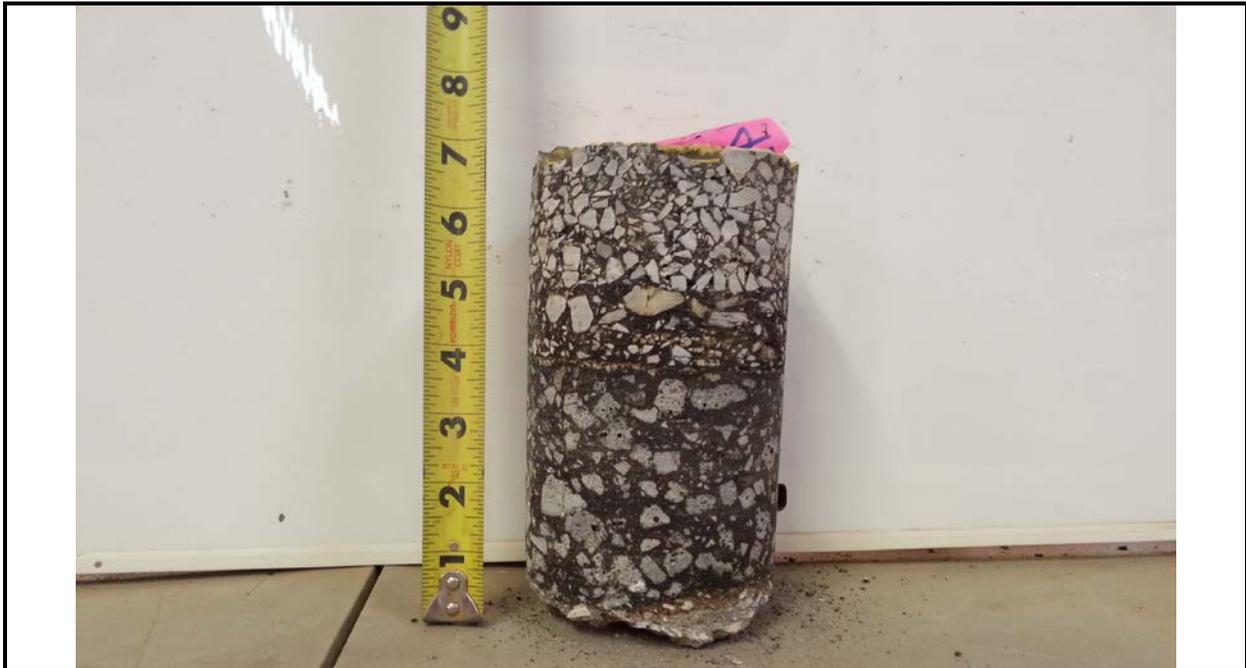
Pavement Core B-143.  
Approximately 4 layers of flexible pavement. No noticeable separation geotextile. No observed cracking or delamination.

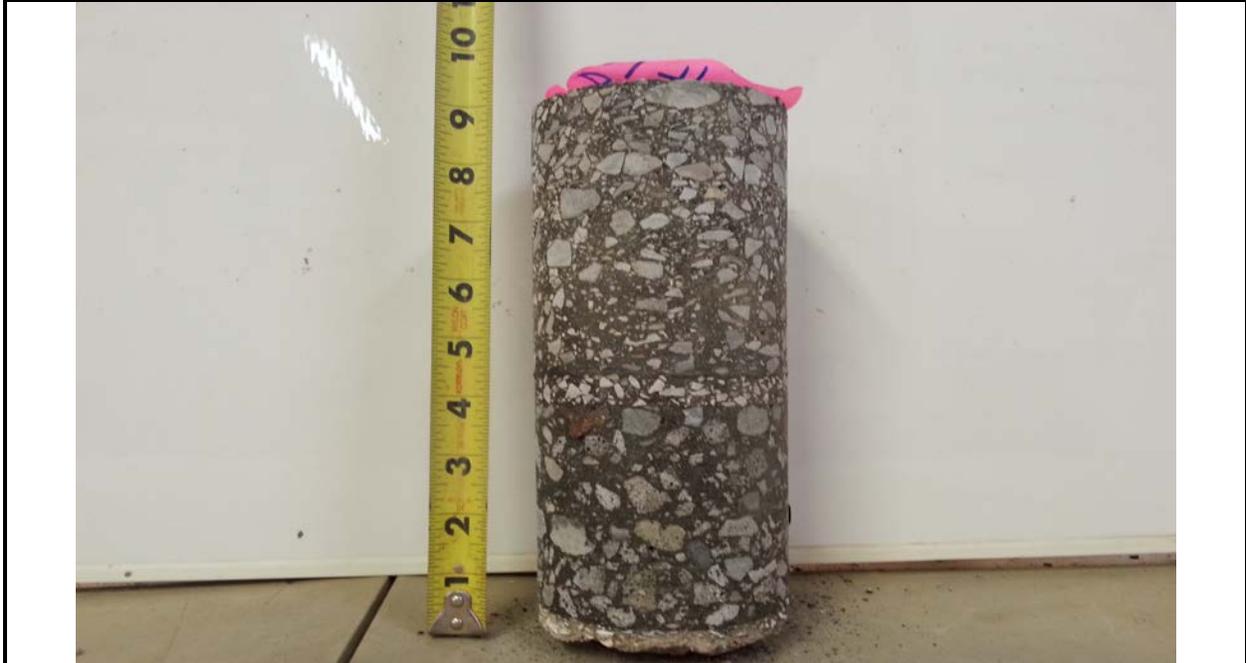
Pavement Core B-144.  
Approximately 5 layers of flexible pavement. Separation geotextile located 4.5" below the pavement surface. No observed cracking or delamination.

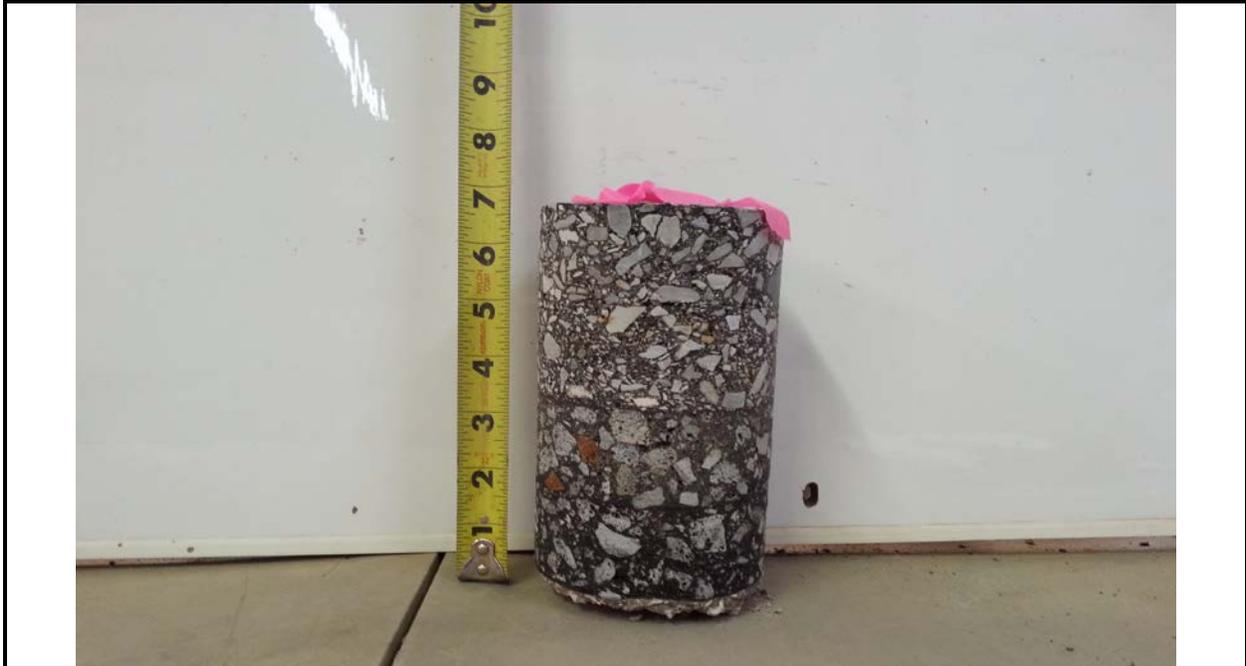
Pavement Core B-145.  
Approximately 4 layers of flexible pavement. No noticeable separation geotextile. No observed cracking or delamination.

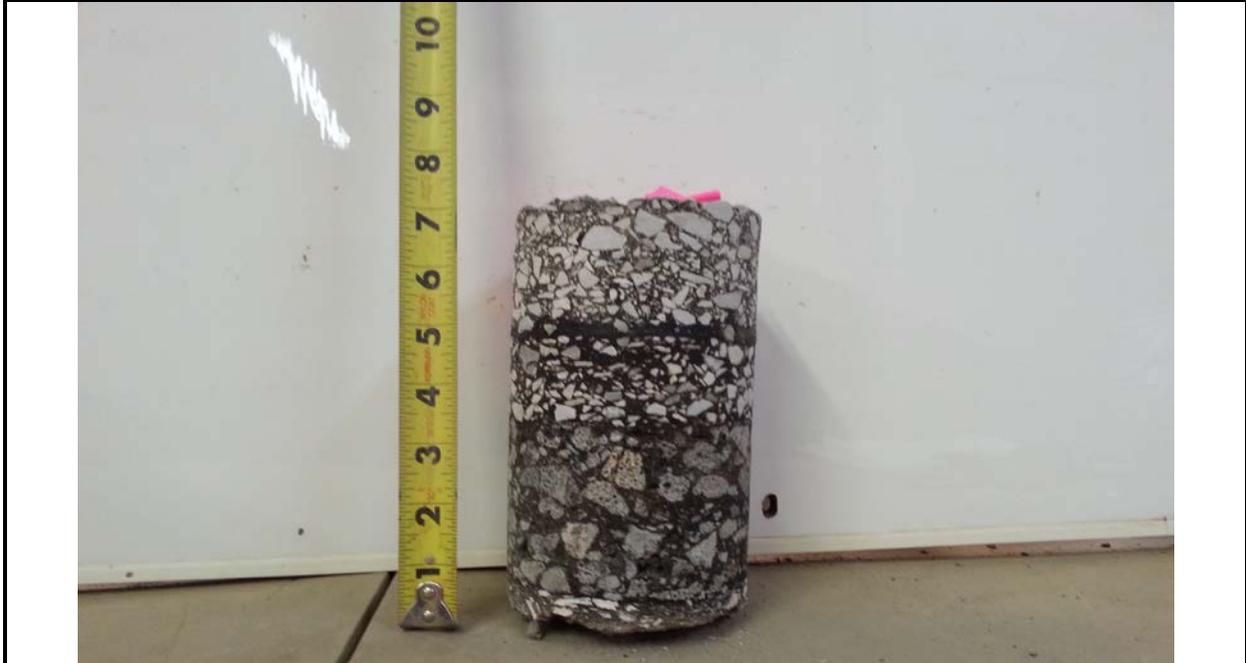
Pavement Core B-146.  
Approximately 4 layers of flexible pavement. Separation geotextile located 2" below pavement surface. No observed cracking or delamination.
