AMENDMENT OF SOLICITATION

1. This contract shall cover structural repairs to DLA Buildings 404 and 505 only. All references and plans for Buildings 205, 206 and 406 shall be disregarded as they are NOT part of this contract. Plan sheets 2 of 26 through 9 of 26 shall be disregarded. Exception: Plan Sheet 7 of 26 'GIRDER ELEVATION' shall be used in conjunction with Detail C on plan sheet 25 of 26.
2. Submission of Invoices: NFAS clause 5252.232-9301 is no longer valid; the correct clause is DFARS 252.232-7006. This section shall be omitted and the Contract Specialist shall provide instructions for submitting invoices.
3. Replace Work Order Number 1158199 with Work Order Number 1172316. Work Order Number 1158199 is no longer valid and all references shall be replaced with Work Order Number 1172316.
4. Replace Building No. 404 Table on S-602 with table listed below:

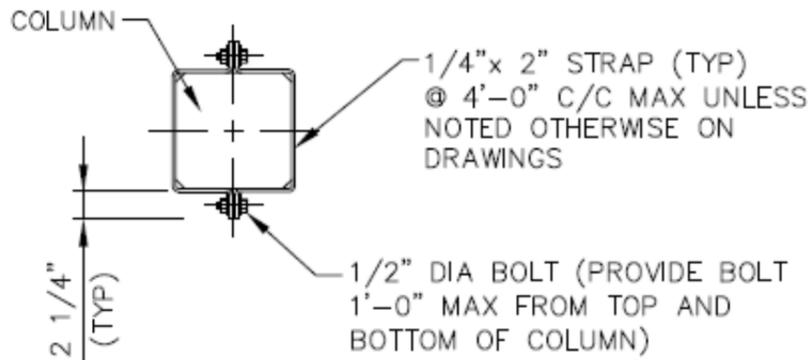
DETAIL E
NO SCALE

| BUILDING NO. 404 | | | |
|---|---|---|---|
| H11 | SPLIT | N/A | CONFLICT #3 H11: HAS CRACKS ON (2) SIDES, THEREFORE USE CLAMP PER "DETAIL E" IN AMENDMENT OF SOLICITATION #6 (Below) |

6. Alternate Column Repair Detail
