**Site Specific Report  
CR-NAVFAC EXWC-CIOFP-1310**

**TANK INSPECTIONS AND ASSESSMENTS AT  
NAVAL AIR STATION  
SIGONELLA, ITALY**

November 2012

Contract No. N62583-10-D-0340  
Delivery Order No. 0018

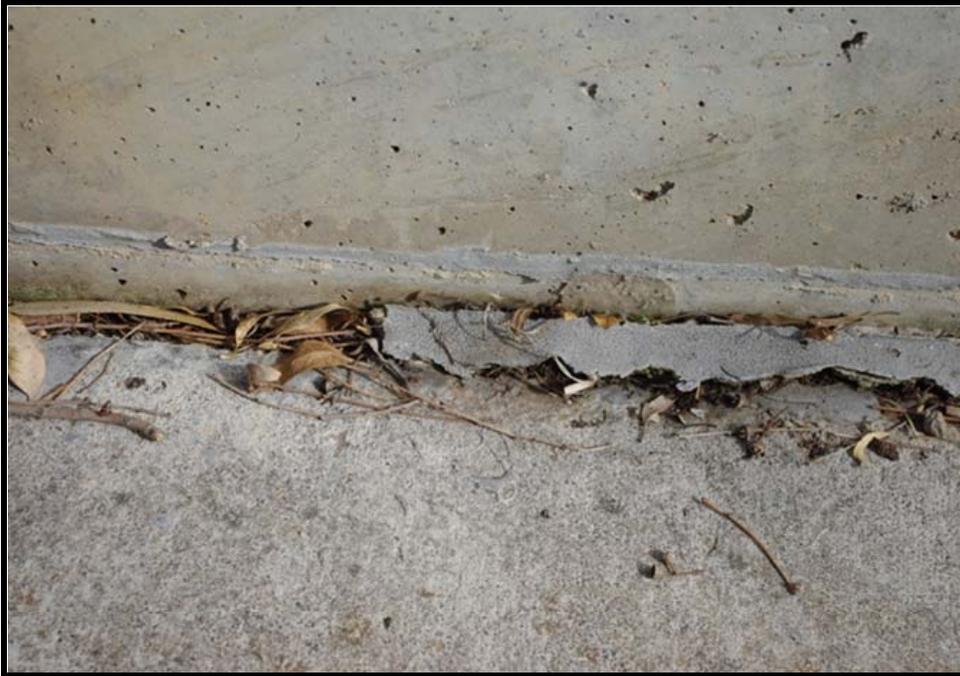
PHOTO 3.1-7 Debris and voids in sealant around apron-to-tank interface.

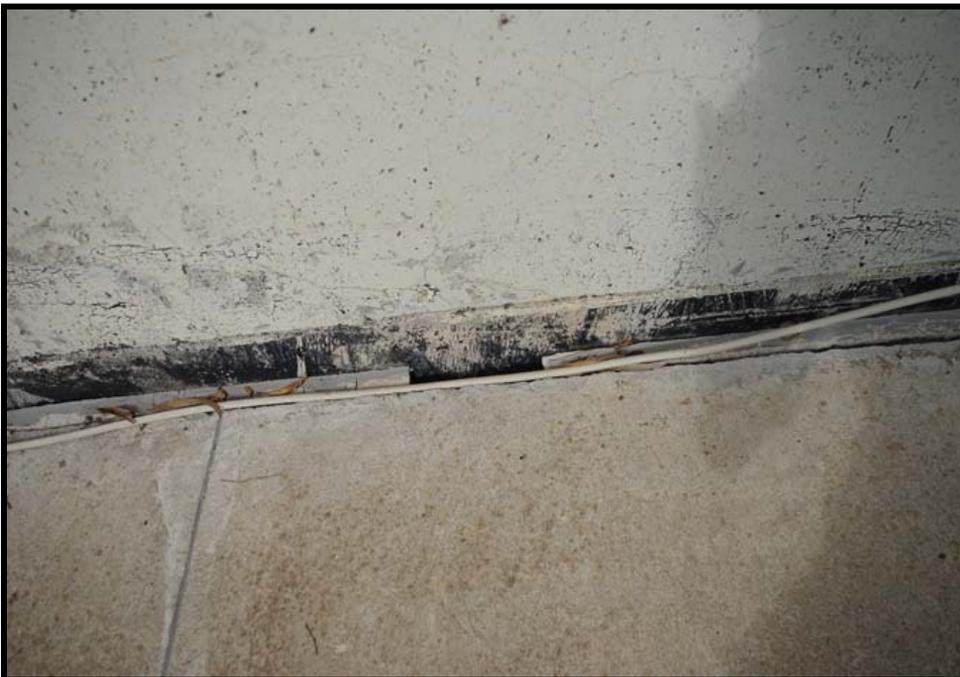
PHOTO 3.1-8 Voids in sealant around apron-to-tank interface.

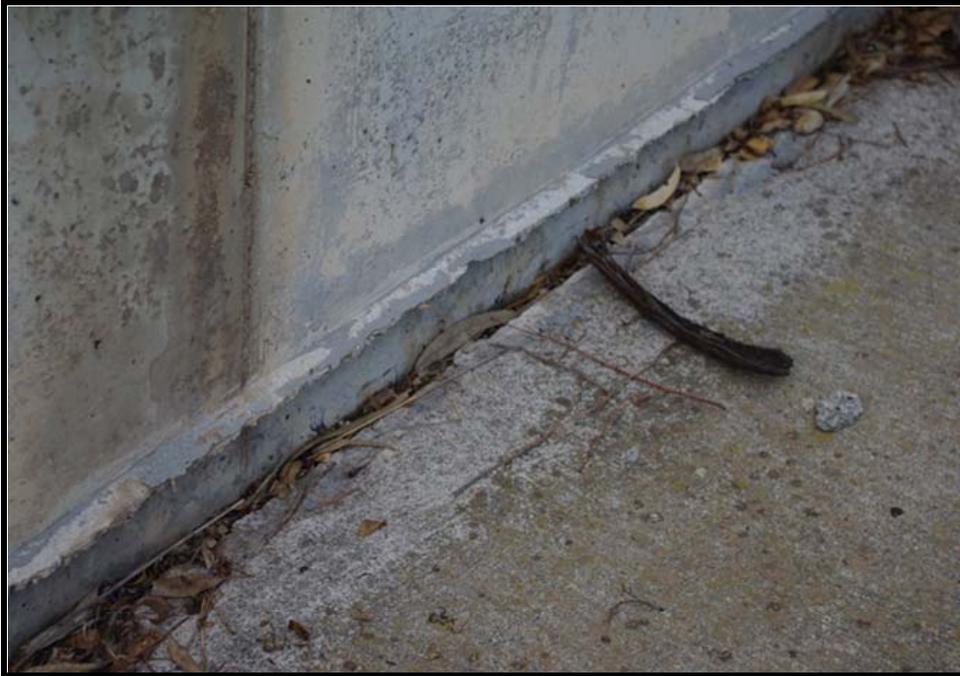
PHOTO 3.1-9 Debris and voids in sealant around apron-to-tank interface.

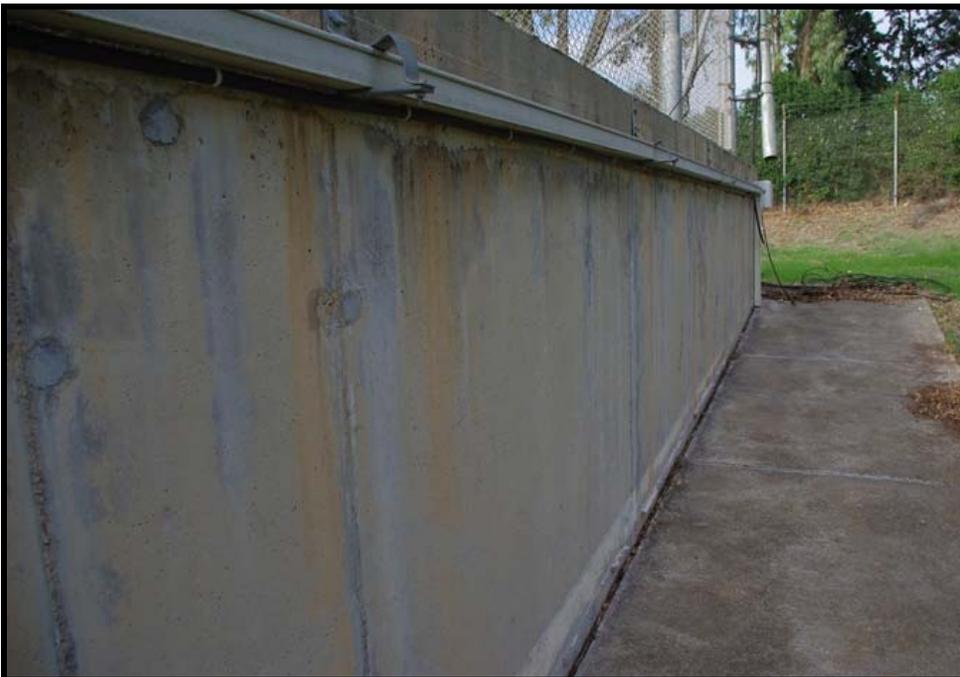
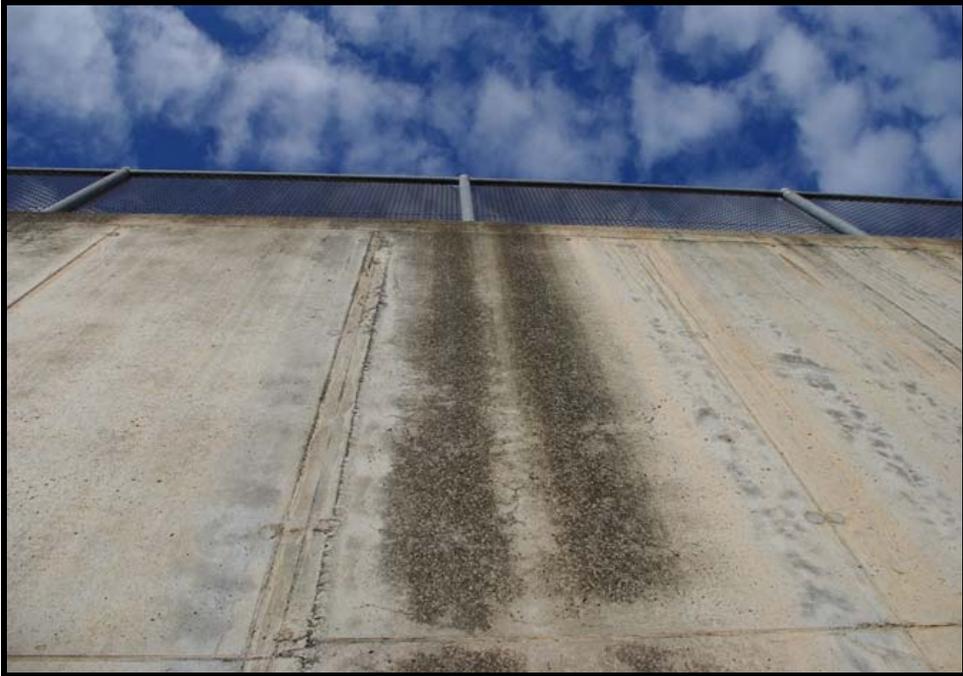
The exterior concrete shell projection was in good condition at the time of the field evaluation as only a few minor hairline cracks were observed (See photos 3.1-10 through 3.1-11). There is mildew in some areas. A conduit extends along the east side of the shell (See photo 3.1-10).

PHOTO 3.1-10 Shell exterior.

PHOTO 3.1-11 Shell exterior.

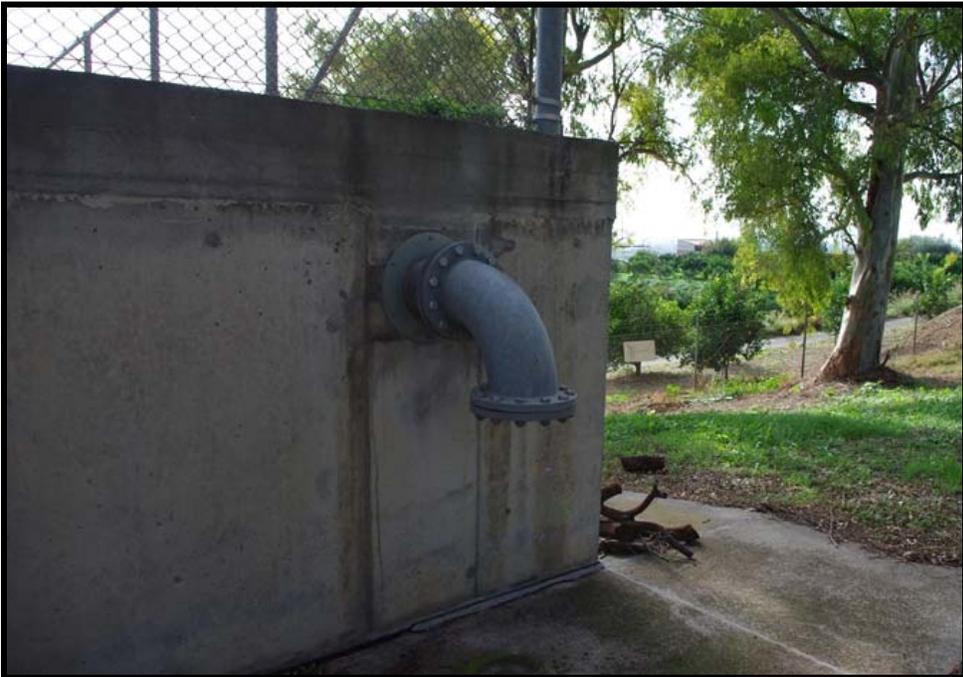
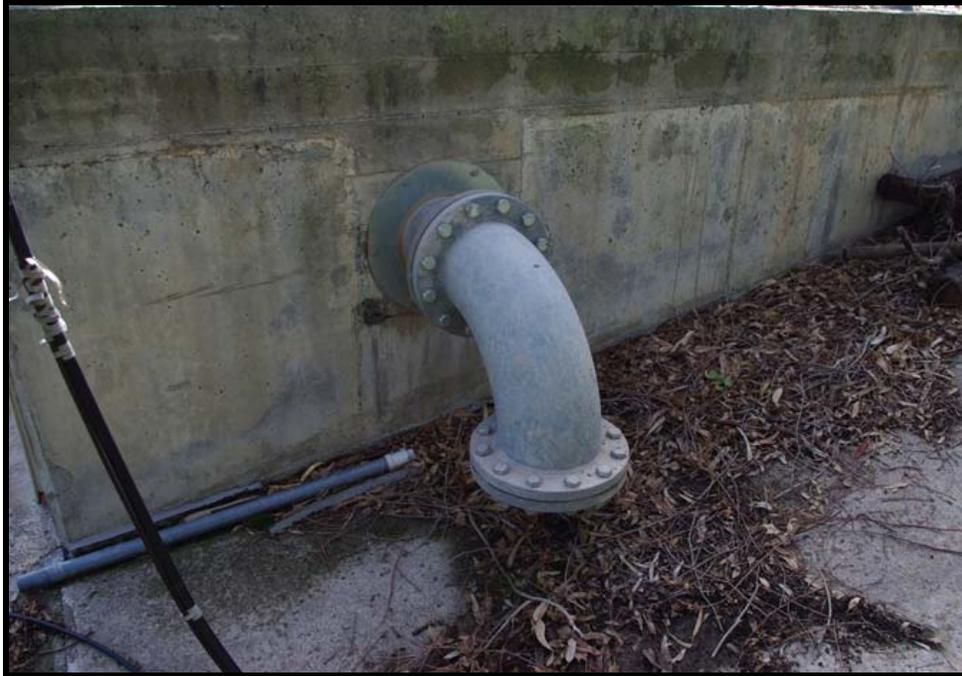
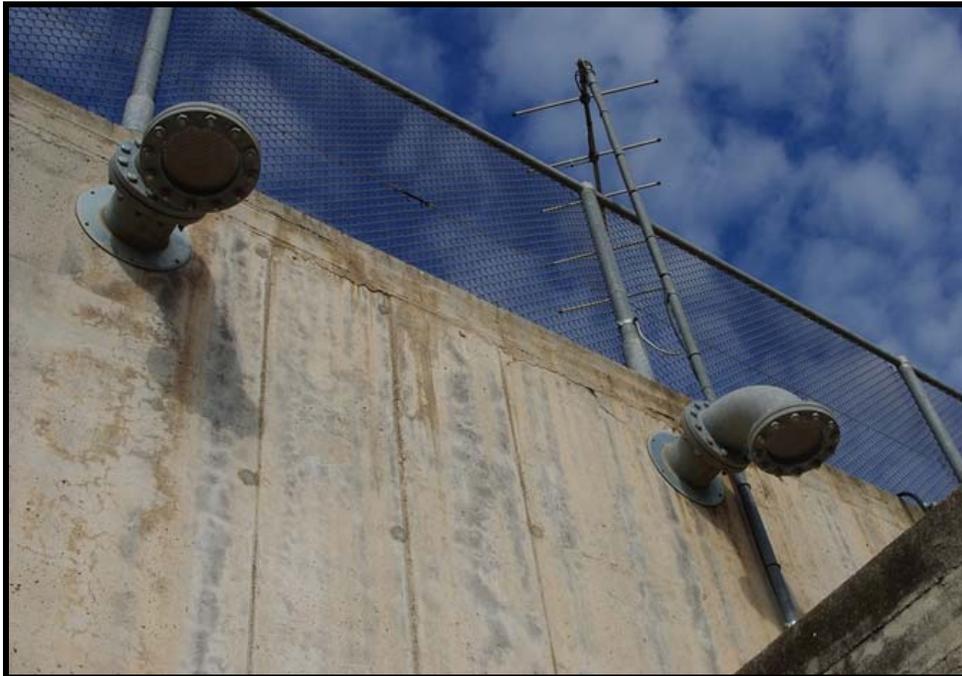
Six fittings that function as both overflows and venting project from near the top of the shell and elbow downward before discharging (See photos 3.1-12, 3.1-13, 3.1-15, and 3.1-16). Perforated plate screening is located on the discharges which is intact (See photos 3.1-14 and 3.1-17). There was no significant corrosion or coating failure observed on the fittings at the time of the field evaluation. Four of the fittings are oriented such that they discharge above the roof of the pump house, and the other two discharge above the concrete apron.

PHOTO 3.1-12 Elbowed pipe fitting.

PHOTO 3.1-13 Elbowed pipe fitting.

PHOTO 3.1-15 Elbowed pipe fittings.

PHOTO 3.1-16 Elbowed pipe fittings.

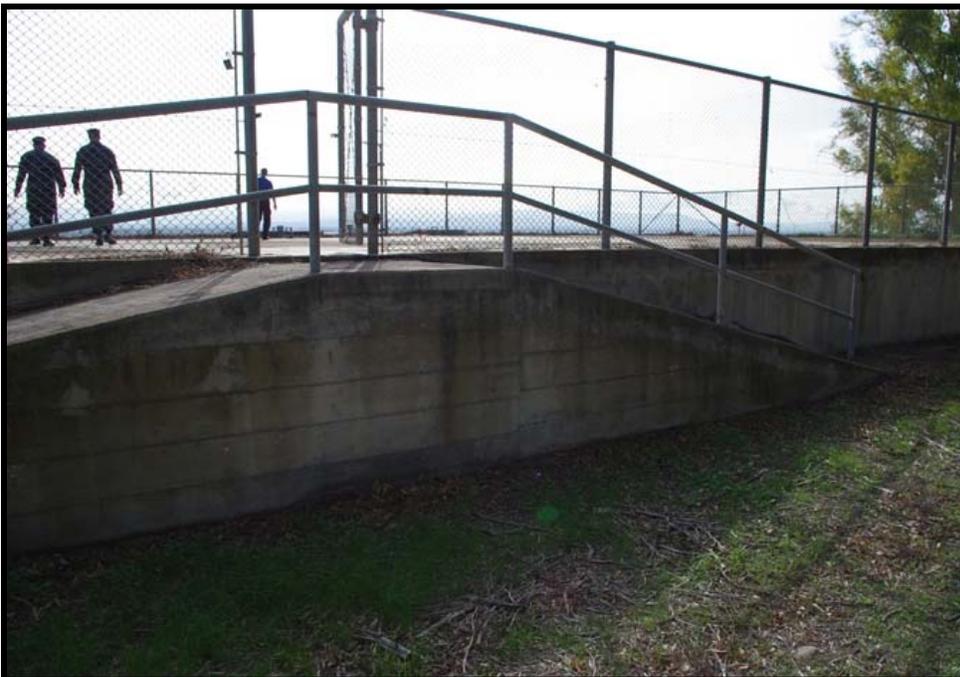
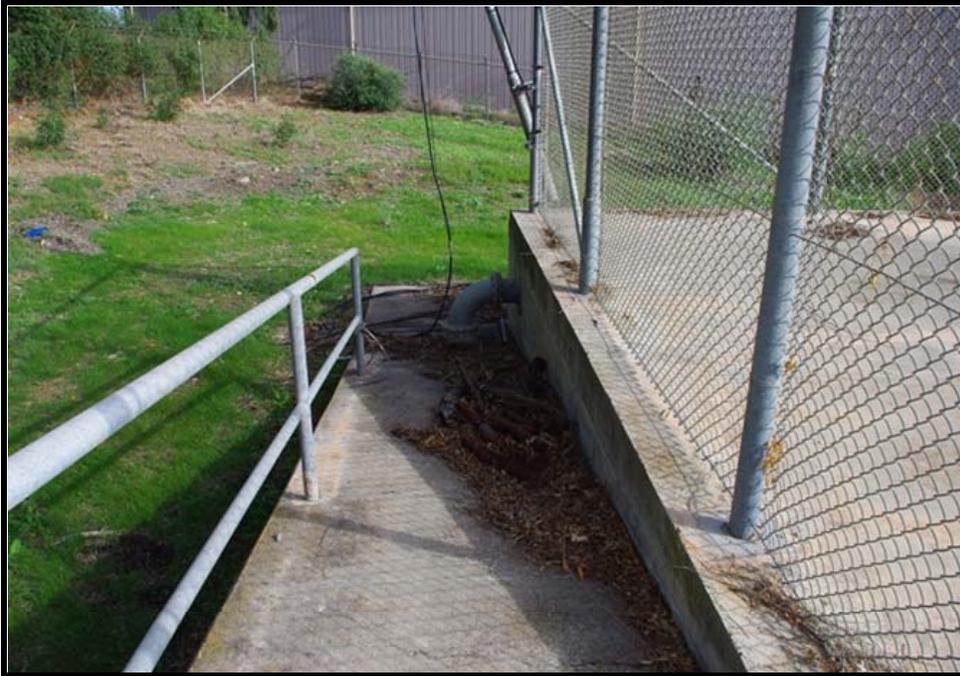
A ramp provides access from the north side of the concrete apron to the roof, and there is debris on it (See photos 3.1-18 and 3.1-19). A chain link fence extends around the perimeter of the roof which has a locked gate (See photo 3.1-21). An antenna is mounted to the fence on the south side of the roof (See photo 3.1-30). The roof's edge does not have safety railing at the roof manholes which is an OSHA deficiency.

PHOTO 3.1-18 Ramp to roof.

PHOTO 3.1-19 Debris on ramp to roof.

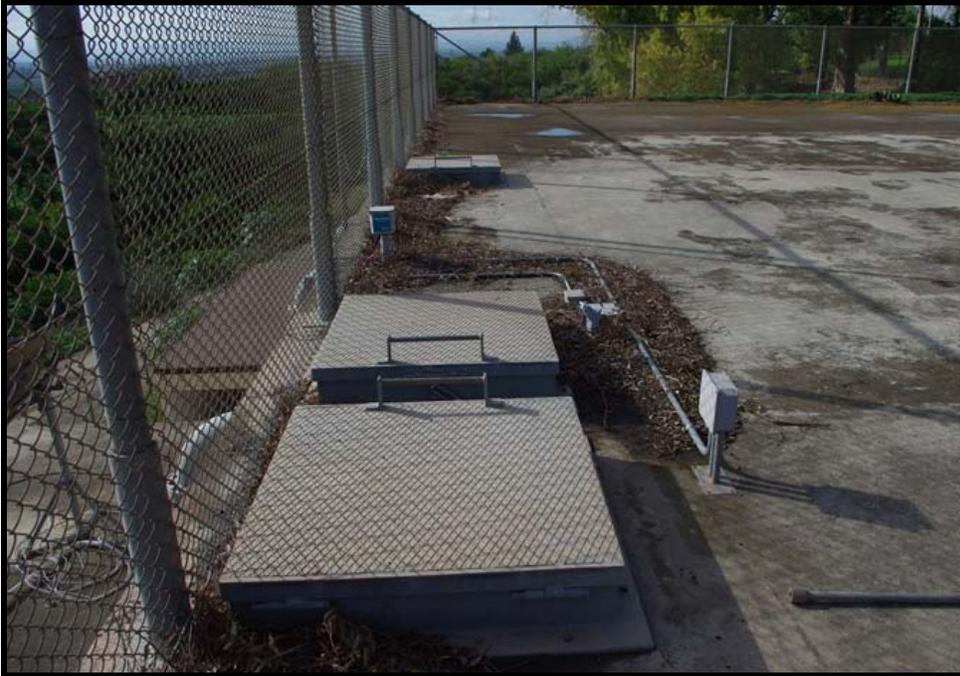
PHOTO 3.1-23 Roof manholes and equipment. Note standing water.

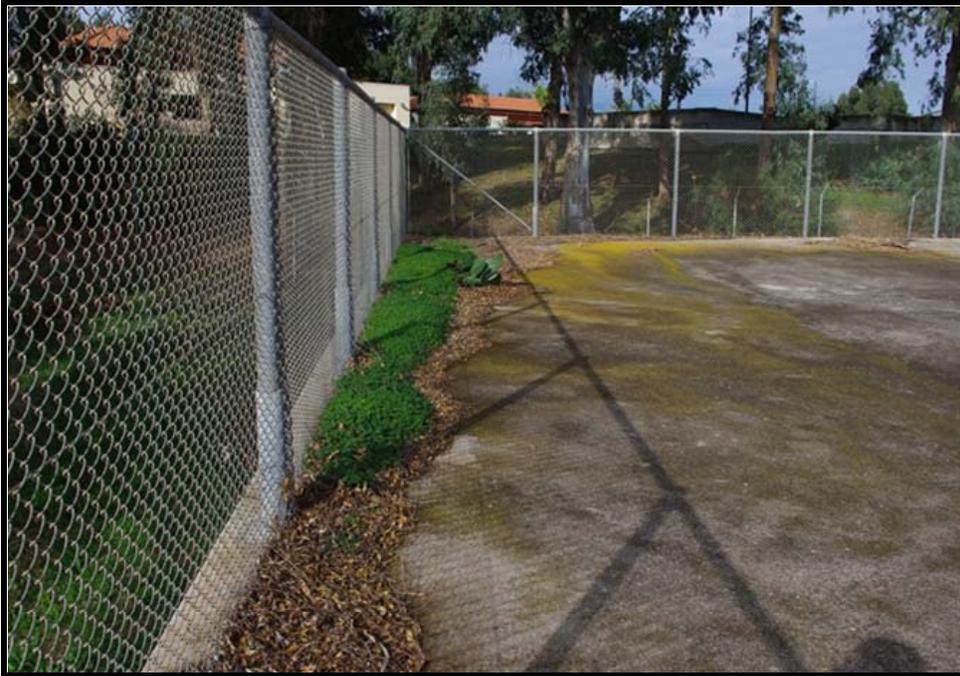
PHOTO 3.1-27 Debris and vegetation on roof.

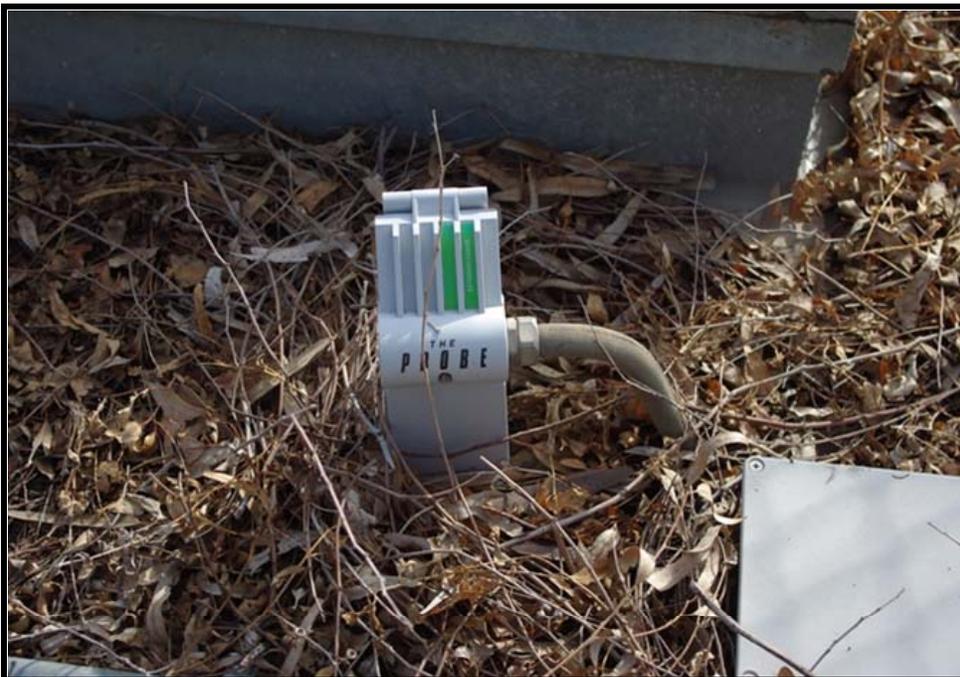
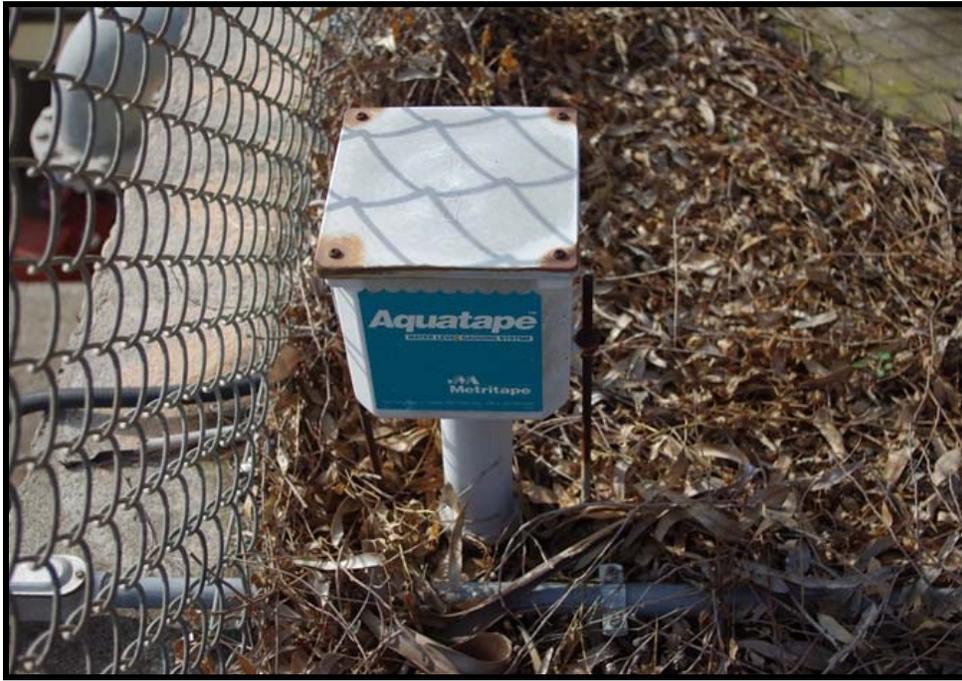
The concrete roof is in fair condition as there are some hairline cracks, particularly on the east side of the roof (See photos 3.1-34 through 3.1-36 and 3.1-38 through 3.1-42). Leaves and debris have accumulated on the roof against the chain link fence and around the roof manholes, and vegetation has grown in some of the leaf-covered areas (See photos 3.1-27 and 3.1-31 through 3.1-33). Moss and mildew are located in the roof, and there is standing water (See photos 3.1-23 and 3.1-43). What appears to be sensor equipment penetrates near the center chamber roof manhole (See photos 3.1-28 and 3.1-29). Three capped pipes are flush with the roof (See photo 3.1-37).

PHOTO 3.1-28 Debris on roof around equipment.

PHOTO 3.1-29 Debris on roof around equipment.

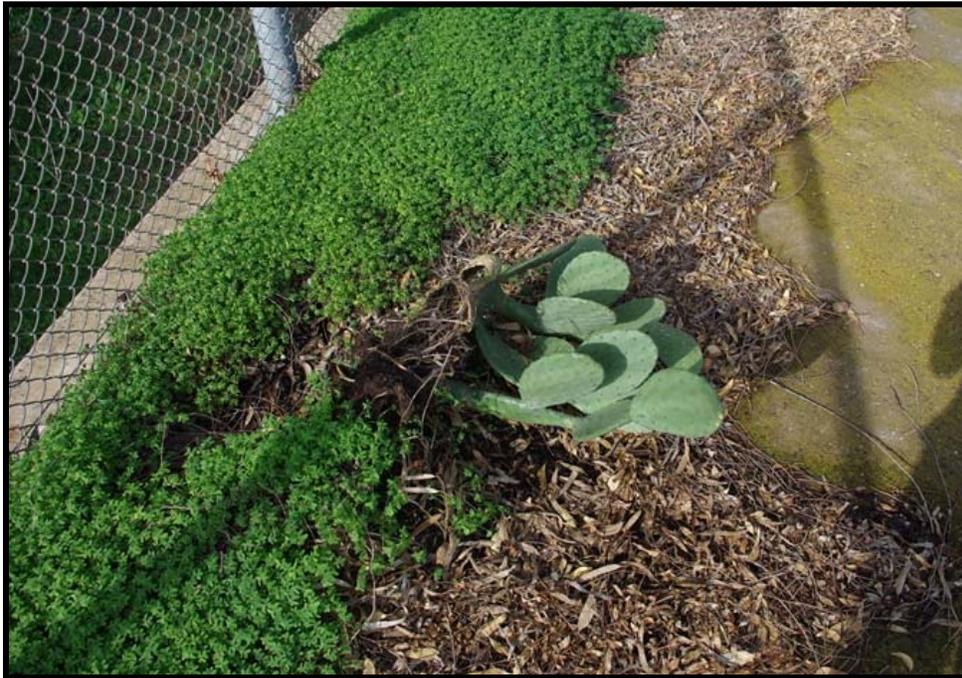
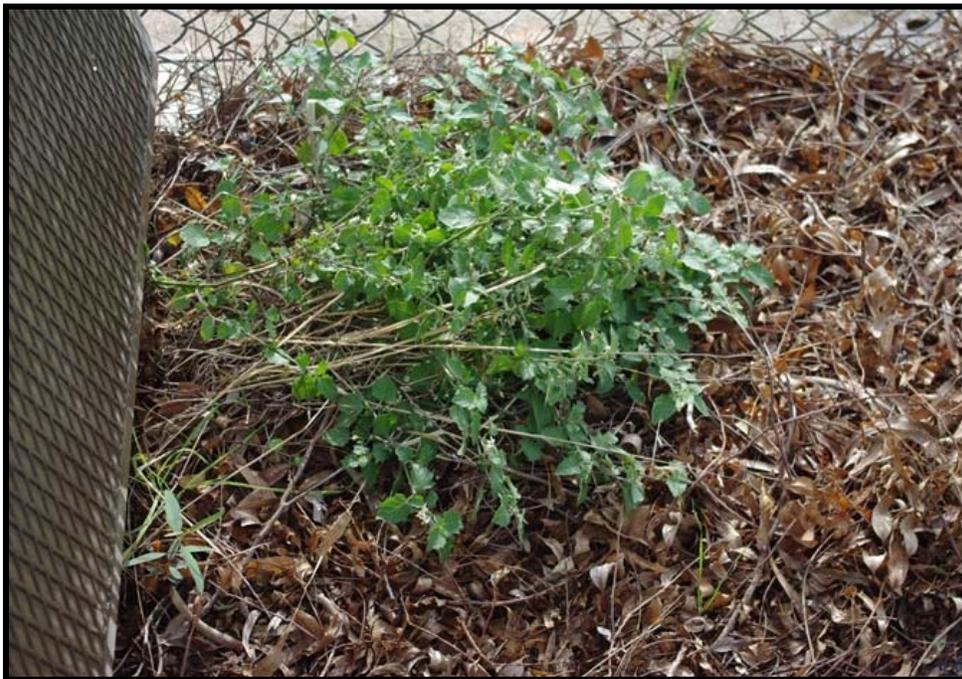
PHOTO 3.1-31 Debris and vegetation on roof.

PHOTO 3.1-32 Debris and vegetation on roof.

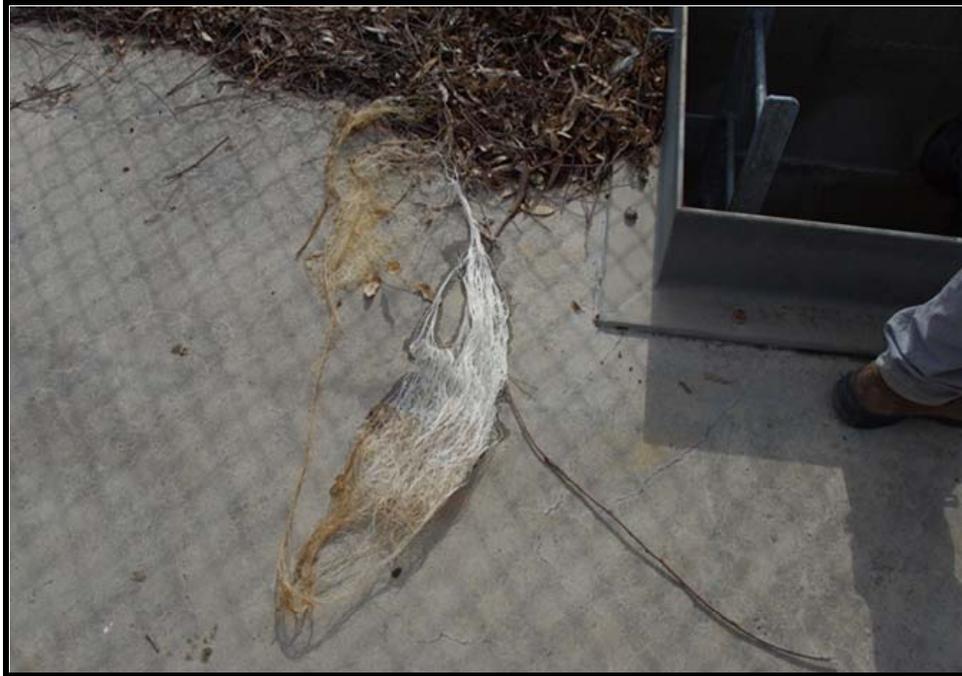
PHOTO 3.1-33 Debris on roof.

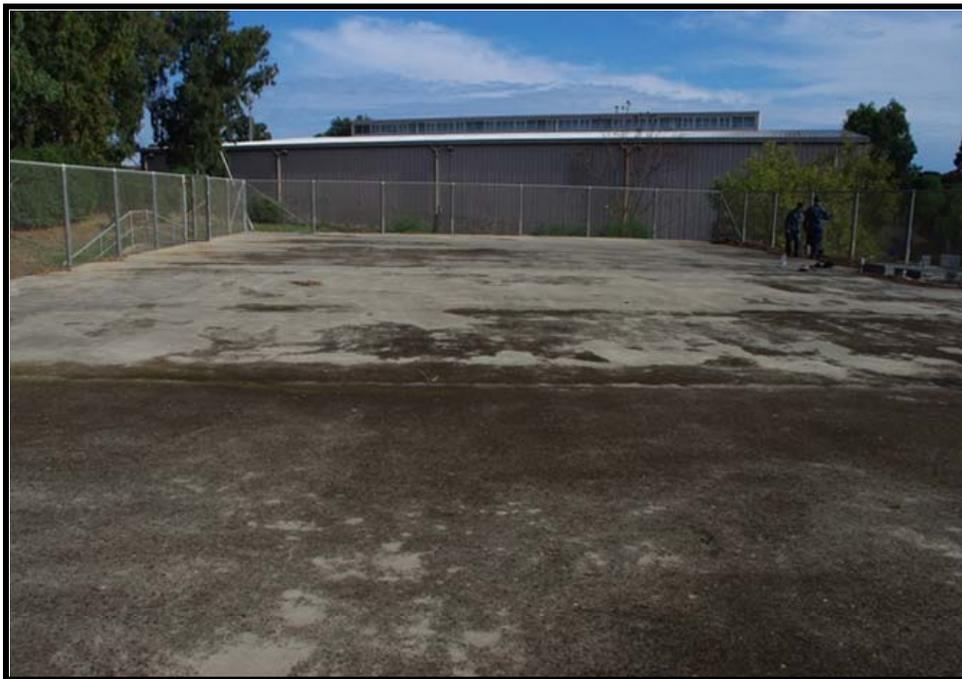
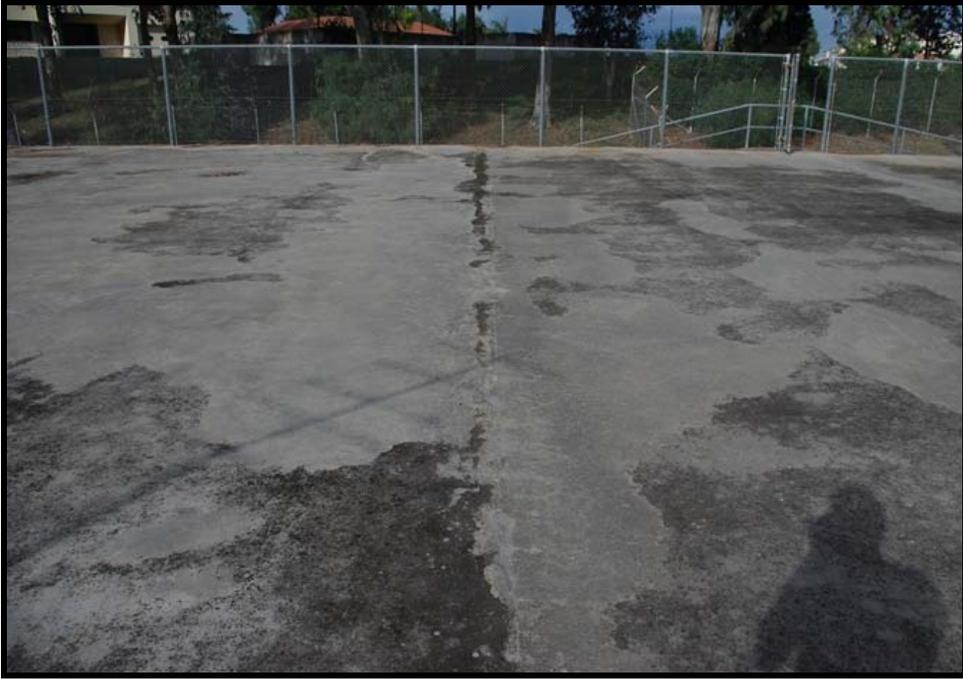
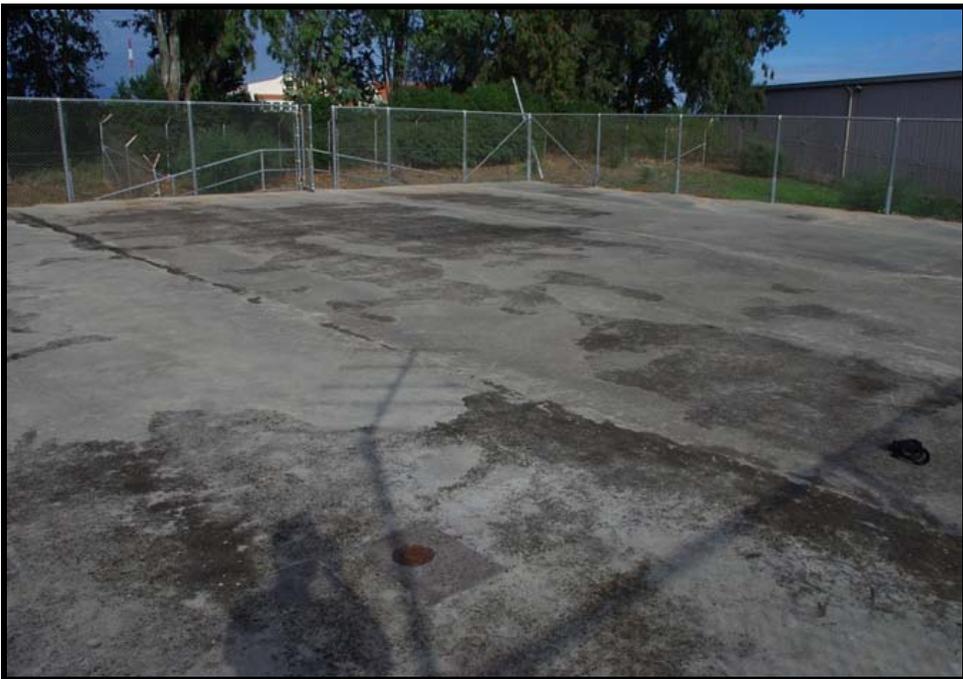
PHOTO 3.1-34 Roof exterior.

PHOTO 3.1-35 Roof exterior.

PHOTO 3.1-36 Roof exterior.

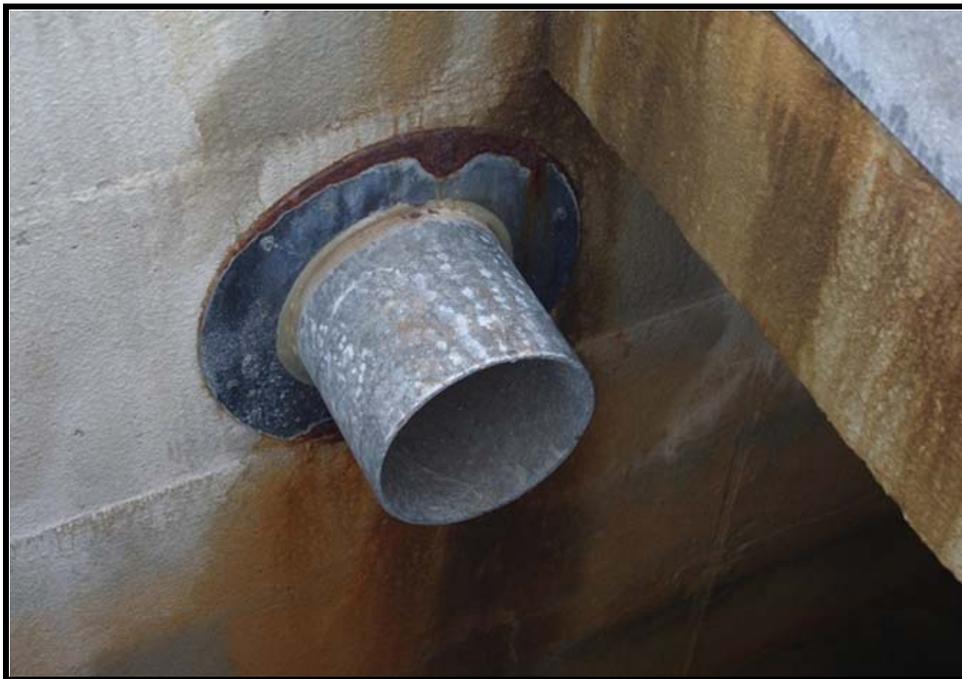
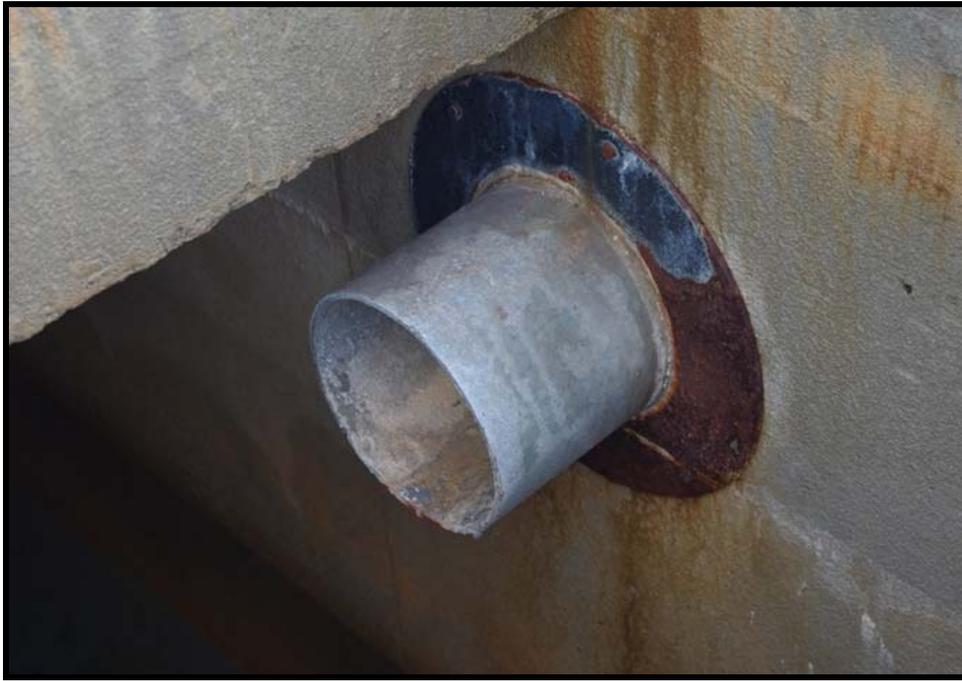
Pipe openings are located near the top of the shell (See photos 3.1-44 and 3.1-45). There is corrosion and rust tubercles on all of the pipes observed in the tank (See photos 3.1-55 through 3.1-58). Pipe openings are located in the shell wall just above sumps in the floor (See photos 3.1-68 and 3.1-69). What appears to be sensor

PHOTO 3.1-44 Pipe projection.

PHOTO 3.1-45 Pipe projection.

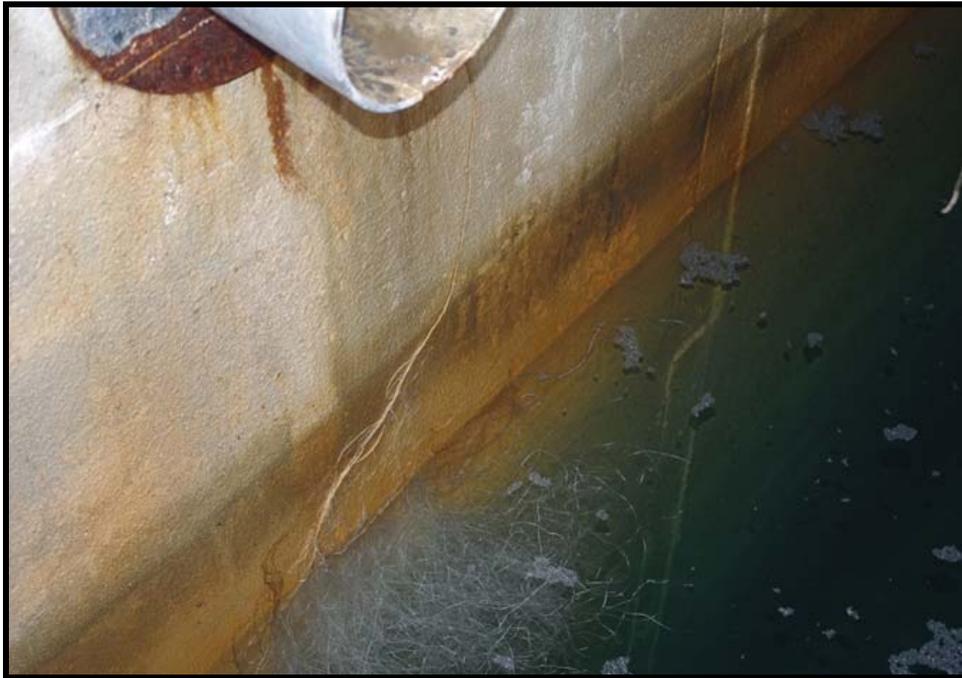
PHOTO 3.1-47 Vegetation extending into tank.

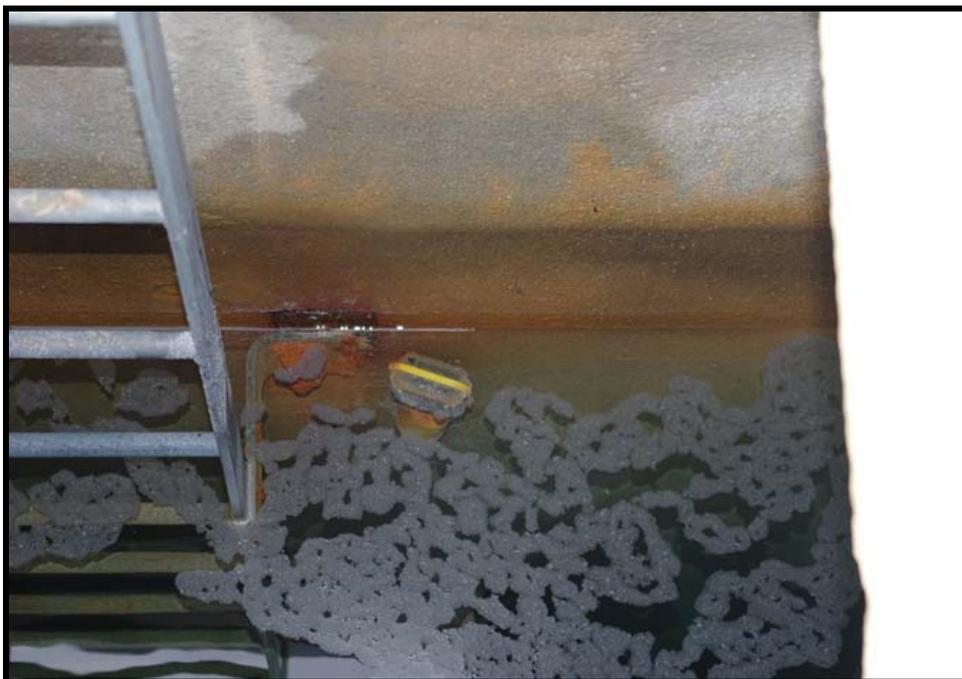
PHOTO 3.1-48 Equipment on shell.

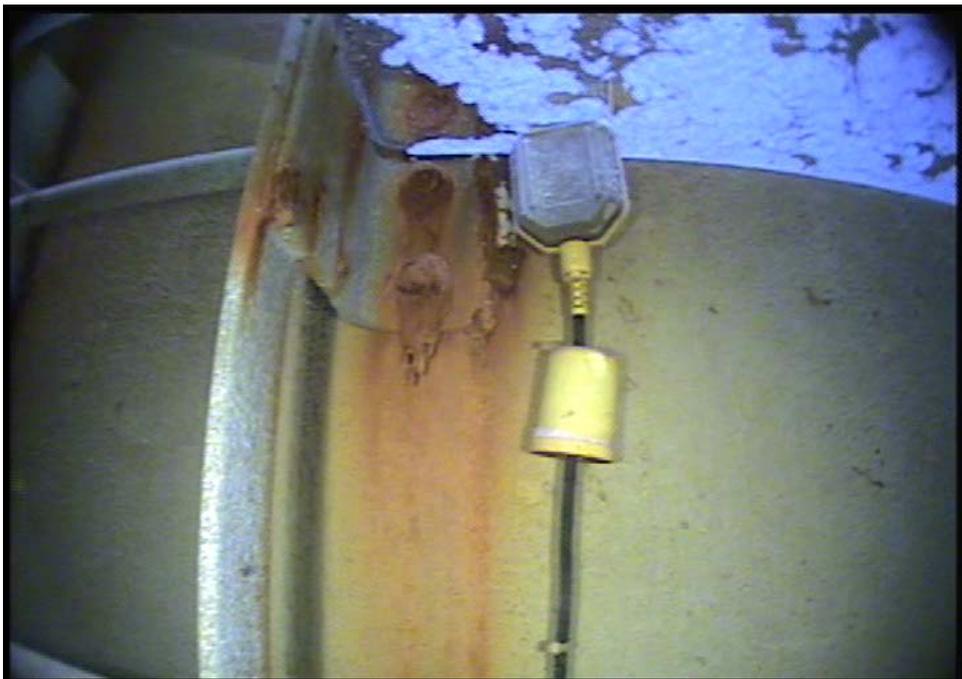
PHOTO 3.1-50 Equipment on shell.

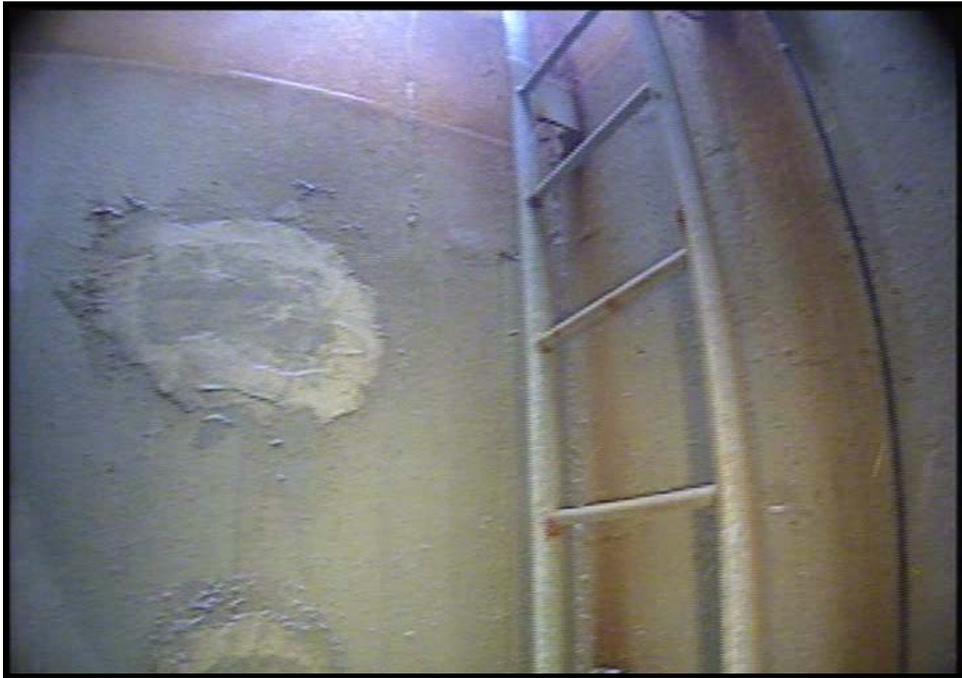
PHOTO 3.1-51 Shell interior and interior ladder.

**Interior Ladders:** Interior ladders are susceptible to accelerated rates of corrosion. If the Navy decides to keep an interior ladder, the existing access ladders should be replaced with new ladders which meet current OSHA requirements. The existing ladders did not include slip-resistant rungs. Slip-resistant rungs are required for all ladders constructed after March 1991 by the OSHA Construction standards.

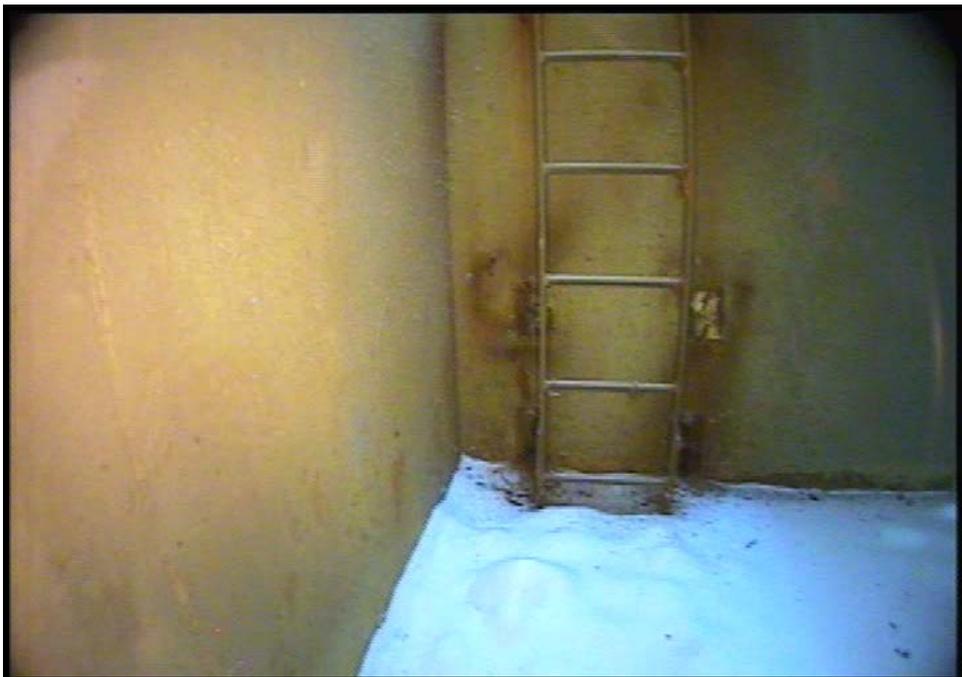
PHOTO 3.1-54 Interior ladder.

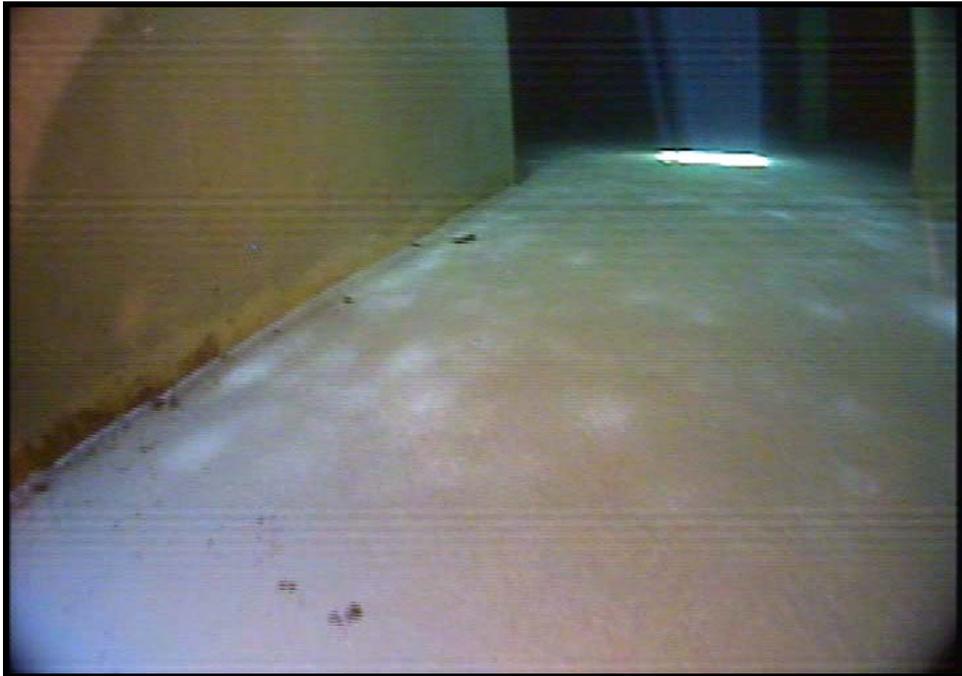
PHOTO 3.1-63 Silt on floor.

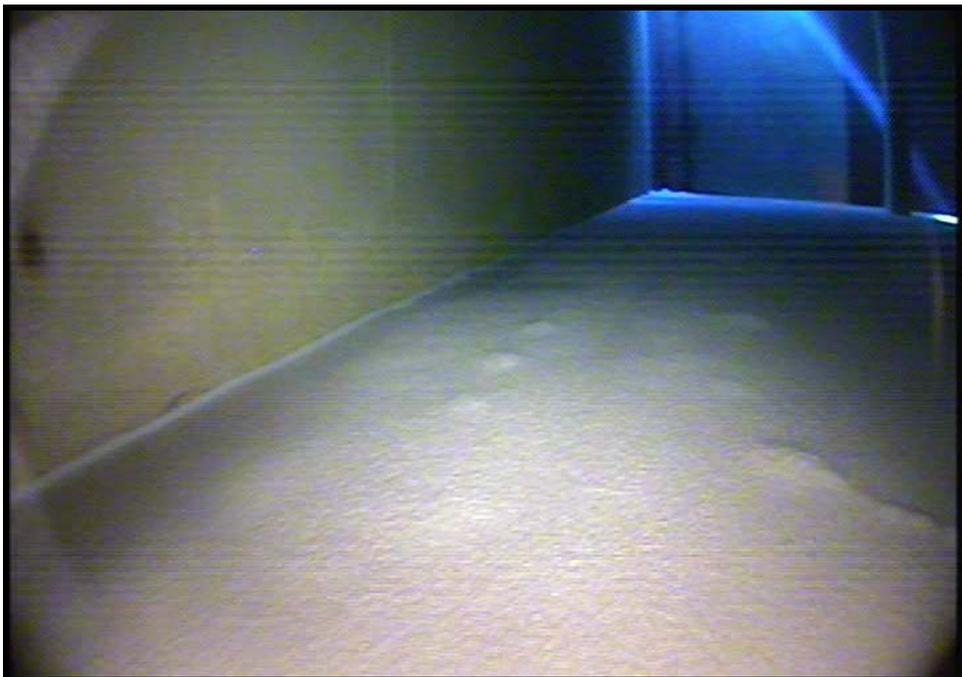
PHOTO 3.1-64 Silt on floor.

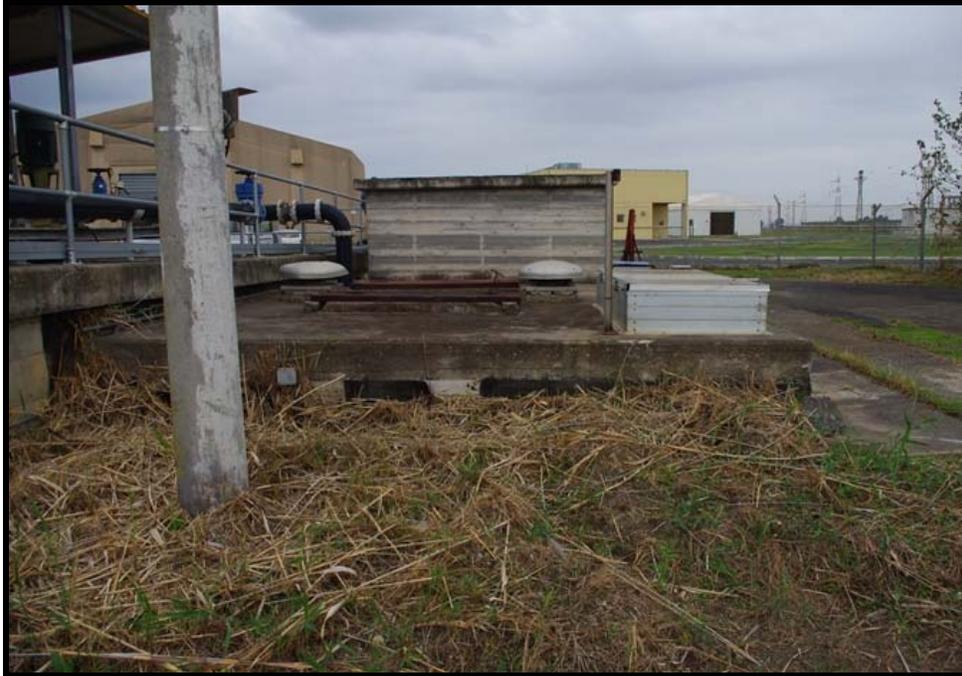
A valve vault is attached to the south side of the tank which is accessed by stairs (See photos 3.2-3 and 3.2-11). The entrance was not locked prior to or after the field evaluation. Four vault pipes penetrate the tank wall, and there is some corrosion on the piping (See photos 3.2-13 through 3.2-18). A heater, lights, and electric cabinets are located in the vault, and the vault contains a sump and pump (See photos 3.12 and 3.2-19). The 46-1/2 in. (1181 mm) minimum handrail height on the valve vault stairs exceeds the maximum allowed 34 in. (863 mm) which is a safety deficiency.

PHOTO 3.2-3 Tank 823 and valve vault adjacent to tank.

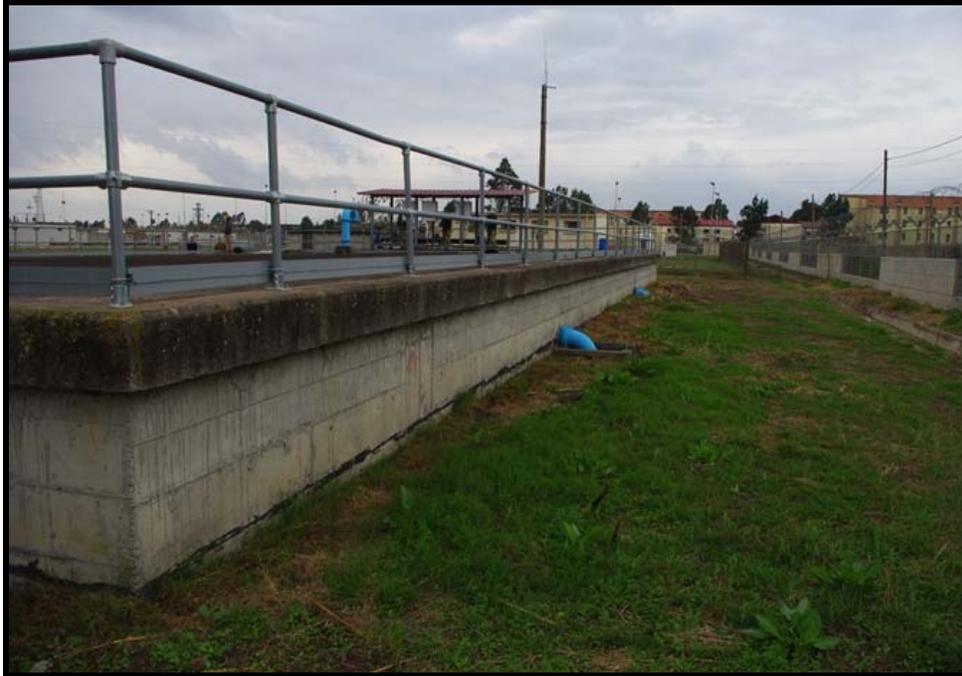
The exterior concrete shell surfaces are in generally good overall condition as there are only a few hairline cracks (See photos 3.2- 7 through 3.2-9). The part of the shell which was visible from the valve vault is also in good overall condition (See photo 3.2-14). An area which had been patched is located on the west side of the shell. Conduit is attached to the shell, and straw is stuck in and around the conduit (See photo 3.2-10).

PHOTO 3.2-7 Tank 823.

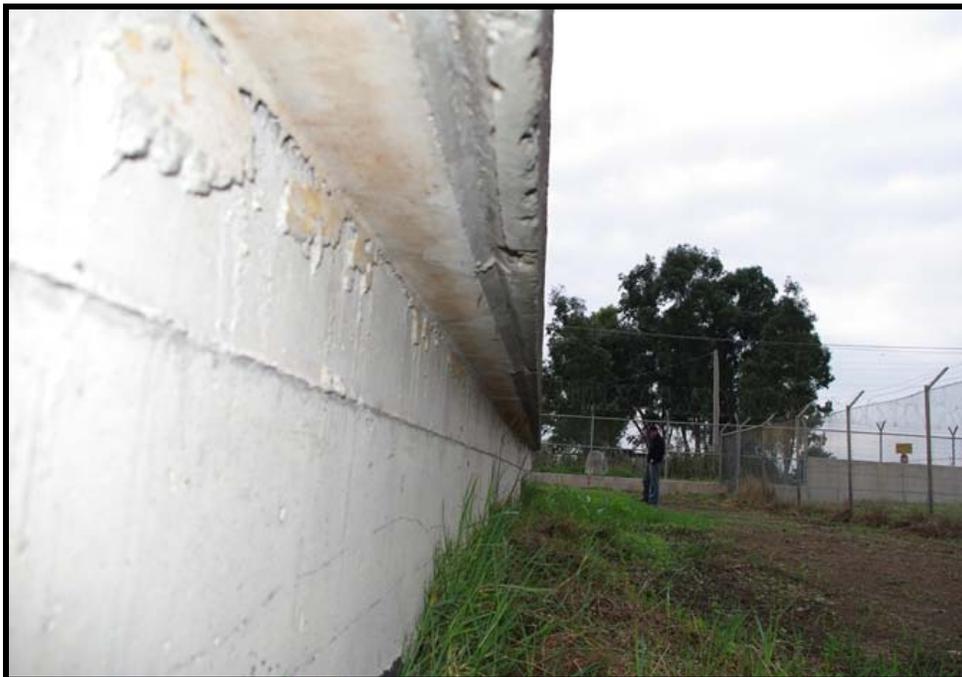
The concrete roof is in good overall condition except for a few minor hairline cracks (See photo 3.2-40). The roof overhangs the shell, and a gutter extends along the east side of the roof (See photo 3.2-8). The gutter and some of the downspouts are clogged with vegetation and debris (See photos 3.2-24 through 3.2-26). Piping and pumping equipment is located on the roof (See photos 3.2-6, 3.2-30, and 3.2-31). What appeared to be sensor equipment is also located on the roof (See photos 3.2-32 and 3.2-33).

PHOTO 3.2-8 Shell and roof overhang.

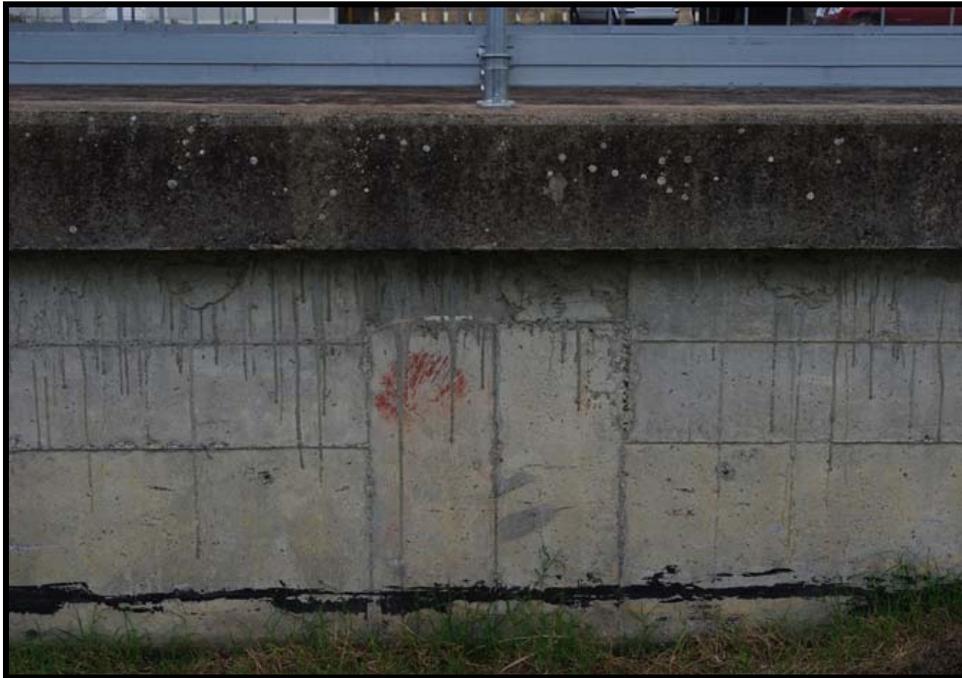
PHOTO 3.2-9 Shell exterior.
