**Site Specific Report  
CR-NAVFAC EXWC-CIOFP-1310**

**TANK INSPECTIONS AND ASSESSMENTS AT  
NAVAL AIR STATION  
SIGONELLA, ITALY**

November 2012

Contract No. N62583-10-D-0340  
Delivery Order No. 0018

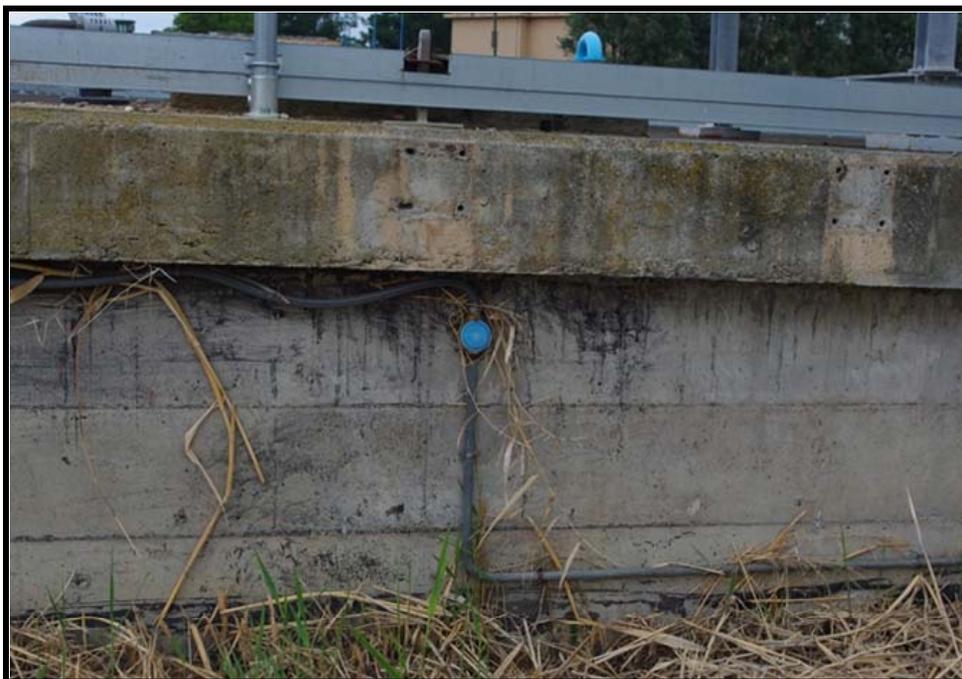
The exterior concrete shell surfaces are in generally good overall condition as there are only a few hairline cracks (See photos 3.2- 7 through 3.2-9). The part of the shell which was visible from the valve vault is also in good overall condition (See photo 3.2-14). An area which had been patched is located on the west side of the shell. Conduit is attached to the shell, and straw is stuck in and around the conduit (See photo 3.2-10).

PHOTO 3.2-10 Equipment and debris on shell.

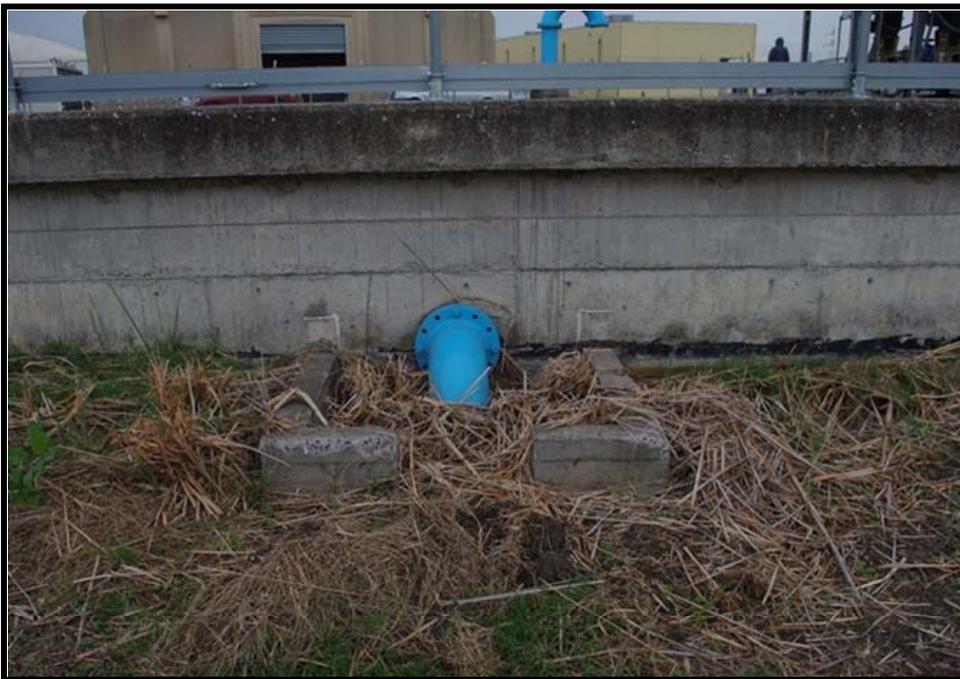
The overflow pipes have been replaced since the previous evaluation. Two overflow pipes now project from near the top of the shell and elbow downward before discharging within drain basins (See photos 3.2-20 and 3.2-22). The overflow pipes have above-grade air breaks although there is straw and debris in the drain basin around one of the discharges (See photo 3.2-21). Perforated plate screens are located at the discharges which appear to be intact, and some of the flange bolt holes are open (See photos 3.2-20 and 3.2-23).

PHOTO 3.2-20 Overflow pipe and debris in drain basin. Note open flange bolt holes.

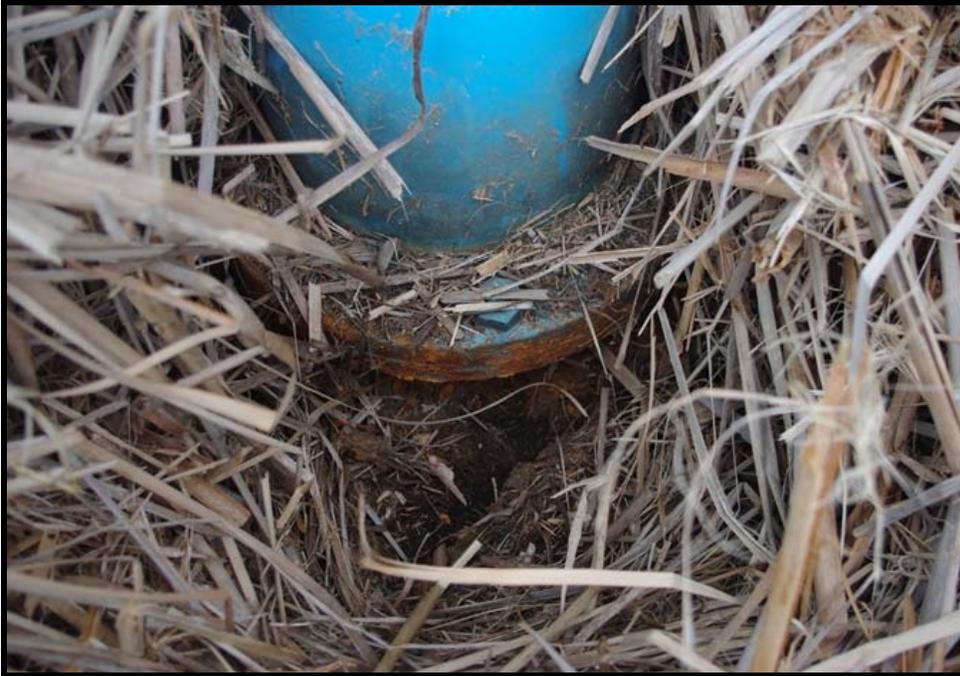
PHOTO 3.2-21 Overflow pipe and straw in drain basin.

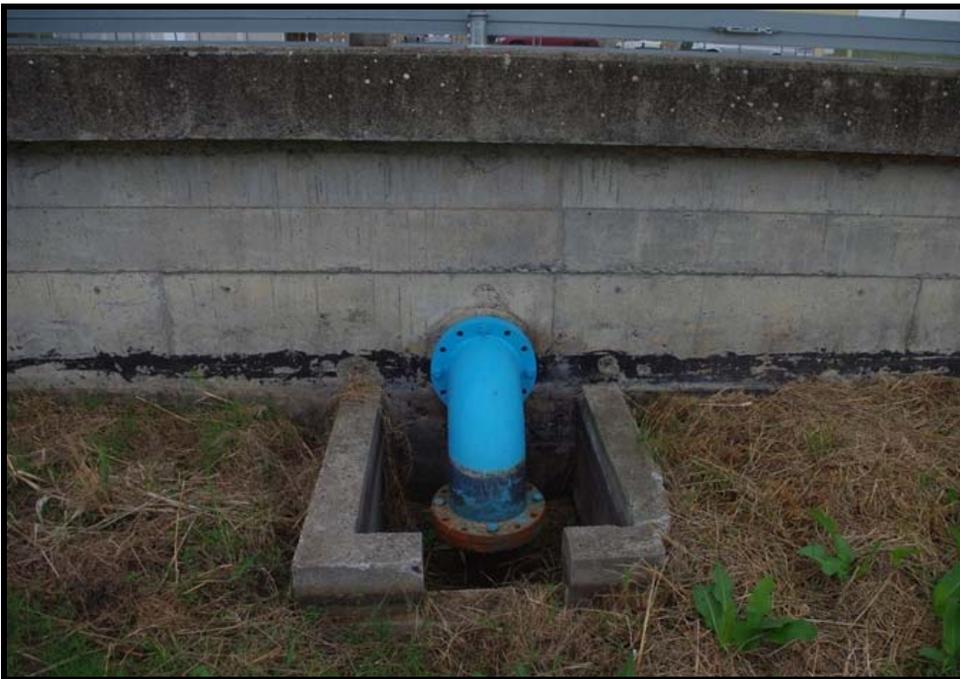
PHOTO 3.2-22 Overflow pipe in drain basin.

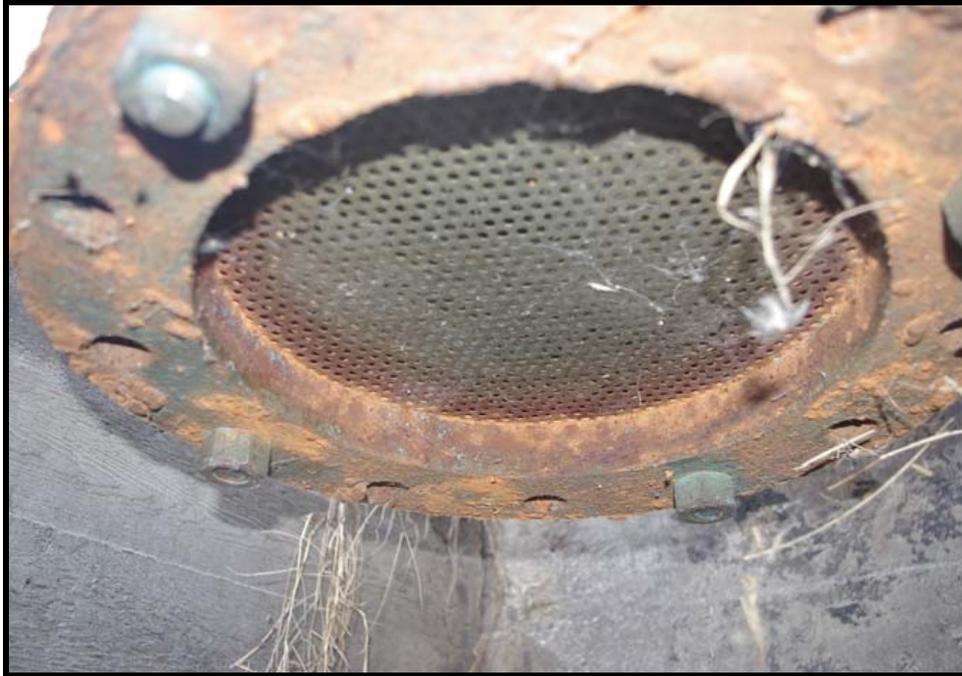
PHOTO 3.2-23 Screened overflow pipe discharge. Note open bolt holes and debris.

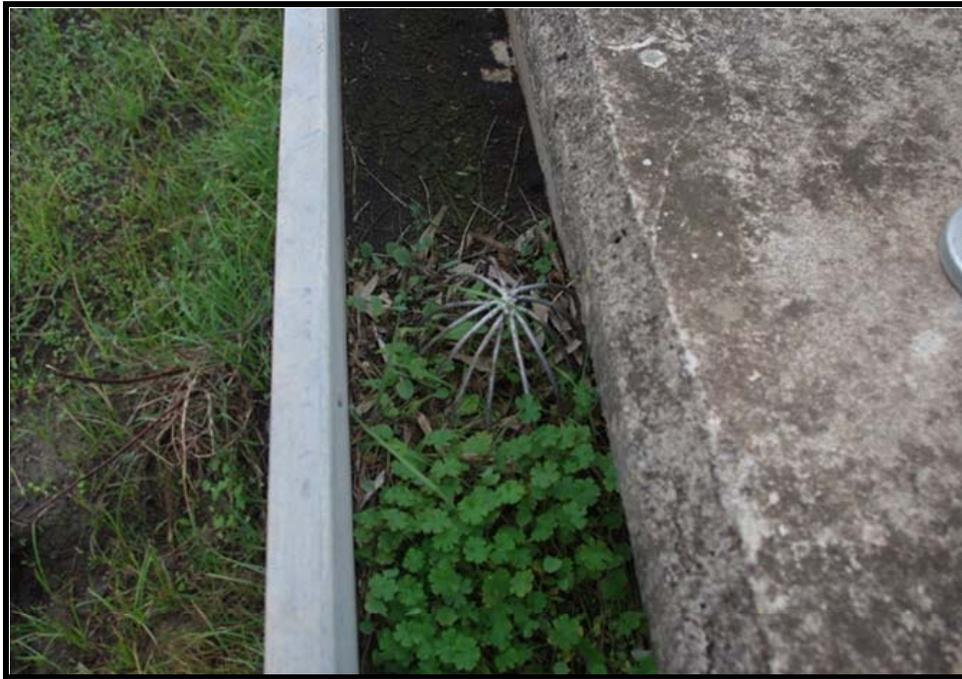
The concrete roof is in good overall condition except for a few minor hairline cracks (See photo 3.2-40). The roof overhangs the shell, and a gutter extends along the east side of the roof (See photo 3.2-8). The gutter and some of the downspouts are clogged with vegetation and debris (See photos 3.2-24 through 3.2-26). Piping and pumping equipment is located on the roof (See photos 3.2-6, 3.2-30, and 3.2-31). What appeared to be sensor equipment is also located on the roof (See photos 3.2-32 and 3.2-33).

PHOTO 3.2-25 Vegetation and debris in gutter.

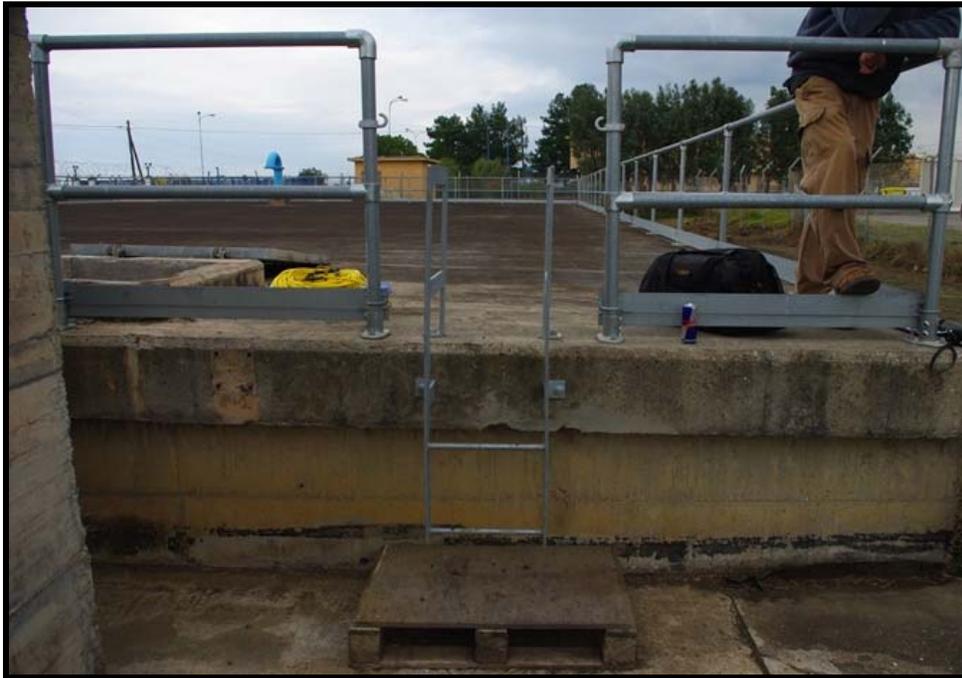
PHOTO 3.2-27 Exterior ladder and roof safety railing.

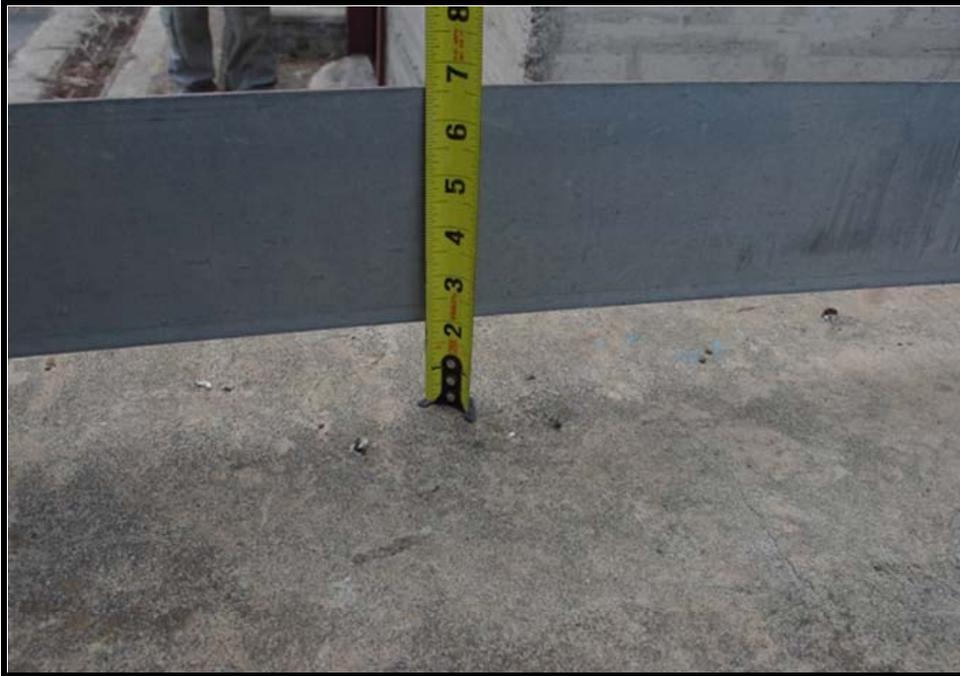
PHOTO 3.2-29 Gap between toe bar and roof.

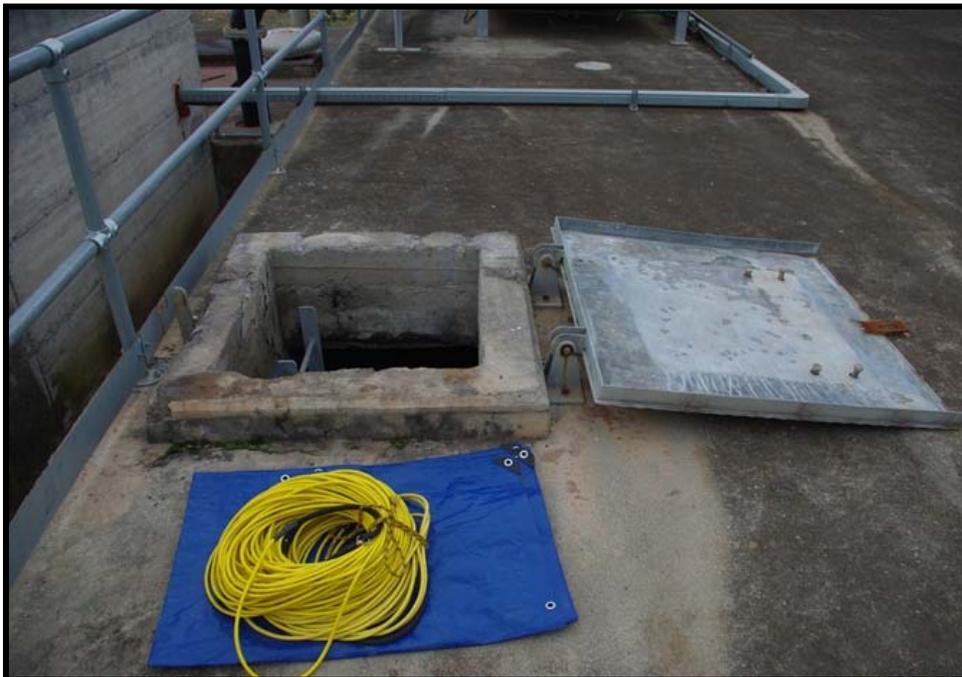
PHOTO 3.2-35 Corrosion on exposed steel in roof manhole neck.

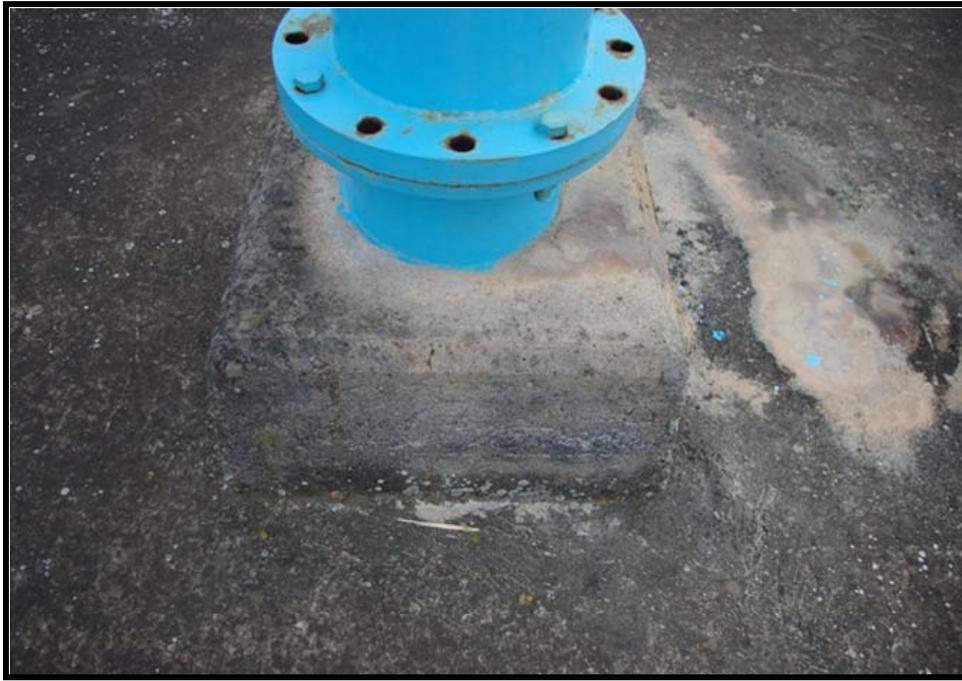
PHOTO 3.2-41 Roof vent neck. Note open bolt holes.

**Clog-Resistant Vents:** The roof vents are not clog-resistant. The AWWA D100 Standard (applicable for steel tanks) recommends that all vents with screening against insects be designed to ensure "fail-safe" operation if the insect screens become occluded. However, AWWA D110 does not require a clog-resistant vent, and a concrete roof is typically capable of withstanding more pressure or vacuum than a steel roof. Bolts should be installed at the open holes.

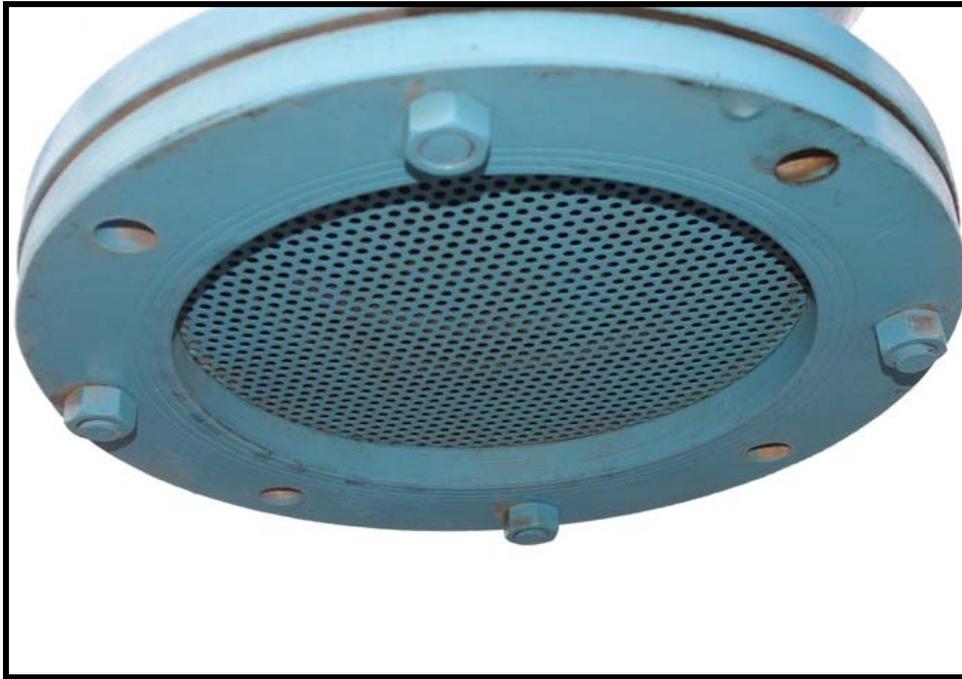
PHOTO 3.2-43 Screened roof vent. Note open bolt holes.

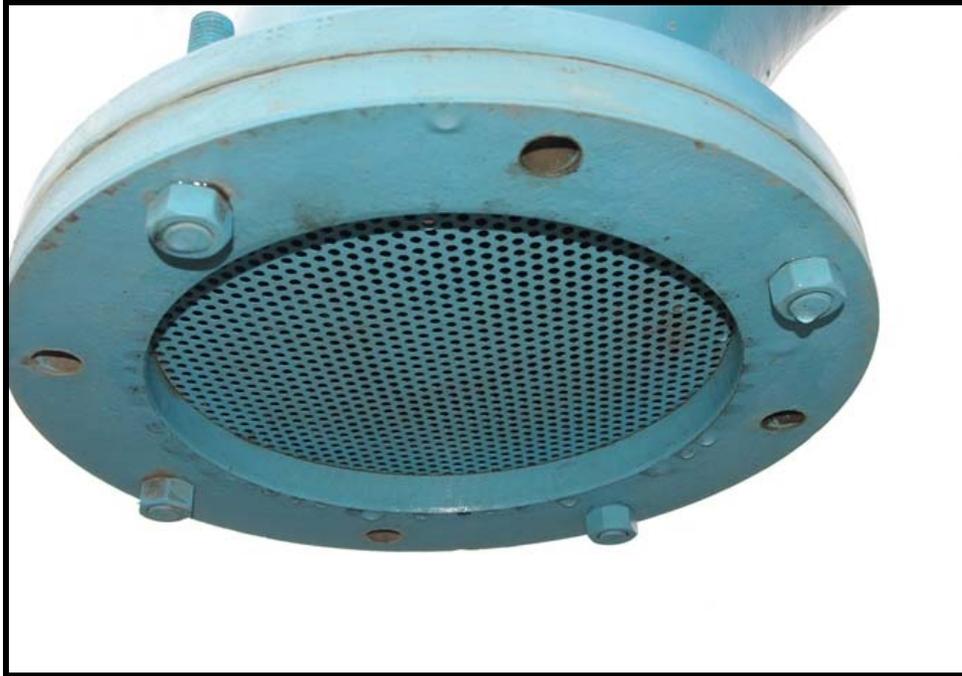
PHOTO 3.2-45 Screened roof vent. Note open bolt holes.

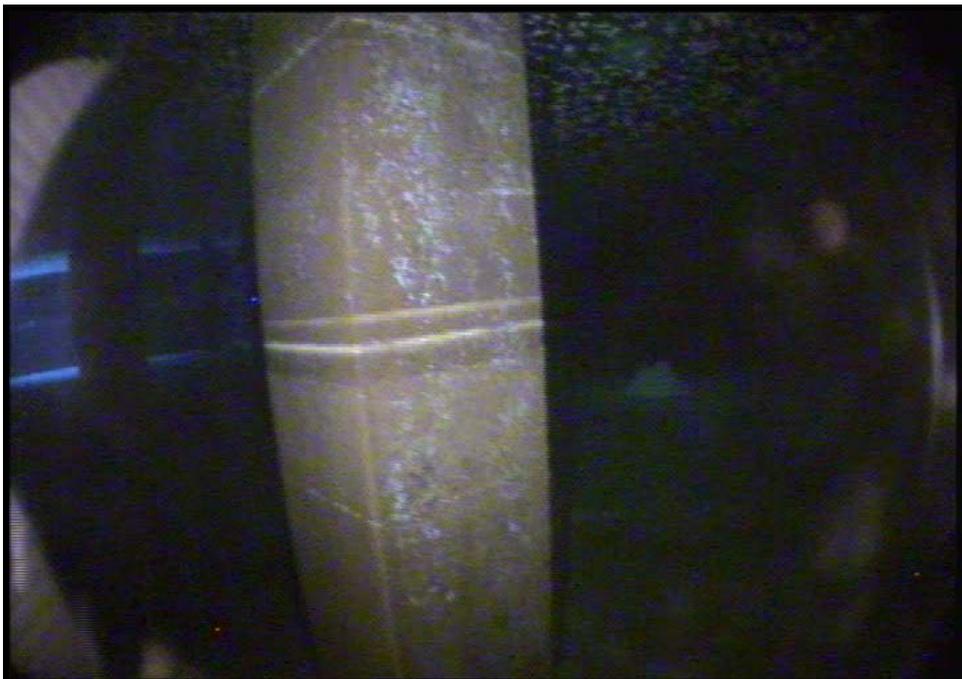
PHOTO 3.2-59 Corrosion interior piping and interior piping splash block.

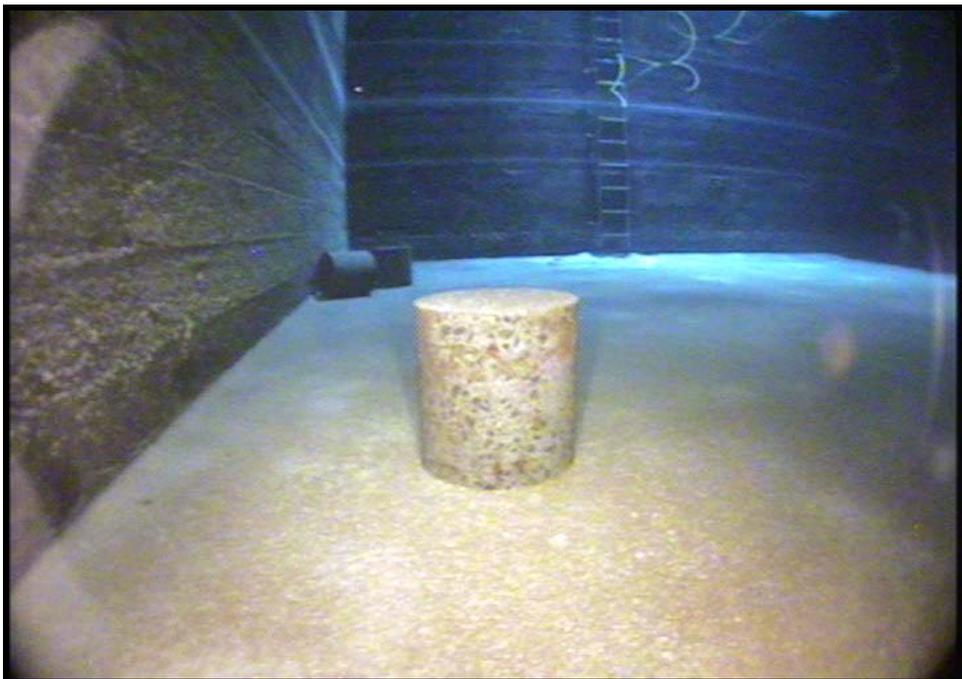
PHOTO 3.2-66 Concrete and silt on floor.

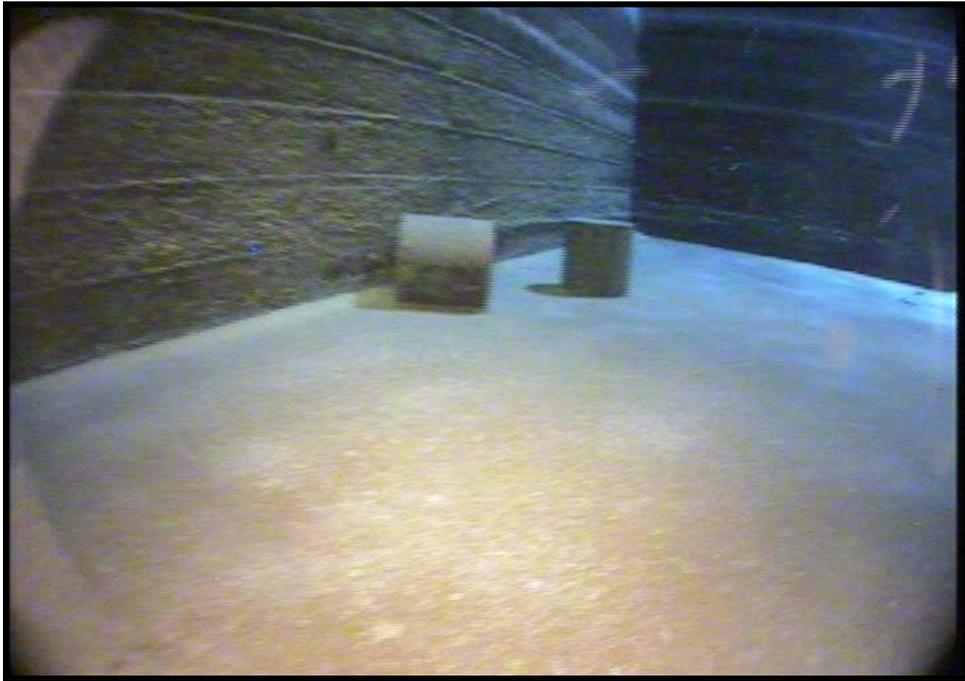
PHOTO 3.2-67 Concrete and silt on floor.

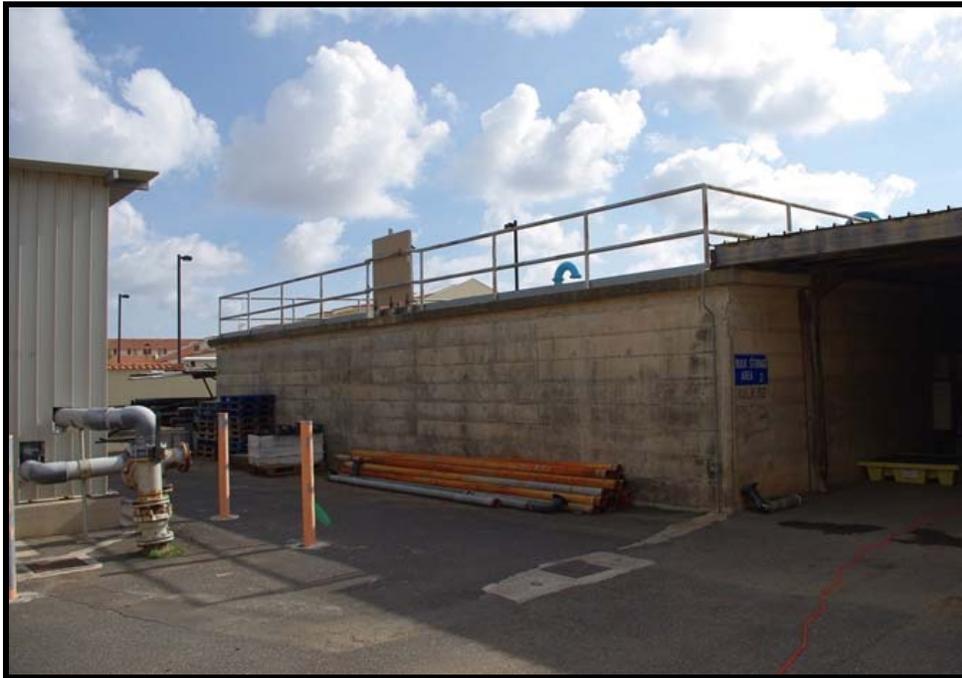
PHOTO 3.3-5 Tank 535.

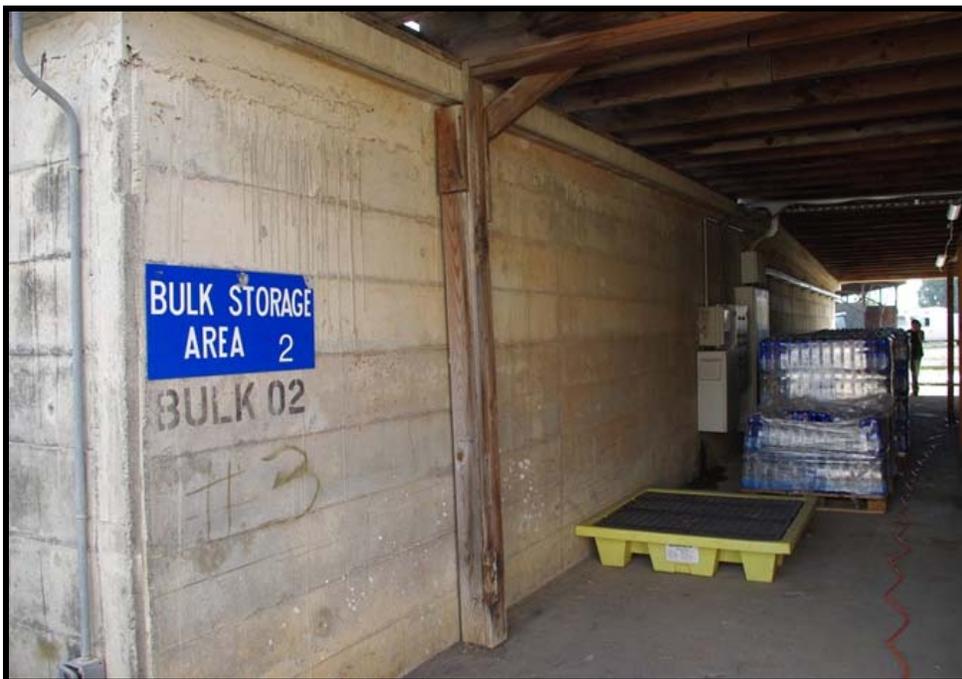
PHOTO 3.3-6 Tank 535.

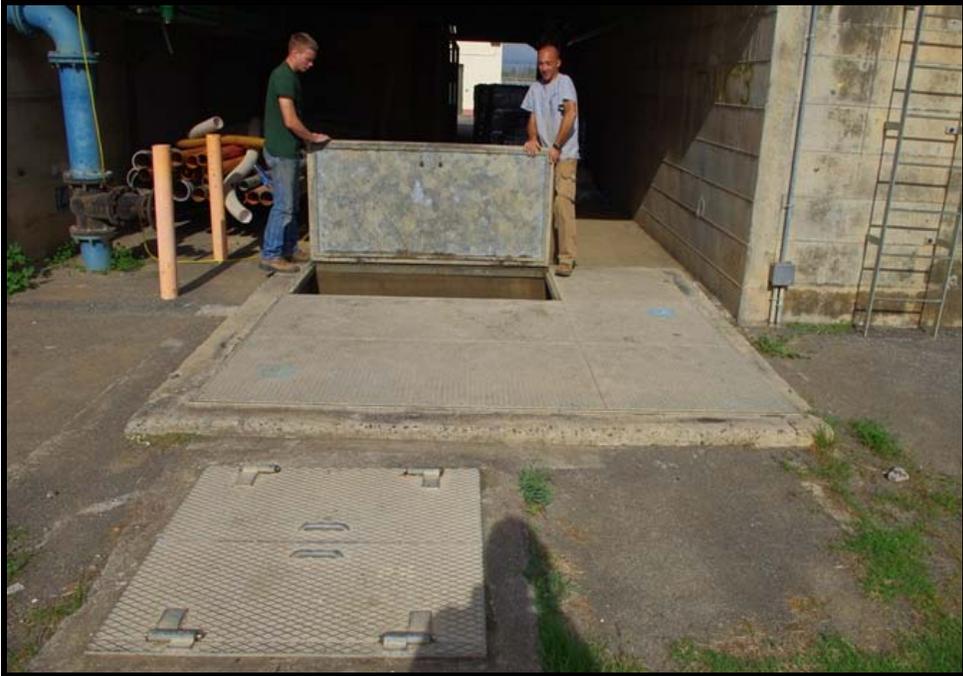
PHOTO 3.3-7 Valve vault.

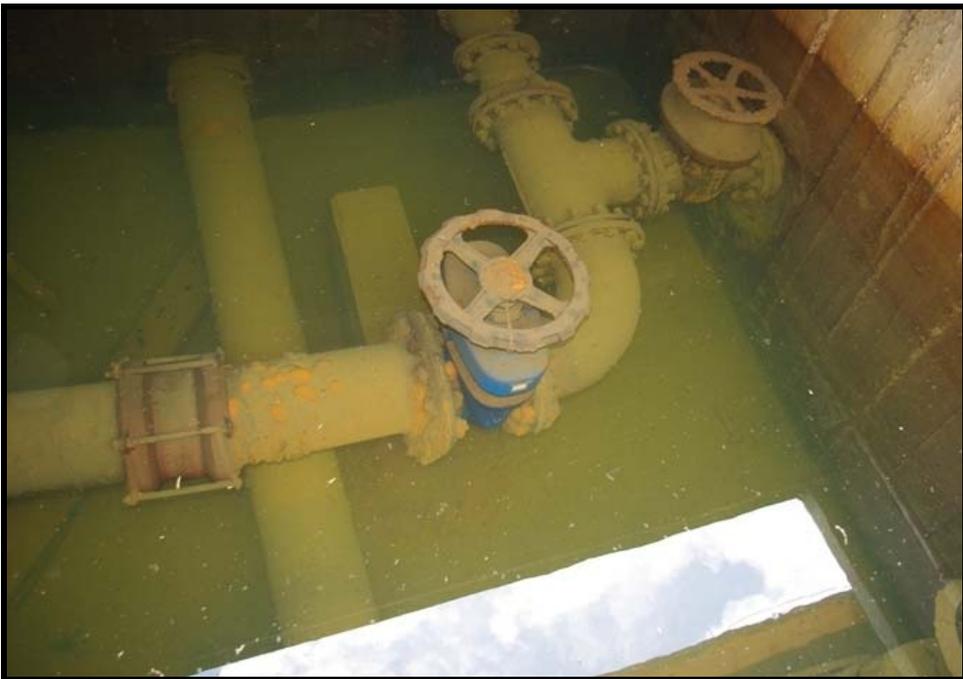
PHOTO 3.3-8 Water standing in valve vault.

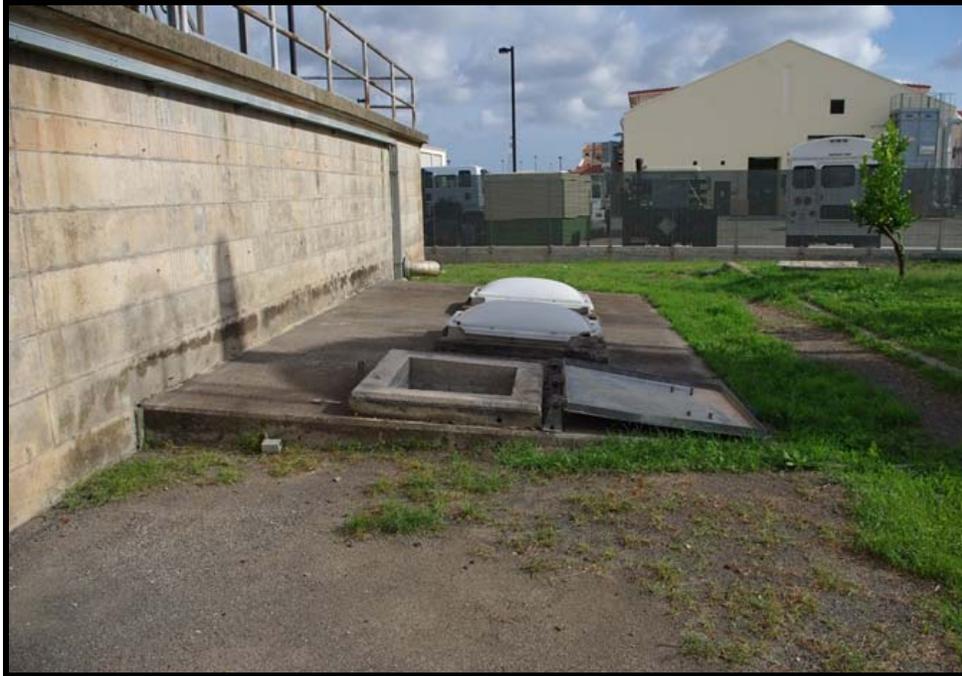
PHOTO 3.3-9 Valve vault exterior.

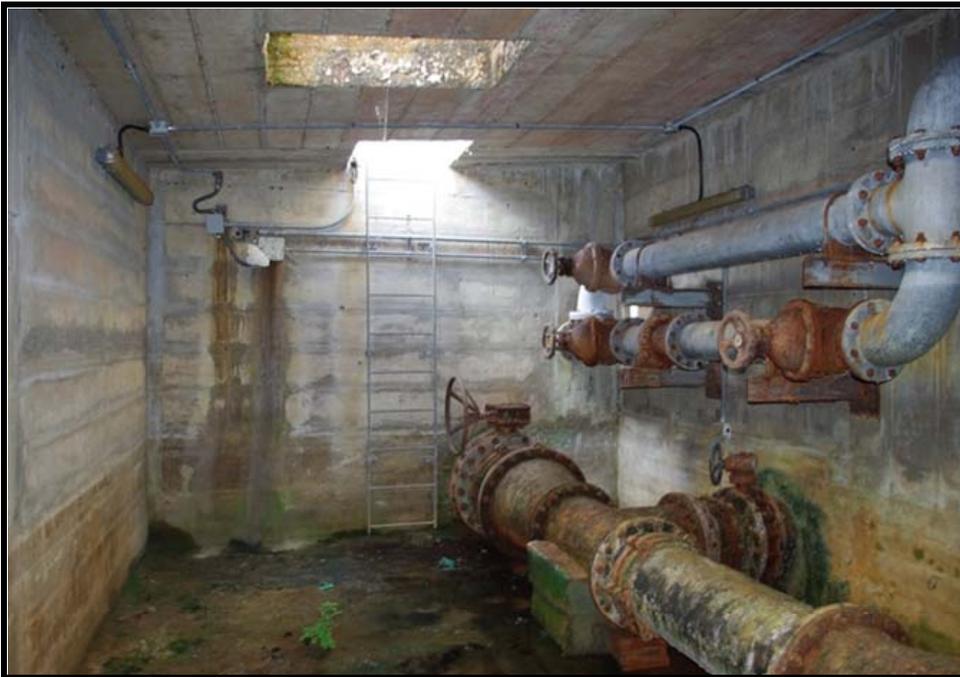
PHOTO 3.3-12 Valve vault interior.

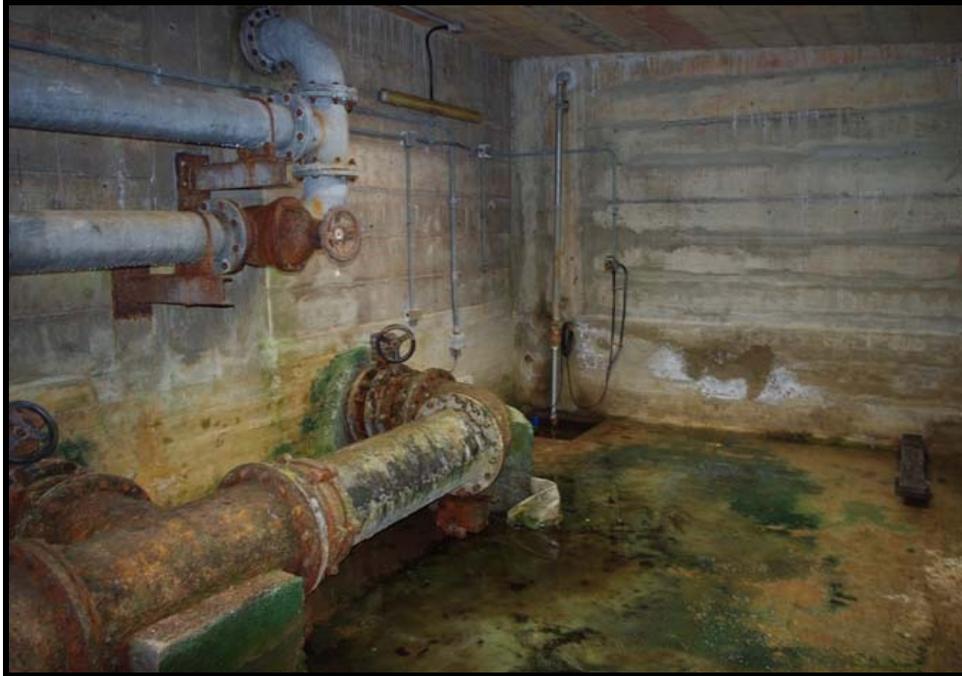
PHOTO 3.3-13 Valve vault interior.

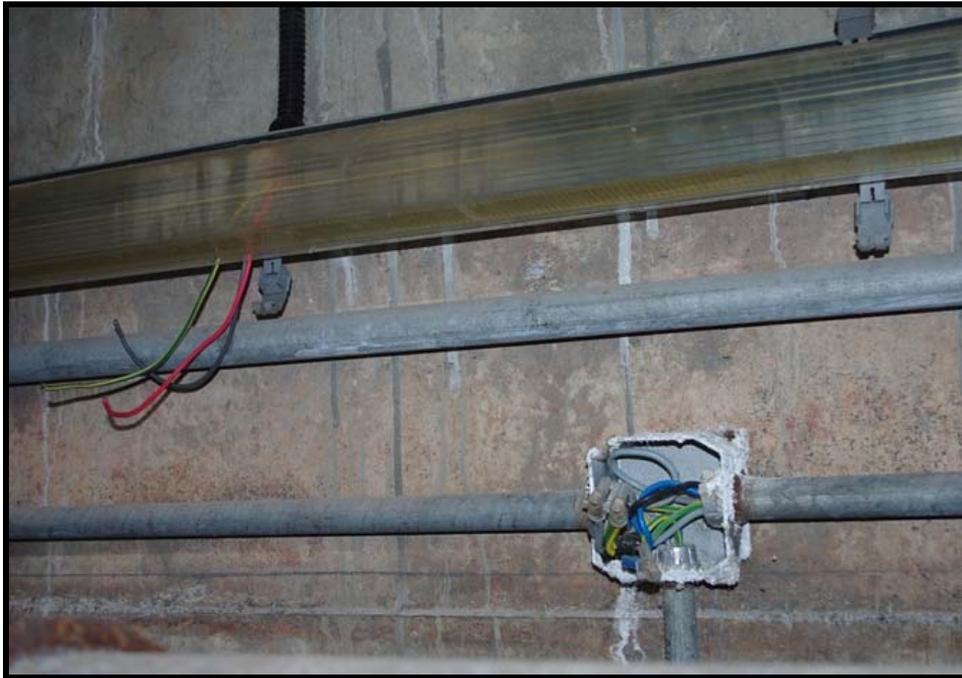
PHOTO 3.3-19 Exposed wiring in valve vault.

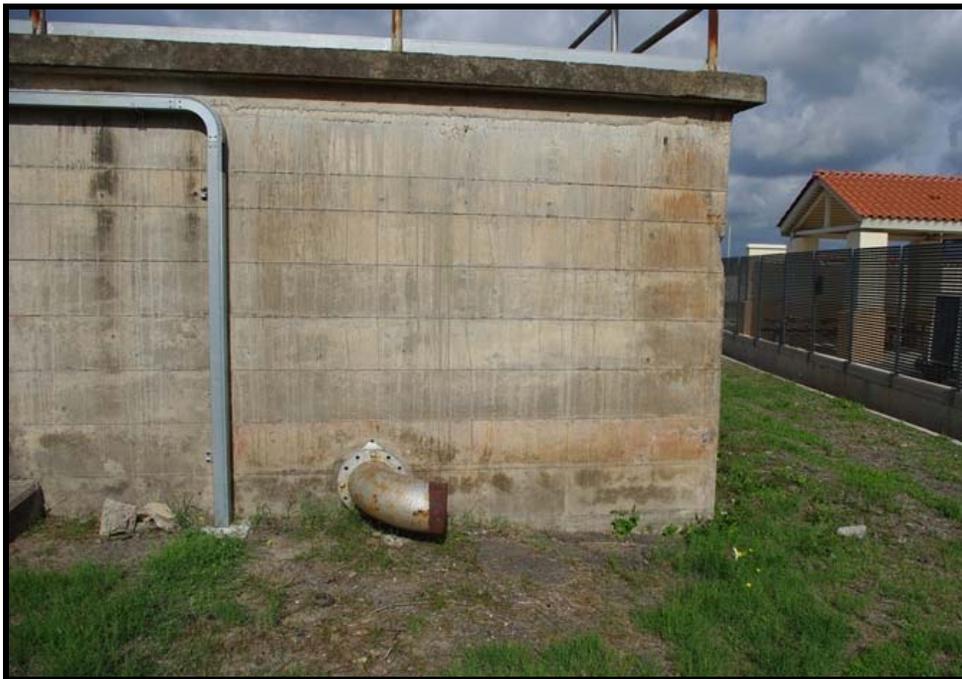
PHOTO 3.3-20 Overflow pipe.

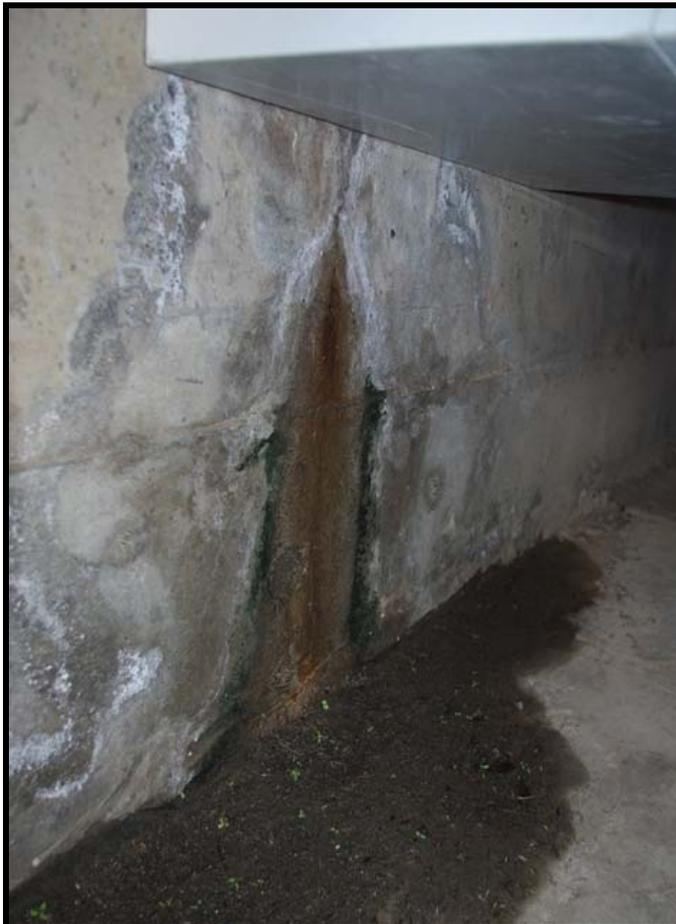
PHOTO 3.3-22 Apparent leak in concrete shell.

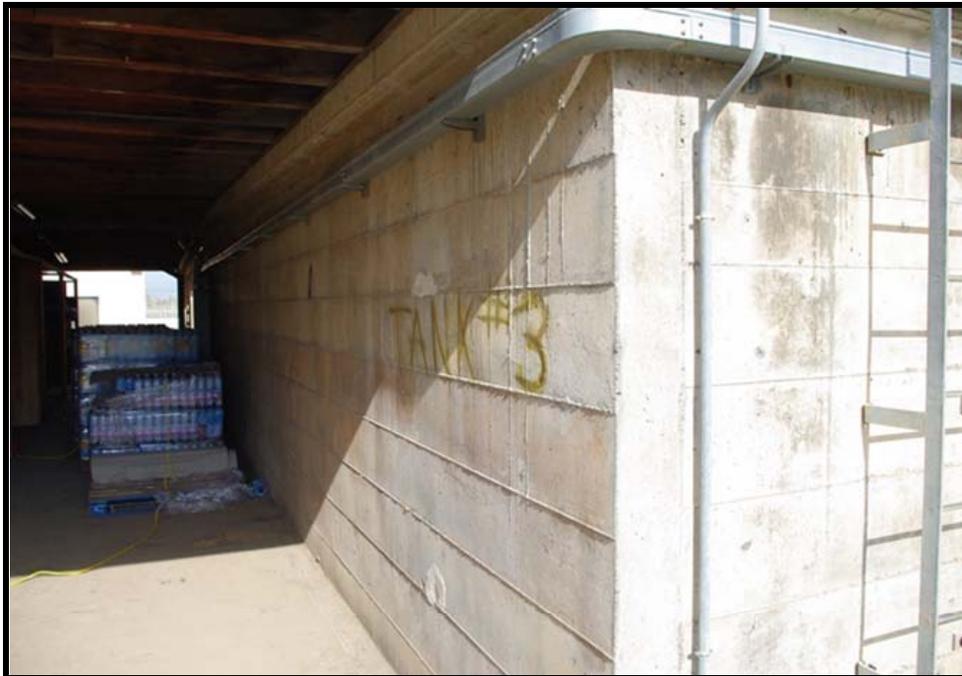
PHOTO 3.3-24 Information painted on tank.

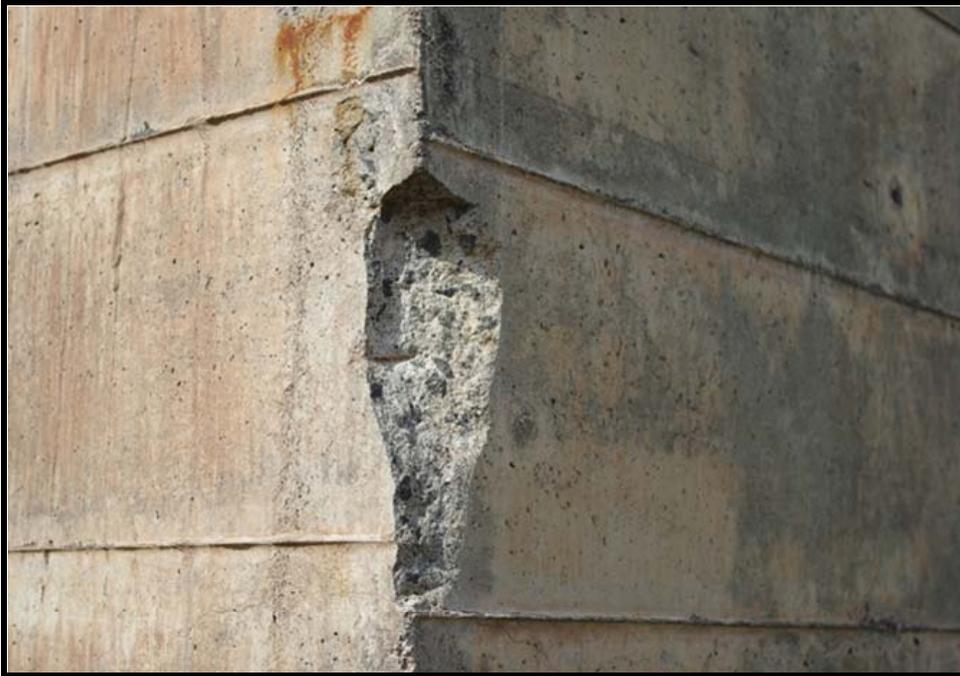
PHOTO 3.3-25 Chip in shell corner.

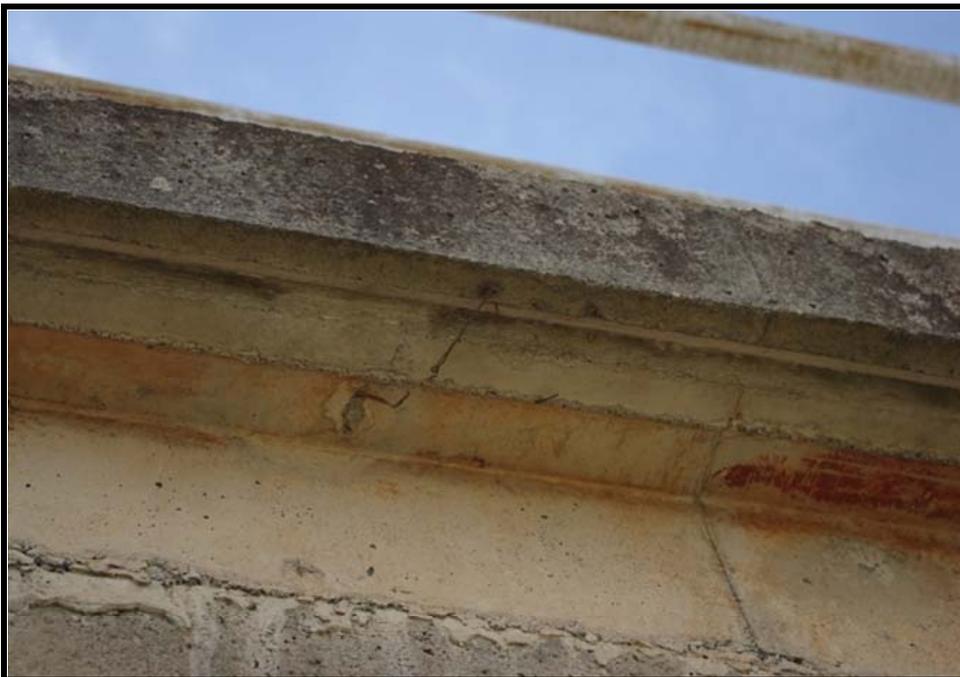
The concrete roof appears to be in good overall condition as there are only a few hairline cracks and some efflorescence (See photos 3.3-42 and 3.3-43). The roof overhangs the shell, and it appeared the overhang had been repaired previously. Piping and pump equipment have been installed on the south part of the roof (See photos 3.3-36 through 3.3-38).

PHOTO 3.3-28 Roof overhang.

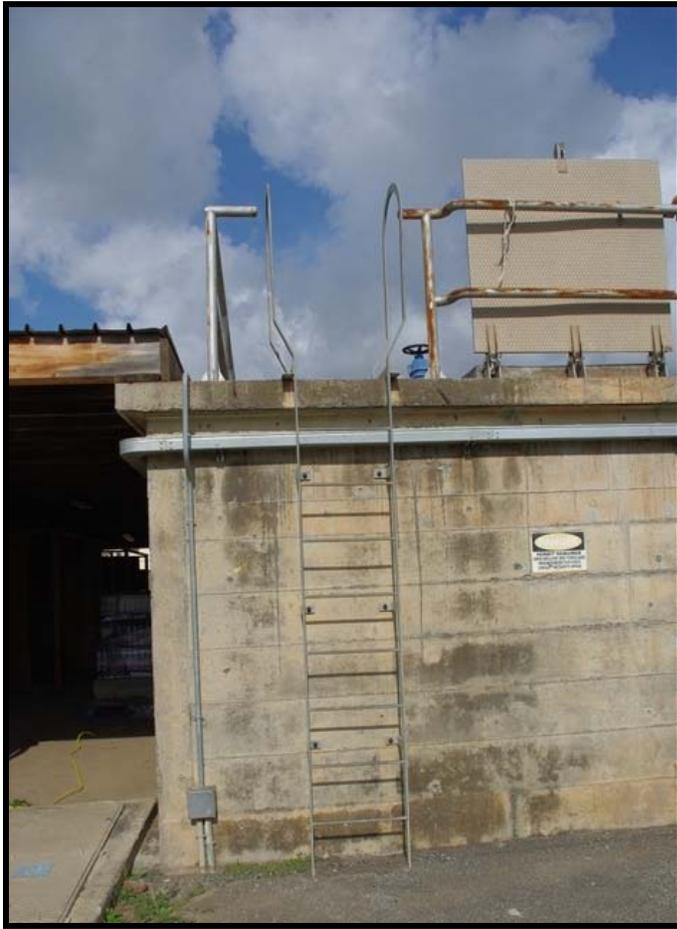
A ladder provides access from near grade to the roof which is equipped with bolted brackets (See photo 3.3-29). Some of the brackets and bolts are rusty but appear to be in nearly their original structural condition. The ladder does not have a safe-climbing device, but there are terminals at the roof access (See photo 3.3-30). Safety-related and OSHA deficiencies noted include: (1) the 2 in. (51 mm) x 3/8 in. (19 mm) side rails do not precisely meet the required 2-1/2 in. (64 mm) x 3/8 in. (19 mm) minimum, and (2) the 5/8 in. (16 mm) diameter ladder rungs do not precisely meet the required 3/4 in. (19 mm) diameter minimum.

PHOTO 3.3-29 Exterior ladder.

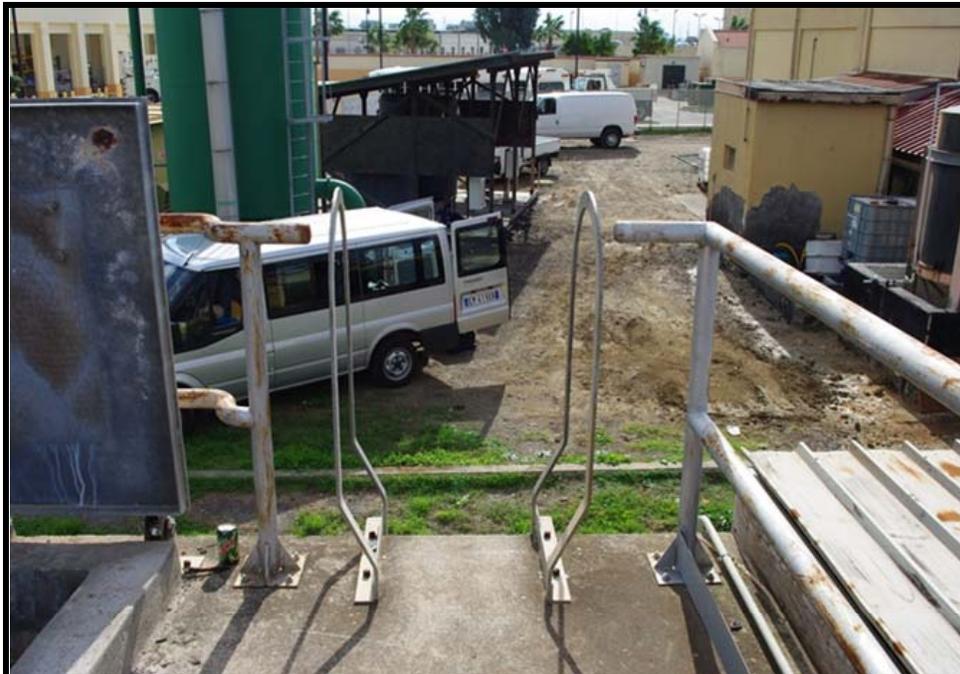
PHOTO 3.3-30 Roof access.

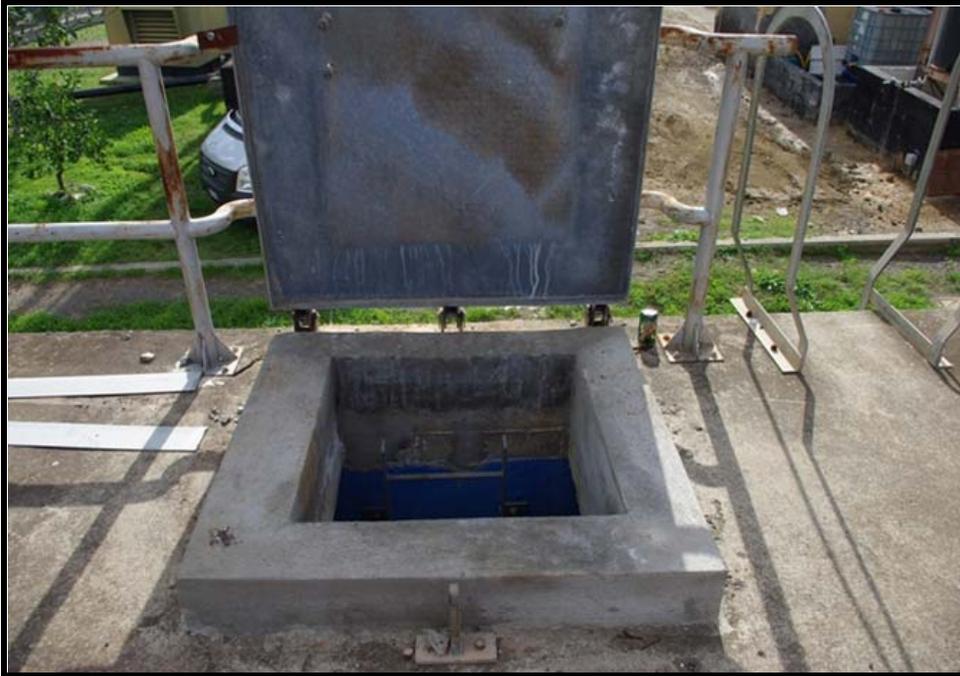
The roof has two manholes which include locked covers (See photos 3.3-31 through 3.3-33 and 3.3-35). There are cracks, spalls, and exposed rebar in the concrete necks (See photo 3.3-34).

PHOTO 3.3-31 Roof manhole.

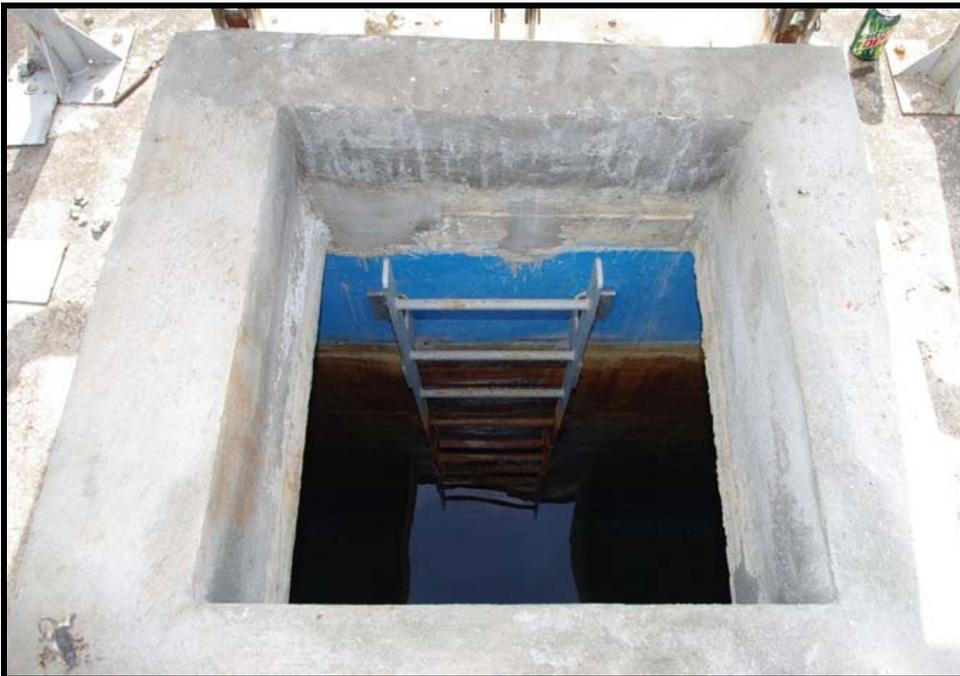
PHOTO 3.3-32 Roof manhole.

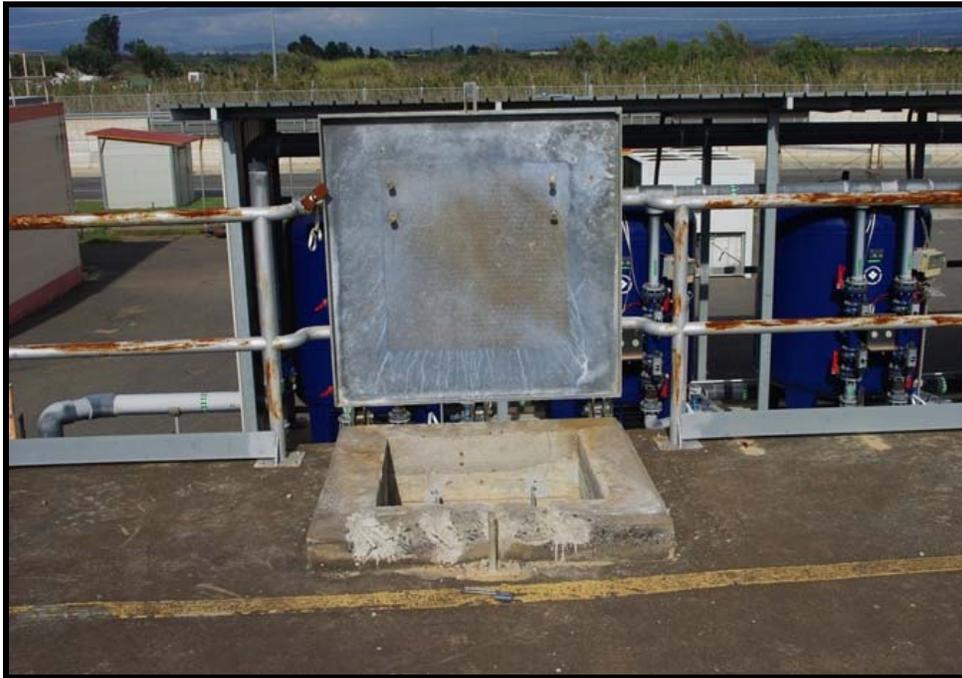
PHOTO 3.3-33 Roof manhole.
