**Site Specific Report  
CR-NAVFAC EXWC-CIOFP-1310**

**TANK INSPECTIONS AND ASSESSMENTS AT  
NAVAL AIR STATION  
SIGONELLA, ITALY**

November 2012

Contract No. N62583-10-D-0340  
Delivery Order No. 0018

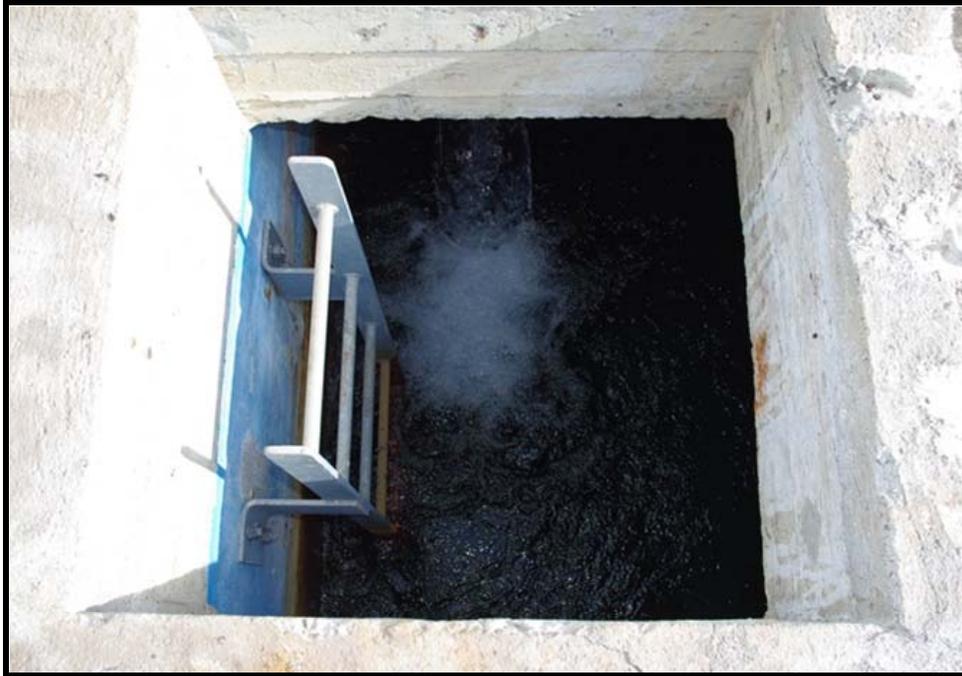
The roof has two manholes which include locked covers (See photos 3.3-31 through 3.3-33 and 3.3-35). There are cracks, spalls, and exposed rebar in the concrete necks (See photo 3.3-34).

PHOTO 3.3-35 Roof manhole interior.

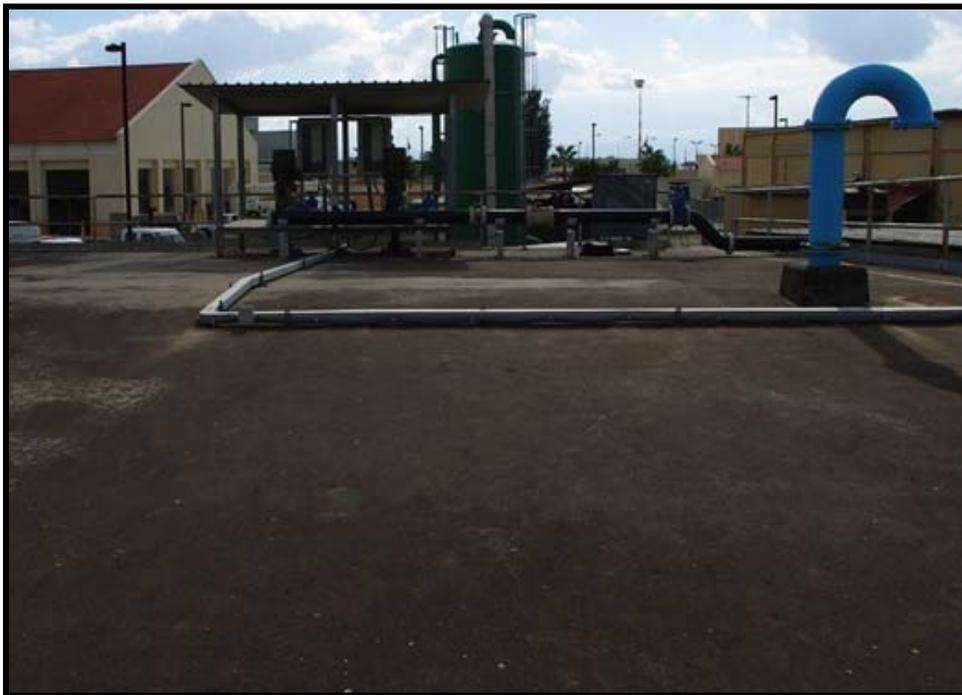
The concrete roof appears to be in good overall condition as there are only a few hairline cracks and some efflorescence (See photos 3.3-42 and 3.3-43). The roof overhangs the shell, and it appeared the overhang had been repaired previously. Piping and pump equipment have been installed on the south part of the roof (See photos 3.3-36 through 3.3-38).

PHOTO 3.3-36 Pump equipment on roof.

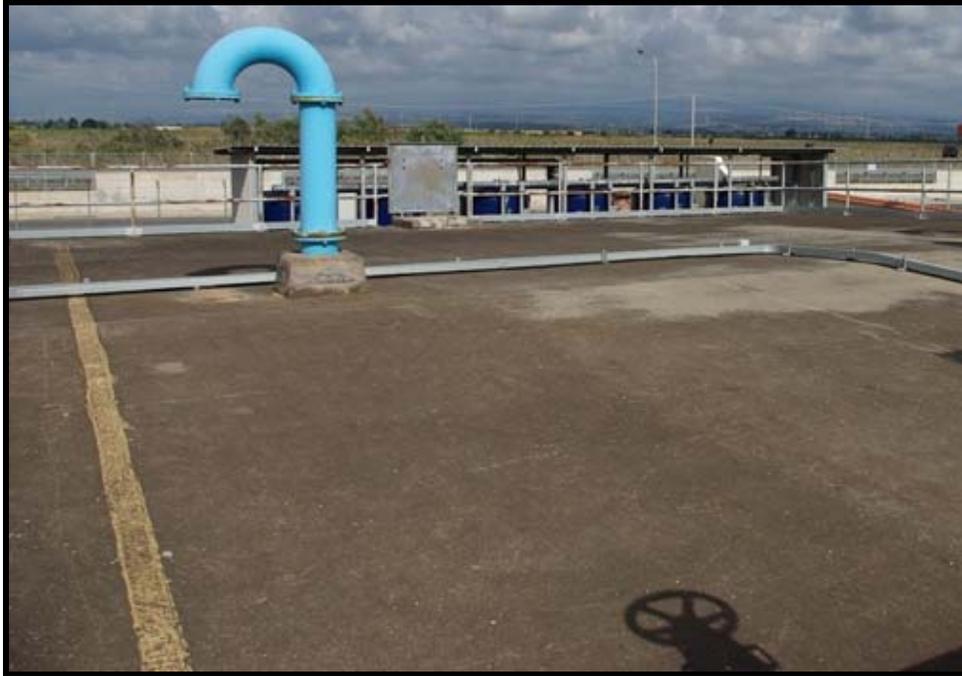
PHOTO 3.3-37 Piping is located on the roof.

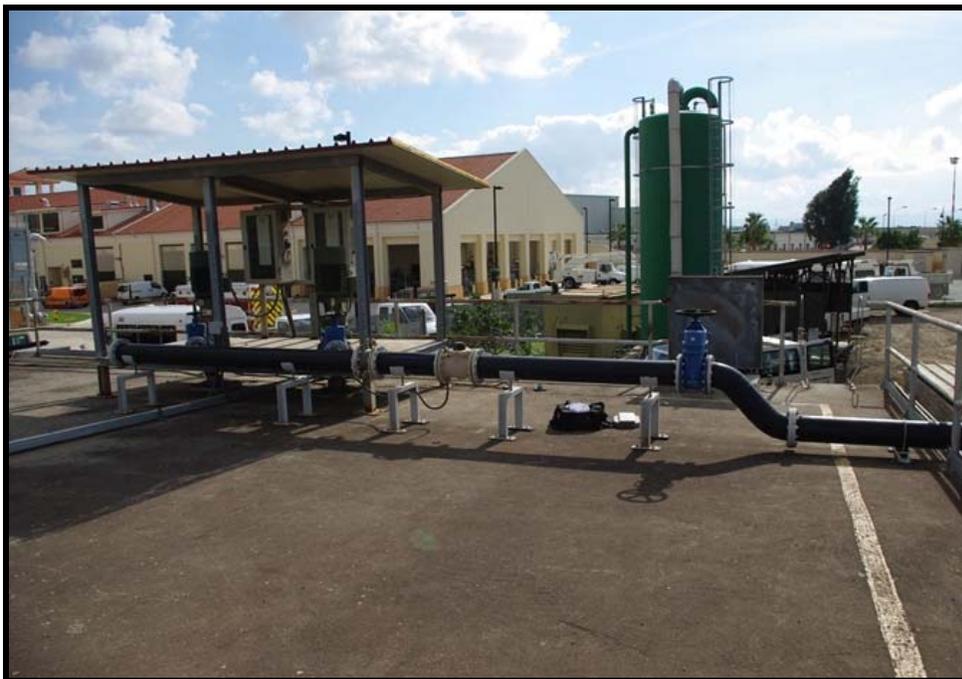
PHOTO 3.3-38 Pump equipment on roof.

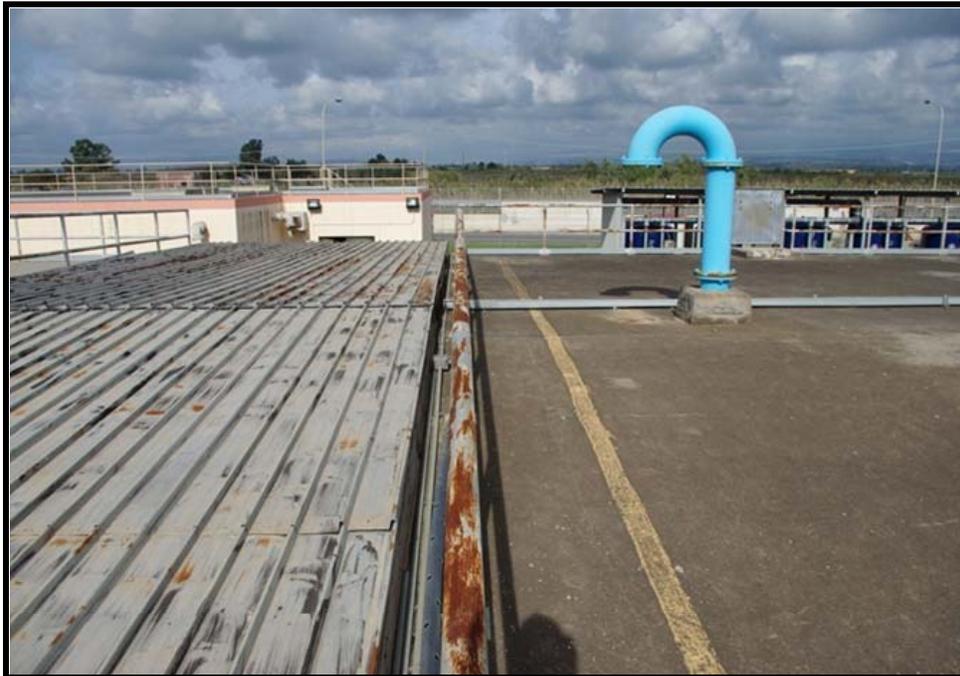
Safety railing extends around the perimeter of the roof which is constructed of welded pipe members. The safety railing has been painted, but there is corrosion on it (See photo 3.3-39). The railing has been equipped with a toe bar since the previous evaluation, but some section of the toe bar are broken and lying on the roof. OSHA and safety-related deficiencies noted include: (1) the access opening does not have closure chains to deter personnel from inadvertently falling from the roof, (2) some of the toe bar sections have broken (See photo 3.3-40), and (3) the gaps between the roof and toe bar exceed the maximum allowed 1/4 in. (6 mm).

PHOTO 3.3-39 Corrosion on roof safety railing.

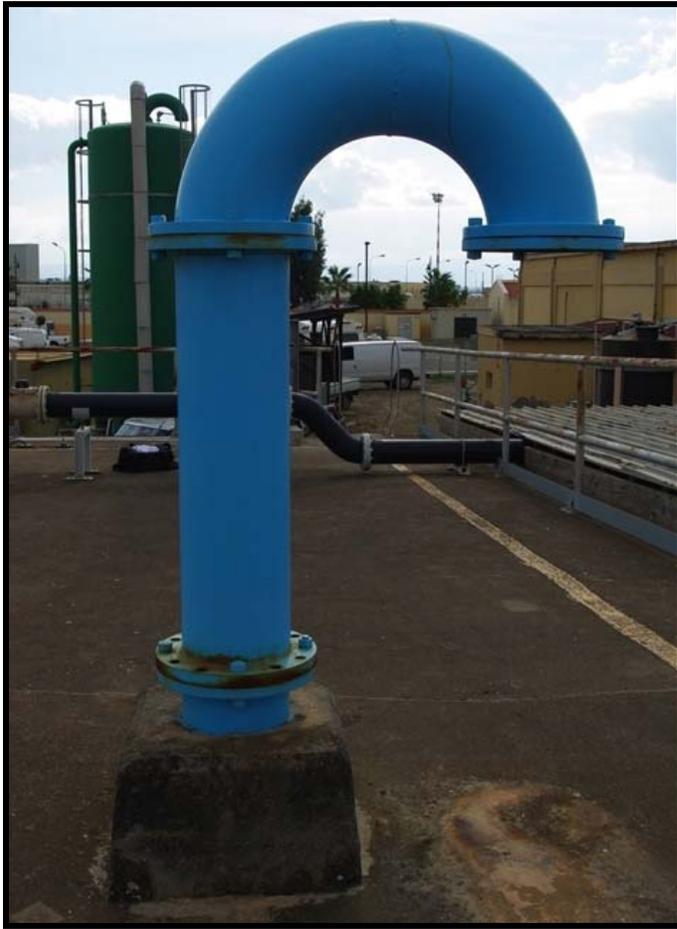
Two gooseneck-type vents are located in the roof, and cracks are located in their concrete necks (See photos 3.3-43 and 3.3-44). There is corrosion on the steel vent and screening, and some of the bolt holes on the flanges are open (See photos 3.3-45 and 3.3-46). The screening is intact although it is not adequately sized to prevent the ingress of insects into the tank which is a sanitary deficiency.

PHOTO 3.3-43 Roof vent. Note rust staining and open bolt holes at flanges.

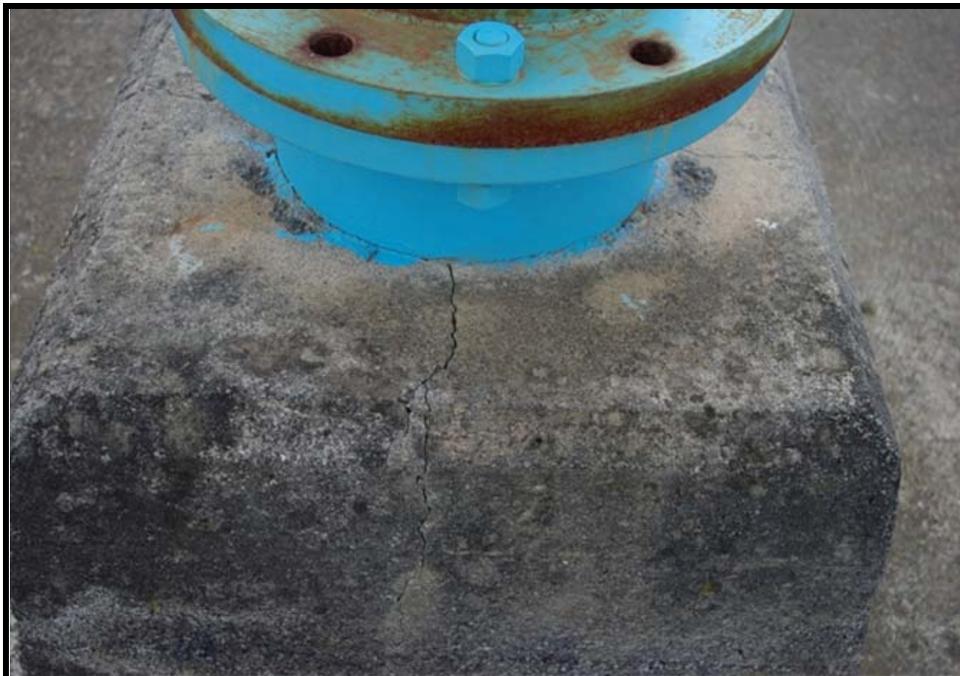
PHOTO 3.3-44 Cracks in roof vent concrete vent neck.

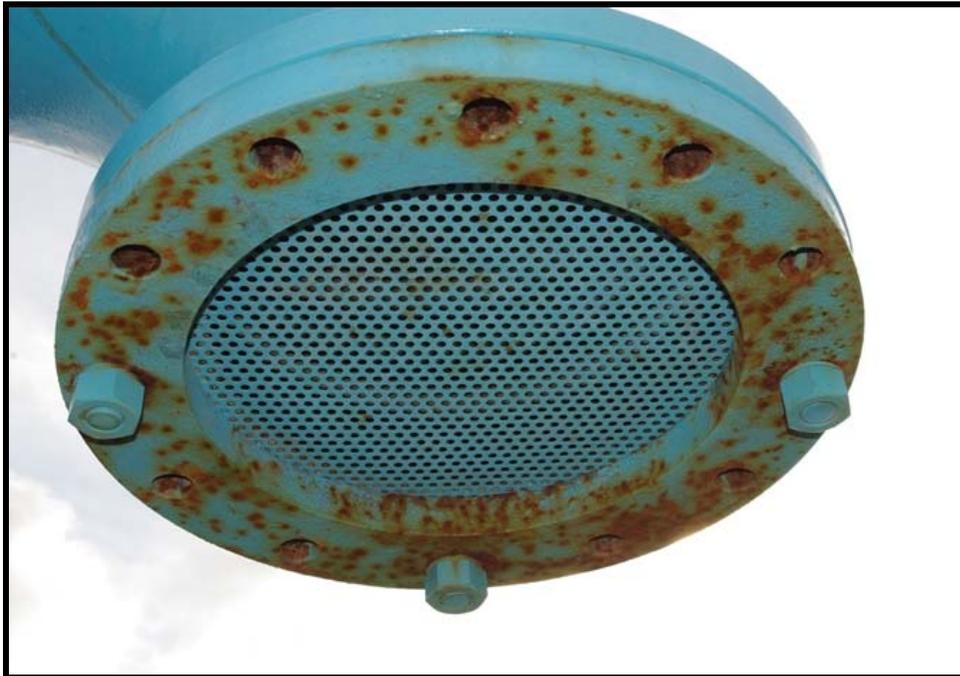
PHOTO 3.3-45 Rust staining and open bolt holes on flange around roof vent screening.

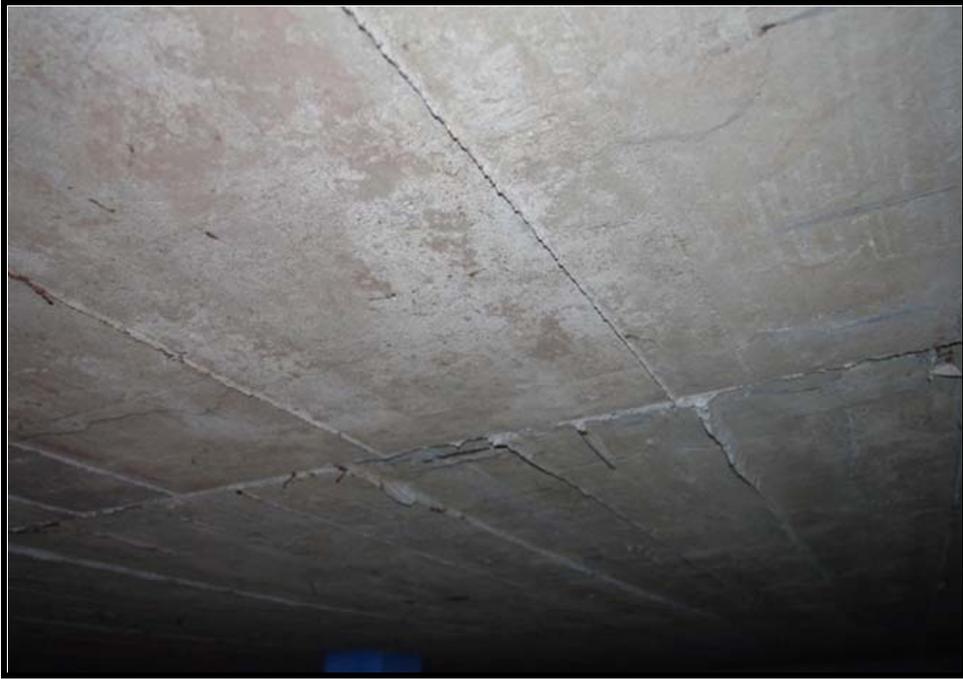
PHOTO 3.3-47 Roof interior.

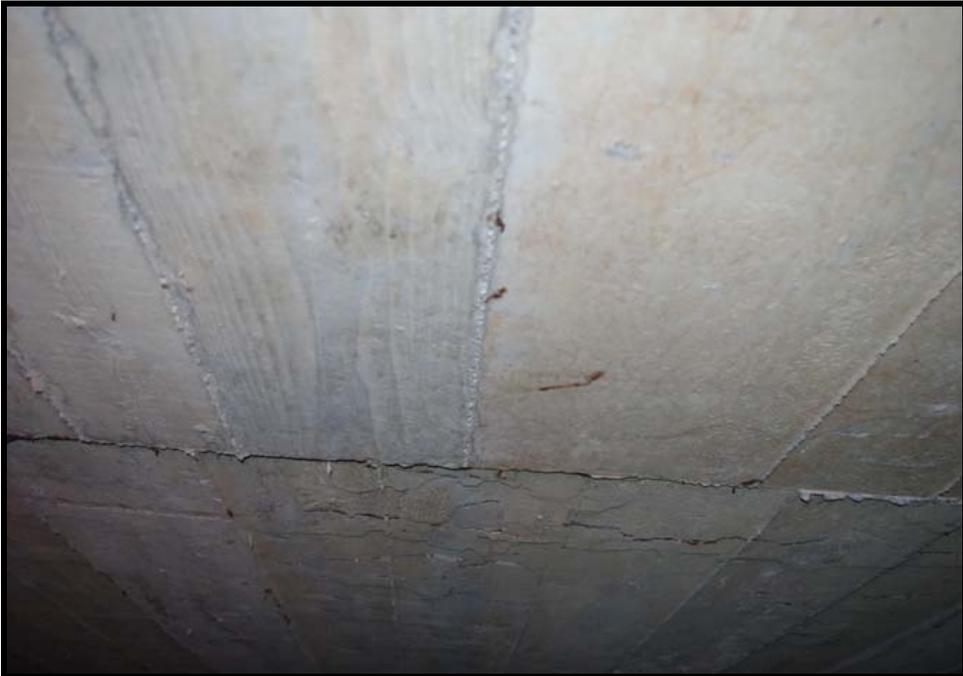
PHOTO 3.3-48 Roof interior.

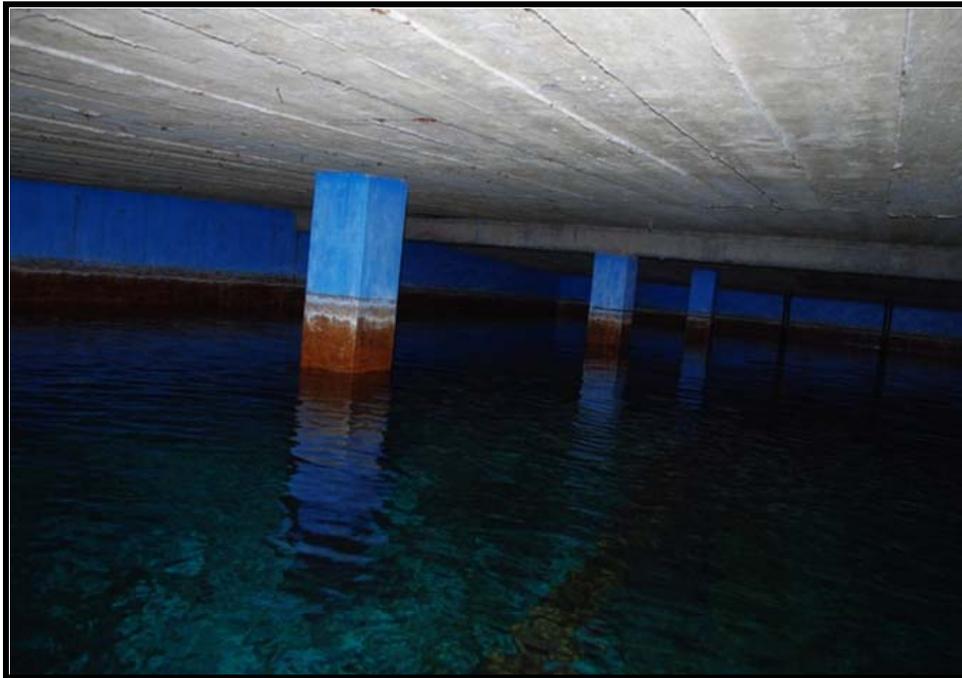
PHOTO 3.3-49 Tank interior.

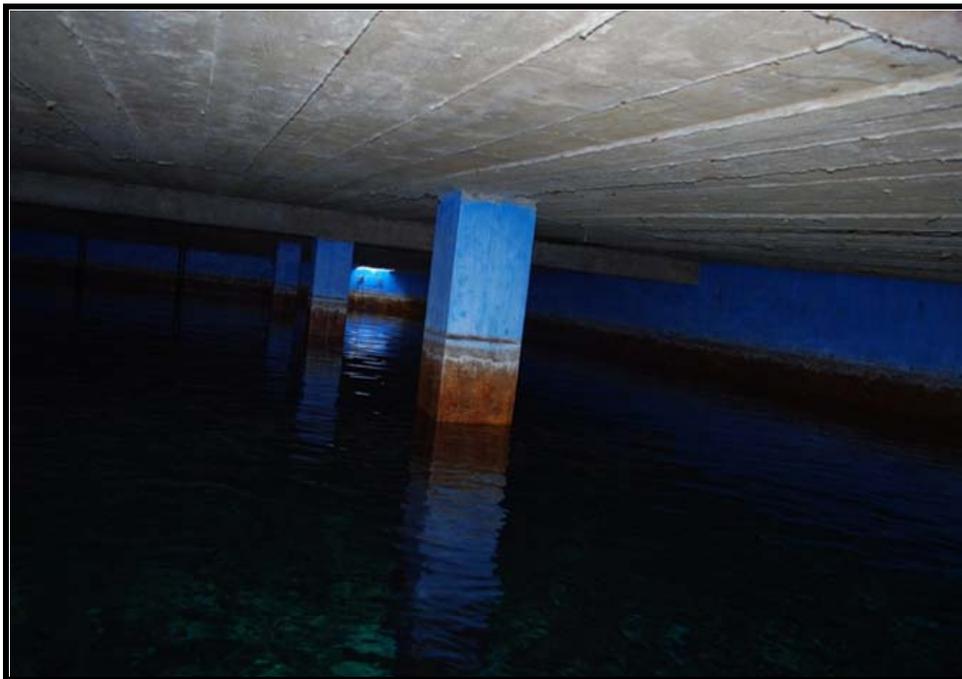
PHOTO 3.3-50 Tank interior.

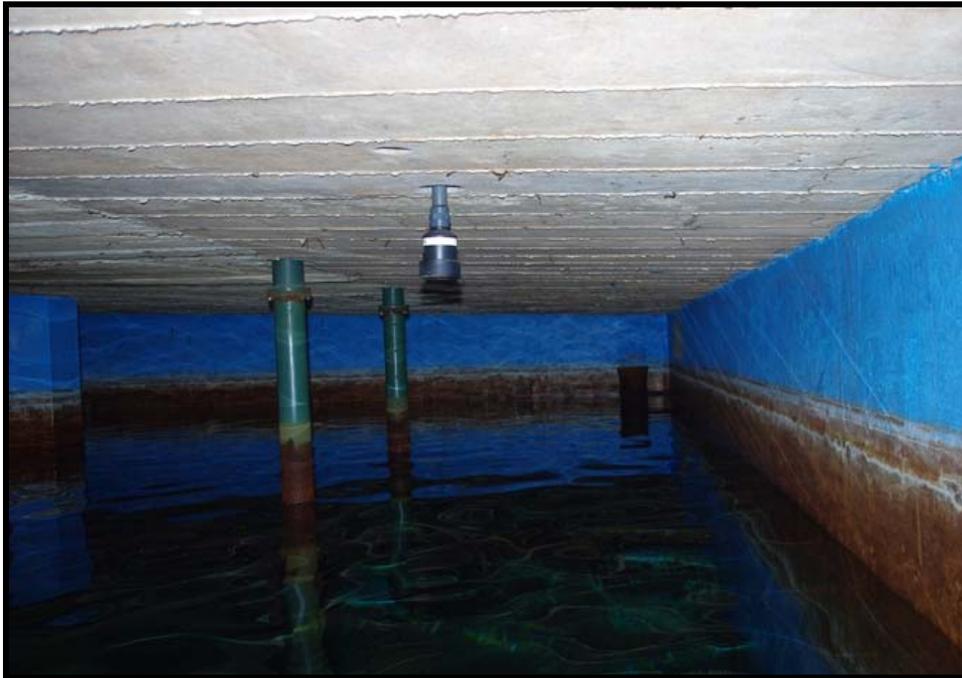
PHOTO 3.3-51 Tank interior. Note roof equipment projection.

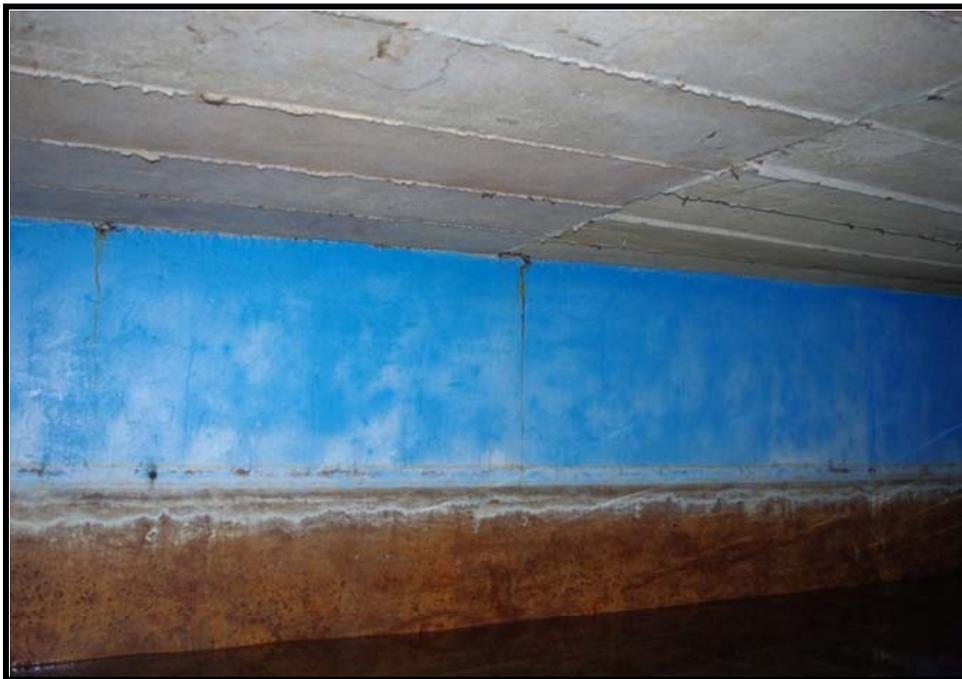
PHOTO 3.3-52 Roof and shell.

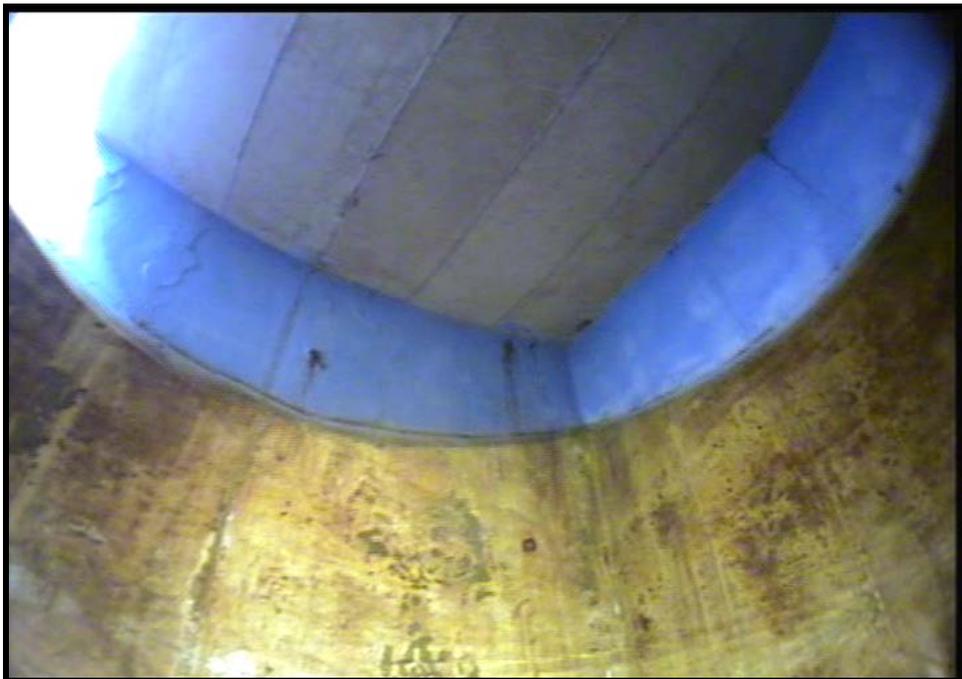
PHOTO 3.3-54 Roof and shell.

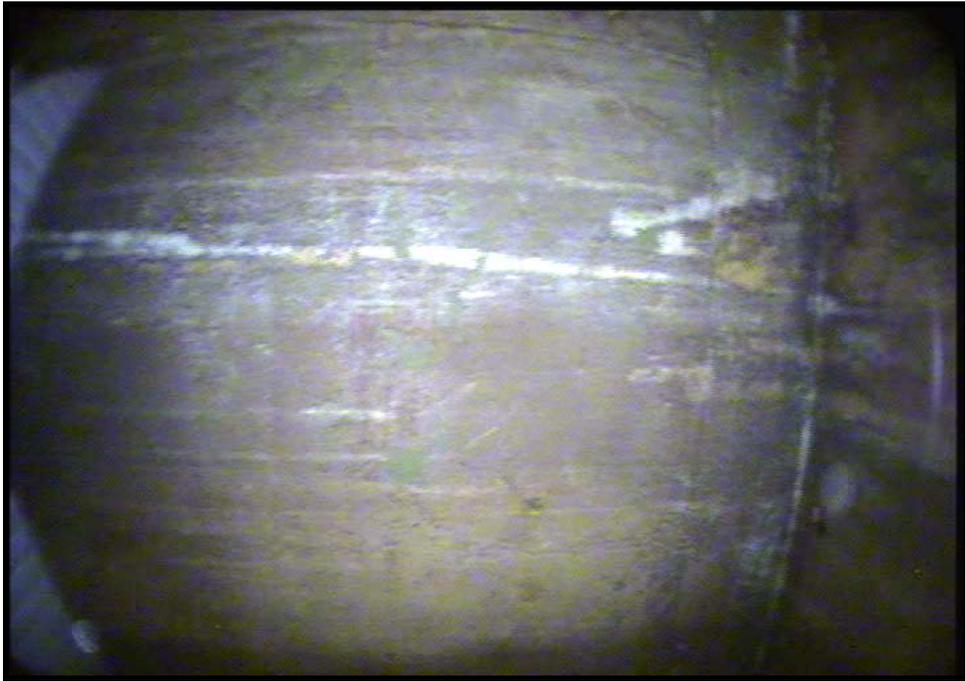
The interior concrete surfaces are in good condition except for corrosion on an isolated area of exposed steel in the roof and efflorescence near the top of the shell (See photos 3.3-55, 3.3-68 through 3.3-70, 3.3-73, and 3.3-74). There is graffiti on the shell (See photos 3.3-71 and 3.3-72). There were no significant areas of cracking, spalling, or deterioration noted at the time of the field evaluation (See photos 3.3-47 through 3.3-52 and 3.3-54). The silt on the floor restricts its evaluation (See photos 3.3-75 through 3.3-77).

PHOTO 3.3-69 Efflorescence on shell.

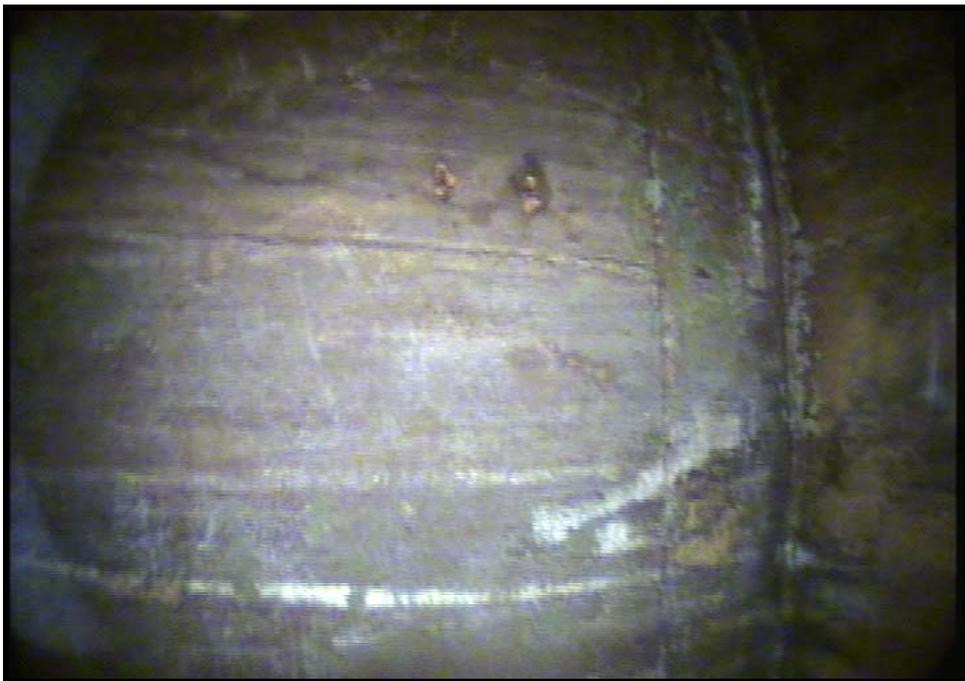
PHOTO 3.3-70 Shell interior.

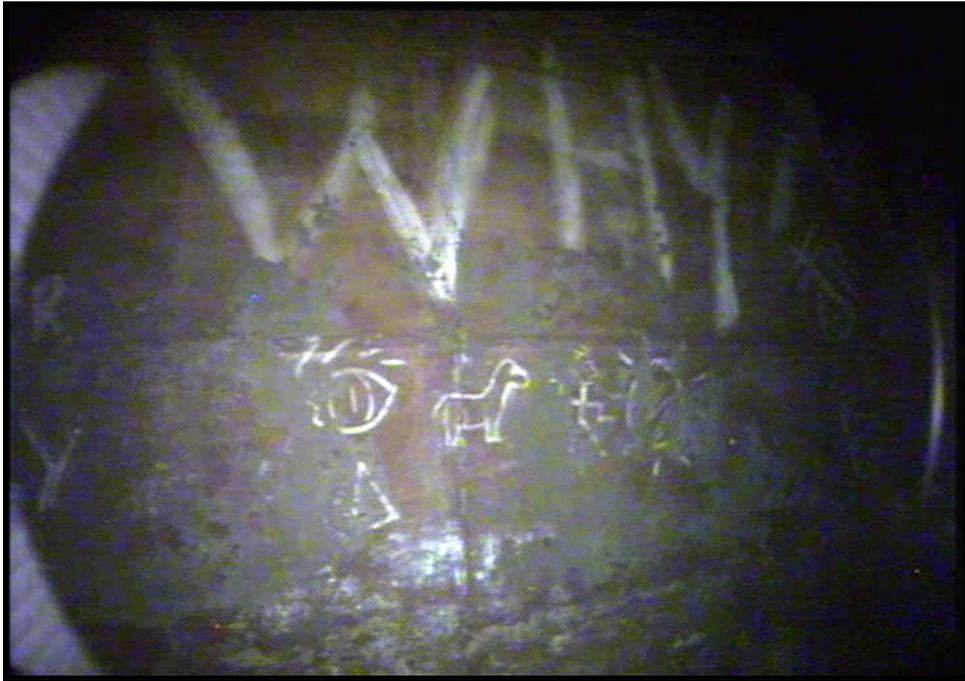
PHOTO 3.3-71 Graffiti on interior shell.

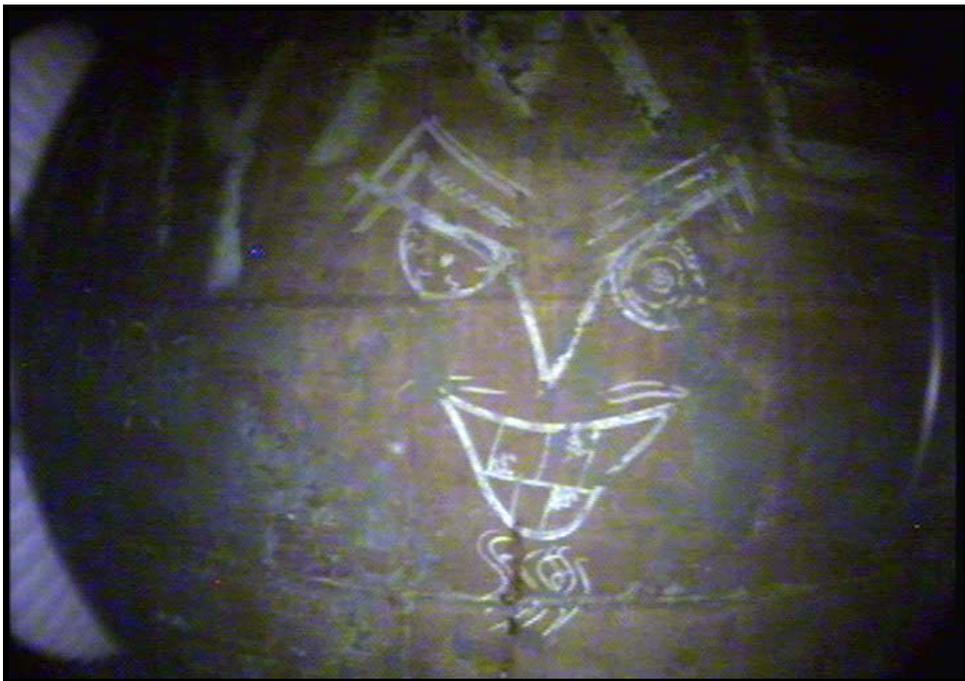
PHOTO 3.3-72 Graffiti on interior shell.

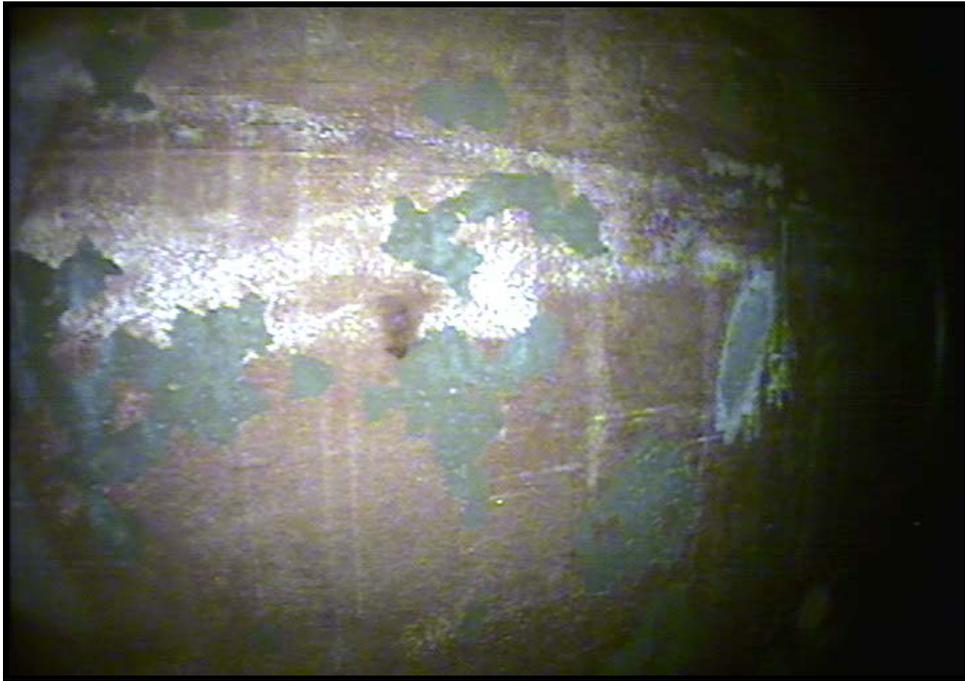
PHOTO 3.3-73 Discoloration on shell.

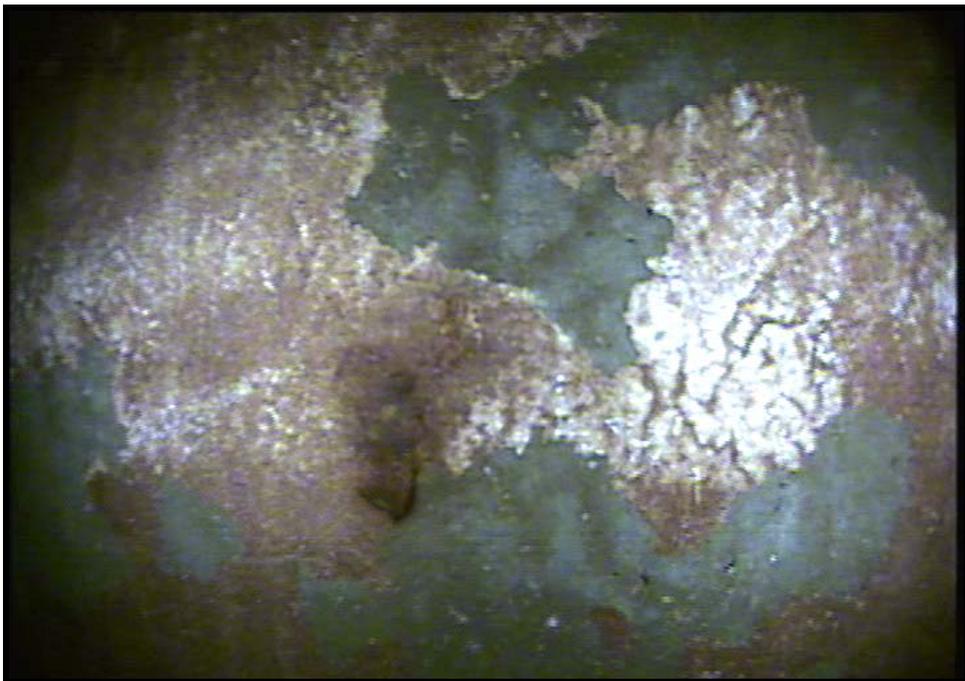
PHOTO 3.3-74 Discoloration on shell.

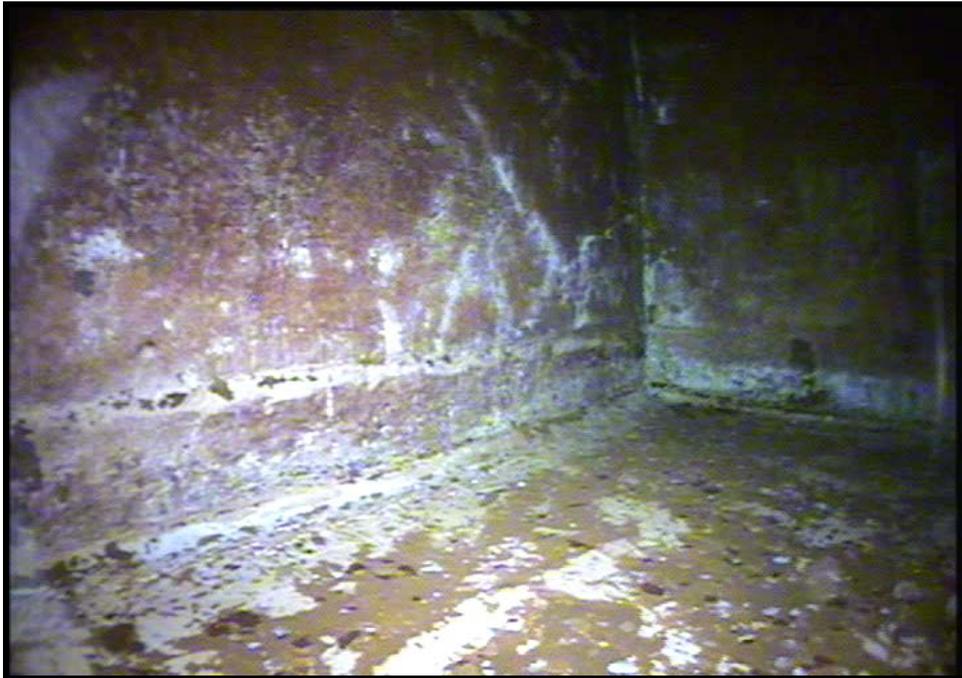
PHOTO 3.3-75 Shell and floor.

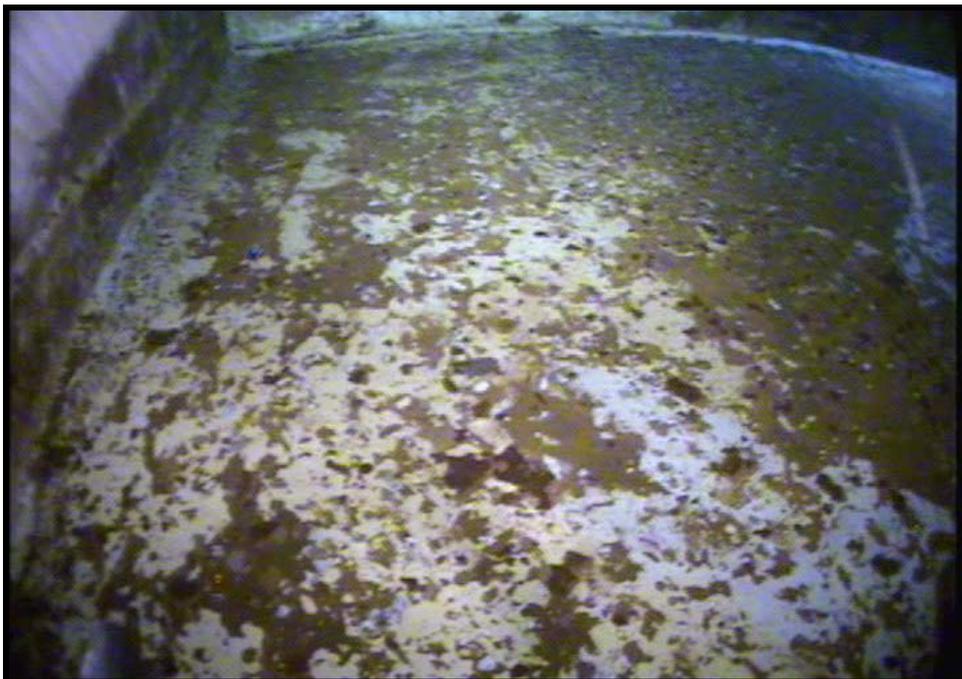
PHOTO 3.3-76 Silt on floor.

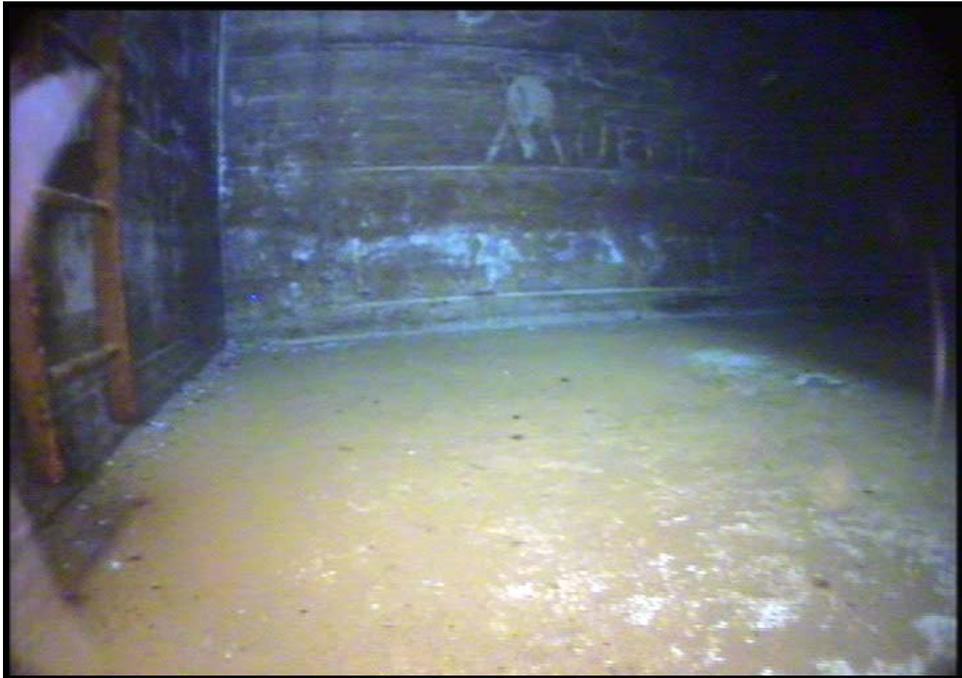
PHOTO 3.3-77 Silt on floor.

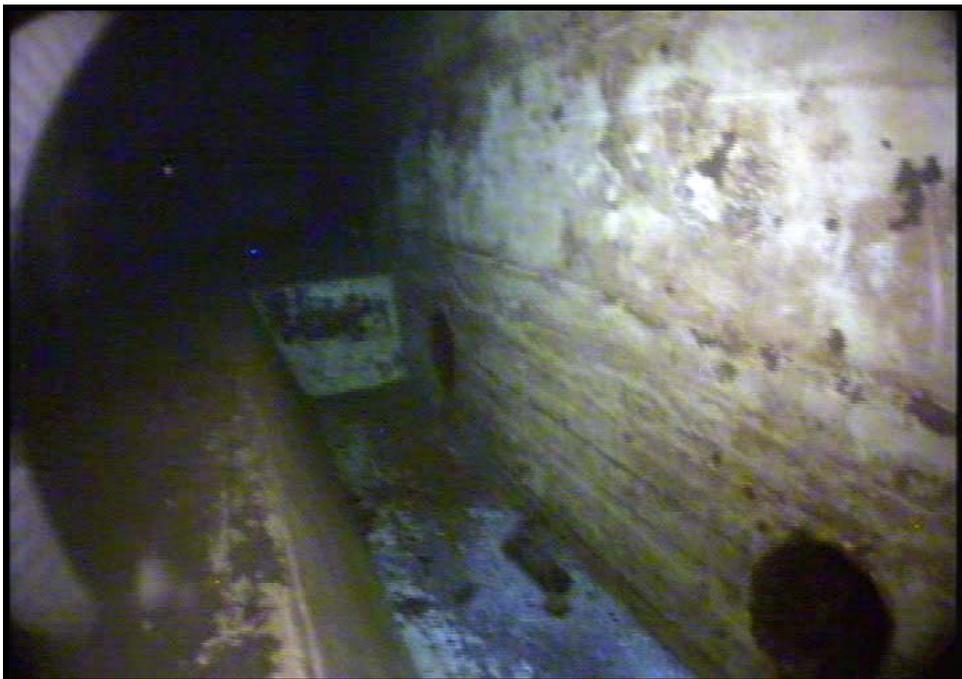
PHOTO 3.3-78 Pipe openings in sump.

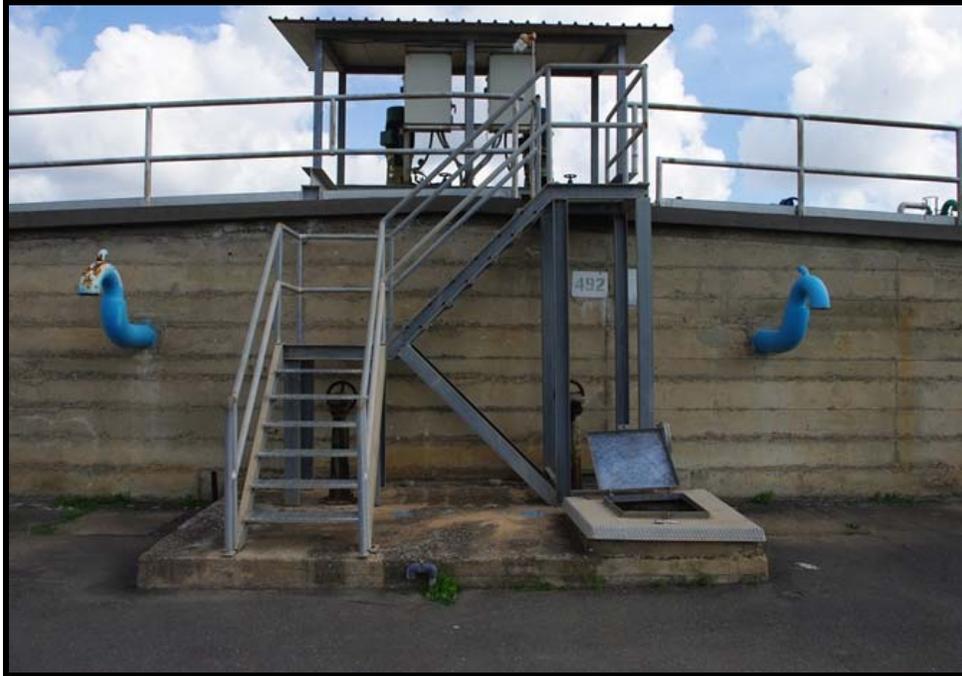
PHOTO 3.4-5 Stairs, pump equipment on roof, and valve vault exterior.

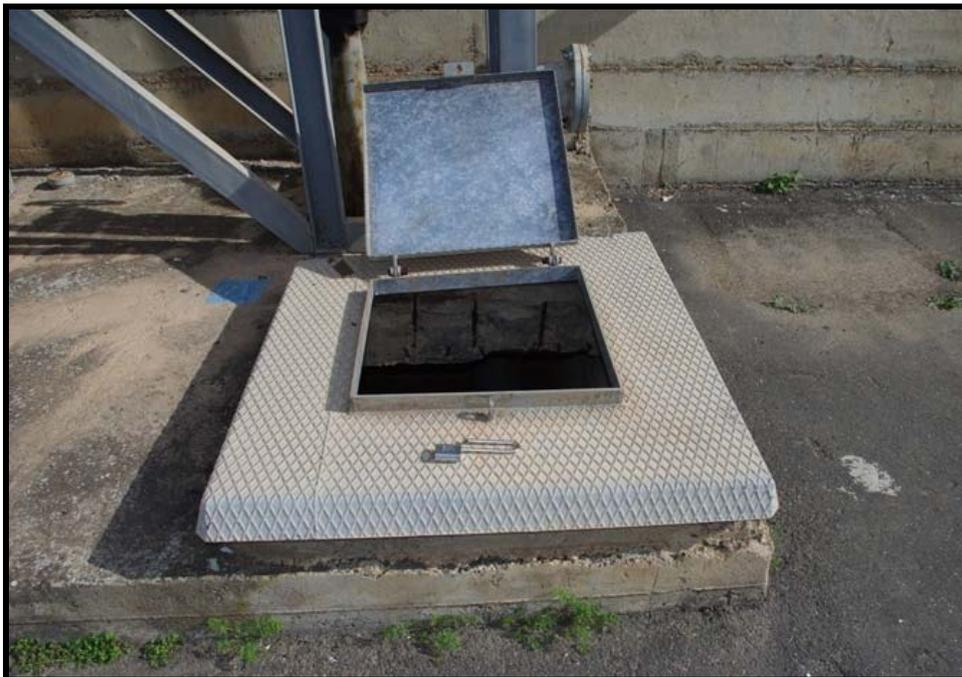
PHOTO 3.4-6 Valve vault access.
