3.10 TANK 425

Tank 425 stores nonpotable water for the Naval Air Station in Sigonella, Italy.

3.10.1 Description of the Facility

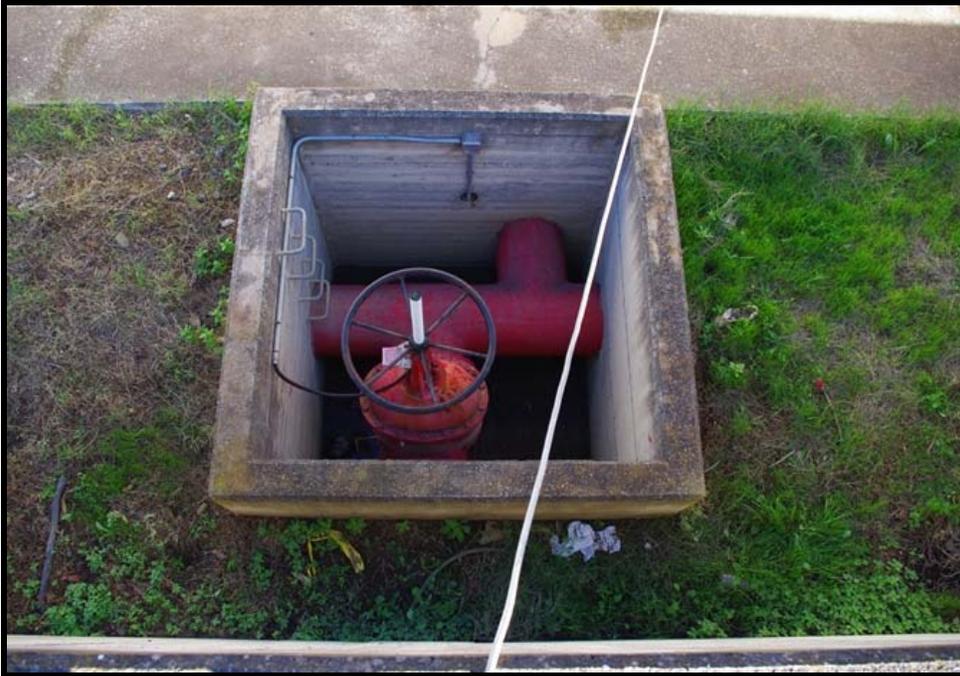
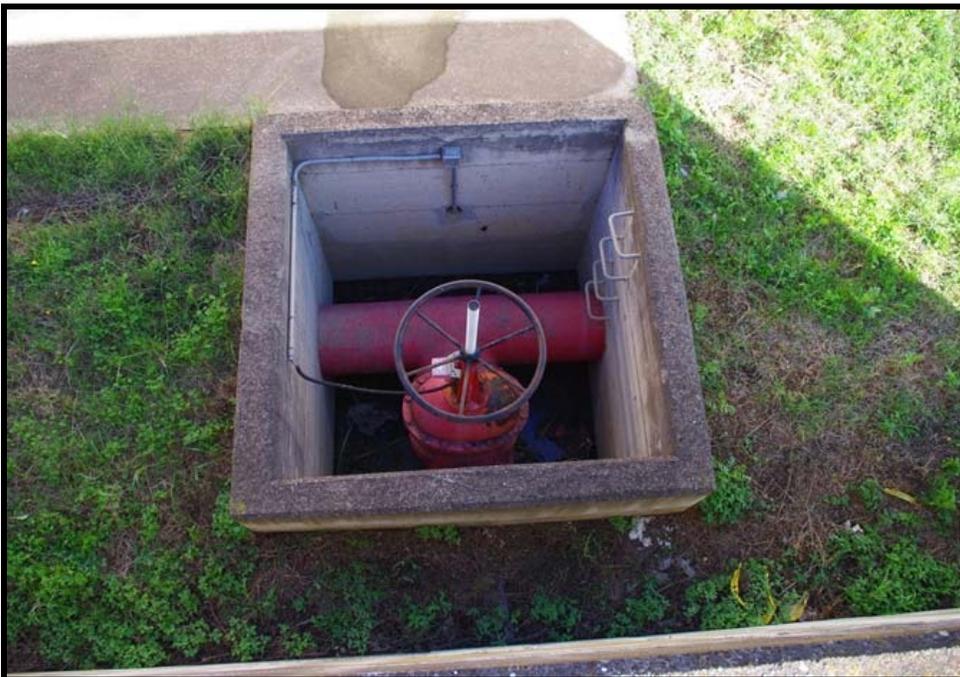
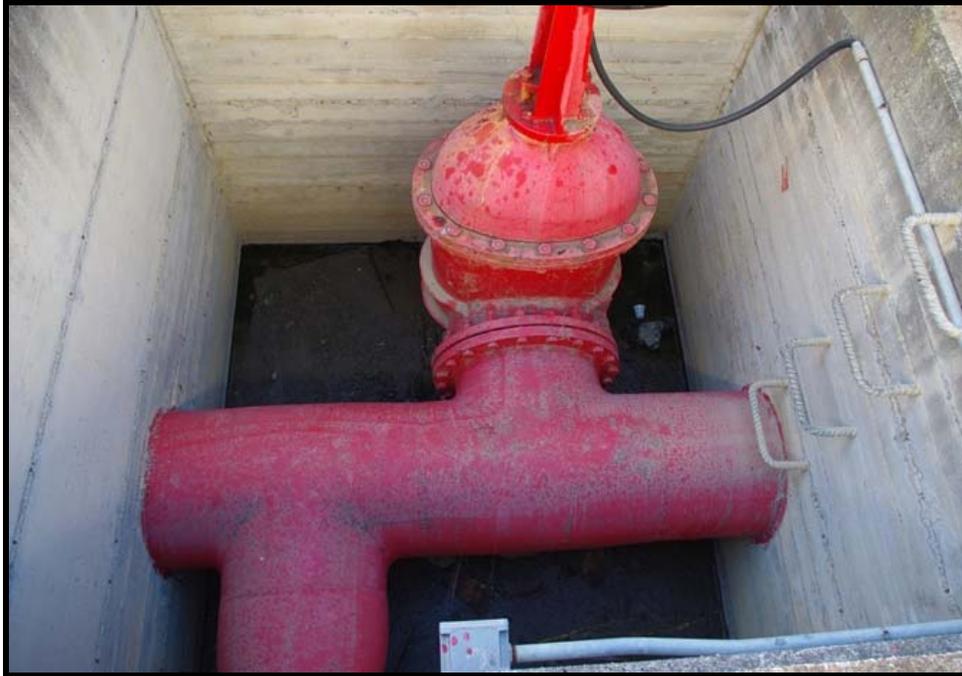
Two uncovered valve vaults are located to the north of the tank, and a pipe extends from each vault to the tank (See photos 3.10-5 through 3.10-8). The piping in the vault is in generally condition with a minimal amount of corrosion. Each of the vaults has a drain and includes access rungs. Wiring is exposed in the east vault (See photo 3.10-9). OSHA and safety-related deficiencies include: (1) the 11 in. (279 mm) rung width does not meet the required 16 in. minimum, (2) the 5-1/4 in. (133 mm) toe room does not meet the required 7 in. (178 mm) minimum, and (3) wiring in the east vault is exposed (See photo 3.10-9).

PHOTO 3.10-5 Valve vault.

PHOTO 3.10-6 Valve vault.

PHOTO 3.10-7 Valve vault piping.

PHOTO 3.10-8 Valve vault.

Valve Vaults: The access rungs should be replaced with ladders which meet current requirements. When the exterior is rehabilitated, the piping and valves located in the valve vaults should be cleaned and painted. The concrete surfaces should be cleaned to the equivalent of a brush-off blast cleaning and painted with a concrete sealer. The exposed wiring should be covered.

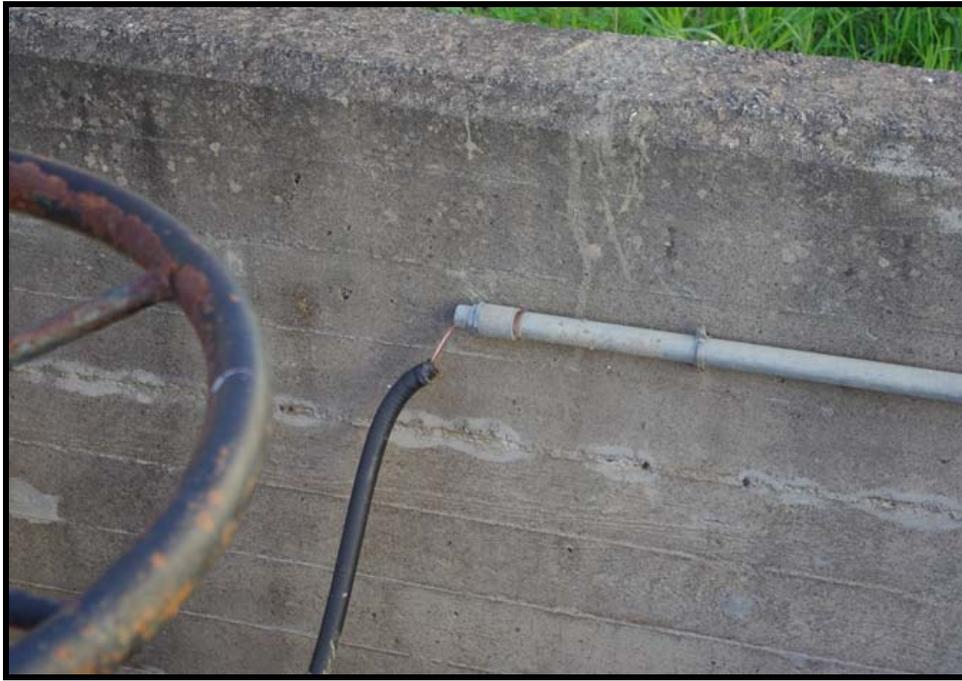
PHOTO 3.10-9 Exposed wiring in valve vault.

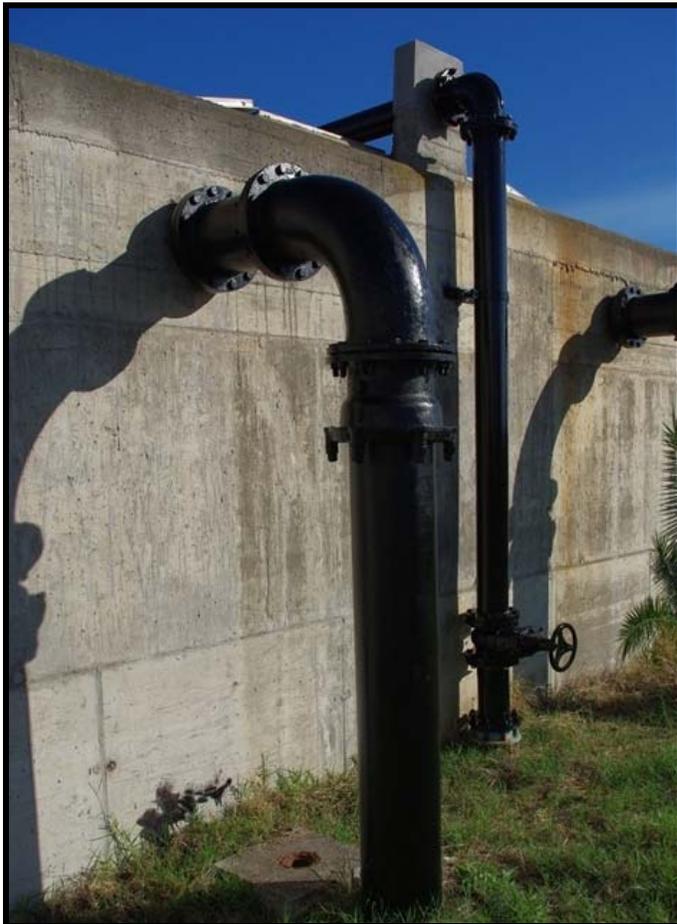
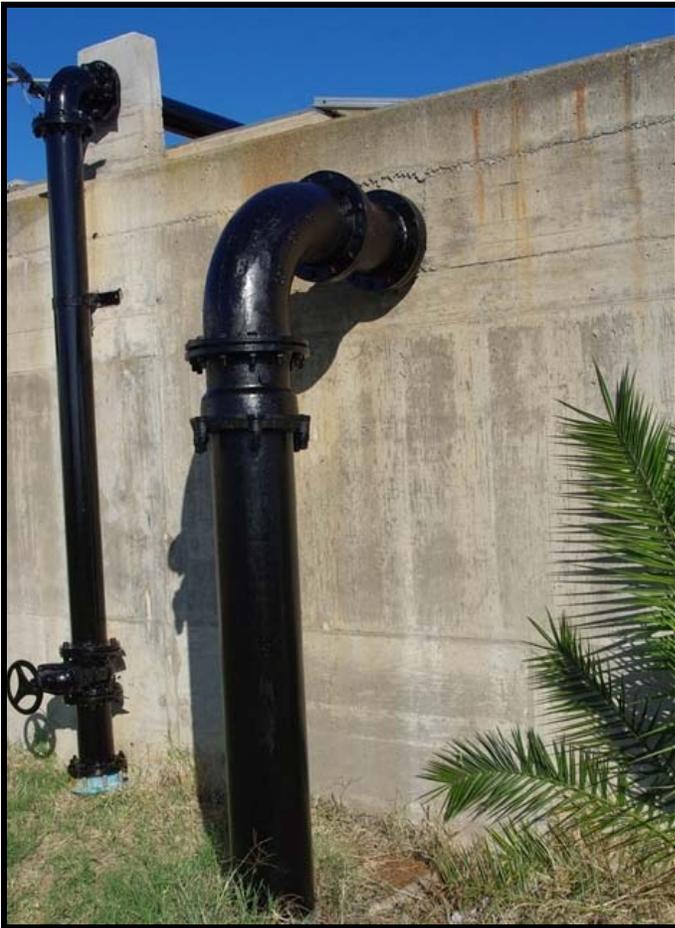
Two overflow pipes project from the south side of the shell (See photos 3.10-10 and 3.10-11). The pipes do not include visible air breaks and do not have brackets. No significant areas of corrosion are located on the piping.

PHOTO 3.10-10 Overflow pipe.

PHOTO 3.10-11 Overflow pipe.

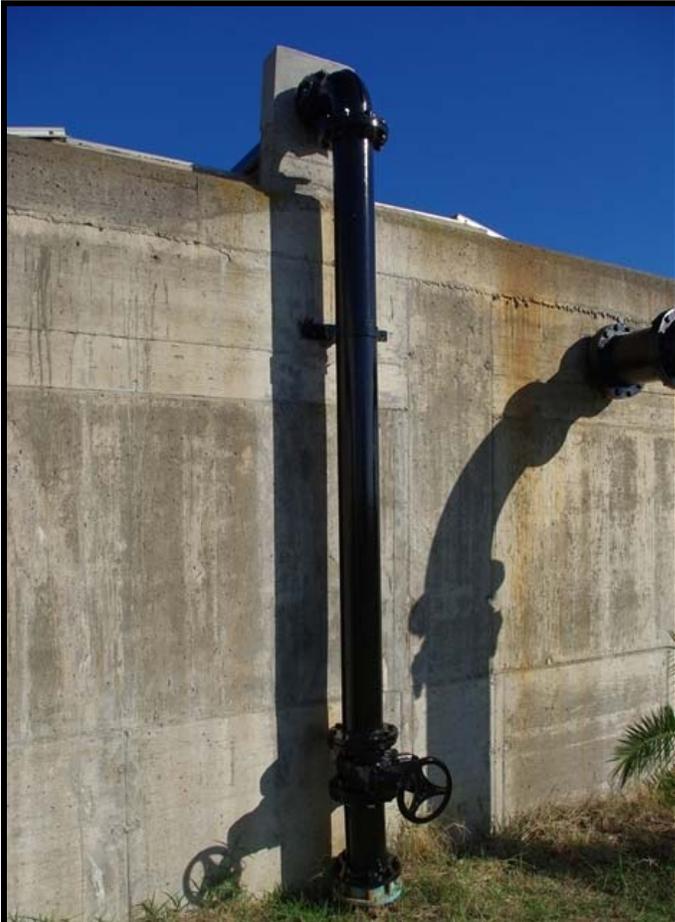
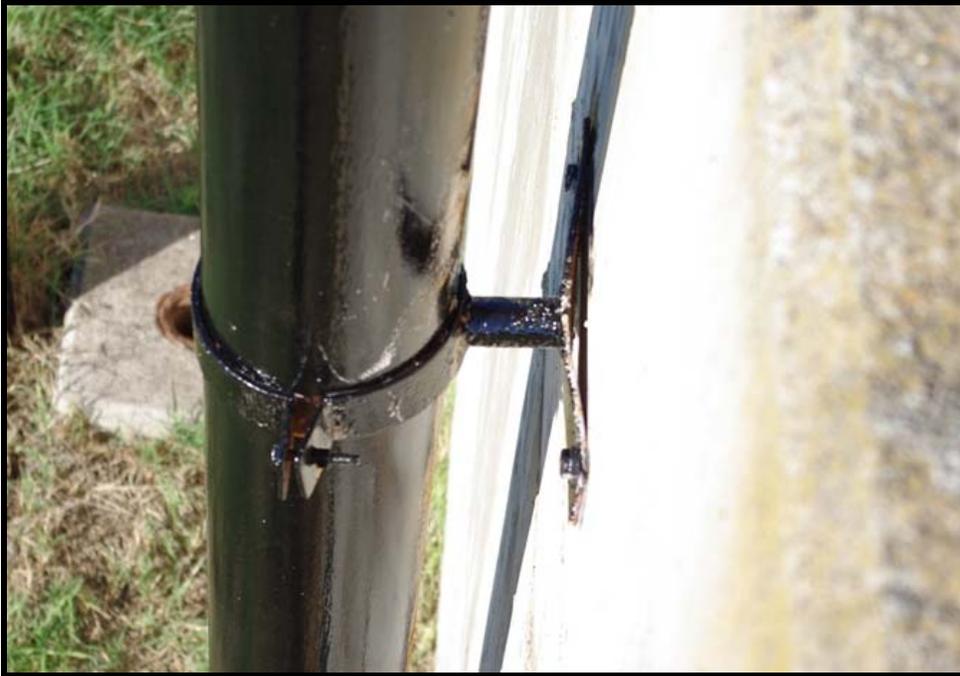
The inlet pipe extends from below grade up the south side of the shell and penetrates the roof (See photo 3.10-12). The inlet pipe has a flat bar bracket (See photo 3.10-13). At the roof, the inlet pipe splits into four pipes each of which has a valve wheel above its penetration through the roof (See photos 3.10-25 through 3.10-28). A pipe extends from each vault and penetrates the north side of the shell. Two pipes extend from the adjacent pump house and also penetrate the north side of the shell, and one of these pipes also has a conduit running with it (See photo 3.10-17). There is corrosion on the pump house pipes (See photos 3.10-15, 3.10-16, 3.10-18, and 3.10-19).

PHOTO 3.10-12 Inlet pipe.

PHOTO 3.10-13 Inlet pipe and bracket.

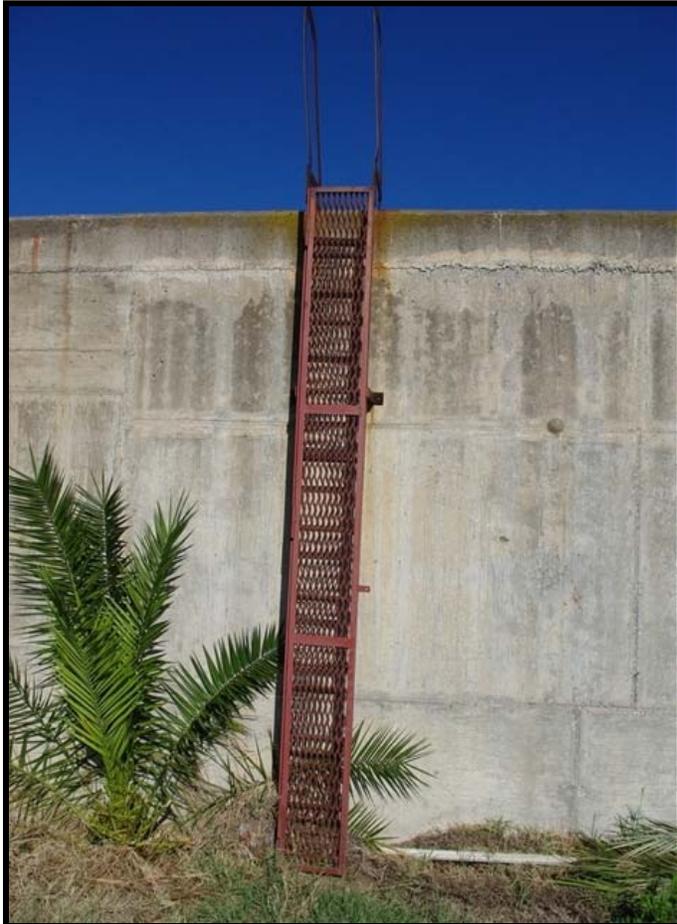
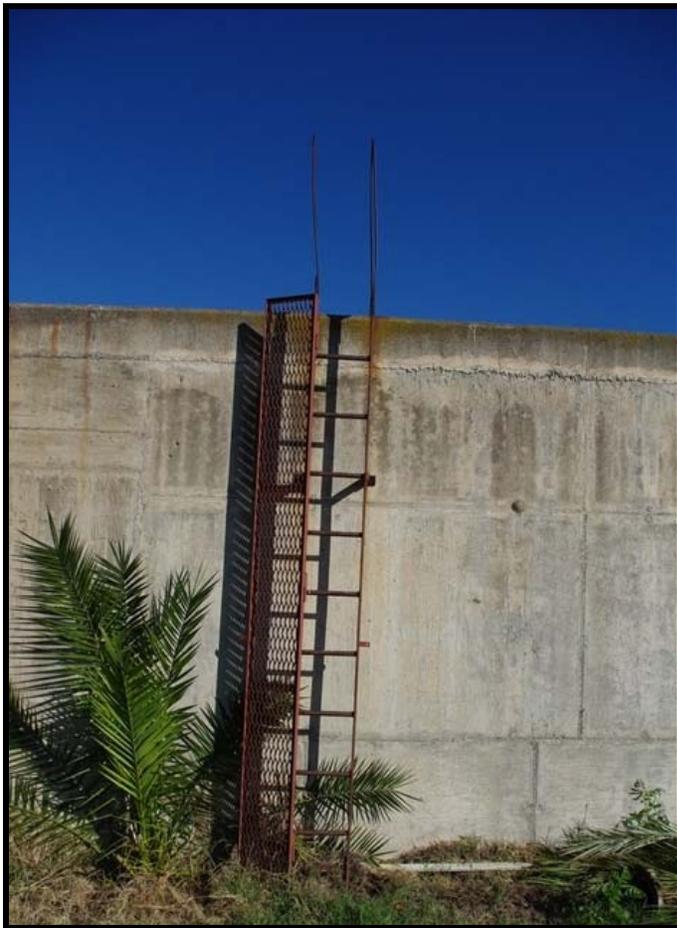
A ladder extends from the ground to the roof of the tank which has terminals at the roof (See photos 3.10-20, 3.10-21, and 3.10-24). The ladder is equipped with two sets of brackets although only the top brackets are bolted to the tank (See photos 3.10-22 and 3.10-23). The ladder does not have a safe-climbing device. A ladder-gate vandal deterrent is located at the base of the ladder although it does not have a lock (See photos 3.10-20 and 3.10-21). OSHA and safety-related deficiencies include: (1) the 11-1/8 in. (283 mm) ladder width does not meet the minimum required 16 in. (406 mm), (2) the 1-3/4 in. (45 mm) x 3/8 in. (9 mm) side rails do not meet the required 2-1/2 in. (61 mm) x 3/8 in. (9 mm) minimum, and (3) the vandal deterrent is not locked.

PHOTO 3.10-20 Exterior ladder and vandal deterrent.

PHOTO 3.10-21 Exterior ladder and vandal deterrent.

Exterior Ladder: The exterior ladder should be replaced with a new ladder which meets current OSHA requirements and has its brackets sufficiently bolted into the concrete. The vandal deterrent should be locked.

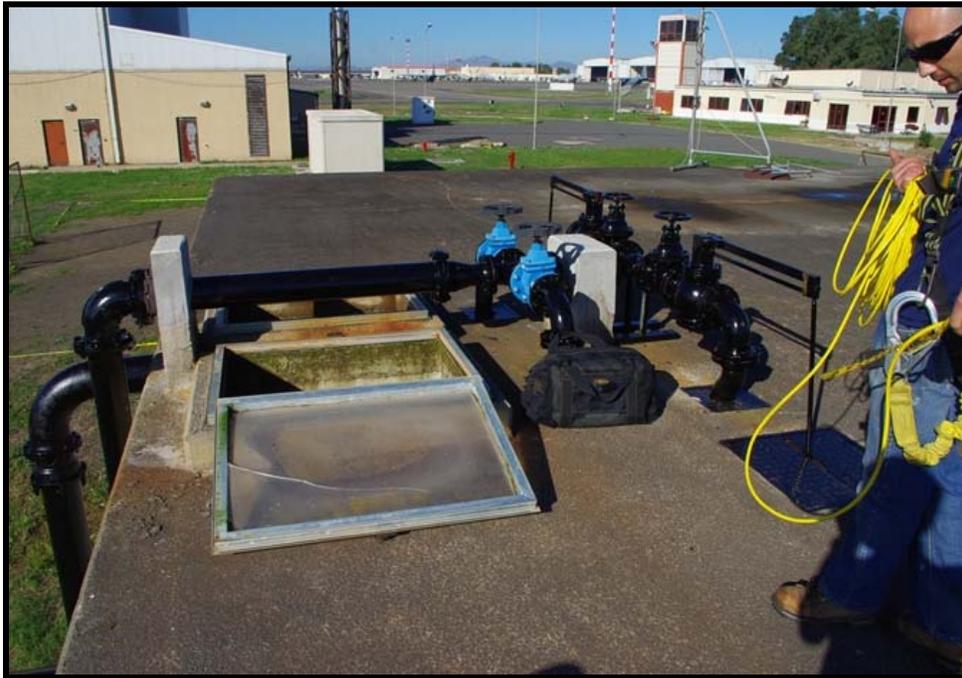
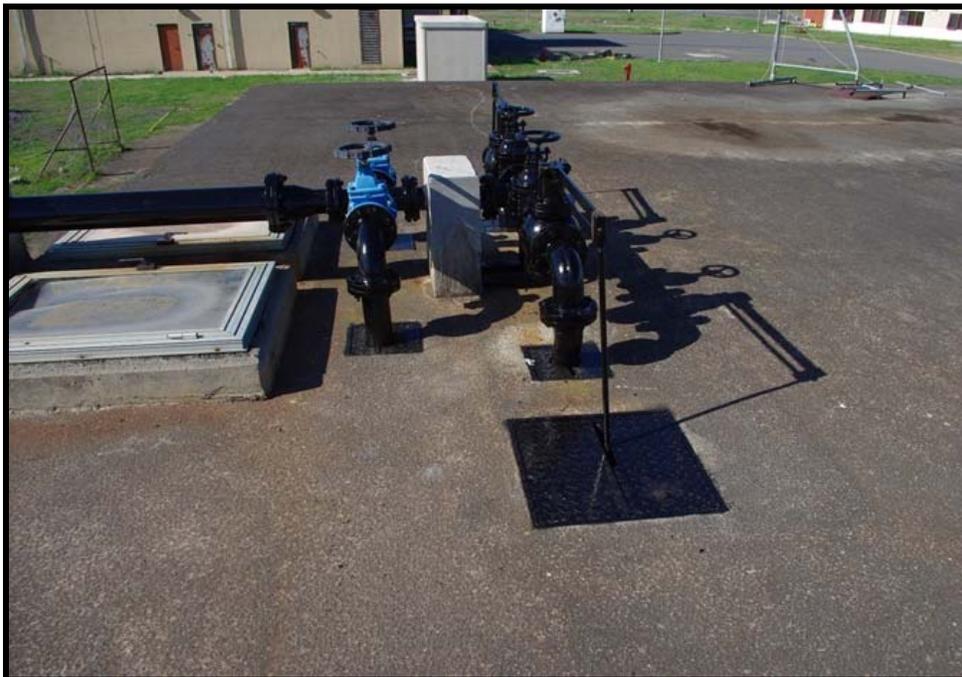
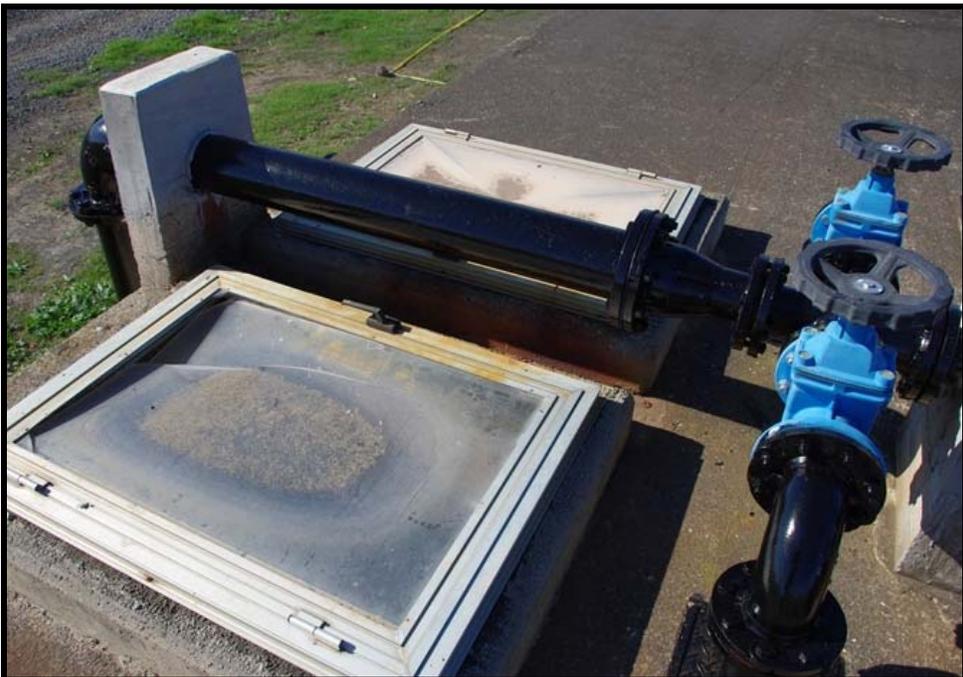
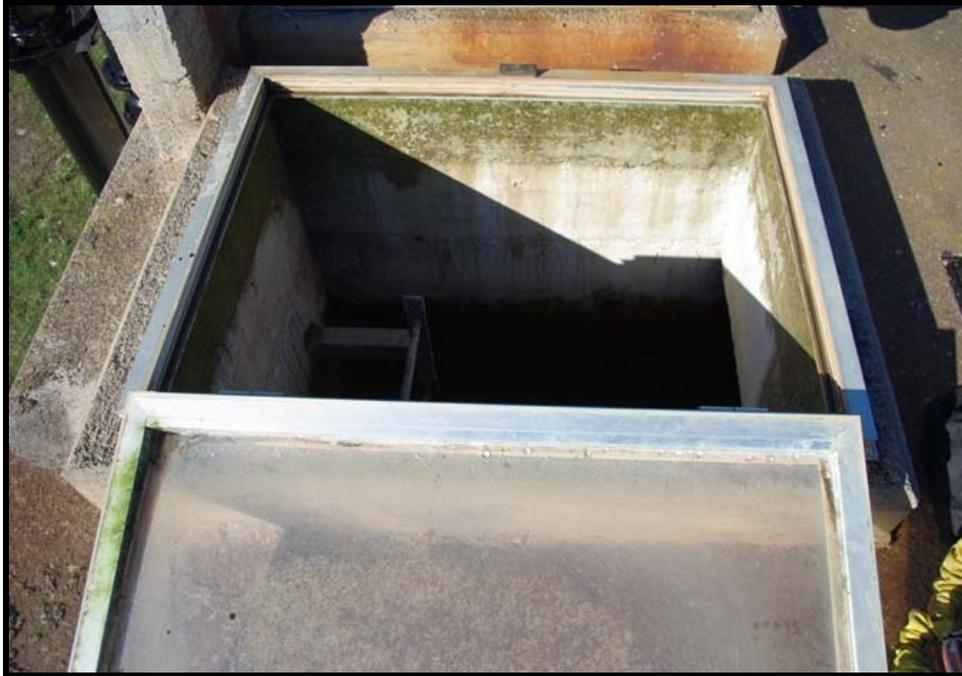
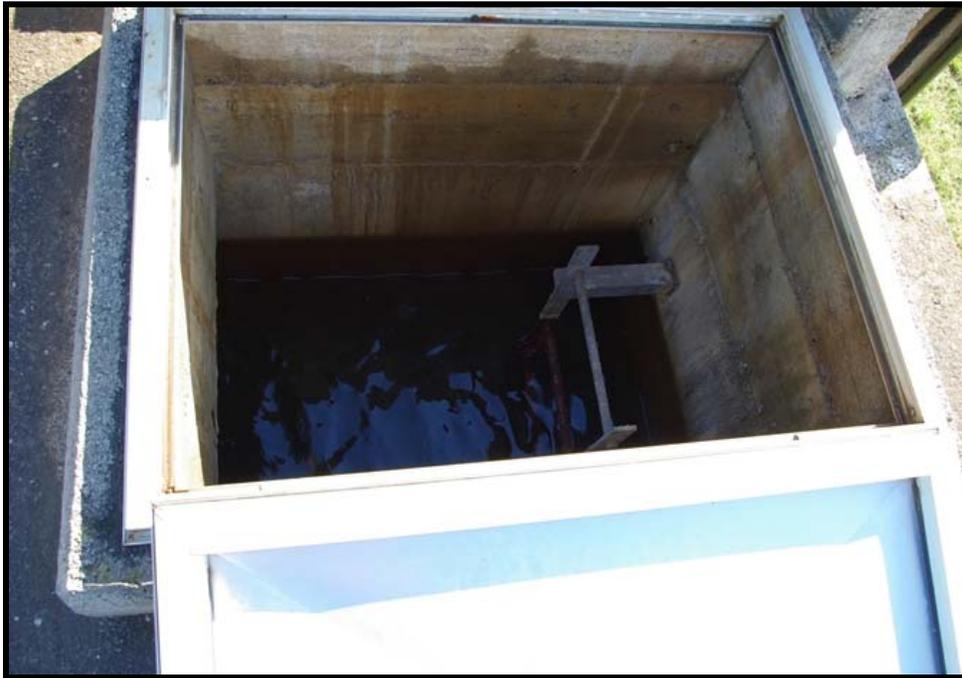
The roof has a hinged cover manhole above each of the two chambers, but the manholes are not locked (See photos 3.10-25, 3.10-26, 3.10-28, 3.10-29, and 3.10-31). The roof manholes have a gasket material which is cracked in one of the manholes (See photo 3.10-30). There is deterioration in the interior concrete surfaces of one of the manholes (See photo 3.10-32).

PHOTO 3.10-25 Roof manholes and piping.

PHOTO 3.10-26 Roof manholes and piping.

PHOTO 3.10-28 Roof manholes and piping.

PHOTO 3.10-29 Roof manhole.

PHOTO 3.10-31 Roof manhole.

Roof Manholes: The broken gasket on one of the manhole covers should be replaced.

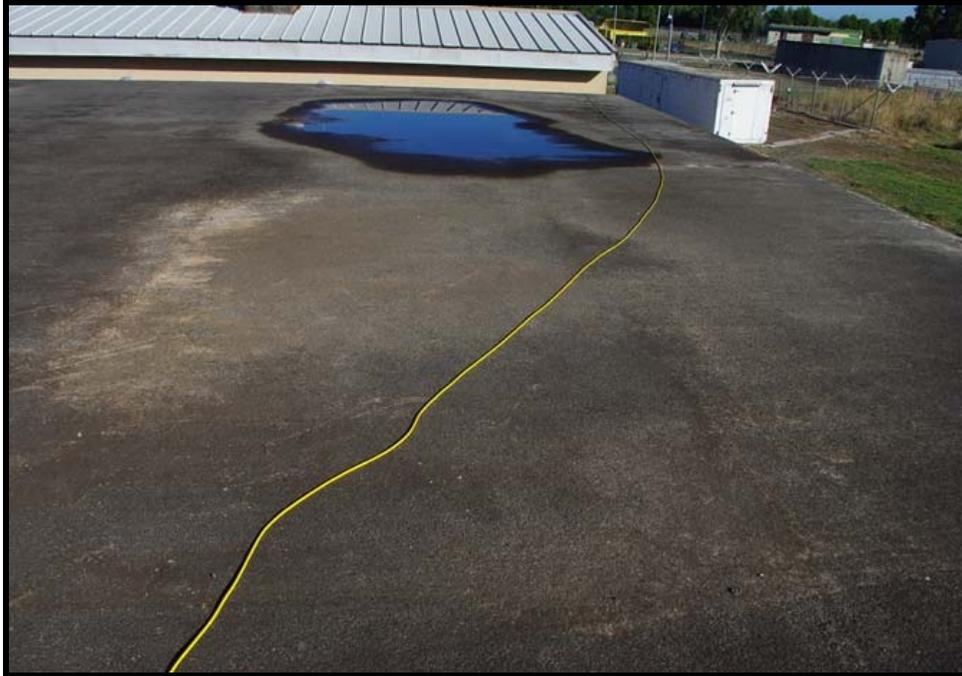
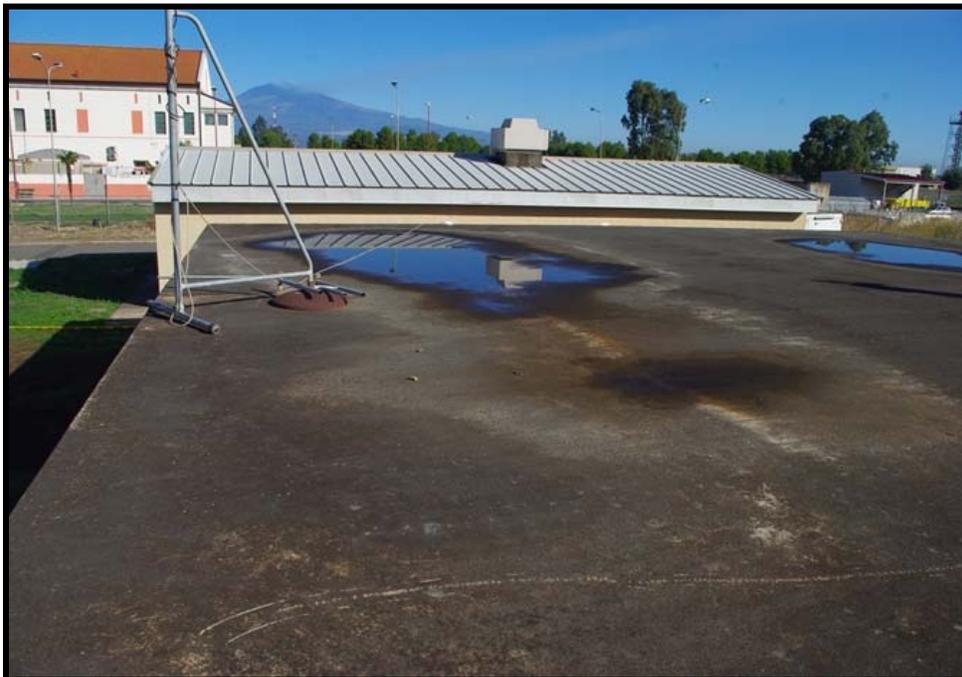
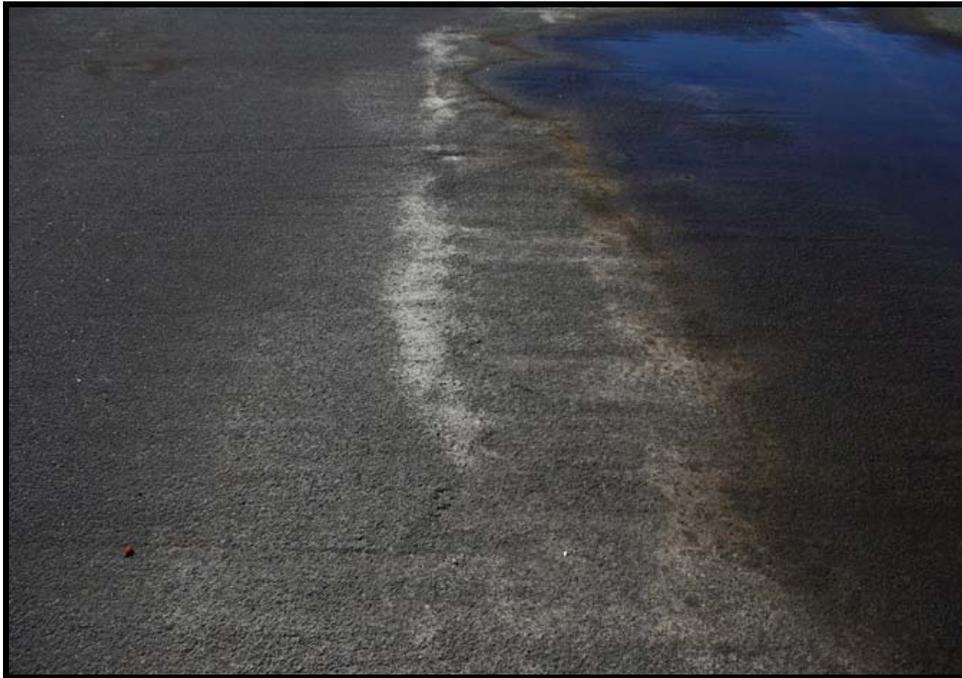
The exterior of the concrete roof is in good overall condition as there are only a few minor cracks (See photo 3.10-18). Water was standing in two large areas located on the northeast and northwest sides of the roof (See photos 3.10-35 through 3.5-37). A light and associated equipment are mounted to the roof of the tank (See photo 3.10-39). There is no safety railing at the roof access and adjacent to the roof manholes which is a safety-related and OSHA deficiency. Ponding water may lead to infiltration through the roof which is potential operational deficiencies.

PHOTO 3.10-35 Roof exterior. Note standing water.

PHOTO 3.10-36 Roof exterior. Note standing water.

PHOTO 3.10-37 Roof exterior. Note standing water.

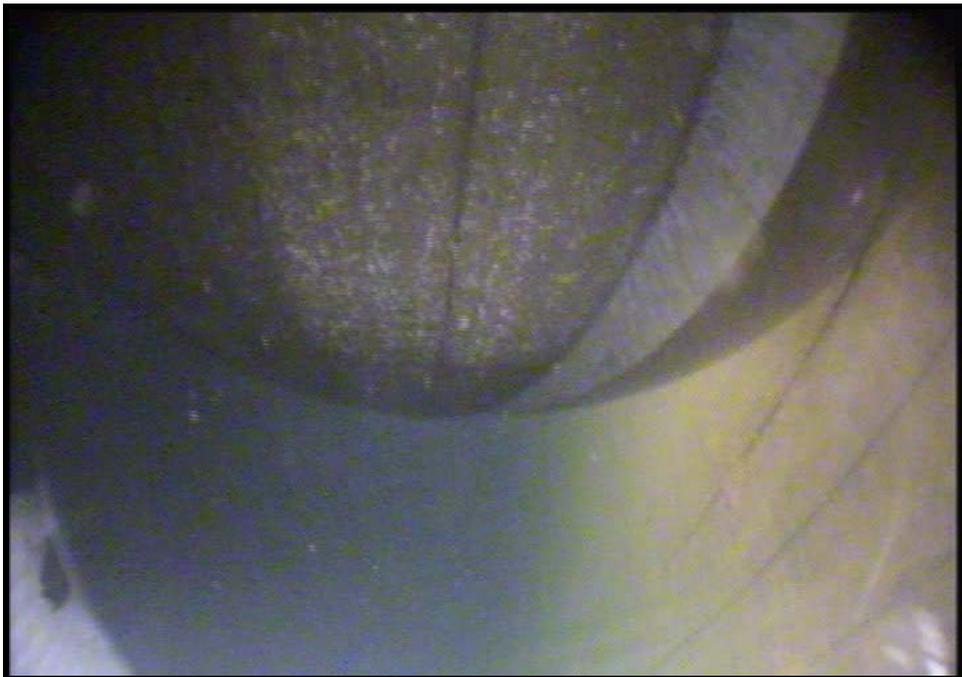
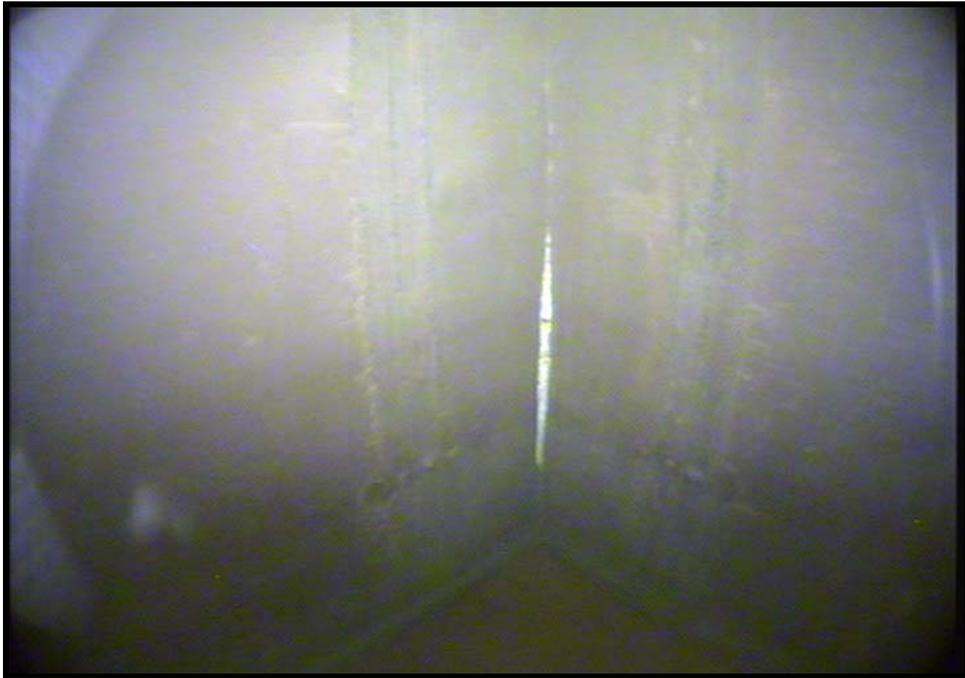
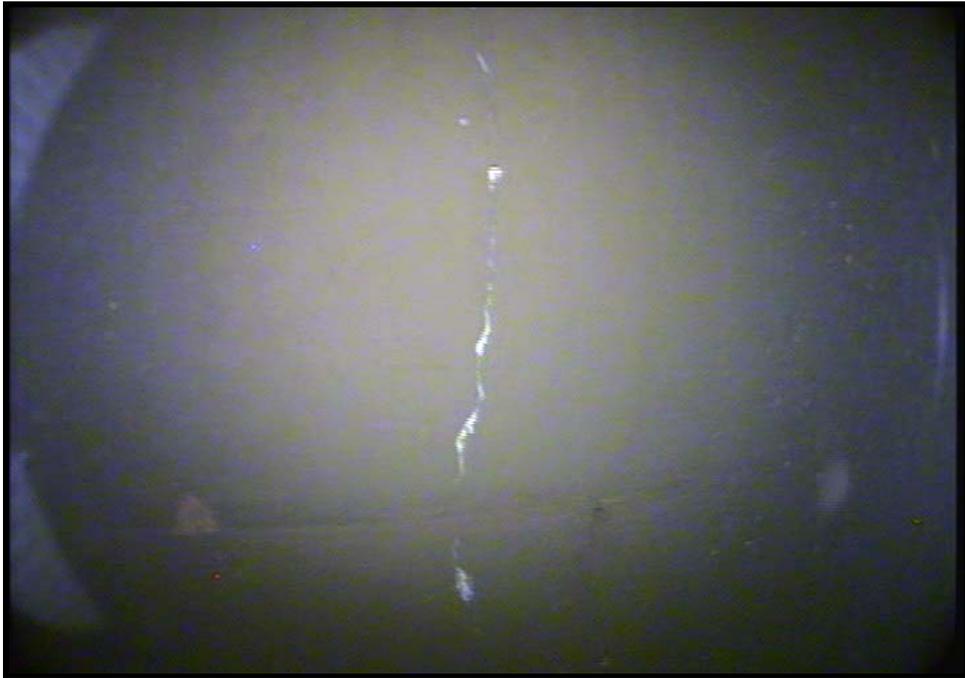
Most of the interior concrete surfaces are in good condition except for a few areas of corrosion at exposed steel and efflorescence located on the shell (See photos 3.10-40 and 3.10-44 through 3.10-49). A sealant material which is located in some of the corners appears intact (See photo 3.10-50). A layer of silt restricts the evaluation of the floors, and what appears to be a few small pieces of concrete are located in the silt (See photos 3.10-60 and 3.10-65). What appears to be a metal sheet is lying on the floor and covered with silt (See photos 3.10-62 through 3.10-64). The purpose of the metal sheet could not be determined at the time of the field evaluation.

PHOTO 3.10-40 Roof interior.

PHOTO 3.10-47 Efflorescence at corner.

PHOTO 3.10-49 Efflorescence on shell.

Interior Concrete: The interior concrete surfaces appeared to be in adequate condition as no significant cracking and chipping were observed. The interior surfaces should be re-evaluated in 3 to 4 years to determine if repairs are required at that time.

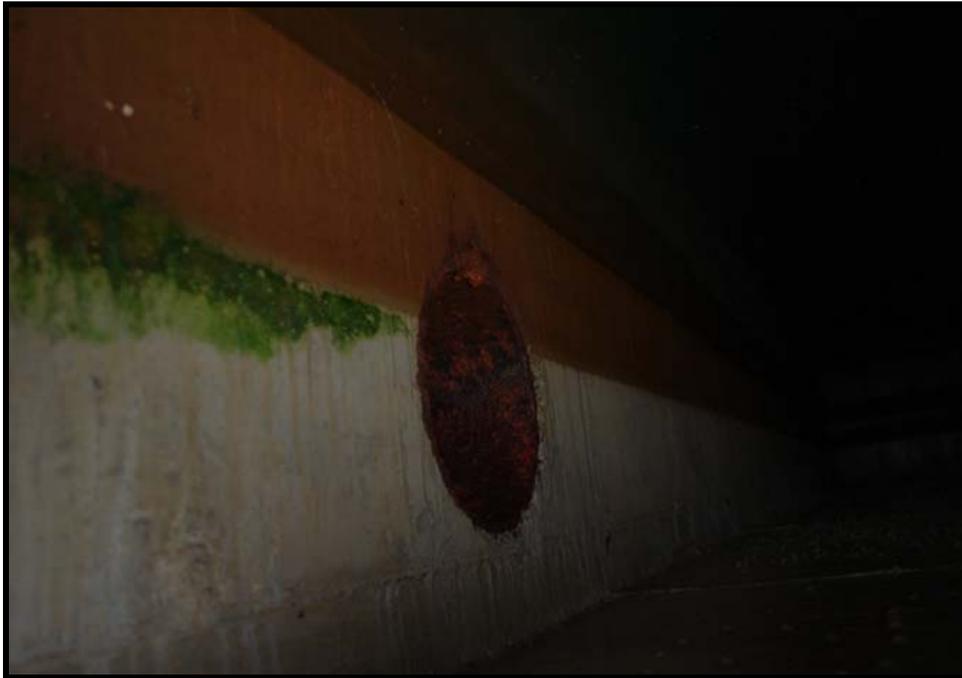
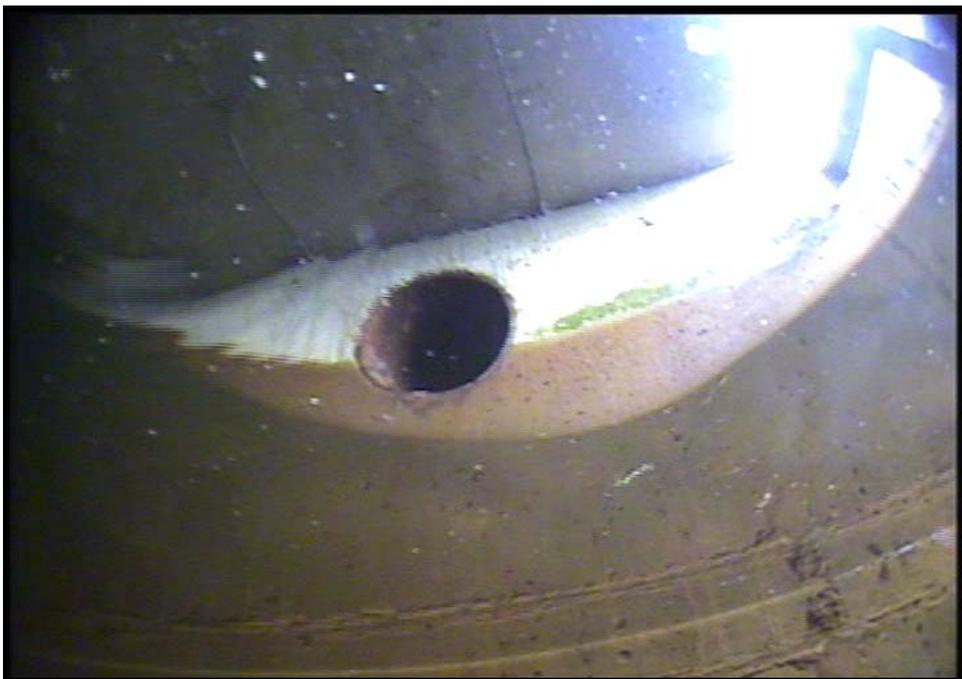
Open pipes for the overflows are flush mounted with the wall, and there is corrosion on the visible interior surfaces of the overflow pipes and rust staining beneath one of the pipes (See photos 3.10-41 through 3.10-43). A float for the target gage is located in the interior (See photo 3.10-51). A pipe penetrates the lower shell and elbows downward before ending. This pipe has an anti-vortex assembly and is covered with corrosion and rust tubercles (See photos 3.10-57 through 3.10-59). Two pipe openings are flush mounted near the top of the shell (See photos 3.10-60 and 3.10-61).

PHOTO 3.10-41 Pipe opening near top of shell.

PHOTO 3.10-42 Pipe opening near top of shell.

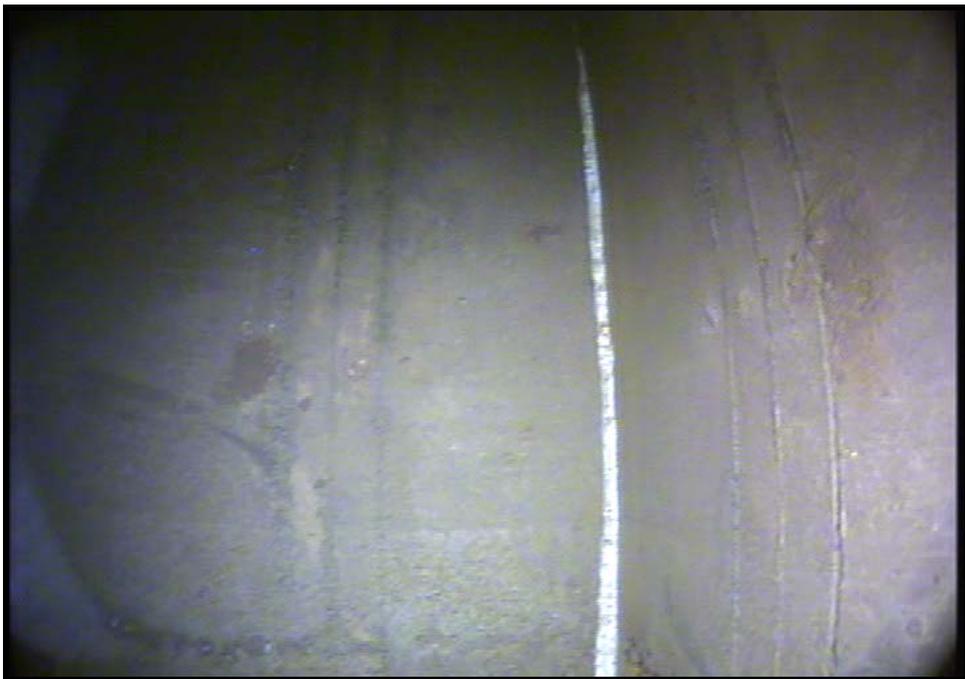
PHOTO 3.10-50 Sealant material in corner.

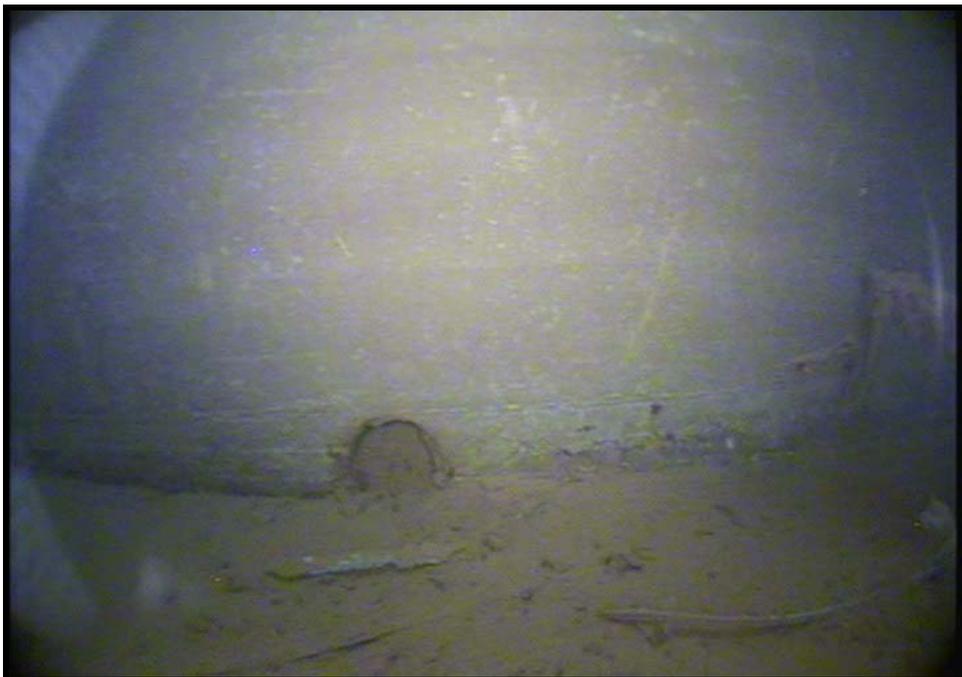
PHOTO 3.10-60 Pipe opening in shell and silt on floor.

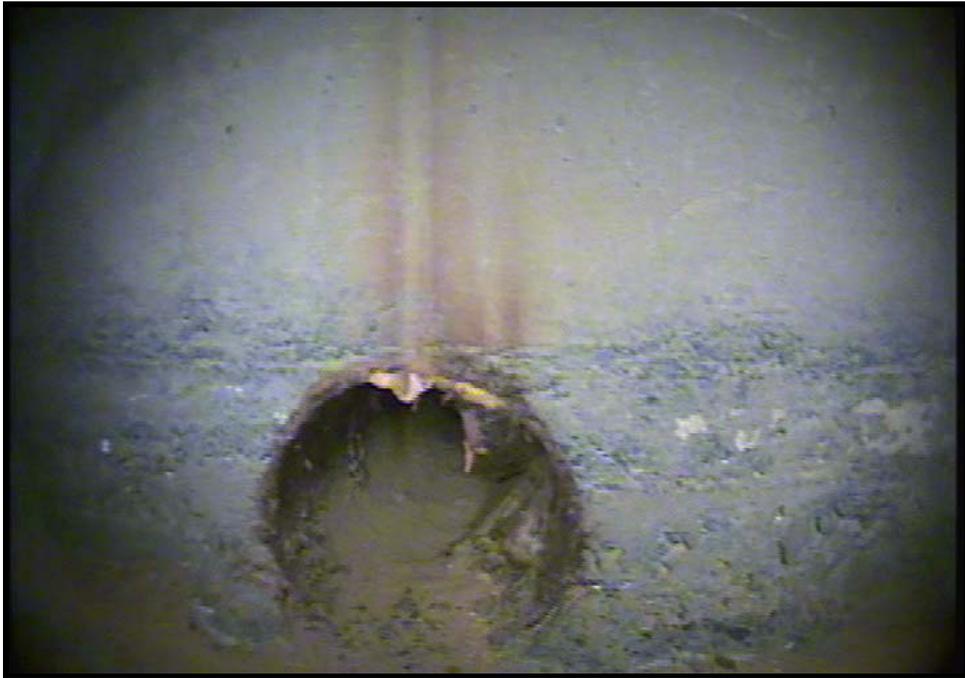
PHOTO 3.10-61 Pipe opening in shell.

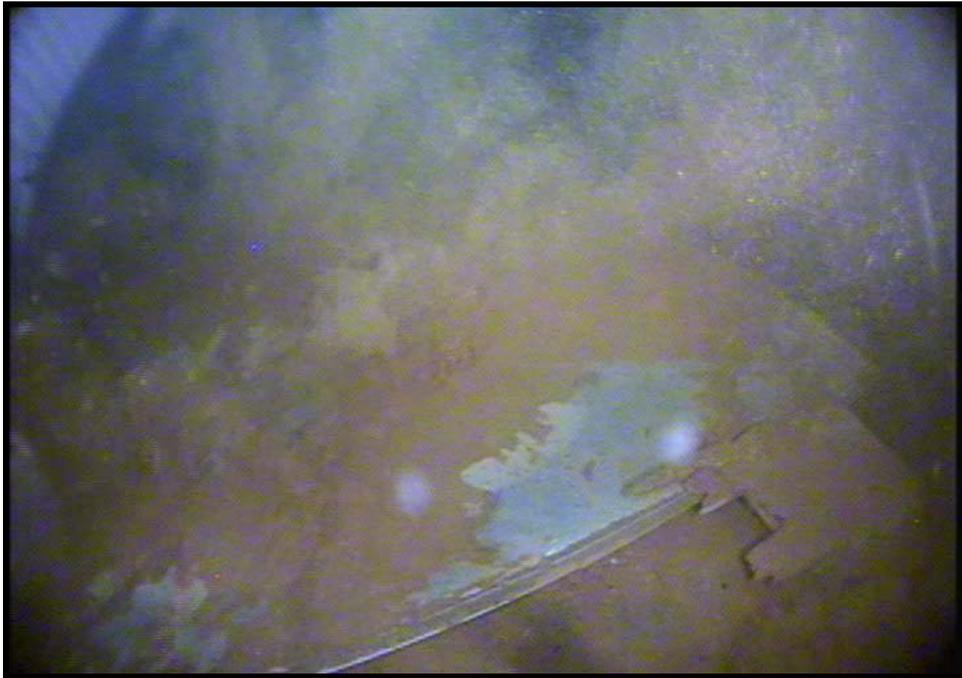
PHOTO 3.10-63 Debris and silt on floor.

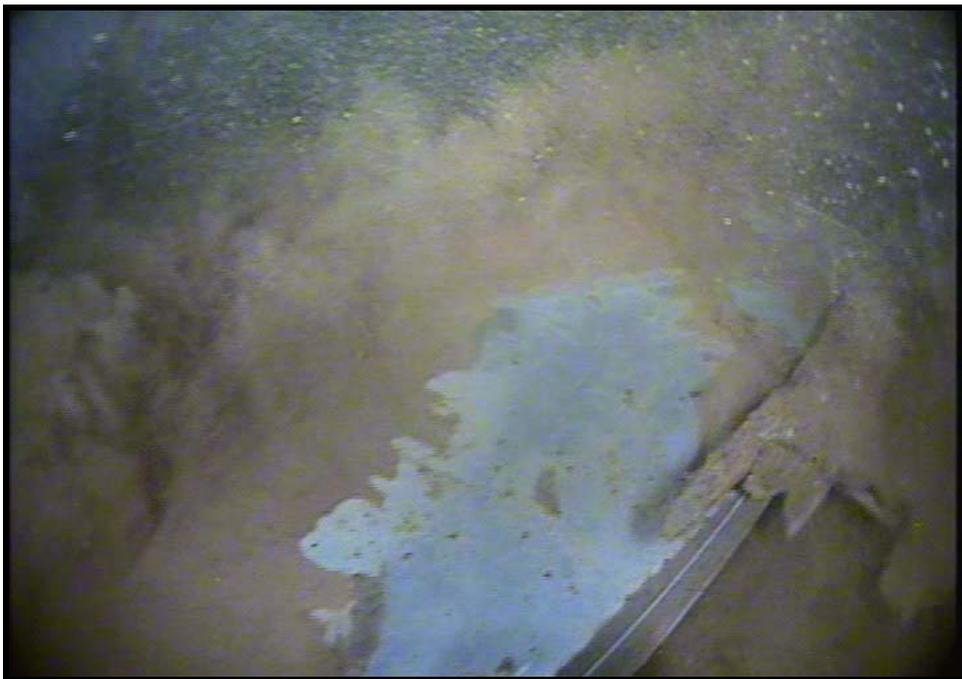
PHOTO 3.10-64 Debris and silt on floor.

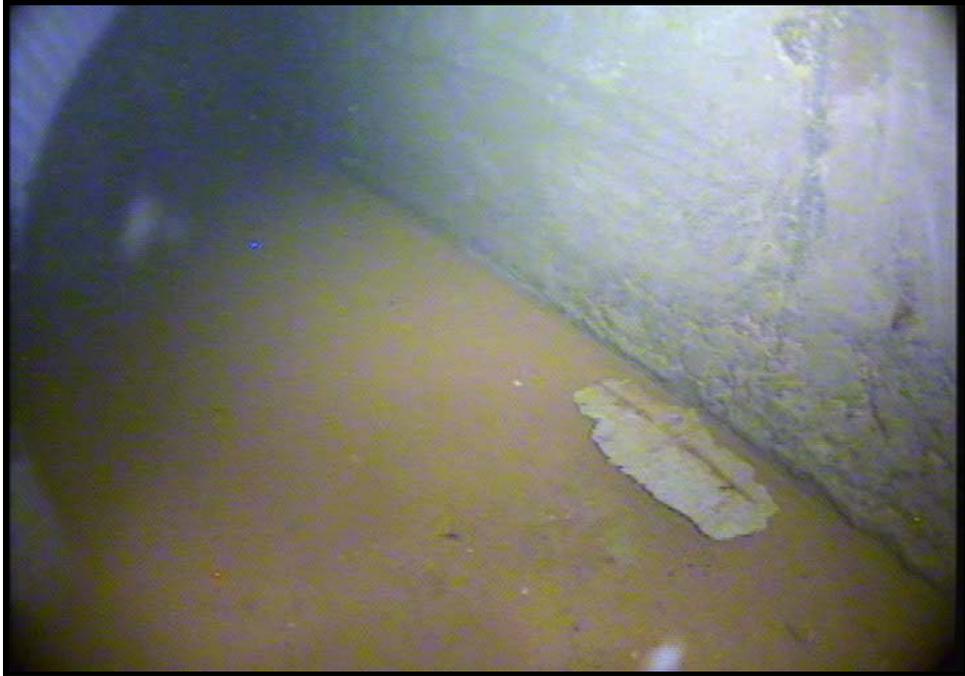
PHOTO 3.10-65 Debris and silt on floor.

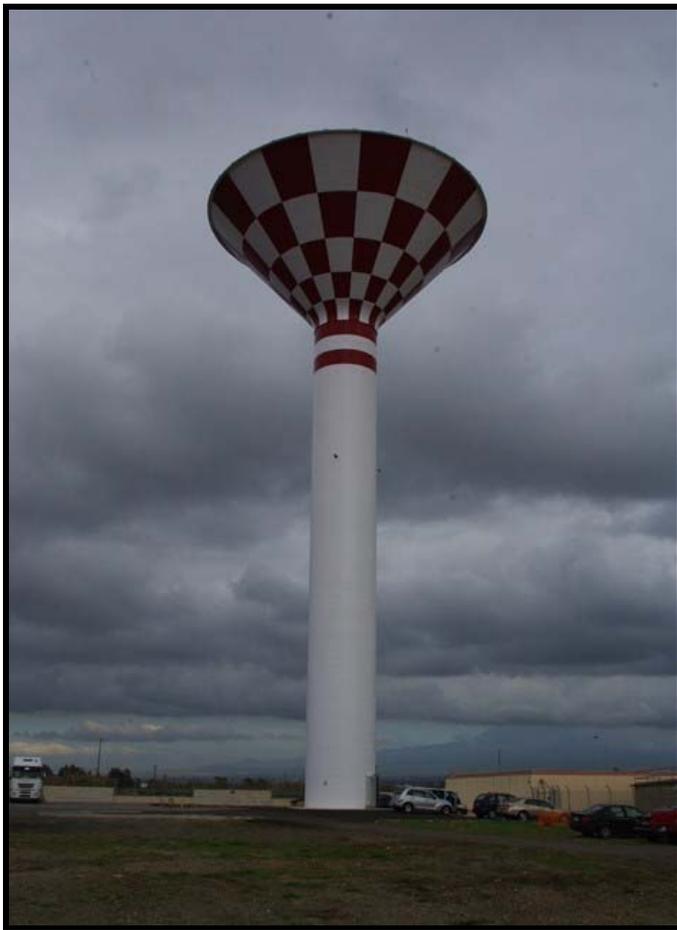
PHOTO 3.11-1 Tank 707 and site.

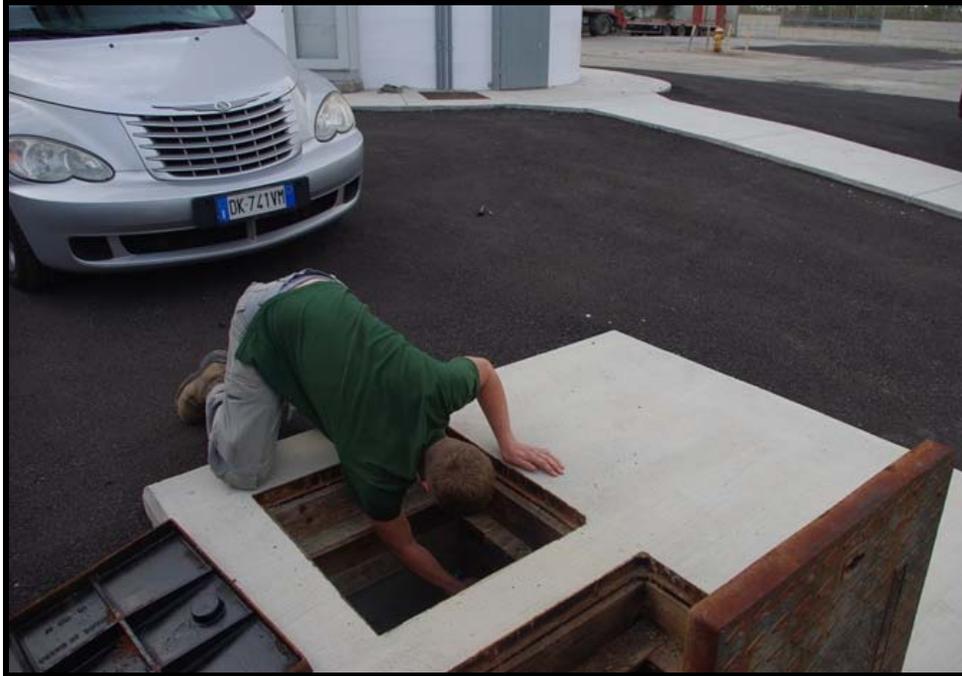
The overflow pipe discharges within a drain basin located southeast of the tank on the site (See photos 3.11-3 and 3.11-4). The overflow pipe does not have an above grade air break which is a sanitary deficiency (See photo 3.11-4).

PHOTO 3.11-3 Drain basin exterior.

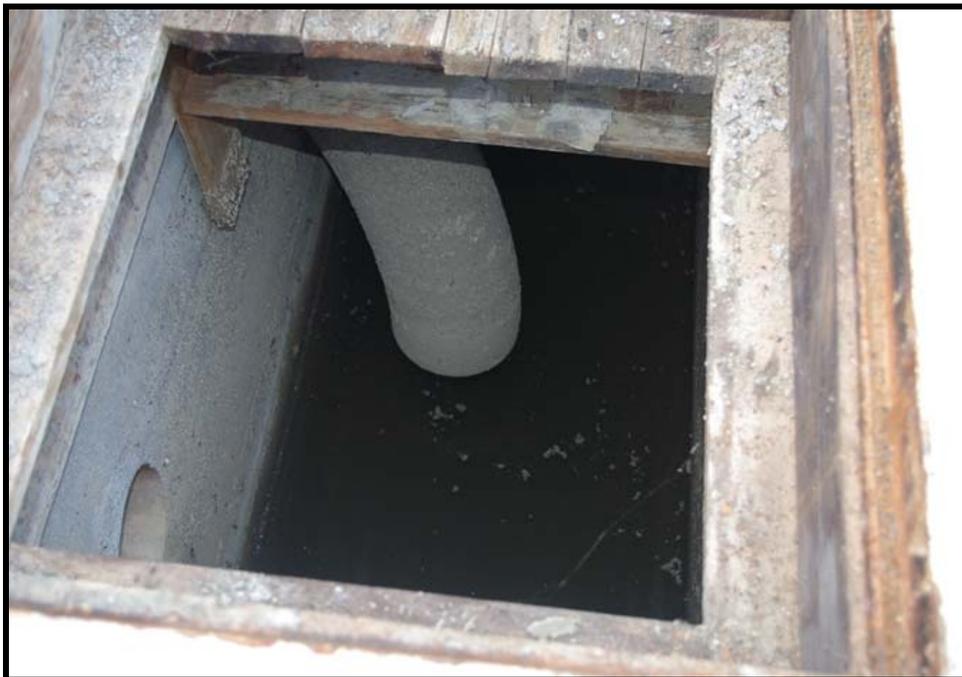
PHOTO 3.11-4 Drain basin interior.
