3.10 TANK 425

Tank 425 stores nonpotable water for the Naval Air Station in Sigonella, Italy.

3.10.1 Description of the Facility

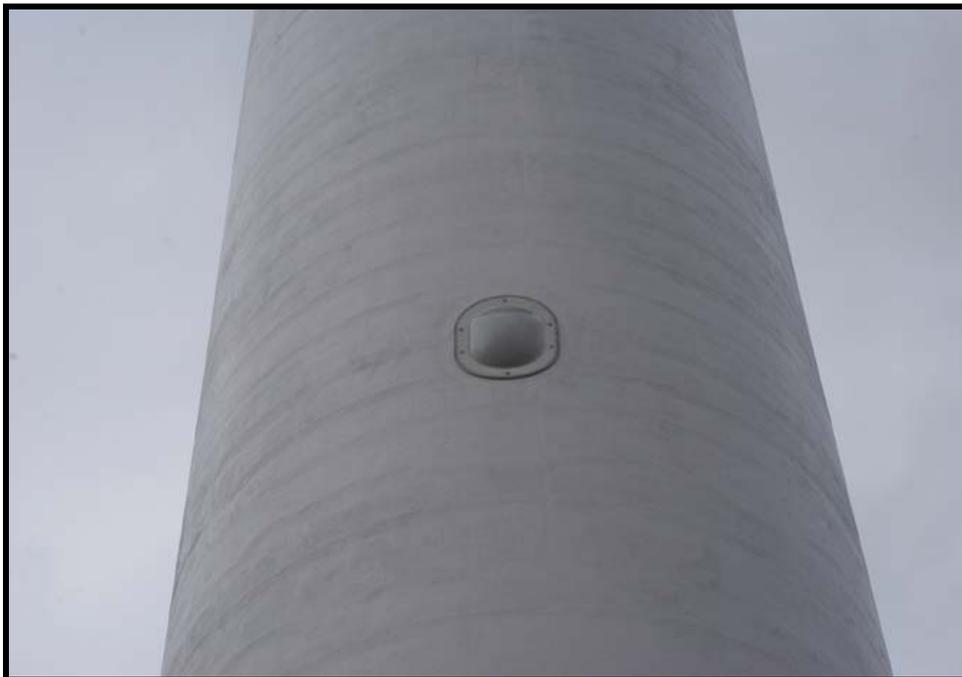
The concrete pedestal appears to be in generally good condition as there is no significant deterioration. A locked personnel-sized door is located near the base of the pedestal, and conduits extend up the pedestal to cabinets mounted above the door (See photo 3.11-7). Two warning signs, the tank number, and another cabinet are mounted near the base of the pedestal (See photos 3.11-6, 3.11-8, and 3.11-9). Three single-globe obstruction lights are mounted near the middle of the pedestal on the east, southwest, and northwest sides of the tank (See photos 3.11-11 and 3.11-12). There are skylights for passive lighting located in the pedestal (See photos 3.11-10 and 3.11-11).

PHOTO 3.11-10 Skylight in pedestal.

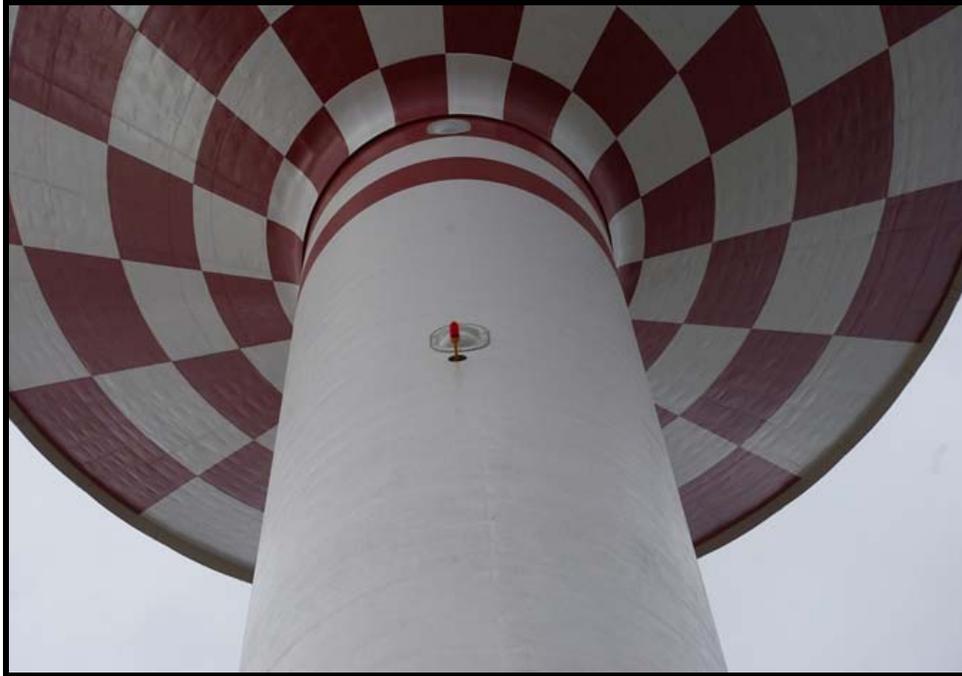
PHOTO 3.11-11 Pedestal manhole and obstruction light.

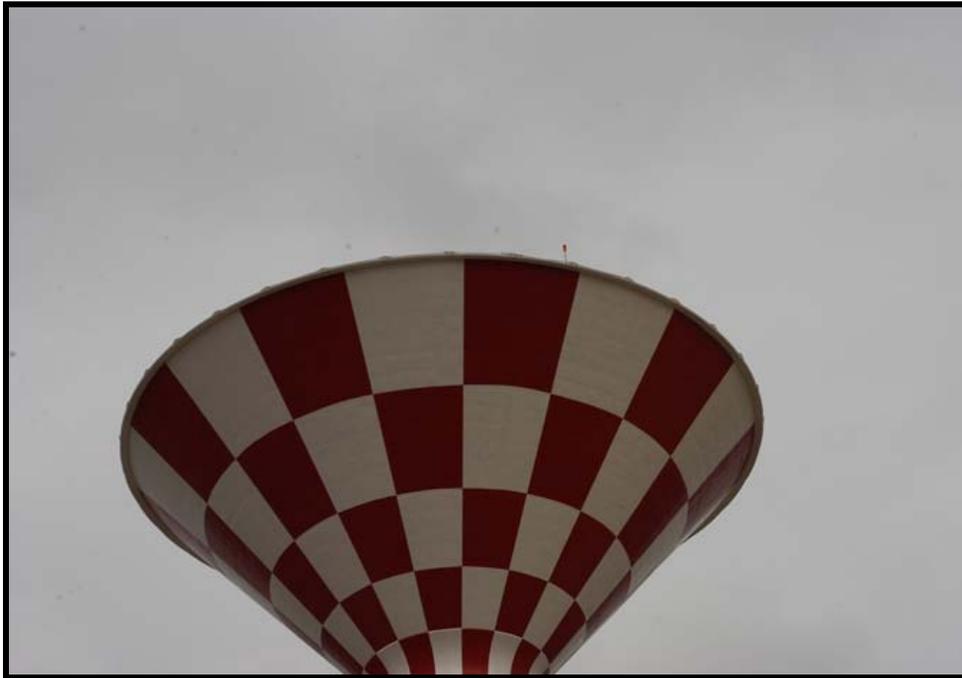
The concrete bowl is painted with the FAA obstruction lighting checkerboard. The visible coating is in good condition, and the visible concrete is also in good condition (See photos 3.11-13 and 3.11-14).

PHOTO 3.11-13 Bowl cone.

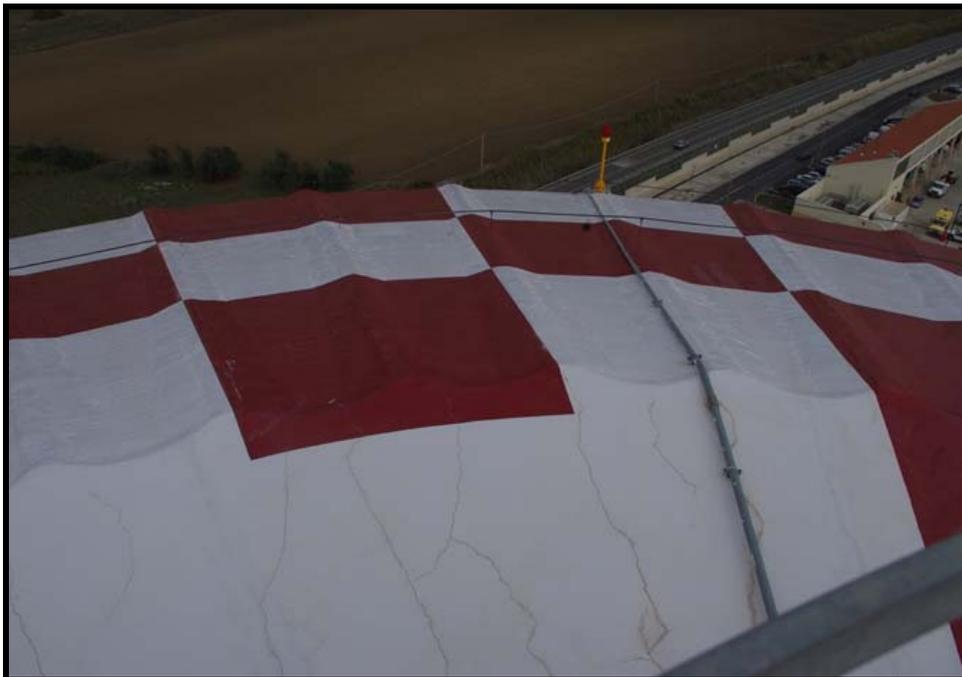
The concrete roof surfaces are covered with a fabric-type coating (See photo 3.11-16). The coating has peeled and chipped in areas, and there are several cracks in the coating (See photos 3.11-17 through 3.11-24). Due to the thickness of the coating, it is difficult to determine if the roof surface is cracking as well. Grounding cables and conduits extend across the roof, and there are three hooks on the roof (See photos 3.11-18 through 3.11-21 and 3.11-23). Note: the hooks should not be used for rigging purposes.

PHOTO 3.11-16 Roof exterior.

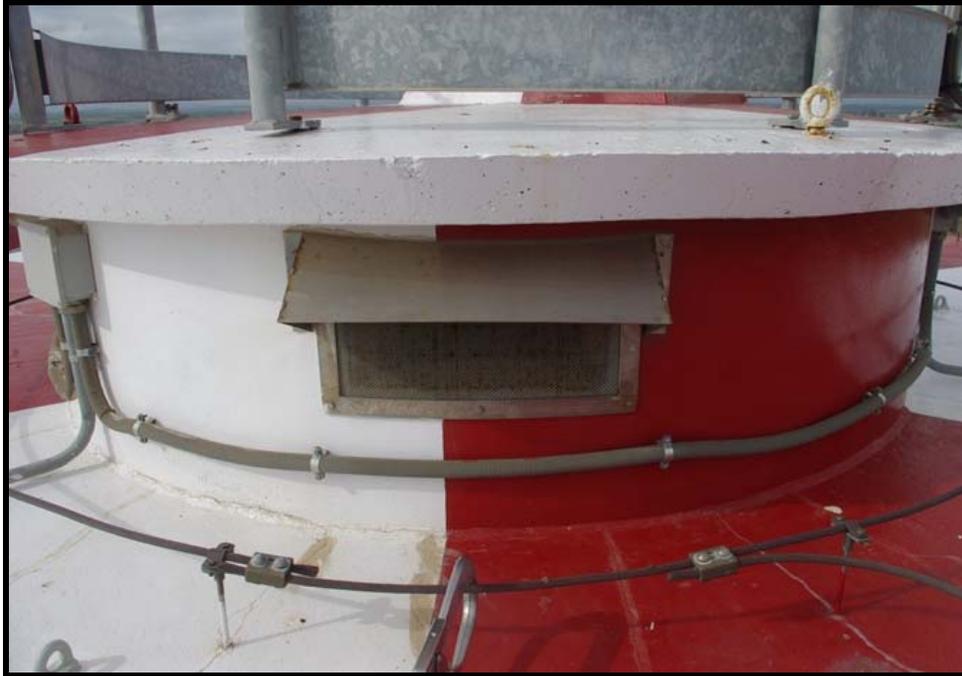
PHOTO 3.11-25 Shielded vent and electrical equipment on access tube projection.

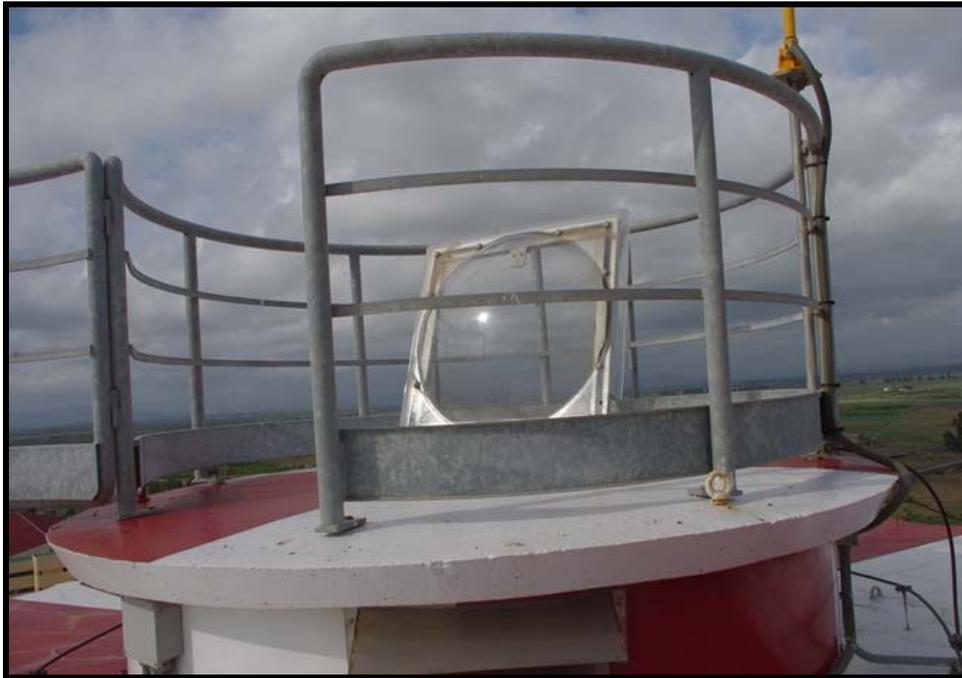
located in the top of the access tube (See photos 3.11-29, 3.11-32, and 3.11-33). The manhole cover is hinged but is not locked. The cover has a gasket but it is cracked (See photo 3.11-34). Three hooks are located on the top of the projection (See photo 3.11-27). There are vent openings in the side of the access tube projection which are shielded from wind-driven dust and debris (See photos 3.11-25 and 3.11-26). The screening is intact. Note: the hooks should not be used for rigging purposes. Safety-related, OSHA, AWWA, and sanitary deficiencies include: (1) the 40 in. (1016 mm) handrail height does not meet the minimum required 42 in. (1067 mm) minimum, (2) the 1 in. (25 mm) x 5/16 in. (8 mm) mid-rails do not meet the required 2 in. (51 mm) x 2 in. (51 mm) x 3/8 in. (9 mm) minimum, (3) the 2 in. (51 mm) wide gaps between the toe bar and top of the access tube exceed the maximum allowed 1/4 in. (6 mm), (4) the roof has only one manhole, (5) the manhole cover has cracked, and (6) the roof manhole is not locked.

PHOTO 3.11-29 Safety railing and roof manhole cover on access tube projection.

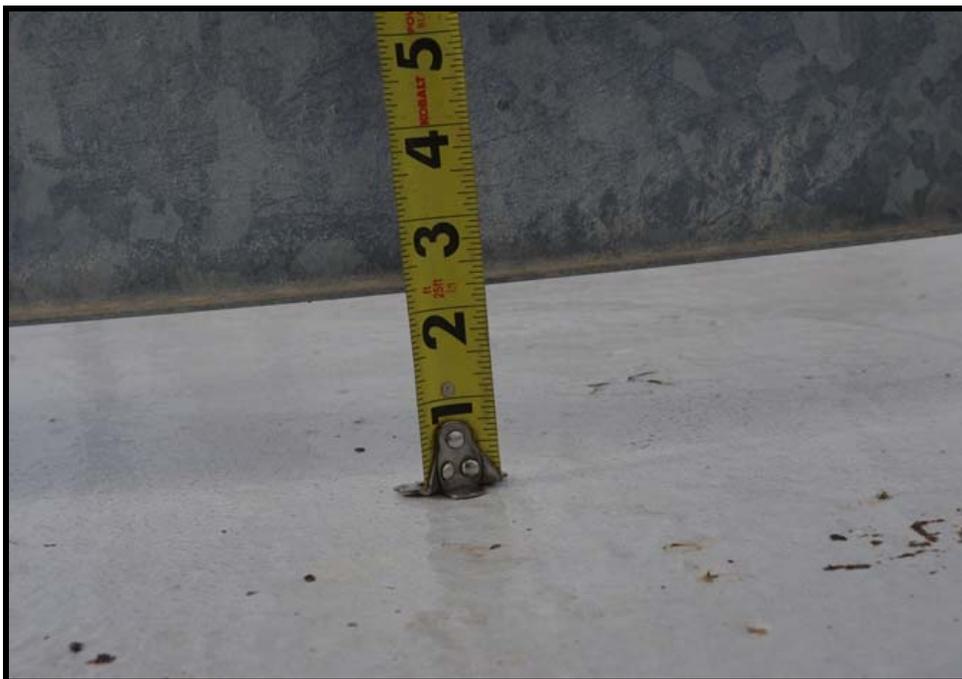
PHOTO 3.11-30 Gap between toe bar and top of access tube projection.

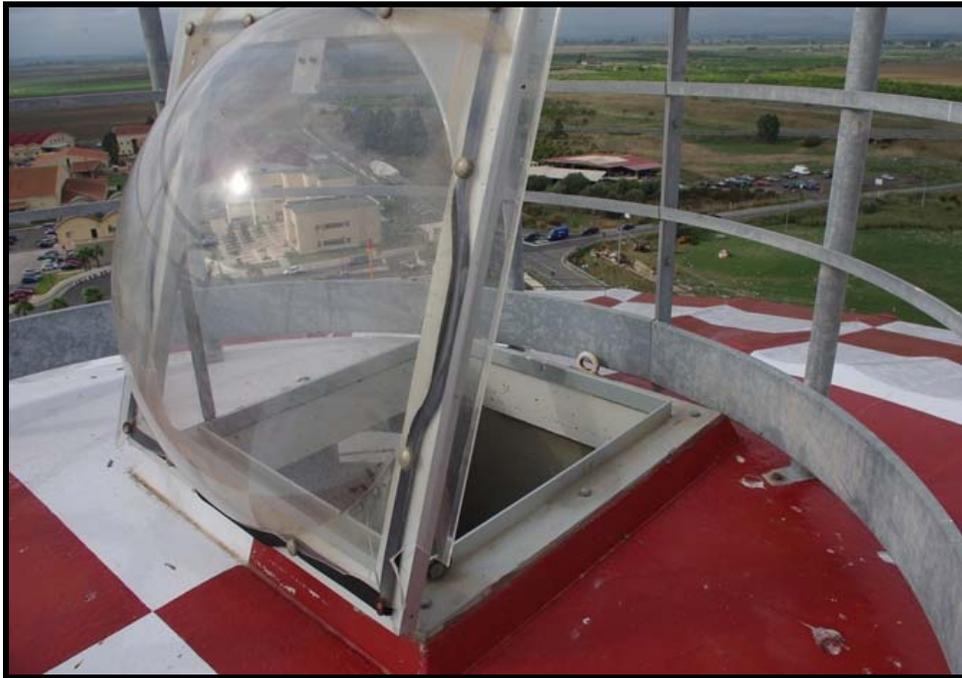
PHOTO 3.11-33 Roof manhole.

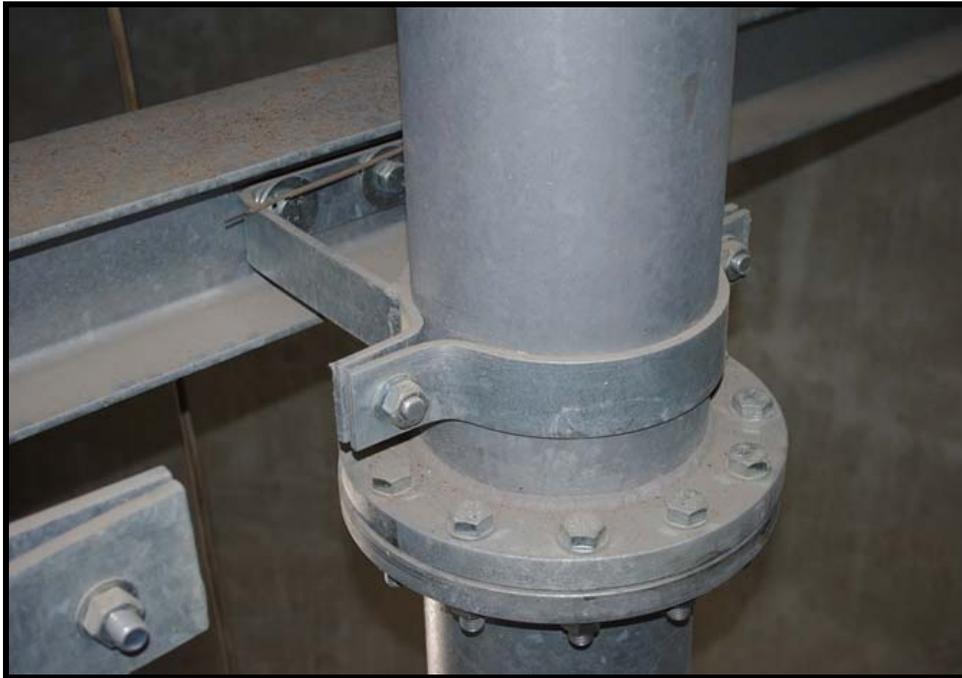
PHOTO 3.11-43 Interior dry piping and brackets.

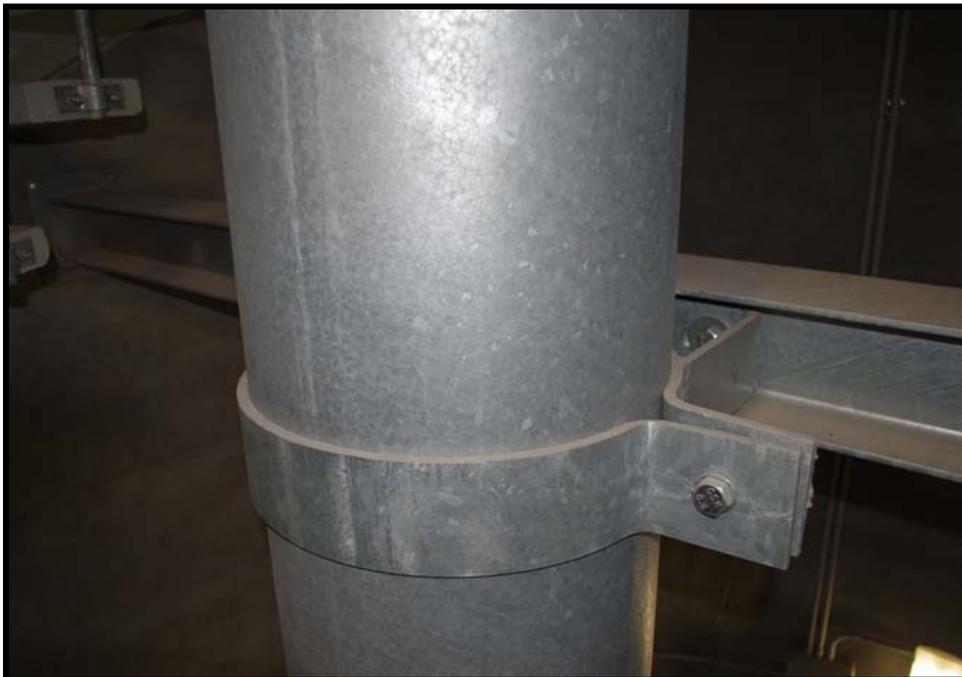
PHOTO 3.11-44 Interior dry piping and brackets.

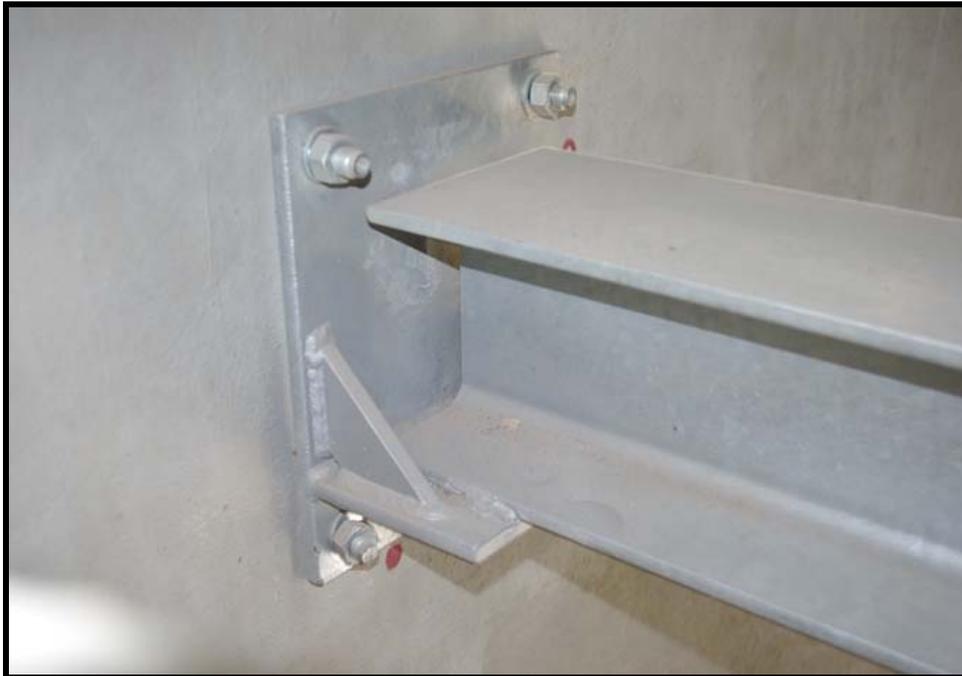
PHOTO 3.11-45 Interior dry piping bracket attachment to pedestal.

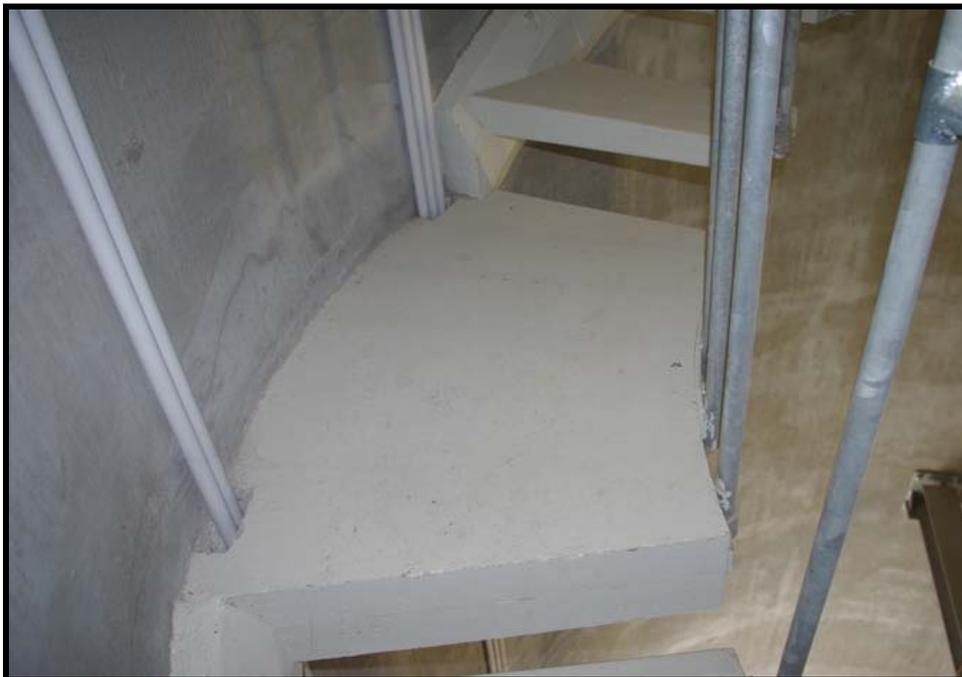
PHOTO 3.11-46 Platform between stair sections.

Pedestal and Access Tube Platforms: The access openings through the platforms should be equipped with closure chains. The mid-rails on the platforms should be replaced with mid-rails which meet current OSHA requirements and have a handrail at least 42 in. (1067 mm) tall. The platforms should all have toe bars which are 4 in. (102 mm) tall and have gaps between the toe bars and platforms of less than 1/4 in. (6 mm) wide.

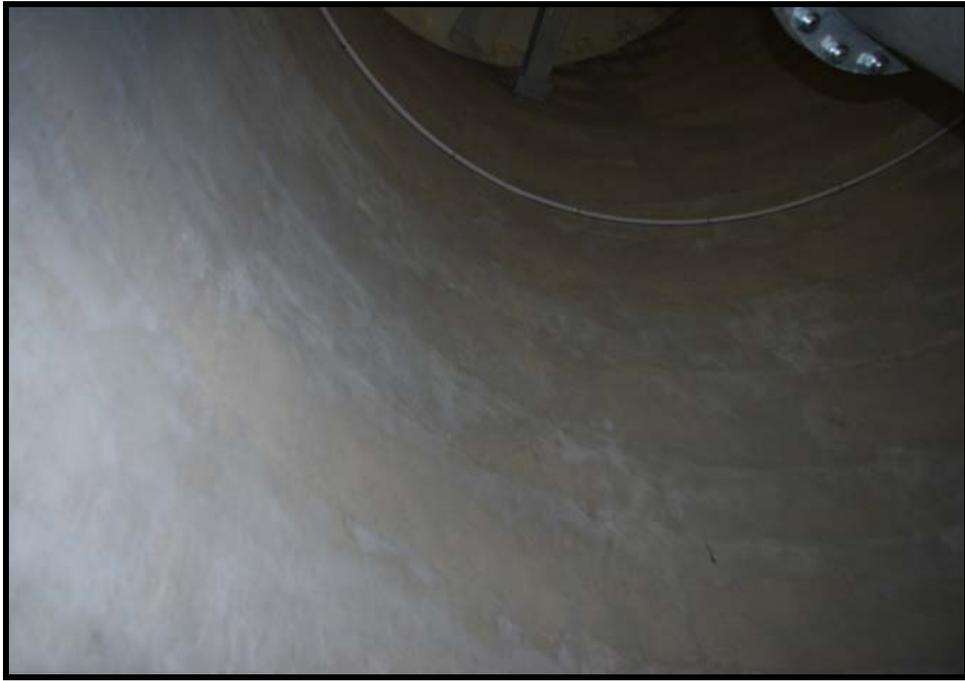
PHOTO 3.11-47 Concrete pedestal interior.

Interior Dry Concrete: The interior dry concrete surfaces appeared to be in adequate condition as no significant deterioration was observed. The interior surfaces should be re-evaluated in 3 to 4 years to determine if repairs are required at that time.

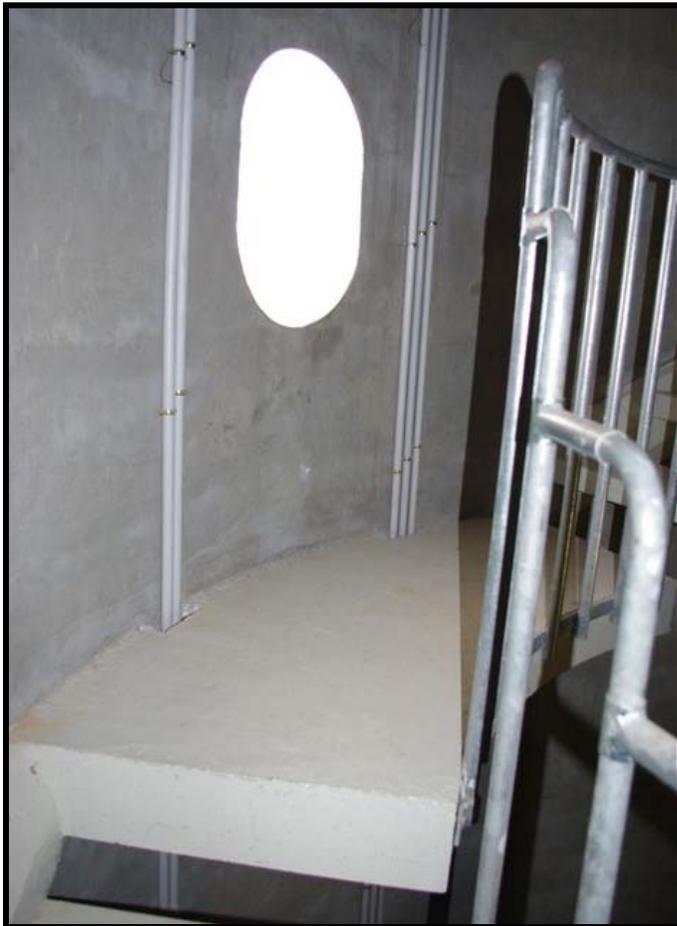
PHOTO 3.11-48 Platform, safety railing, and skylight.

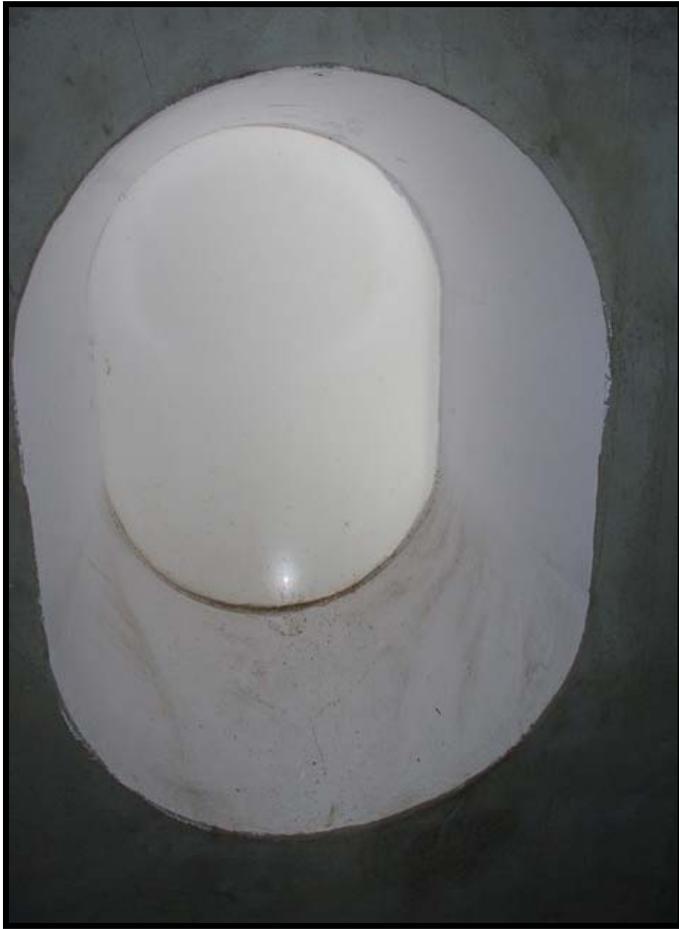
PHOTO 3.11-49 Skylight in pedestal.

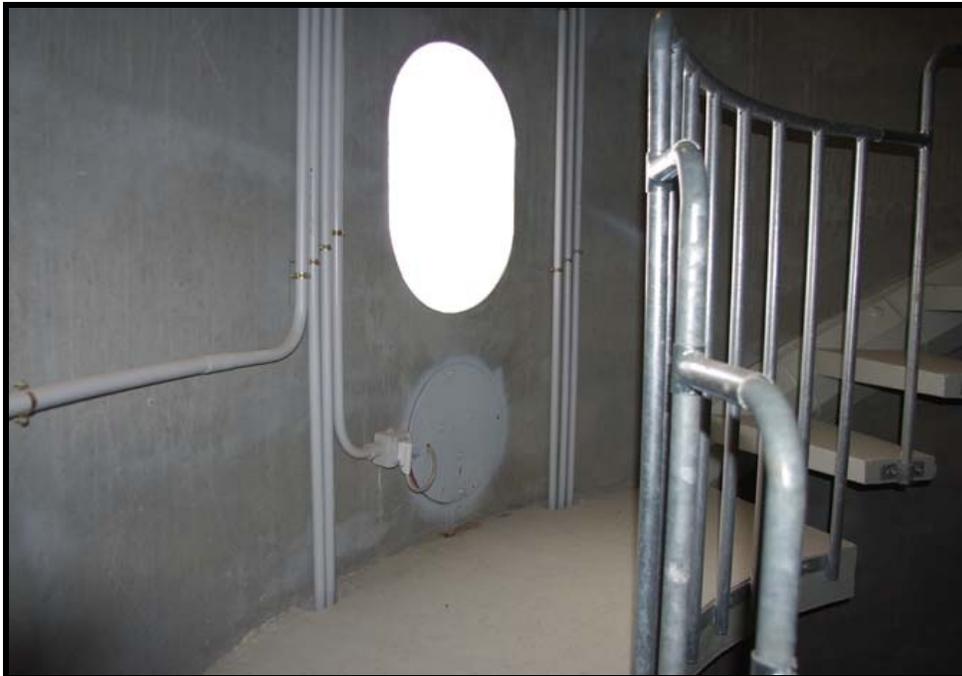
PHOTO 3.11-50 Platform, safety railing, pedestal manhole, and electrical equipment.

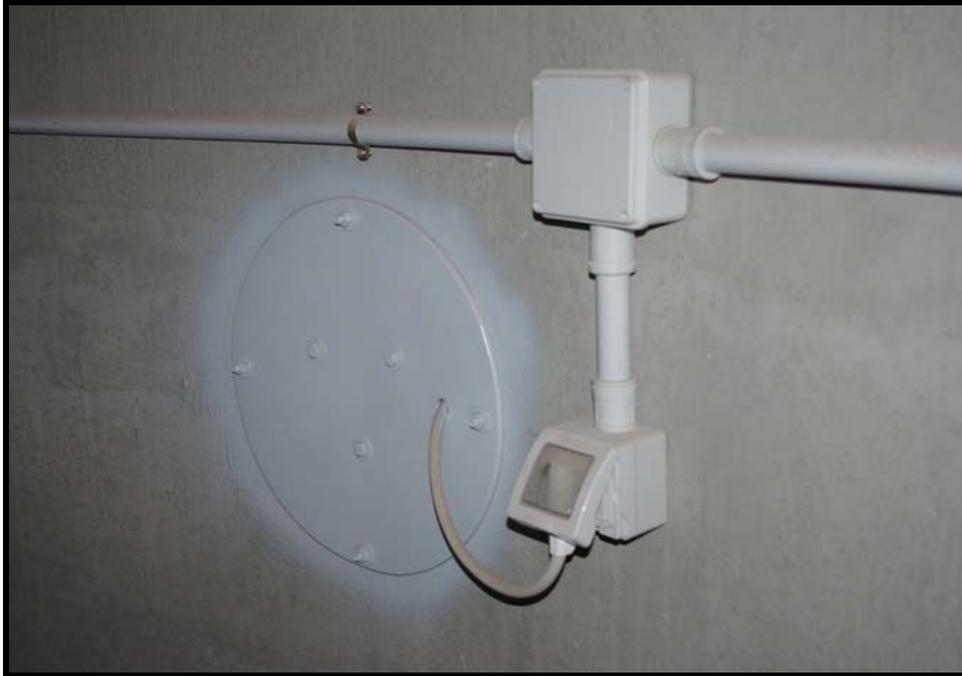
PHOTO 3.11-51 Electrical equipment in pedestal.

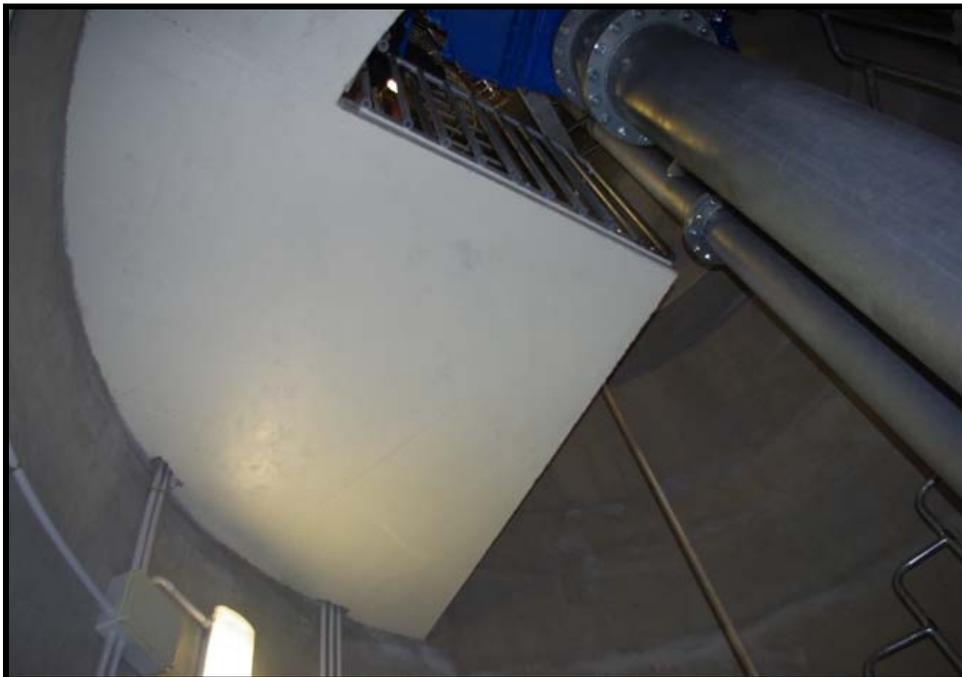
PHOTO 3.11-52 Underside of platform.

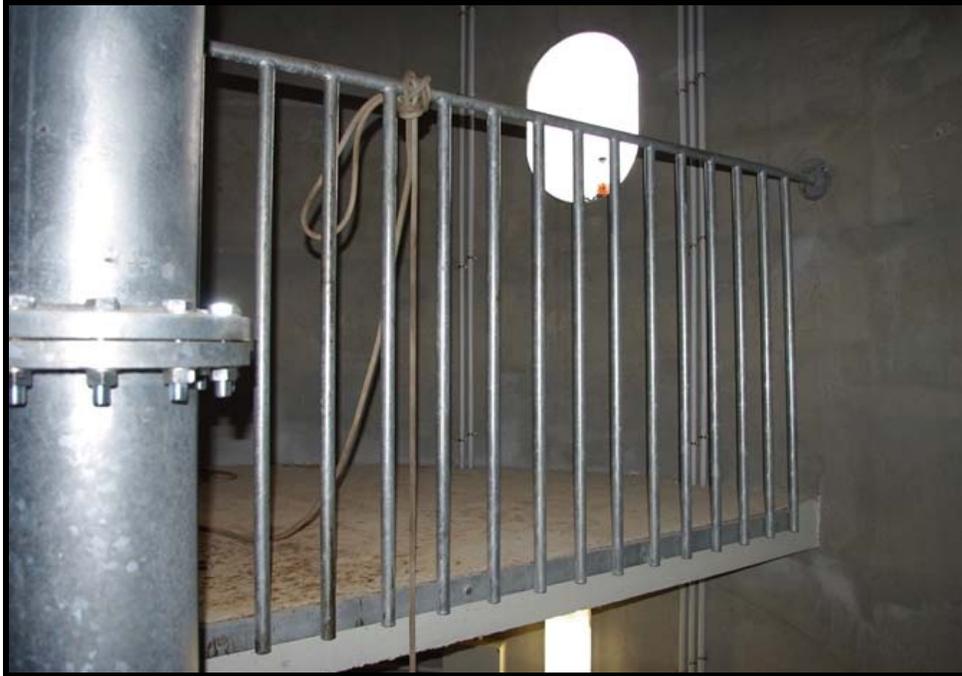
PHOTO 3.11-53 Platform and safety railing.

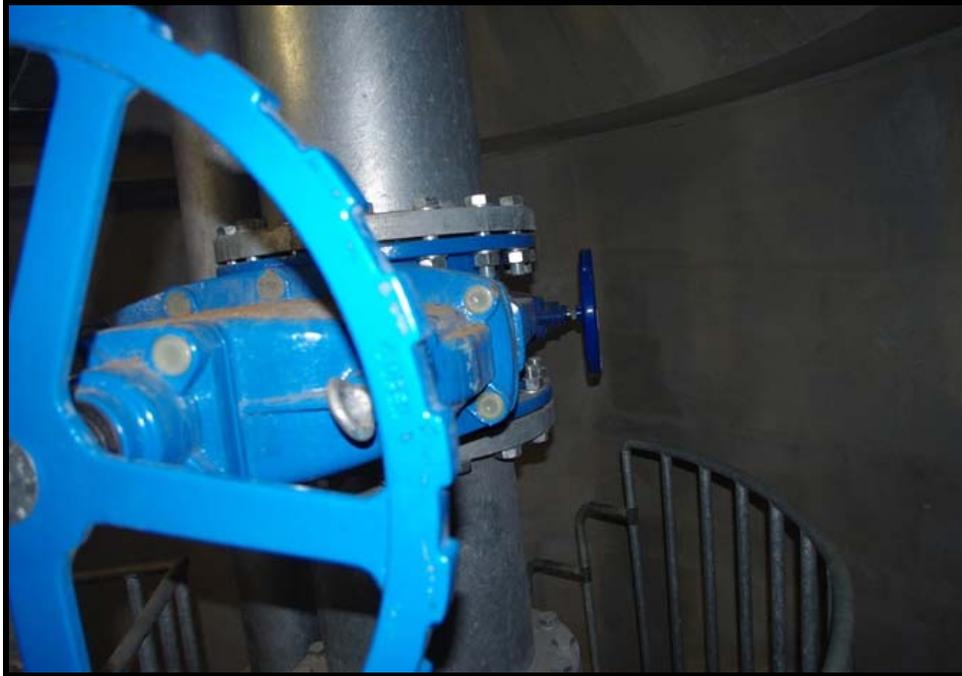
PHOTO 3.11-55 Interior dry piping.

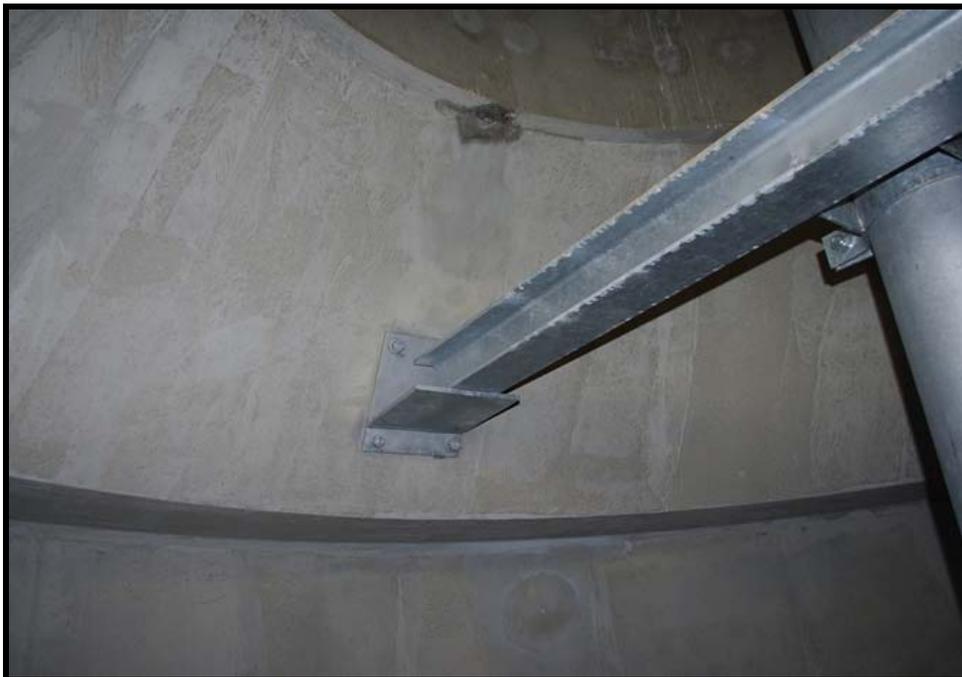
PHOTO 3.11-56 Interior dry piping bracket and bowl cone.

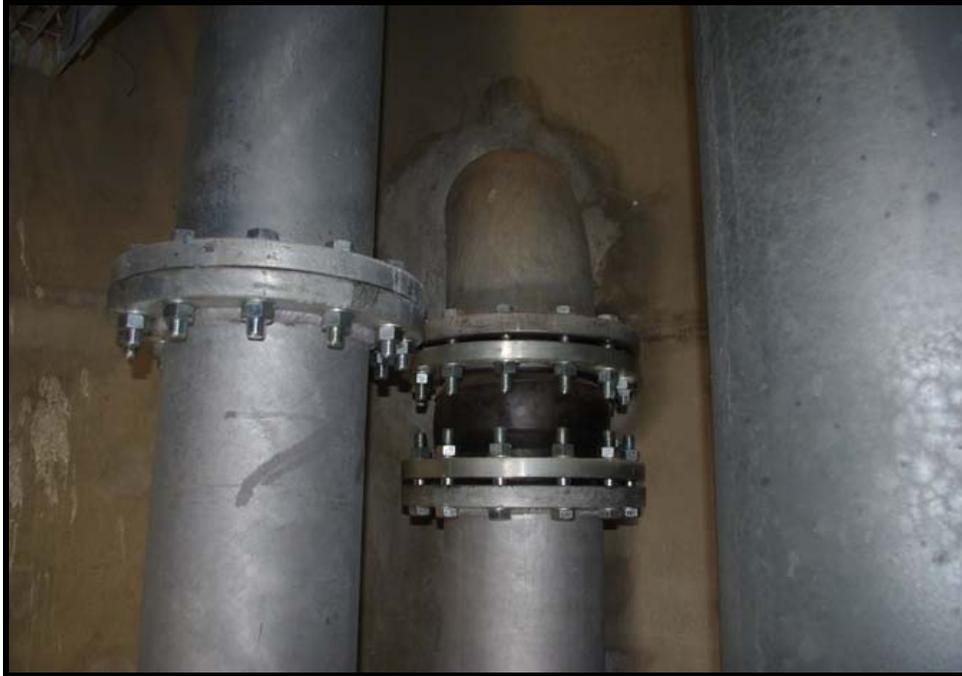
PHOTO 3.11-57 Expansion joint in interior dry piping.

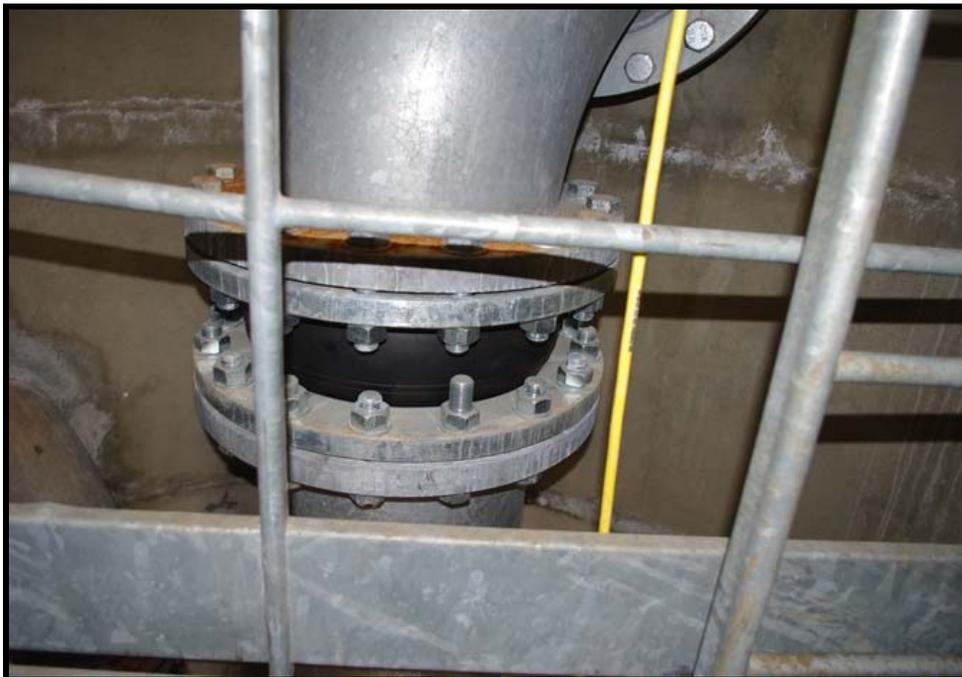
PHOTO 3.11-58 Expansion joint in interior dry piping.

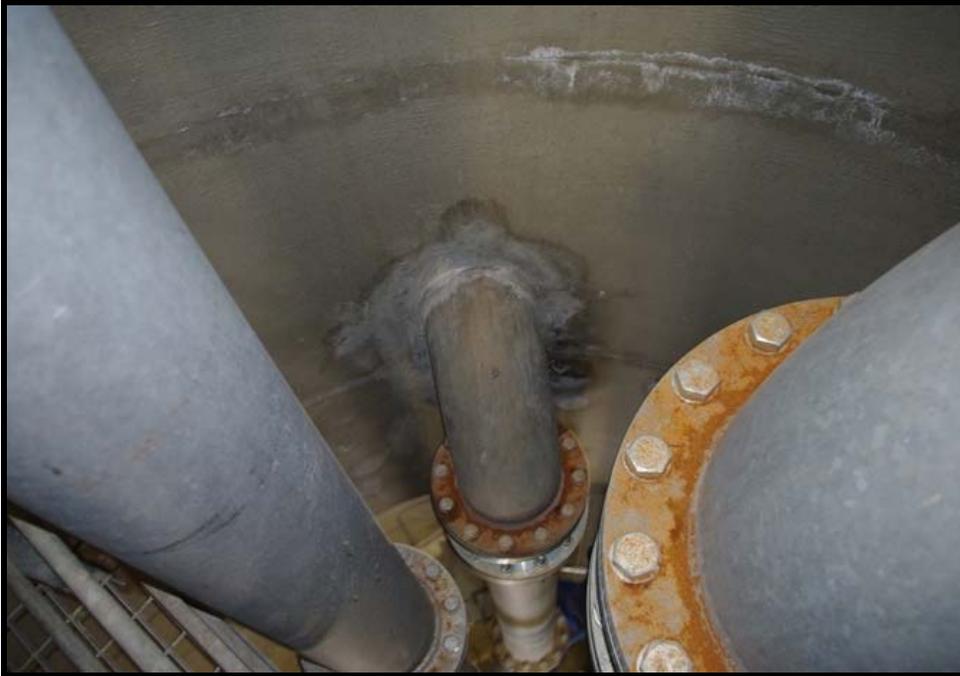
PHOTO 3.11-59 Interior dry piping.

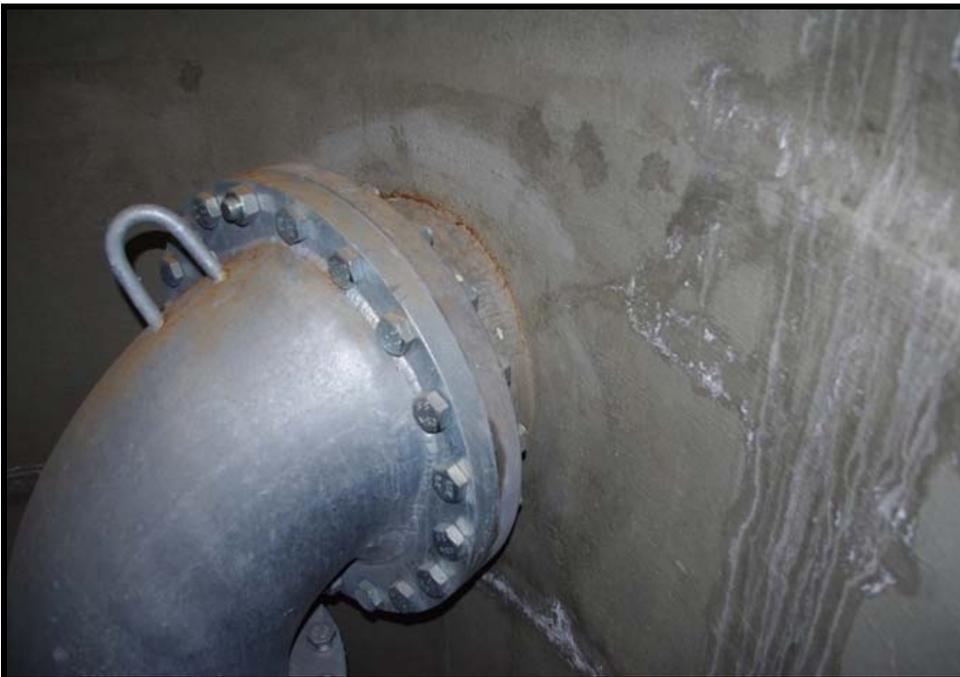
PHOTO 3.11-60 Interior dry piping.

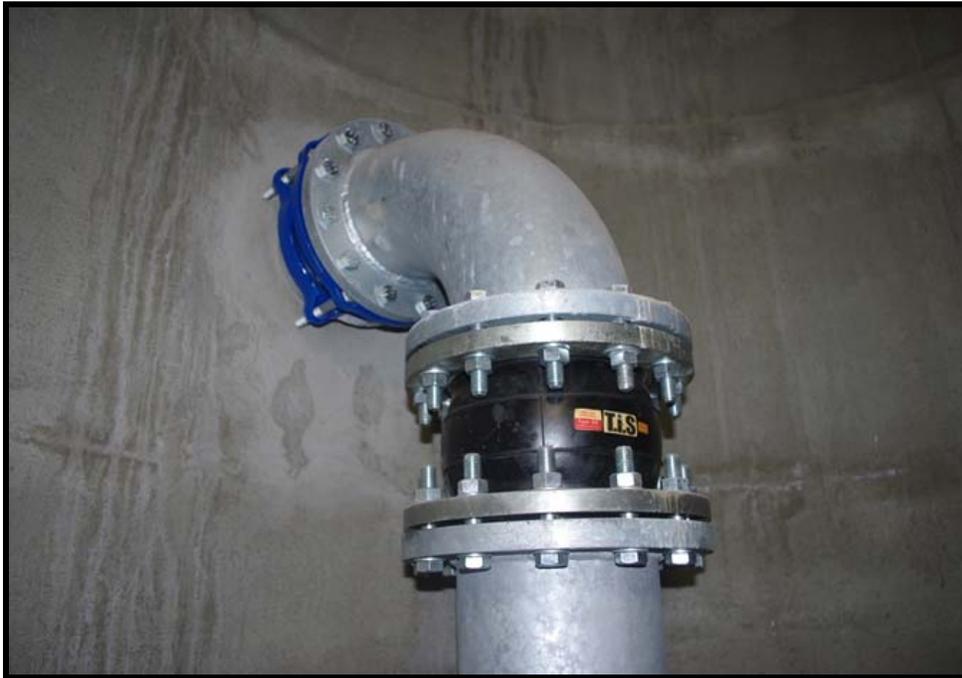
PHOTO 3.11-61 Expansion joint in interior dry piping.

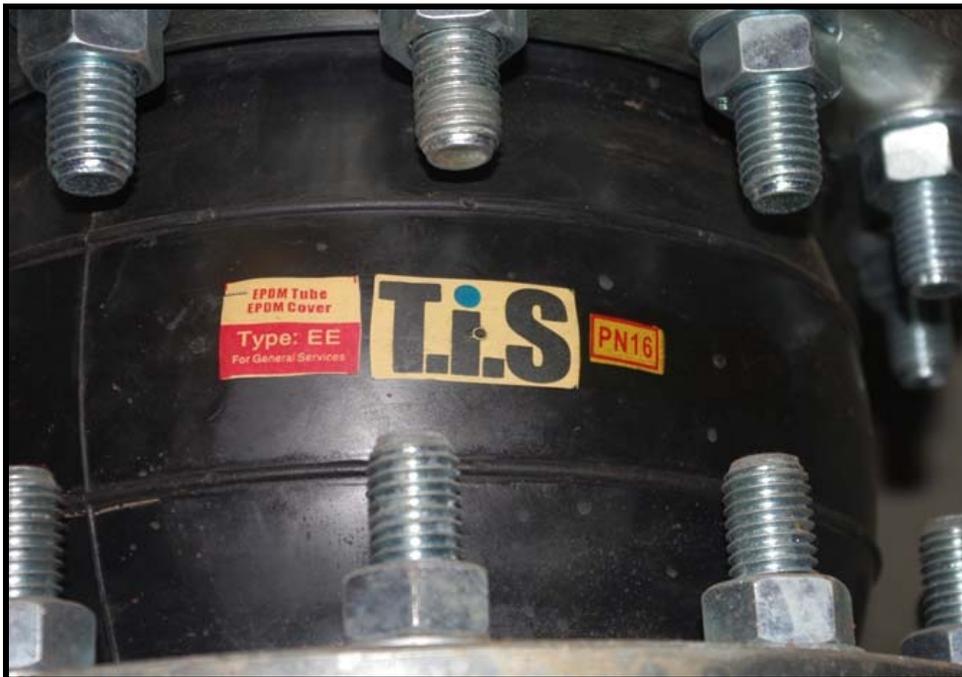
PHOTO 3.11-62 Expansion joint in interior dry piping.

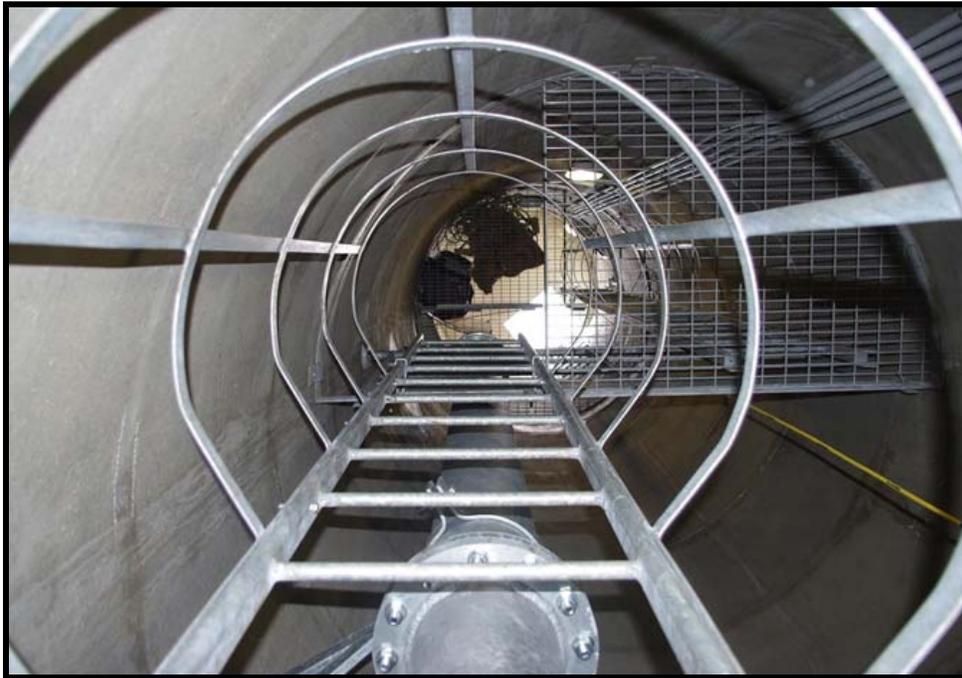
PHOTO 3.11-63 Access tube, ladder, safety cage, piping, and platform.

Access Tube Ladder: The existing access tube ladder sections should be replaced with new ladder sections which meet current dimensional requirements and allow adequate head clearance. In addition, the safety cage is not required on ladders with safe-climbing devices. Because the existing safety cages are not OSHA compliant, Tank Industry Consultants recommends that the safety cages be removed and safe-climbing devices be installed. The ladder does not include slip-resistant rungs. Slip-resistant rungs are required for all ladders constructed after March 1991 by the OSHA

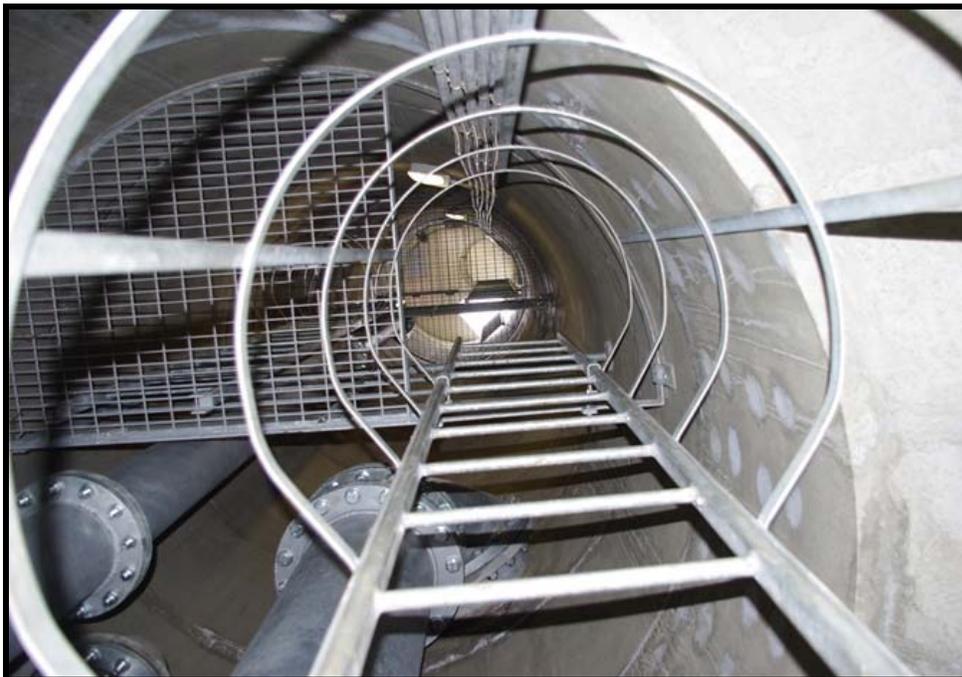
PHOTO 3.11-64 Access tube, ladder, safety cage, piping, and platform.

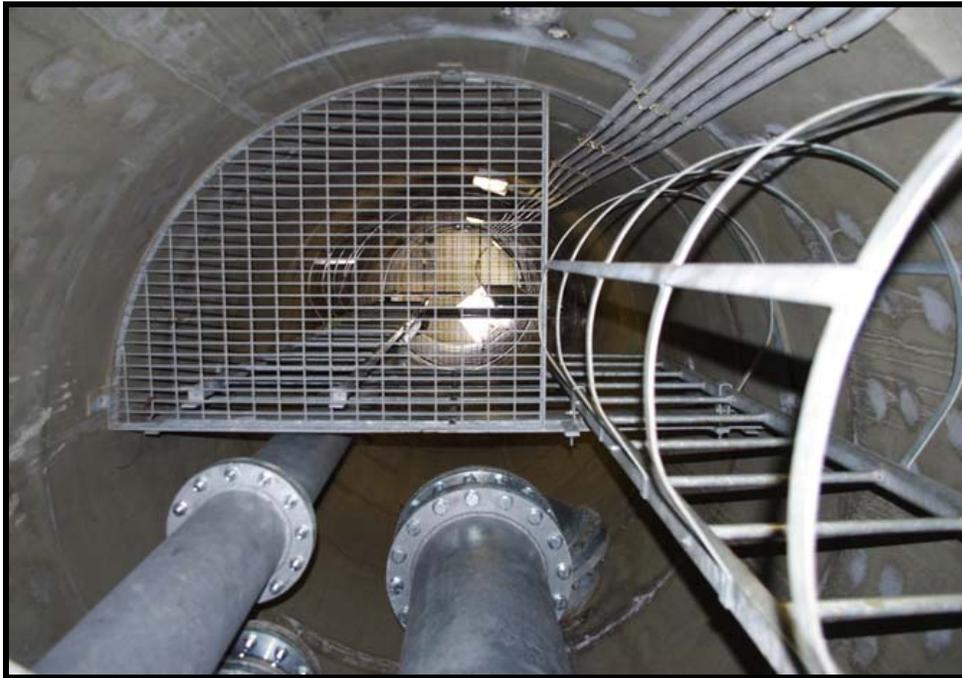
PHOTO 3.11-65 Access tube, ladder, safety cage, piping, and platform.

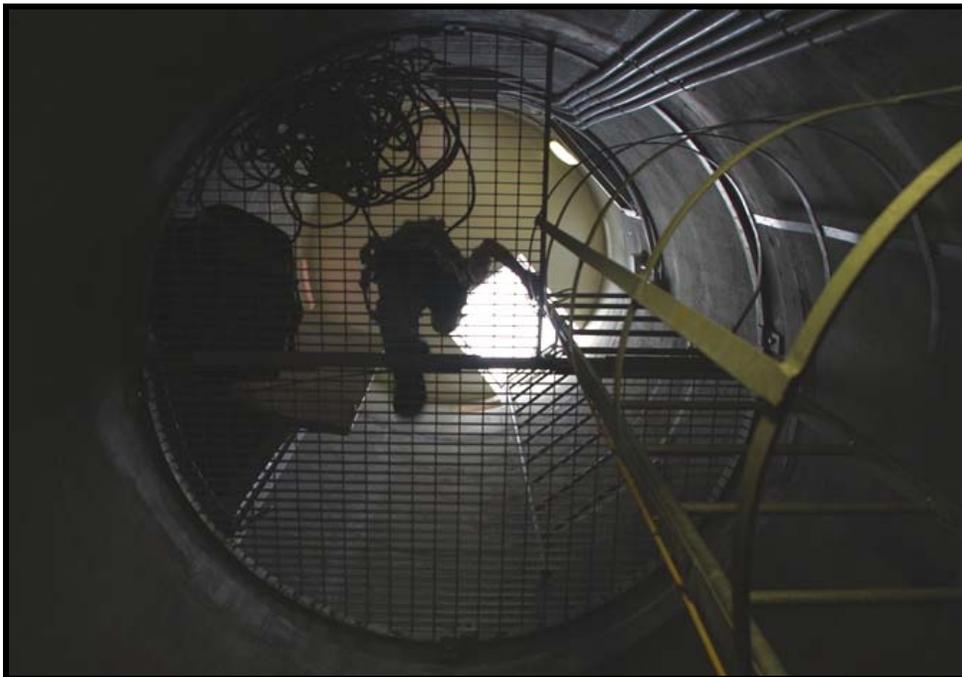
PHOTO 3.11-66 Access tube, ladder, safety cage, and platform.

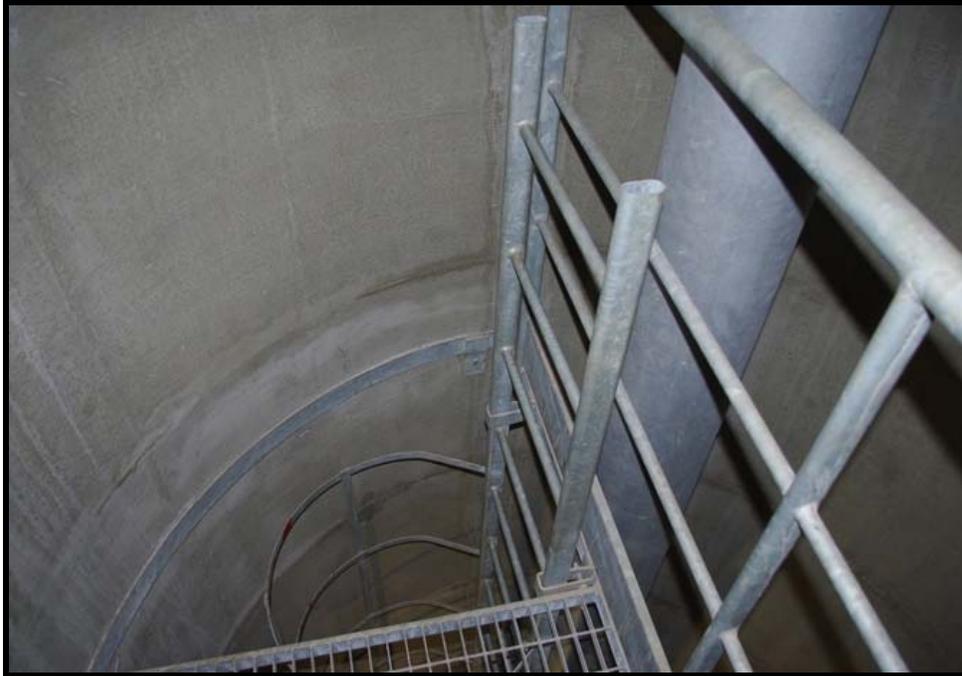
PHOTO 3.11-67 Access tube, ladder, piping, and platform.

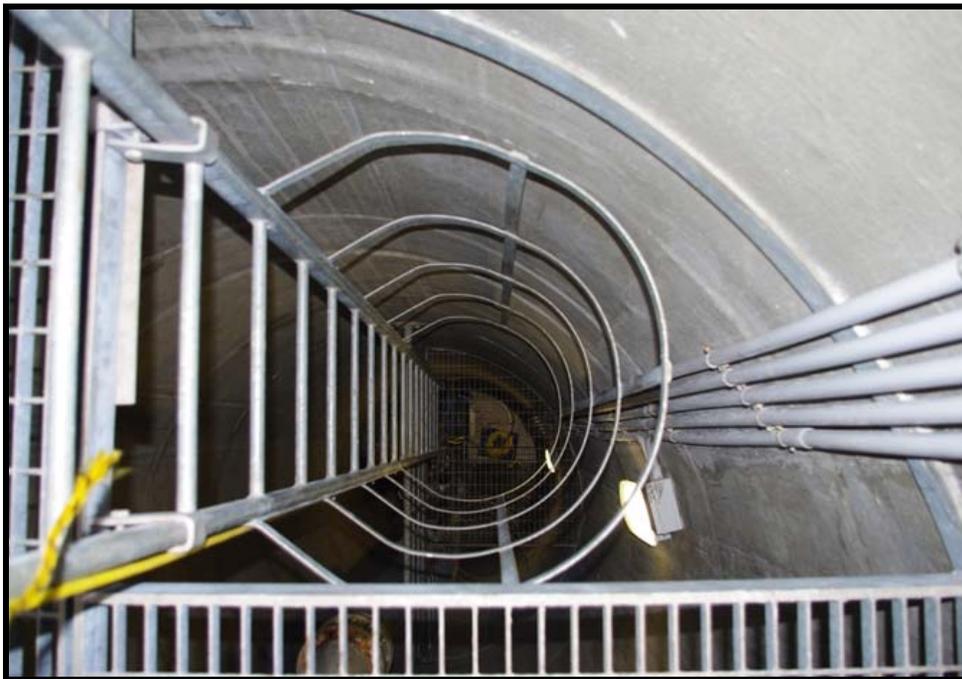
PHOTO 3.11-68 Access tube, ladder, and safety cage.
