3.10 TANK 425

Tank 425 stores nonpotable water for the Naval Air Station in Sigonella, Italy.

3.10.1 Description of the Facility

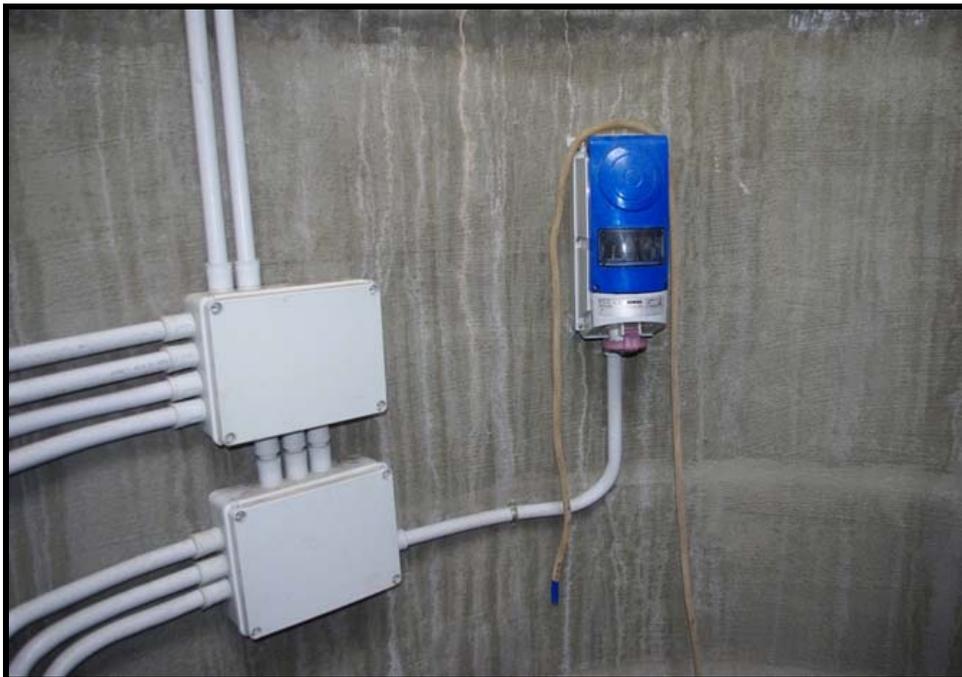
PHOTO 3.11-70 Electrical equipment in access tube.

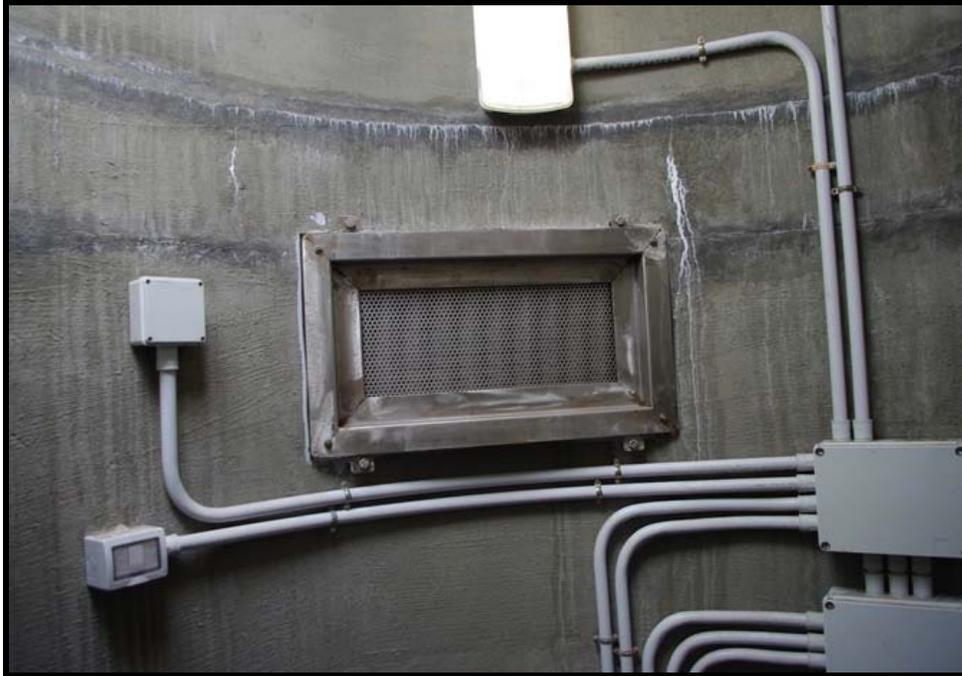
PHOTO 3.11-71 Electrical equipment and vent opening to container.

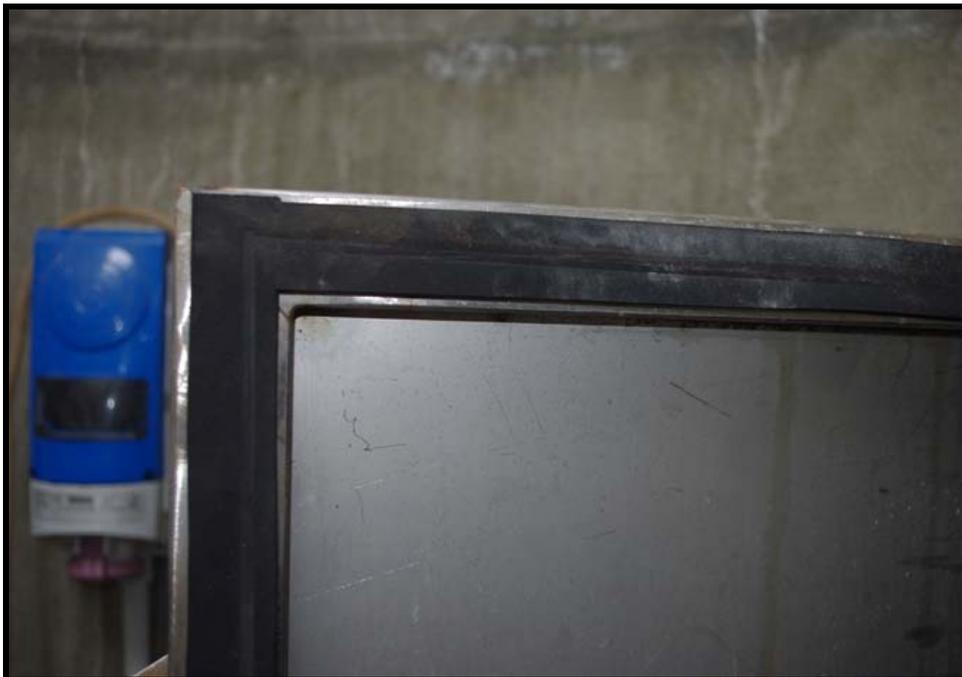
PHOTO 3.11-72 Gasket material around access door to wet container.

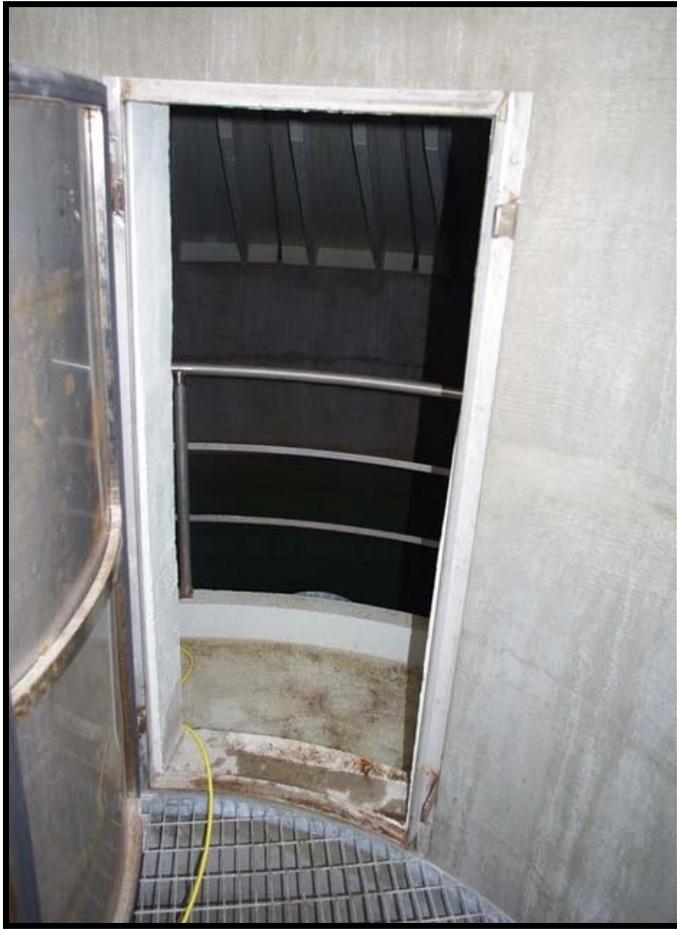
PHOTO 3.11-73 Access door to wet container.

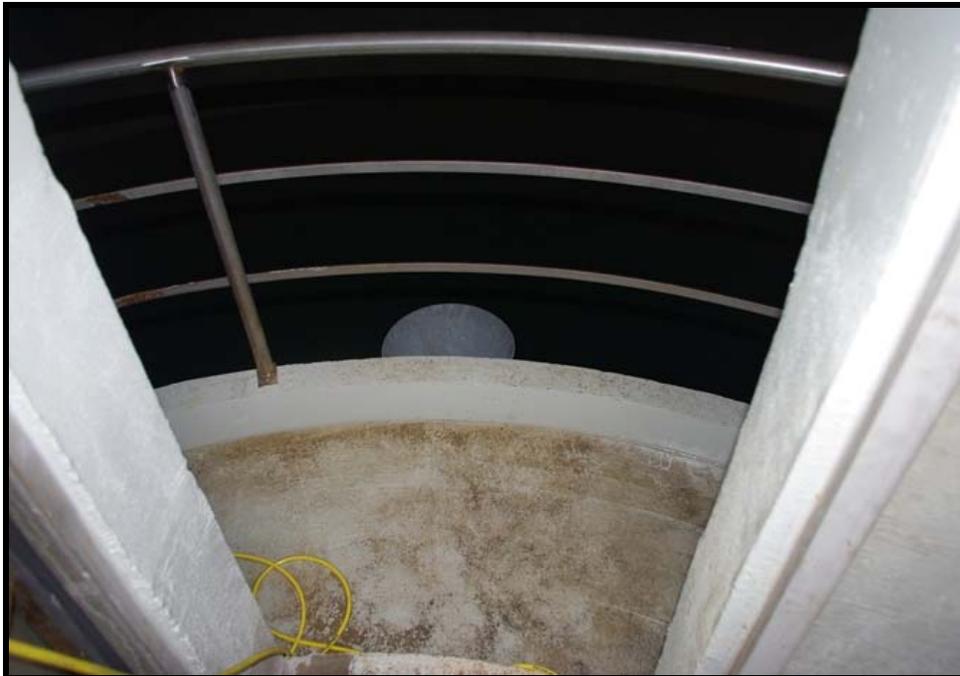
PHOTO 3.11-74 Access door and platform to wet container.

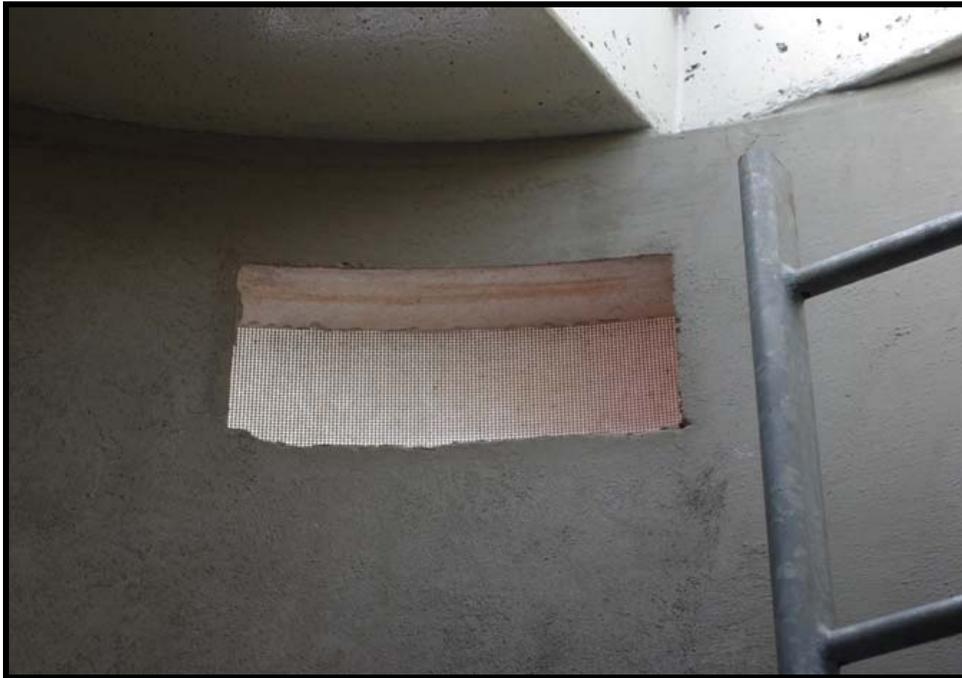
PHOTO 3.11-75 Vent opening near top of access tube.

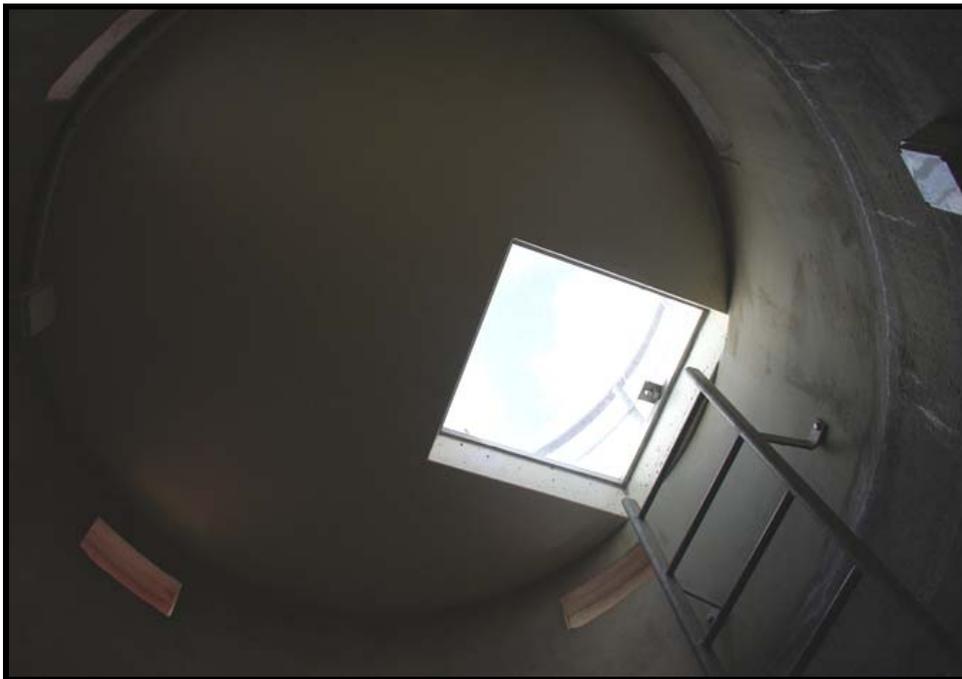
PHOTO 3.11-76 Access tube, manhole, and ladder.

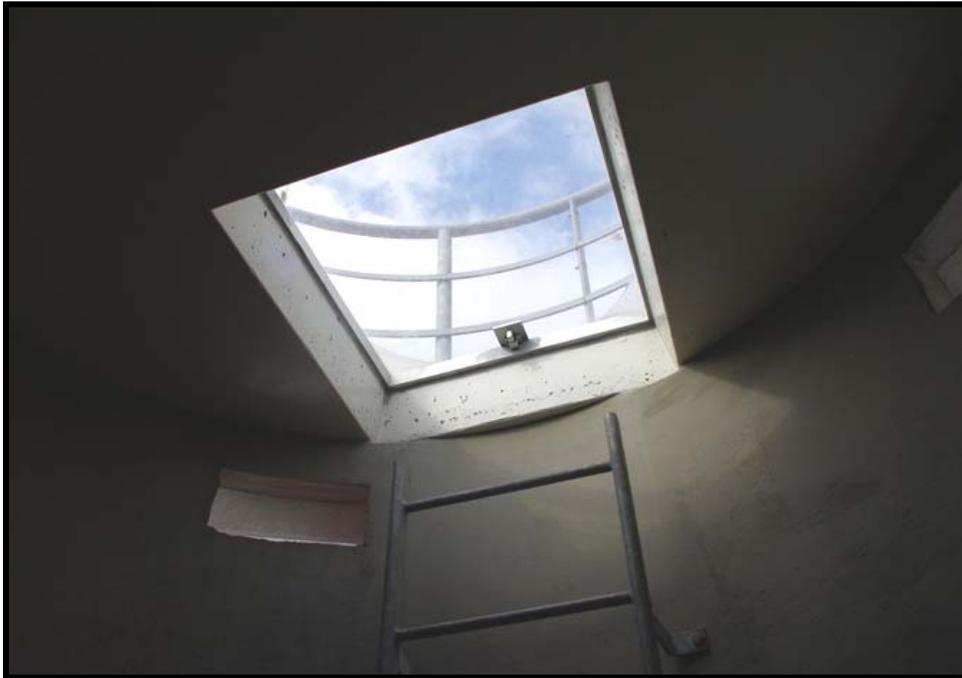
PHOTO 3.11-77 Access tube, manhole, and ladder.

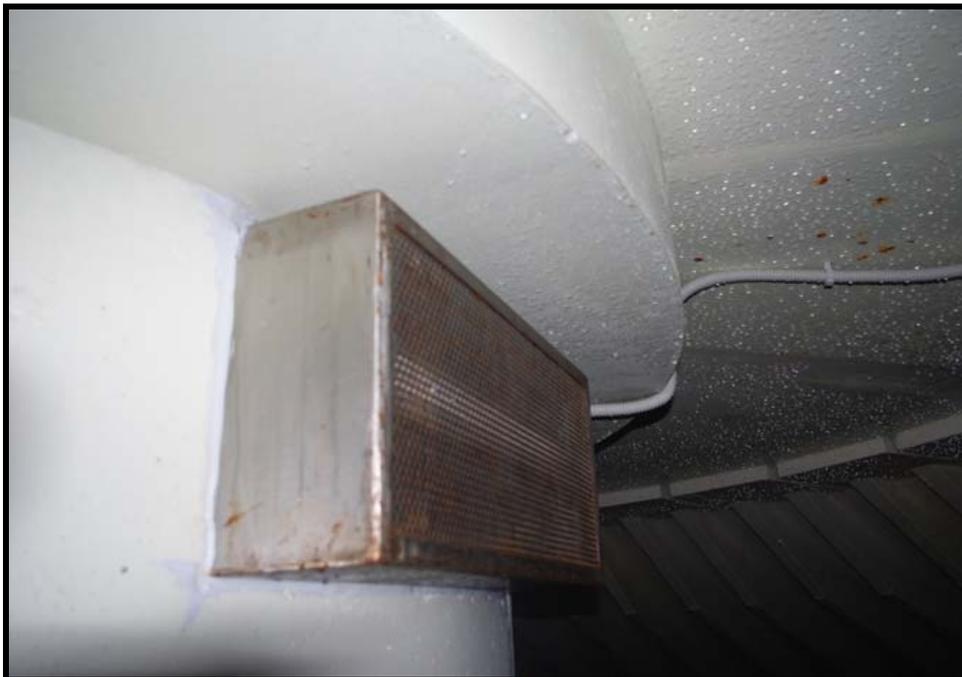
PHOTO 3.11-78 Vent from access tube interior in container.

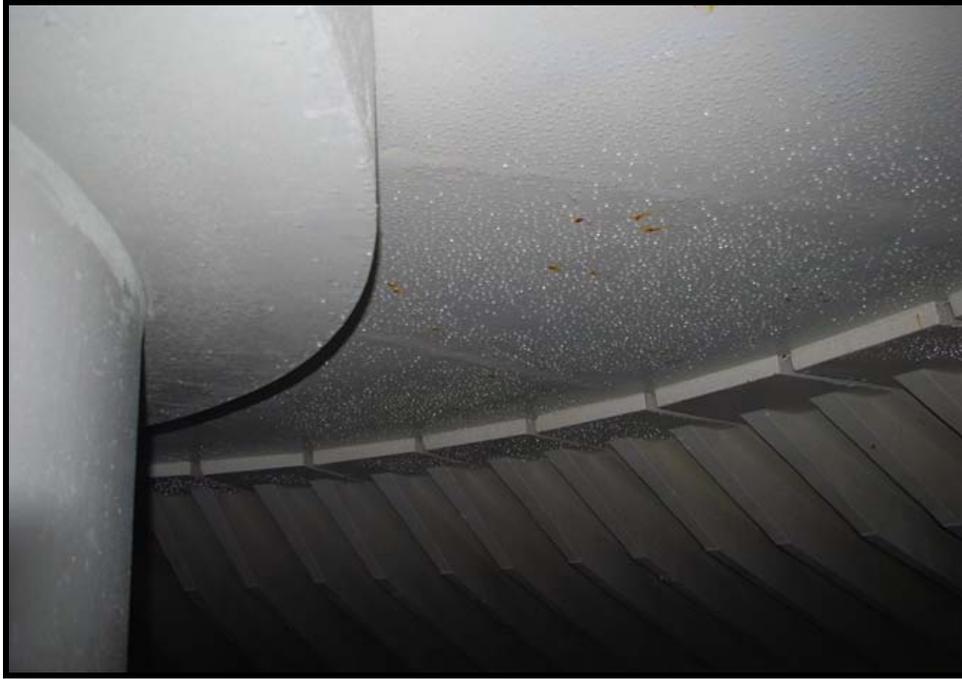
PHOTO 3.11-79 Interior container roof.

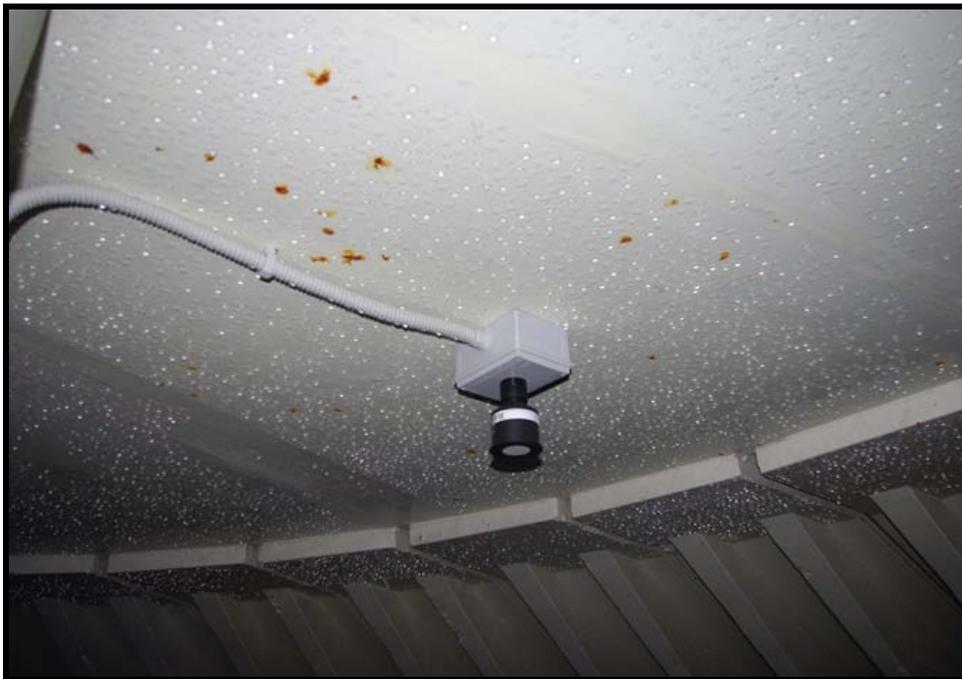
PHOTO 3.11-80 Sensor equipment on interior container roof.

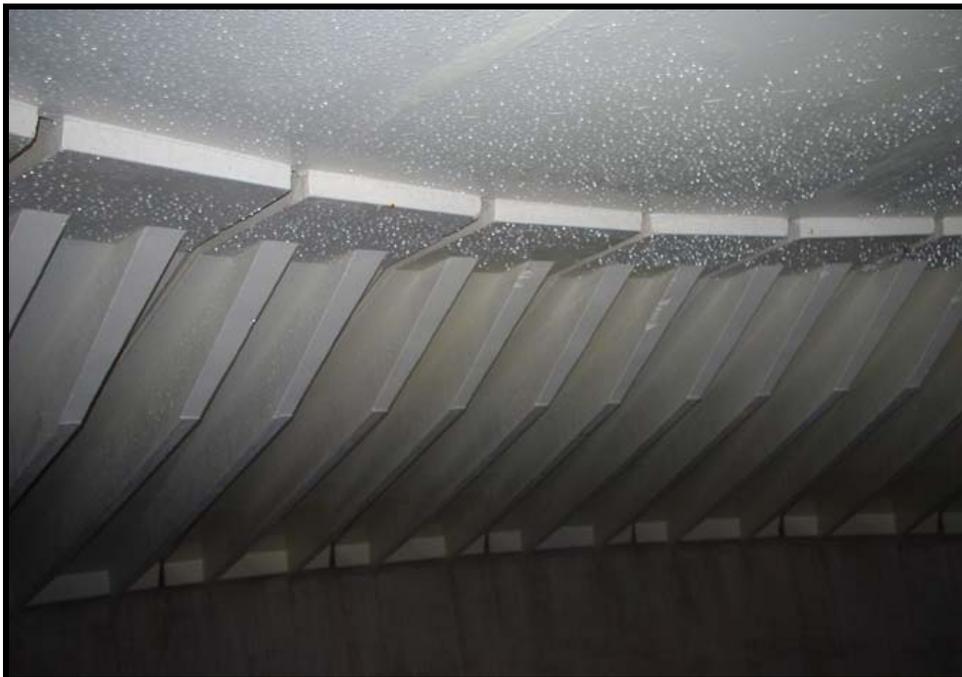
PHOTO 3.11-82 Interior container roof and stiffeners.

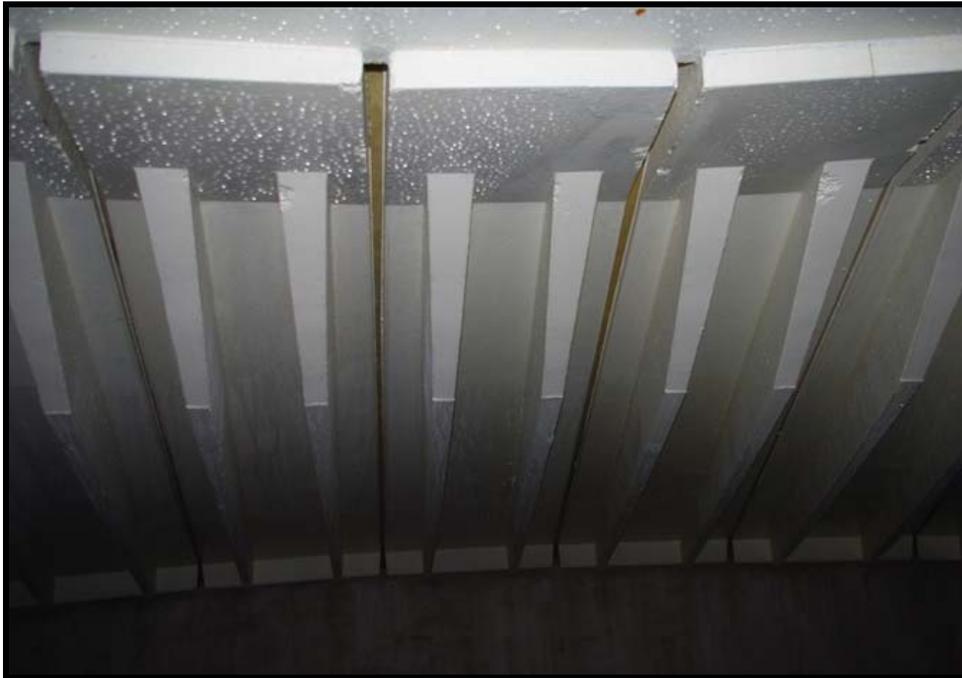
PHOTO 3.11-83 Interior container roof and stiffeners.

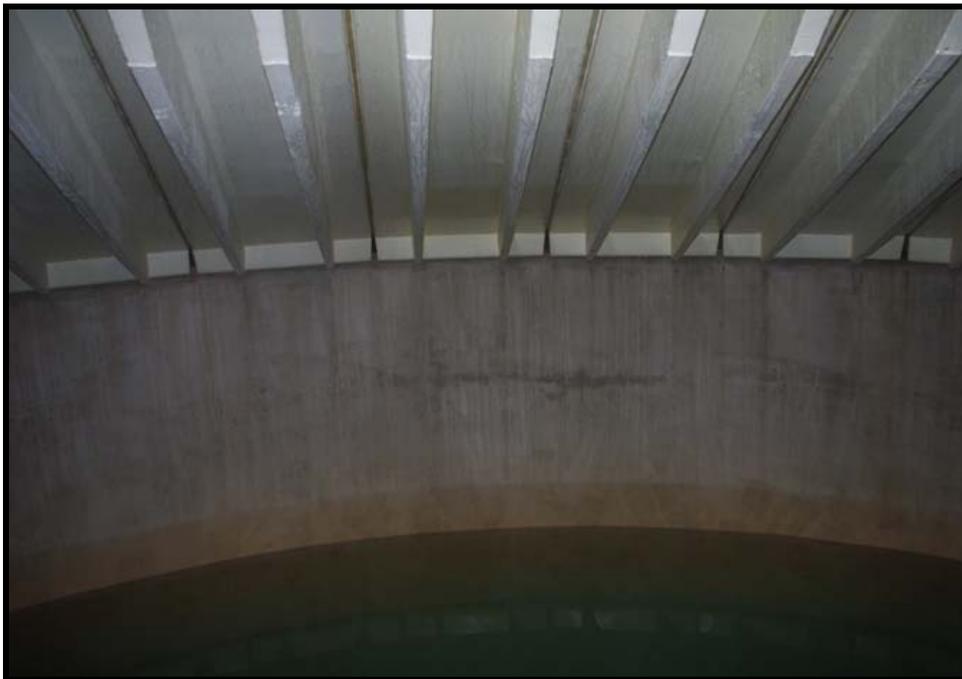
PHOTO 3.11-84 Interior container roof, stiffeners, and upper bowl cone.

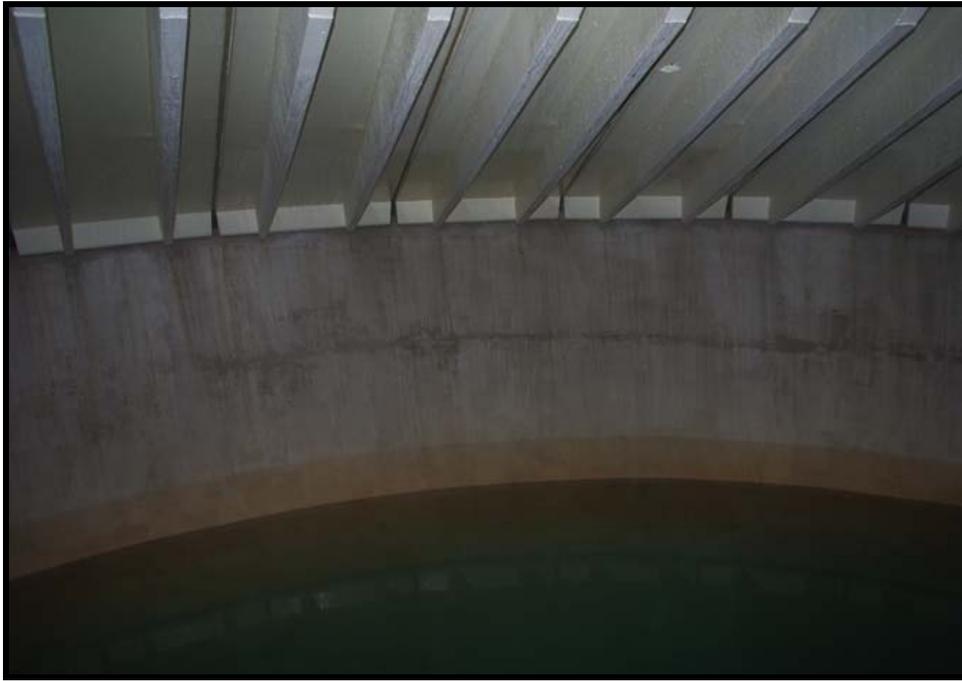
PHOTO 3.11-85 Interior container roof, stiffeners, and upper bowl cone.

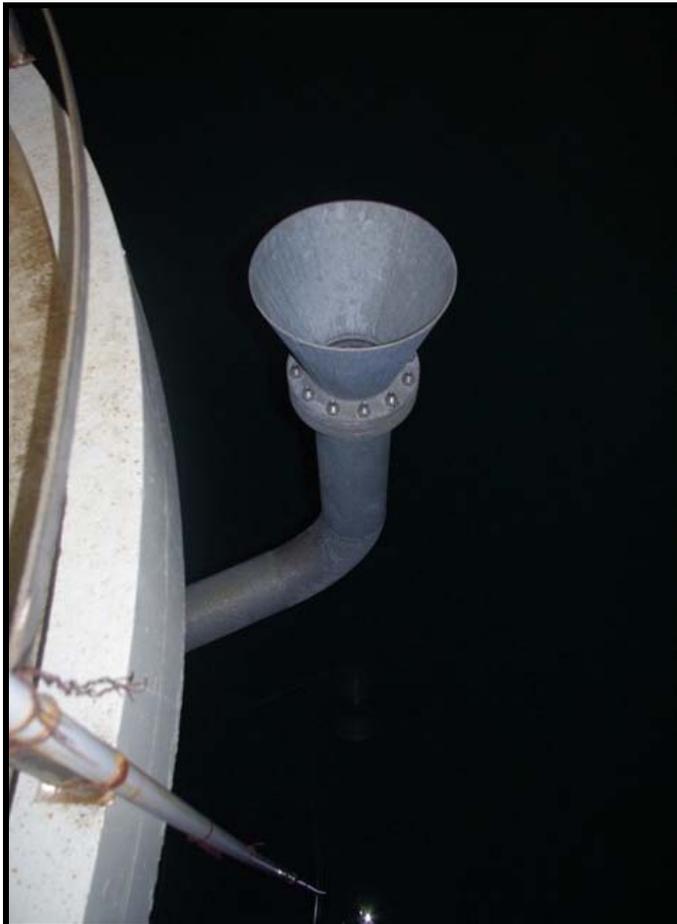
PHOTO 3.11-86 Overflow inlet funnel.

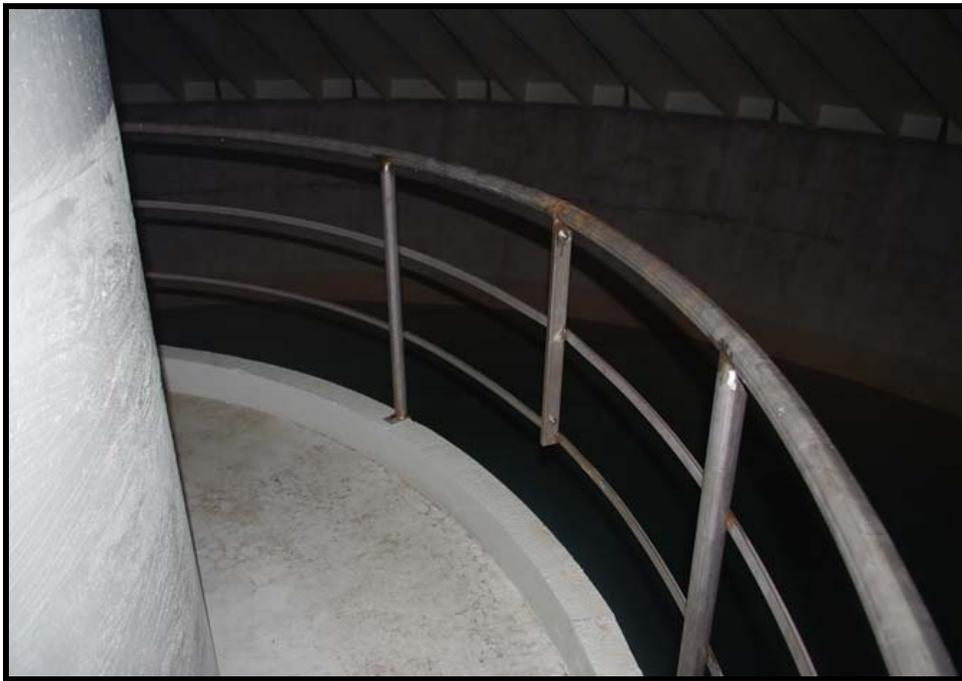
PHOTO 3.11-87 Platform in interior container.

Interior Wet Platforms: Interior wet platforms are also susceptible to accelerated rates of corrosion. If the Navy decides to keep the platforms, the new access openings should both have closable covers and 4 in. (102 mm) high curbs. The mid-rails on the platforms should be replaced with mid-rails which meet current OSHA requirements.

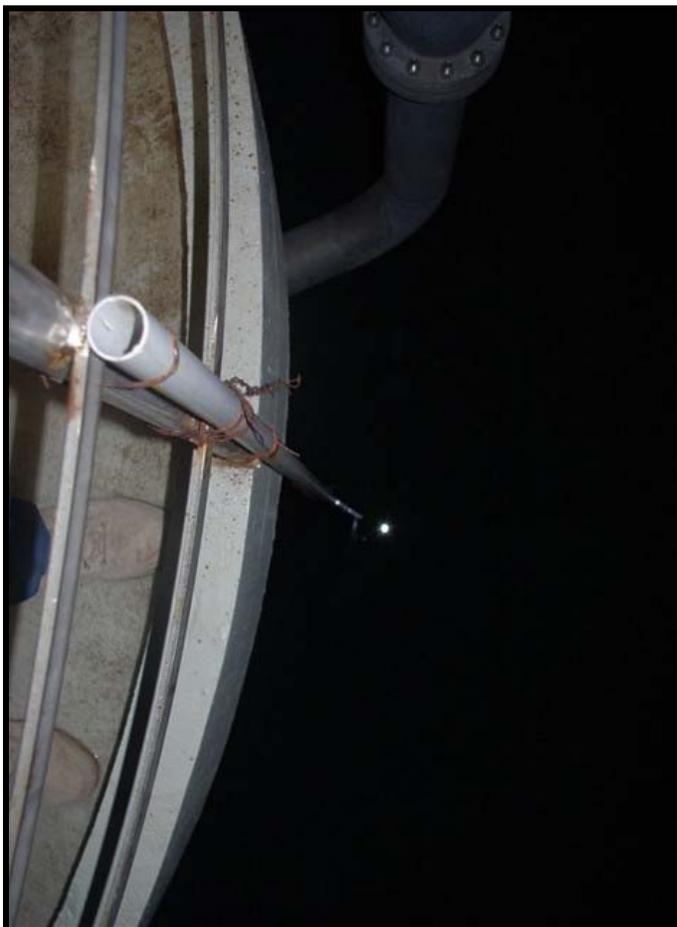
PHOTO 3.11-88 Apparent sensor equipment extending into container.

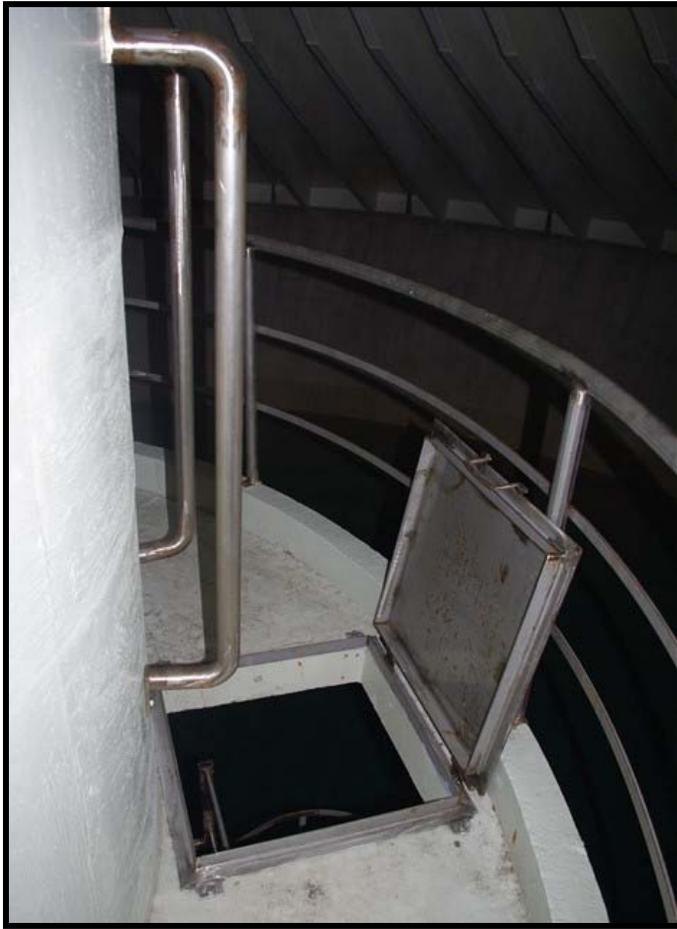
PHOTO 3.11-89 Access opening through container platform.

Pedestal and Access Tube Platforms: The access openings through the platforms should be equipped with closure chains. The mid-rails on the platforms should be replaced with mid-rails which meet current OSHA requirements and have a handrail at least 42 in. (1067 mm) tall. The platforms should all have toe bars which are 4 in. (102 mm) tall and have gaps between the toe bars and platforms of less than 1/4 in. (6 mm) wide.

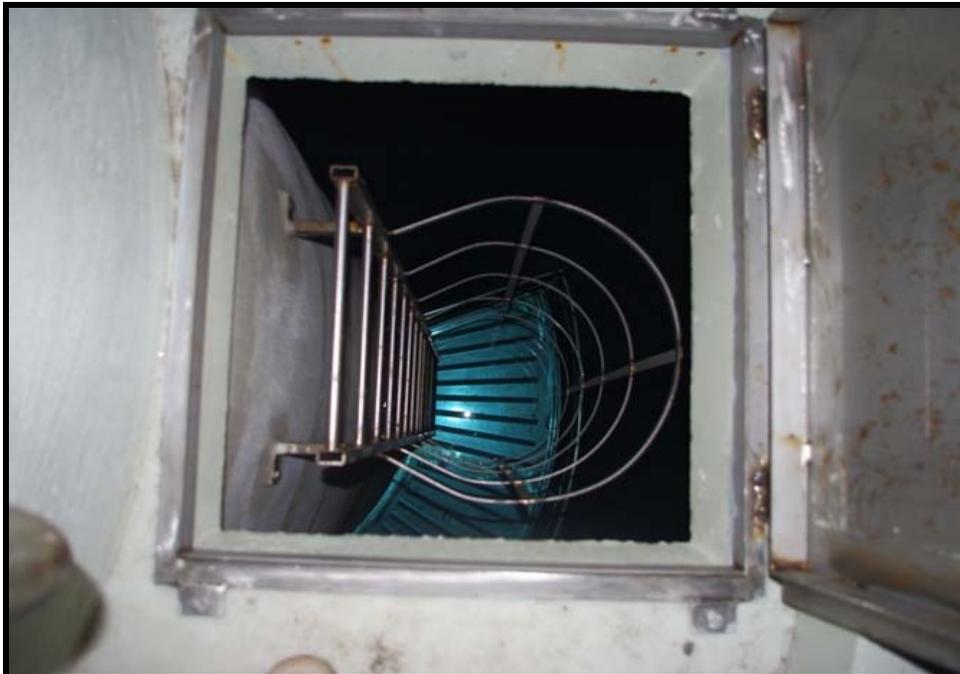
PHOTO 3.11-90 Access opening through container platform.

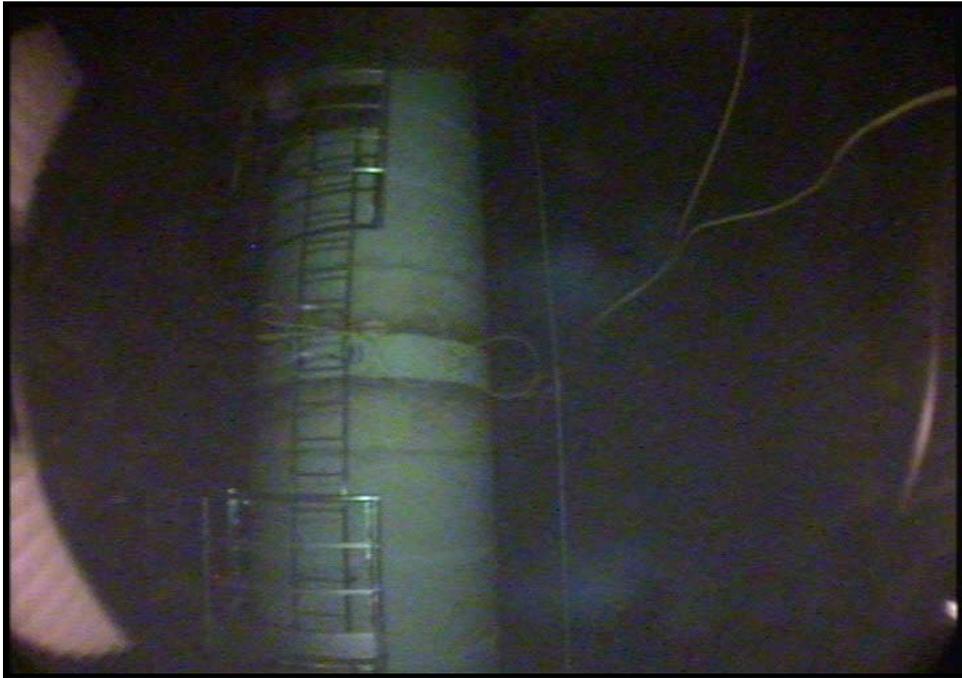
PHOTO 3.11-91 Access tube, interior container ladder, and platform.

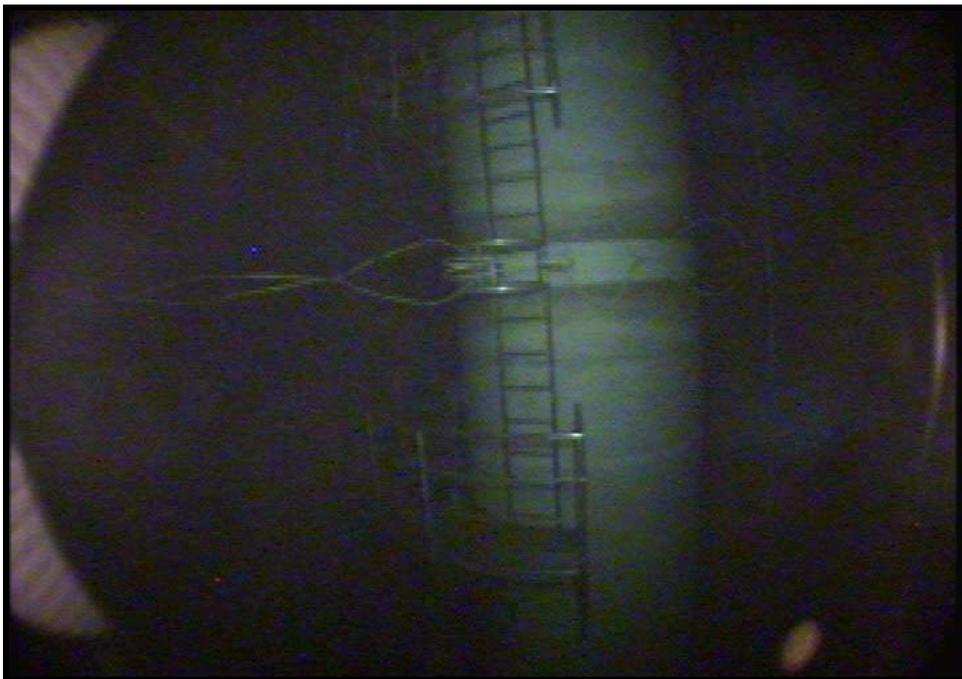
PHOTO 3.11-92 Access tube, interior container ladder, and platform.

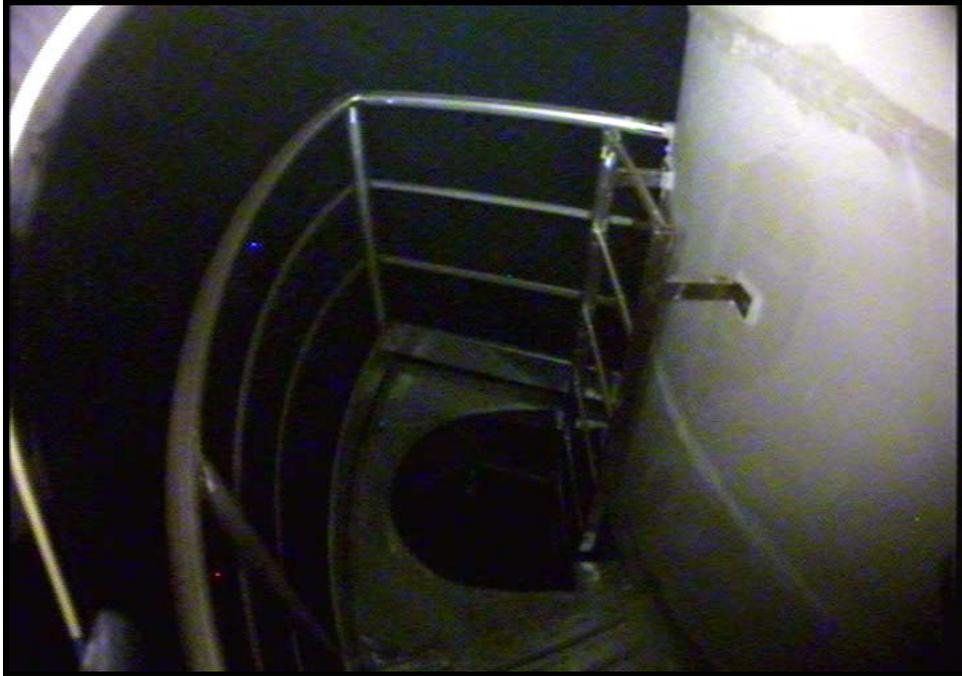
PHOTO 3.11-93 Access tube, interior container ladder, and platform.

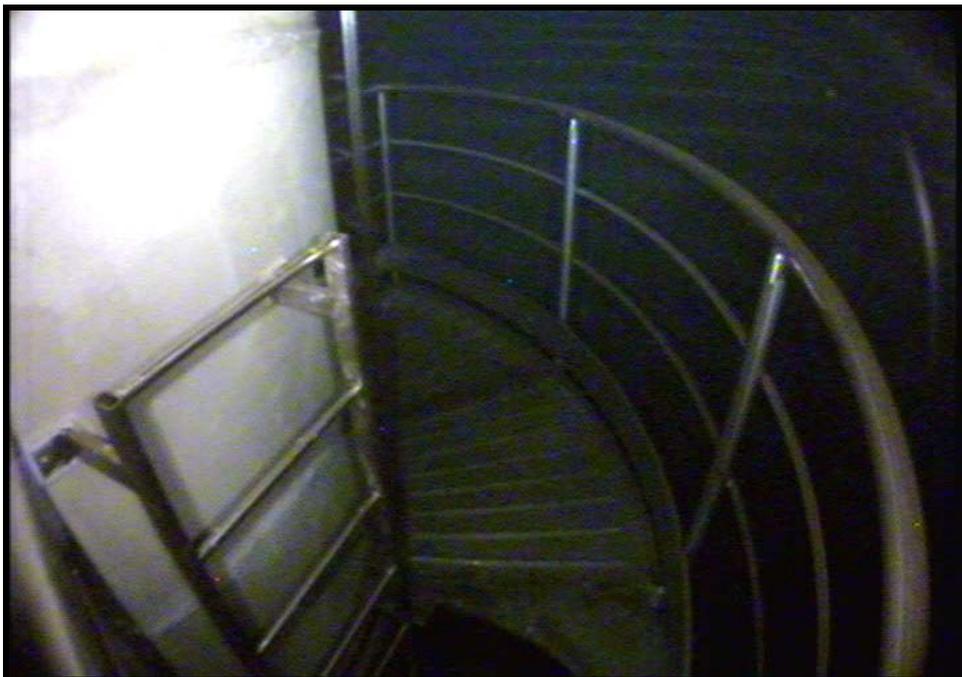
PHOTO 3.11-94 Access tube and platform.

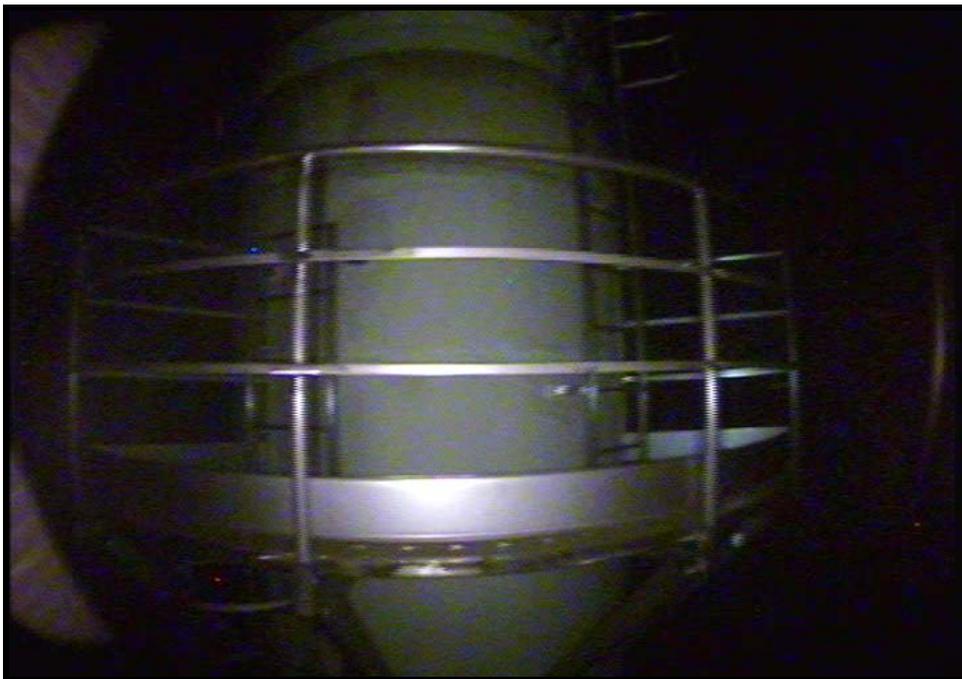
PHOTO 3.11-96 Access tube and platform.

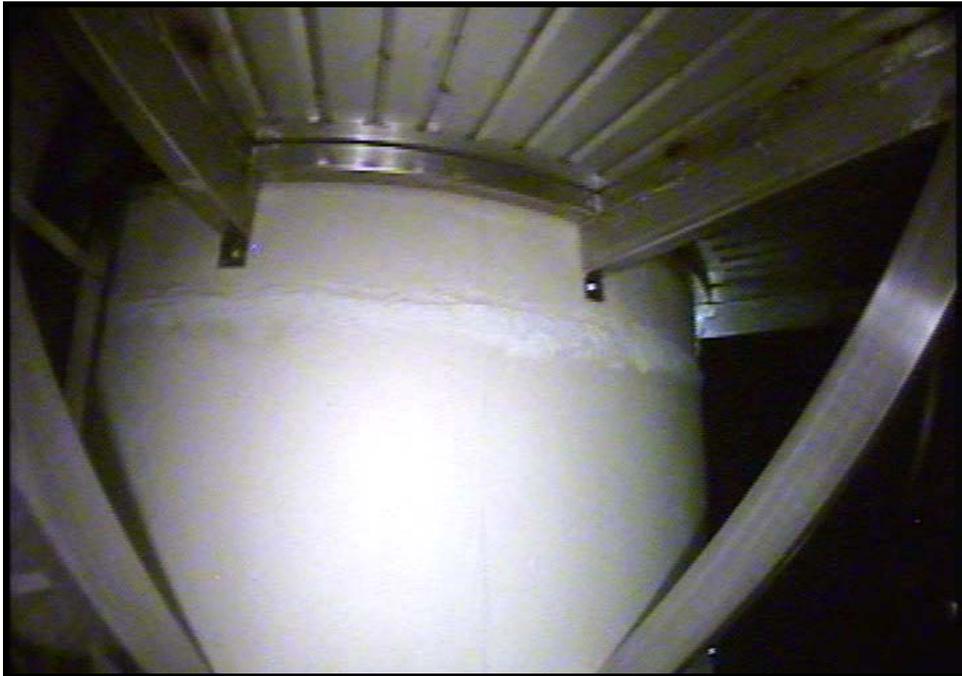
PHOTO 3.11-97 Underside of platform.

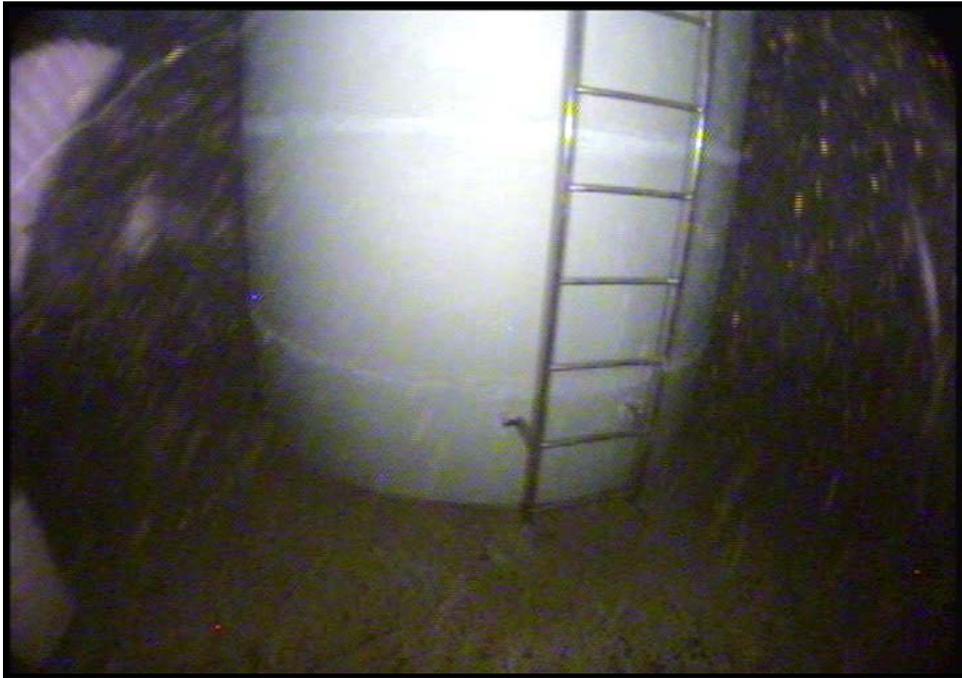
PHOTO 3.11-99 Access tube and interior container ladder.

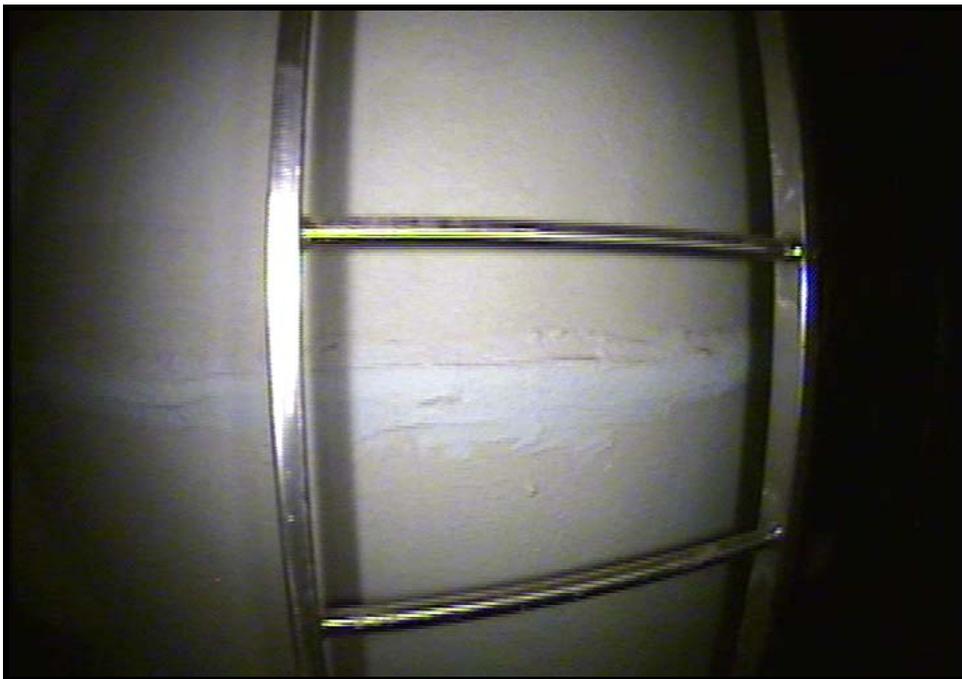
PHOTO 3.11-100 Access tube and interior container ladder.

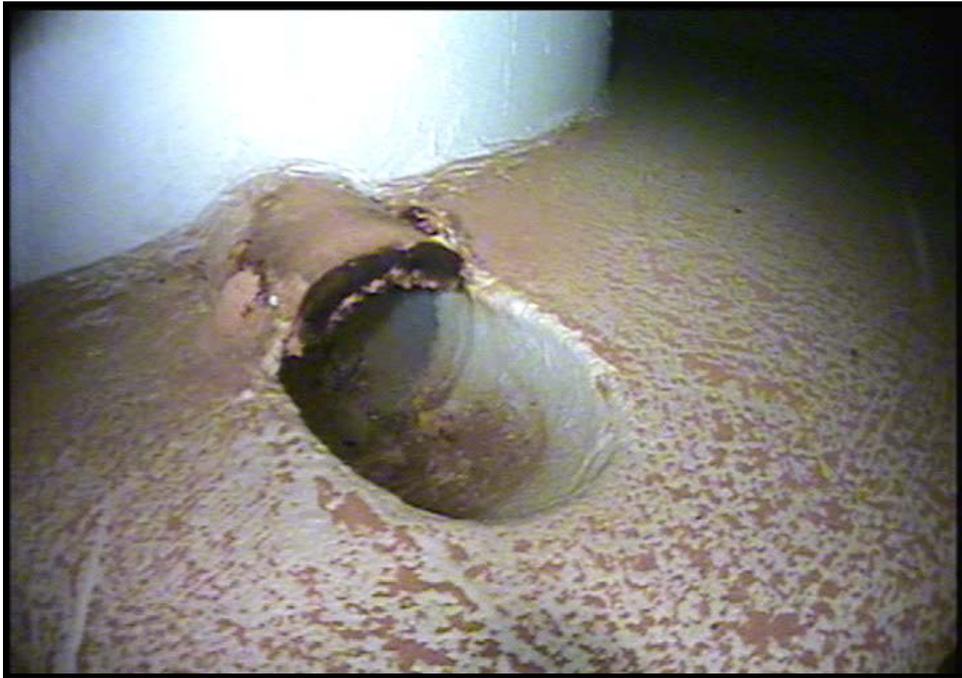
PHOTO 3.11-103 Pipe opening.

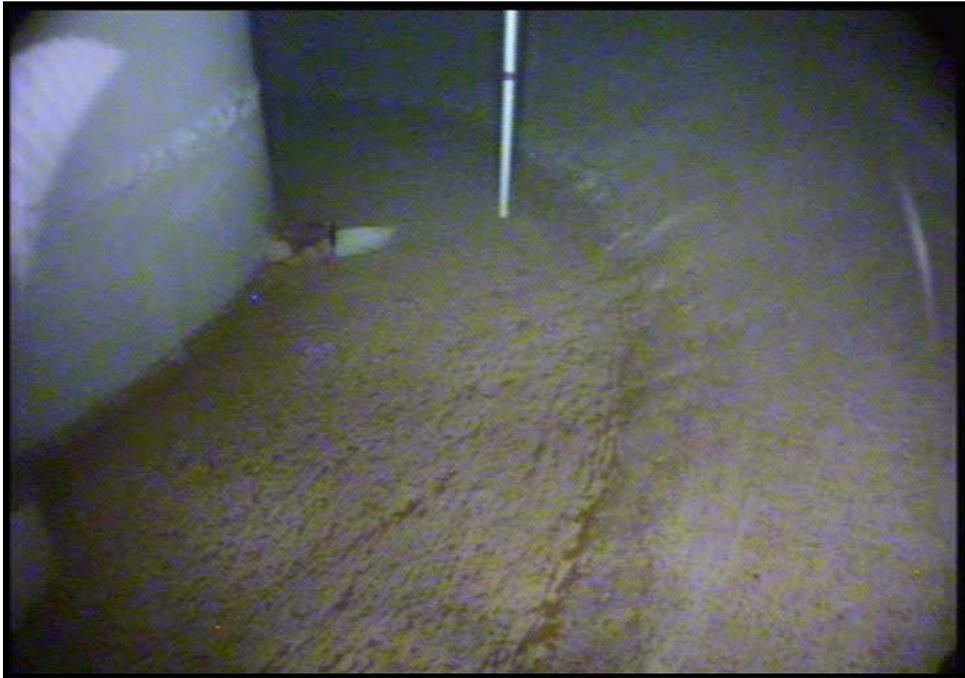
PHOTO 3.11-105 Bowl dome and cone.

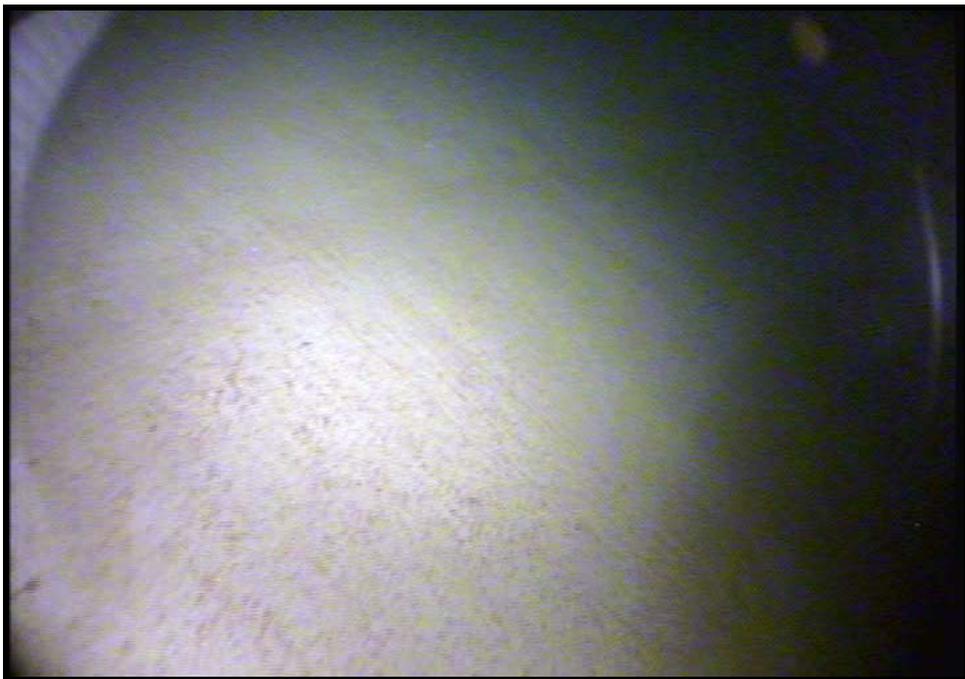
PHOTO 3.11-106 Bowl cone.

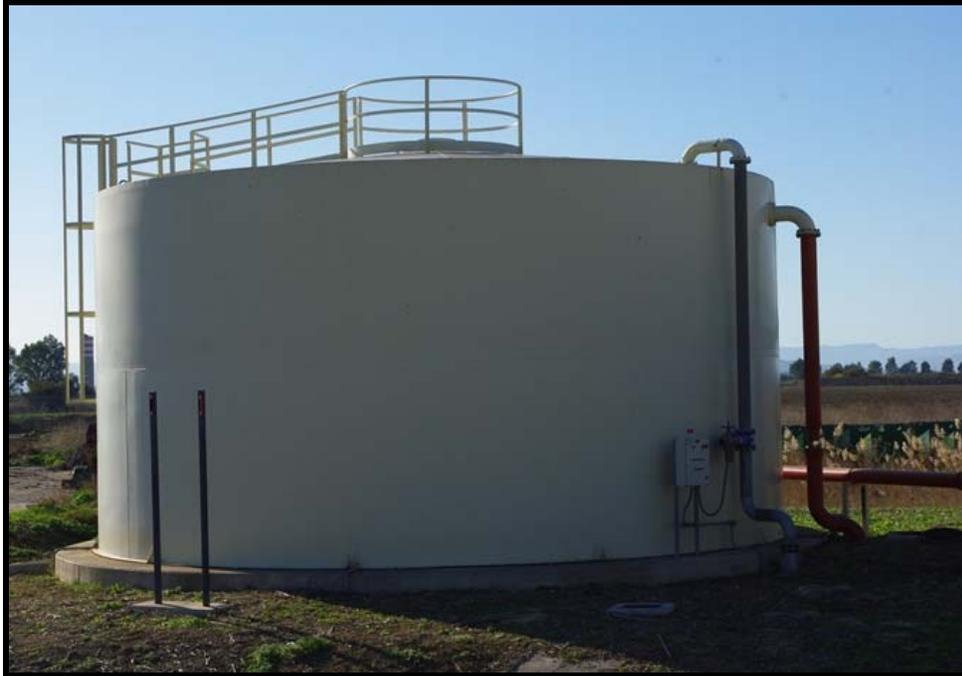
PHOTO 3.12-1 Tank 1011 and site.

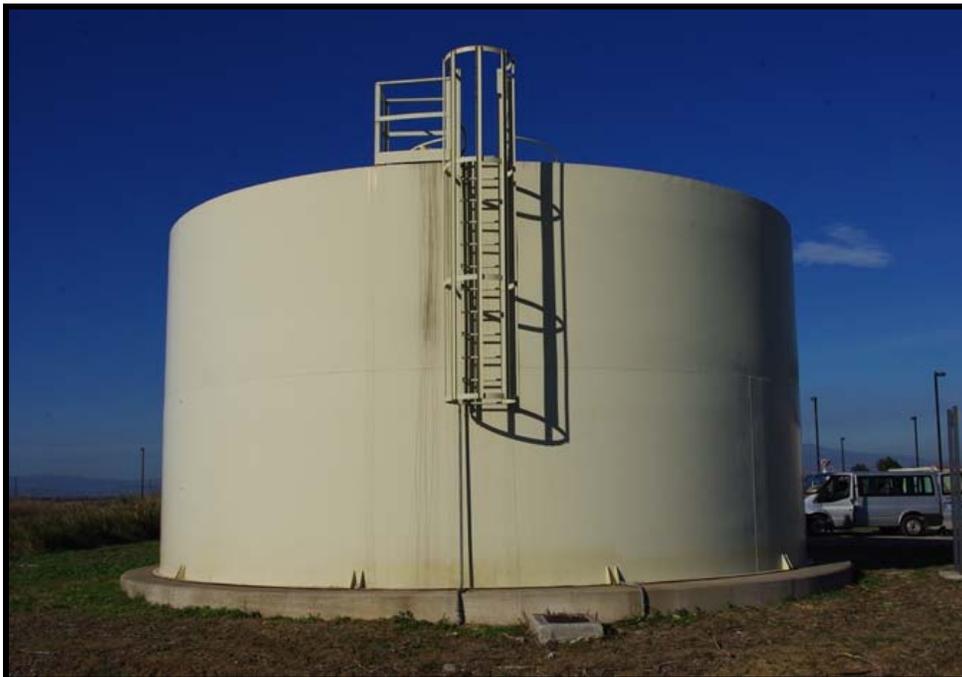
PHOTO 3.12-2 Tank 1011 and site.

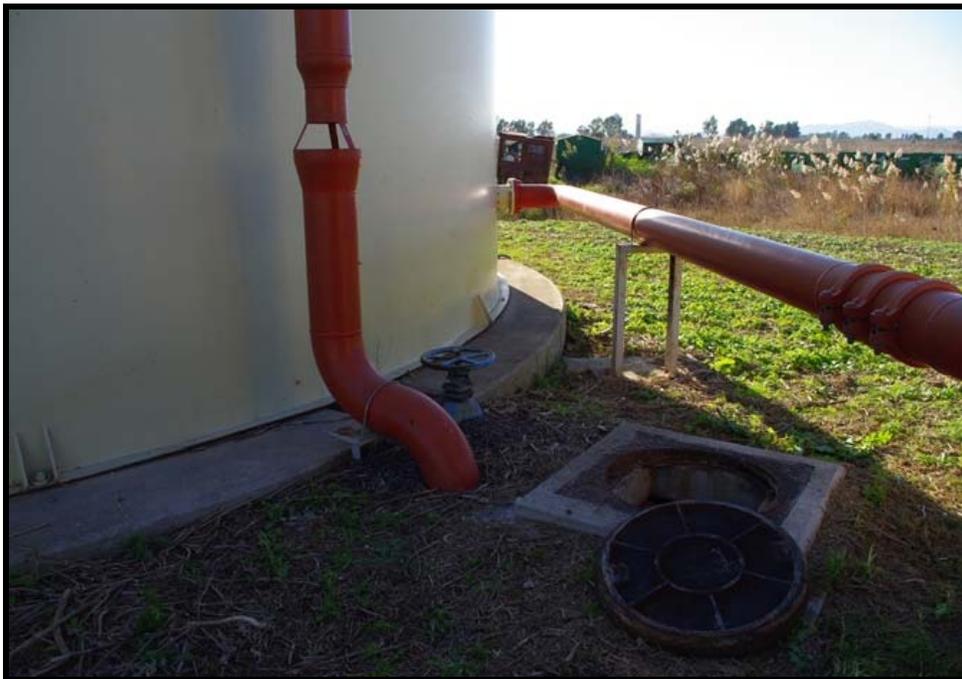
PHOTO 3.12-4 Overflow pipe, exterior piping, and drain basin.
