3.10 TANK 425

Tank 425 stores nonpotable water for the Naval Air Station in Sigonella, Italy.

3.10.1 Description of the Facility

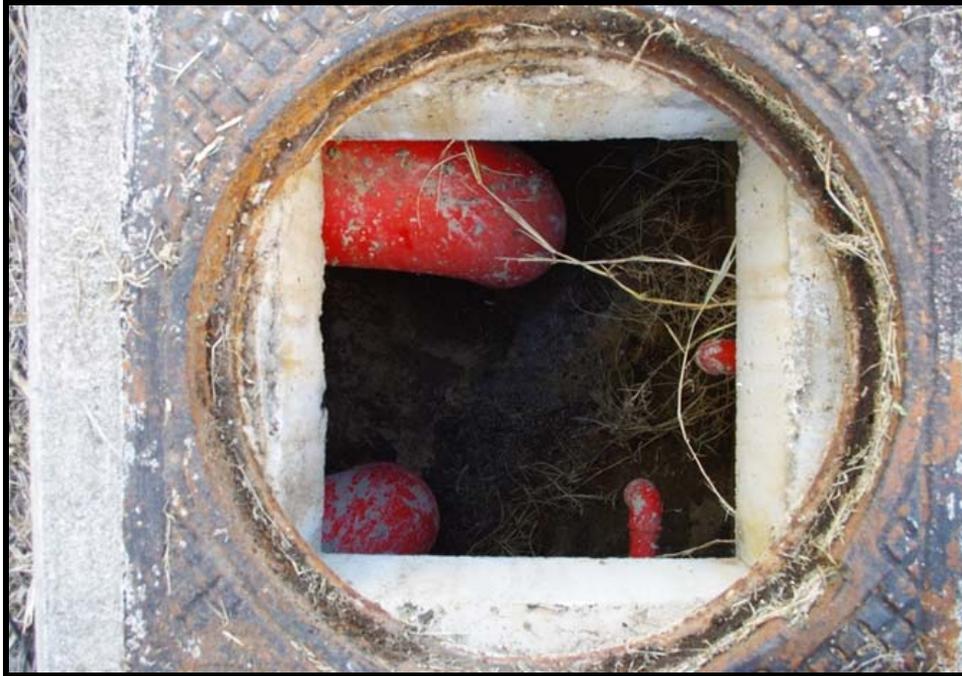
PHOTO 3.12-5 Drain basin interior.

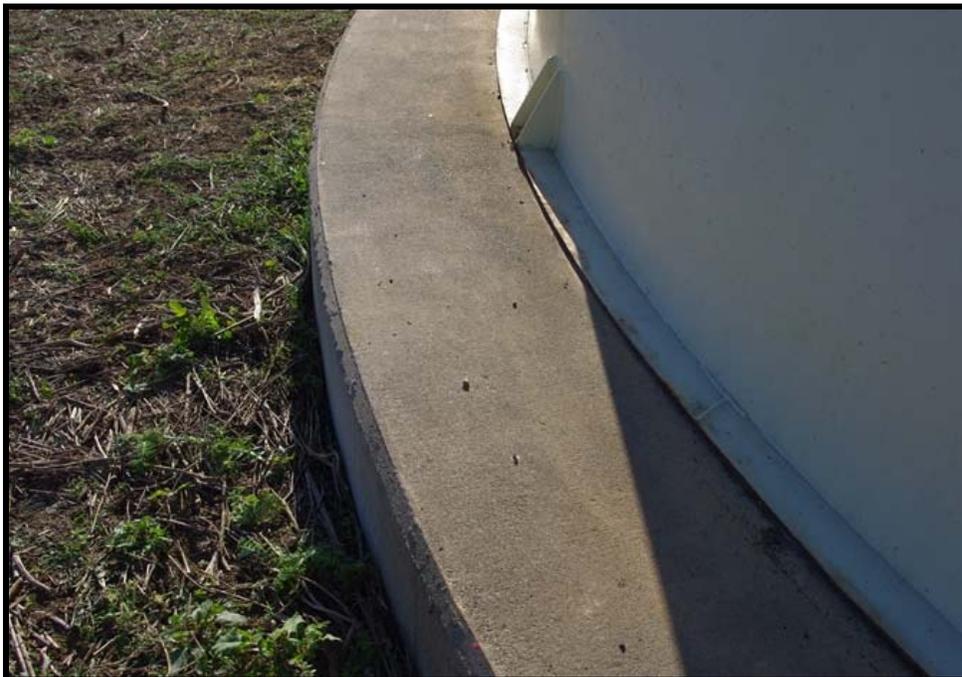
The concrete foundation does not project the AWWA recommended 6 in. (152 mm) to 12 in. (305 mm) above grade in all areas. The foundation is in good condition as there is no significant cracking or deterioration (See photo 3.12-6). No grout is visible at the bottom plate-to-foundation interface although a hard, rubber-type sealant is located in this area. However, voids in this sealant material have created gaps up to 5/8 in. (16 mm) between the bottom plate and foundation (See photo 3.12-8).

PHOTO 3.12-6 Tank foundation and bottom plate.

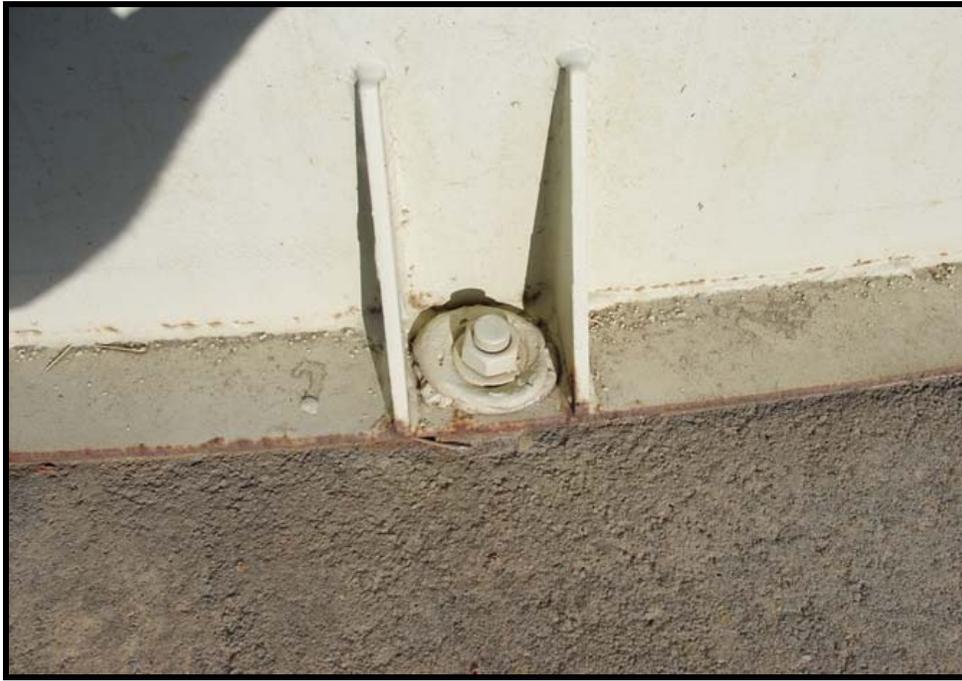
There is corrosion along the edge of the bottom plate projection (See photo 3.12-7). The tank has ten anchor bolts which each have two gusset side plates (See photo 3.12-9). Grounding cables extend to three of the gussets (See photo 3.12-10).

PHOTO 3.12-9 Anchor bolt and gussets.

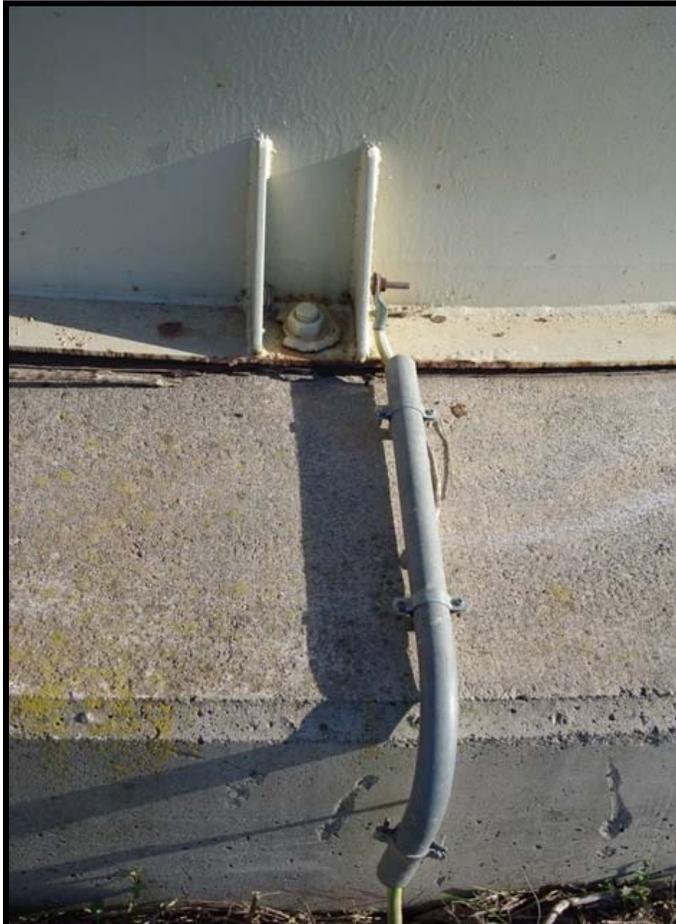
PHOTO 3.12-10 Anchor bolt, gussets, and grounding cable.

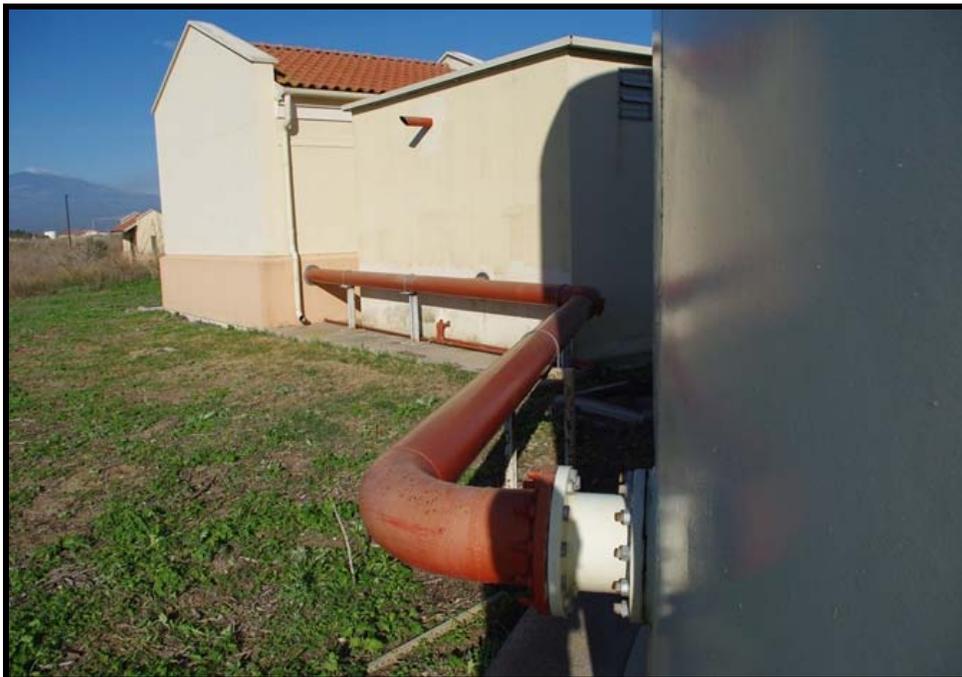
PHOTO 3.12-12 Piping extending to tank.

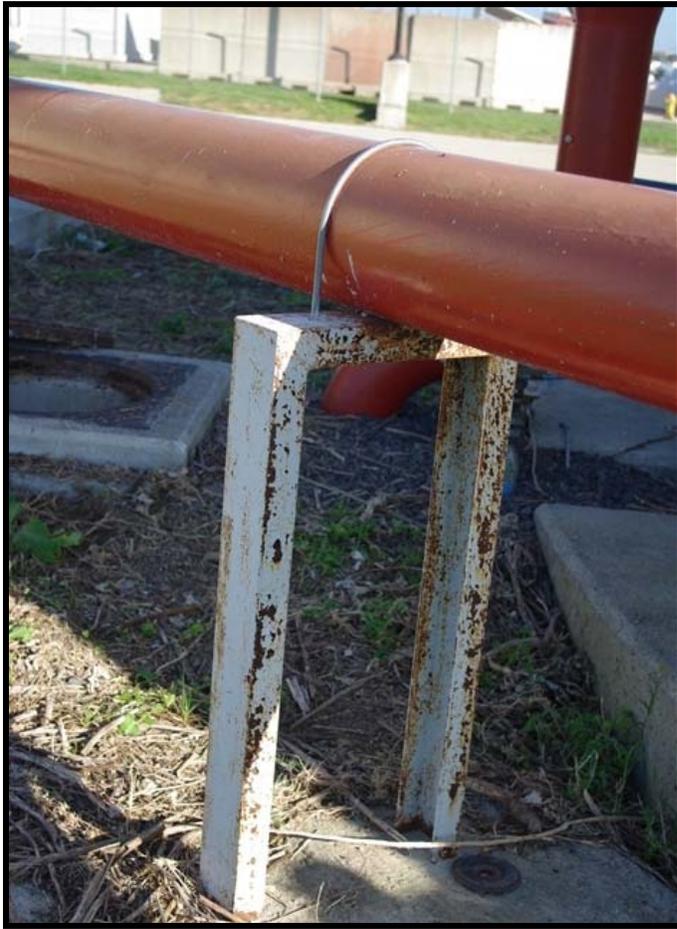
PHOTO 3.12-13 Pipe U-bolted to bracket.

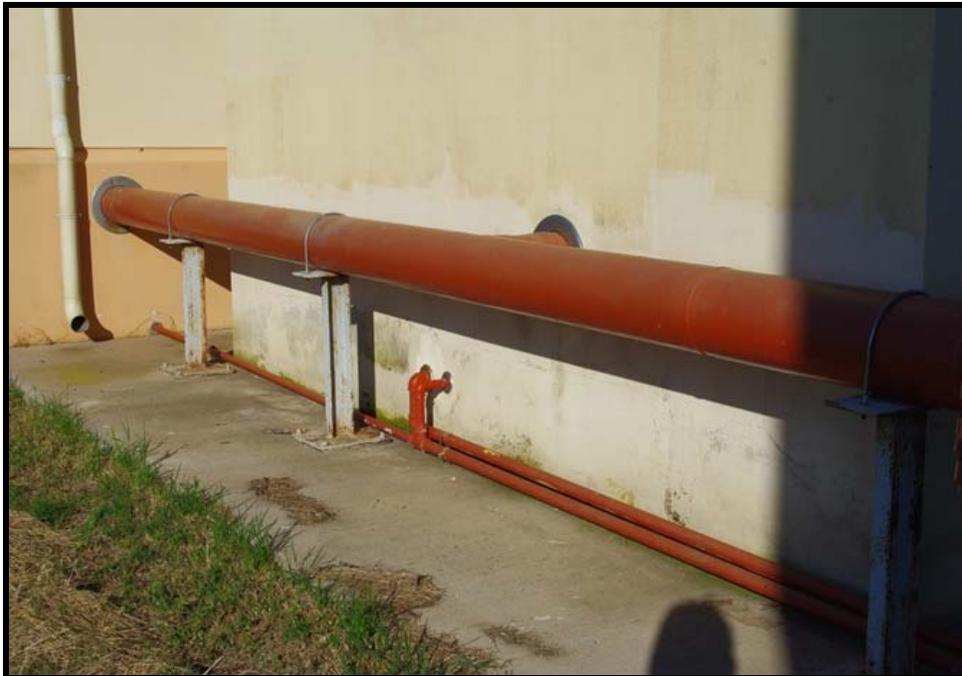
PHOTO 3.12-14 Piping extending from building to tank.

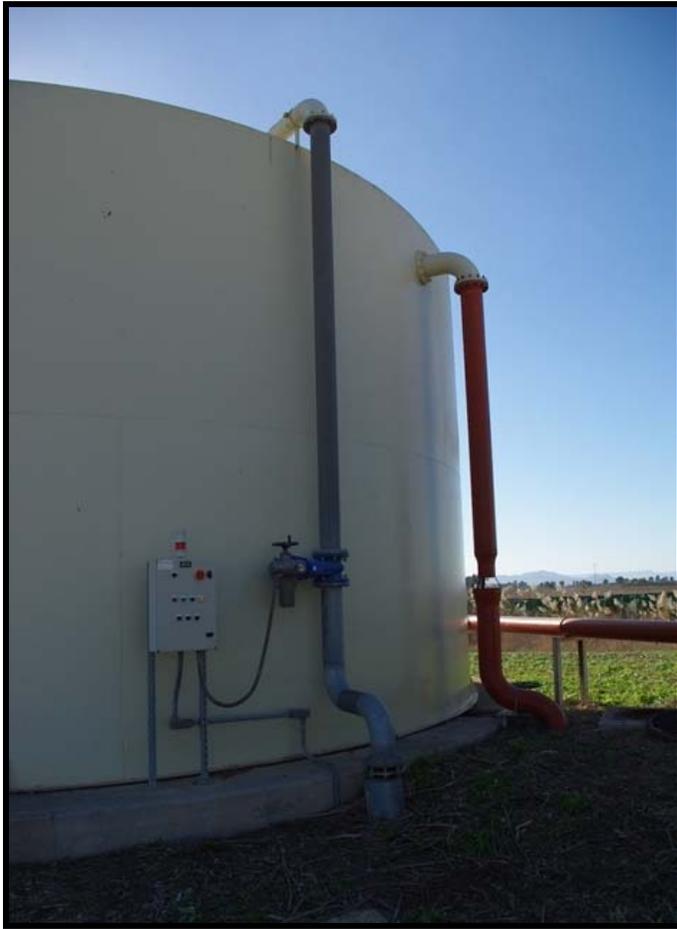
PHOTO 3.12-15 Control cabinet, exterior piping, and overflow pipe.

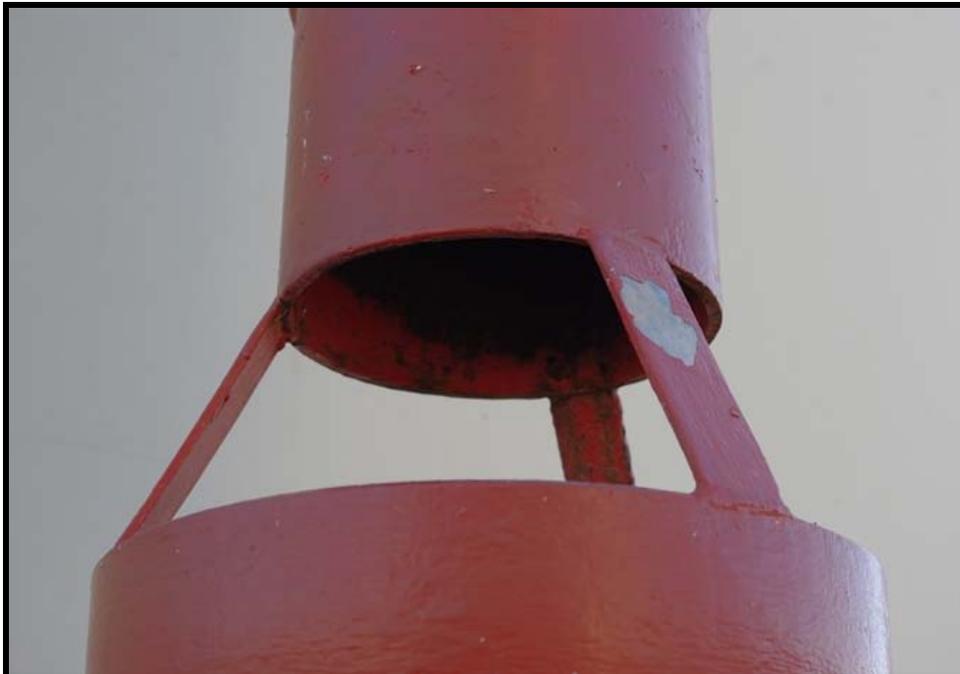
PHOTO 3.12-16 Air break in overflow pipe.

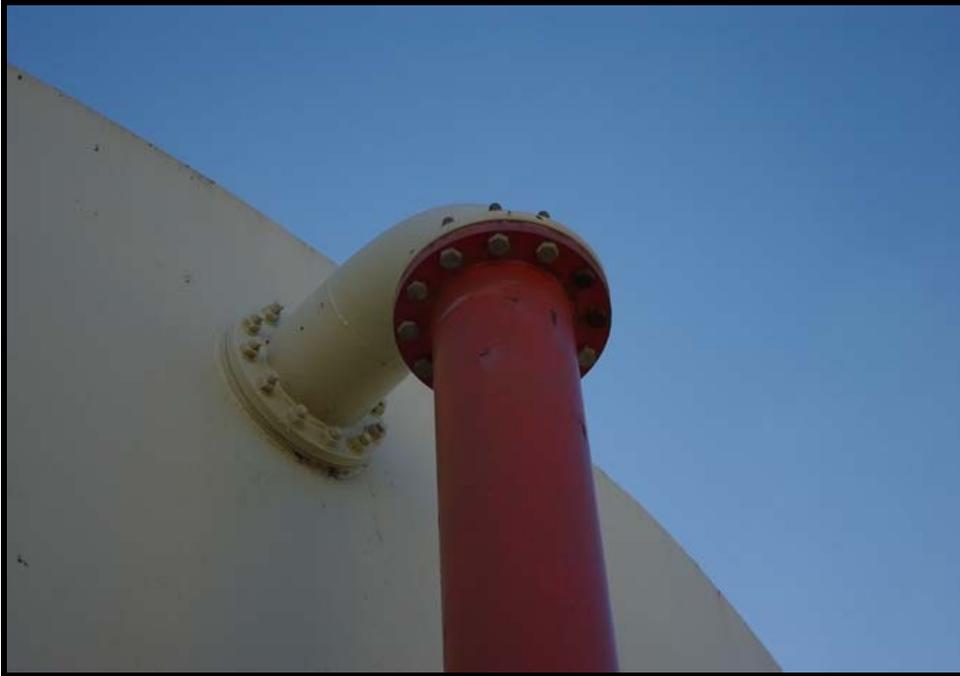
PHOTO 3.12-17 Overflow pipe.

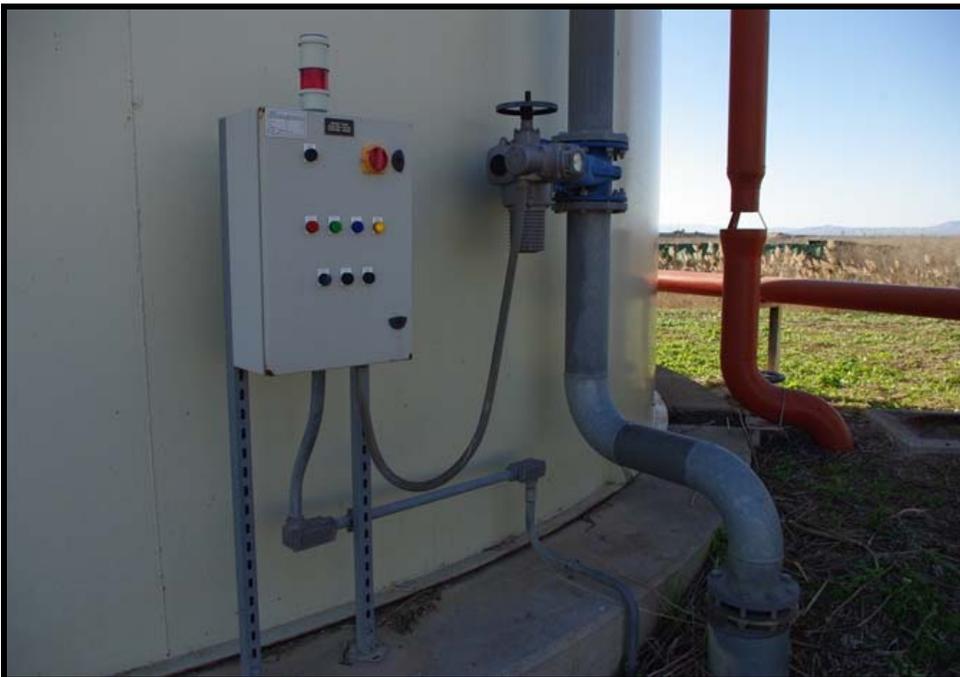
PHOTO 3.12-18 Control cabinet and exterior piping.

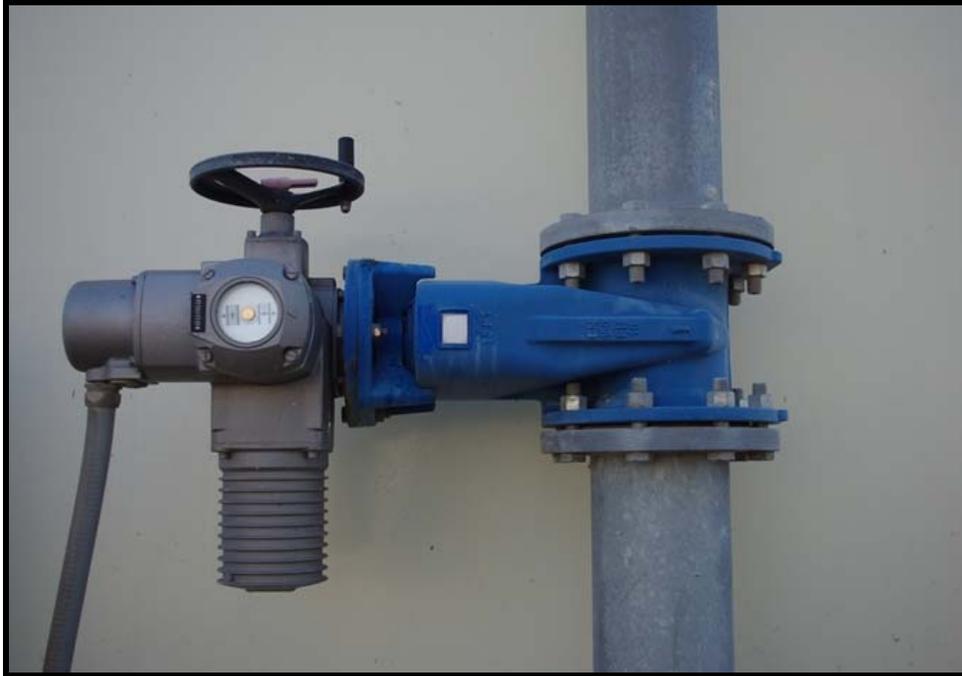
PHOTO 3.12-19 Valve and equipment in exterior piping.

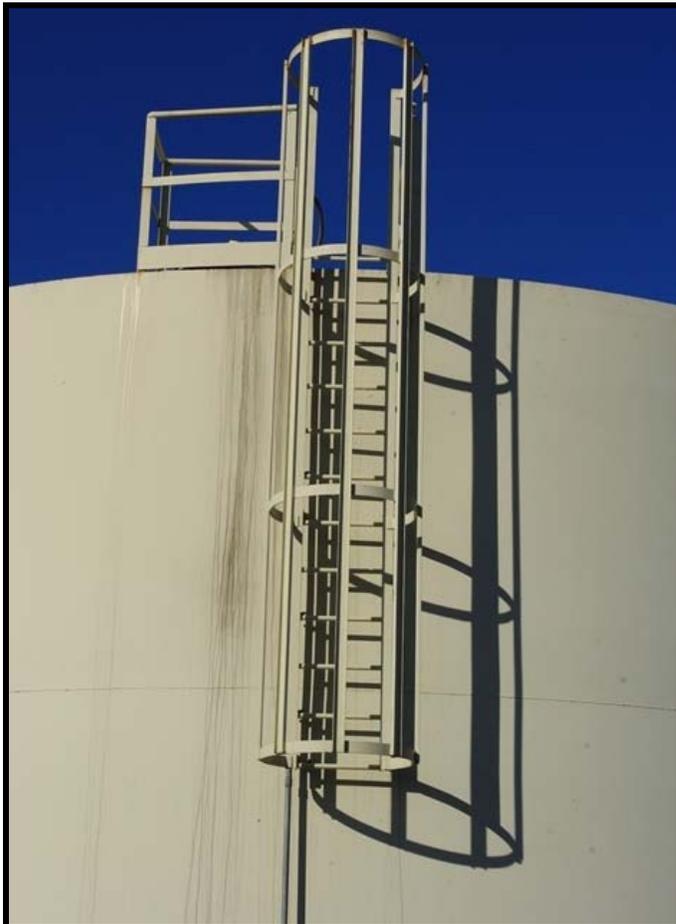
PHOTO 3.12-22 Exterior ladder and safety cage.

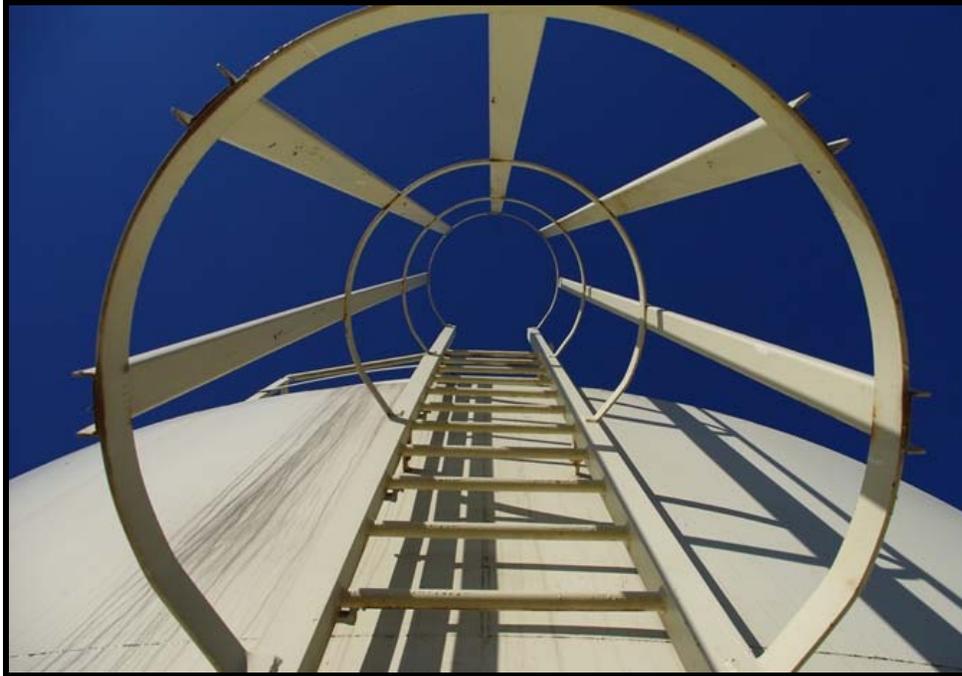
PHOTO 3.12-23 Exterior ladder and safety cage.

Consultants recommends that the safety cage be removed. The exterior ladder did not include slip-resistant rungs. Slip-resistant rungs are required for all ladders constructed after March 1991 by the OSHA Construction standards. However, slip-resistant rungs are not required by the OSHA General Industry standards for ladders or by the AWWA D100.

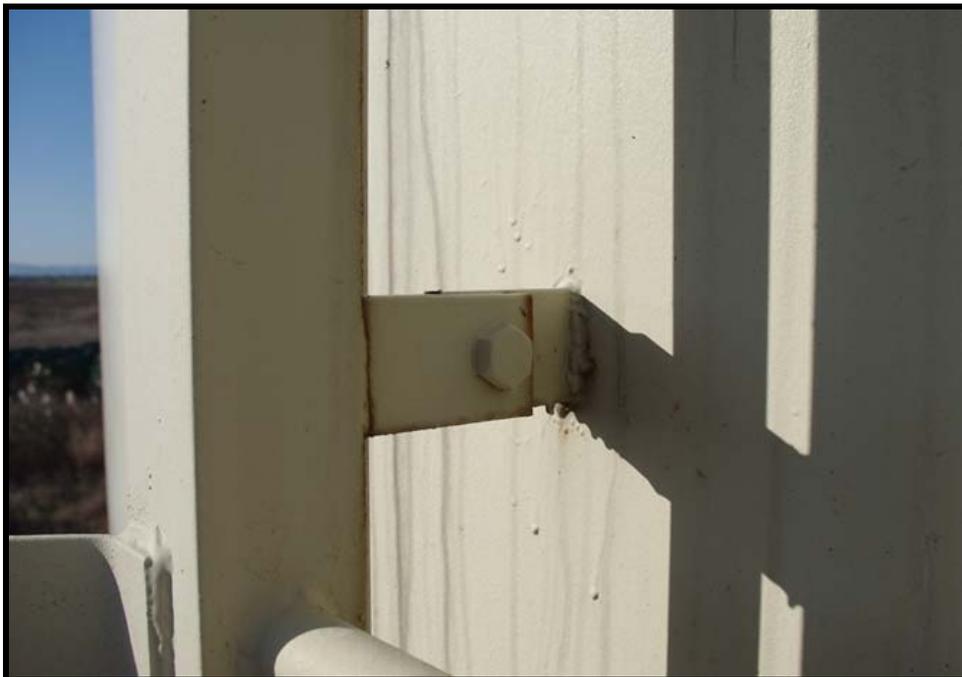
PHOTO 3.12-24 Exterior ladder and bracket.

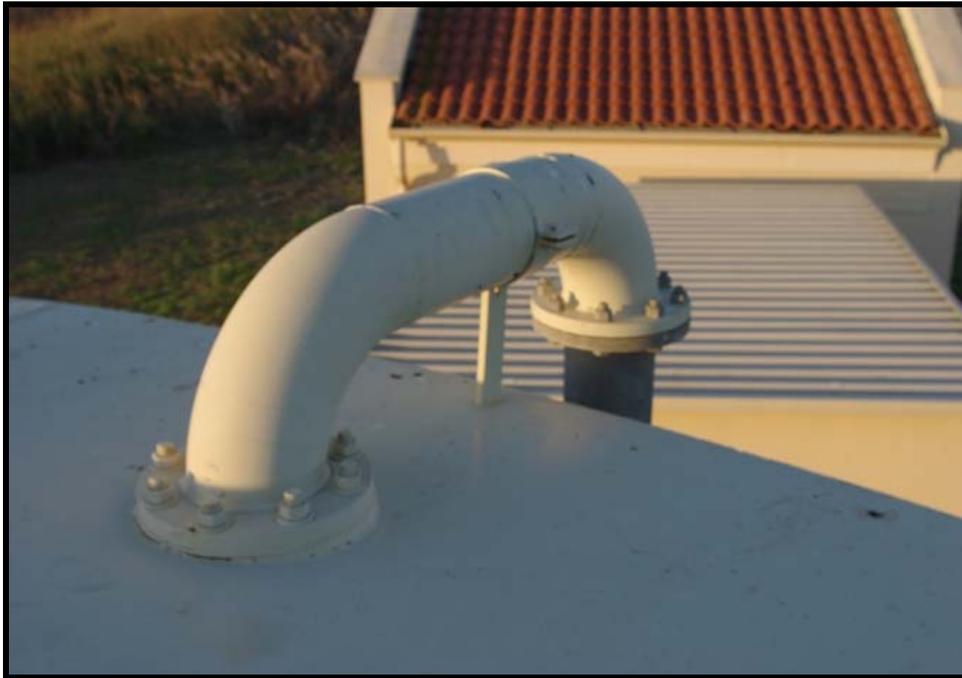
PHOTO 3.12-25 Exterior piping.

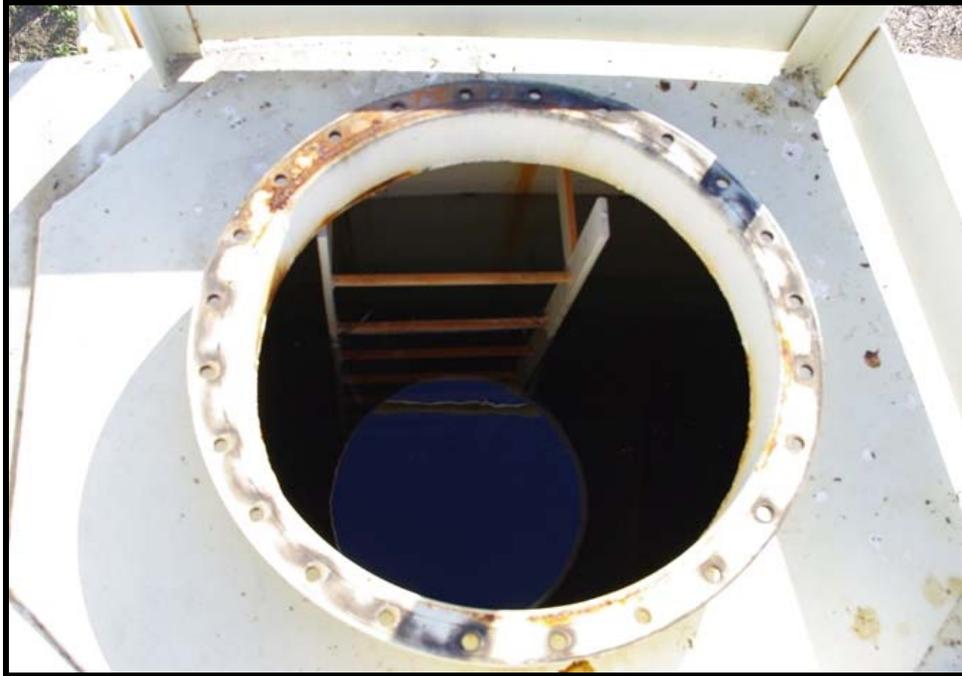
PHOTO 3.12-27 Roof manhole.

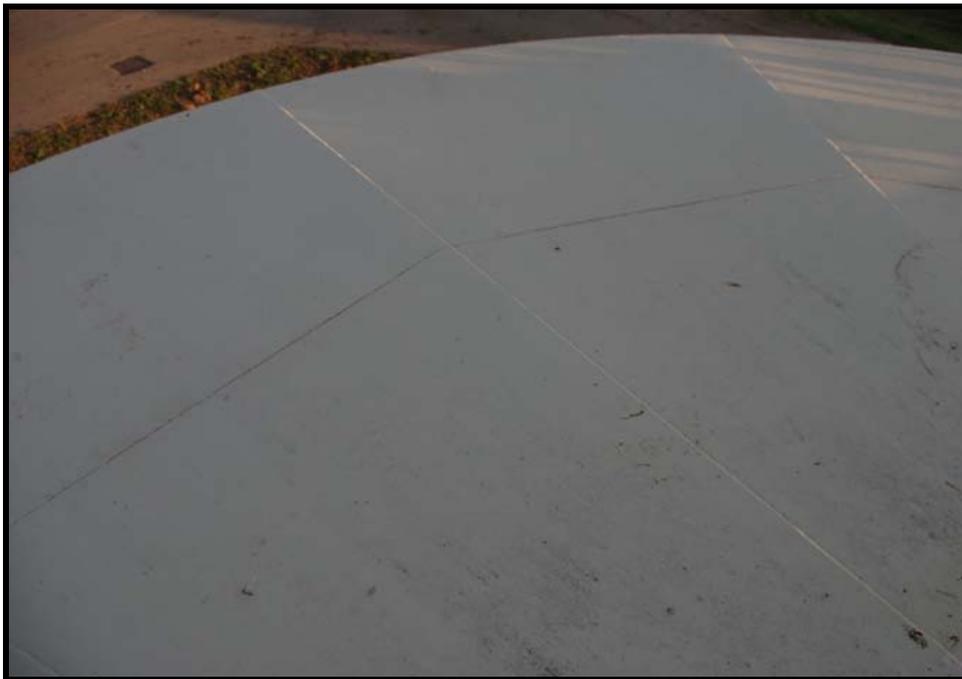
PHOTO 3.12-30 Roof exterior.

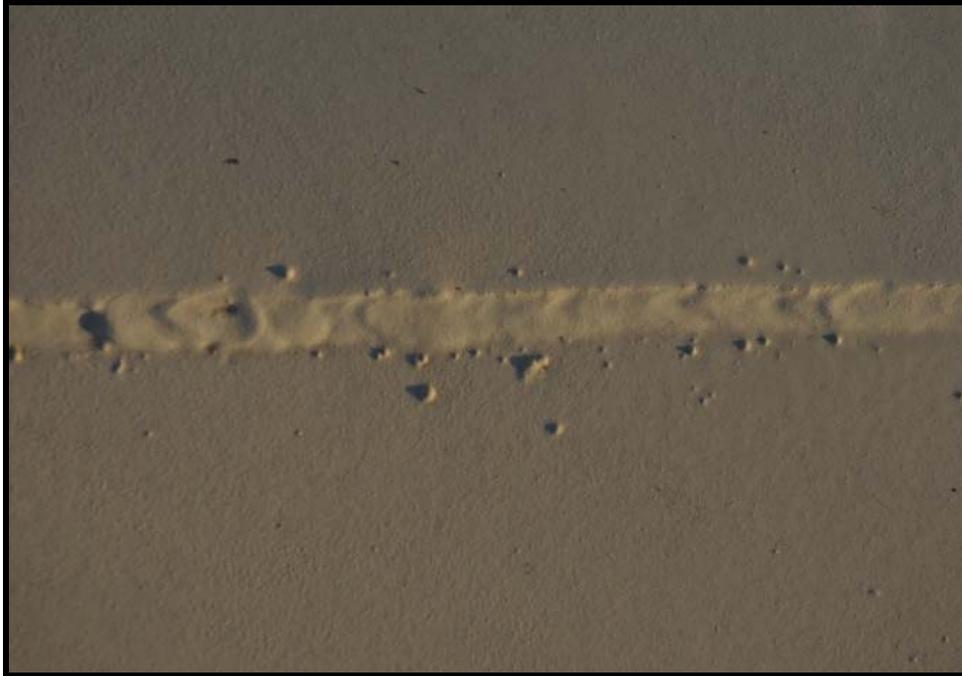
PHOTO 3.12-31 Weld spatter on roof.

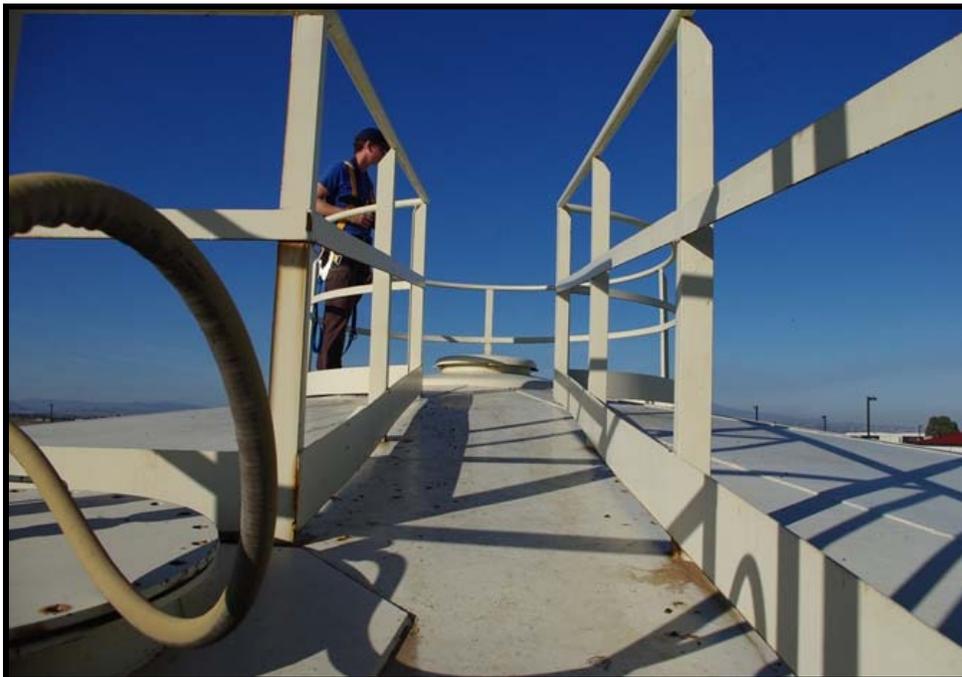
PHOTO 3.12-32 Roof safety railing and roof manhole/vent.

Roof Safety Railing: The toe bar should be modified so the gap between it and the roof is less than 1/4 in. (6 mm) wide, and the bent part of the toe bar should be repaired or replaced. Closure chains should be installed at the roof access.

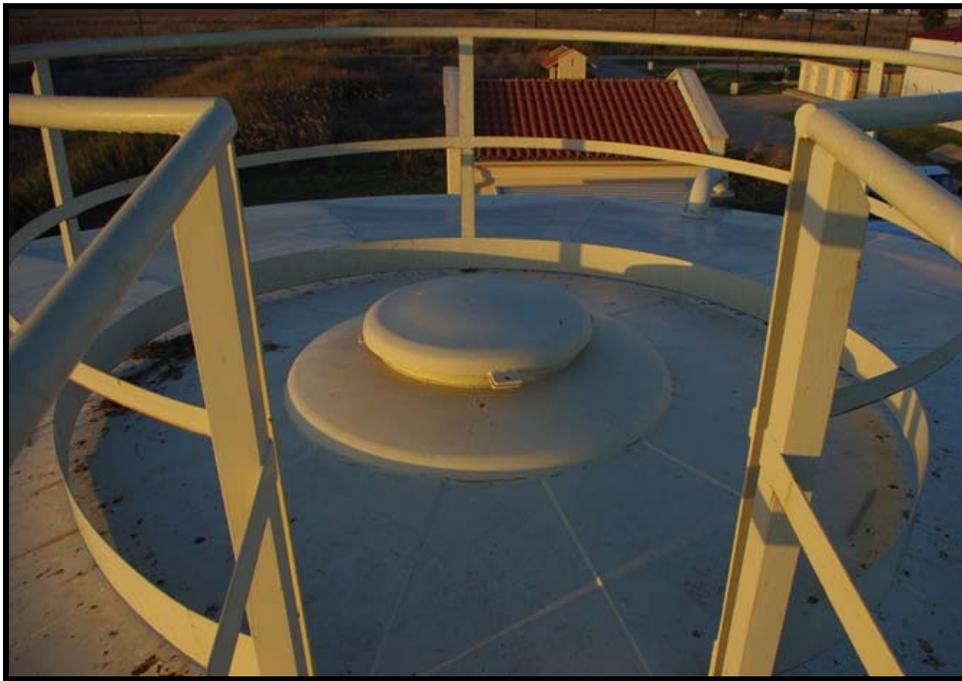
PHOTO 3.12-33 Roof safety railing and roof manhole/vent.

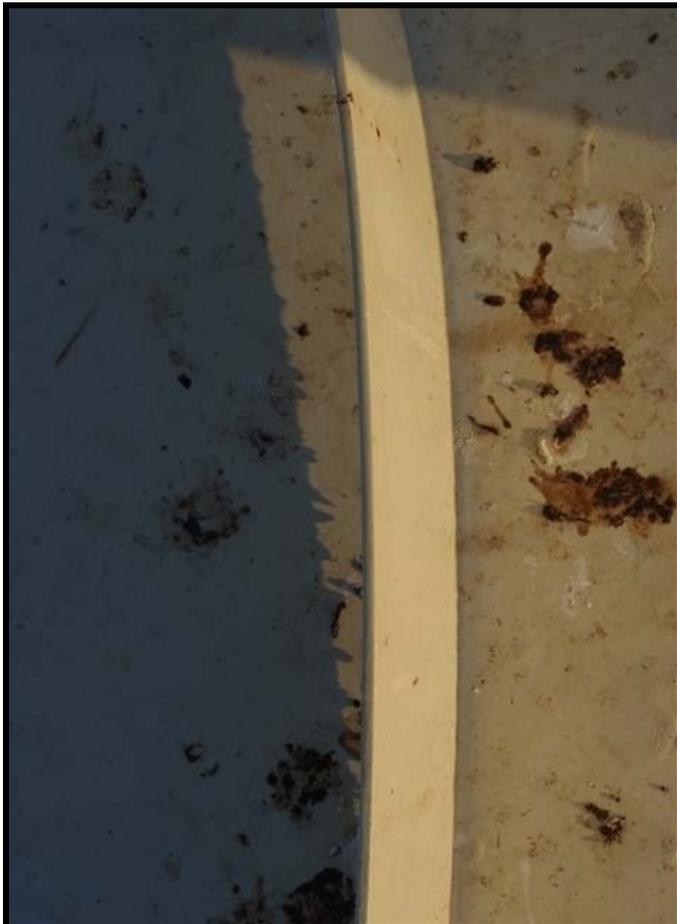
PHOTO 3.12-34 Bent toe bar.

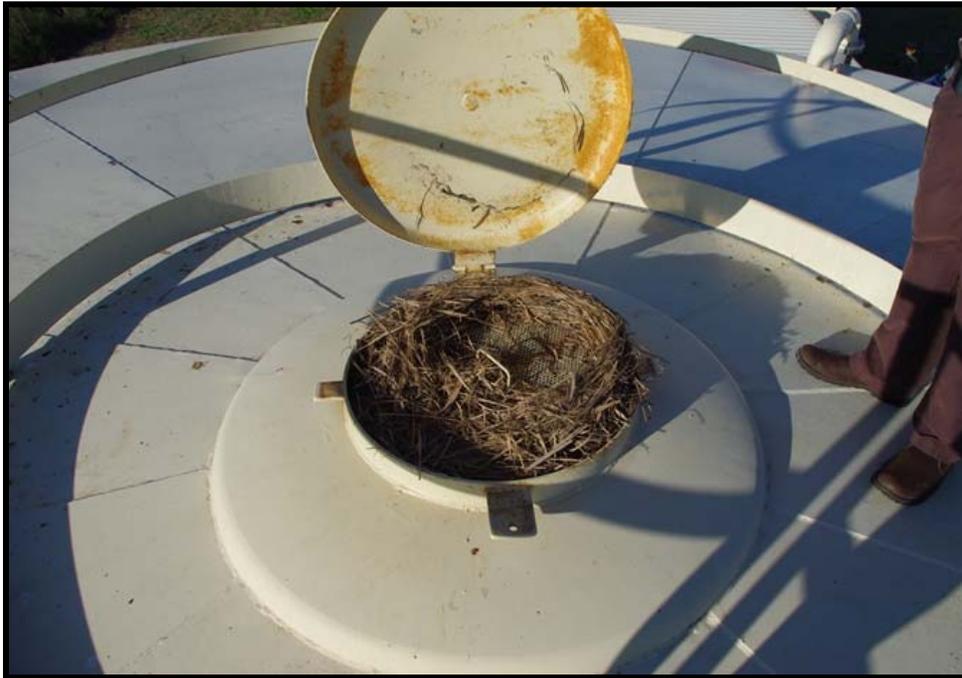
PHOTO 3.12-35 Debris on screening prior to removal.

Clog-Resistant Vent: AWWA D100 recommends that all vents with screening against insects be designed to ensure "fail-safe" operation if the insect screens become occluded. Therefore, it is recommended that the existing vent be replaced with a new, clog-resistant vent. Until such time as the existing vent is replaced, it should be modified to eliminate the gap and so that debris does not accumulated on the screening.

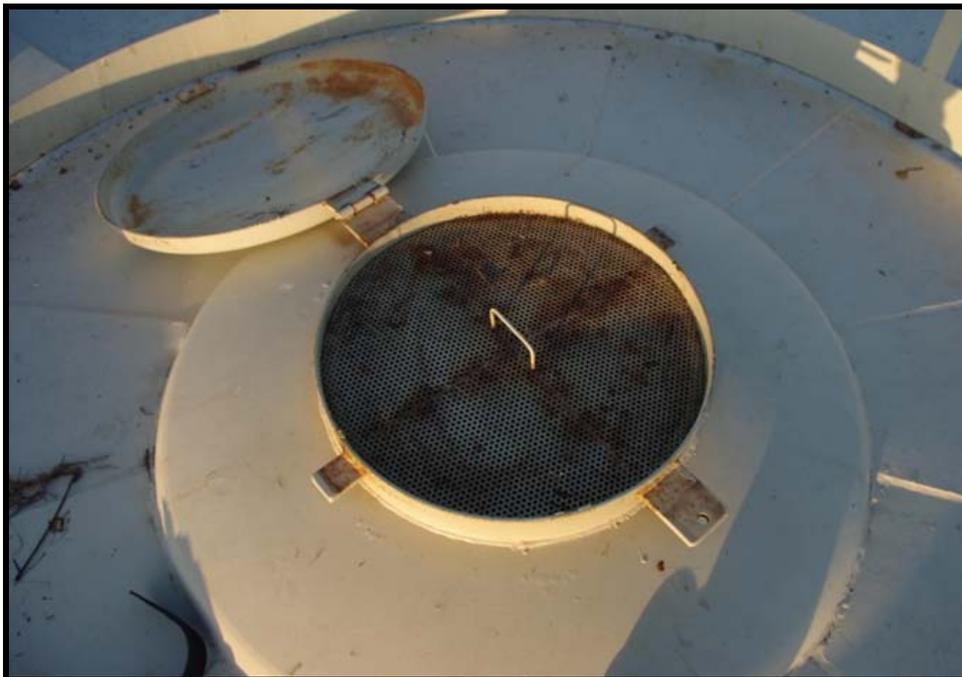
PHOTO 3.12-36 Roof manhole/vent interior.

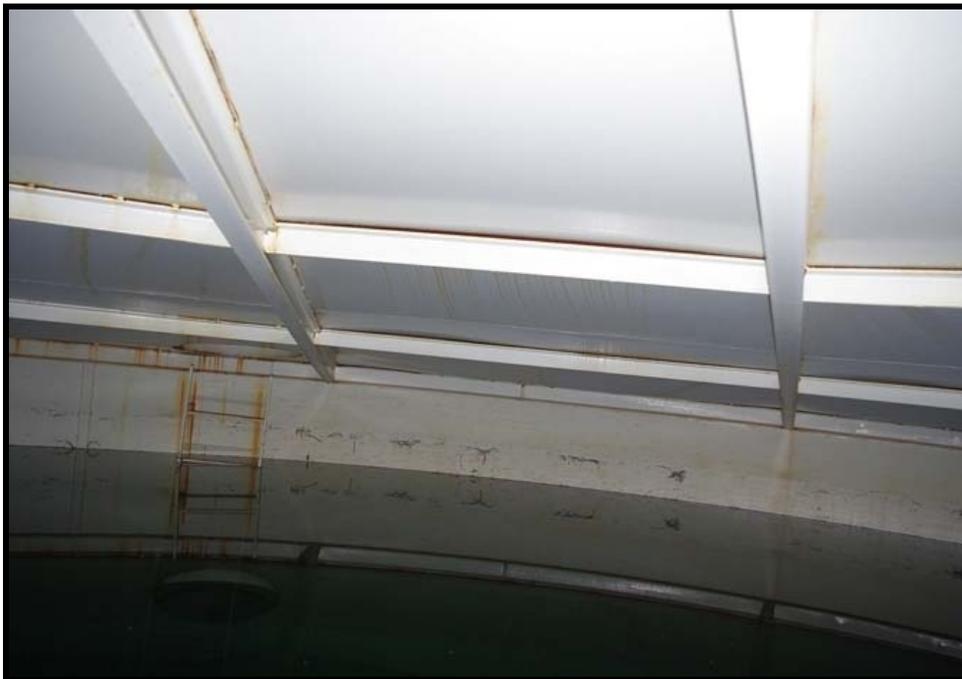
PHOTO 3.12-40 Roof rafters.

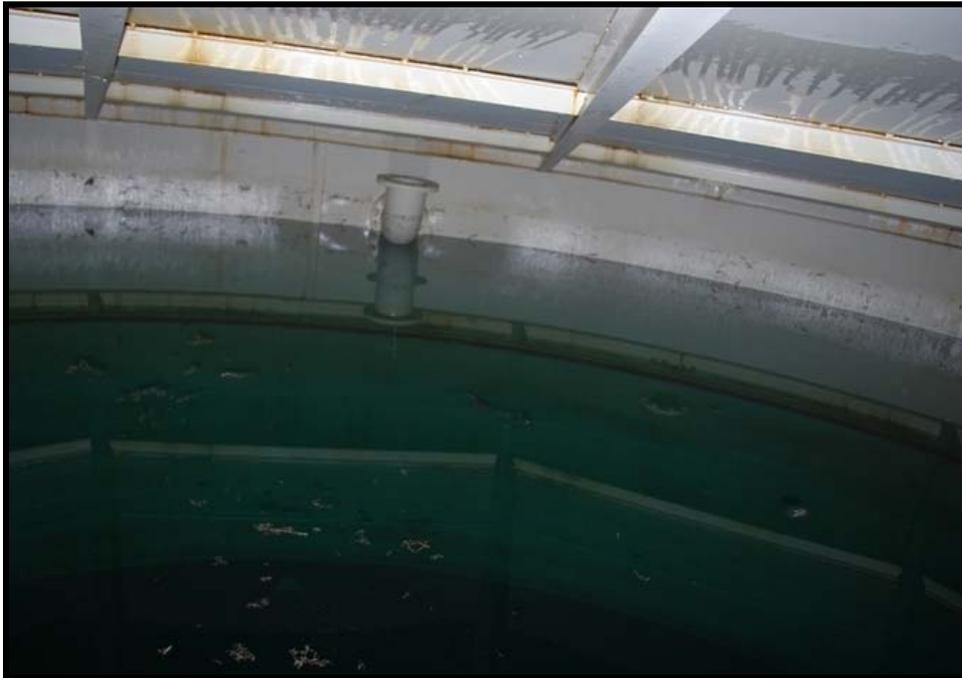
PHOTO 3.12-43 Overflow inlet funnel.

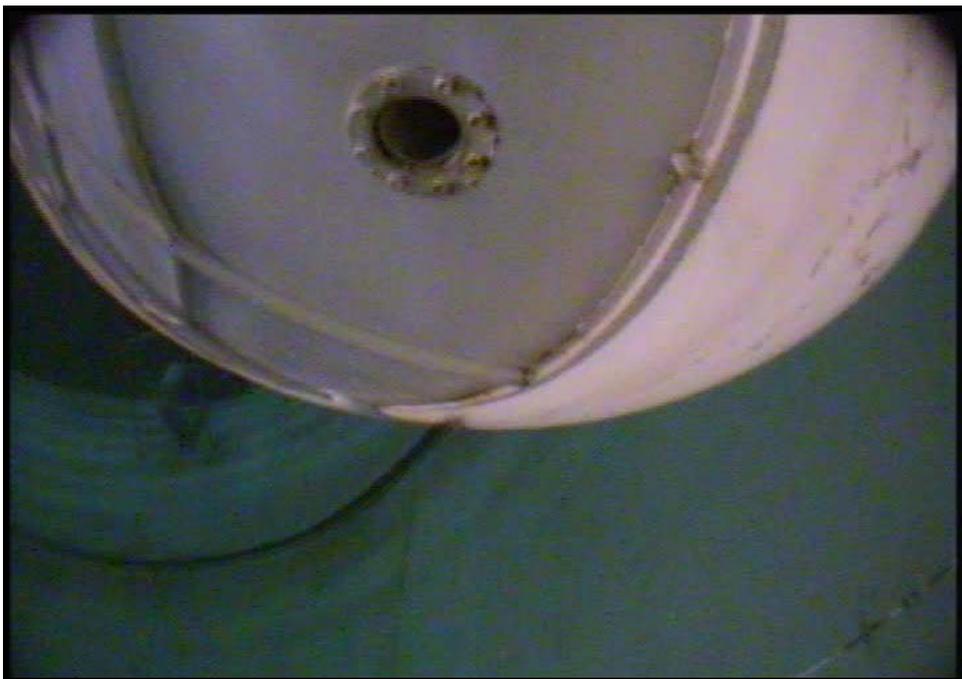
PHOTO 3.12-44 Pipe opening in roof.

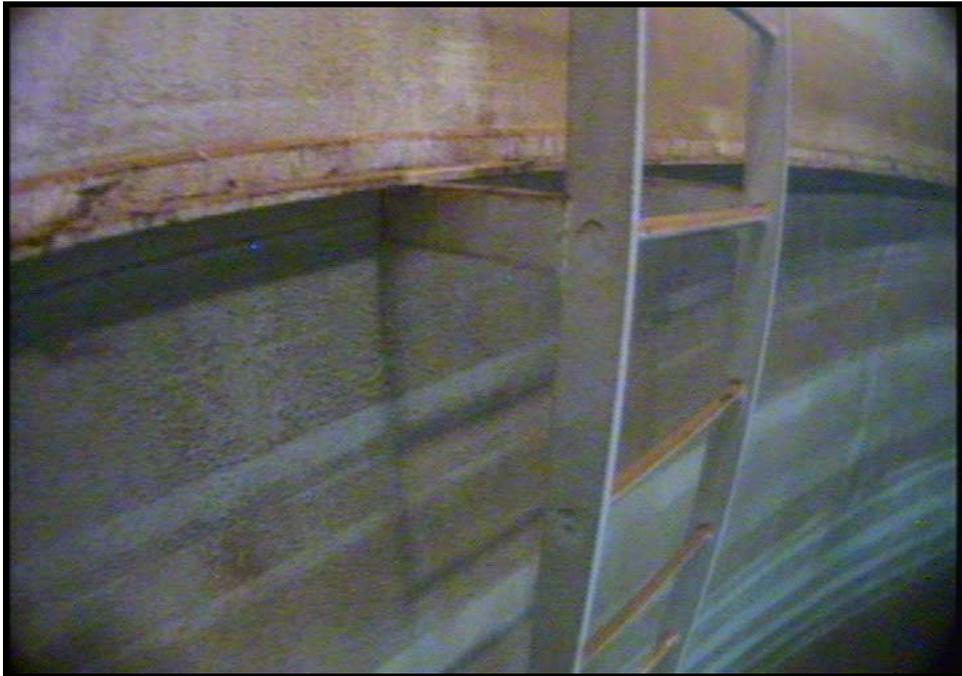
PHOTO 3.12-47 Interior ladder.

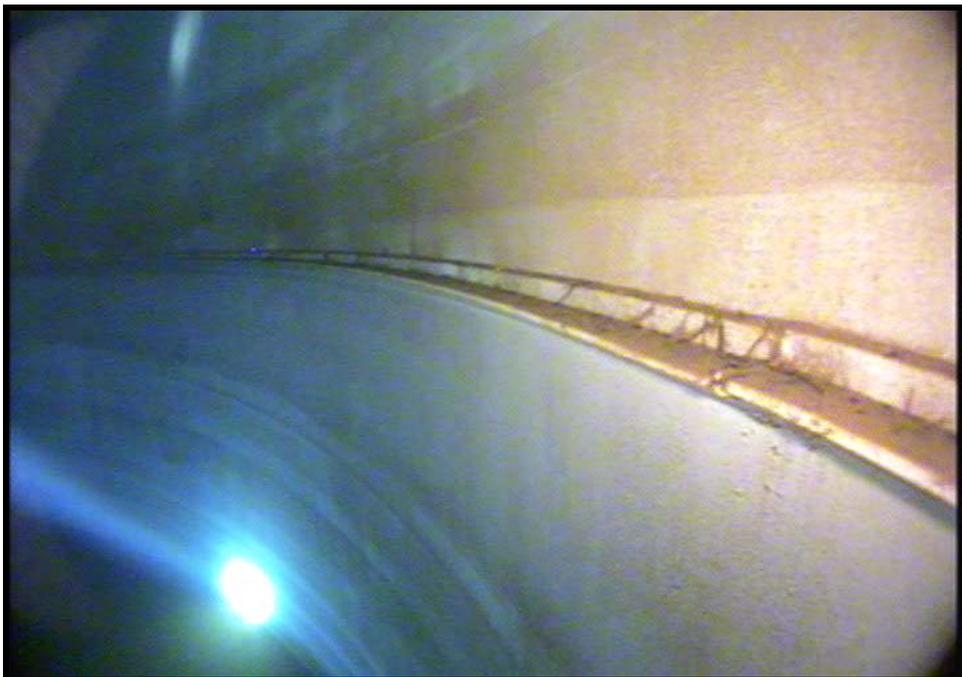
PHOTO 3.12-48 Shell stiffener.

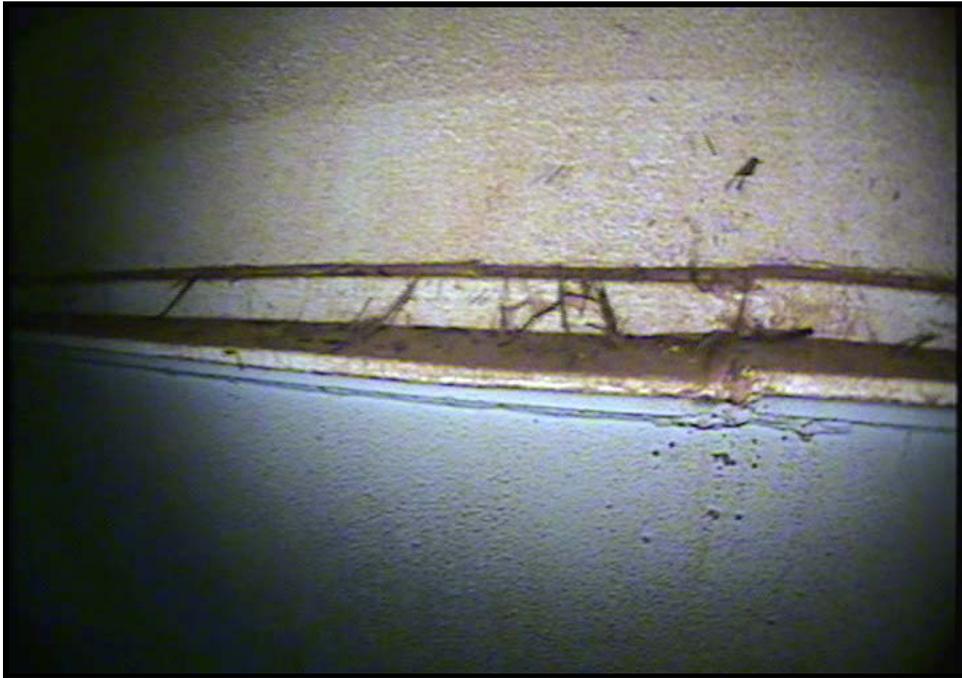
PHOTO 3.12-49 Shell stiffener.

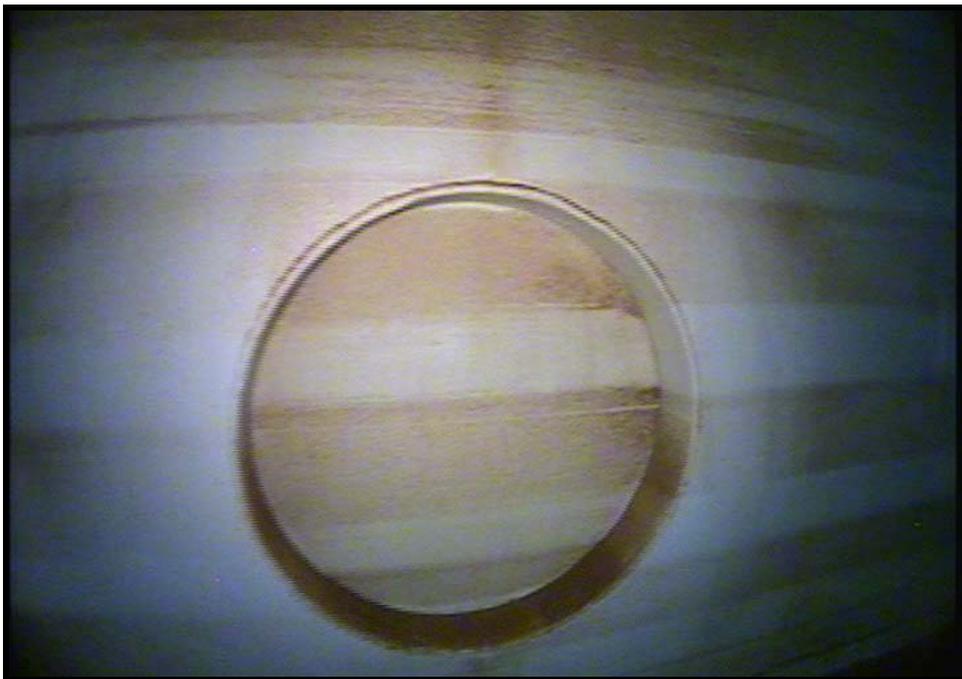
PHOTO 3.12-50 Shell manhole interior.

Existing Shell Manhole: At the time of recoating and repairs, the gasket for the shell manhole should be replaced.

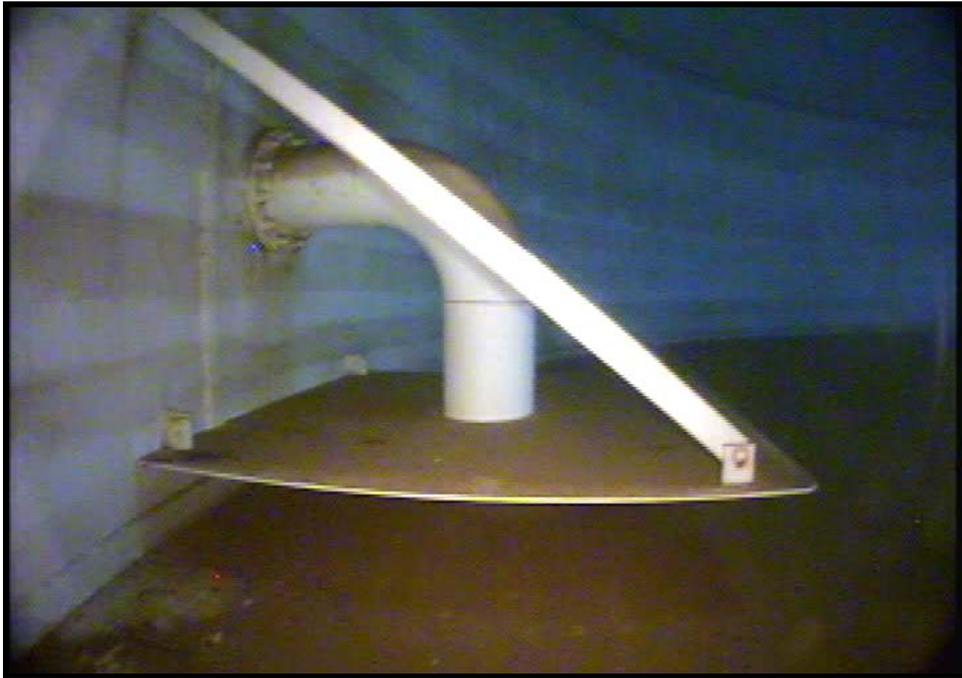
PHOTO 3.12-51 Interior piping.

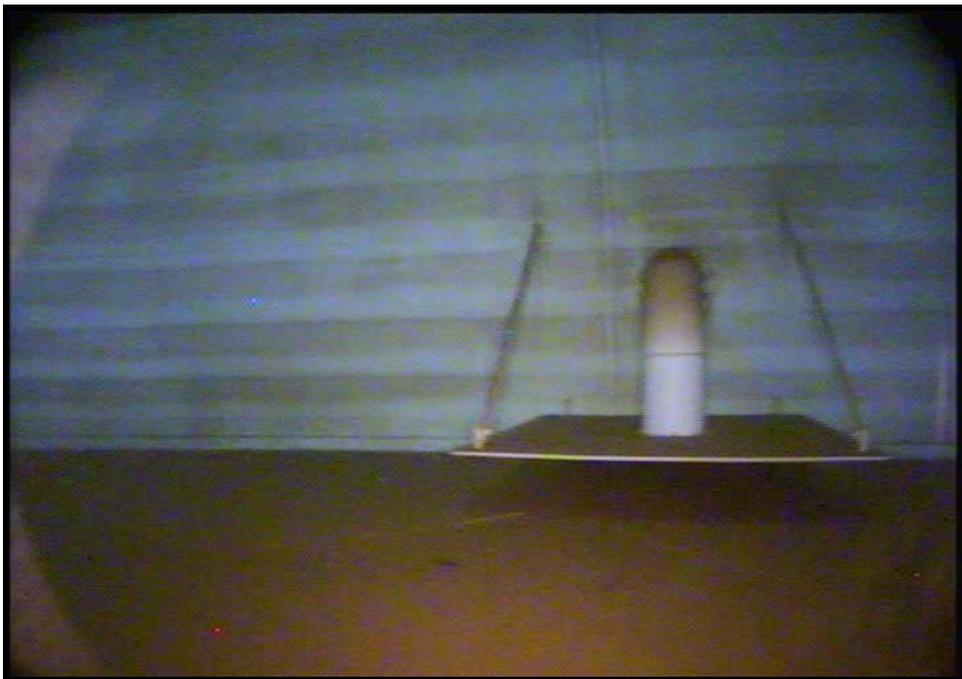
PHOTO 3.12-52 Interior piping.

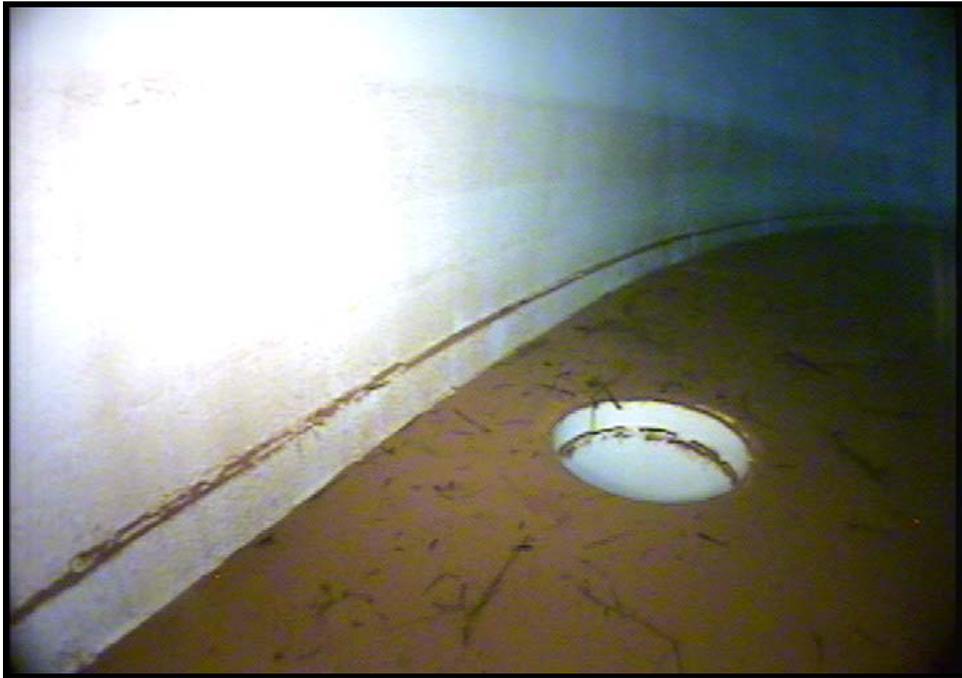
PHOTO 3.12-53 Pipe opening and silt on floor.
