3.10 TANK 425

Tank 425 stores nonpotable water for the Naval Air Station in Sigonella, Italy.

3.10.1 Description of the Facility

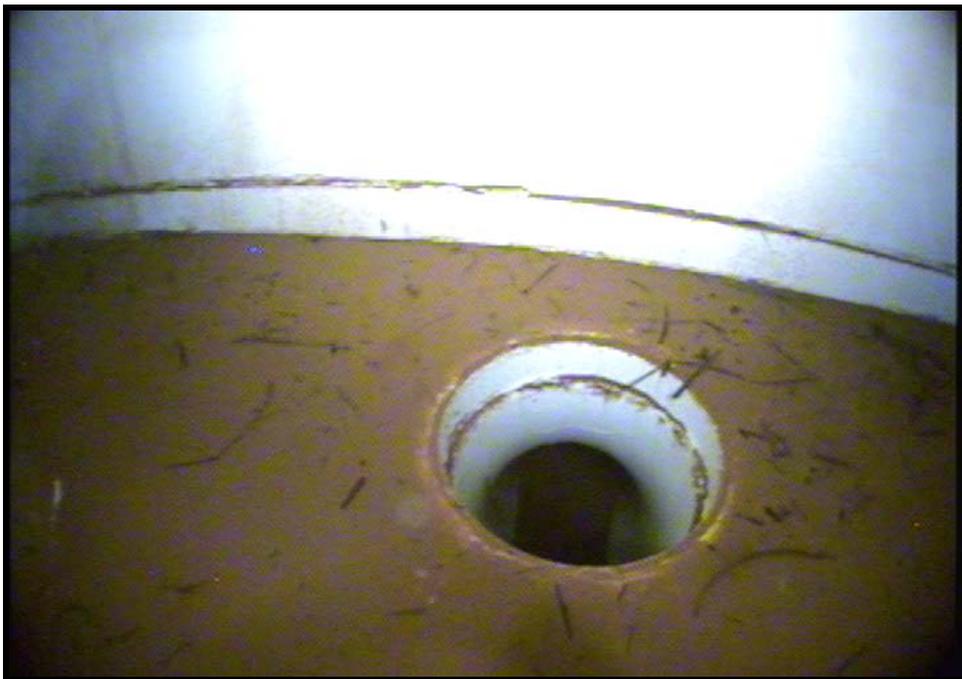
PHOTO 3.12-54 Pipe opening and silt on floor.

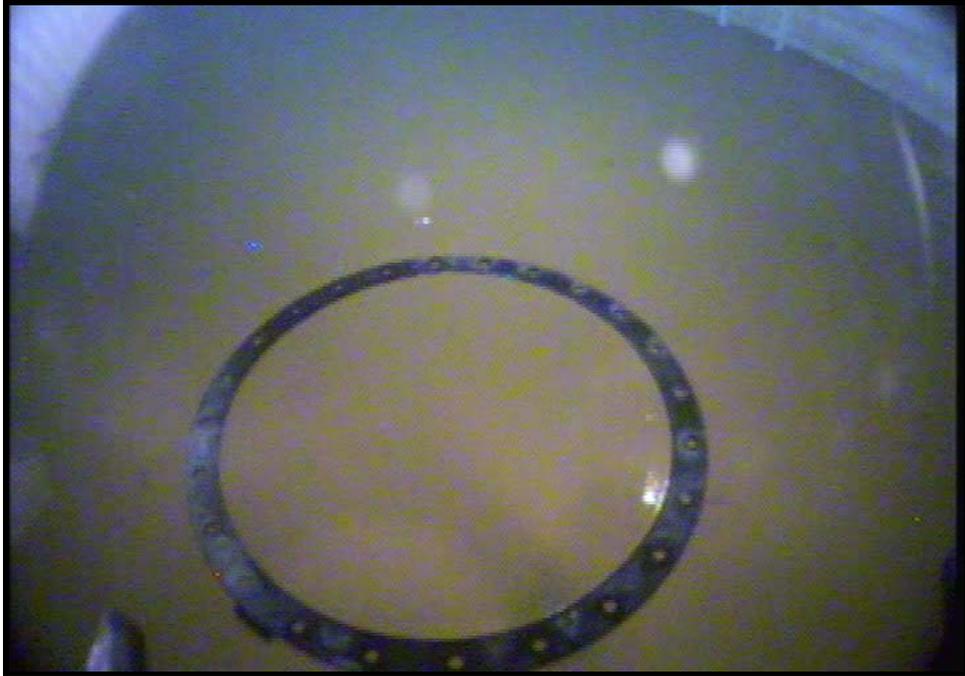
PHOTO 3.12-55 Unused gasket and silt on floor.
